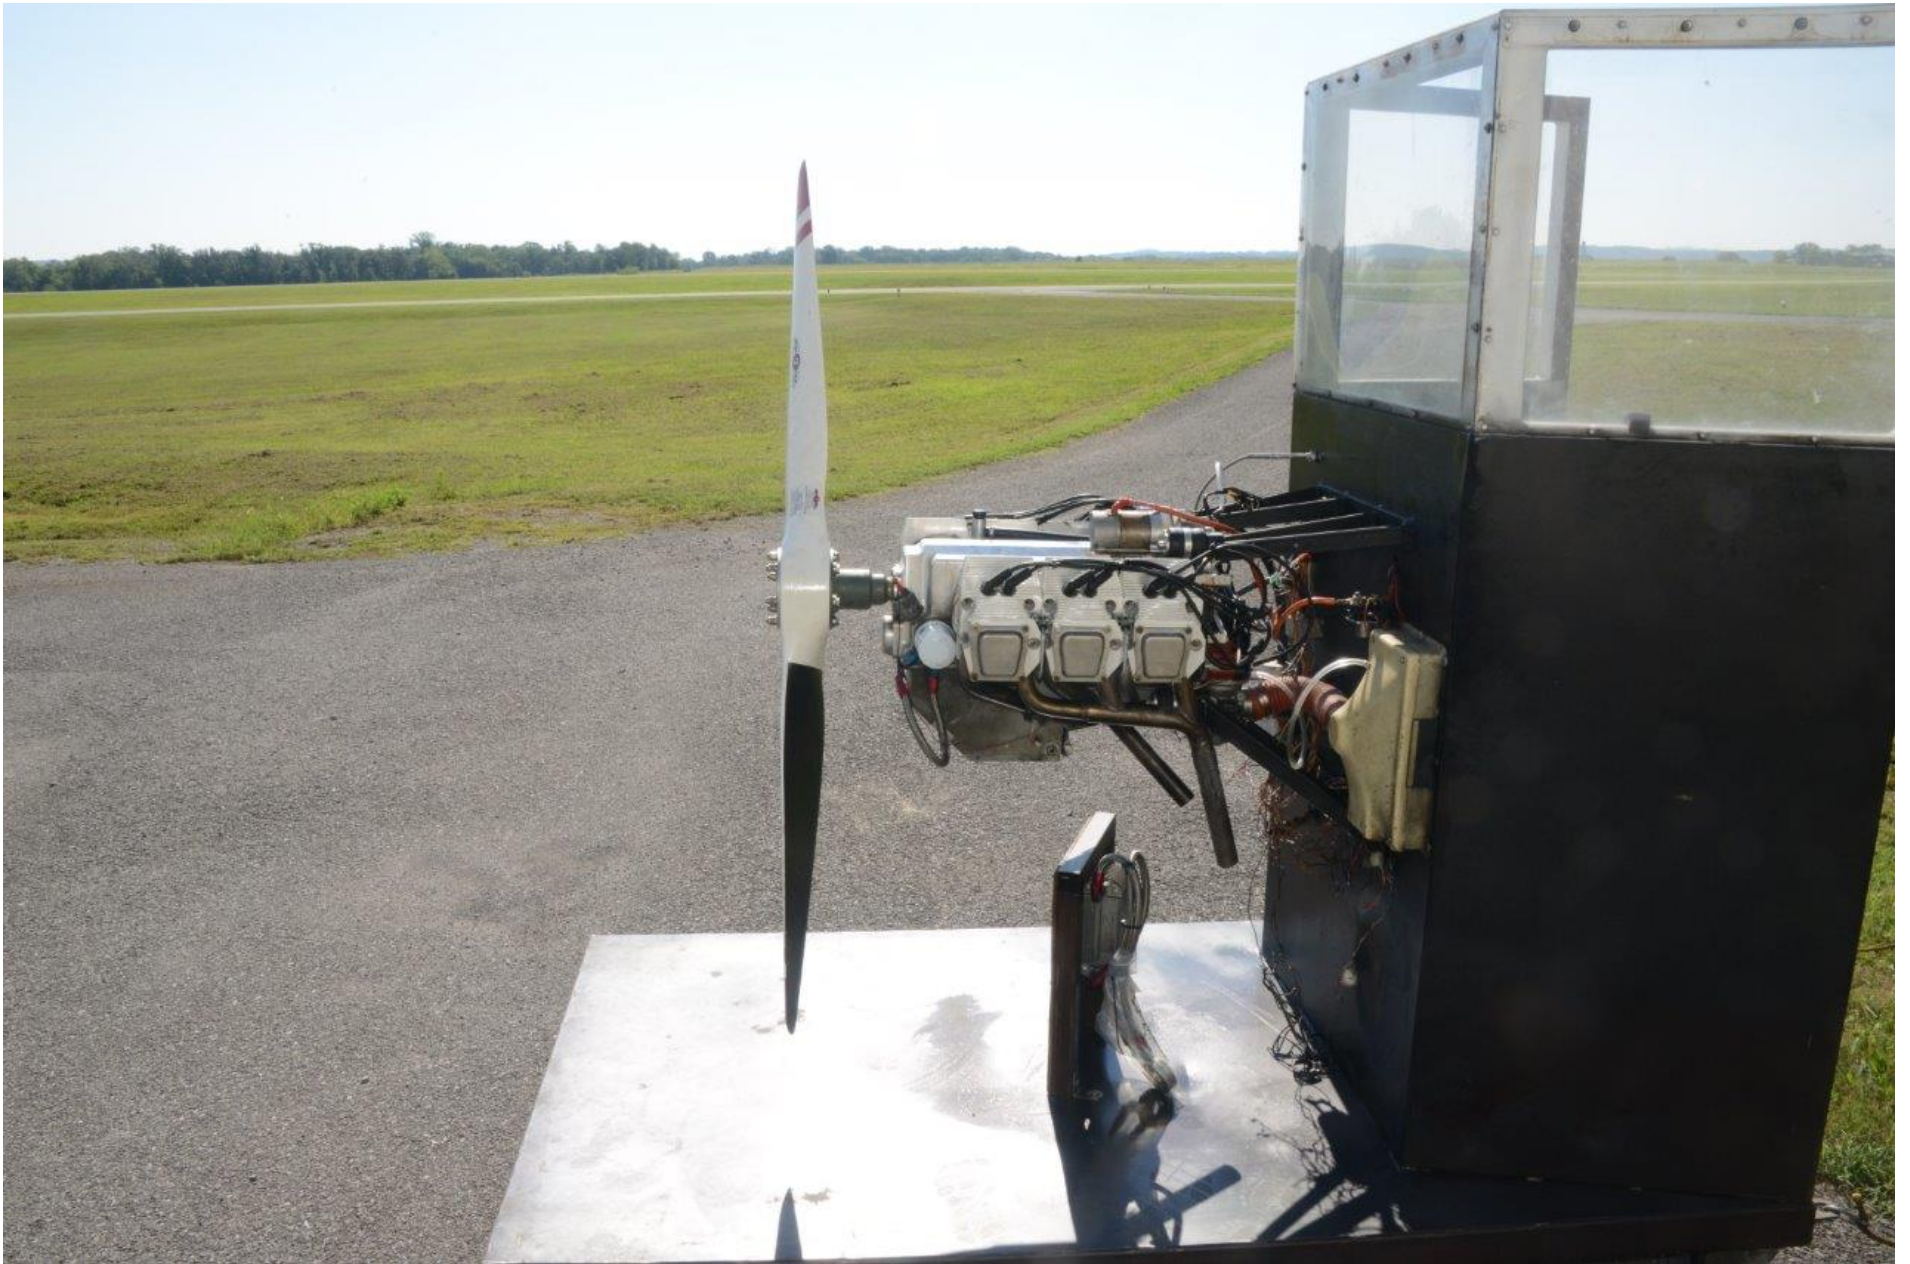
Photo 10 - View of the accident engine mounted on a test stand.

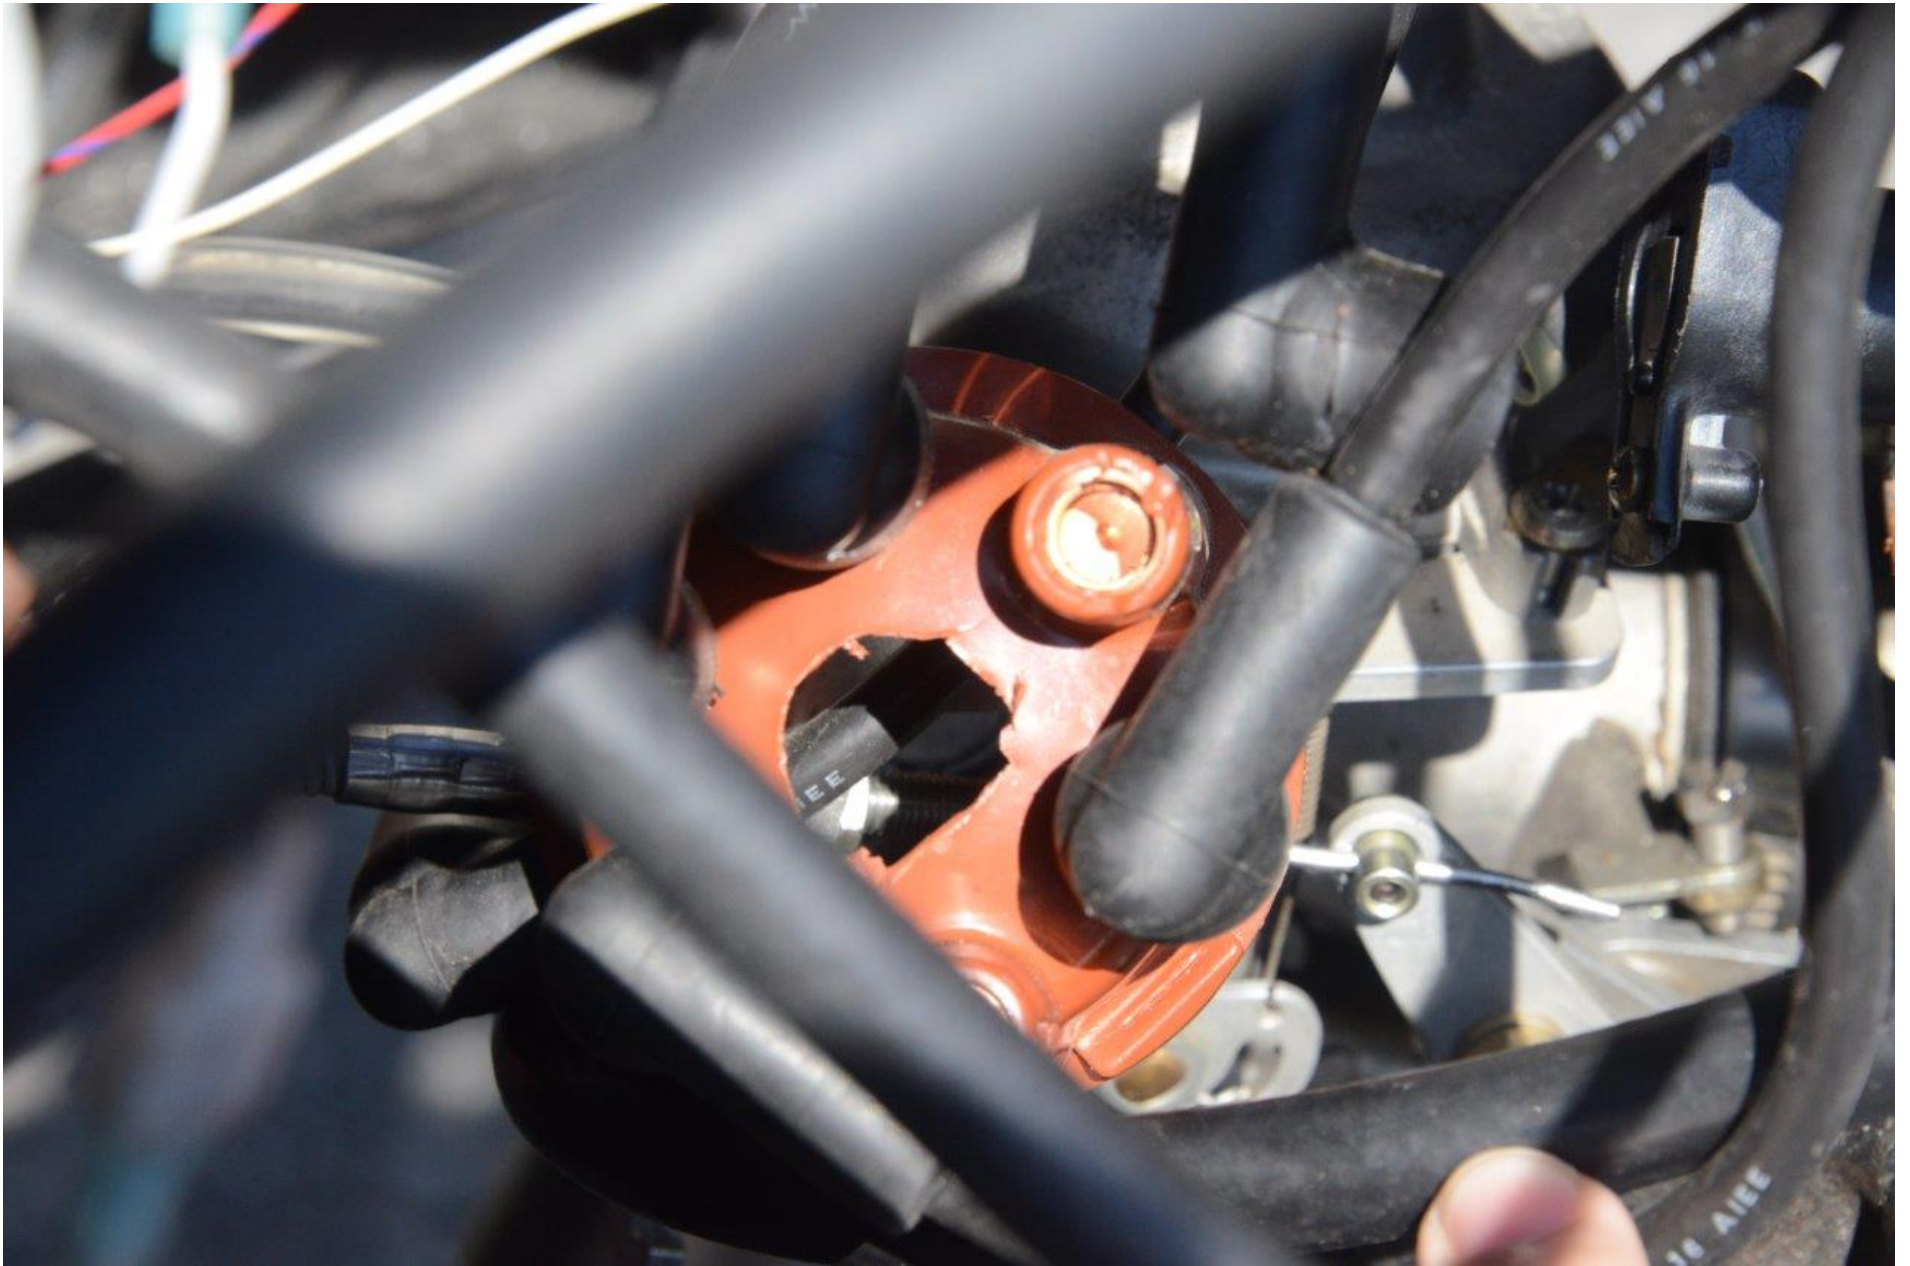
Photo 11 - View of the distributor cap with the separated center tower.
