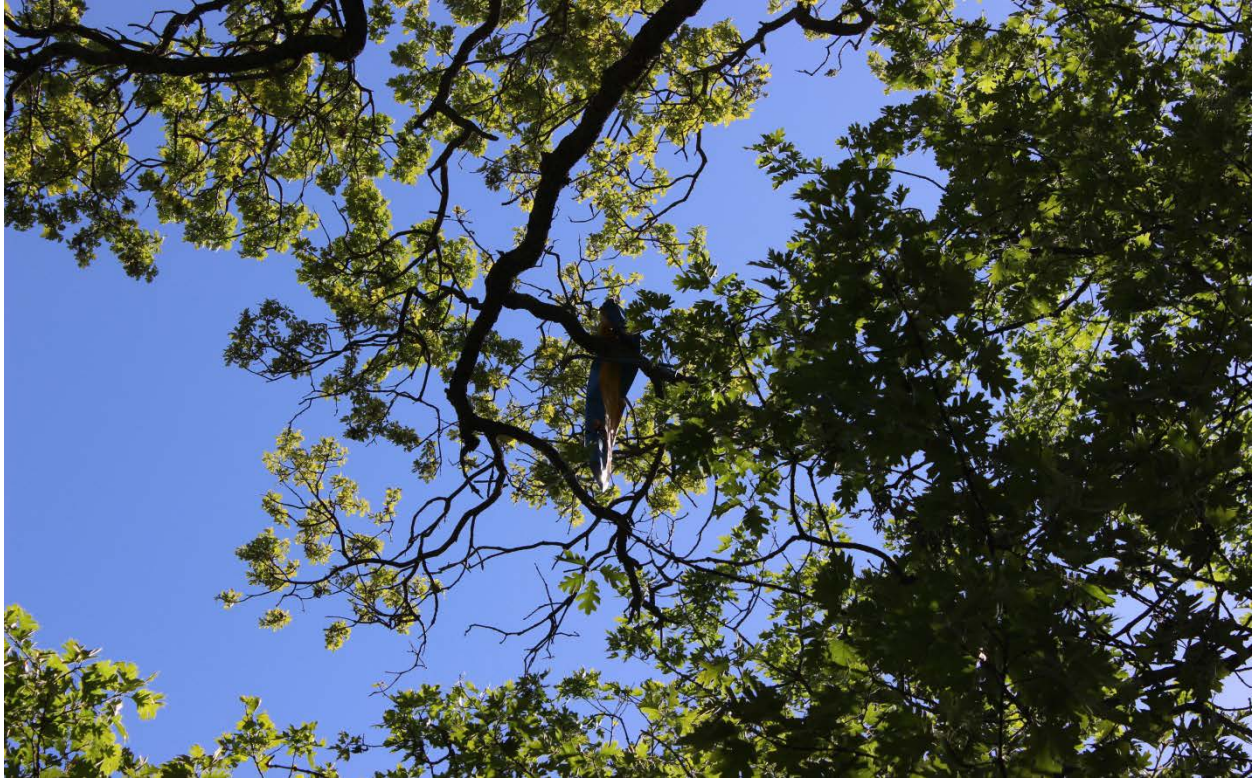
Figure 1: Airplane fragment in tree

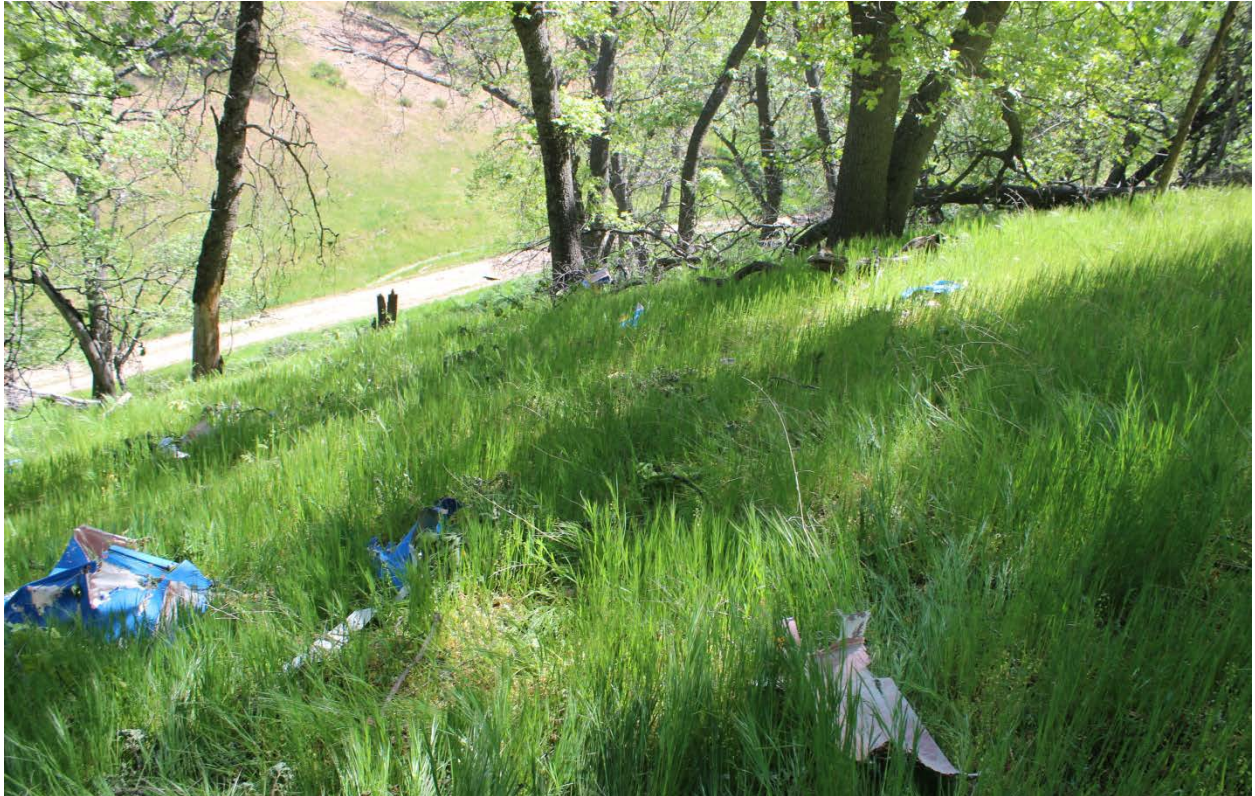
Figure 2: View from initial impact point looking downhill

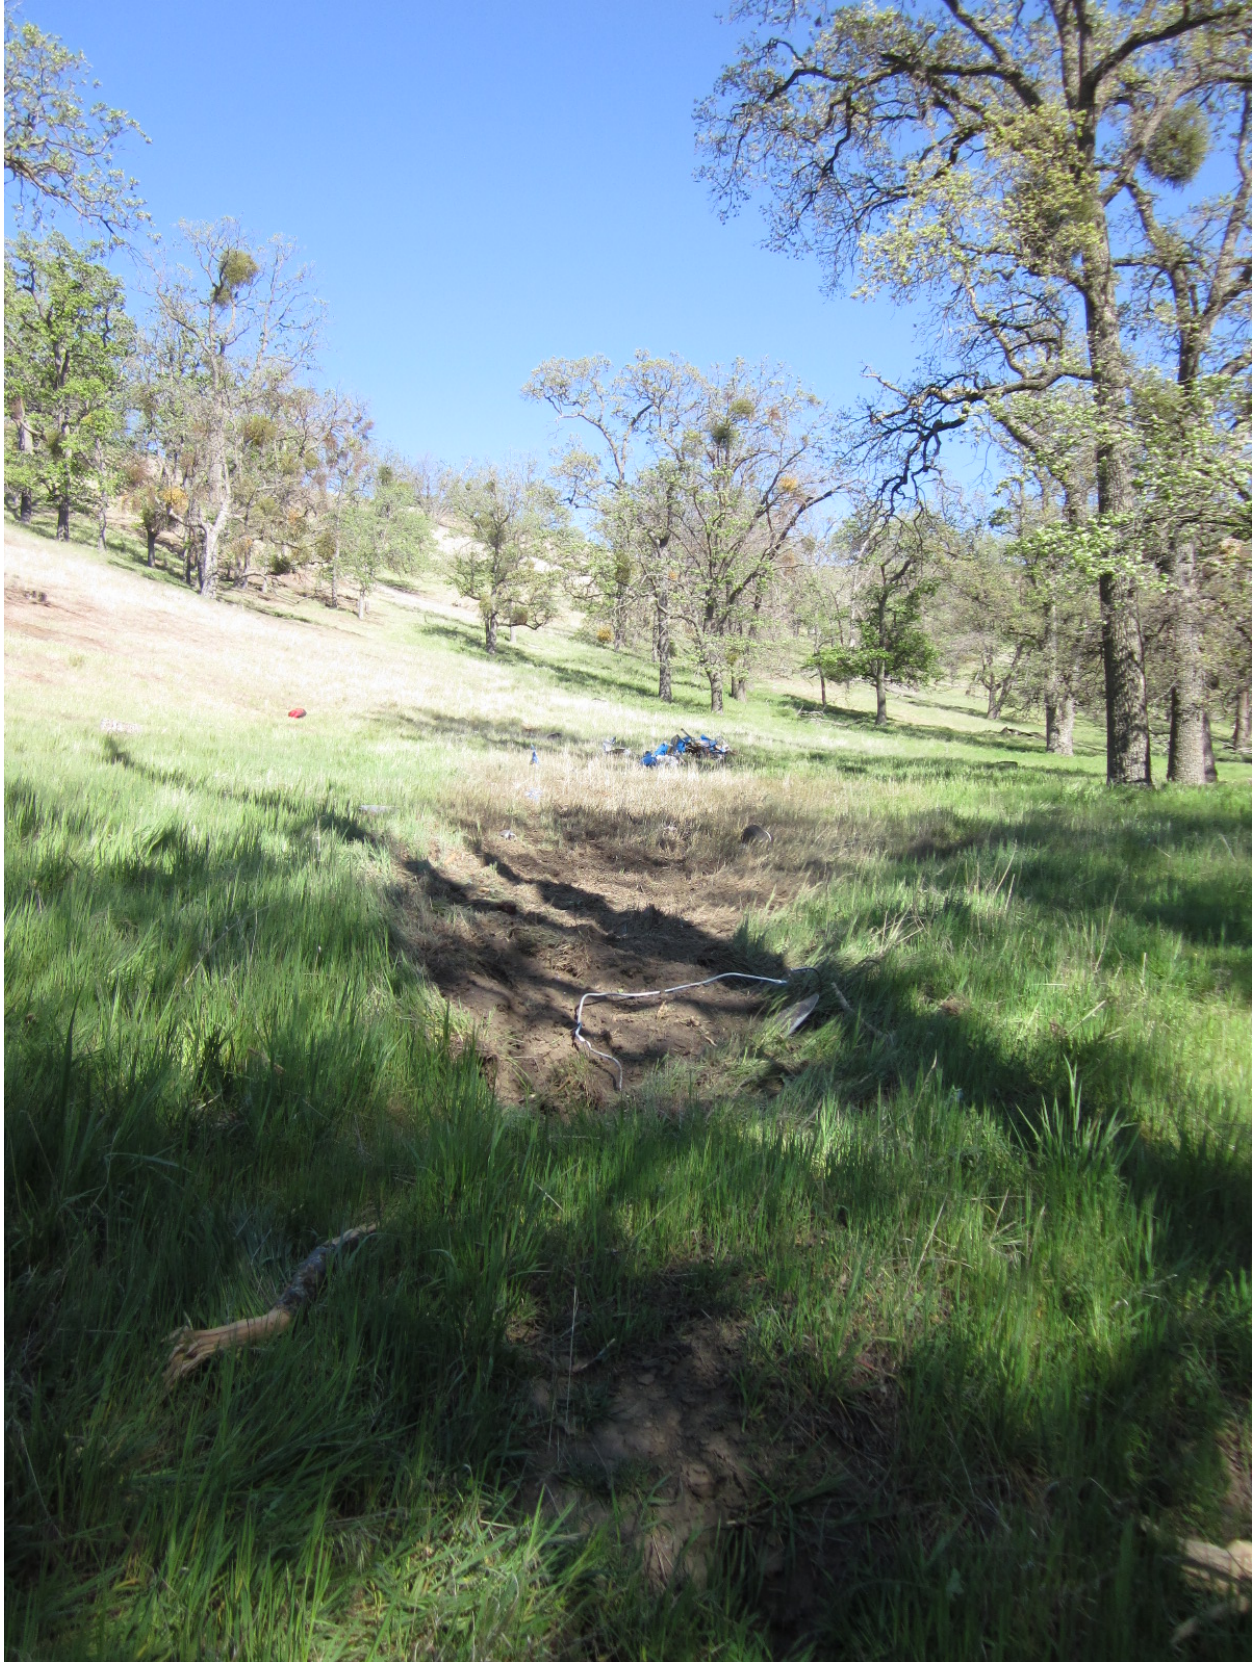
Figure 3: Initial ground impact point and main wreckage

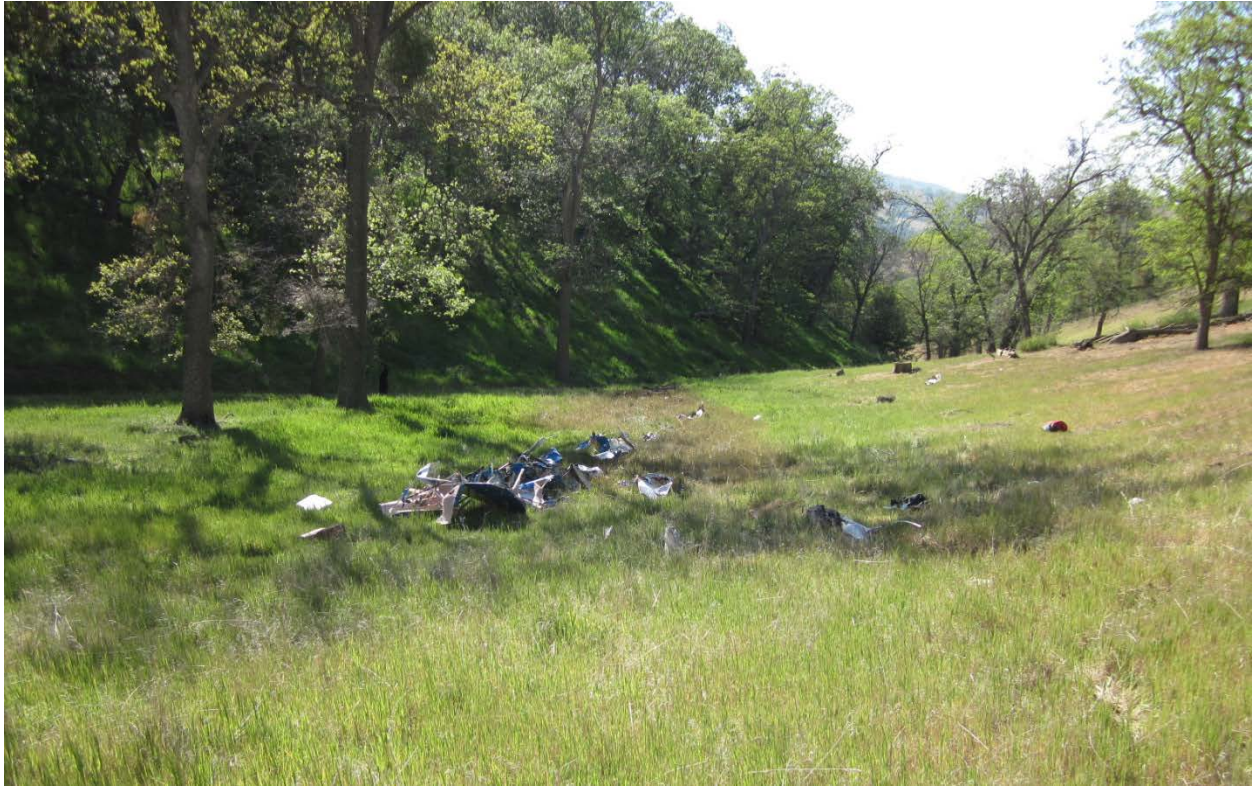
Figure 4: View of main wreckage looking back over the debris field

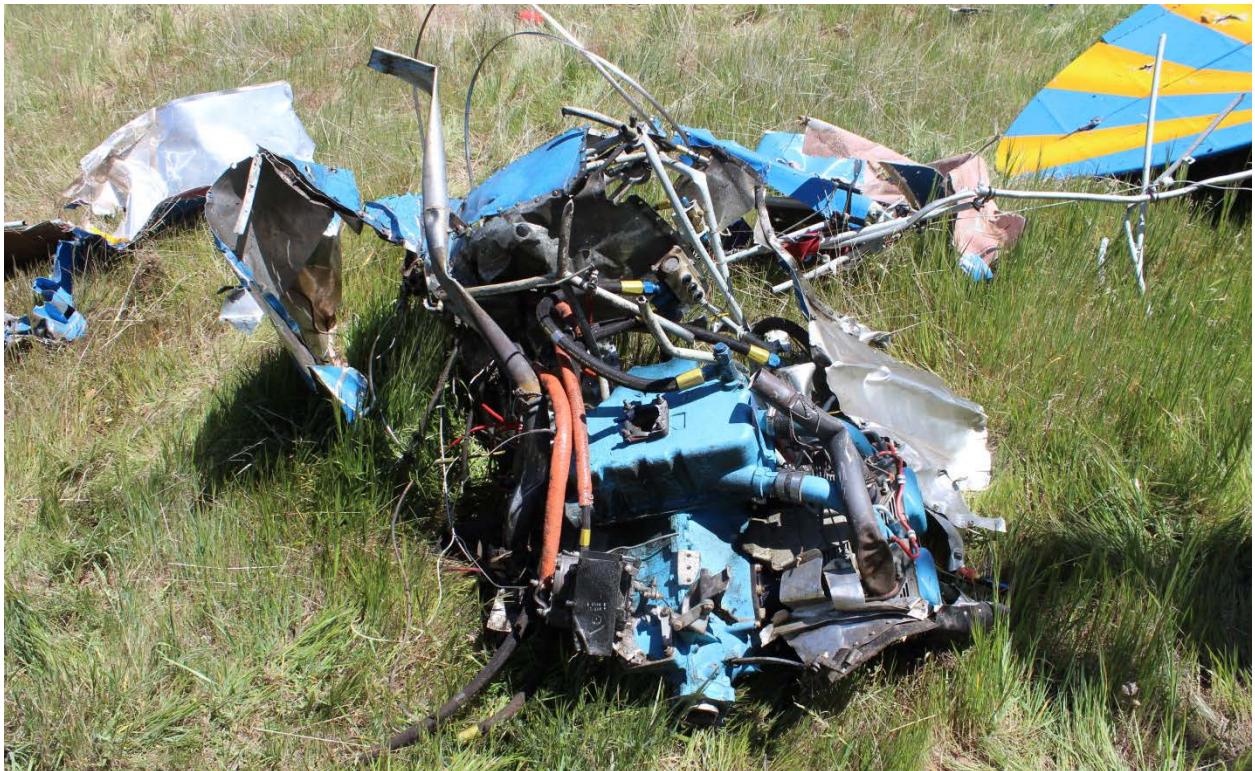
Figure 5: Engine and airframe fragments

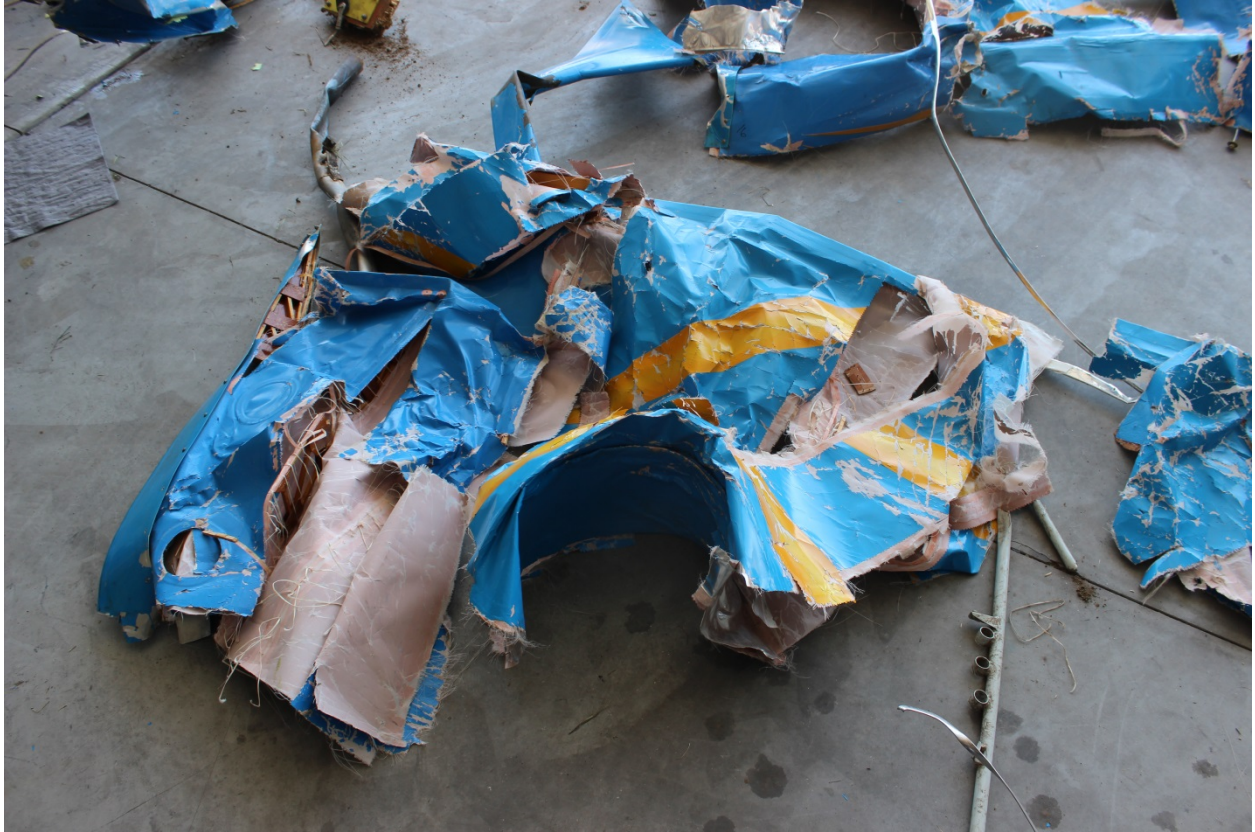
Figure 6: Impact damage to the left lower wing
