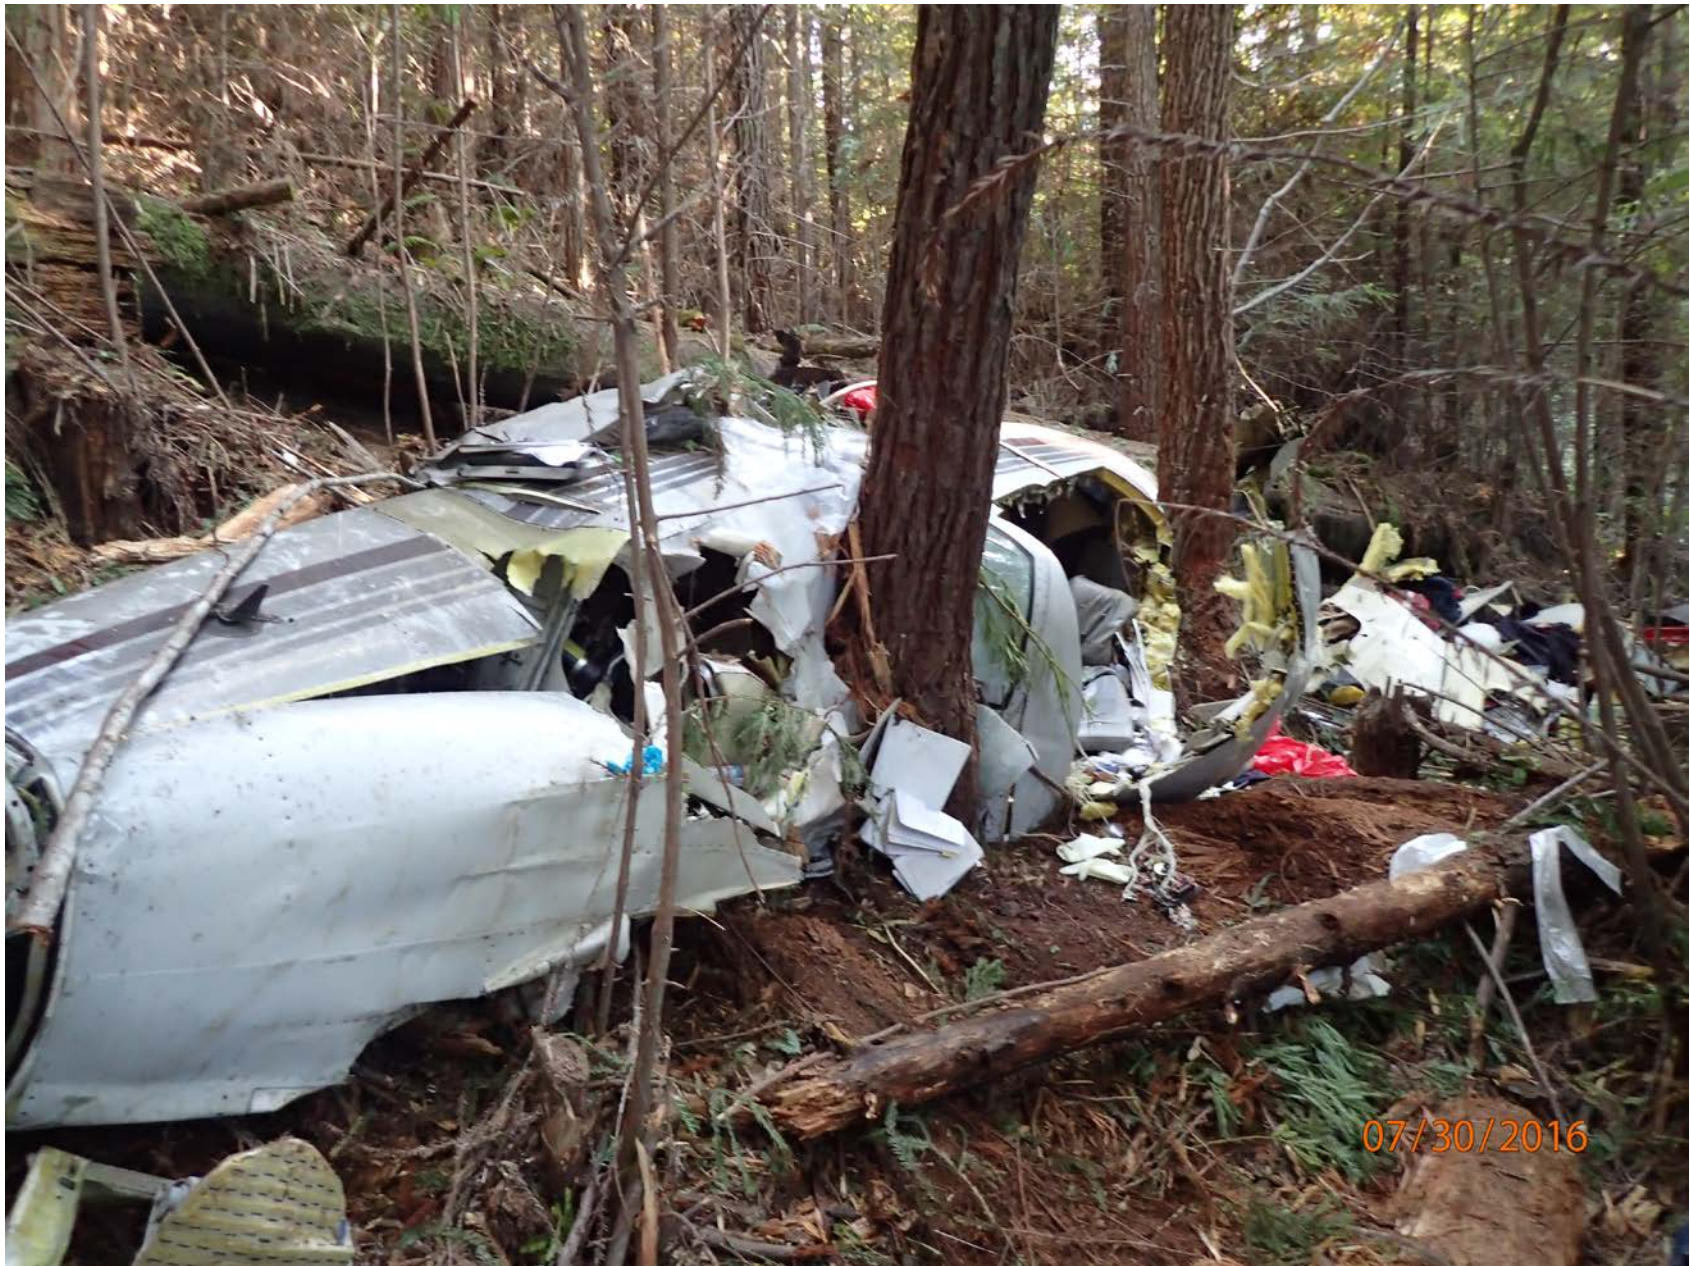
Photo 1 – Fuselage at accident site.

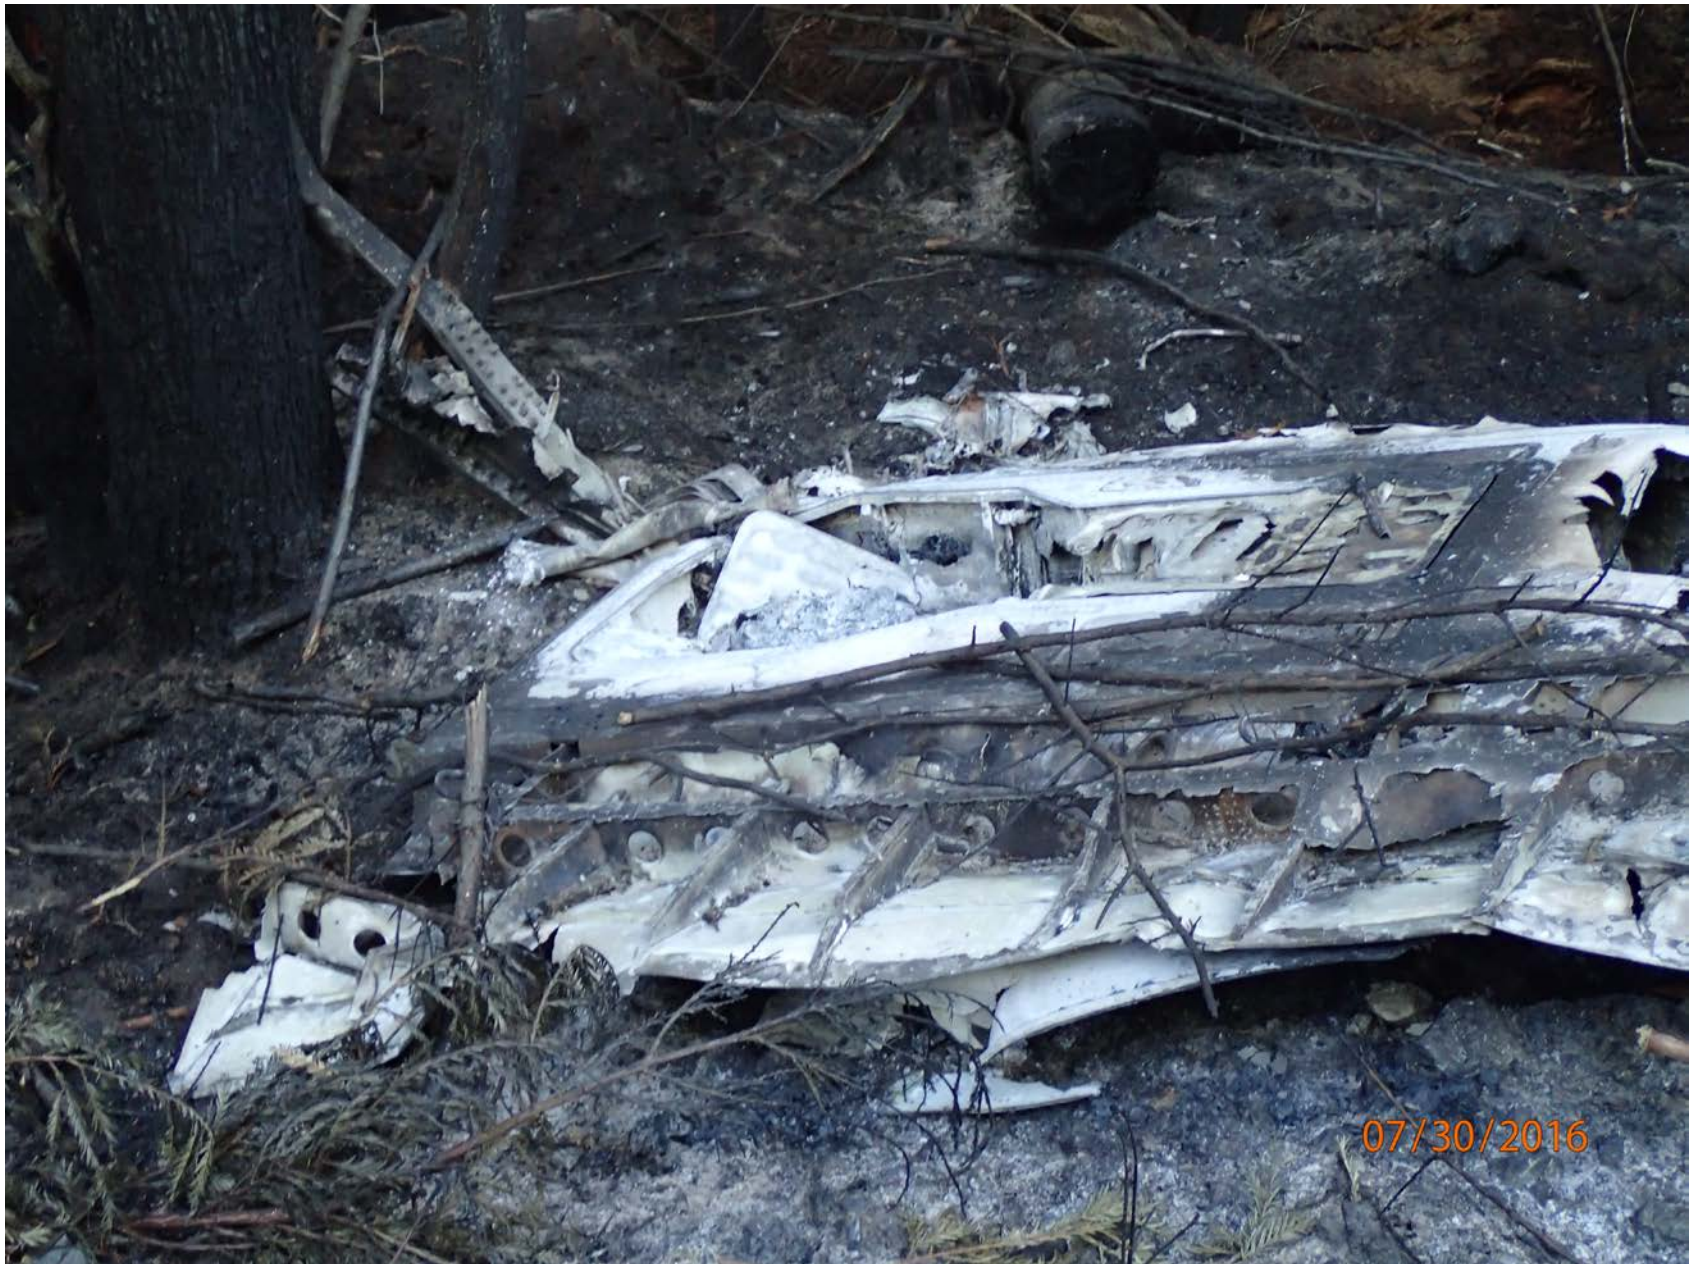
Photo 2 – Left inboard wing section at accident site.

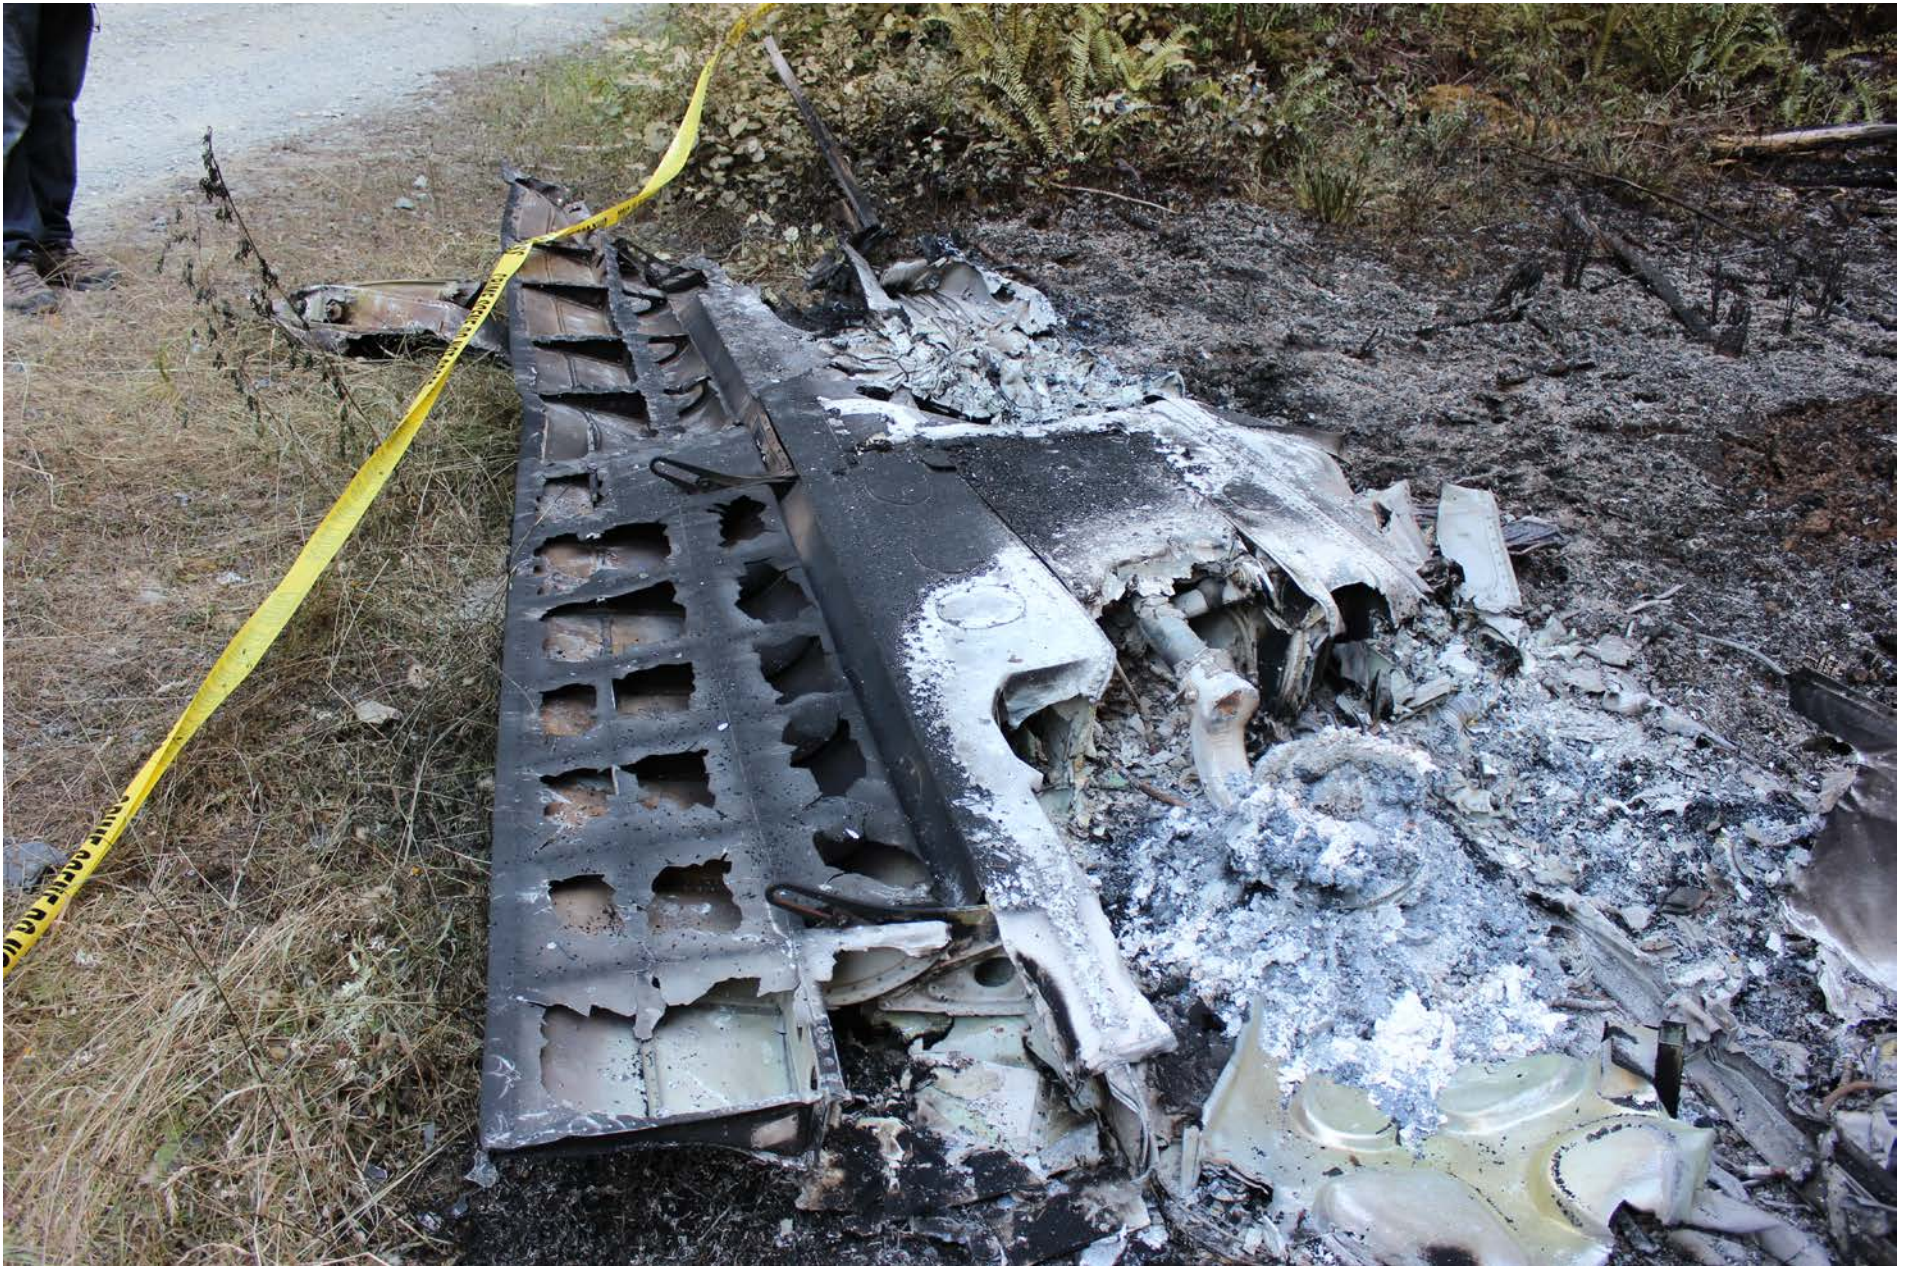
Photo 3 – Right inboard wing section at accident site.

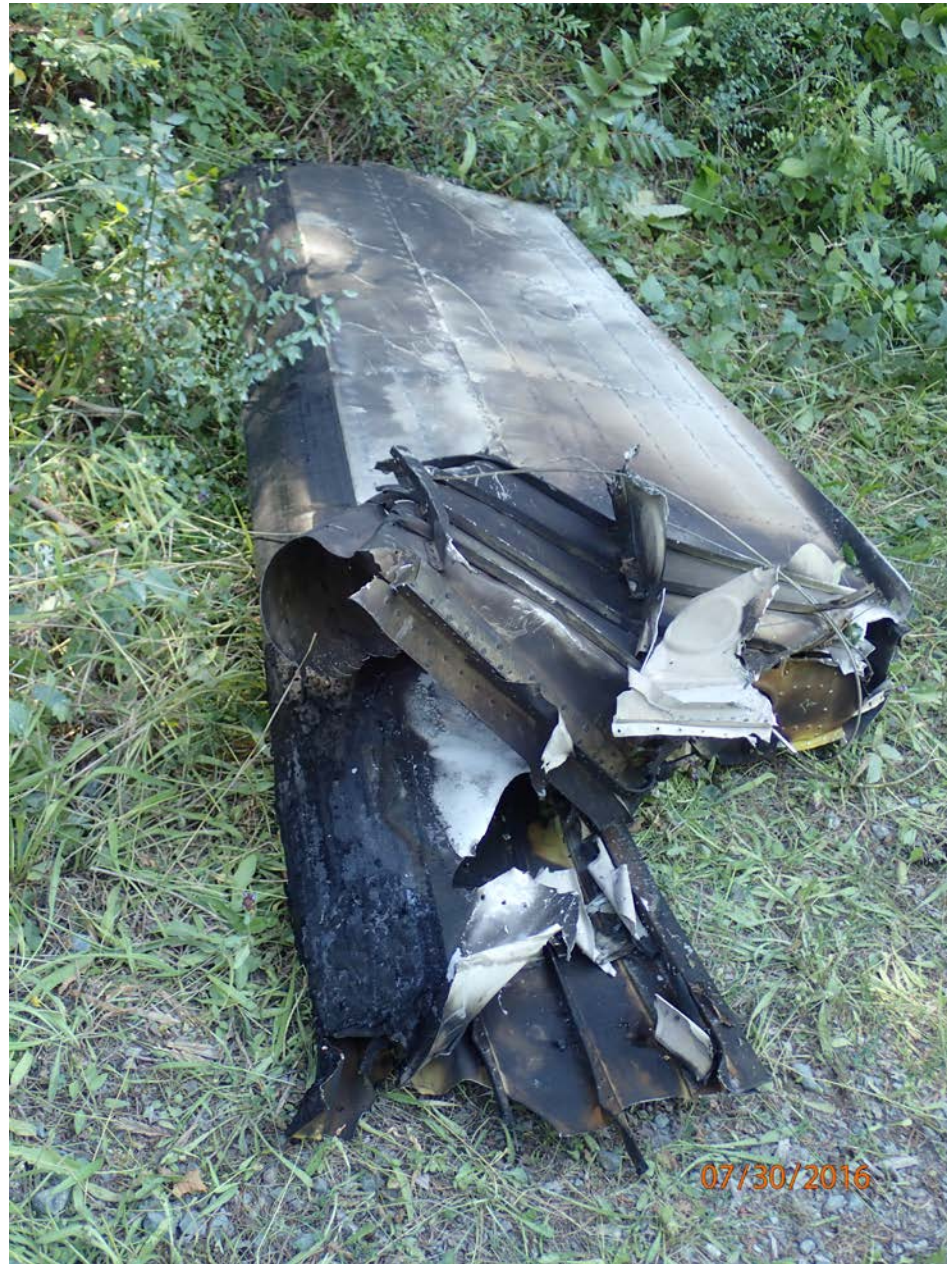
Photo 4 – Left outboard wing section at accident site.

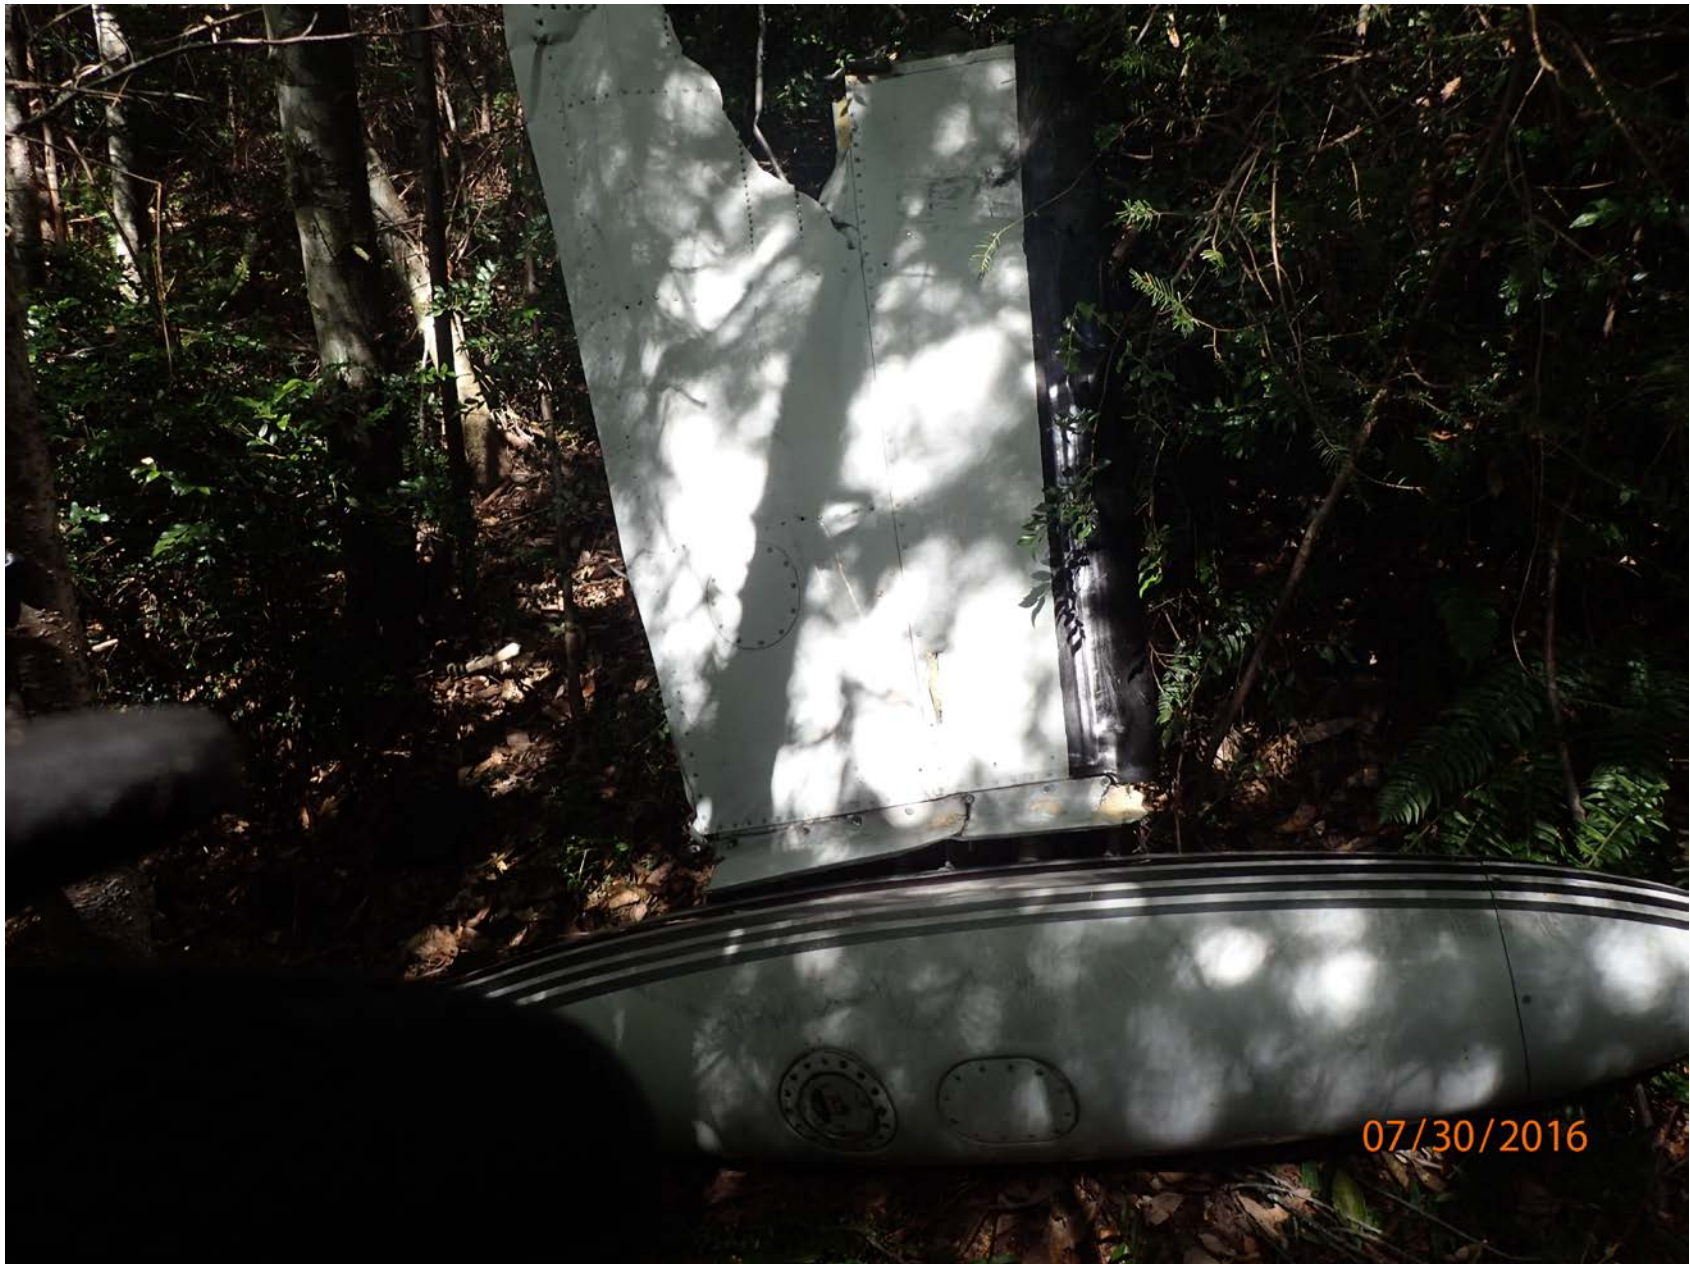
Photo 5 – Right outboard wing section at accident site.

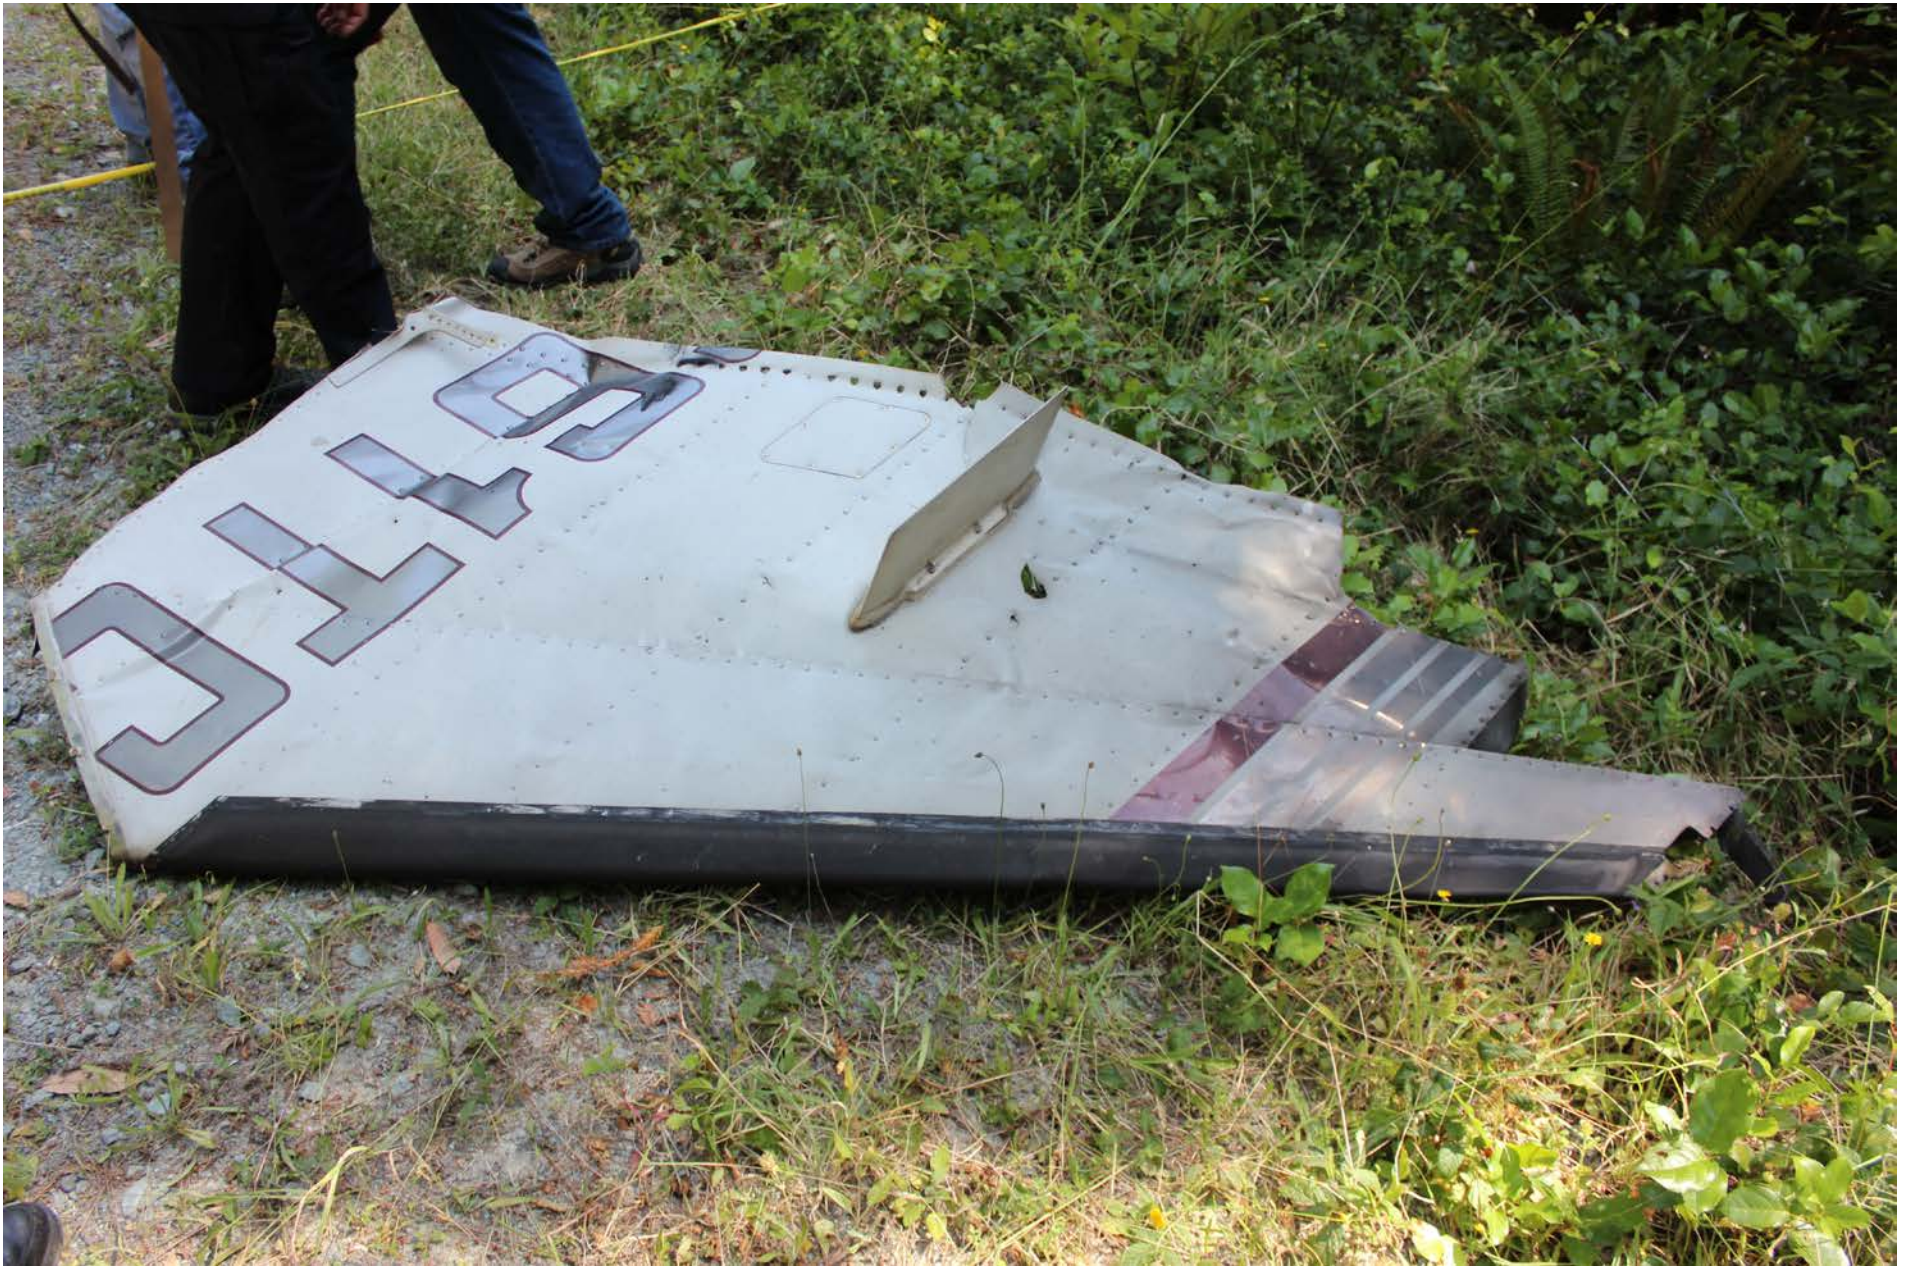
Photo 6 – Vertical stabilizer at accident site.

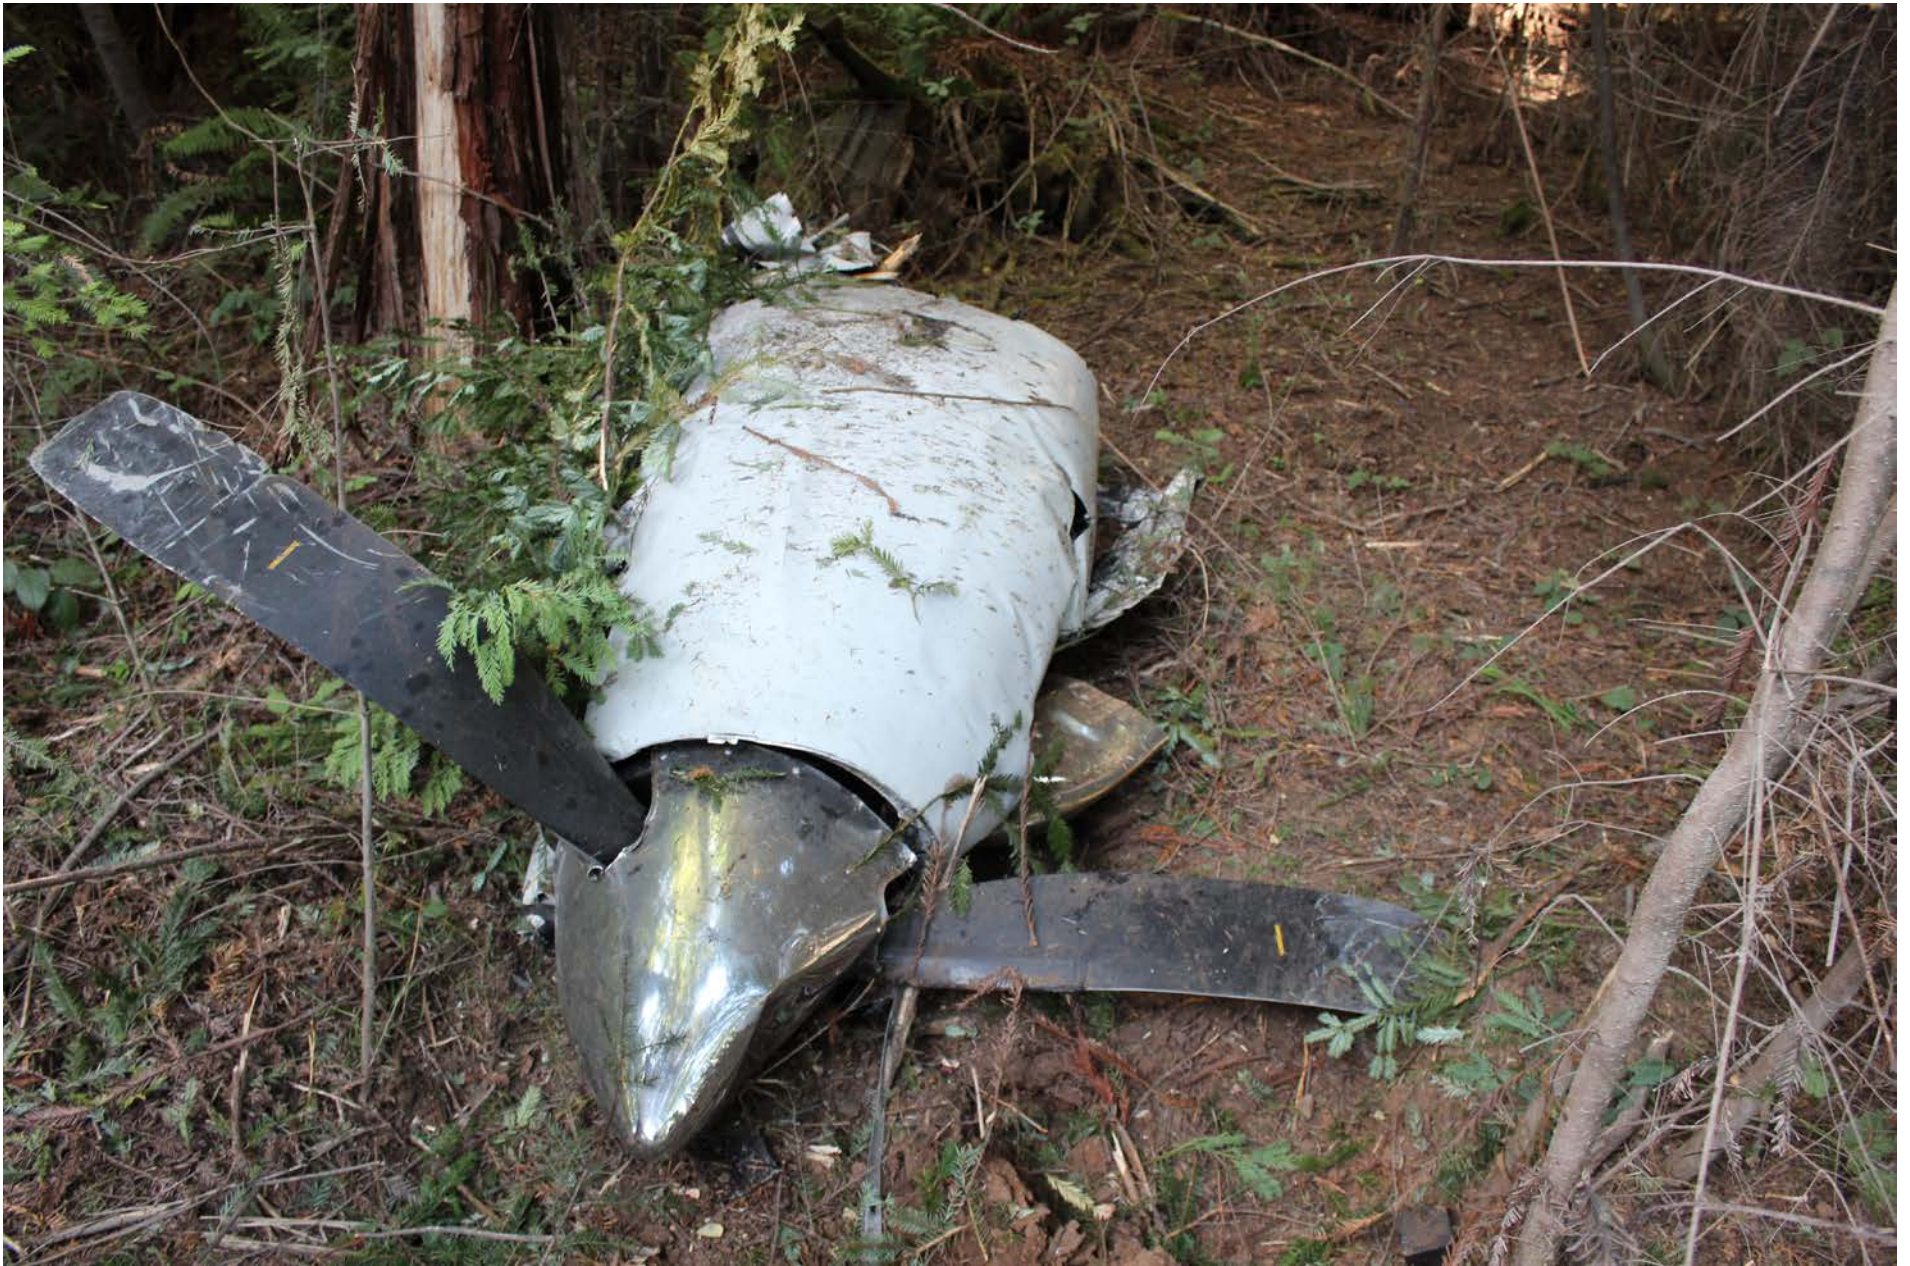
Photo 7 – Right engine and propeller at accident site.

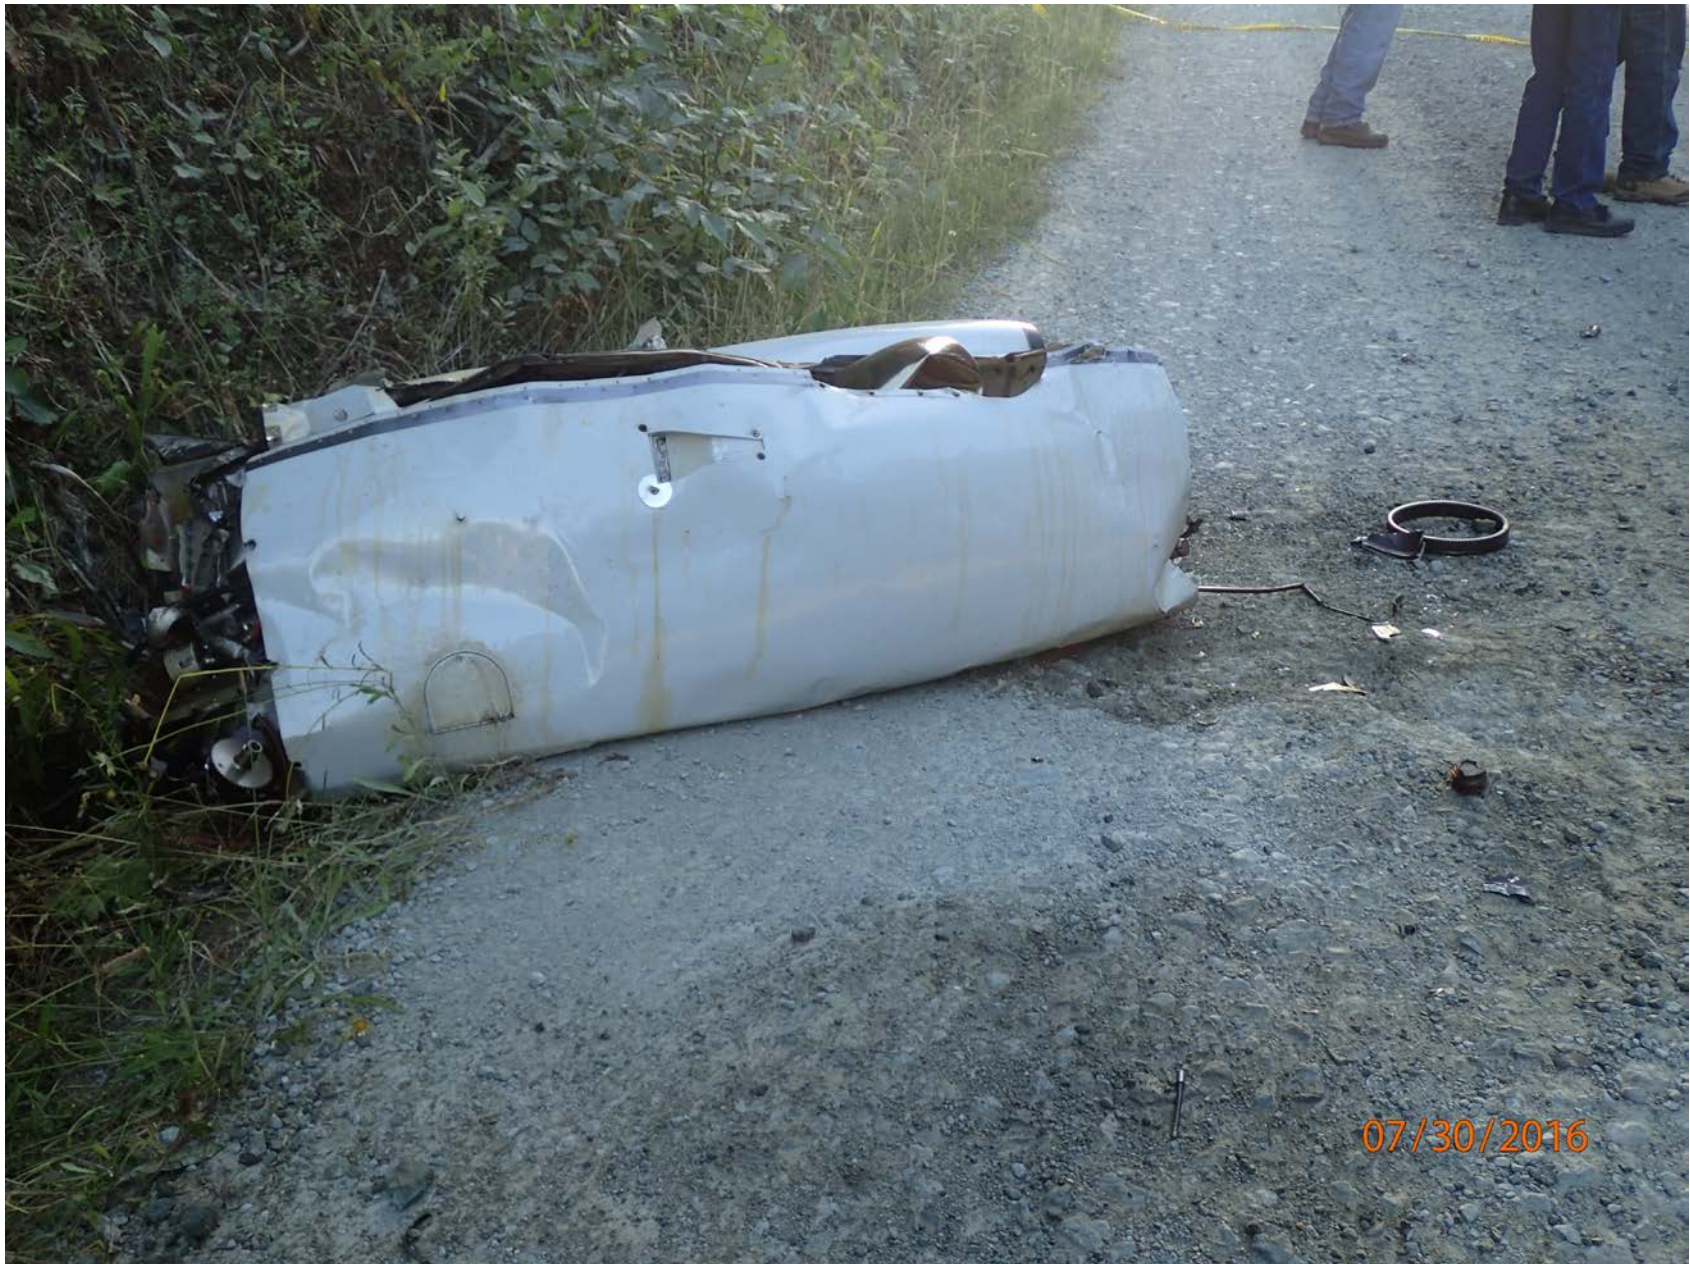
Photo 8 – Left engine at accident site.
