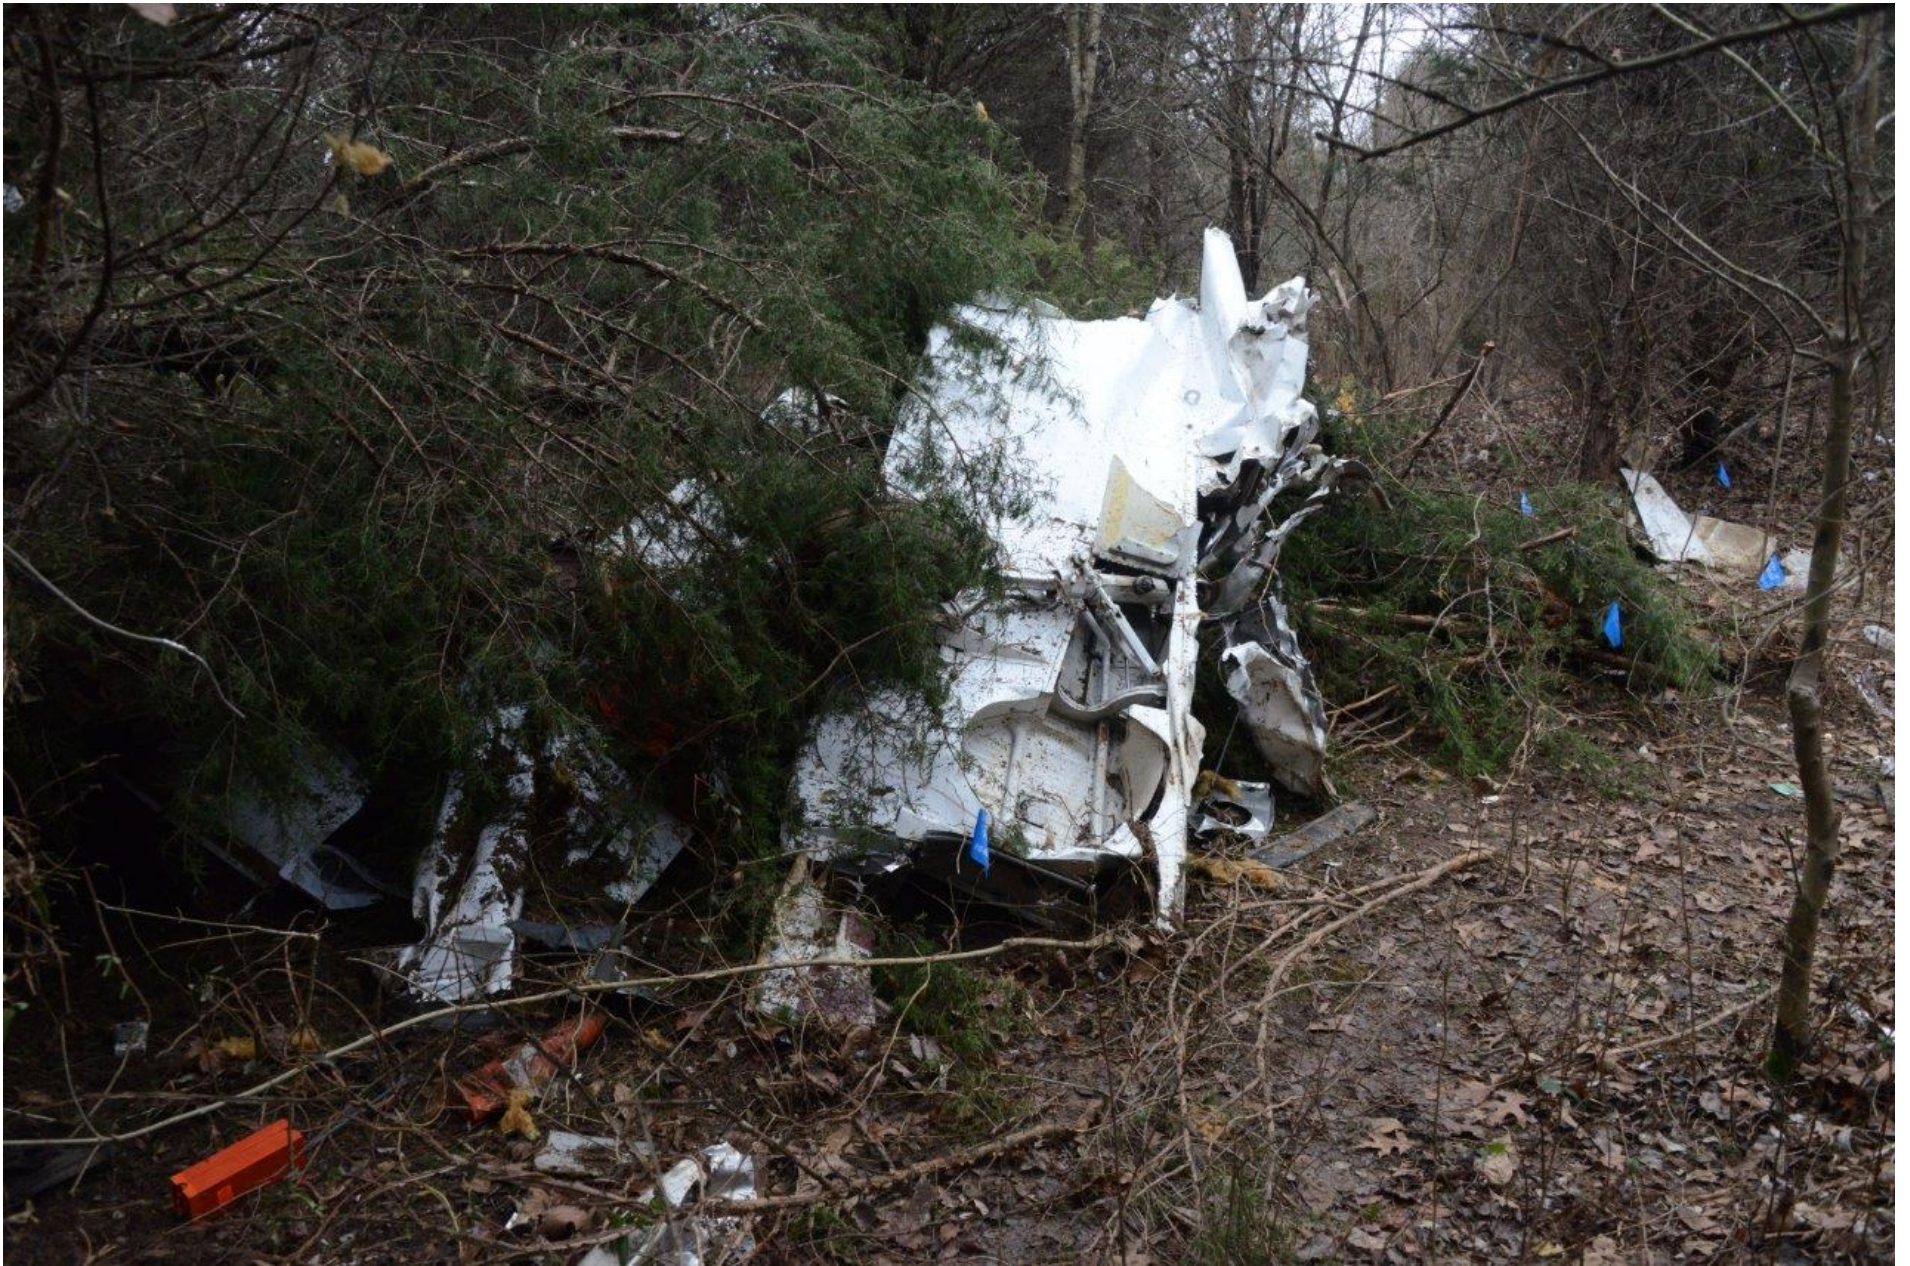
Photo 1 – View of the main wreckage site.

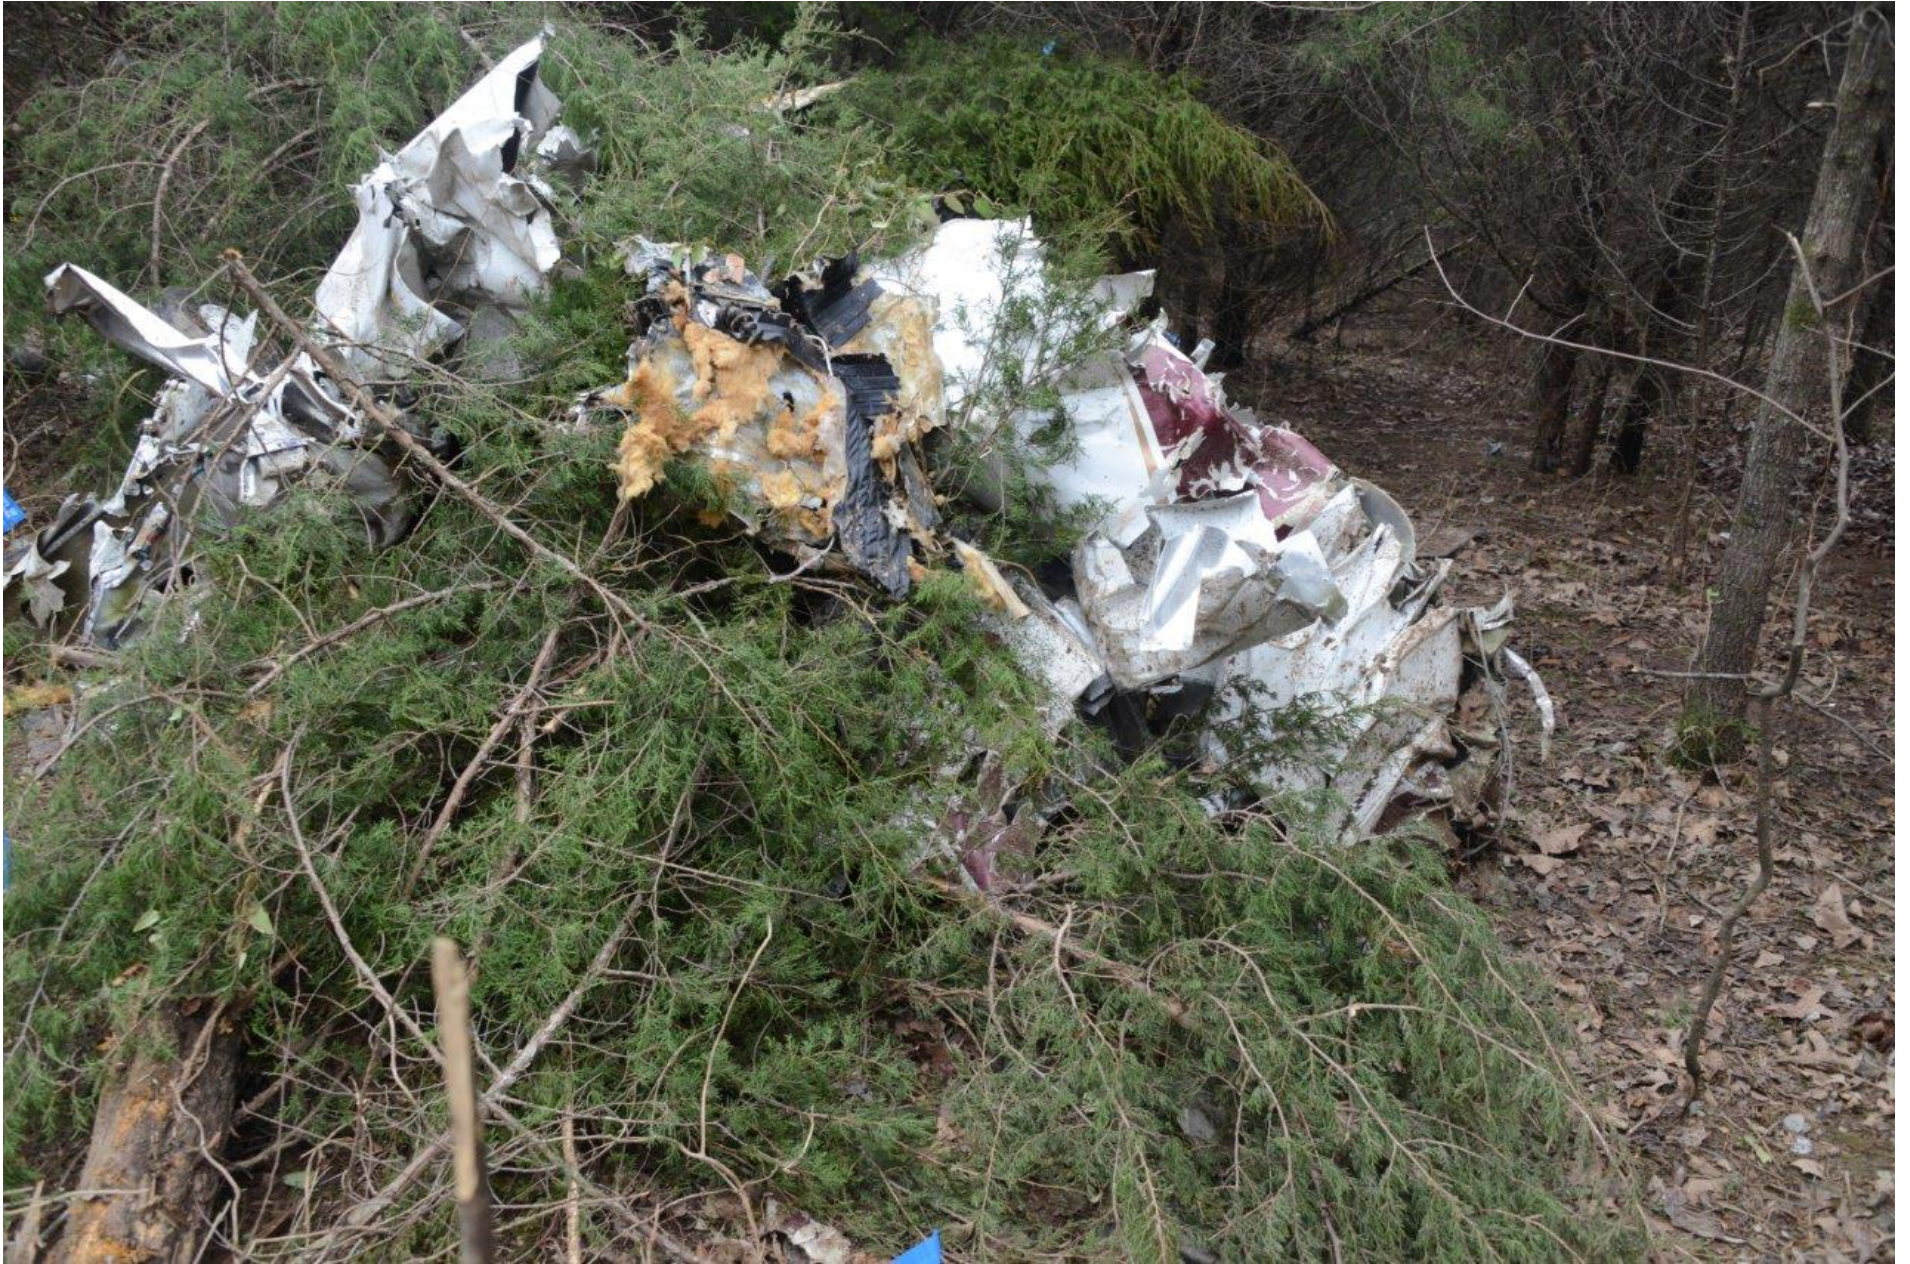
Photo 2 - View of the main wreckage site.

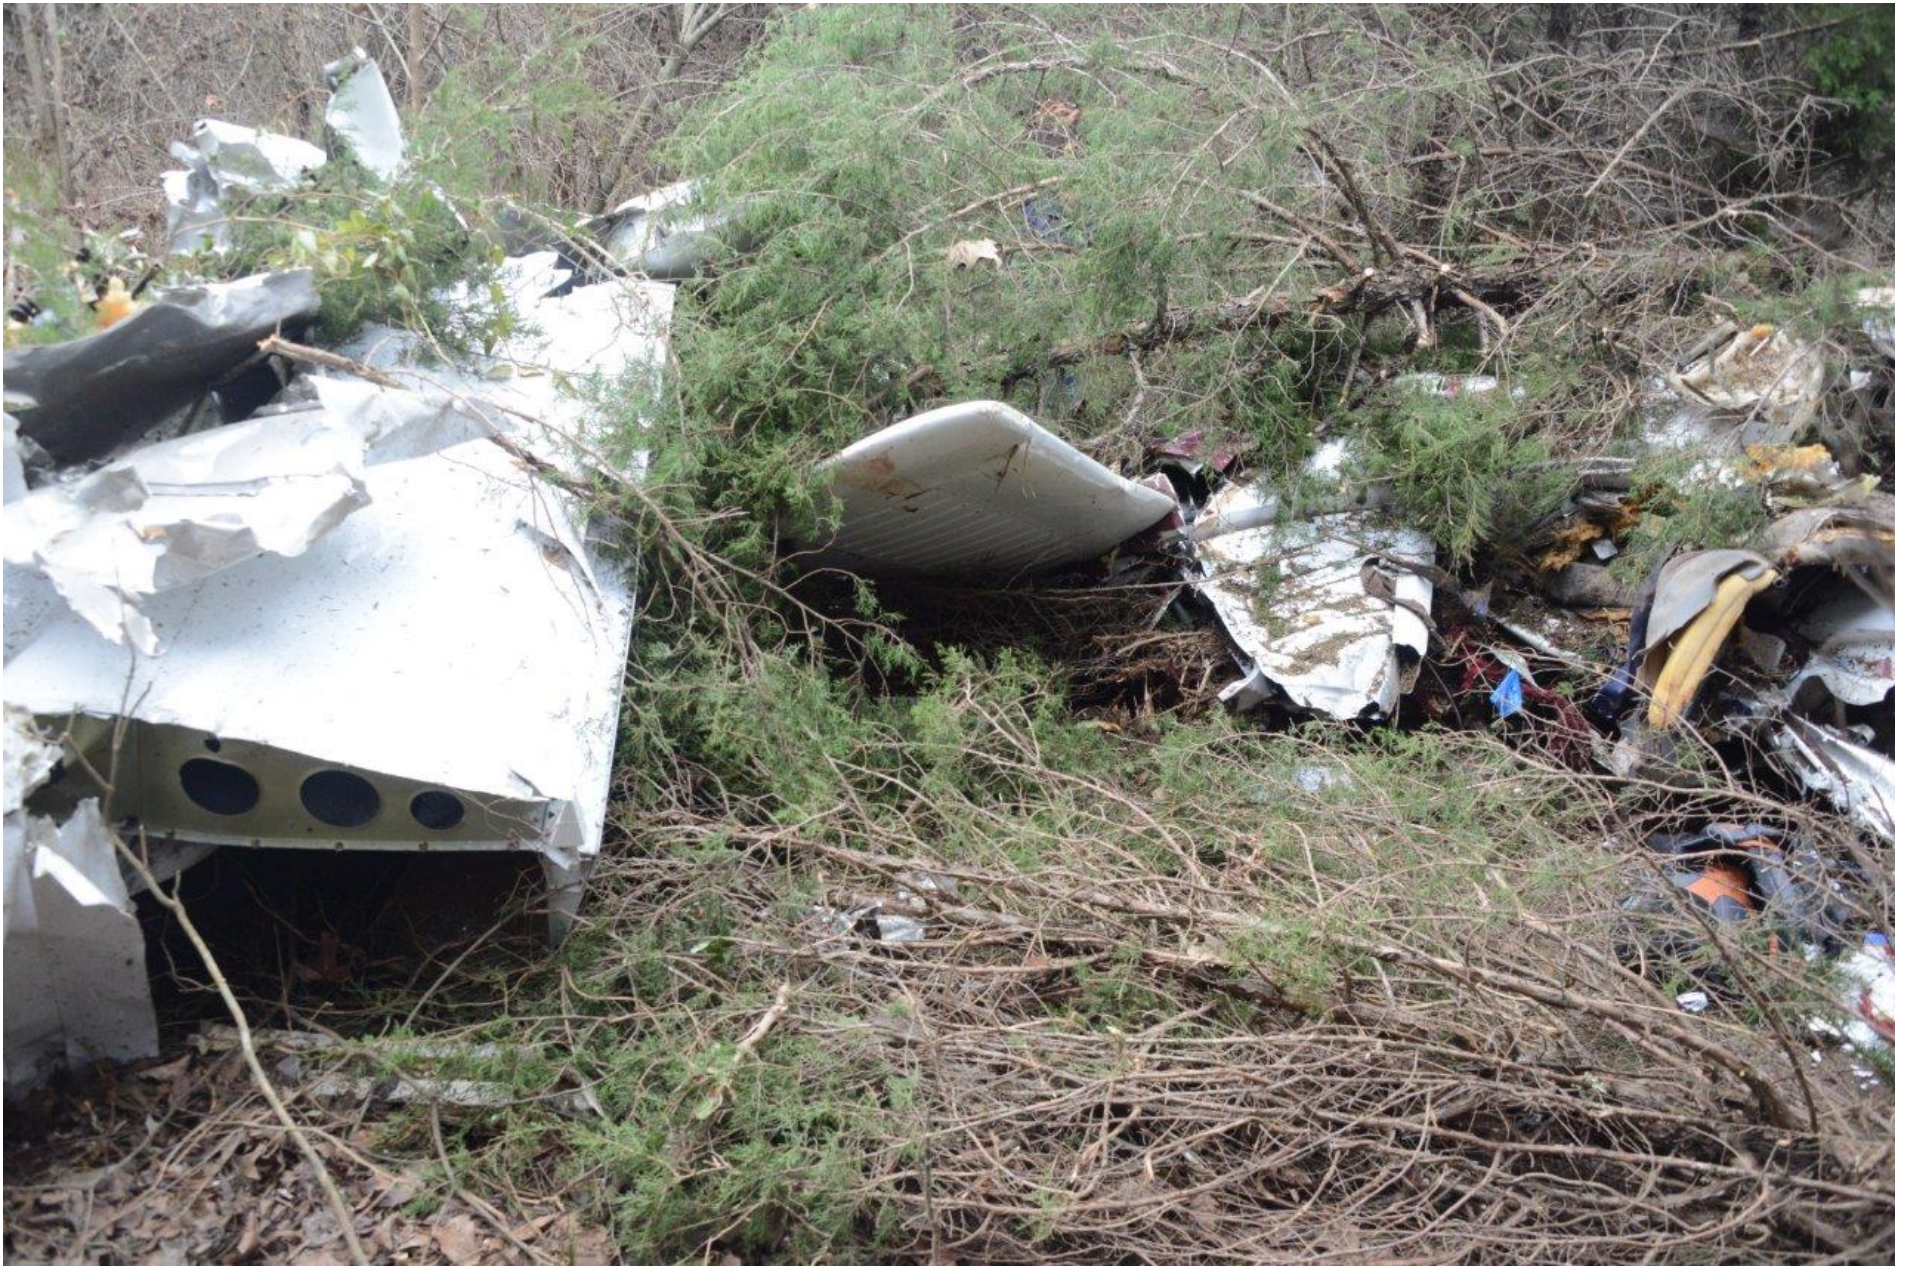
Photo 3 - View of the main wreckage site.

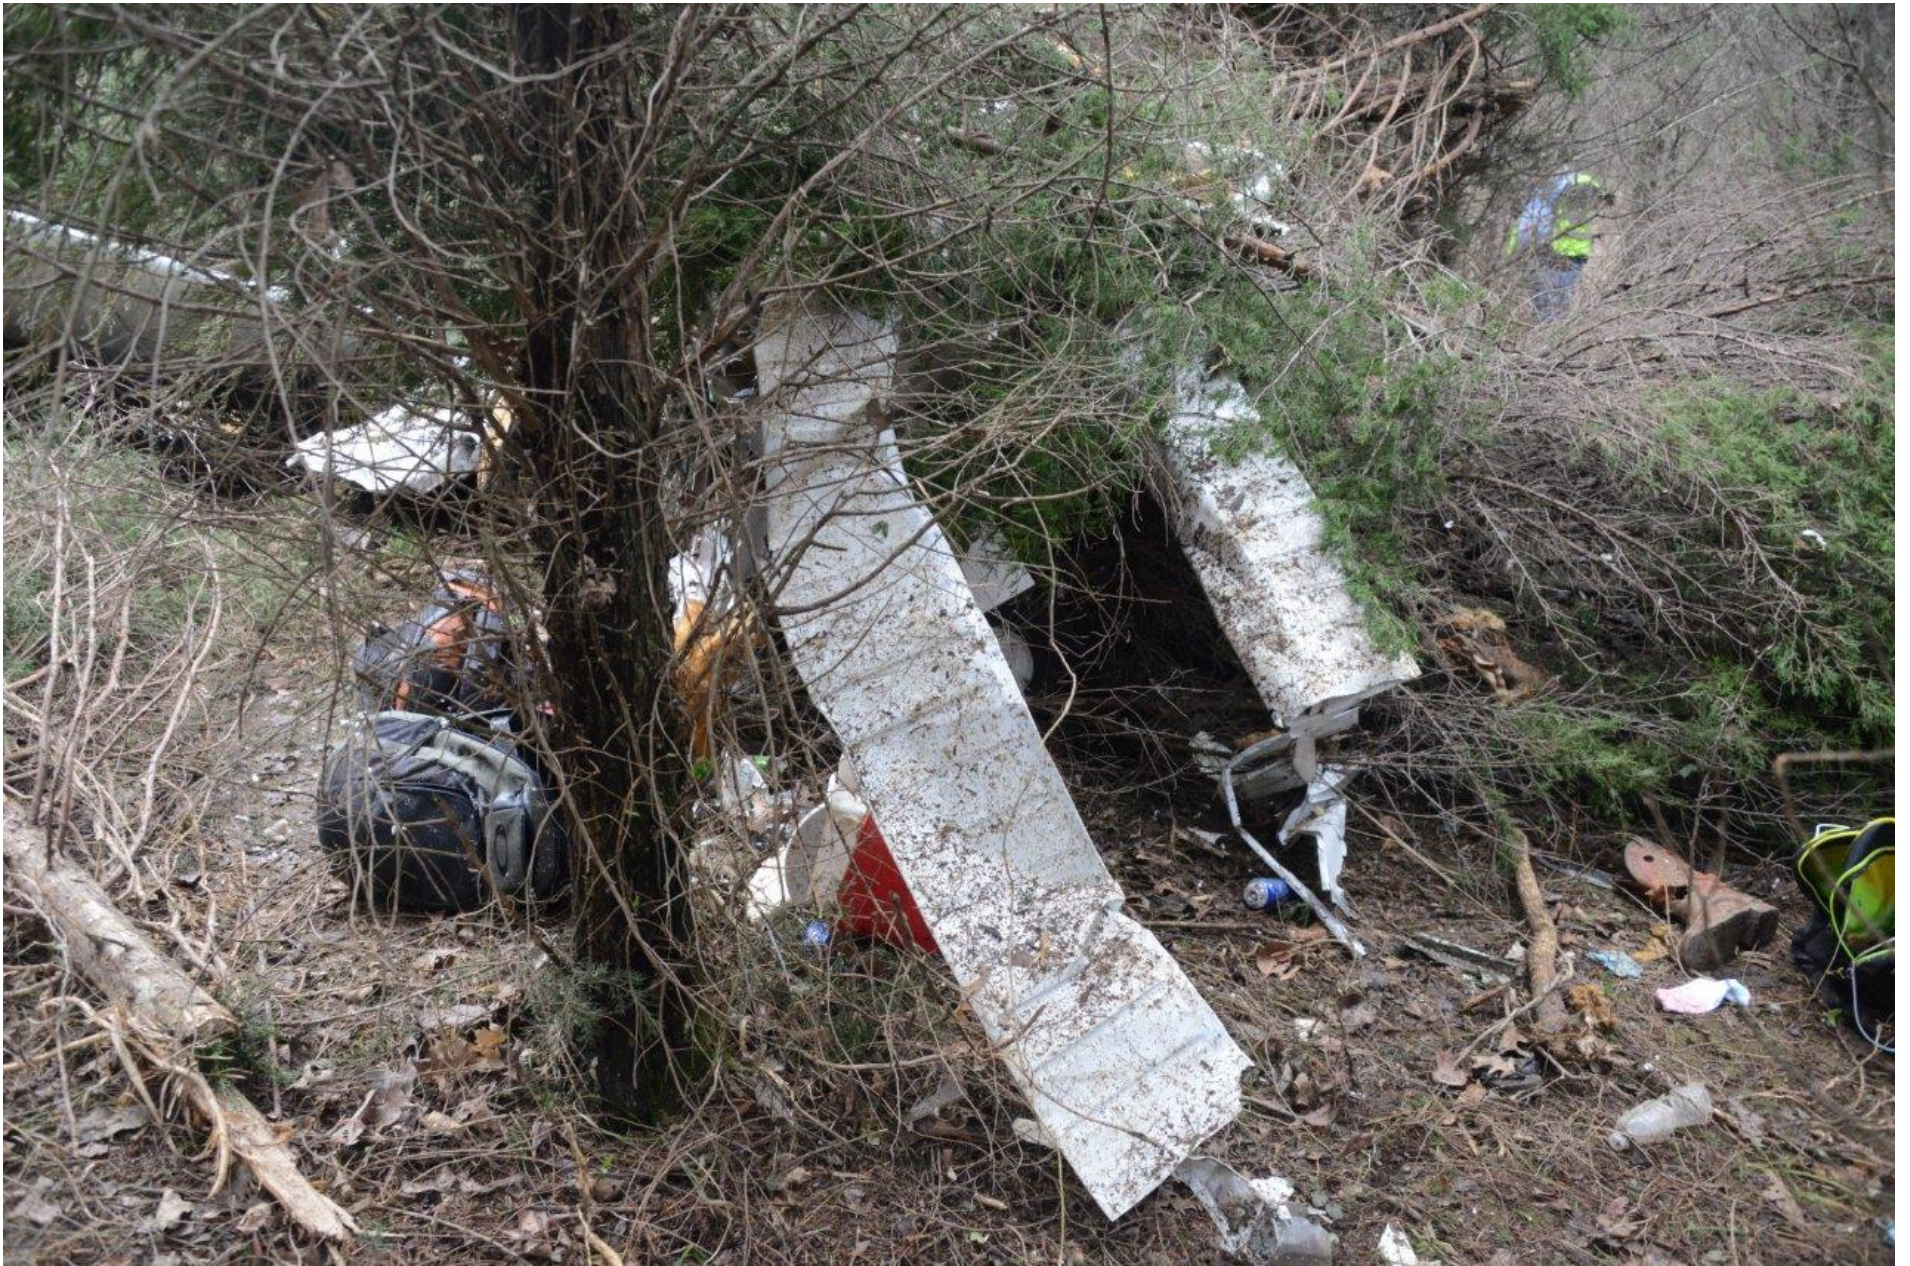
Photo 4 - View of the main wreckage site.

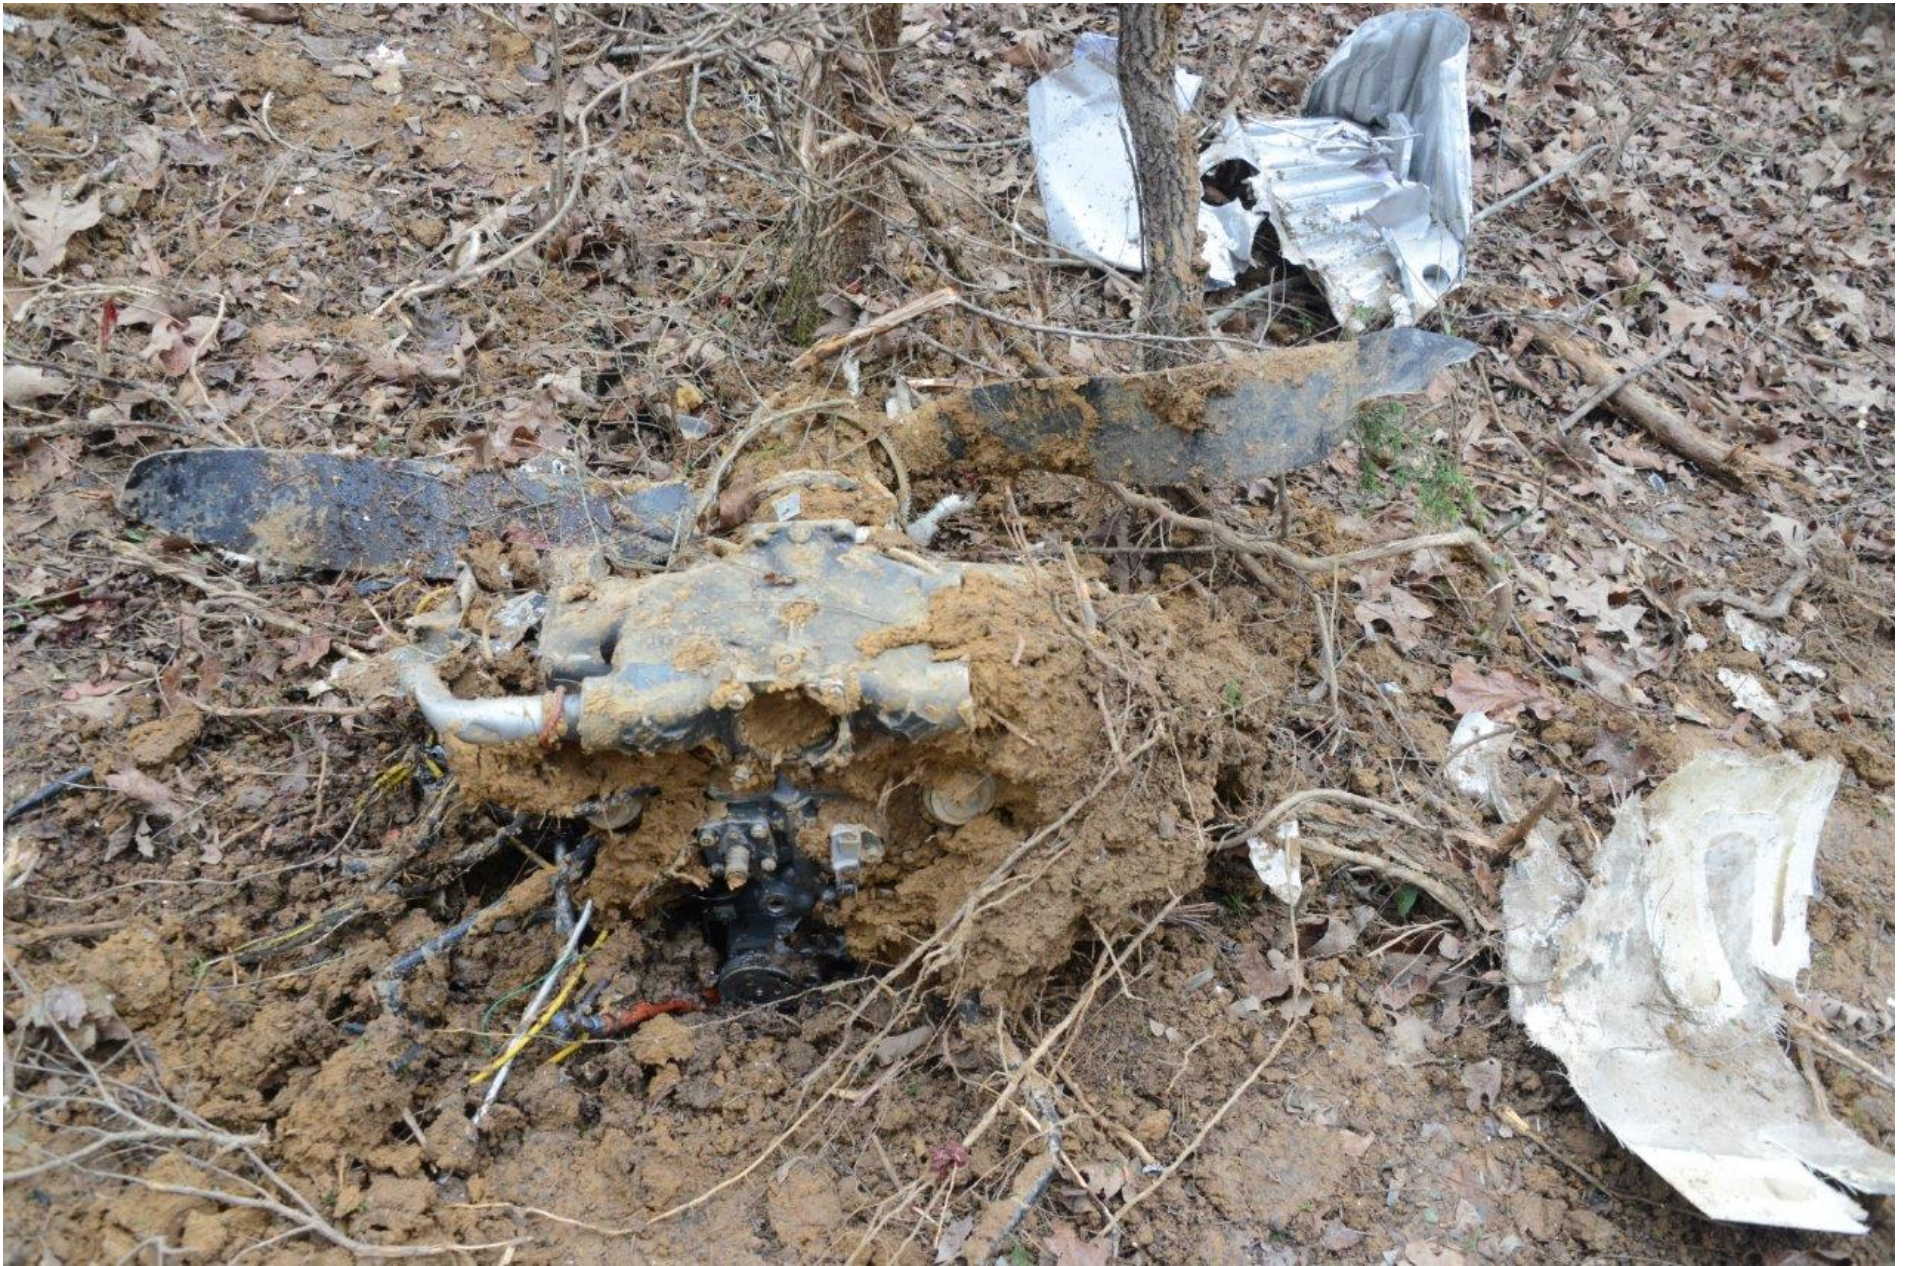
Photo 5 - View of the engine and propeller.

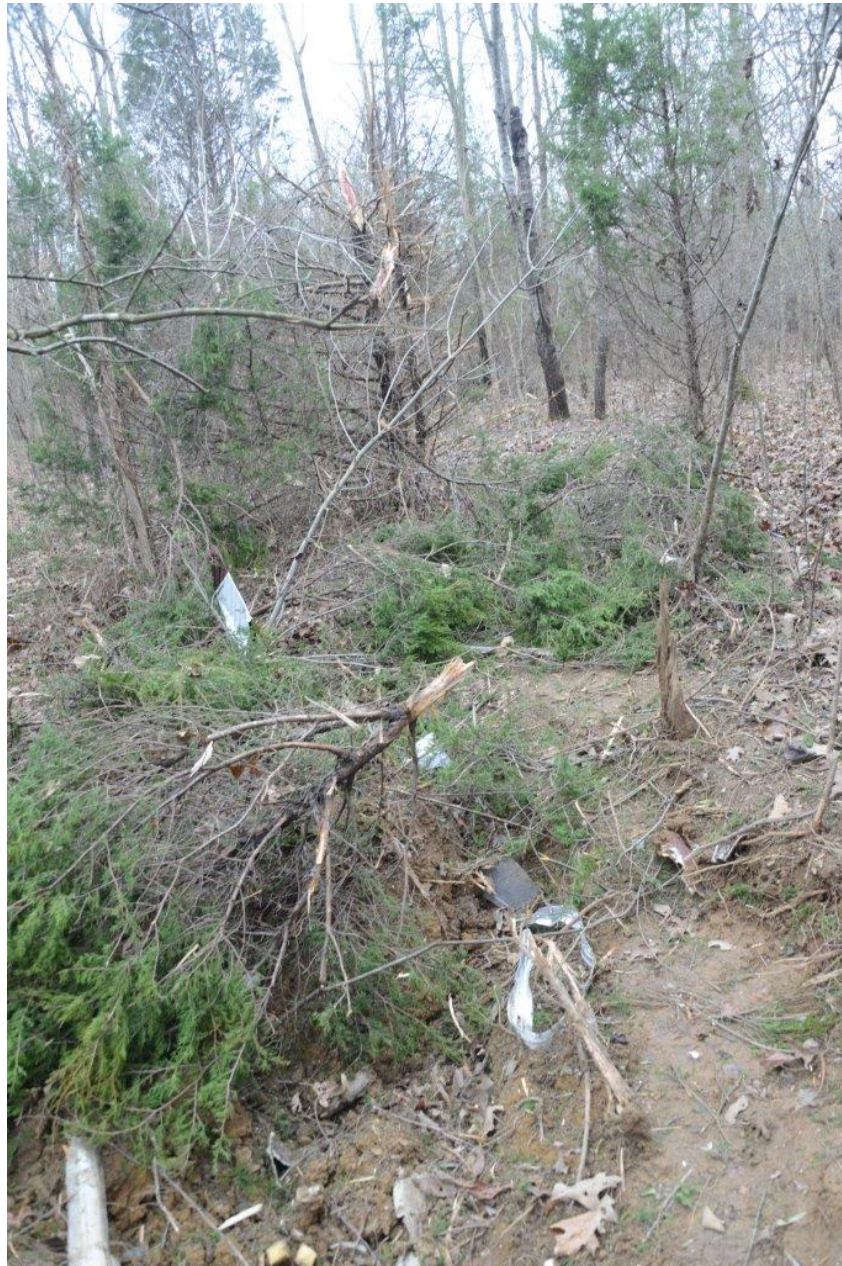
Photo 6 - View of the debris path and trees with separated branches.

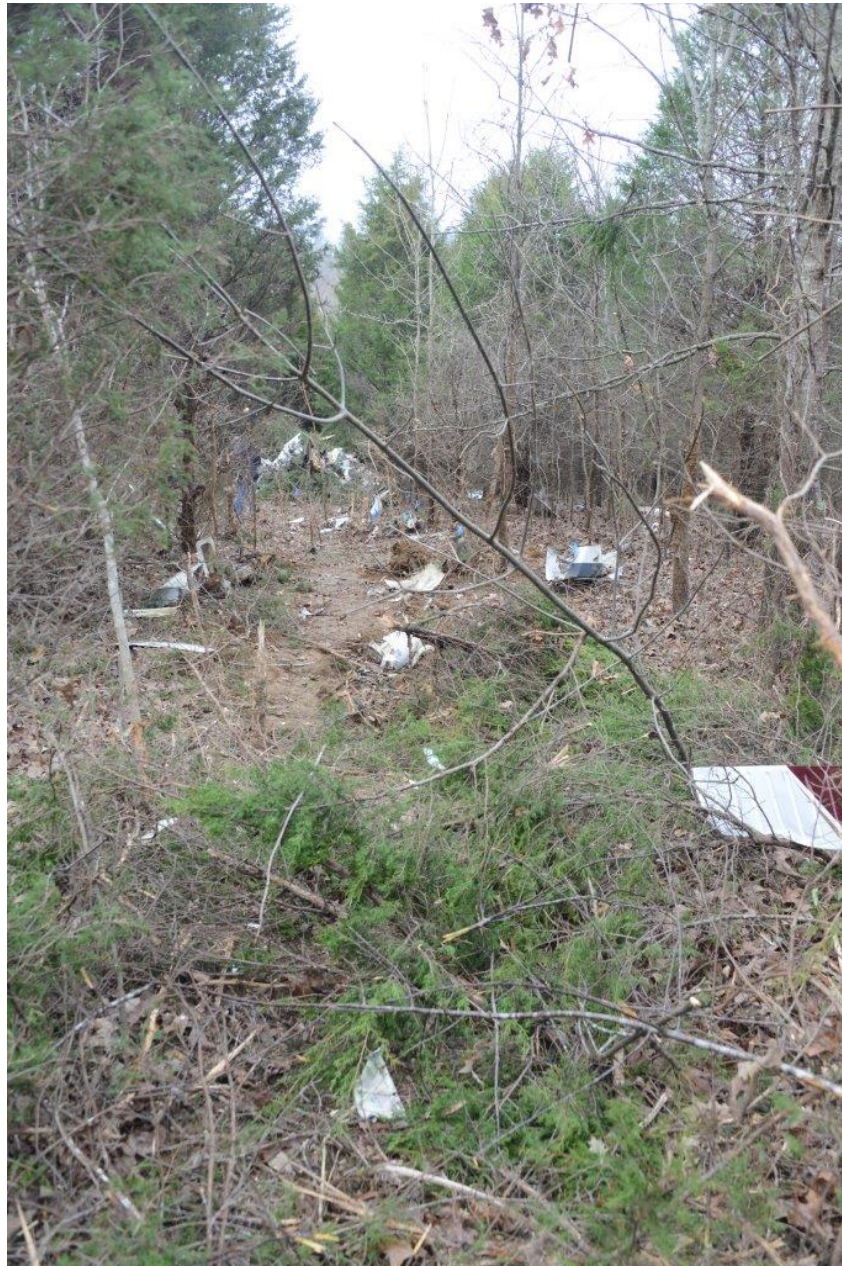
Photo 7 - View of the debris path and trees with separated branches.

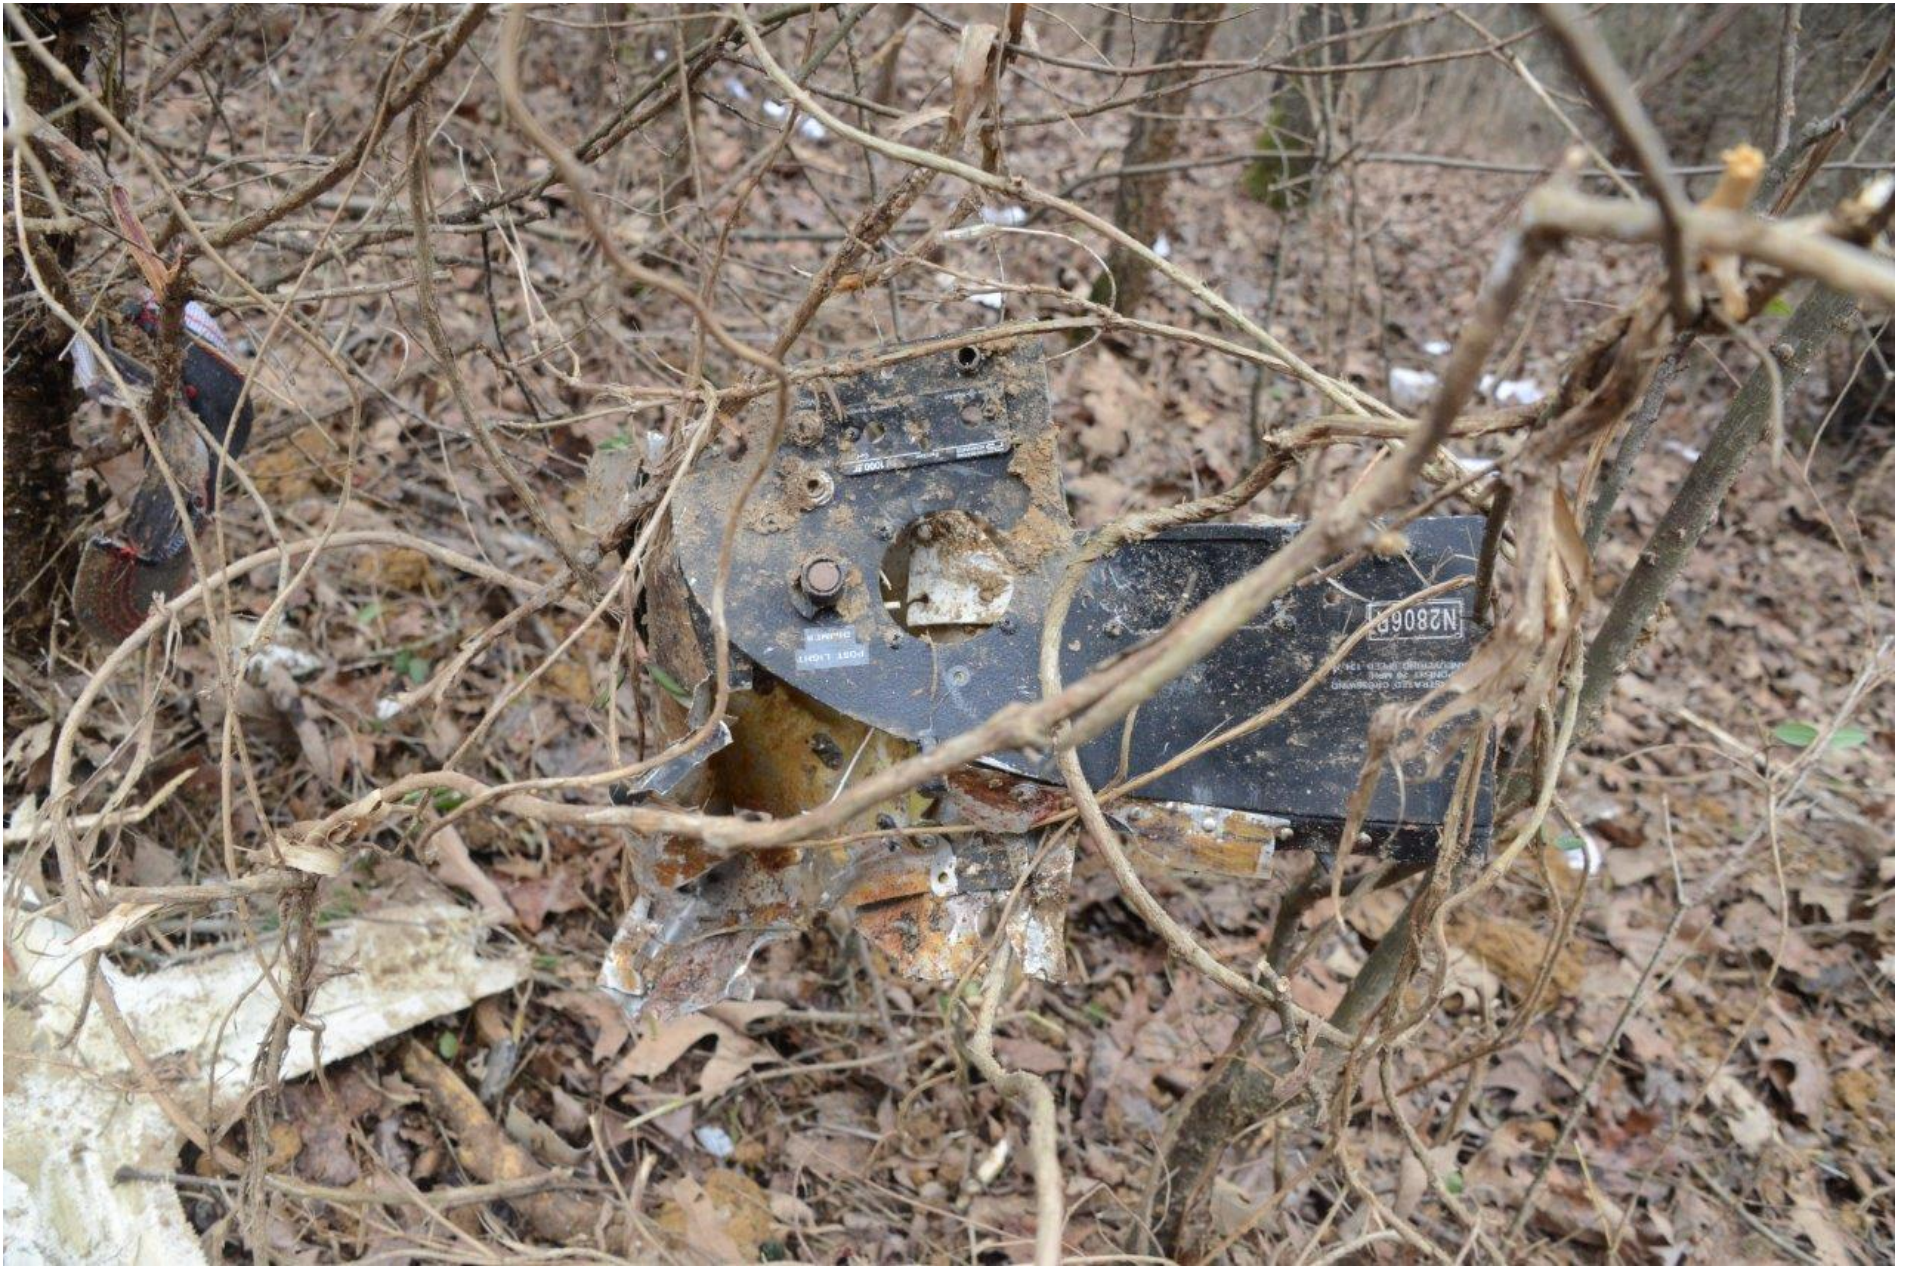
Photo 8 - View of a section of the instrument panel in the debris path.

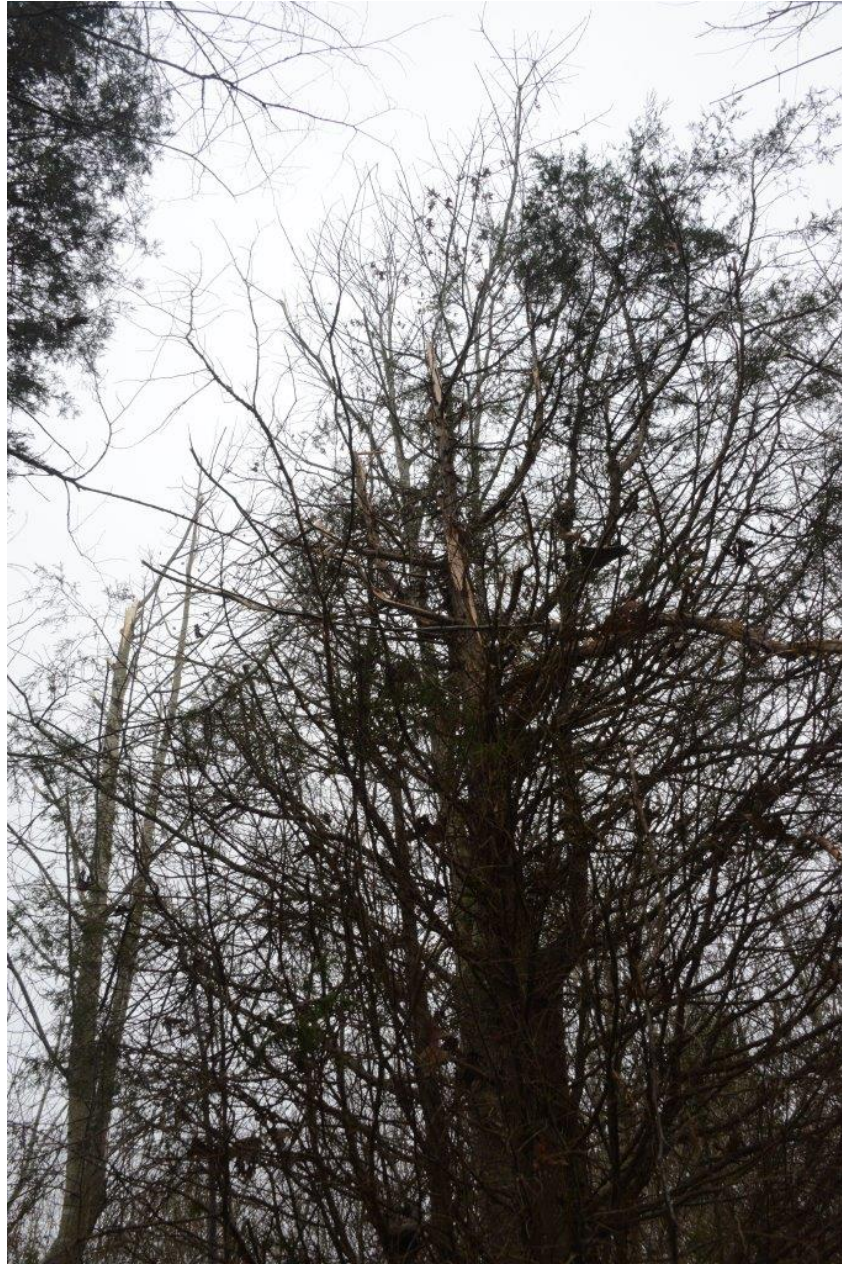
Photo 9 - View of a tree with its top branch separated.

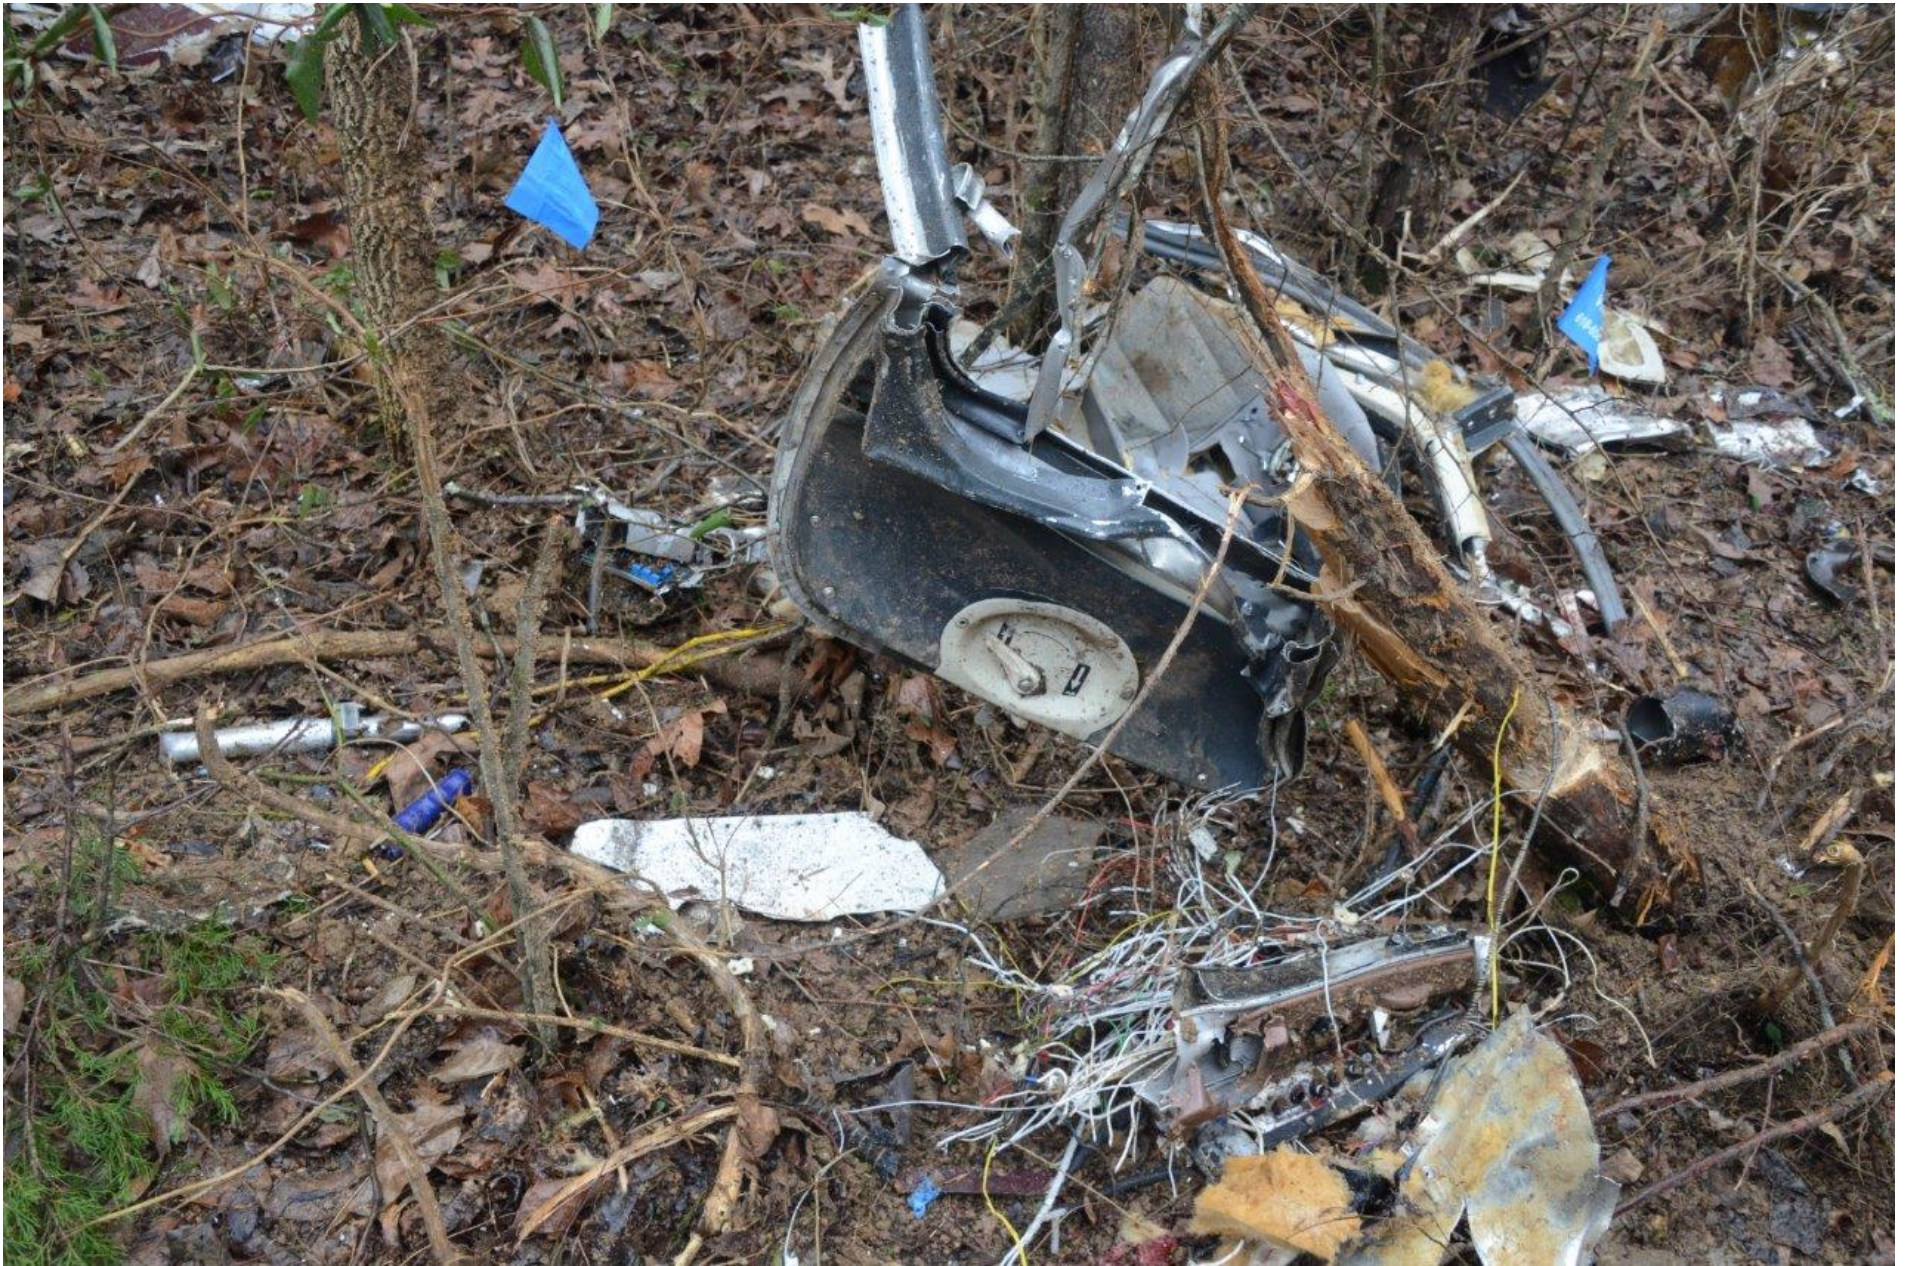
Photo 10 - View of the cockpit door.

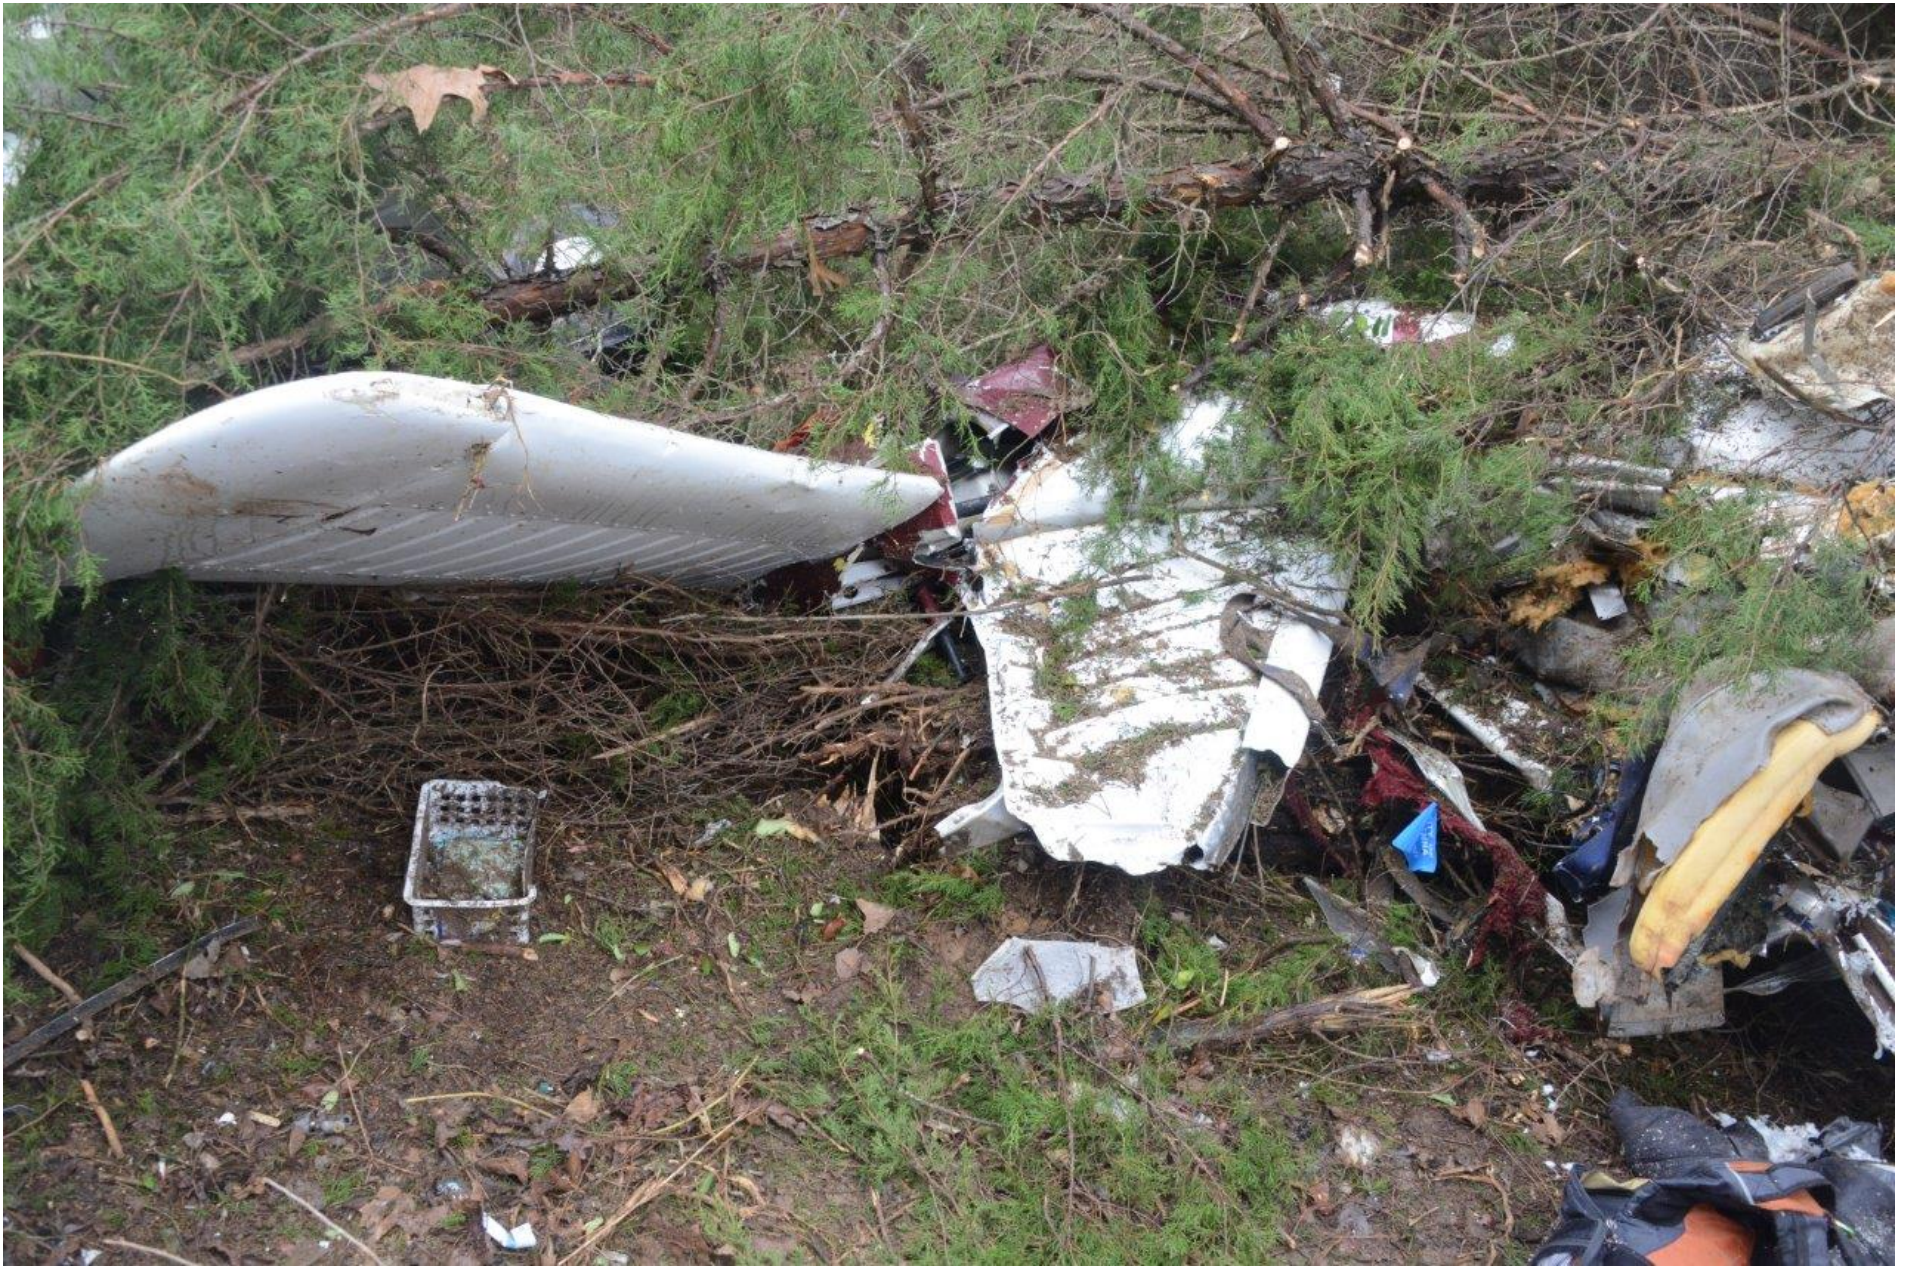
Photo 11 - View of the empennage at the main wreckage site.
