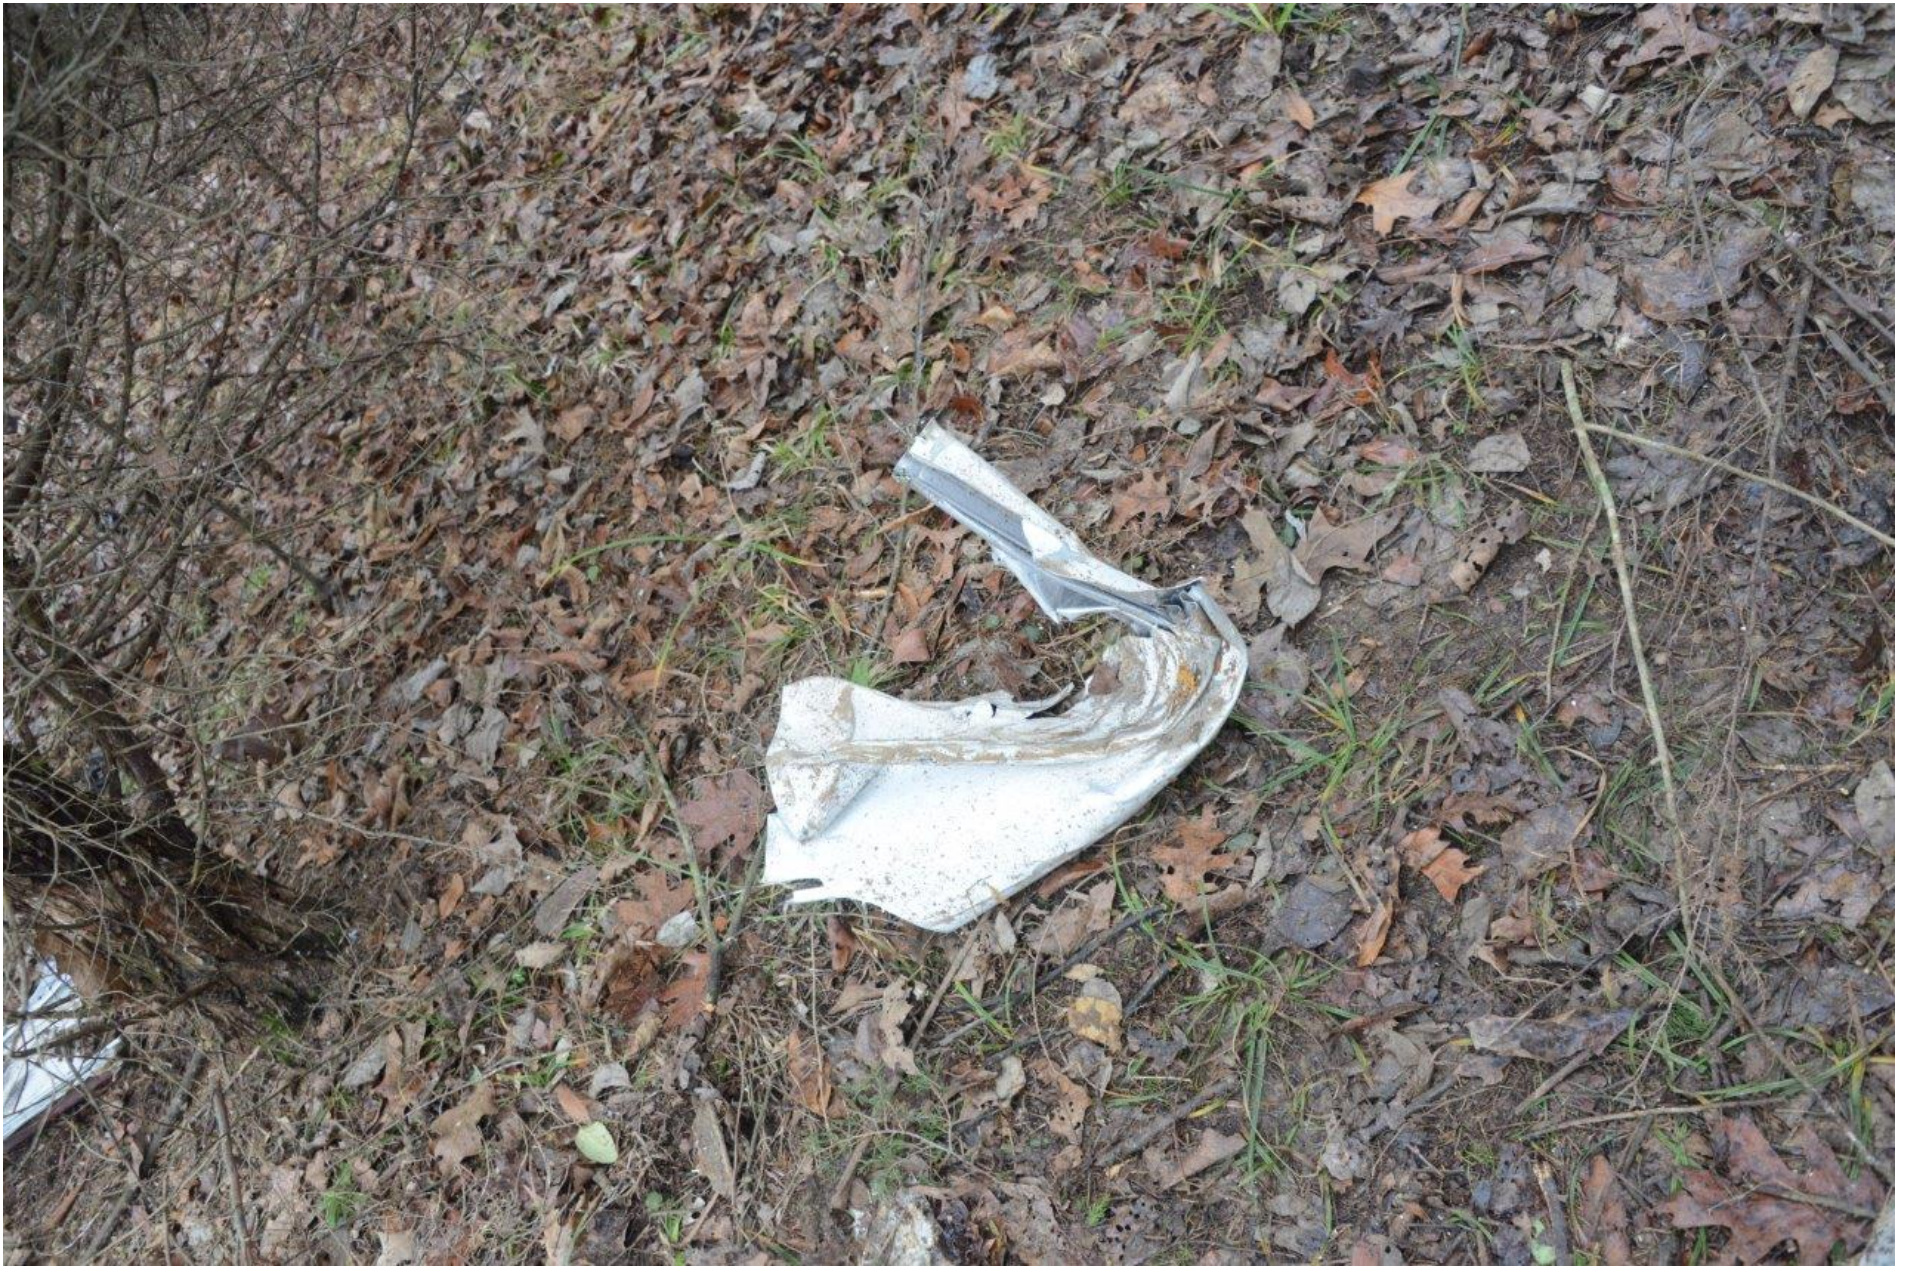
Photo 12 - View of a section of airplane skin with a semicircular deformation.

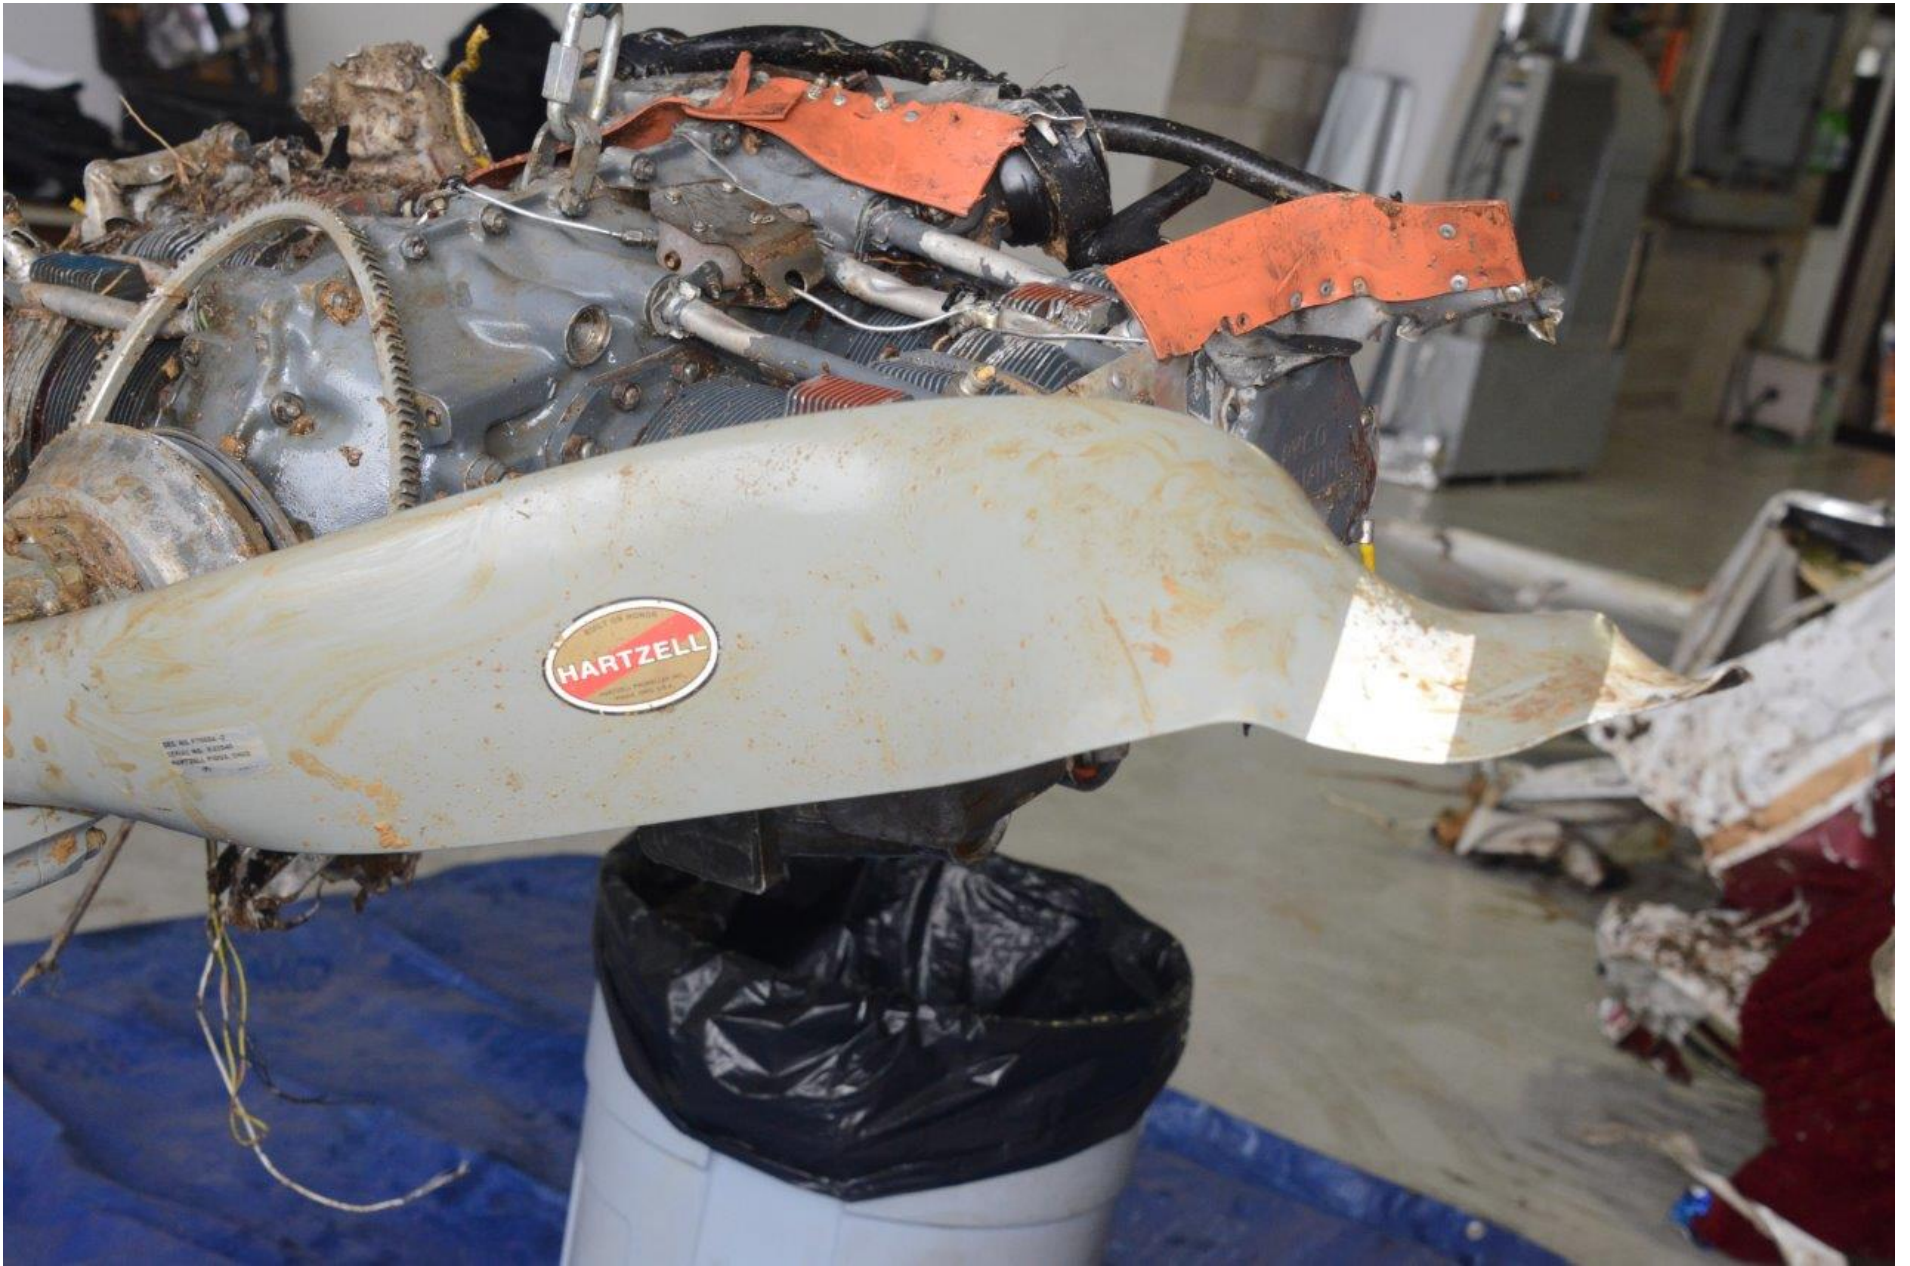
Photo 13 - View of a propeller blade marked no.1 with S shaped bending.

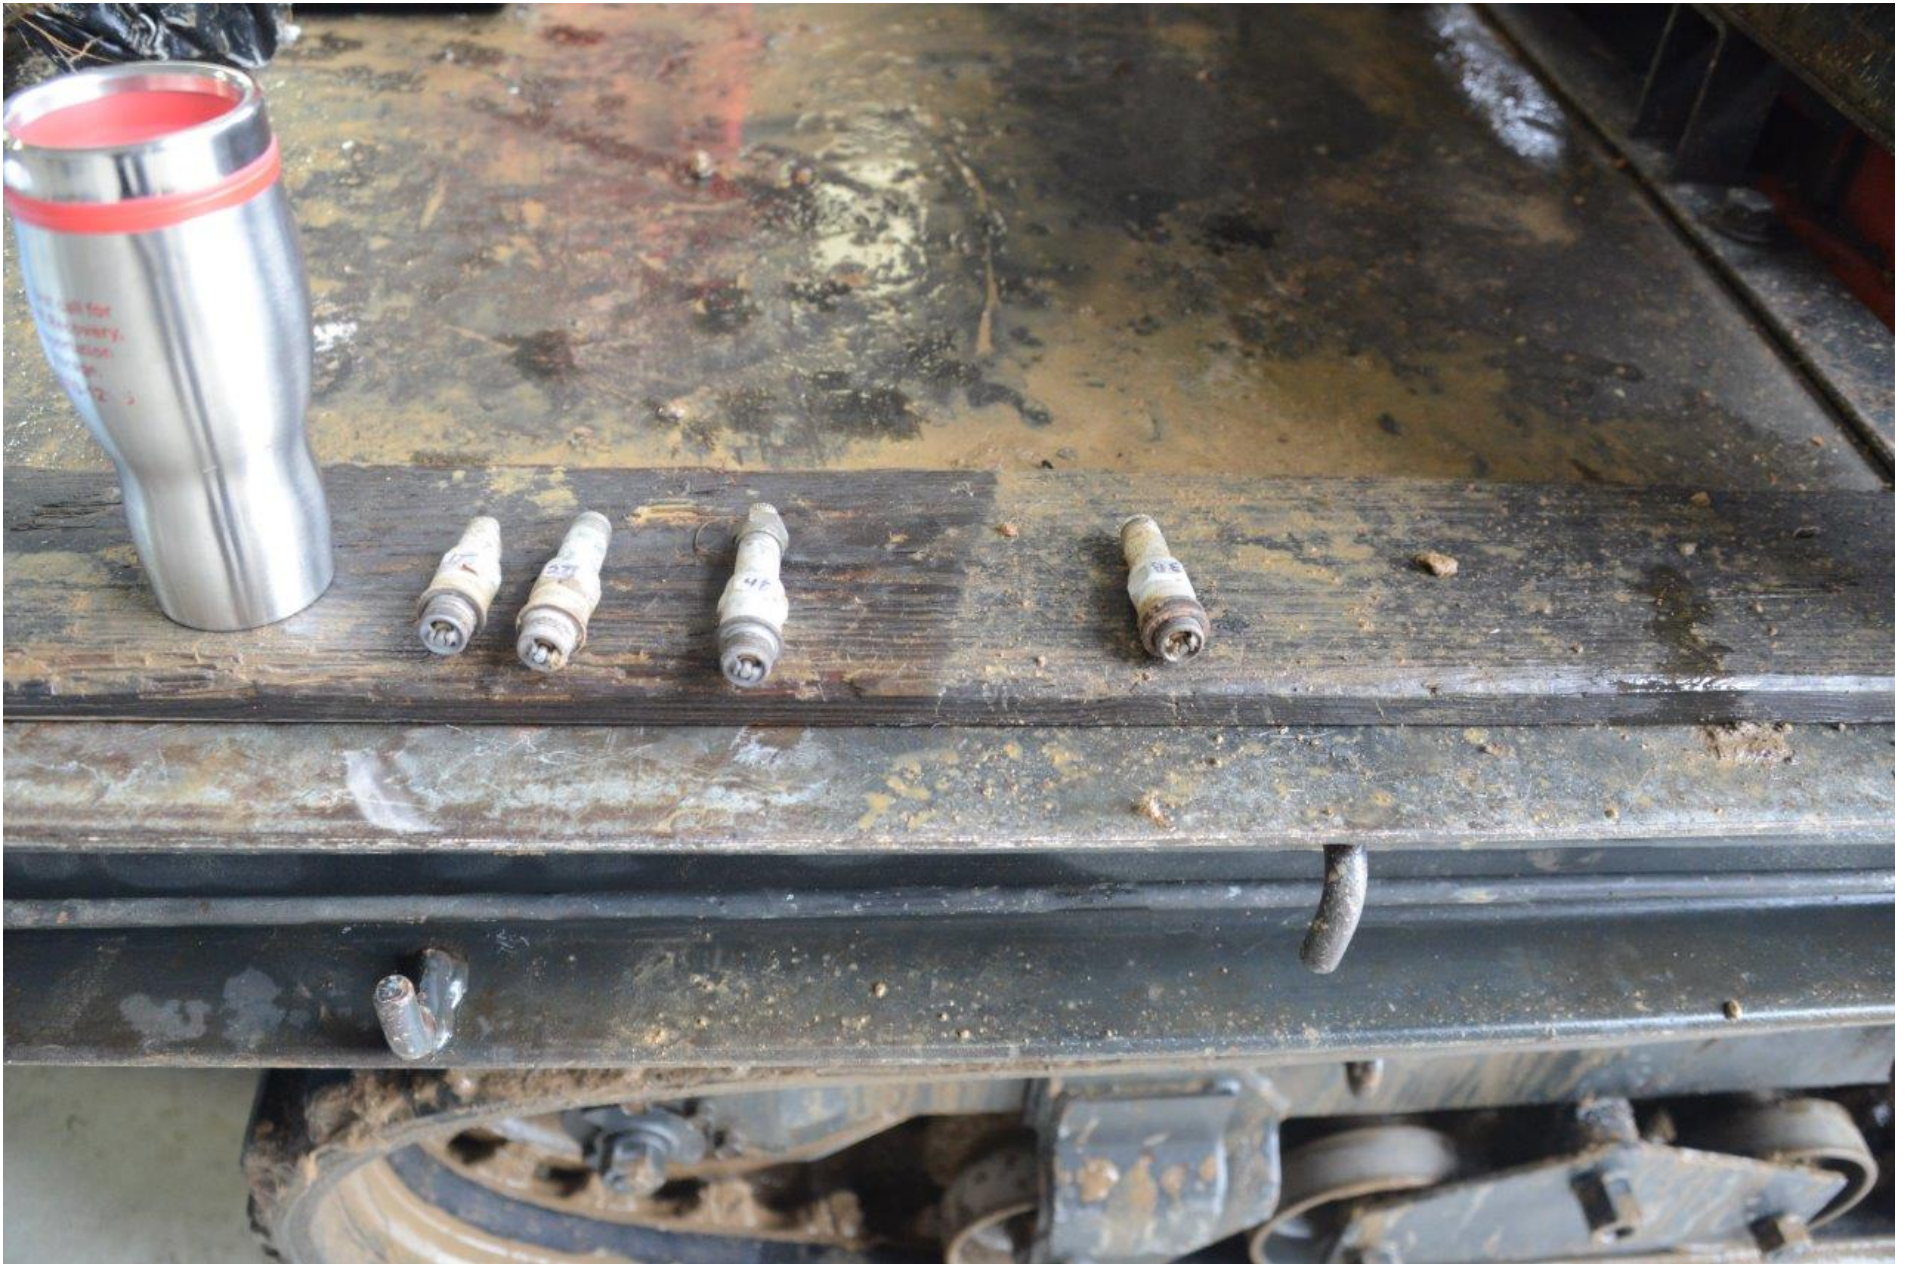
Photo 14 - View of removed sparkplugs.

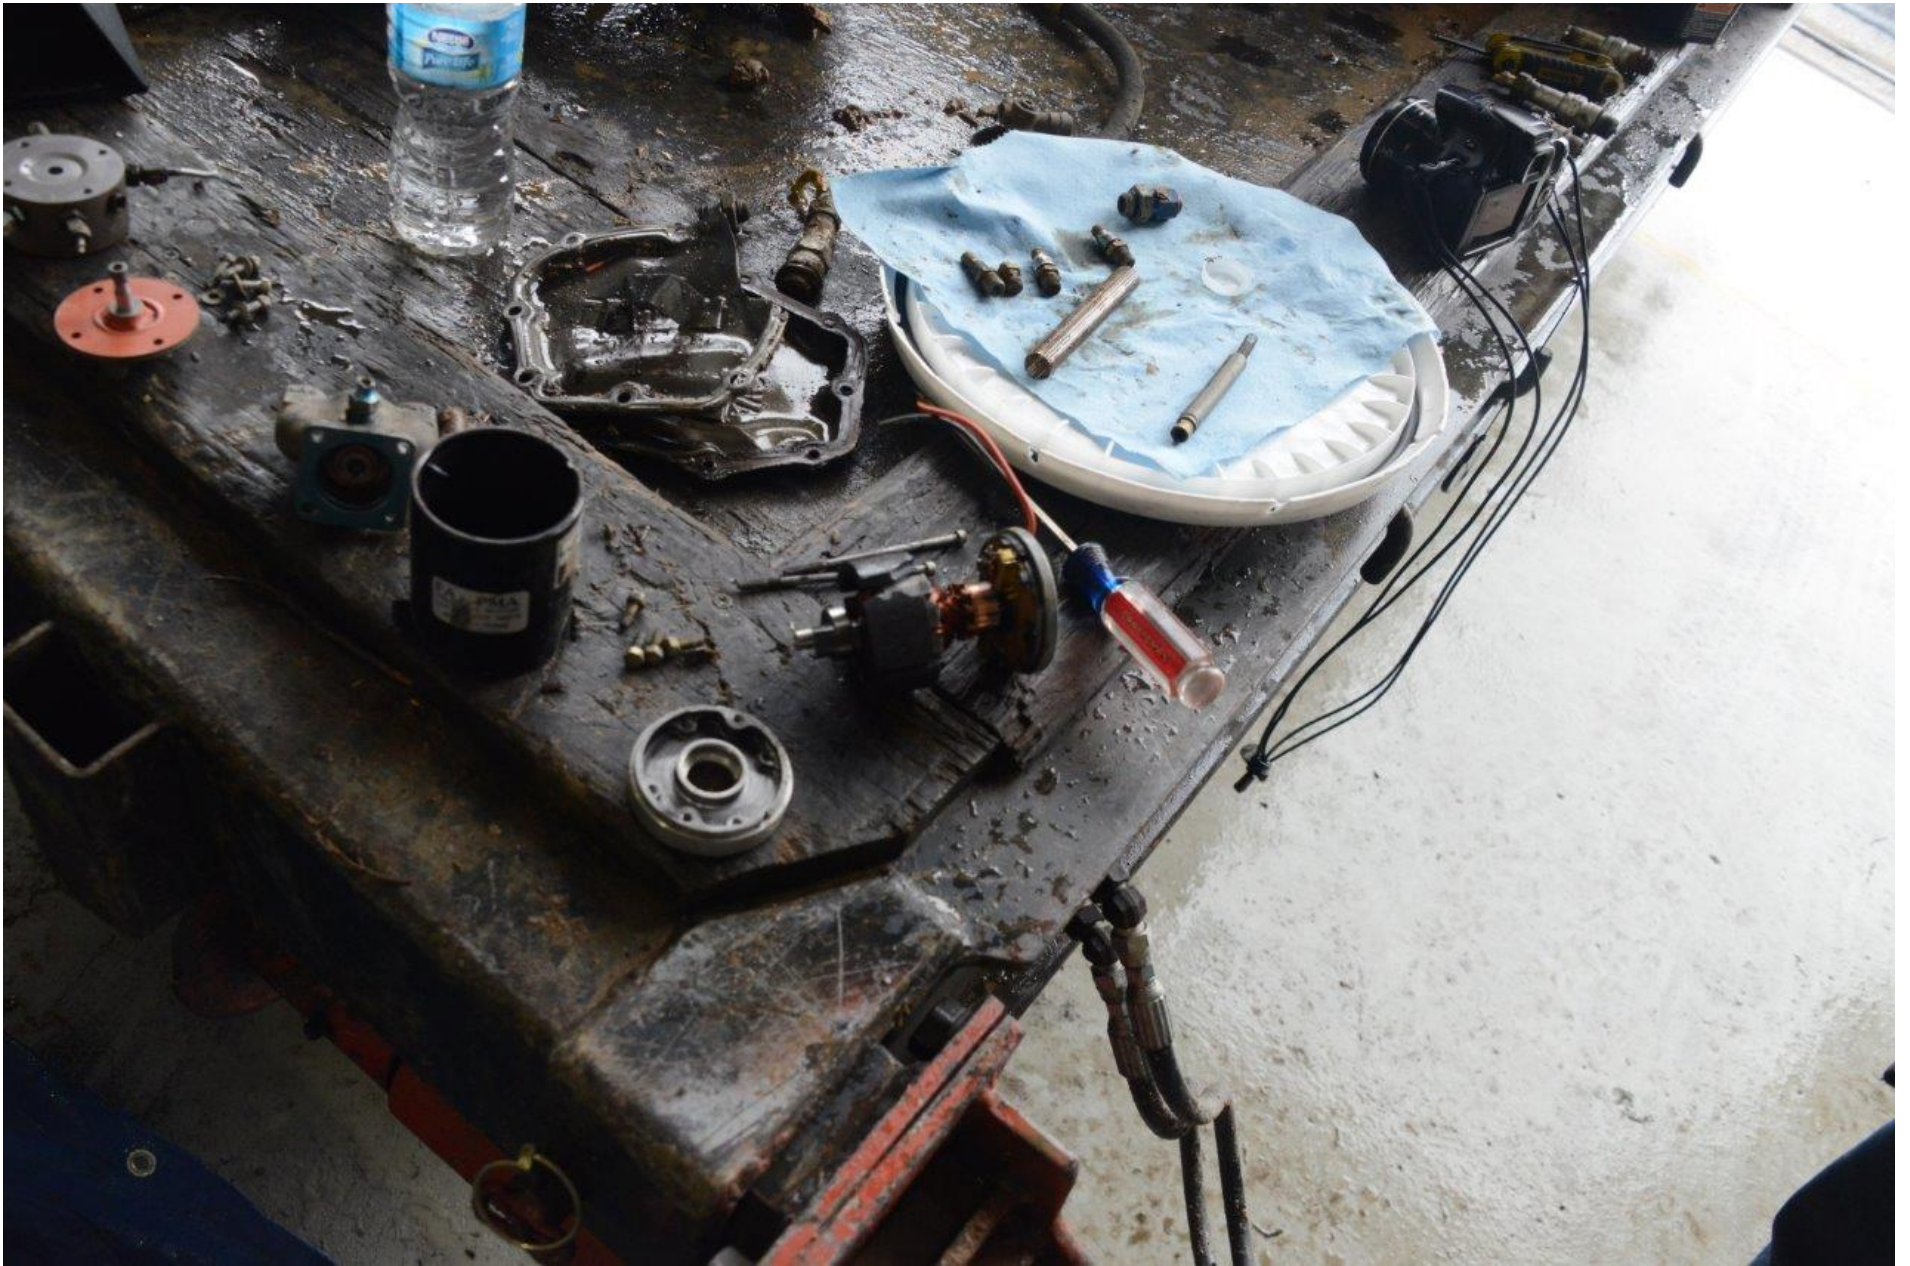
Photo 15 - View of fuel servo filter, disassembled electric fuel pump, and disassembled fuel divider.

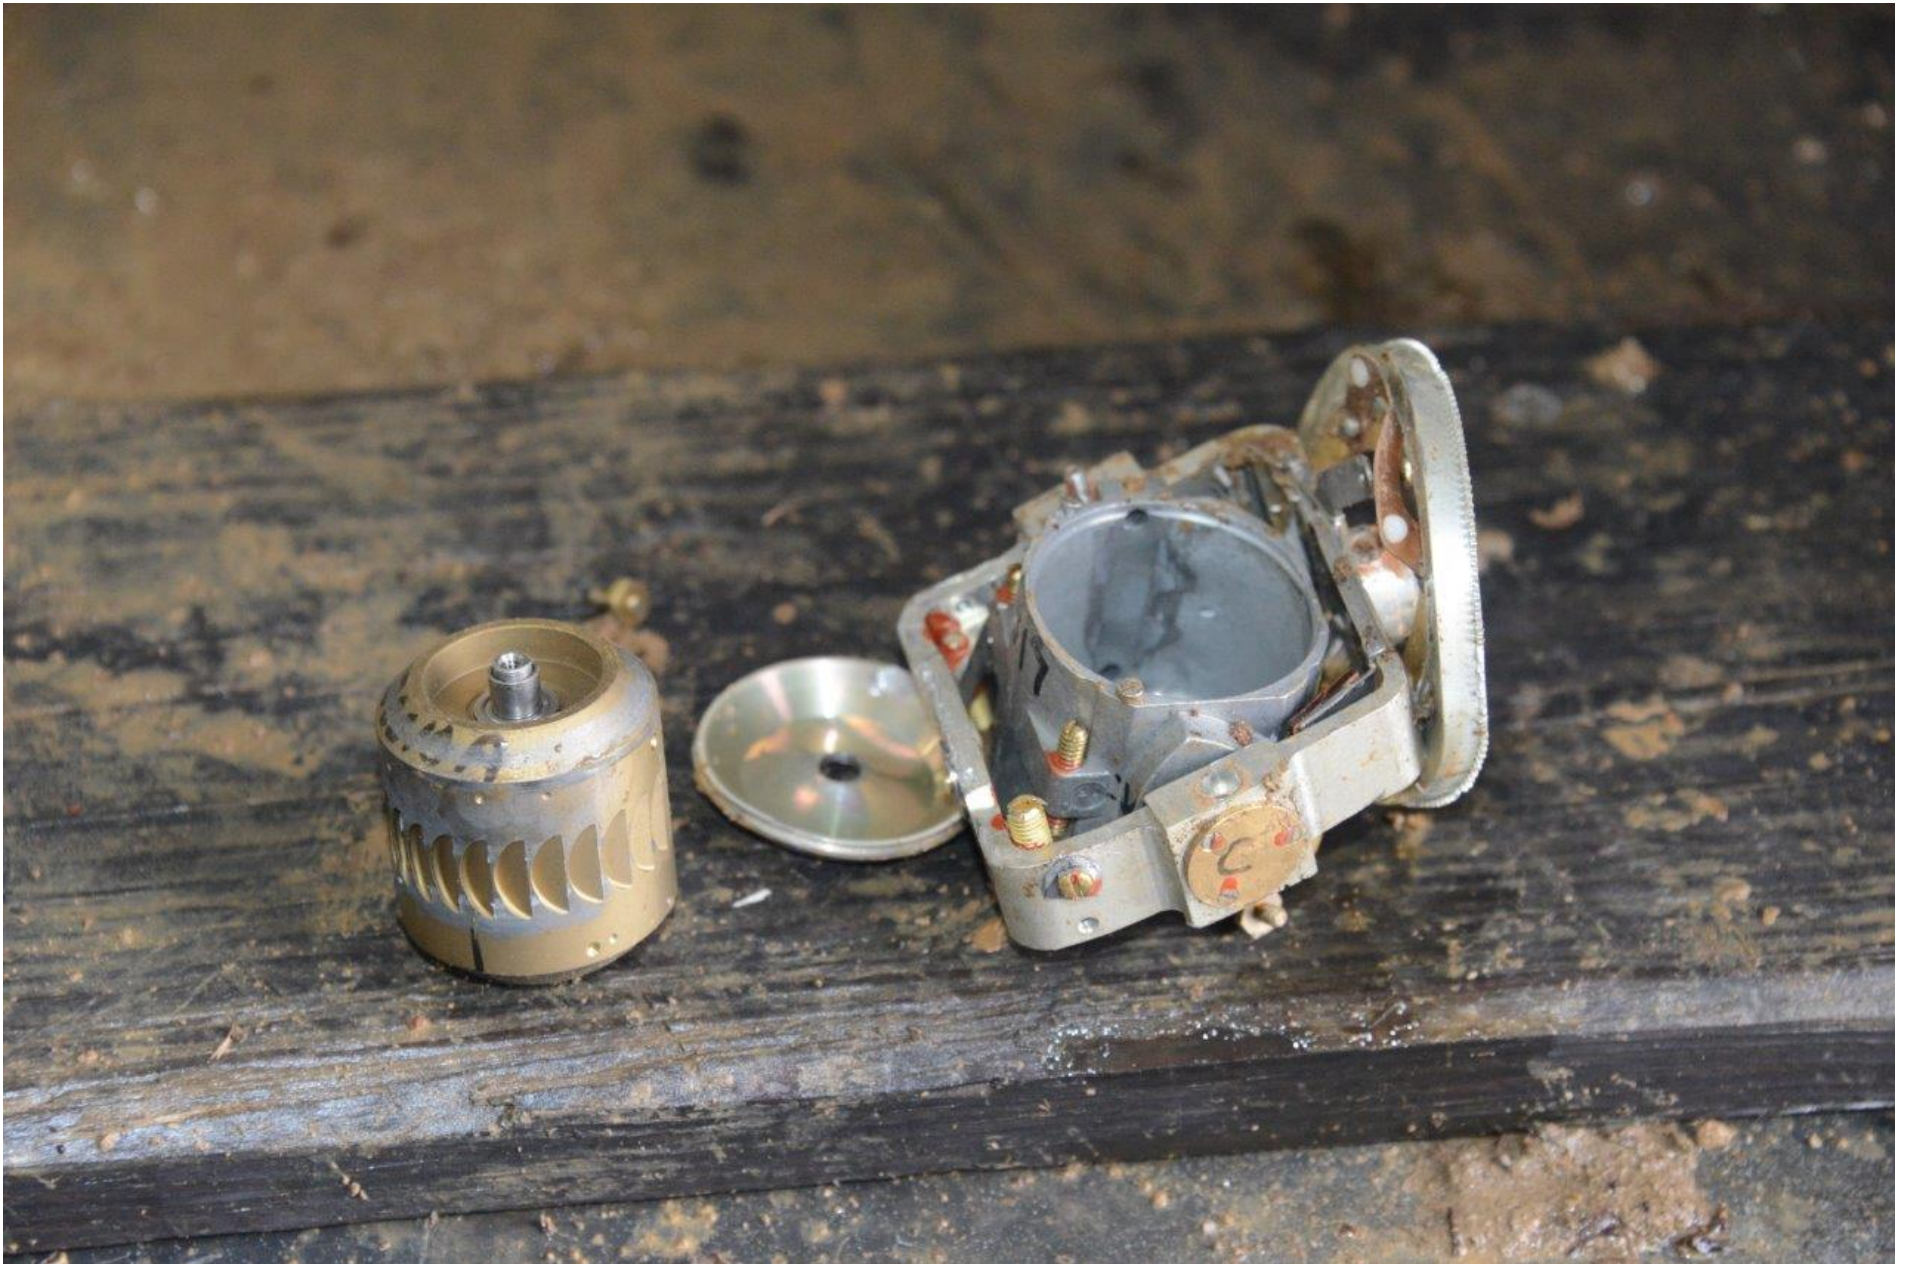
Photo 16 - View of the disassembled instrument gyro and its housing.

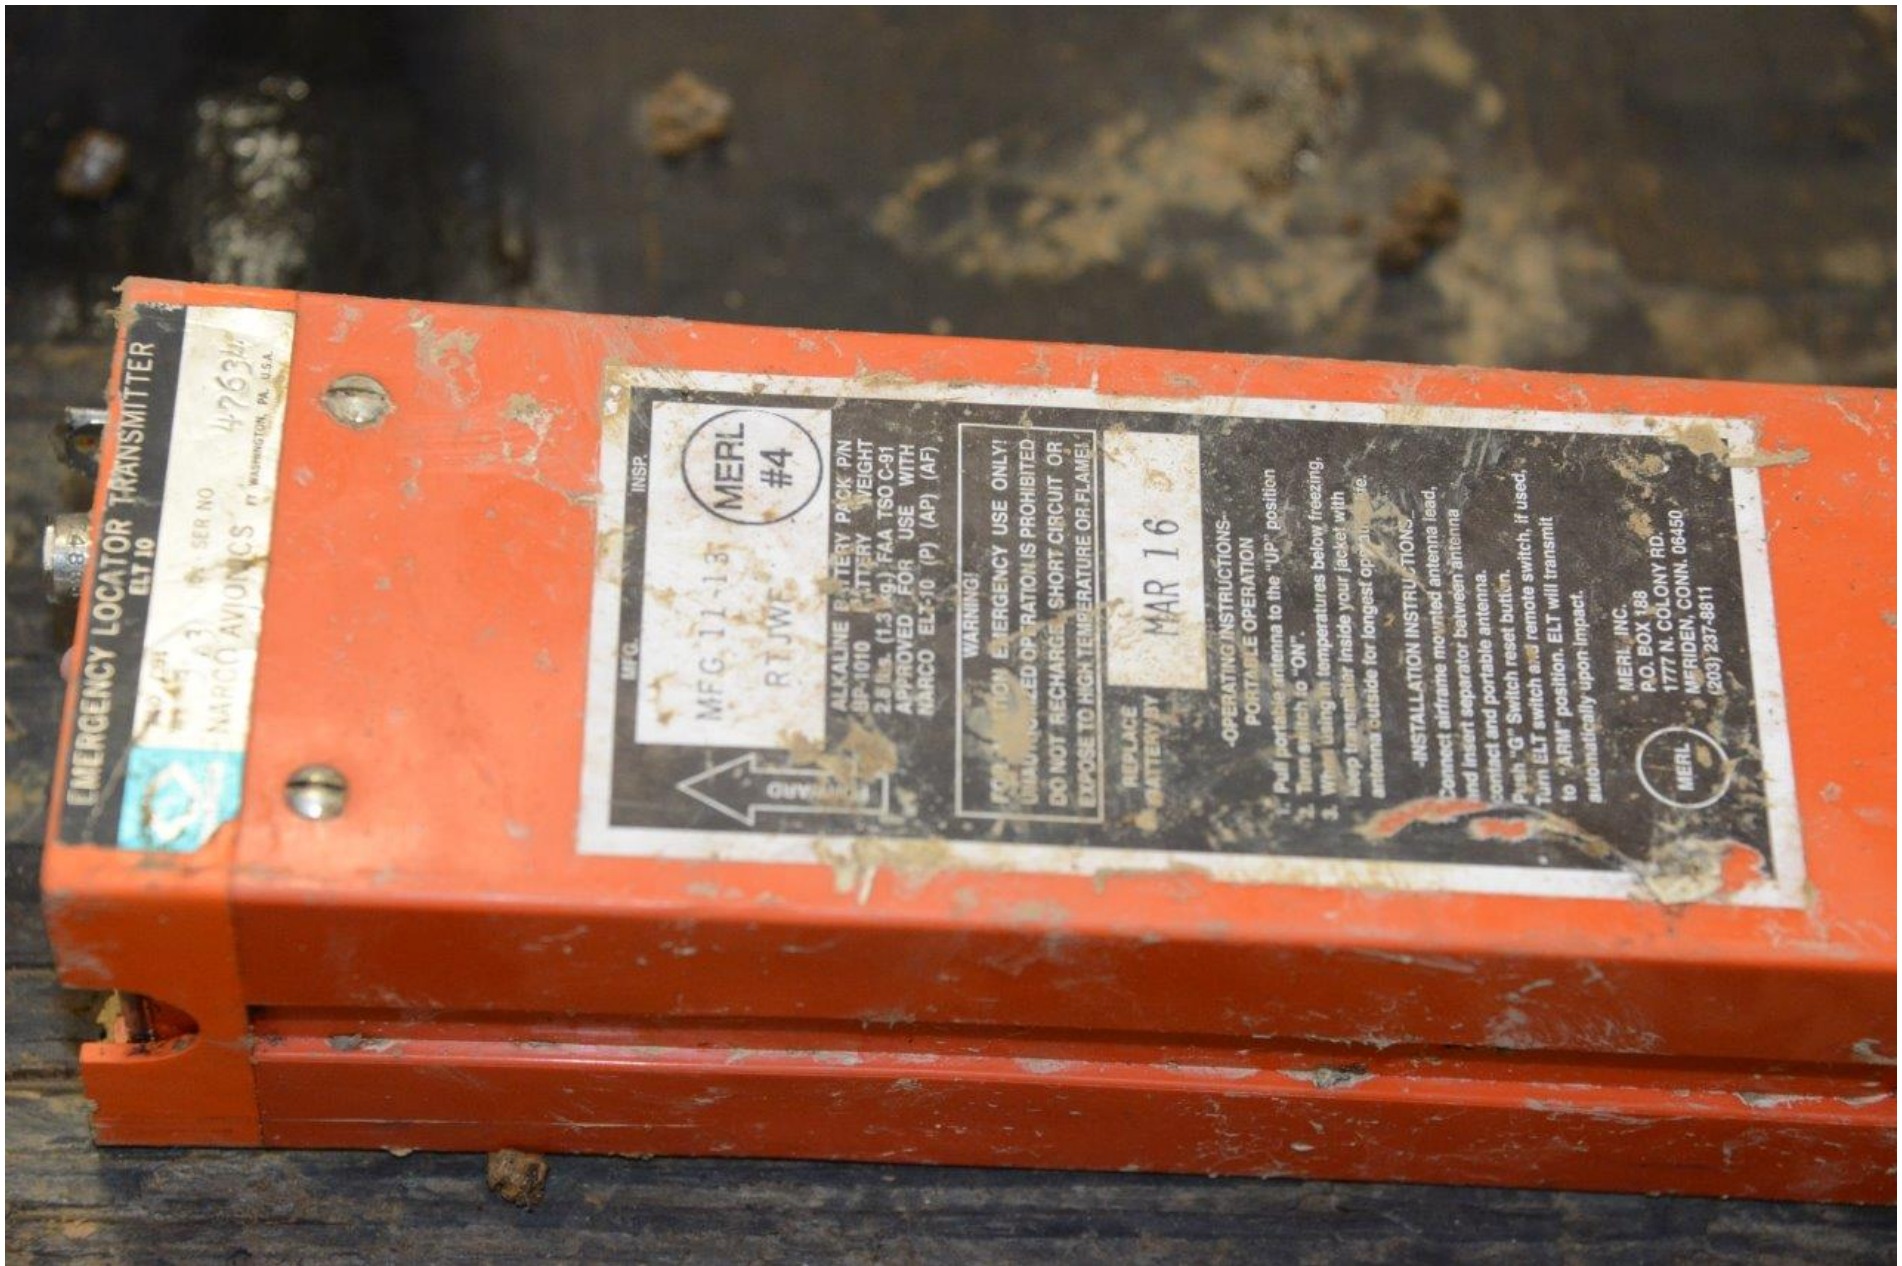
Photo 17 - View of the emergency locator transmitter.

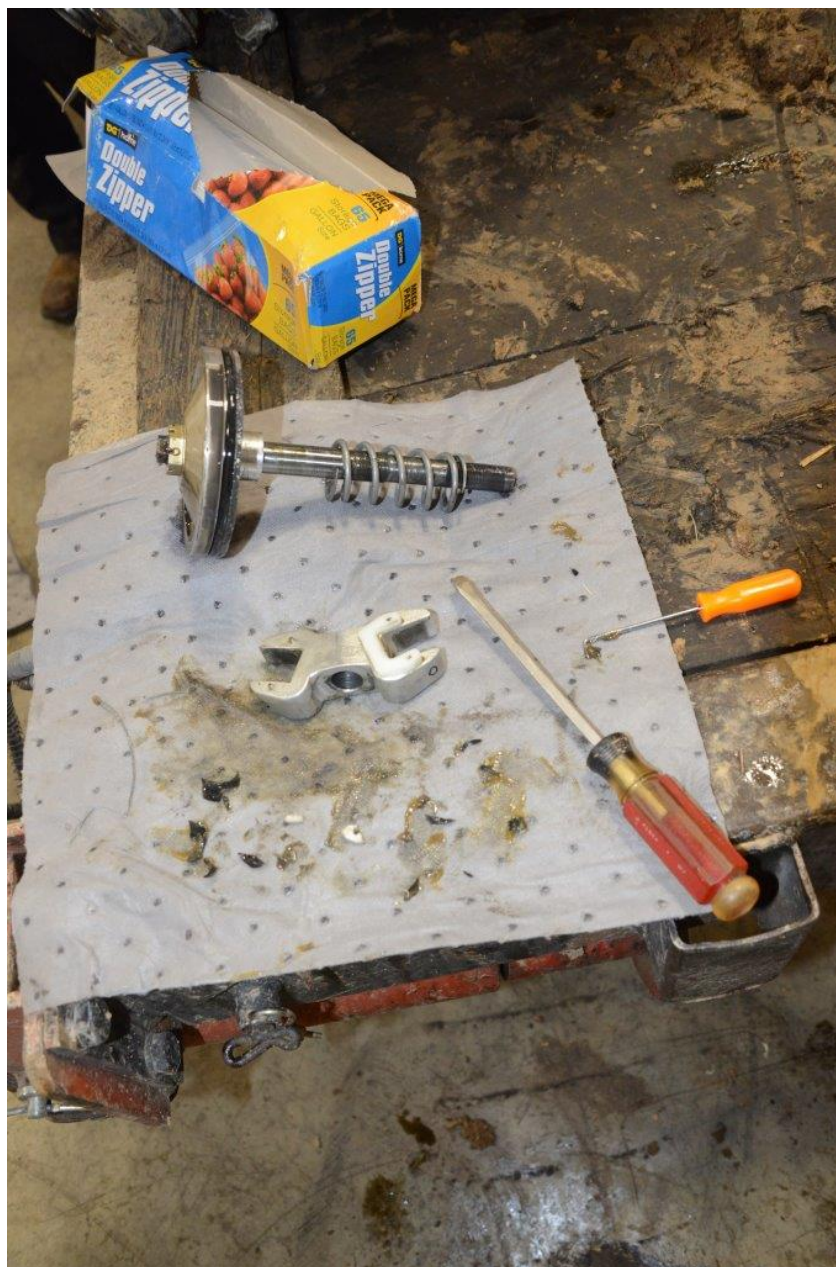
Photo 18 - View of the propeller piston, pitch change rod, spring, and pitch change fork.

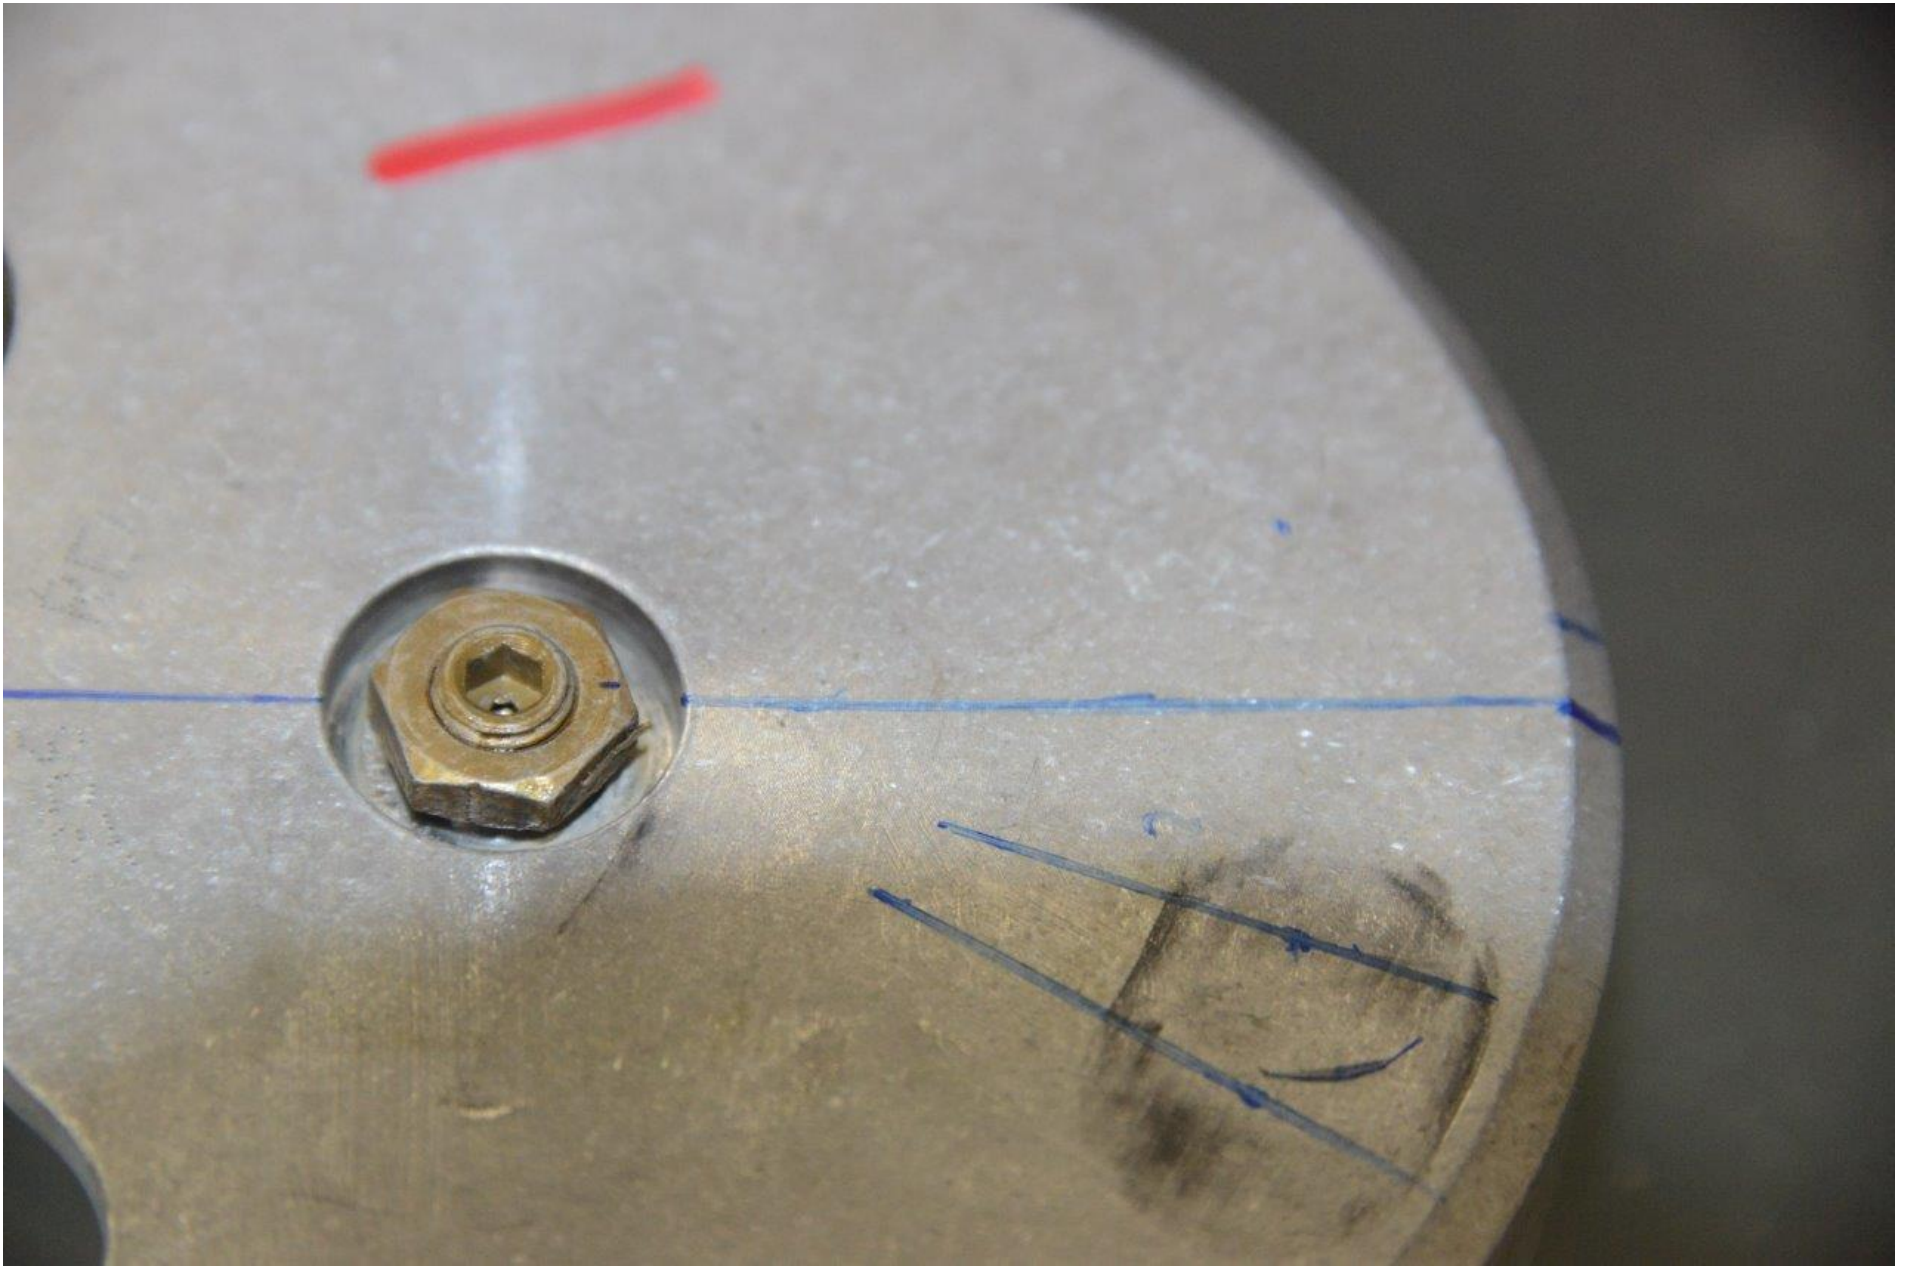
Photo 19 - View of the propeller preload plate marked no. 1.

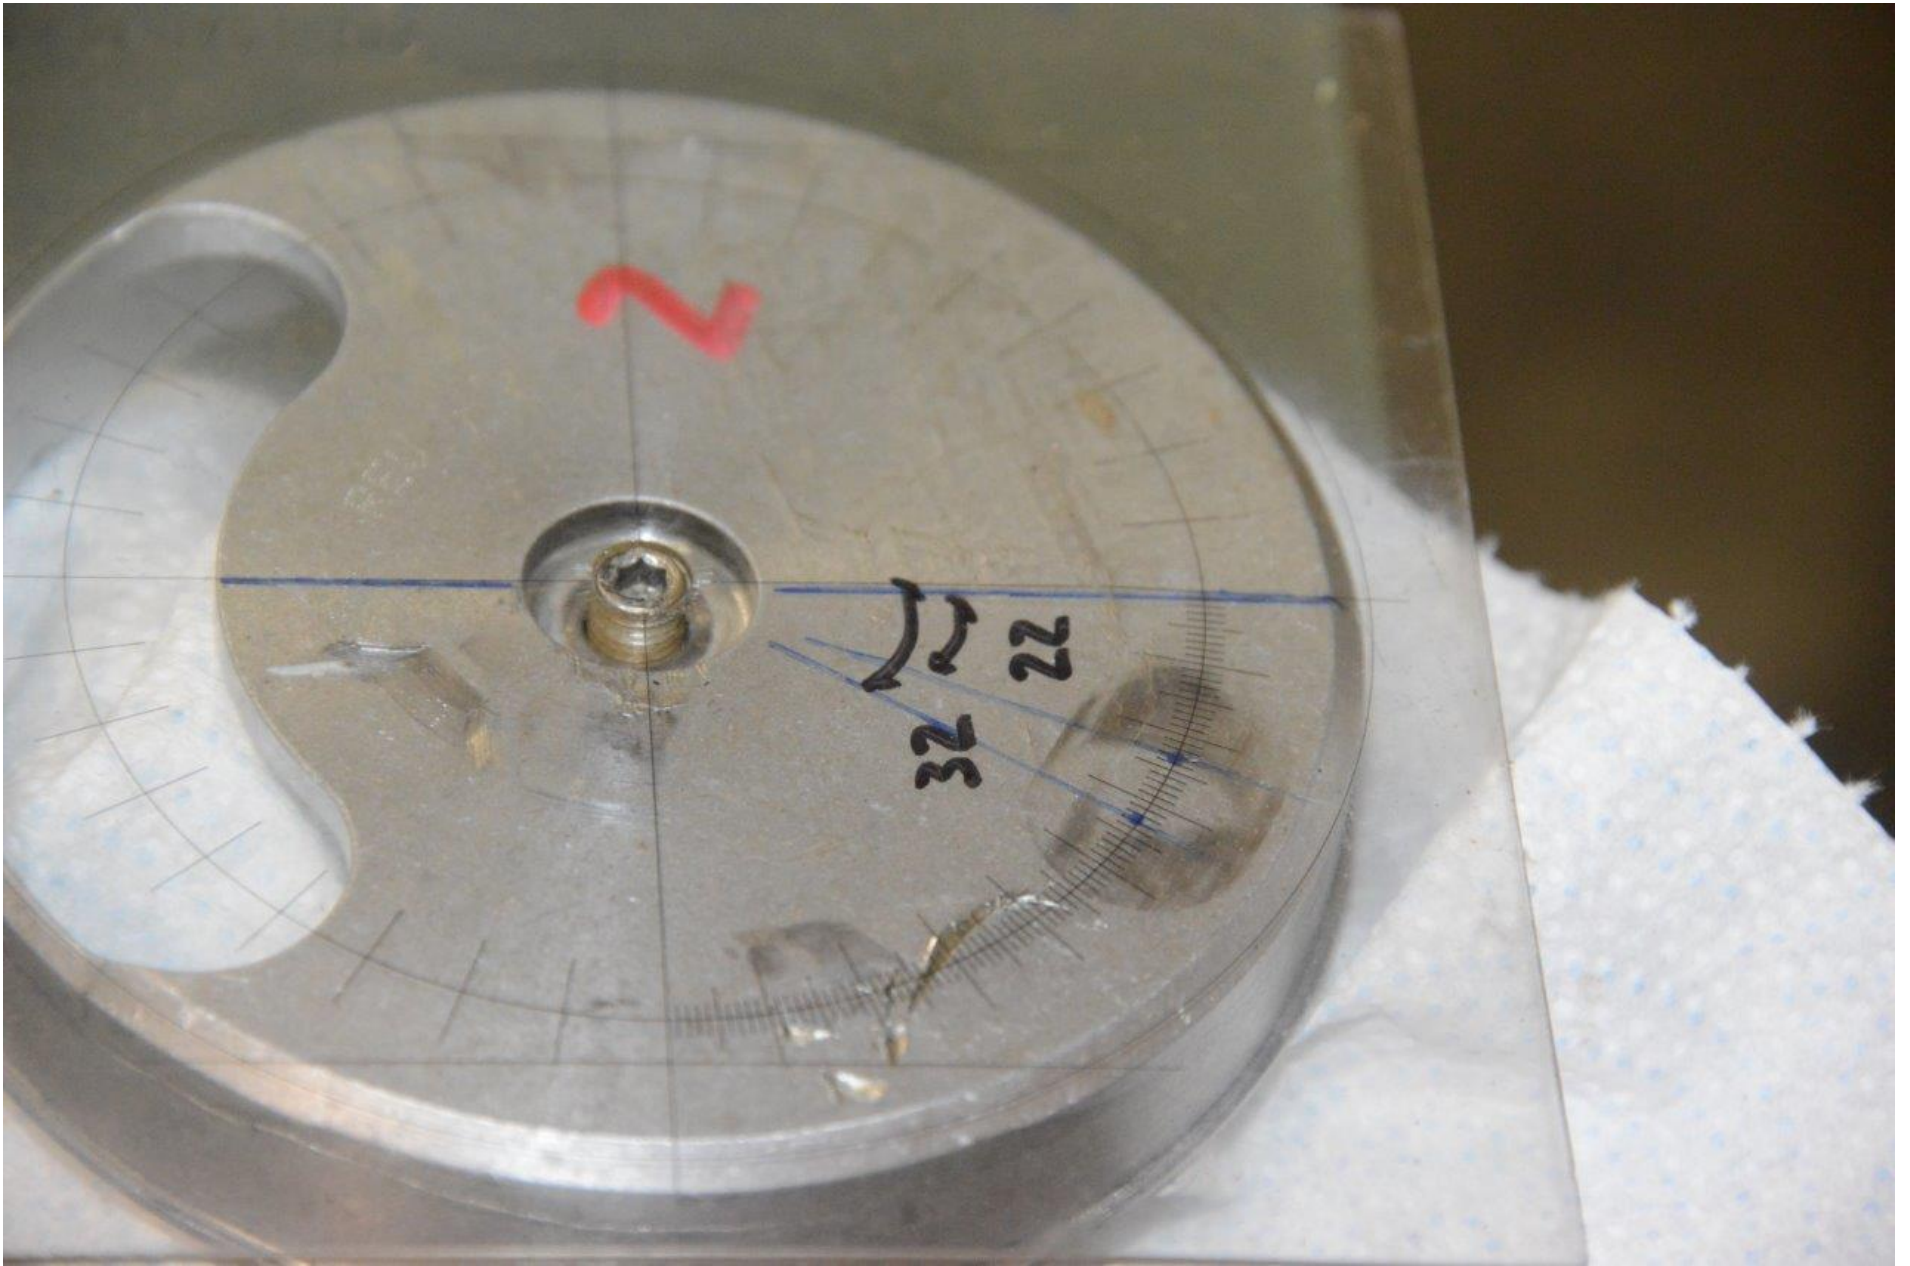
Photo 20 - View of the propeller preload plate marked no. 2.
