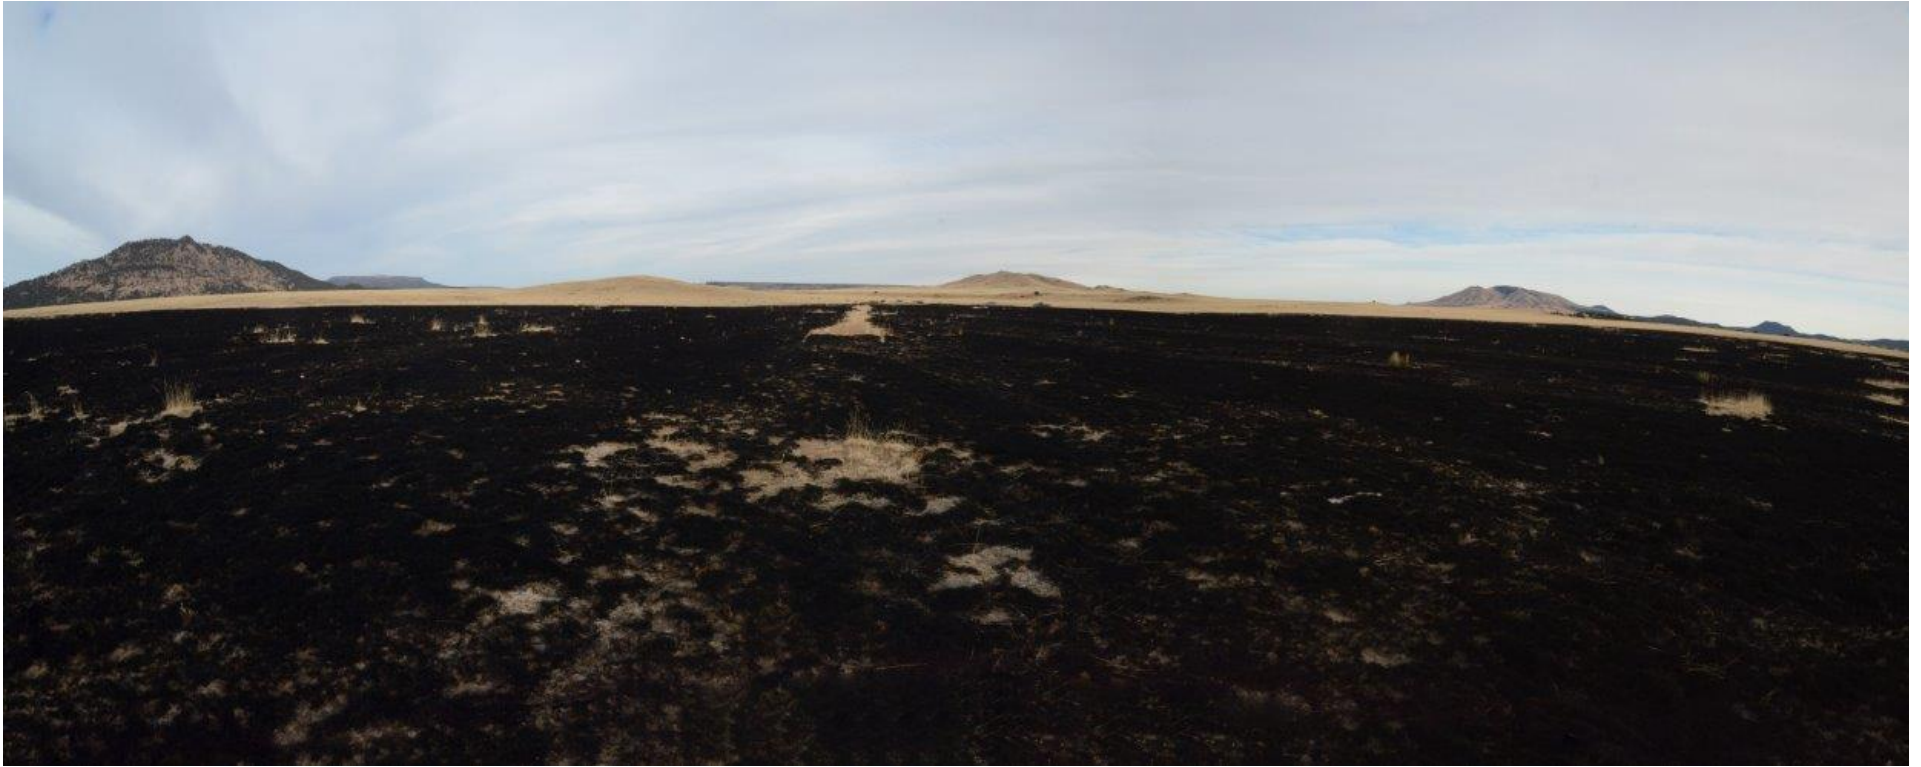
Photo 1 – View looking towards the initial impact site.

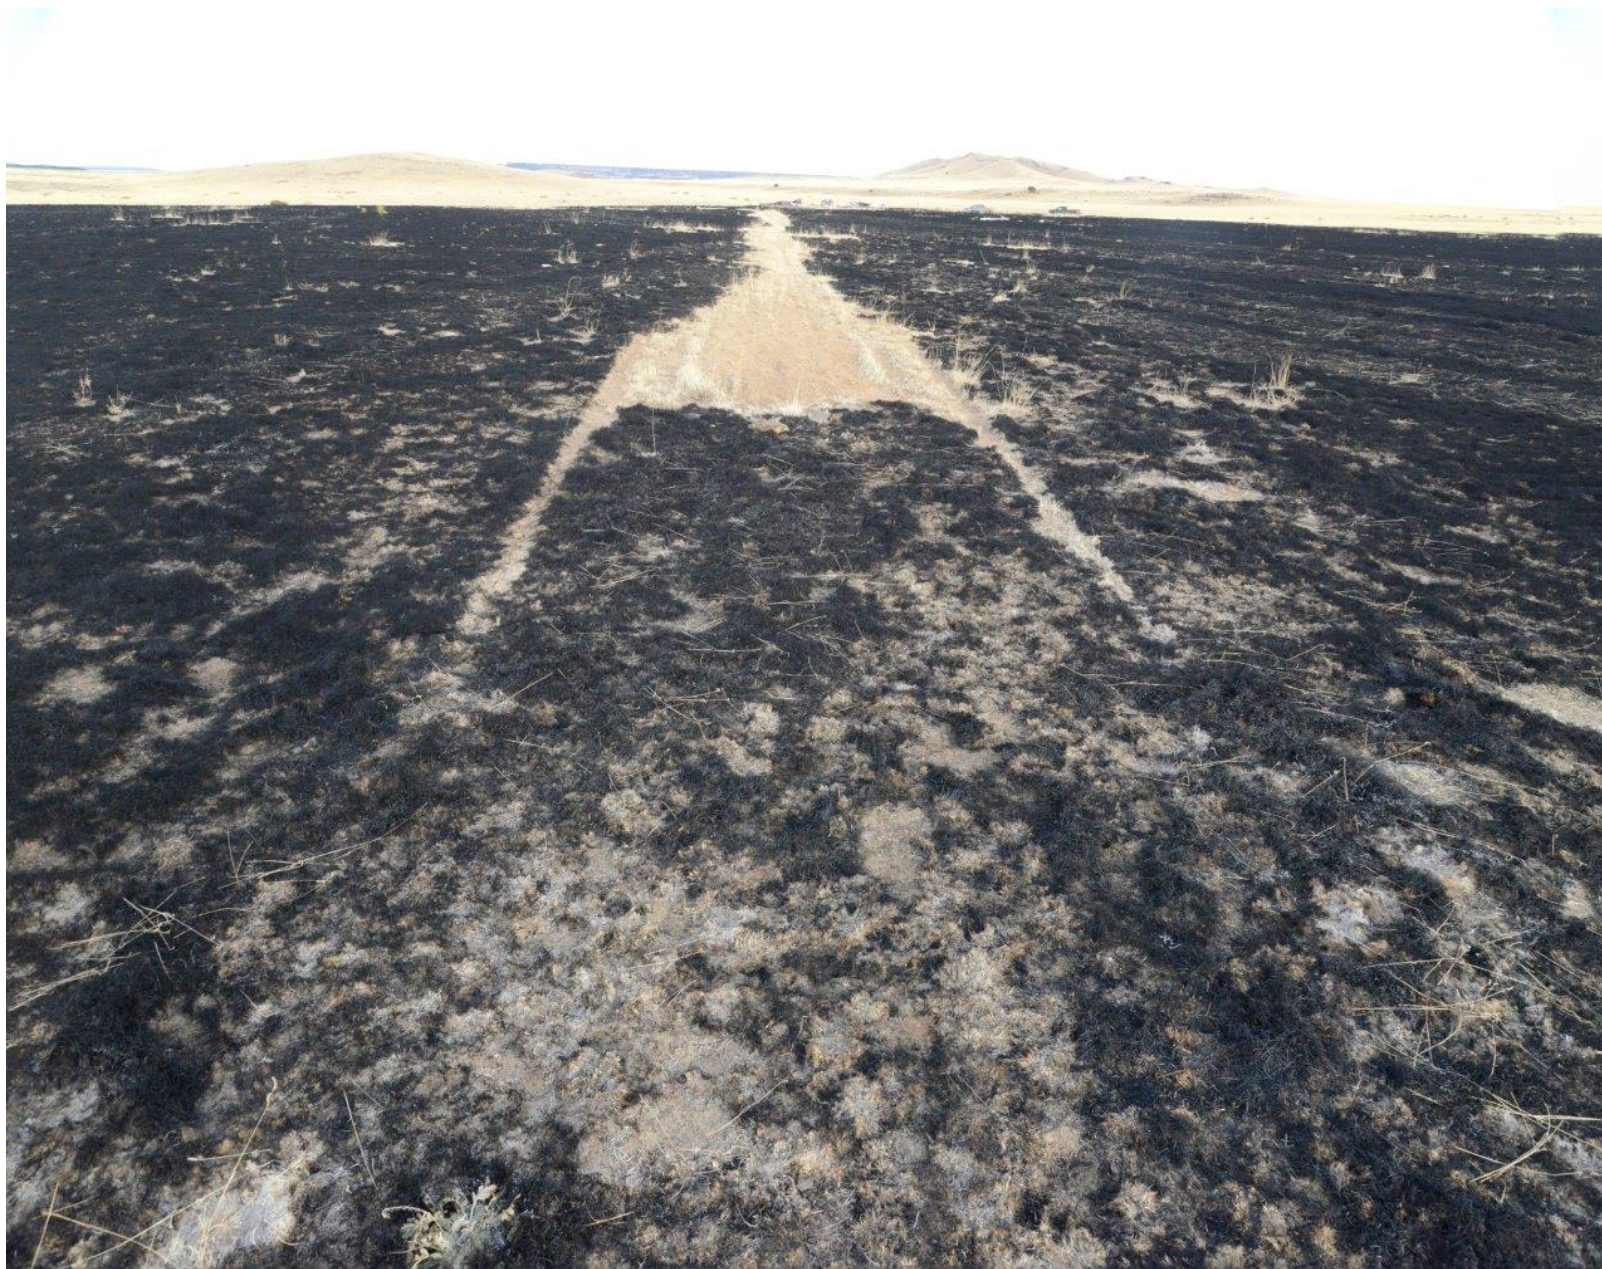
Photo 2 - Close-up view looking towards the initial impact site.

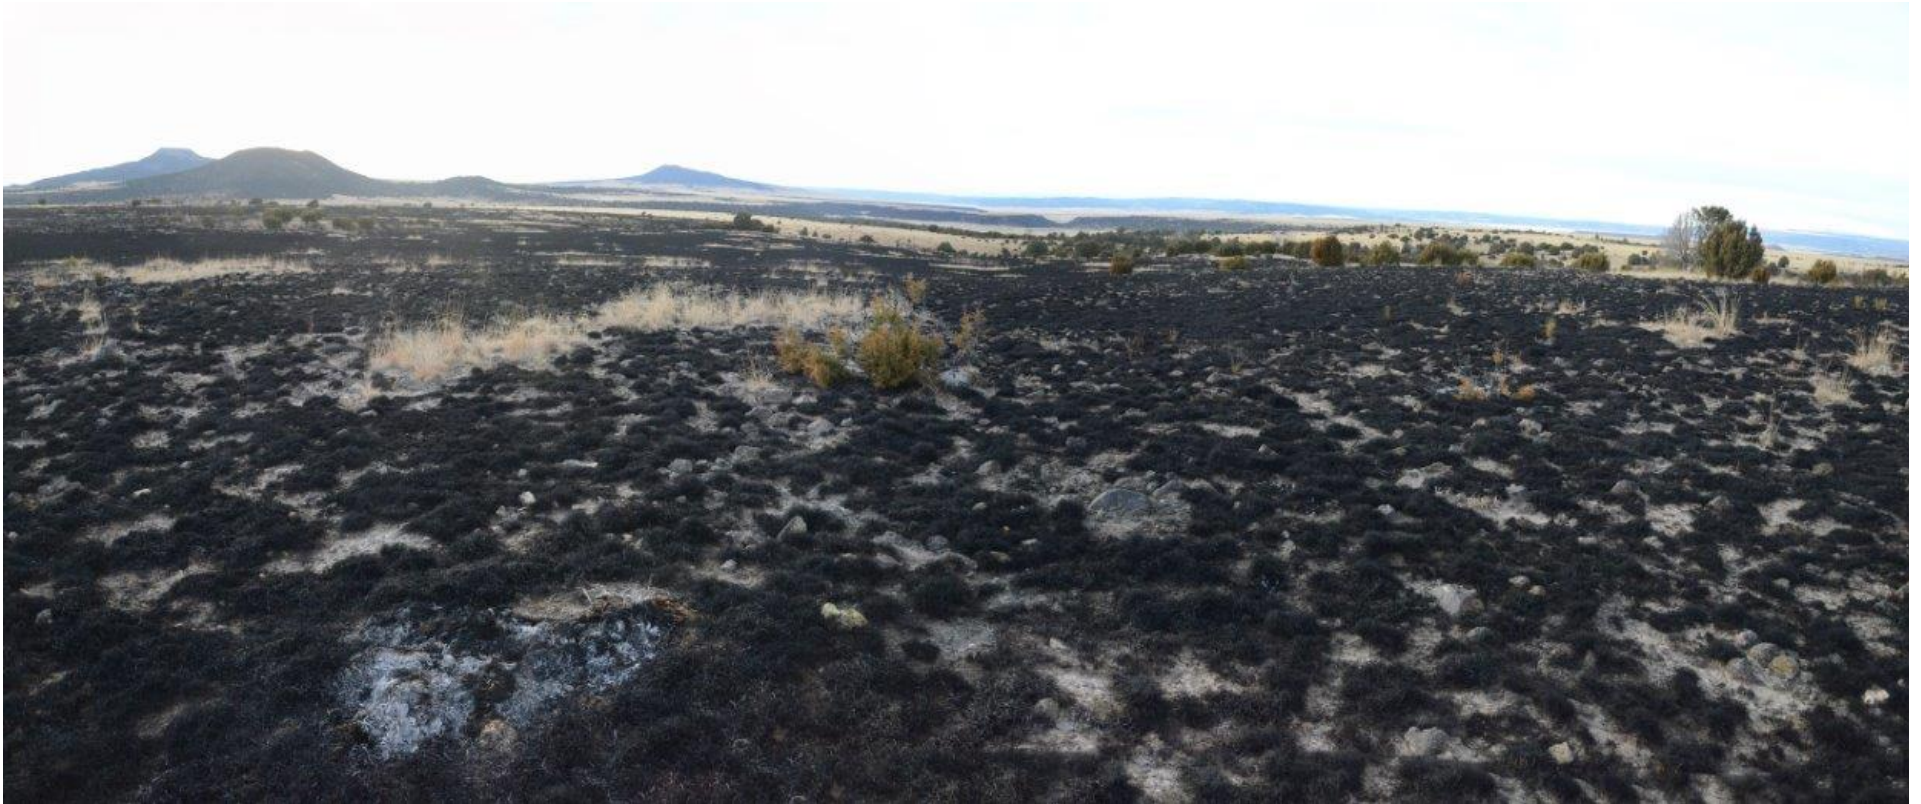
Photo 3 - View looking towards RTN from the initial impact site.

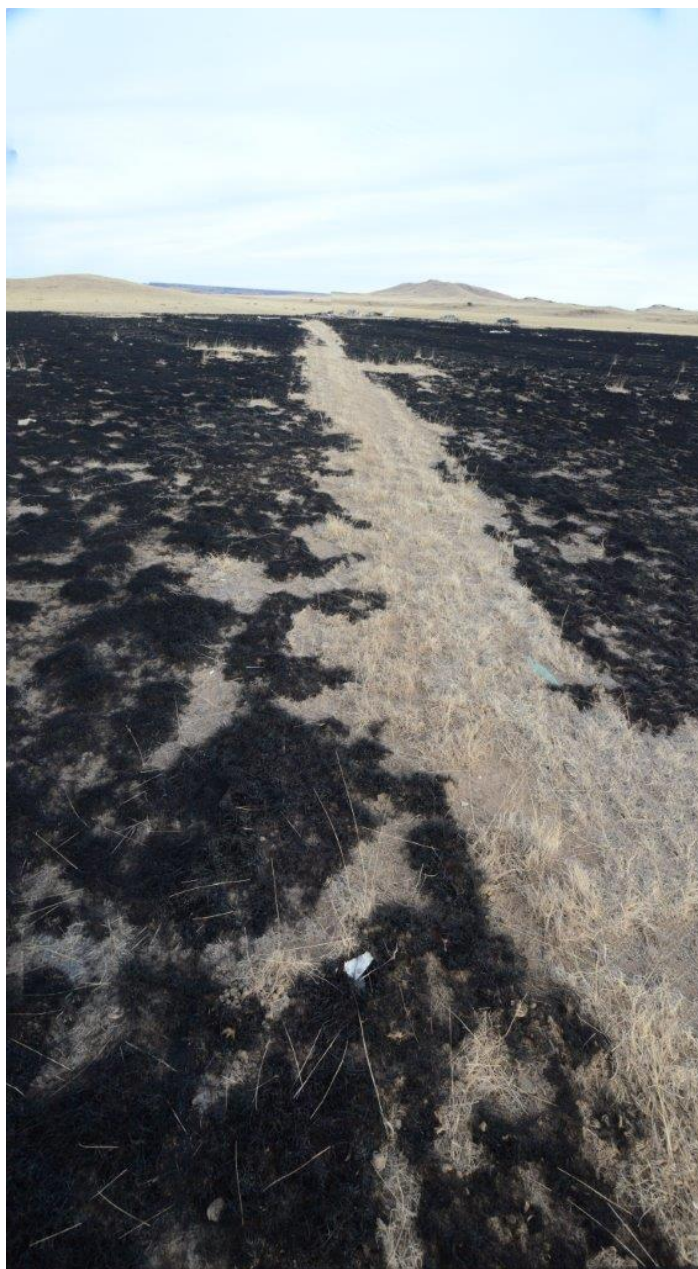
Photo 4 - View of the debris path looking towards the main wreckage.

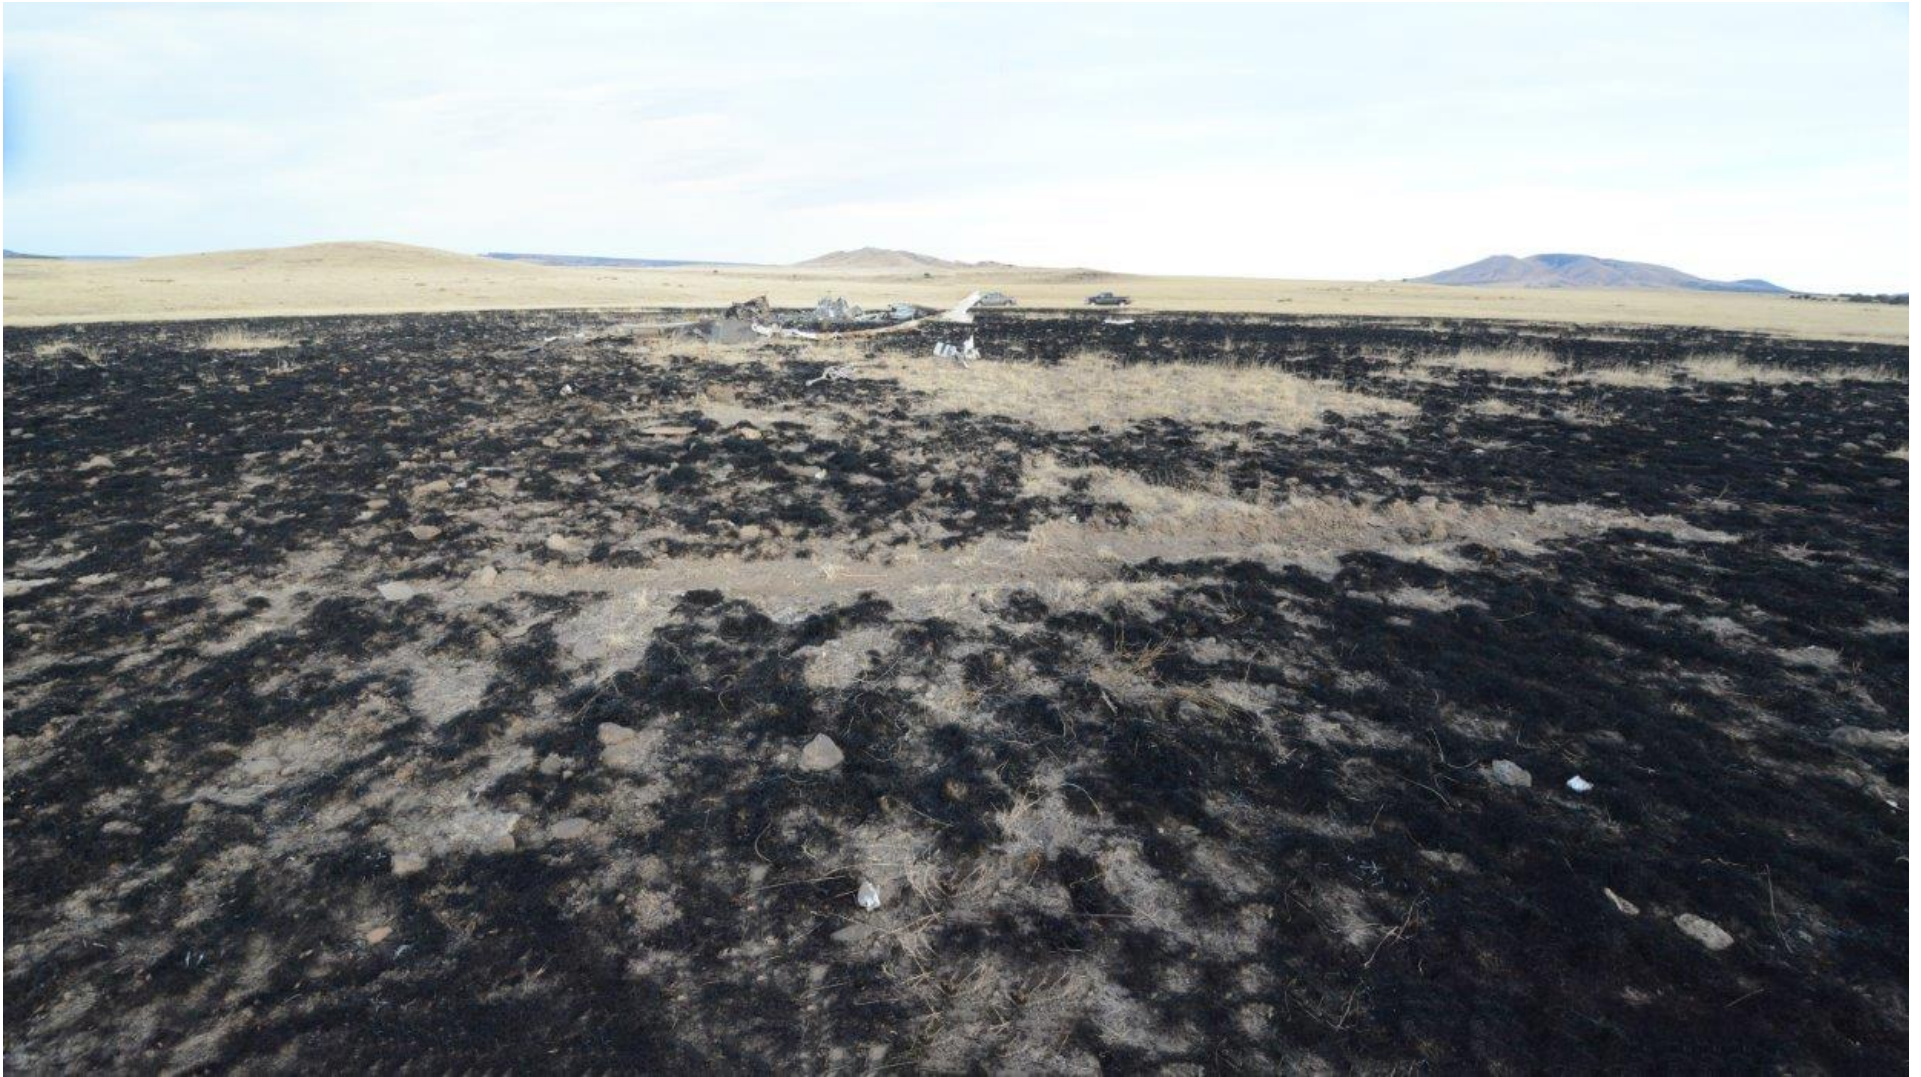
Photo 5 - View of a ground scar that is perpendicular to the debris path.

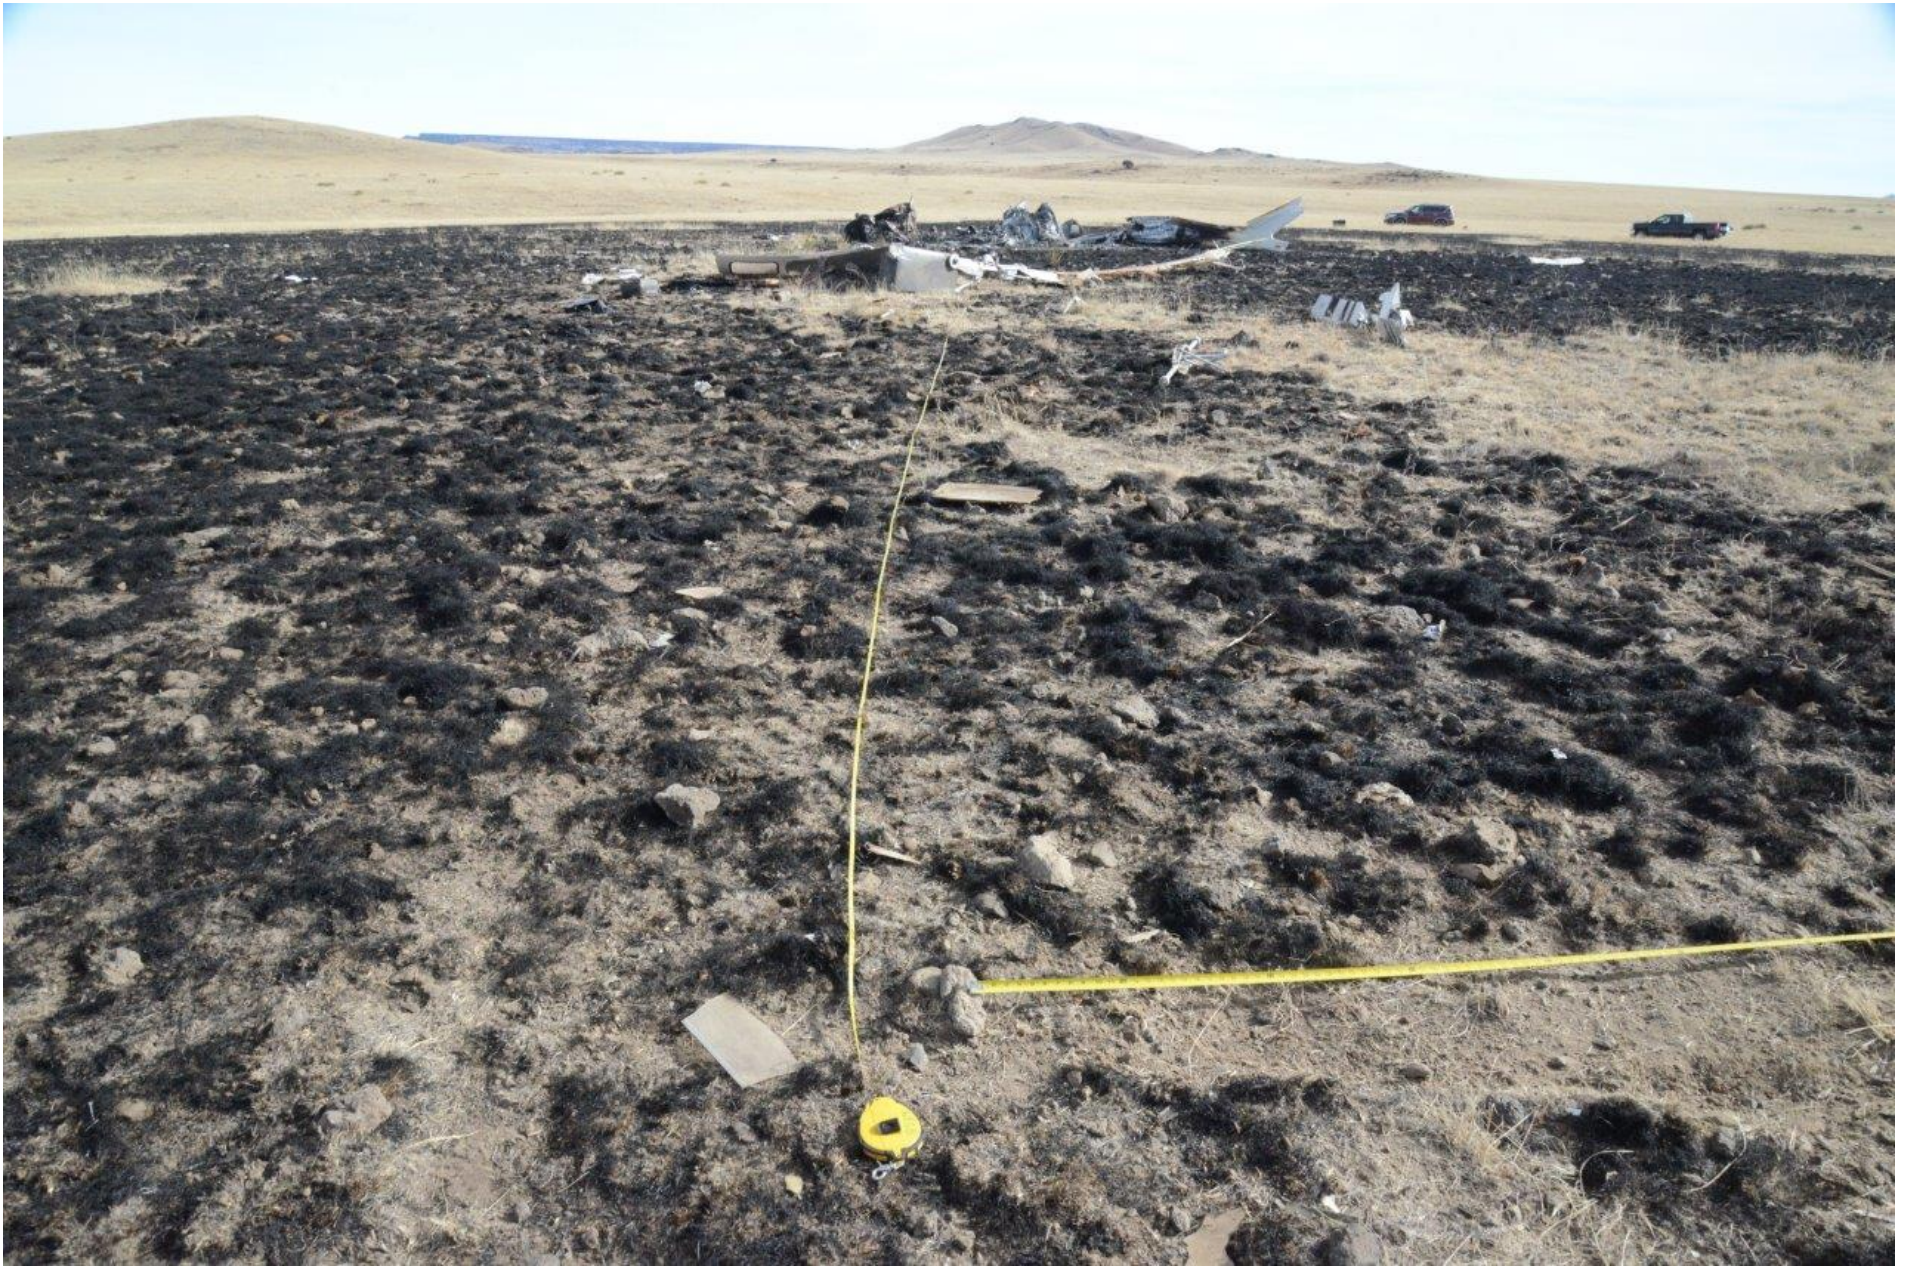
Photo 6 - View from the ground scar looking towards the main wreckage.

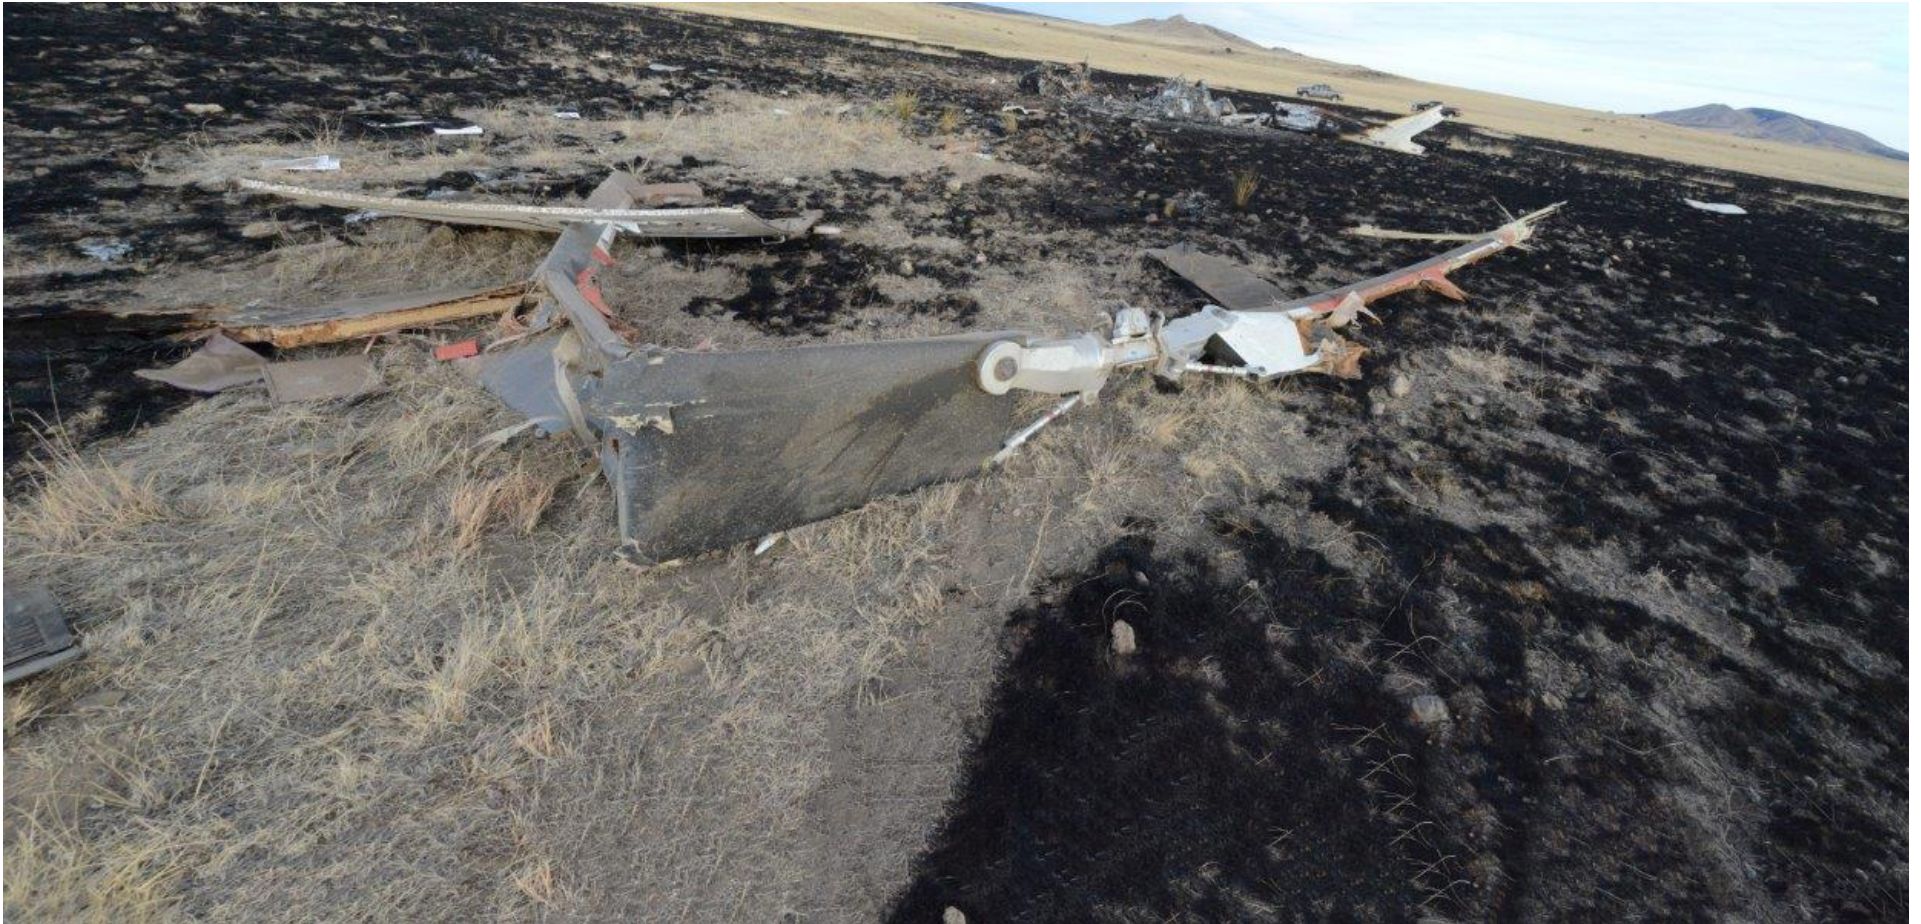
Photo 7 - View from the main rotor blades looking towards the main wreckage.

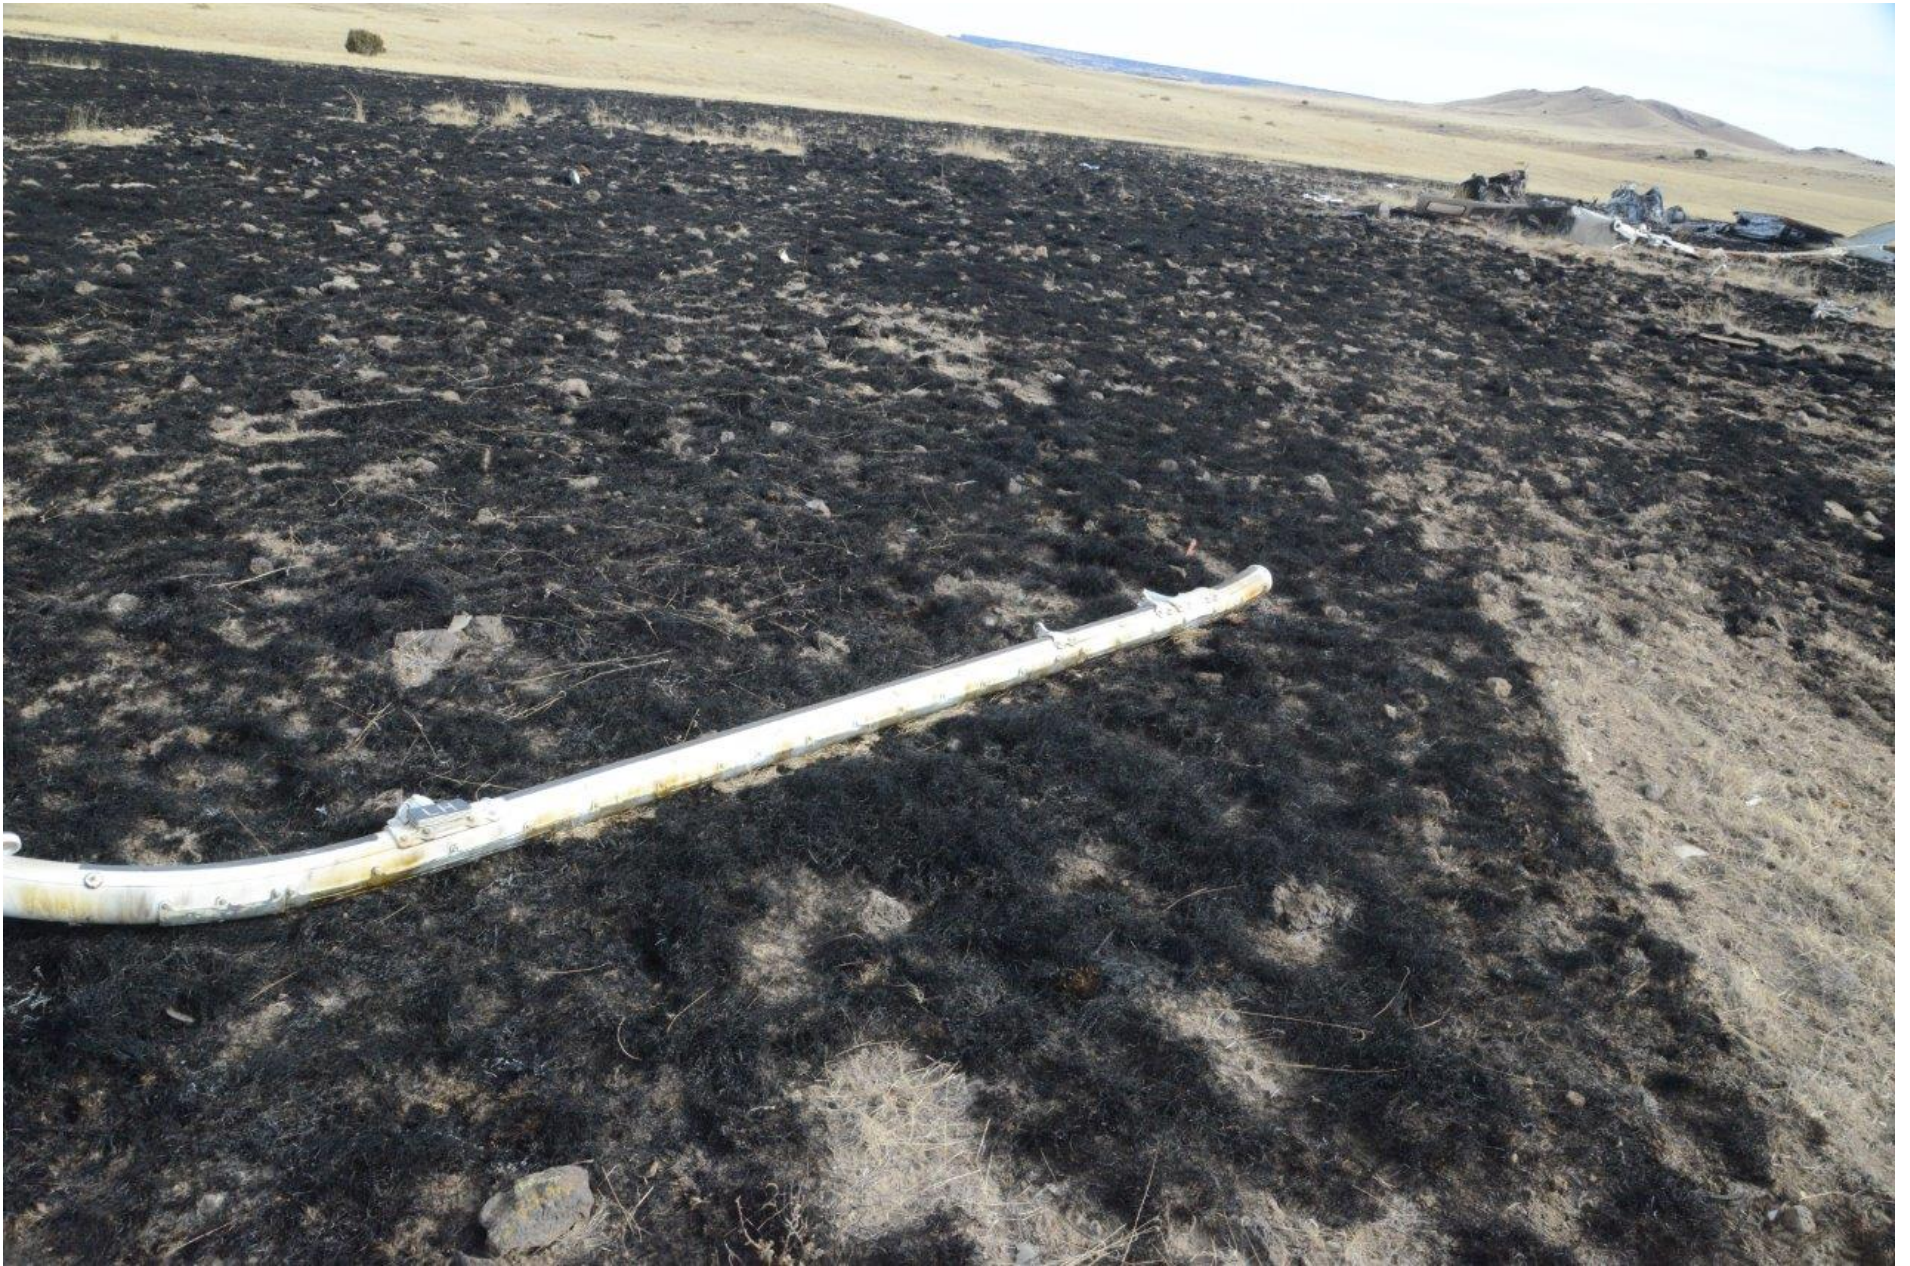
Photo 8 - View from the separated left skid looking towards the main wreckage.

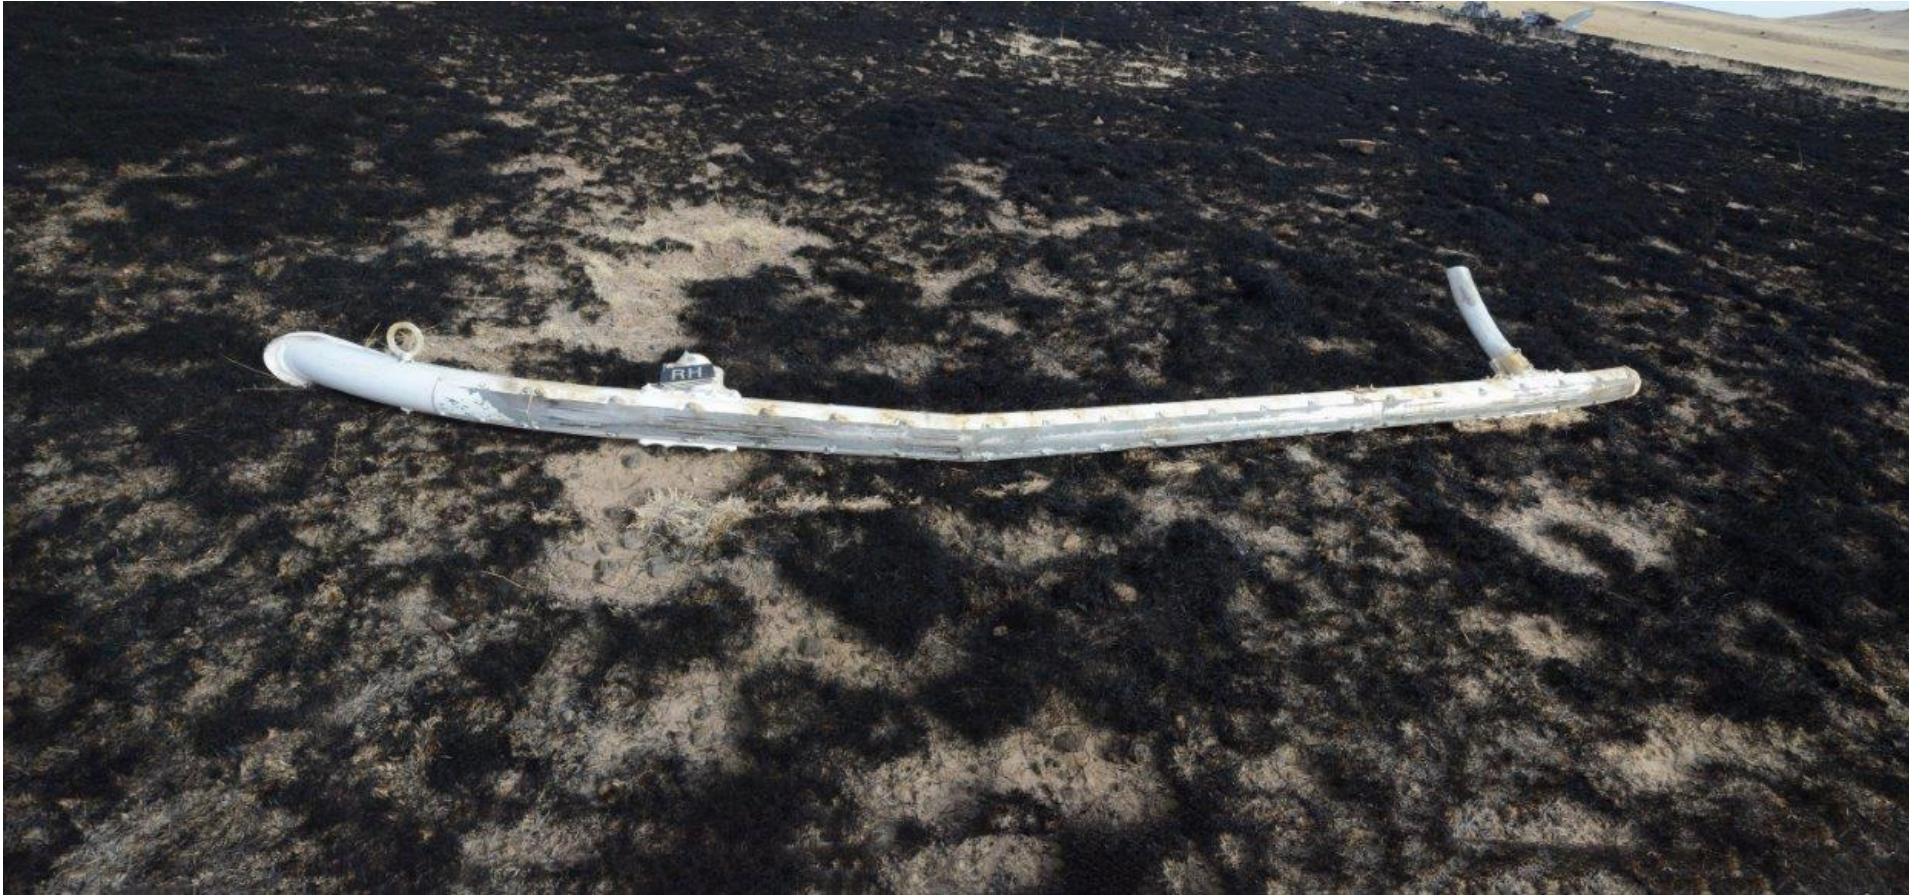
Photo 9 - View from the separated right skid looking towards the main wreckage.

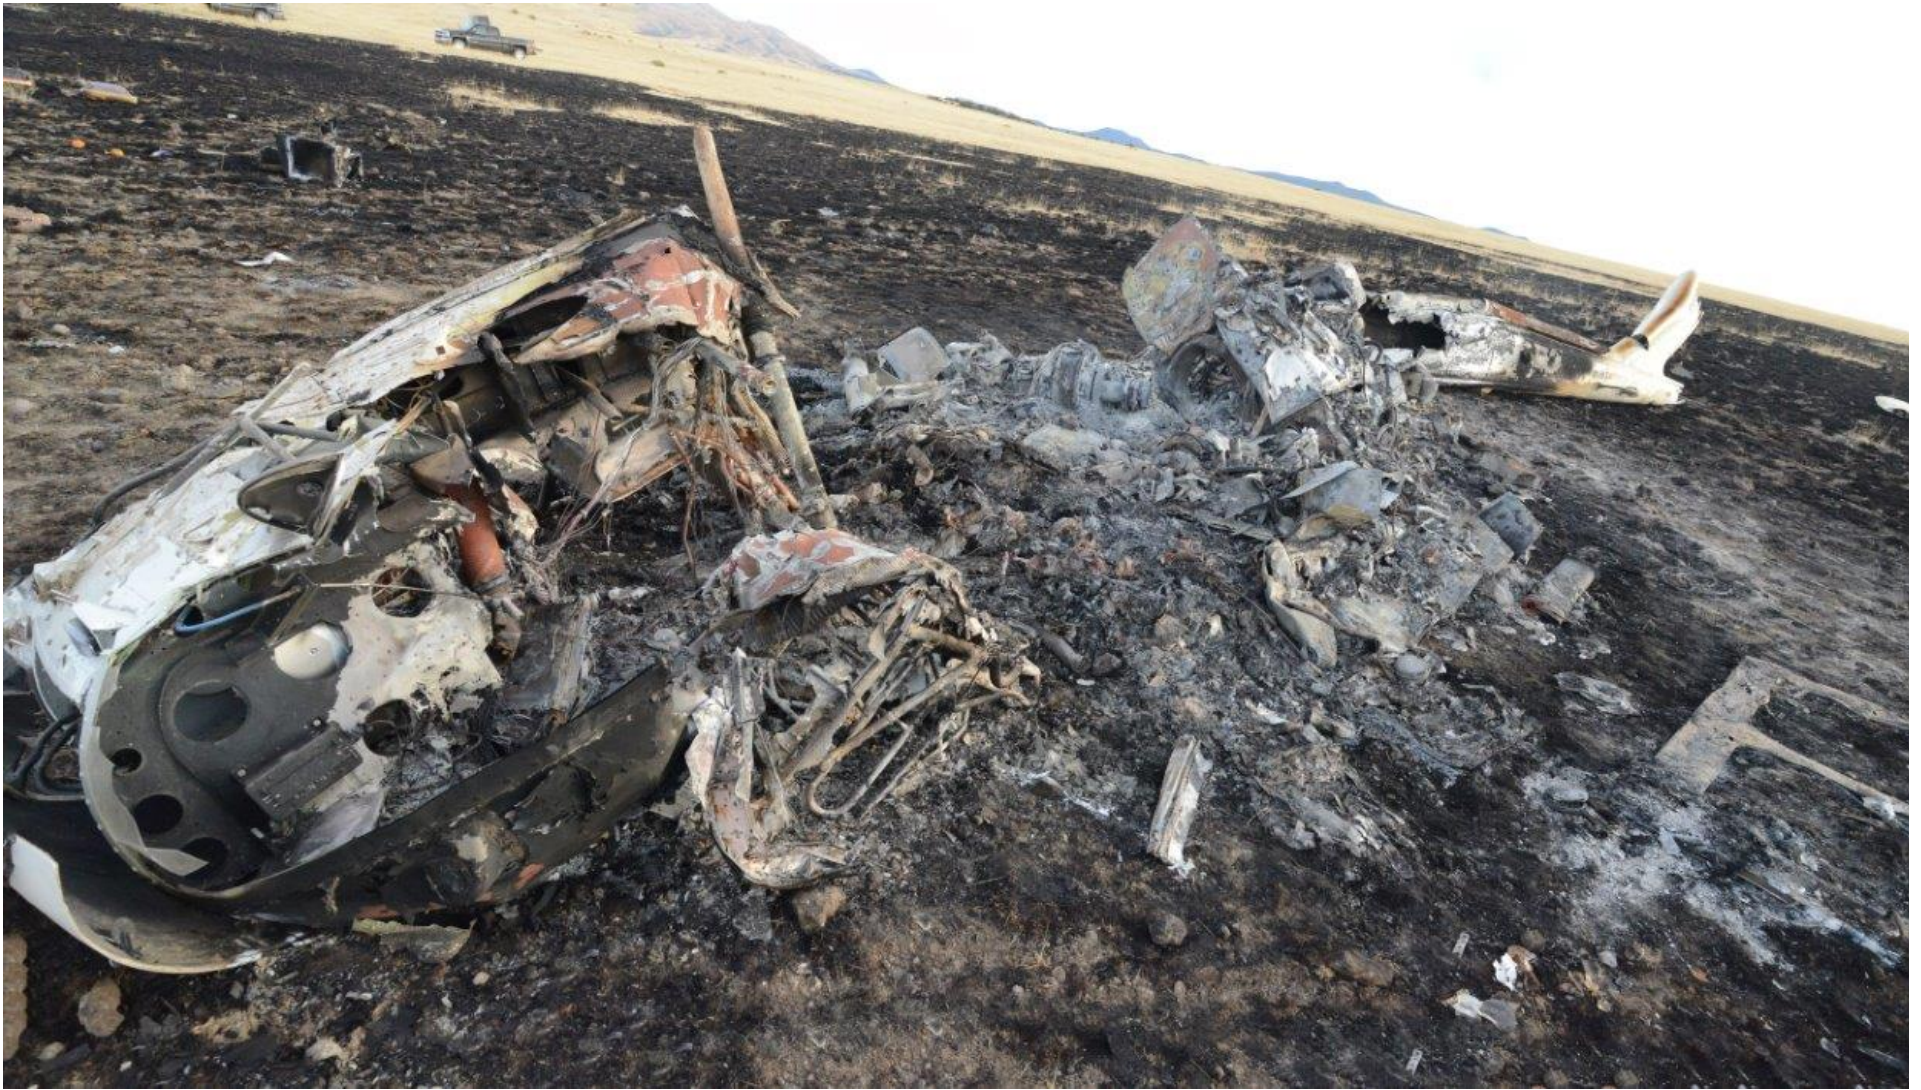
Photo 10 - View of the main wreckage.

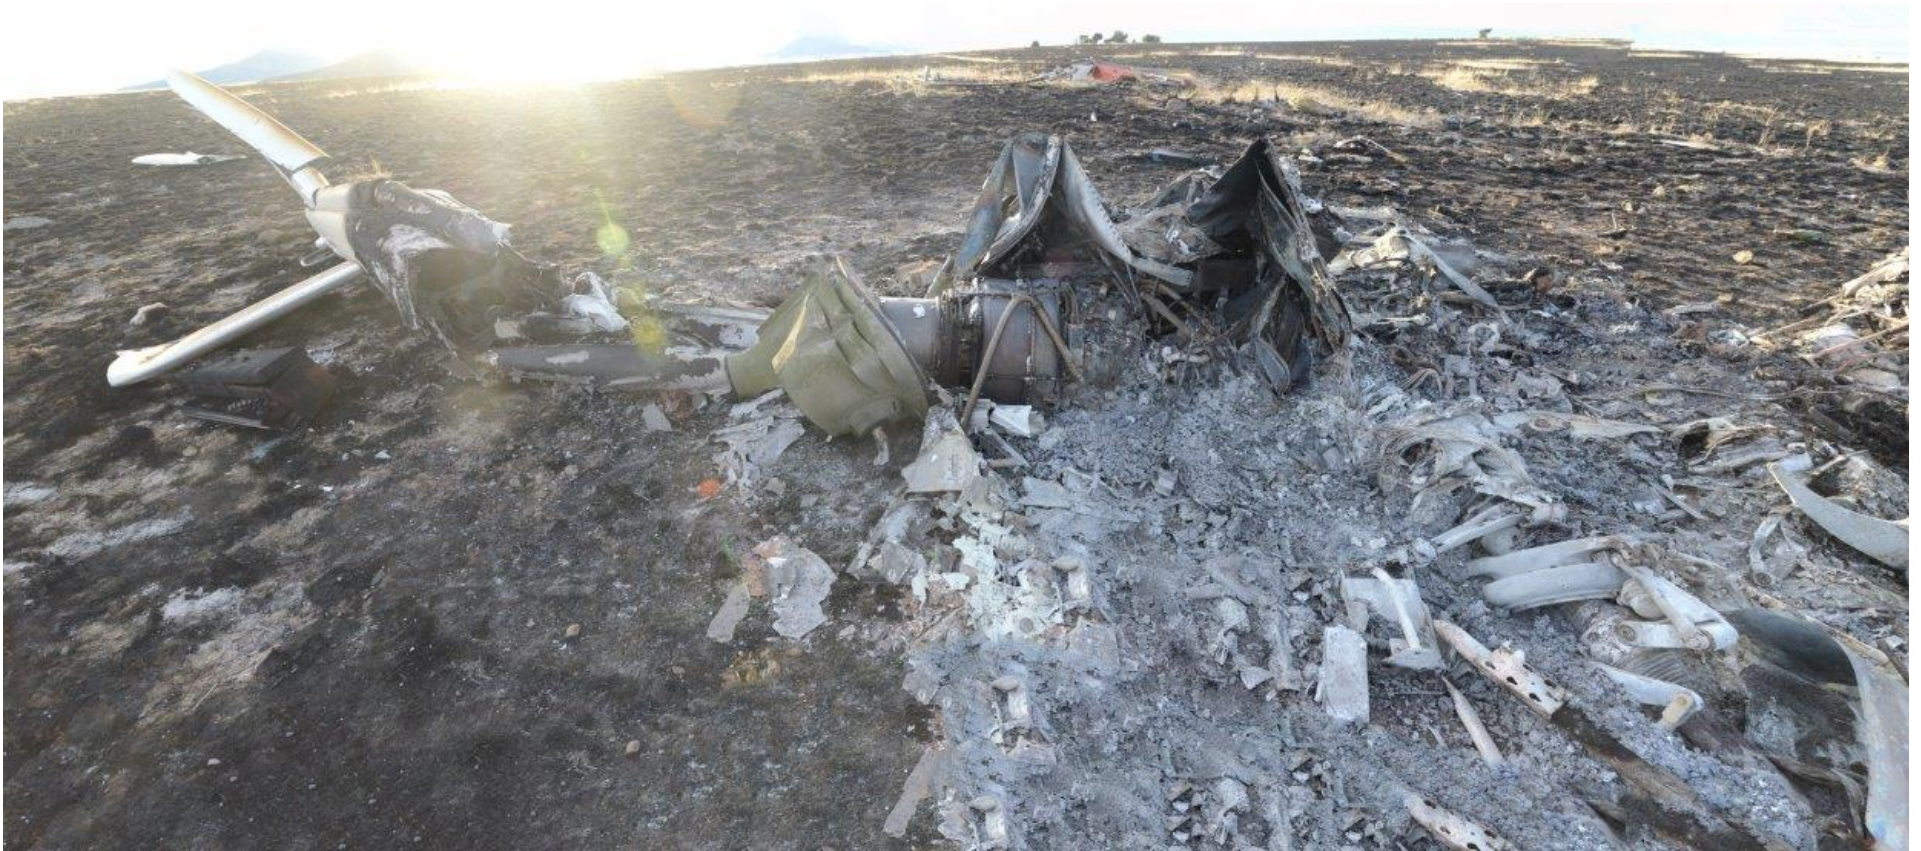
Photo 11 - View of the engine in the main wreckage.

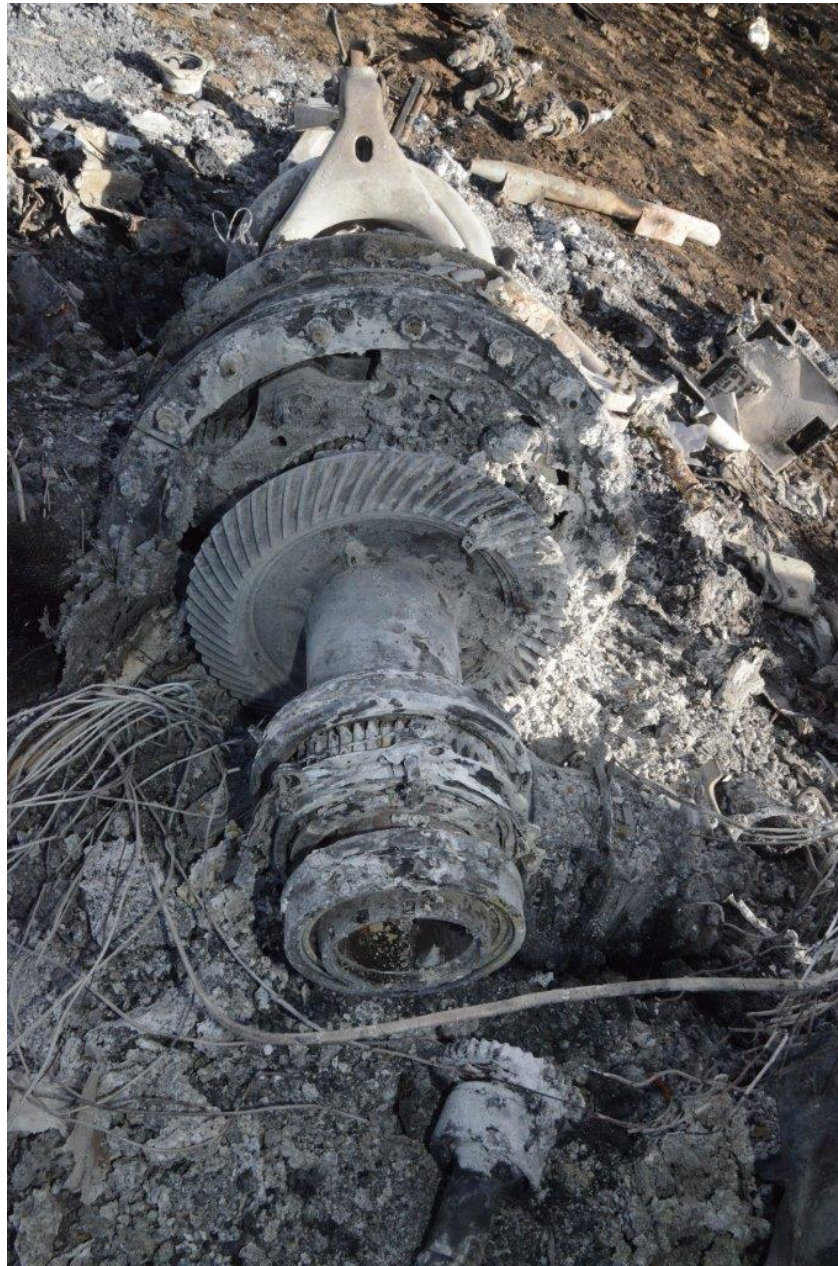
Photo 12 - View of transmission gears.

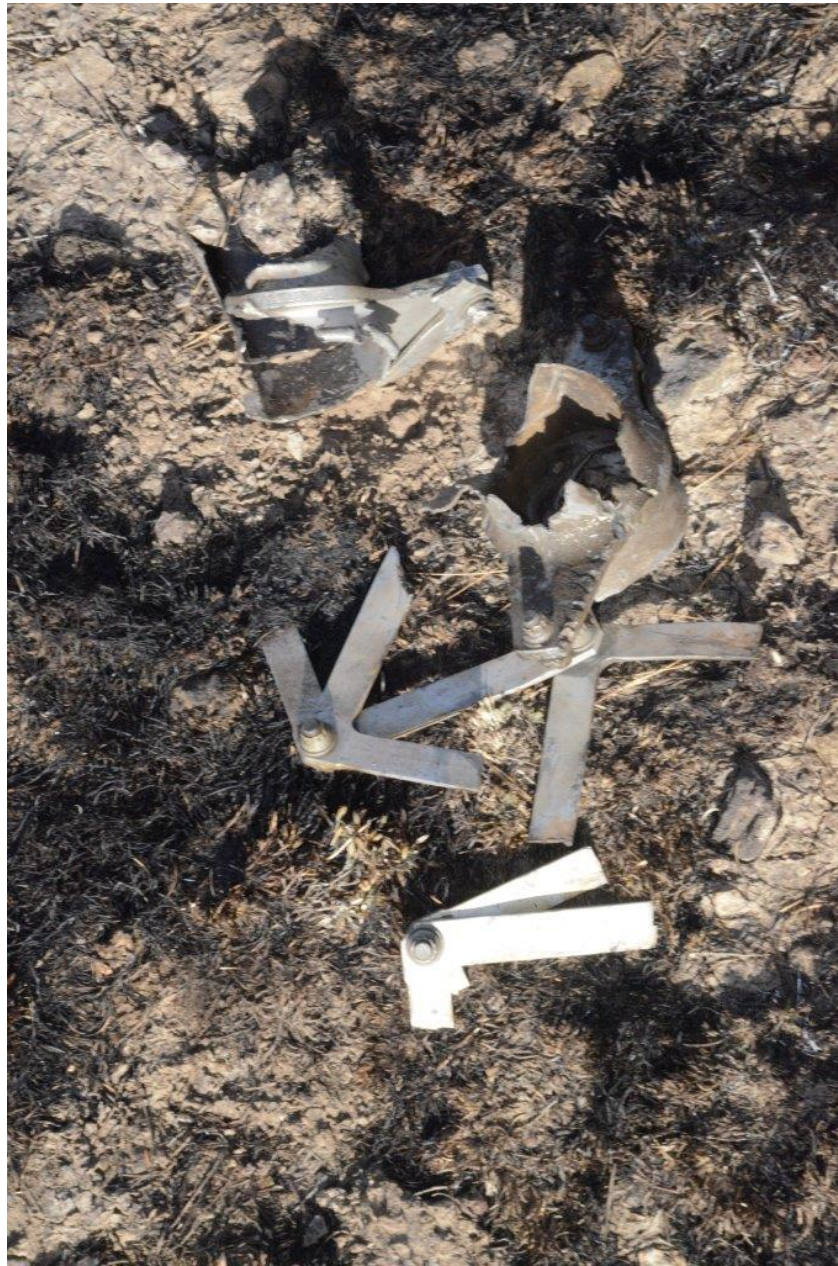
Photo 13 - View of liberated K-flex components.
