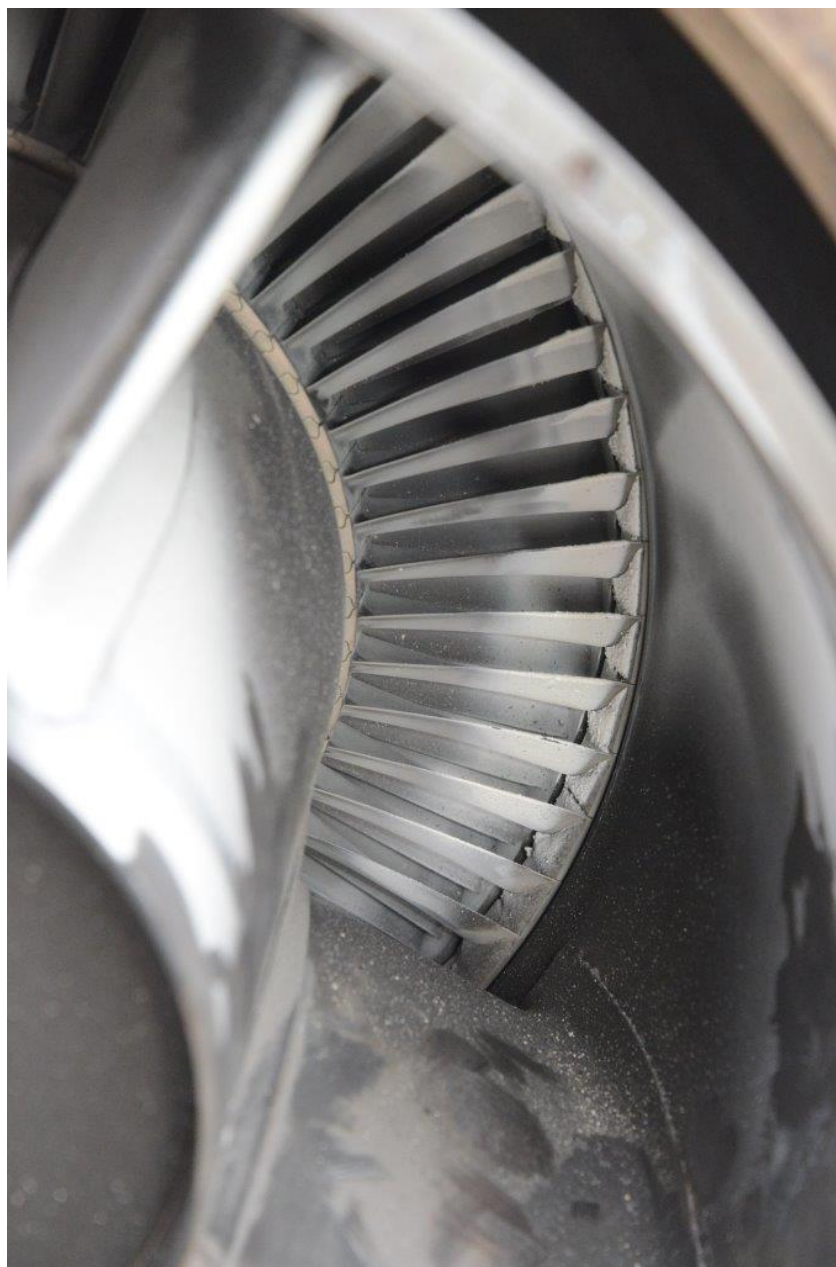
Photo 14 - View of engine turbine blades.

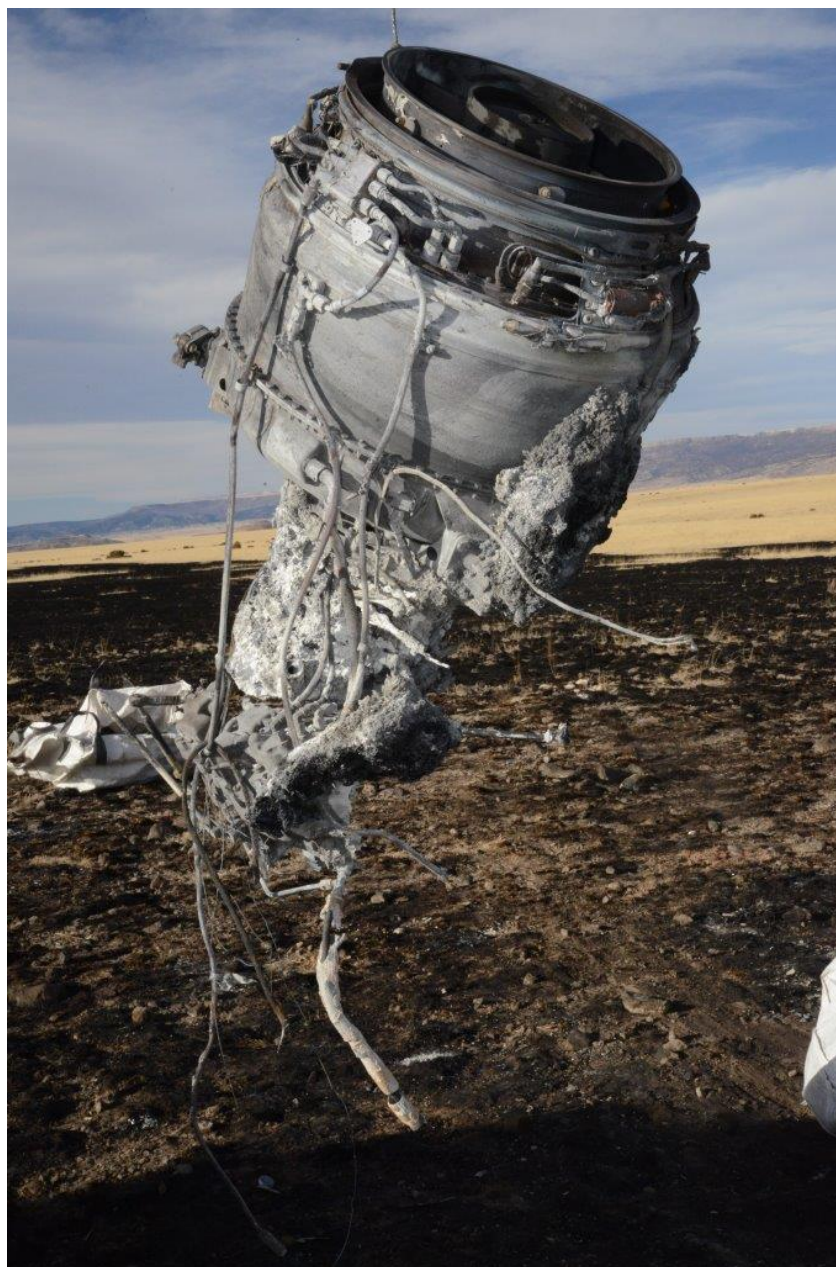
Photo 15 - View of the engine during recovery.

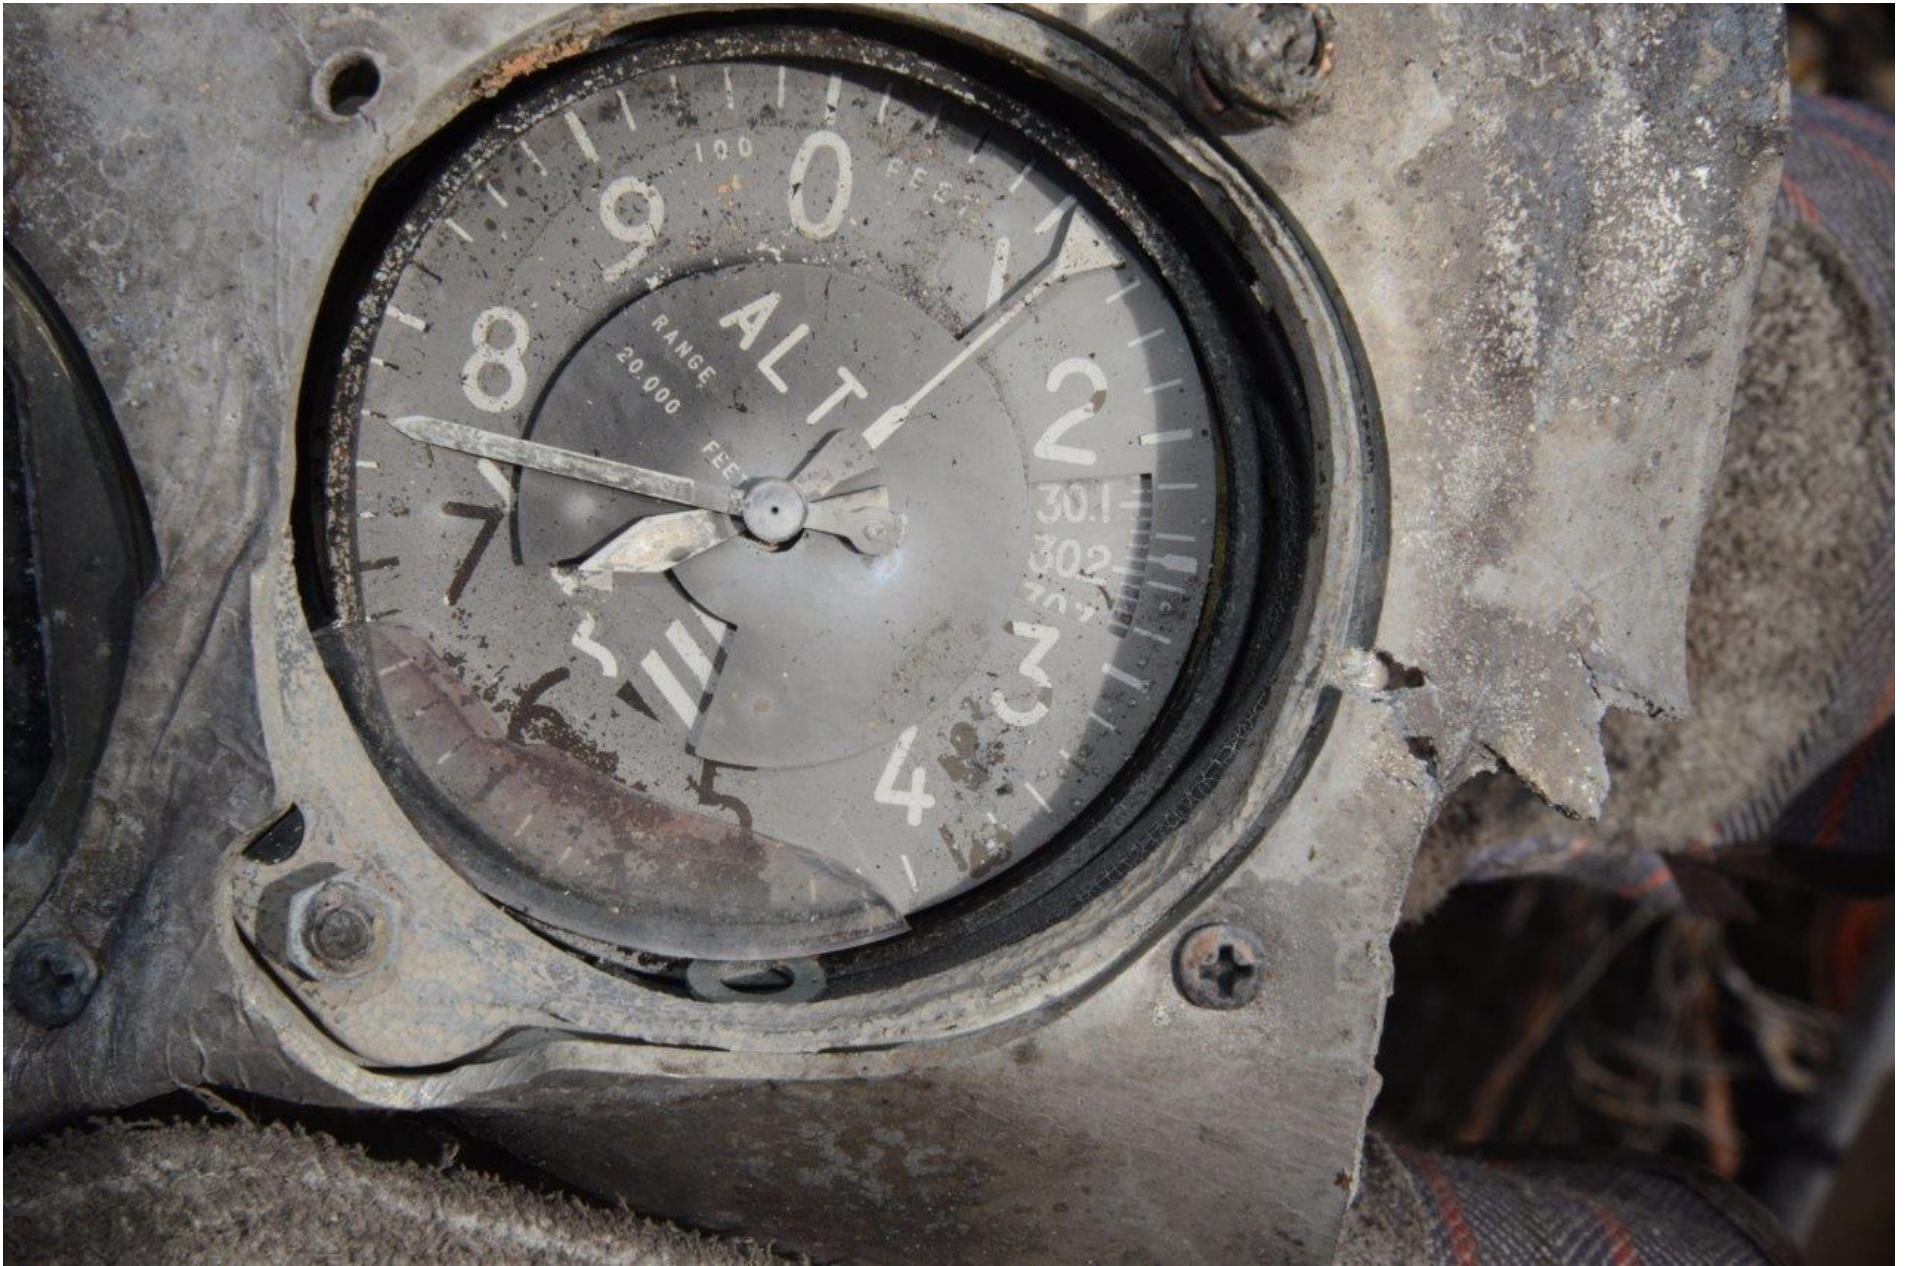
Photo 16 - Close-up view of an altimeter.

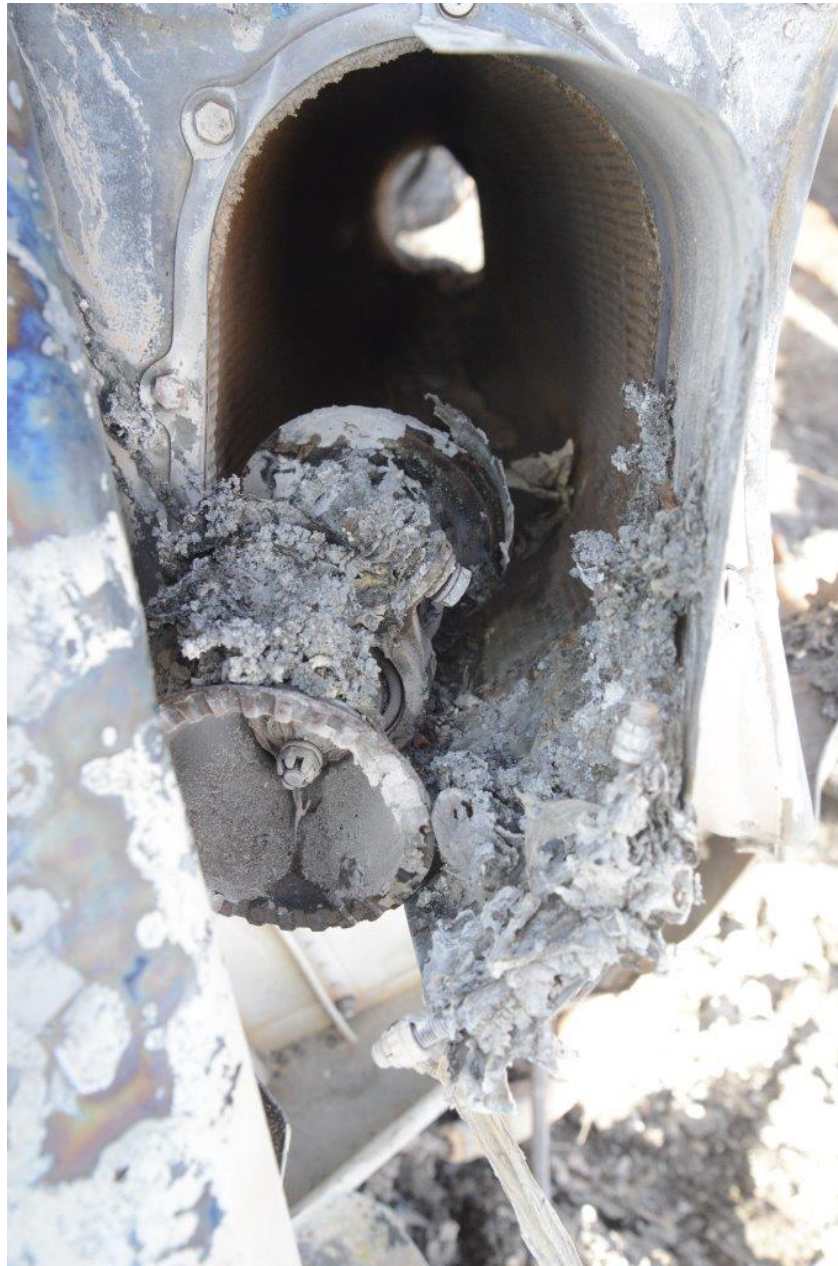
Photo 17 - Close-up view of a coupling in the tail rotor drive system.

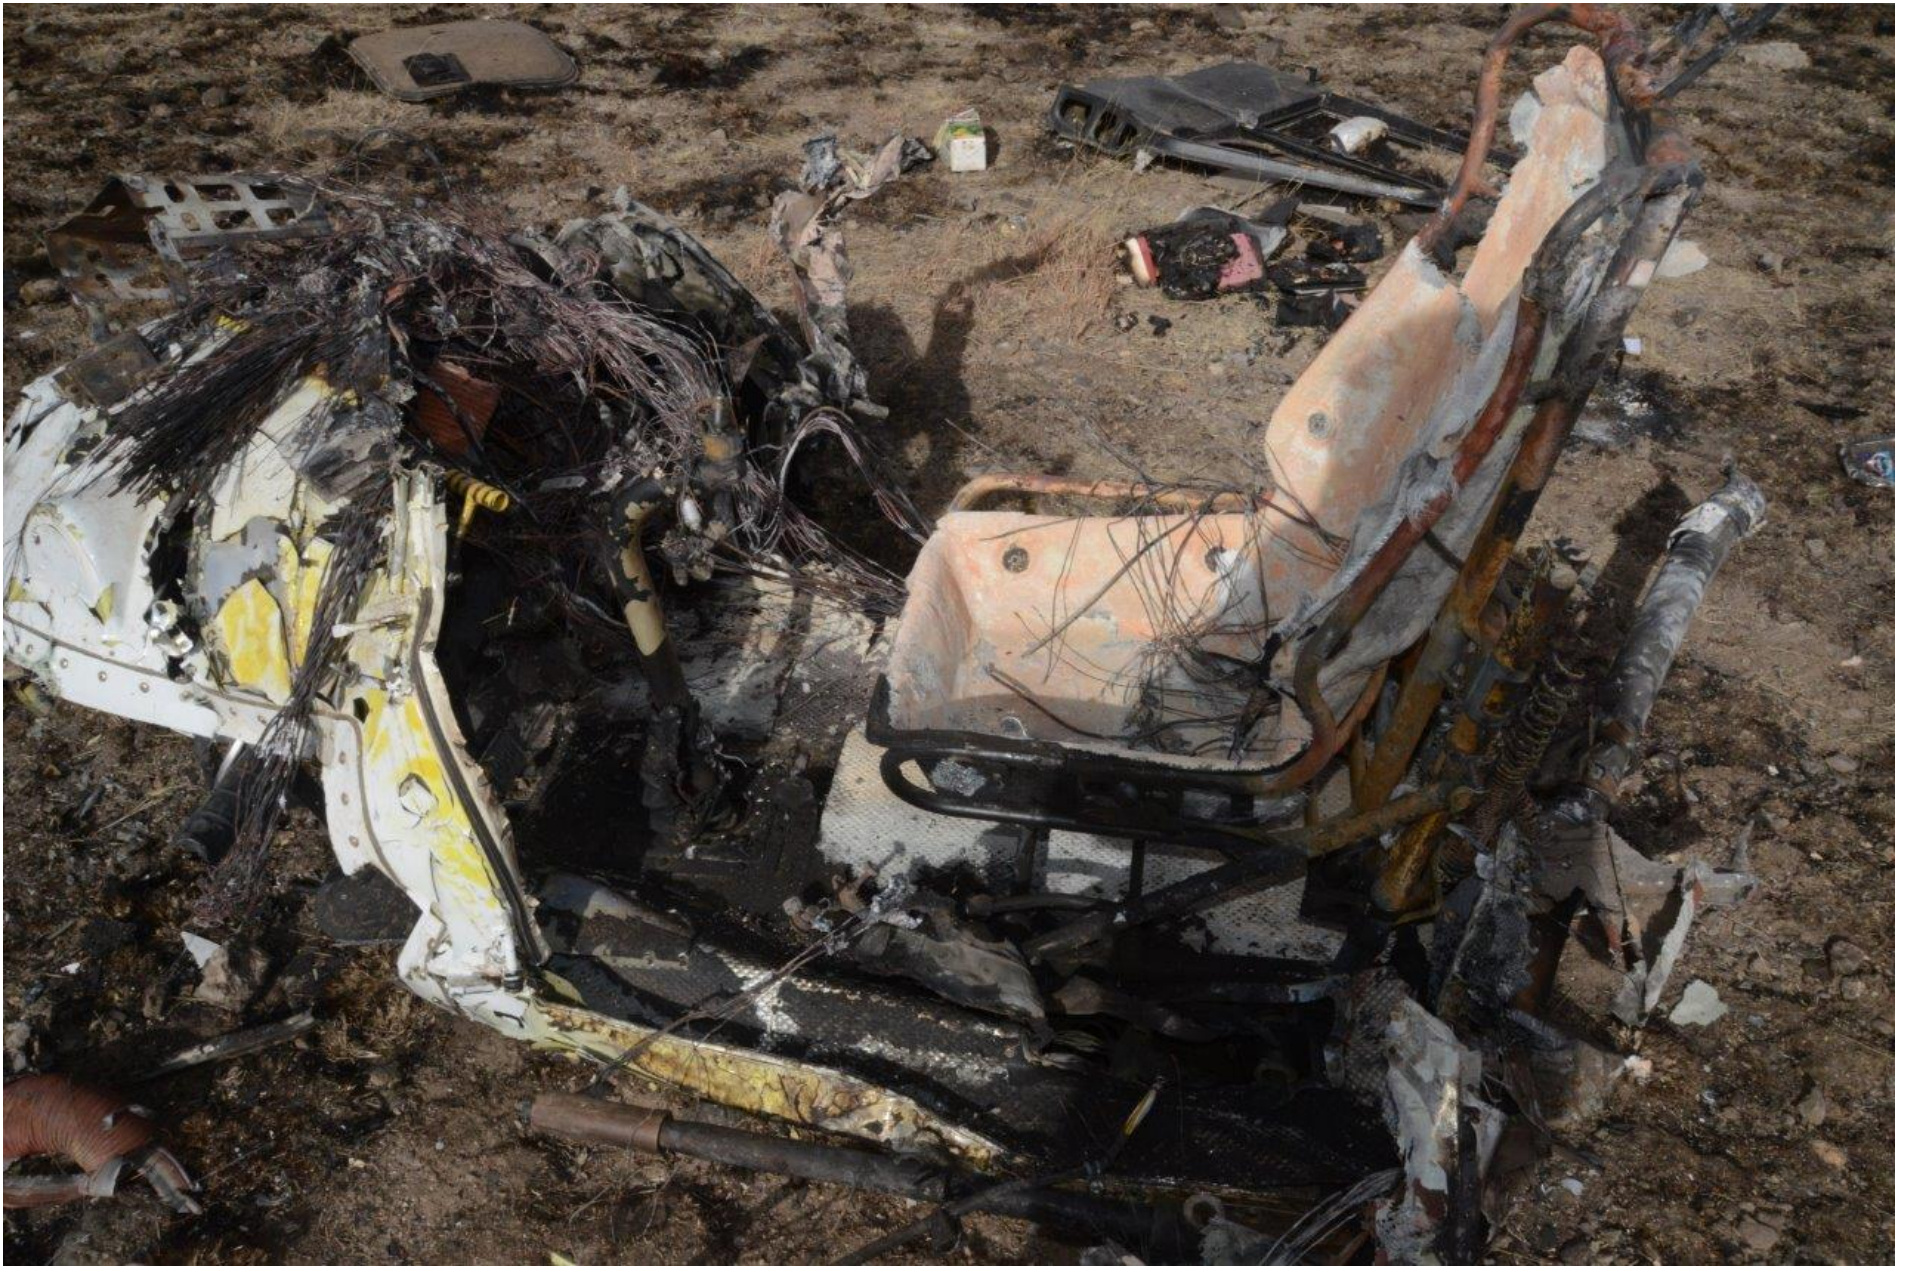
Photo 18 - View of the left cockpit seat during recovery.

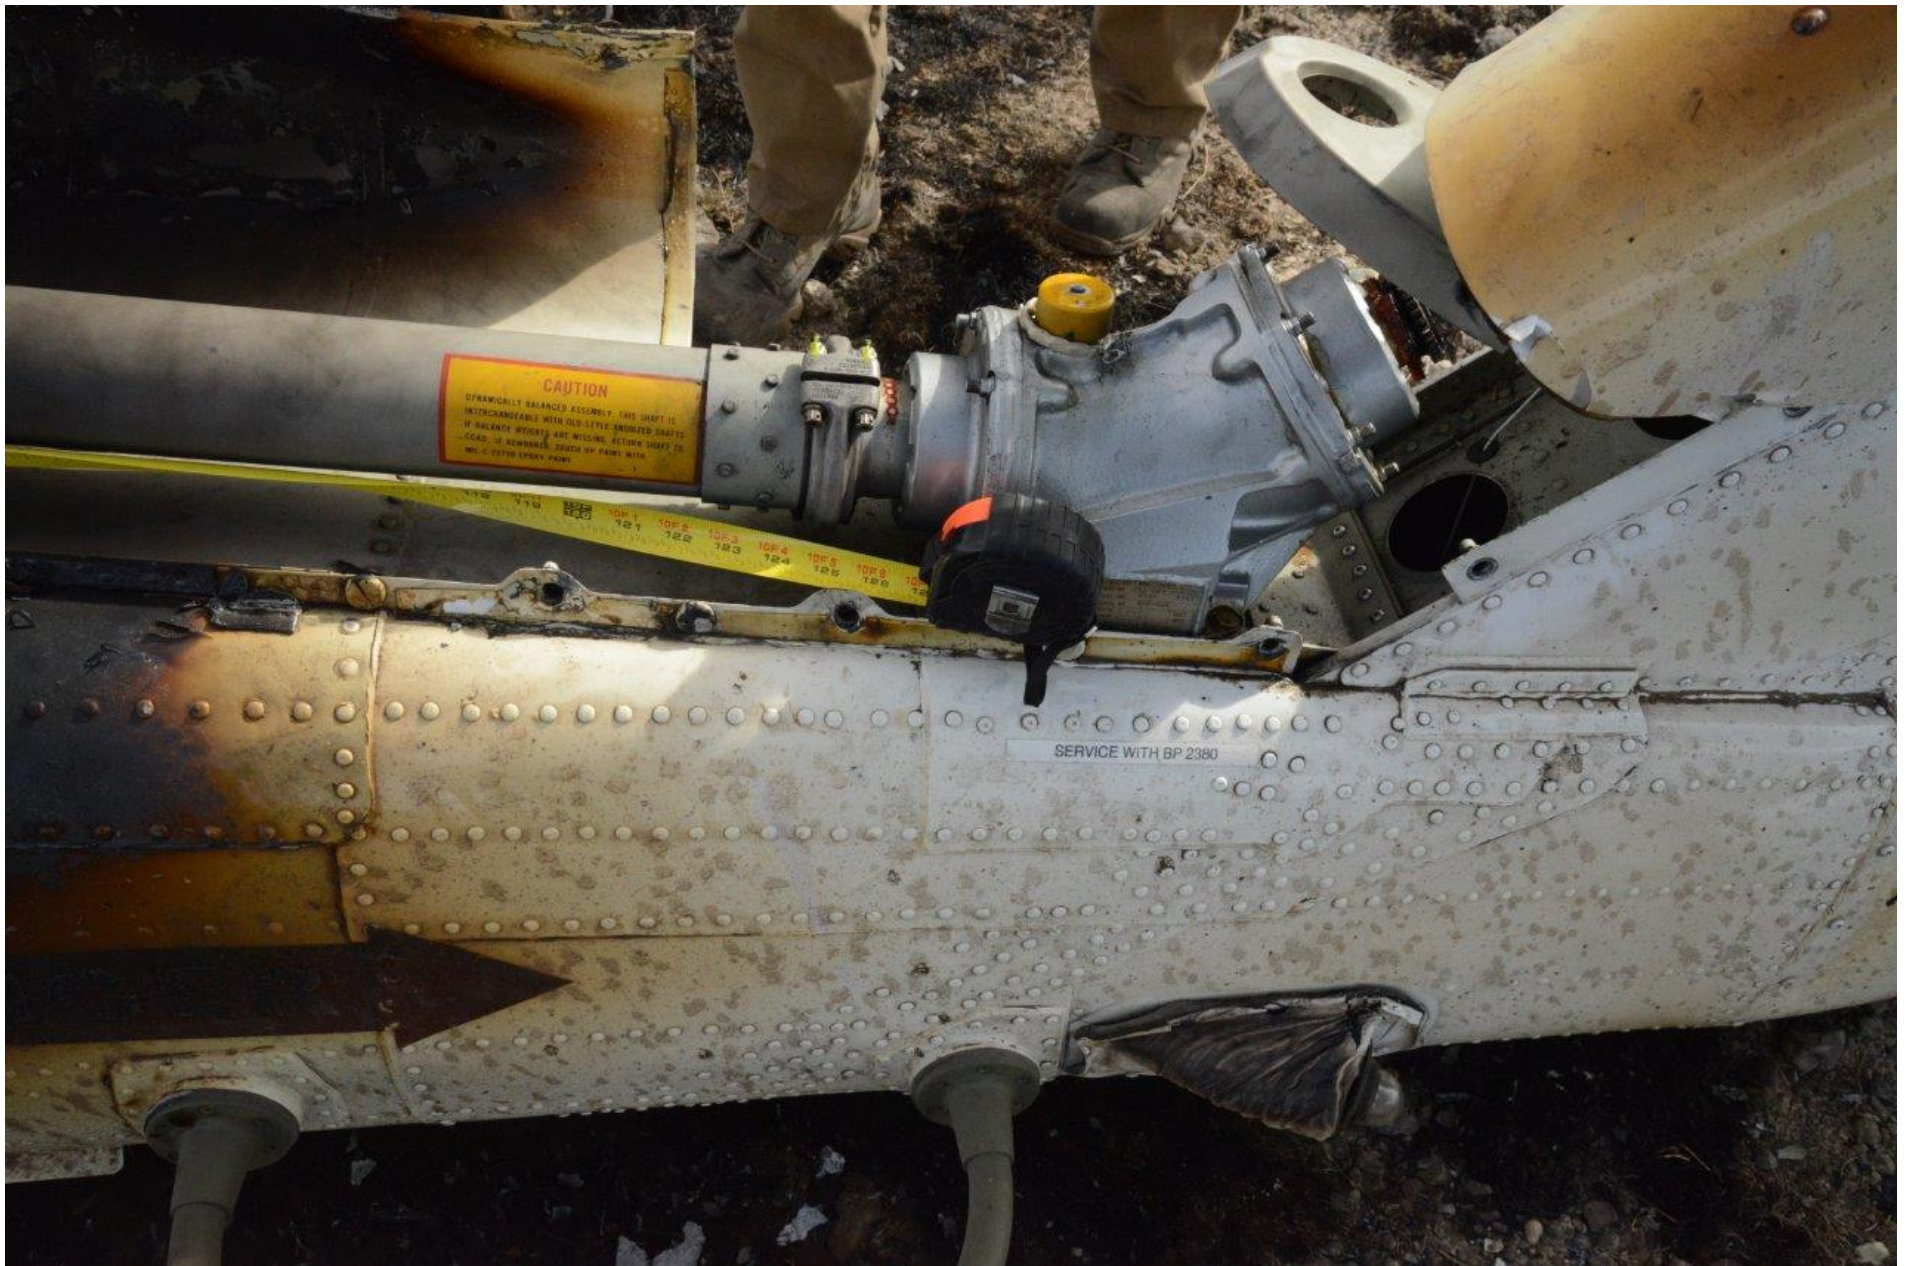
Photo 19 - View of the intermediate tail rotor gear box.

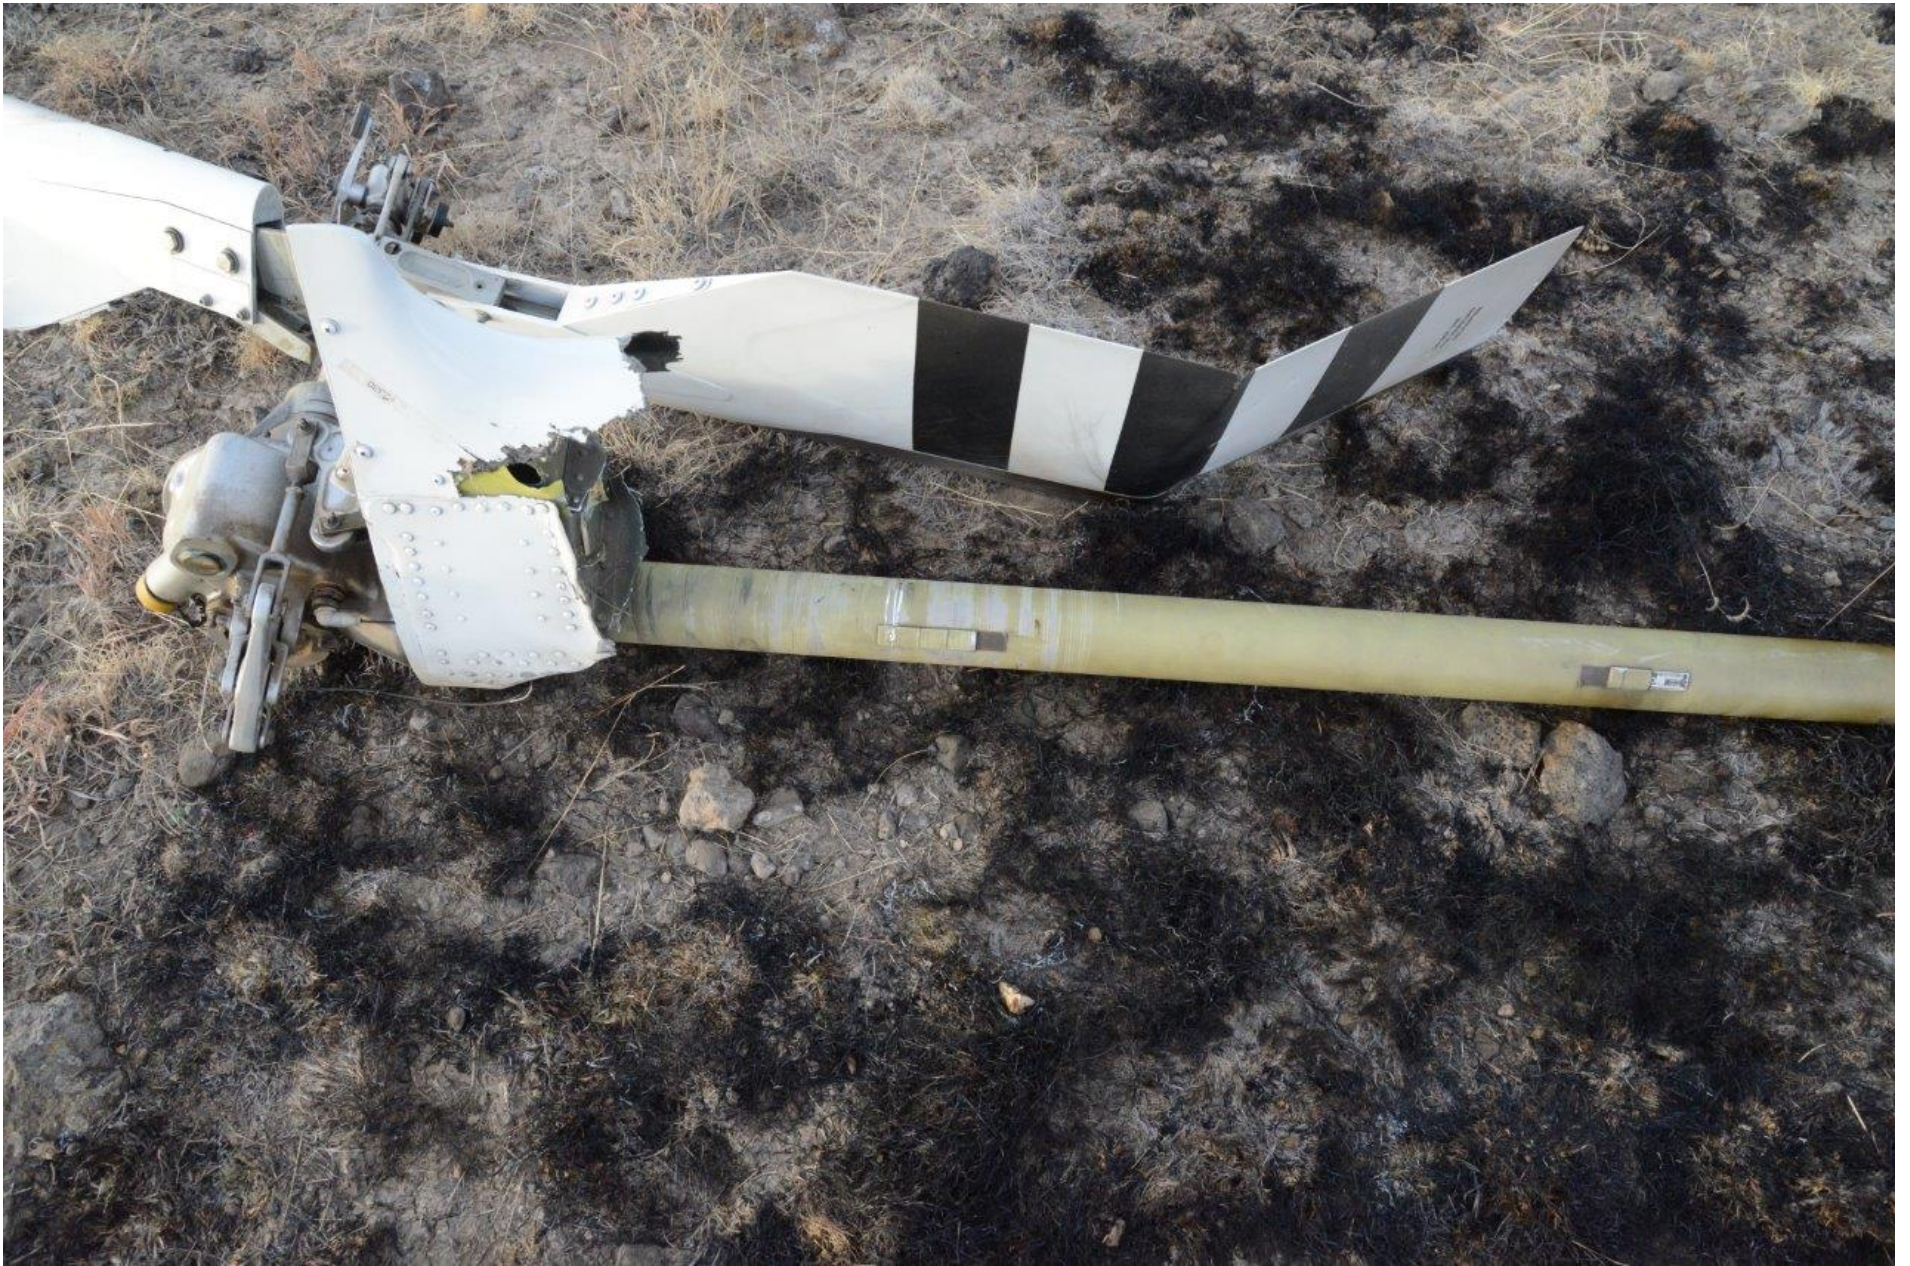
Photo 20 - View of the tail rotor gear box, a tail rotor blade, and tail rotor drive shaft.
