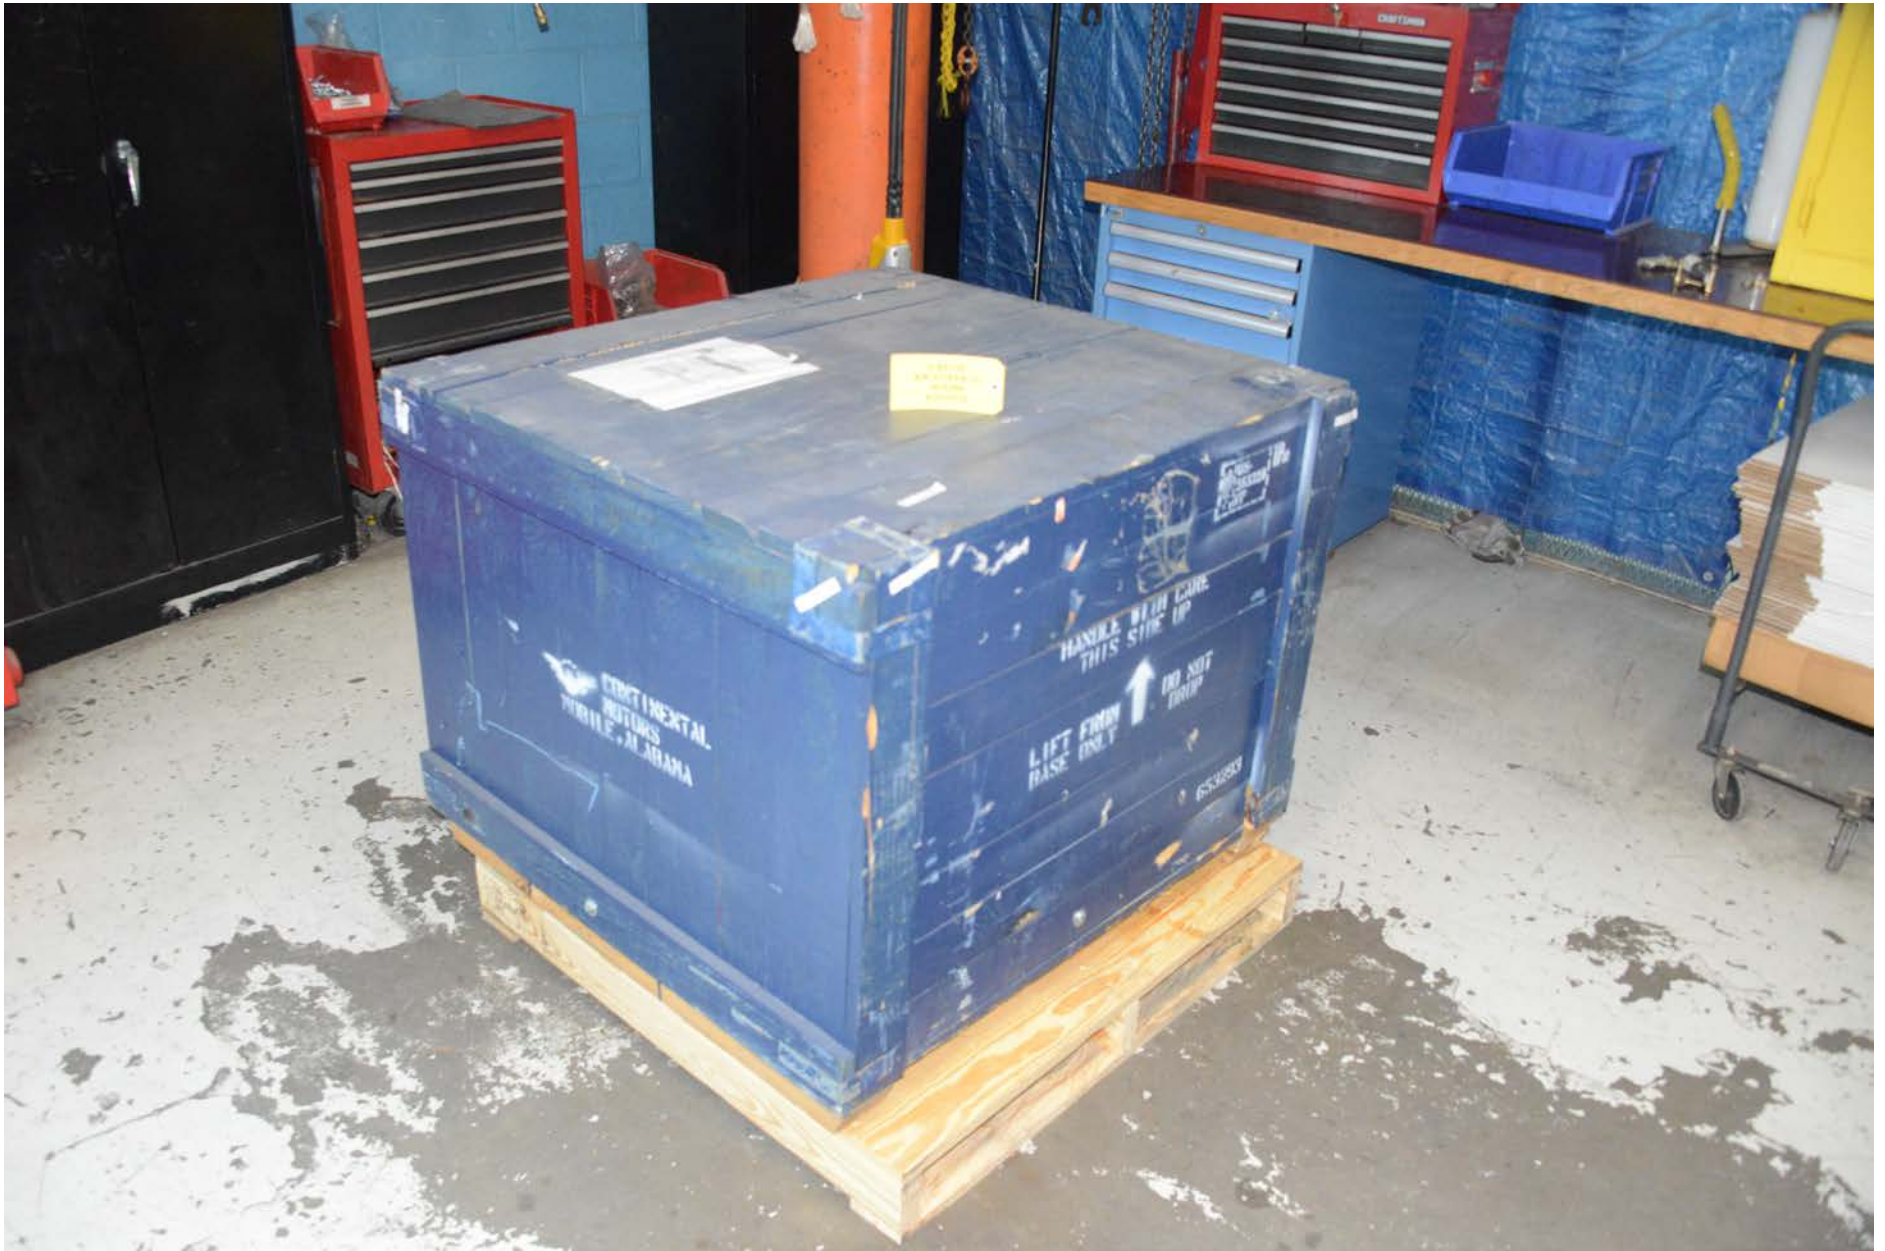
Photo 1 – Crated engine as received.

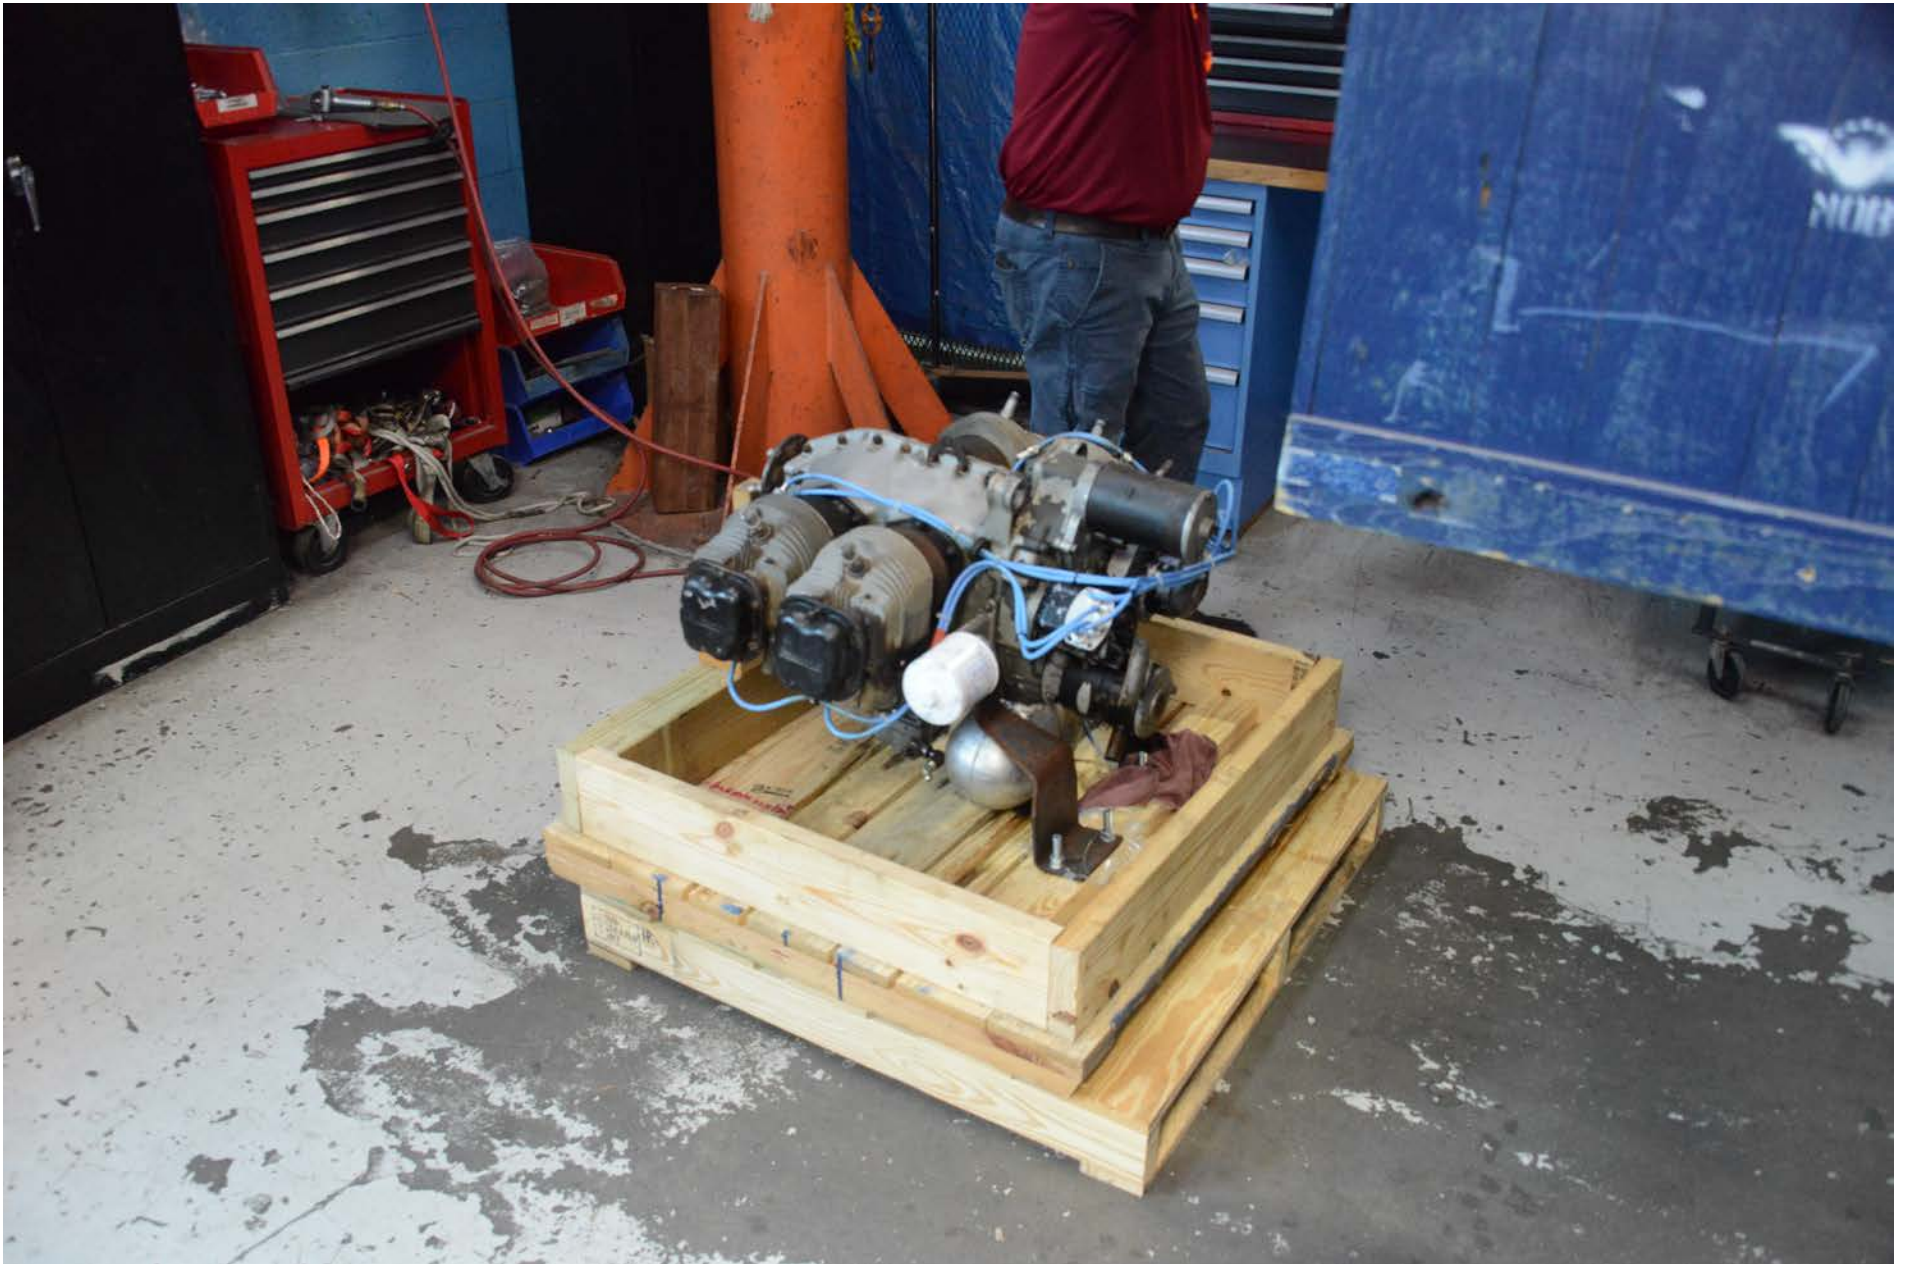
Photo 2 - Crate top of crated engine being removed.

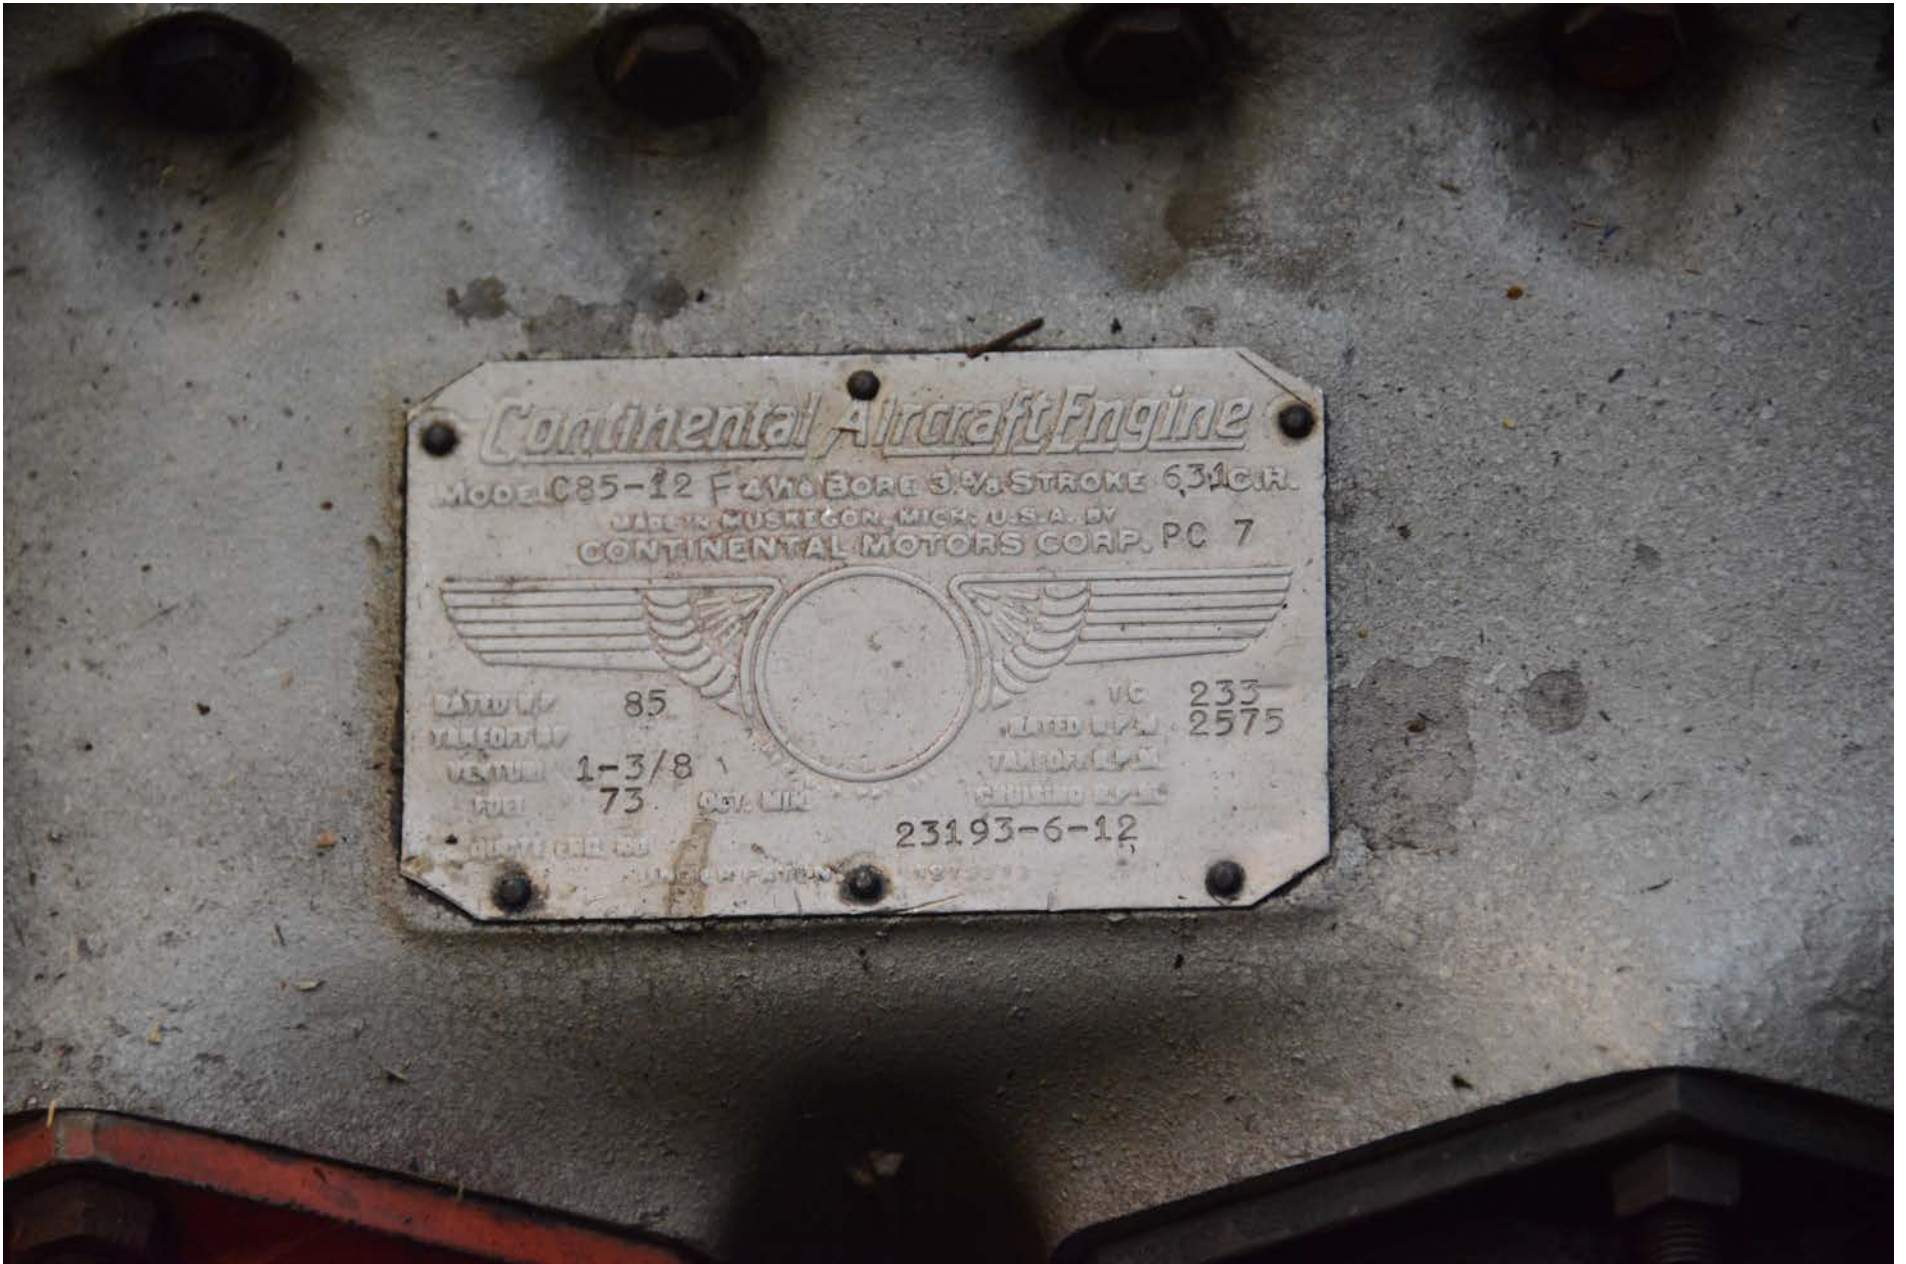
Photo 3 - View of the engine's data plate.

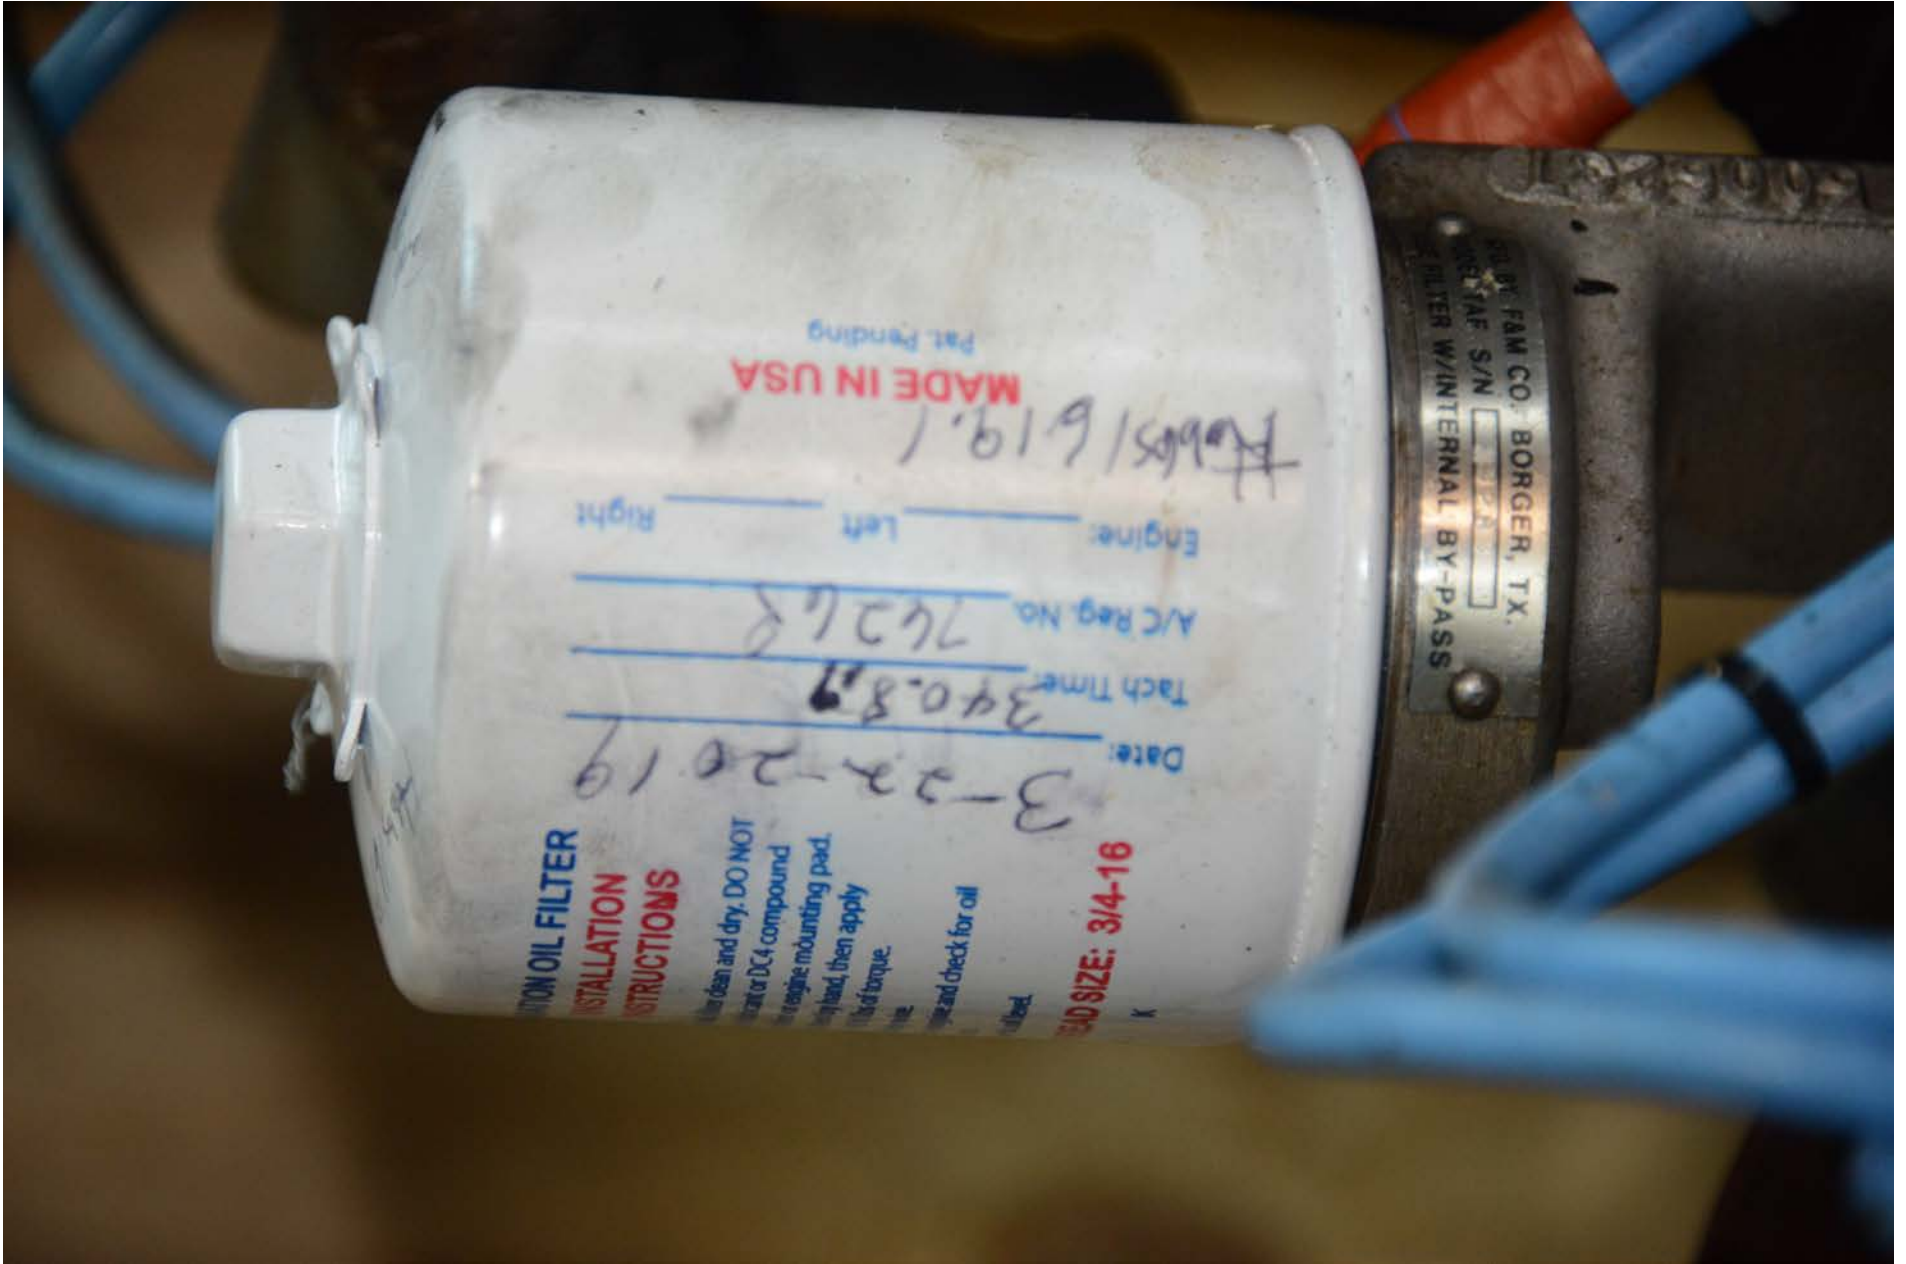
Photo 4 - View of the installed oil filter.

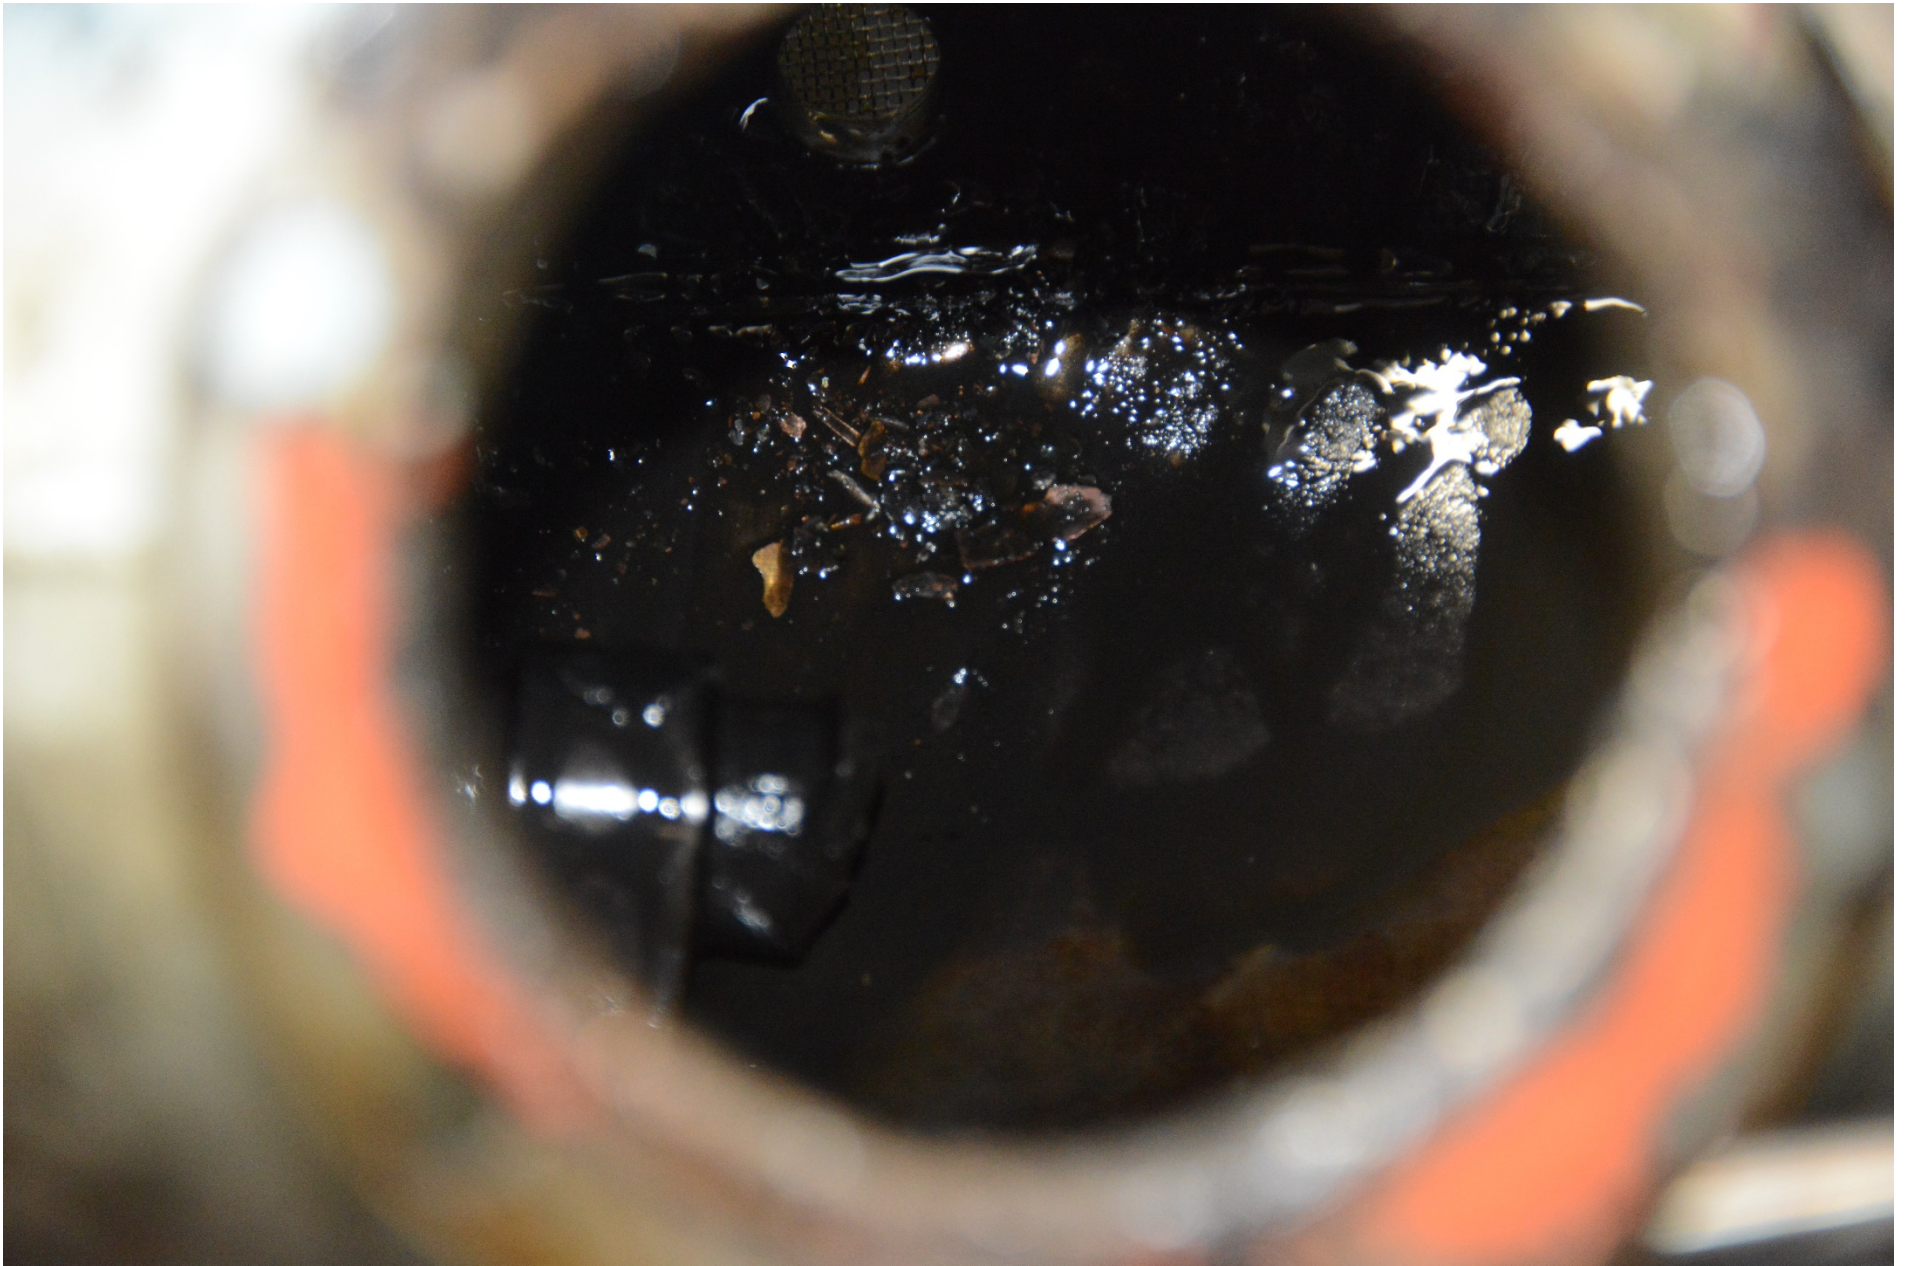
Photo 5 - View inside the oil sump showing debris and a liberated section of camshaft.

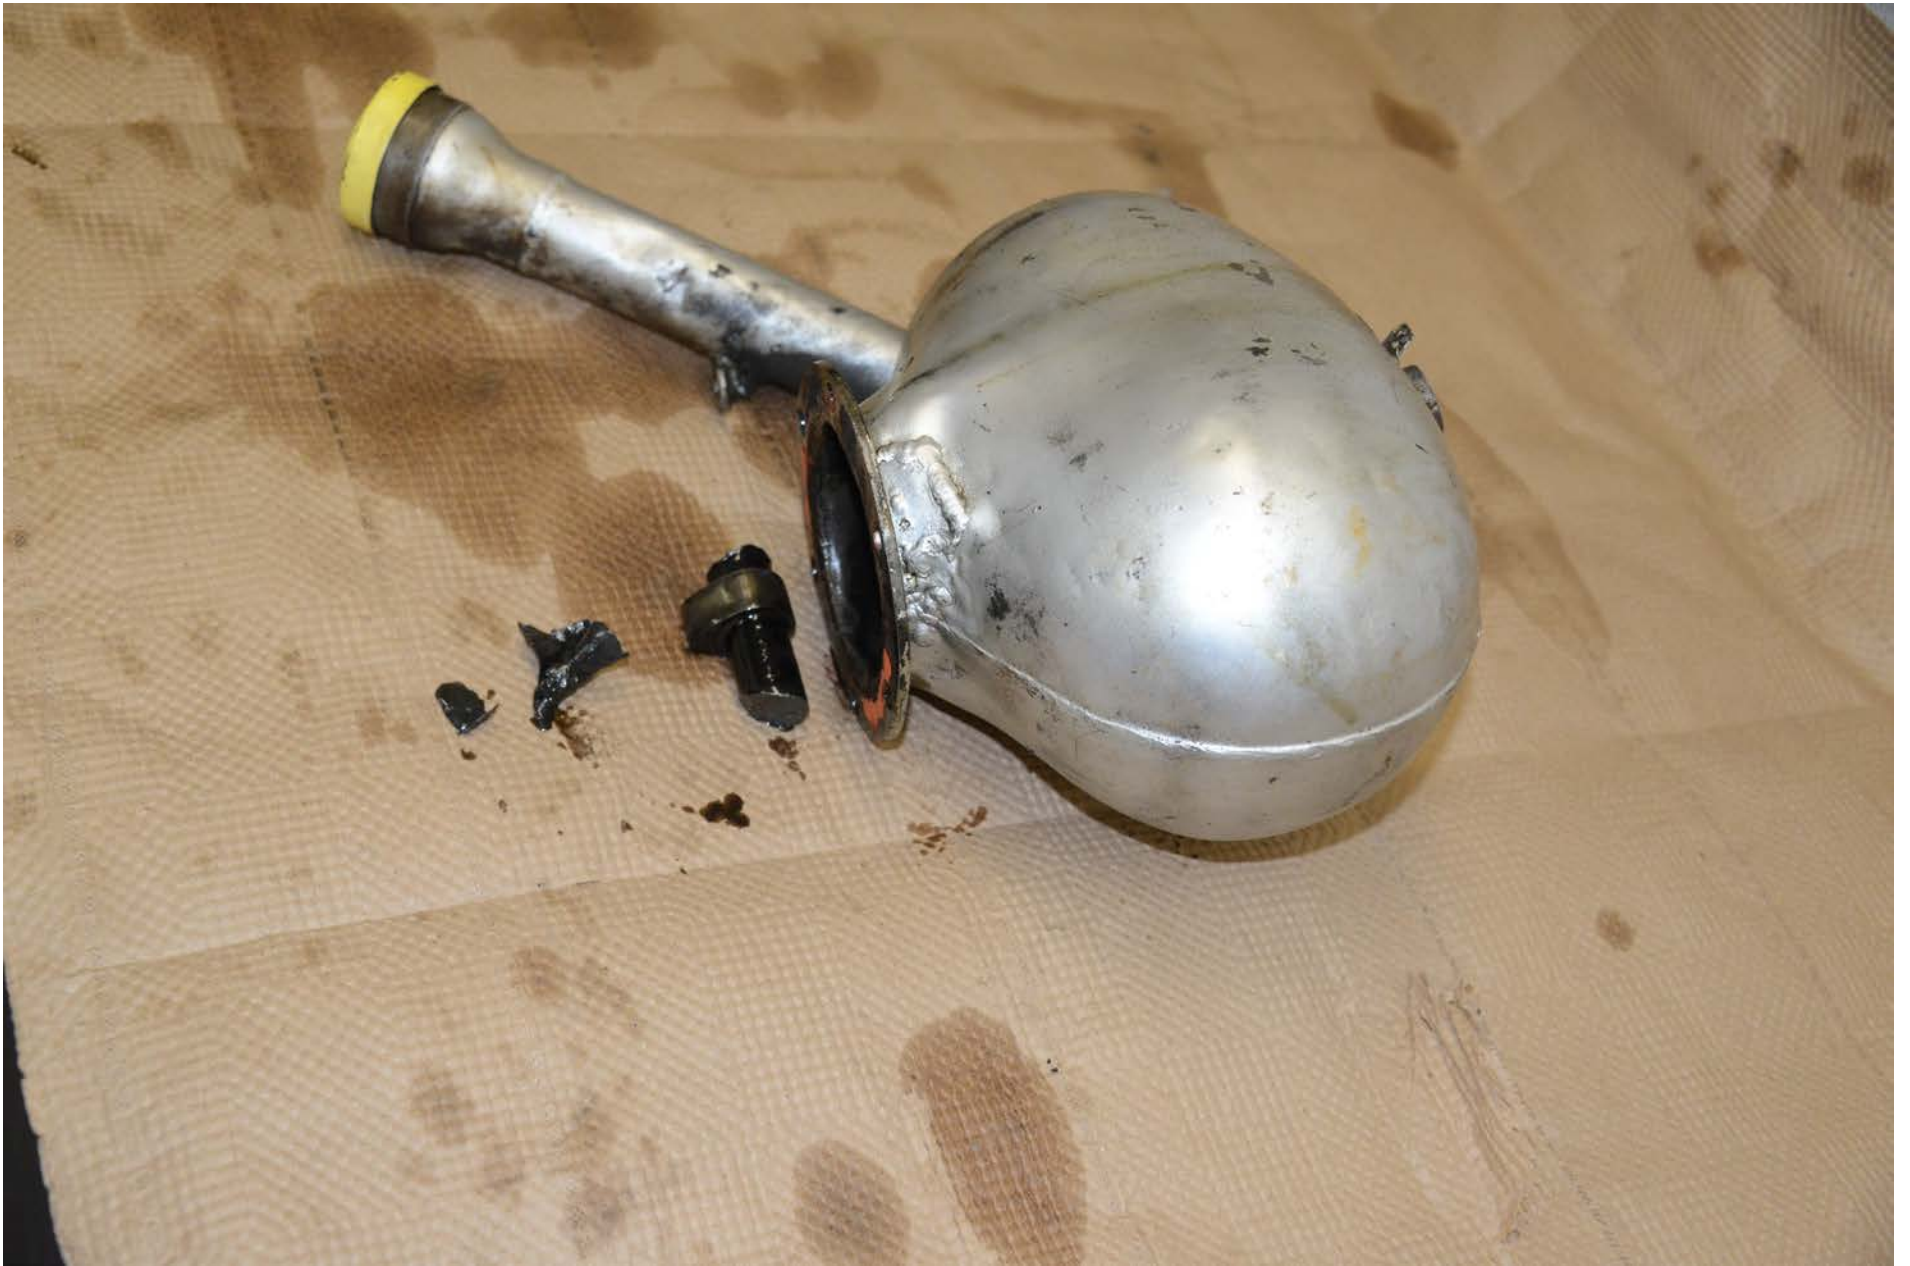
Photo 6 - View of the oil sump, debris. and a liberated section of camshaft.

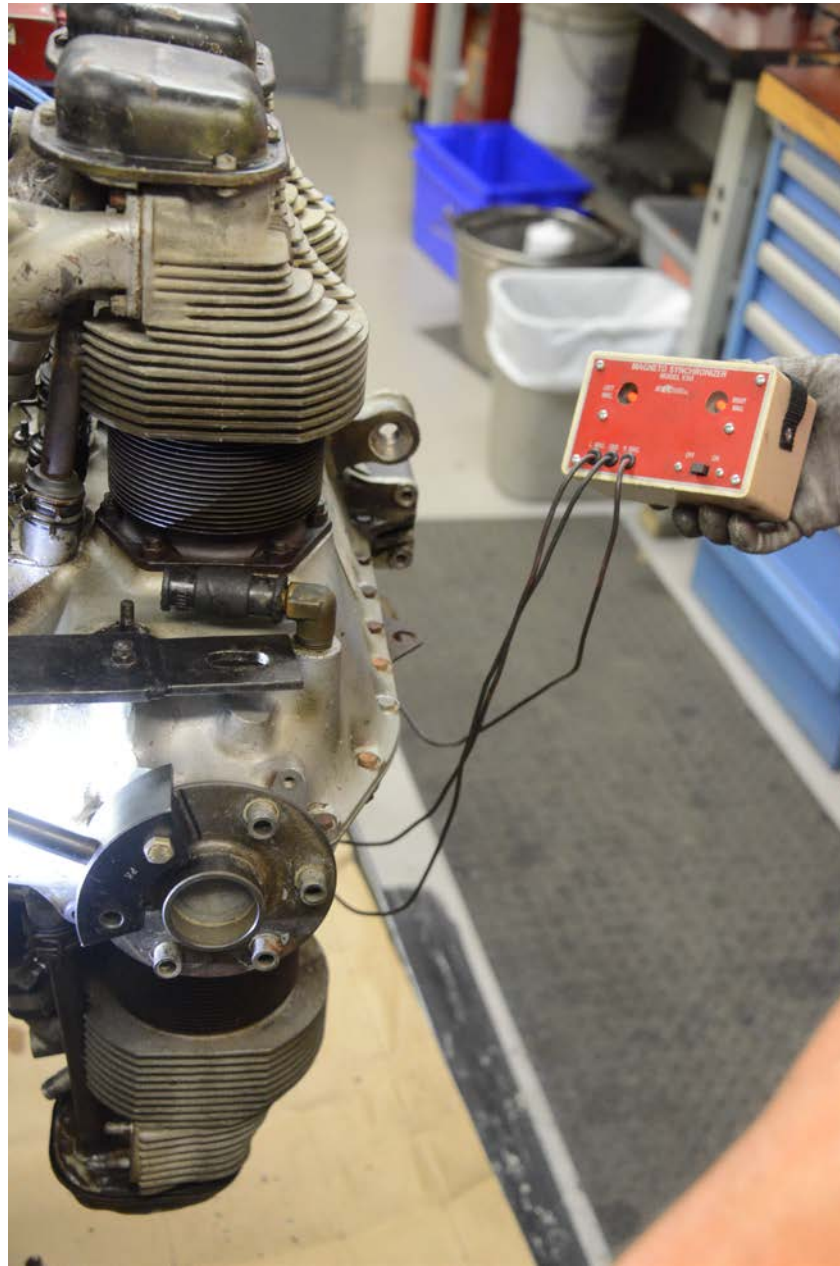
Photo 7 - View of the magnetos' timing being checked.

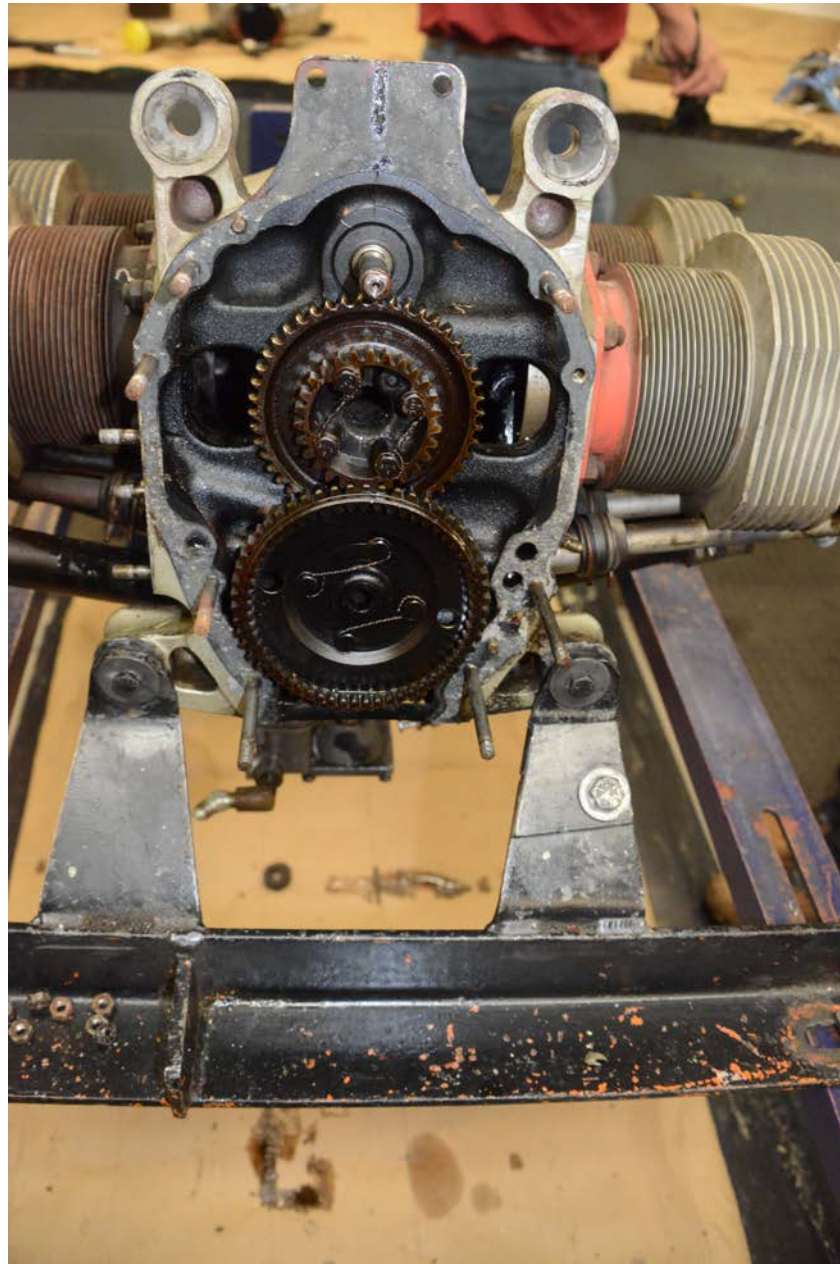
Photo 8 - View of the crankshaft and camshaft gears.

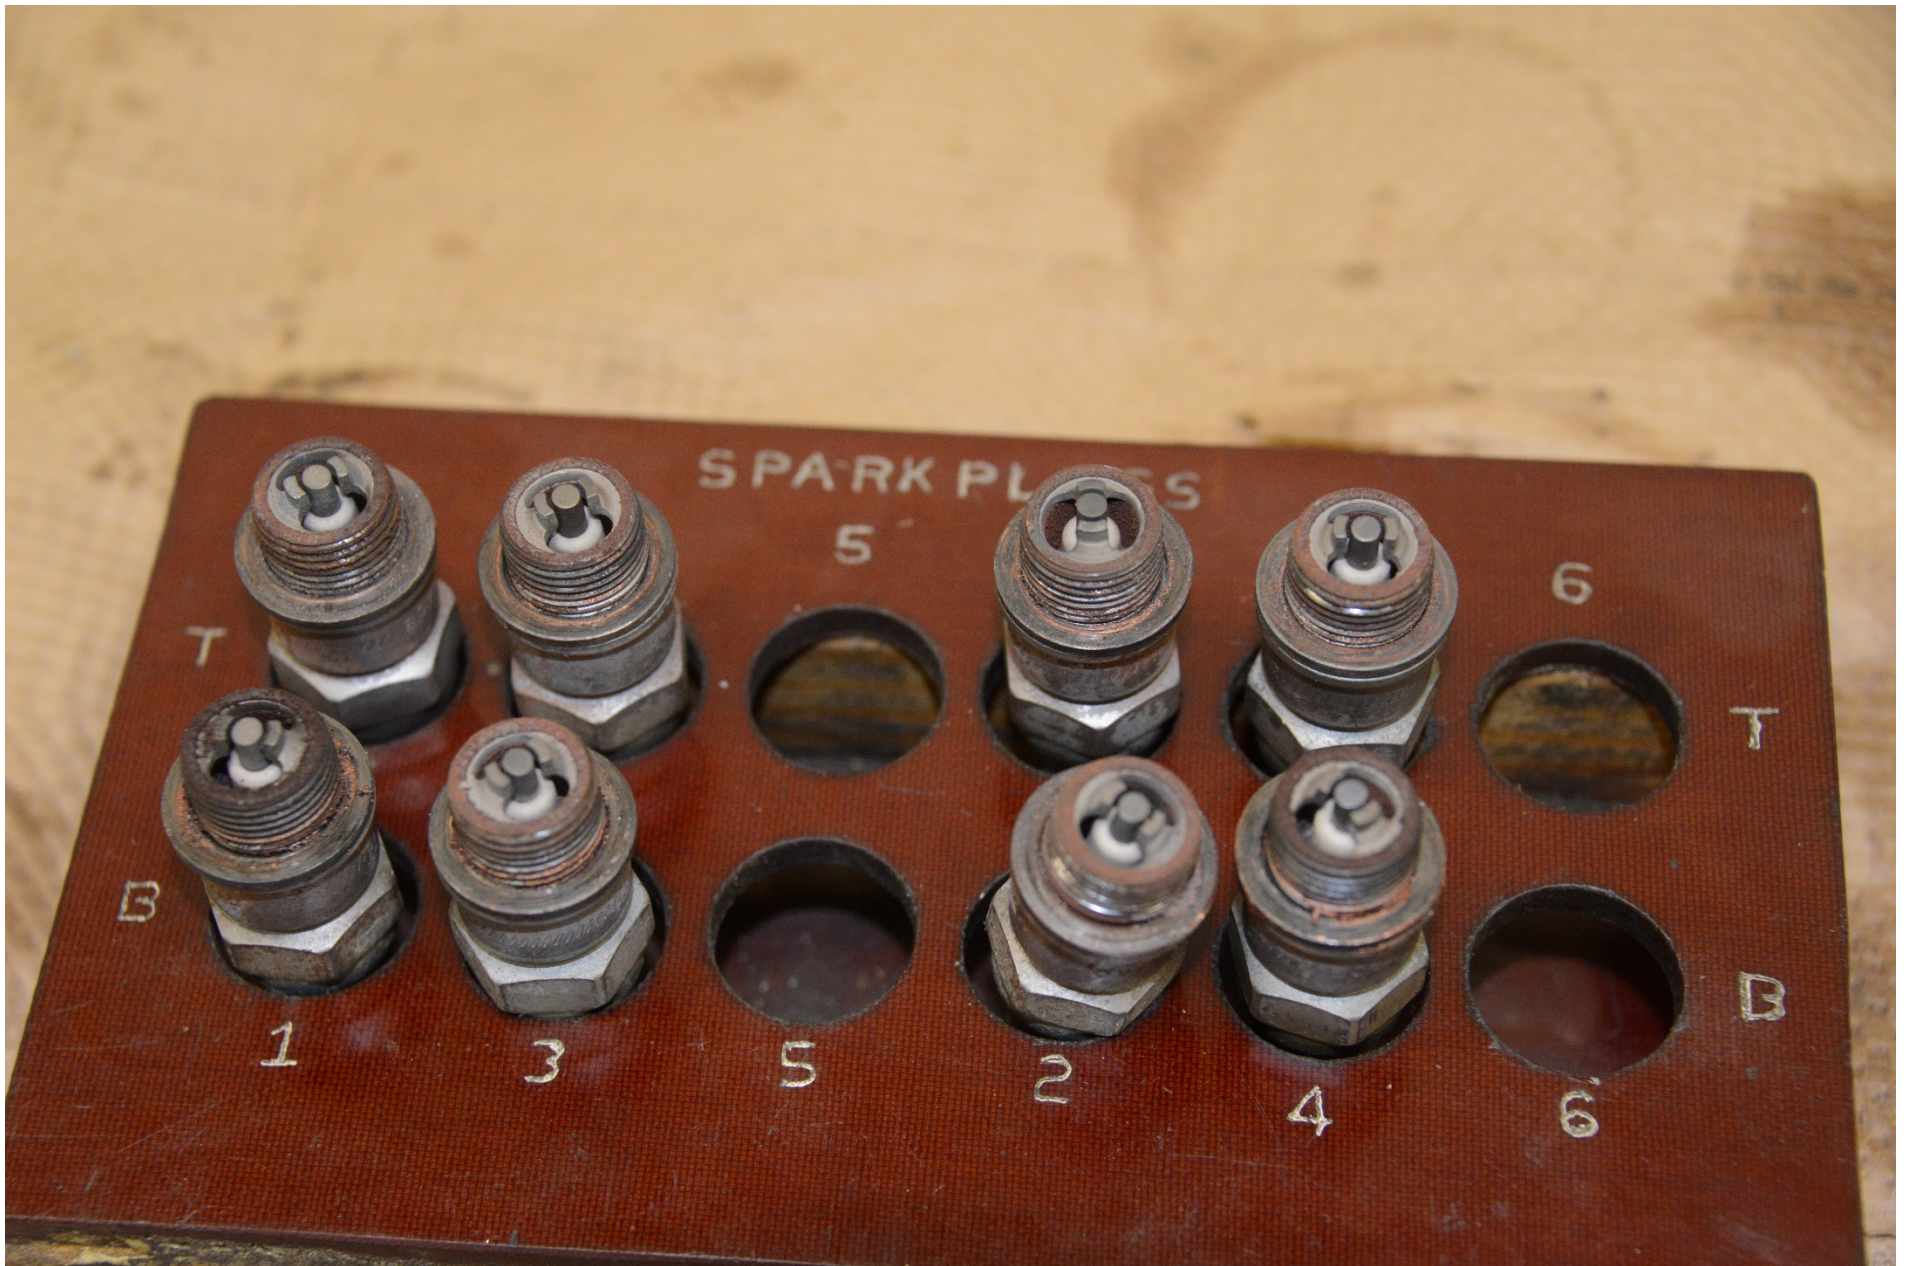
Photo 9 - View of removed sparkplugs.

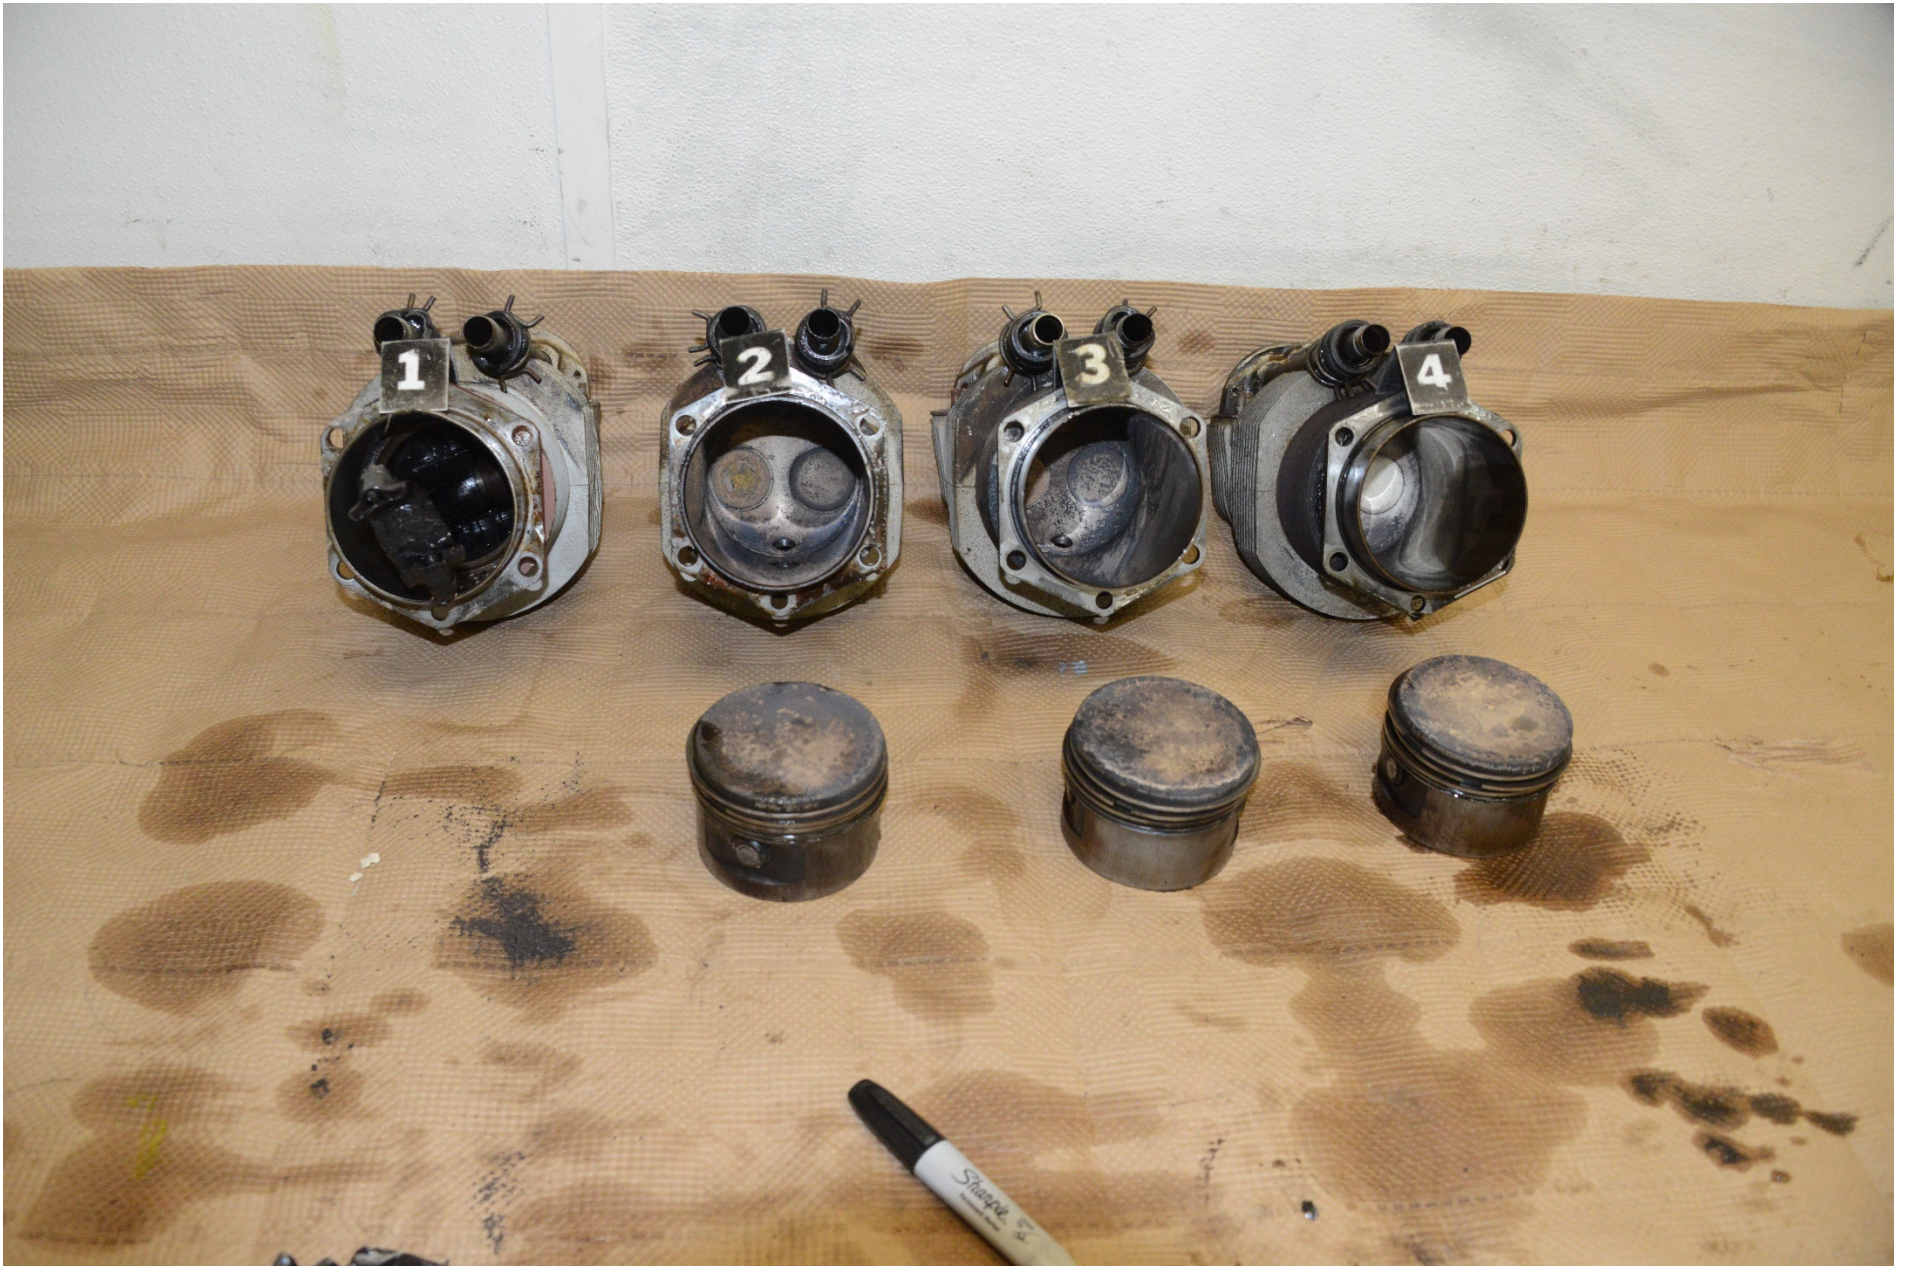
Photo 10 - View of removed cylinders.

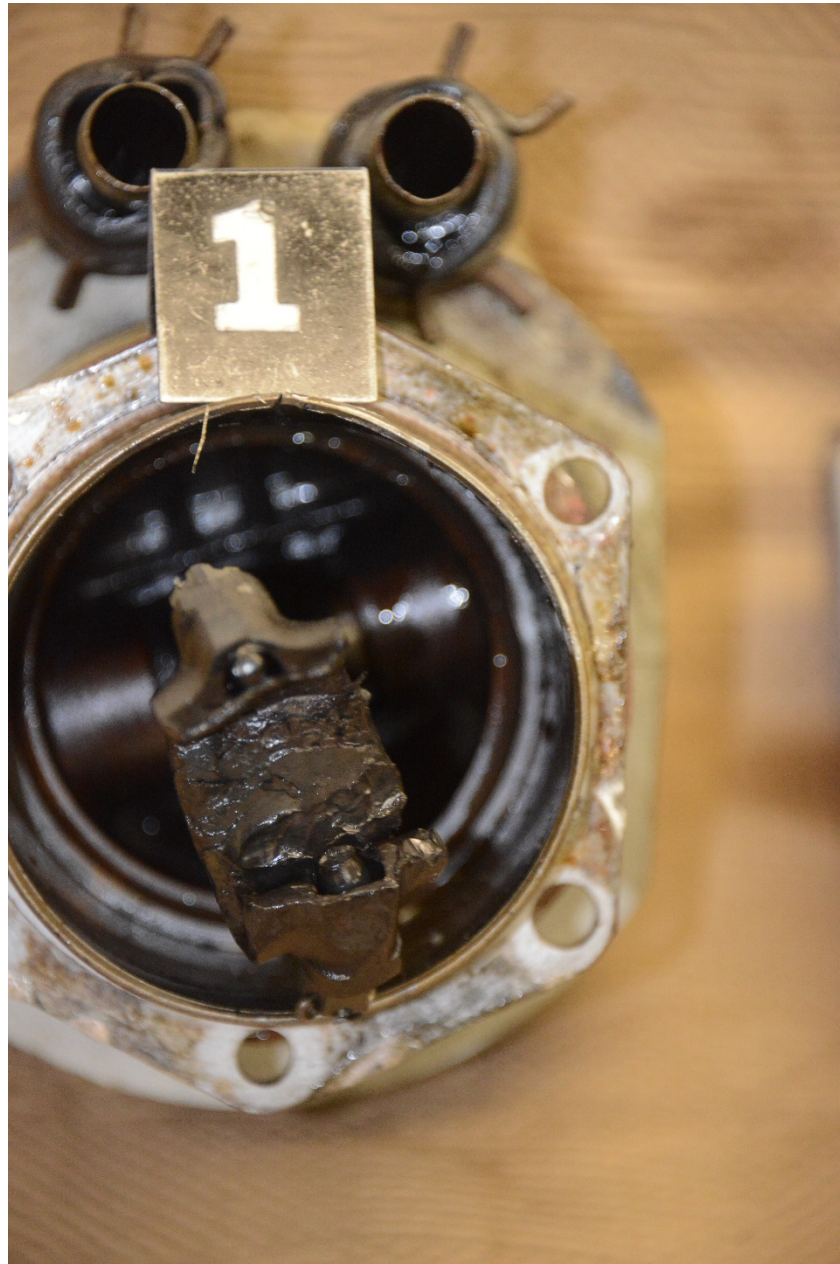
Photo 11 - Close-up view of the No. 1 Cylinder rod end.
