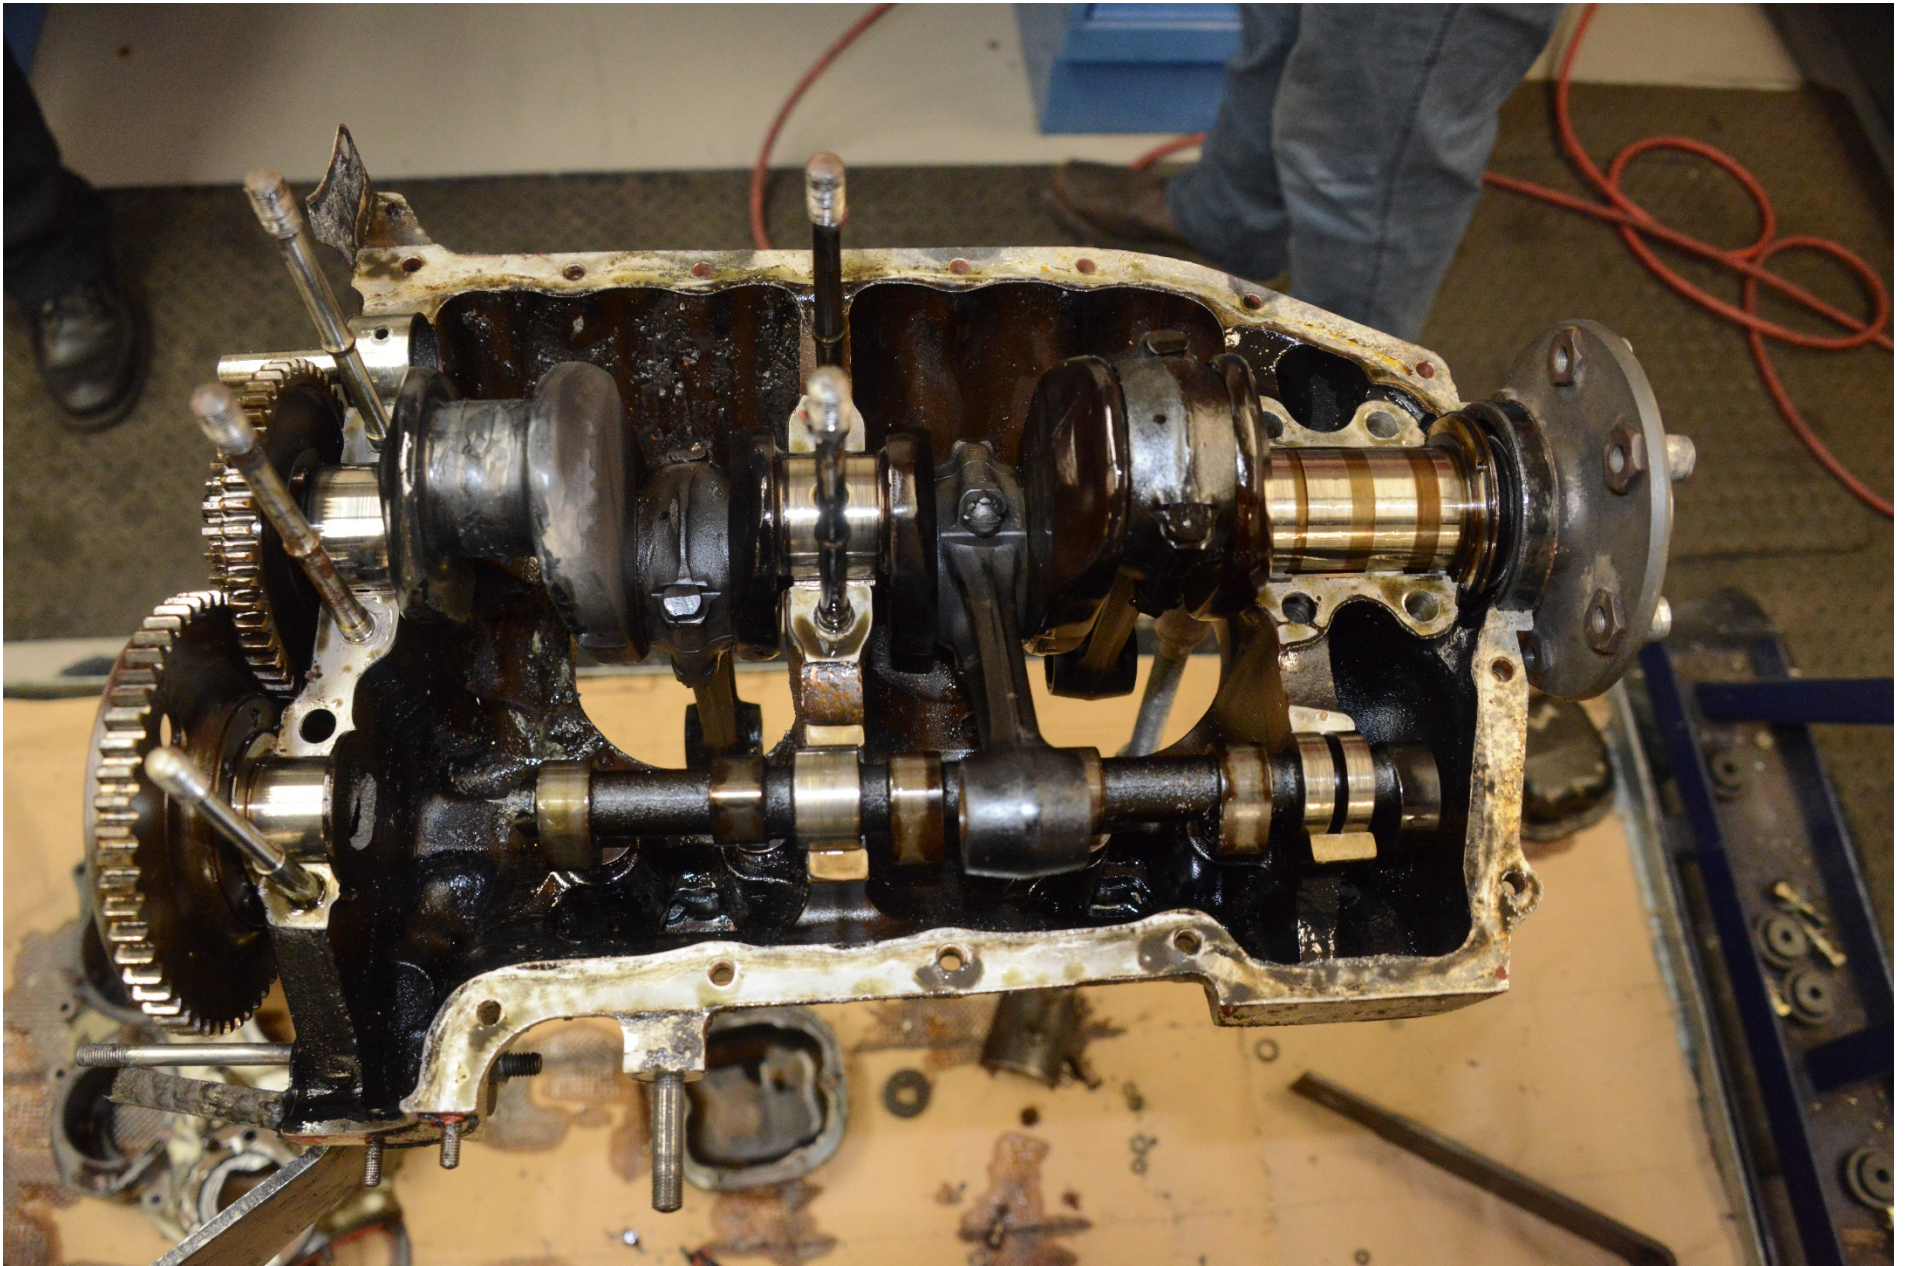
Photo 12 - View of the crankshaft and camshaft in half of the crankcase.

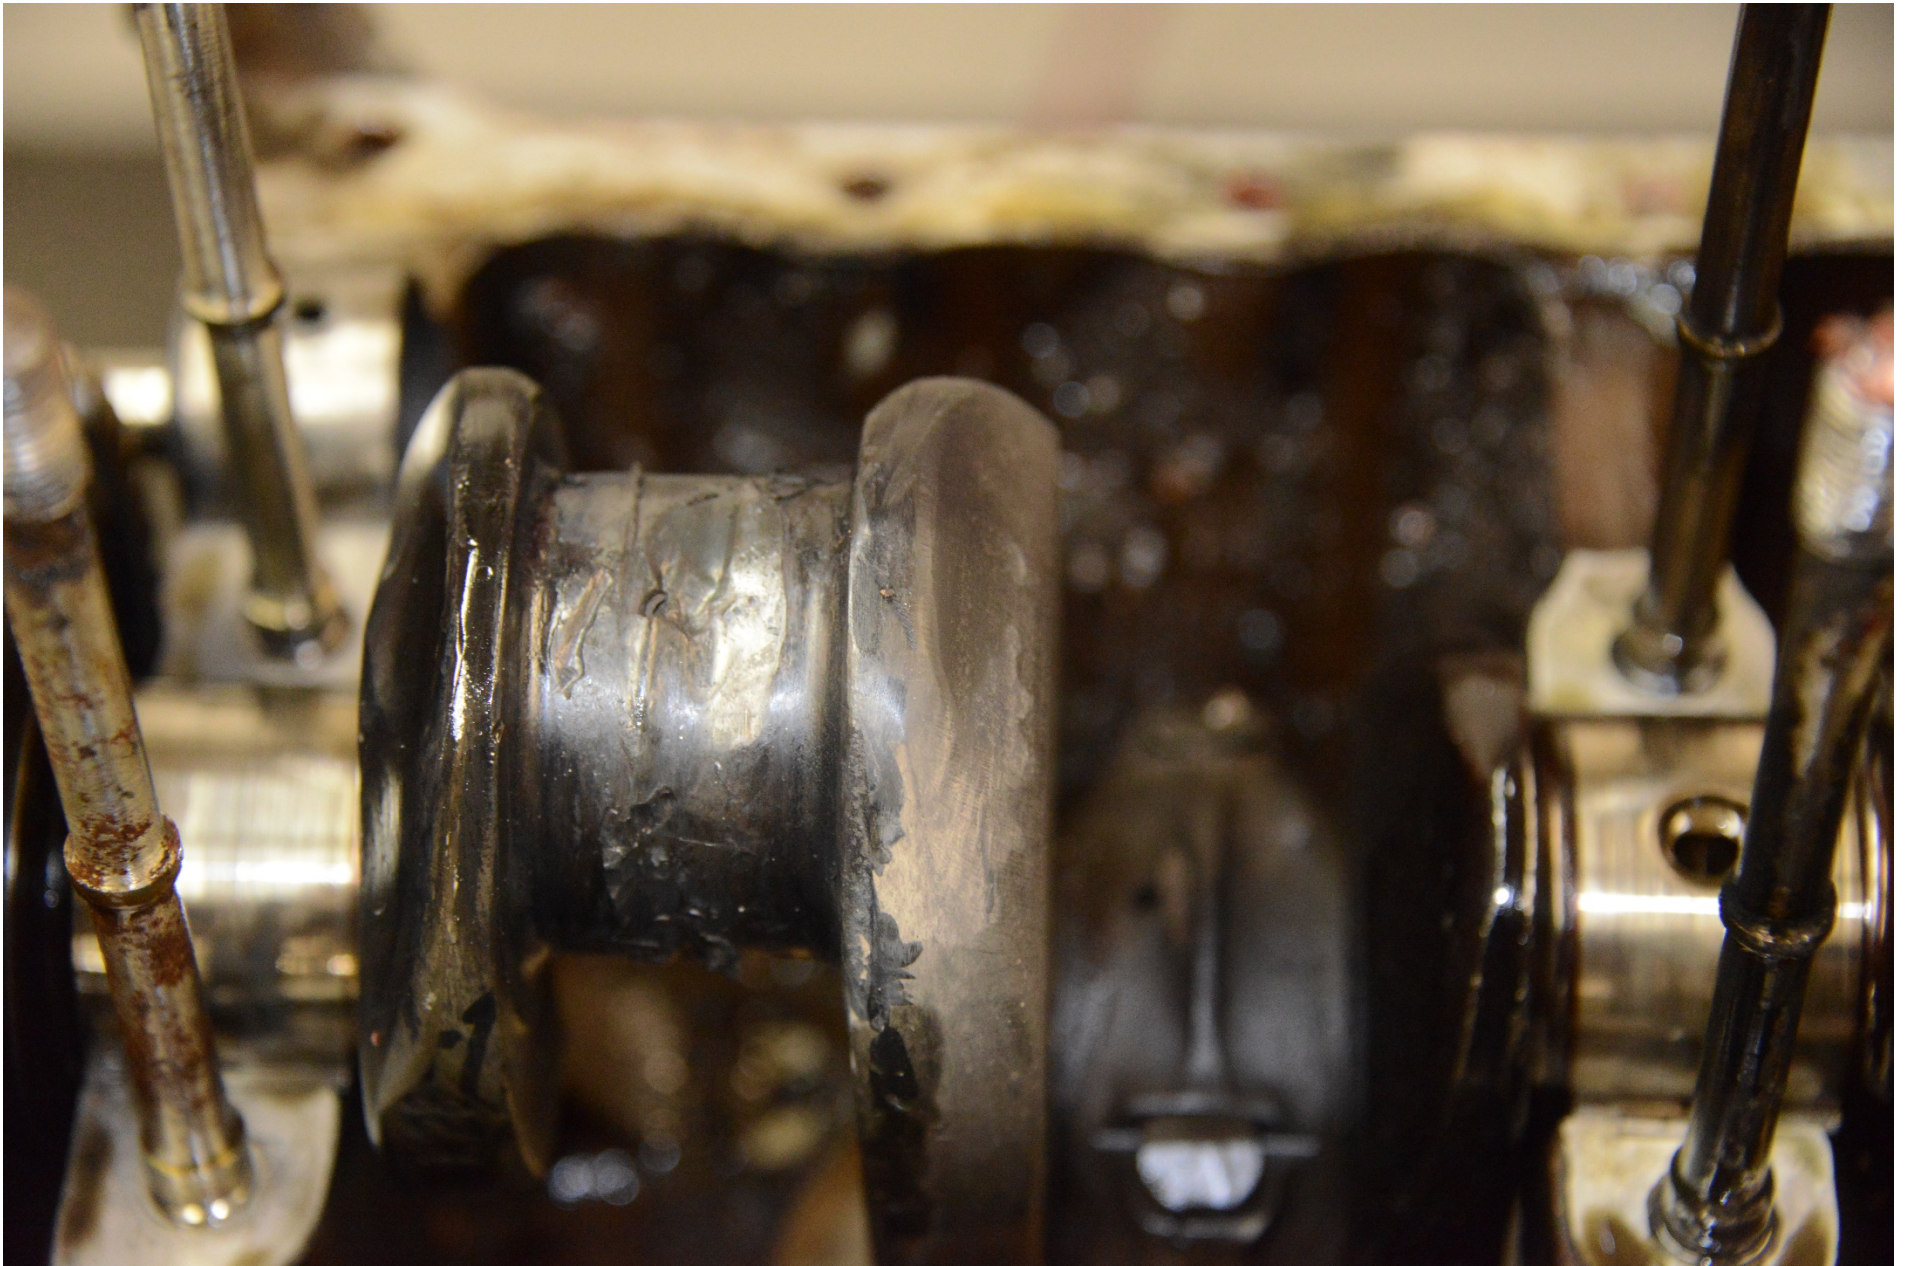
Photo 13 - Close-up view of the No. 1 connecting rod journal. The journal exhibits smeared metal appearance.

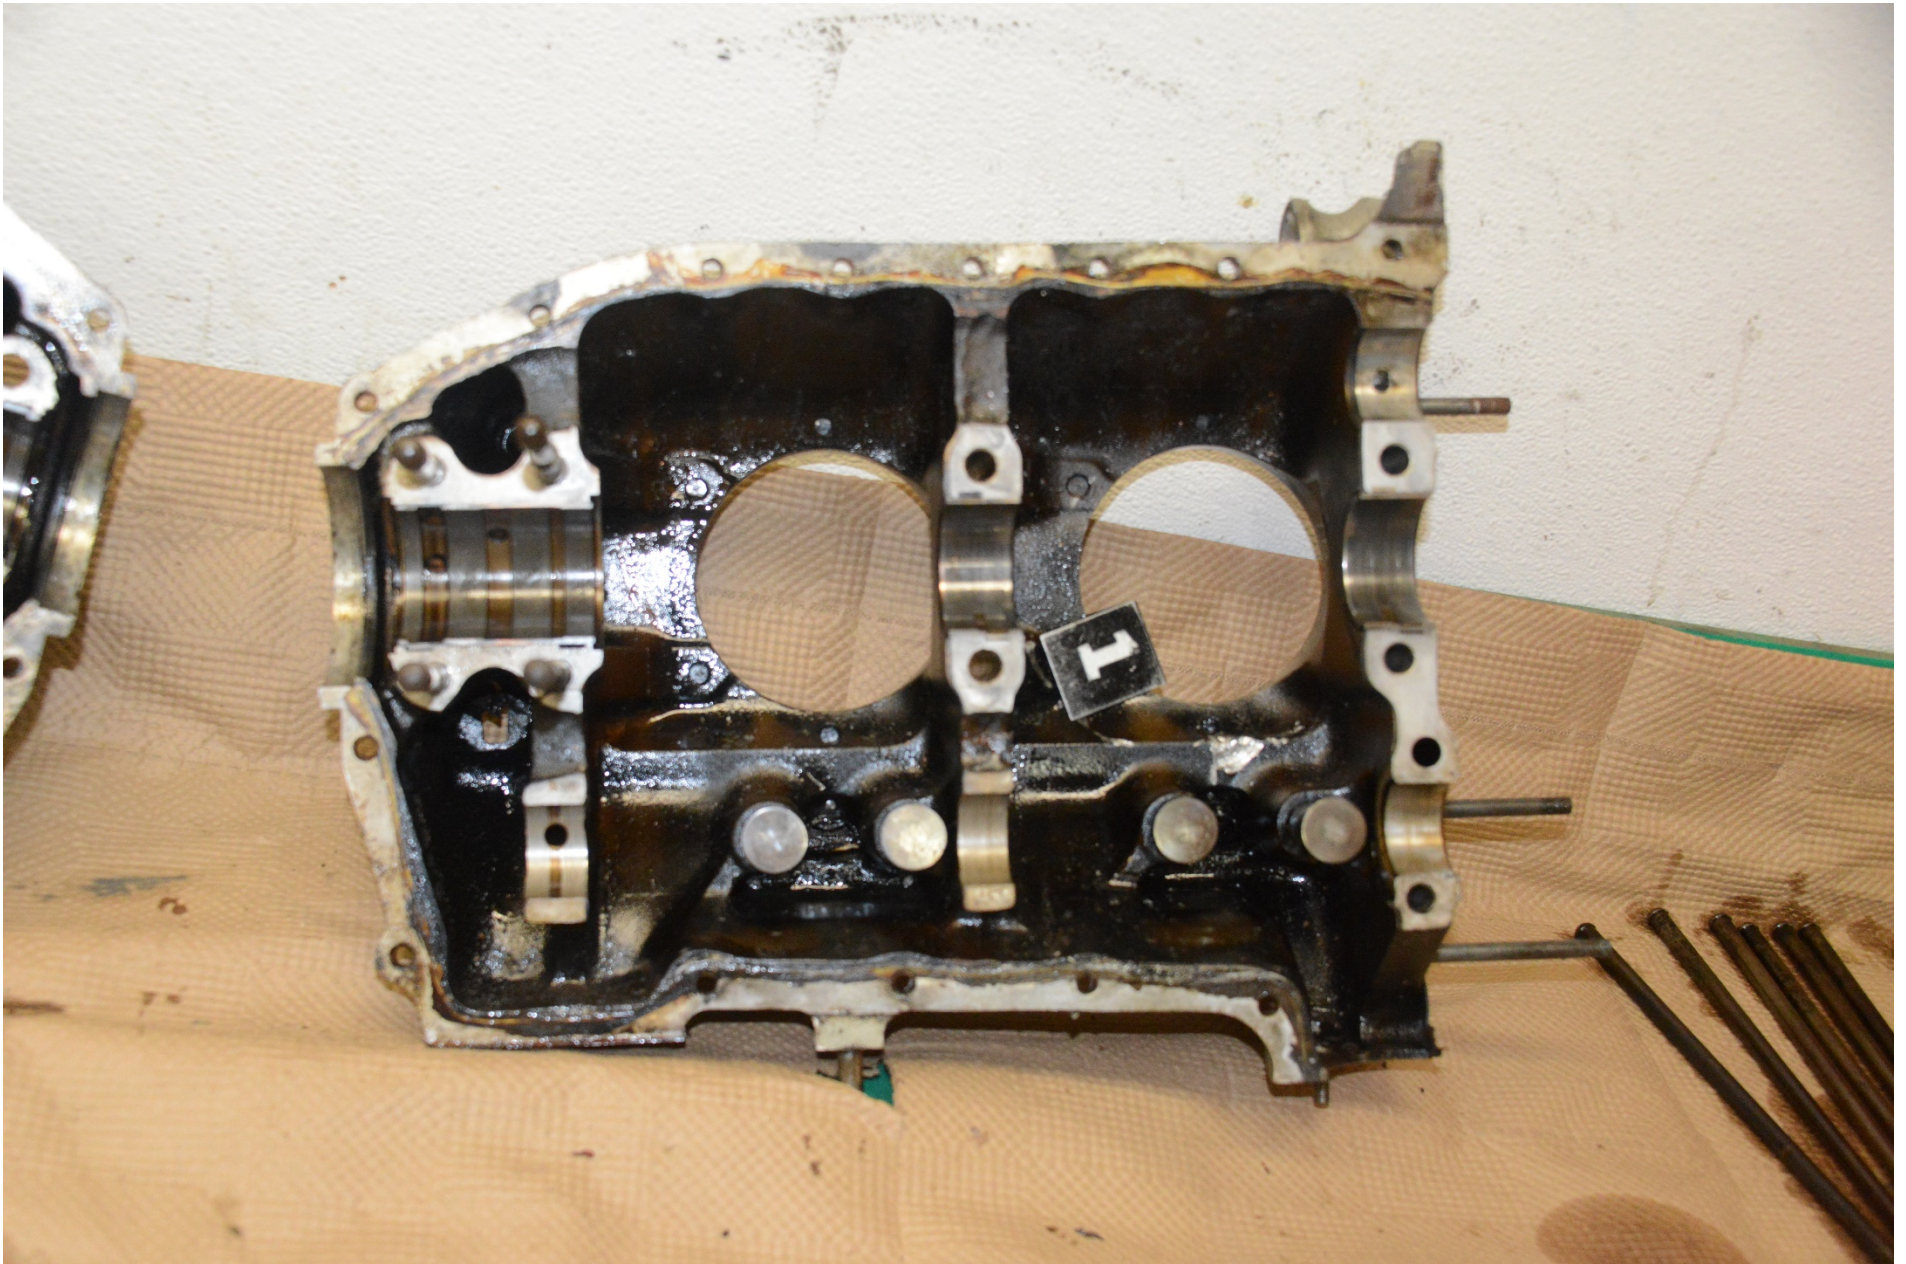
Photo 14 - View of the other half of the crankcase. The crankcase exhibits a witness mark between the No. 1 cylinder opening and its lifter assemblies.

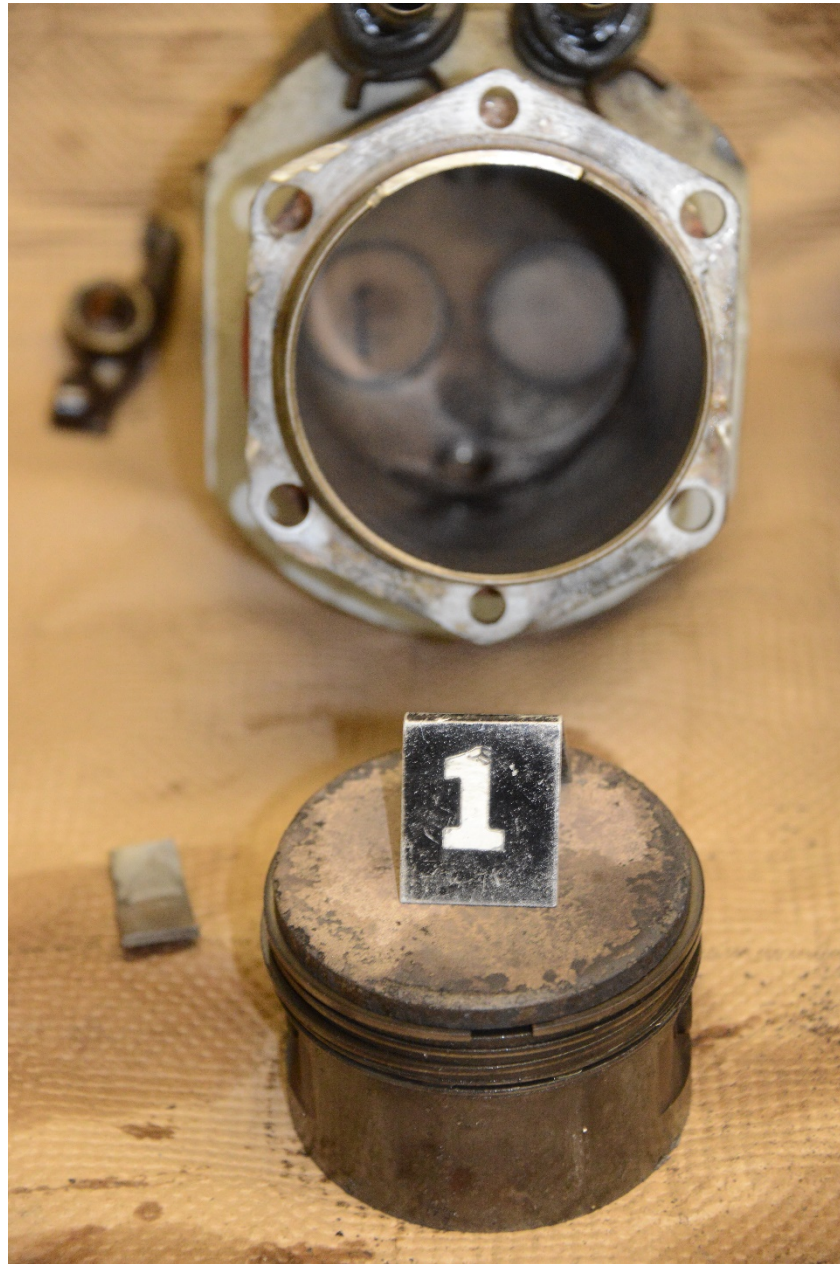
Photo 15 - View of the disassembled No. 1 cylinder.

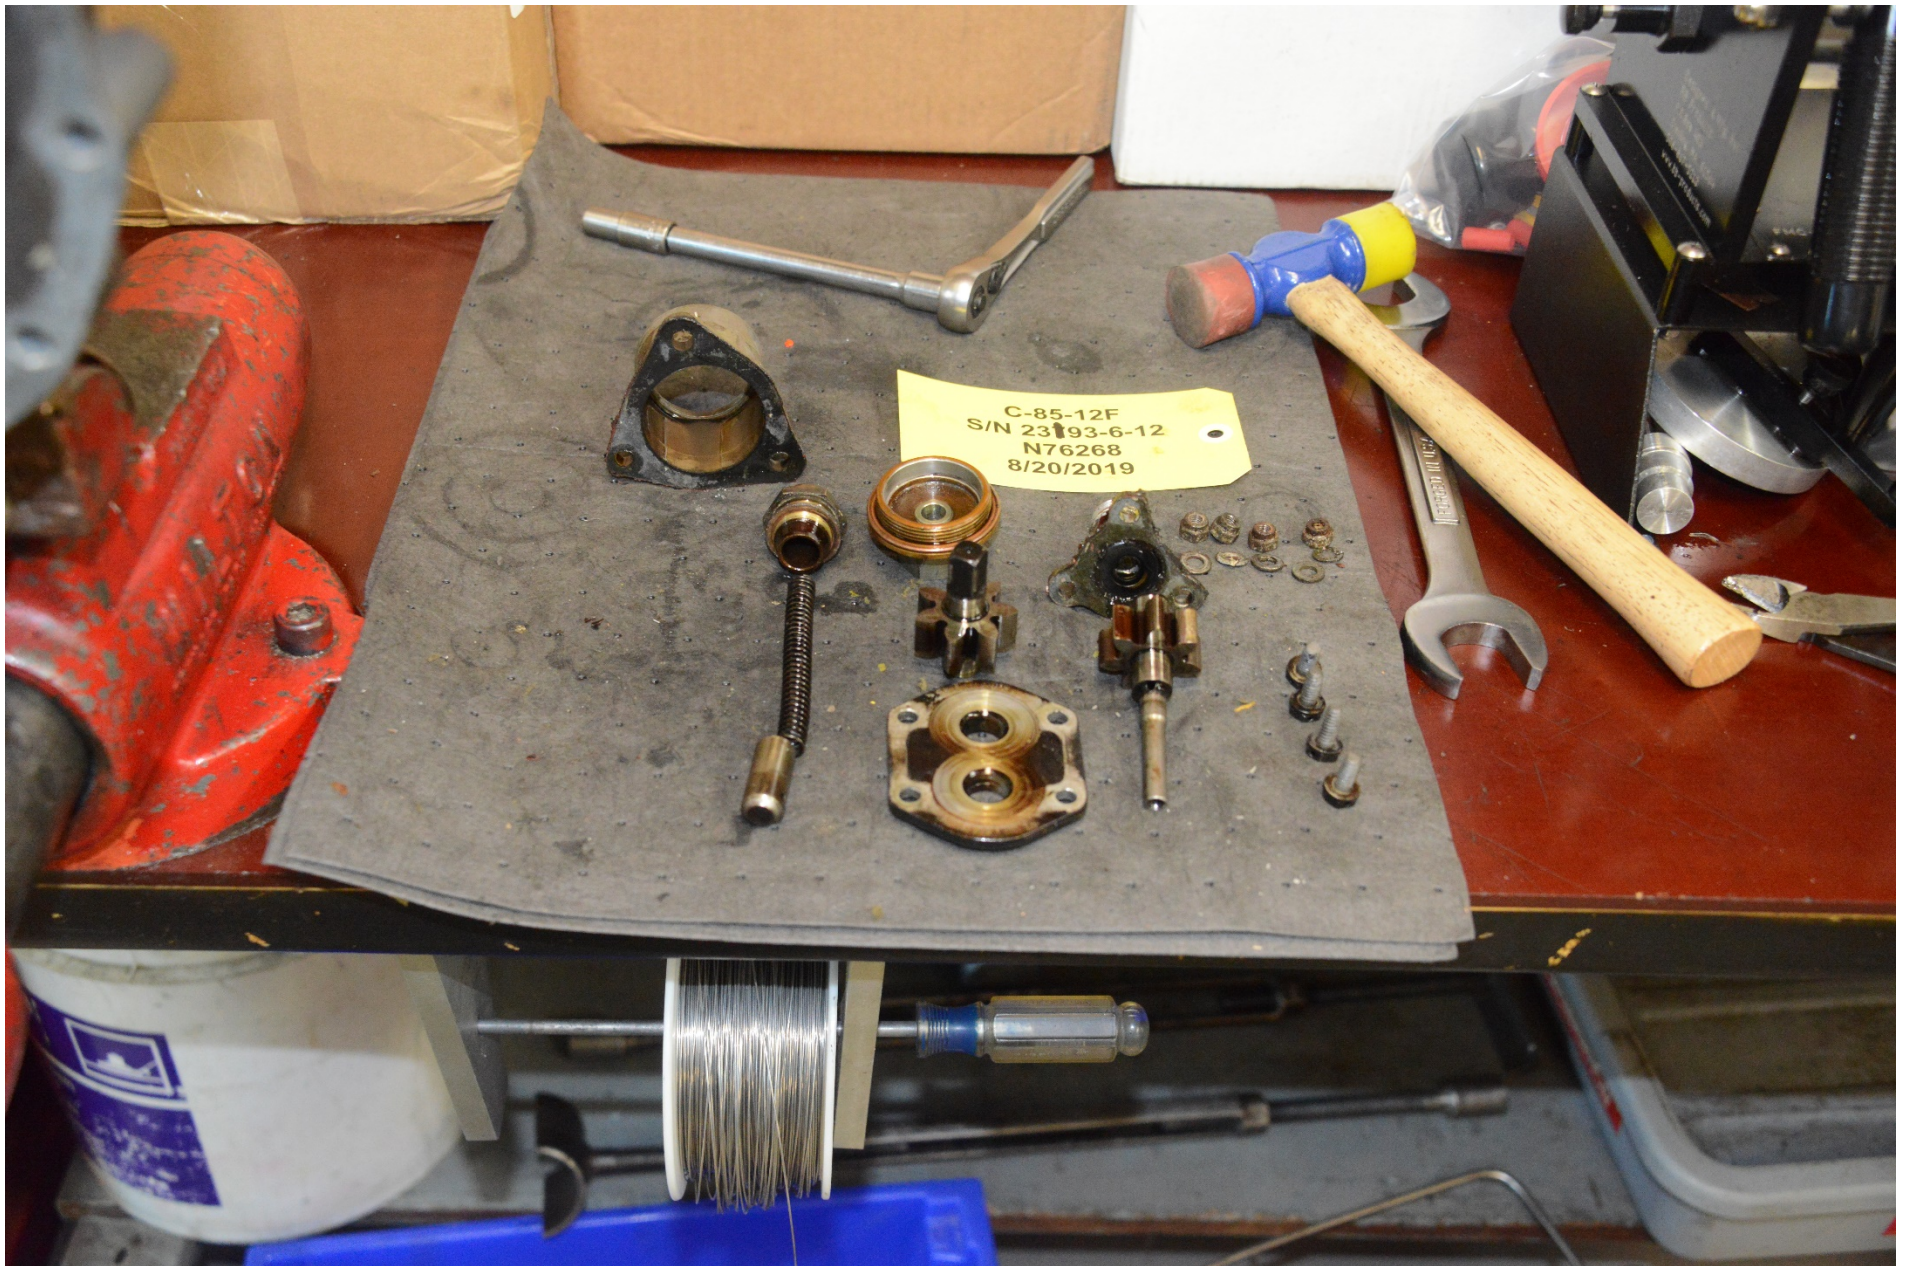
Photo 16 - View of the disassembled oil pump. The pump exhibits scoring consistent with hard particle passage.

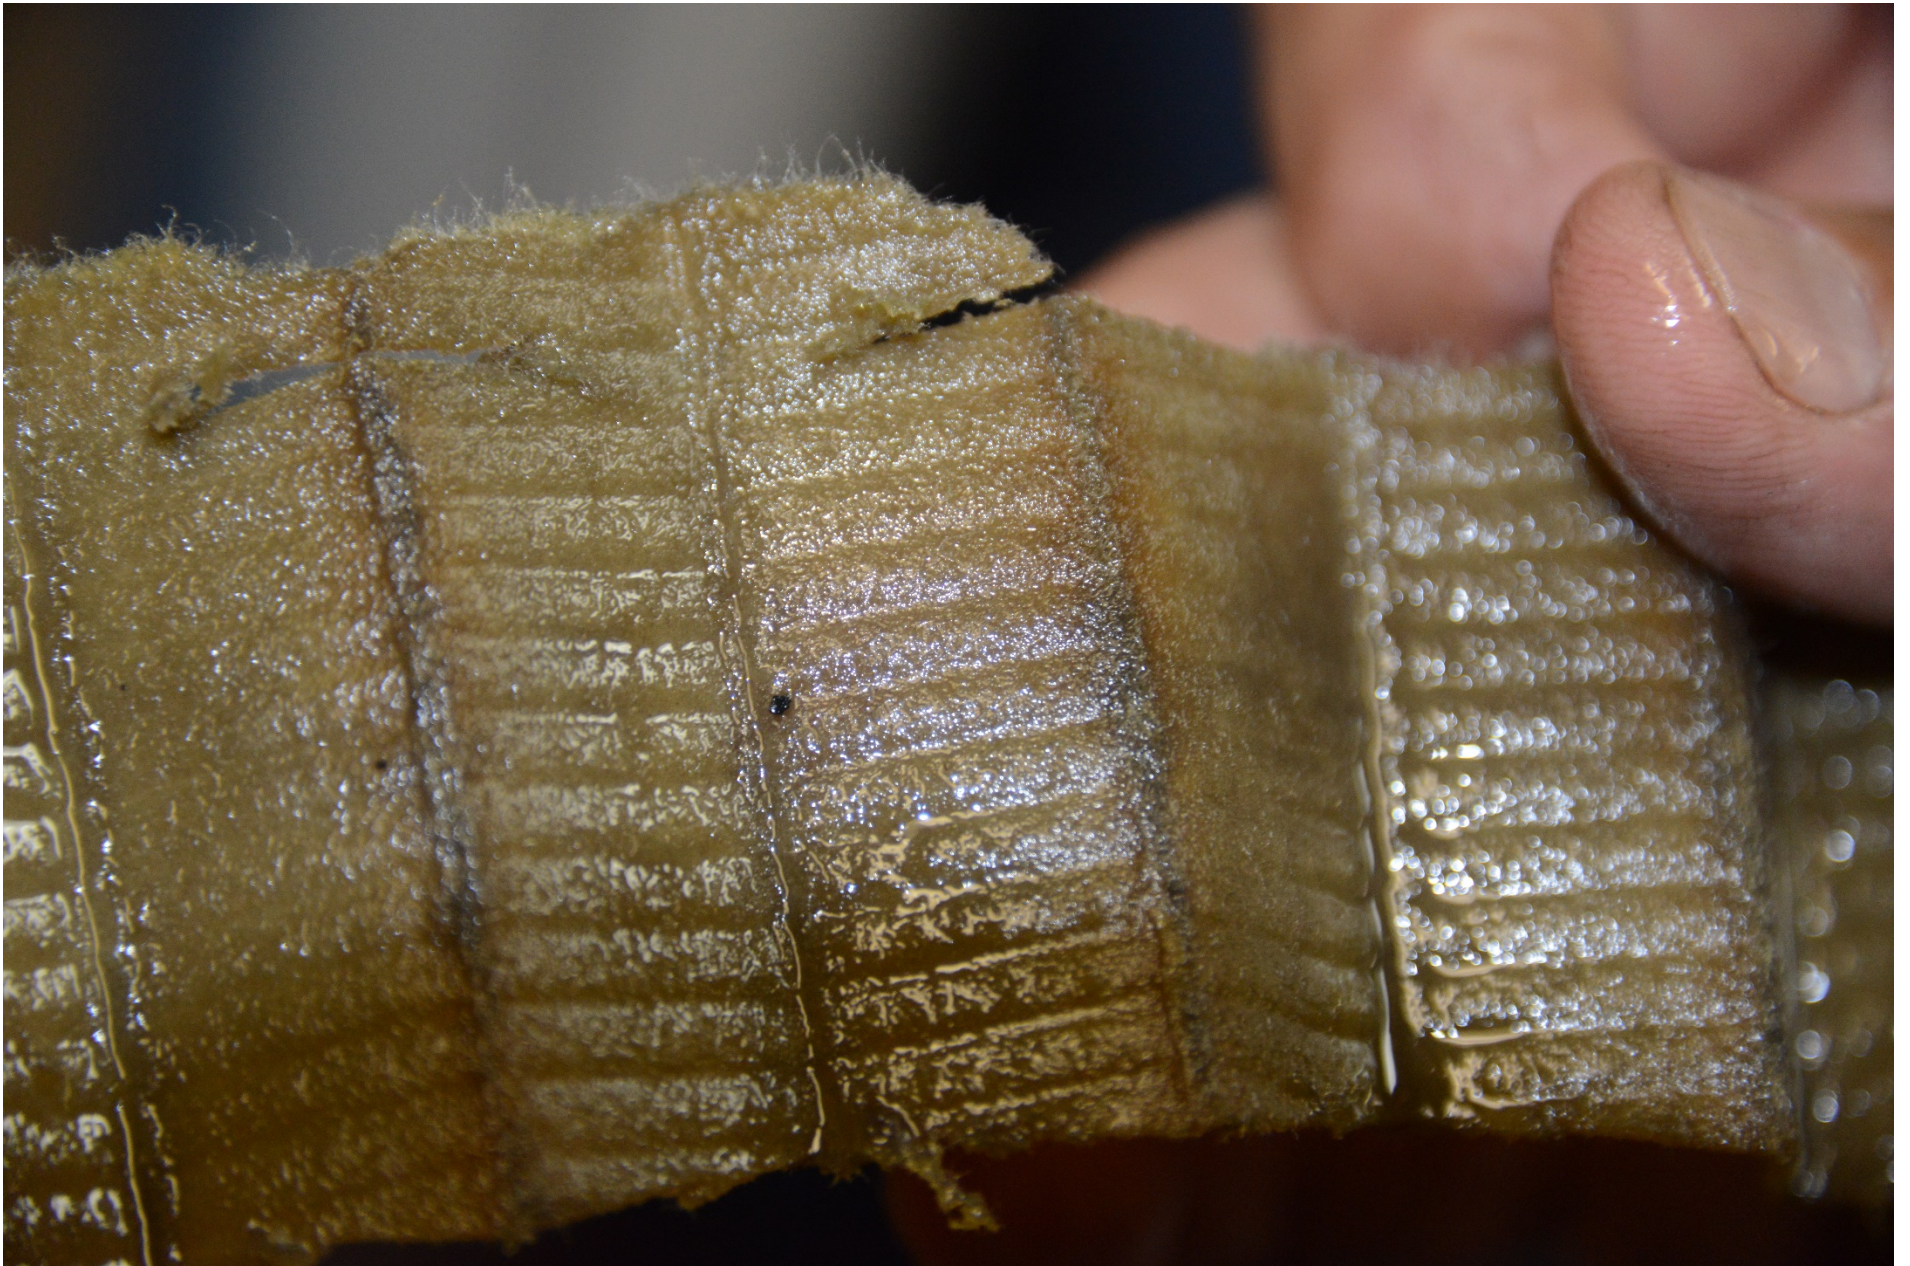
Photo 17 - Opened oil filter element exhibiting one dark colored piece of debris.

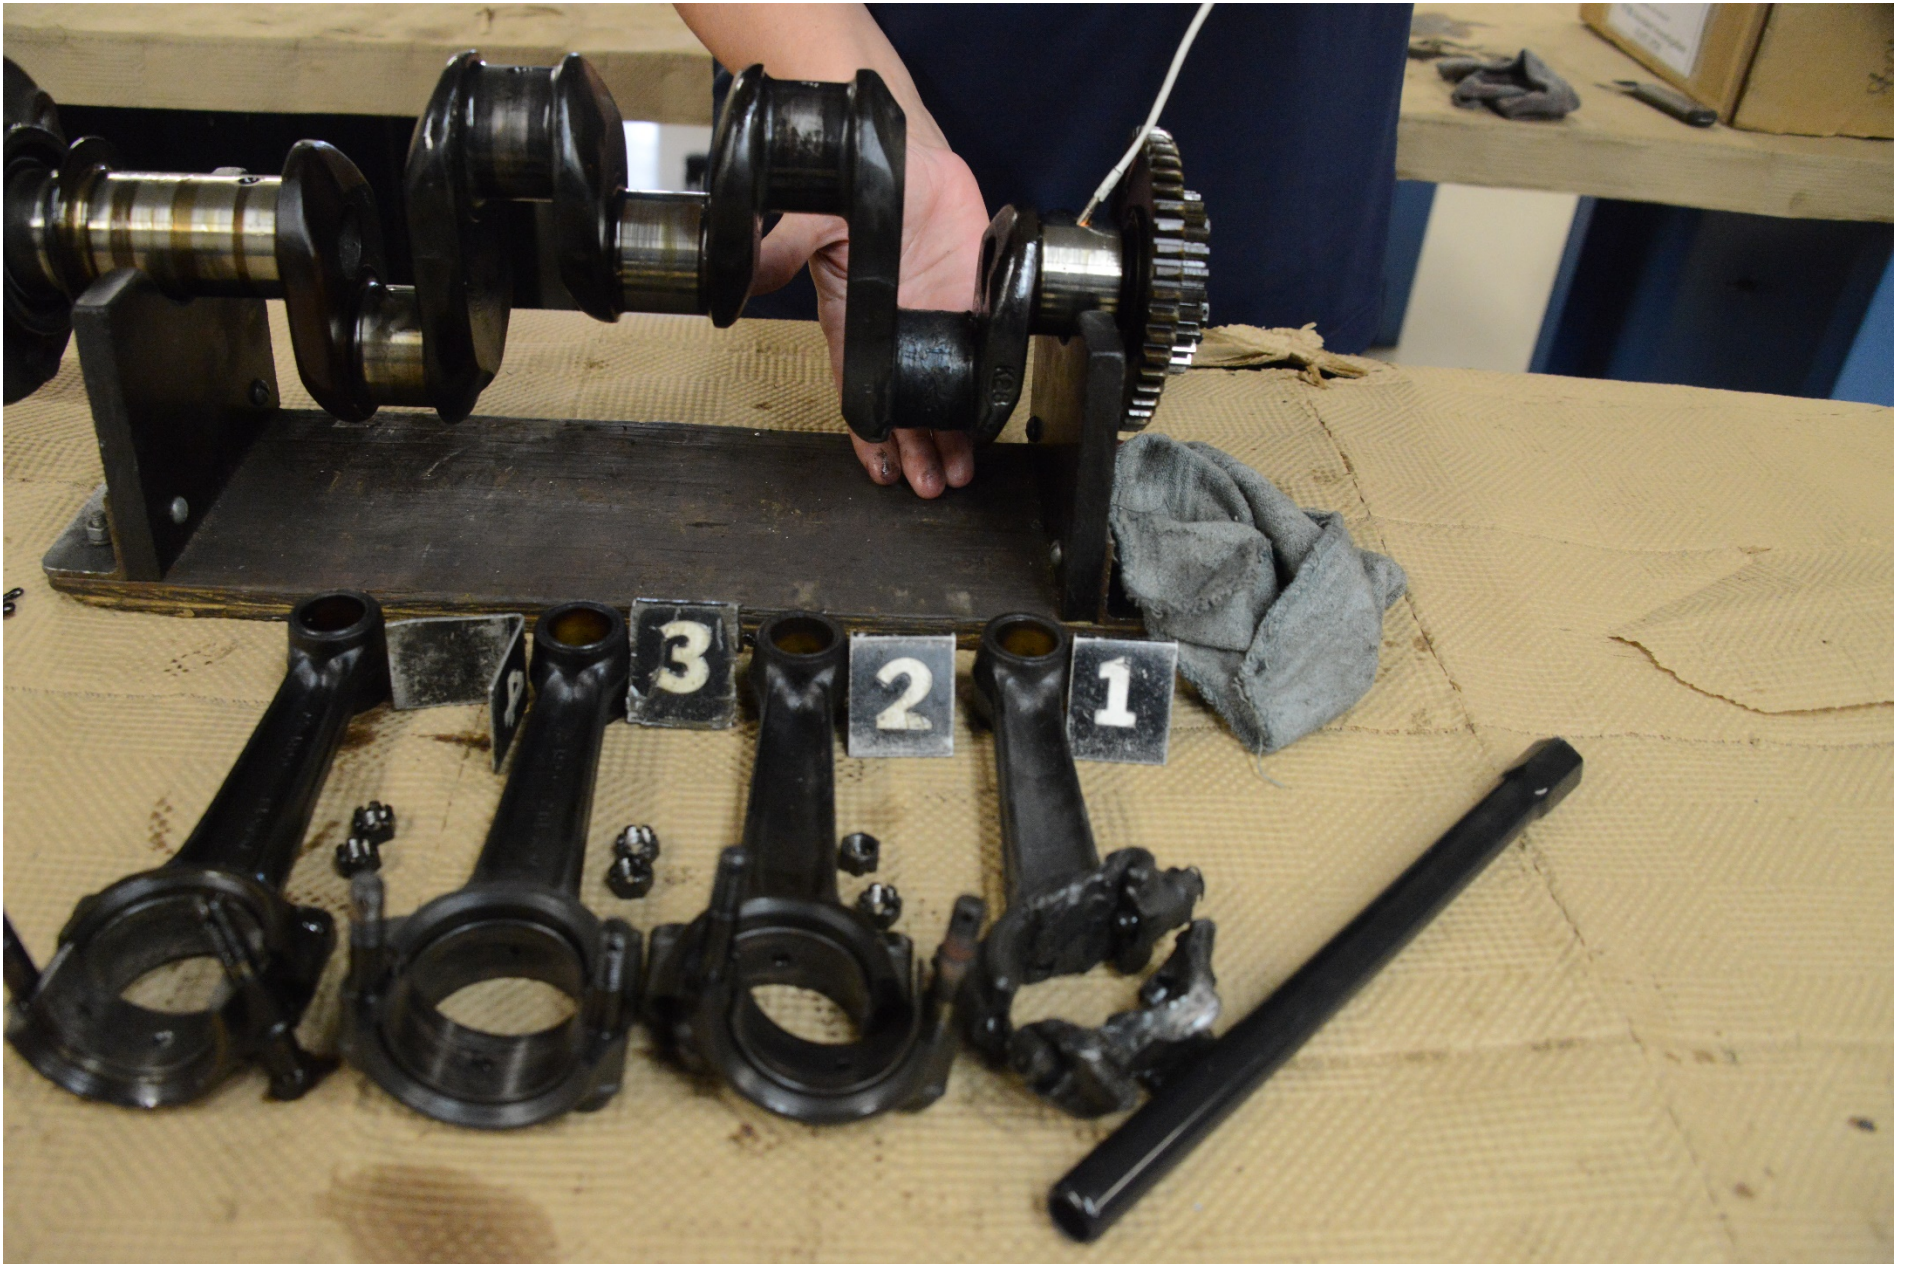
Photo 18 - View of the crankshaft with a light in the oil passage to the No. 1 rod journal. No light can be seen through the journal end of the oil passage.

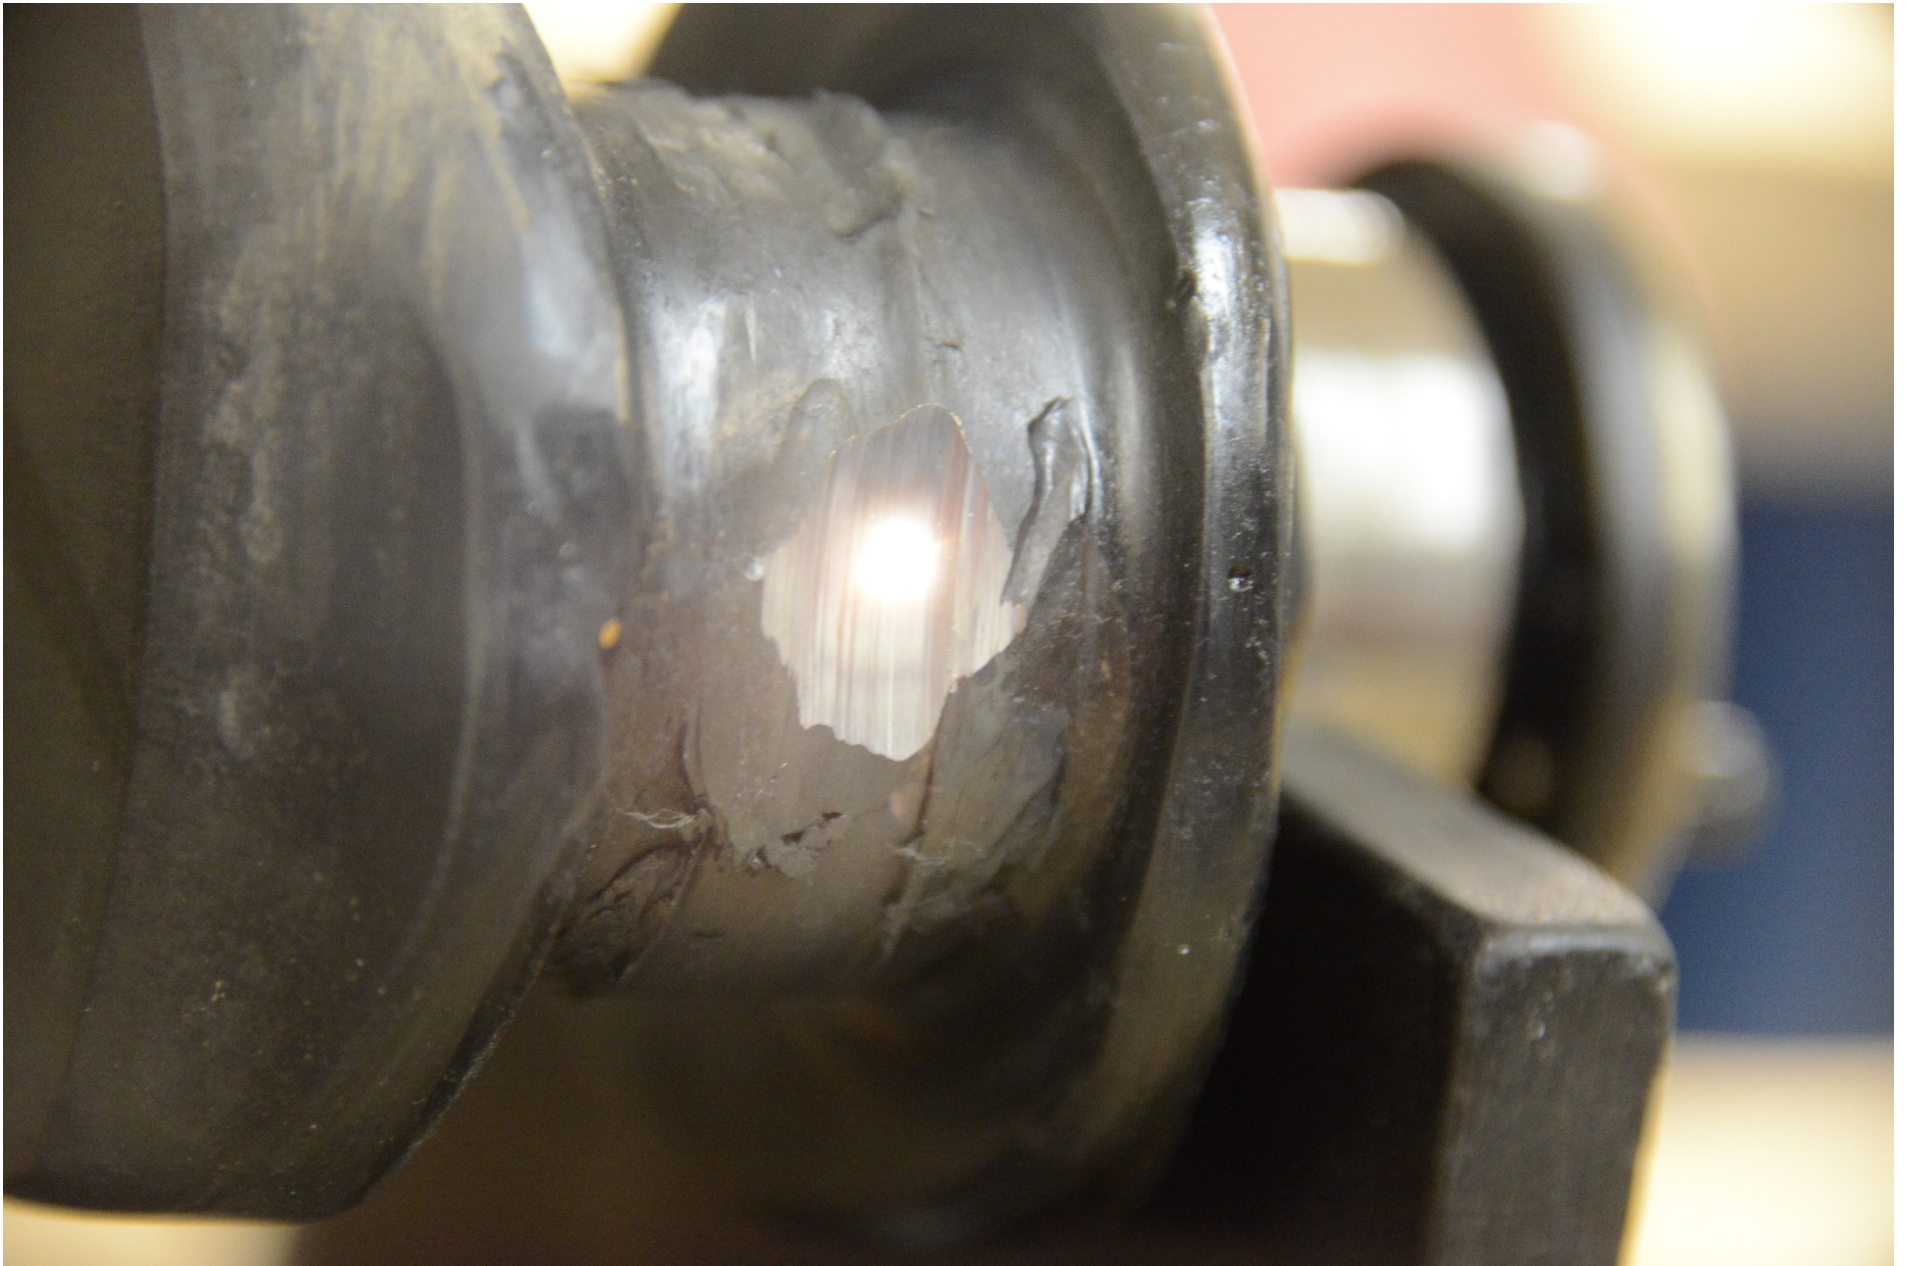
Photo 19 - View of the smeared metal removed over the oil passage on the No. 1 rod end journal. The view shows that the oil passage was not obstructed under the smeared metal..

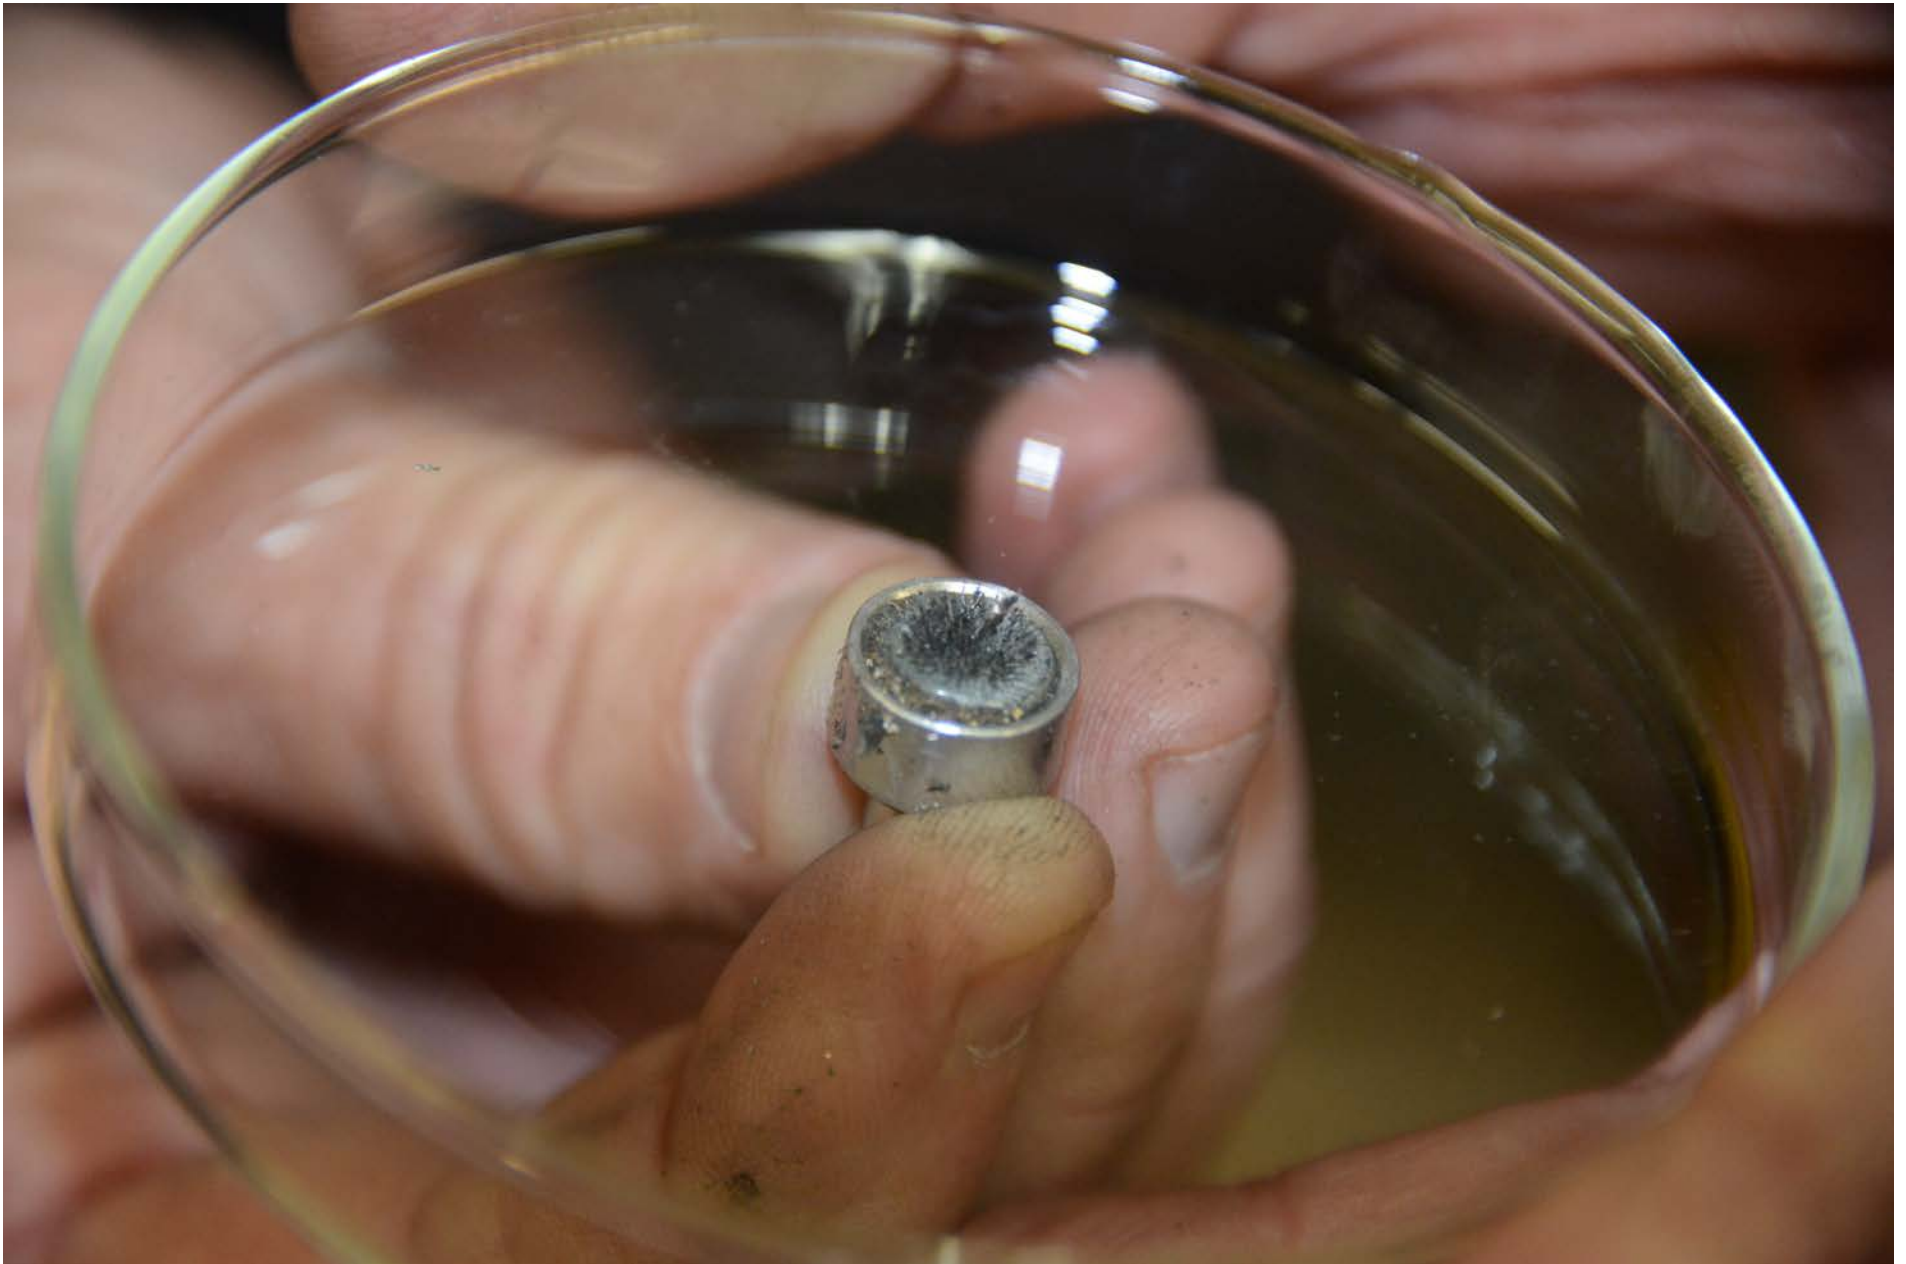
Photo 20 - View of the removed material from the smeared section over the No. 1 connecting rod's journal. The view exhibits that a magnet attracts that material.
