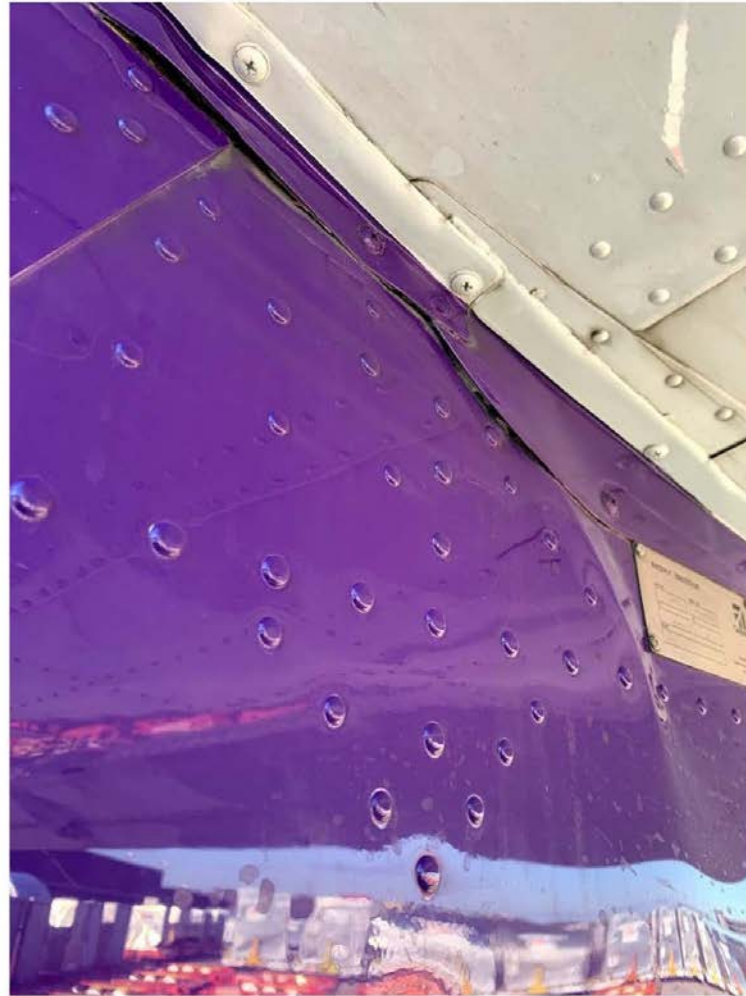
**Photo 1 – View of left side of horizontal stabilizer root**

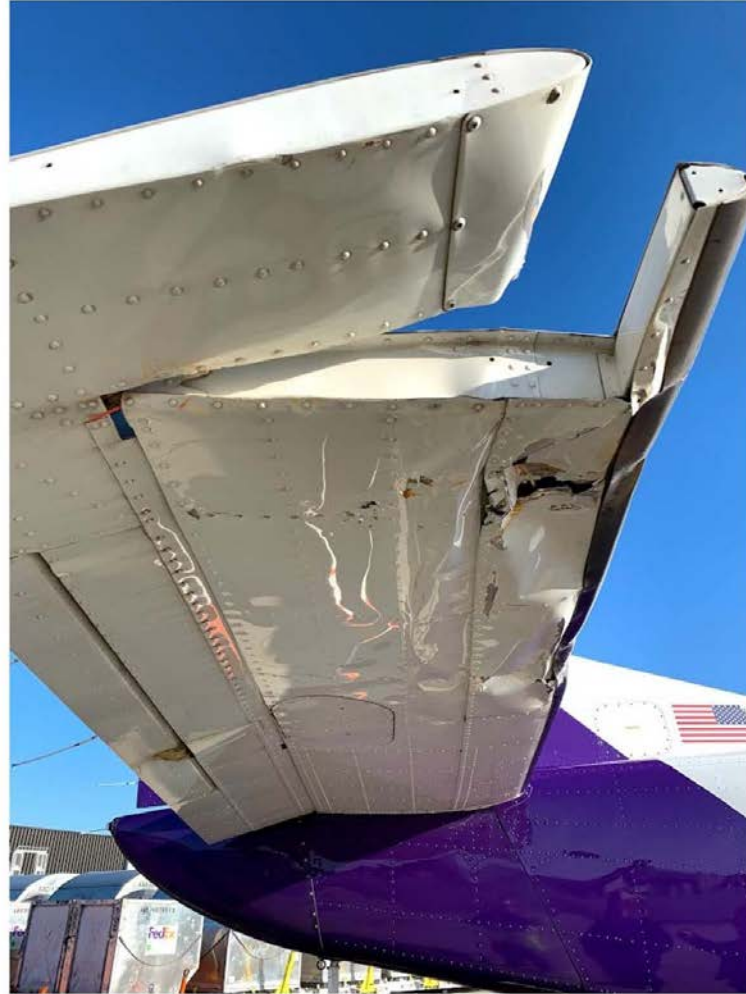
**Photo 2 – View of right horizontal stabilizer damage**

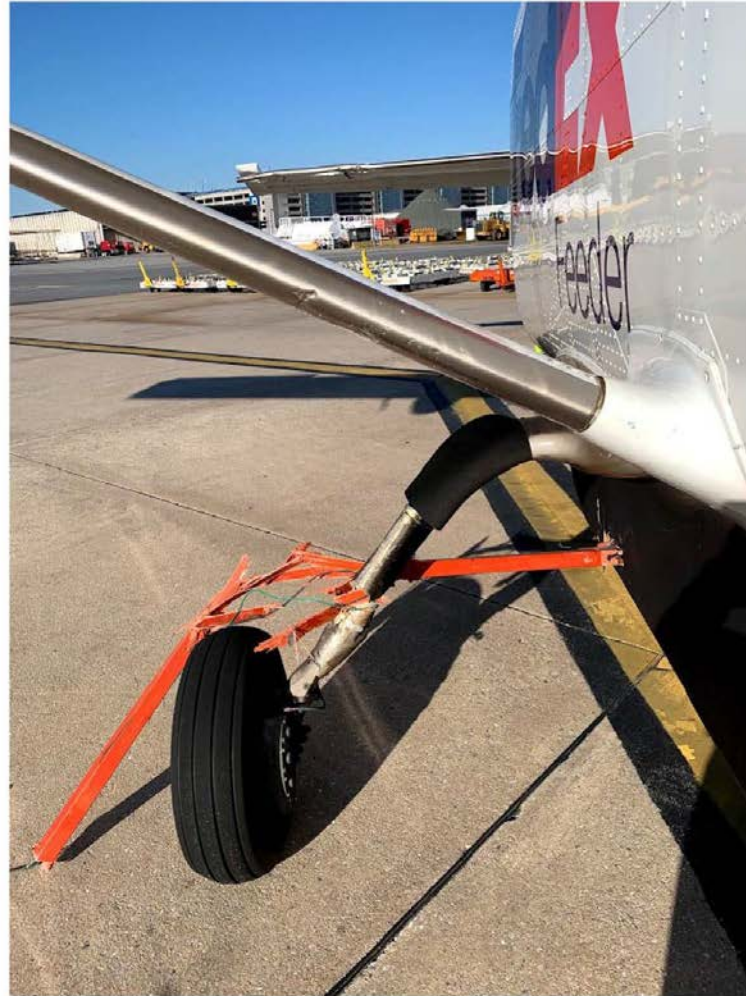
Right MLG

**Photo 3 – View of right main landing gear with lighting system parts attached**

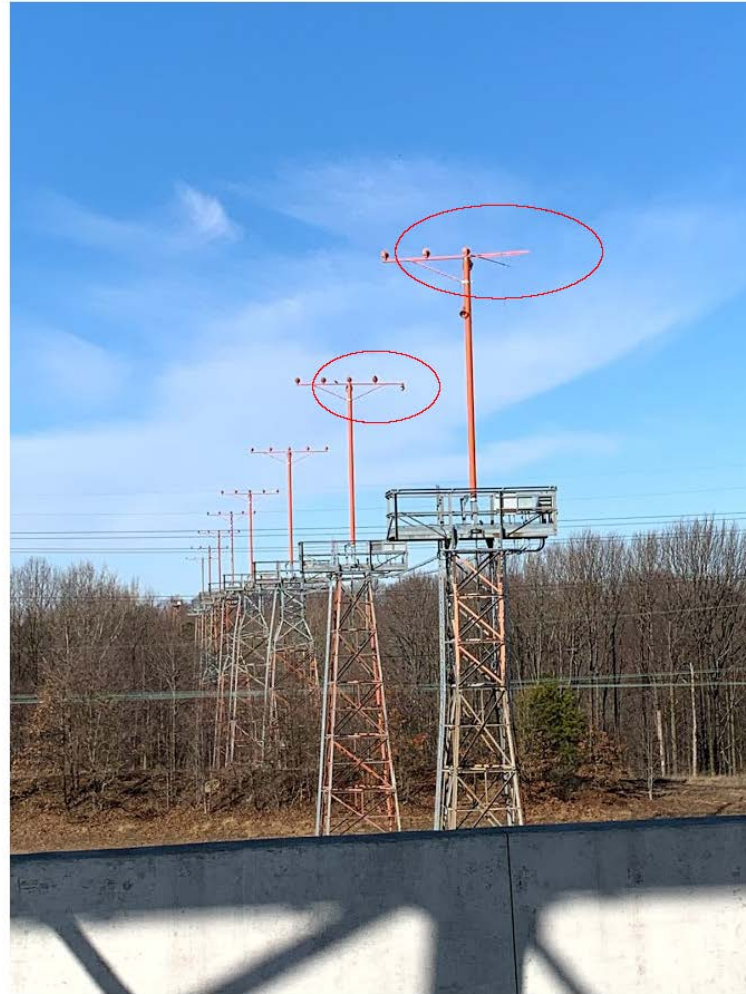
Approach light towers looking away from approach end of RWY 10

**Photo 4 – View of approach lighting towers showing damaged area in red circles**
