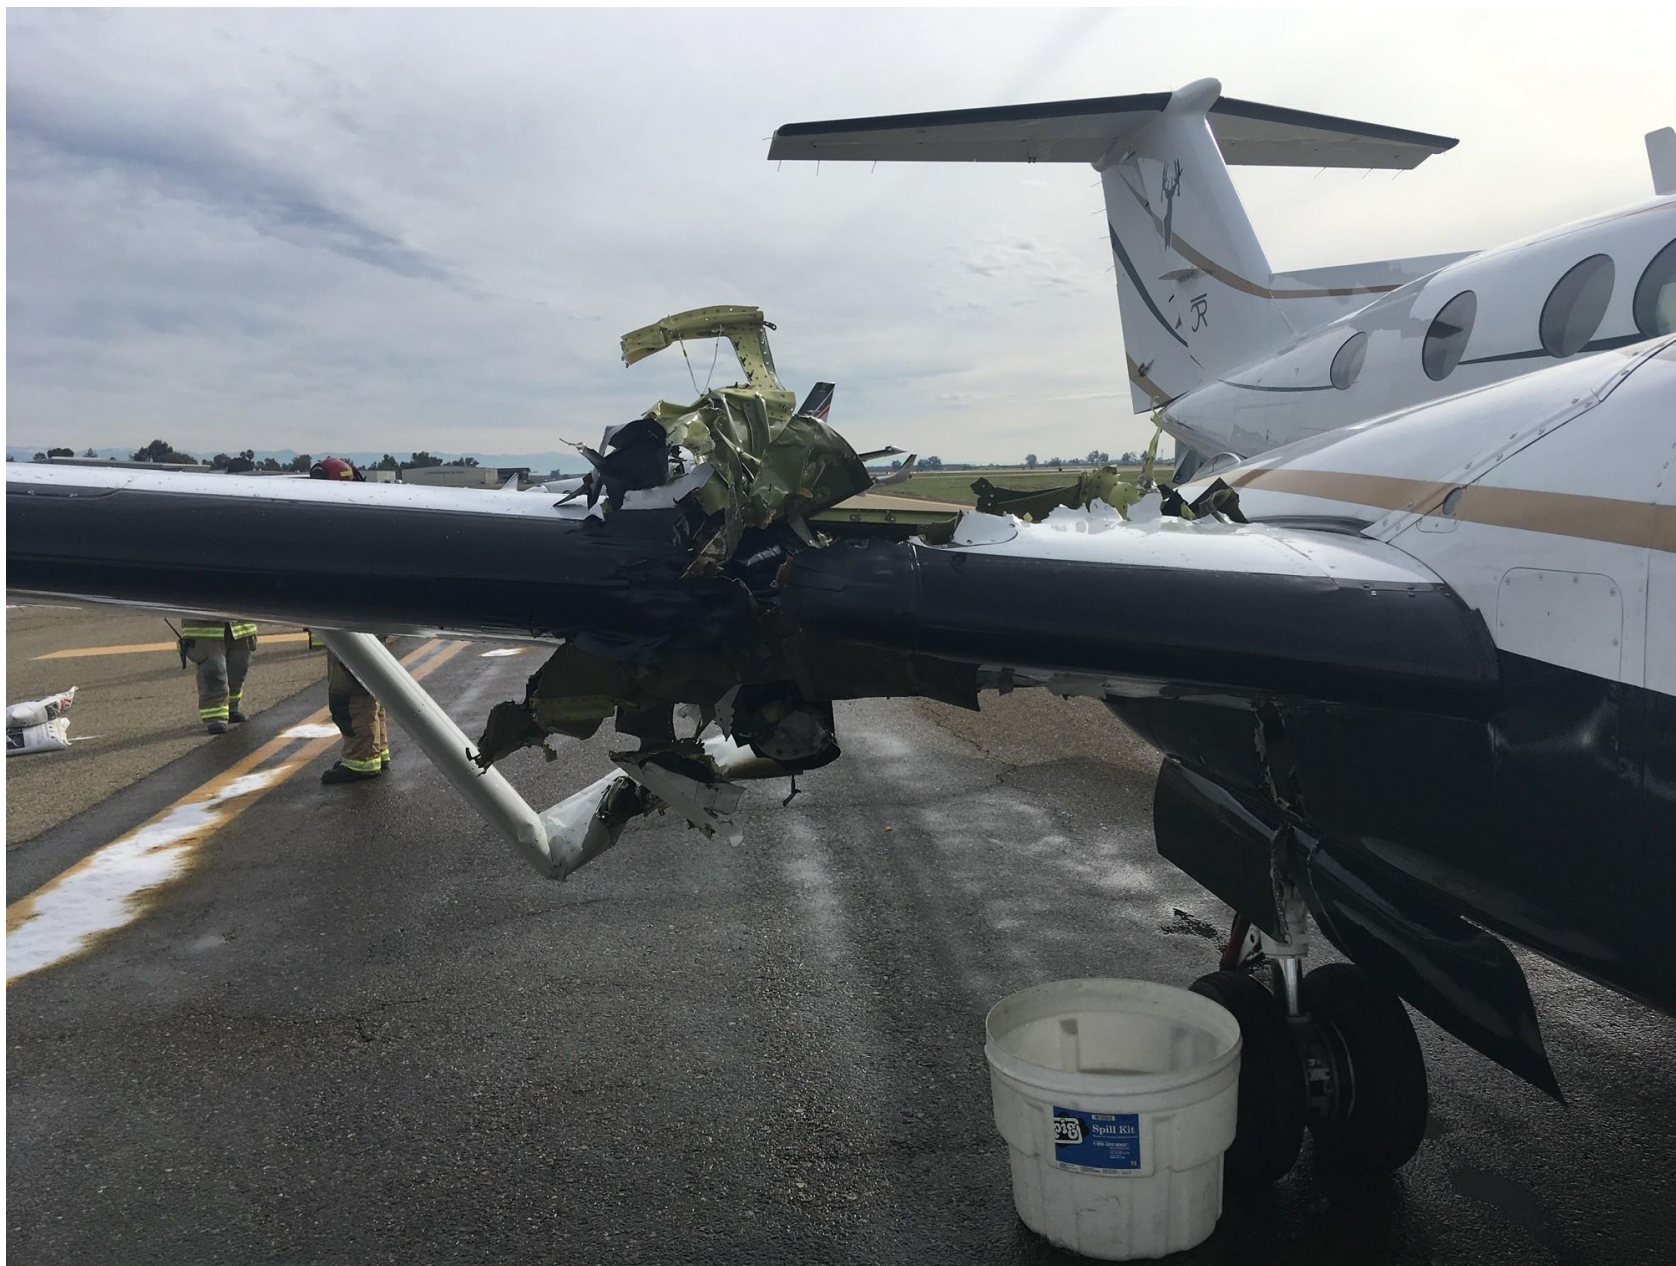
Photo 1 – N160RW showing Substantial Damage to the Right Wing

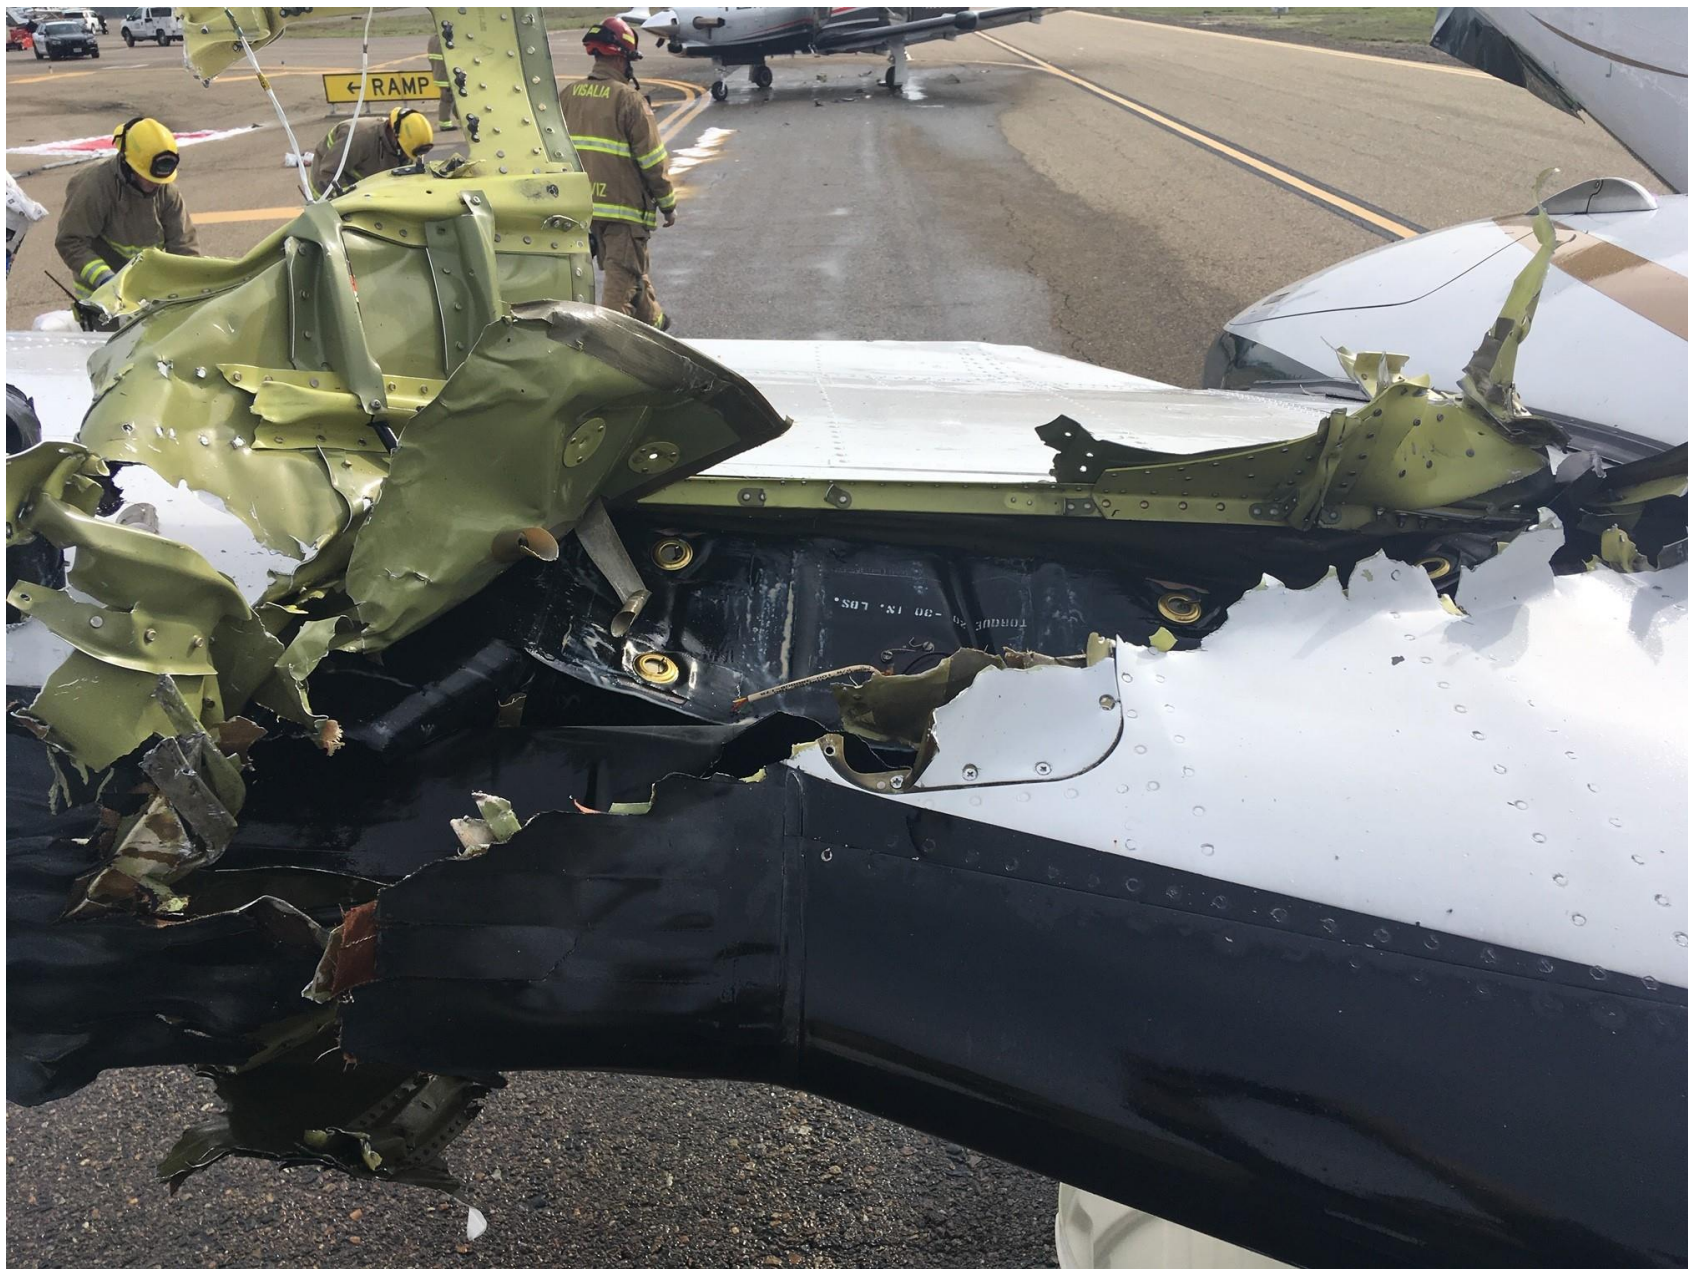
Photo 2 – N160RW showing Substantial Damage to the Right Wing

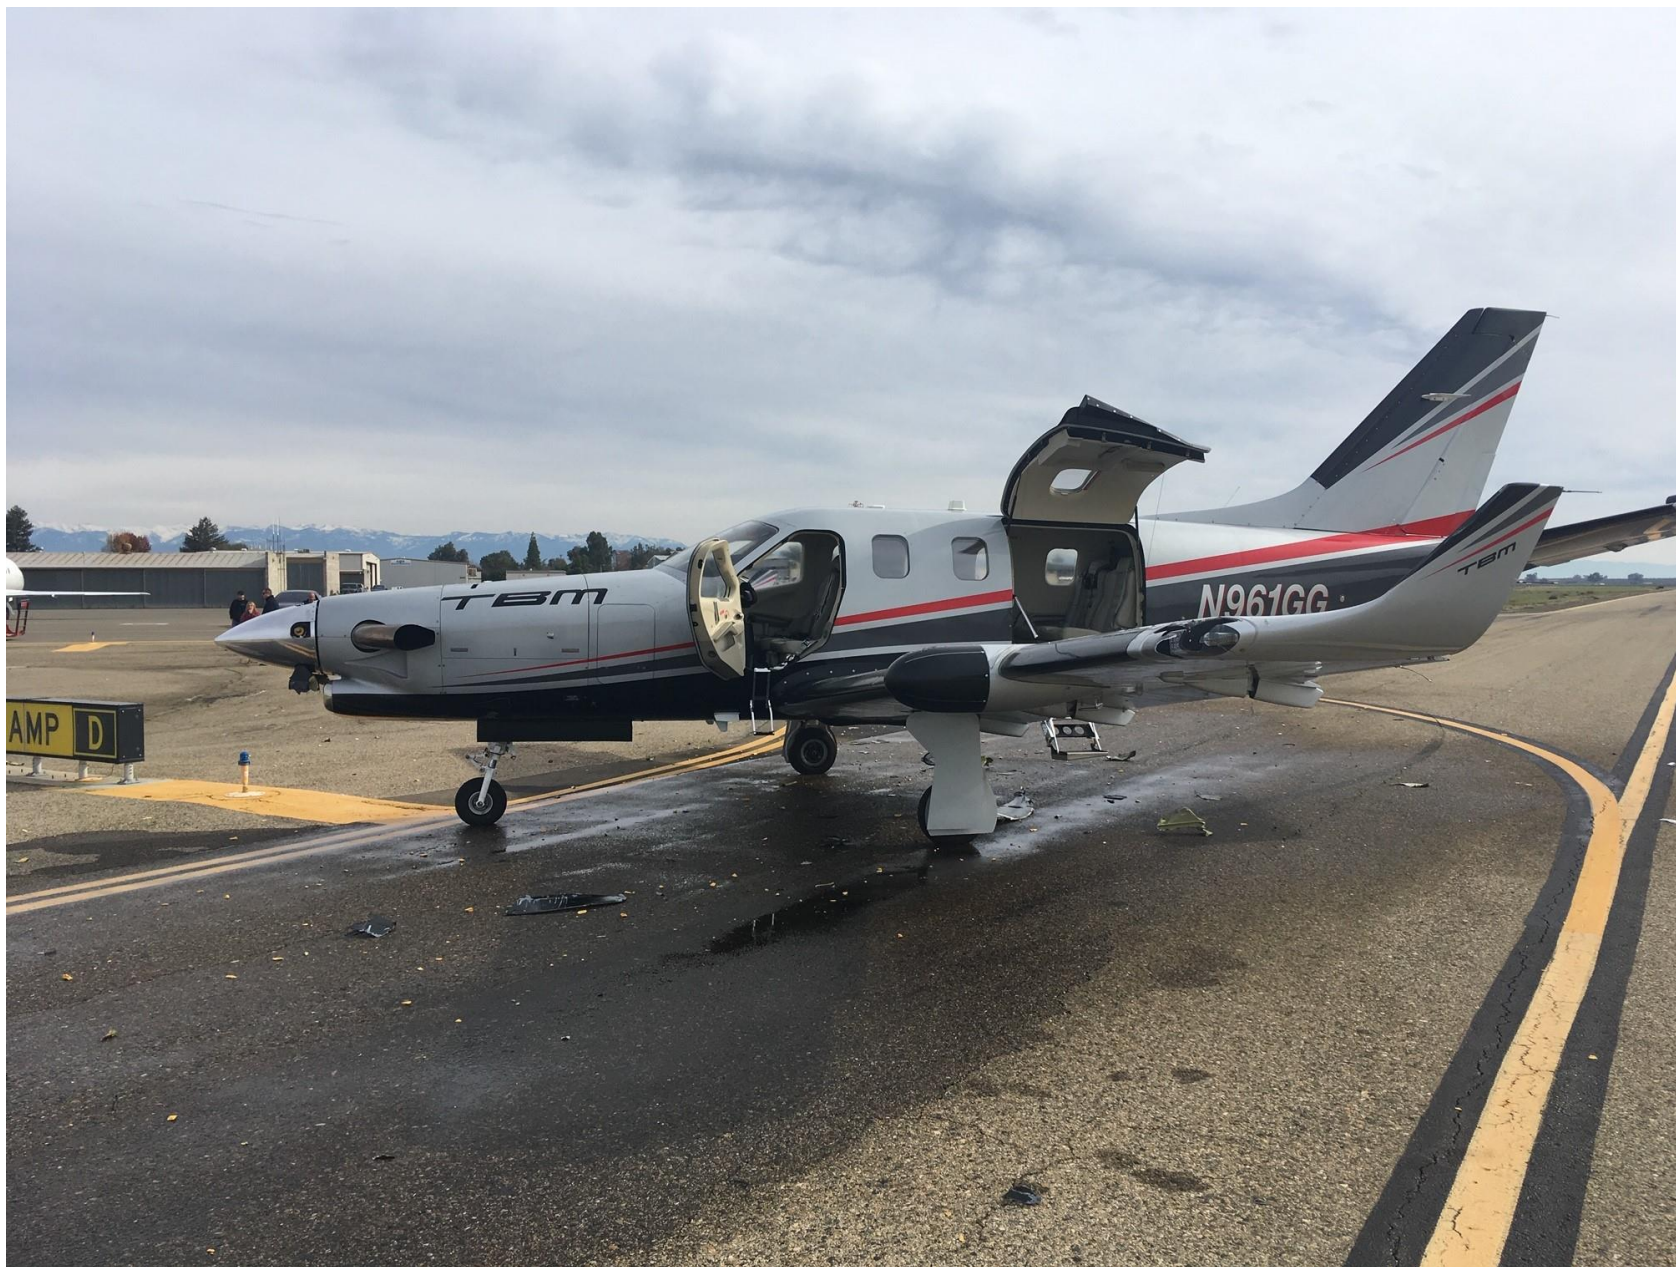
Photo 3 – N961GG Showing damage to the Propeller

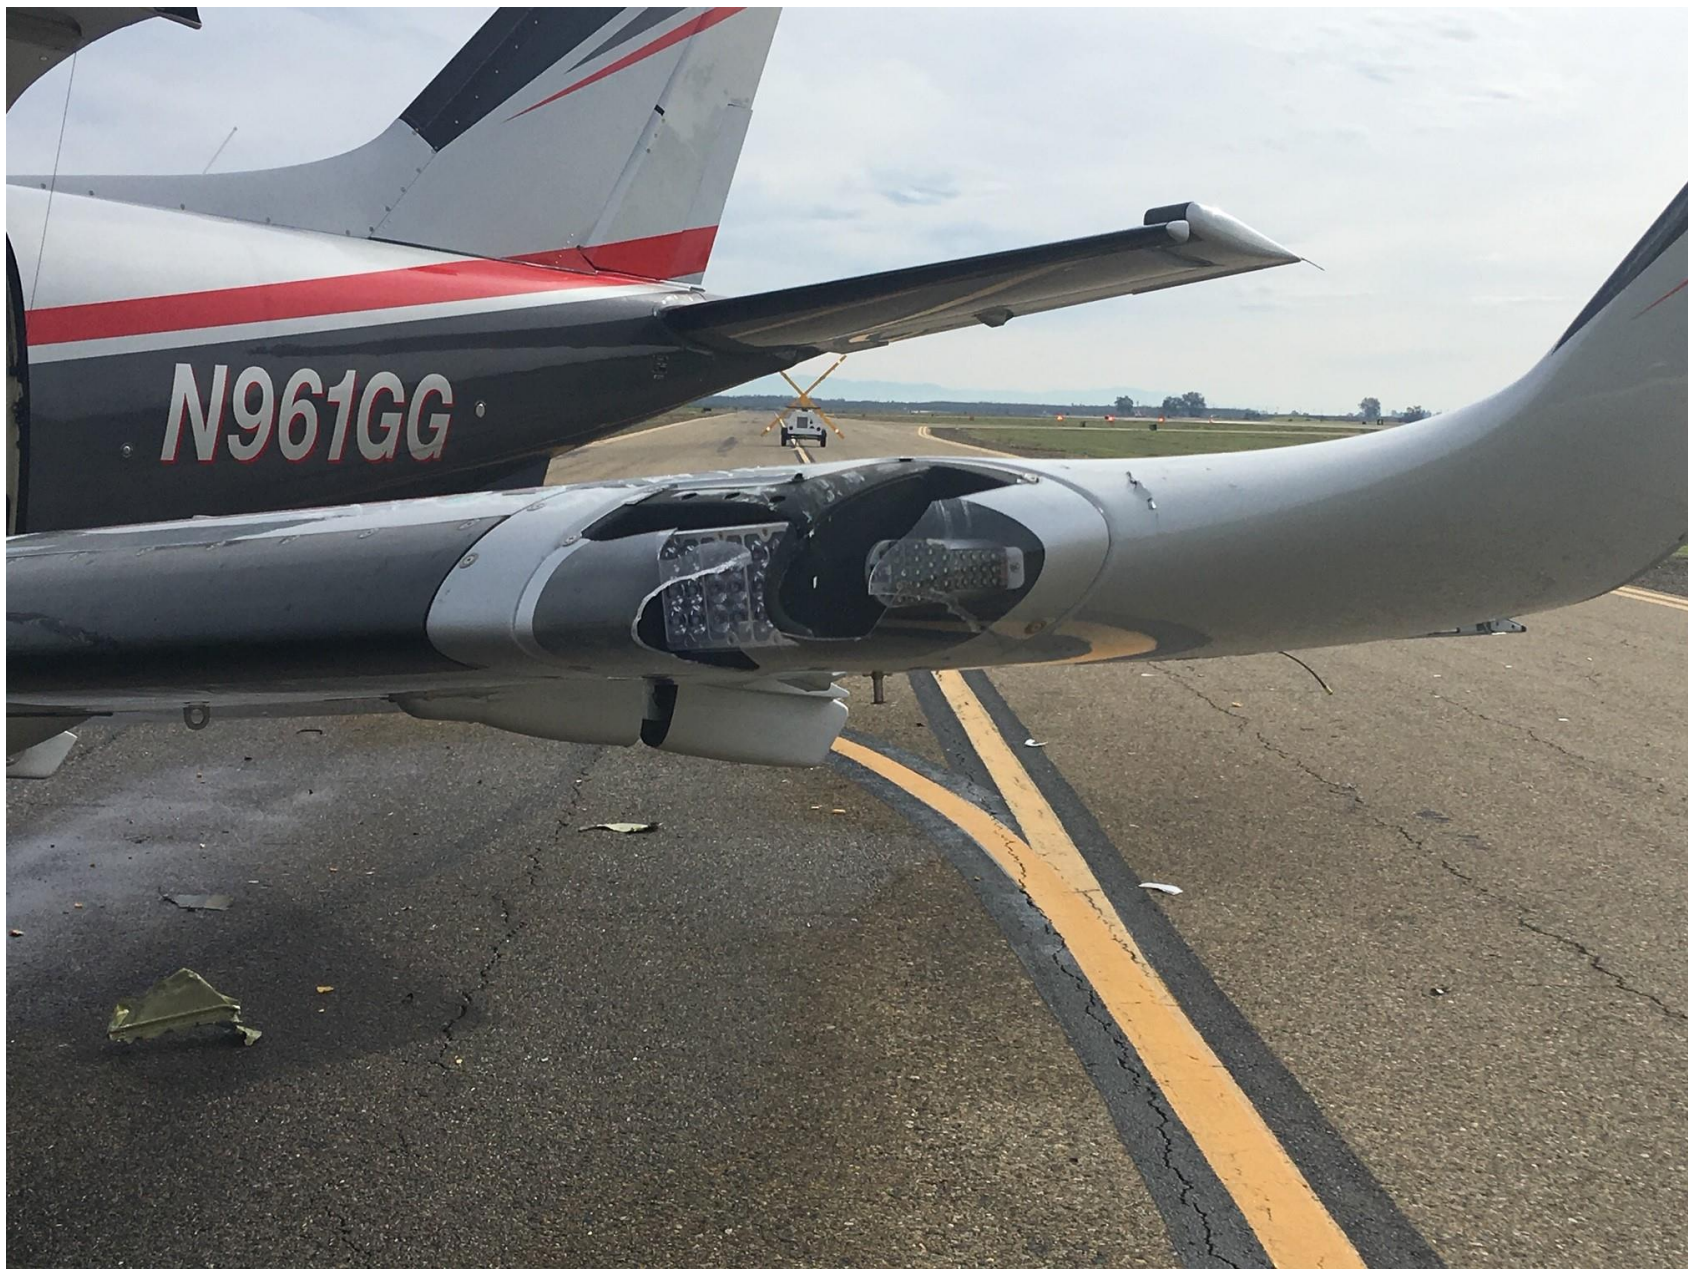
Photo 4 – N961GG showing damage to the Wing Tip
