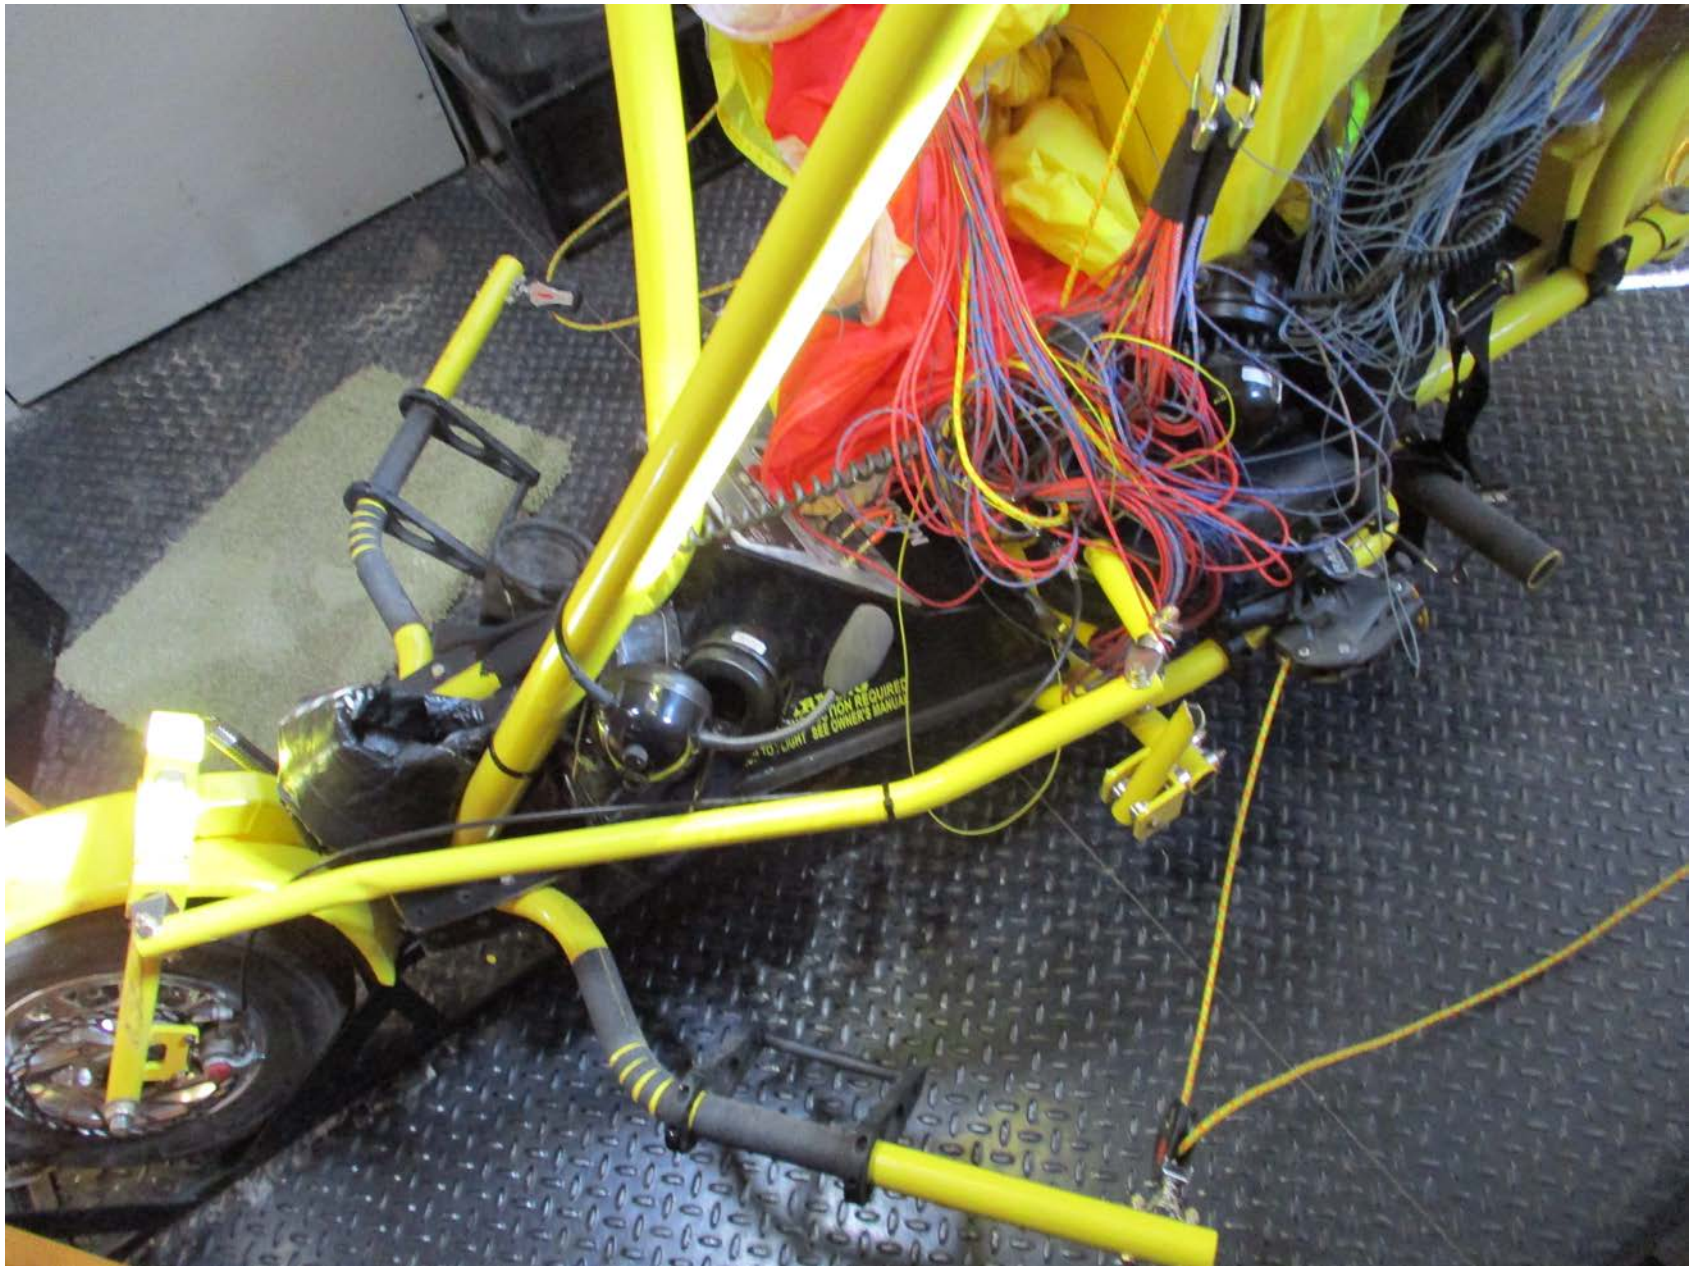
Photo 1 – Left Side View showing Steering Control damage

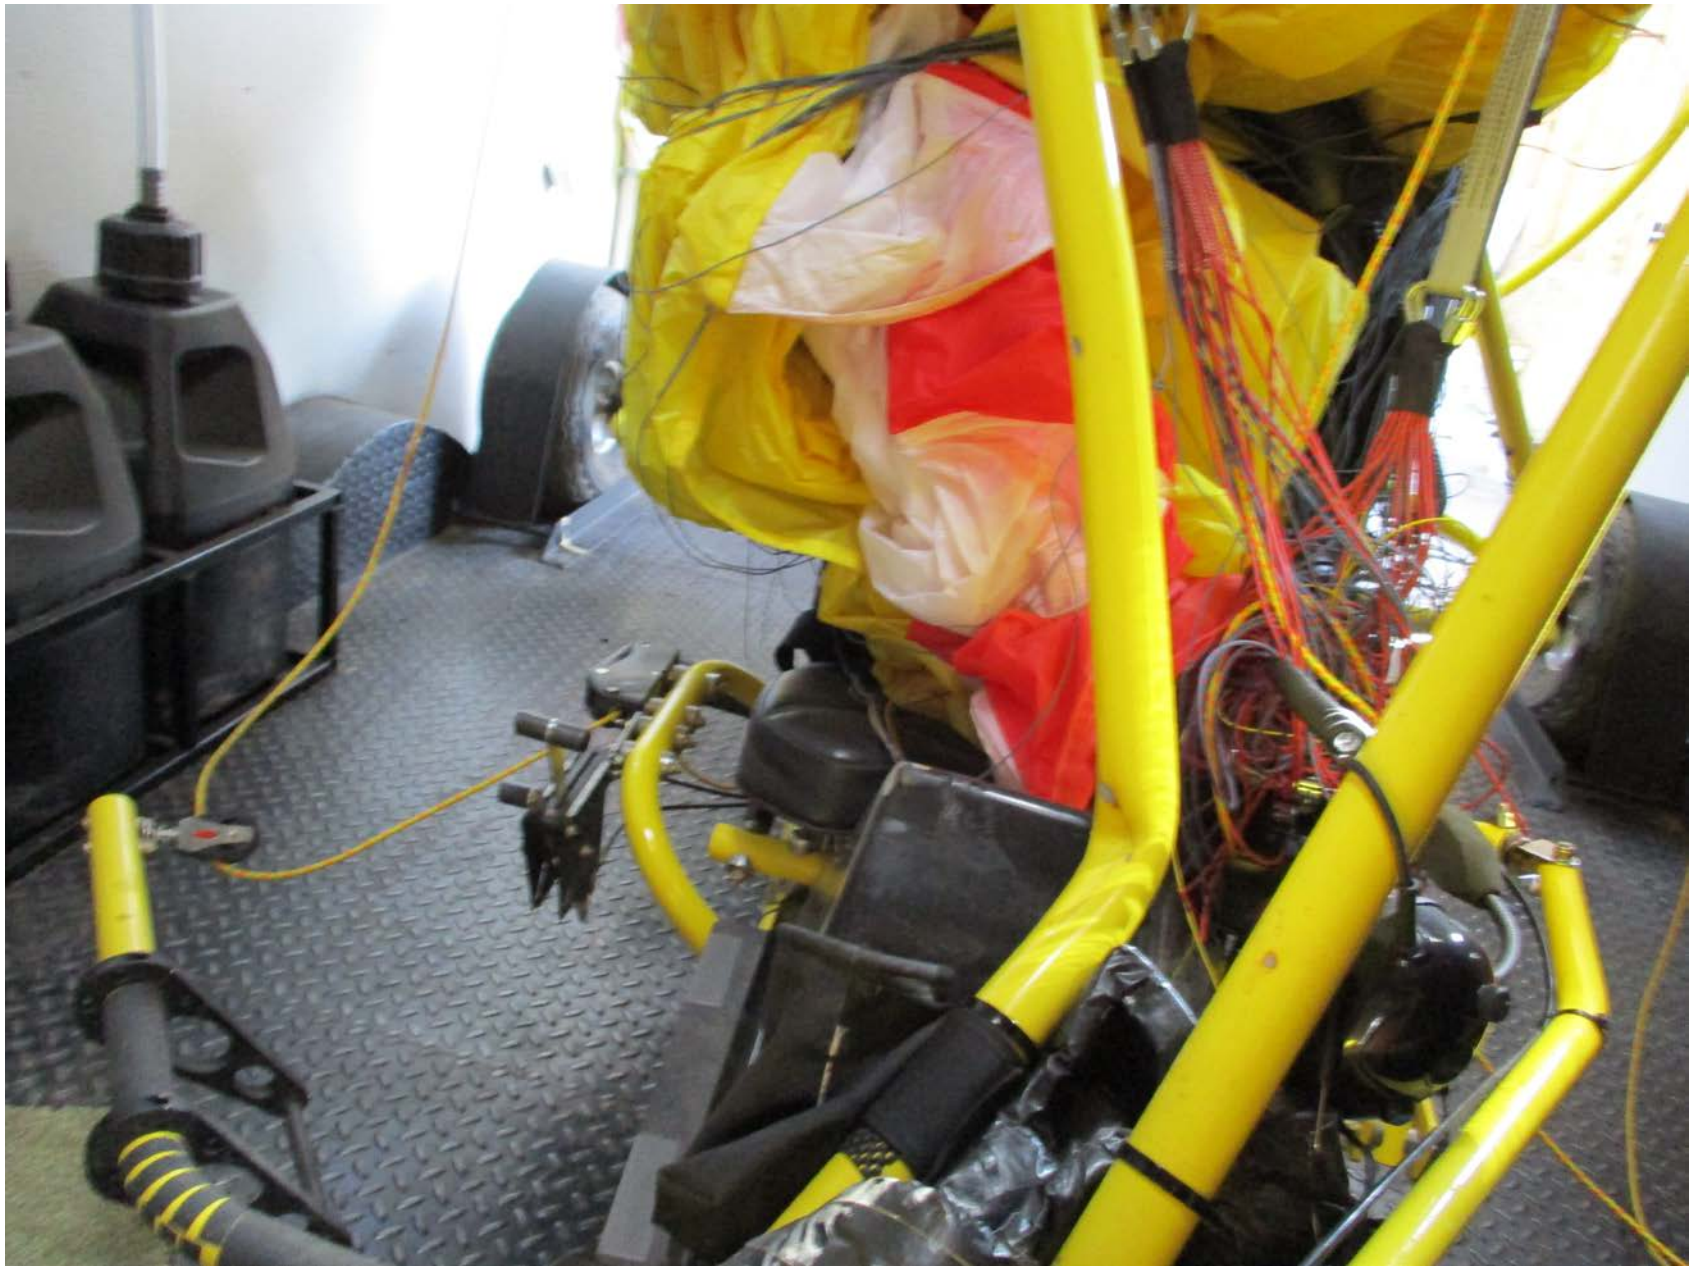
Photo 2 - Front View showing Frame Damage
