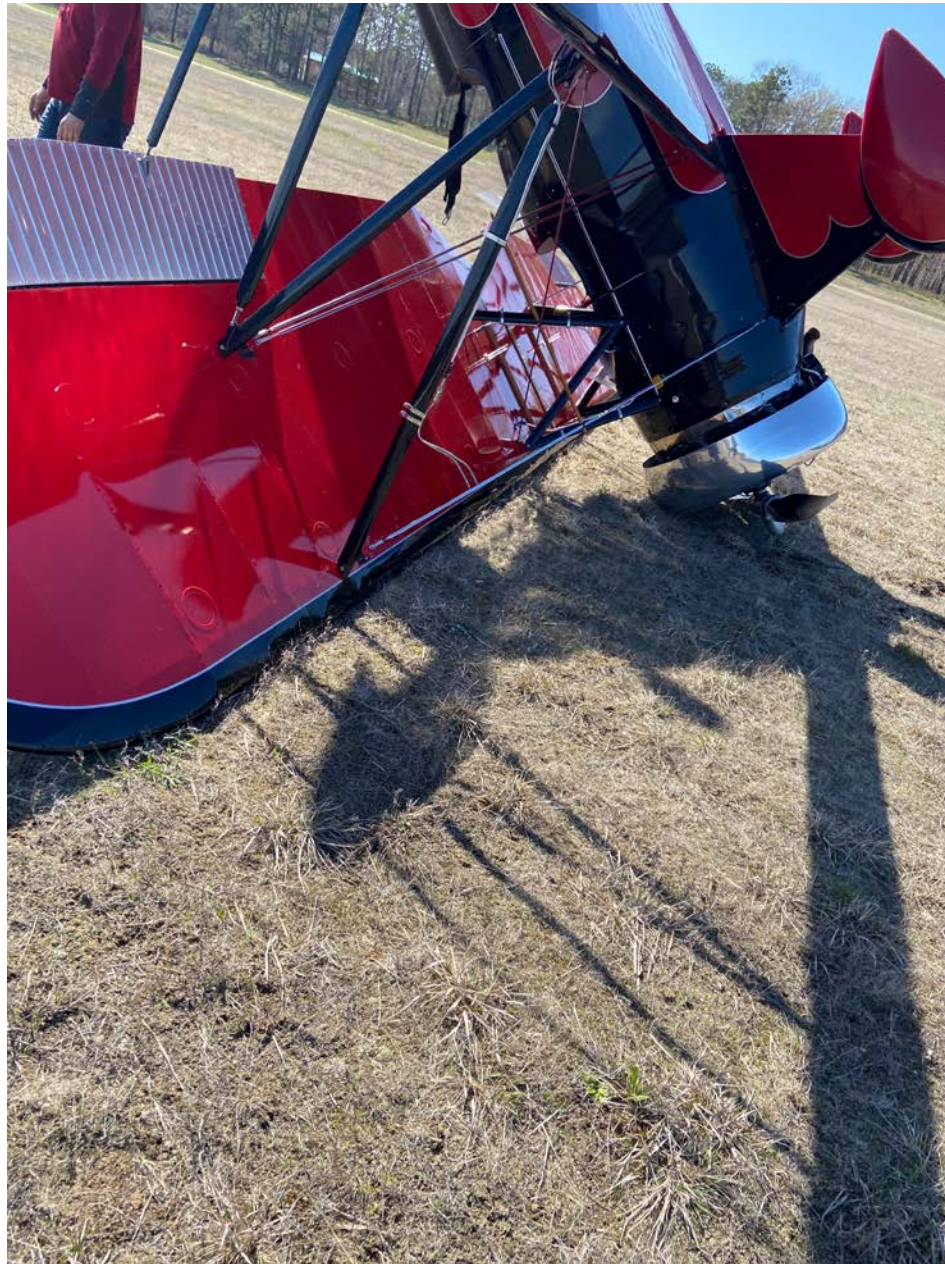
Photo 1 – View of the wreckage as it came to rest. (Photo courtesy of FAA)

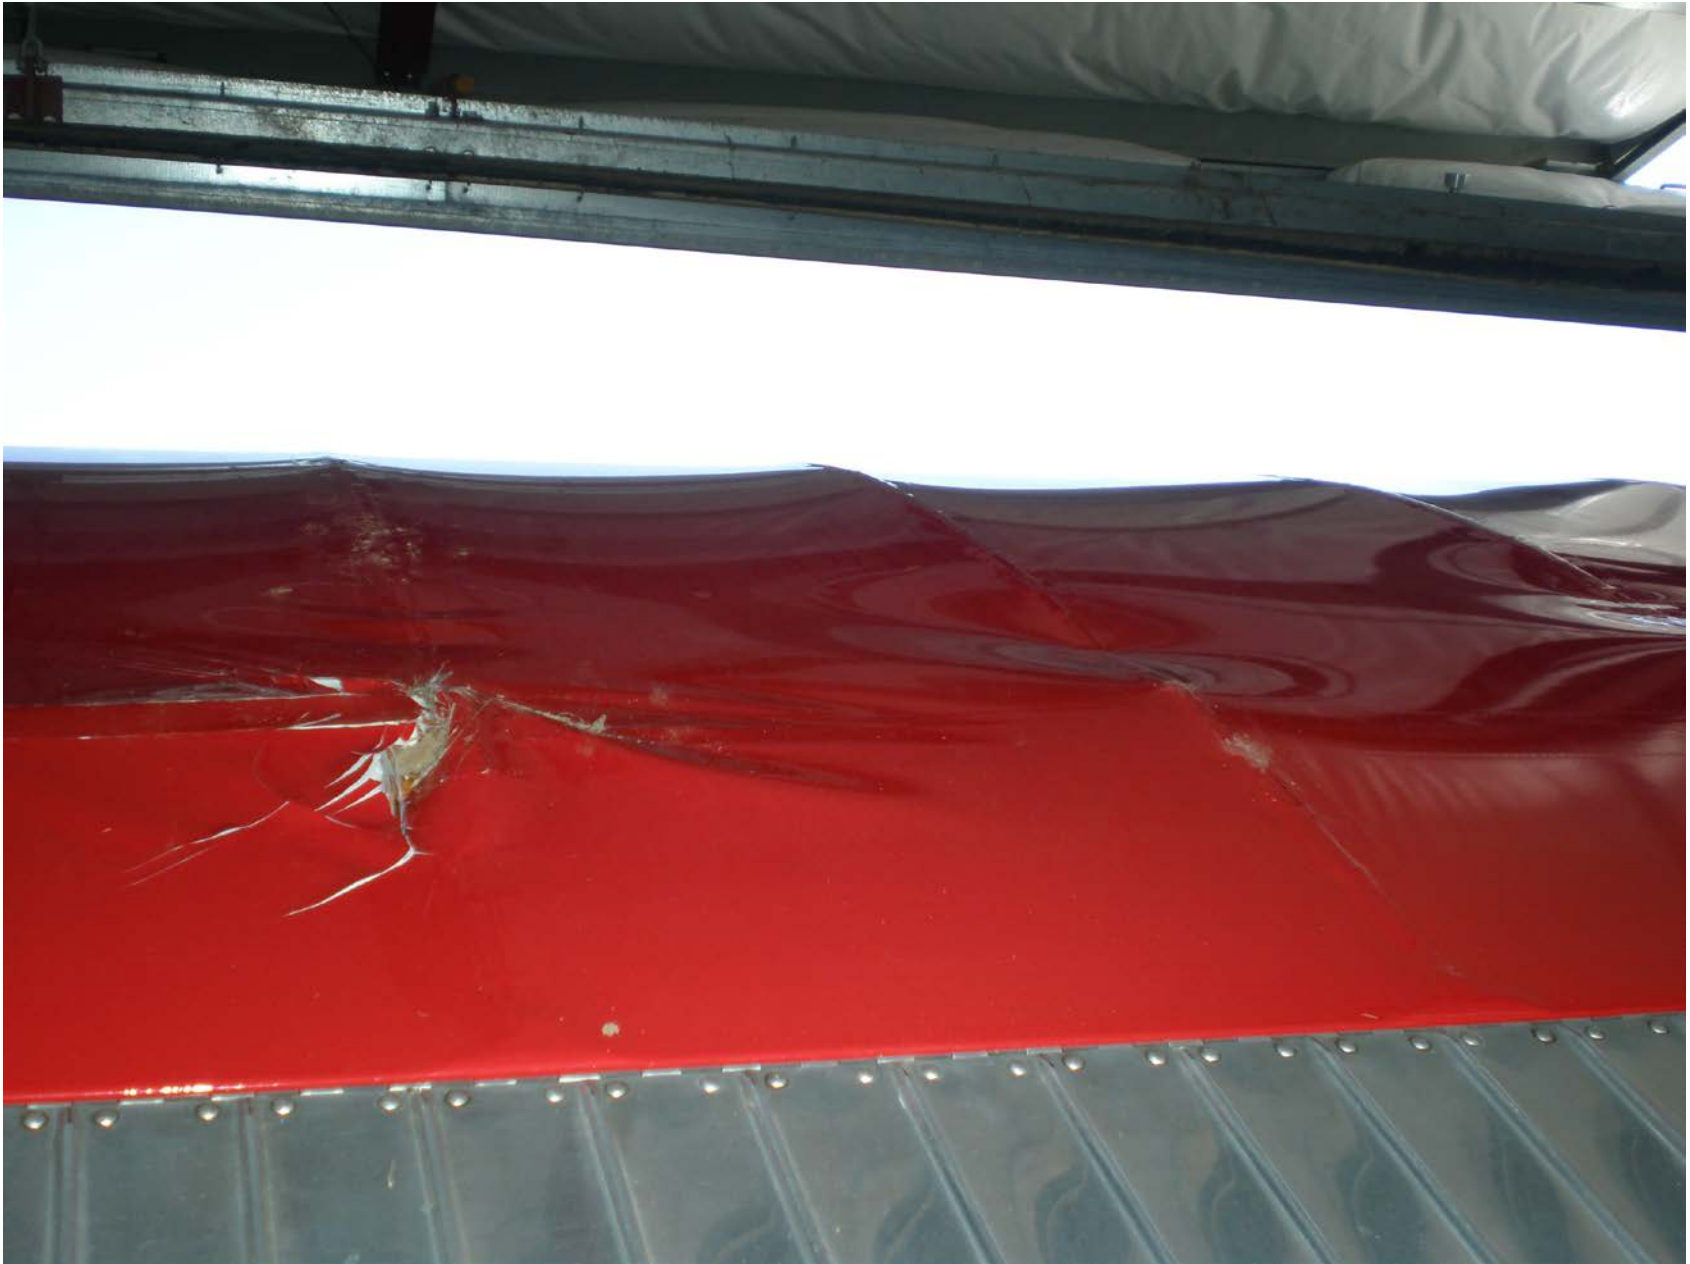
Photo 2 – View of the outboard portion of the right upper wing.(Photo courtesy of FAA)

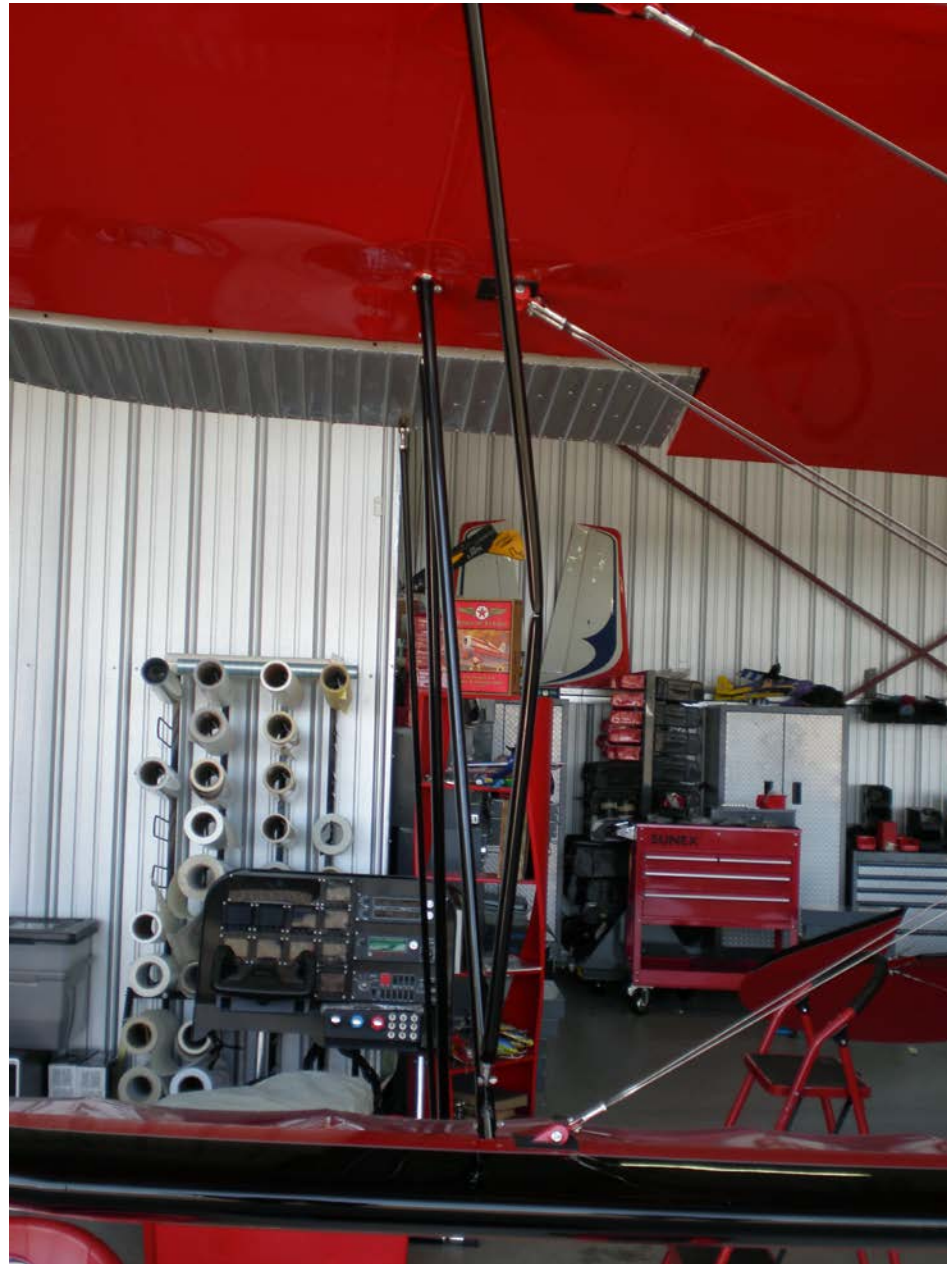
Photo 3 – View of the right wing support strut. (Photo courtesy of FAA)

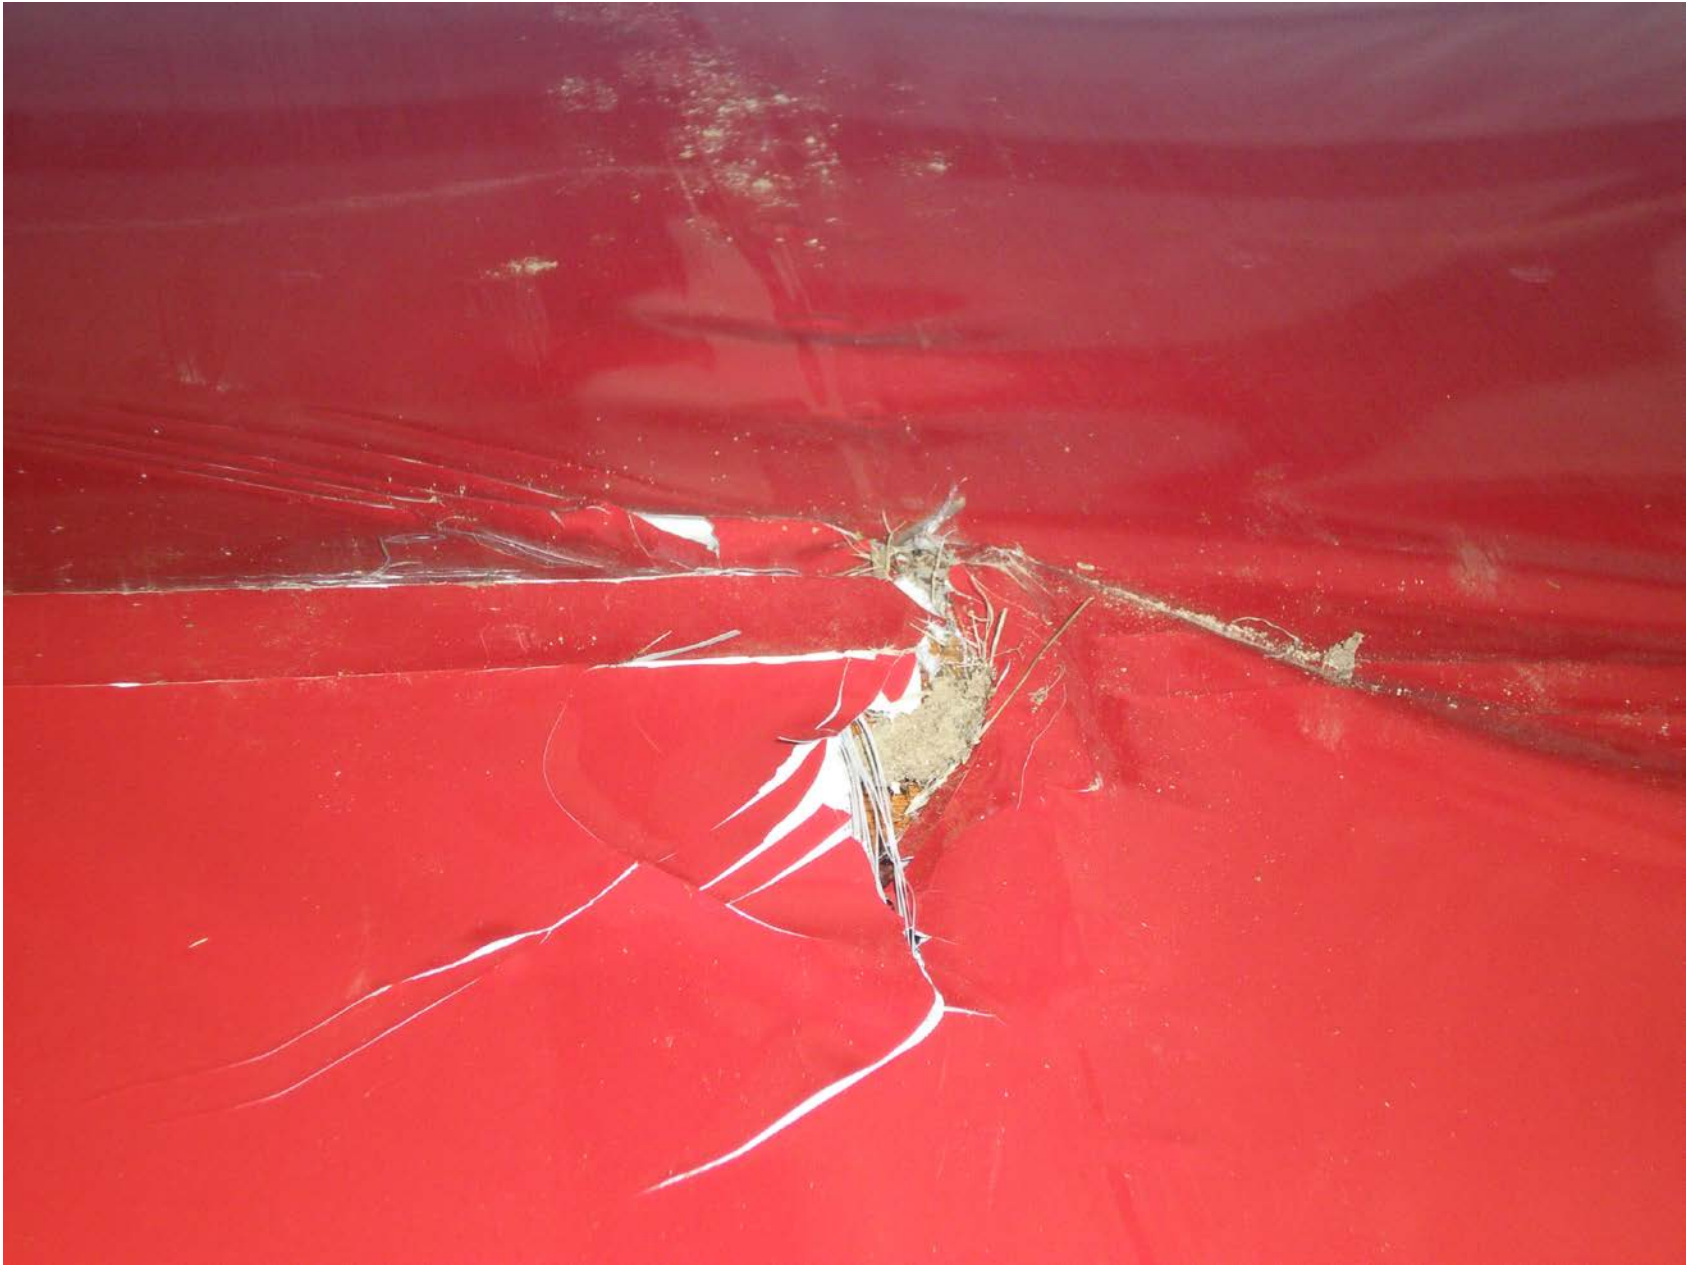
Photo 4 – View of the right upper rear spar damage. (Photo courtesy of FAA)

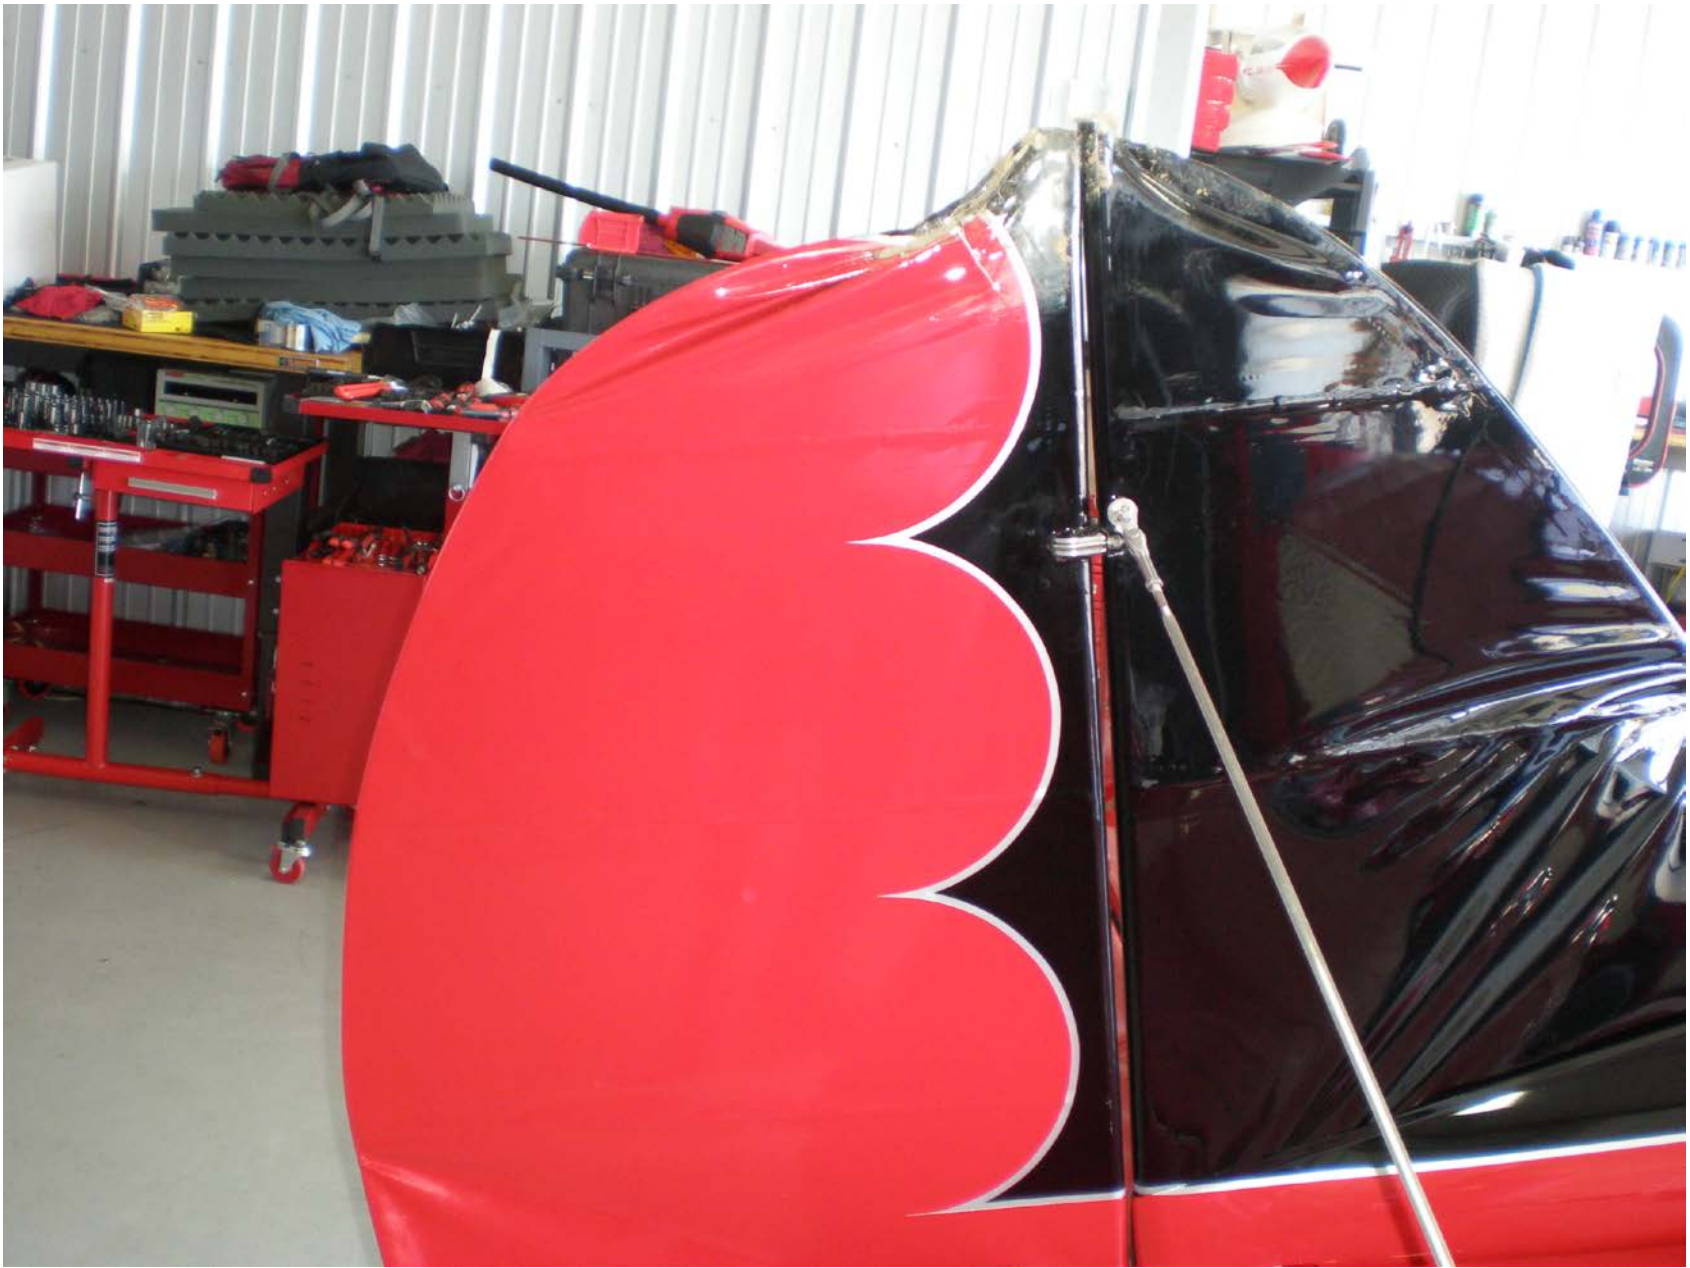
Photo 5 – View of the right side of the rudder. (Photo courtesy of FAA)
