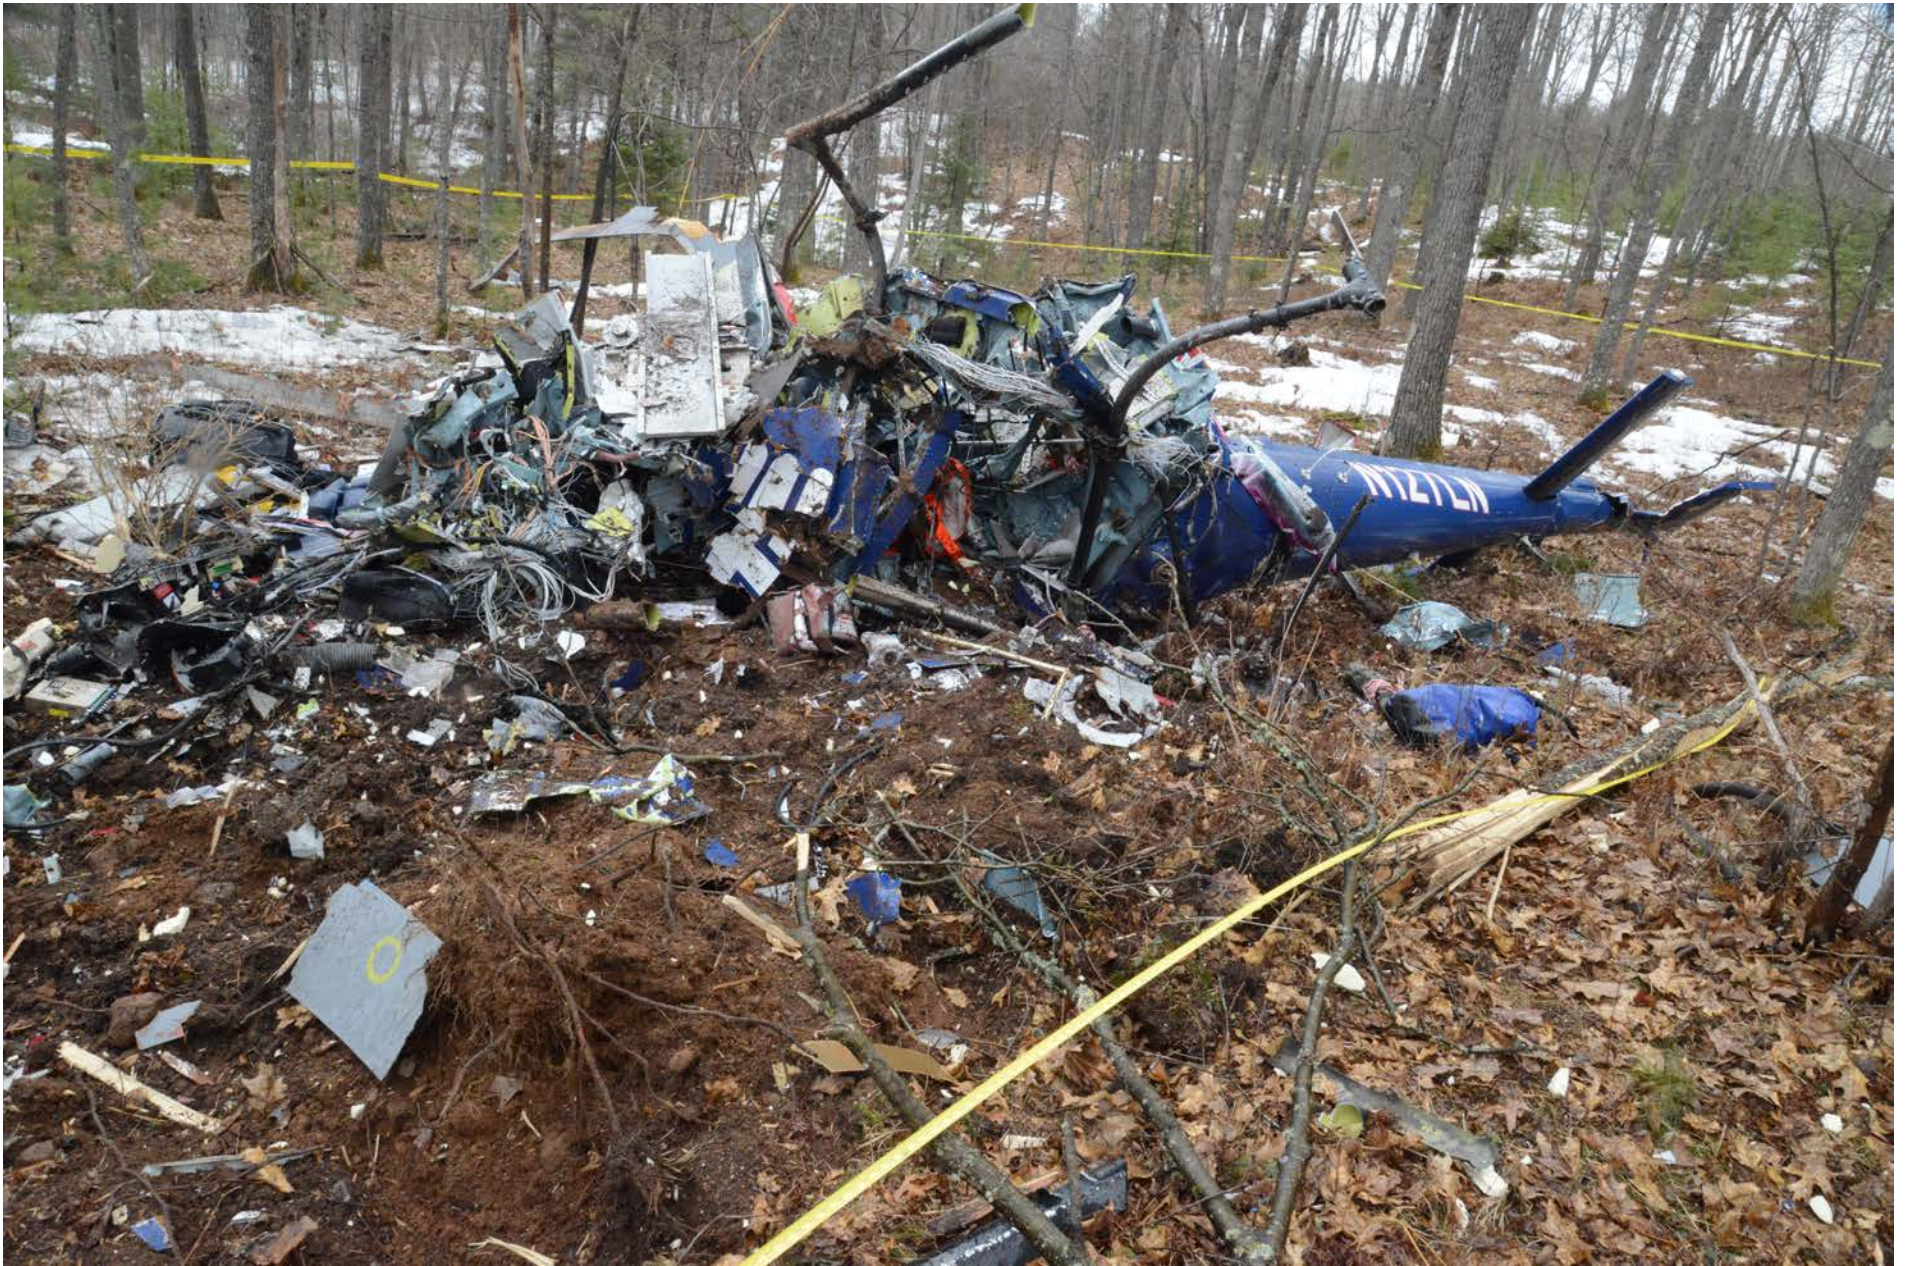
**Photo 1 – View of the accident site.**

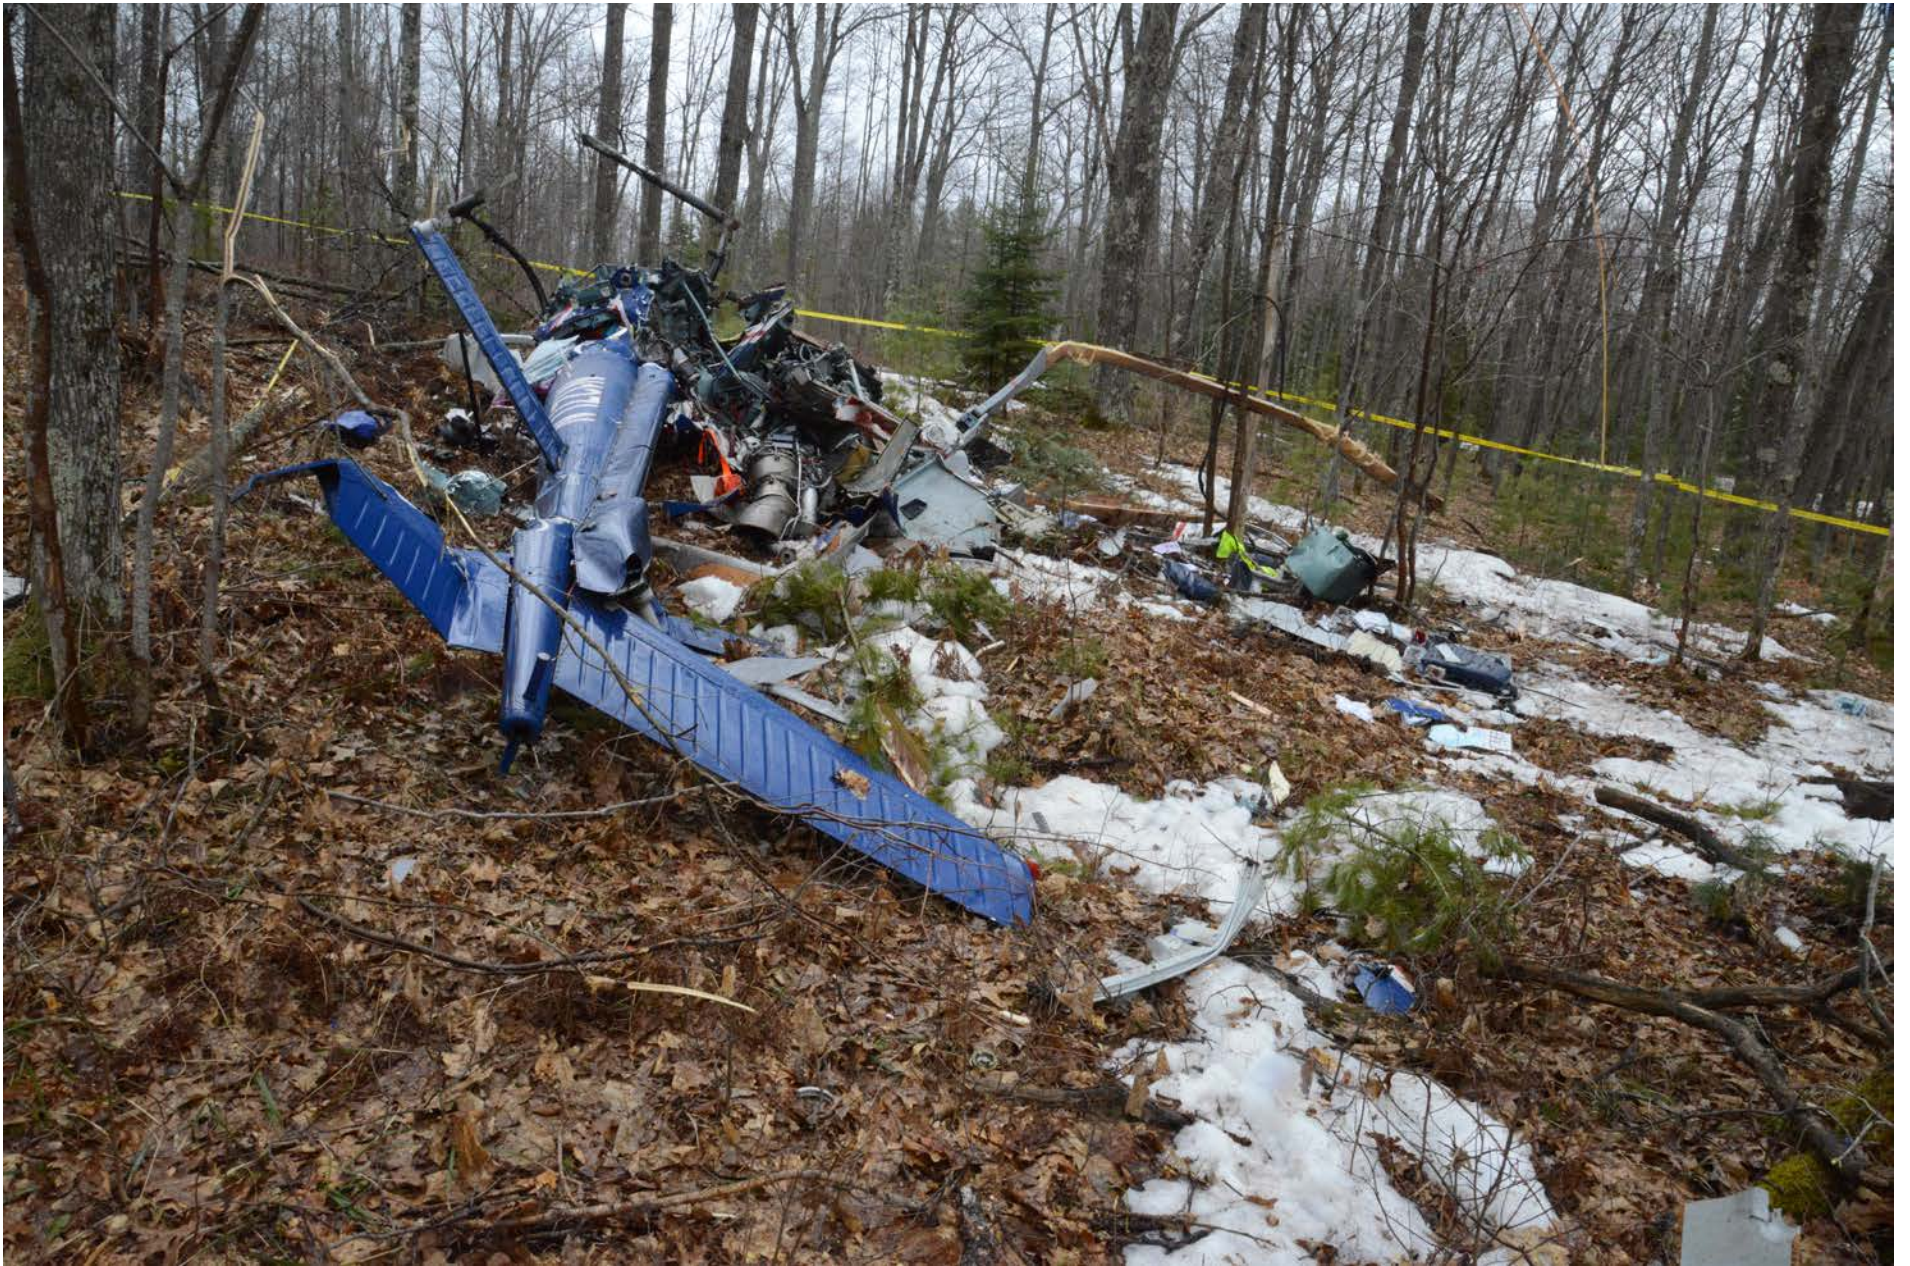
**Photo 2 - View of the accident site.**

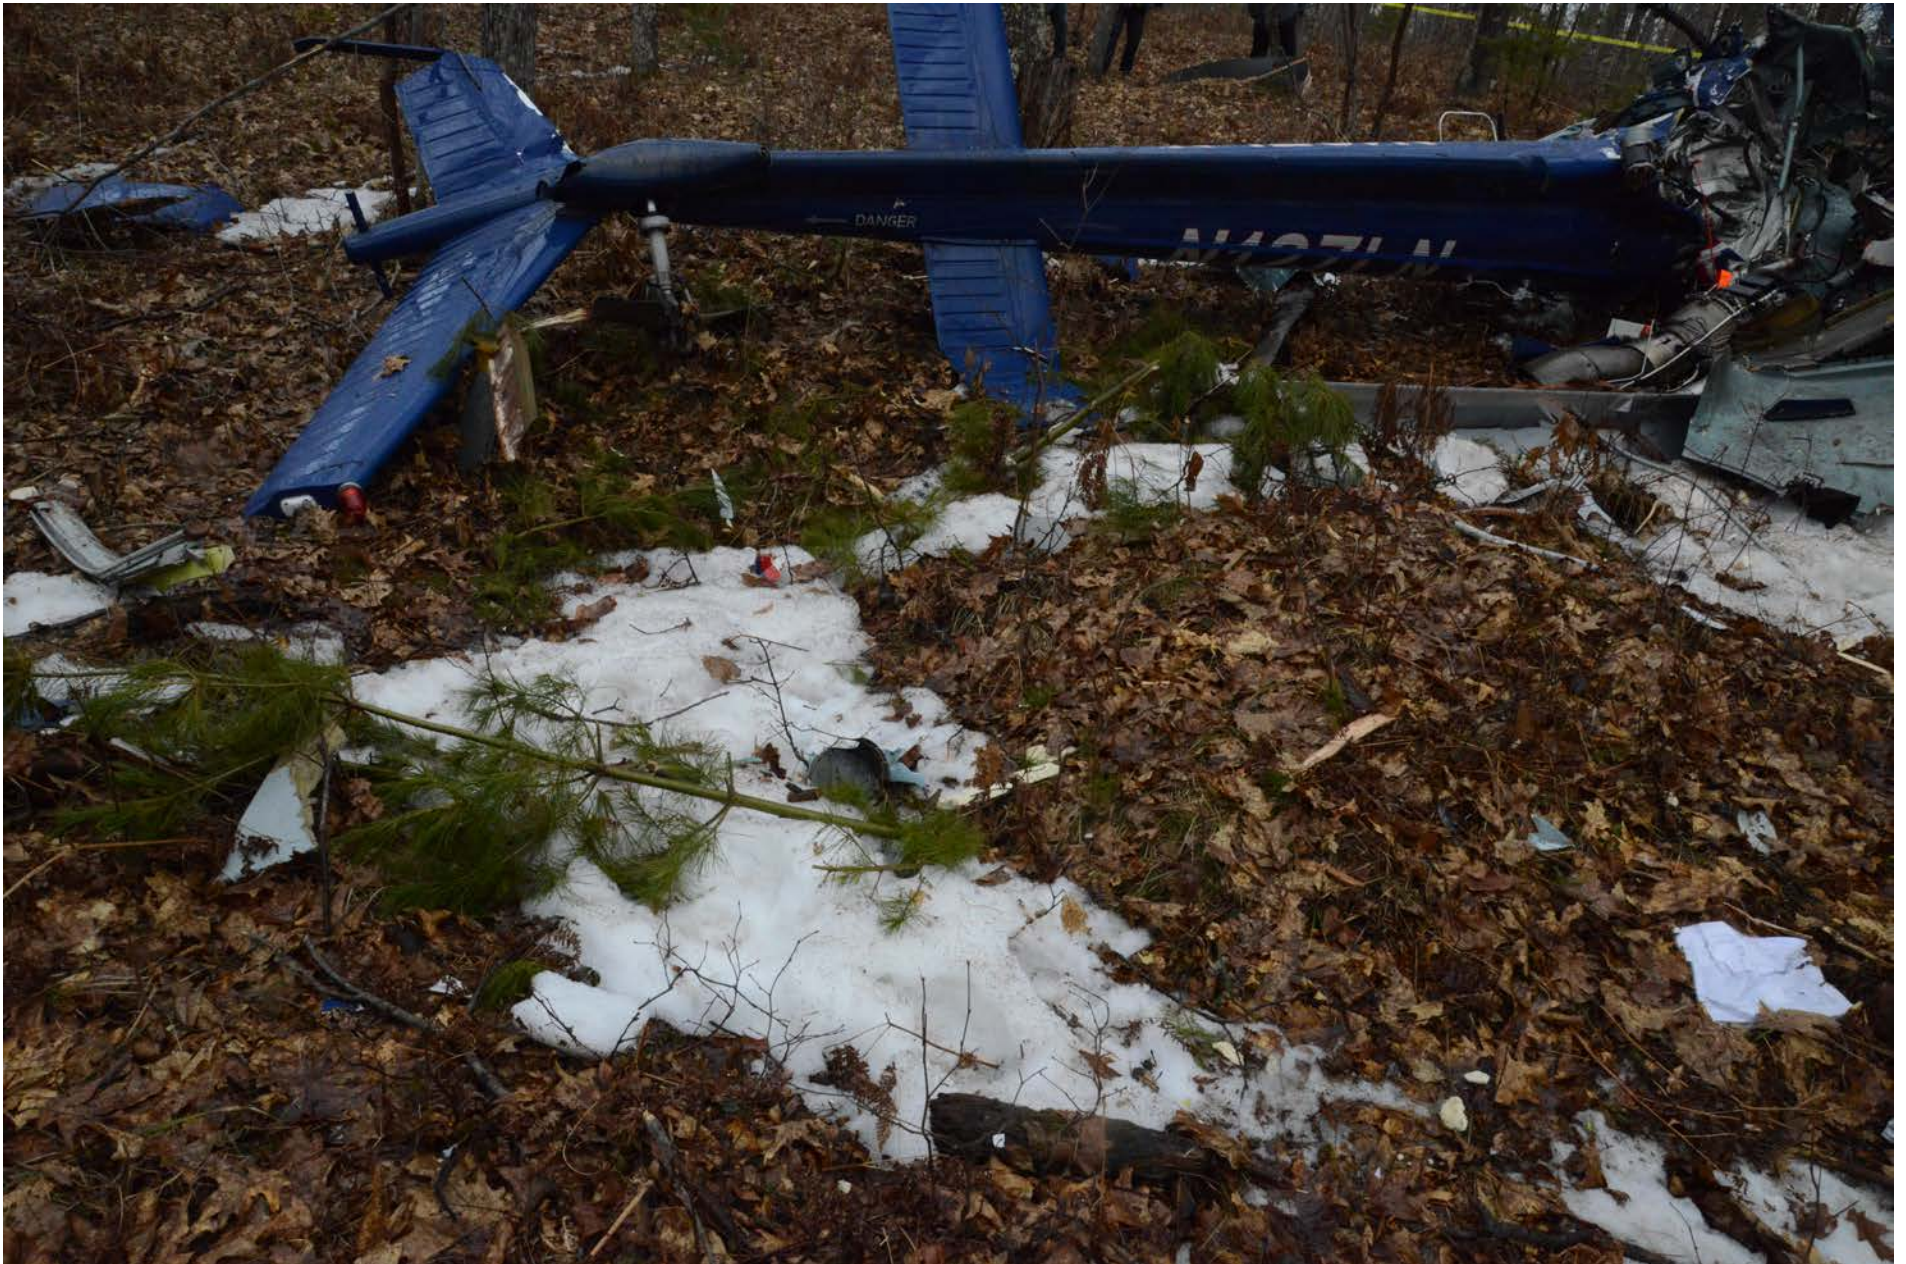
**Photo 3 - View of the accident site.**

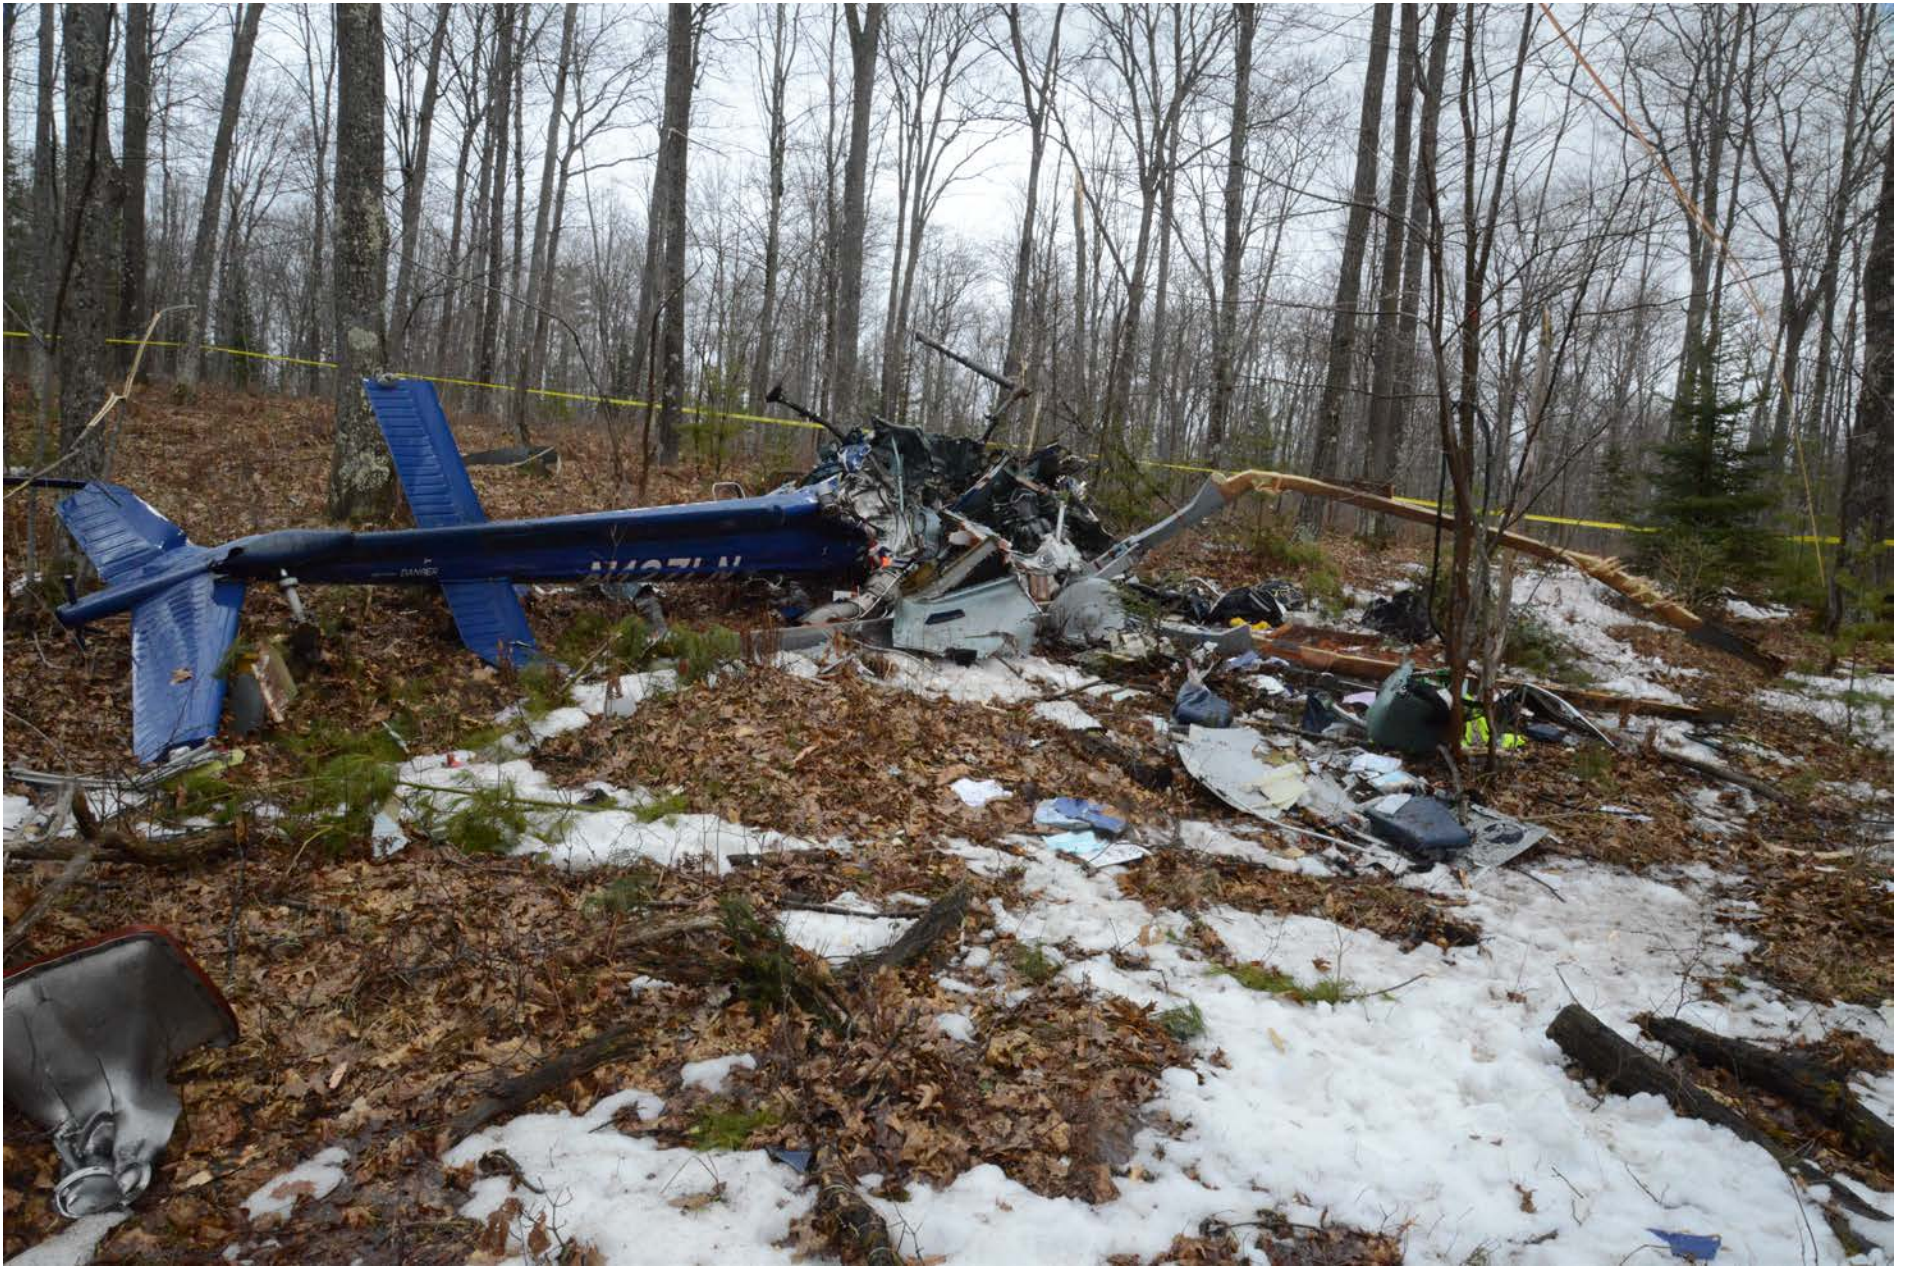
**Photo 4 - View of the accident site.**

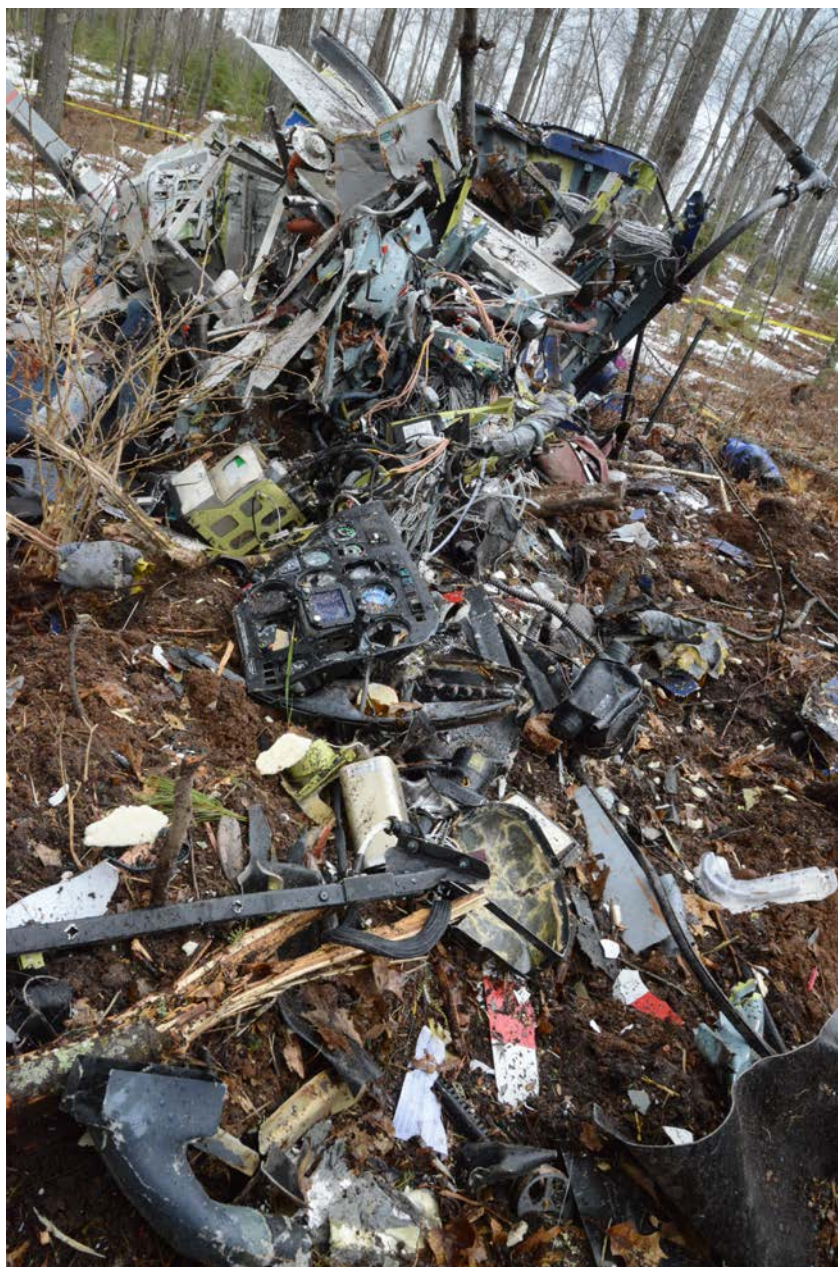
**Photo 5 - View of the cockpit area.**

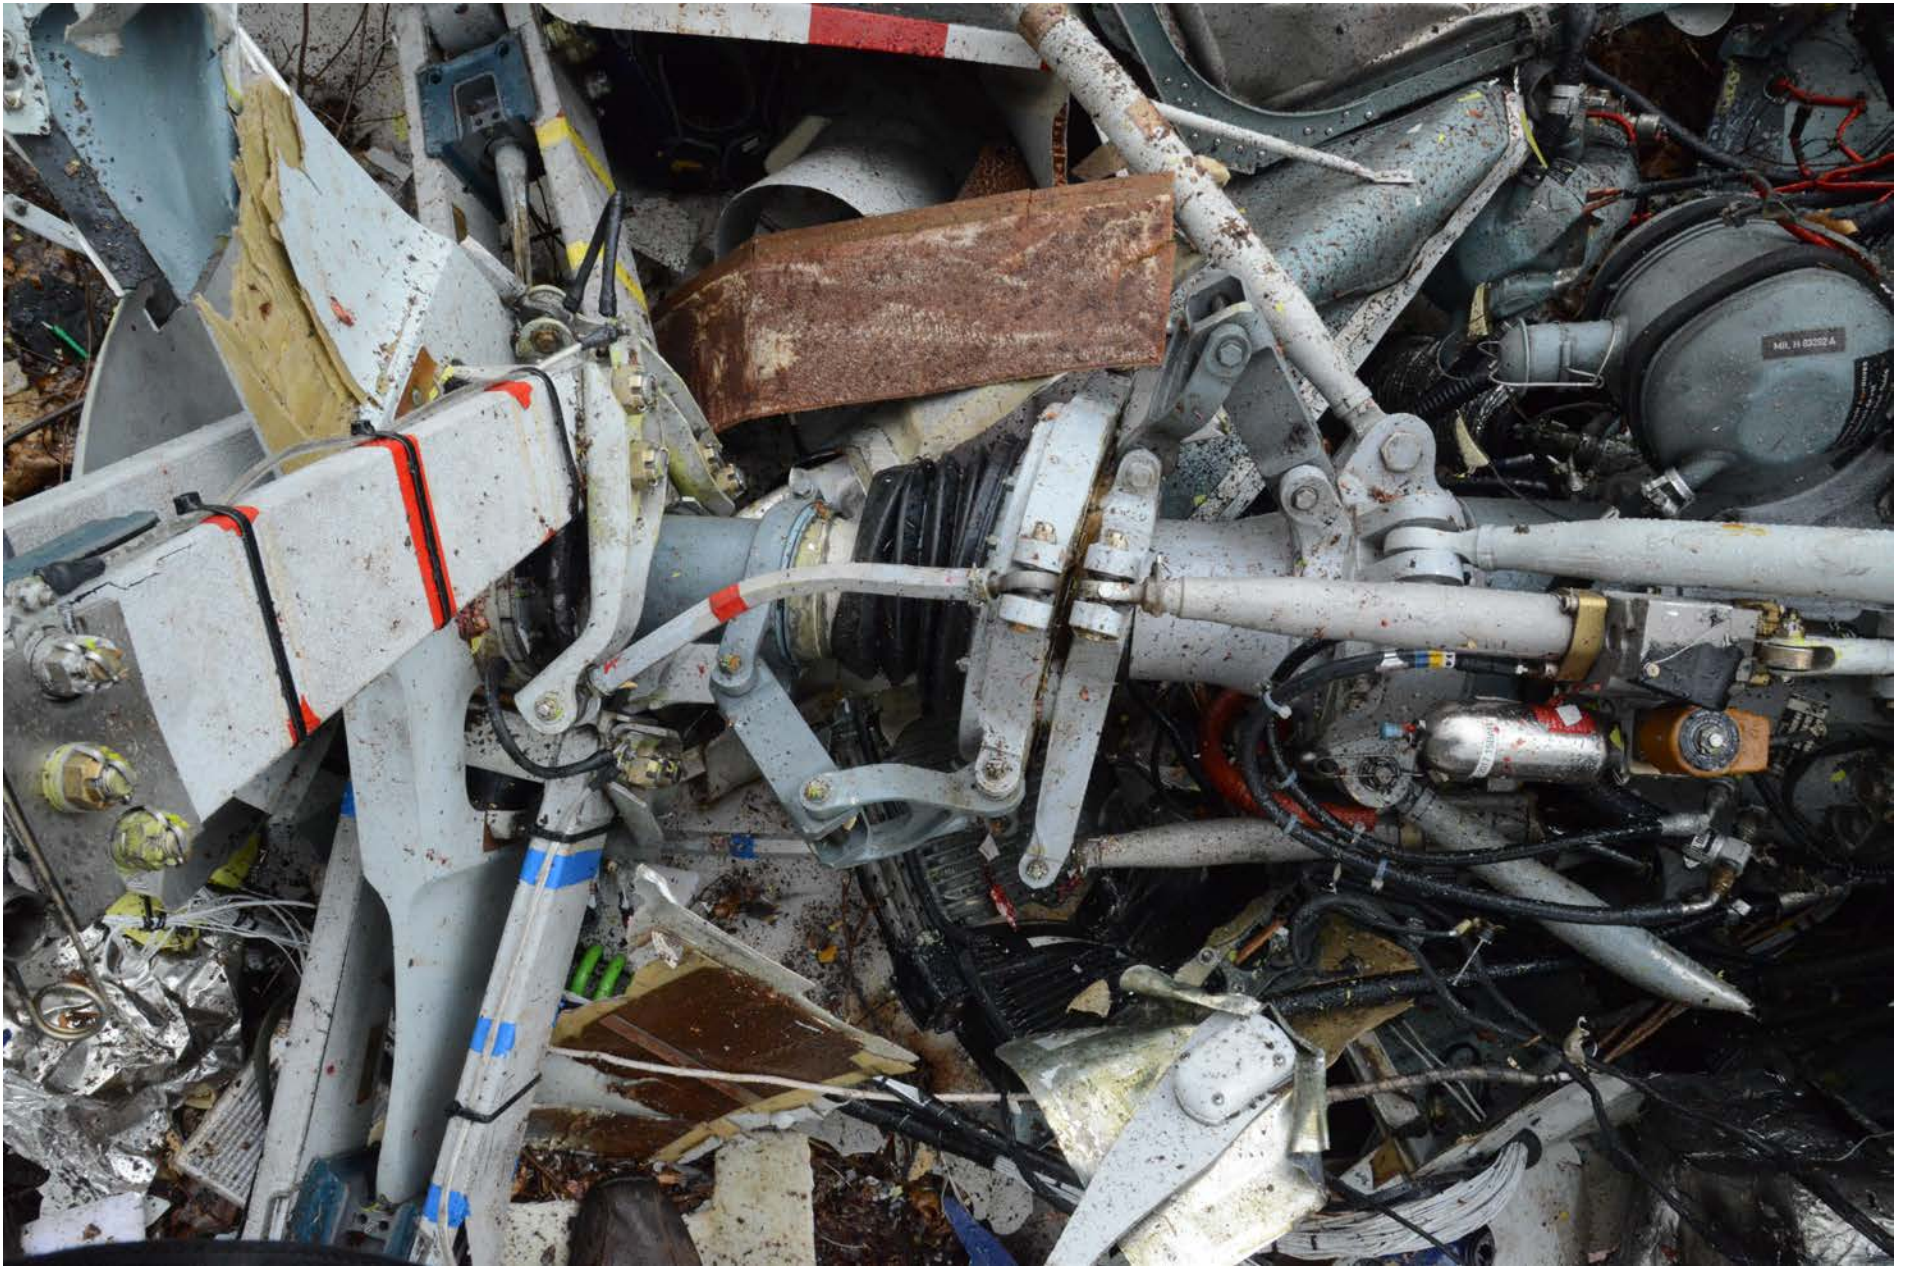
**Photo 6 - View of the mast.**

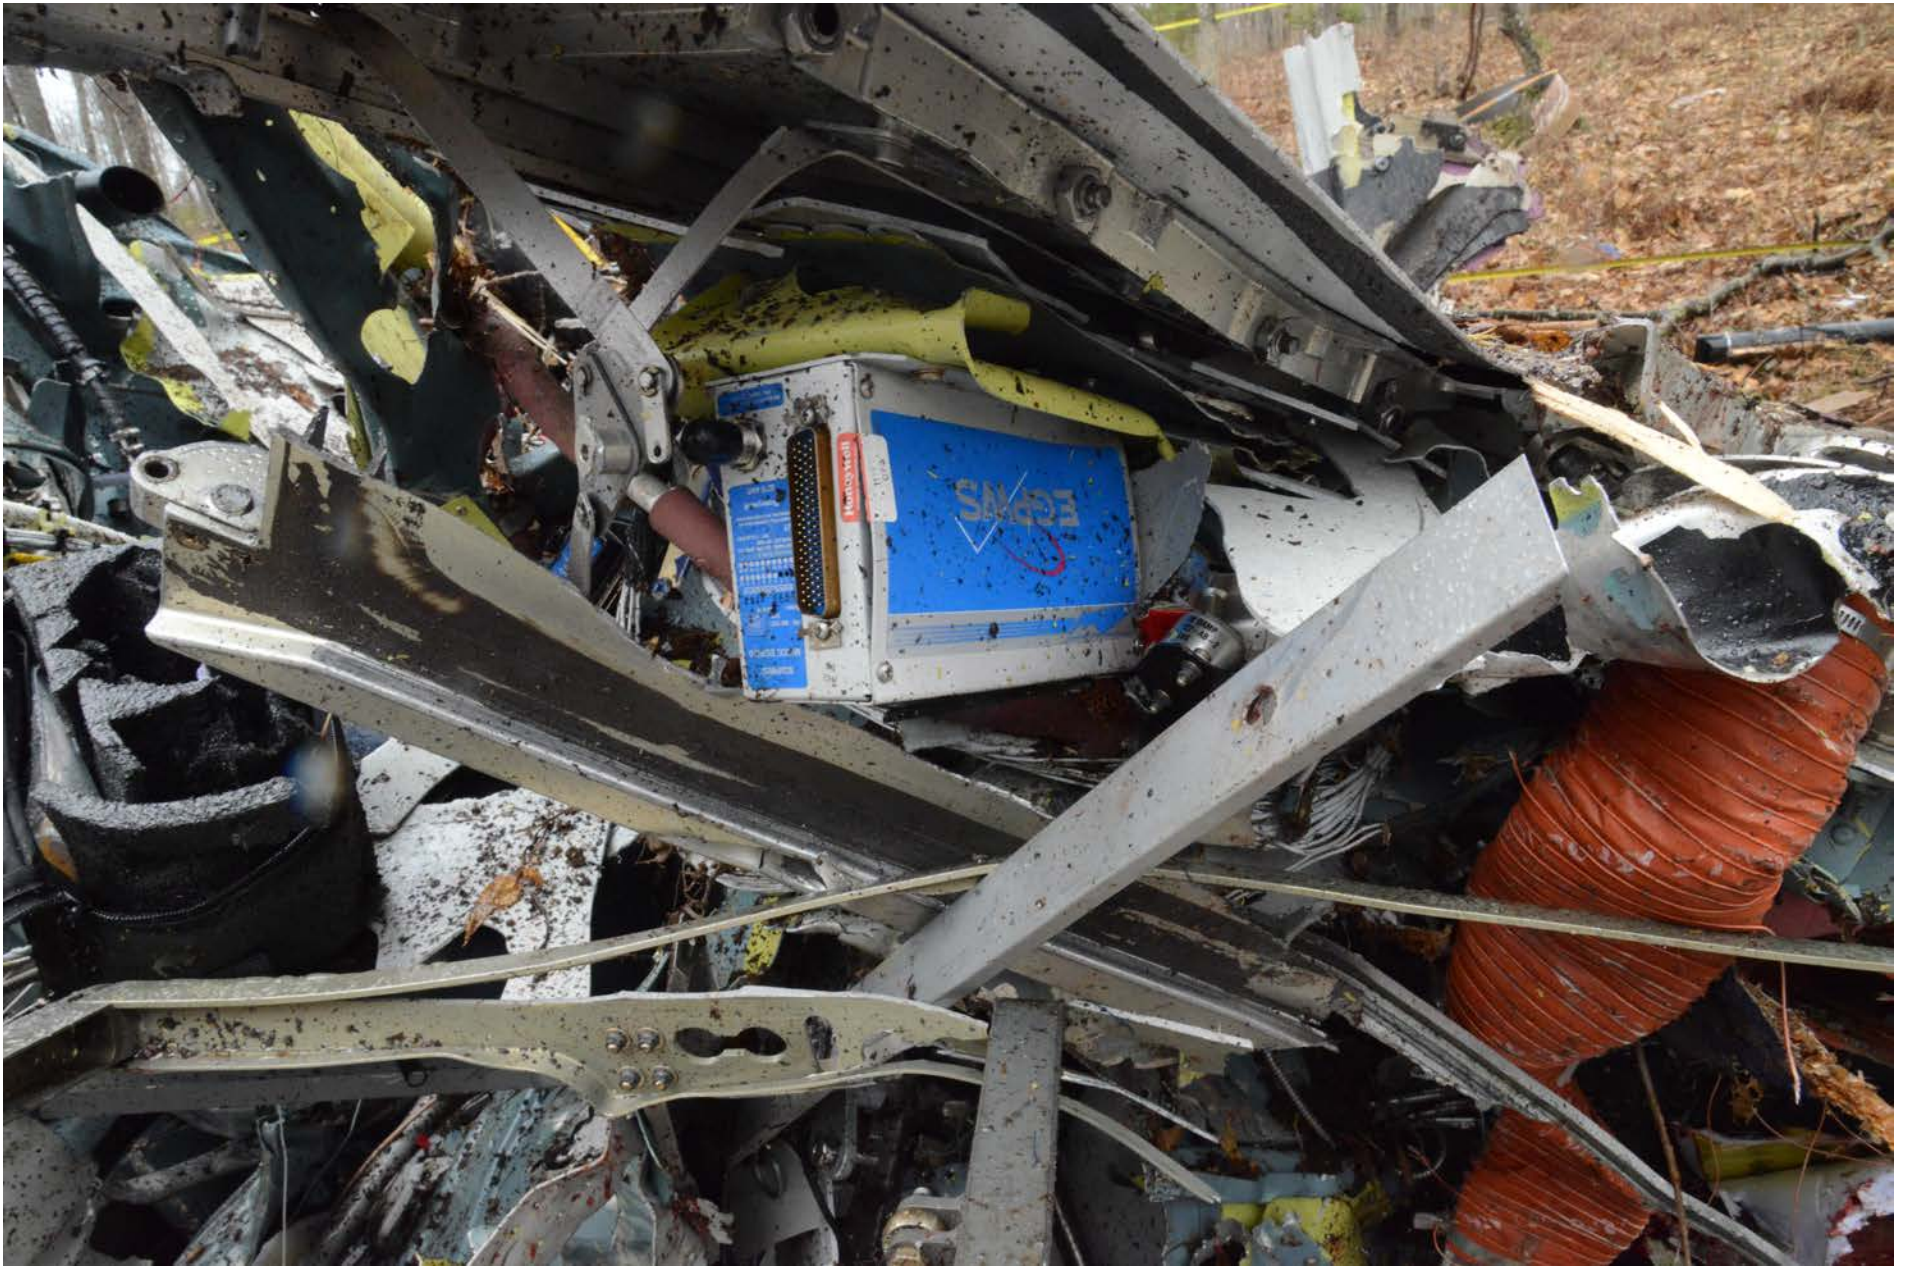
**Photo 7 - View of the EGPWS unit.**

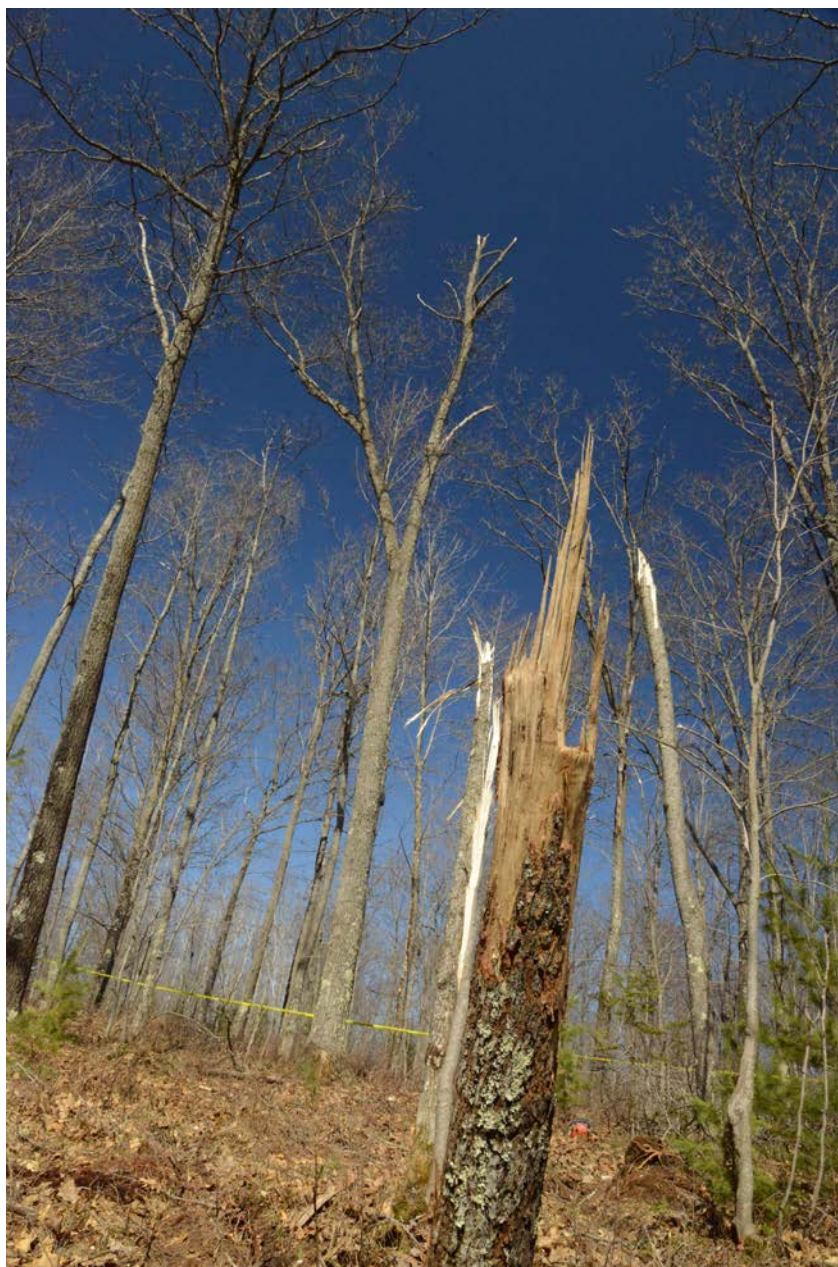
**Photo 8 - View of trees near the accident site with broken branches.**

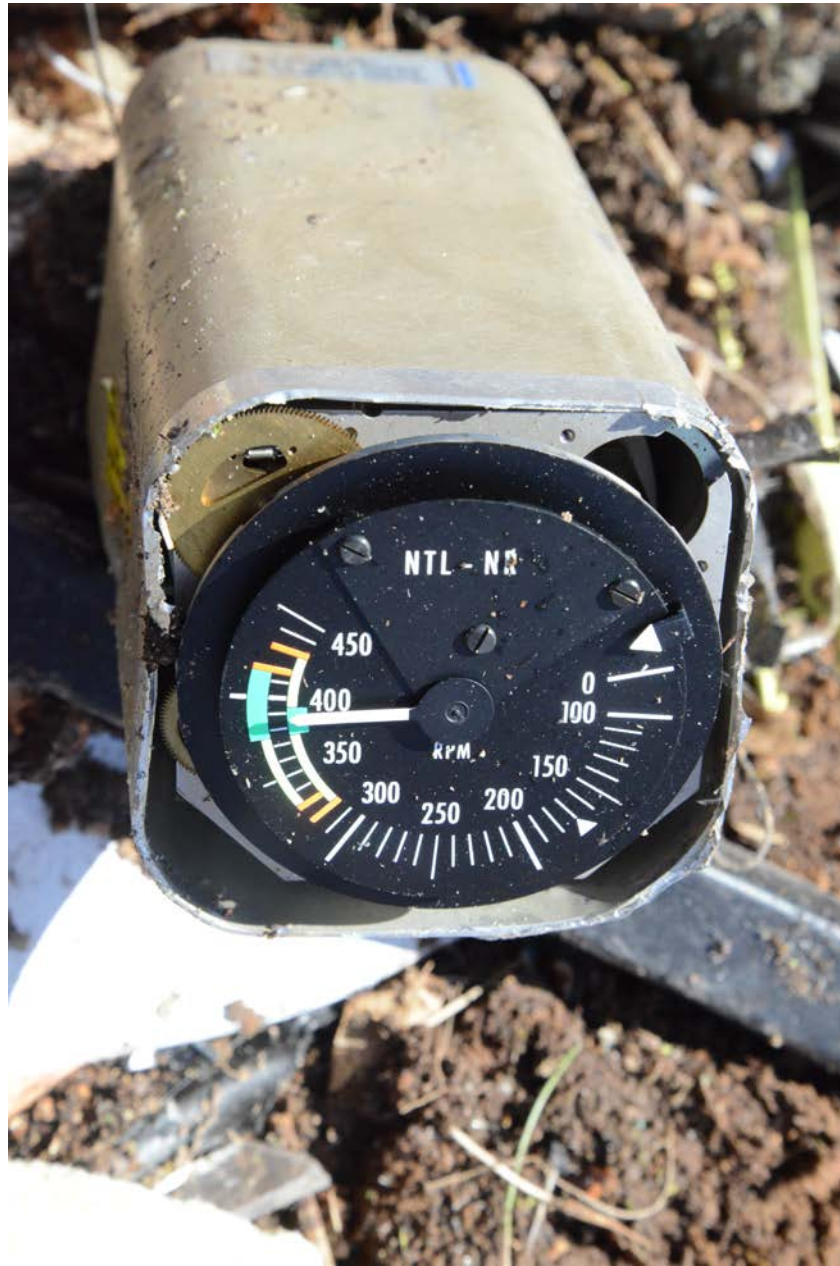
**Photo 9 - View of the NTL-NR gauge.**

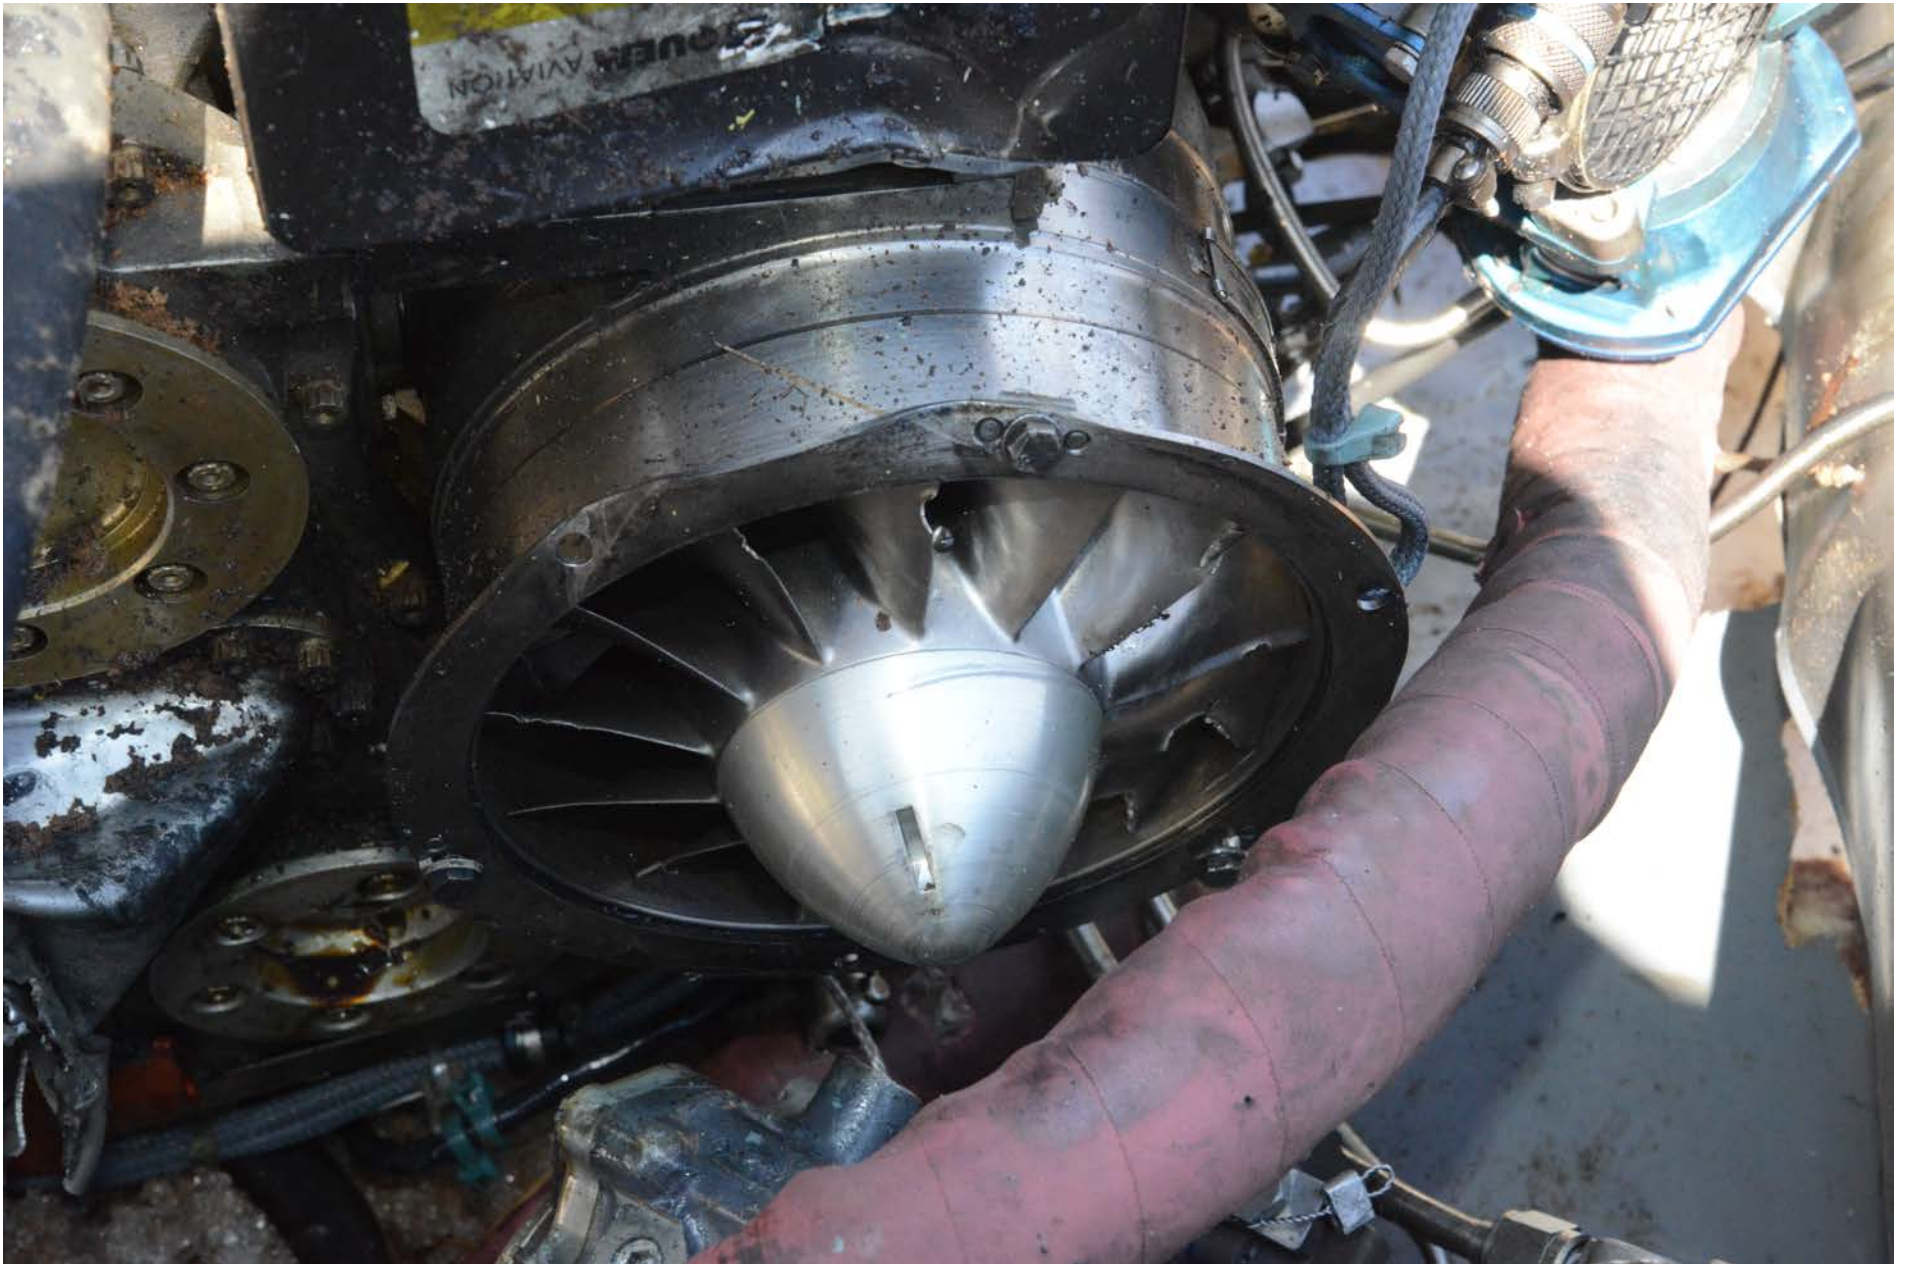
**Photo 10 - View of the engine intake. Blades exhibit damage consistent with FOD ingestion.**

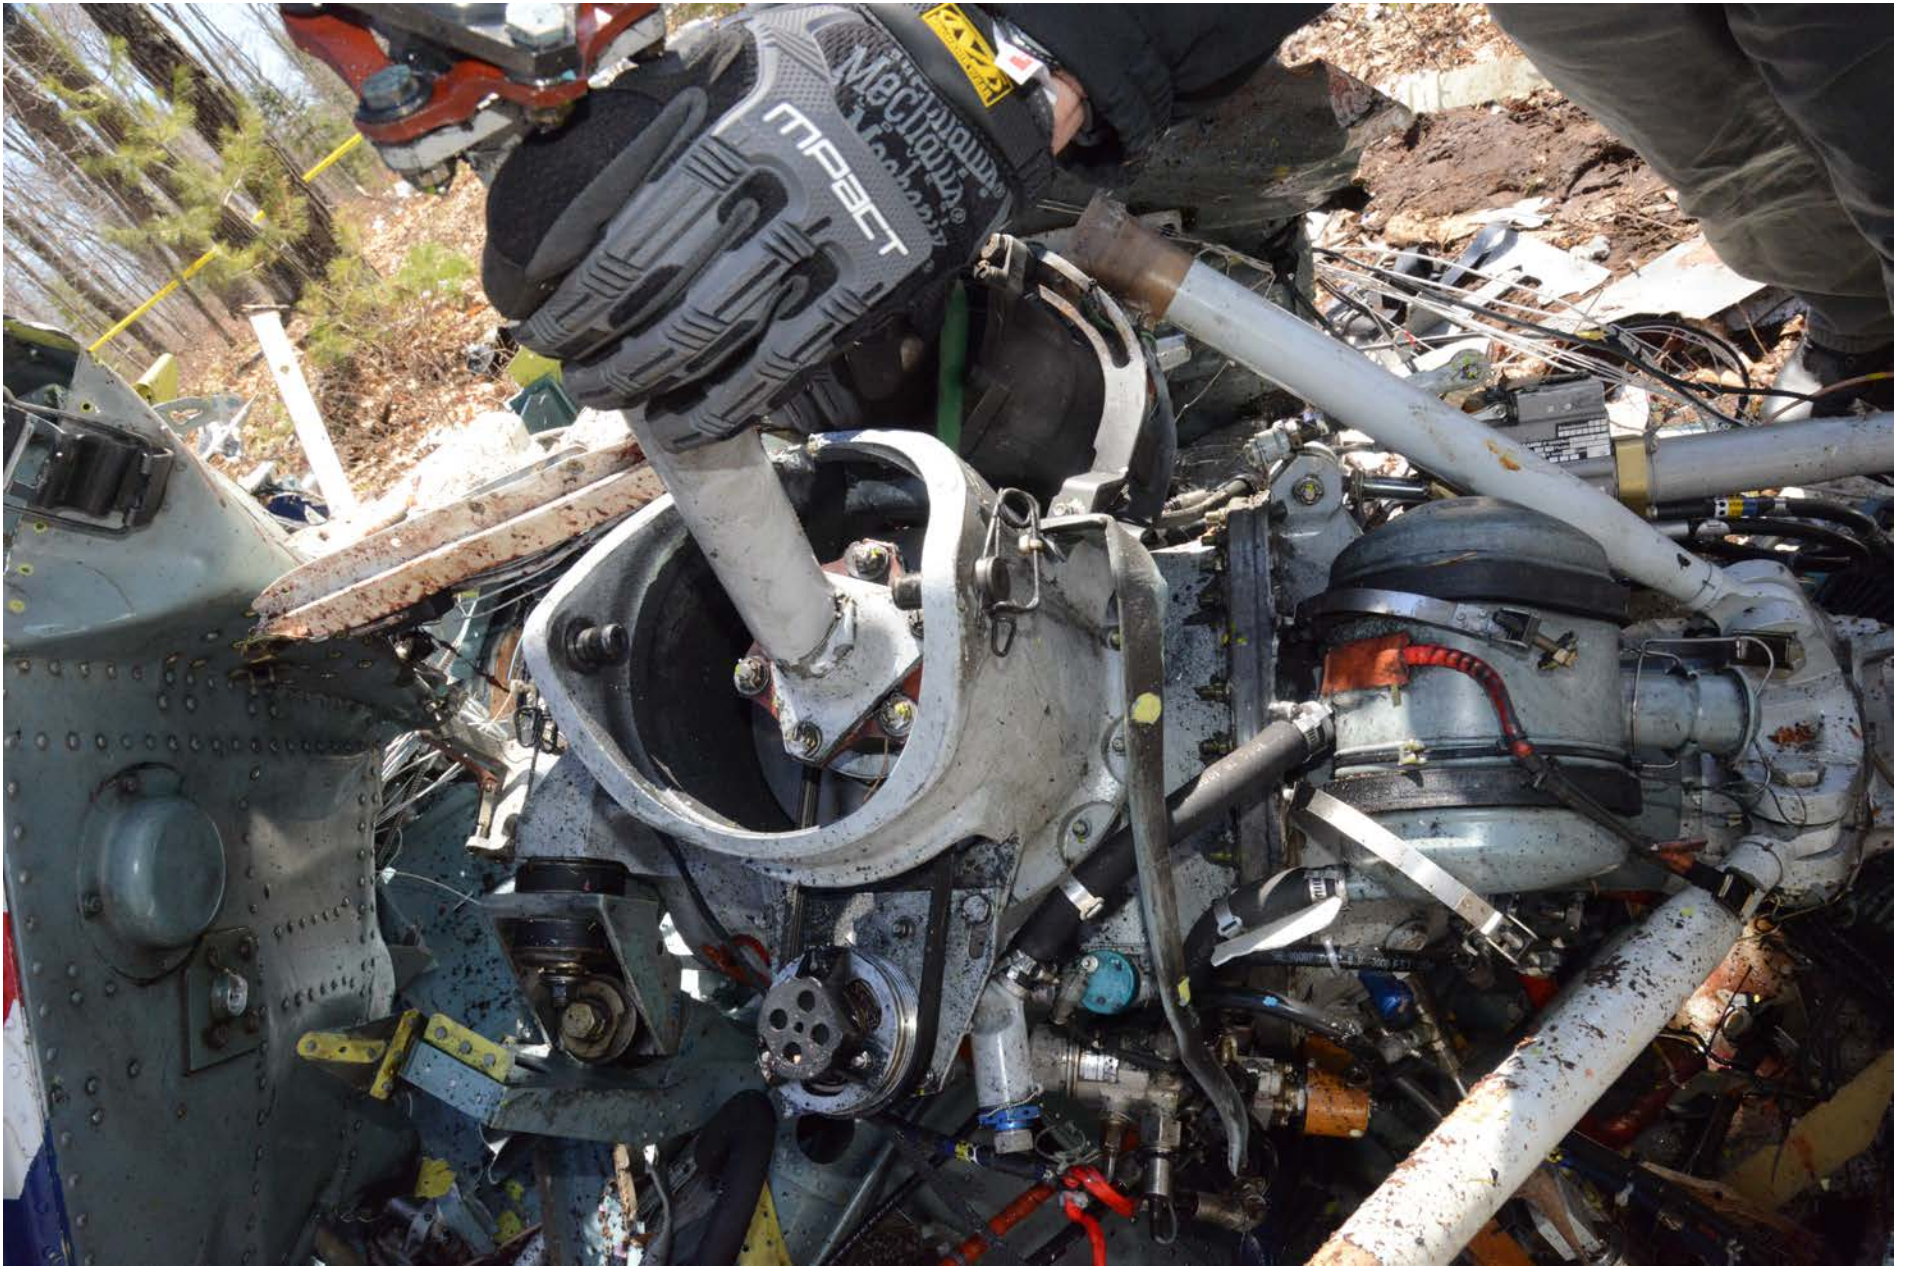
**Photo 11 - View of a separation in the driveshaft.**
