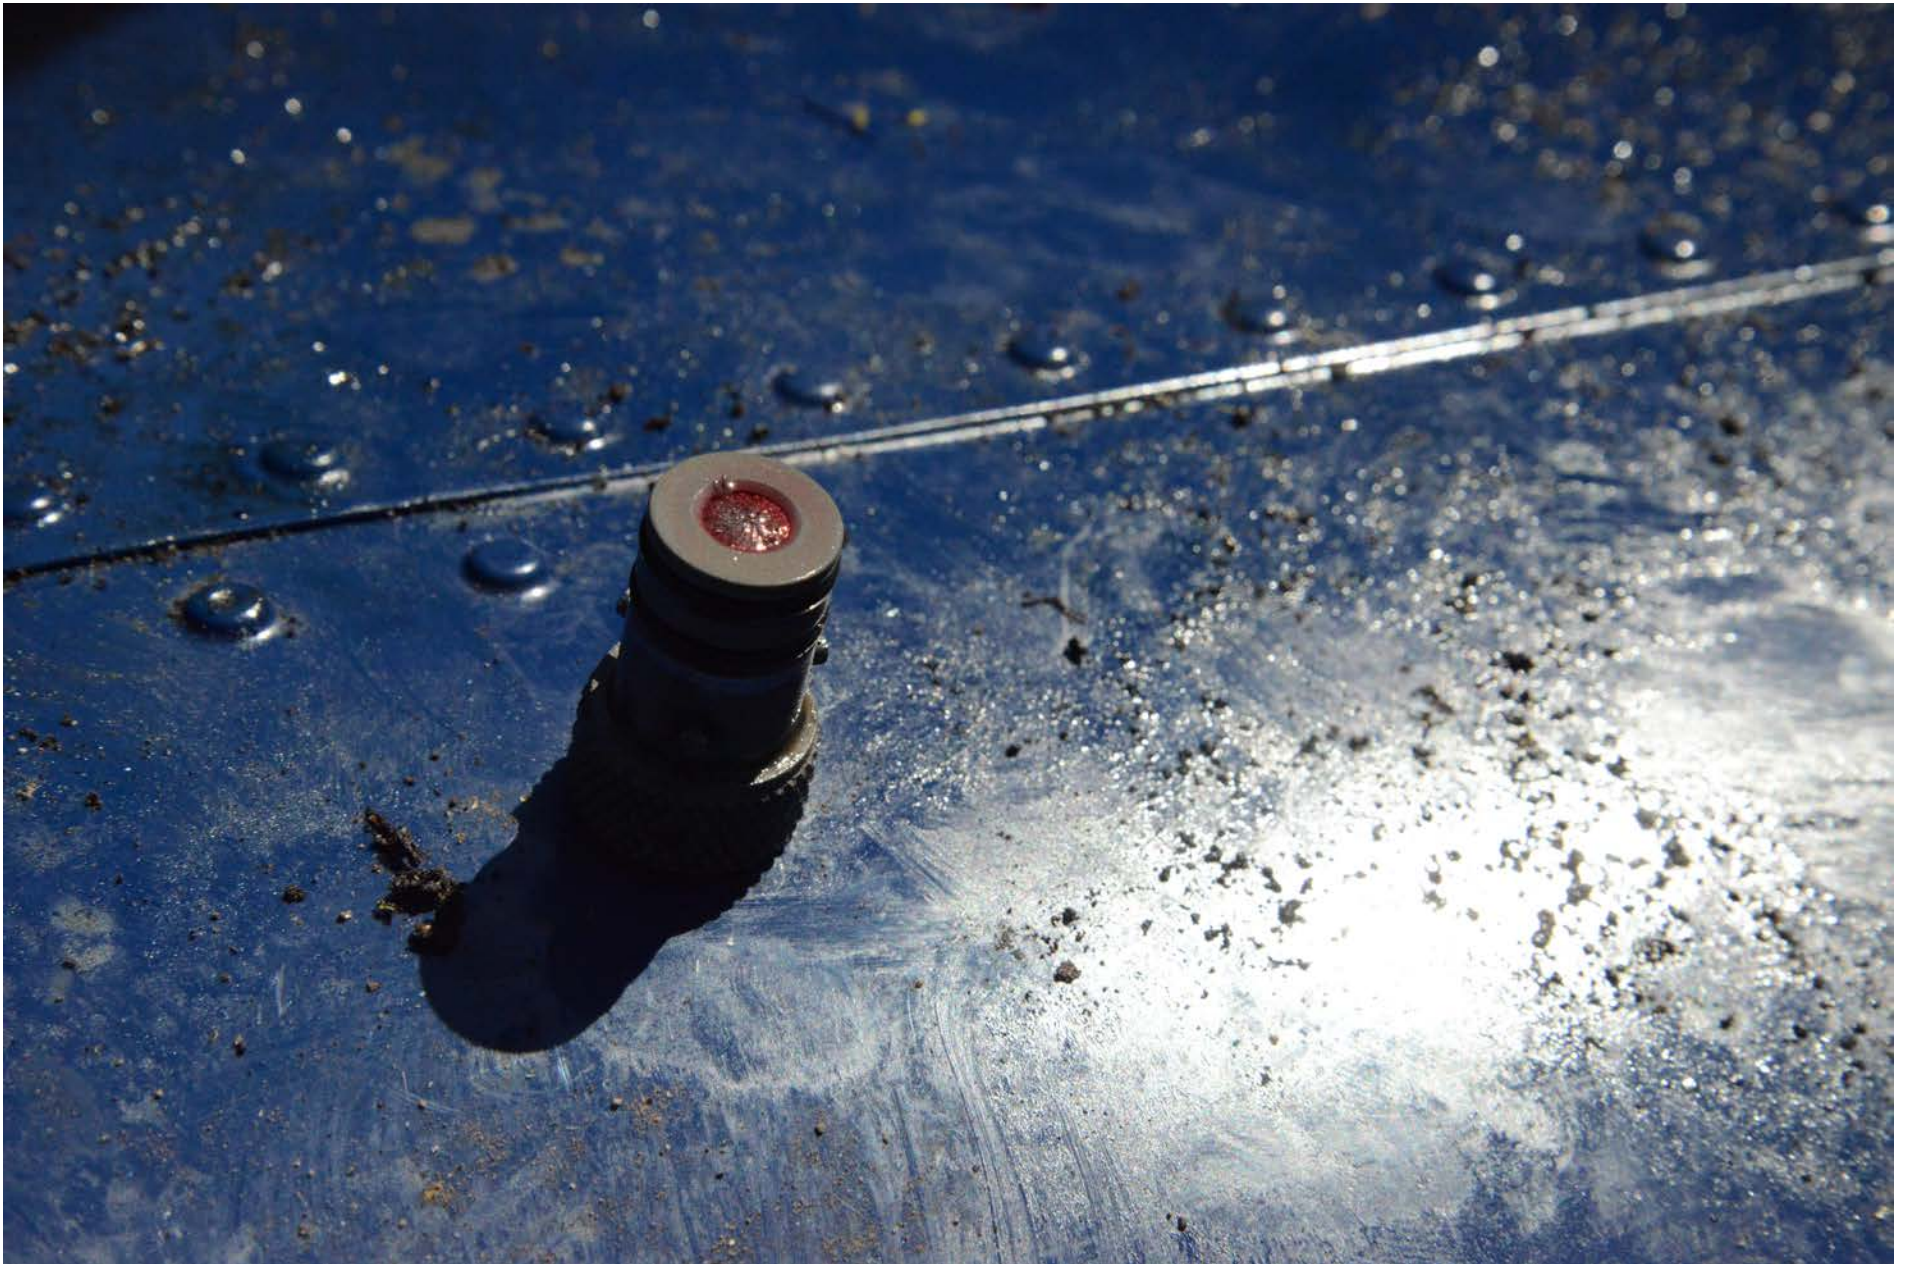
**Photo 12 - View of the removed magnetic plug from the hydraulic system.**

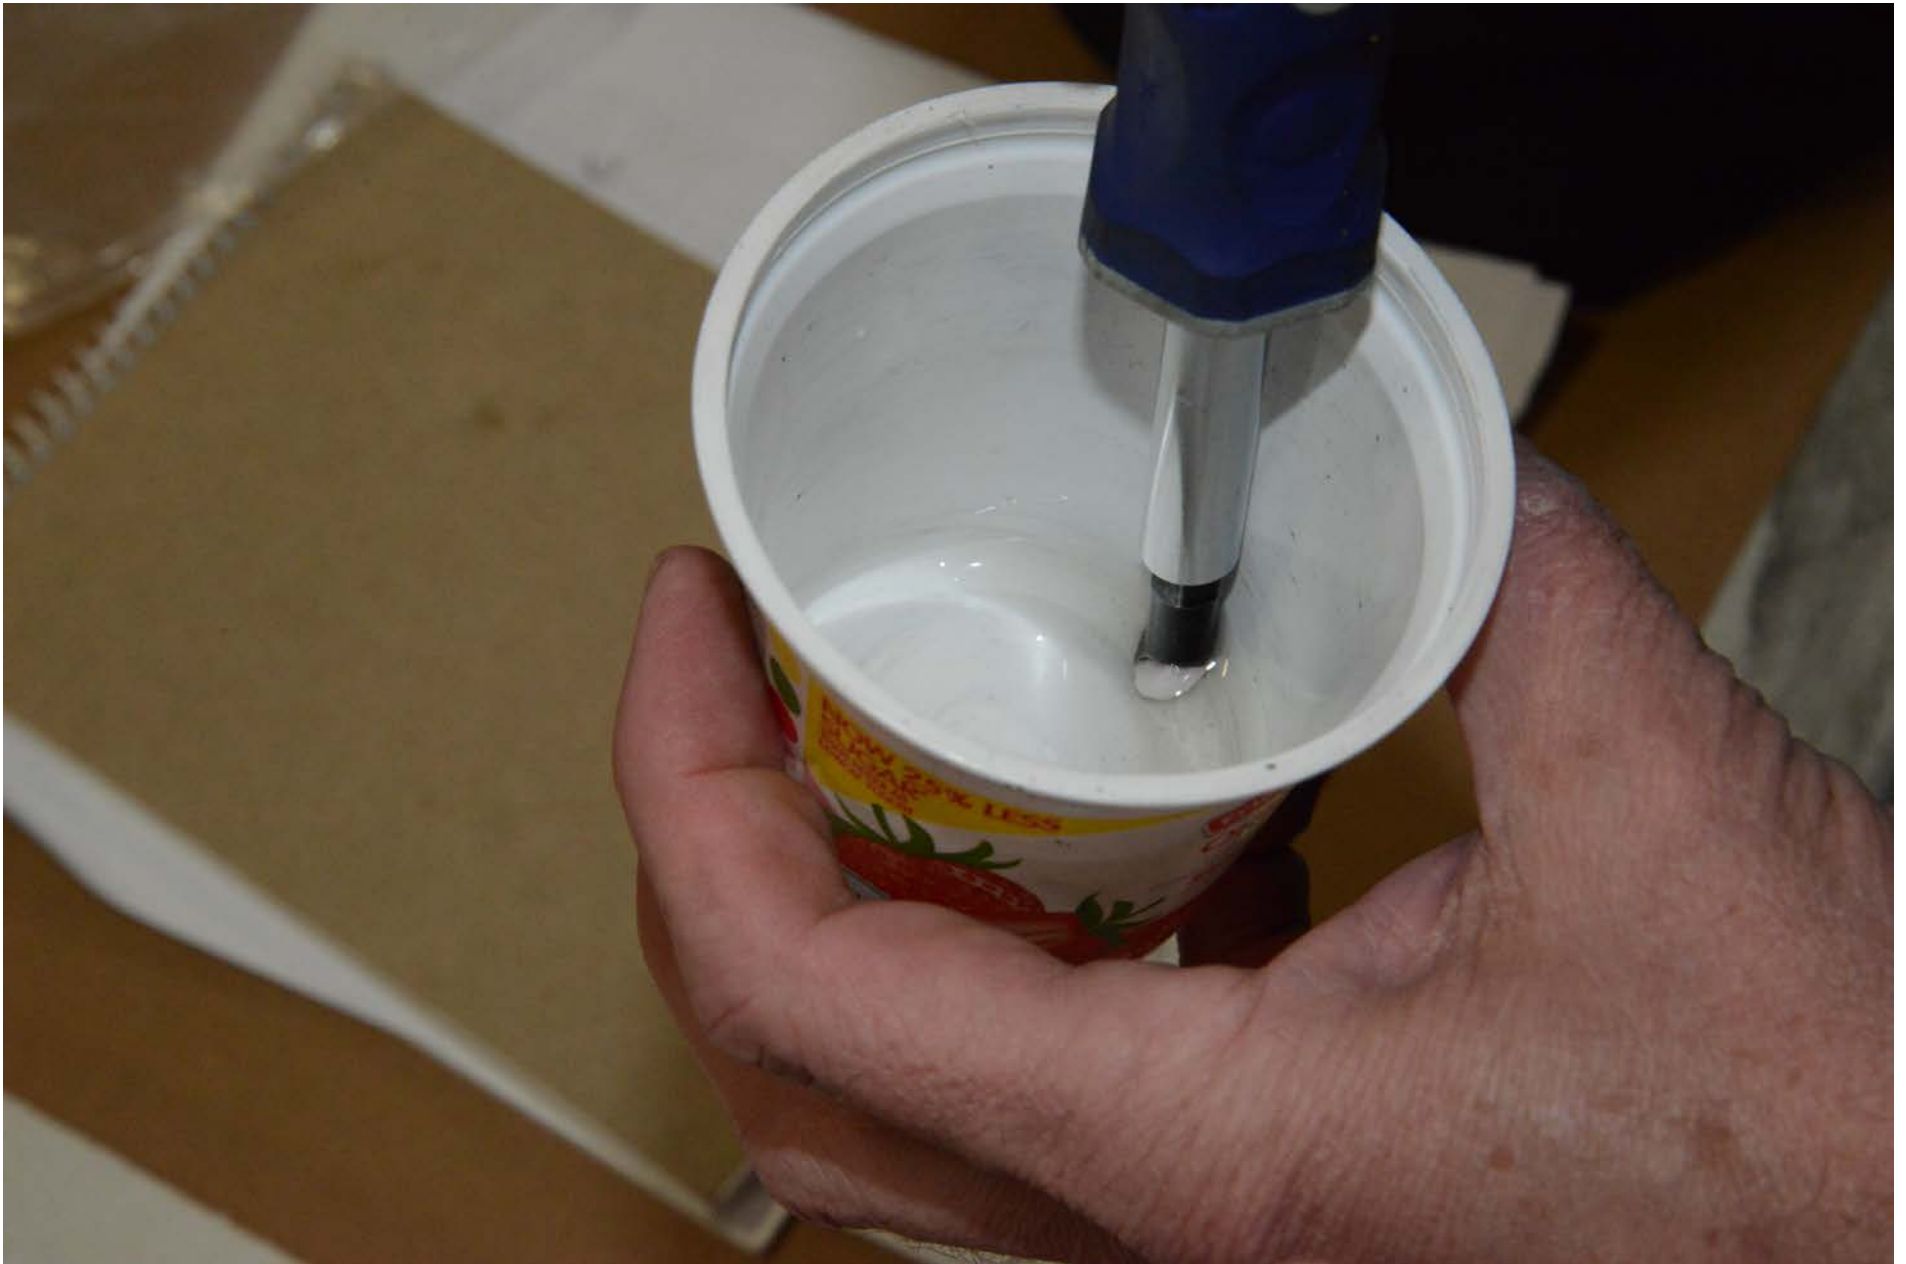
**Photo 13 - View of recovered fuel being tested for water. The water testing paste did not indicate a presence of water.**

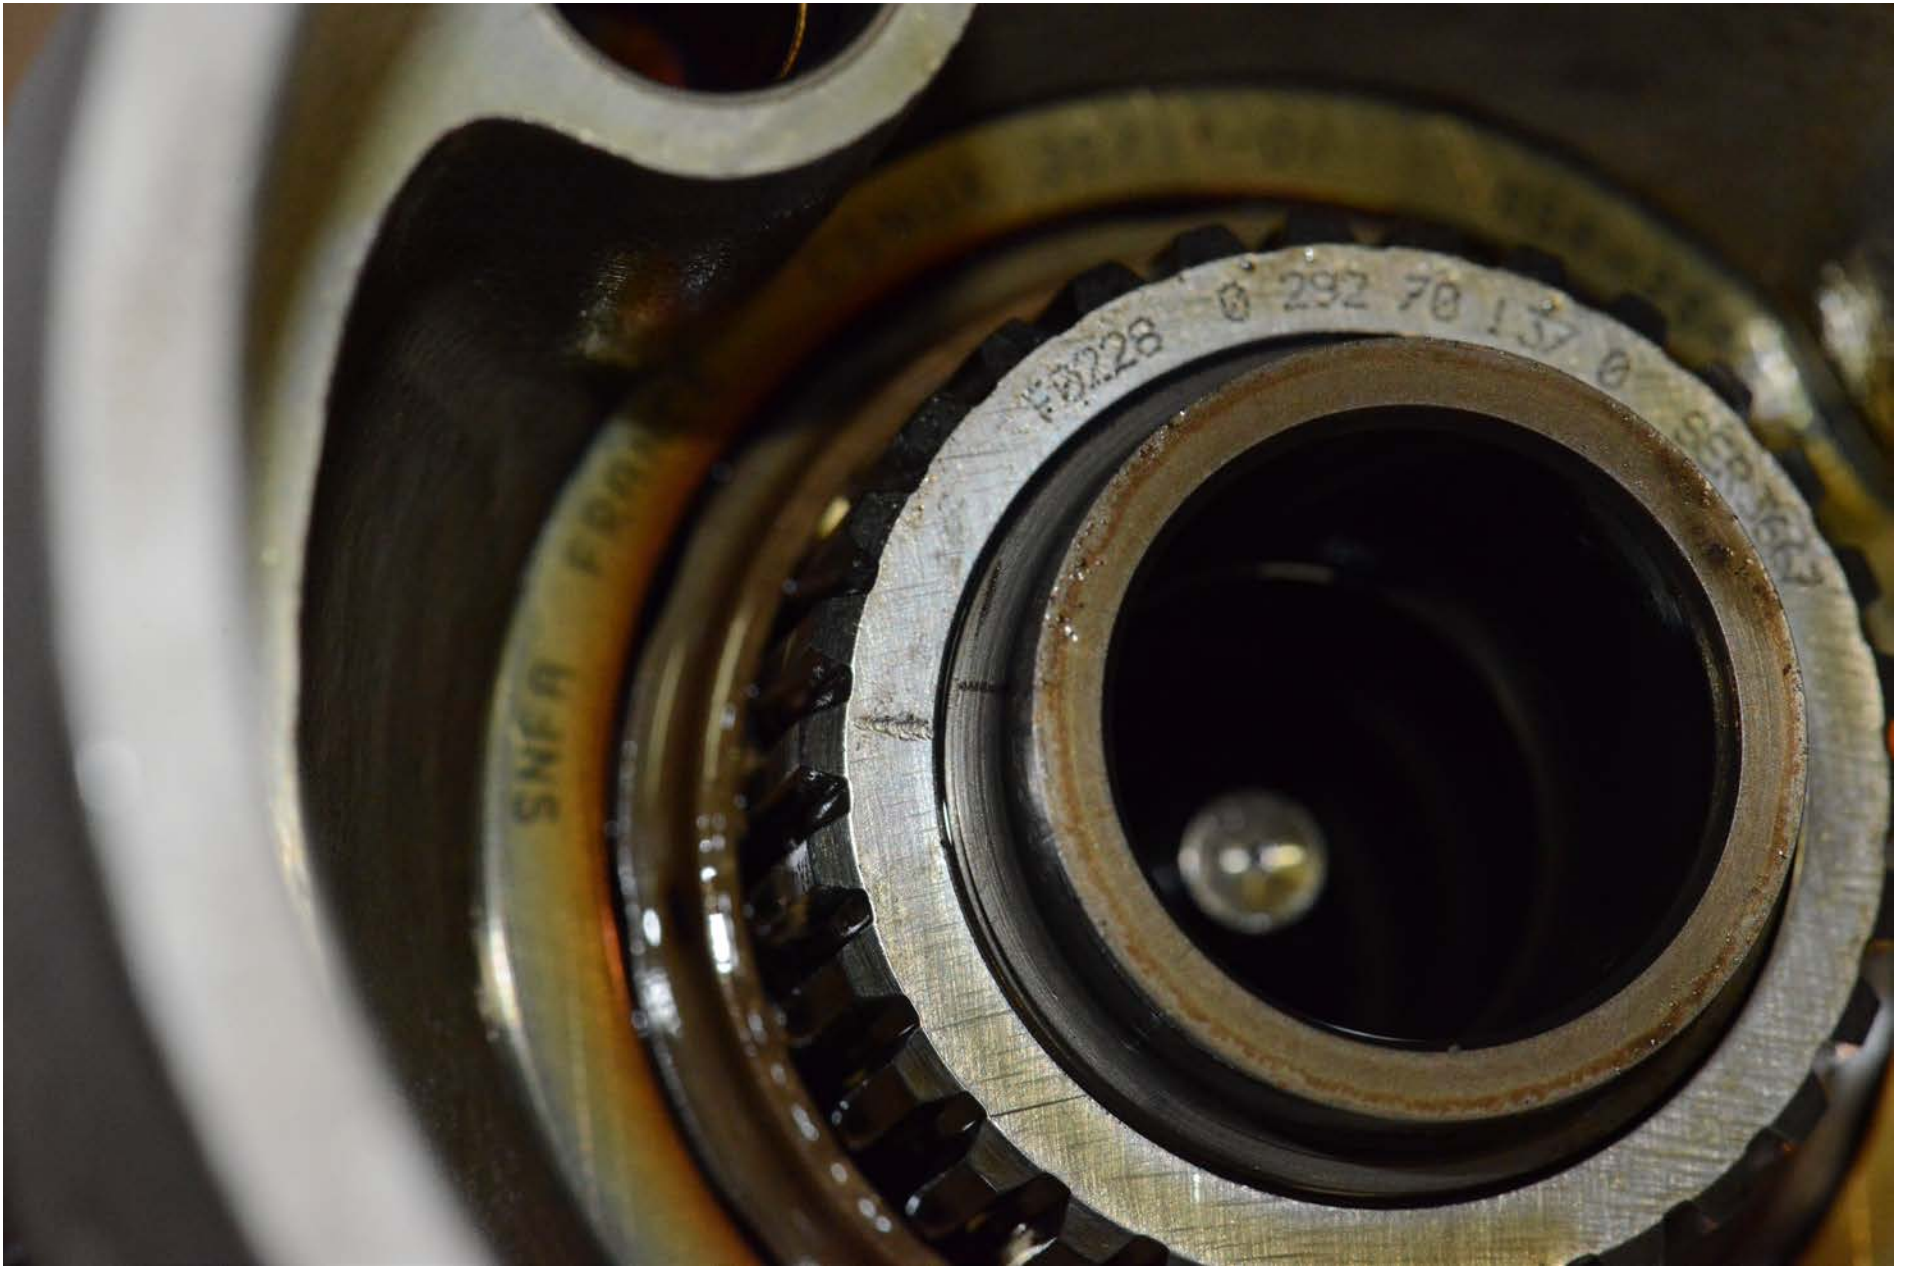
**Photo 14 - View of slippage marks. The marks are not aligned.**

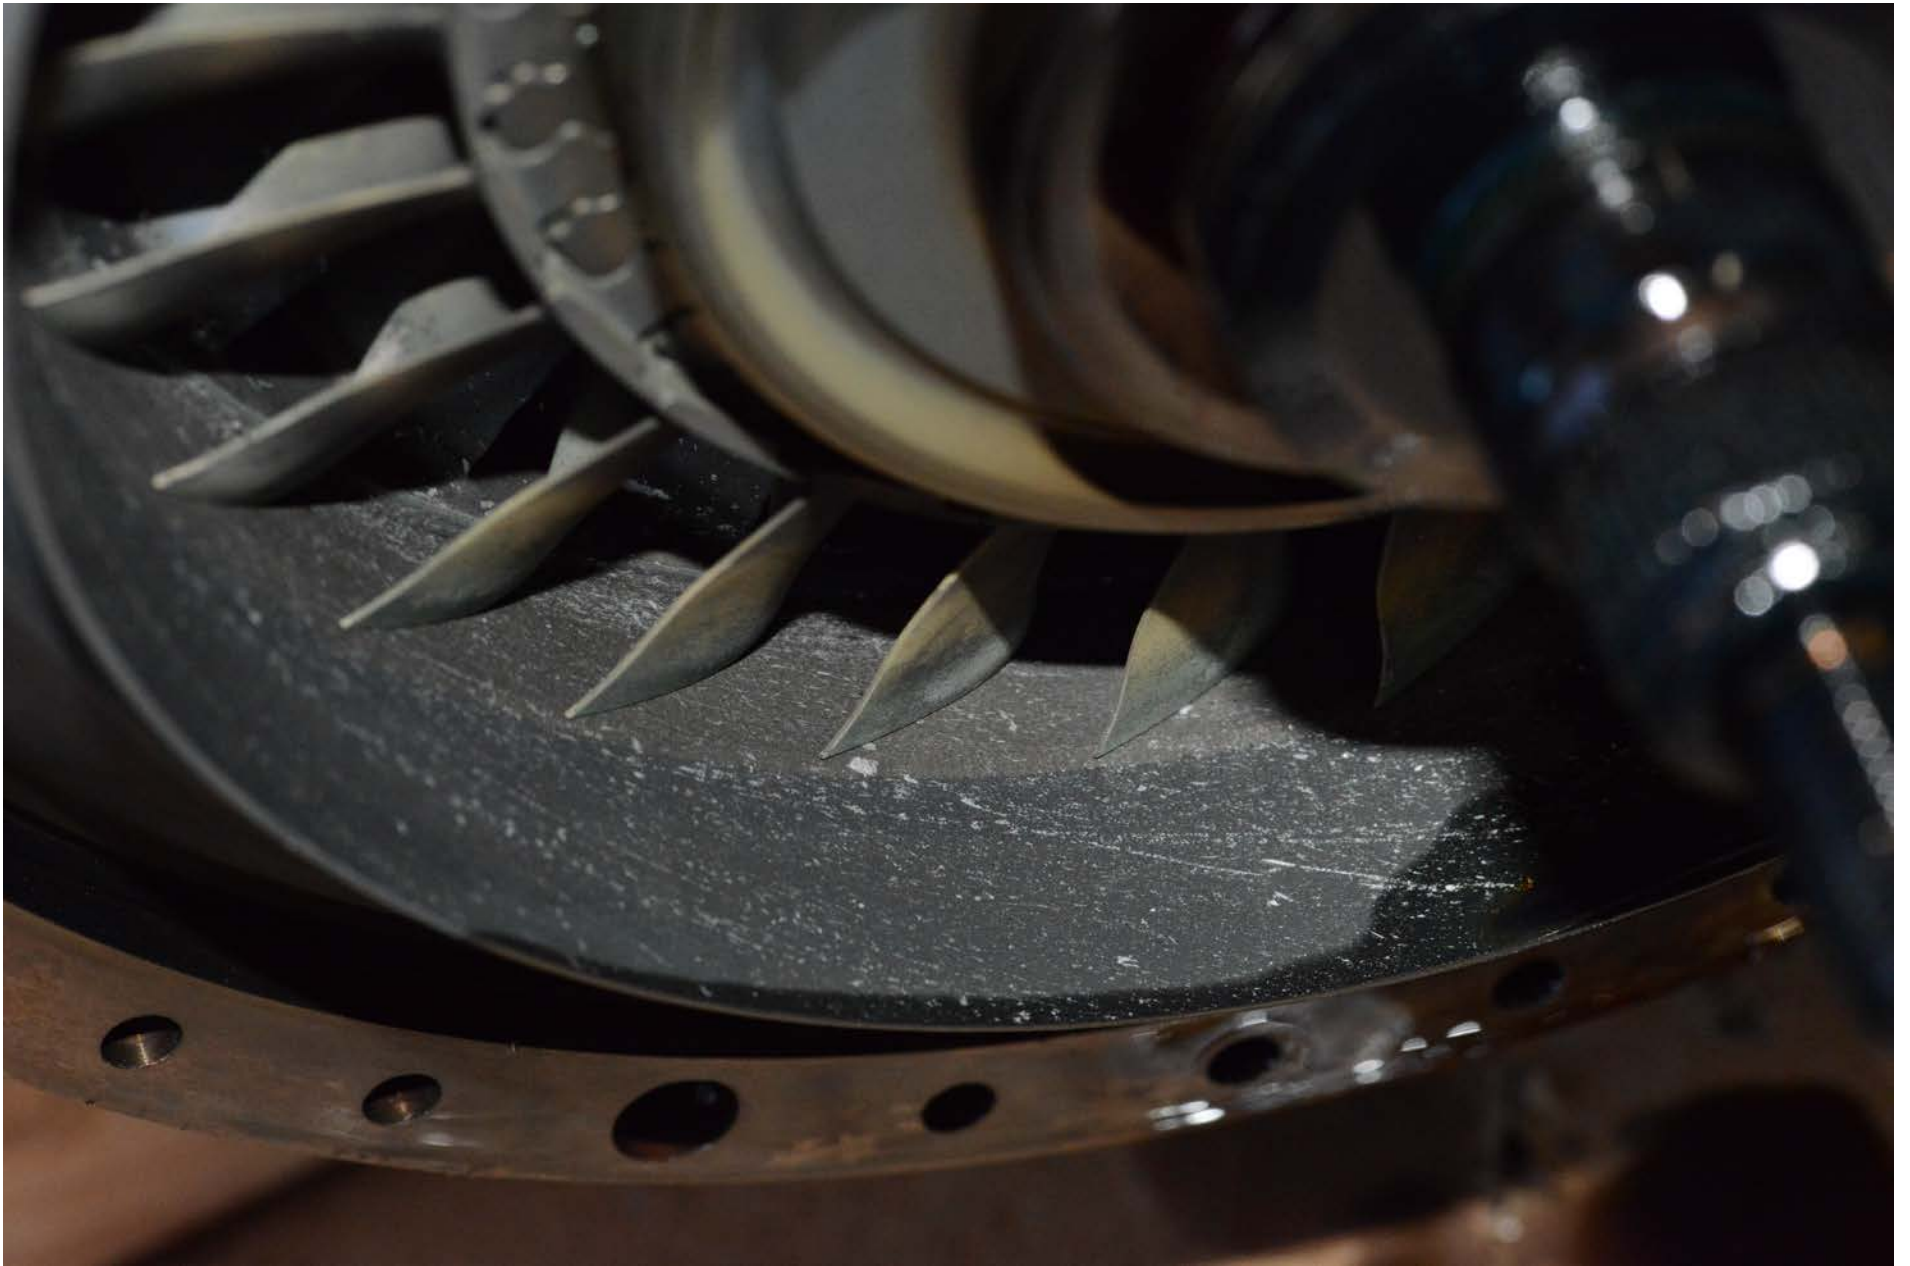
**Photo 15 - View of turbine blade rubbing witness marks.**

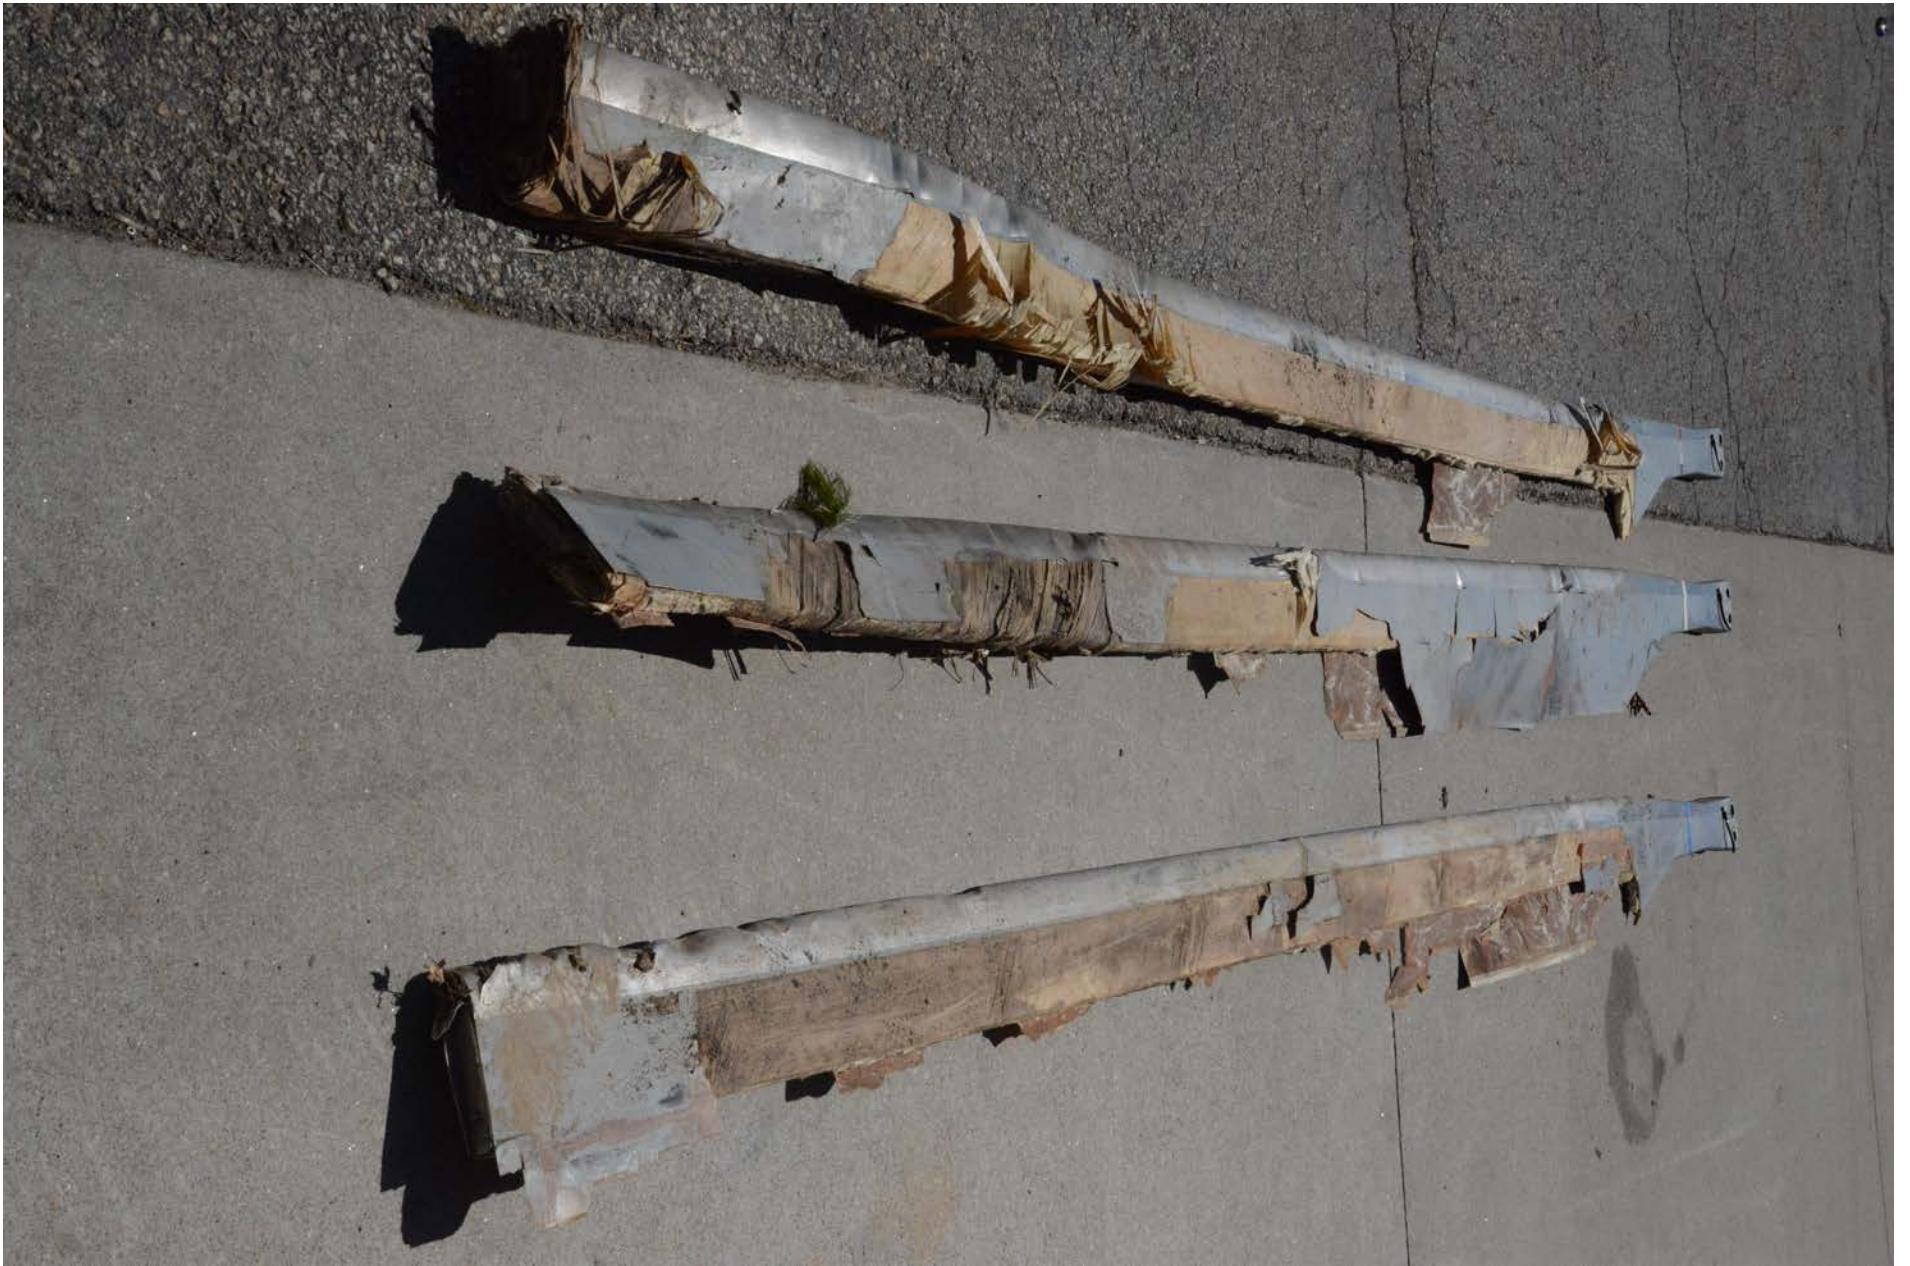
**Photo 16 - View of removed main rotor blades.**

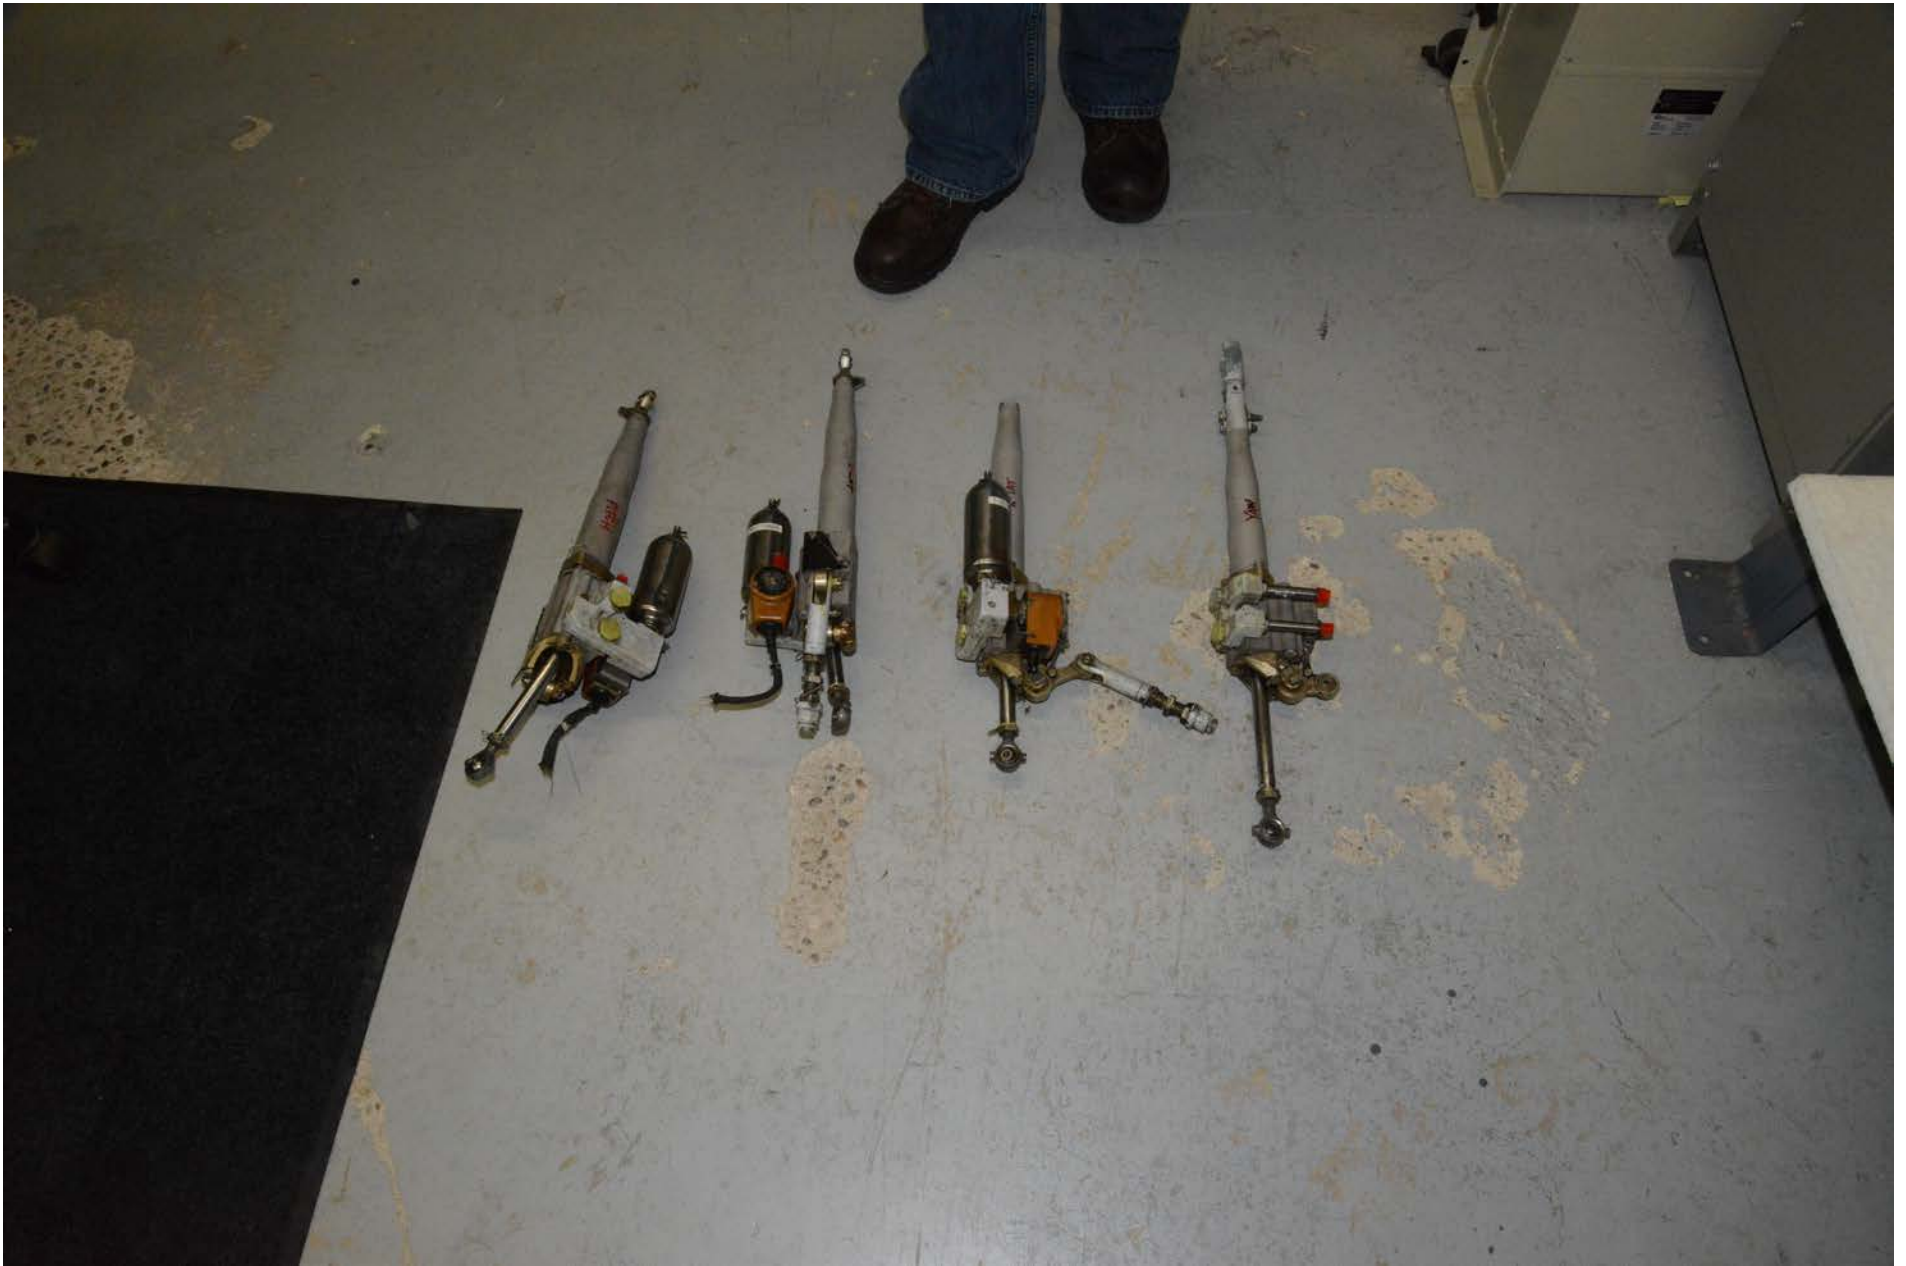
**Photo 17 - View of removed actuators before CT examination.**

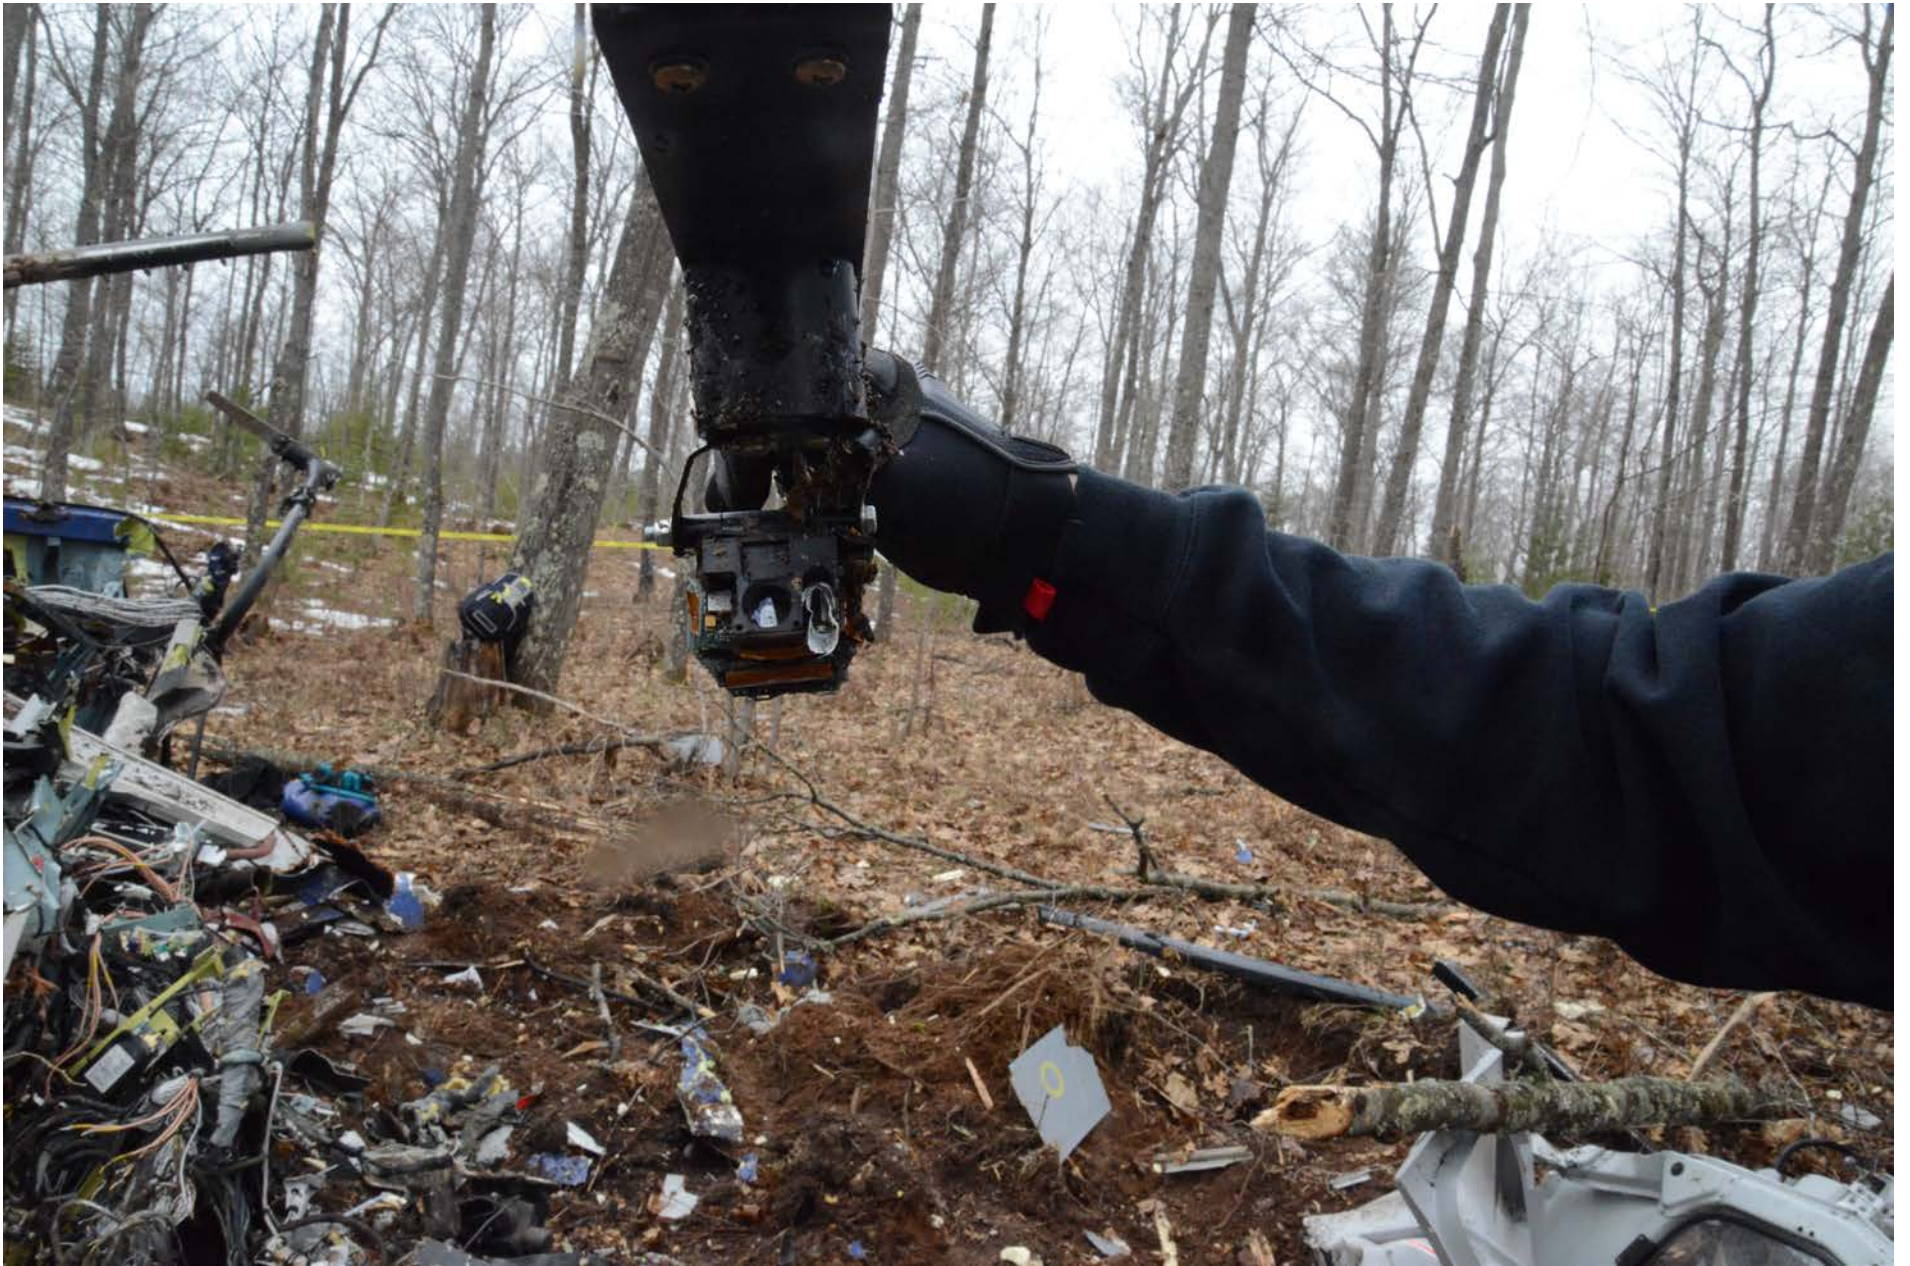
**Photo 18 - View of the Appareo unit.**

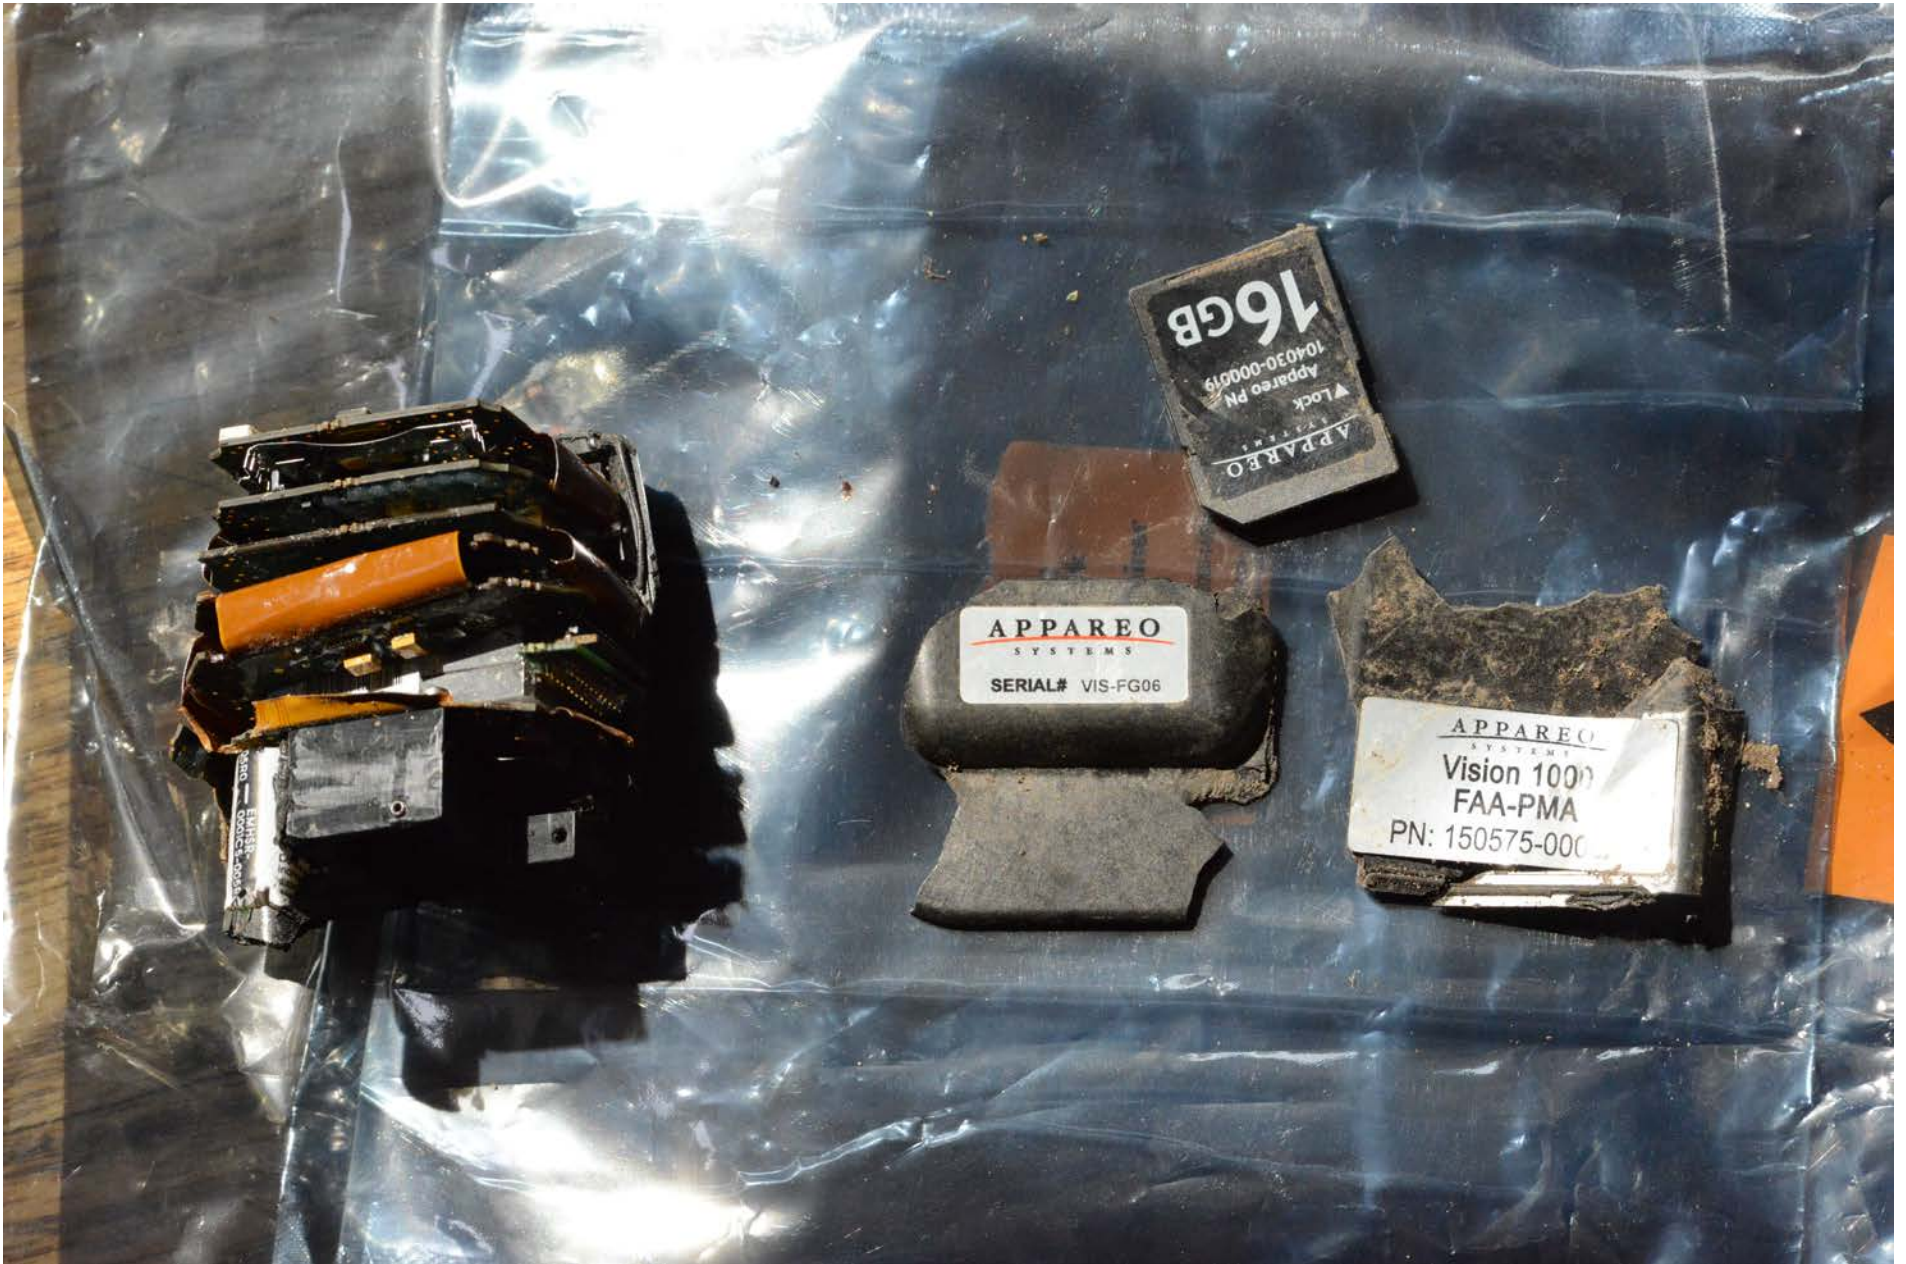
**Photo 19 - View of recovered Appareo components.**

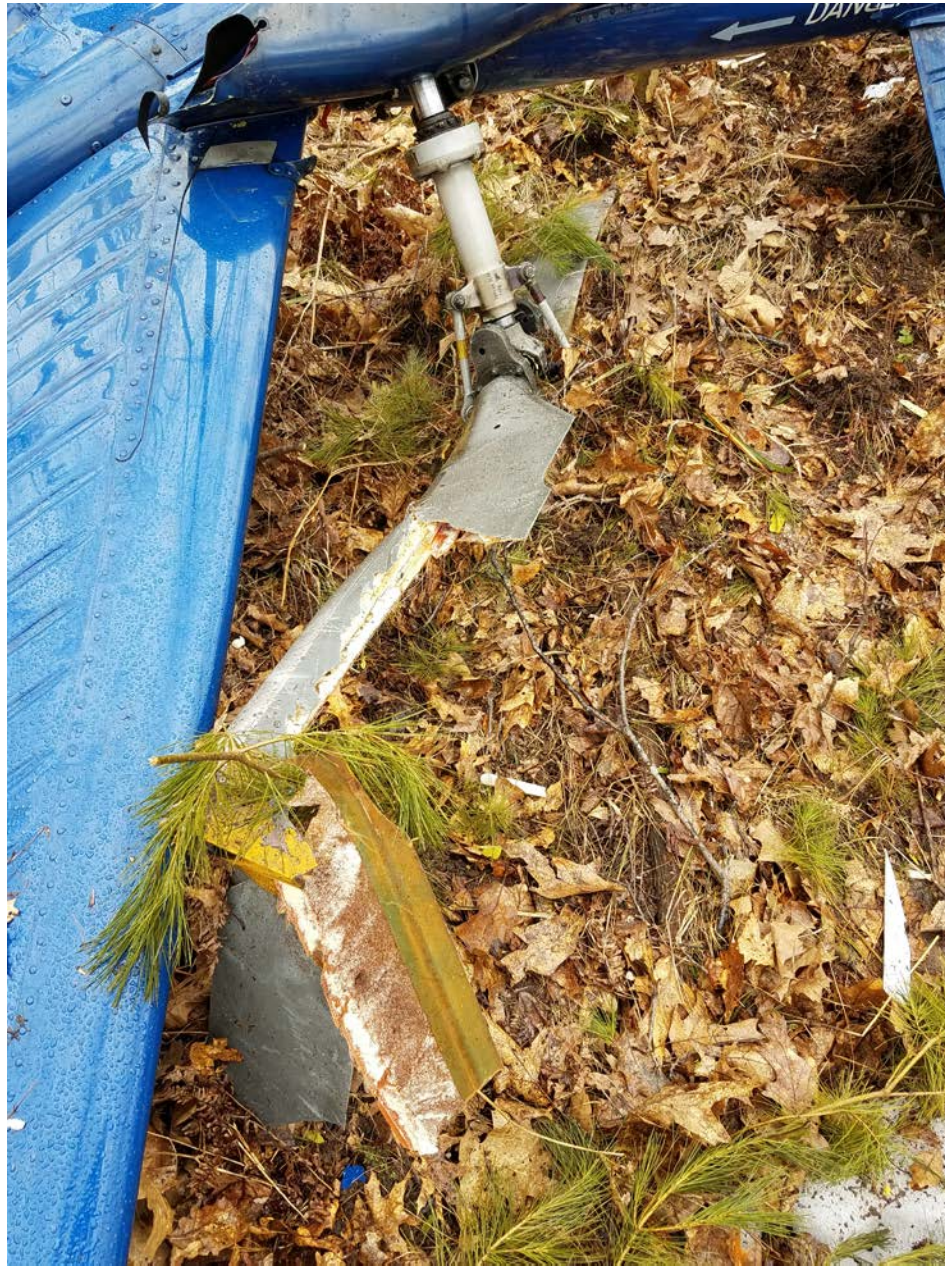
**Photo 20 - View of the tail rotor supplied by Air Methods.**
