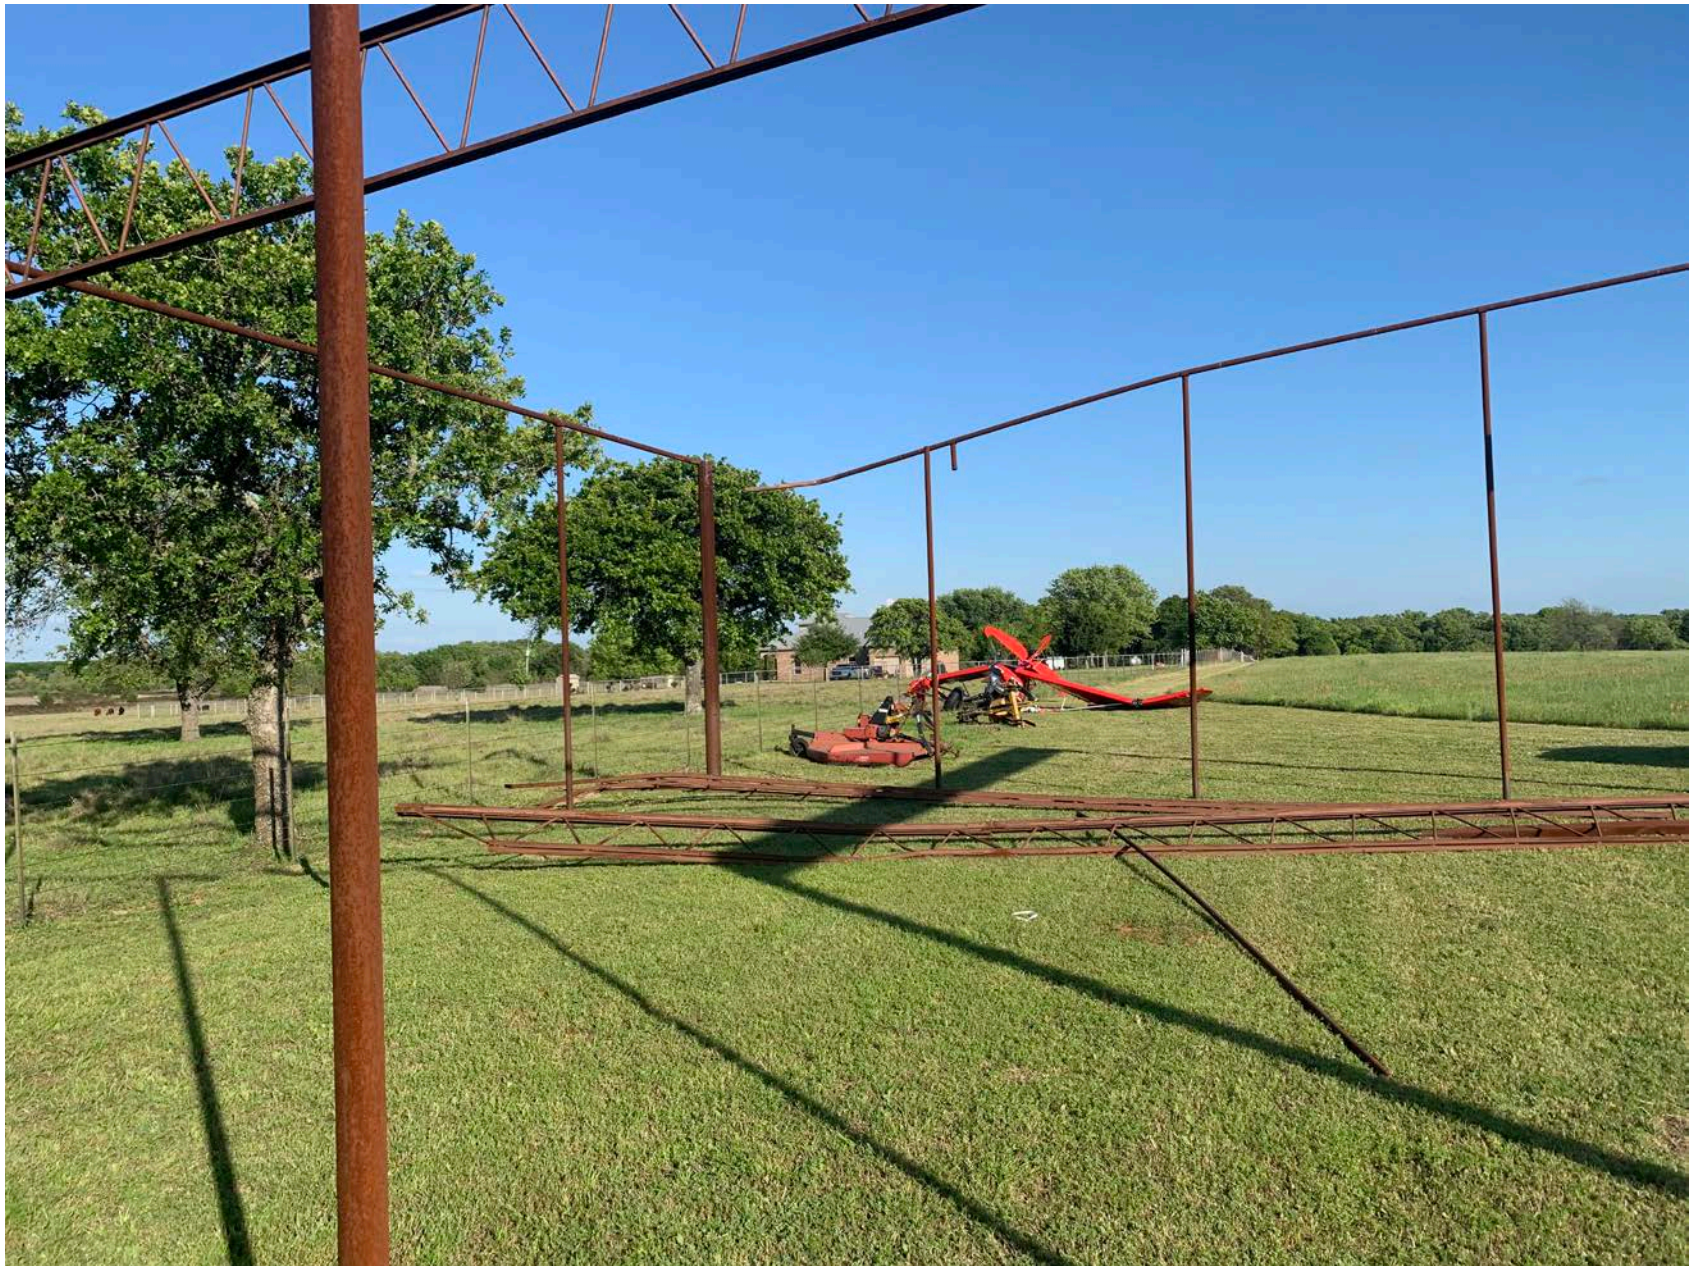
**Photo 1 – Metal building frame with airplane in the background**

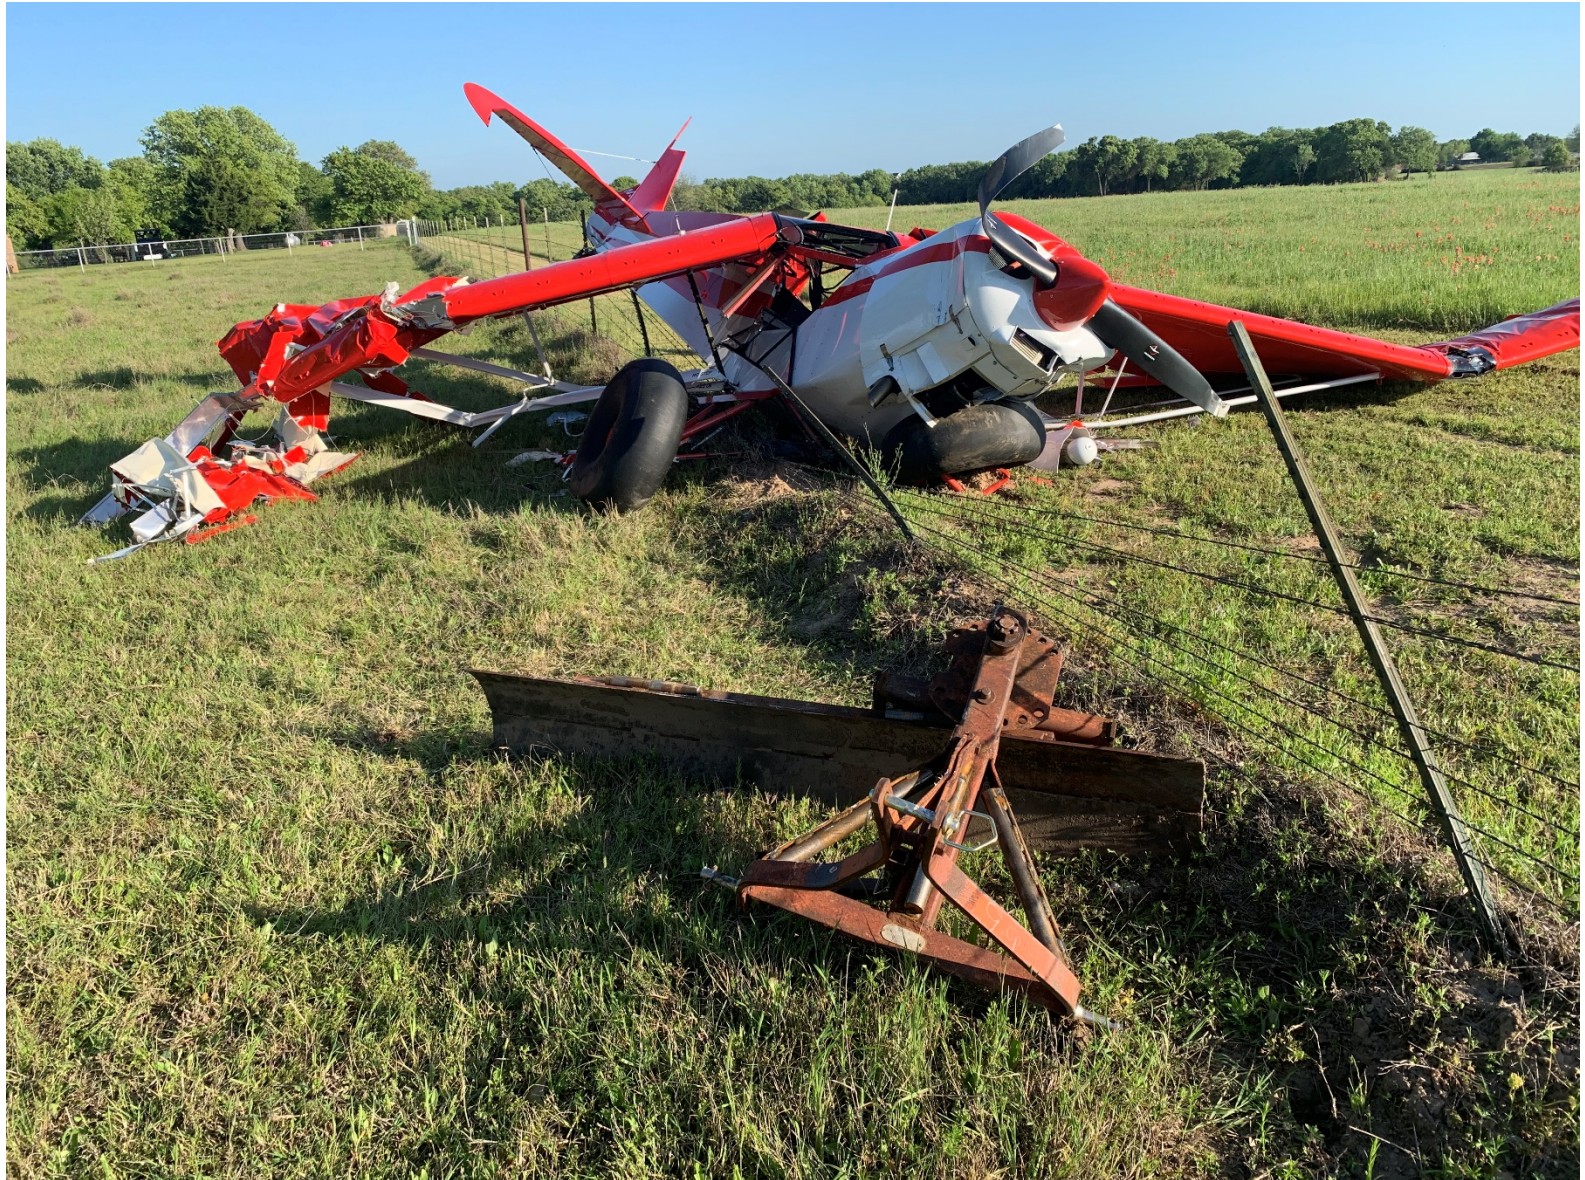
**Photo 2 – Front of wreckage with field in the background**

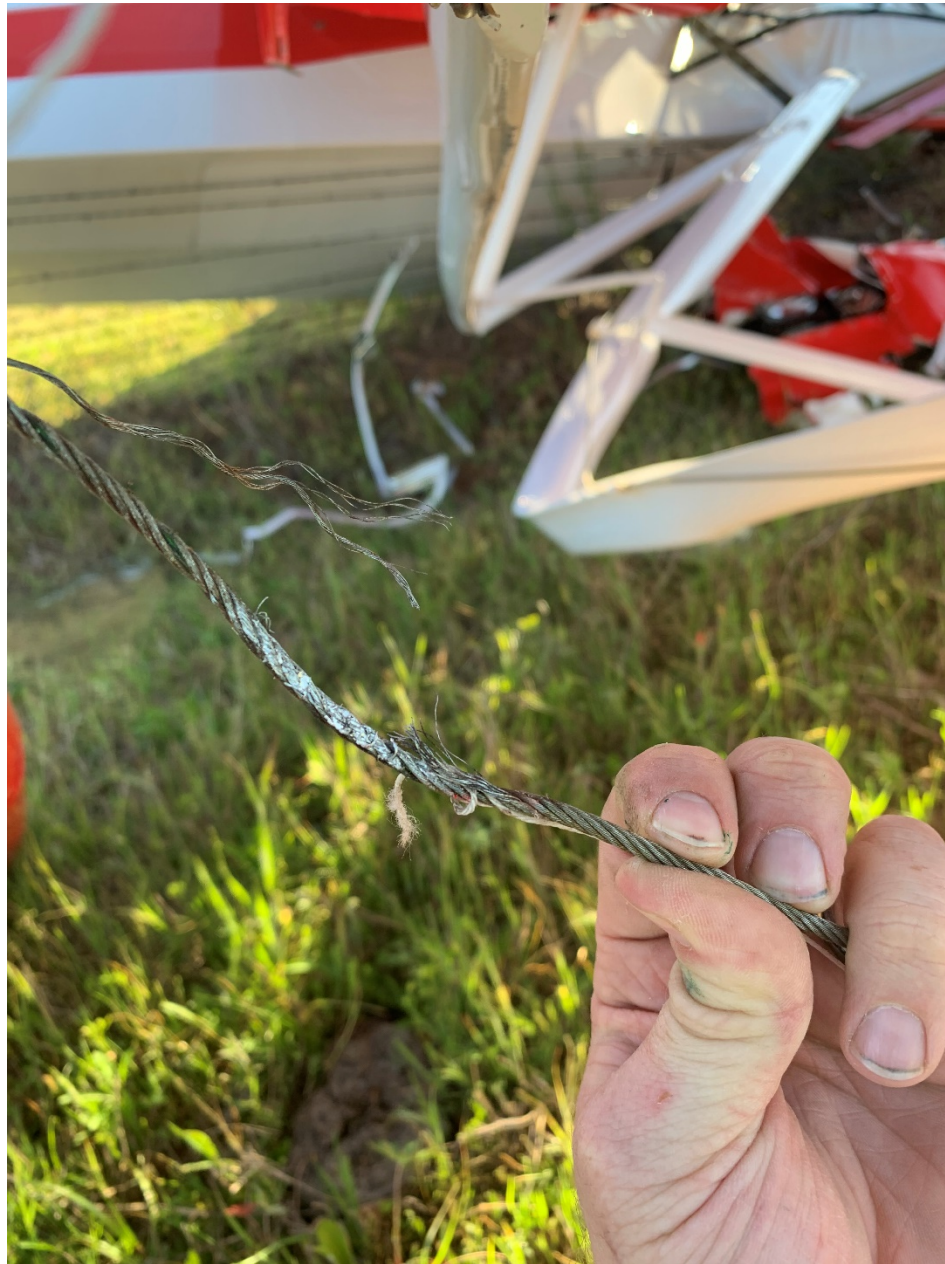
**Photo 3 – Damage to aileron control cable**
