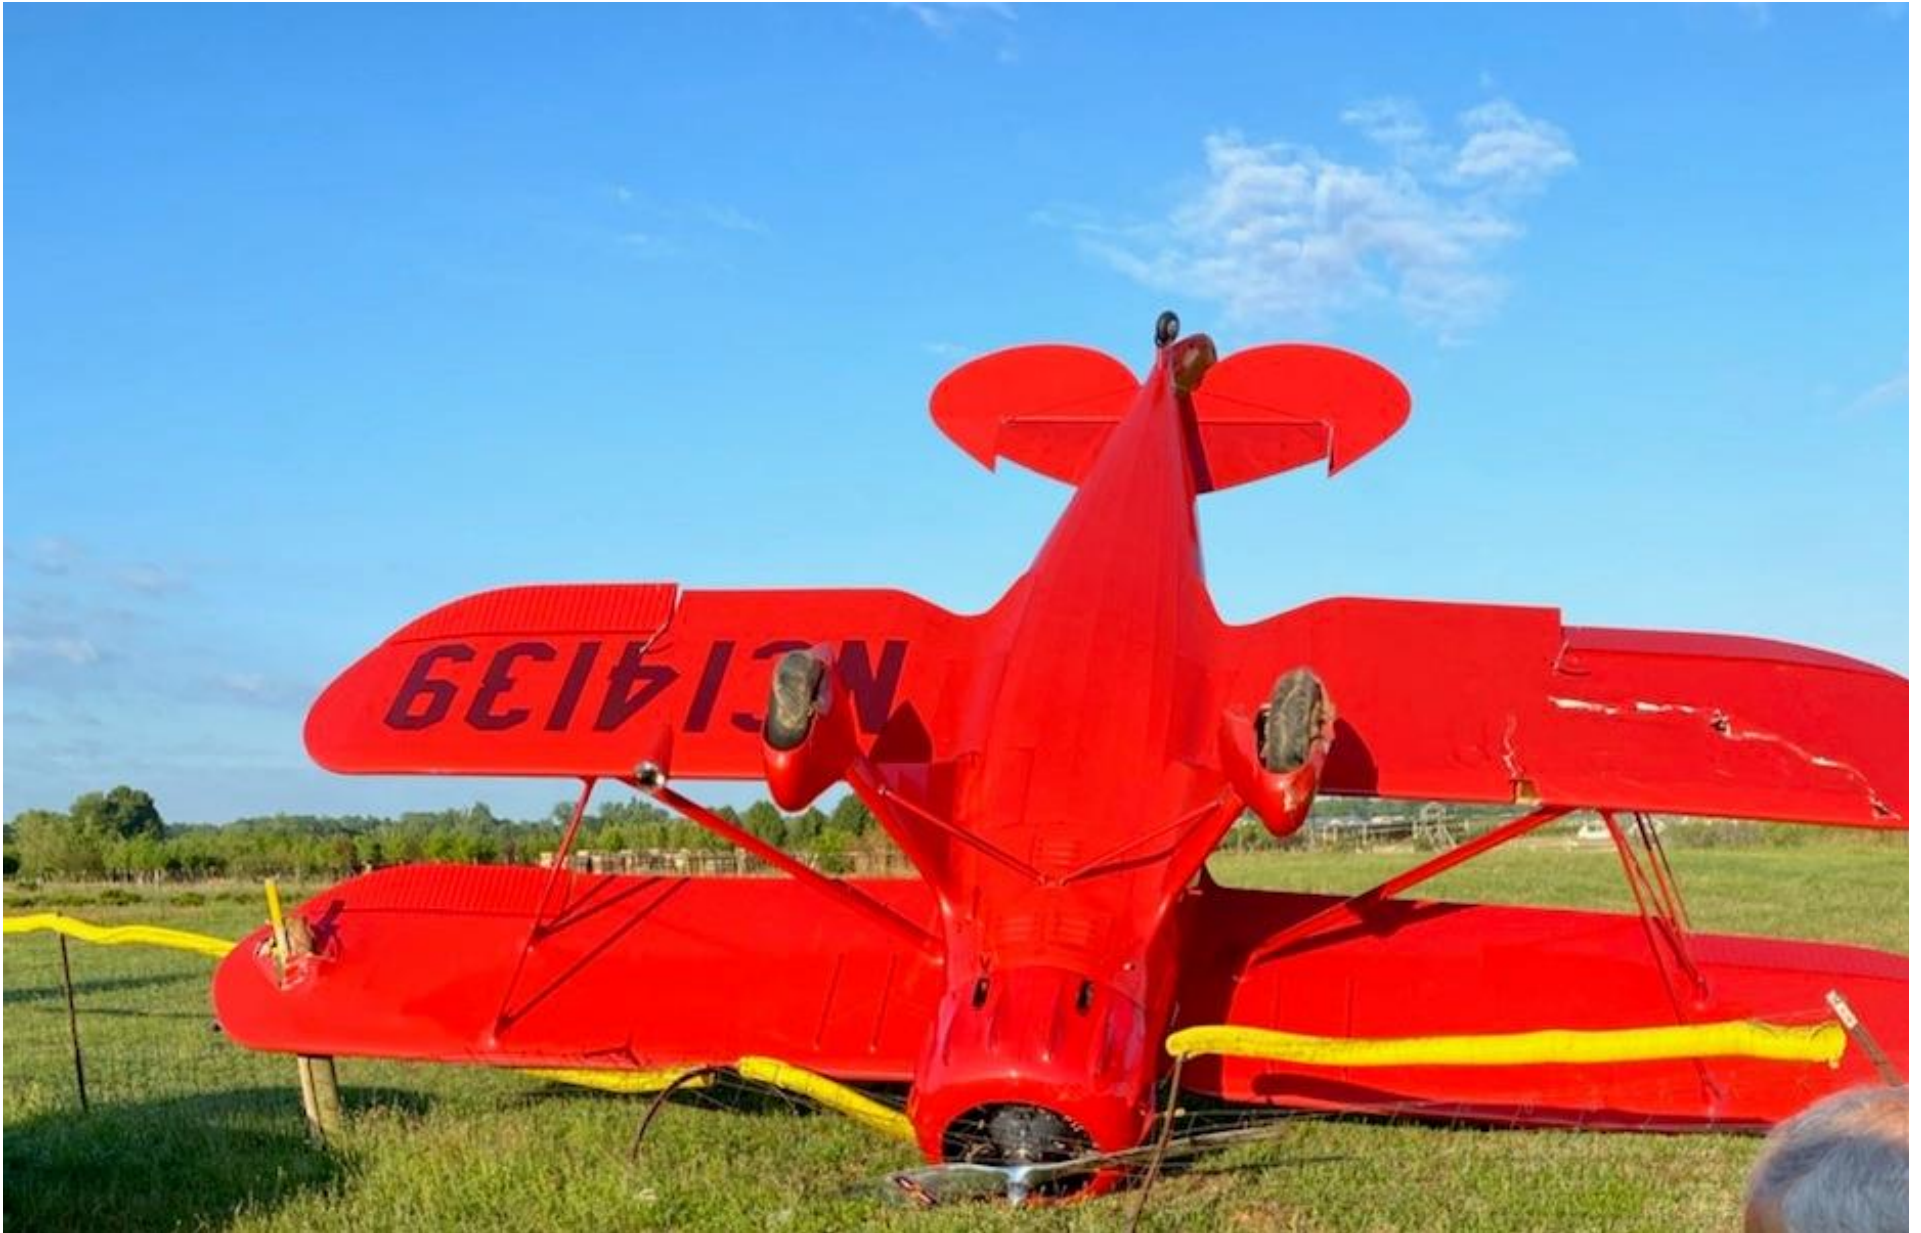
Photo 1 – Accident Site

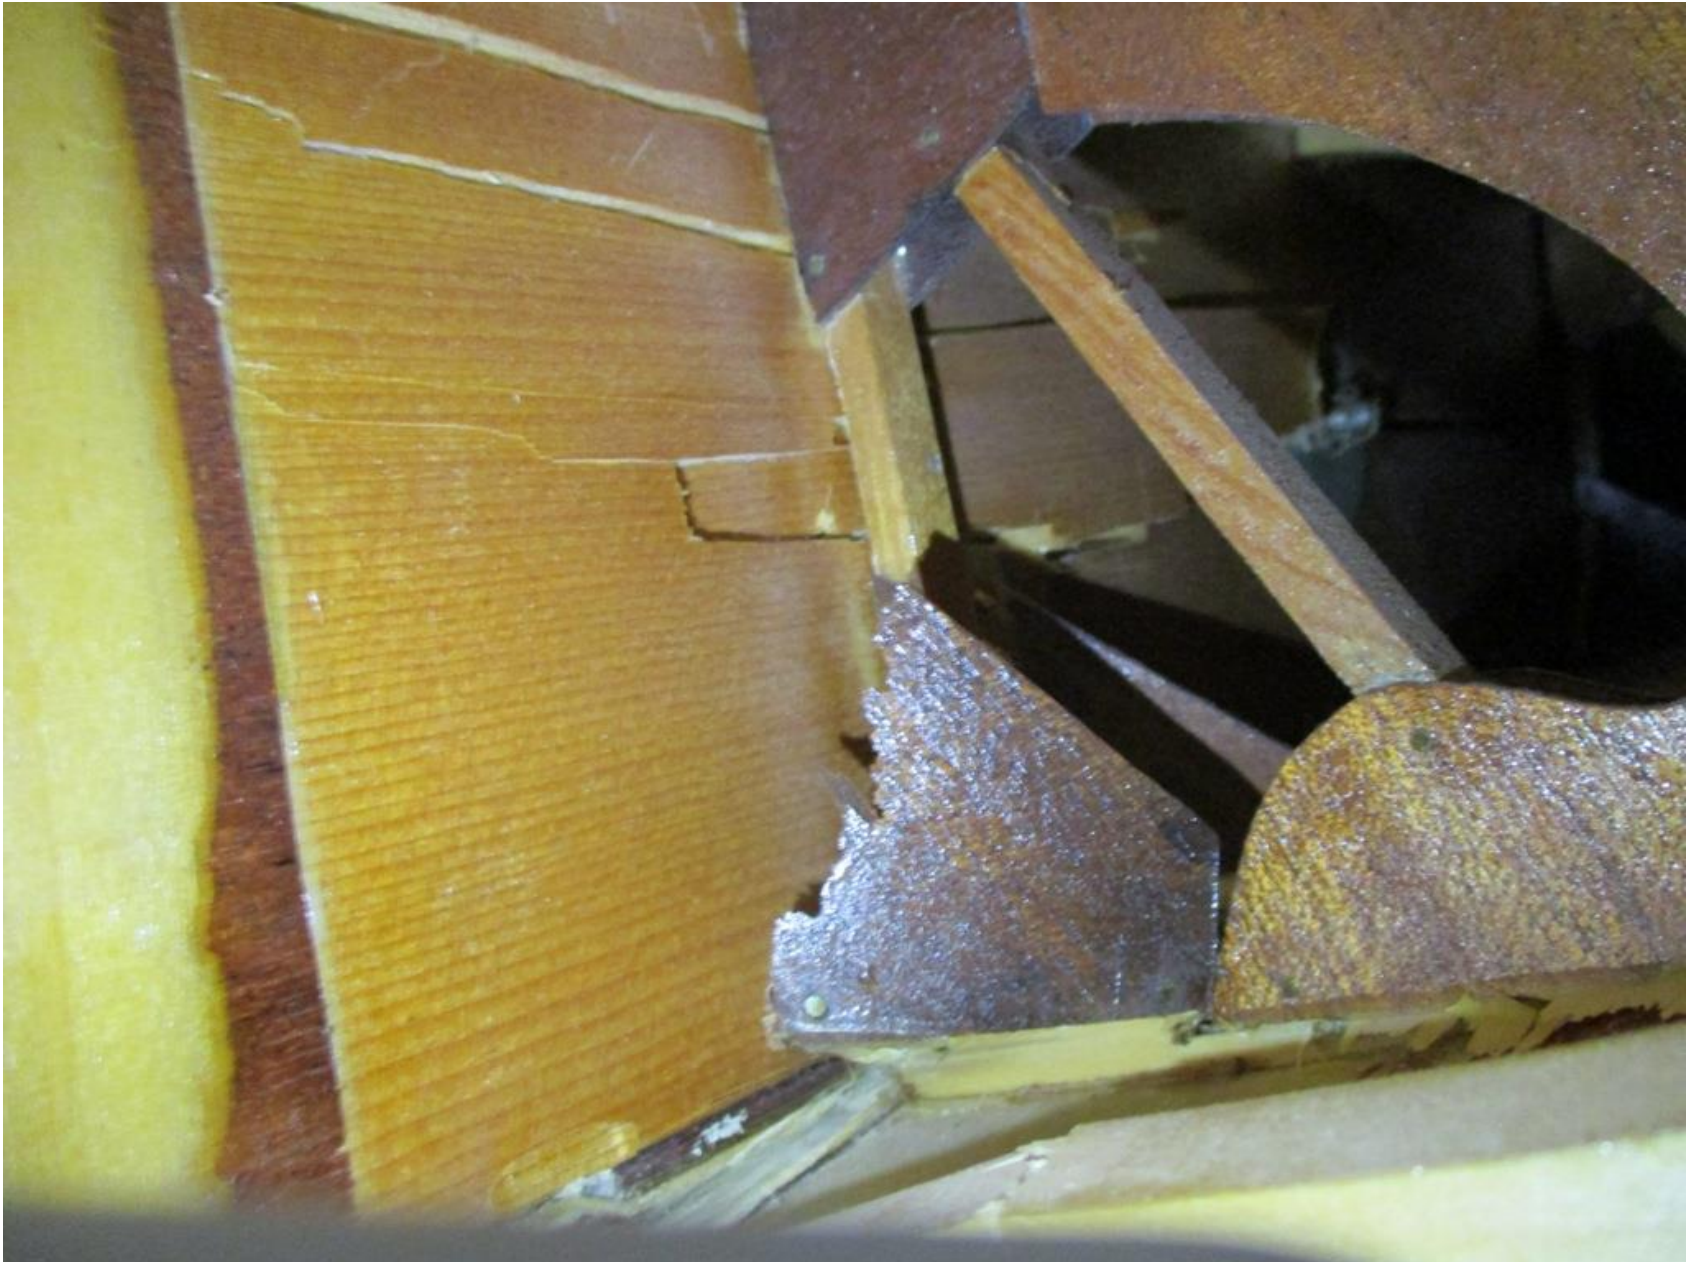
Photo 2 – Lower Right Wing Main Spar
