RE: Navion N 4827K crash 09/24/2014 Atigun Pass Alaska

Re: Navion Propeller and Clamp pictures you shared

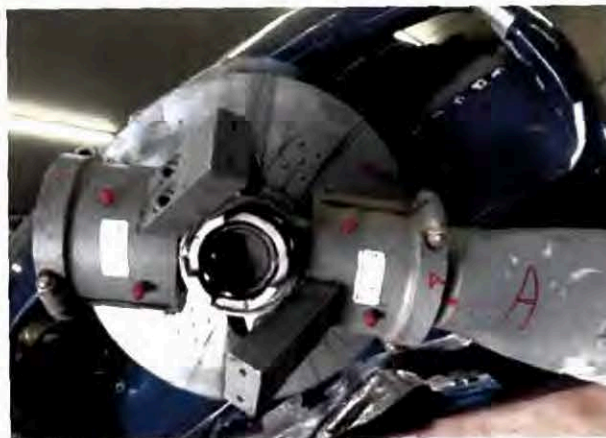
The propeller clamp, indicated "B" below, was reported to have one of the two mounting bolts missing at and around the crash site. This bolt has not been found to date.

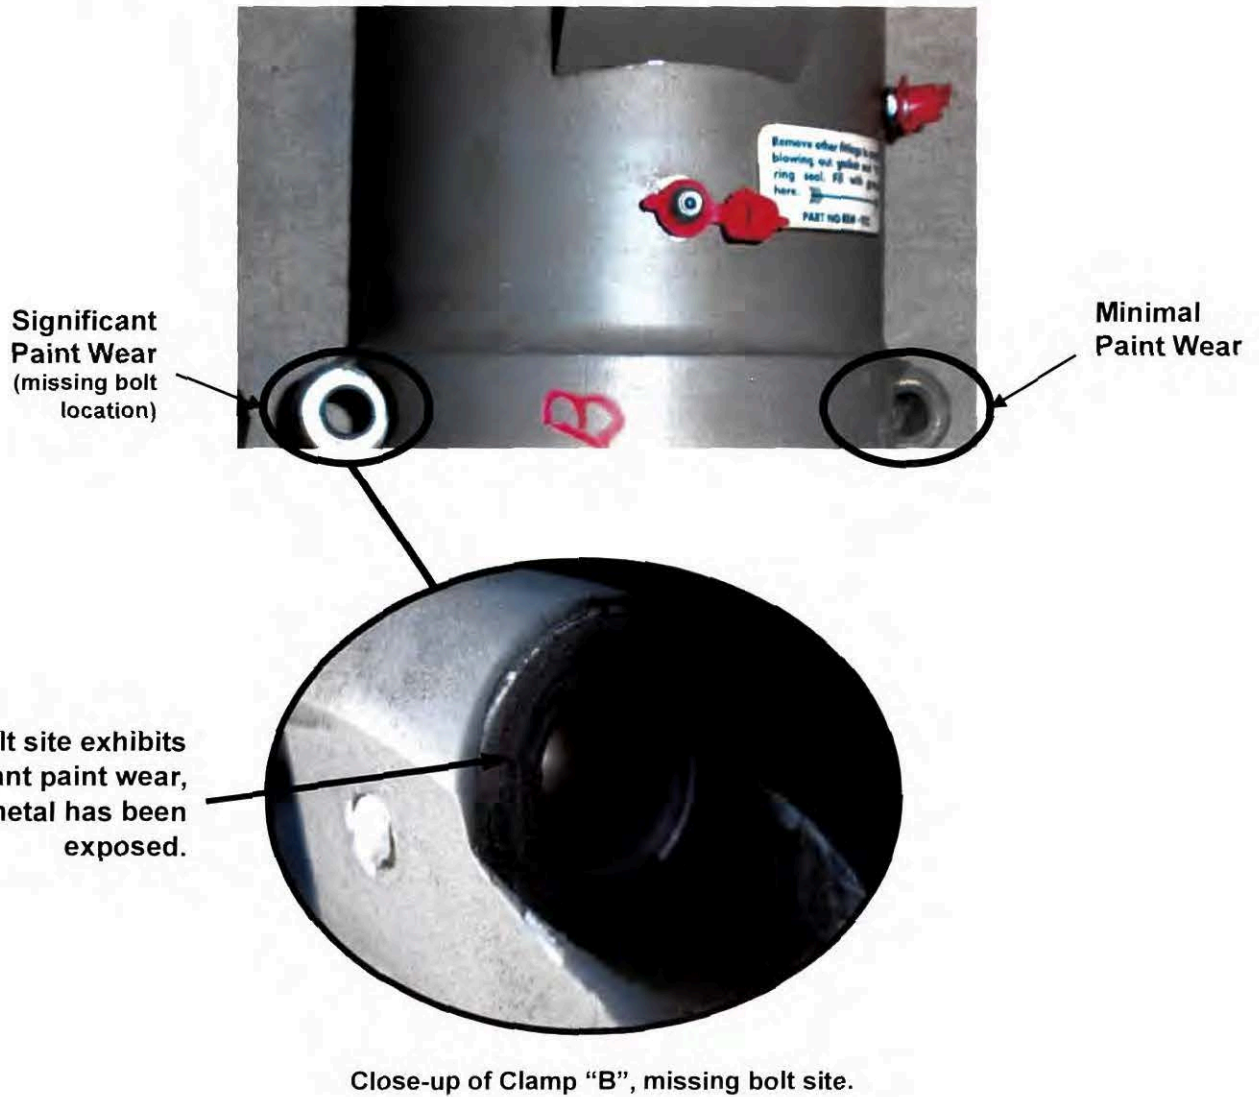
It is evident that at lower-right bolt location on propeller clamp "B" that the paint wear was limited. The location at the lower-left exhibits exposed metal, indicating that this interface has been exposed to significant relative motion (sliding motion) under the bolt or nut. This would be caused by insufficient bolt preload, that is, a loose bolted joint. The bolt at this location has not been recovered to date. This indicates that significantly higher bolt preload existed at this bolt location.

Based on the pictures of the propeller clamp, the missing paint at the bolt interface indicates that the propeller clamp bolt at location "B" did not have sufficient preload. This could be due to either insufficient (low) installation torque or torquing the bolt past the yield point (too much torque), both of which could cause bolt failure during flight. The bolt backing out during flight vibration would be expected and may explain why the bolt has not been recovered to date.

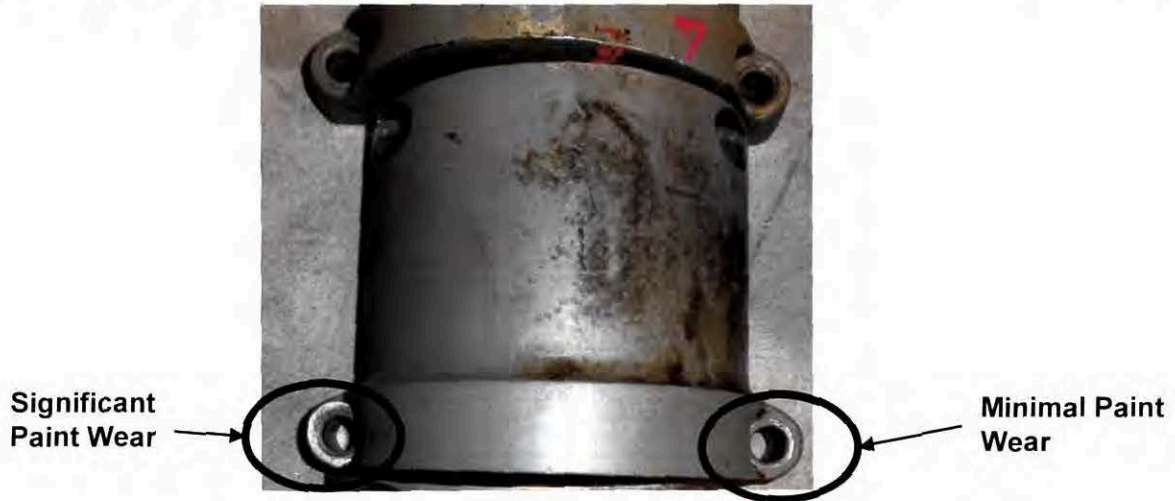
As an additional point, it's evident that Clamp "A" also shows significant paint wear at one bolt location (bare metal) and minimal paint wear at the opposite side. This indicates that this clamp also has been flown with an improperly torqued clamp bolt. It has been exposed to enough vibration cycles to expose the base metal as with Clamp "B".

Clamp "A" wear at bolted joint interfaces.
