# National Transportation Safety Board

## Pipeline Accident Brief

### Birmingham Public Housing Gas Explosion

| <b>Accident No.:</b> | DCA14MP001 |

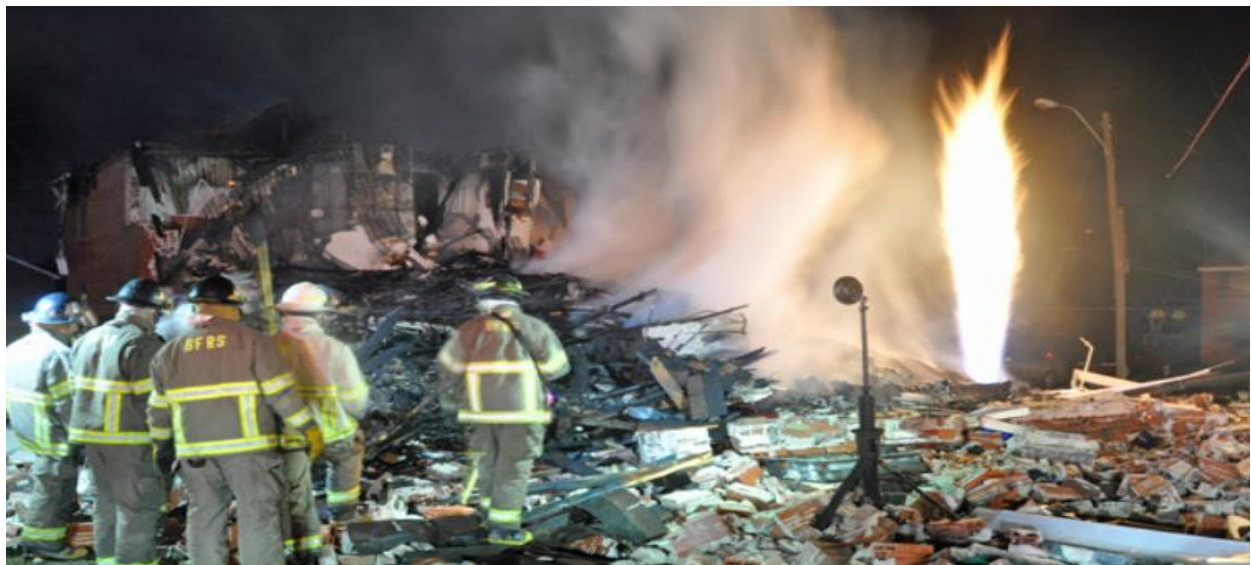
**Figure 2.** The riser fire shoots up from the ground amid the rubble at Charles P. Marks Village.

Two separate fires burned during the accident, the structure fire and a riser fire at the natural gas service line riser adjacent to the northeast wall of unit 80. Early in the emergency operation and continuing until approximately 6:30 a.m., the BFRS presumed there were no trapped victims inside the burning building. This presumption was based on their search efforts and limited information from the other building tenants who were transported to the hospital. The riser fire prevented firefighters from gaining access to the collapsed unit, which delayed a comprehensive search for possible survivors.

About 6:00 a.m. when technicians were still unable to locate the buried service line to stop the riser fire, Alagasco decided to shut off the gas using the riser isolation valve directly below the venting, burning gas. At 6:14 a.m., the technician closed the service isolation valve, which stopped the gas flow.

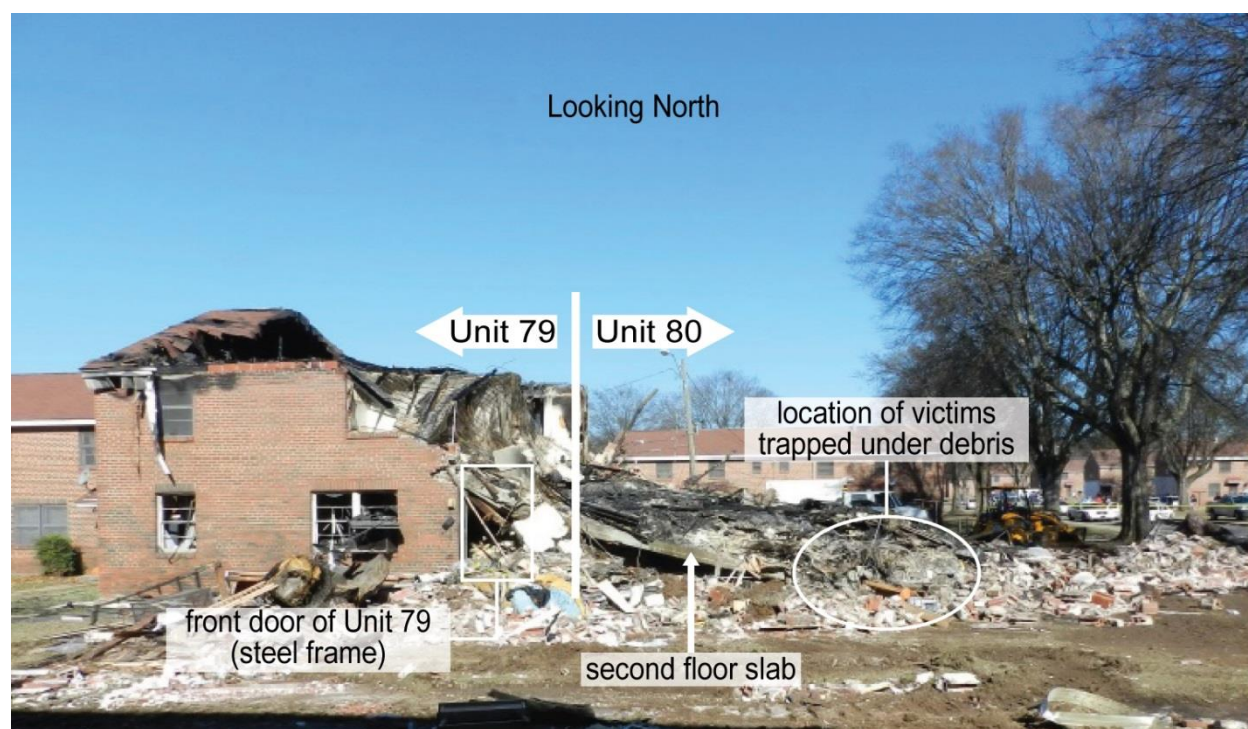
The explosion destroyed unit 80. Unit 79, the other half of the duplex, sustained less severe damage, mostly from the post-explosion fire. The common wall between units 79 and 80 pushed away from unit 80; debris from the top of the wall landed into the living areas of the first floor of unit 79. (See figure 3.)

**Figure 3.** Units 79 and 80 after the explosion.

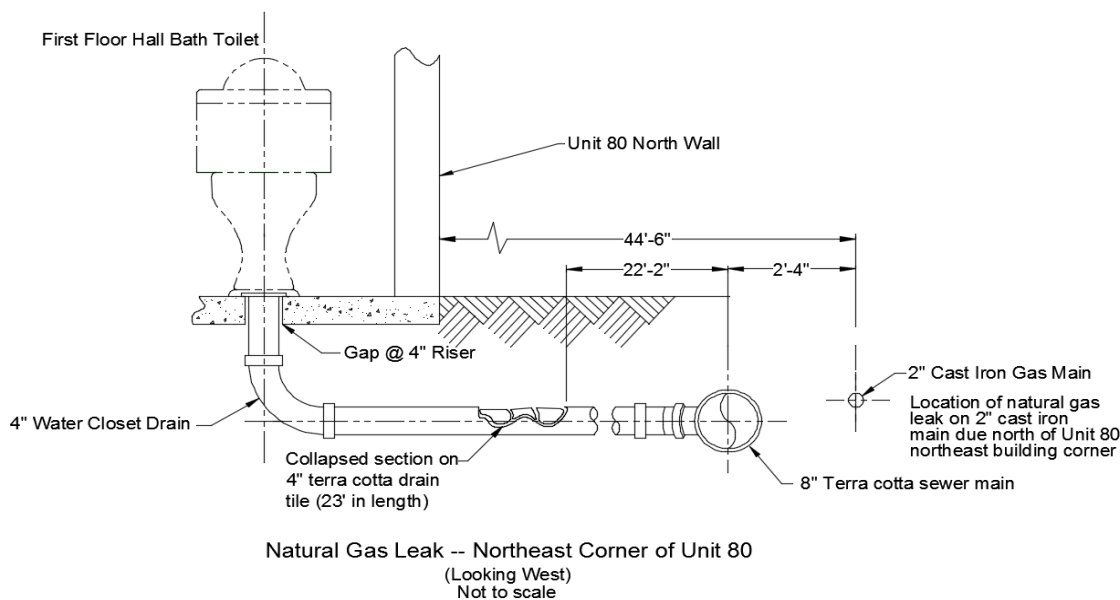
The sewer and gas mains ran parallel along 65th Courtway South. Units 79 and 80 receive gas through service lines that branch from the main gas line in a southward direction. The sewer connection for the units—made of 4-inch terra cotta—runs north from the units and ties into an 8-inch sewer main. After the explosion, investigators excavated the 4-inch sewer lateral from unit 80 and discovered a 23-inch-long broken (collapsed) section. (See figure 5.) The break was located approximately 20 feet from the north edge of the foundation of unit 80 and about 25 feet south of the gas main leak.

**Figure 5.** Cross section of underground piping to the northeast corner of the half-bath in unit 80.

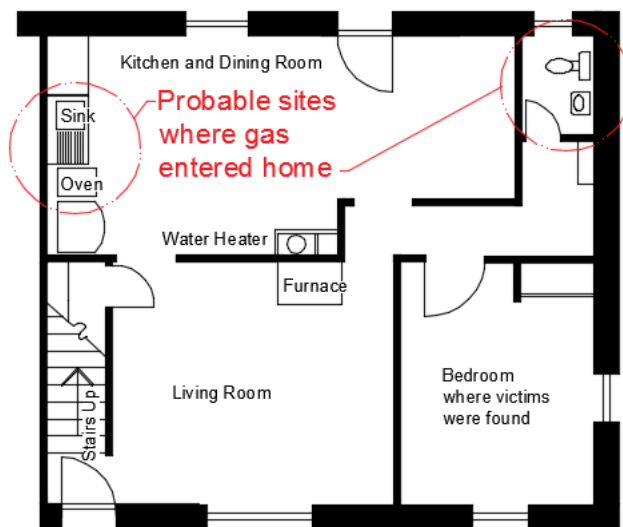
The NTSB determined that one credible path for the natural gas to enter unit 80 was by migrating through the soil from the cracked cast iron gas main to the buried sewer main about 3 feet away. It then traveled along the exterior of the buried sewer main to the building about 45 feet away. (See figure 5.) It accumulated under the first floor slab and entered the unit where the sewer pipe passed through the concrete slab at:

- The annulus around the 4-inch cast iron sewer pipe below a toilet located in the northeast corner of unit 80 on the first floor. Close examination of the floor penetration around the pipe revealed gaps in the annulus.
- The 4-inch waste piping penetration through the slab near the kitchen sink, the area at the annulus of the 4-inch penetration also had gaps.

The second credible path involved the gas leaking inside of the 4-inch sewer at the collapsed section described earlier. In this scenario, gas flowed through the soil from the cracked gas main and into the collapsed, 4-inch sewer lateral about 22 feet away. Gas could travel inside the sewer pipe and pass through the water traps in the toilet and under the bathroom sink and into the ground floor. Based on the nearly 20 psig gas pressure, the expected gas flow volume out of the cracked gas main, and the breach in the 4-inch sewer, natural gas likely bubbled through the water seals in the toilet and the sink drains. From either route, the appliances provided the ignition source for the gas inside the apartment; the range had three open, active pilots, and the room heater had one pilot and might have had the main burner operating. (See figure 6.)

**Figure 6.** First level of unit 80 showing areas gas entered the apartment.

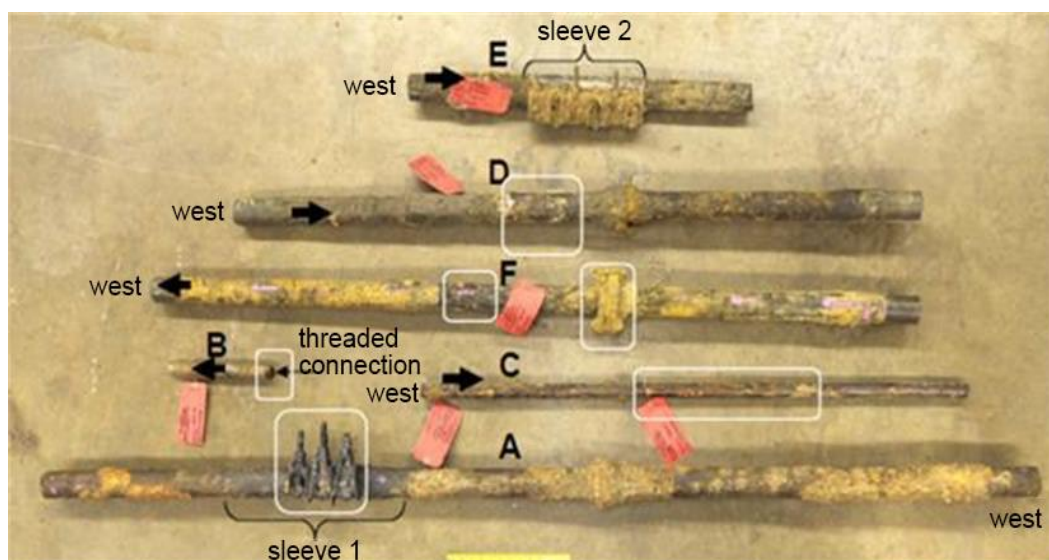
At the request of the NTSB, Alagasco leak-surveyed the community for indications of a natural gas leak near the damaged unit 80 as well as other addresses within the property in the days following the accident. In areas where technicians suspected a leak, they excavated the region to approximately 3 feet below grade to expose the suspected leak location. In total, excavations would involve the removal of six gas-piping segments, labeled A through F. (See figure 7.) All the segments were shipped to the NTSB laboratory in Washington, DC, for examination. Alagasco technicians detected gas leaks at the locations marked with the white rectangles. The clamp on segment A (sleeve 1 in figure 7) was installed the morning after the explosion to stop the leak and stabilize the pipe for removal.

**Figure 7.** Pipe segments recovered from the accident; rectangles indicate the leak locations.

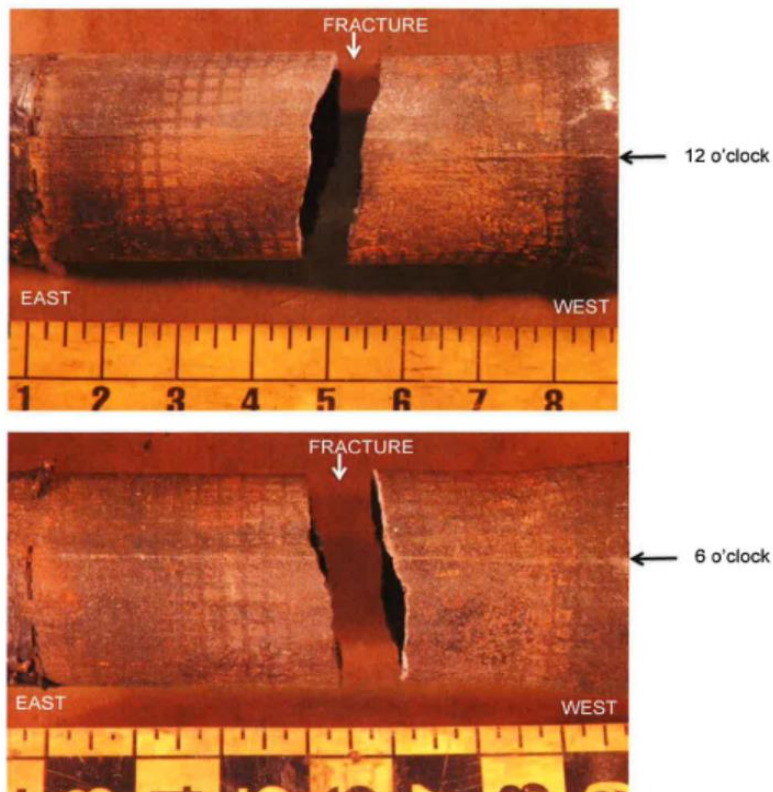
NTSB investigators disassembled and removed the new clamp on pipe segment A. They discovered a fracture that extended circumferentially around the pipe. (See figure 8.) The fracture surface revealed a radiating pattern that originated from the outer surface at the bottom of the pipe. The fracture extended from each side of the fracture origin and propagated circumferentially up toward the top of the pipe.

**Figure 8.** Pipe segment A after the new clamp was removed to expose the crack.

The fracture face exhibited five regions adjacent to the outside surface consistent with oxidized cast iron. The largest oxidized region was located at the bottom of the pipe and extended through the pipe wall. The circumferential length of the oxidized region measured approximately 1.6 inches along the outer surface. The oxidized region at the inner surface measured approximately 0.7 inch circumferentially.

In addition, NTSB investigators examined the large tree root and rock that had been recovered with the pipe segment. They concluded that the tree root around the pipe increased the force exerted by the rock against the corroded cast iron pipe wall. The compressive, pinpoint forces exerted by the rock and downward forces from ground settlement likely caused the corroded pipe to crack.

- Replaced the cast iron pipe in Marks Village in early 2014. The cast iron mains were replaced with polyethylene pipe ranging from ¾-inch to 4-inch diameter. The majority of the service lines were replaced with polyethylene pipe from the main lines to the meter locations. In addition, Alagasco added main isolation valves with the capability of stopping the flow of gas into this community if such an action is required in the future.

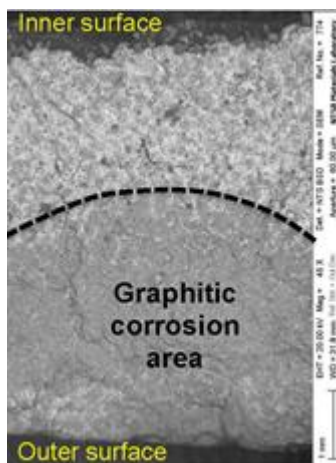
The dark gray area on the fracture face in the area adjacent to the outer surface indicates significant graphitic corrosion in the cast iron gas main. (See figure 9.) Graphitic corrosion reduced the strength of pipe segment A and made it more brittle.

**Figure 9.** SEM electron backscatter image of the pipe segment A fracture face.
