**National Transportation Safety Board**

**Group Chairman's Factual Report of the Investigation**

**CenterPoint Energy Minnesota**

**Minnehaha Academy, Minneapolis, MN**

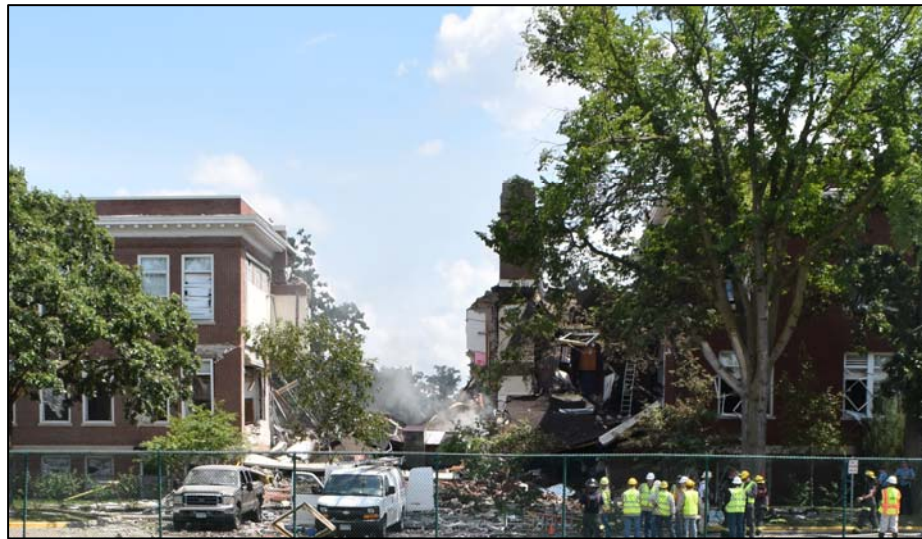
On August 2, 2017, at 10:22 a.m. central daylight time, a building at the North Campus of the Minnehaha Academy (Academy) in Minneapolis, Minnesota, was destroyed by a natural gas explosion (Figure 1). The accident resulted in the death of two Minnehaha Academy employees and injuries to nine others. In addition, the accident caused damage to two other Academy buildings.

*Figure 1 – Photo of the accident site taken after the building explosion with several personnel and emergency responders on scene. Source: Minneapolis Fire Department*

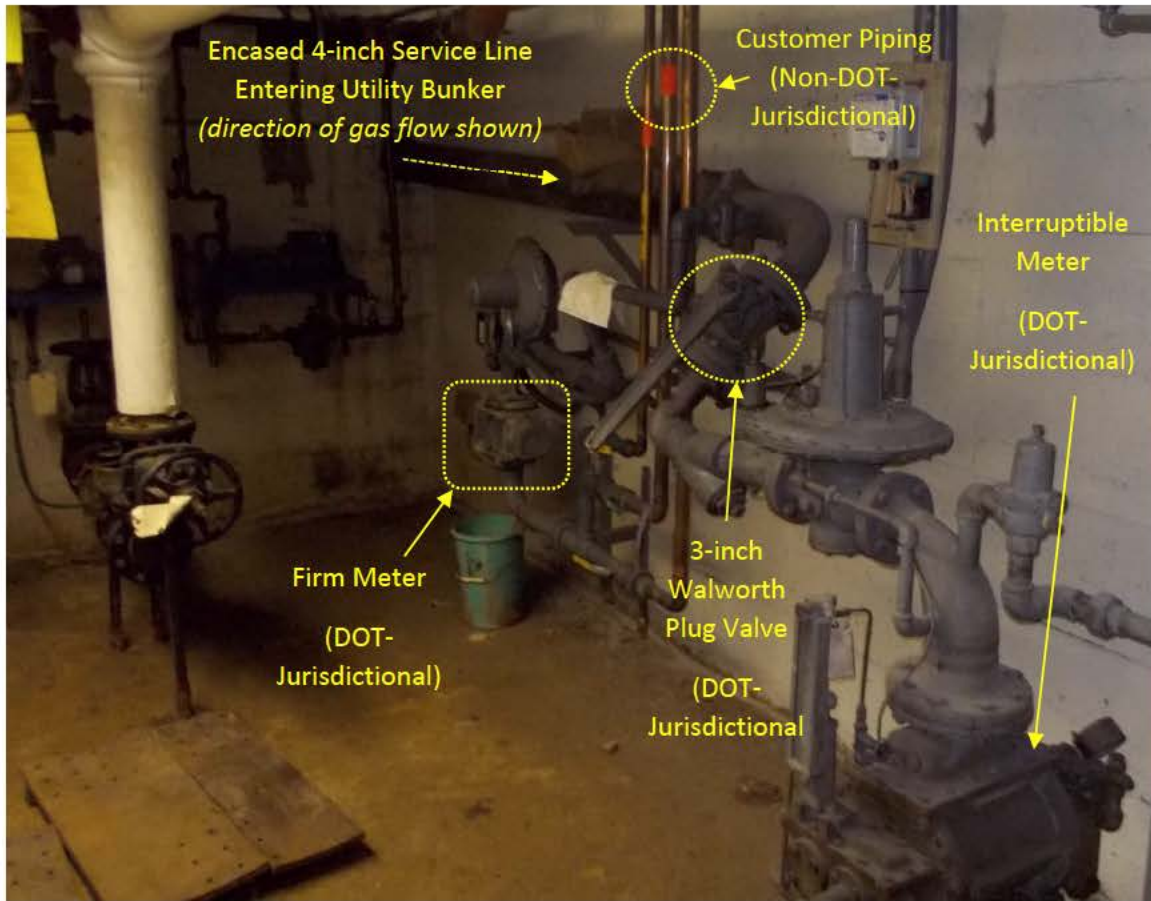
Figure 6 – Configuration of Natural Gas Service Equipment in Utility Bunker (Gas Meter Room), Source: CPEMG with NTSB annotations, Taken: Feb2016 (~1.5 years pre-accident)

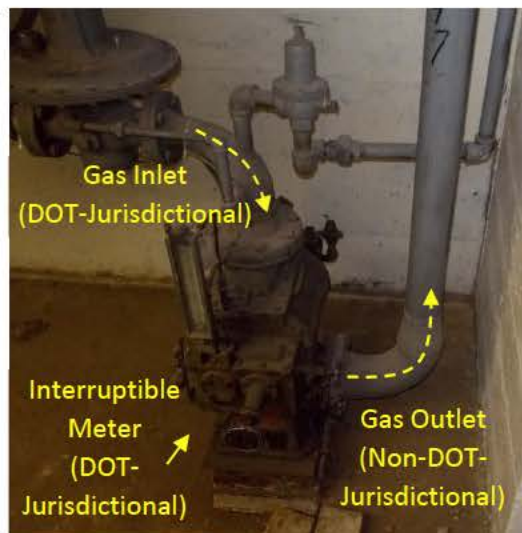
Figure 7 – Interruptible Meter and Non-DOT-Jurisdictional Customer Piping in Utility Bunker, Source: CPEMG with NTSB annotations, Taken: Feb2016 (~1.5 years pre-accident)

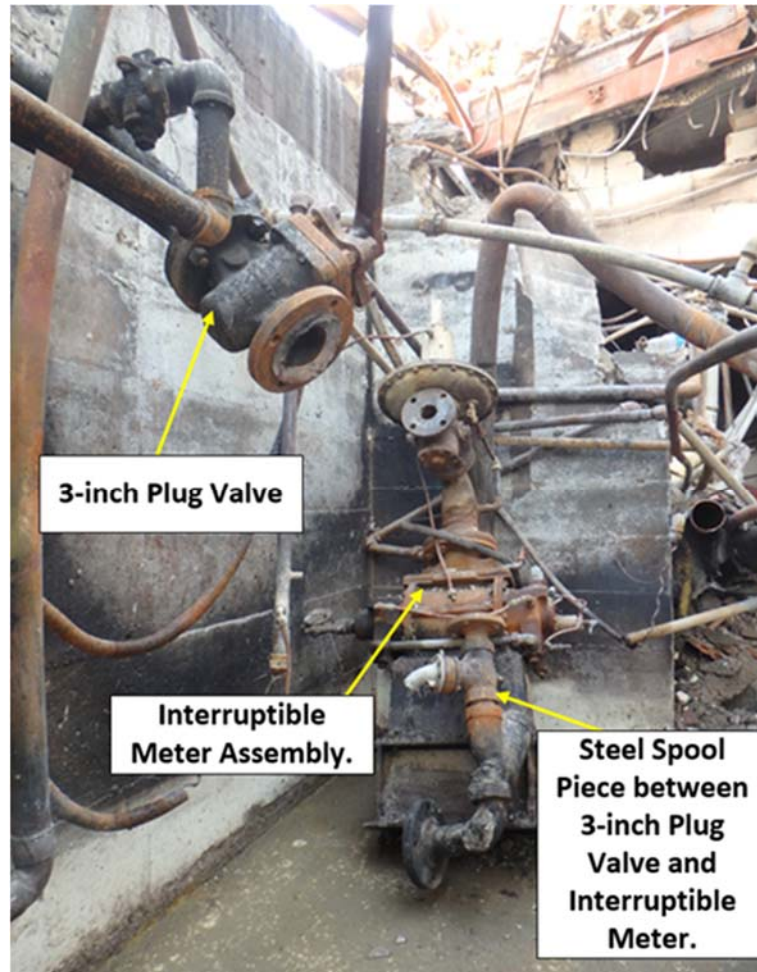
The natural gas explosion destroyed the Academy’s connection building superstructure, as well as the basement and bunker areas of the building. The accident resulted in the death of two Minnehaha Academy employees and injuries to nine others. In addition, the accident caused damage to two other Academy buildings. The portion of DOT-jurisdictional service line between the plug valve and the interruptible gas meter which was removed while at pressure is shown tilted on the right and seated on the floor in Figure 9.

*Figure 9 – 3-inch Walworth plug valve (involved in accident) on upper left and a spool between this valve and the interruptible gas meter resting against the interruptible meter on the floor right.*

1. The 3-inch service outlet gas piping from the interruptible meter was corroded, bent and damaged.
2. The gas service outlet piping components from the firm meter were damaged and broken off.
3. The gas service piping, 3-inch Walworth plug valve and meters sets were corroded.
4. The alloyed metal and relief device attached to the spool between the 3-inch Walworth plug valve and the regulator attached to the interruptible meter and small diameter service piping had melted during the fire.
5. The 3-inch Walworth plug valve was in the complete open position.

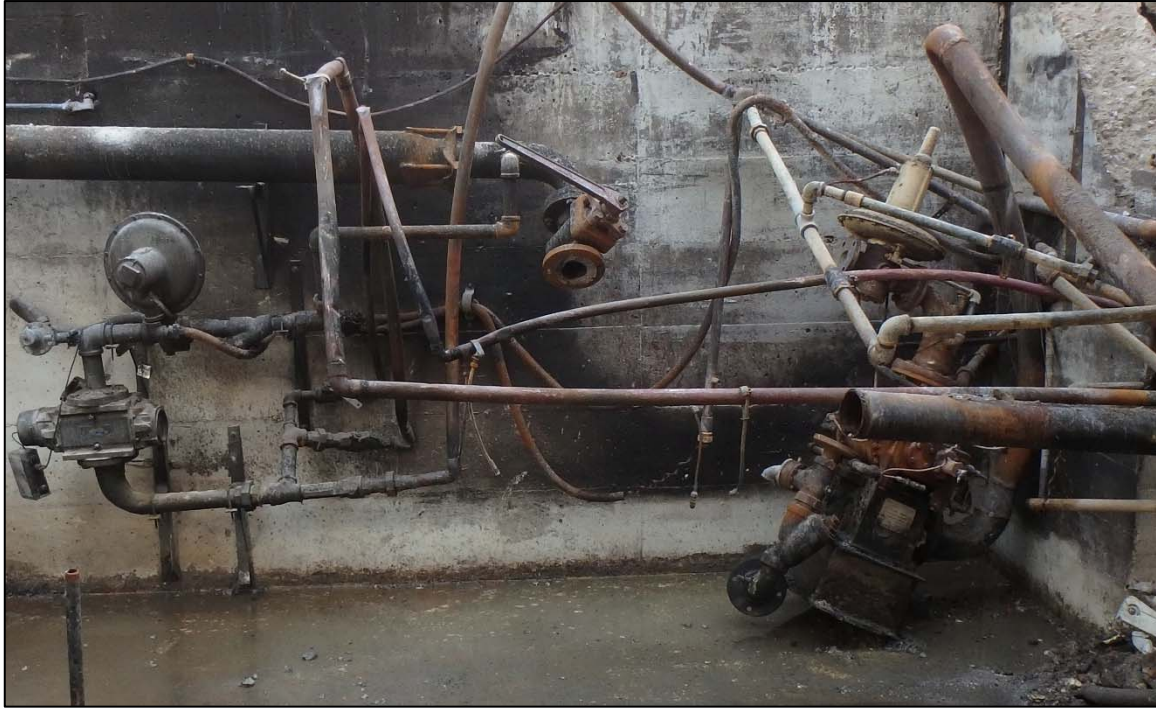
The investigation team observed that the plug valve had a removable arm (handle) that was not keyed to the valve stem. The handle could be oriented in at least four positions. The only locking mechanism for this handle was a bolt that tightened against the stem. This bolt could also be completely untightened, allowing removal of the valve handle. The bolt was loose enough immediately after the fire that the plug valve handle could be removed from the plug valve without further loosening of the bolt. CPEMG indicated that their meter installers are instructed to securely tighten the set screw on valve handles to ensure that they will not move while operating the valve.<sup>15</sup>

Briefly summarized, the NTSB Laboratory report indicated [1] the valve wrench was found oriented perpendicular to the valve body; [2] the “valve plug” was oriented in the open position; [3] a “witness mark” was found on two surfaces of the valve stem that were consistent with contact by a valve wrench set screw; [4] the valve stem collar had embossed arrows indicating the state of the valve (open or closed), in which the arrows were oriented parallel to the direction of flow, which was consistent with the valve being in the open state; [5] a measurement of 344 and then 152 foot-pounds of torque was required to rotate the valve wrench (handle) of an exemplar plug valve; [6] a measurement of 721 foot-pounds of torque that was applied to the wrench (handle) of the accident plug valve with a four-foot extension attached, resulting in no rotation.<sup>55</sup> Based on discussions with the accident plug valve manufacturers’ representative, the force of 721 foot-pounds of torque was not unusual for a valve of this type following exposure to fire.<sup>56</sup>

Figure 10 – Plug valve handle positioned perpendicular to the direction of gas flow. Source: NTSB, Taken: 6Aug2017

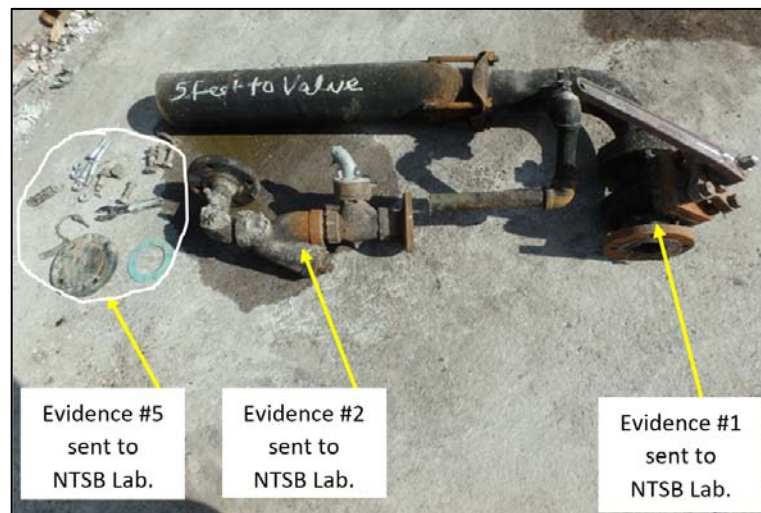
- Two feet of 3-inch piping, overpressure shut off and 3 by-2-inch transition to a flange (Evidence #2)
- One gasket, a flange, 10 bolts & nuts and a wrench found by the evidence materials (Evidence #5)

Figure 11 -- Evidence collected at the accident site and sent to NTSB laboratory. Source: NTSB, Taken: 6Aug2017

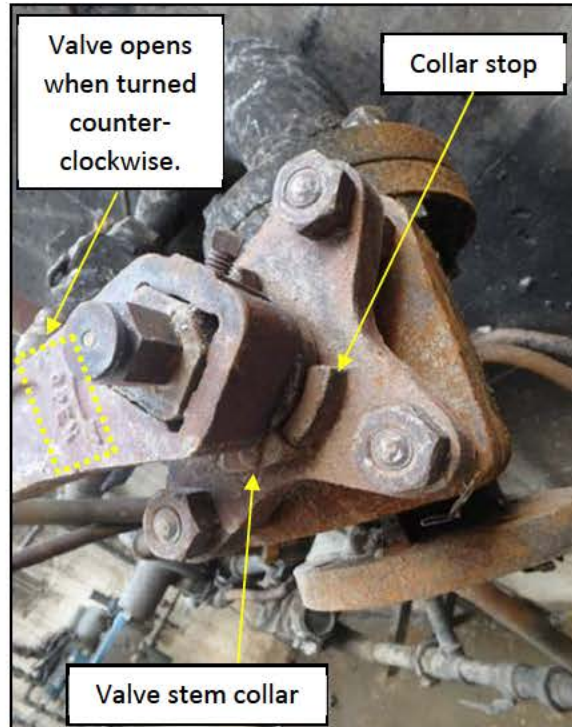
Figure 12 -- The fully open 3-inch plug valve by Walworth involved in the accident shows the arrow on the handle indicating the open direction, pointing toward the stopper location. Source: NTSB, Taken: 6Aug2017
