**NATIONAL TRANSPORTATION SAFETY BOARD**  
Office of Railroad, Pipeline, and Hazardous Materials  
Investigations  
Washington, D.C. 20594

### **Group Chairman's Factual Report of the Investigation**

#### **NiSource / Columbia Gas**

#### **Merrimack Valley, Massachusetts**

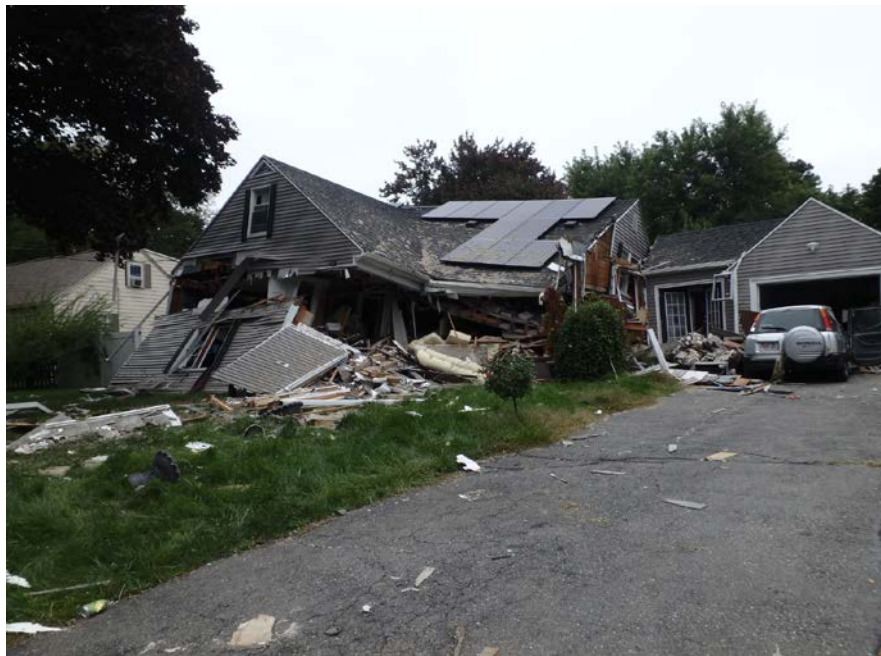
*Figure 1-- Damaged home where fatality occurred*

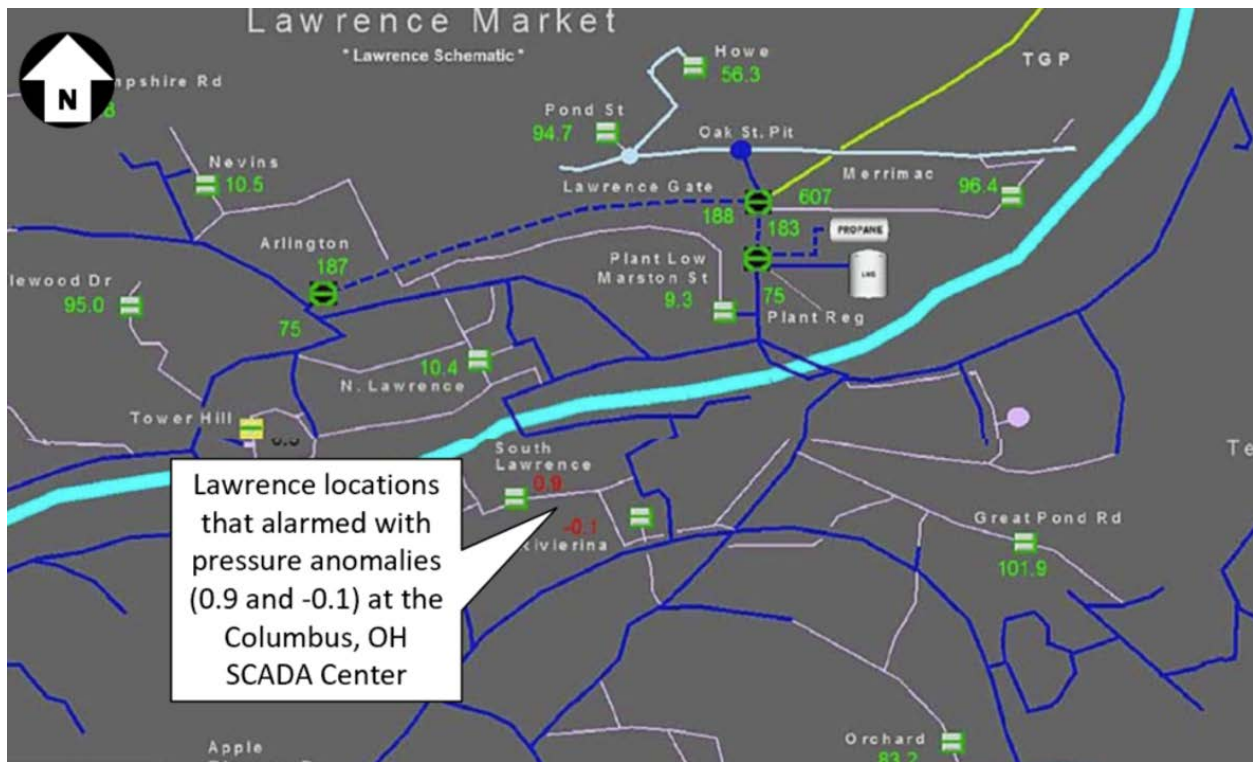
On the day of the event, the first alarm within the SCADA center occurred at 4:04 p.m. at pressure 15.02 inches w.c. (Figure 3). The second alarm occurred at 4:05 p.m. at pressure 16.94 inches w.c. The required response time for controllers to respond to these alarms is ten minutes. At 4:06 p.m., Gas System Control notified the Lawrence on-call technician for Measurement and Regulation about the alarms. The Lawrence technician then immediately notified all Lawrence Measurement and Regulation technicians who then immediately moved to perform field checks on the affected distribution system's 14 regulator stations to identify and shutdown any station that was continuing to feed the system.

Figure 3 -- Lawrence locations that alarmed at the Columbus, OH SCADA Center

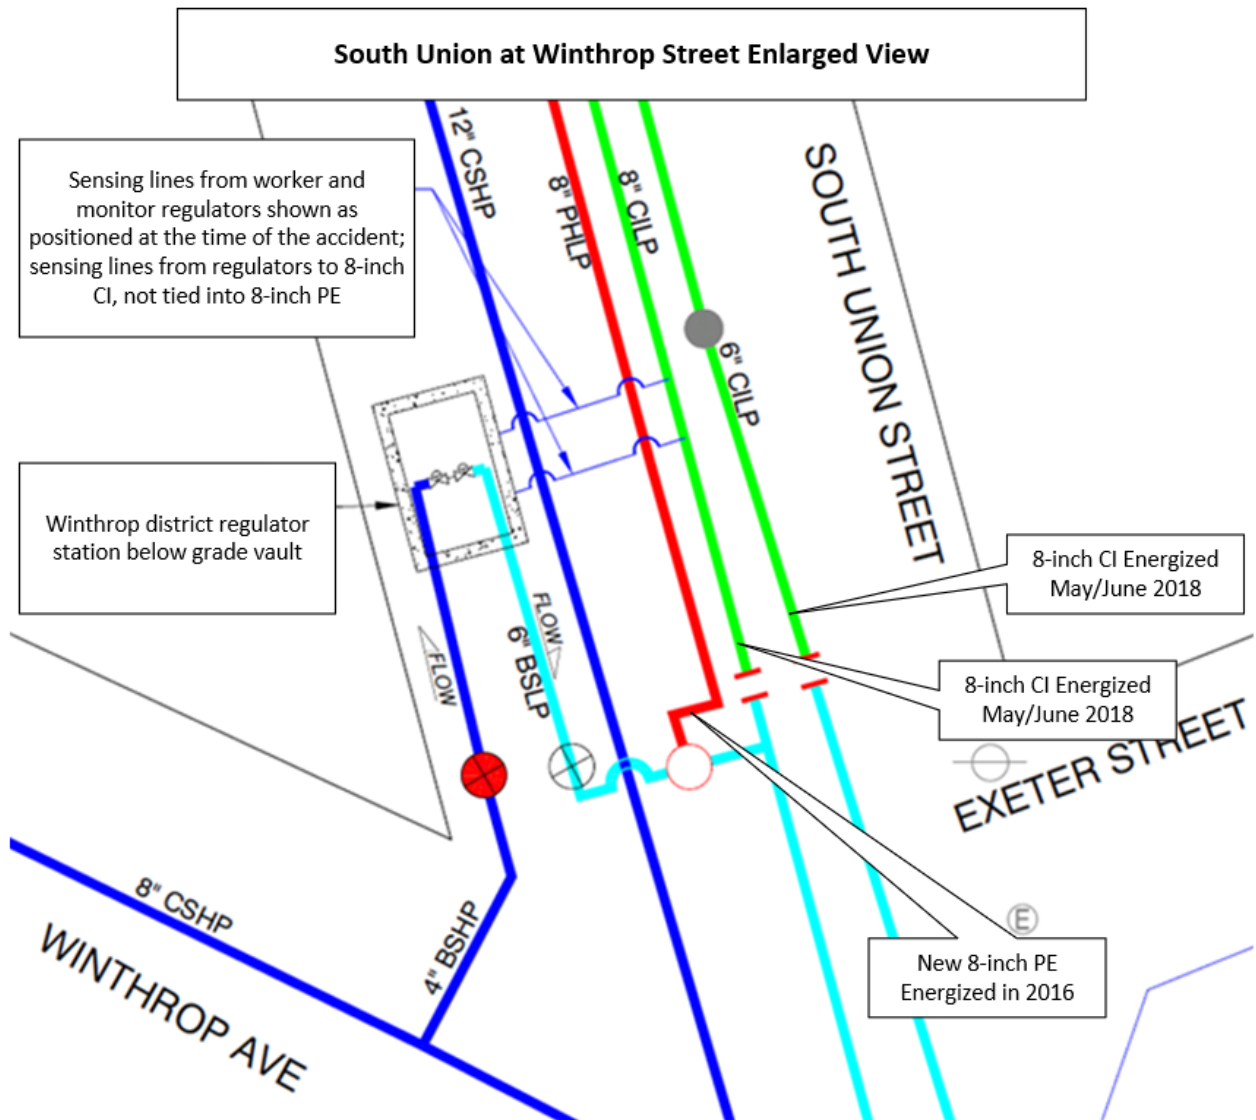
Figure 4-- Sensing lines from the regulator station

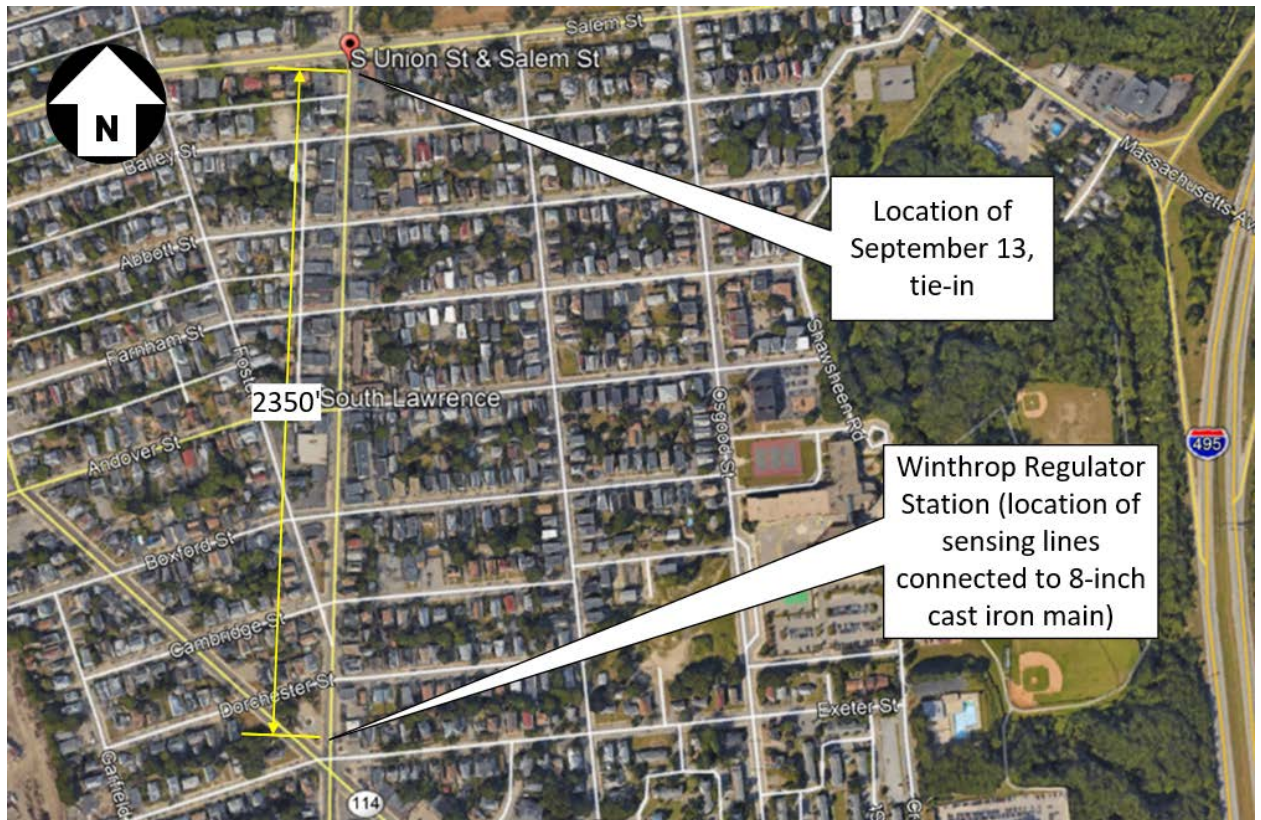
Figure 8 -- Relative location of Feeney Brothers crew to regulator vault location

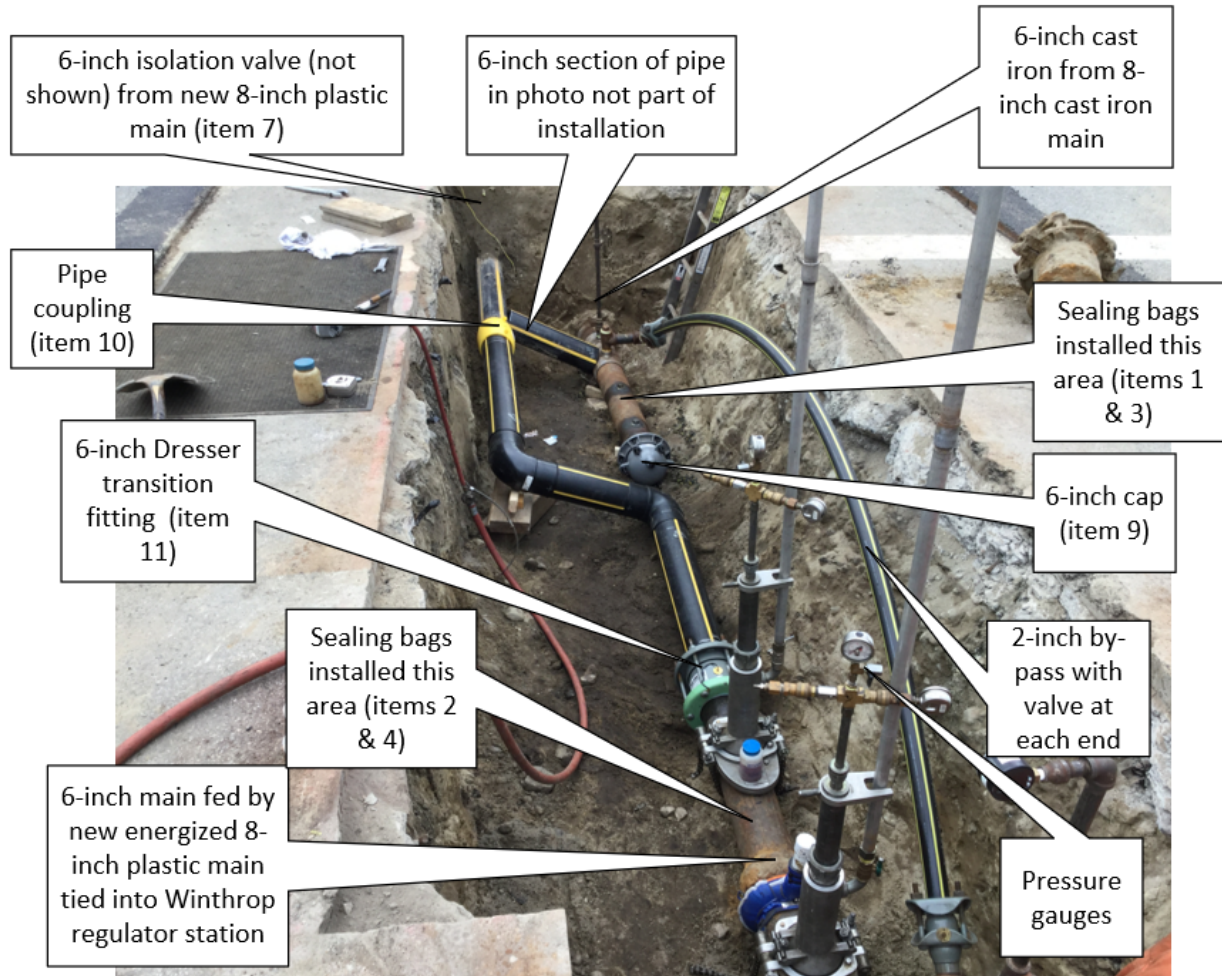
Figure 10 -- Annotated photo of South Union Project tie-in referenced to South Union Job Order (Courtesy The Feeney Brothers)

Unknown to the crew and the construction coordinator in 2018 was the fact that the sensing lines, although intact, were not connected to the new 8-inch PE main: The sensing lines were attached to the 8-inch cast iron main that was no longer connected to the distribution system.

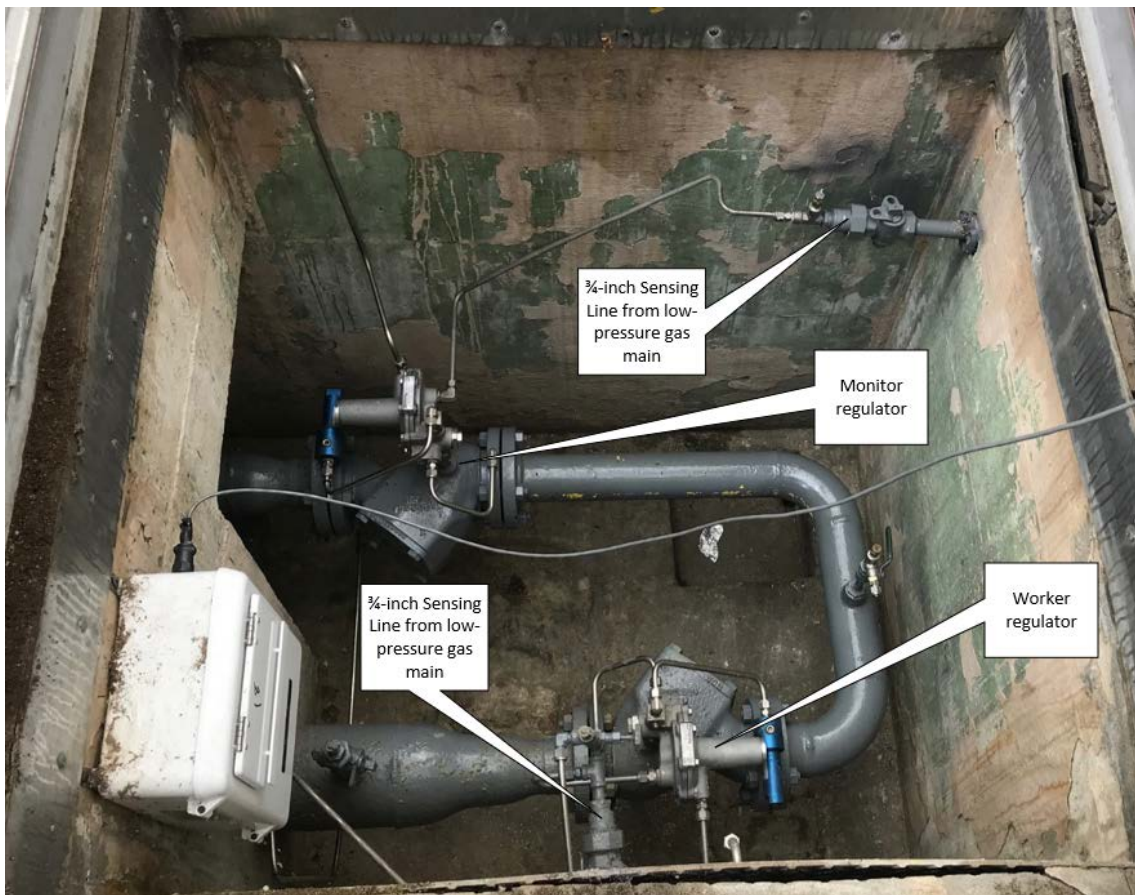
As the by-pass removal work progressed, the disconnected cast iron line began to lose pressure. In keeping with standard procedure, this section of line had not yet been vented or purged, and the 9.5 inches of w.c. remained for a period of time. The regulators at the Winthrop station (Figure 11) began to operate (open) after about a .25-inch w.c. drop in pressure in the main.

Figure 11-- The Worker and Monitor regulators with sensing line connections at the Winthrop station
