SERVICE BULLETIN

NO. 1103E

ENGINE MOUNT INSPECTION

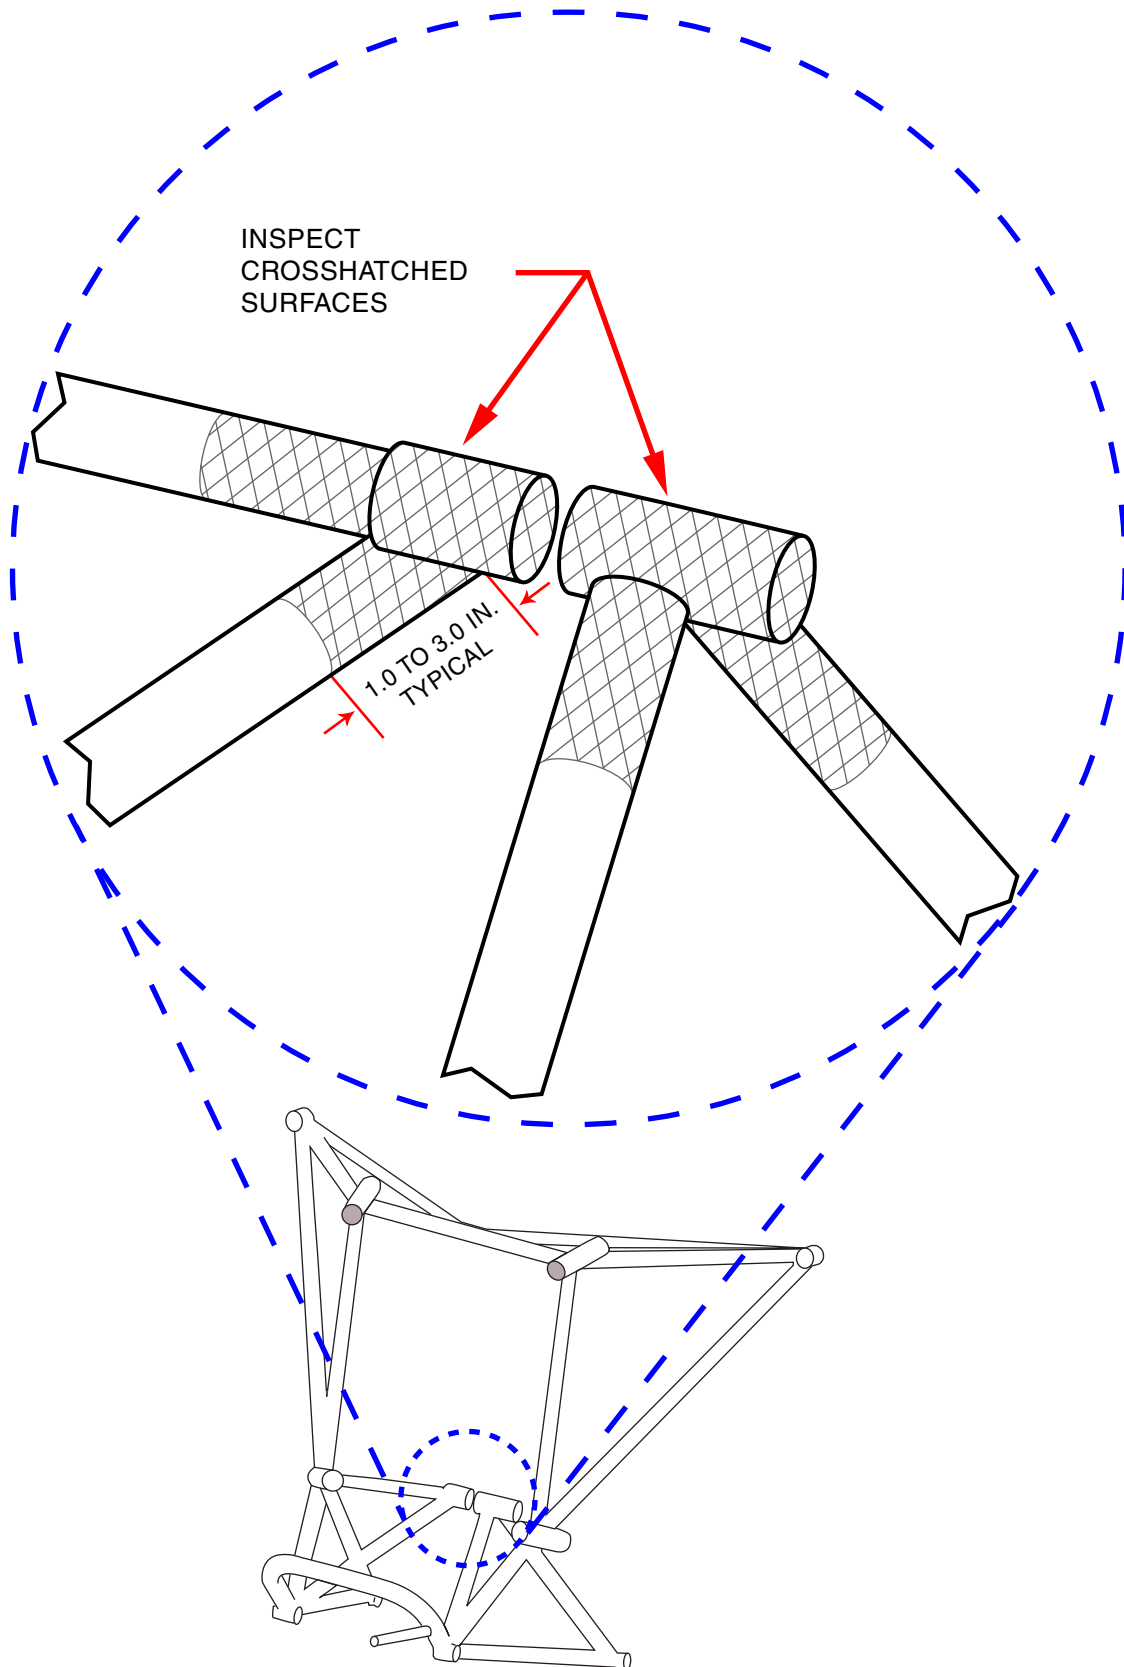
Figure 1
Engine Mount Inspection Areas

Cracks may develop in the area of the nose gear actuator attach feet on the engine mount (see Figure 1). This condition can occur when the nose landing gear is subjected to excessive loads due to hard landings, rough field operations, excessive speed turns, improper airplane towing (sudden, aggressive starts and stops), or other improper operations.

1. Clean the engine mount actuator attach feet area.
2. Completely remove all of the paint or Dinitrol AV8 and AV30, if the paint was previously removed and covered with Dinitrol AV8 and AV30, from the inspection area (refer to Figure 1).

3. Perform fluorescent penetrant inspection of the nose gear actuator attach feet for cracks per AC 43.13-1B, Chapter 5, Section 5. Inspect the surfaces identified in Figure 1, with specific emphasis on welded areas.
4. If a crack is discovered, the engine mount must be replaced prior to further flight (refer to Table 1).
5. If no cracks are found, continue the repetitive inspection per the compliance time above.
6. Clean the feet and apply a two-coat corrosion prevention compound (CPC) to the area where the paint was removed. This two-coat CPC consists of Dinitrol/Ardrox AV8 as a primer coating and (after the AV8 has dried) Dinitrol/Ardrox AV30 as a top coating.
7. Make an appropriate logbook entry of compliance with this service bulletin for each repetitive inspection.

If cracks are found during the Inspection in Part I, the cracked engine mount is to be replaced.

1. If cracks are found on the engine mount, order the appropriate replacement engine mount found in Table 1, and hardware, as required.
2. Install the new engine mount according to procedures in the applicable Piper airplane maintenance manual. For PA-46-350P Mirage or PA-46R-350T Matrix model airplanes only: fasten the aft end of the nose gear actuator to the engine mount using the hardware arrangement shown in Figure 2. Torque nut according to requirements in section 91-10-00 of the applicable Piper airplane maintenance manual. At all other locations, hardware in serviceable condition may be reused.
