## **NATIONAL TRANSPORTATION SAFETY BOARD**

### **POST ON-SITE EXAMINATION**

**NTSB Accident: WPR14FA132**

Location: Near Carson City Nevada  
Date: Unknown  
Aircraft: Cessna 120, N76856, Serial # 11290  
NTSB IIC: Michael Huhn

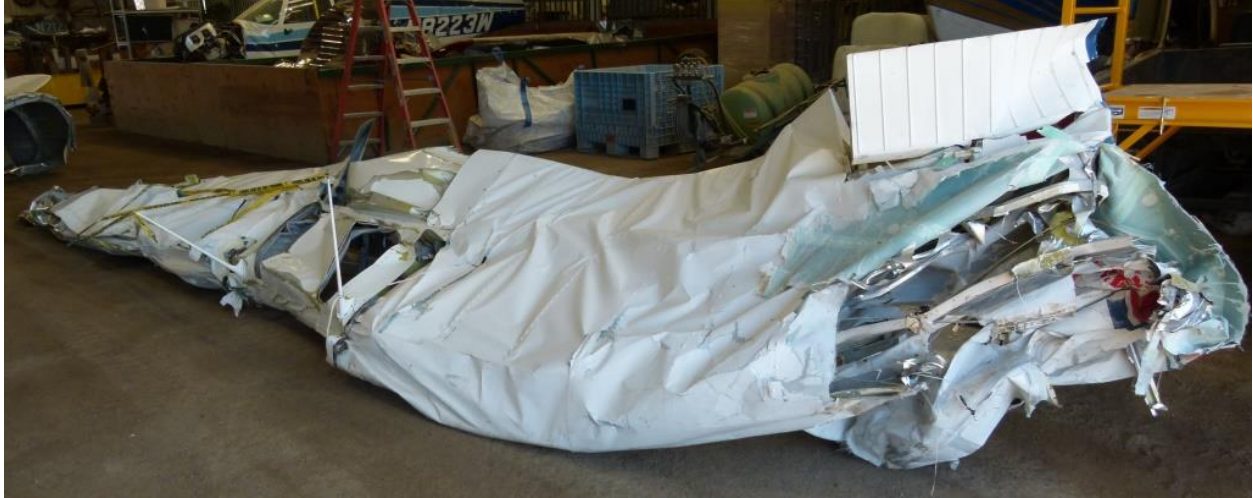
**Figure 1 - Wing at Recovery Facility**

The airframe had been separated into 3 major sections (wing, empennage, and lower cockpit/firewall/engine) for recovery

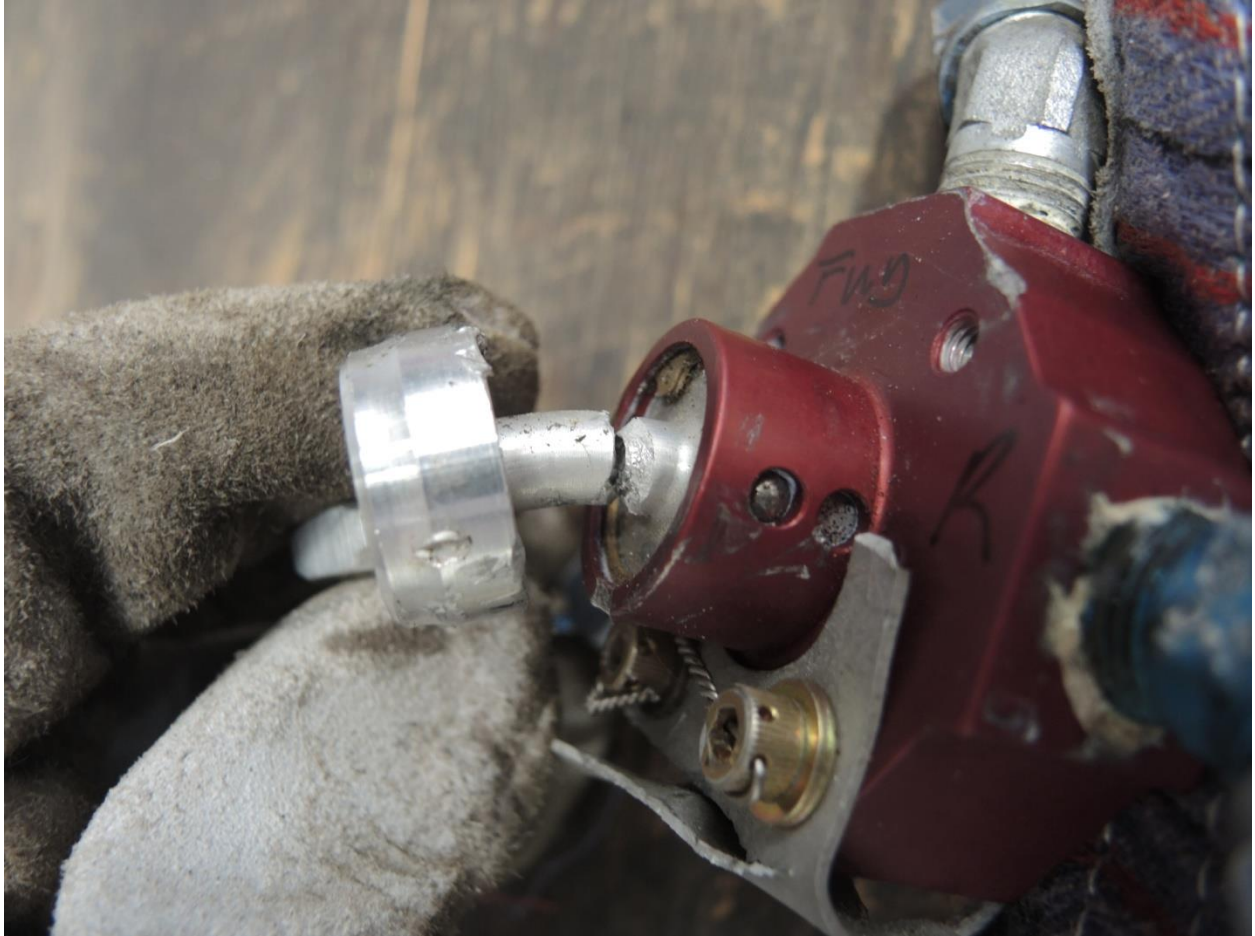
**Figure 4 - Fuel Selector Valve and Handle**

- The fuel selector valve was accessed and removed from the structure
  - All three fuel lines (left tank, right tank, engine) were securely attached to the valve body
  - The valve handle was fracture-separated from the valve
  - Alignment of the handle fractures indicated that the valve had been set to the left tank at impact.
  - The valve ports and internal spool chamber were observed to be clear of obstructions, debris or corrosion
  - The valve internal spool was set to and fully aligned with the valve being selected to the left tank

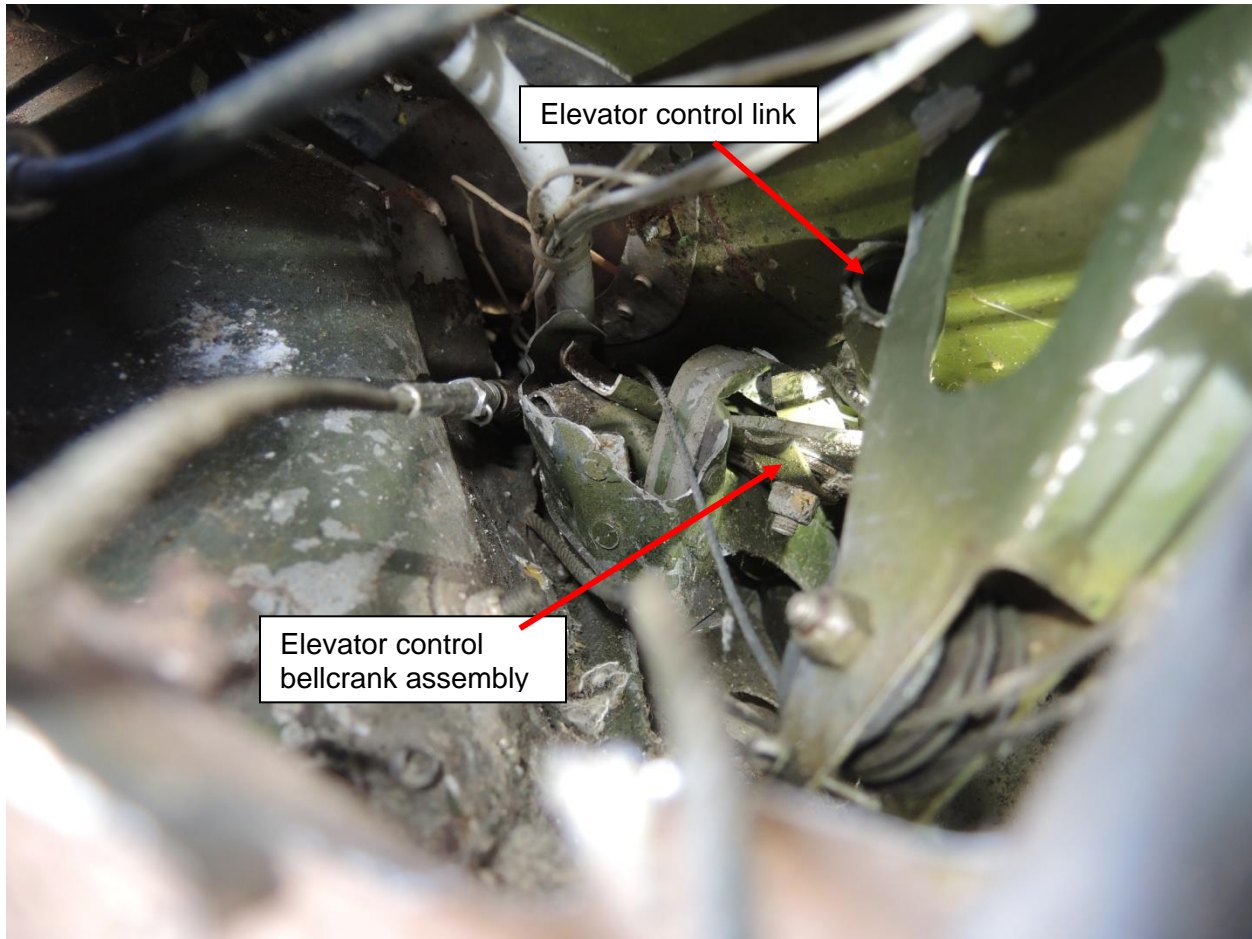
Figure 6 - Under-Floor Flight Control Linkage

- During the on-site examination, complete flight control cable continuity could not be confirmed due to the condition of the wreckage under the cabin floor.
- During post recovery examination, flight control cable continuity was confirmed under the cabin floor.
- All the flight control cables were attached to their respective cockpit controls.
- The elevator control link had been driven aft during the accident sequence, which separated it from the elevator control bellcrank assembly that was mounted under the cabin floor.

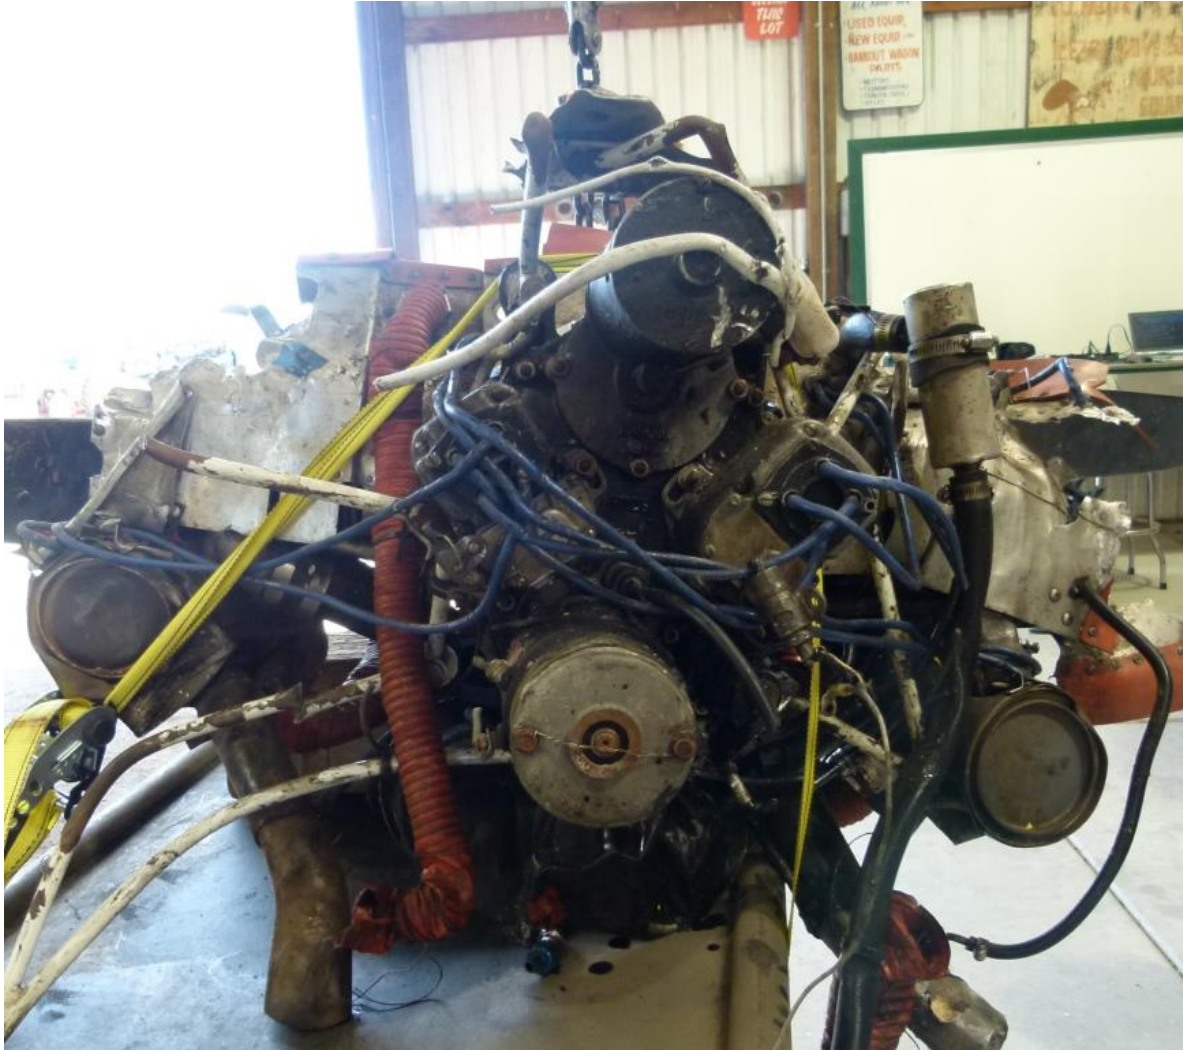
Figure 7 - Aft (Accessory) Side of Engine

- The engine remained attached to the engine mount, and the engine mount remained attached to the airframe
- The engine mount structure was severely deformed in the aft and up direction from impact
- The propeller remained attached to the engine crankshaft
- Engine: C-85-12 S/N 25936-6-12
- Propeller: Sensenich 76AK-2-44 S/N 37949
- Left Magneto – Bendix P/N: 10-51360-26 S/N: 749233
- Right Magneto – Bendix P/N: 10-51360-26 S/N: 749232
- Generator – Delco Model 7335, S/N: 1101898RX
- Starter – P/N: Illegible S/N: 2969

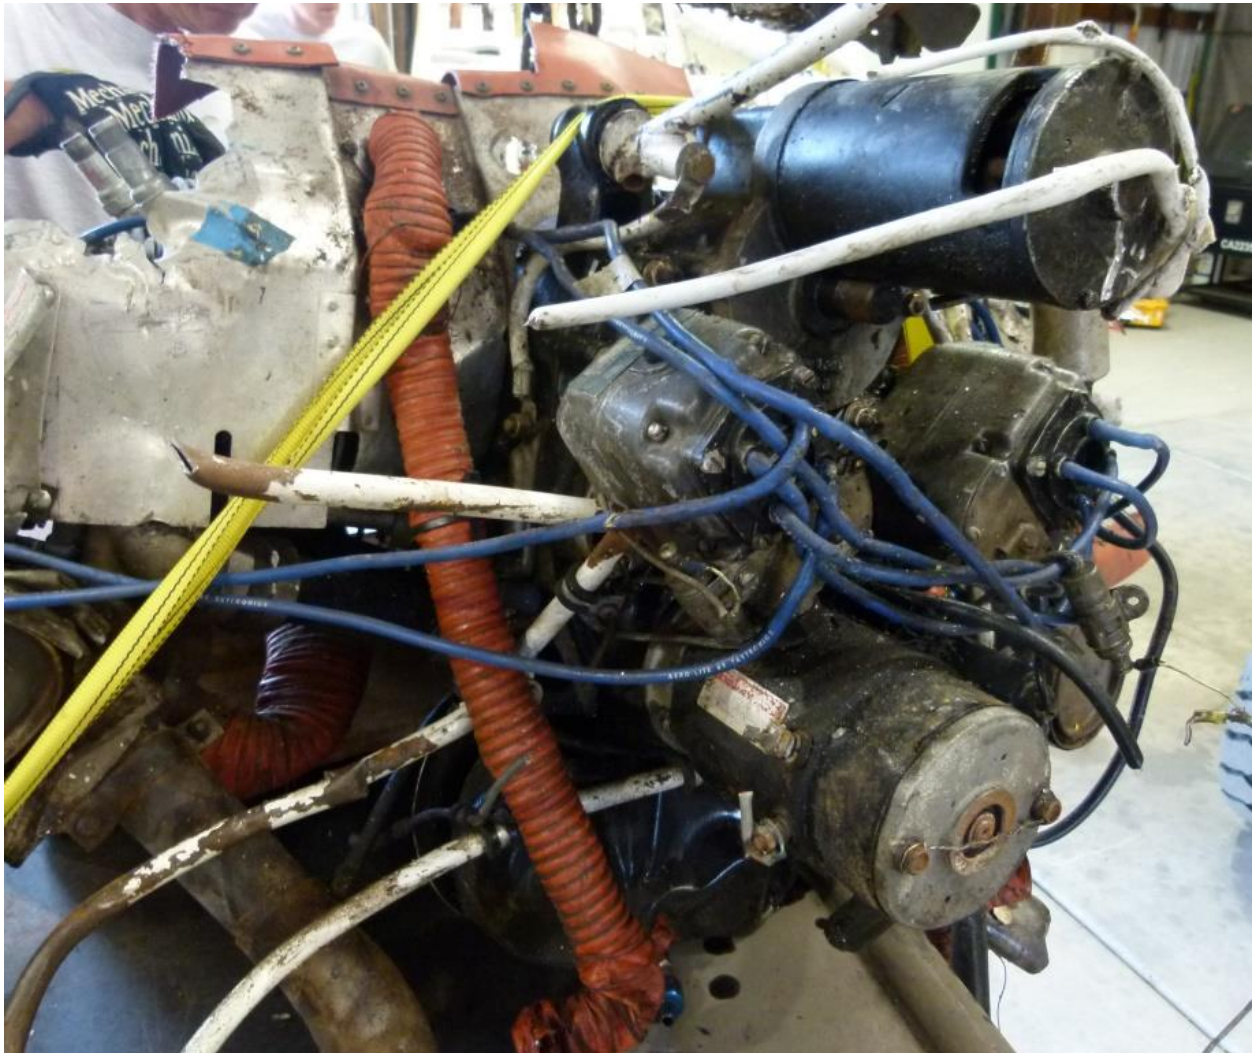
**Figure 8 - Magnetos**

- The engine remained partially attached to the airframe and was separated for inspection. The top spark plugs and rocker arm covers had been previously removed at the accident scene. The number three spark plug was not observed with the engine. The carburetor was separated in the accident and had previously been disassembled by the NTSB and Cessna investigators.
- The exhaust system exhibited impact/crush damage.
- The induction system exhibited impact/crush damage.
- The ignition harness exhibited impact damage, and some of the leads were partially or completely cut/severed.

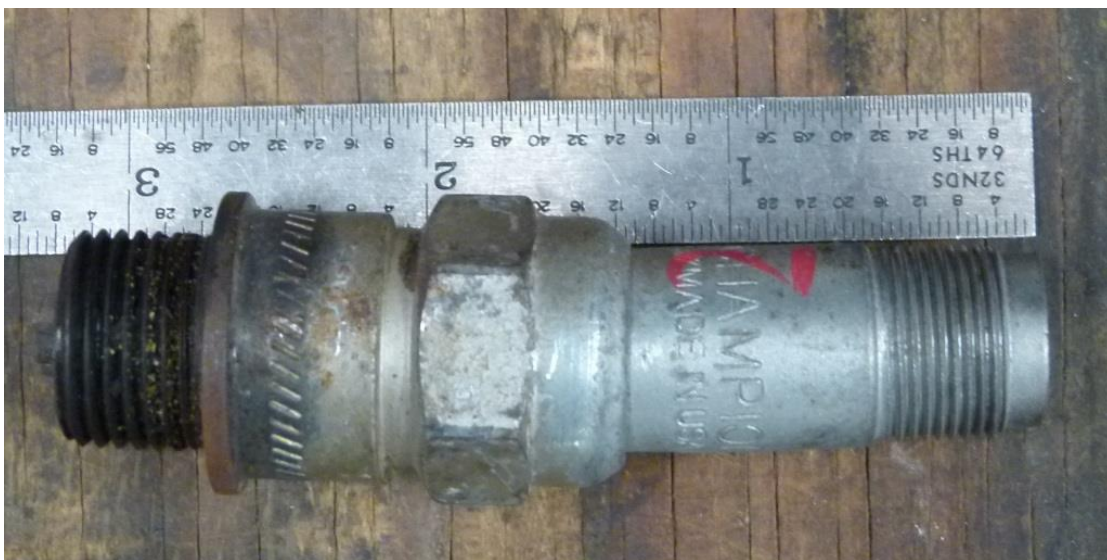
**Figure 10 - Cylinder 2 Top Spark Plug Deformation**

- The top spark plugs exhibited light- and dark-colored combustion deposits, and the electrodes exhibited "worn out – normal" in accordance with the Champion Aviation 'Check-a-Plug' chart. The bottom spark plugs were inspected using a lighted bore scope and exhibited "worn out – normal" operating signatures. As noted during the initial on-scene examination, the center electrode of the top number 2 spark plug was not centered between the two side electrodes. Closer examination revealed that that spark plug was impact-damaged, and that the barrel had been cocked to one side.

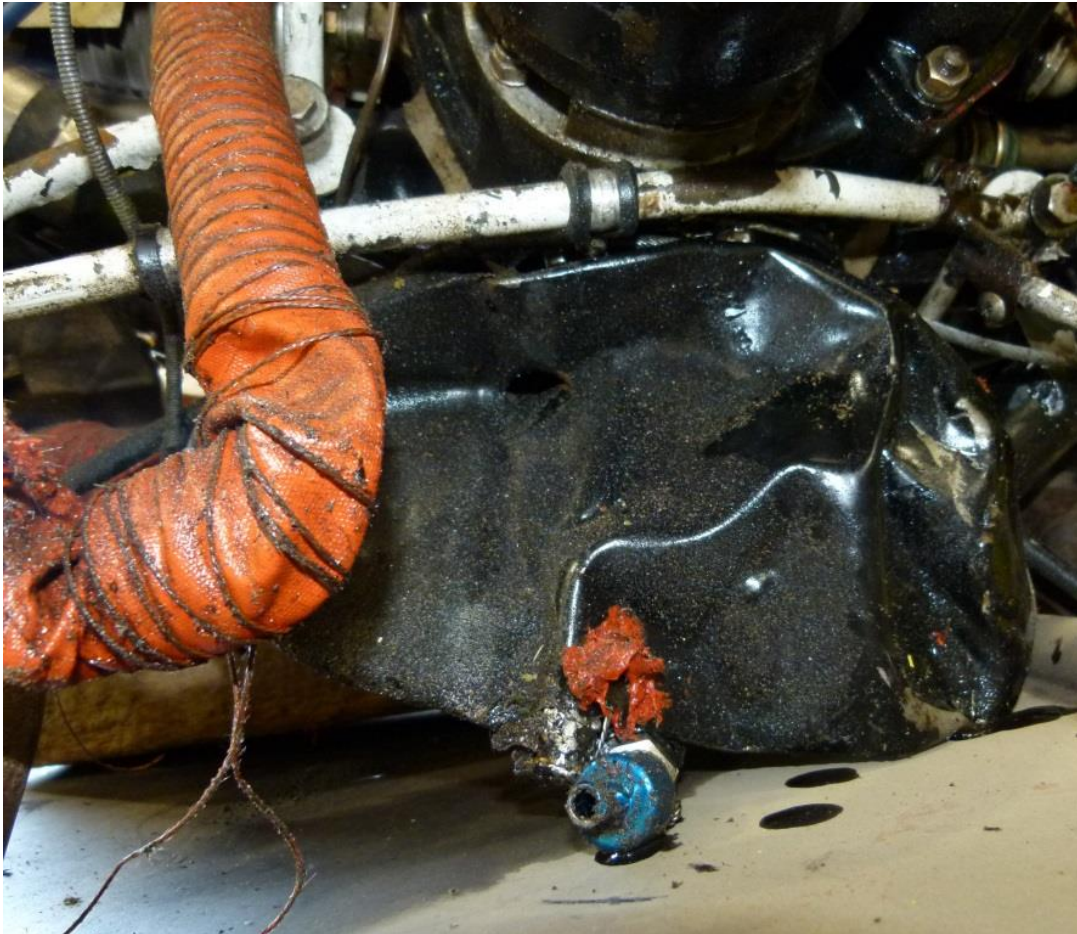
**Figure 11 - Oil Sump Damage**

- The oil sump was crushed upward and breached. The oil filter was fracture-separated from its adapter-mount, and was trapped between the engine and firewall until the engine was separated from the wreckage by investigators. Crush damage precluded opening and internal examination of the oil filter.

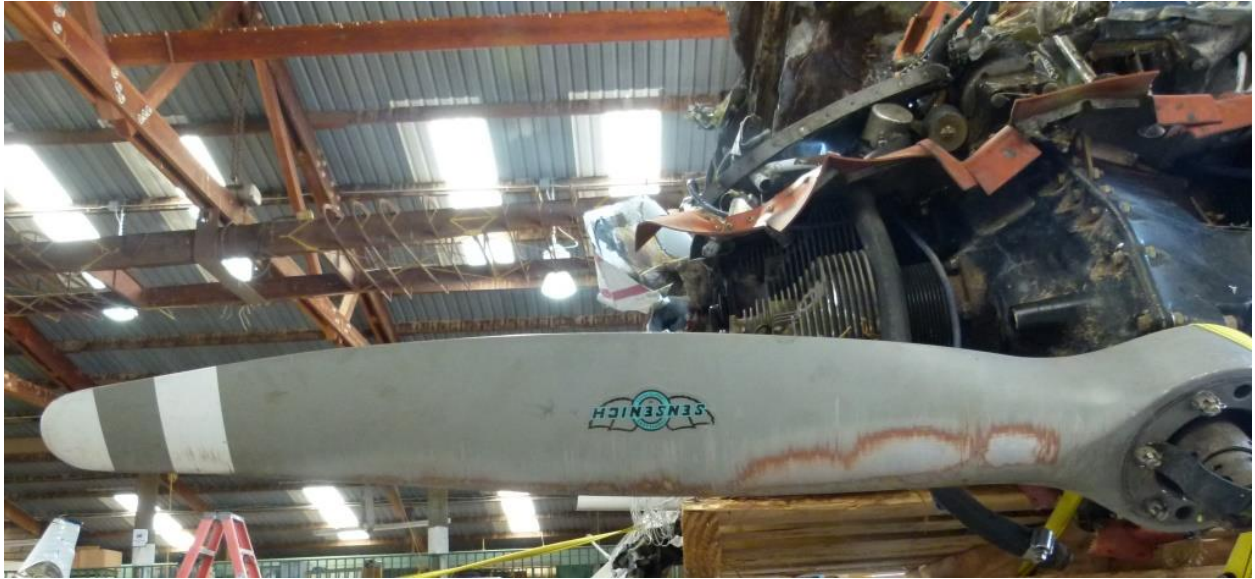
**Figure 13 - Less-Damaged Propeller Blade**

- The two-bladed, fixed pitch propeller remained attached to the engine. Both propeller blades exhibited leading edge nicks and polishing. Polishing and chordwise scratches were observed on the cambered faces of the blades. One blade exhibited aft bending and twisting. The other blade exhibited light “S” bending from mid-span to the tip.
