POWERPLANT GROUP CHAIRMAN'S FACTUAL REPORT

ENG14IA001

**Pratt & Whitney Materials Process and Engineering Summary of
Metallurgical Investigation of Spirit Airlines V2500-A5 Engine No. V12069
(34 Pages)**

Subject: Metallurgical Investigation of Spirit Airlines V2500-A5 Engine No. V12069

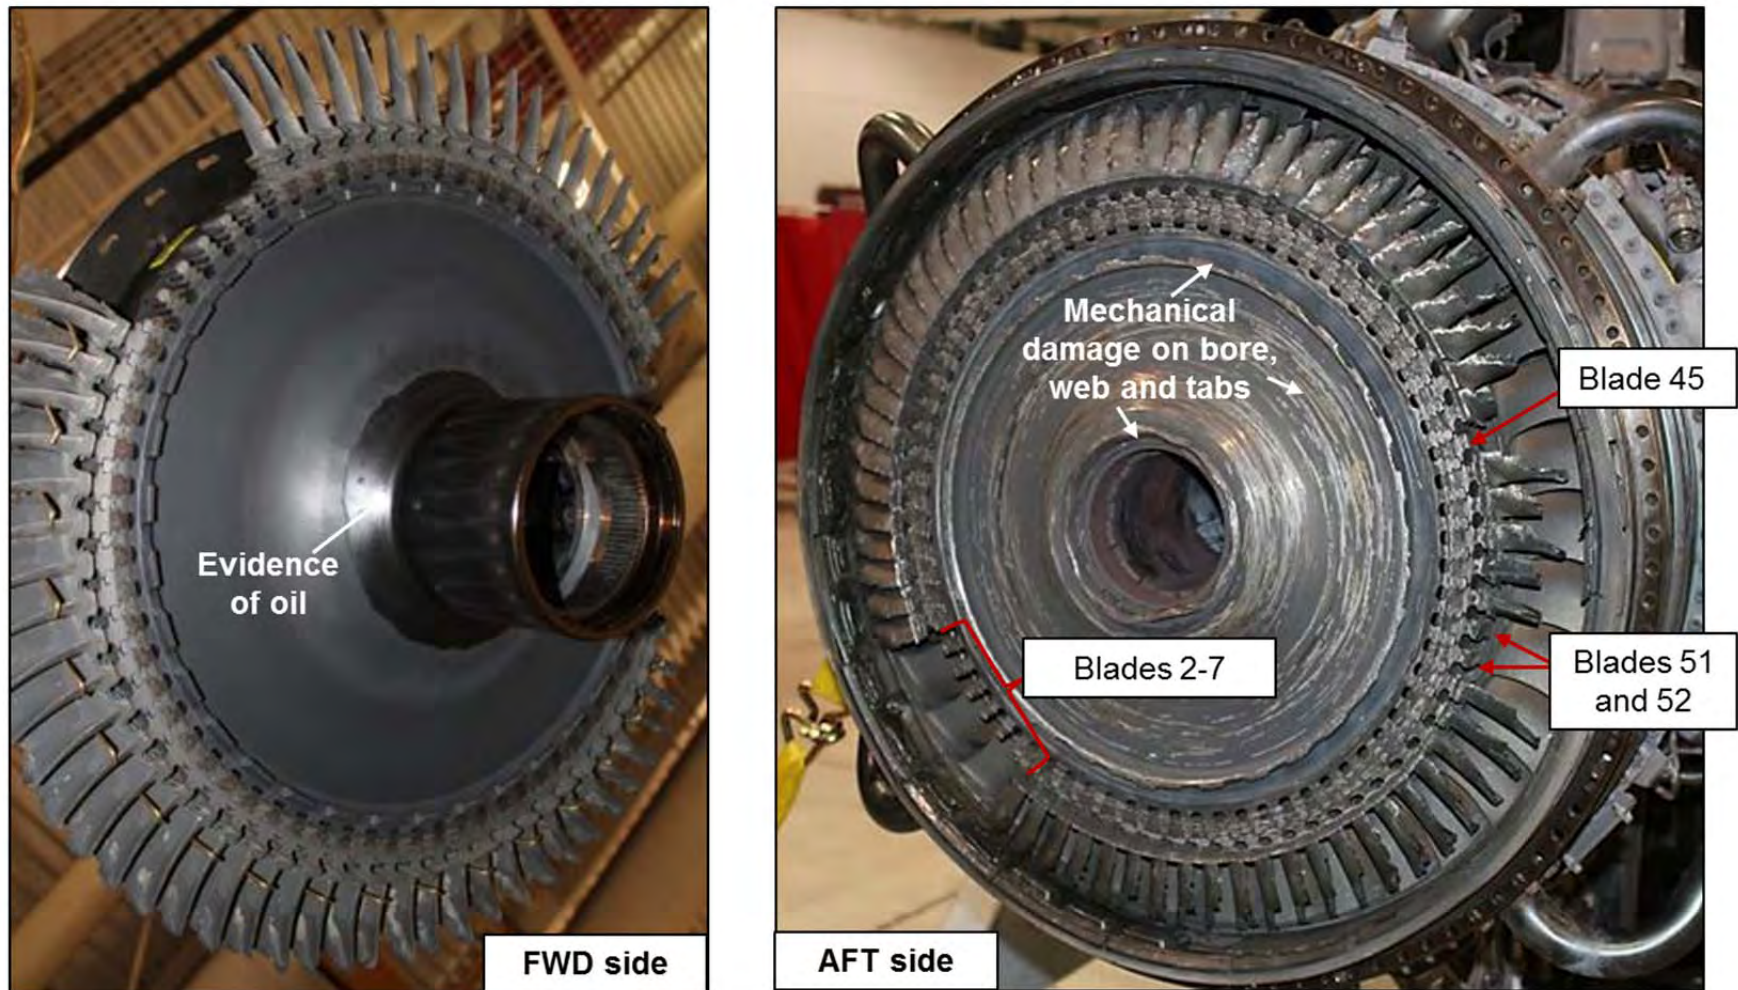
Figure 1: Images of the forward and aft side of the 2nd stage HPT hub with blades installed*

During teardown review of the 2nd stage HPT, it was noted that six (6) 2nd stage HPT blades were missing from the 2nd stage hub slots; the 6 blades were located at wheel positions 2-7. Four (4) of the blades were recovered, two (2) were not. Additionally, three (3) blades had fractured below platform. The 3 blades that exhibited below platform fractures were located at wheel positions 45, 51 and 52 (Figure 1). The remaining seventy (70) out of the full set of seventy two (72) 2nd stage HPT blades were submitted for review. Review of the part markings revealed that the blades were all the same part number. Each of the blades also exhibited repair markings. Review of the repair markings found that fifty-two (52) of the blades were marked with one repair shop code while eighteen (18) of the blades were marked with another code which indicated two different repair shops. It was noted that the wheel positions were marked (at the engine teardown) on the aft side of the root attachment of the blades; however, due to the fact that the blades were covered in significant dirt deposits, many of these markings had been removed due to handling prior to arrival. There were a total of nineteen (19) blades that retained the wheel position markings. The 19 blades were as follows: 13, 30, 37, 39, 40, 41, 42, 44, 45, 46, 47, 48, 49, 50, 51, 52, 53, 54 and 55.

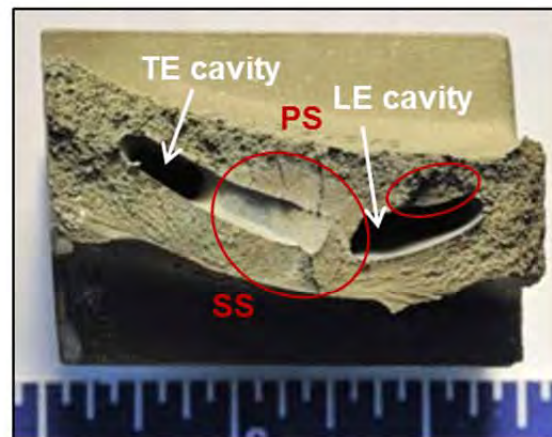
Figure 2: Images of each of the fracture surface of the three blades that fractured below platform. Each of the blades exhibited multiple stress corrosion cracking (SCC) cracks.

Visual inspection of the 3 blades that exhibited below platform fractures found that blade 45 fractured at approximately 1.125 in. above the base of the blade; blades 51 and 52 fractured at 1.250 in. above the base of the blades. Each of the three blades was from the population that exhibited the same repair marking.

Binocular examination of each of the 3 blades found that the fracture surfaces were covered in a layer of dark deposits. Each of the blades exhibited flat, shingled, low aspect ratio cracks in the trailing edge (TE) cavity in the vicinity of the J-channel rib (Figure 2). The crack morphology was consistent with stress corrosion cracking (SCC) in high temperature nickel superalloys.

The cracking in blade 45 extended from multiple, shingled SCC initiation sites in the trailing edge cavity that progressed through the suction side (SS) wall and into approximately 75% of the pressure side (PS) wall. A small progression was also noted in the leading edge cavity extending from an origin site on the internal surface of the PS wall. The crack in blade 45 continued in fatigue from the extremities of the SCC on the SS wall until the blade eventually fractured in overload.

Binocular examination of blades 51 and 52 found multiple stepped and shingled cracks, typical of SCC, from origin sites at the rib and on both the PS and SS walls. None of the SCC in blades 51 and 52 progressed through-wall and no fatigue extension was observed at the extremities.

Blade 45 exhibited the most extensive SCC progression and was considered to be the primary blade fracture. The cracks in blades 51 and 52 were likely representative of the earlier stages of the cracking observed on blade 45 and the fractures were considered secondary to the fracture and release of the primary blade.

- SCC cracks extended from the internal surface and were predominantly located in the vicinity of the rib
- Blade 45 showed the most extensive SCC cracking (likely primary)

Blade 45
SN PKLBFG3691

Red ovals show approximate regions of SCC cracking

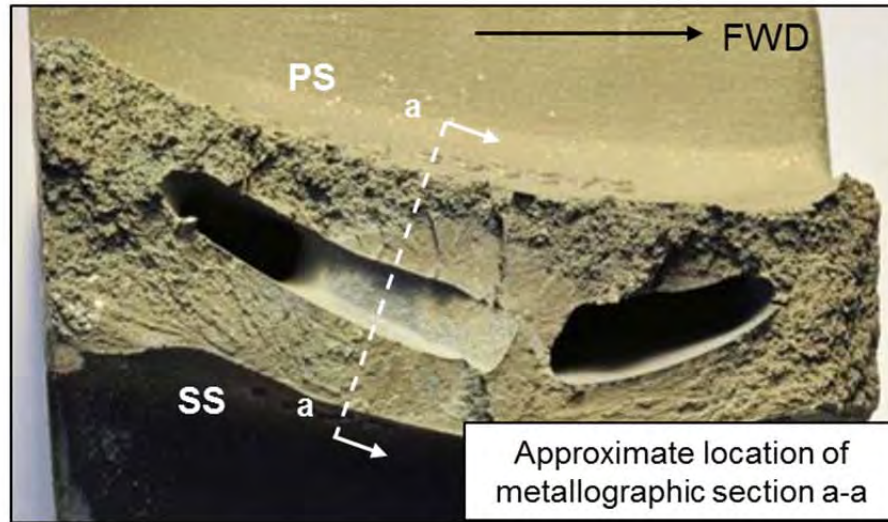
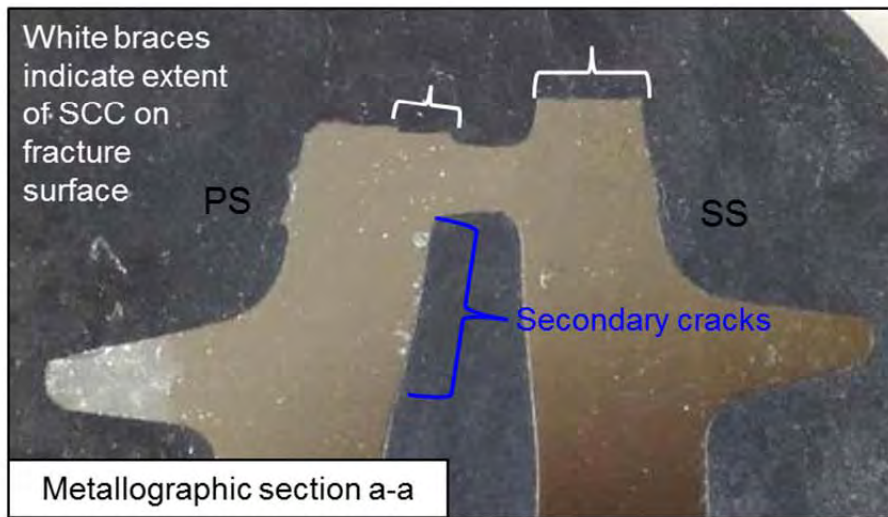
Figure 3: Images showing the metallographic section prepared through the origin area of blade 45.

A transverse metallographic section, section a-a, was prepared through the fracture surface of blade 45. The section intersected the origin sites on both the SS and PS walls (Figure 3). Metallographic examination of this section revealed a thick scale of oxidation/corrosion product

on the SCC fracture surfaces of both the PS and SS walls. Multiple product filled secondary cracks were noted extending from both the internal and external surfaces, adjacent to the primary crack through the SS wall. Additionally, examination of the center cavity found multiple additional secondary cracks, predominantly on the PS wall. The appearance of the cracks in the micro-section was consistent with stress corrosion cracking.

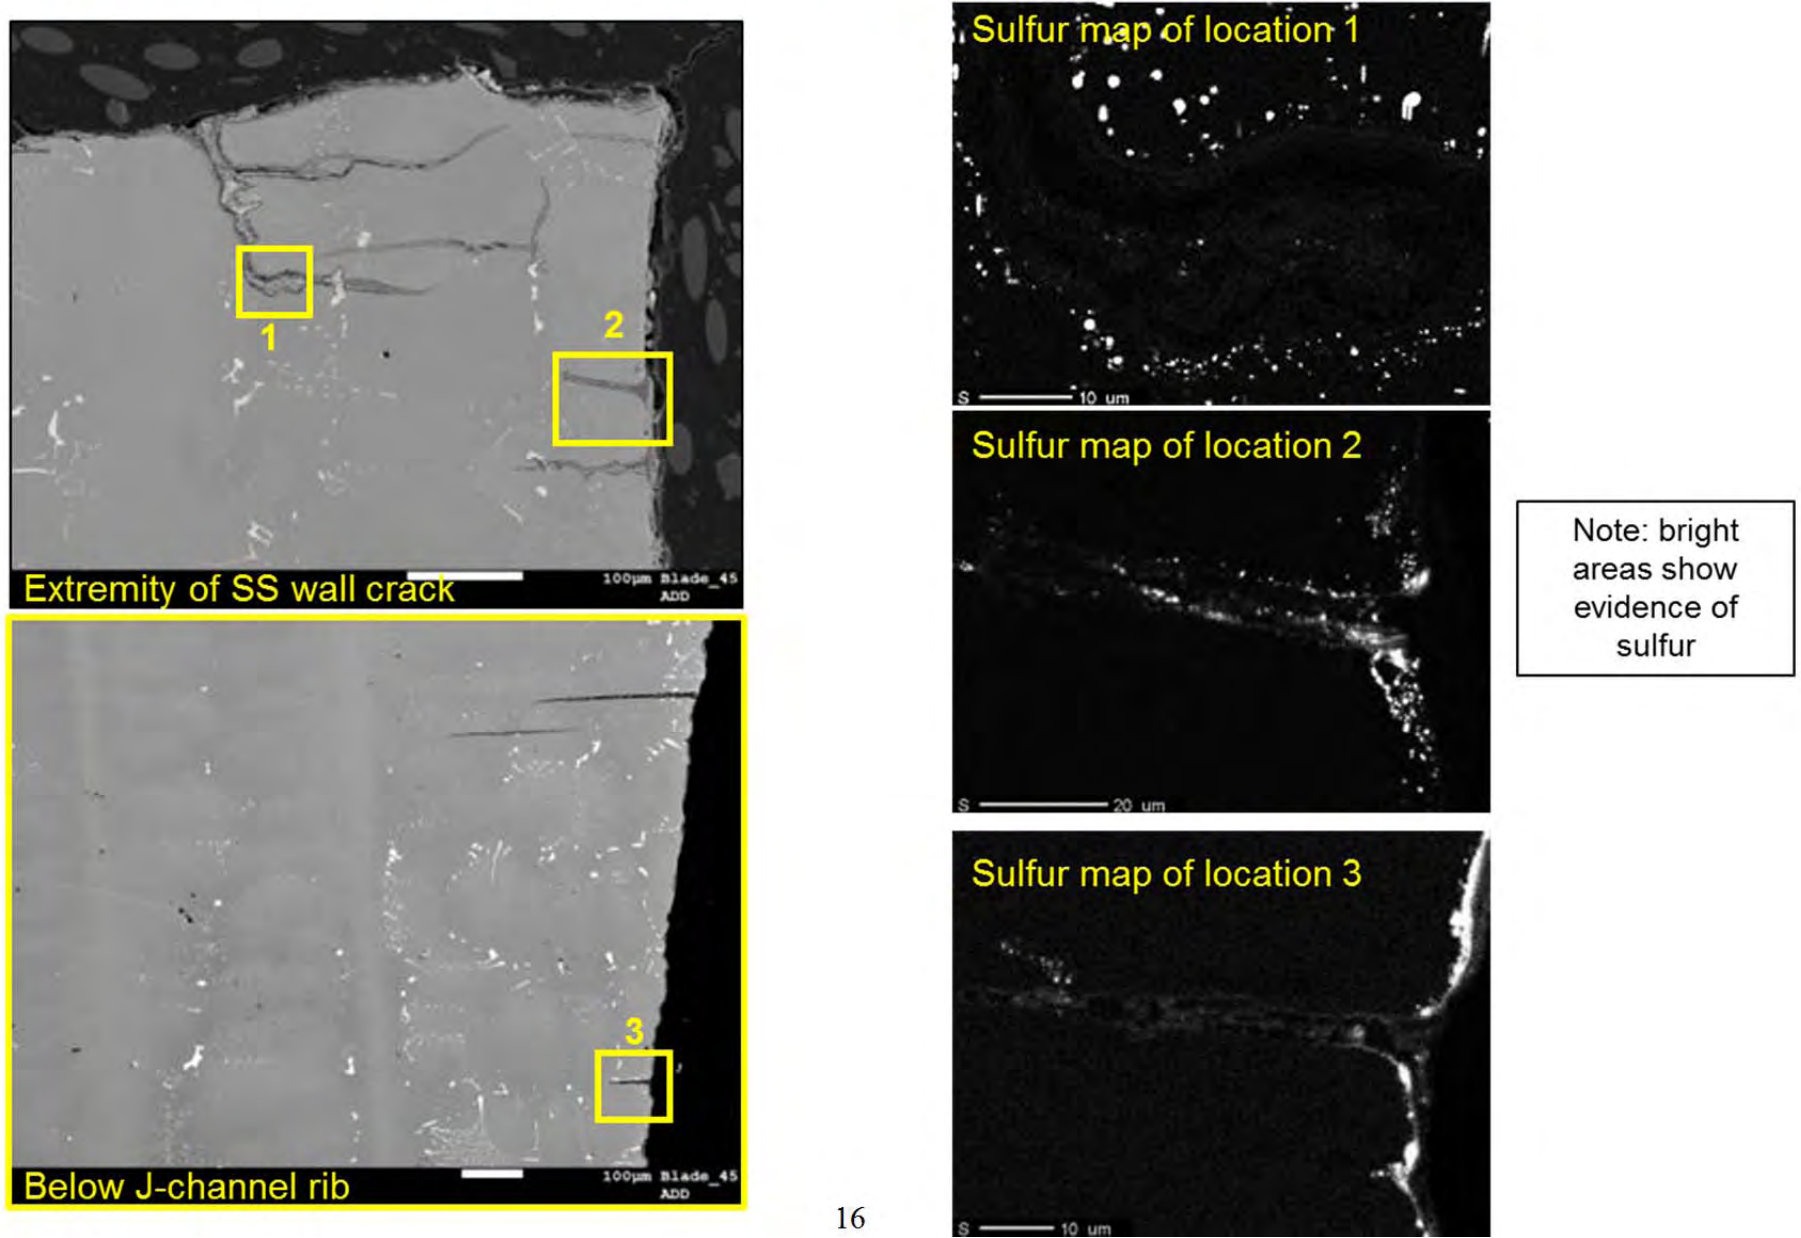
Figure 4: EMP analysis showing evidence of sulfur at the corrosion front

Electron microprobe (EMP) and SEM/EDS were used to analyze the oxidation/corrosion product on the fracture surface as well as within the secondary cracks. The product was found to be predominantly comprised of oxidized base metal elements. Sulfur (S) dot maps were collected at three cracks locations. In each case, evidence of S was confirmed at the corrosion front. Further evaluation of discrete particles at the corrosion front that exhibited high S content was conducted via wavelength dispersive spectroscopy (WDS). This evaluation revealed that evidence of increased chromium (Cr) was associated with particles that were high in S, which suggested that the particles were likely chromium-sulfides (Figure 4).

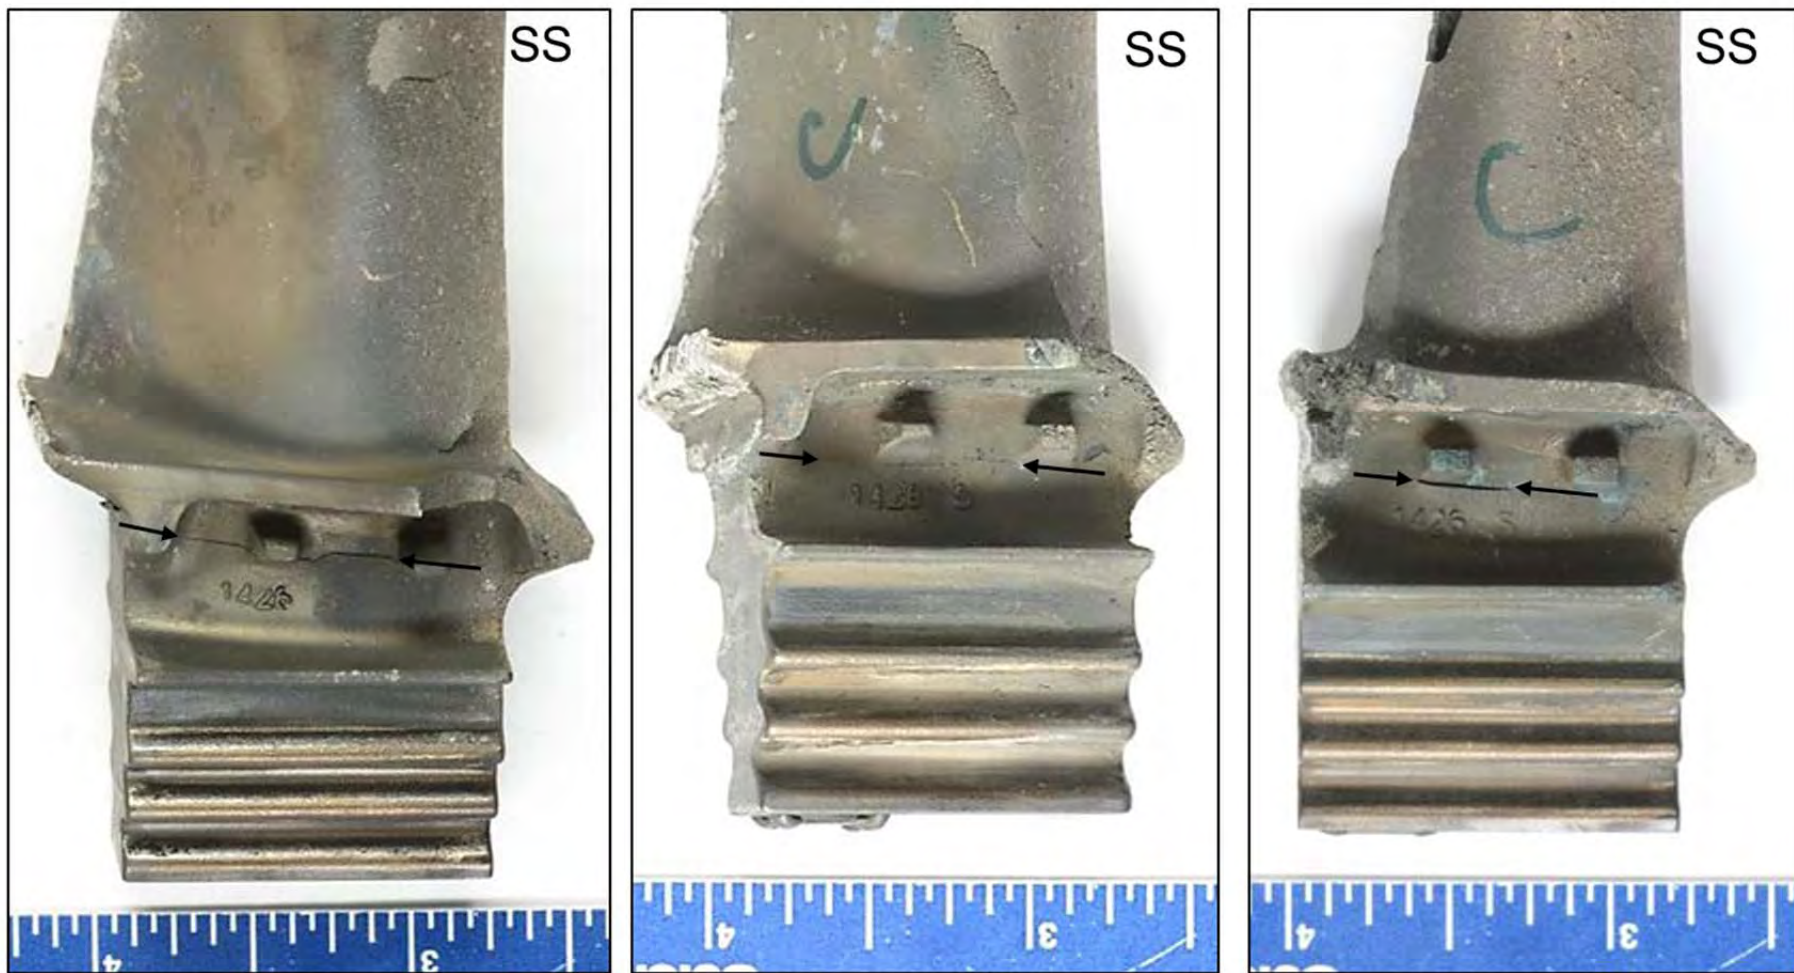
Figure 5: Images of additional 2nd stage HPT blades that exhibited under platform cracks (arrows).

Further inspection of the under platform areas of each of the remaining sixty-seven (67) blades from the set revealed five (5) additional blades that exhibited cracks in close proximity to the damper posts on the SS of the blade. One of these blades also exhibited a small crack near the damper posts on the PS (Figure 5).

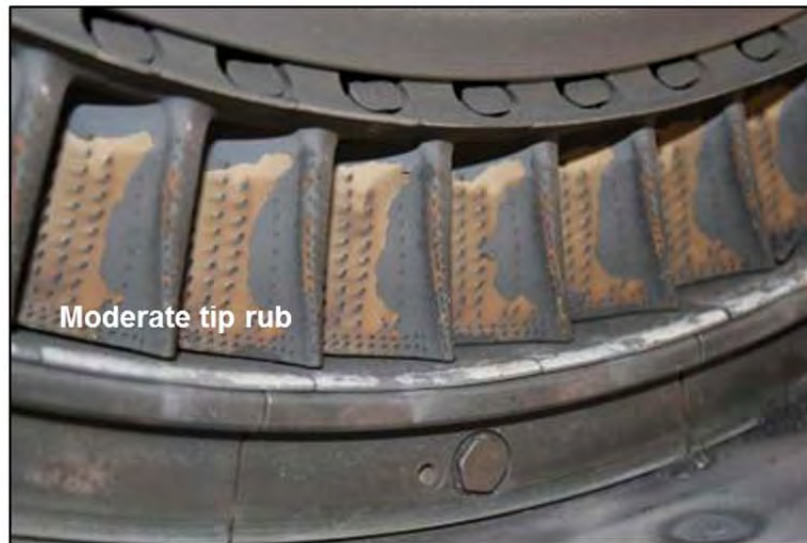
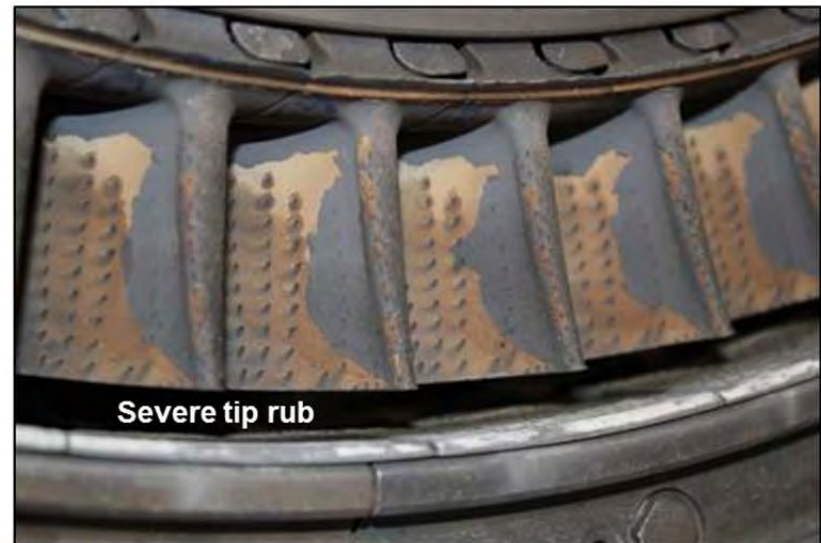
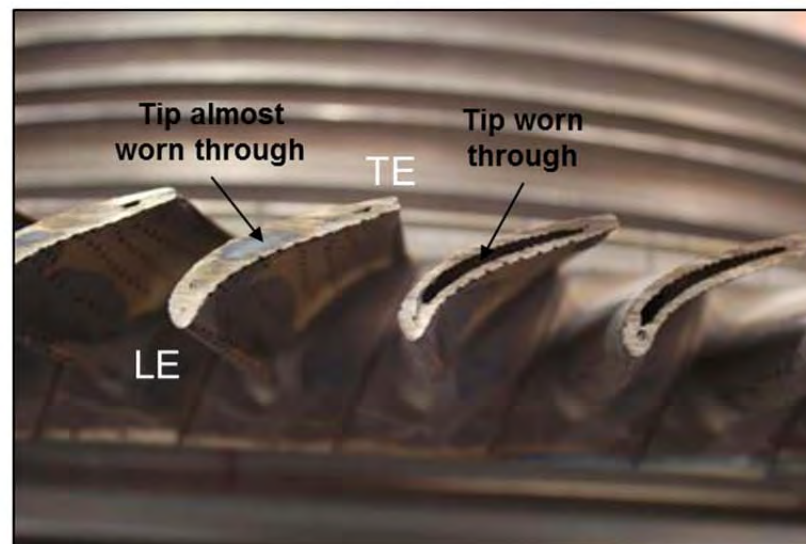
Figure 7: Images of the forward side (upper) and outboard side (lower) of the 1st stage HPT blades

The set of sixty-four (64) 1st stage HPT blades was submitted for review. The entire set was reported as first run, as confirmed by the fact that no repair markings were noted on the blade attachments. Visual review of the blades found that ten (10) consecutive blades exhibited span wise airfoil fractures that occurred at various, ascending radial locations (Figure 6). Binocular examination of each of the airfoil fractures found features consistent with overload. The remainder of the blades exhibited evidence of excessive tip rub. The severity of the tip rub varied from one side of the wheel to the other (Figure 7).

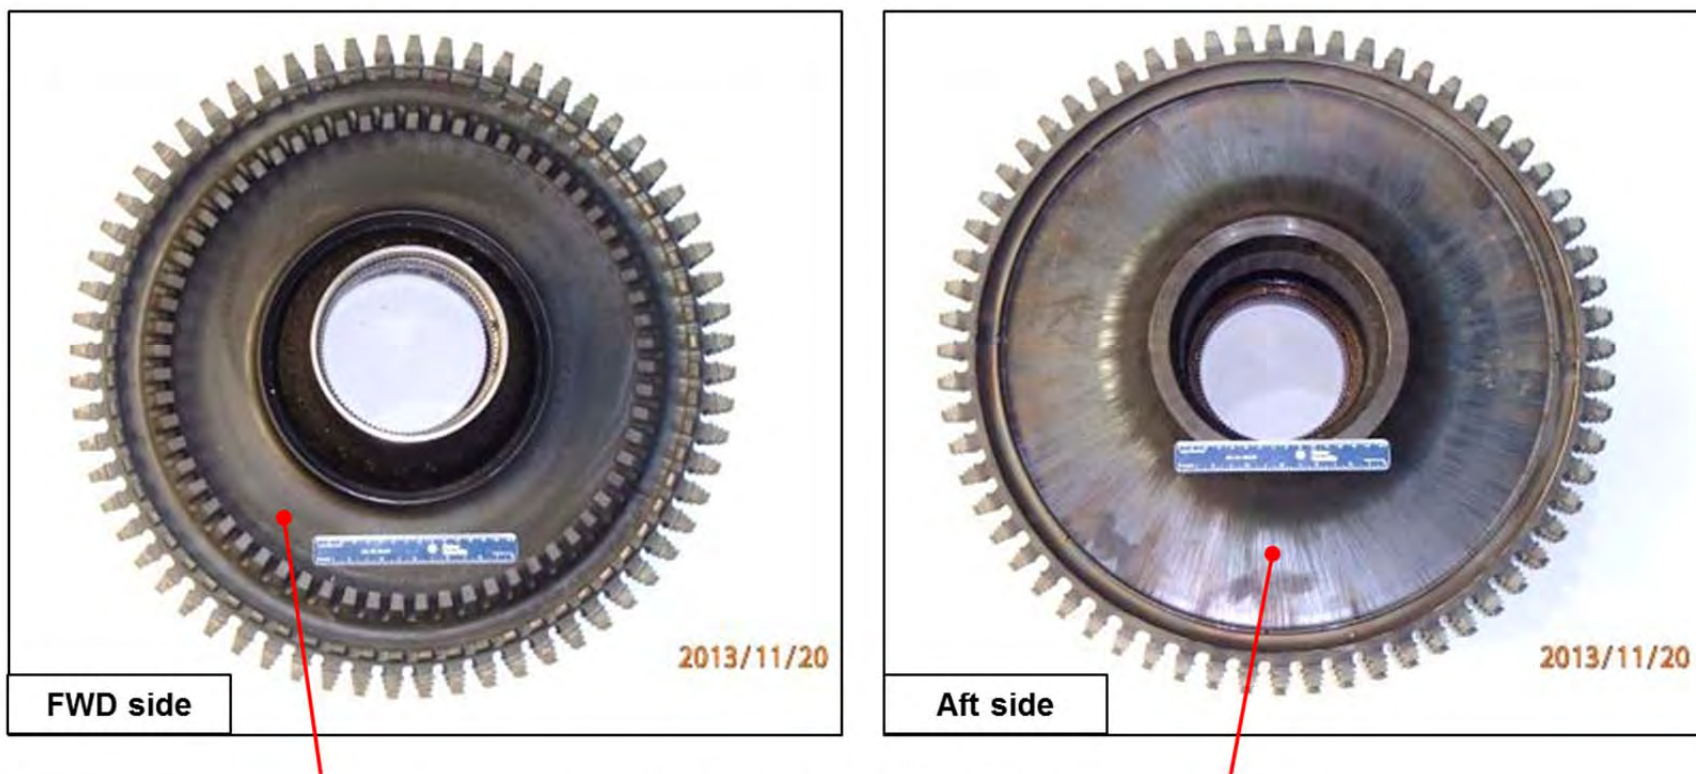
Figure 8: Overall images of the 1st stage HPT hub

Visual review of the hub found that the forward side of the web and hub surface was oil wetted while the aft side exhibited dark radial streaks that extended from the bore inner diameter (ID) to the underside of the aft snap land. The oil wetting on the front of the hub and the appearance and the path (i.e. from the bore) of the streaks were consistent with engine oil in the turbine due to event related leakage from the No. 4 bearing compartment (Figure 8).

Oil wetting/streaking evident on both sides of hub

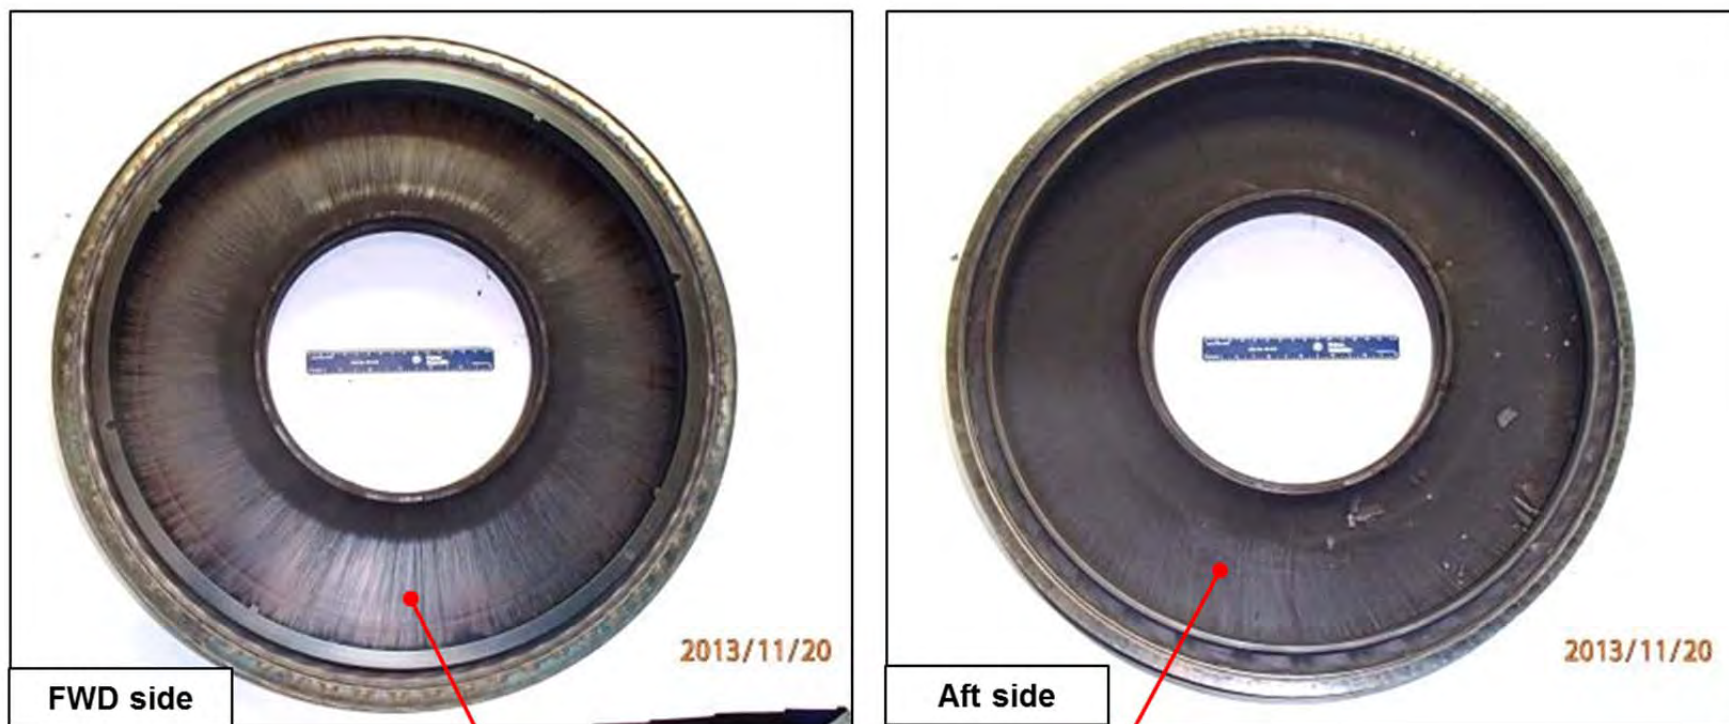
Figure 9: Overall images of the 2nd stage HPT air seal

The 2nd stage HPT air seal (1-2 seal) was submitted for review. Visual examination of the seal revealed evidence of oil streaking on the forward side of the seal. Oil streaking was also observed on the aft side of the seal (Figure 9).

Oil streaking evident on both sides of seal

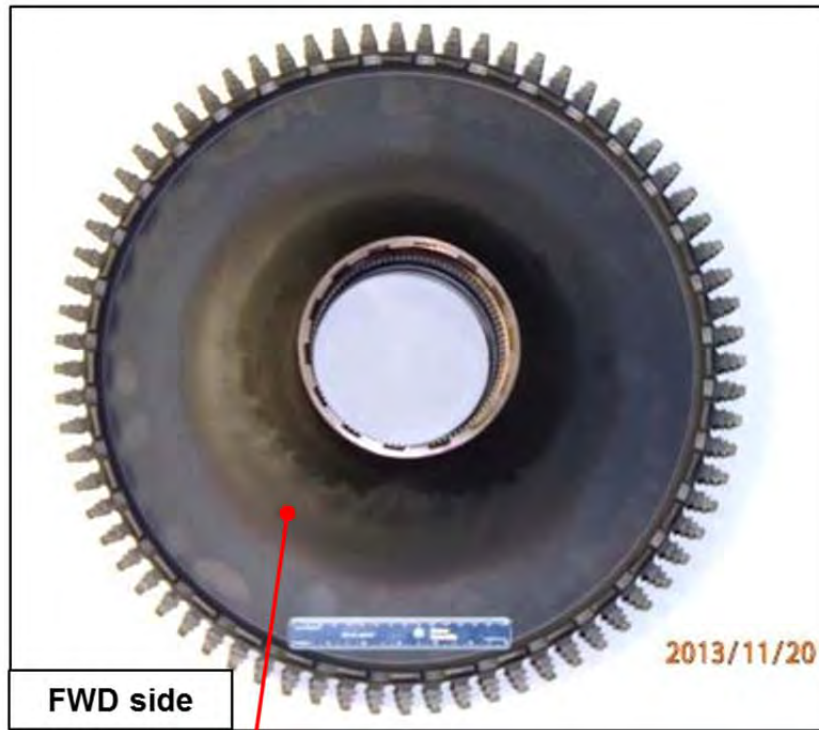
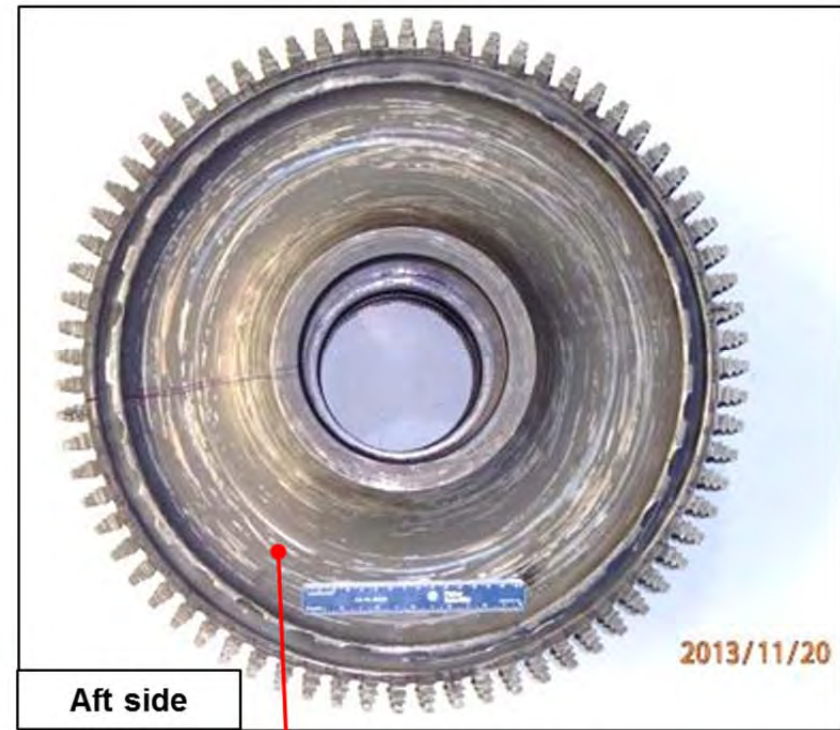
Figure 10: Overall images of the 2nd stage HPT hub

Visual review of the 2nd stage HPT hub and hub heat shield found radial oil streaks and soot on the forward side of the hub section and web. The oil wetting on the front of the hub and the appearance and the path (i.e. from the bore) of the streaks were consistent with engine oil in the turbine due to event related leakage from the No. 4 bearing compartment (Figure 10).

Oil wetting evident on FWD side of hub

Mechanical damage evident on AFT side of hub

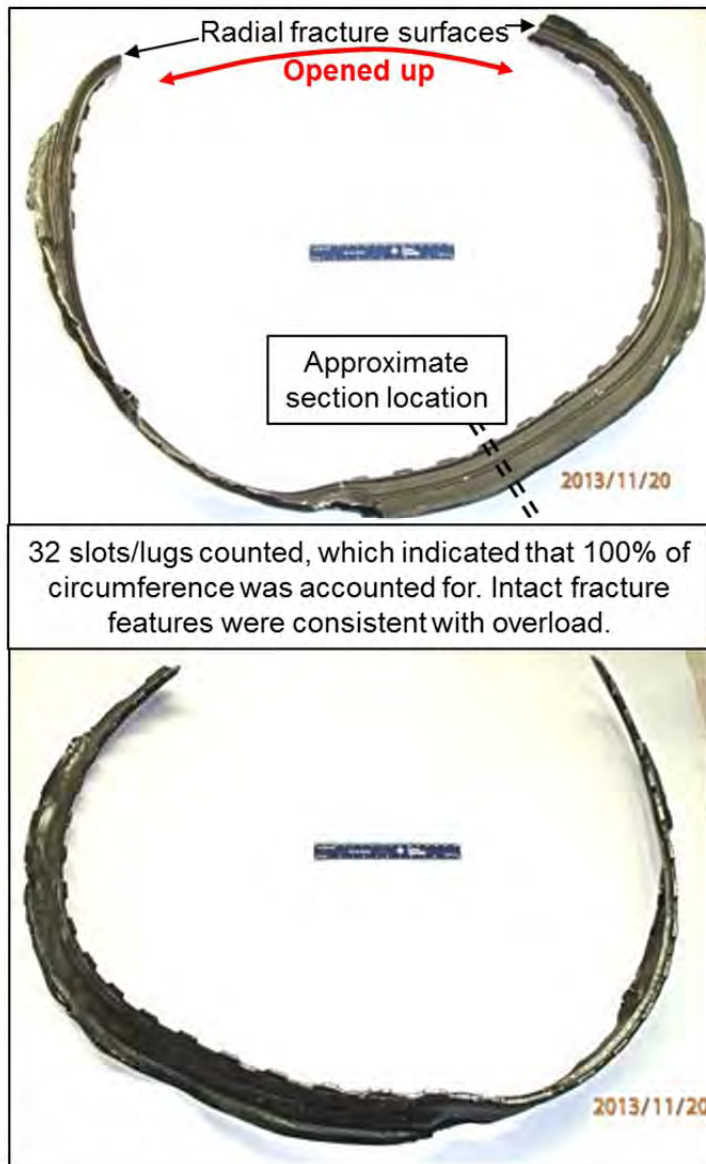
Figure 11: Overall images of the 2nd stage HPT retaining plate and hardness results taken through the cross section

The 2nd stage HPT retaining plate was submitted for review of the fracture surfaces and for assessment of metal temperature exposure via a hardness survey. The subject part had radially fractured and opened up during the engine event to the extent that it was no longer round, but more resembled the shape of a 'C'. Evaluation of the 'circumference' of the retaining plate revealed multiple secondary fractures and that all thirty two (32) slots and tabs remained, which indicated that most of the plate's circumference was accounted for. Examination of both sides of the radial fracture found that one side was severely damaged; the other side of the fracture was intact and exhibited features consistent with overload. Additionally, the aft knife edge was fractured from the part and the remnant knife edge arm was folded forward (see Figure 11).

A radial metallographic section was prepared through the most intact region of the retaining plate in order to complete a hardness survey through the cross section. Hardness measurements made with a Vickers hardness tester along the approximate centerline of the section ranged within typical hardness values for precipitation heat treated Waspaloy (Figure 11). The observed hardness values indicated that the heat shield was not exposed to temperatures in excess of typical service use.

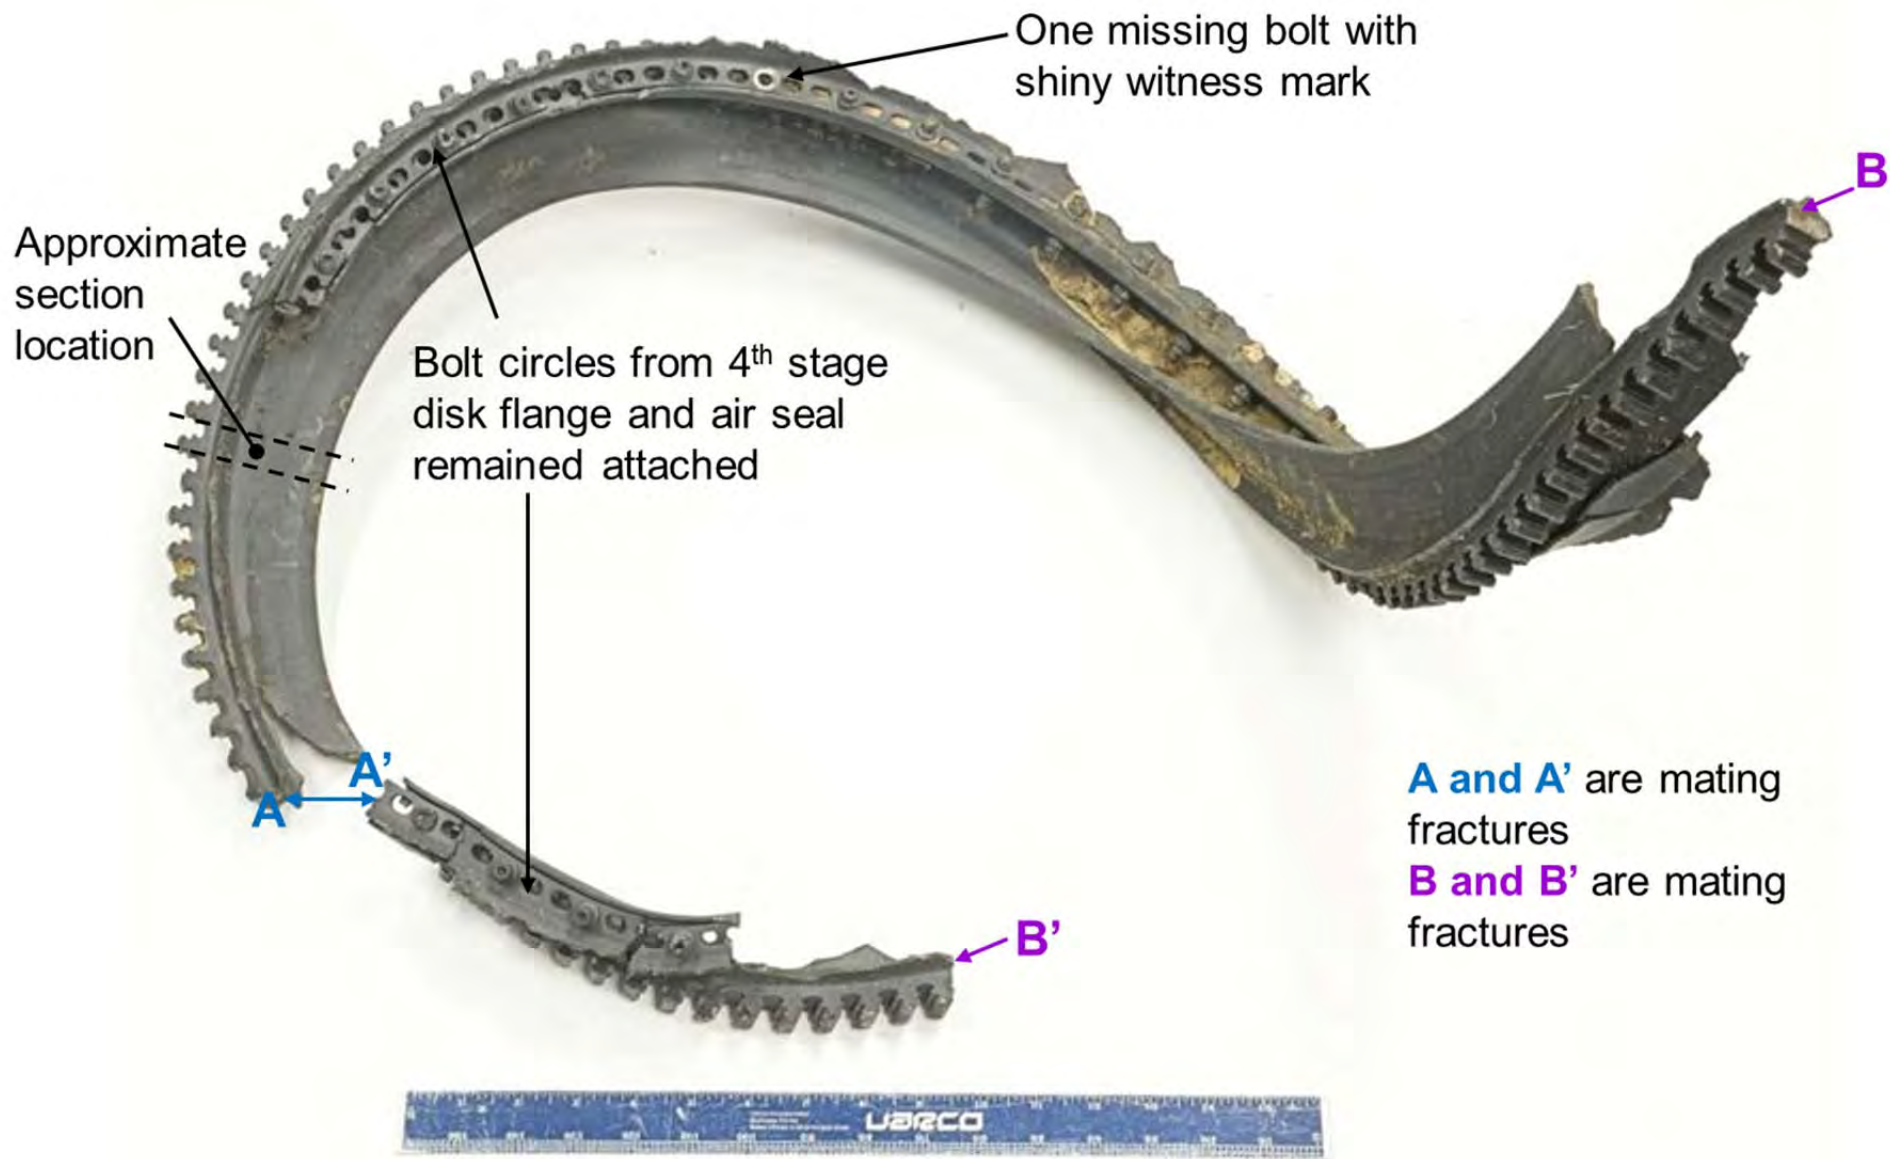
Figure 12: AFT side of 3rd stage LPT disk

The 3rd stage LPT disk fractured and was ejected from the tail pipe during the subject engine event. Two fragments of the disk – one larger and one smaller - were recovered and submitted for review. Visual examination of the larger of the two pieces found that it was severely distorted and twisted. The larger piece measured 52 inches circumferentially, as measured under the rim, and the majority of the bore was intact with the exception of a 4.5 inch fractured section on one end and a fractured wedge of the bore/rim on the other end. The smaller piece measured 9.5 inches circumferentially, as measured under the rim and the entire bore and most of the web had been fractured off. Review of the fractures through the rim found that the ends of the smaller piece mated up with either end of the larger piece, which indicated that the two recovered pieces accounted for the complete disk rim.

The entire forward side arm had been fractured on both of the recovered pieces while a significant portion of the aft side arm and bolt flange remained intact. The remaining aft side flange measured on both the larger and smaller disk piece totaled 48.5 inches in circumference. The corresponding fractured flanges from the 4th stage air seal and 4th stage disk remained bolted in place to the remaining aft flange on the 3rd stage disk. One bolt was noted missing within this

“intact” region; a shiny witness mark surrounding the bolt hole indicated that a bolt had once been seated at this location and had recently liberated.

Visual and binocular review of each of the fracture surfaces found rough, granular features which were consistent with a mixture of tensile overload and stress rupture failure modes; no evidence of fatigue was observed. Figures 12 and 13 are images showing the overall condition of the 3rd stage LPT disk.

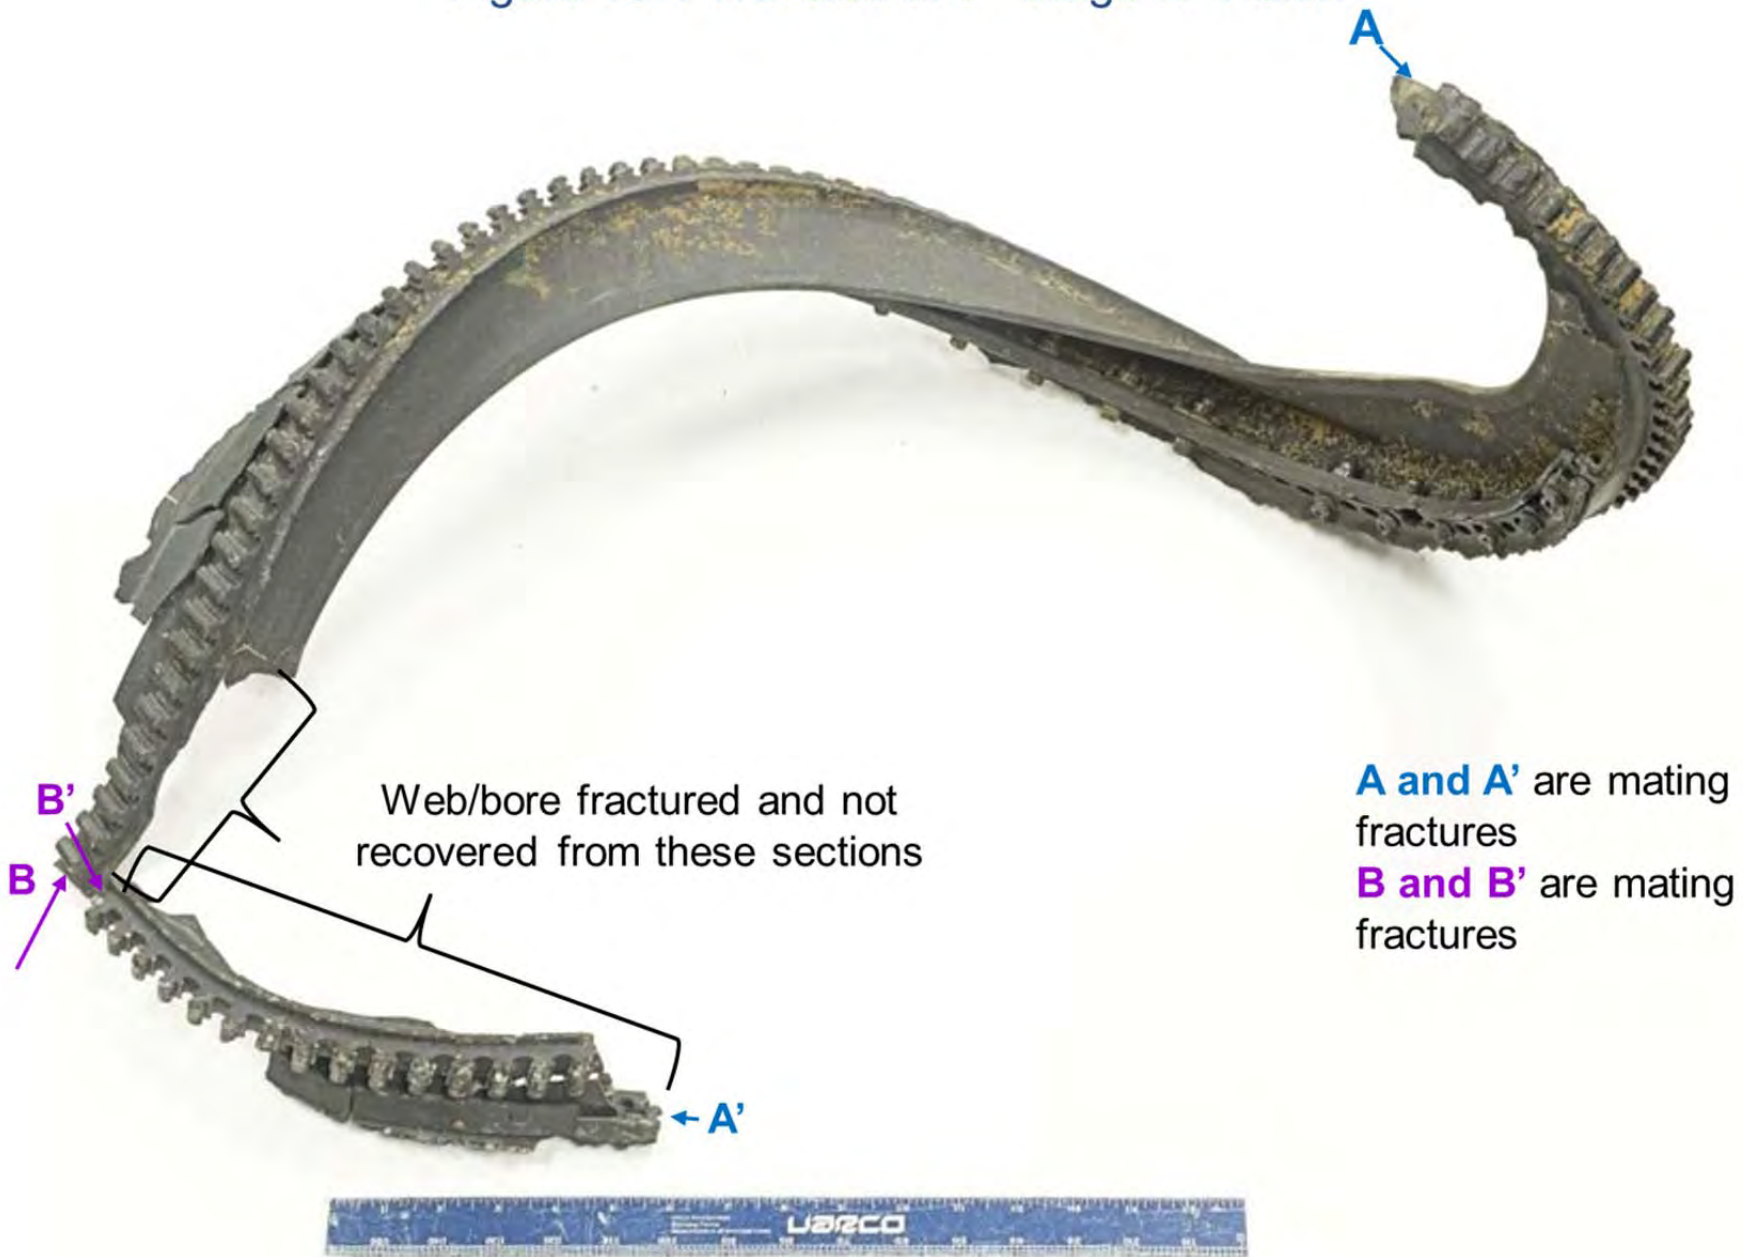
Figure 13: FWD side of 3rd stage LPT disk

A and A' are mating fractures
B and B' are mating fractures

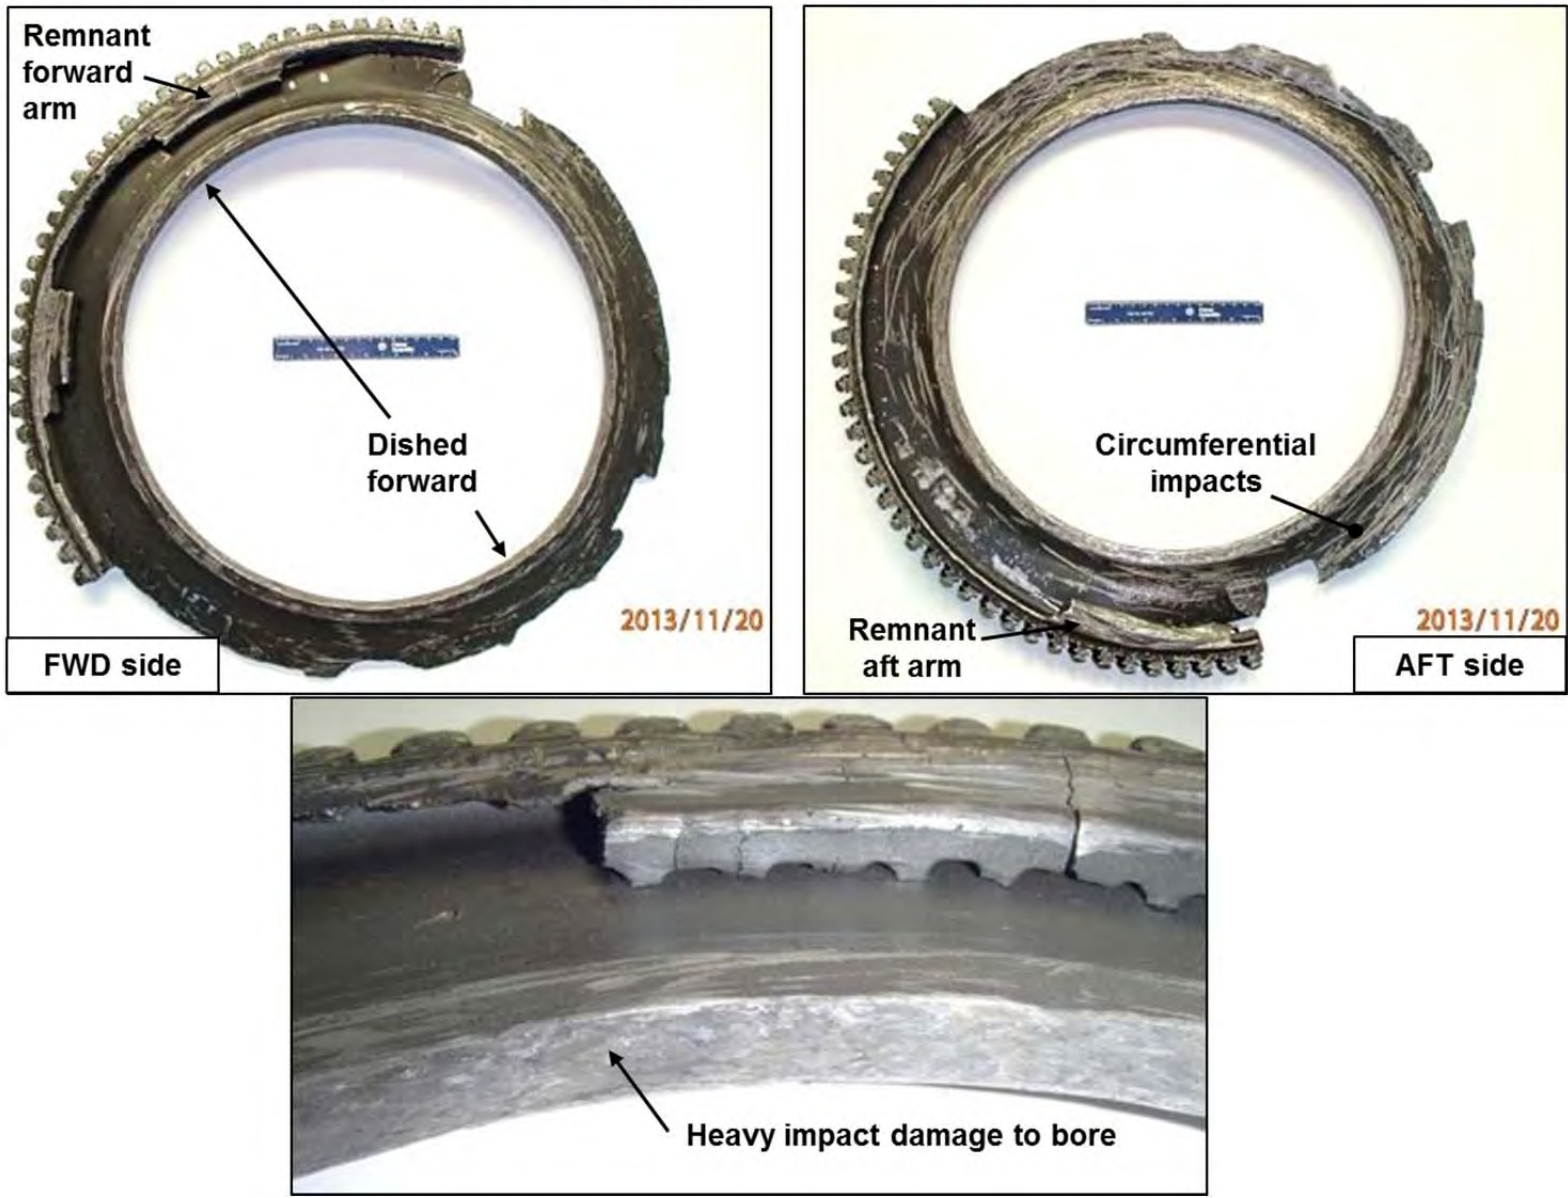
Figure 14: Images of the 5th stage LPT disk

The 5th stage LPT disk was submitted for visual review and for assessment of metal temperature exposure via a hardness survey. Visual inspection upon receipt revealed that the disk was severely damaged. Both sides of the disk exhibited multiple circumferential impact marks, with the aft side being the most severe, and the entire web/bore of the disk was dished forward. Additionally, the bore of the disk exhibited severe deformation and heavy impact damage. It was noted that more than 50% of the rim was fractured. The forward and aft arms were fractured in the region where the rim remained with any remnant pieces folded inward. Binocular examination of the fractures found features consistent with overload. No evidence of fatigue was observed (Figure 14).
