POWERPLANT GROUP CHAIRMAN'S FACTUAL REPORT

ENG14IA001

**Pratt & Whitney Materials Process and Engineering Summary of
Metallurgical Investigation of Spirit Airlines V2500-A5 Engine No. V12069
(34 Pages)**

Subject: Metallurgical Investigation of Spirit Airlines V2500-A5 Engine No. V12069

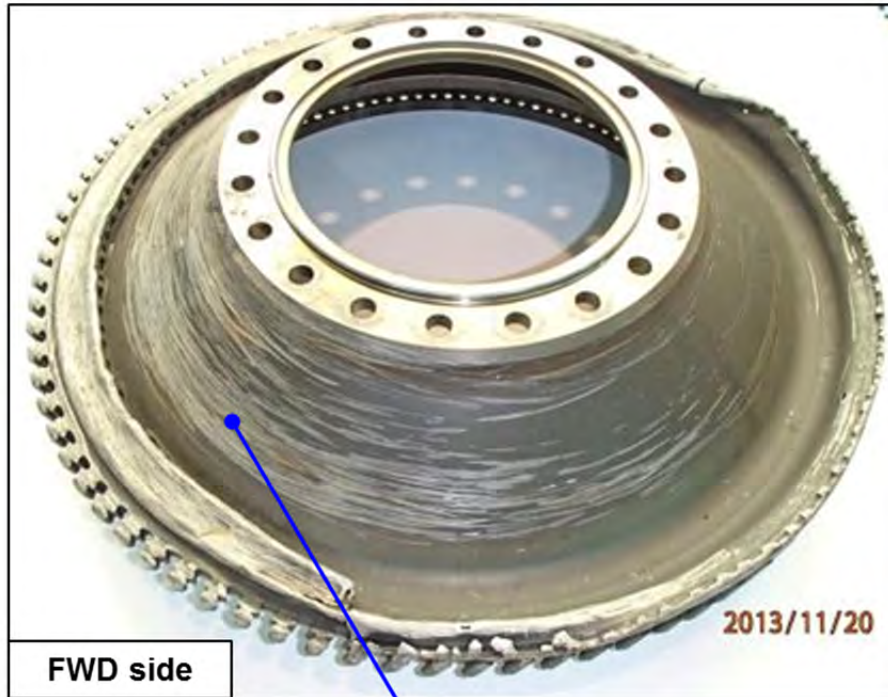
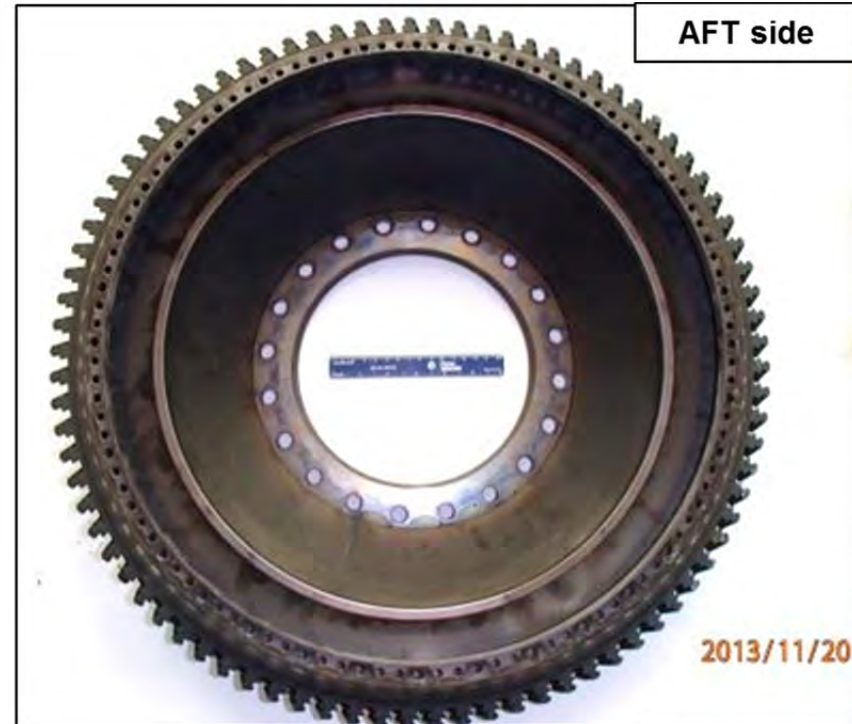
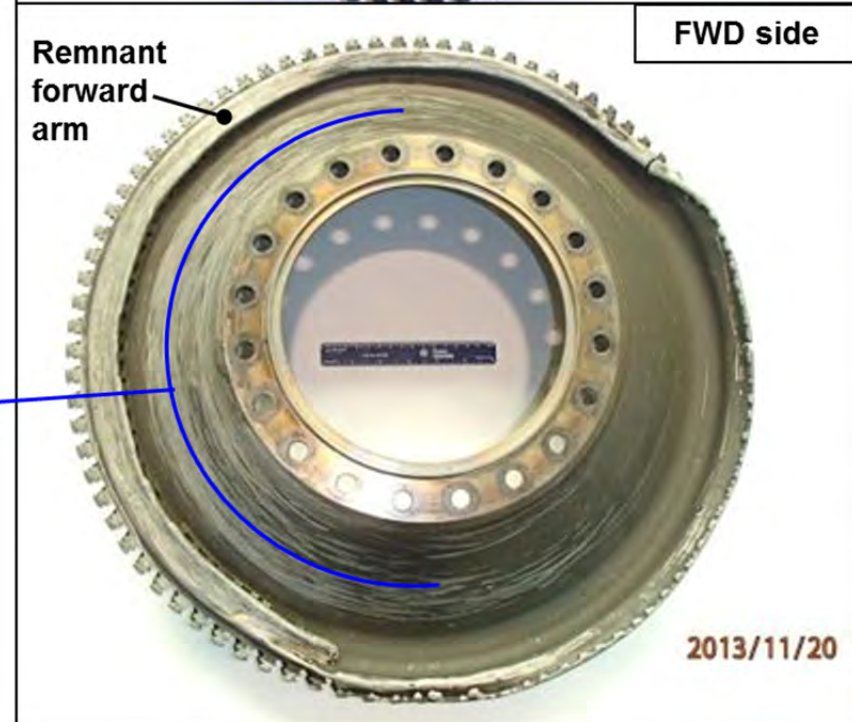
Figure 15: Overall images of the 6th stage LPT disk

The 6th stage LPT disk was submitted for visual review and for assessment of metal temperature exposure via a hardness survey. Visual inspection upon receipt revealed that the forward side of the disk was severely damaged. The forward side arm was fractured over approximately 40% of the circumference while the remaining 60% was deformed inward. Additionally, the conical section of the disk exhibited multiple circumferential impact marks. The aft side of the disk exhibited minimal damage, though the surfaces exhibited dark discoloration/heat tint (Figure 15).

Circumferential impacts - heavier on this half of disk

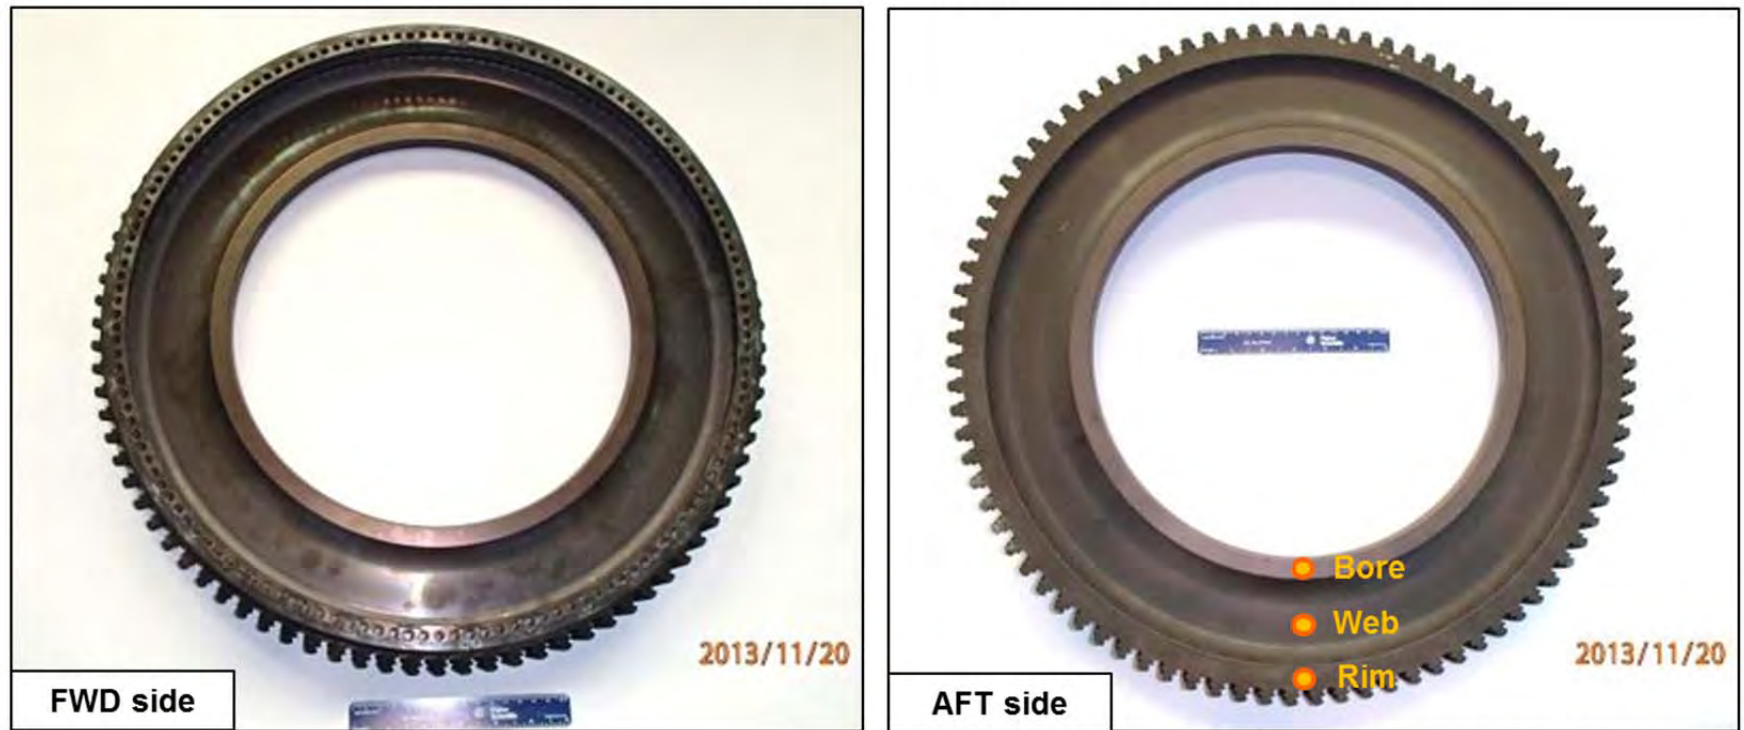
Figure 16: Overall images of the 7th stage LPT disk

The 7th stage LPT disk was submitted for assessment of metal temperature exposure via hardness evaluation. The disk was fully intact, though it exhibited a dark discoloration/heat tint (Figure 16). Multiple hardness measurements were made directly on the disk with a Rockwell hardness tester. Due to the geometry of the part, a full radial traverse was not possible. However, representative hardness measurements were taken at the disk rim, web and bore. Hardness measured at each of these locations was lower than the expected hardness minimum for properly precipitation heat treated Inconel 718.

Both sides of disk exhibited dark discoloration/heat tint

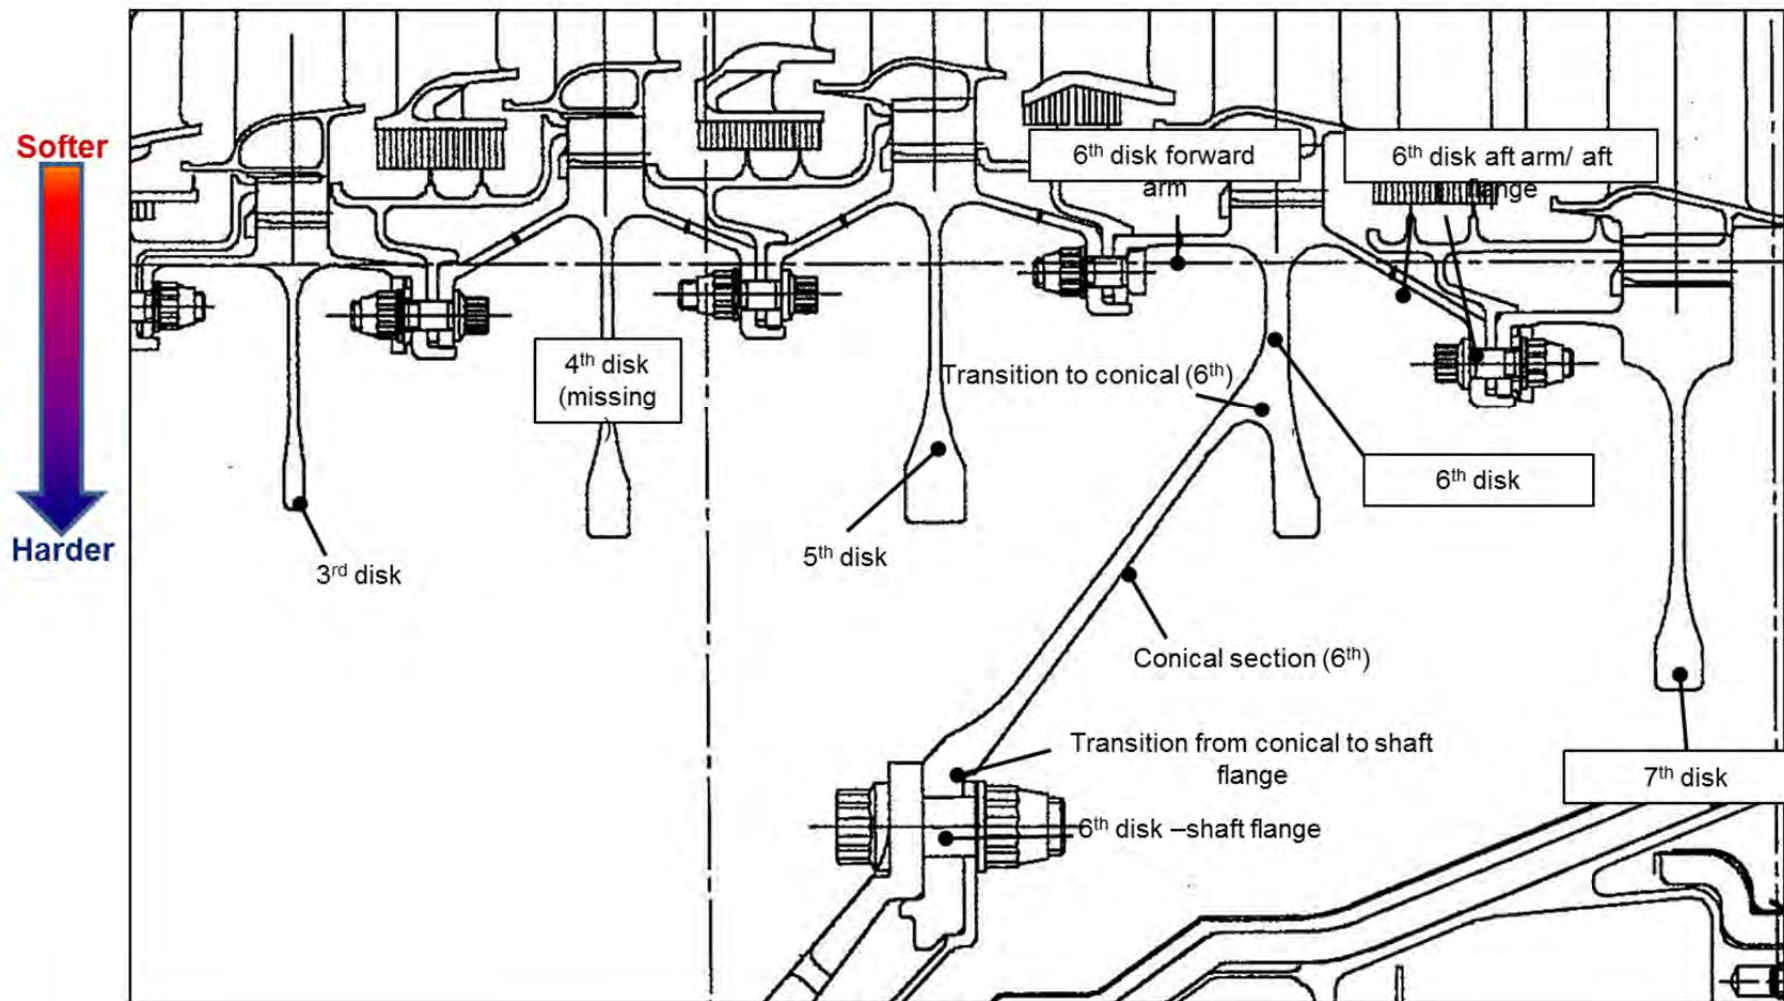
Figure 17: LPT 3rd, 5th, 6th and 7th Disk Hardware Measured for Hardness

Figure 17 shows the consolidated hardness results for metal temperature evaluation of each of the LPT disks.

Dots denote general area where hardness was measured on the rim, web and bore

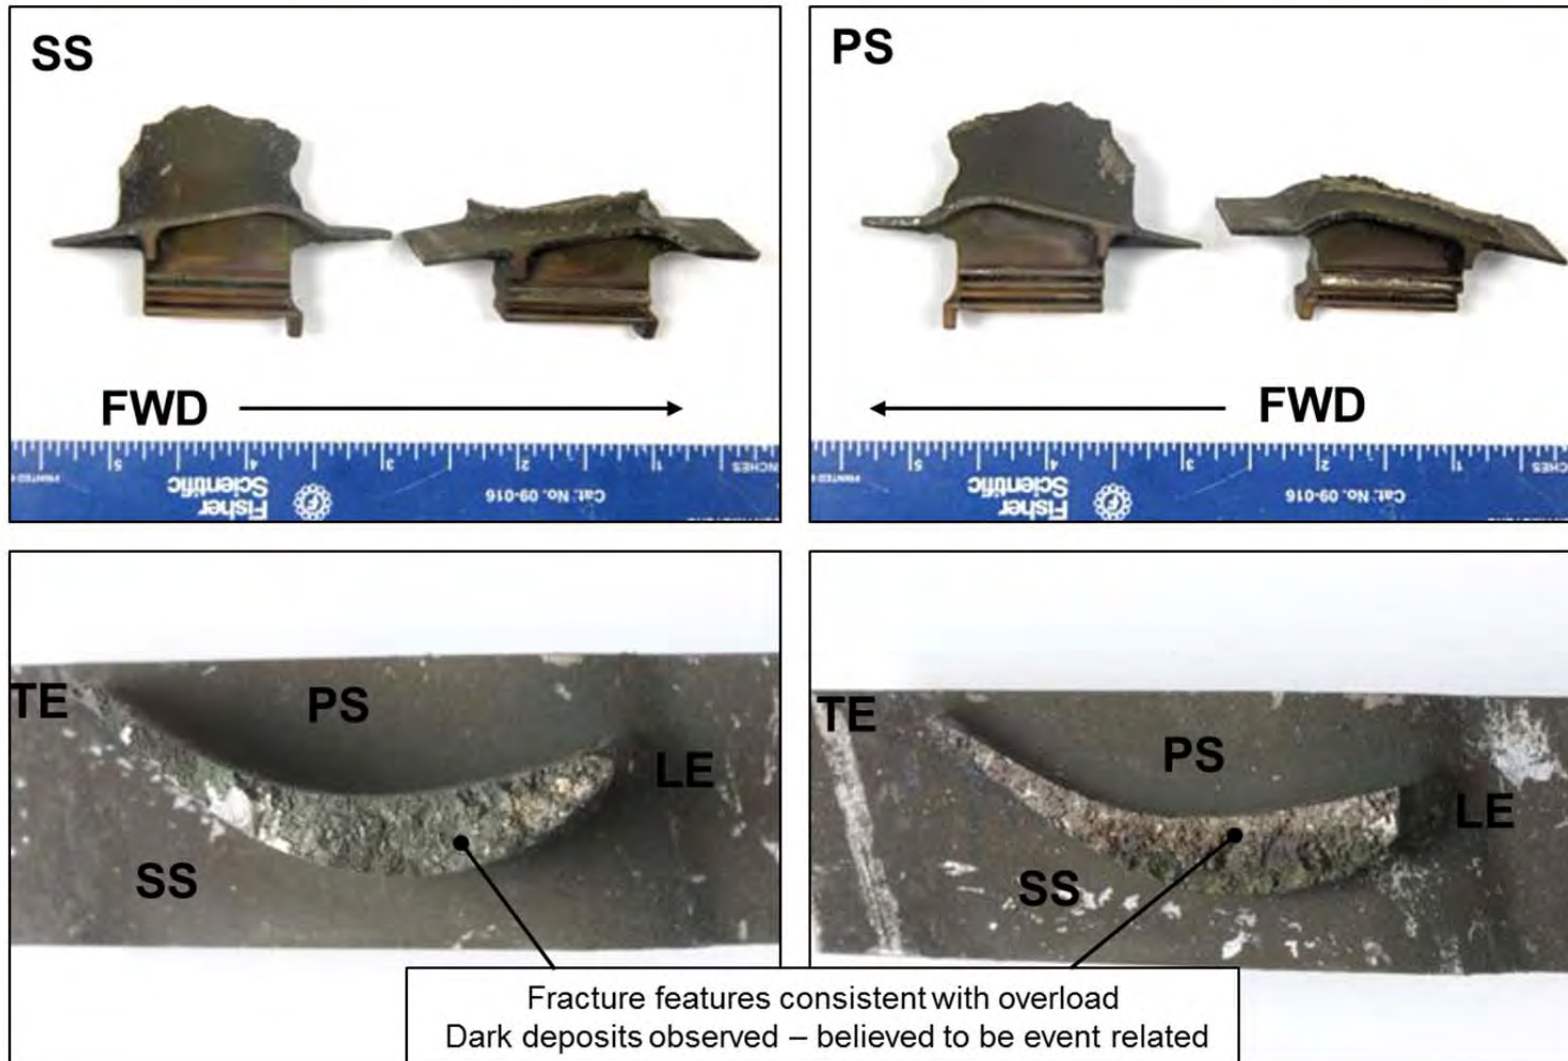
Figure 18: Images of 7th stage LPT blades representative of the range of radial fracture locations observed. All blades fractured in close proximity to the platform.

The entire set of eighty-nine (89) 7th stage LPT blades was submitted for review. Visual examination of the blades found that each of the airfoils had fractured near the platform. The remaining blade stubs exhibited additional damage and fractures associated with multiple impact sites. Thermal distress and dark deposits were also observed. Binocular examination of the fractures found features consistent with overload. No evidence of fatigue was observed (Figure 18).

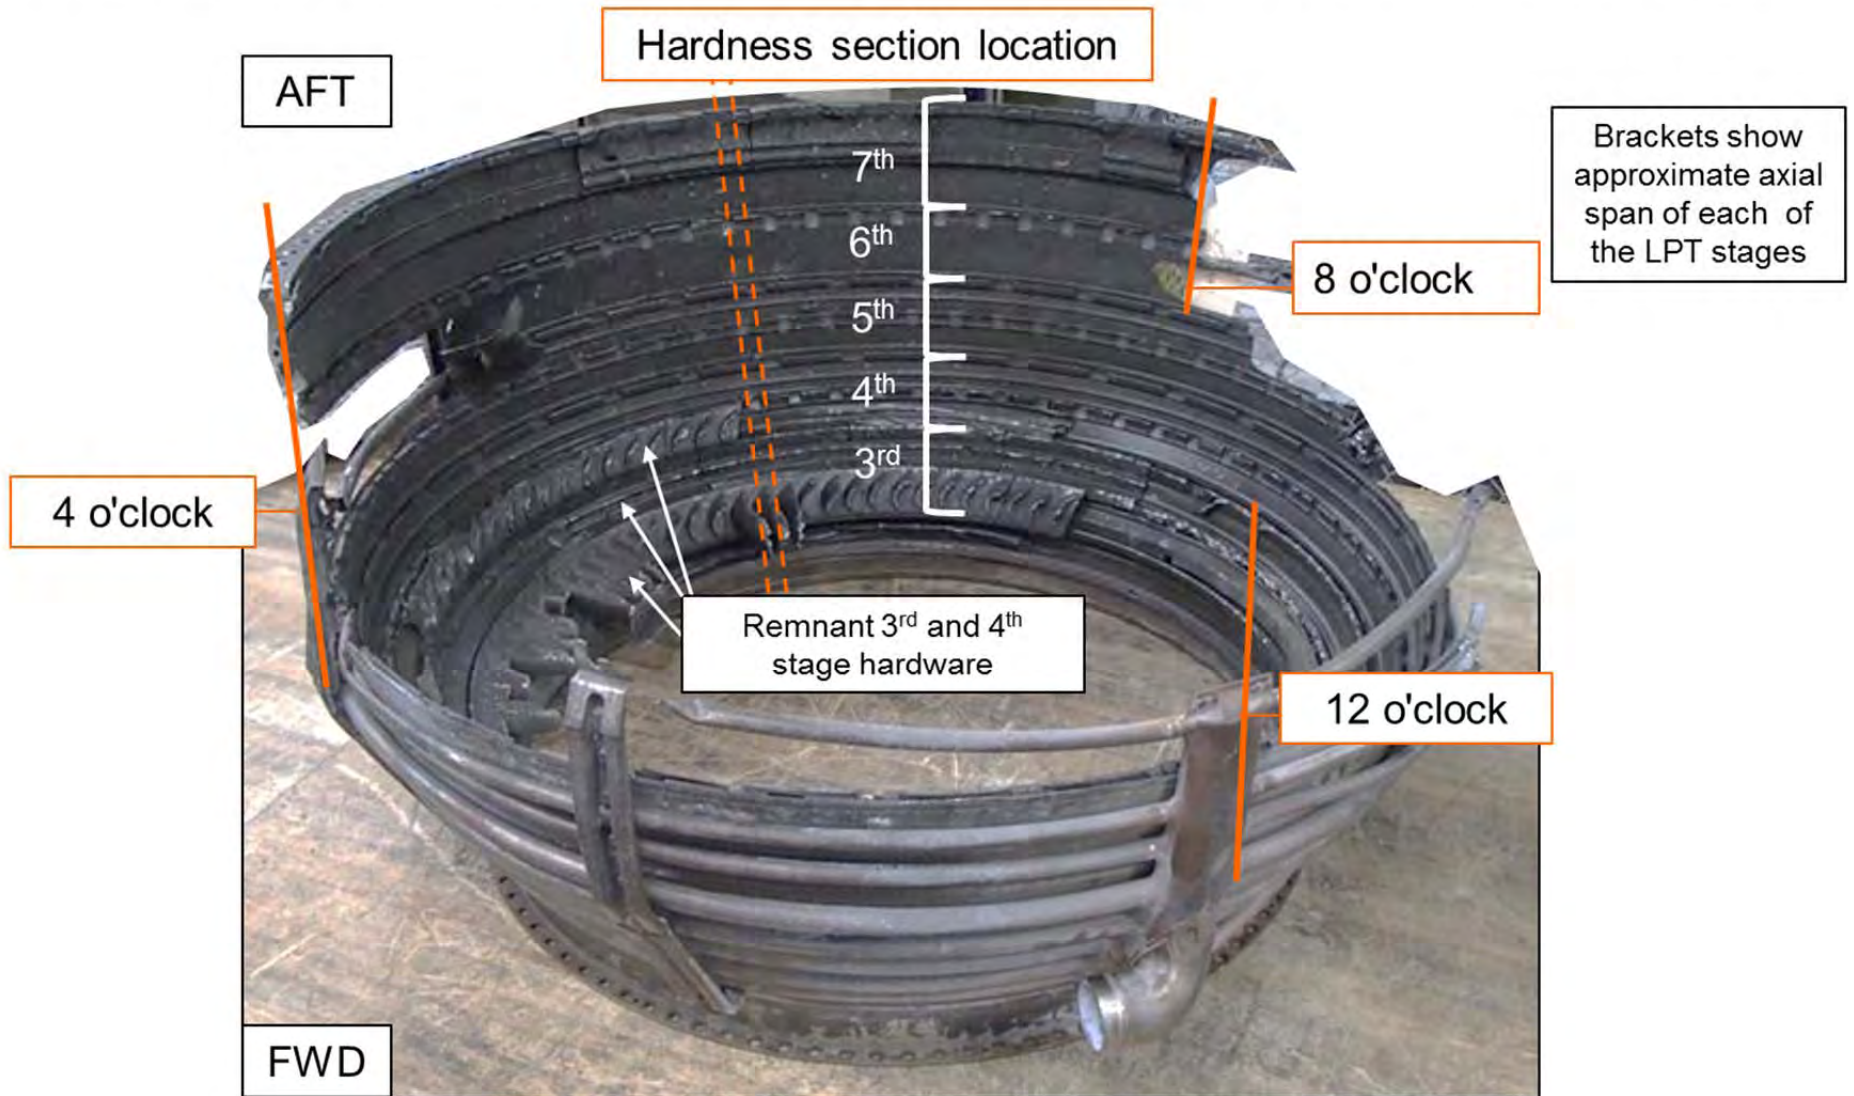
Figure 19: Image of the LPT case

separated. The fracture occurred along the upper half of the case from approximately 8 o'clock to 4 o'clock. The fracture was comprised of multiple linked up circumferential cracks that eventually turned axial/diagonal and continued through the aft flange. The circumferential crack paths occurred at axial locations just aft of the 5th, 6th and 7th stage vane hooks, where a distinct change in cross section was observed. Further examination of the case revealed remnant outboard portions of fractured 3rd and 4th stage hardware (vanes, heat shields and outer air seals); the majority of the mating hardware aft of the 4th stage had fractured and liberated with very little hardware remaining in place (Figure 19).

Fracture and separation of a large portion of the case from 8 o'clock to 4 o'clock. Fracture comprised of multiple linked up circumferential cracks at axial locations just aft of the 5th, 6th and 7th stage vane hooks.

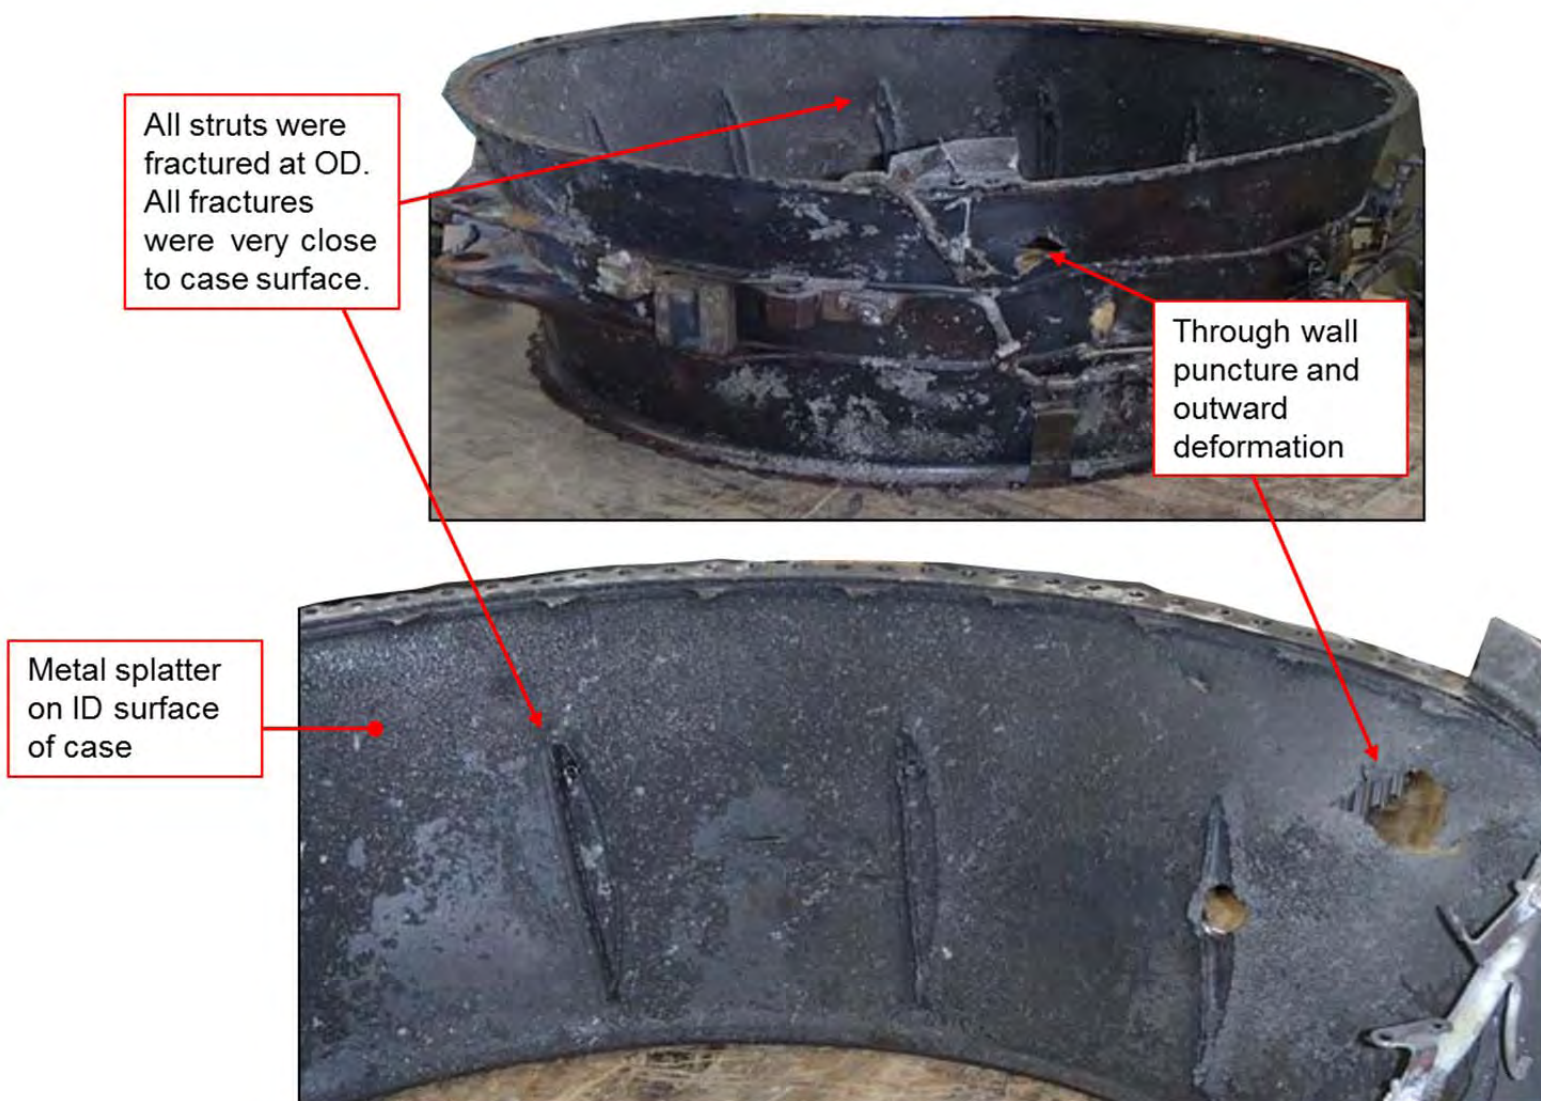
Figure 20: Images of the turbine exhaust case (TEC)

The turbine exhaust case (TEC) was submitted for review and assessment of metal temperature exposure via a hardness survey. Visual examination of the TEC revealed that all of the struts as well as the No. 5 bearing support and housing had fractured and separated from the assembly; only the outer case remained. Further review found that the case exhibited multiple outward bulges with two areas where the case had been punctured. The inner surface was covered in metal splatter. Examination of the strut fractures found that each had occurred at similar radial locations, approximately 0.25-0.50 inch from the case ID surface. The surfaces of the fractures exhibited extensive mechanical and thermal damage, though the irregular fracture paths suggested overload or stress rupture as likely failure modes (Figure 20).

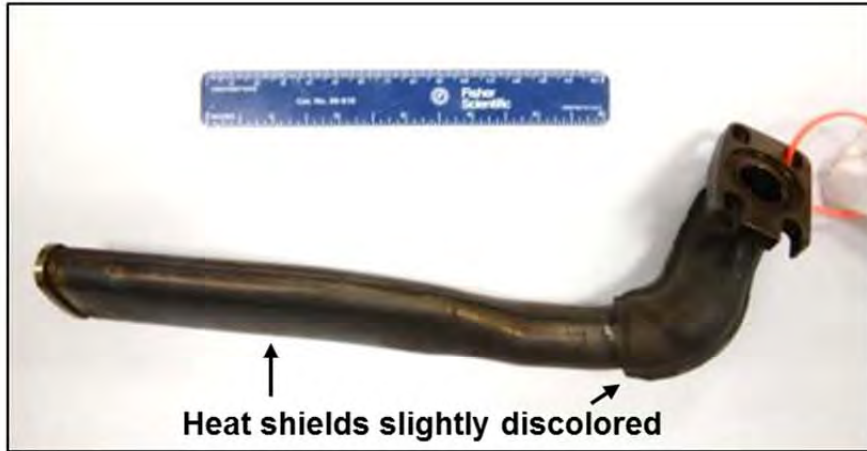
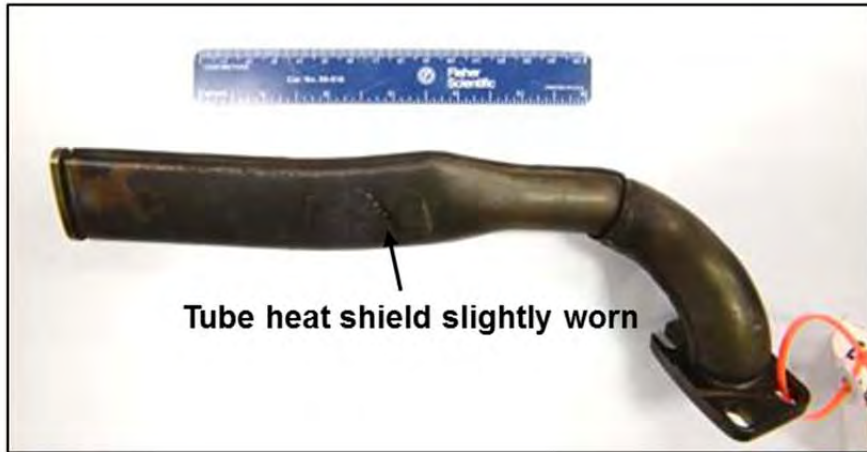
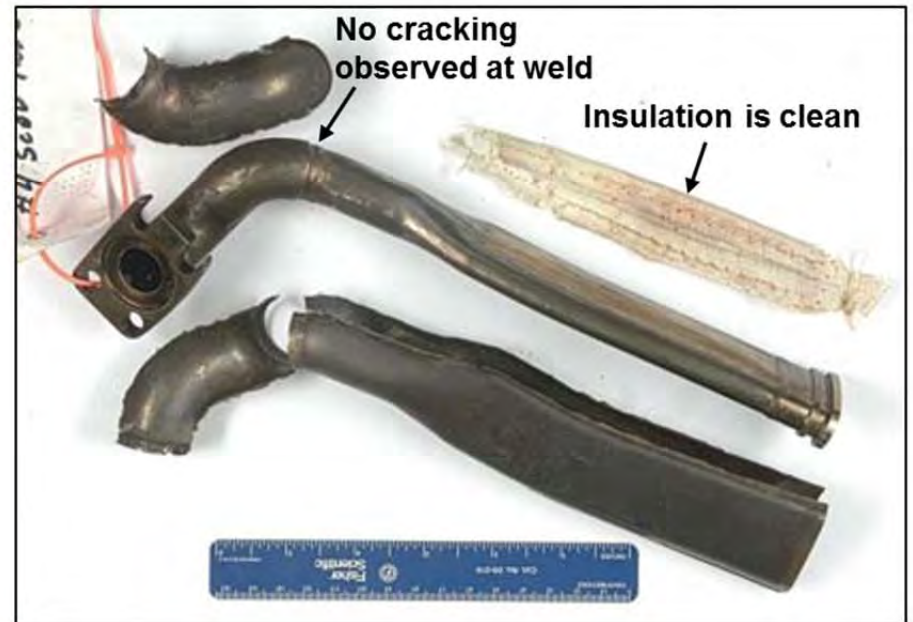
Figure 21: Overall images of the No. 4 bearing compartment scavenge tube before (left) and after (right) removal of the heat shields

The No. 4 bearing compartment scavenge tube was submitted in order to inspect for evidence of an oil leak, particularly at the inboard end tube to end fitting weld joint. Visual review of the scavenge tube as received found that it appeared discolored, indicating that it was exposed to elevated temperatures, but no obvious damage or evidence of an oil leak was observed. There was a patch of wear on the tube-end heat shield, however this is typical of what has been observed of engine operated scavenge tubes. The heat shields were removed from the tube and subsequent review found that much of the inner insulation remained intact and had not been oil soaked, which has previously been observed of leaking tubes. Additionally, the tube to end fitting weld was reviewed under the binocular microscope with no evidence of cracking observed (Figure 21).

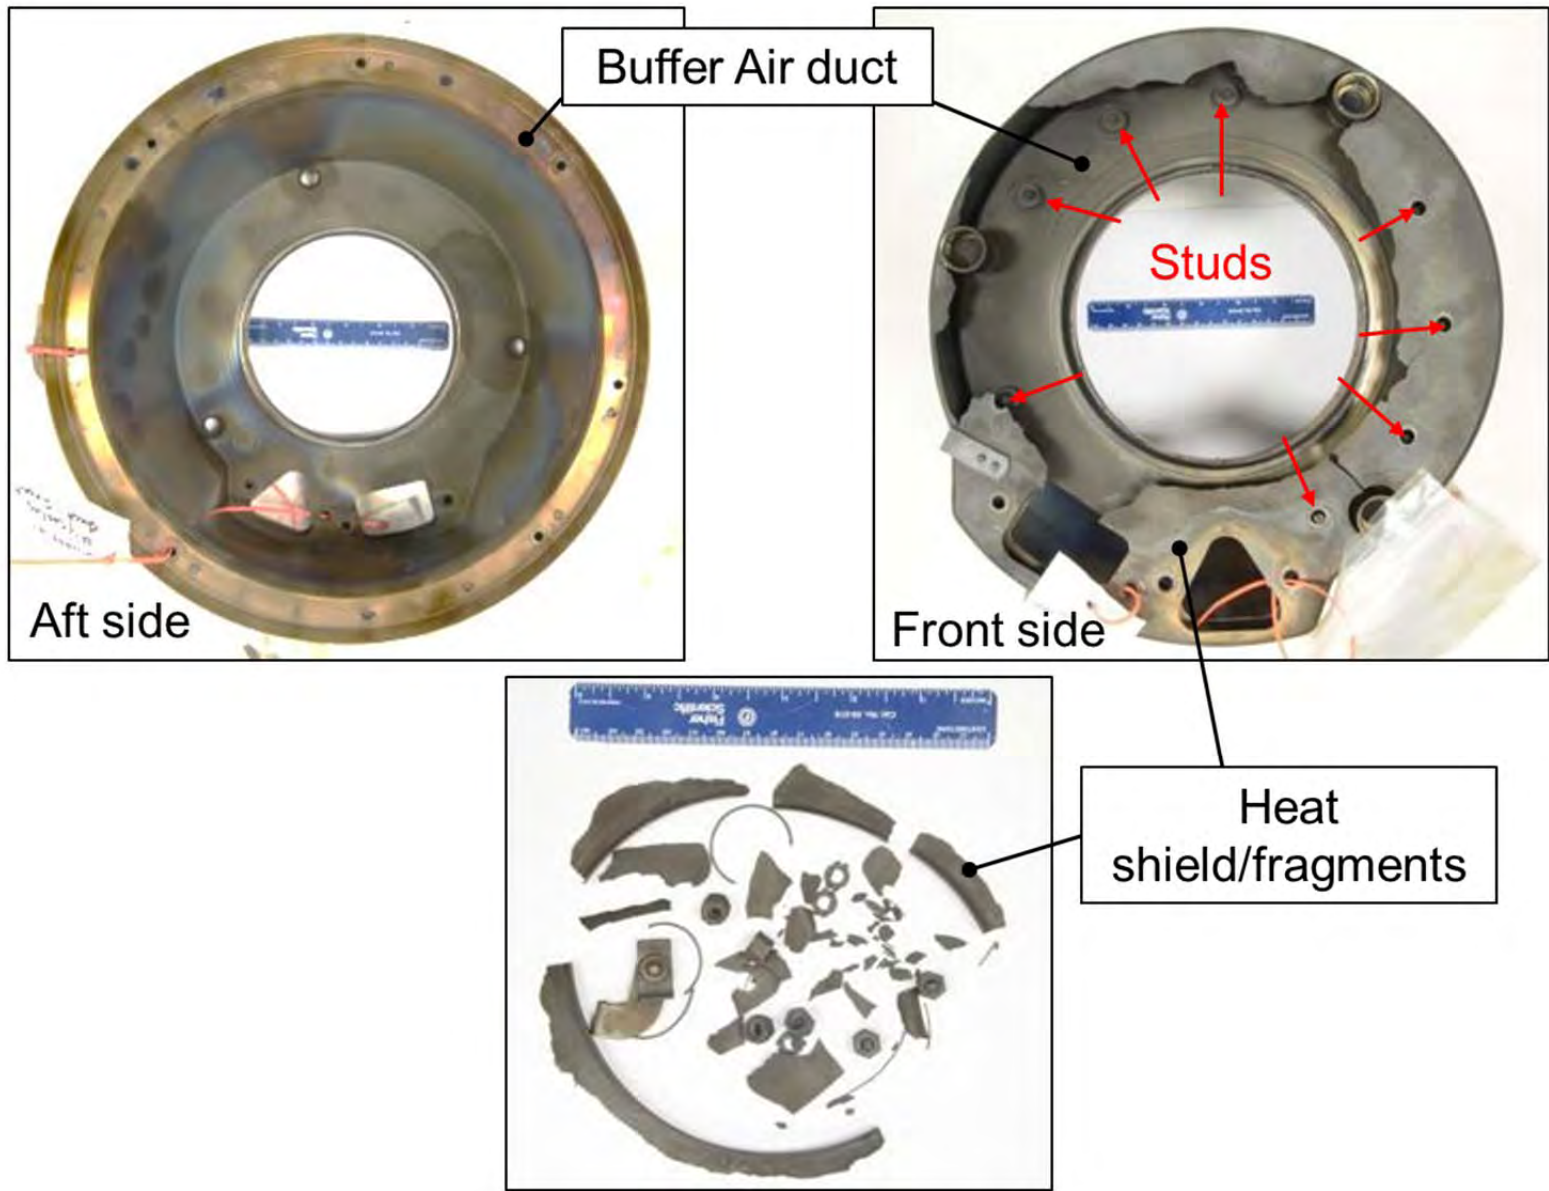
Figure 22: Images of the No. 4 Buffer Air duct and fractured heat shield and fragments

The No. 4 bearing compartment front heat shield was submitted for review. Multiple intersecting fractures and cracks allowed for the liberation of almost 50% of the front cover; the liberated fragments were recovered and also submitted for review. Review of the fracture surfaces found granular features suggestive of a stress rupture mode of fracture. The heat shield also exhibited thermal distress, as evidenced by discoloration and localized bulging (Figure 22).

The No. 4 bearing compartment front buffer cooling duct was submitted for review of the fracture of seven (7) out of eight (8) welded studs and for confirmation of the stud material. Review of each of the stud fractures found surfaces consistent with overload failures; no evidence of fatigue was observed (Figure 22). One stud was spot polished in order to facilitate compositional analysis via scanning electron microscope/energy dispersive spectroscopy (SEM/EDS). Analysis of the stud found a composition consistent with Inconel 718, the required stud material.
