NATIONAL TRANSPORTATION SAFETY BOARD
Office of Aviation Safety
Washington, D.C. 20594

POWERPLANT GROUP CHAIRMAN'S FACTUAL REPORT

NTSB No: ENG14IA019

Aircraft: Delta Air Lines, Boeing 767-332, registration number N139DL, Flight 101

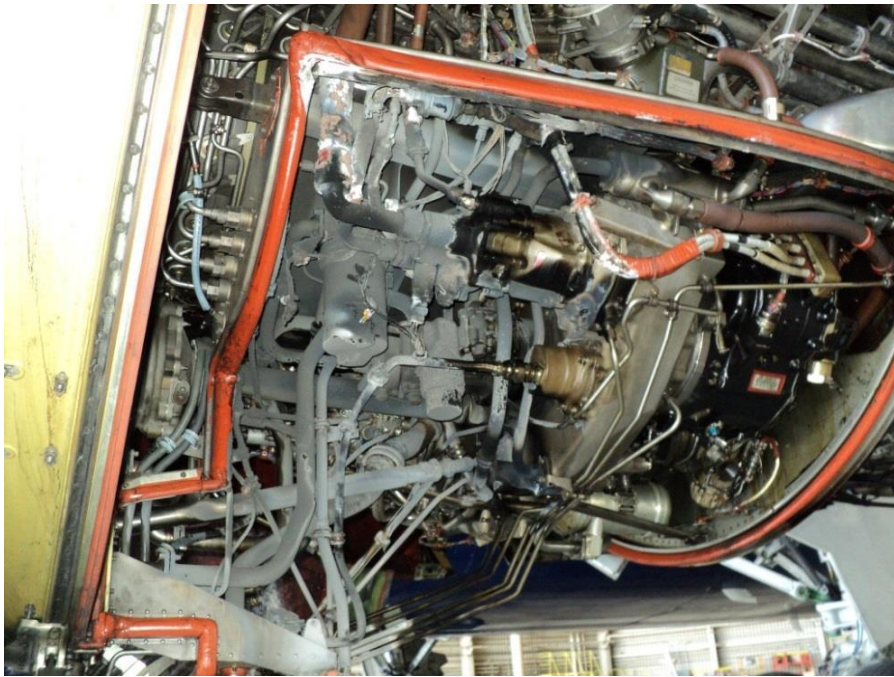
DAL mechanics confirmed the No. 1 engine experienced an undercowl fire and the damage was located primarily on the left side of the engine under the engine heatshield forward of the accessory gearbox (**PHOTO 3**).

PHOTO 3: THERMAL AND FIRE DAMAGE ON LEFT SIDE OF NO. 1 ENGINE UNDER ENGINE HEATSHEILD
Photo Courtesy of Delta

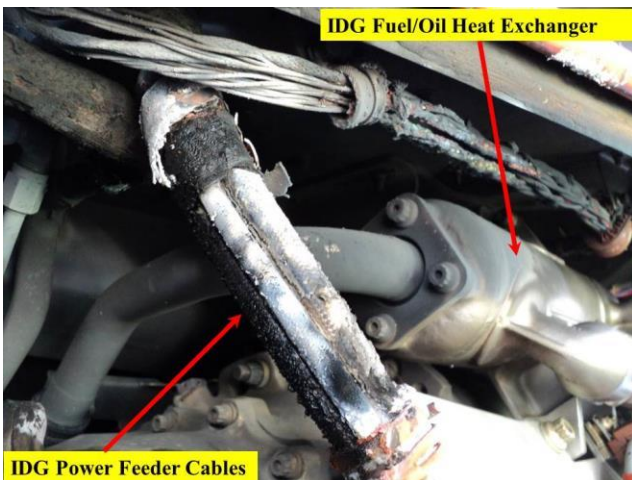
PHOTO 4: THERMAL DAMAGE TO IDG POWER FEEDER CABLES AND IDG FUEL/OIL HEAT EXCHANGER LOCATION

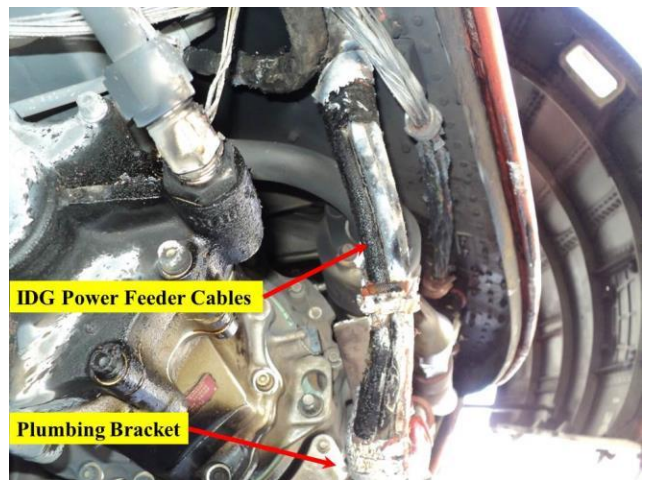
PHOTO 5: THERMAL DAMAGE TO IDG POWER FEEDER CABLES & LUBE AND SCAVENGE PUMP PRESSURE LINE SUPPORT BRACKET LOCATION
Photos Courtesy of Delta

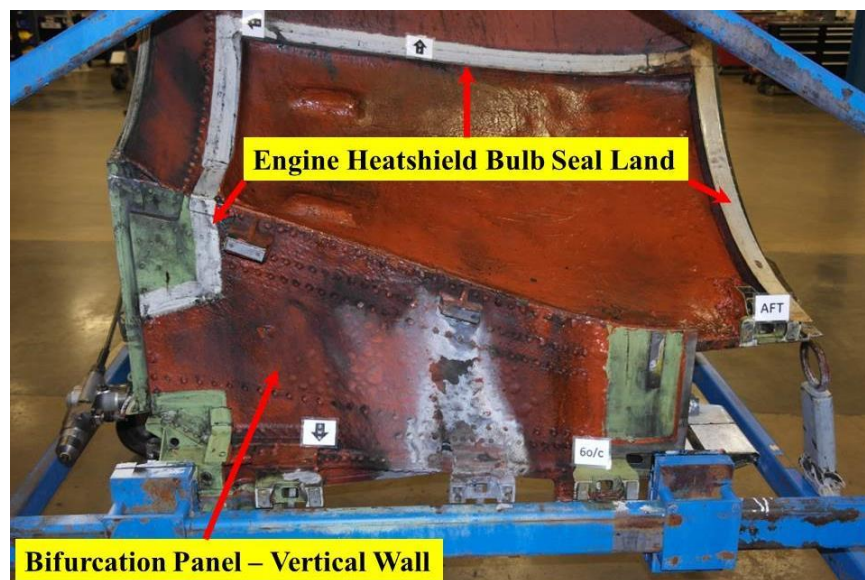
The right TR was in generally good condition with the only thermal damage noted on the lower bifurcation panel (vertical wall) of the inner barrel inner skin. Areas of the lower bifurcation panel exhibited some of the top coat of the MA25S coating peeled away, was brittle, and had a white/gray discoloration but was intact beneath (**PHOTO 6**). All 5 TR latch hooks (3 located on the outer barrel, 1 on the torque box forward wall, and 1 located on the inner barrel) were in good condition, intact, and functioned properly. The guide pin hole located near the front of the TR was undamaged. The bypass air flow path exhibited no damage and the TR hardware such as the blocker doors and blocker door drag link. The translating sleeve was in good condition. All the thermal and fire damage was located in a designated fire zone.

PHOTO 6: RIGHT TR INNER BARREL INNER SKIN THERMAL DAMAGE

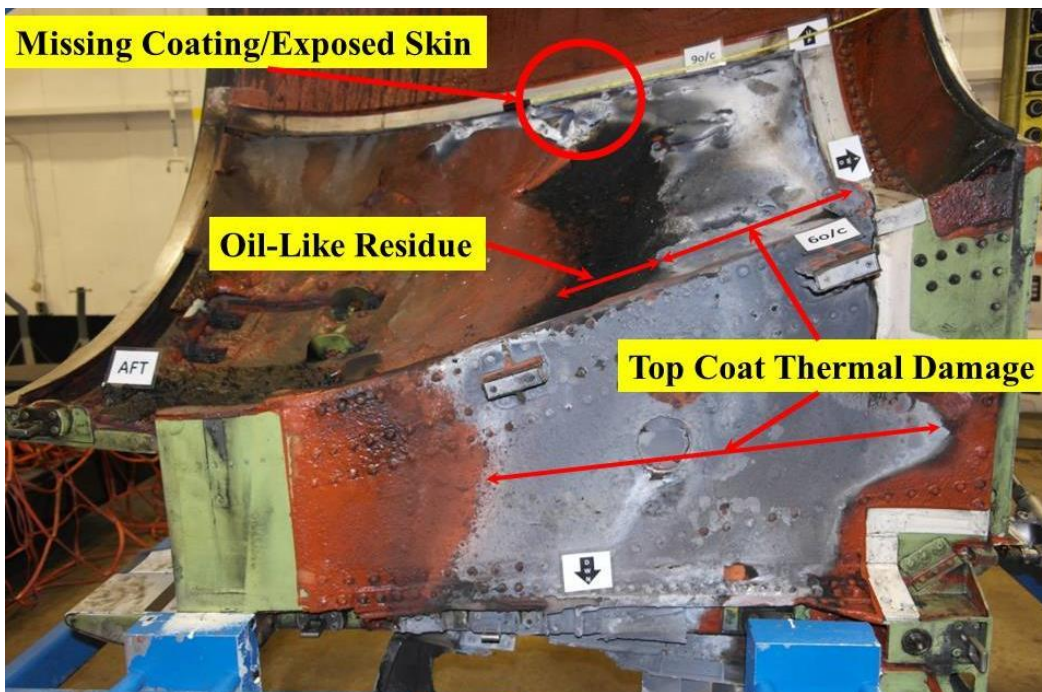
The left TR exhibited more thermal and fire damage than the right TR. All the thermal damage was located within the area surrounded by engine heatshield bulb seal land (**PHOTO 7**). The thermal damage to both the curved portion of the TR inner barrel skin and the lower bifurcation panel was concentrated on the forward part of the TR. The majority of the thermal damage to the curved portion of the inner barrel skin extended from the bulb seal land to about 19-inches aft of the leading edge. The top coat of the MA25S coating in this area turned white/gray in color with the coating beneath appearing to be intact except for a 3 x 5-inch triangular-shaped portion near the longitudinal bulb seal land where the MA25S coating was consumed. The aluminum inner barrel skin beneath the consumed MA25S coating was visible but no burn-through or apparent thermal damage was noted. An oil-like residue was also noted on top of the MA25S coating aft of the white/gray discolored area with

the MA25S coating beneath appearing to be intact. The lower bifurcation panel exhibited similar thermal damage to the top coat consisting of the MA25S coating turning white/gray in color. This area of top coat damage extended from the bulb seal land to about 27-inches aft of the leading edge; the coating beneath appeared to be intact. The IDG access door was found in the CLOSED and latched position, and the latches and the return springs were in good condition and functioned properly. Initial photos provided by DAL of the airplane at LAX shows the IDG access door was in the OPEN position. DAL mechanics at LAX who worked on the airplane after the event indicated that when they first arrived at the airplane that everything was normal, saw some oil dripping from the core cowl, and decided to open up the TR and core cowls to gain access to the engine. The mechanics made no mention of the IDG access door in the OPEN position, so it is assumed that it was initially CLOSED but was opened as the mechanics gained access to the engine as shown in **PHOTO 2** and was not opened as a result of a nacelle over pressurization event. All five latch hook keepers and the TR guide pin were in good condition and intact. Similar to the right TR, the bypass air flow path exhibited no damage, and the TR hardware such as the blocker doors and blocker door drag links and the translating sleeve were in good condition. All the thermal and fire damage was located in a designated fire zone.

PHOTO 7: LEFT TR INNER BARREL INNER SKIN THERMAL DAMAGE

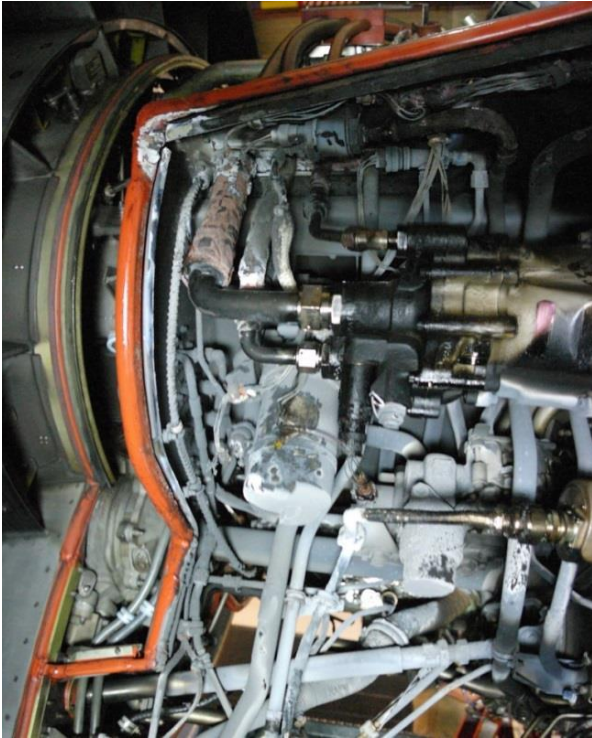
Thermal damage consisting of melted and consumed wire insulation and P-clamp insulation, exposed wiring, accessory gearbox fire loop isolators melted or consumed, and sooting was observed underneath the accessory gearbox heatshield from the 6:00 o'clock position to approximately the 8:30 o'clock position forward of the accessory gearbox (**PHOTO 8**). No thermal damage was noted on the right side of the engine underneath the heatshield (**PHOTO 9**), or aft or above the heatshield; only oil-like deposits and drips were noted on the right side of the engine both underneath and aft of the heatshield. The rubber clamping block for the drain lines located at the 6:00 o'clock position exhibited thermal damage (rubber was brittle and crumbly) and on the left side was partially consumed exposing one of the attachment bolts. On the right side of the clamping box, thermal damage was observed but

the rubber remained pliable. The section of the accessory gearbox fire loops that ran along the drain lines at the 6:00 o'clock position and its electrical junction box were intact and sooted; the four isolators from the electric junction box rearward were either present with thermal damage or totally consumed.

PHOTO 8: FIRE DAMAGE ON LEFT SIDE OF ENGINE UNDERNEATH HEATSHIELD

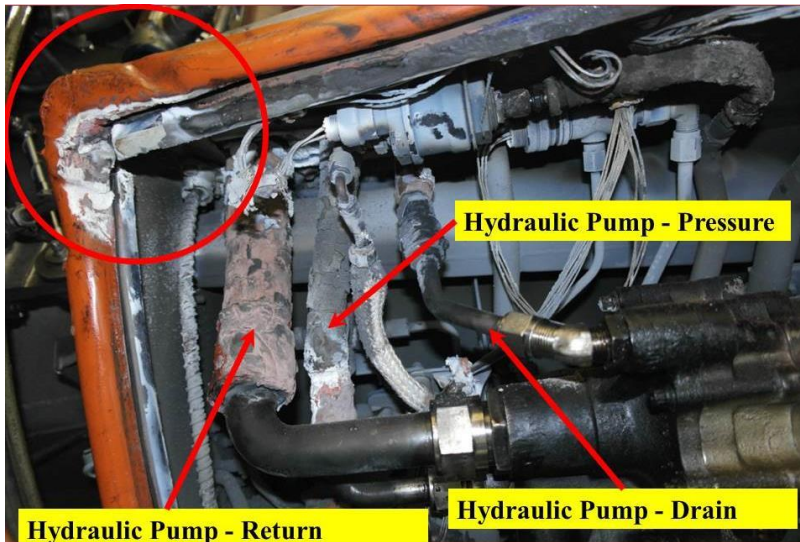
The fire proof bulb seal runs along the perimeter of the engine heatshield and mates with the TR. The entire heatshield bulb seal was in good condition, pliable, and the typical red/orange-color except at two locations. The bulb seal on the front left corner of the heatshield (transition corner from the vertical to the longitudinal part of the seal) exhibited thermal distress, discoloration (white-ash color), and consumption of part of the seal (**PHOTO 10**). The vertical bulb seal on the left side of the bifurcation exhibited thermal distress to the glossy top coat but remained intact and pliable (**PHOTO 11**). All the other bulb seals were undamaged.

PHOTO 10: LEFT SIDE CORNER BULB SEAL DAMAGE

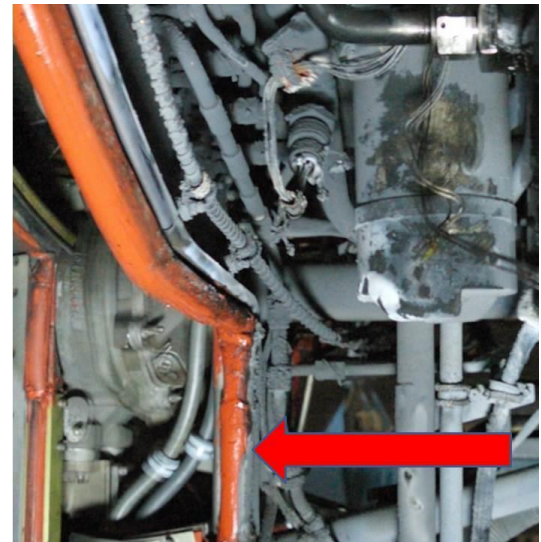
PHOTO 11: LEFT SIDE VERTICAL BIFURCATION DAMAGE

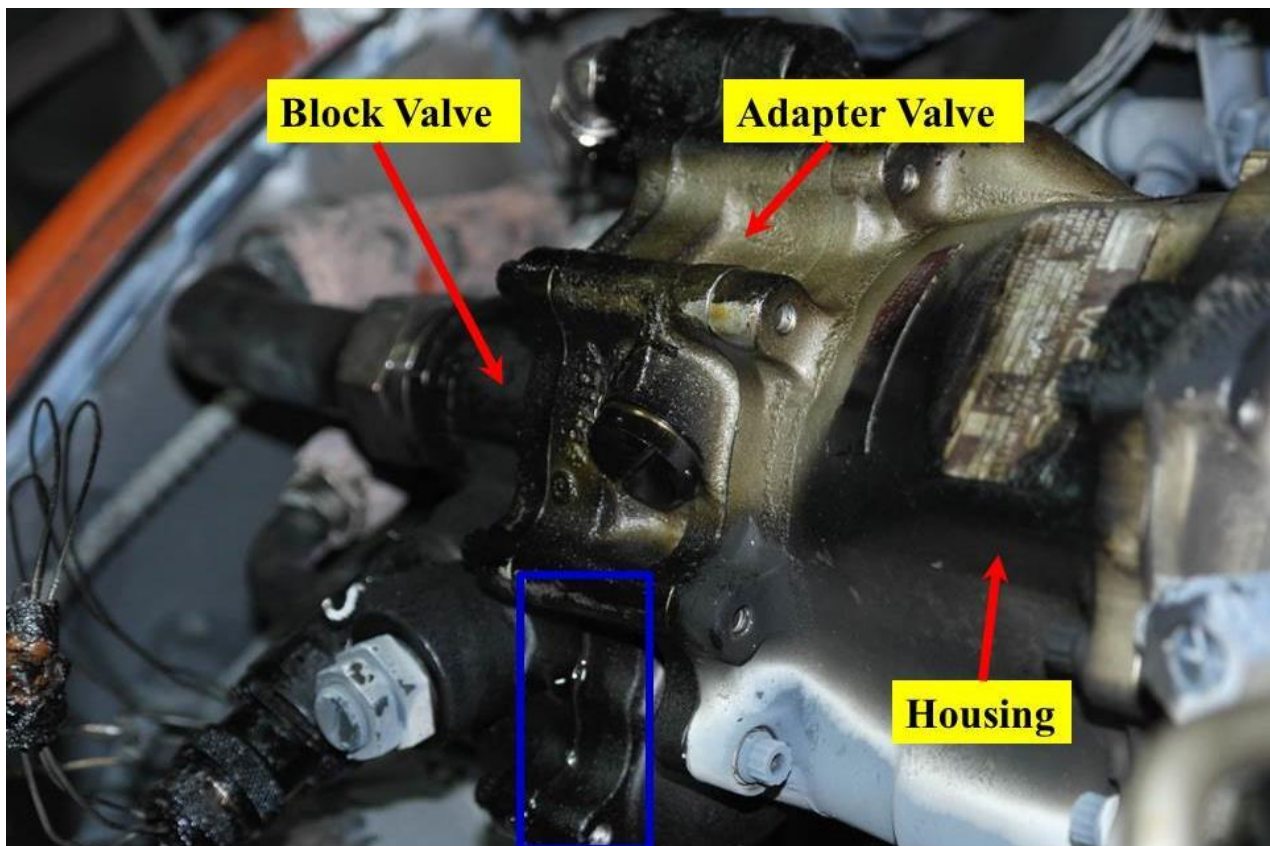
With the pressure and return lines capped where those lines connect to the airplane pylon, 100 pounds per square inch (psi) of air pressure was introduced into the case drain line and held. A decrease in air pressure would indicate a leak; the air pressure held at 100 psi. This test was repeated with the pressure and case drain lines capped and air introduced into the return line with similar results; no loss of air pressure. When the return and case drain lines were capped and air introduced into the pressure line, the air pressure slowly decreased but stabilized at about 52 psi. Initial observation indicated that fluid leaked from the forward flange area between the valve block and control subassembly (subsequently referred to as the valve block) and adapter and case relief valve subassembly (subsequently referred to as the adapter valve) (**PHOTO 12 – SEE BLUE BOX TO DROPLETS**). The hydraulic pump was removed (very little hydraulic fluid was present confirming the fact that the hydraulic fitting has been disconnected prior to the engine’s arrival at TechOps) and was disassembled to ascertain the condition of the flange seals (See Section 5.1 ‘HYDRAULIC PUMP DISASSEMBLY’ for results).

PHOTO 12: HYDRAULIC PUMP LEAK

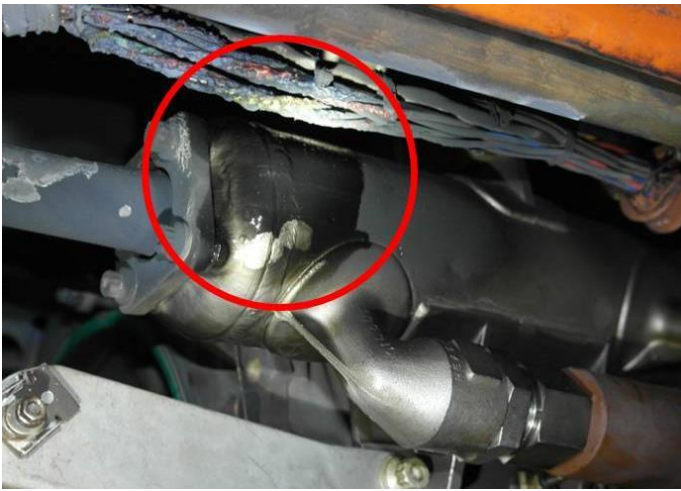
With the hydraulic pump removed, wet motoring of the engine was accomplished by installing a blanking plate where the hydraulic pump had been installed, a fuel line was connected to the inlet port of the main fuel pump, an electrical connection to the fuel shutoff solenoid to shuttle the valve OPEN or CLOSE and an air supply line to the air starter to rotate the core. Wet motoring involves rotating the engine and introducing fuel to the fuel system (fuel shutoff in the OPEN position) with no ignition (**FIGURE 5**). Wet motoring of the engine revealed a fuel leak from the IDG fuel/oil heat exchanger main housing just aft of the forward weld (fuel inlet port) at about the 12:00 o'clock position as installed in the engine (**PHOTO 13**). The forward weld attaches the inlet port cap to the main housing body. There is a similar aft weld used to attach the outlet port cap to the main housing body. Removal of the unit revealed a surface circumferential imperfection that measured about 4³/₄-inches (about a 90° arc) and was located approximately 0.80-inches aft of the inlet port circumferential weld in main housing body (**PHOTO 14**). Fluid was found weeping from the surface imperfection indicating a through-wall crack (**PHOTO 14**). The cracked measured about 0.25-inches circumferentially. The IDG fuel/oil heat exchanger was sent to the TechOps fuel shop for pressure testing (See Section 5.2 'IDG FUEL/OIL HEAT EXCHANGER TESTING' for results).

PHOTO 13: FLUID LEAK FROM TOP OF IDG FUEL/OIL HEAT EXCHANGER AFTER WET MOTOR

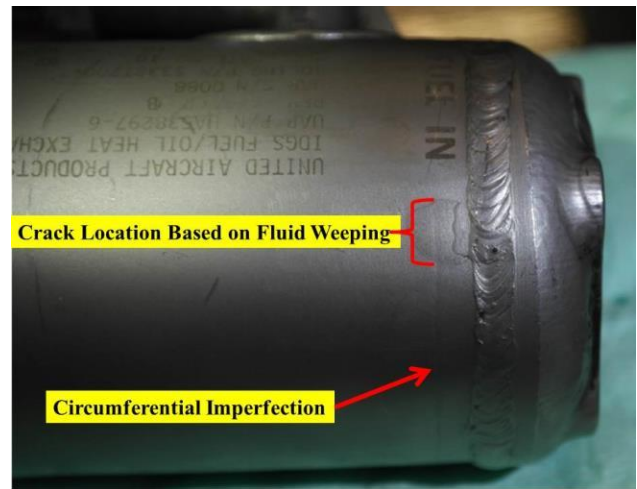
PHOTO 14: IDG FUEL/OIL HEAT EXCHANGER CRACK & CIRCUMFERENTIAL IMPERFECTION

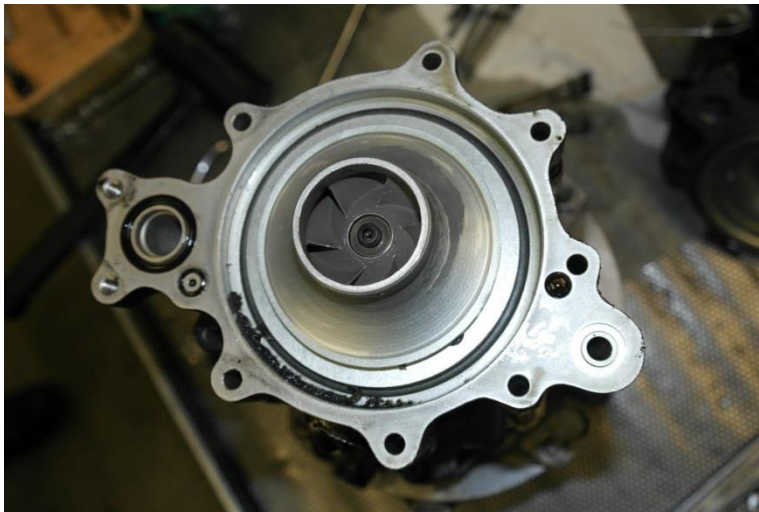
The valve block was separated from adapter valve exposing the impeller. The impeller was intact and black debris was found slung out on the diffuser (**PHOTO 15**). The debris was not brittle but somewhat pliable. The valve block packing used to seal between the valve block and adapter valve was intact, pliable, and exhibited no compression set but was not tightly seated within its recess groove on the valve block as intended but was loose. Comparing a new exemplar valve block packing with the event valve block packing revealed that the event packing diameter was larger, consistent with it expanding or swelling (**PHOTOS 16** and **17**). The two other packings on the adapter valve appeared intact and in good condition.

PHOTO 15: BLACK DEBRIS IN HYDRAULIC PUMP

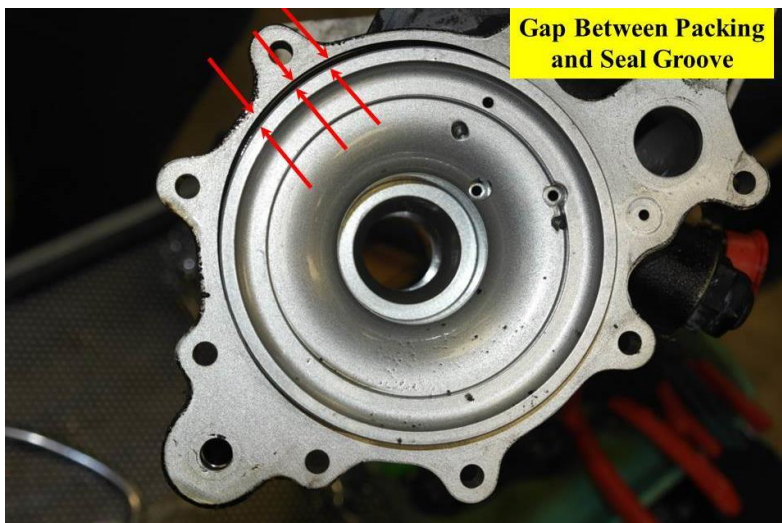
PHOTO 16: EVENT VALVE BLOCK PACKING LOOSE WITHIN RECESS GROOVE OF THE VALVE BLOCK

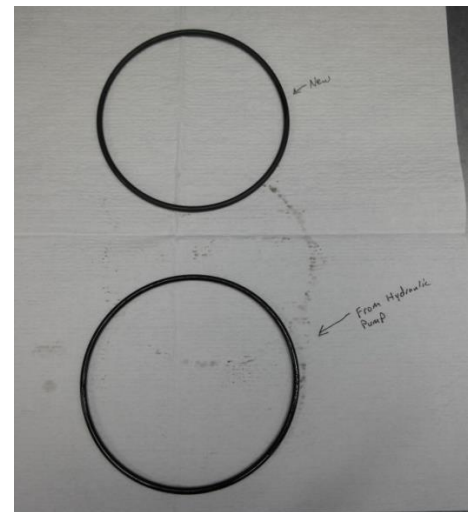
PHOTO 17: COMPARISON OF EXEMPLAR AND EVENT PACKING

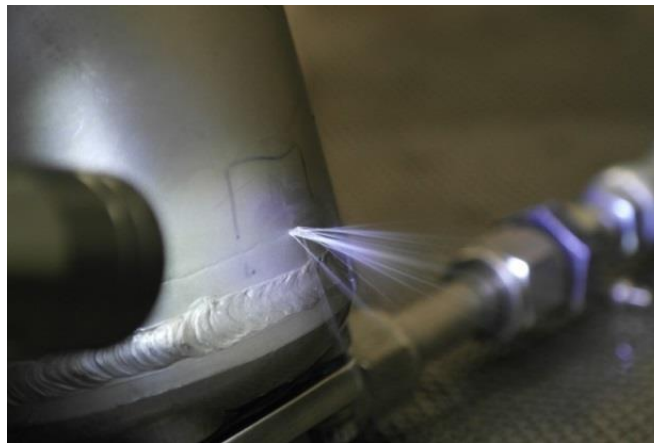
The test was performed on Fuel Flow Test stand #22 (46271), with a calibration sticker indicating re-calibration due date of May 9, 2015. With the oil inlet and outlet ports capped, fluid was flowed at various pressures through the core and fluid was observed spraying from the crack previously identified. At 10 pounds psi fluid pressure a light spray was observed (**PHOTO 18**). According to the IDG Fuel/Oil Heat Exchanger Component Maintenance Manual (CMM) the fuel side of the unit is pressure checked by capping off the fuel outlet port and applying 1800 ± 20 psi fuel pressure to the inlet port for 2 minutes. No external or internal leakage is permissible. Due to concerns with the structural integrity of the unit because of the main housing body crack, the Powerplant Group decide not to bring the pressure up to the CMM test pressure of 1800 ± 20 psi but instead agreed to bring the pressure up to only 400 psi. At 60 psi fluid pressure, the spray pattern was more pronounced. At 100 psi fluid pressure, the spray pattern was visible essentially the same as at 60 psi test point (**PHOTO 19**). At 250 psig fluid pressure, the spray pattern was visible essentially the same as at 60 psi and 100 psi test points

but appeared a little more dense (**PHOTO 20**). At the last test point of 400 psi fluid pressure, the spray pattern fanned out more and the spray appeared more atomized (**PHOTOS 21 and 22**).

PHOTO 20: LEAK AT 250 PSI FLUID PRESSURE

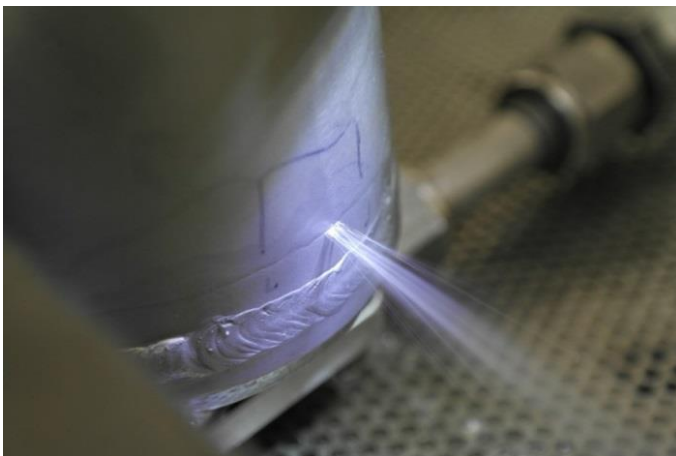
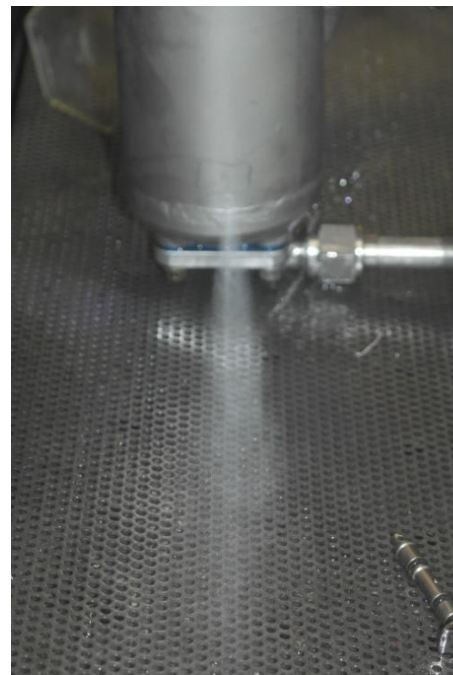
PHOTO 21: LEAK AT 400 PSI FLUID PRESSURE

PHOTO 22: LEAK AT 400 PSI FLUID PRESSURE

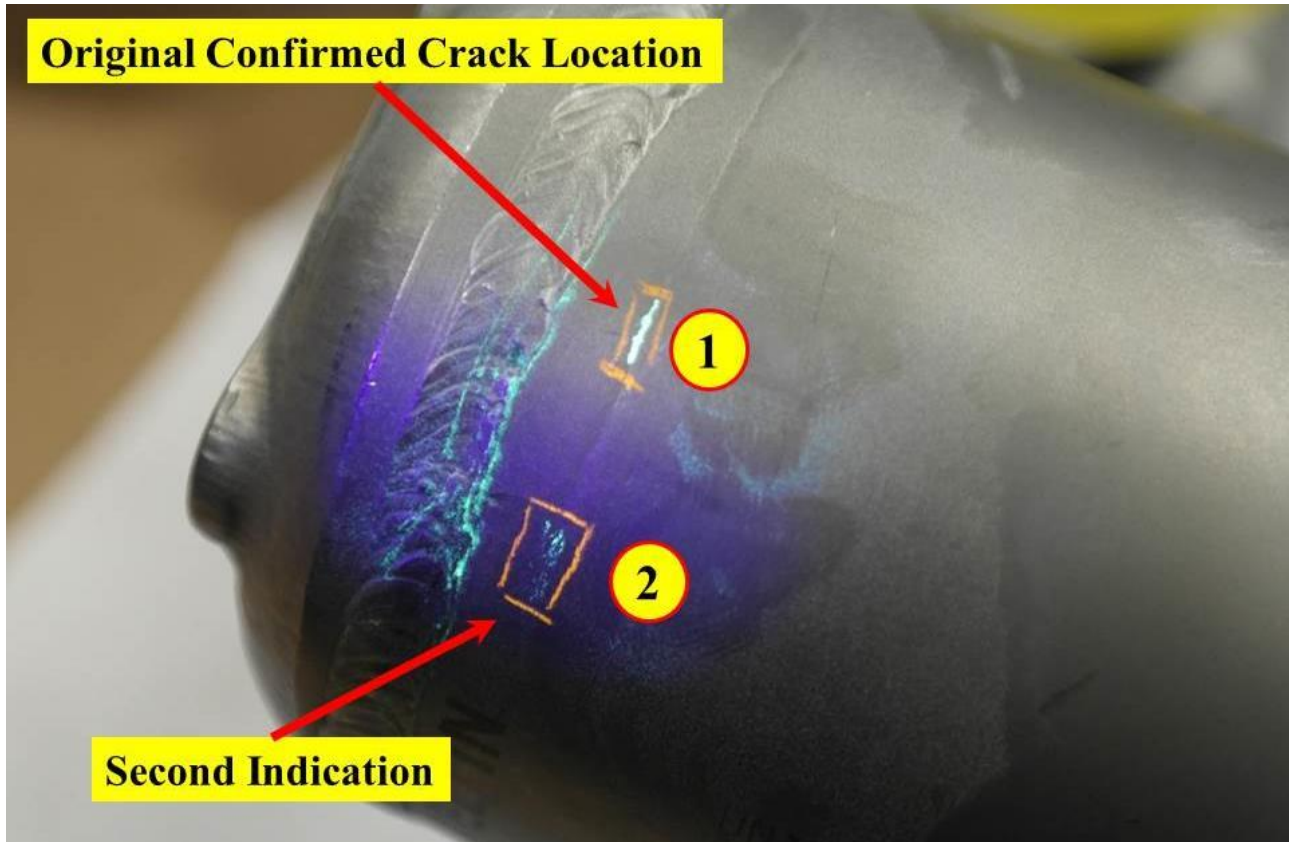
After the pressure test, a florescent penetrant inspection (FPI) was performed on the main body housing. The through-wall crack location ❶ held the penetrant as did a second surface indication ❷ (PHOTO 23), also aligned with the circumferential surface imperfection previously documented in PHOTO 14. This second indication measured about 0.25-inches in length. Looking into the inlet fuel port, penetrant was observed at the core-to-main body housing junction. An attempt was made to x-ray the housing to quantify the crack; the location of the crack coupled with the density of the housing and the inner core prevented the crack from being observed.

PHOTO 23: IDG FUEL/OIL HEAT EXCHANGER MAIN HOUSING FPI INDICATIONS

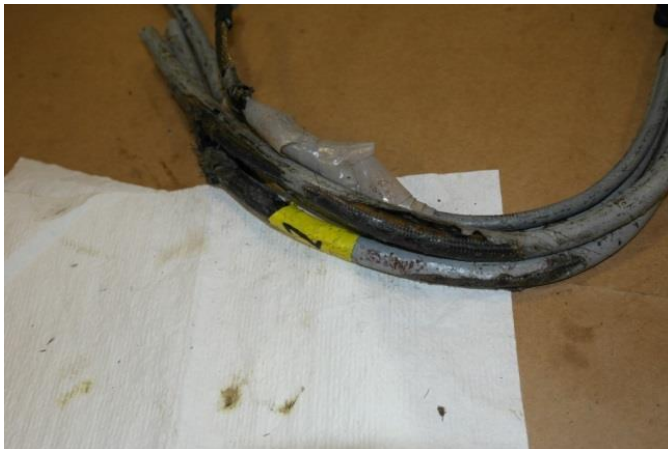
Examination of the IDG power feeder cables revealed thermal distress that included melted and missing outer protective sheathing, exposed inner cloth insulation, and exposed electrical cable (PHOTO 24). The IDG is mounted to the aft left hand side of the accessory gearbox and converts the varying input speed of the engine into 115/200 voltage (V), 3-phase (hence the 3 power cables and 1 neutral cable), 90 kilovolt-amperes (KVA) at 400±4 hertz (H) frequency. The electrical power feeder cables provide the transmission of the alternating current (AC) power to the airplane's electrical power

PHOTO 24: THERMAL DISTRESS TO IDG POWER FEEDER CABLES

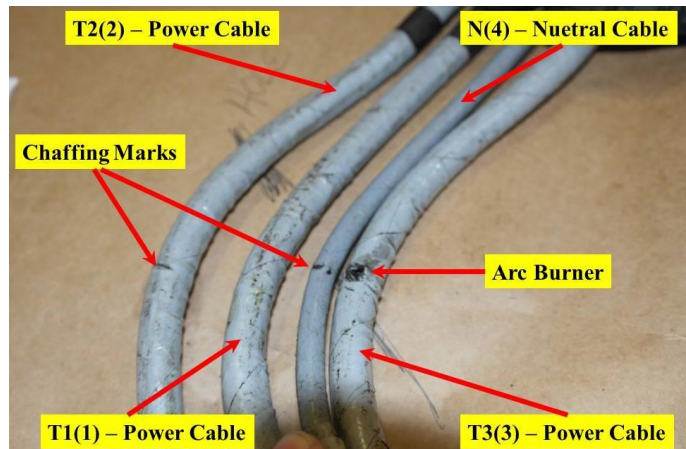
distribution system. Closer examination of the power feeder cables revealed evidence of chafing on the outer sheath of cables Nos. 2 and 4 and evidence of an arc burn on cable No. 3 (**PHOTO 25**).

PHOTO 25: CHAFE MARKS AND ARC BURN ON IDG POWER FEEDER CABLES

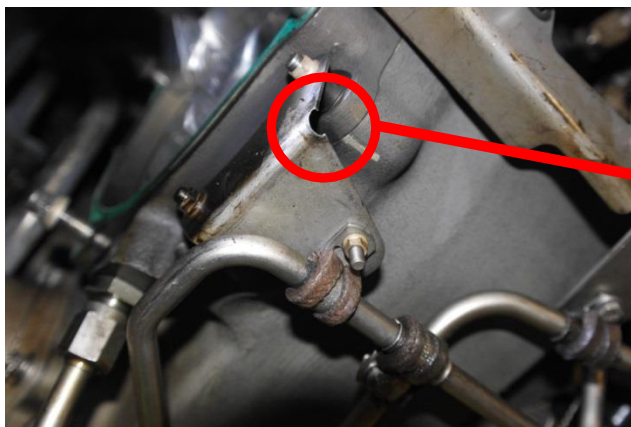
Examination of the engine hardware along the path of the IDG power feeder cables from their IDG terminal block to the pass-through hole in the engine heatshield revealed that the accessory drive lube and scavenge pump pressure (supply) line support bracket (PN 9254M14P001A), which is located on the front side of the accessory gearbox just below the hydraulic pump pad, exhibited signs of an arc burn (**PHOTOS 26** and **27**). For simplicity the accessory drive lube and scavenge pump pressure line support bracket will be subsequently referred to as the 'oil line bracket'.

PHOTO 26: OIL LINE BRACKET CORNER CONSUMED

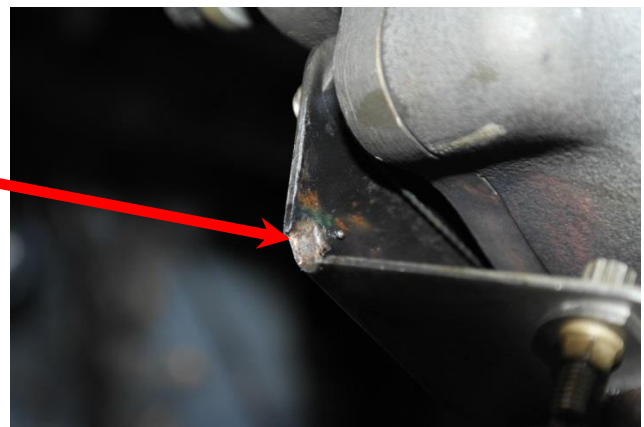
PHOTO 27: MOLTEN METAL ON AFT SIDE OF OIL LINE BRACKET

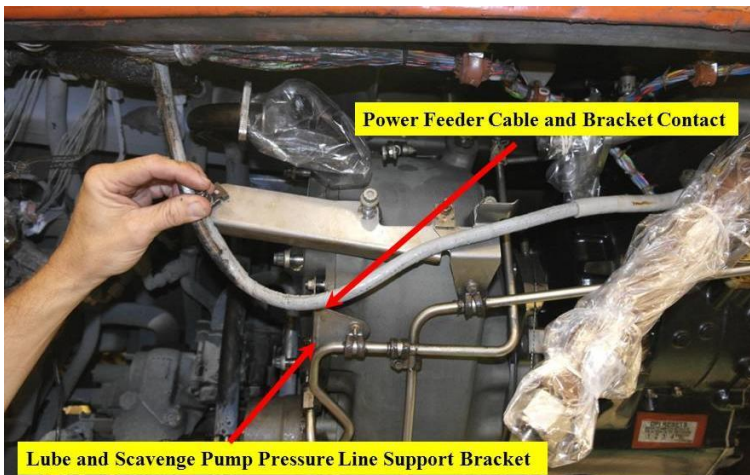
Power feeder cable No. 3 that had the arc burn was reinstalled on the engine to access the relative position of the arc burn observed on the cable to the oil line bracket that also had an arc burn. The No. 3 feeder cable was reinstalled as close to the event orientation as possible (**PHOTO 28** – See **PHOTOS 3** and **30** for at event installation position). The arc burn on the No. 3 cable aligned closely with the arc burn on the corner of the oil line bracket (**PHOTO 29**).

PHOTO 28: POWER FEEDER CABLE NO. 3 REINSTALLED SIMILAR TO EVENT INSTALLATION ORIENTATION

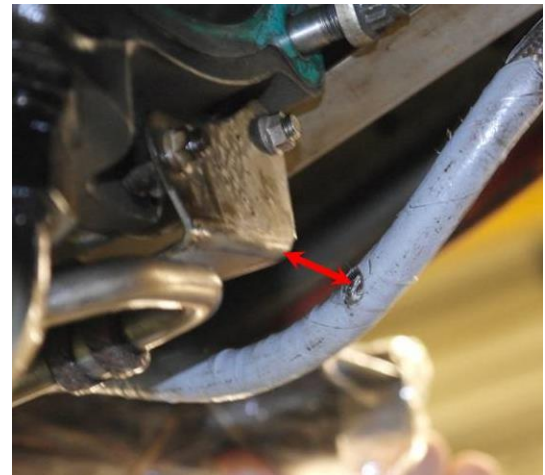
PHOTO 29: MATCHING ARC BURN DAMAGE ON POWER FEEDER CABLE AND OIL LINE BRACKET

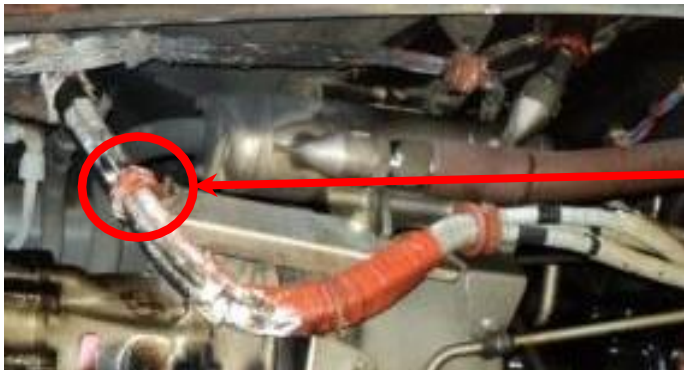
The slack observed on the IDG power feeder cables for the event engine was compared to an exemplar DAL 767 CF6-80A powered airplane. On the exemplar engine, the power feeder cables ran along the power feeder cable support bracket (PN 332T1111-142)⁵ and had no slack before it passed-through the engine heatshield (**PHOTO 31**), which was not the case in the event installation. For simplicity the power feeder cable support bracket will be subsequently referred to as the ‘cable bracket’. Also noted was the difference in orientation of the forward P-clamp; on the event engine the clamp was oriented down (attachment bolt is above the clamp) and on the exemplar engine the clamp was oriented up (attachment bolt is below the clamp). The correct orientation of the forward P-clamp is up (See Section 6.0 for more details). Also noted was the amount of tape to bundle the event power feeder cables was much more extensive than what was observed on the exemplar engine.

PHOTO 30: EVENT ENGINE IDG POWER FEEDER CABLE ORIENTATION WITH FORWARD P-CLAMP DOWN

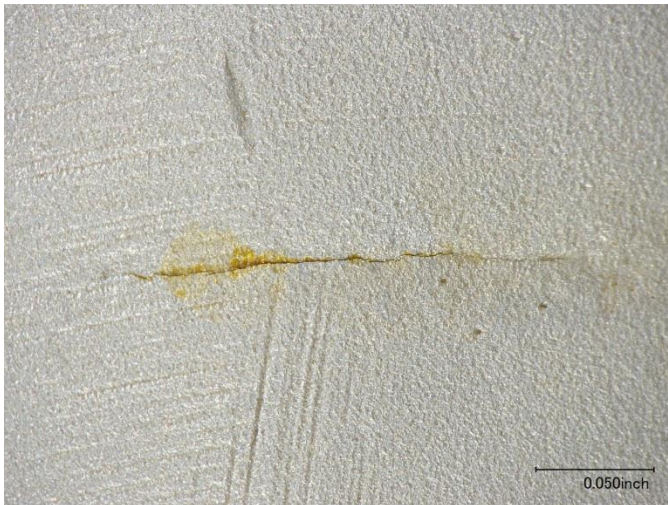
The IDG fuel/oil heat exchanger was submitted to the NTSB Materials Laboratory in Washington DC for a metallurgical examination. The OD of the main housing was examined in more detail using a 5X to 50X magnification stereo-zoom microscope. The through-wall crack (❶ in **PHOTO 23**) was a distinct linear crack exhibiting a brown-colored stain around it (**PHOTO 32**). The second indication area (❷ in **PHOTO 23**) was confirmed to be very short linear cracks that appeared to be linked together by nonlinear bridging cracks and consisted of a cluster of small lines and dots (**PHOTOS 33** and **34**). This second crack was not a through-wall crack and was co-located within what appears to be a weld/braze bead (**PHOTOS 33** – yellow dotted line).

PHOTO 32: HIGH MAGNIFICATION OF THROUGH-WALL CRACK (❶)

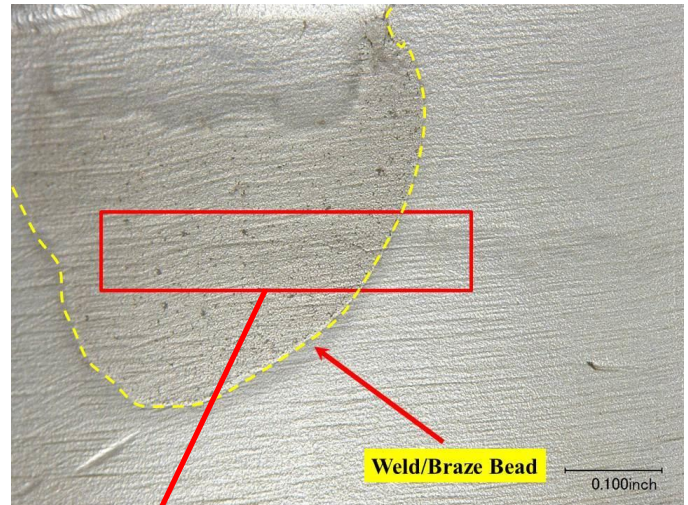
PHOTO 33: HIGH MAGNIFICATION OF NON THROUGH-WALL CRACK (❷)

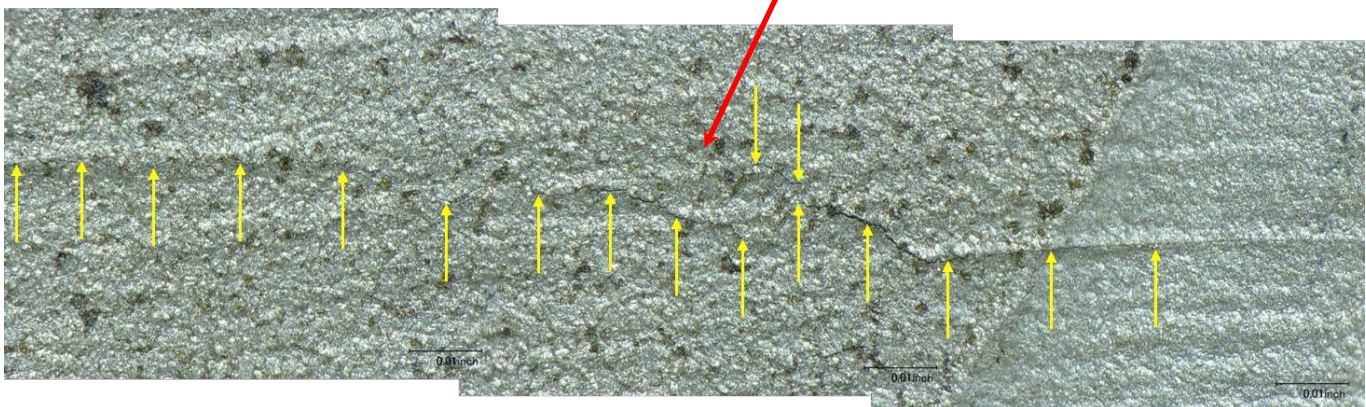
PHOTO 34: HIGHER MAGNIFICATION OF NON THROUGH-WALL CRACK (❷)

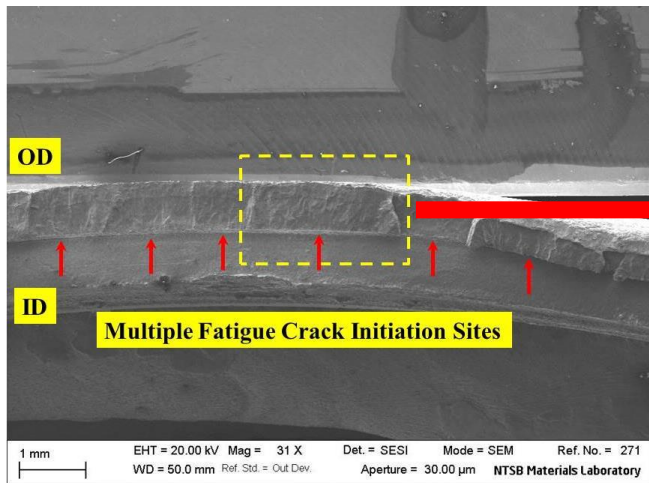
The main housing was sectioned in the area near the through-wall (❶) and the non-through wall cracks (❷), the cracks were mechanically exposed, and the fracture surfaces were analyzed in a field emission scanning electron microscope (SEM). The through-wall crack fracture surfaces showed features consistent with multiple fatigue crack initiation sites that included thumbnail-shaped patterns and ratchet marks (**PHOTOS 35** and **36**). A distinct step was observed on the fracture surfaces approximately two-thirds of the way through the housing wall thickness from the ID of the housing (See **PHOTO 36** – yellow dotted line). The multiple fatigue cracks emanated from the ID surface of the

housing and propagated radially towards the OD and the crack orientation - circumferential instead of longitudinal - was more consistent with high longitudinal stresses than with hoop (radial) stresses (FIGURE 6). The fracture surfaces of the non through-wall crack also consisted of features consistent with fatigue cracking. However different from the through-wall crack, the non through-wall crack had multiple small OD surface cracks with a larger ID crack; the ID and OD cracks did not link up to produce a through-wall crack (PHOTO 37). The OD cracks appeared to be confined to the weld/braze bead.

PHOTO 35: MULTIPLE THROUGH-WALL CRACK INITIATION SITES

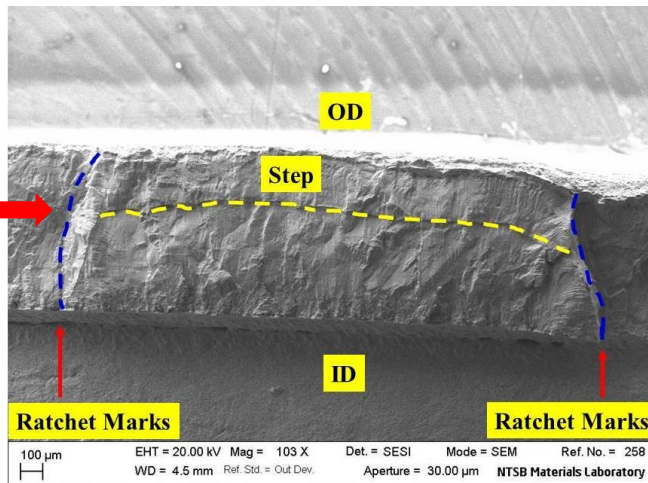
PHOTO 36: THROUGH-WALL CRACK FRACTURE FEATURES

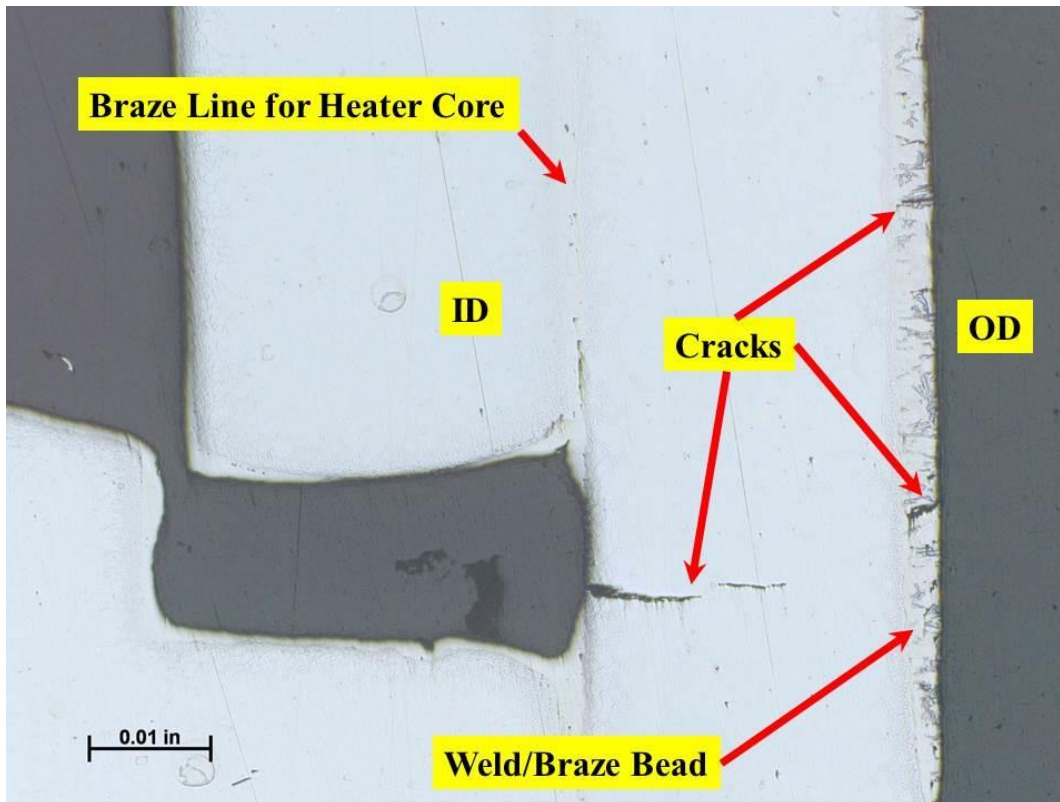
PHOTO 37: NON THROUGH-WALL CRACK (②) LOCATION SHOWS ID AND OD CRACKING (UNETCHED)

Cross-sections were prepared through both the through-wall and the non through-wall cracks. In both locations, the cracks were relatively flat and transgranular, and were consistent with fatigue cracking. No anomalies were detected in the area of the cracks or at the fatigue crack origins. The microstructure of the base material of the housing was consistent with austenitic stainless steel. The housing material was analyzed using a Thermo Scientific Niton XL3T-980 x-ray fluorescence (XRF) alloy analyzer. The housing material was consistent with Type 321 stainless steel as specified by the manufacturer.

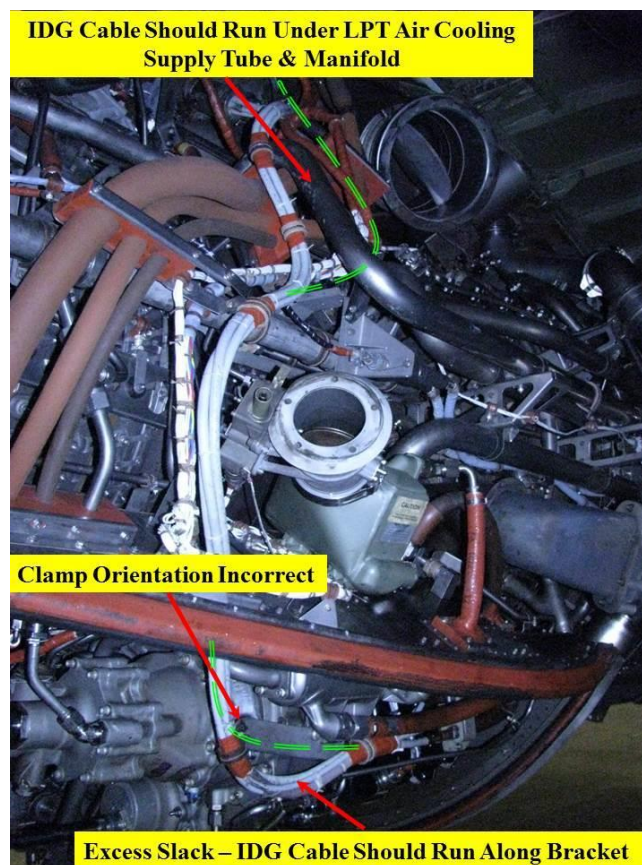
DAL reported that of the 24 installed engines inspected, none exhibited damaged IDG power feeder cables. Along with the chaffing damage, the investigation identified routing issues – above and below the engine heatshield - that contributed to the observed excessive slack in the IDG power feeder cables below the engine heatshield. **PHOTO 38** provides an exemplar of the misrouting of the IDG power feeder cables found during the fleet inspection; the dashed green lines indicate the correct routing. **PHOTO 39** shows the entire routing of the IDG power feeder cables on the event engine. The once-through-the-fleet inspection found that 3 airplanes totaling 3 engines had the excessive slack. Of note, both engines on the event airplane, N139DL, were found to have excessive slack; this included the IDG power feeder cables that had been repaired to return the airplane to service. Subsequently the IDG power feeder cables on all 5 engines were rerouted to remove the slack.

PHOTO 38: MISROUTED IDG POWER FEEDER CABLE FOUND DURING THE FLEET INSPECTION

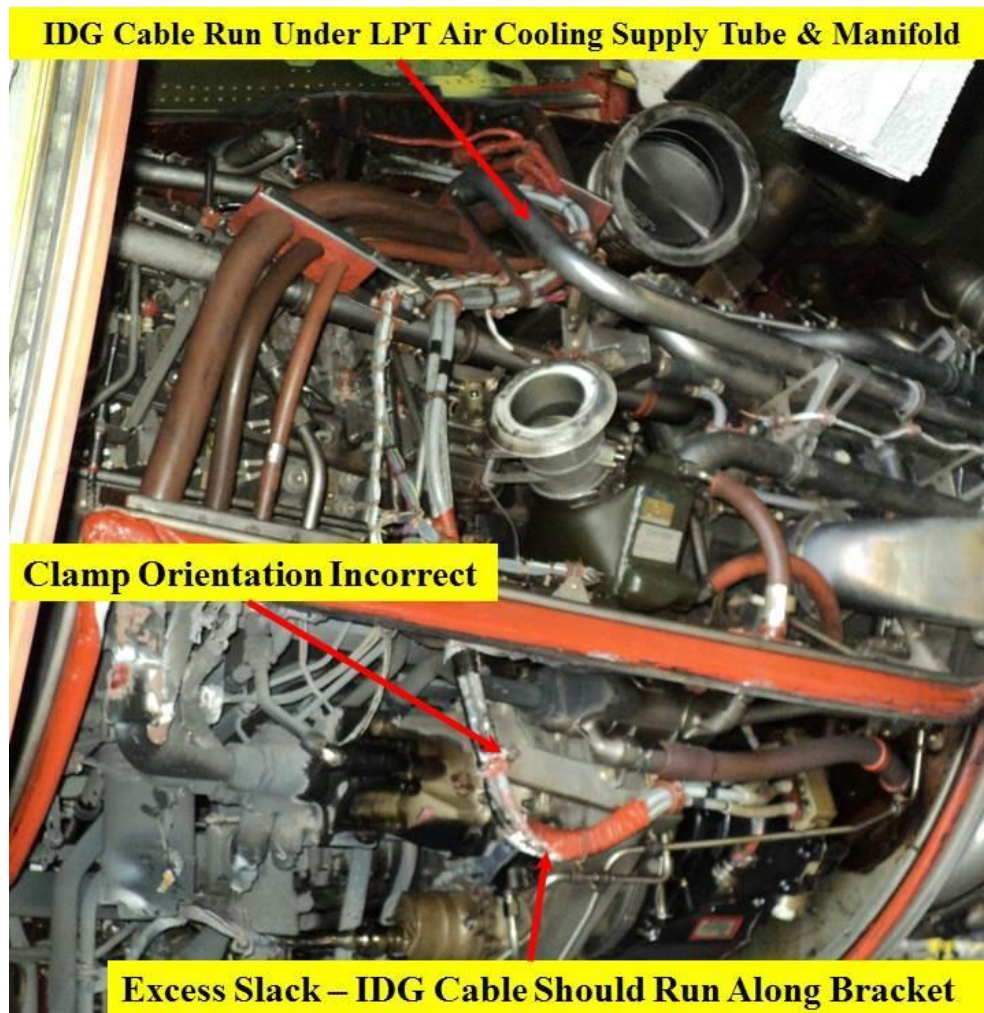
PHOTO 39: MISROUTED IDG POWER FEEDER CABLE ON EVENT ENGINE

Caution: proper generator feeder cable routing and feeder cable clamp orientation is critical to prevent interference with engine components which could cause arcing. Ensure that generator cables do not rub against T/R cowling when closed to prevent chafing of cables.
