**NATIONAL TRANSPORTATION SAFETY BOARD**  
**Office of Aviation Safety**  
**Washington, D.C. 20594**

**POWERPLANT GROUP CHAIRMAN'S FACTUAL REPORT**

**NTSB No: DCA16FA013**

Aircraft: Boeing 767-200ER, N251MY, Dynamic International Airways

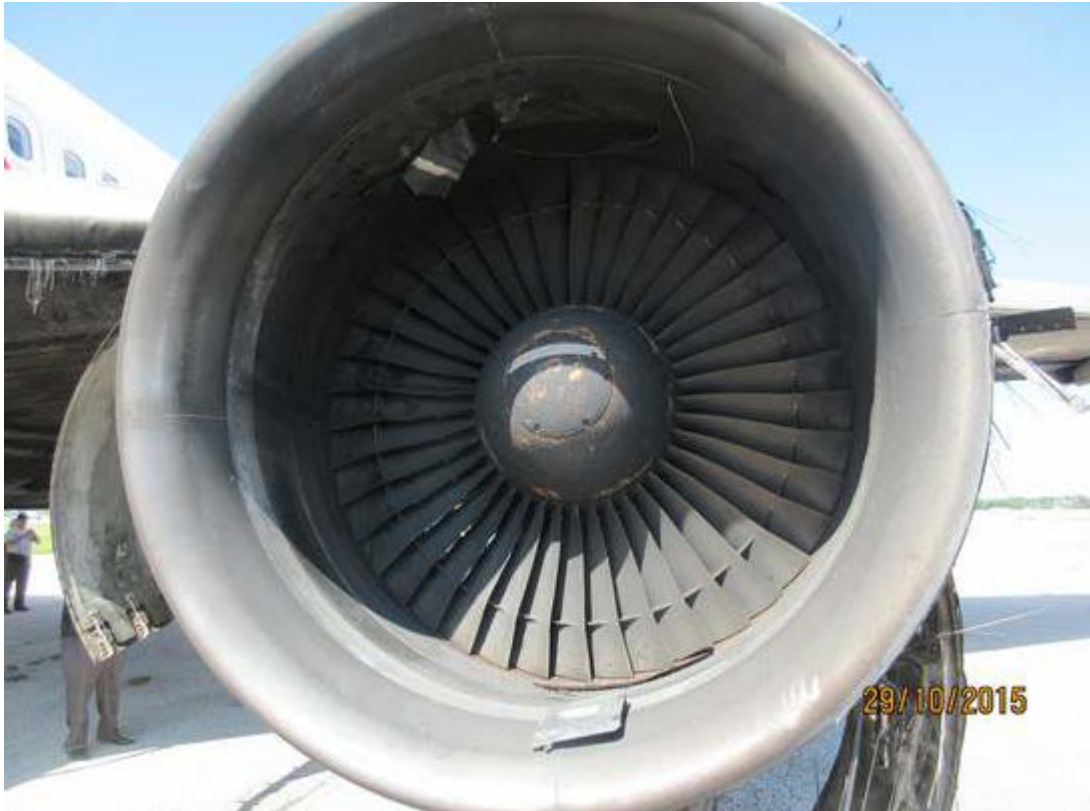
**Photo 1- Left Engine Inlet**

A visual examination of the engine and cowls was performed beginning at the inlet. The fan blades were all intact and in good condition without indications of shingling or tip rub (**Photo 1**). All

fan blades were lightly sooted but did not exhibit thermal distress. Sections of the inlet cowl inner barrel face sheet (aluminum perforated sheet) were sagging and a piece was missing from the 10 to 12:30 positions. The face sheet was rippled and bulged from the 1 to 4 o'clock positions. The spinner was lightly sooted and the paint was bubbled on the cap. A cowl access door and a fabric strip were resting at the bottom of the engine inlet cowl. Both items were placed in the inlet after the aircraft was moved from the taxiway following the fire according to an FAA representative who was on site immediately after the event.

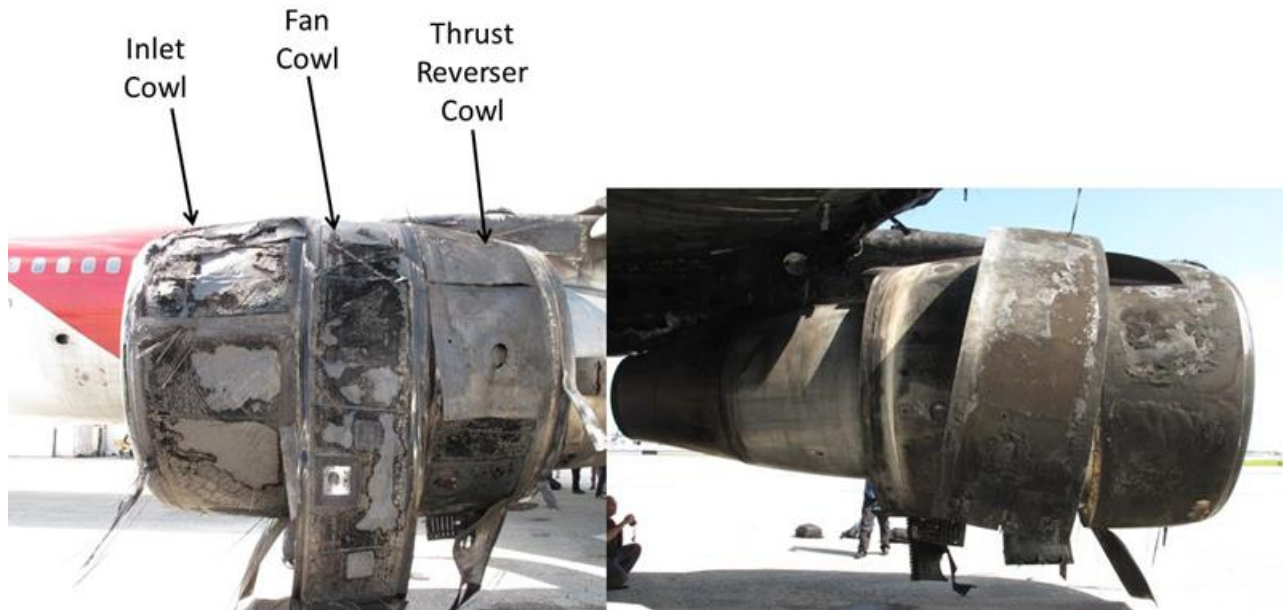
**Photo 2- (L) Outboard Cowlings, (R) Inboard Cowlings**

The inlet cowl was thermally damaged and most of the external ply on the outboard side of the engine was consumed, exposing the honeycomb. Large sections of the honeycomb were missing and the pieces that remained attached to the inlet cowl were charred and brittle from the 6 to 12 o'clock positions (**Photo 2**). A section of the outer diameter inlet cowl lip was thermally consumed from the 8 to 11 o'clock positions and the edges around the consumed area exhibited melting (**Photo 3**). On the inboard side of the engine, the inlet cowl external ply was intact but blistered and flaking. A sheet of the inlet cowl external ply was hanging from the engine at the 6 o'clock position.

When the investigative team arrived, the inboard fan cowl was held open by the support rods and the outboard side of the fan cowl had lost rigidity from the 6 to 9 o'clock positions and was hanging freely (**Photo 2**). The fan cowl was thermally damaged and sections of the external ply on the

outboard side of the engine were consumed and the exposed honeycomb was charred and brittle. The external ply on the inboard side of the engine was present but charred and flaking. The fan cowl hooks and latches were intact.

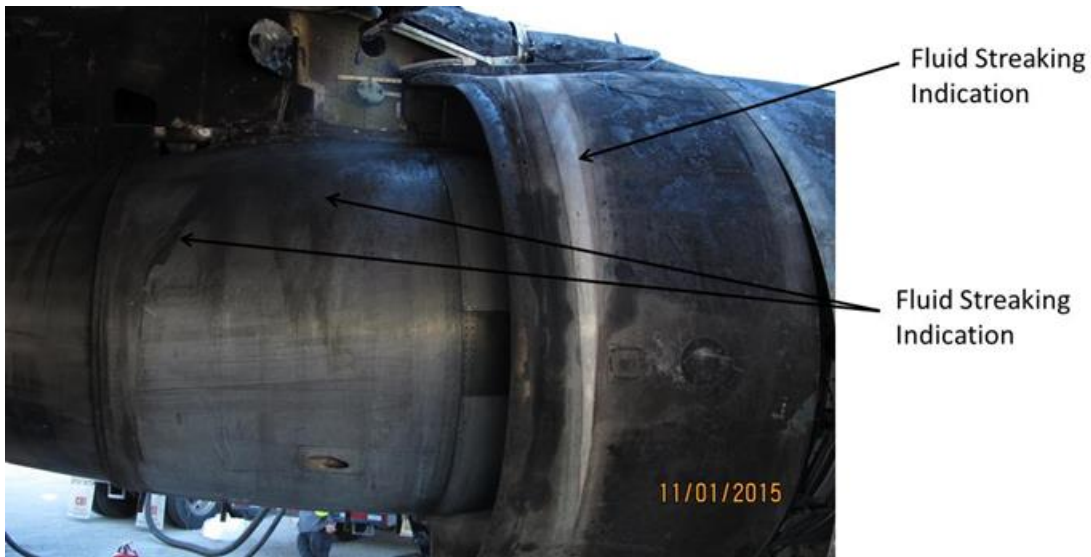
**Photo 4- Thrust Reverser and Core Cowl Streaking – Inboard Side**

The thrust reverser cowl was thermally damaged and the external ply was peeled away from the 6 to 9 o'clock positions. The exposed honeycomb below the peeled external ply was charred and brittle but mostly intact. The external ply from the 9 to 11 o'clock positions was also separated from the honeycomb but remained resting against the case. The inboard side of the thrust reverser cowl was sooted and the external ply exhibited some flaking/charring/bubbling. Indications of fluid streaks were noted about six inches forward of the aft edge of the inboard thrust reverser cowl, originating below the forward strut fairing. The cowl surface where streaks were observed retained a majority of the white cowl paint and exhibited little thermal distress. The streak was about twelve inches wide at the gap below the strut fairing cover and tapered down to a point at the 5 o'clock position (**Photo 4**).

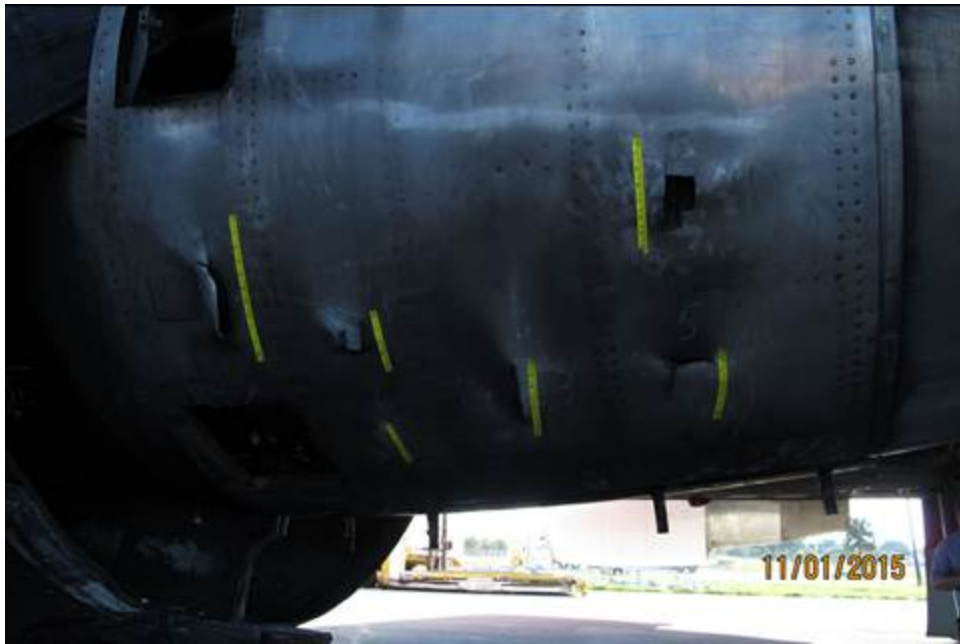
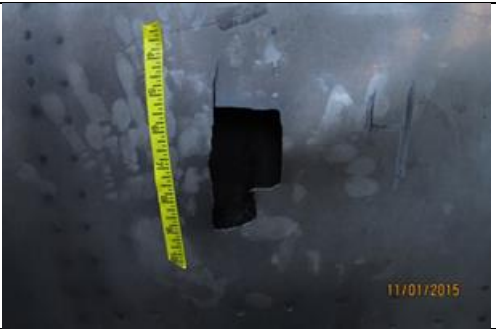
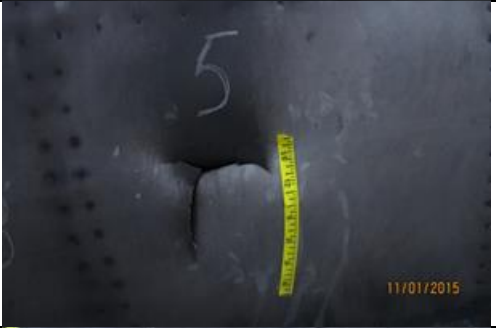
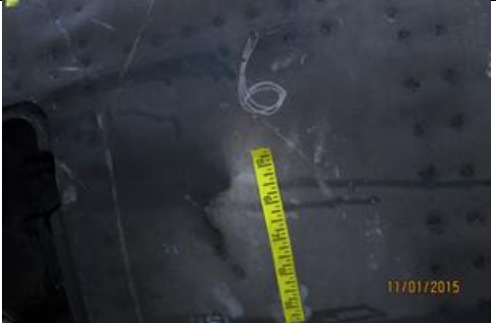
**Photo 5- Core Cowl Thermal Damage, Outboard Side**

The outboard side of the core cowl external aluminum layer exhibited thermal damage including cracking, curling, and/or materials chunking at six locations between the 7 and 9 o'clock positions (**Photo 5 and Table 1**). The inner layer of the core cowl was not breached. The remainder of the core cowl was intact and the external condition was typical of a service run engine according to Boeing and Dynamic Airways. Streaking indications in the form of darker colored residue were observed on the inboard side of the core cowl originating from the strut interface and drain holes and moving in the downward aft direction. The aft most streak indication appeared to emanate from the lower forward corner of the strut pressure relief door.

Location	Dimensions (inches) Circumferential x Axial	Photo
1	10" x 2 3/4"	
2	3" x 3"	
3	6"

4	5" x 2"

5	4" x 4"

6	3"

**Table 1- Core Cowl Thermal Damage- Outboard Side**

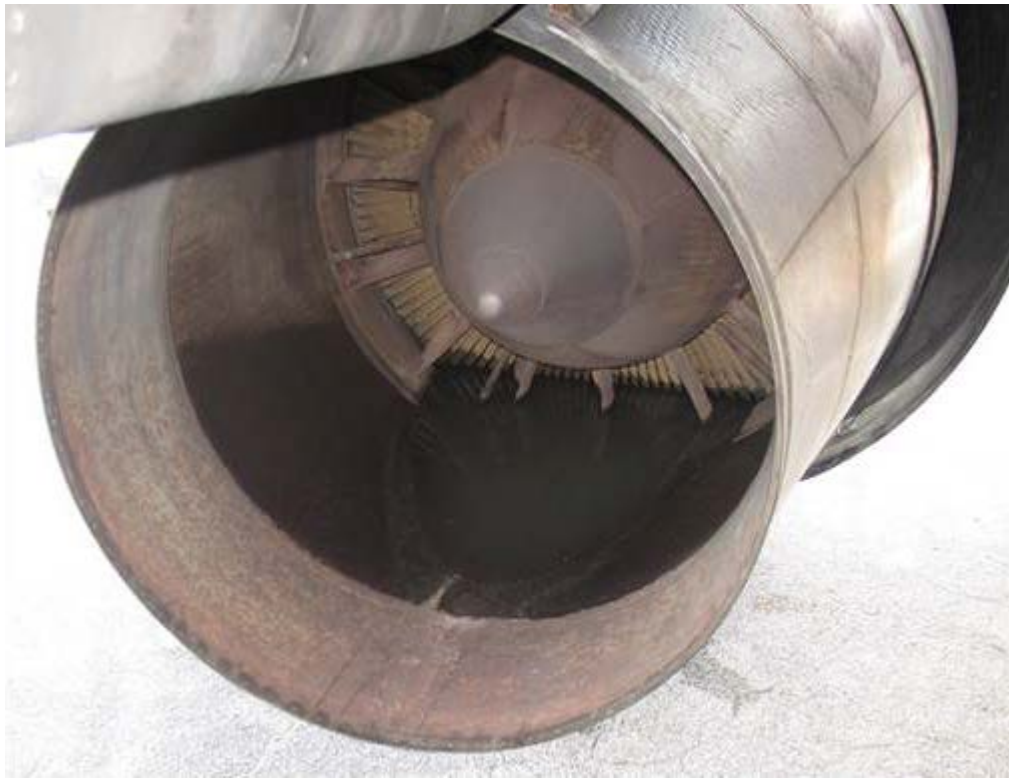
**Photo 6- Left Engine Exhaust**

The fan exit guide vanes and intermediate case struts were all intact. The inner face sheet aft of the reverser block doors was raised and bubbled in the 6 to 9 o'clock location. The sixth stage low pressure turbine blades were intact and in good condition. The tail cone and exhaust plug were present and undamaged. A pool of water was collected in the exhaust nozzle from the firefighting efforts (**Photo 6**).

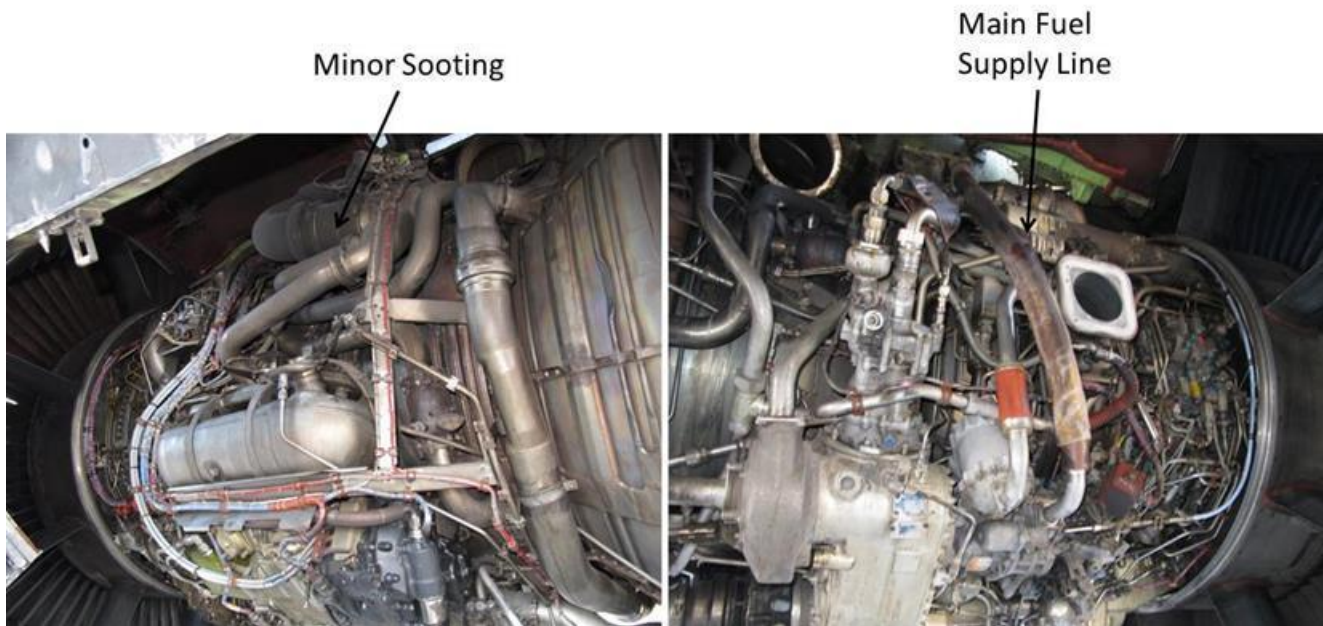
**Photo 7- Left Engine (L) Left, (R) Right**

The cowls were raised to examine the engine. The engine cases did not exhibit any indications of uncontainment or thermal distress (**Photo 7**). There were no visual indications of fuel leakage, including areas around the main fuel supply line from the strut to the fuel pump. The engine had light sooting most concentrated at the 12 o'clock position on the aft half of the engine. There was no evidence of thermal distress on the wire insulation or clamps. The three fire loops (left upper, right upper, and lower forward) were traced around the engine and were all complete and the teflon grommets were in good condition. The oil tank was opened and the oil level was near the maximum fill line and did not have an acrid smell. The fan was rotated by hand and spun freely with concurrent rotation of the low pressure turbine blades.

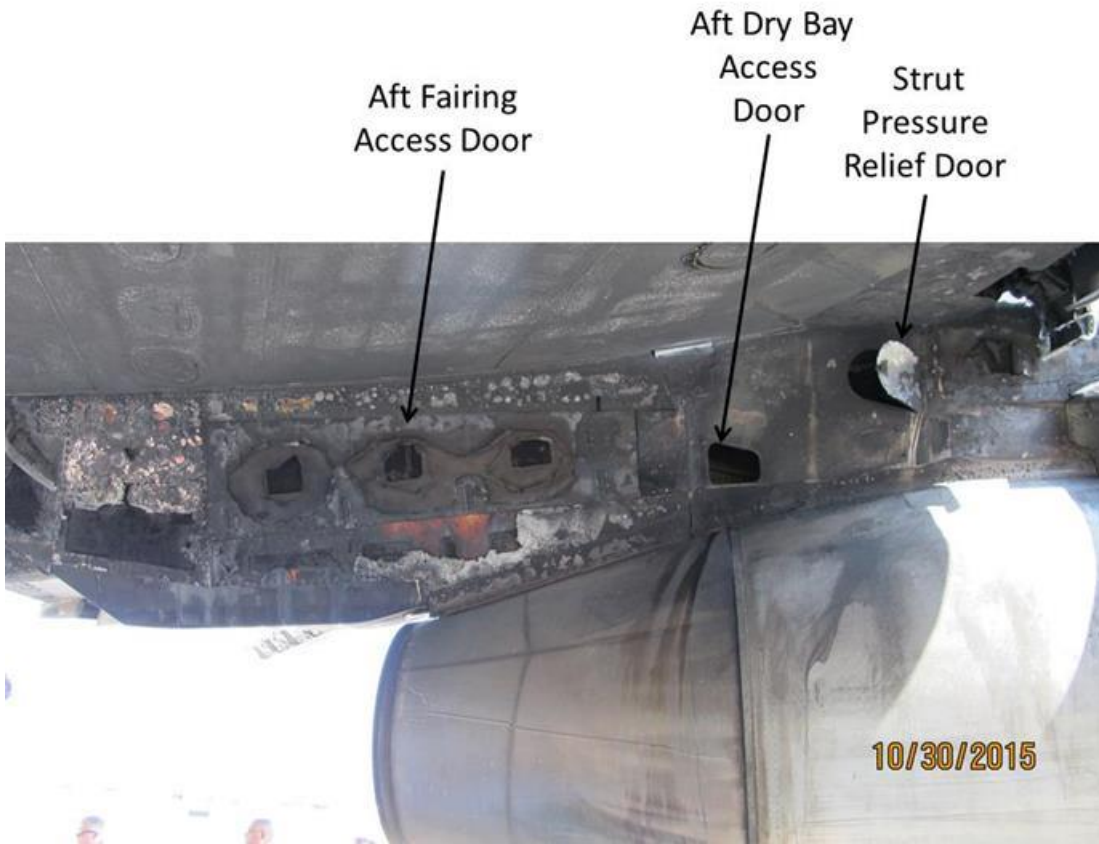
**Photo 8- Engine Strut - Inboard Side**

All inboard strut surfaces were blackened and sooted with the exception of a streak indication from the lower forward corner of the pressure relief door cutout. There was no burn through on any inboard strut structure surfaces. The inboard pressure relief door was open when the team arrived on scene and the inboard access panel cover was separated and not recovered. The inboard aft strut fairing access door external ply was partially consumed exposing the honeycomb at three equally spaced locations in the center of the panel (**Photo 8**). The aft most strut fairing external ply was partially consumed, exposing the honeycomb.

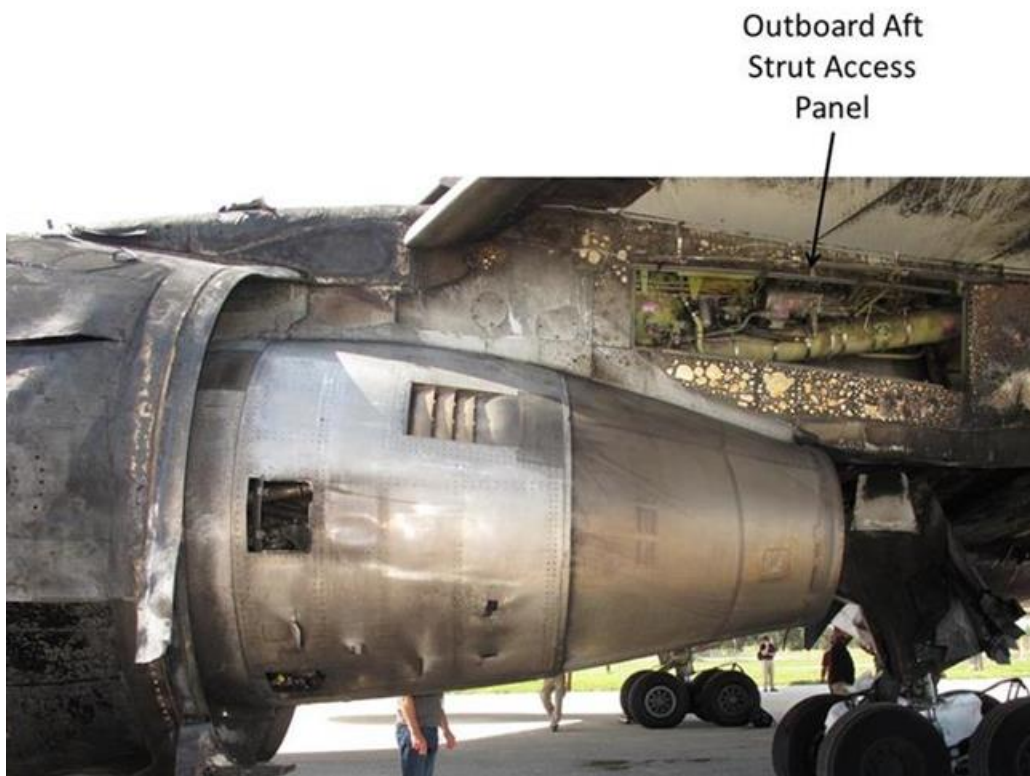
**Photo 9- Engine Strut – Outboard Side**

The outboard strut aft access panel was open when the team arrived but all visible components inside the compartment were intact and free of thermal distress with light sooting present on the aft end. The outboard strut surfaces exhibited light sooting and had no indications of thermal distress beyond paint bubbling (**Photo 9**). The strut pressure relief door was found in the closed position. The aft most section of the outboard strut fairing external ply was consumed, exposing the honeycomb.

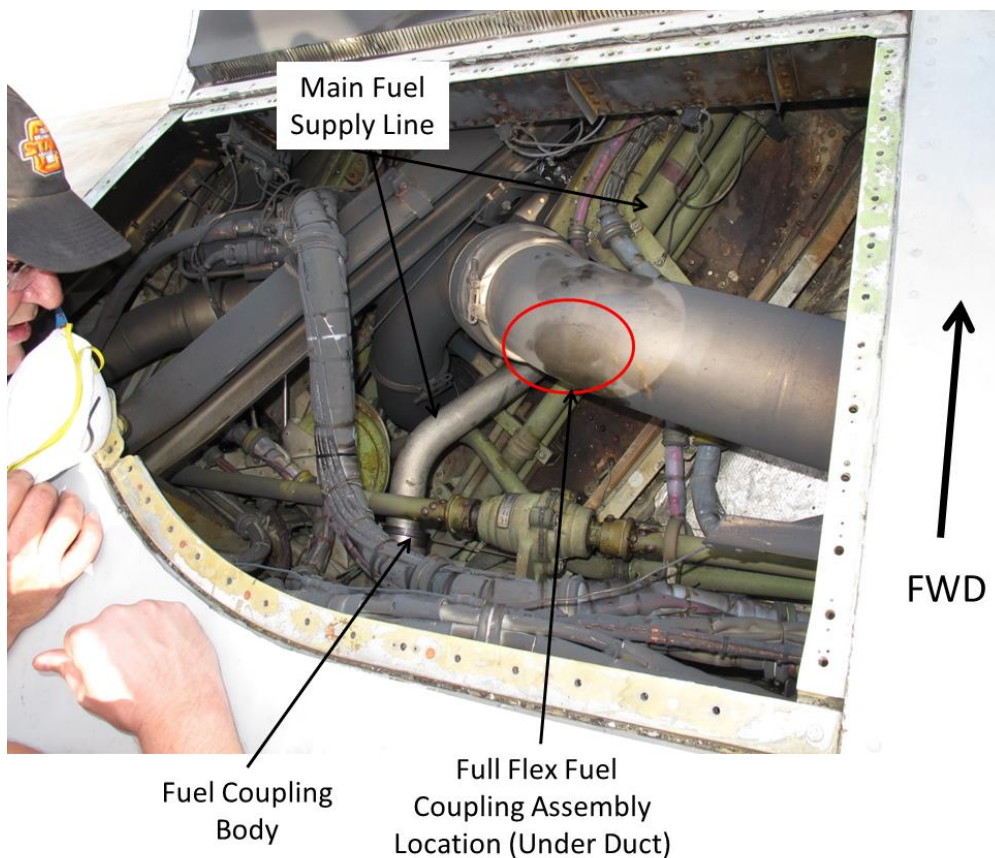
**Photo 10- Leading Edge Access Panel Compartment**

The left wing leading edge access panel above the left engine was removed to document the aft strut compartment and main fuel supply line (**Photo 10**). The compartment smelled strongly of fuel and light sooting was observed. Between nacelle stations 192 and 234, the fuel supply line features a full flex coupling assembly (**Figure 2**). The coupling body was found disconnected and resting loosely near the wing spar fuel coupling (**Photo 10**). The remaining components of the fuel coupling were located adjacent to the fuel supply tube mating flanges. The aft retaining ring and o-ring were displaced in the aft direction and the nut, forward o-ring and retaining ring were displaced in the forward direction. The retainer halves remained clamped around the mating tube flanges and were free to rotate (**Photo 11**). Lockwire was not present in either the coupling body or nut assembly lockwire holes and the team was unable to locate the lockwire in the surrounding compartments. All lockwire holes in both the coupling body and nut were observed to be intact with no break-through. The forward bonding clamp was present but loose on the fuel supply line. No aft bonding clamp or bonding jumper was present or recovered. An exemplar photo of the fuel coupling in the correct installation configuration from the right engine is shown in (**Photo 12**).

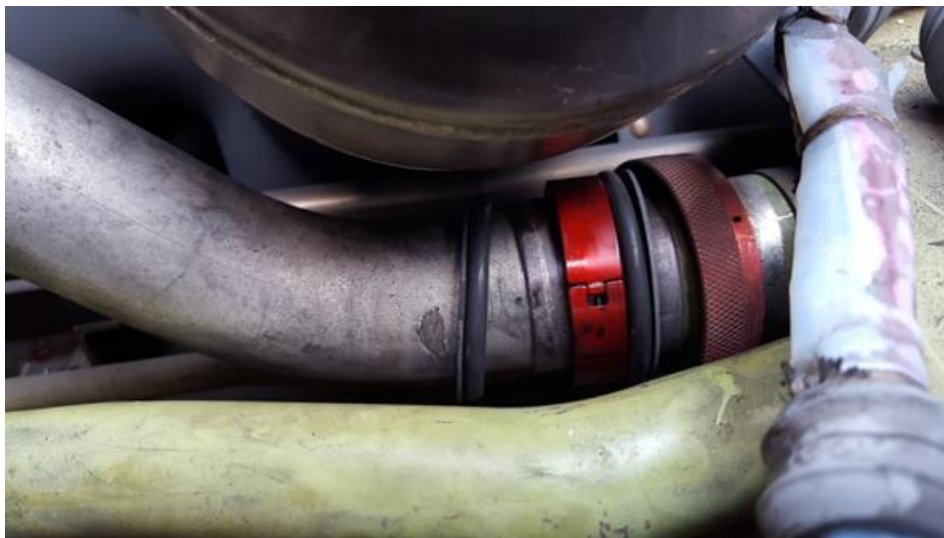
**Photo 11- Fuel Coupling Assembly, As Found In-situ**

During a visual examination of the left engine and strut, a fuel coupling assembly was found separated with the coupling body pushed aft on a main fuel supply line. There were indications of fuel leakage at the flange interface of the fuel supply lines where the coupling had separated including discoloration from fluid pooling in the strut compartments and streaking down the left engine cowling. There was no safety lockwire present on either the body or nut side of the fuel coupling as required in the Boeing aircraft maintenance manual (AMM), and no broken lockwire was recovered in the surrounding strut compartments. A material examination of the fuel supply lines and coupling components verified that the parts met dimensional drawing specifications and were free of defects or damage that would have affected normal operation. A simple static pressure test setup was constructed to pressurize the fuel supply lines and coupling assembly recovered from the accident airplane to better understand leak initiation under simulated operational conditions. Initial testing concluded that a fuel leak would likely not be detected until the coupling was close to separating. Boeing is developing a test plan to complete additional testing on the fuel supply line and coupling assembly to determine how vibration levels similar to those measured during flight conditions affect coupling torque in the absence of lock wire.

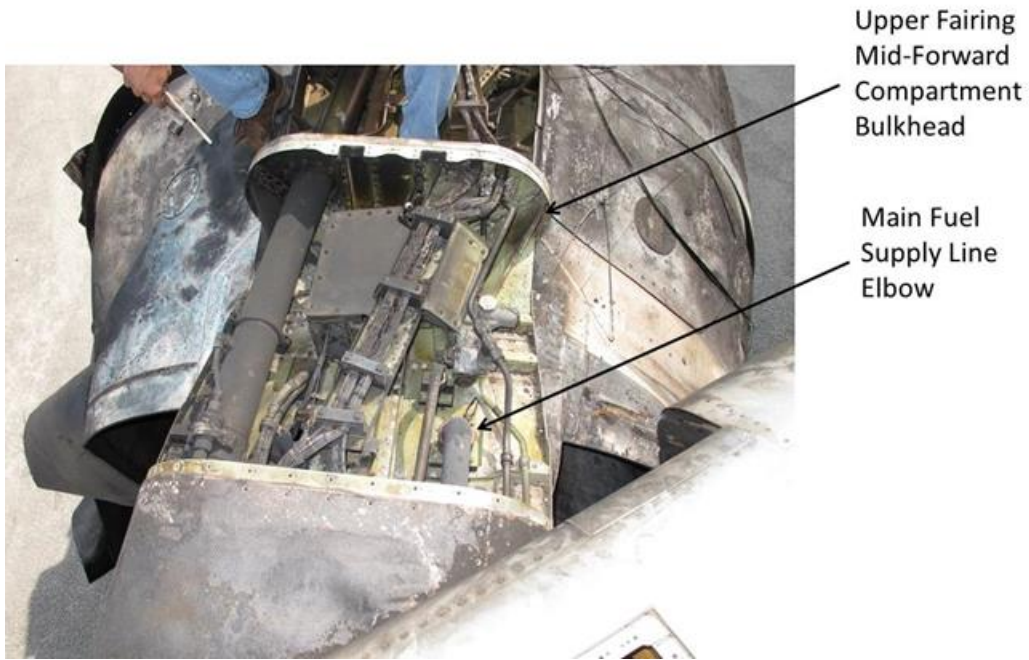
**Photo 13- Upper Mid Strut Fairing Compartment**

The mid and forward upper spar strut covers were removed to view both compartments. The upper mid strut compartment was sooted but had no signs of thermal damage (**Photo 13**). The main fuel supply line feeds through the aft fairing compartment bulkhead and then has a 90 degree elbow that leads down towards the engine main fuel pump. The full flex fuel coupling located at the elbow that passes through the spar web was intact, secured, and was verified to have the proper configuration per installation drawings (**Photo 14**). Channel locks were required to remove the fuel coupling body. The spar web between the aft and mid strut compartments is sloped downward and bounded by a bulkhead on the forward end. The streaking indications on the inboard thrust reverser cowling were adjacent to the upper mid strut compartment bulkhead. The forward upper strut compartment had very light sooting but was otherwise unremarkable (**Photo 15**).

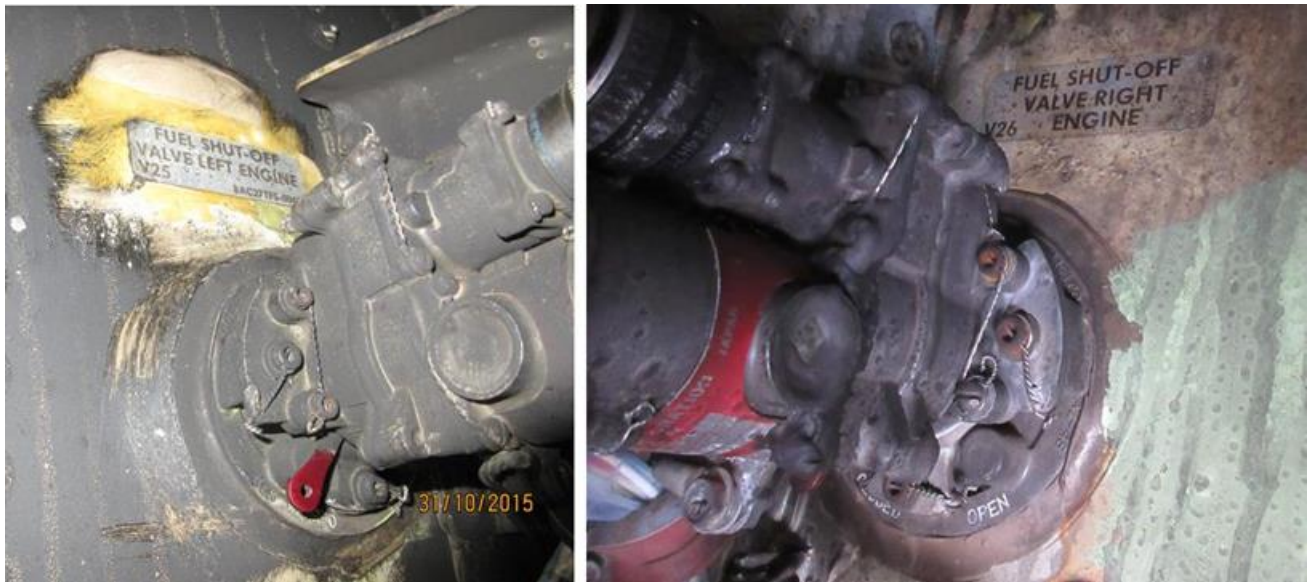
**Photo 16- (L) Left Spar Valve (R) Right Spar Valve, Both Closed**

The left and right spar valve indicators were both in the closed position (**Photo 16**). This is consistent with the valves operating correctly following selection of the run-cutoff switch in the cockpit.

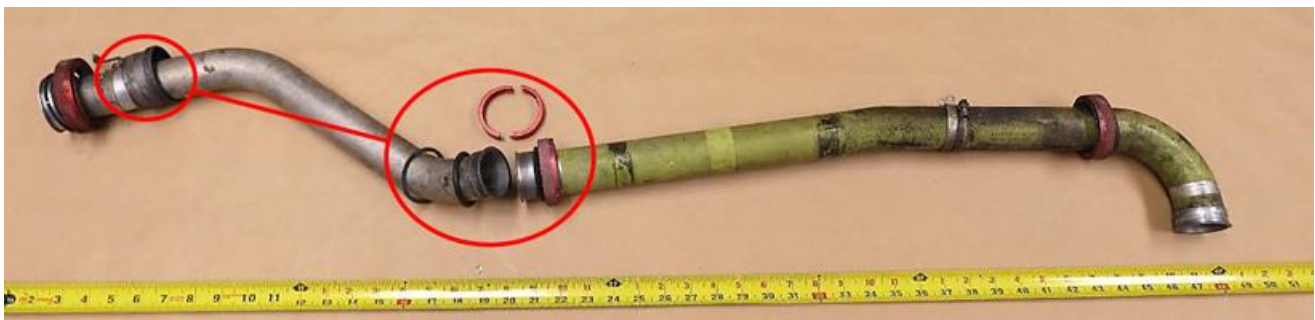
**Photo 167- Left Engine Main Fuel Supply Lines and Fuel Coupling Assembly, as received at Boeing**

Two sections of the left engine main fuel supply line and the fuel coupling assembly were shipped to the Boeing EQA lab for material inspection and testing (**Photo 17**). The material examination found that all components met dimensional specification except the o-rings which had an inner diameter and width thickness measurements below Aerospace Standard AS29513 specifications. These values are consistent with an o-ring that has taken a compression set during service use. Minor damage was also noted on the fuel supply line ferrule flange, coupling body threads and retaining halves that was considered normal wear for the age of the components according to Boeing. A binocular examination of the fuel coupling body lockwire holes identified material wear around two of the four holes.

A test setup was constructed using the accident hardware to pressurize the fuel lines and coupling assembly in order to simulate operating conditions except vibration. Water was used as the fluid and a pressure regulator was plumbed to maintain the pressure at about 28 pounds per square inch (psi)<sup>2</sup>. The accident fuel lines and coupling assembly (including the recovered o-rings) were assembled in accordance with the Boeing 767 AMM. The coupling nut was backed off about ¼ turn under constant pressure and monitored for leaks. A steady leak did not occur until about 3<sup>3/4</sup> turns, ¼ turn before the coupling separated. A full report of material analysis and test results titled “Boeing EQA Lab Report #AS12458- Fuel Leak at Flexible Coupling in Left Hand (LH) Engine Strut” is available in the docket.

Boeing plans to perform additional vibration and pressure impulse testing on the accident coupling hardware in 2016 to evaluate the effects vibration has on coupling nut torque and back off characteristics in the absence of lock wire. The vibration spectrum that will be used for testing will be based on levels measured in strut during normal engine operation.
