**NATIONAL TRANSPORTATION SAFETY BOARD**  
**Office of Aviation Safety**  
**Washington, D.C. 20594**

**POWERPLANT GROUP CHAIRMAN'S FACTUAL REPORT**

**NTSB No: ERA18MA099**

Location: New York, New York  
Date: March 11, 2018  
Time: 1908 EDT  
Aircraft: Airbus AS350B2, Registration Number N350LH

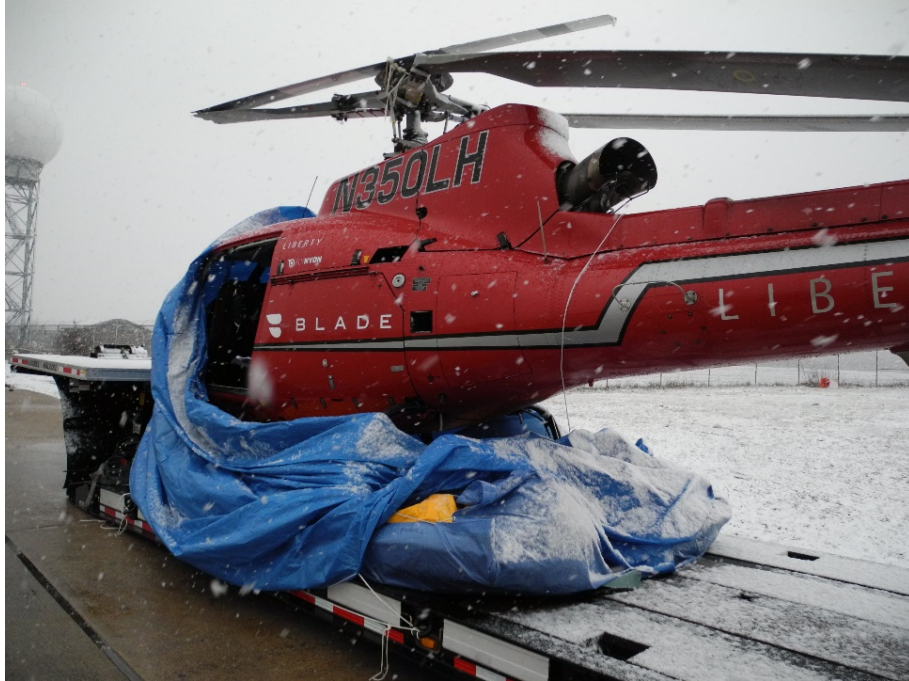
The engine cowling was intact<sup>3</sup> (Photo 1). After the helicopter was in the hangar, the cowling was removed (Photo 2), revealing the engine was still attached to the engine mounts of the helicopter and a clean engine and engine bay. There were no signs of oil or fuel leaks, fire or un-containment. The exhaust duct was intact and undamaged. The air inlet duct was mildly corroded, consistent with being in contact with salt water. The rear engine mounts and the front engine mount flange were intact and undamaged. All the airframe fuel, oil and pneumatic tubes, control cables, linkages and electrical wires and connectors were present and intact. There was mild surface corrosion on some electrical connectors, consistent with salt water contact. An air pressure port at the compressor discharge stage sends a pressure signal to the diaphragms of the acceleration and deceleration control units in the FCU via a P2 tube. A leak in the P2 tube 'b'- nut fittings will result in an engine that will not accelerate. The 'b'- nuts on both ends of the P2 tube were properly torqued. The starter/generator was in its normal location on the accessory gearbox.

Photo 1 - Safran Turbomeca Arriel 1D1 Engine In-Situ on N350LH

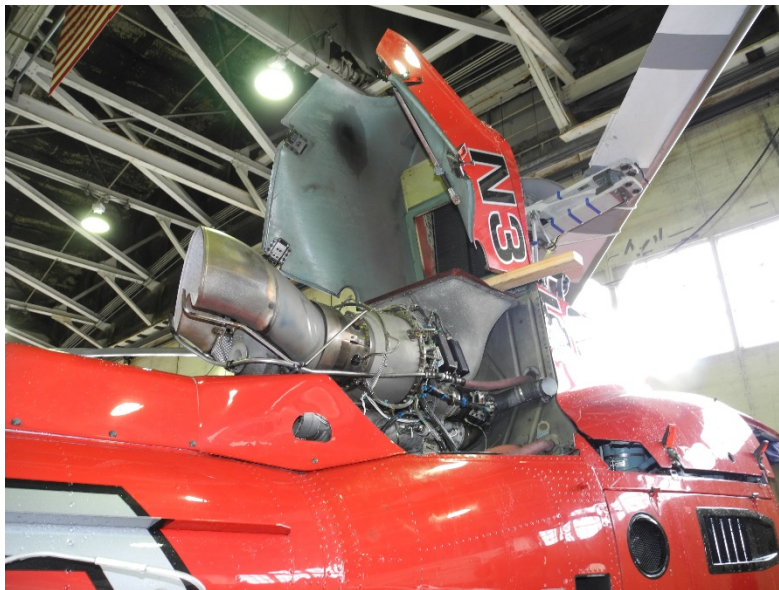
Photo 2 - N350LH Engine Cowling Raised

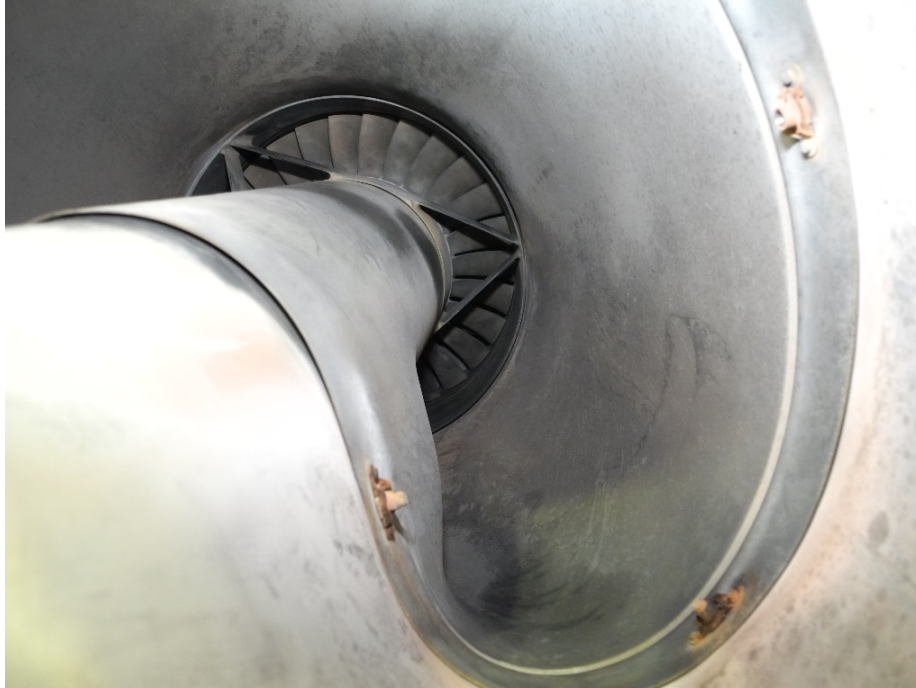
The PT wheel was accessed through the exhaust duct and could be rotated with normal effort, but only in the free-wheeling direction, which is consistent with internal gearbox mechanical continuity as well as an intact and operating rotor clutch. The trailing edges of the PT blades were examined through the exhaust duct and were all present and undamaged (Photo 3). The GG spool was accessed by reaching into the air inlet duct and turning the axial compressor wheel. The GG spool could be rotated easily by hand; however, a faint scratching noise could be heard from the core, consistent with corrosion due to salt water contact on the shaft bearings. Because of the possibility that the main shaft bearings could be corroded, it was decided that a safe test cell run could not be accomplished at the factory, so instead, a field strip the engine at the hangar was performed.

Photo 3 – Power Turbine Blades – Undamaged

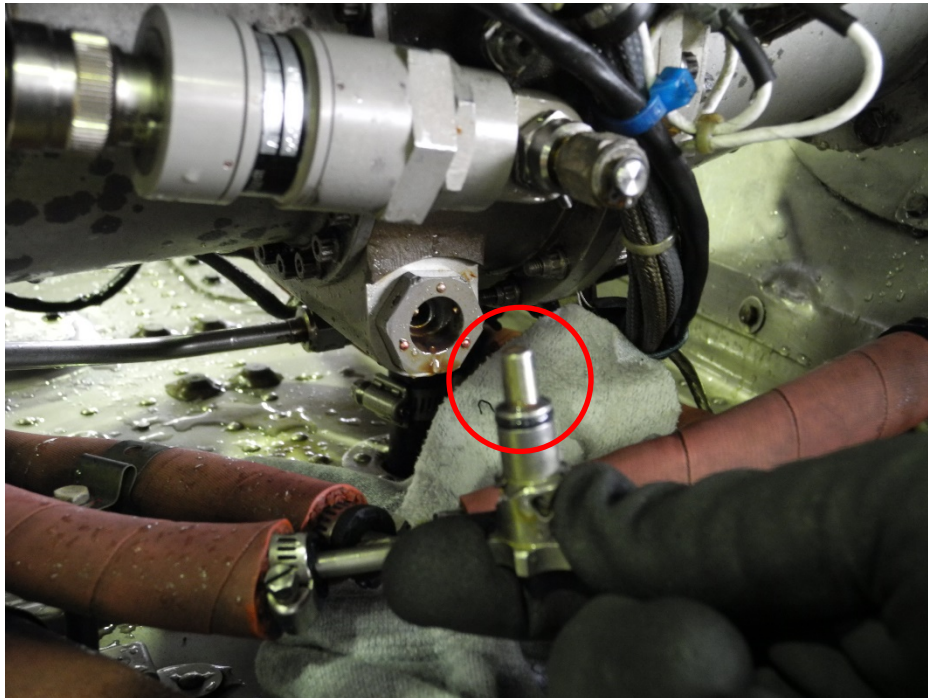
There are two manual and two electric magnetic (mag) oil chip detectors. The manual chip detectors monitor the oil from module 1 accessory gearbox (AGB) and module 5 reduction gearbox (RGB), while the electric mag plugs respectively monitor the oil from the oil tank and the rear bearing. The manual mag plugs were removed and found to be clean (Photo 4 & Photo 5). The check valves on the mag plug orifices were depressed, which allowed oil to flow from the internal cavity, and a mixture of water and oil was seen to drain. The two electric mag plugs were also examined and found to be clean.

Photo 4 – Manual Magnetic Chip Plug from Module 01 (AGB) - Clean

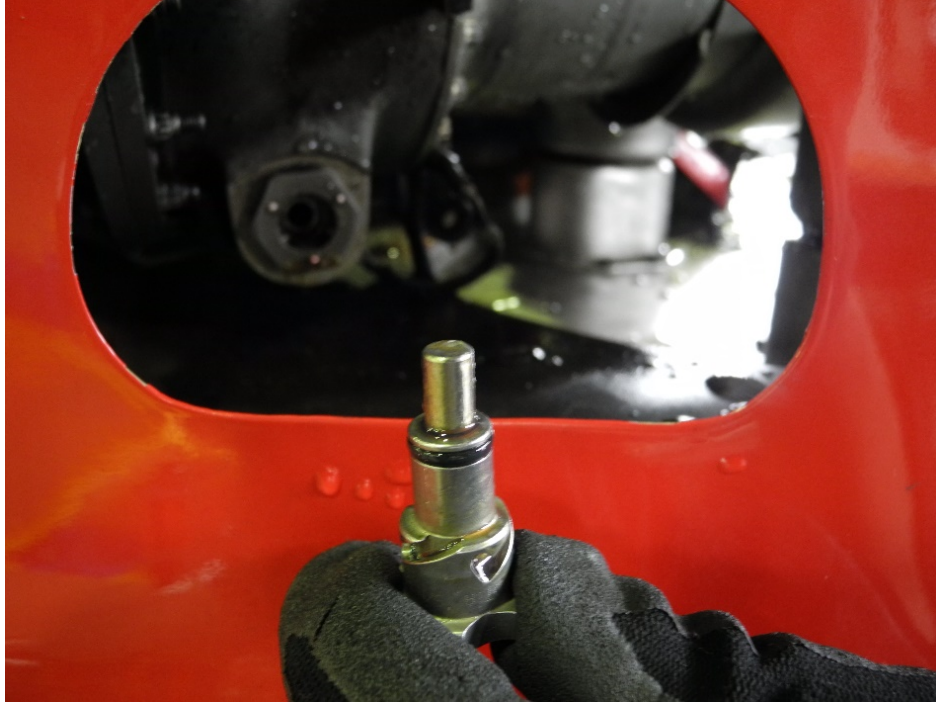
Photo 5 – Manual Magnetic Chip Plug from Module 05 (RGB) - Clean

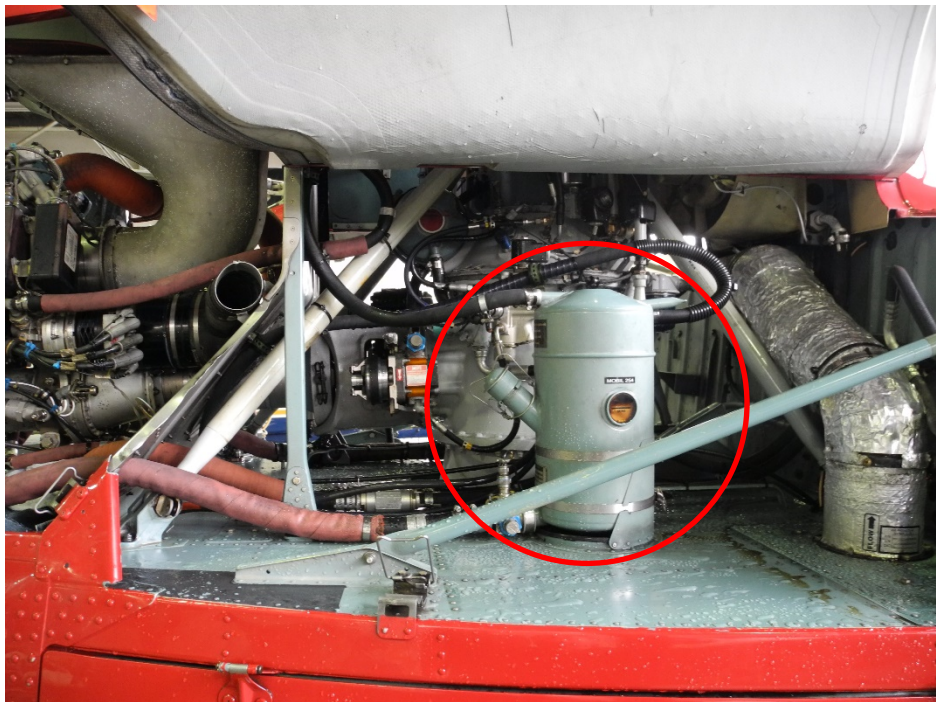
The Arriel 1D1 engine is a dry sump engine, requiring a separate oil tank, which is remotely installed and the AS350B2 installation has the oil tank mounted on the right<sup>4</sup> side of the transmission deck. The oil level in the tank was just above the minimum level (Photo 6). The oil filter bypass indicator was not triggered indicating no blockage in the oil filter (Photo 7).

Photo 6 – Engine Oil Tank – On Transmission Deck

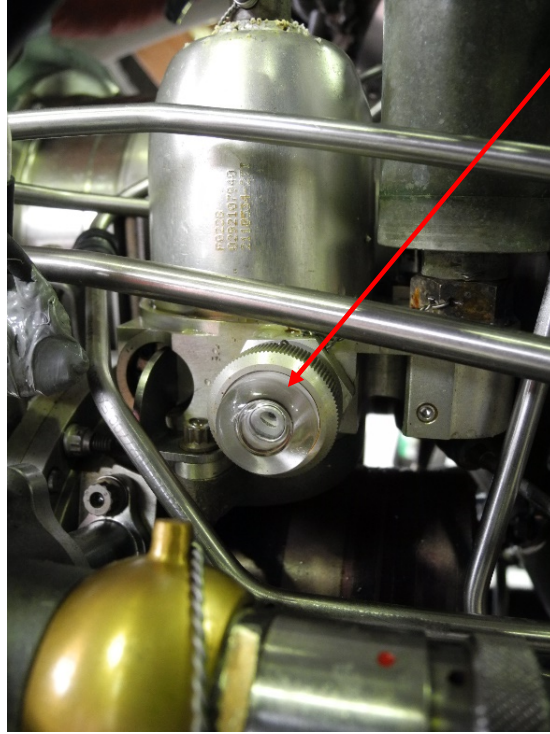
Photo 7 – Engine Oil Filter Bypass Indicator – Not Triggered

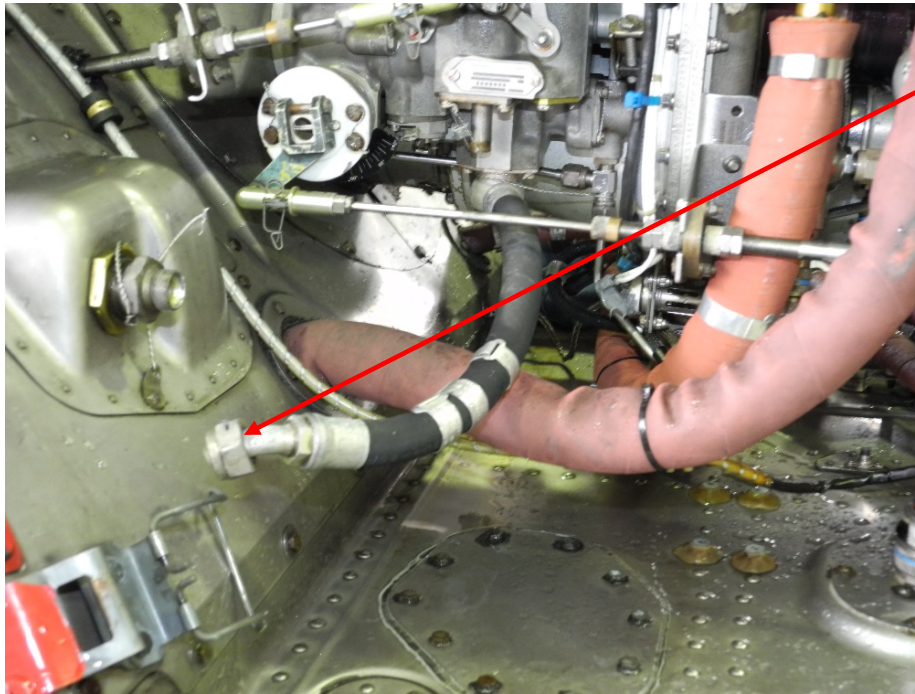
The fuel supply line from the firewall to the fuel pump (Photo 8) was disconnected at the firewall fitting and fuel was observed to drain from the line. Several ounces were noted to have drained.

Photo 8 – Fuel Supply Line from the Firewall to the HP Pump (in FCU)

Fuel Supply Line has been Disconnected from the Firewall Fitting

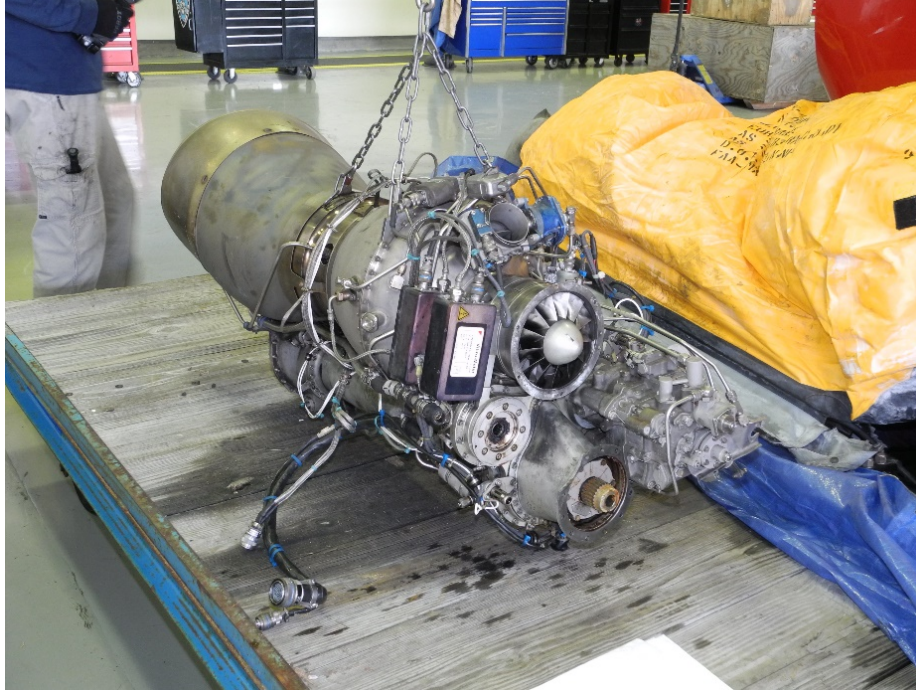
Prior to removal of the engine, all airframe-related fittings and electrical connections were checked for integrity as they were being removed and no discrepancies were found. The engine was then hoisted from the helicopter with an overhead crane and placed on an engine stand (Photo 9) in preparation of a field strip. The transmission input shaft spline was undamaged (Photo 10). The engine bay was generally clean and undamaged (Photo 11). The engine is comprised of 5 modules (Figure 2) and are listed below in order of removal.

Photo 9 – Engine Removed from the Helicopter

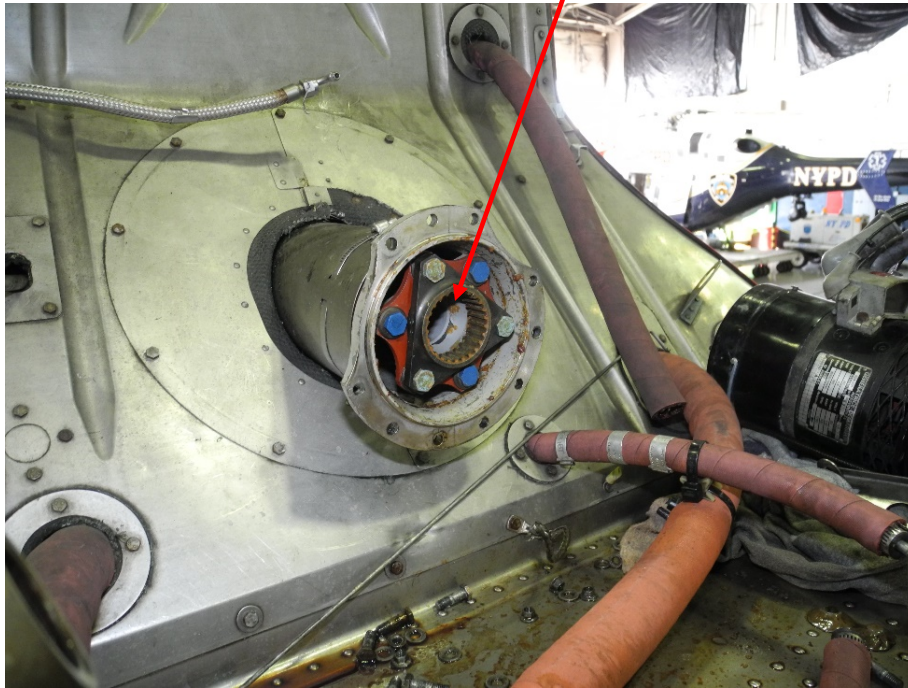
Photo 10 – Transmission Input Shaft Spline - Undamaged

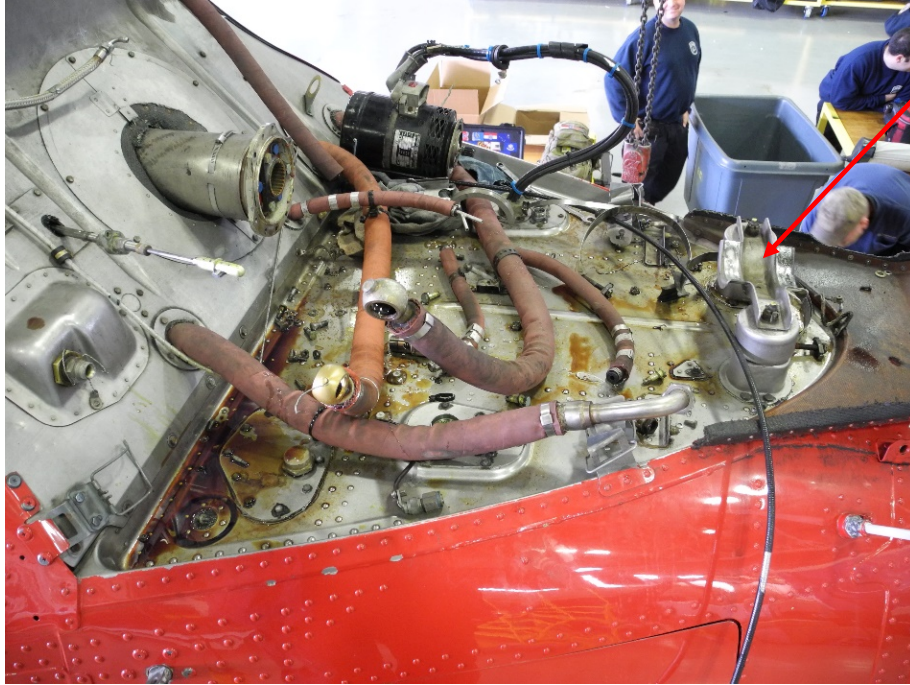
Photo 11 – Engine Bay After Removal of Engine – Undamaged

Aft Engine Mount - Undamaged

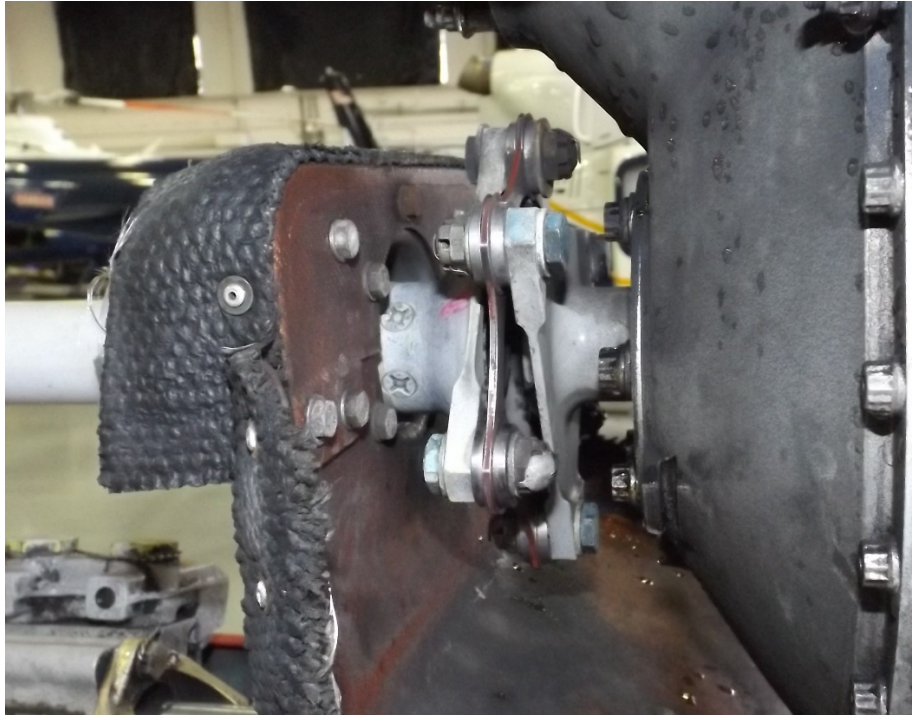
The engine-related external lines and electrical connectors were checked for integrity as they were being removed and no discrepancies were noted. The tail rotor drive flange was intact and undamaged (Photo 12). Module 05 (RGB) was removed with no difficulties (Photo 13). The input shaft could be rotated smoothly with normal effort and a corresponding rotation of the output shaft was observed, consistent with internal integrity of the reduction gearbox. The input and output splines were intact and undamaged. The input pinion alignment mark was found aligned (Photo 14), consistent with an engine that had not sustained a sudden stoppage while under power.

Photo 12 - Tail Rotor Drive Flange - Undamaged

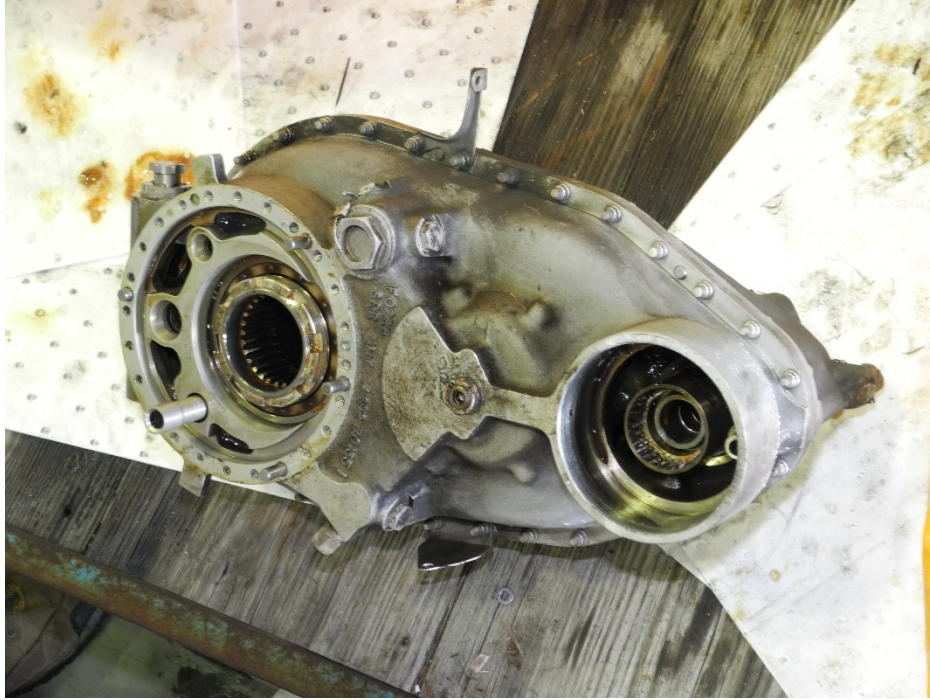
Photo 13 – Module 05 – RGB – Intact & Undamaged

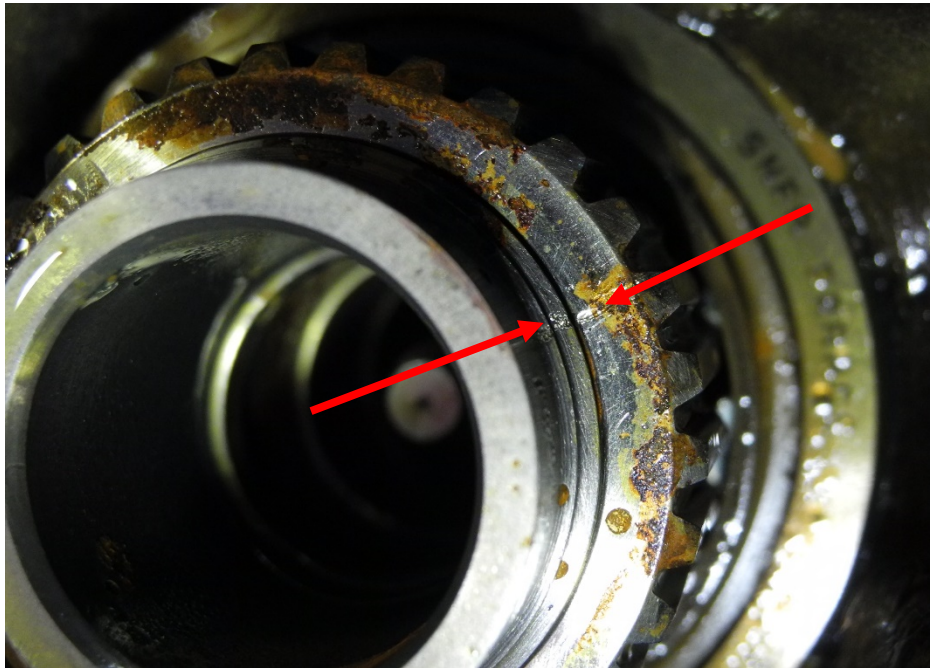
Photo 14 – Input Pinion Alignment Marks – Still Aligned

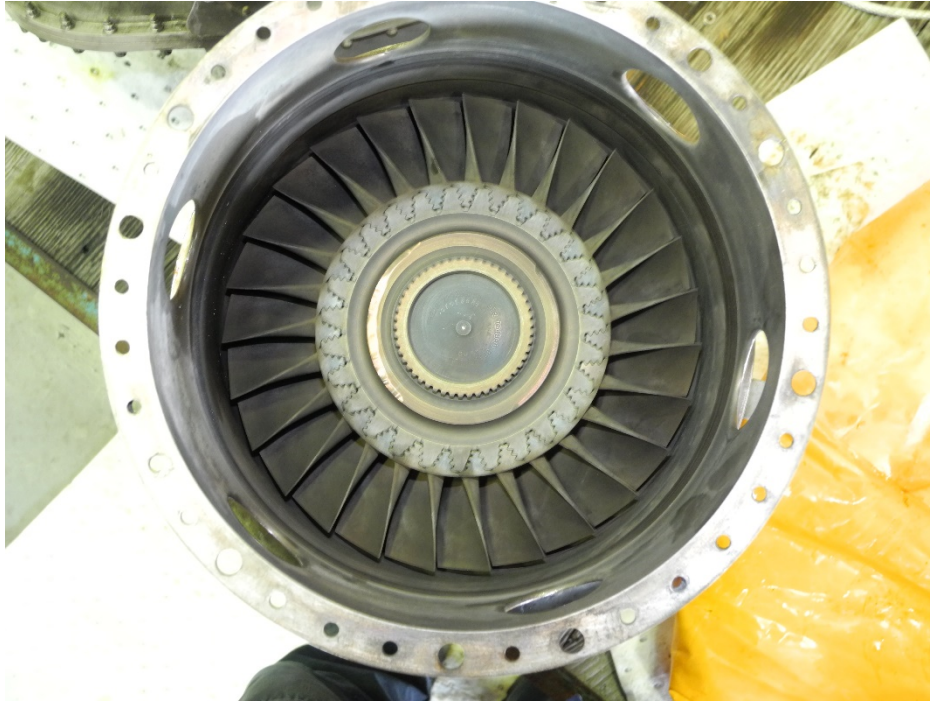
Module 04 (power turbine) was removed, revealing intact and undamaged leading edges and pressure side chords of the power turbine blades (Photo 15). The power turbine ball bearings (Photo 16) were oil wetted and could be easily rotated by hand.

Photo 15 – Power Turbine Blades – Leading Edges and Pressure Side Chords - Undamaged

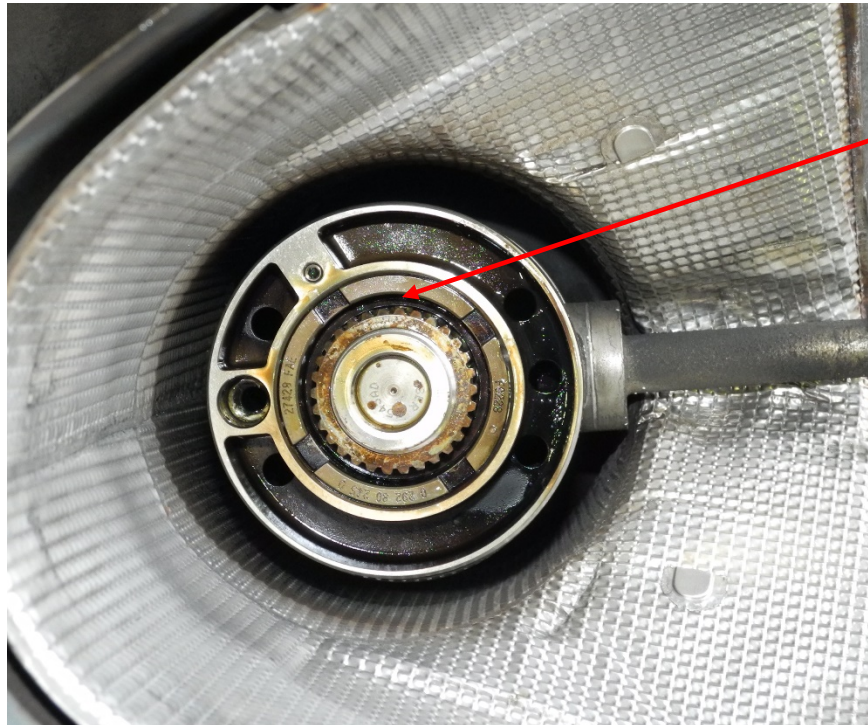
Photo 16 – Power Turbine Aft Bearing - Undamaged

Roller Elements  
are Intact and Oil  
Wetted

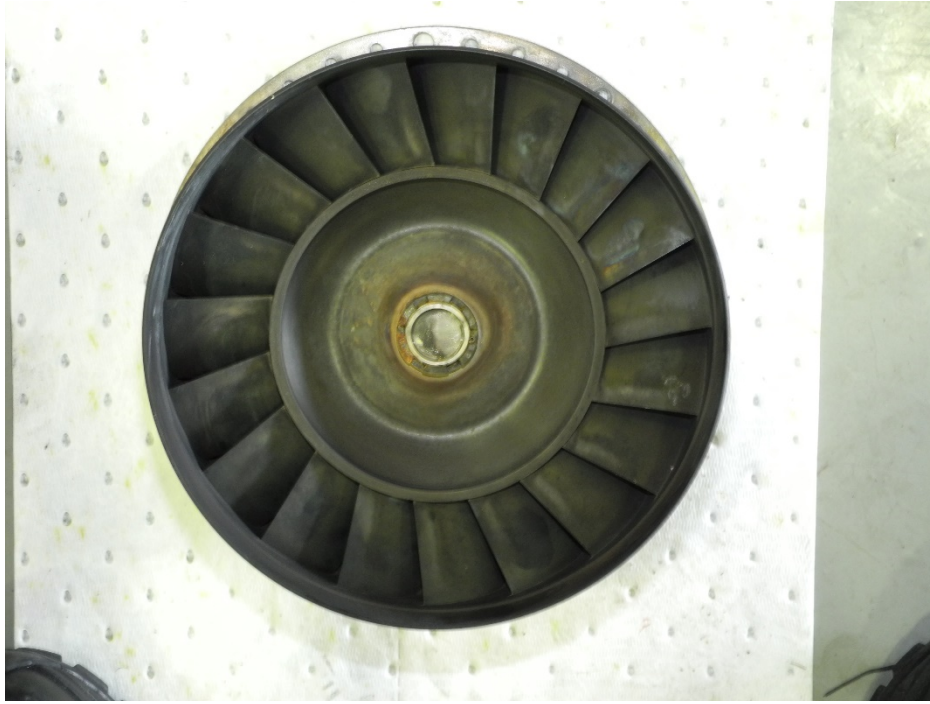
The power turbine nozzle guide vanes were undamaged (Photo 17). The GG rear bearing was oil wetted, undamaged (Photo 18) and could be smoothly rotated by hand with normal effort.

Photo 17 - Power Turbine Nozzle Guide Vane – Trailing Edges - Undamaged

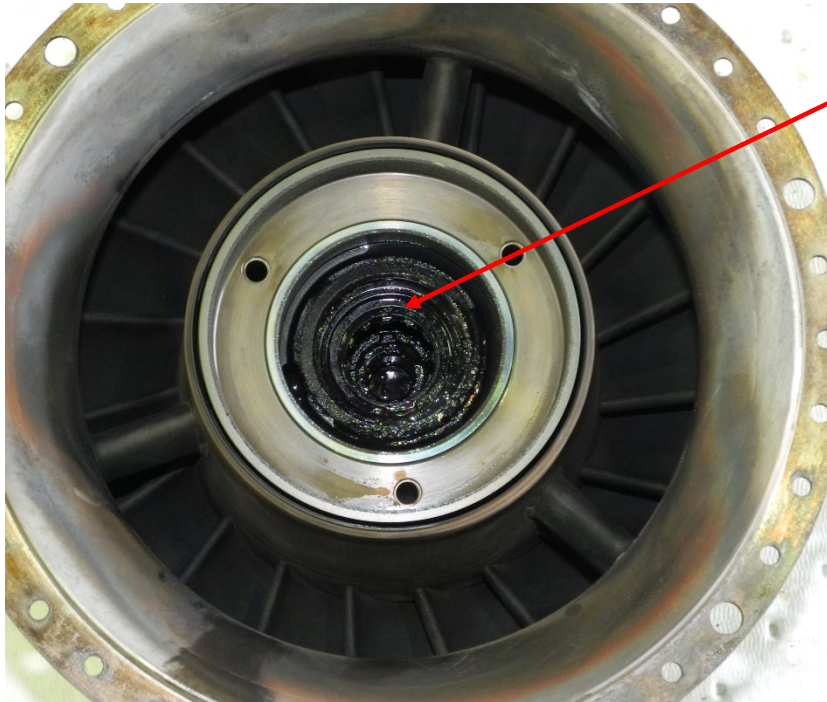
Photo 18 - GG Rear Bearing - Undamaged

Roller Elements are Intact and Undamaged

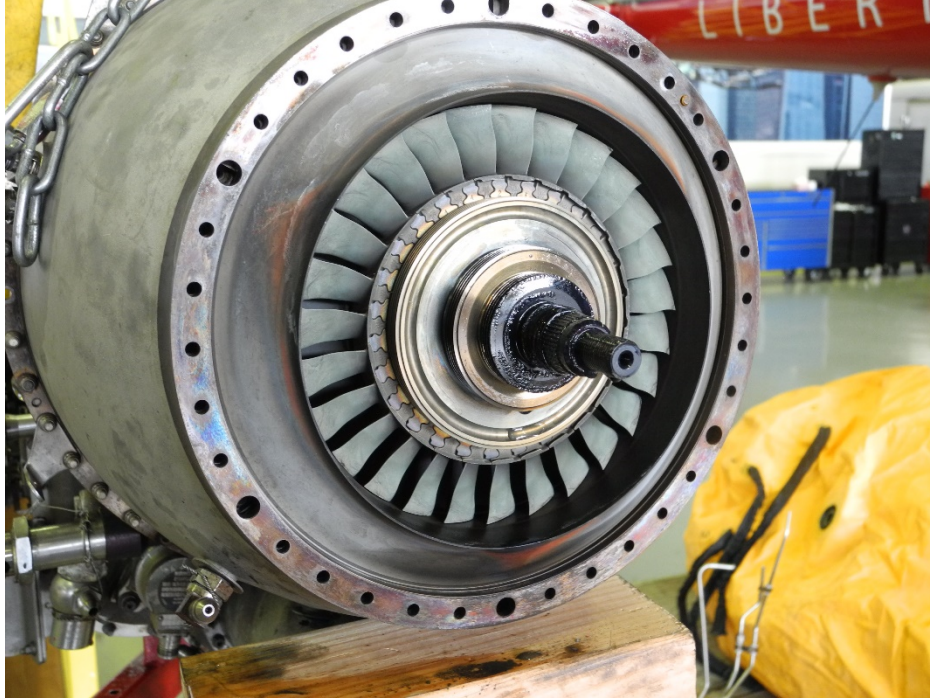
The module 02 (axial compressor) and module 03 (GG) assemblies were not separated but were removed as a unit from module 01 (AGB). The GG spool could be rotated by hand with minimum effort, consistent with undamaged GG spool bearings. The 2<sup>nd</sup> stage GG turbine was intact and undamaged (Photo 19). The 1<sup>st</sup> stage axial compressor could be examined, and it was intact and undamaged (Photo 20). The centrifugal compressor and the 1<sup>st</sup> stage GG turbine could not be examined because the field strip tooling could not disassemble the module.

Photo 19 - 2<sup>nd</sup> Stage GG Turbine - Undamaged

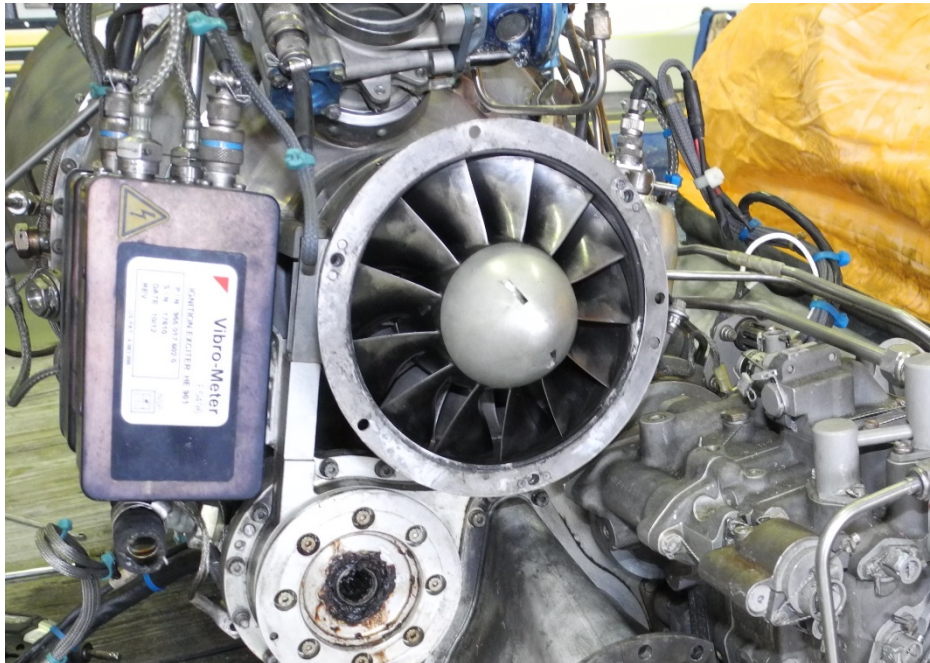
Photo 20 – 1<sup>st</sup> Stage Compressor Wheel - Undamaged

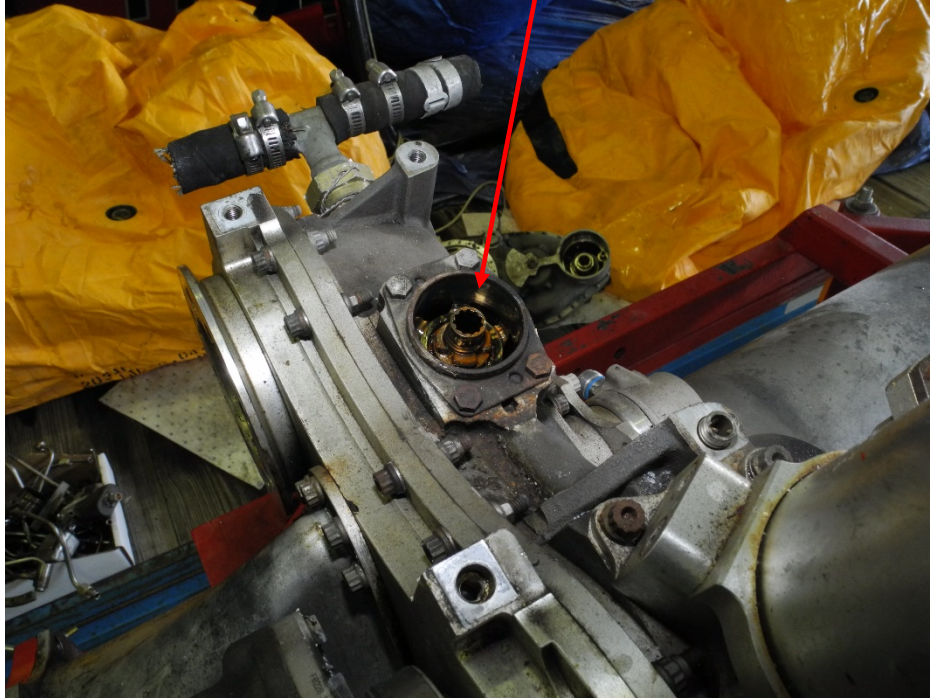
Continuity of the AGB internal gear train was confirmed through the gearbox which included the bevel gears and accessory drive shafts (Photo 21). The FCU part number (P/N) 0164850960, S/N 1587 was removed from the module 01 with no difficulty. It was shipped to the Turbomeca facilities in Grande Prairie, Texas where it was disassembled and examined. The N2 input to the FCU continuity was confirmed. The FCU output splines for N1 and N2 were intact and undamaged (Photo 22). The freewheel shaft spline was intact and undamaged (Photo 23). The freewheel clutch assembly (Photo 24) was intact and could be rotated in both directions and the proper freewheel and drive operation was confirmed.

Photo 21 - Bevel Gear Input Spline - Undamaged

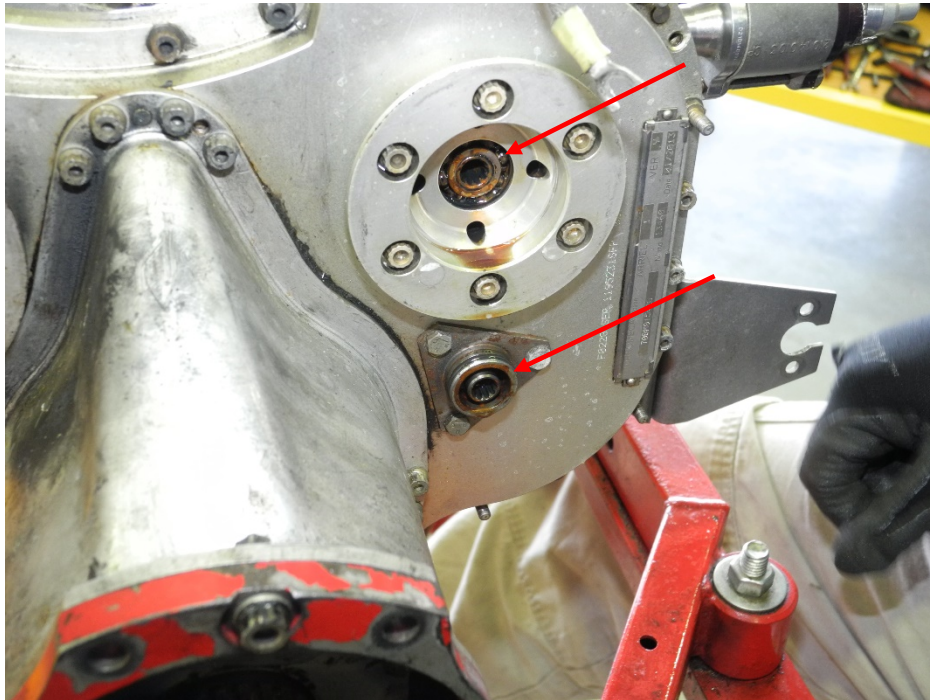
Photo 22 – AGB N1 & N2 Output Splines for FCU - Undamaged

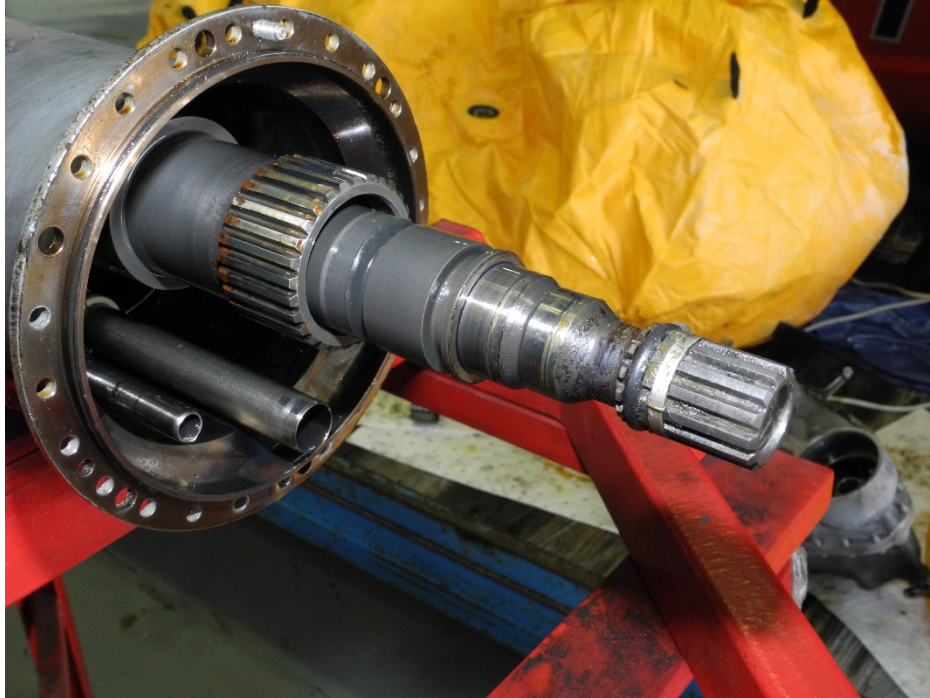
Photo 23 - Freewheel Shaft Spline - Undamaged

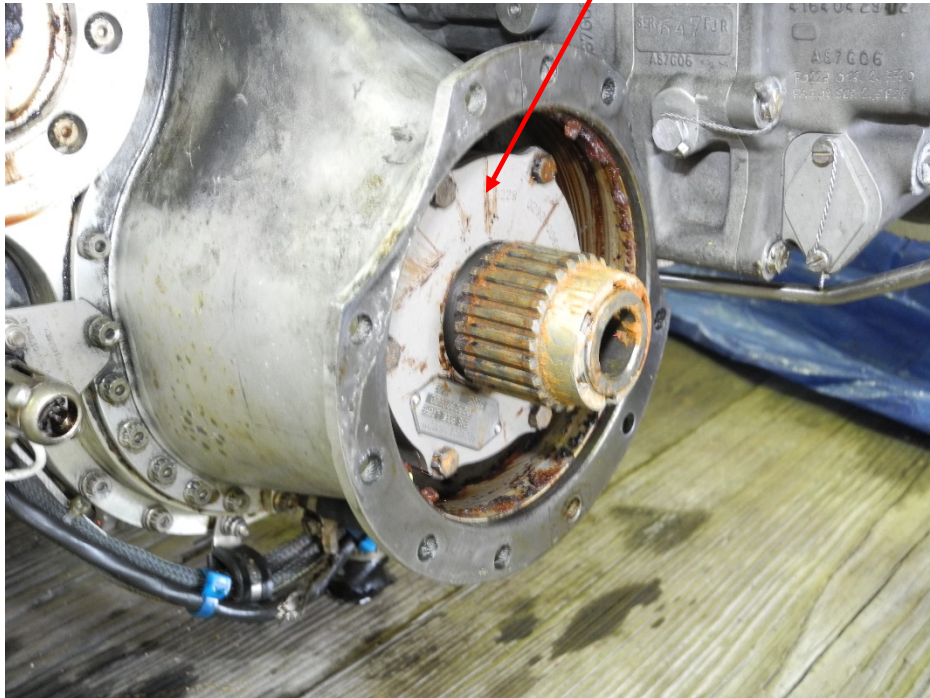
Photo 24 – Freewheel Clutch Assembly - Undamaged

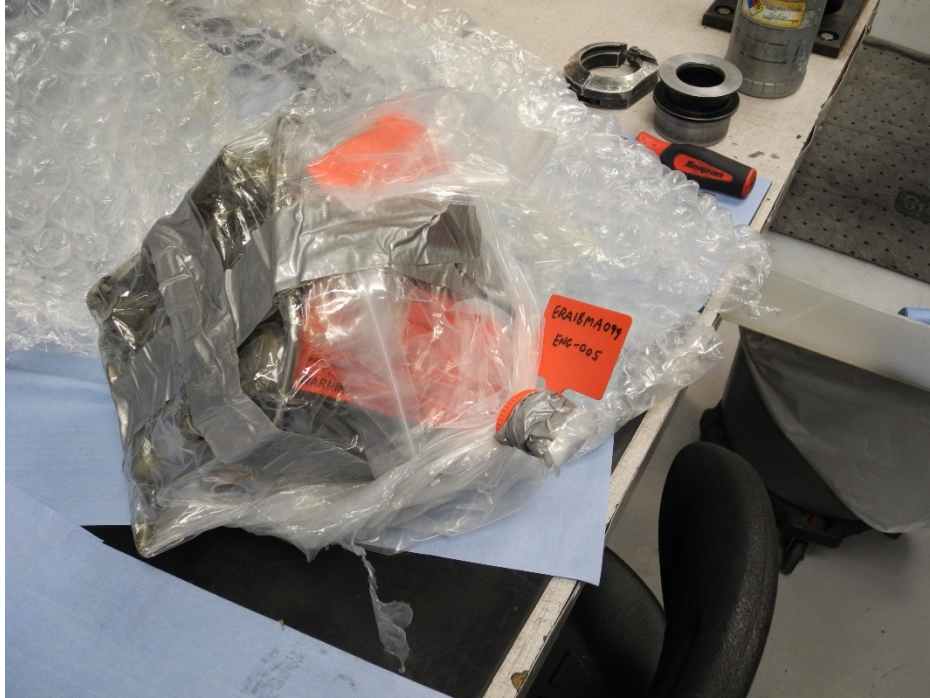
The FCU was wrapped in a plastic bag and shipped in a cardboard box from the Anglin Aircraft Recovery Services in Clayton, Delaware and stored in a secure locker at Safran Turbomeca ([Photo 25](#)).

Photo 25 – FCU - As Received at SAFRAN Factory

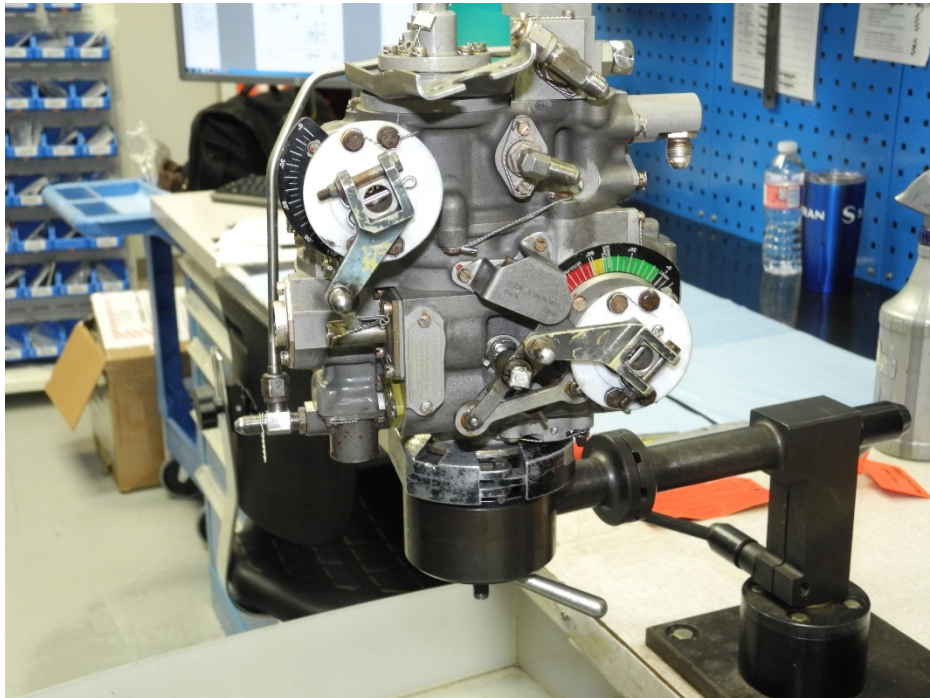
The FCU was secured to a factory bench support ([Photo 26](#)) and examined. Most of the external screw head surfaces were mildly corroded, consistent with salt water contact. An examination of the open P2 fitting revealed the presence of an orange colored liquid.

Photo 26 – FCU in Factory Support Fixture

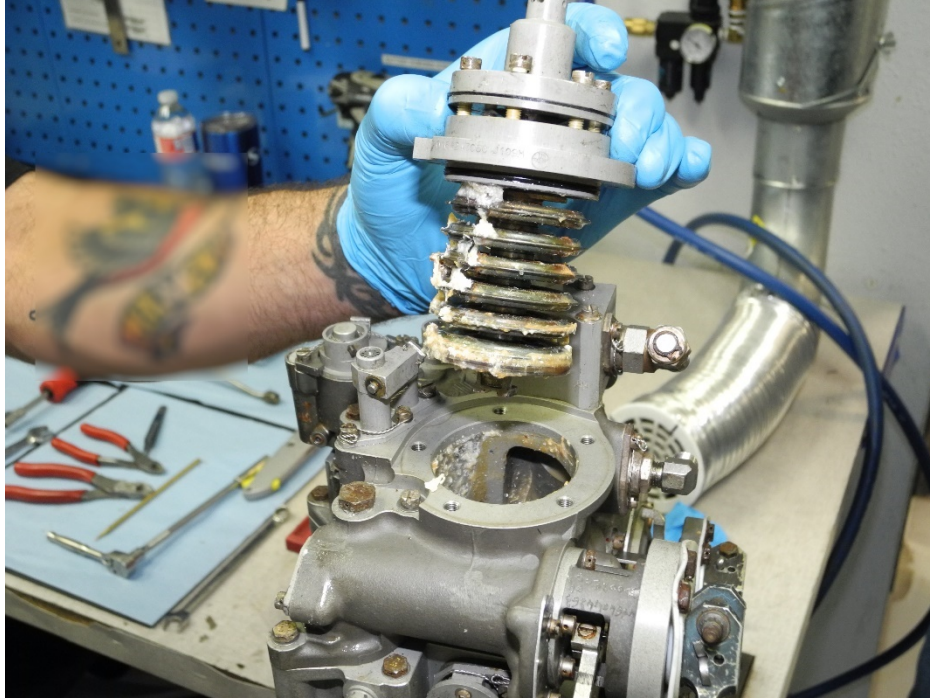
The acceleration controller section was removed, revealing a cavity that contained a paste-like substance, consistent with a water/grease mixture after a water inundation ([Photo 27](#)). The deceleration controller section was removed and was found to be clean ([Photo 28](#)).

Photo 27 – Acceleration Controller Cavity – Water/Grease Mixture

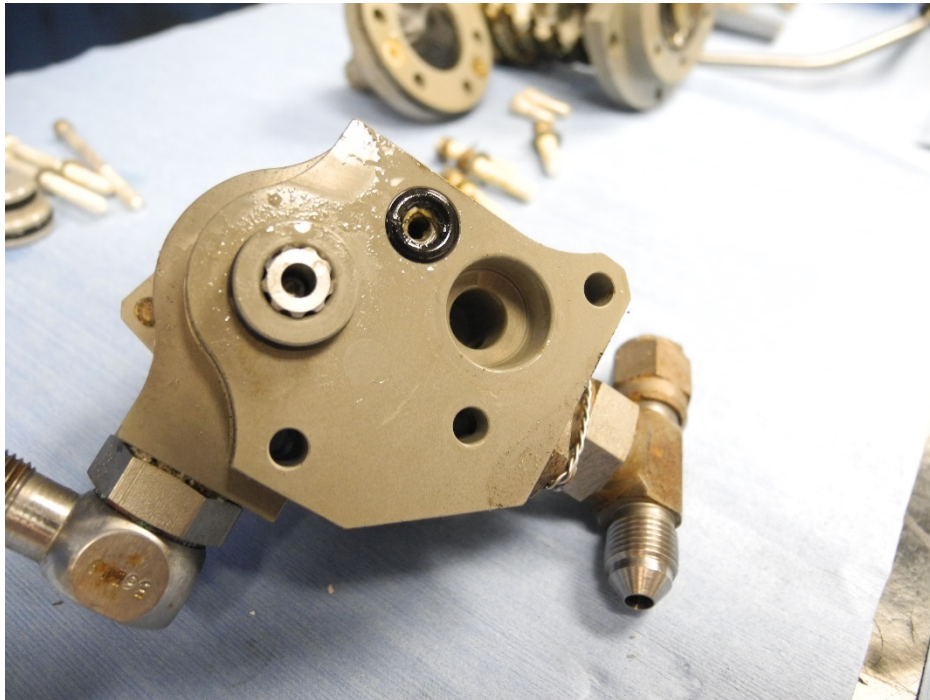
Photo 28 – Deceleration Controller - Clean

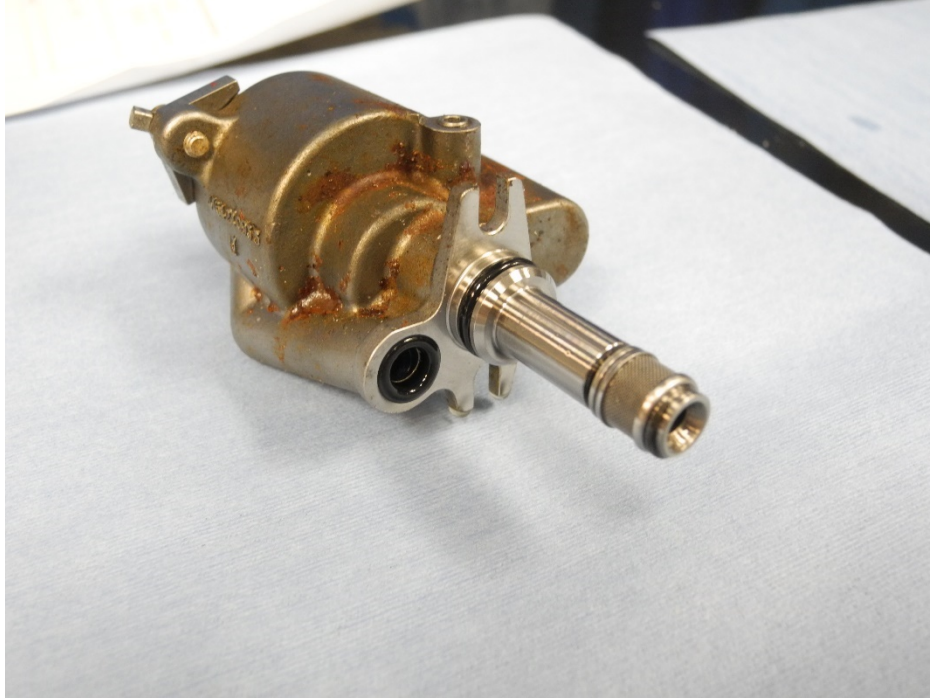
The temperature compensator was removed and found to be clean ([Photo 29](#)).

Photo 29 – Temperature Compensator - Clean

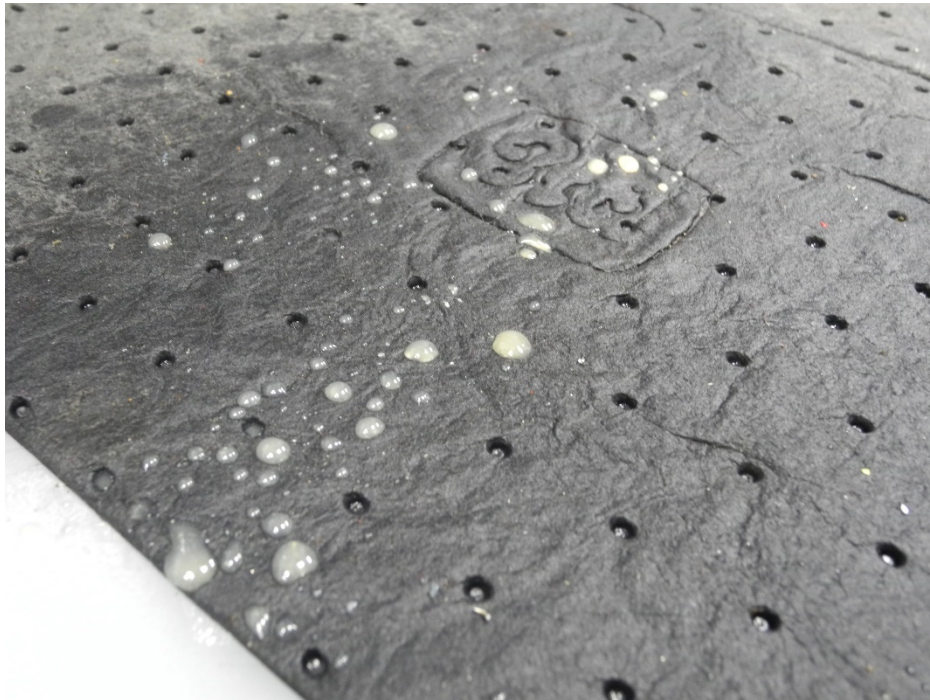
When the anticipator cavity cover was removed, a mixture of fuel and water drained from the cavity ([Photo 30](#)); however, the anticipator cavity was free of corrosion ([Photo 31](#)). The internal helix and worm gears were clean, intact and undamaged.

Photo 30 – Water/Fuel Mixture Drained from Anticipator Cavity

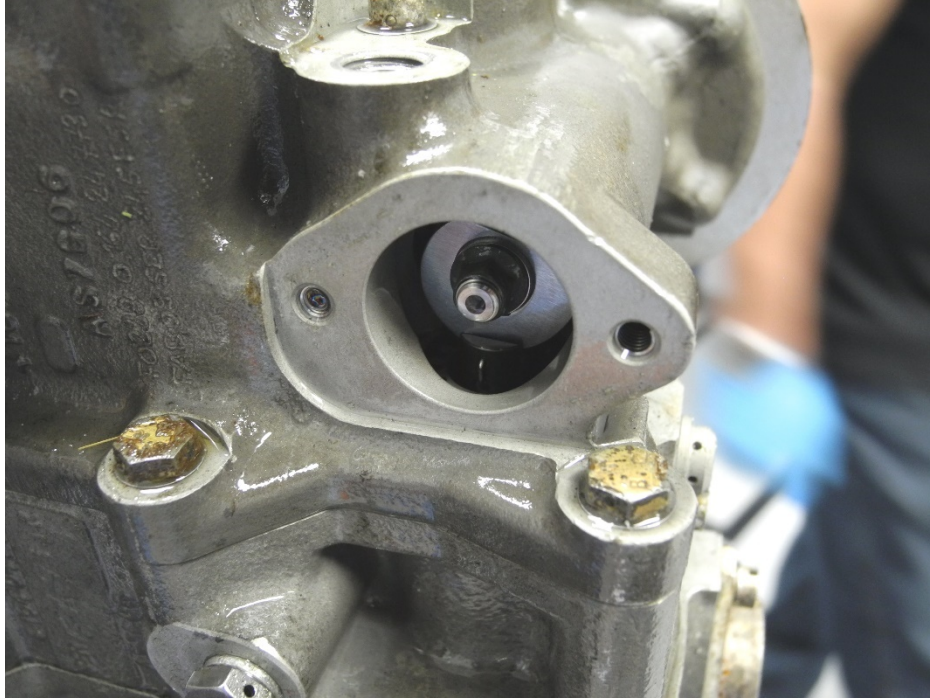
Photo 31 – Anticipator Cavity - Clean

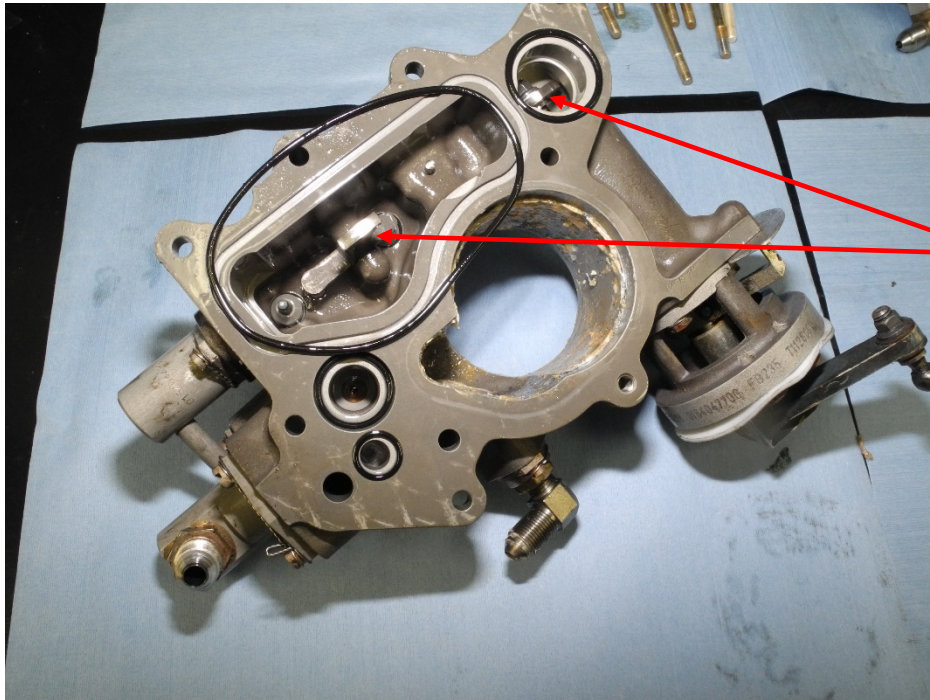
The FCU core housing was removed and was intact. It was generally clean, except for the acceleration controller cavity, previously noted ([Photo 32](#)).

Photo 32 – FCU Core Assembly – Intact and Undamaged
