**NATIONAL TRANSPORTATION SAFETY BOARD**  
**Office of Aviation Safety**  
**Washington, D.C. 20594**

**POWERPLANT GROUP CHAIRMAN'S FACTUAL REPORT**

**NTSB No: ERA18MA099**

Location: New York, New York  
Date: March 11, 2018  
Time: 1908 EDT  
Aircraft: Airbus AS350B2, Registration Number N350LH

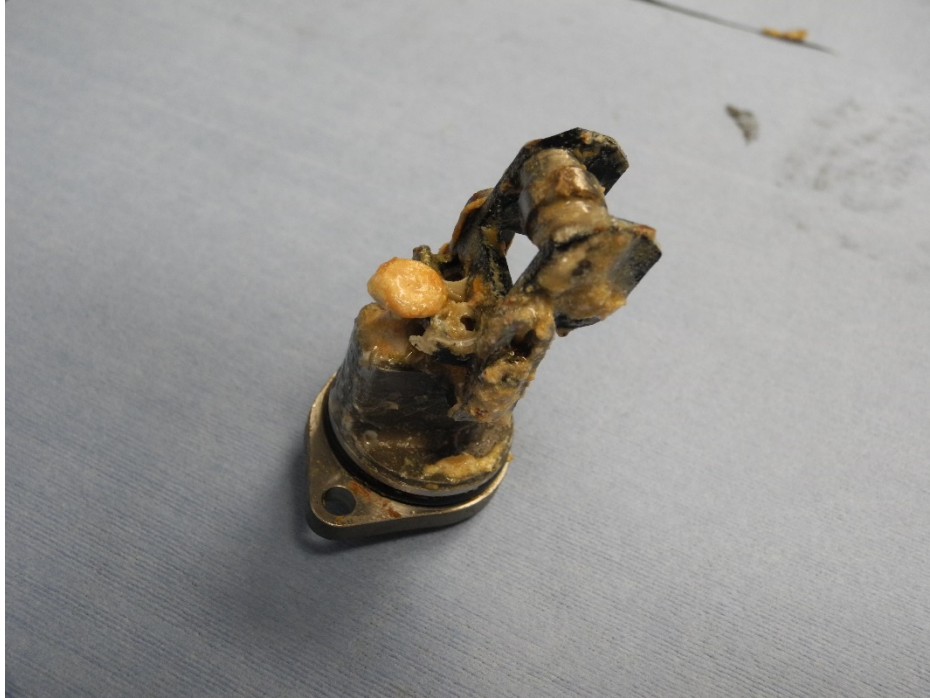
The slope stop assembly was removed, revealing internal cams and mechanisms that were coated with a grease/water slurry; however, all the mechanisms moved smoothly and without effort. Additionally, the cam surfaces were clean and undamaged beneath the grease/water paste ([Photo 33](#)).

Cam Faces –  
Clean and  
Undamaged

Photo 33 – Slope Stop Assembly - Undamaged

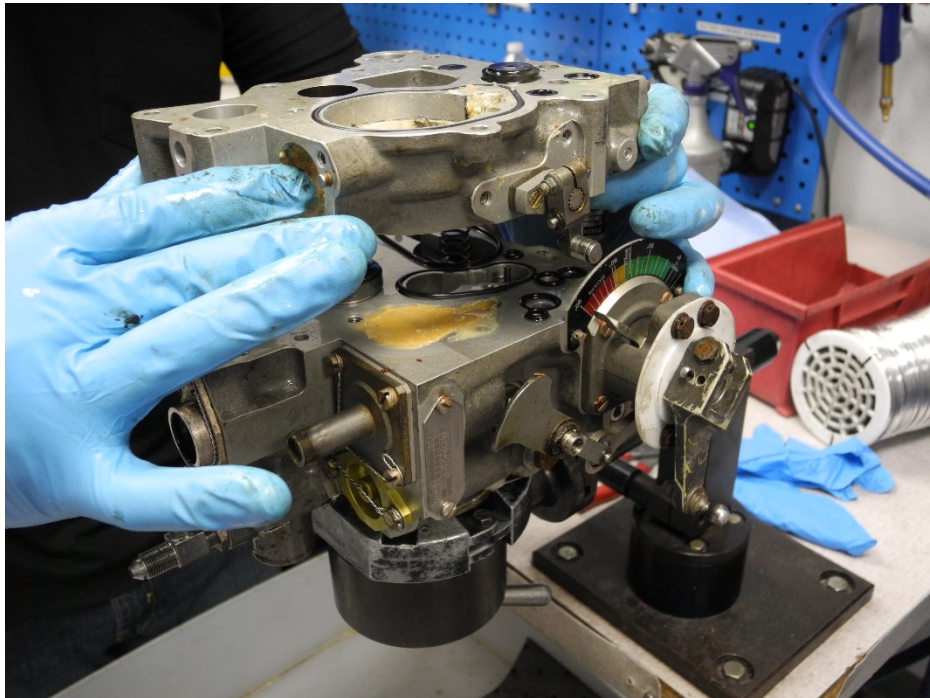
The intermediate body was removed ([Photo 34](#)), revealing clean and undamaged Ng and Nf flyweight mechanisms ([Photo 35](#)) that moved smoothly, an intact P-rod link,

Photo 34 – Removal of Intermediate Body of FCU

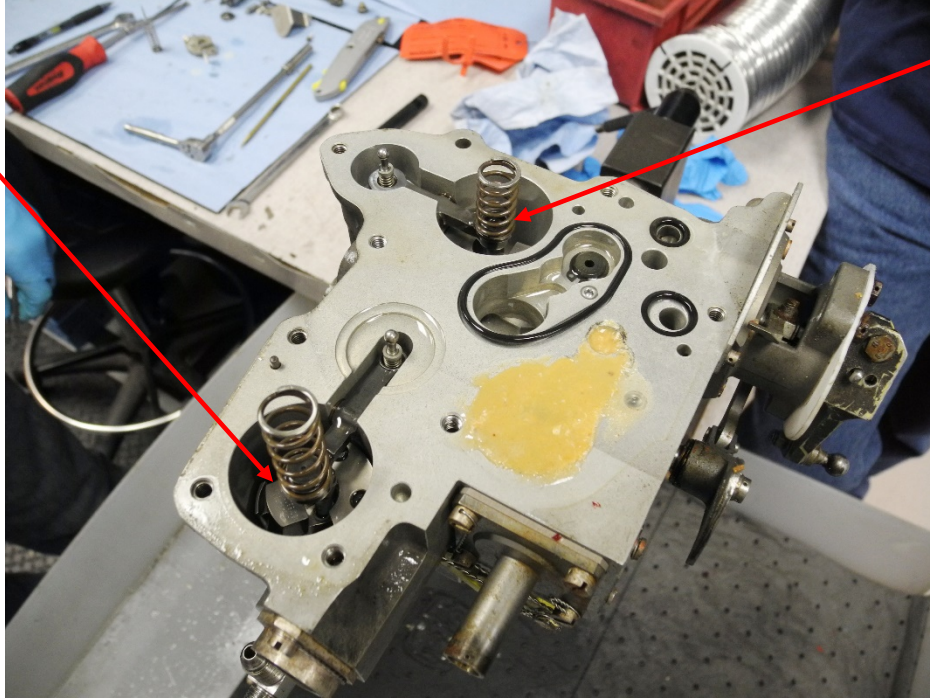
Photo 35 – Ng and Np Flyweights – Clean and Undamaged

Nf Flyweight  
– In-situ

Ng Flyweight  
– In-Situ

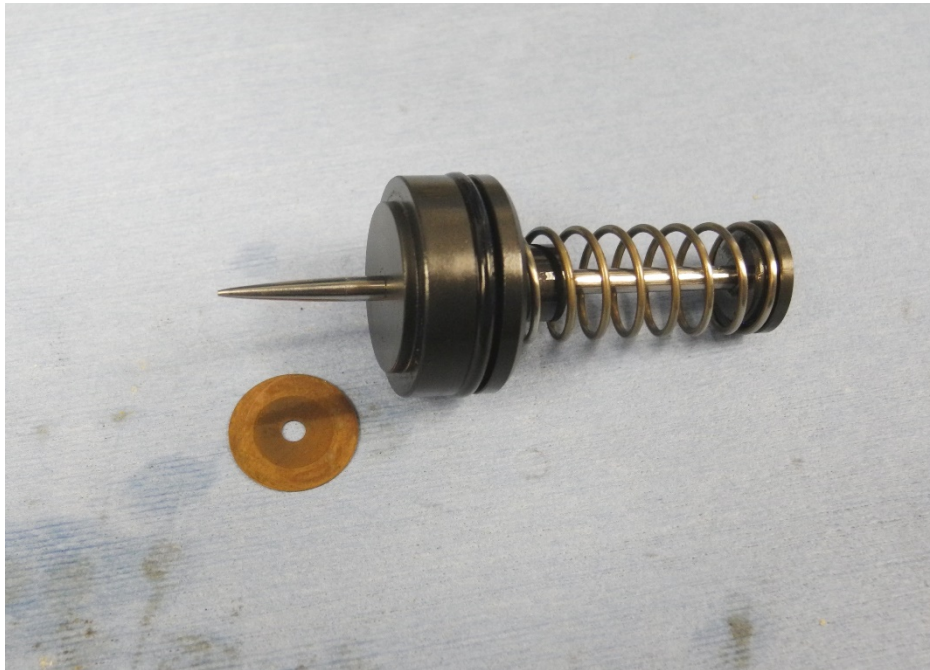
and a clean and undamaged main metering valve (Photo 36). The Nf flyweight shaft was corroded; however, the Nf flyweight seal was undamaged and the shaft bearing rotated smoothly (Photo 37).

Photo 36 – Main Metering Valve – Clean and Undamaged

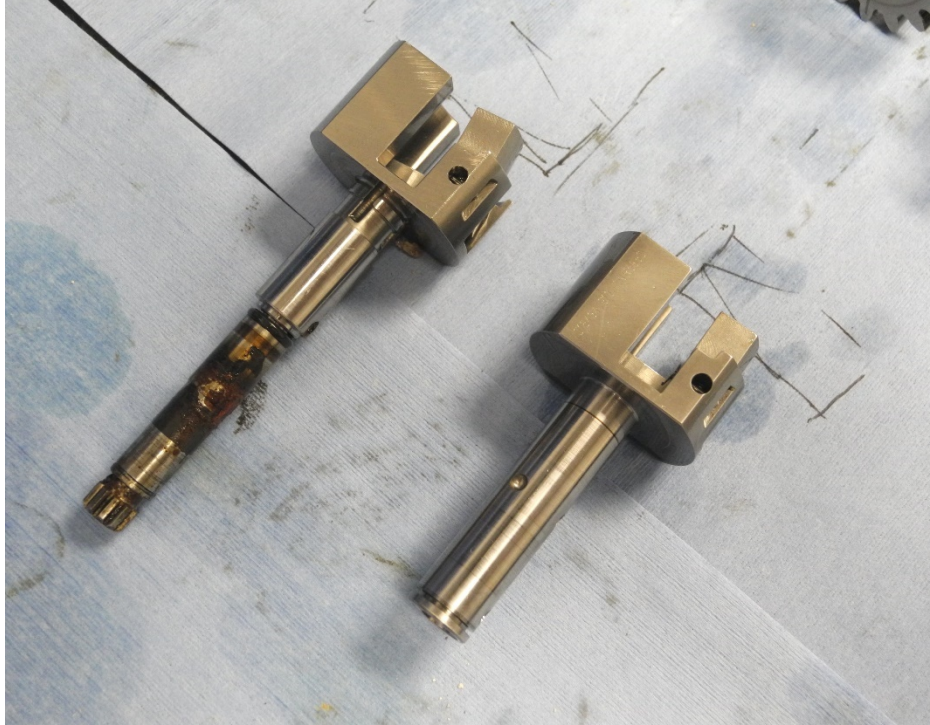
Photo 37 – Nf & Ng Flyweight Assemblies - Undamaged

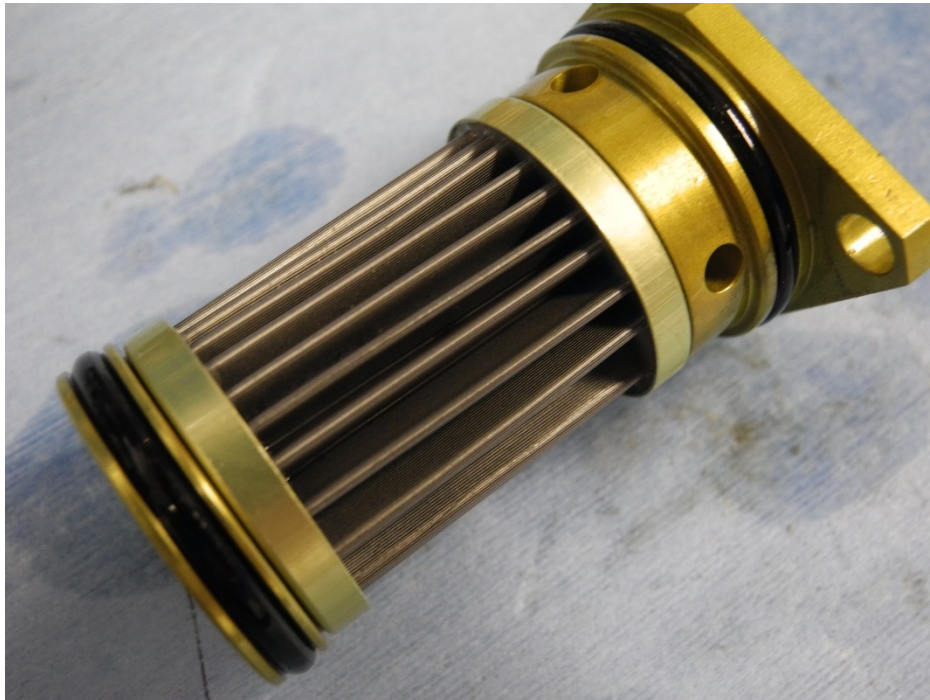
The fuel filter was removed, examined and found to be clean (Photo 38).

Photo 38 – Fuel Filter - Clean

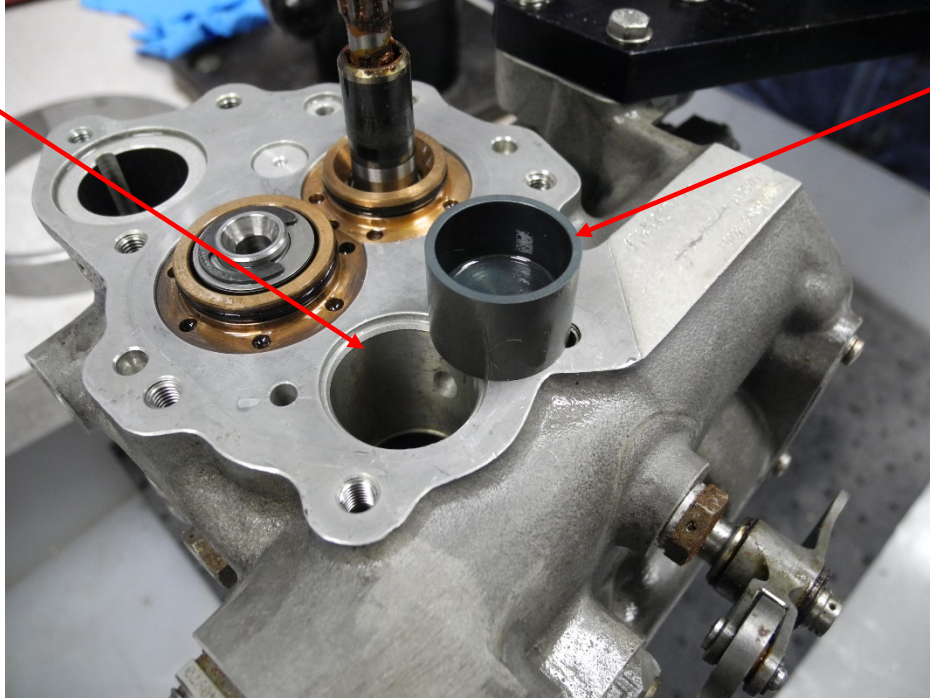
The working piston assembly and sleeve were intact, undamaged and clean (Photo 39). The amplifier piston assembly and sleeve were intact, undamaged and clean (Photo 40).

Photo 39 – Working Piston & Sleeve - Undamaged

Working Piston  
Sleeve -  
Undamaged

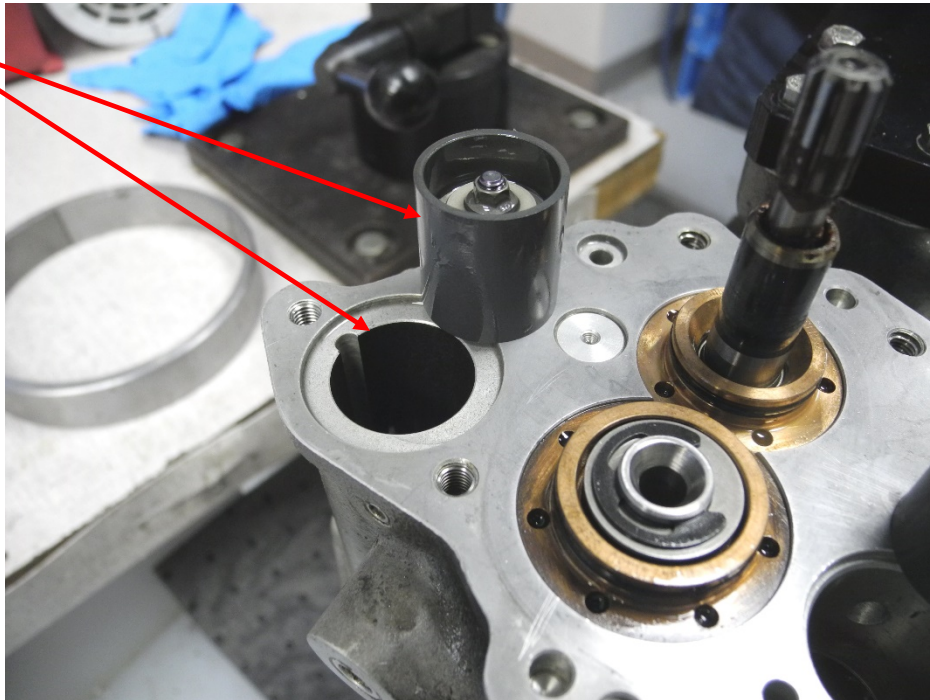
Photo 40 – Amplifier Piston Assembly & Sleeve - Undamaged

Amplifier Piston  
& Sleeve

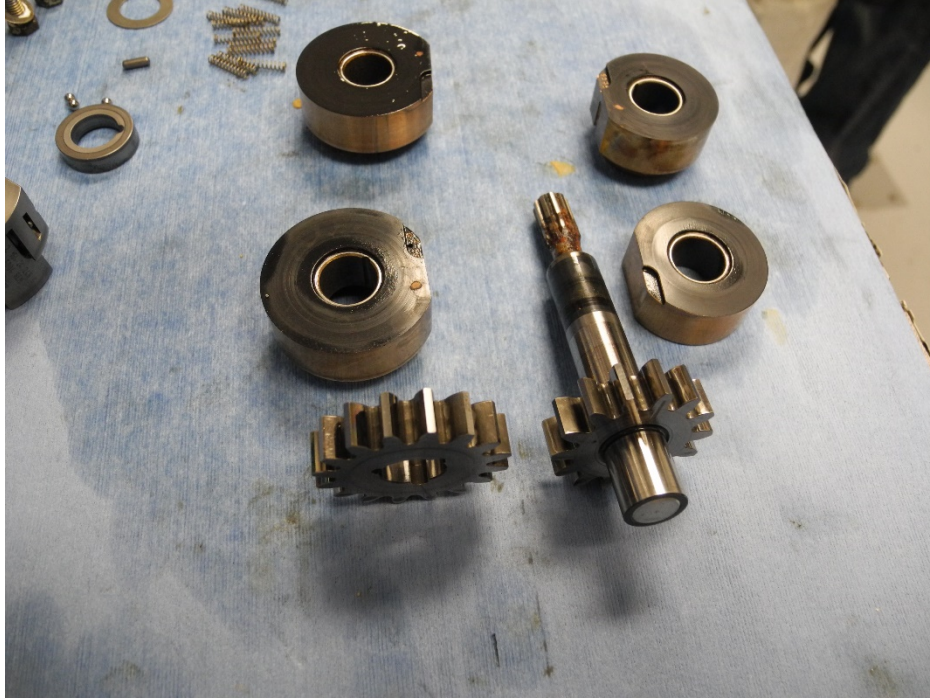
The fuel pump section was disassembled, revealing intact shafts, bearings, gear teeth and side seals (Photo 41). The input shaft spline was intact and there was slight corrosion between the spline and bearing surface.

Photo 41 – Fuel Pump Gears & Side Seals - Undamaged

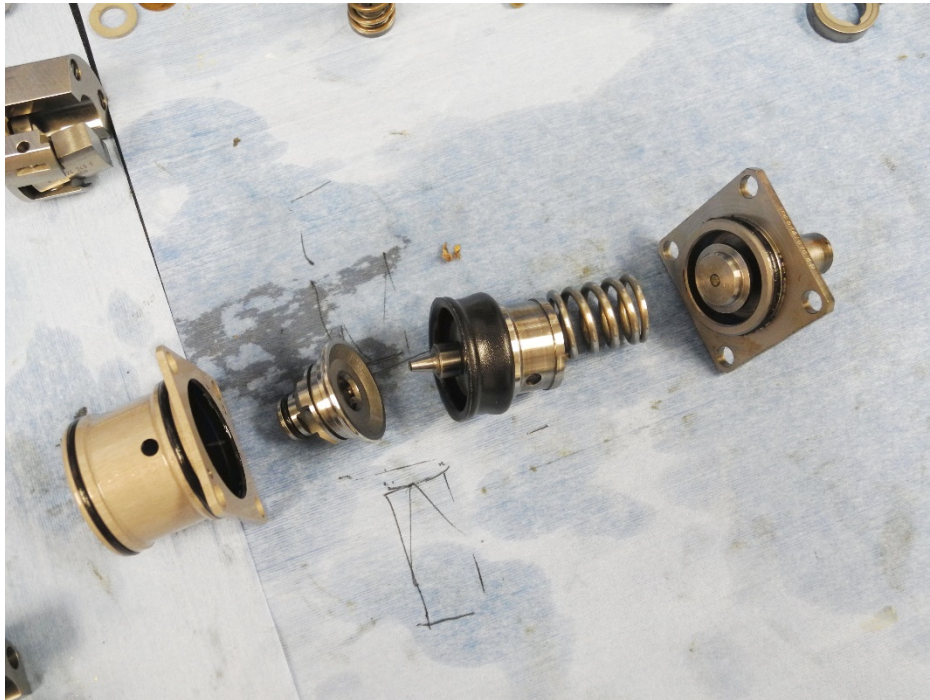
The delta P diaphragm assembly was disassembled and found to be clean, intact and undamaged. The rubber diaphragm was intact, undamaged and still pliable (Photo 42).

Photo 42 – Delta P Diaphragm Assembly - Undamaged
