NATIONAL TRANSPORTATION SAFETY BOARD  
Office of Aviation Safety  
Washington, D.C. 20594

POWERPLANT GROUP CHAIRMAN'S FACTUAL REPORT

NTSB No: DCA15MA029

Aircraft: Embraer Phenom E50P, registration number N100EQ

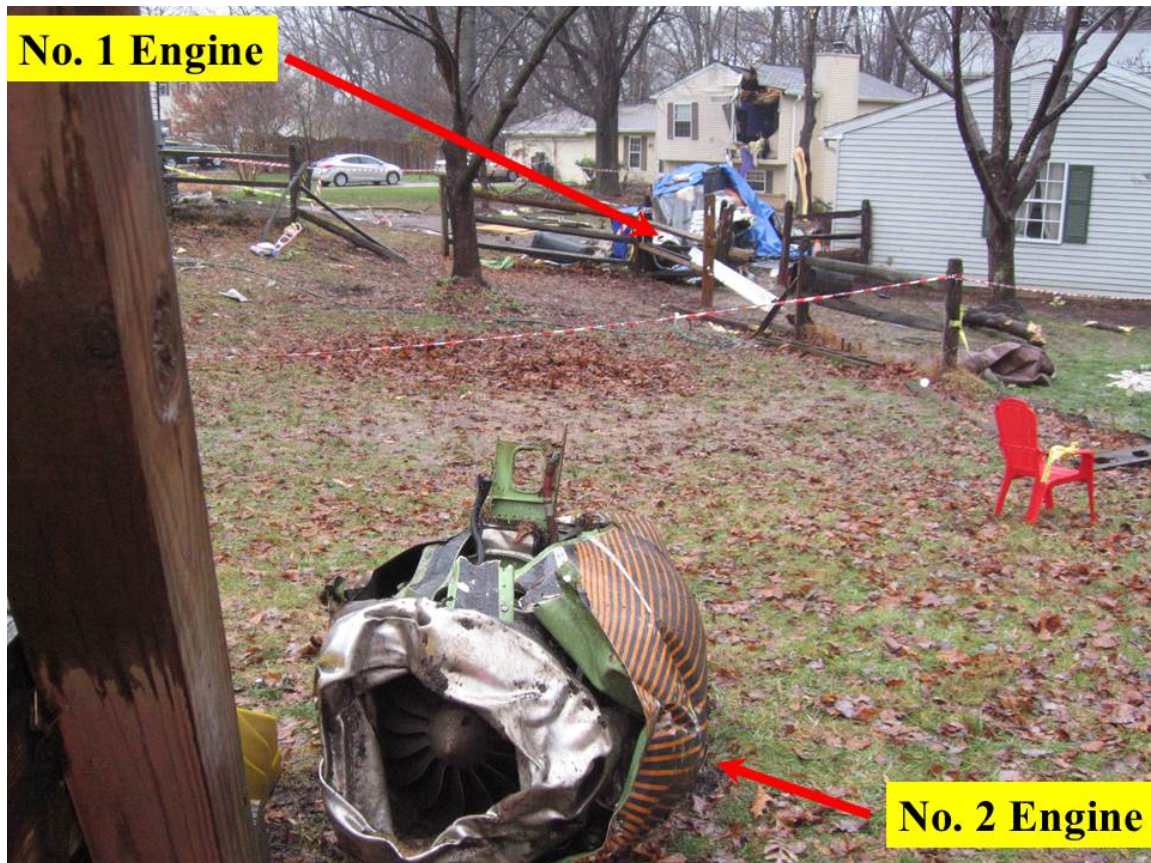
Both engines were collocated at the accident site and were detached from the airplane. The engine installed positions were determined by engine mount orientation. The engine identified as the No. 1 was located near the airplane empennage at the wreckage site while the engine identified as the No. 2 was located in the back yard of the house that experienced the house fire approximately 60 feet from the No. 1 engine (**PHOTO 1**). The cowls and exhaust pipe (airframe supplied hardware) on both engines remained attached, exhibited tears, and neither exhibited any signs of an in-flight fire or damage consistent with an engine uncontainment. The exhaust pipe on both engines was folded over and collapsed onto itself so that the turbine could not be examined in-situ.

**PHOTO 1: BOTH ENGINES LOCATED AT THE CRASH SITE**

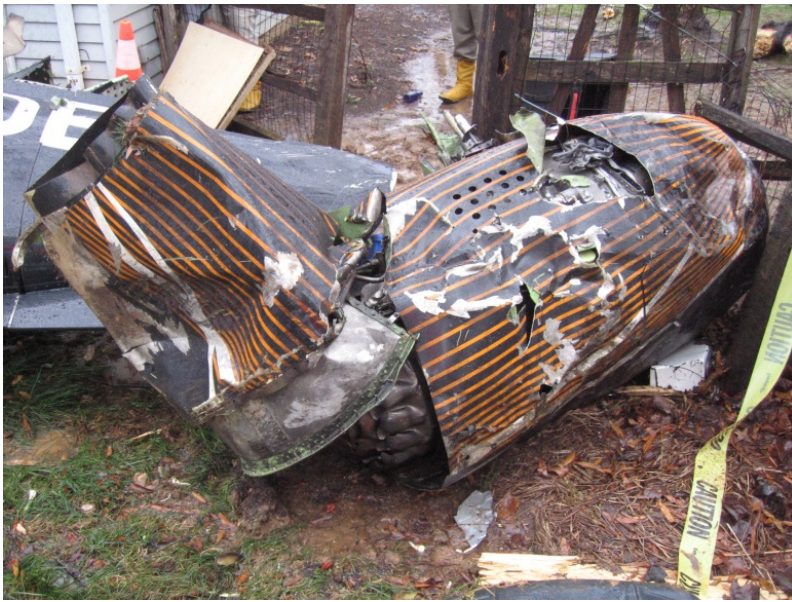
The engine was found resting upside down with the inlet of the engine facing away from the nose of the airplane (**PHOTOS 2 and 3**). Part of the cowl on the bottom of the engine was torn, exposing the gearbox, which exhibited some impact damage. The inlet nose cowl remained attached to the engine, was intact, and exhibited some rounded inward impact damage consistent with soft-body impact (**PHOTO 4**). The exhaust pipe was partially detached from the rest of the engine exposing part of the exhaust mixer (also referred to as the forced mixer). The exhaust mixer exhibited some impact damage and some of the mixer lobes were compressed inwards (**PHOTO 5**). No signs of a ground fire were noted.

**PHOTO 2: NO. 1 ENGINE IN-SITU  
(BOTTOM OF ENGINE FACING UP)**

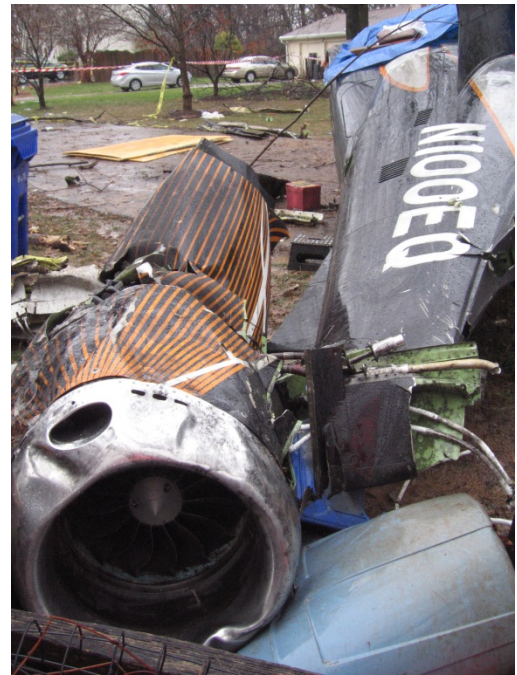
**PHOTO 3: NO. 1 ENGINE IN-SITU  
(RESTING NEAR THE EMPENNAGE)**

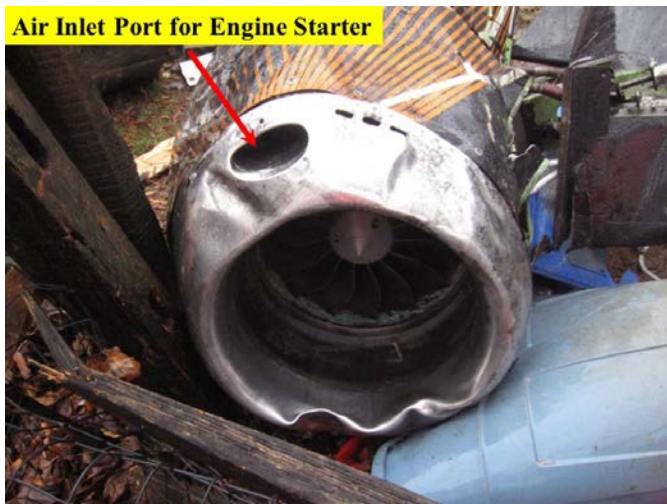
**PHOTO 4: INLET NOSE COWL WITH ROUND-  
BOTTOM IMPACT DAMAGE**

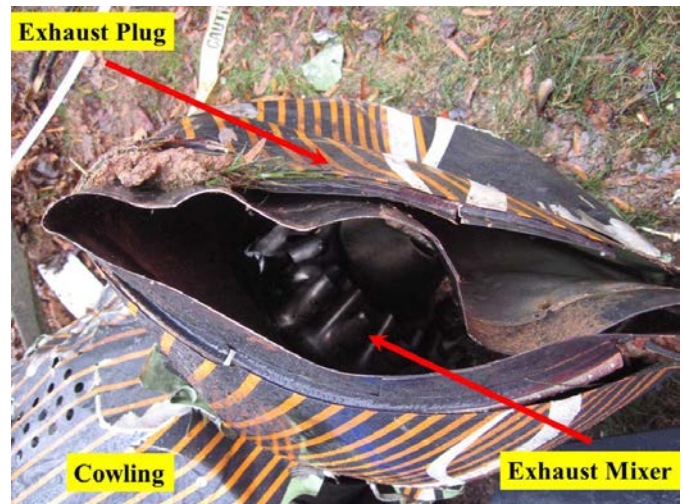
**PHOTO 5: DISTORTED EXHAUST PIPE AND  
PARTIAL VIEW OF EXHAUST MIXER**

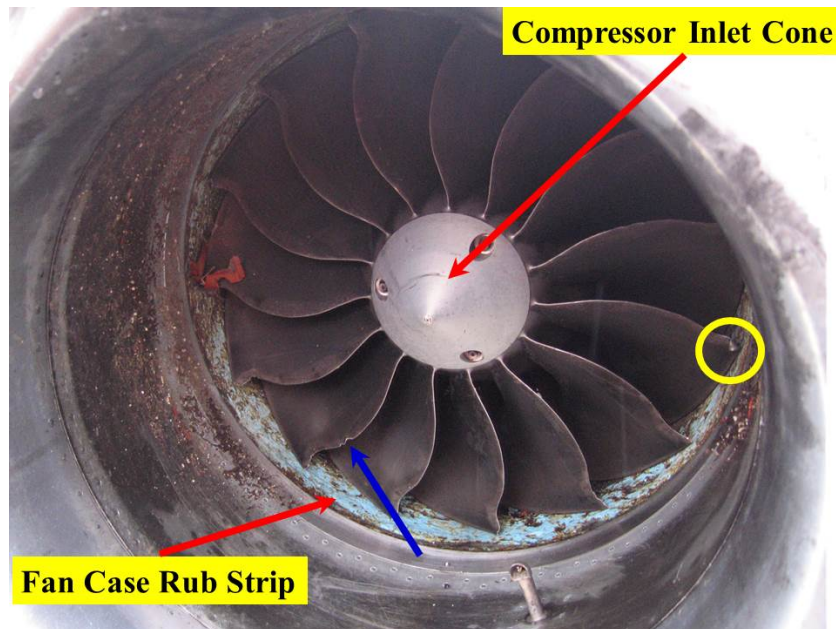
Examination of the LP rotor (fan) through the inlet revealed that the compressor inlet cone (also referred to as the spinner) was intact, still attached to the LP compressor rotor disk (fan disk), and undamaged; and that all of the fan blades<sup>1</sup> were present, intact, and full length. A few blades exhibited slight leading edge tip curl in the direction opposite rotation (**PHOTO 6** – yellow circle) with a few blades exhibited small leading edge round-bottom impact damage consistent with soft-body impact damage (**PHOTO 6** – blue arrow). The fan blade rub strip (bluish color) made of an epoxy resin abrasion resistant liner exhibited contact rub down to the case fan case (**PHOTO 6**). The fan case was intact and no case breaches were noted. The fan was able to be turned freely by hand and some scrapping of the fan blades against the fan case was noted. No appreciable earth or debris was noted in or on the fan and

**PHOTO 6: FAN BLADES INTACT AND WHOLE WITH MINOR LEADING EDGE DAMAGE**

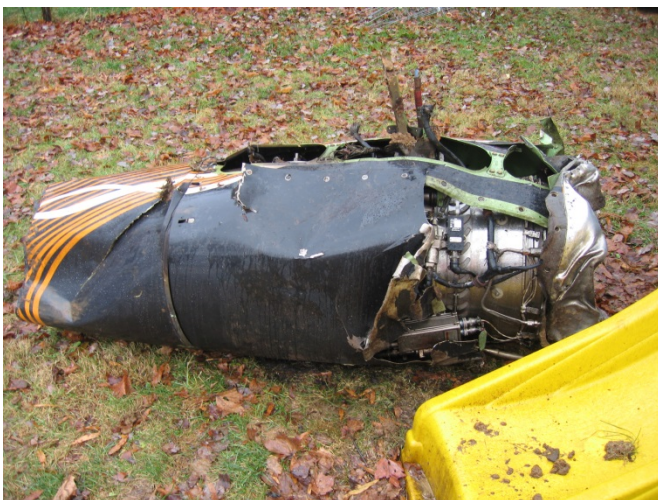
The engine was found resting on its right side with the inlet of the engine facing away from the nose of the airplane (**PHOTO 7**). Part of the cowl on top of the engine was torn exposing the DCU. The inlet nose cowl remained attached to the engine, was intact, crushed rearwards, and exhibited rounded inward impact damage consistent with soft-body impact (**PHOTO 8**). The exhaust pipe remained attached to the engine and collapsed to the point that the exhaust mixer was barely visible (**PHOTO 9**). A small localized ground fire (**PHOTO 10** – red area) and corresponding thermal damage to the bottom of the cowl was noted (**PHOTO 10** – yellow area). Several engine fluid tubes were found fractured in the vicinity of the ground fire.

**PHOTO 7: NO. 2 ENGINE IN-SITU  
(TOP & LEFT SIDE OF ENGINE FACING CAMERA)**

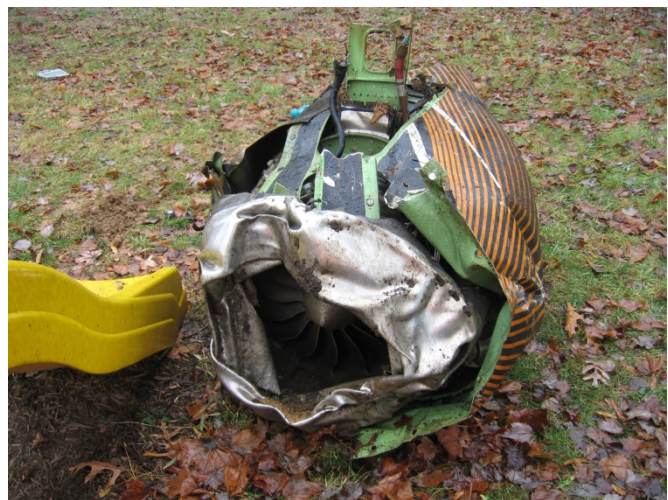
**PHOTO 8: INLET COWL WITH SEVERAL ROUND-BOTTOM IMPACTS**

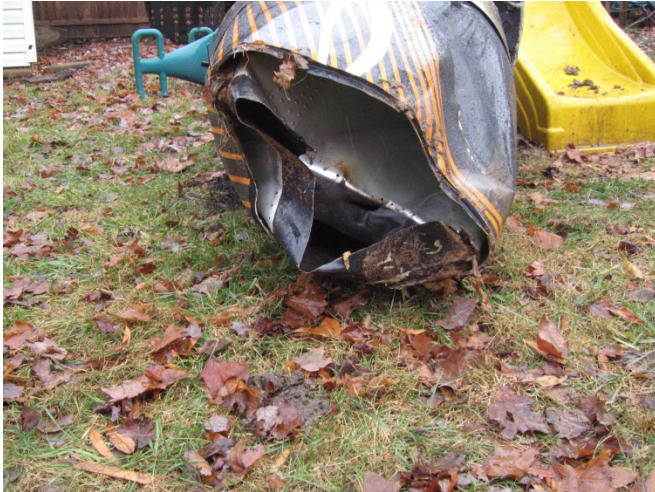
**PHOTO 9: DISTORTED EXHAUST PIPE**

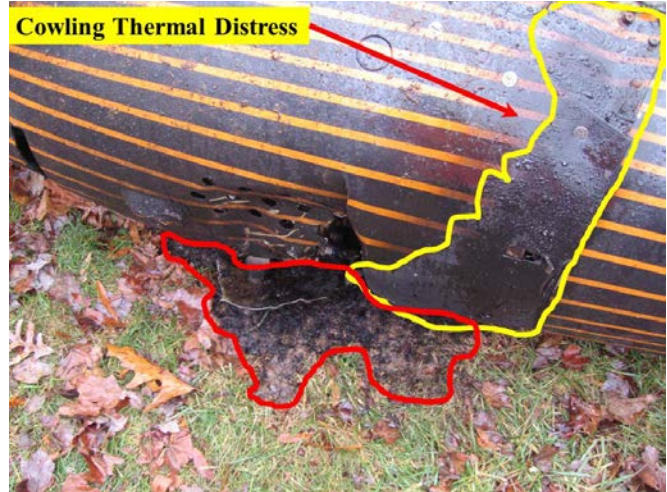
**PHOTO 10: LOCALIZED GROUND FIRE**

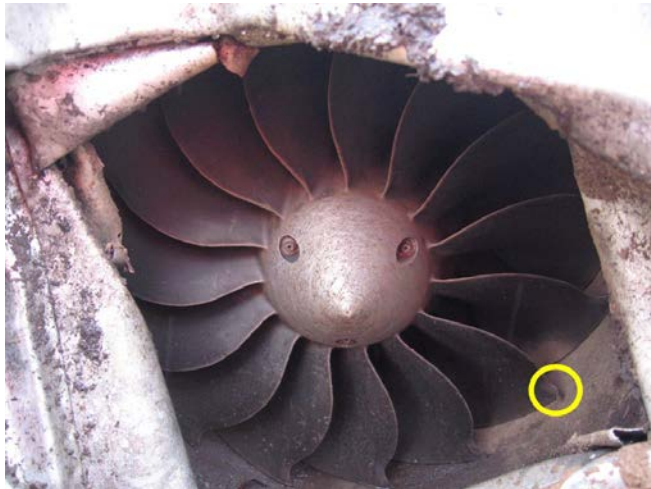
Similar to the No. 1 engine, examination of the LP rotor through the inlet revealed that the compressor inlet cone was intact, still attached to the LP compressor rotor disk, and undamaged; and that all of the fan blades were present, intact, and full length. A few blades exhibited slight leading edge tip curl in the direction opposite rotation (**PHOTO 11** – yellow circle) and no leading edge impact damage was noted. The fan case was intact, no case breaches were noted, and the case inner diameter (flow path) exhibited a thin layer of dirt but no appreciable earth or debris was noted on or between the fan blades (**PHOTO 11**). Looking past the fan blades, again no appreciable earth or debris was noted. The fan was able to be turned freely and smoothly by hand and no scrapping of the fan blades against the fan case was noted. Since the turbine could not be observed in-situ, continuity between the LP compressor and the LP turbine rotors could not be confirmed on-site.

**PHOTO 11: FAN BLADES INTACT AND WHOLE WITH TIP CURL**

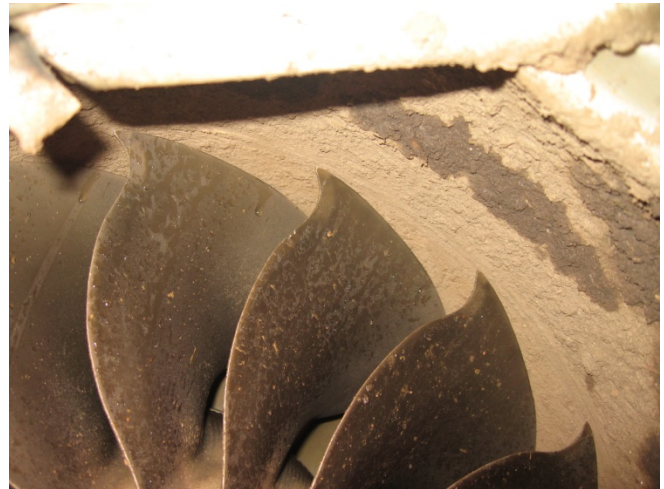
**PHOTO 12: FAN CASE FLOW PATH WITH THIN LAYER OF DIRT**

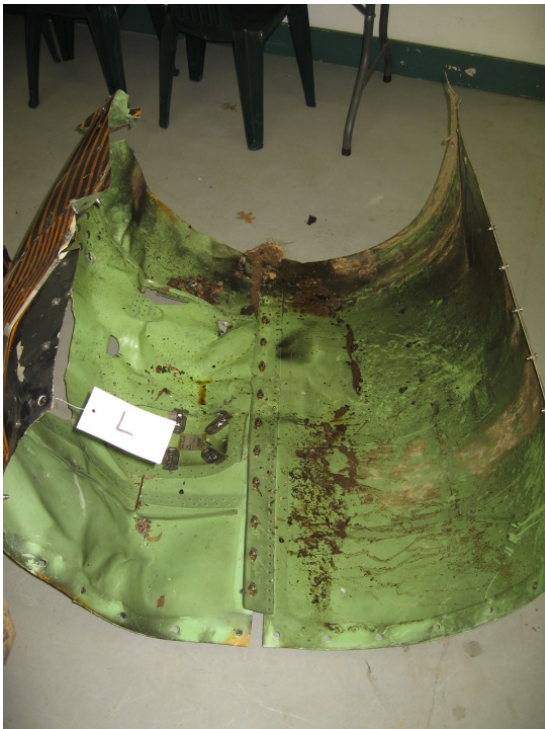
The air inlet port in the inlet nose cowl for the starter generator was free of dirt and debris. With the cowlings removed, examination of the inside of the cowling revealed no thermal distress and the service door (next to the white card labeled “L”) located on the bottom of the cowl was intact, in place, remained latched (**PHOTO 13**). The data plate on the gearbox confirmed the engine to be SN LC0157 (**PHOTO 14**).

**PHOTO 13: COWLING IN GOOD CONDITION**

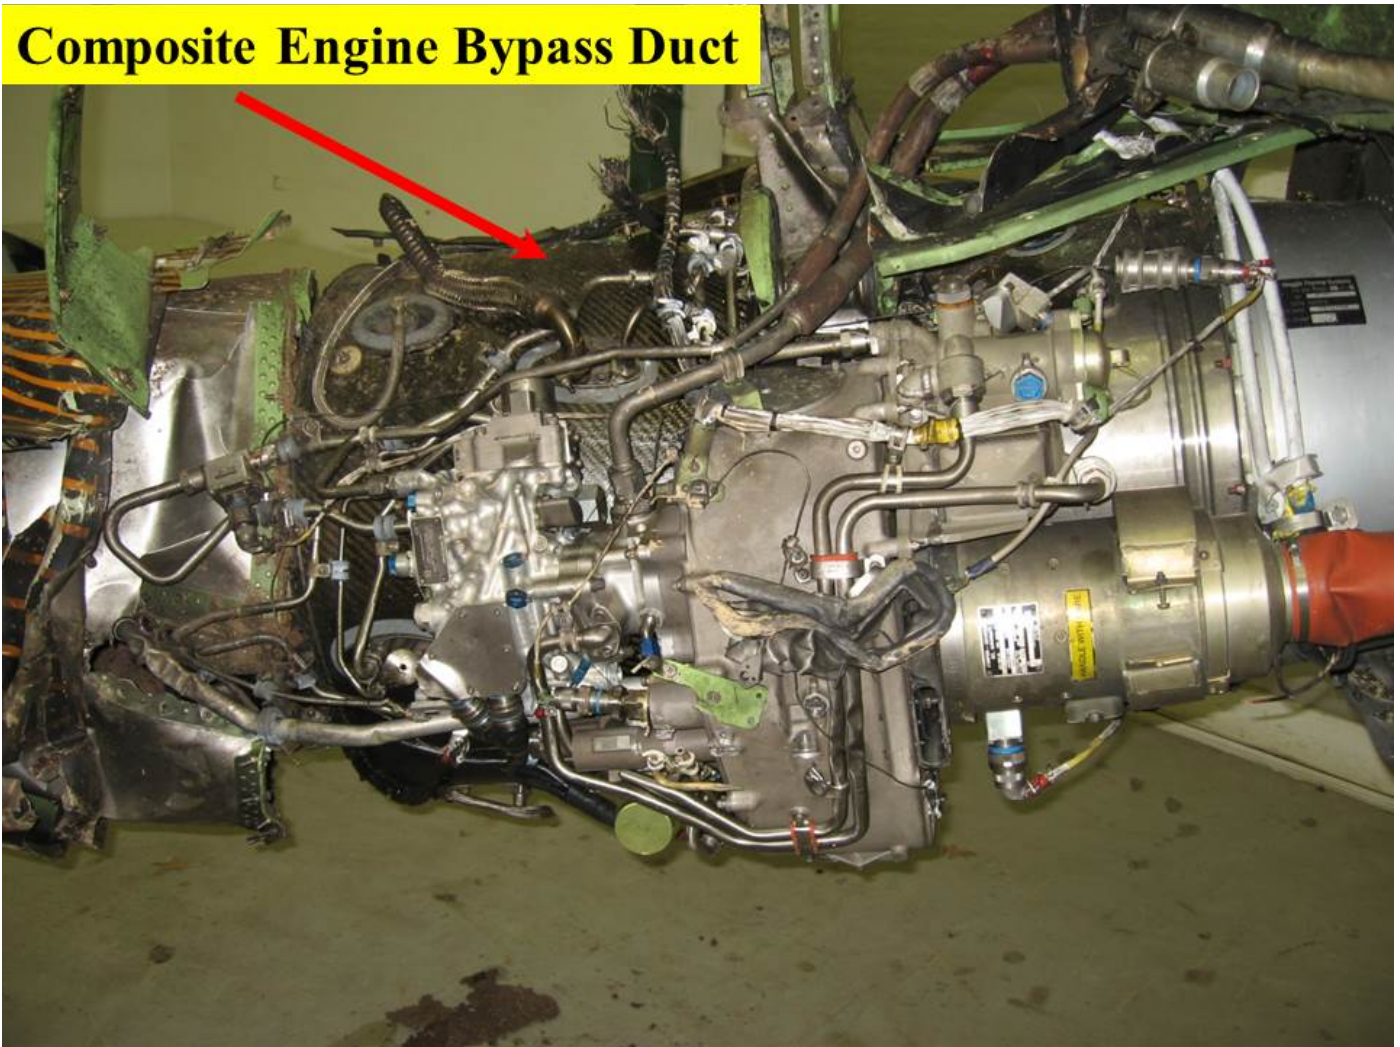
The bottom of the engine exhibited impact damage consisting of flattened and distorted piping and fractured attachment bolt lugs on the gearbox (**PHOTO 15**). Some sooting and thermal distress, consisting of cushion clamp oxidation and melted electrical wire protective sheathing, was noted from about the 3:00 (engine mount location) to about the 5:00 o'clock location in the general vicinity of the gearbox. The gearbox remained secured to the engine and appeared to be intact; no signs of oil streaking or leaking from the gearbox were observed nor were there fresh oil residue noted on the inside of the cowling. The engine bypass duct was still in place but was cracked/torn at the 6:00 o'clock location; sections of the rear flange were missing, and the rear flange engine bypass duct-to-airframe bypass duct attachment bolts were ripped through.

**PHOTO 15: BOTTOM OF NO. 1 ENGINE – IMPACT DAMAGE BUT NO THERMAL DISTRESS**

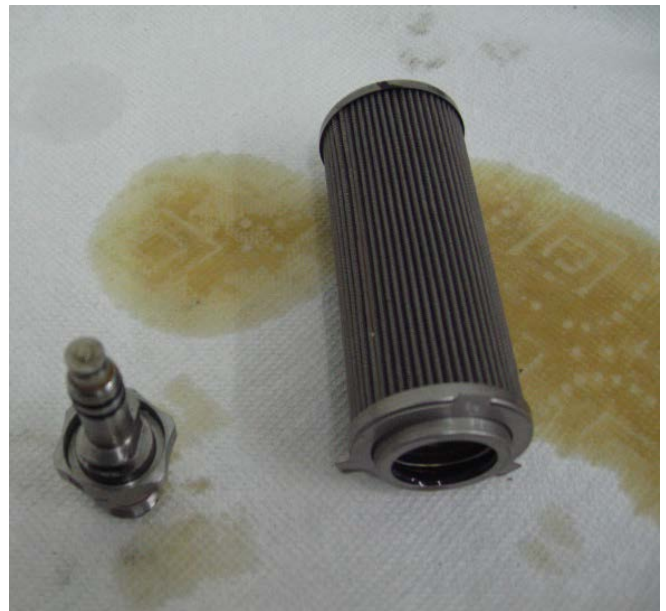
The magnetic chip detector was removed from the gearbox and it was clean with no debris on the tip. The oil filter was removed and it appeared clean and free of debris; the oil from the filter housing appeared clear, clean, and there was no acrid smell (**PHOTO 16**). The fuel filter was also removed and it appeared to be clean and free of debris as well.

**PHOTO 16: CLEAN OIL MAGNETIC CHIP DETECTOR (LEFT) AND OIL FILTER (RIGHT)**

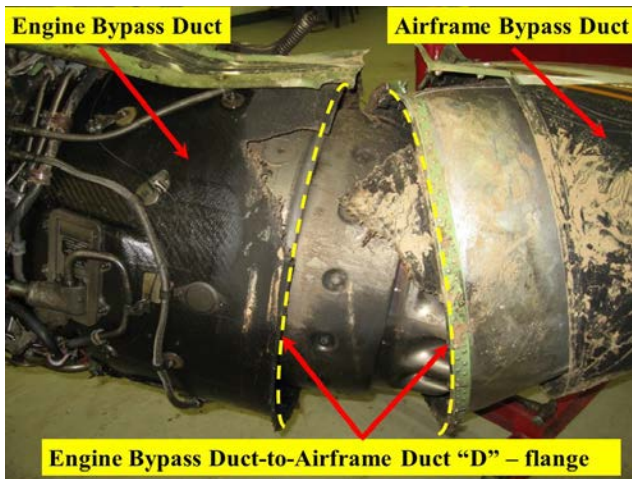
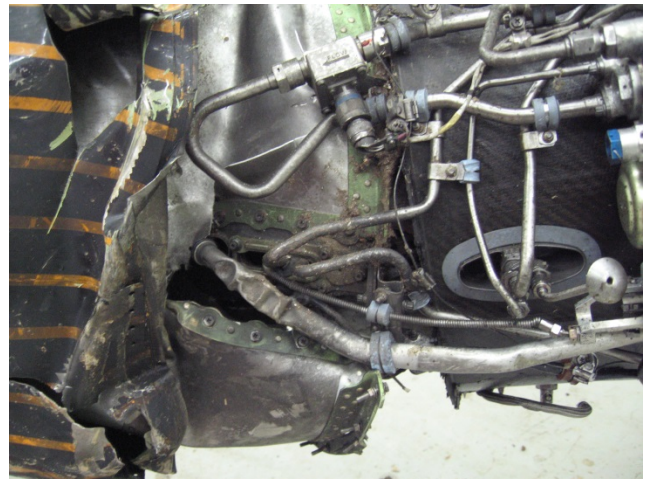
The rear end of the annular bypass duct (actually the airframe duct), which is integral with the exhaust pipe, had completely separated from the engine at the “D”-flange; the engine bypass duct-to-airframe bypass duct flange remained connected to the engine by piping only (**PHOTOS 17** and **18**).

**PHOTO 17: SEPARATED BYPASS DUCT  
(TOP VIEW)**

**PHOTO 18: SEPARATED BYPASS DUCT  
(BOTTOM VIEW WITH PIPING STILL ATTACHED)**

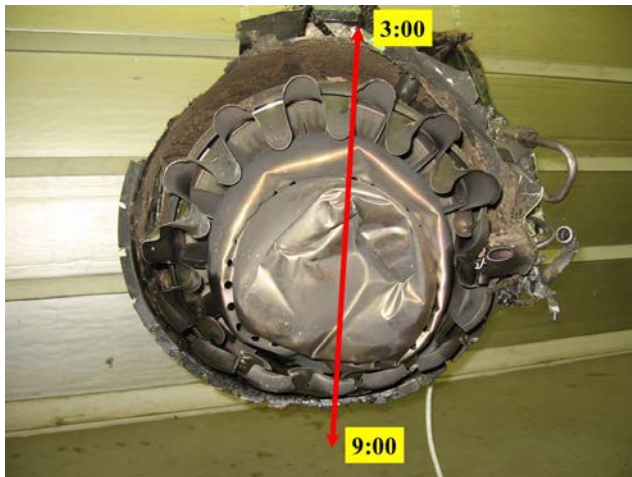
With the exhaust pipe removed, the exhaust mixer was exposed, it was intact and the end cone was crushed in the direction from about the 9:00 to 3:00 o'clock position, and several of the exhaust mixer lobes were pressed radially inwards (**PHOTO 19**). Looking through the exhaust mixer, all the LPT blades were present, intact, and in good condition (**PHOTO 20**). The fan was rotated by hand and the LPT rotated along with it, confirming continuity of the LP rotor system. Again as the fan was turned the fan blades scrapped along the fan case. Covers on the starter generator were removed and the starter generator was rotated using a screw driver; sounds coming from the HP rotor system were heard consistent with the HP rotor system turning and continuity.

**PHOTO 19: CRUSH END CONE**

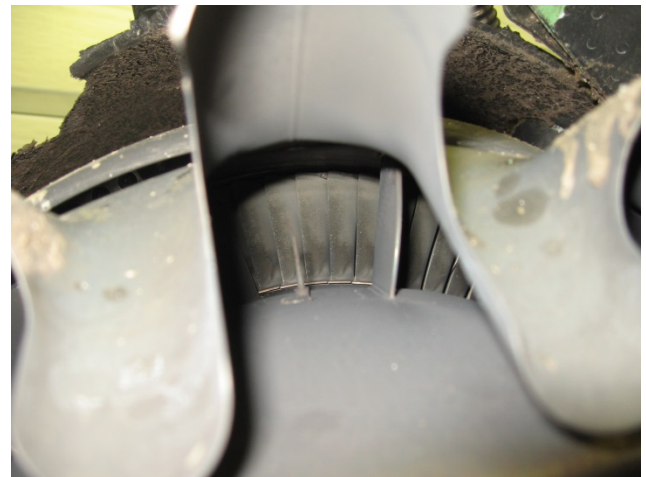
**PHOTO 20: LPT BLADES INTACT AND GOOD  
CONDITION**

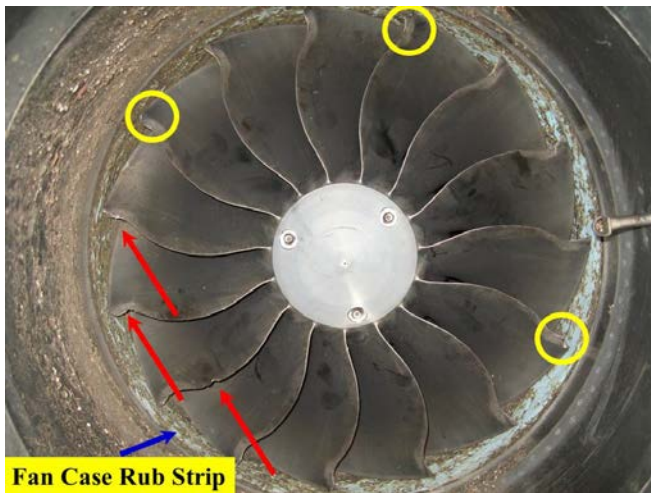
Closer examination of the fan blades found more blades that exhibited leading edge impact damage and tip curl than what was originally observed on-site; however, overall the fan blades were in relatively good condition (**PHOTOS 21**). Looking past the fan blades revealed no appreciable dirt or debris except at the bottom of the engine (6:00 o'clock position) and minor impact damage was visible downstream on the fan exit vanes (**PHOTOS 22**). An overall visual examination of all the engine cases did not find any evidence of breaches of the core or uncontainments. The engine mounts remained secure to the engine and to the airframe pylon strut.

**PHOTO 21: NO. 1 ENGINE FAN BLADE DAMAGE**

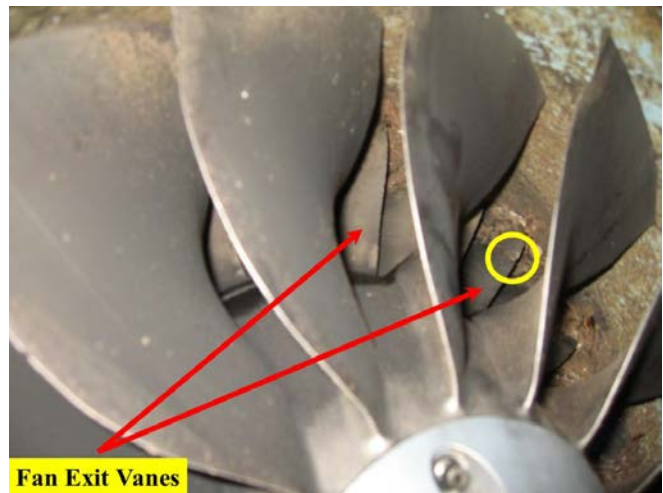
**PHOTO 22: DIRT AND DEBRIS IN COMPRESSOR AND DAMAGE DOWNSTREAM OF FAN BLADES**

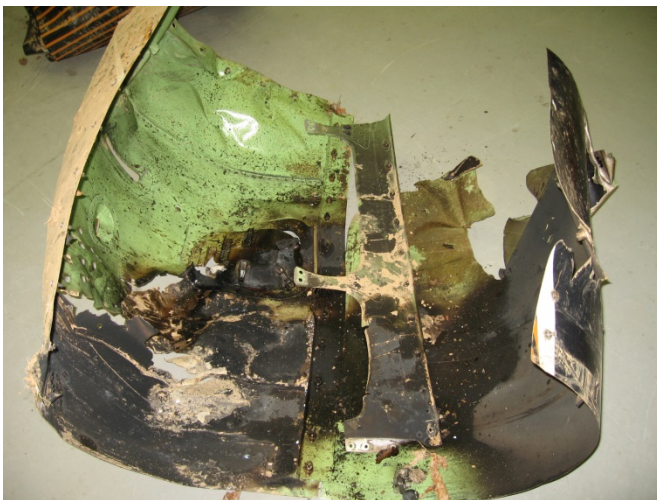
The air inlet port was plugged with dirt; however, the exhaust portion of the inlet port that leads directly to the starter appeared to be clean. With the cowlings removed, the inside of the cowling exhibited thermal distress and some signs of melting (**PHOTO 23**) unlike the No. 1 engine that was free of thermal distress. The service door was distorted but remained latched and in place. The data plate on the gearbox confirmed the engine to be SN LC0158 (**PHOTO 24**).

**PHOTO 23: COWLING THERMAL DAMAGE**

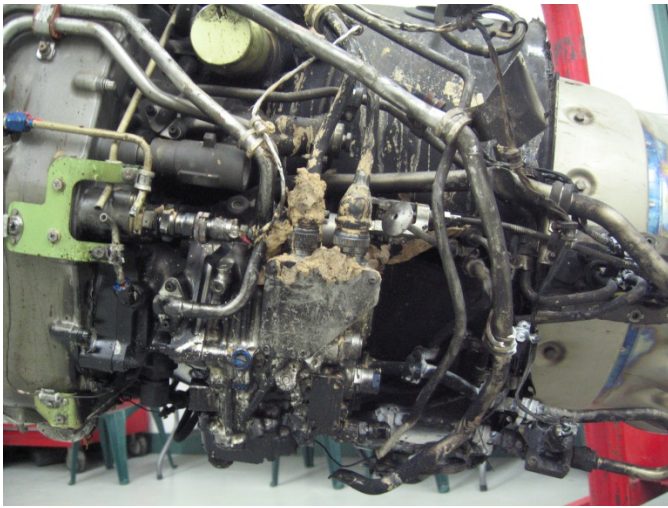
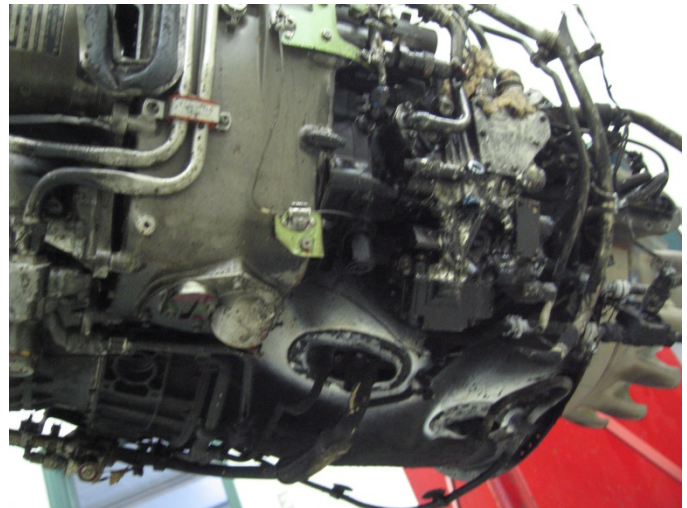
The bottom of the engine exhibited impact damage, sooting, thermal distress, and some of the piping was flattened, distorted or fractured (**PHOTOS 25** and **26**). The thermal distress ranged from the aft side of the gearbox to “D”-flange (the engine bypass duct-to-airframe bypass duct flange) and consisted of cushion clamp oxidation and melted electrical wire protective sheathing.

**PHOTO 25: THERMAL DISTRESS AND IMPACT DAMAGE**

**PHOTO 26: THERMAL DISTRESS AND IMPACT DAMAGE**

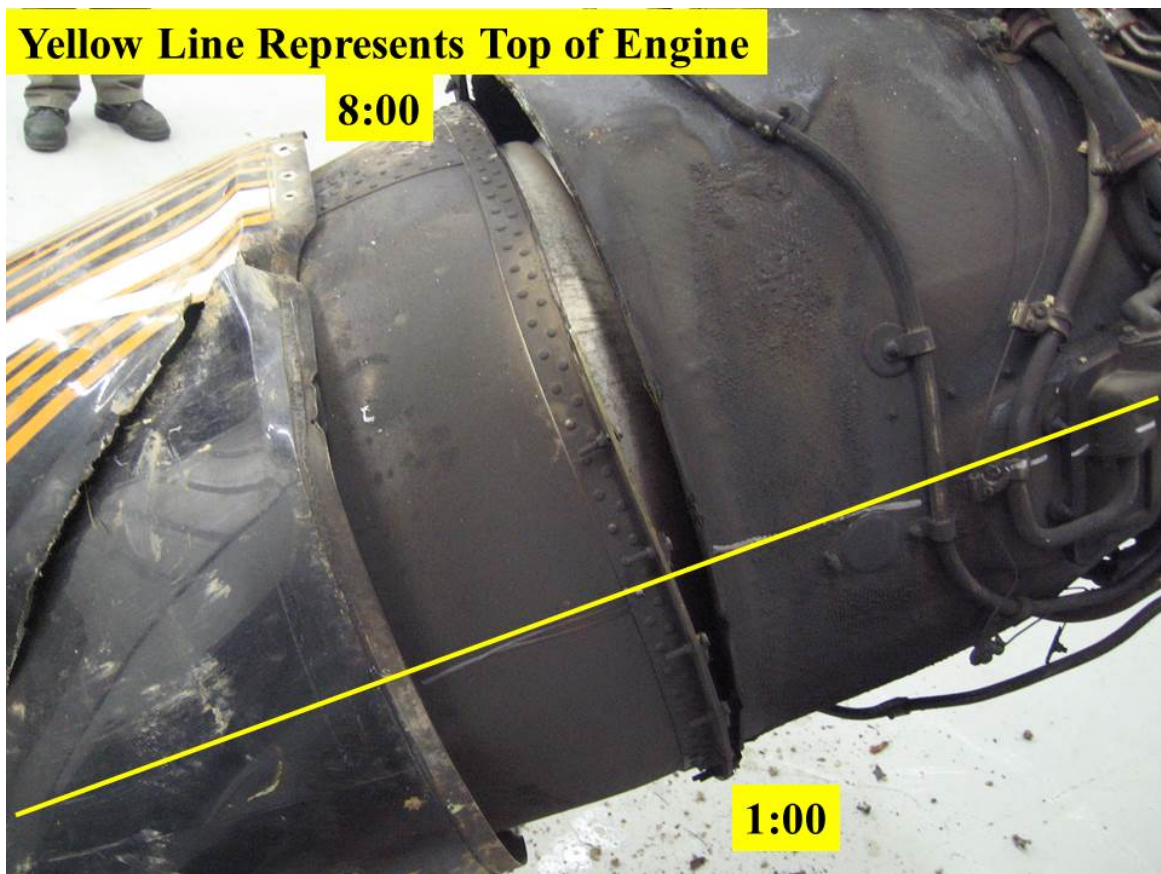
The gearbox remained secured to the engine and it appeared to be intact and no signs of oil streaking or leaking from the gearbox were observed, nor was there fresh oil residue noted on the inside of the cowling. Similar to the No. 1 engine, the No. 2 engine bypass duct was still in place, exhibited impact and thermal damage, and a section of the rear flange was torn and missing. The rear flange was torn and separated from about the 8:00 to 1:00 o'clock location (**PHOTO 27**). Unlike the No.1 engine, the airframe bypass duct still remained attached to the engine bypass duct.

**PHOTO 27: FRACTURED ANNULAR BYPASS DUCT**

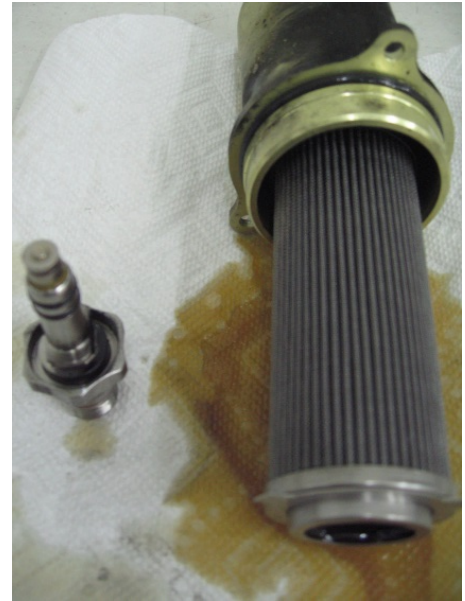
The magnetic chip detector was removed from the gearbox and it was clean with no debris on the tip. The oil filter was removed and it appeared clean and free of debris; the oil from the filter housing appeared clear, clean, and there was no acrid smell (**PHOTO 28**). The fuel filter was also removed and it appeared to be clean and free of debris as well.

**PHOTO 28: CLEAN OIL MAGNETIC CHIP DETECTOR AND OIL FILTER**

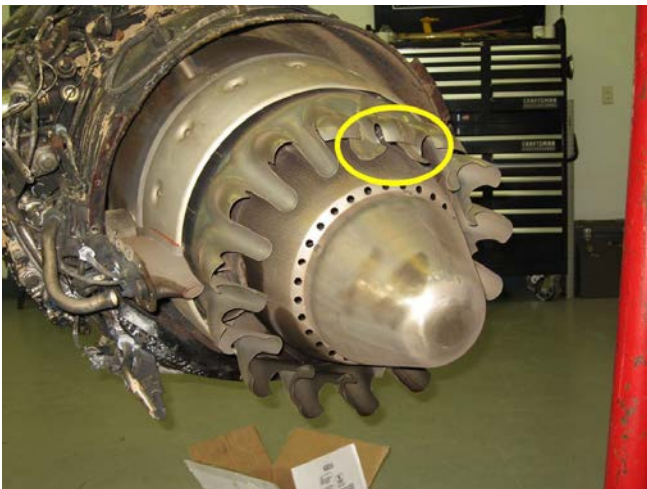
With the exhaust pipe removed, the exhaust mixer was exposed and it was intact and in good condition with some of the exhaust mixer lobes pressed radially inwards (**PHOTO 29**). The end cone appeared to be undamaged. Looking through the exhaust mixer, all the LPT blades were present, intact, and in good condition (**PHOTO 30**). The fan was rotated by hand and the LPT rotated along with it, confirming continuity of the LP rotor system. Once again covers on the starter generator were removed and the starter generator was rotated using a screw driver; sounds coming from the HP rotor system were heard consistent with the HP rotor system turning and continuity.

**PHOTO 29: MIXER TUBE DAMAGE**

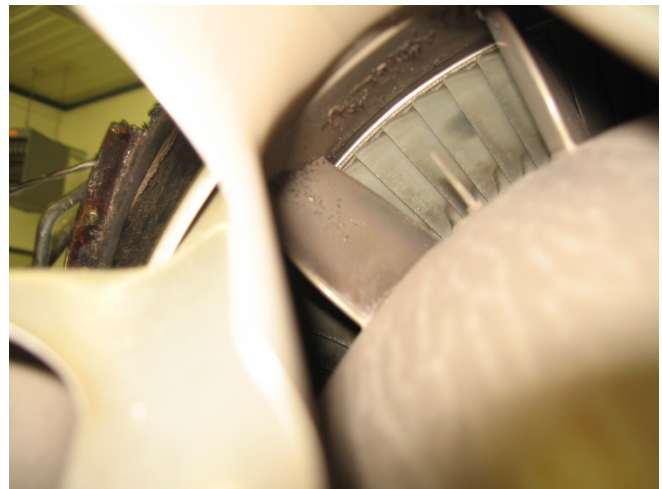
**PHOTO 30: LPT BLADES INTACT AND GOOD CONDITION**

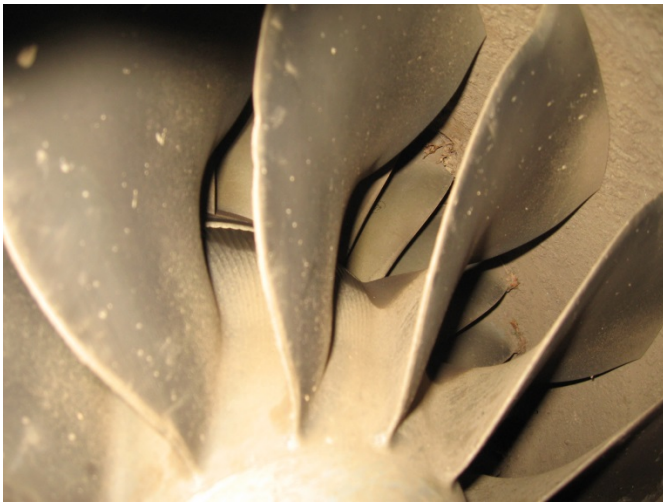
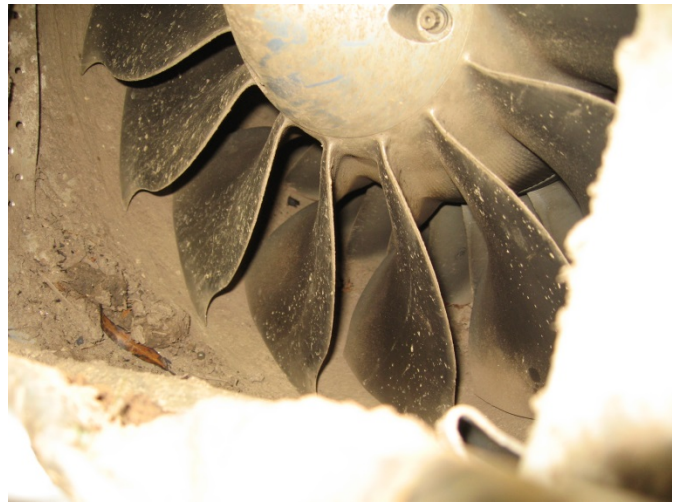
Closer examination past the fan blades revealed no appreciable dirt or debris (**PHOTOS 31** and **32**) and no visible damage downstream on the fan exit vanes. An overall visual examination of all the engine cases did not find any evidence of breaches of the core or uncontainments. The engine mounts remained secure to the engine and to the airframe pylon strut.

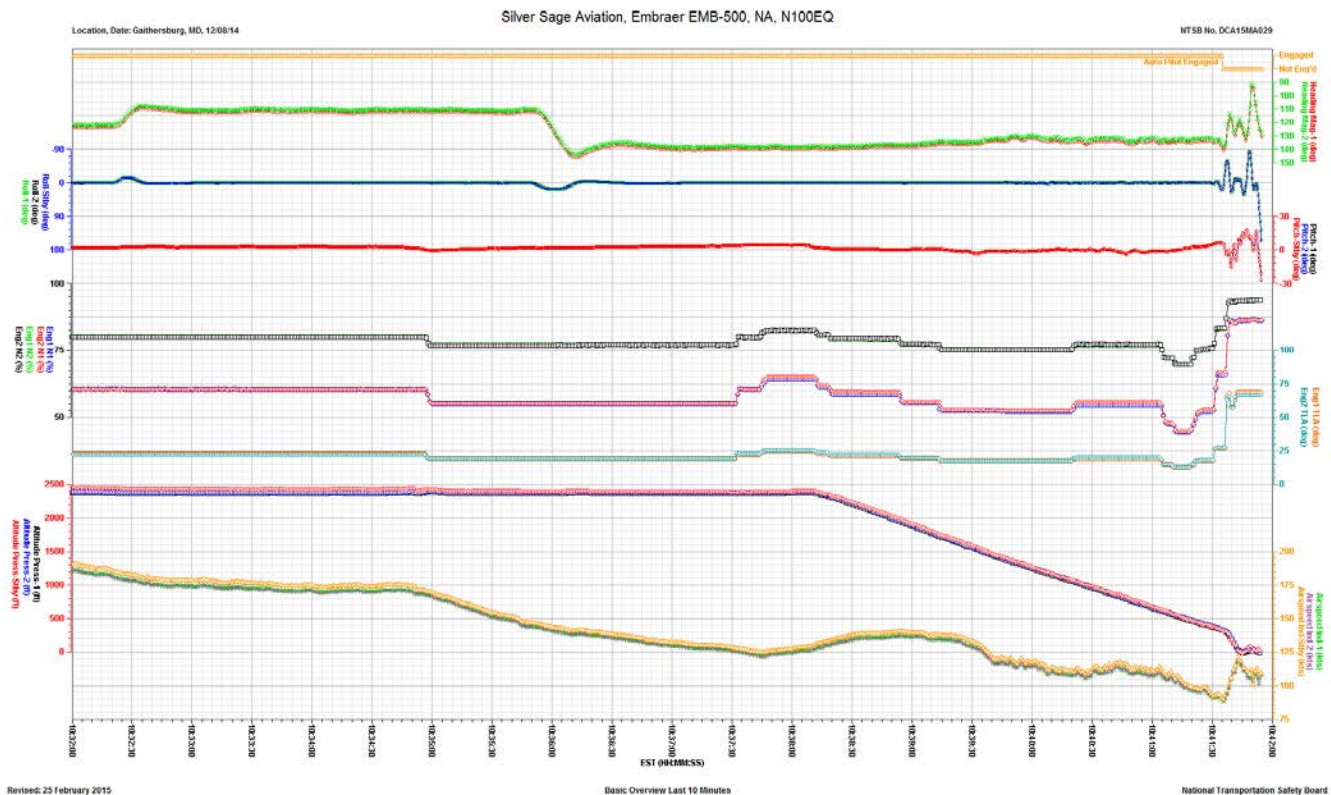
- 1) TLA for engine 1 and 2 were matched within 1° of each other throughout
- 2) TLA changes for each engine were in tandem – no split in TLA was observed
- 3) N1 for engine 1 and 2 were matched within several percent of each other throughout
- 4) N2 for engine 1 and 2 were matched within 1% percent of each other throughout
- 5) Each engine responded to an advance in TLA with a corresponding increase in N1 and N2
- 6) Each engine responded to a decrease in TLA with a corresponding decrease in N1 and N2
- 7) For each engine, when a TLA change was initiated, a corresponding change in N1 and N2 was observed within the subsequent sample (within 1 second)

**FIGURE 5: FDR PLOT FOR THE LAST 10 MINUTES OF FLIGHT**
