**NATIONAL TRANSPORTATION SAFETY BOARD
OFFICE OF AVIATION SAFETY
WASHINGTON, D.C. 20594**

**POWERPLANTS GROUP CHAIRMAN'S FACTUAL REPORT
NTSB ID: CEN15FA034**

Location: Wichita, Kansas
Date: October 30, 2014
Time: 0948 Central Daylight Time (CDT)
Aircraft: Raytheon Aircraft Company Super King Air B200, Reg. N52SZ

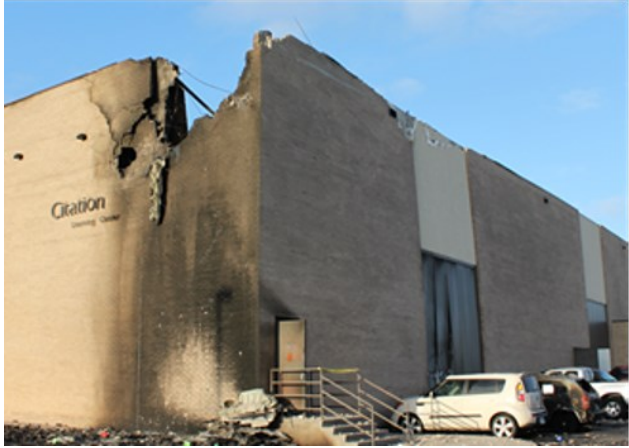
Figure 1. Initial point of impact

An initial point of impact was evident at the northeast corner roofline of the FSI building, a brick structure housing flight simulators. See Figure 1. The left engine and propeller were found inside the building, separated from the airframe and partially buried in rubble just beyond the roofline impact. See Figure 2.

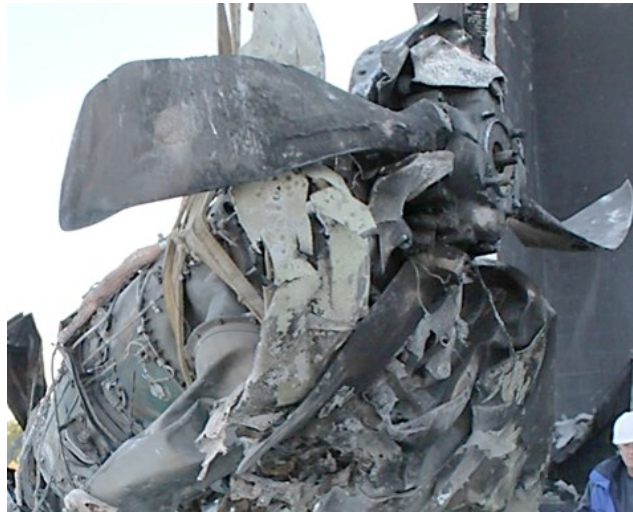
Figure 3. Left engine recover

The propeller remained attached to the engine. See Figure 3. The blades were retained in the hub but were loose in their clamps. The outboard ends of two adjacent blades were fractured off.

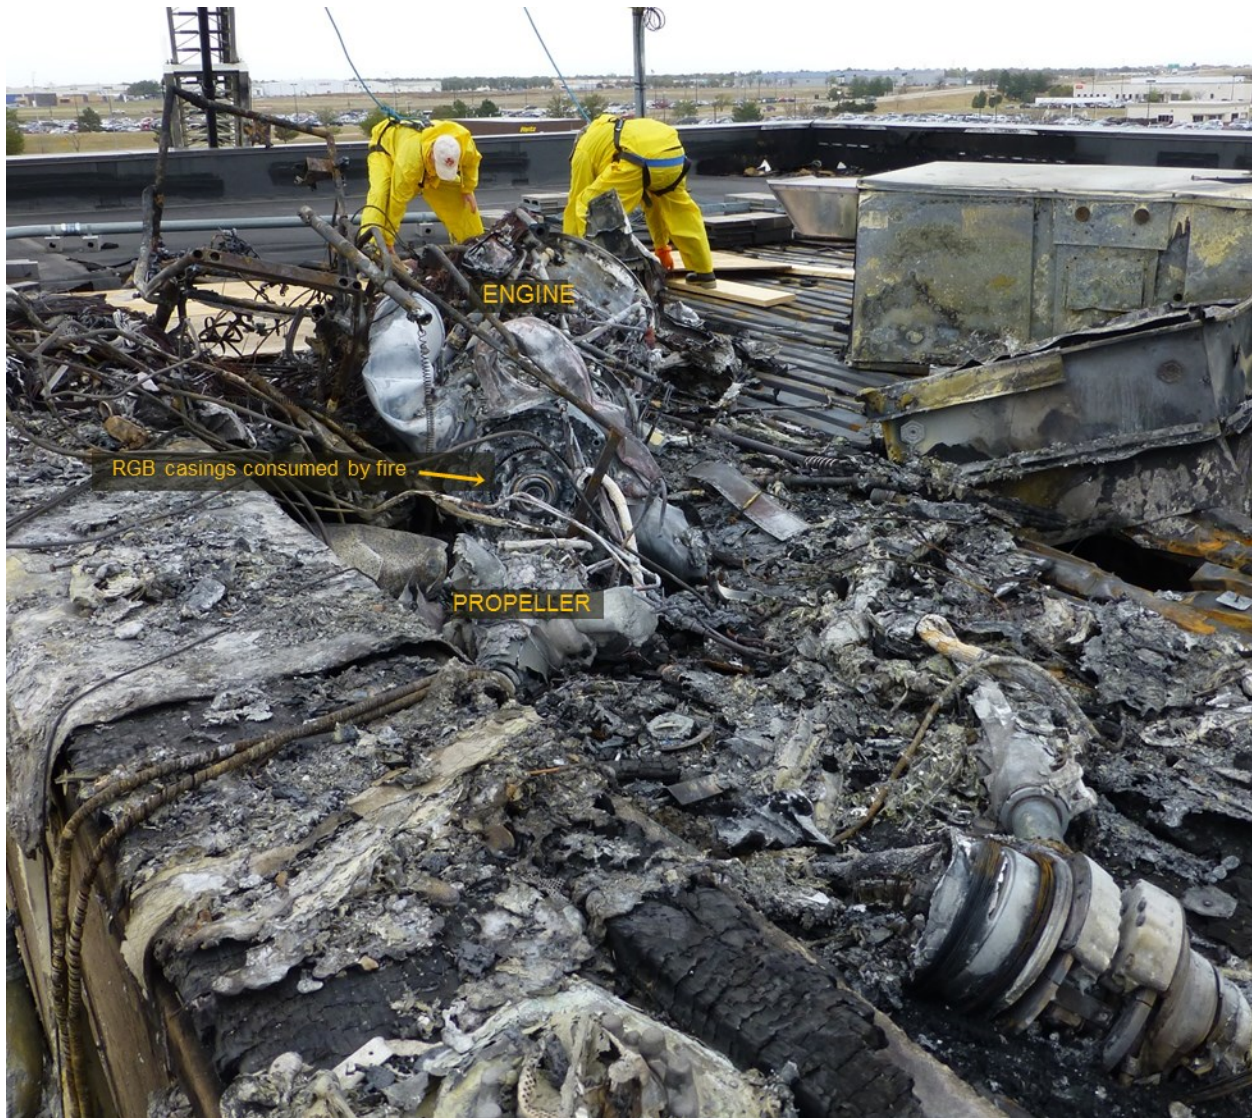
Figure 4. Right engine and propeller recovery

The right engine was recovered from the FSI building roof. It was lying in its airframe mount structure and facing east. The propeller was found in its expected position relative to the engine but was no longer attached to the engine due to thermal damage. All of the propeller blades were installed in the hub. The blades and pitch change mechanism were largely destroyed by fire. See Figure 4.

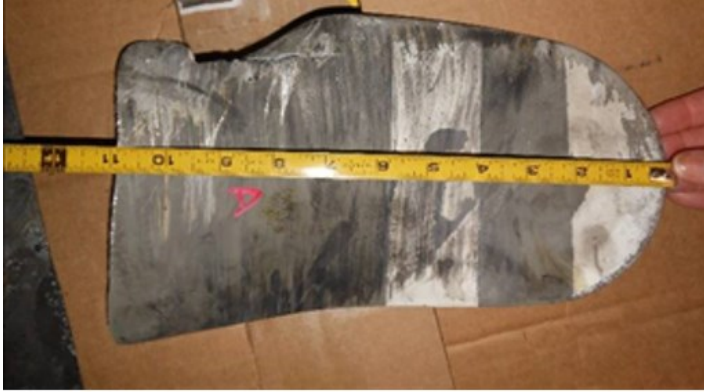
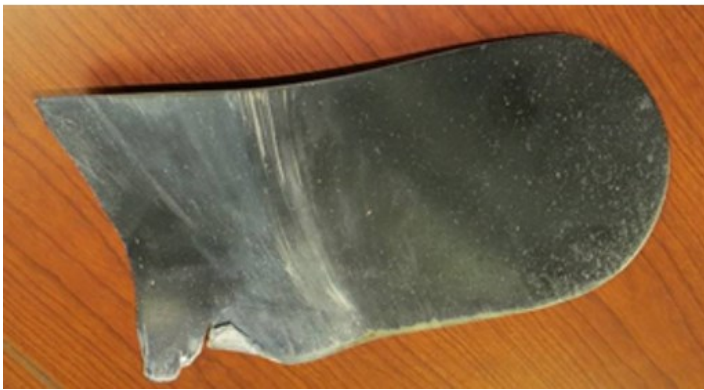
Figure 5. Views of blade tip section recovered from parking lot

An outboard section of propeller blade approximately 11 inches long was found about 200 feet northeast of the initial point of impact. The piece was scraped chordwise and the leading edge (LE) was torn approximately 10 inches from the blade tip. See Figure 5. Another outboard propeller blade section, approximately 23.5 inches long, was recovered from the FSI building roof. See Figure 6.

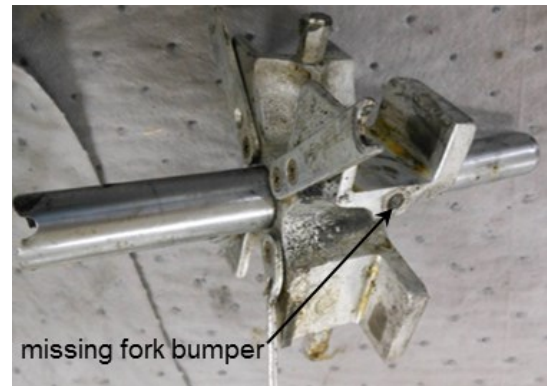
Figure 8. Pitch change rod and fork

The pitch change rod was separated forward of the hub. See Figure 8. The hub end fracture surface exhibited 45° angles typical of overload fracture.

See Figure 8. The fork beta rod guide arms were randomly bent. There were minor dents and gouges in the fork knob slots and normal wear on the slot faces. One of the fork bumpers was broken off.

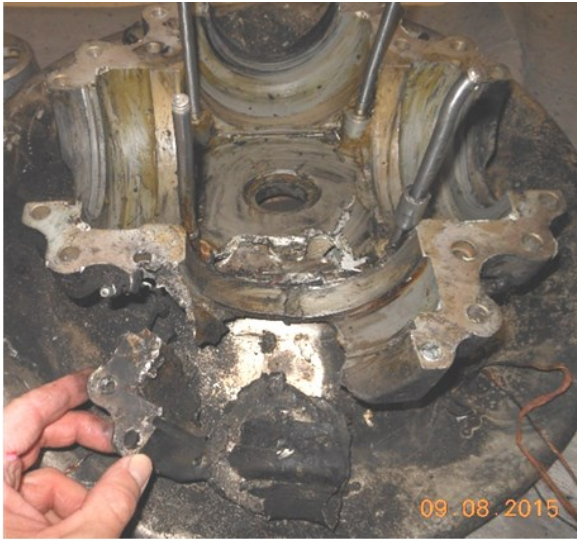
The hub assembly was soot-covered and thermally damaged. The forward hub half was damaged at the D blade retention socket and at the cylinder mounting threads, which had separated. The aft hub half D blade retention socket wall was fractured in the vicinity of the mounting bolt holes and at the D blade hub socket. See Figures 9 and 10. The propeller serial number was marked

Figure 9. Aft hub fractured at D blade socket

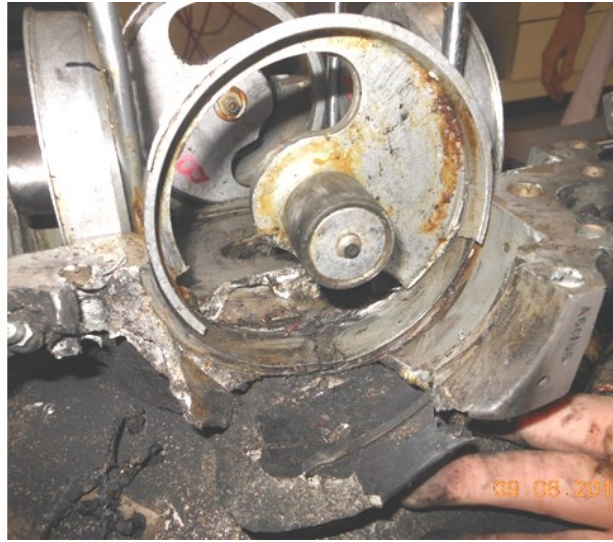
Figure 10. Fractured aft hub with D blade preload plate

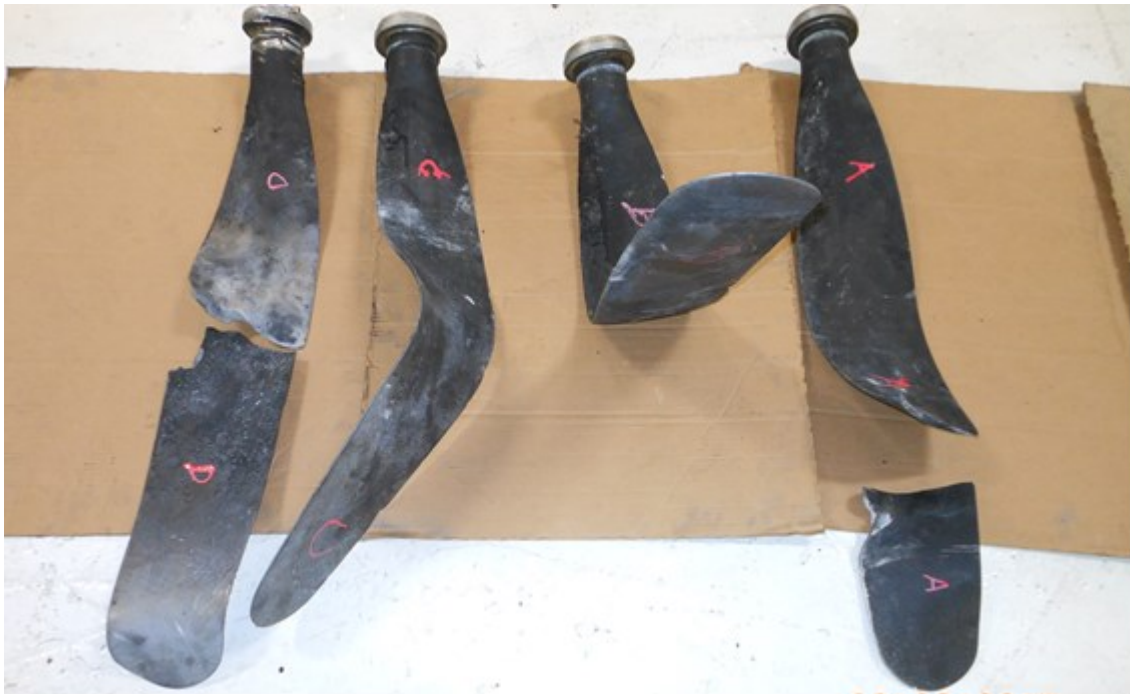
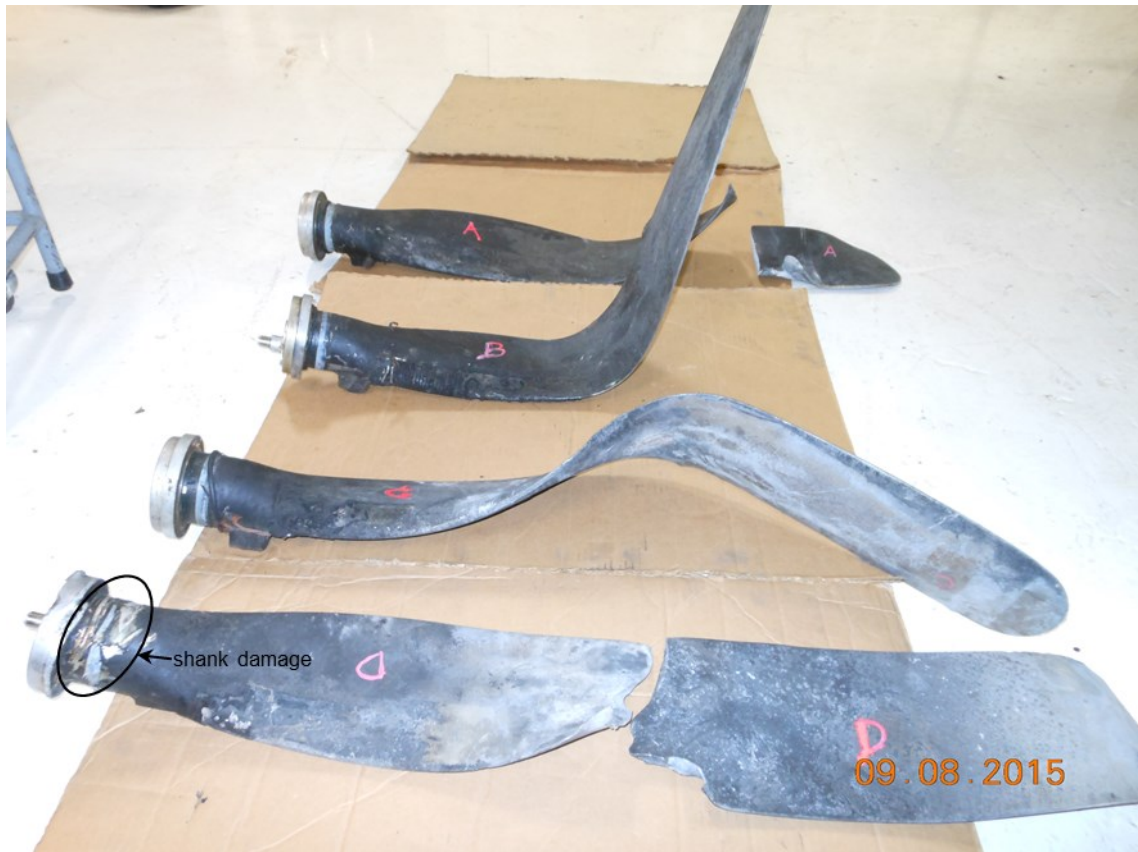
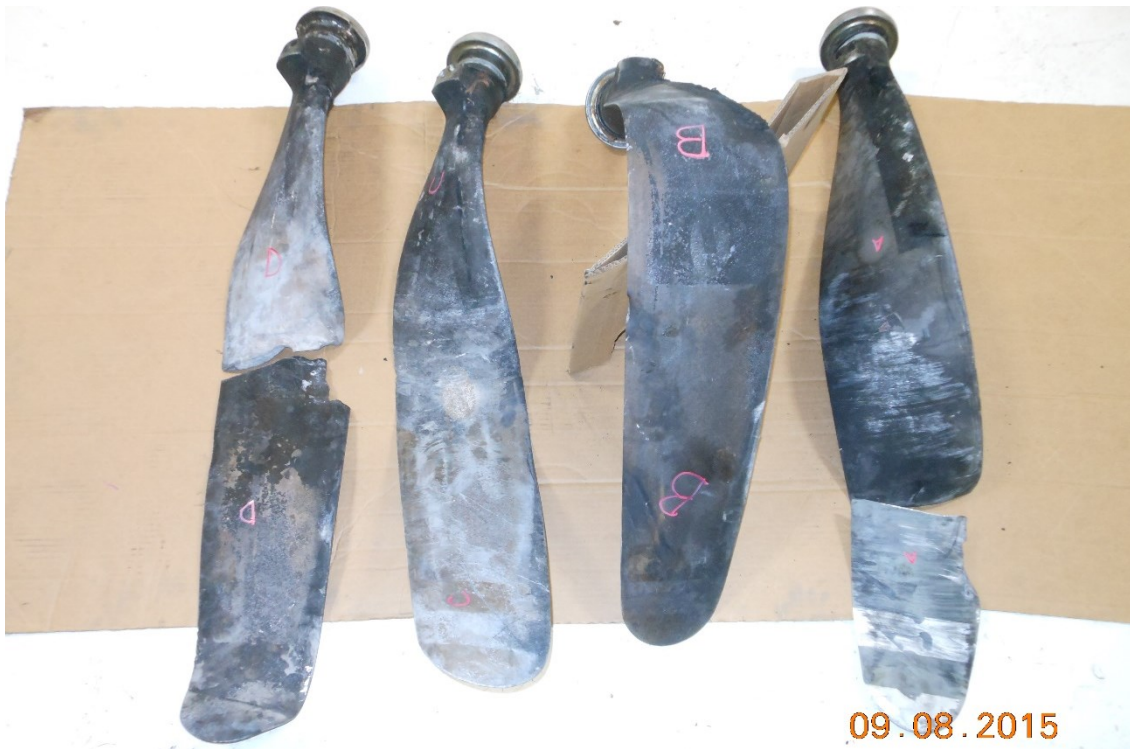
The propeller blade pieces recovered at the site were matched to blades A and D based on blade length and fracture characteristics. Blade damage is described in Table 2. See Figures 11 through 13.

blade	damage	
A	camber side	inboard section: soot, de-ice boot burned, chordwise scoring midblade, chordwise separation 11-inch outboard section: no thermal damage or soot, chordwise scrapes entire span
	face side	inboard section: soot, thermal damage, chordwise scoring 7" from tip, chordwise separation outboard section: no thermal damage or soot, chordwise scraping, both camber and face
	bend	bent aft 21" from the tip
	twist	twisted LE down, midblade to tip
	LE	torn 10" from the tip and fractured/separated 11" from tip
	TE	undamaged
	knob	separated, recovered near the propeller
	counterweight	fractured off, not recovered
B	camber side	sooted, burned. De-ice boot thermally damaged, some thermal damage near the tip. spanwise scoring 29" from tip.
	face side	sooted, thermal damage
	bend	bent aft 90° at mid blade
	twist	undamaged
	LE	dented 8-13" from tip
	TE	locally deformed 18" from tip
	knob	attached; the bearing was missing

counterweight	fractured off, not recovered
C	camber side	sooted, thermal damage, de-ice boot abraded/charred off. Chordwise scoring mid blade
	face side	charred, soot
	bend	bent aft 28" from tip and forward 20" from tip.
	twist	twisted, LE down
	LE	locally deformed 21" from tip
	TE	nicked and gouged mid blade to tip
	knob	separated, recovered near the propeller
	counterweight	fractured off, not recovered
D	camber side	charred, sooted, span wise and chordwise scoring. Chordwise separation 21.5" from tip
	face side	charred, sooted, heavily gouged in the shank area. Chordwise separation 21.5" from tip
	bend	bent aft at midblade and forward 4" from tip
	twist	twisted down at LE
	LE	scraped chordwise. Tear at camber side with missing material: about 4" (l) x 1.5" (w)
	TE	dented and gouged from midblade outboard
	knob	attached; fractured bearing
	counterweight	fractured off, not recovered

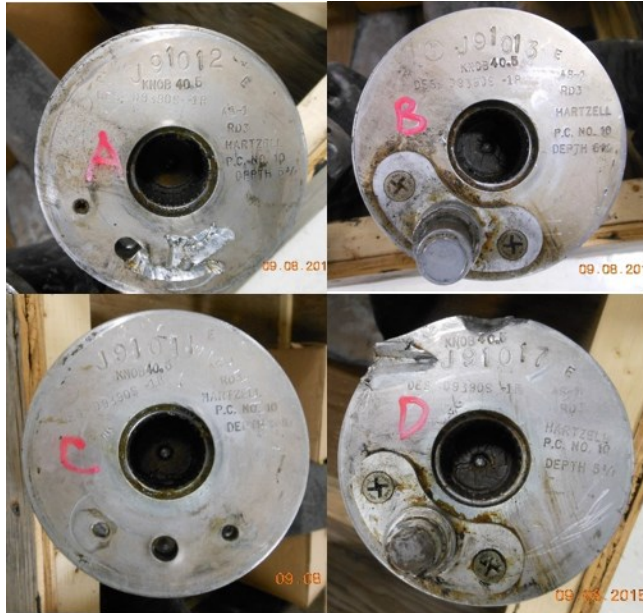
Figure 14. Blade butts with pitch change knob assemblies

The pitch change knobs and dowel pins/dowel pin holes were deformed. See Figure 14. The A blade pitch change knob, which was recovered near the propeller, had one mounting foot broken off; the dowel pin hole on this side was deformed and two gouges/grooves extended from the deformed area across the blade butt. The path and direction of the gouges were consistent with a forcible pitch change knob separation in the high pitch direction.

The D blade pitch change knob remained attached to the blade butt. The knob bearing was fractured. The attaching bolt was partially pulled out and the mounting foot was bent on the high pitch side.

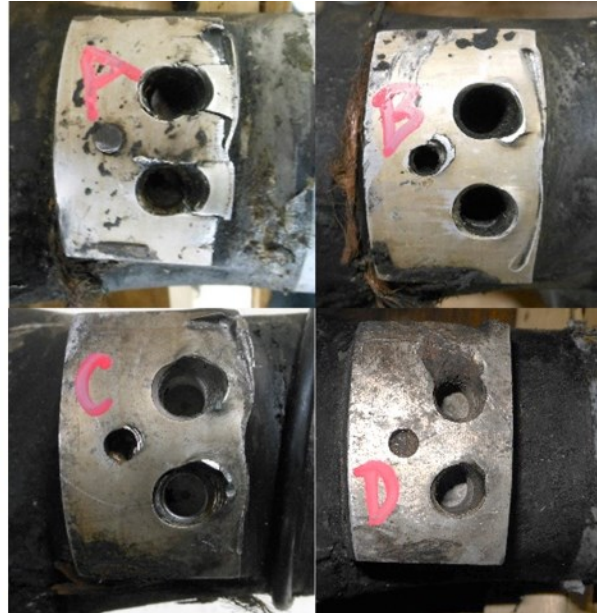
Figure 15. Counterweight block mating surfaces

The blade counterweights had fractured/separated and were not recovered. Hole elongation and other deformities were noted at the counterweight retention boss mating surface. The A blade counterweight boss threaded holes were deformed inward, toward the hub. The B blade counterweight boss threaded holes were deformed inward, toward the hub. The C blade counterweight boss threaded holes were deformed toward the hub and in the direction opposite of rotation. The D blade counterweight boss threaded holes were deformed in the direction opposite of rotation. See Figure 15.

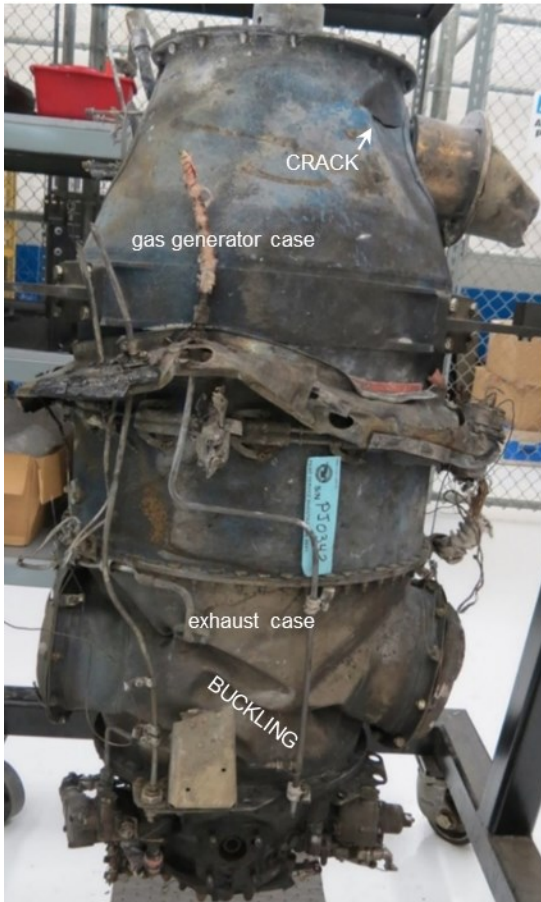
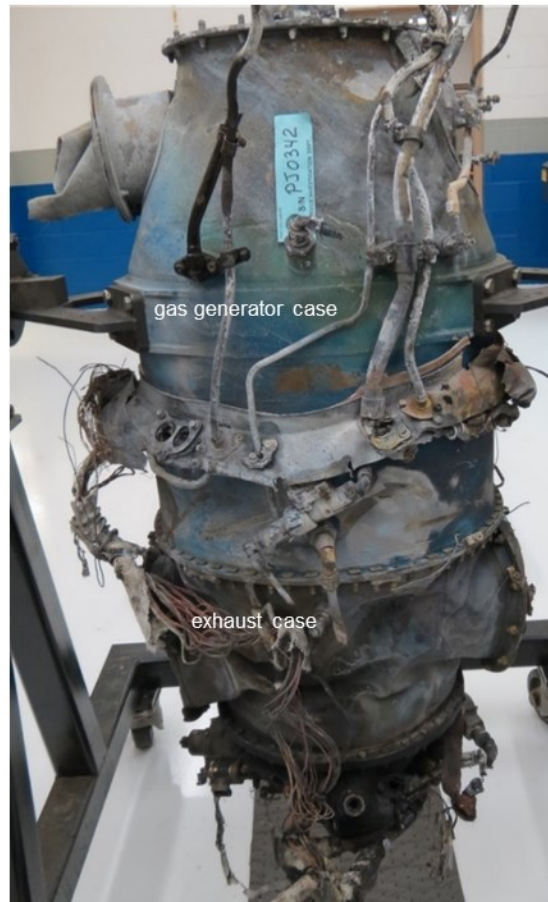
The left engine inlet case, AGB housing, and AGB diaphragm were thermally destroyed. The rear section of the gas generator case (GGC) was deformed and there was a crack in the deformed area at 10 to 11 o'clock. The aft end of the exhaust duct was compressively deformed with the most pronounced deformation between 4 and 8 o'clock and a circumferentially-oriented crack in the compressed area between 1 and 2 o'clock. The engine showed no indications of uncontainment. See Figures 16 and 17.

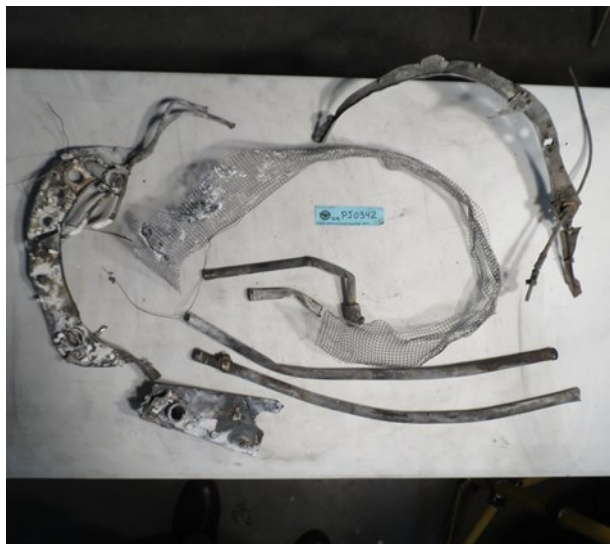
Figure 18. Rear mount ring, tubes and inlet screen

The engine tubes, accessories, and electrical components exhibited moderate to severe thermal and mechanical damage. The high pressure bleed valve was thermally destroyed. The low pressure bleed valve was heat-deformed. There was no significant thermal damage to the reduction gearbox (RGB) and the constant speed governor (CSU), or the overspeed governor (OSG). The center fire seal mount ring assembly had displaced and was mechanically deformed. The rear mount ring assembly was fragmented. See Figure 18.

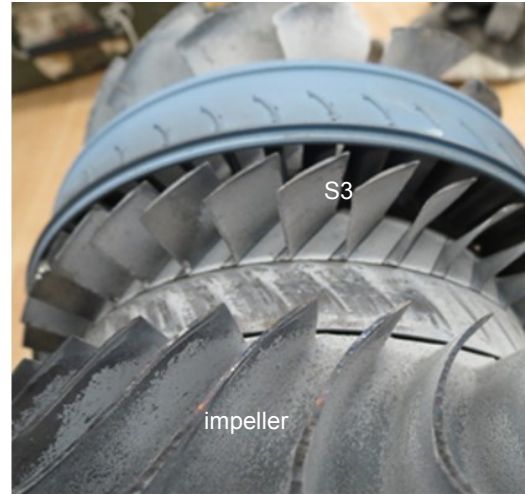
Figure 21. S3 compressor blades

tips were rubbed with associated burring. The S1 compressor spacer was lightly rubbed 360°. The stage 2 (S2) blade LEs were lightly dented and the blade tips were rubbed and burred. See Figure 20. The stage 3 (S3) compressor blades were lightly impact damaged and the blade tips were rubbed and burred. See Figure 21. The S2 and S3 spacers were undamaged.

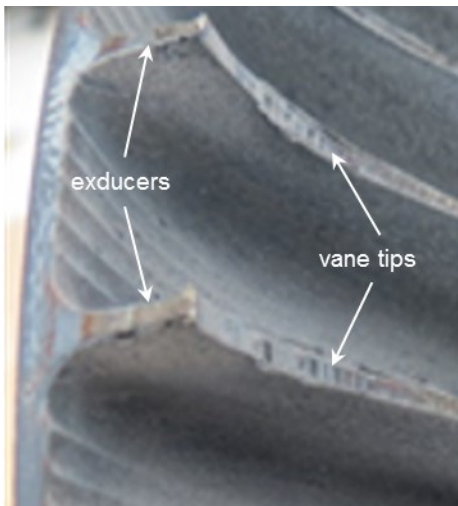
The impeller inducer area was undamaged. All of the impeller vane tips were scored and burred. See Figures 21 and 22. Several exducers were lightly rubbed. See Figure 22.

Figure 22. Impeller exducers and vane tips

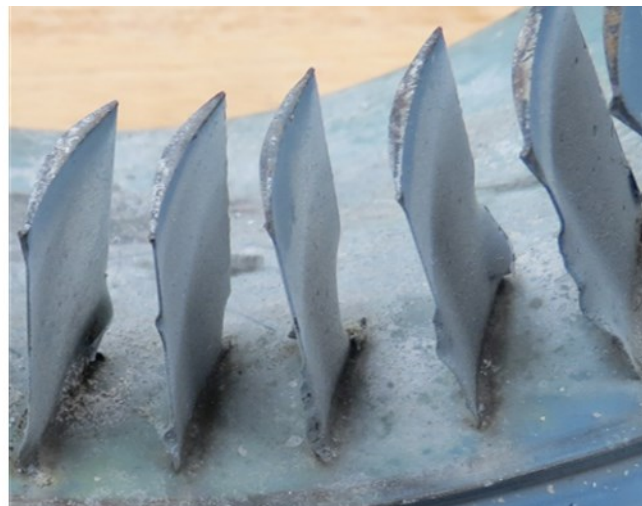
Figure 23. S1 compressor stator vanes

The LE roots of the S1 stator vanes were randomly torn and curled. See Figure 23. The S1 stator vanes exhibited tip rub and associated burring. See Figure 23. No S2 stator vane damage was noted.

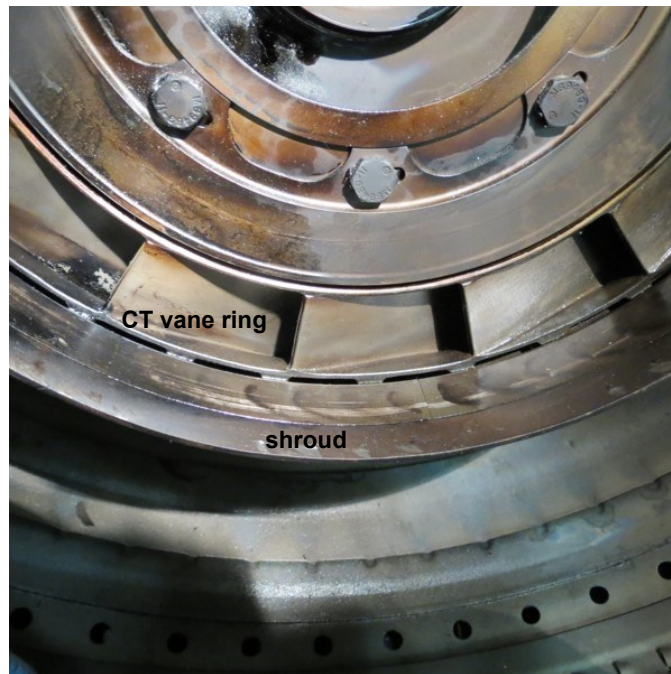
Figure 24. CT vane ring and shroud

The CT shroud was circumferentially rubbed. See Figure 24.

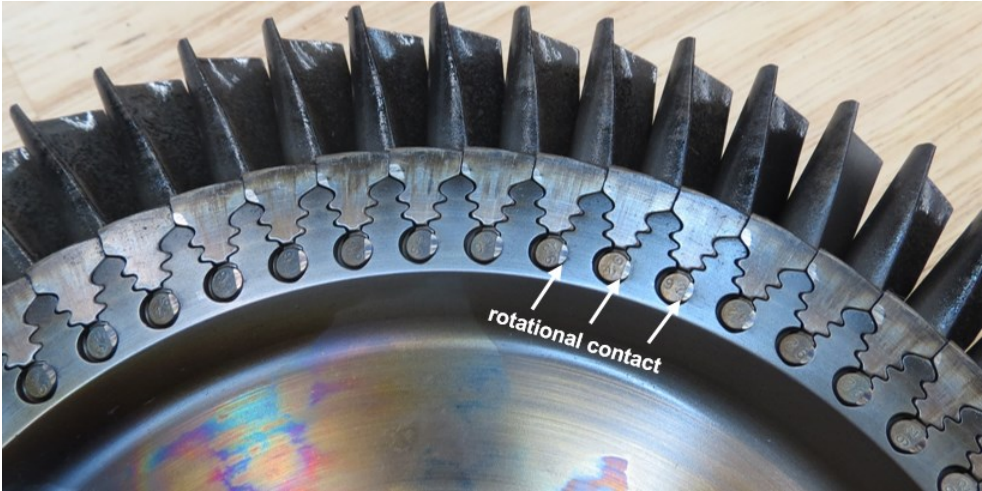
All of the CT blades exhibited tip rub and one blade was torn at the TE. The blade retention rivets and platforms on the upstream side of the CT disk were scored 360°. See Figure 26.

Figure 26. CT disk assembly upstream side showing rotational scoring along blade retention rivets and platforms

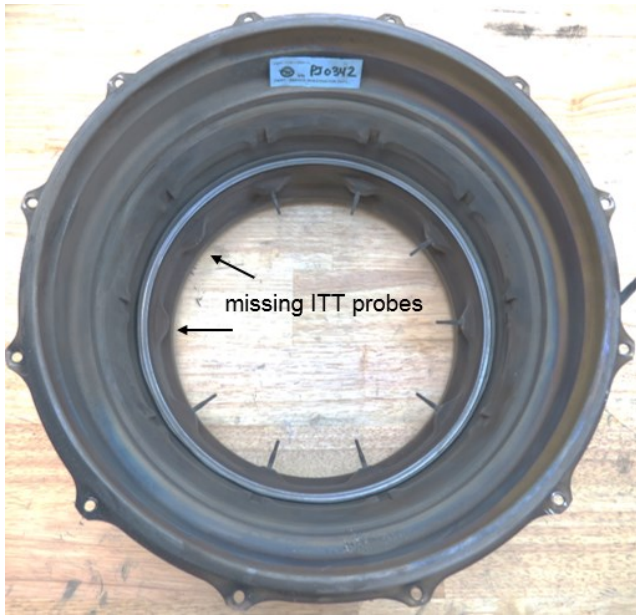
The interturbine temperature (ITT) busbar was undamaged. Two adjacent ITT harness probes located at 6 to 7 o'clock were fractured off. See Figure 27.

Figure 27. PT housing showing missing ITT probes

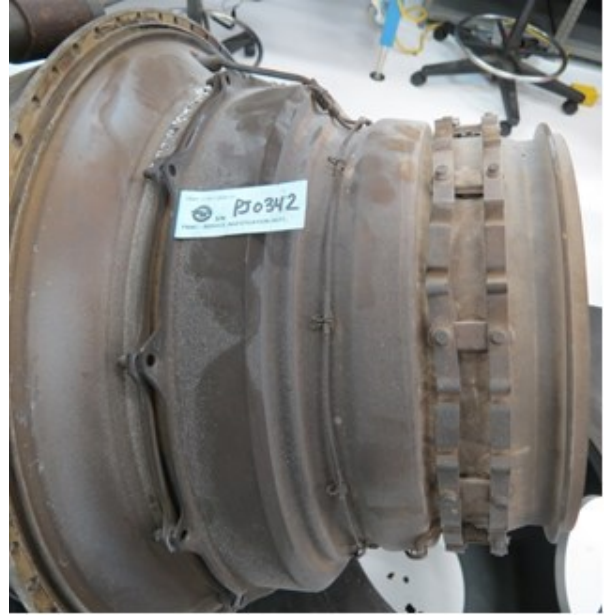
The PT housing was intact. Ten of the 12 PT vane housing-to-exhaust case bolts were fractured. See Figure 28.

Figure 28. Failed PT housing flange attachment

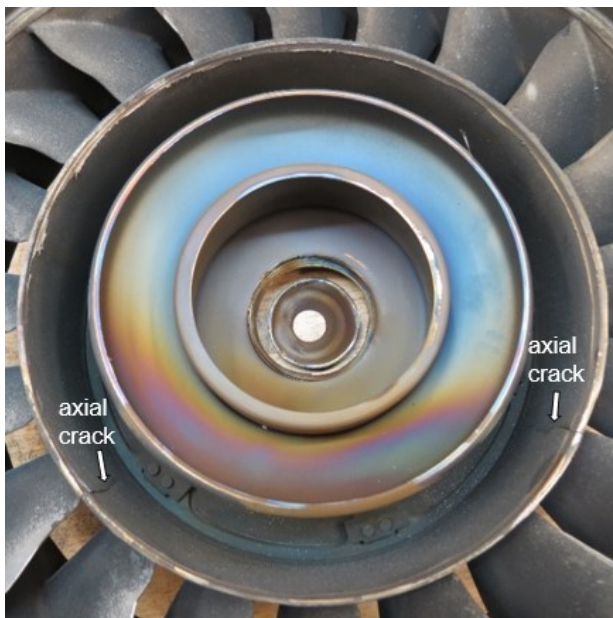
Figure 30. Downstream face of PT S1 vane ring

The upstream side of the S1 PT vane ring exhibited 360° scoring and thermal discoloration on three surfaces, including machining separation of the center of the baffle. See Figure 29. The downstream side of the vane ring exhibited a 190° arc of rotational damage and thermal discoloration on the inside baffle and rotational scoring along the outside baffle. There were two axial cracks in the vane ring inner drum. See Figure 30.

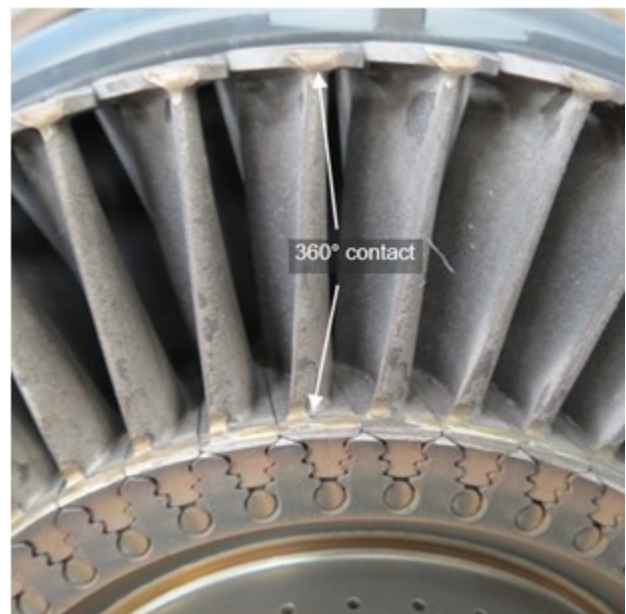
Figure 31. Upstream face of PT S1 disk assembly

The upstream surface of the S1 PT disk assembly was rubbed and burred along the blade roots and root platforms and at the blade shroud knife edges. See Figure 31.

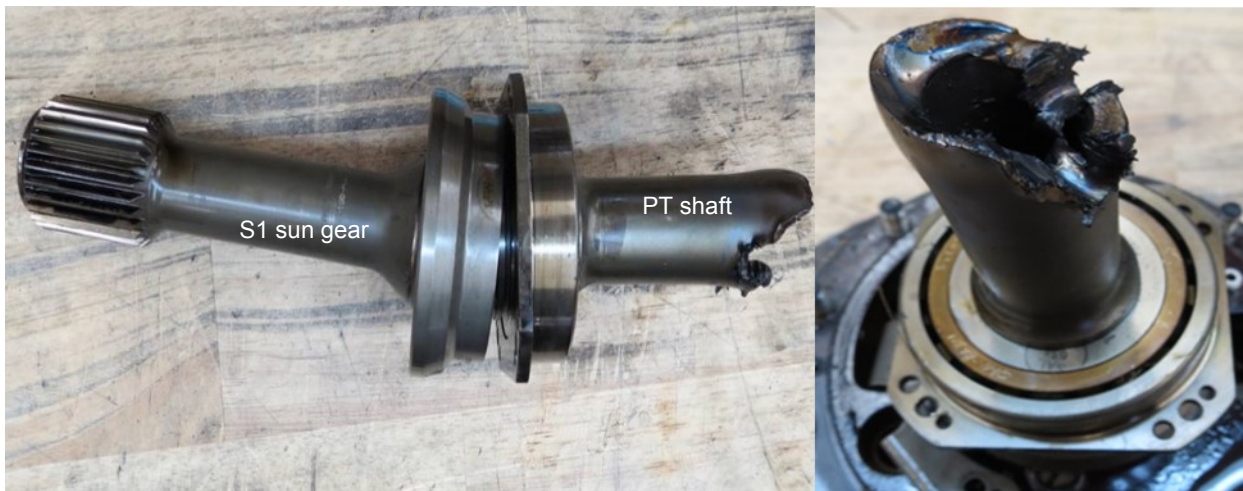
Figure 33. S1 sun gear and forward section of fractured PT shaft; detail of fracture surface

The PT shaft housing was compressively deformed. The PT shaft was separated into 2 pieces upstream of the No. 3 bearing. The aft end of the PT shaft remained attached to the PT rotor assembly. The forward end of the aft section of the shaft was worn and burnished consistent with rotational contact between the shaft fracture surfaces. An undamaged portion of the fracture surface on the aft end of the forward section of the shaft exhibited torsional tensile overload features. See Figure 33. The S1 sun gear showed no distress. See Figure 33.

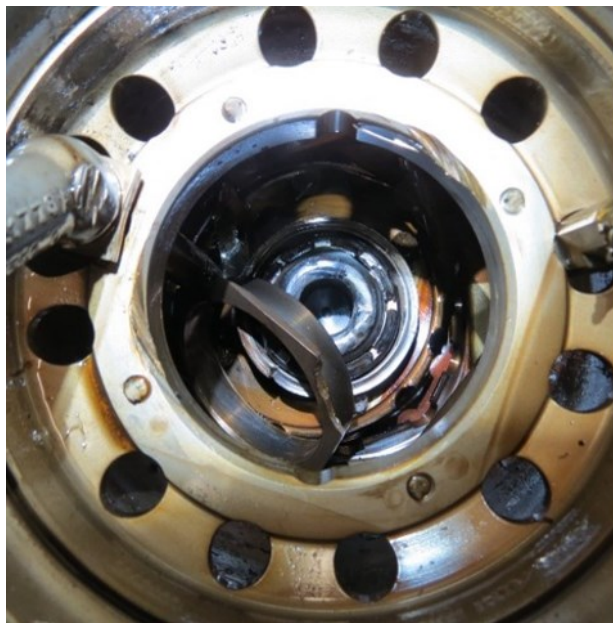
The No. 3 bearing outer race (OR) retaining bolt heads were broken off. The bearing flange was fractured through the weight reduction holes over a 270° arc, centered at 12 o'clock. The OR flange

was deformed and had fractured in overload. The raceway showed no distress. The bearing cage was seized and microwelded to the bearing inner race (IR). See Figure 34.

Figure 34. No. 3 bearing distress

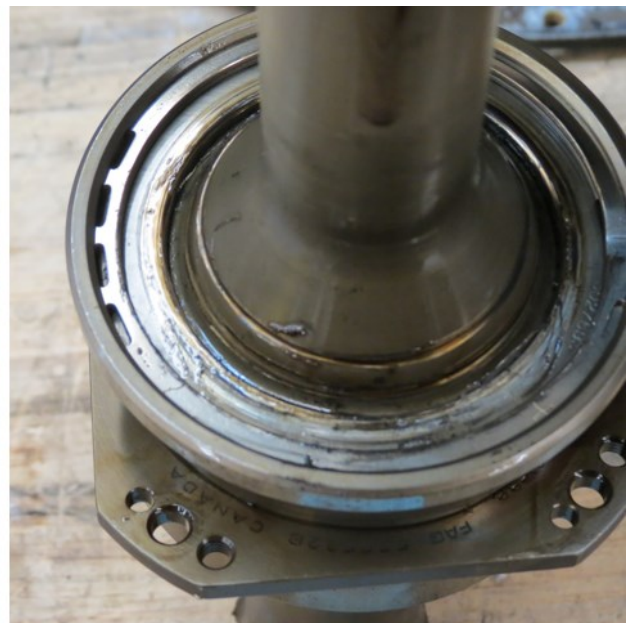
Figure 35. No. 4 bearing face

Inspection of the assembled No.4 bearing found no distress other than a 90° arc of light rub on the OR. See Figure 35. The No. 4 bearing was prevented from turning smoothly by the deformed PT shaft.

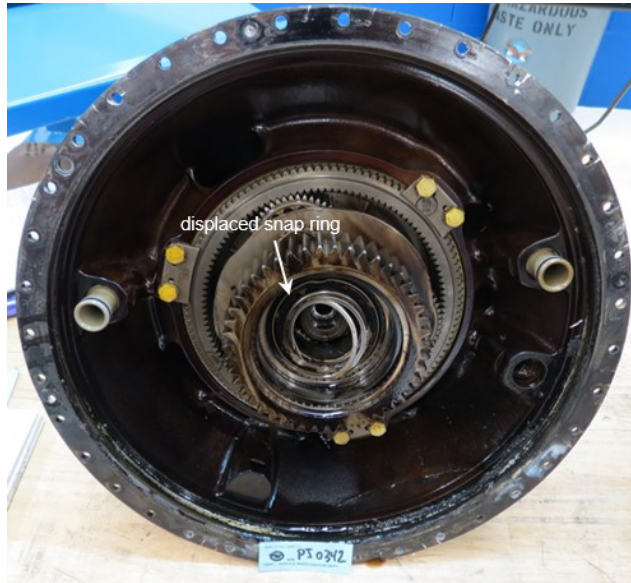
Figure 37. S1 reduction gear carrier

The RGB S1 planet gears, carrier assembly, ring gear, and bearings were inspected as assembled. The flexible shaft retaining ring was displaced. The S2 sun gear was rotationally scored. No other anomalies were noted. See Figure 37.

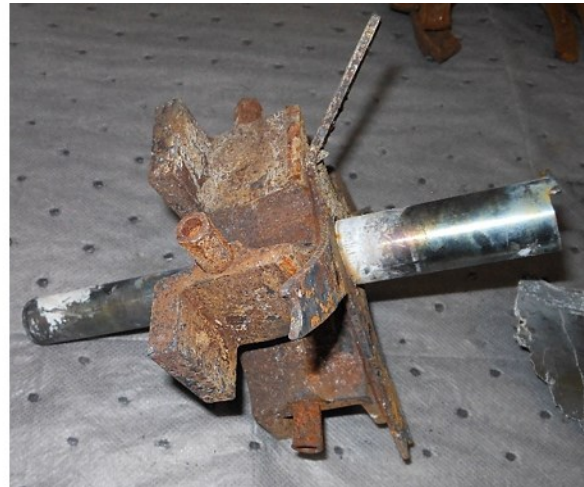
Figure 42. Fork

The fork assembly was corroded and was not perpendicular to the pitch change rod. Two forward tangs were fractured off. The beta rod guide arms were bent. See Figure 42.

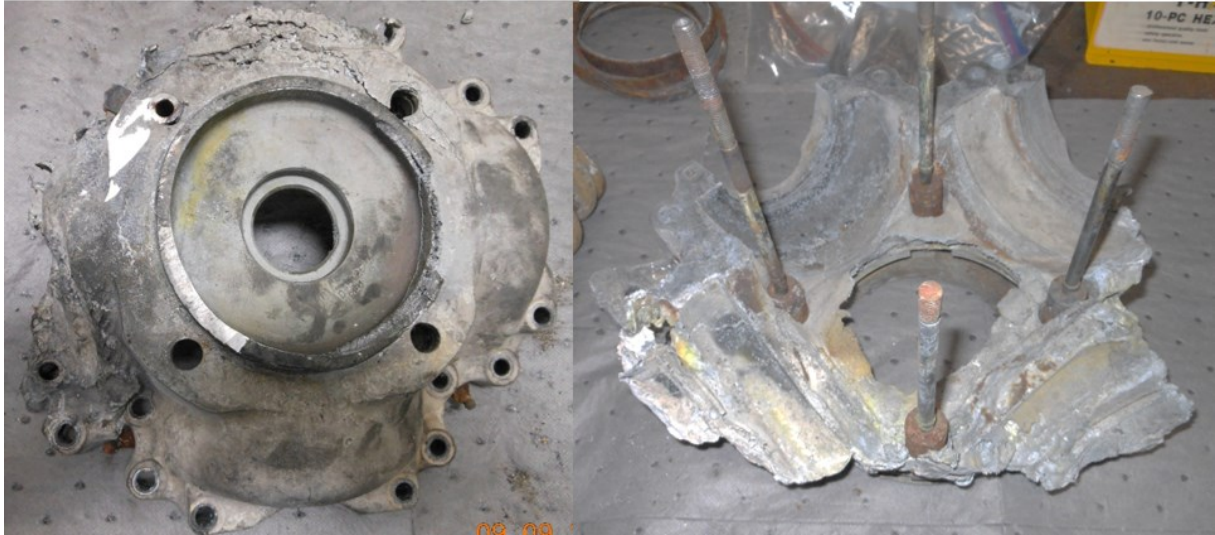
Figure 43. Hub housings

Both the forward and aft hub halves was partially melted and thermally deformed. See Figure 43. The mounting flange was thermally consumed. Blade pockets C and D were melted/consumed. The propeller serial number mark was between the A and B blade sockets.

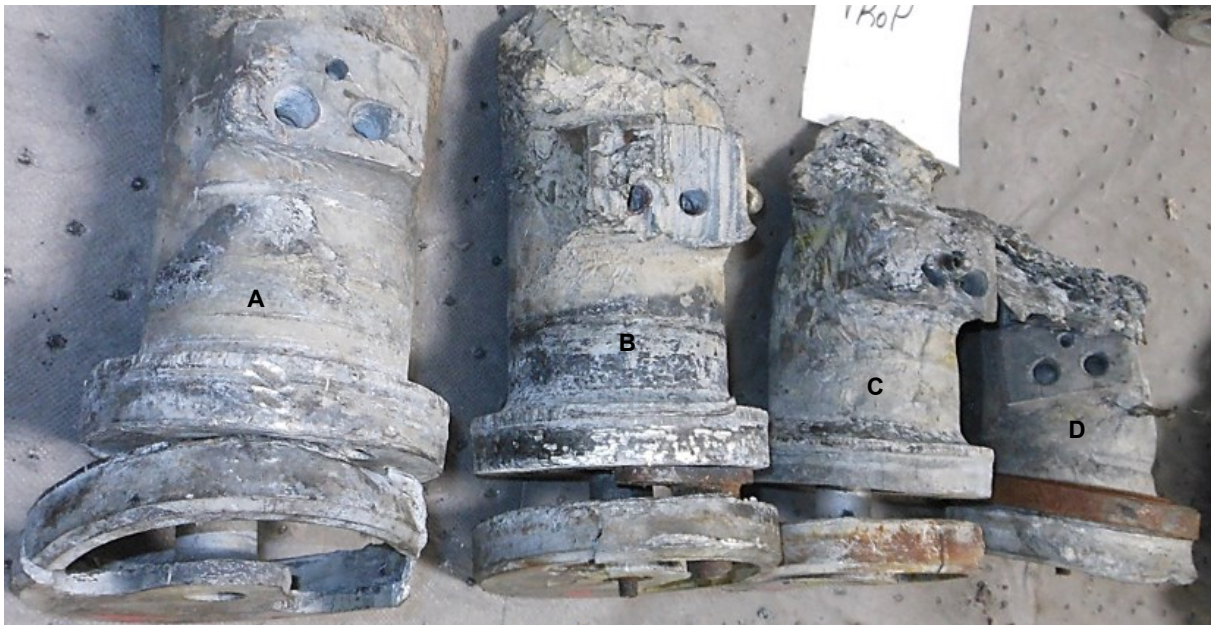
Figure 44. Blades

The blades were thermally destroyed. Blade damage is listed in Table 4. See Figure 44.

BLADE		DAMAGE
A	surface bend twist LE TE	The blade was thermally destroyed except for a 6- to 8-inch stub There was a 3 inch circumferential crack on the face side bearing radius
	knob	The pitch change knob was fractured off and was recovered
	counterweight	The counterweight was fractured off and was not recovered
B	surface bend twist LE TE	The blade was thermally destroyed except for a 6- to 8-inch stub
	knob	The pitch change knob remained attached; the bearing was missing
	counterweight	The counterweight was fractured off and was not recovered
C	surface bend Twist LE TE	The blade was thermally destroyed except for a 6- to 8-inch stub
	knob	The pitch change knob was fractured off and was recovered
	counterweight	The counterweight was fractured off and was not recovered
D	surface bend twist LE TE	The blade was thermally destroyed except for a 6- to 8-inch stub The blade bearings remain attached with the bearing retention ring in place The preload plate could not be removed from the blade butt

knob	The pitch change knob was fractured off; the bearing was missing
	counterweight	The counterweight was fractured off and was not recovered

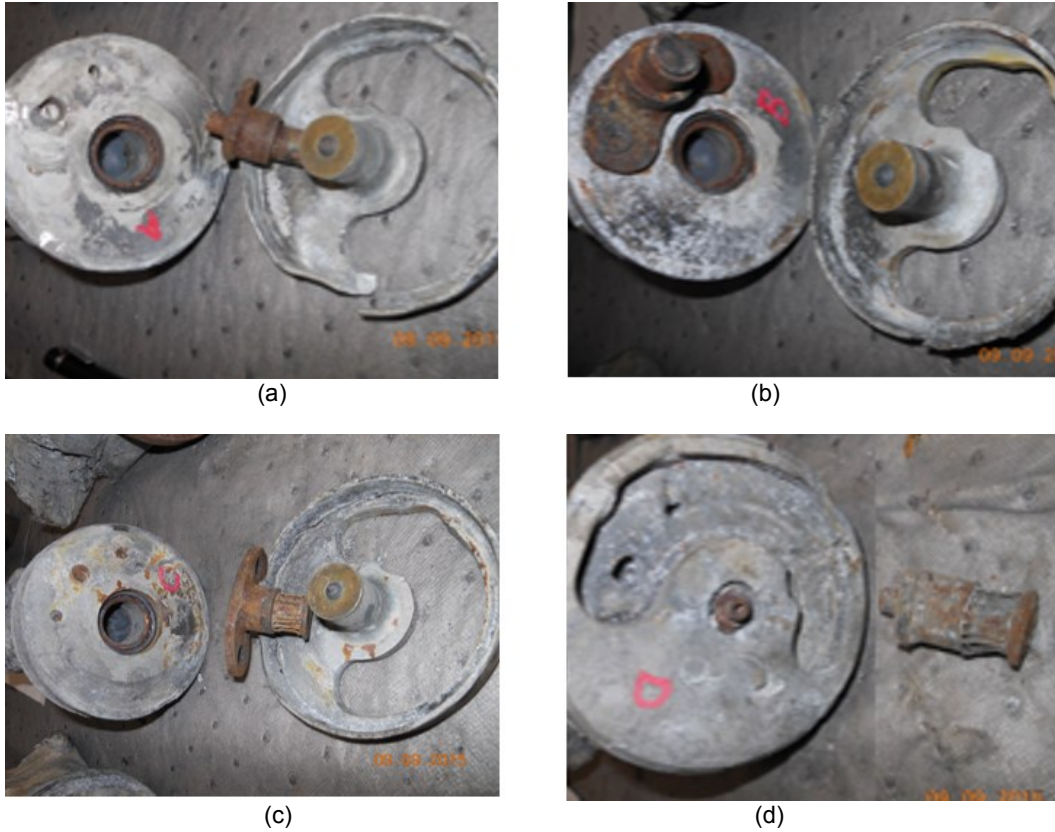
Figure 45. Pitch change knobs

The pitch change knobs and dowel pin holes were deformed. The A blade pitch change knob, recovered near the propeller, was missing one mounting foot; the A blade dowel pin hole was deformed toward high pitch. The B blade pitch change knob remained attached, the bearing was missing. See Figure 45 (a) and (b).

The C blade pitch change knob had separated and was recovered near the propeller; the C blade dowel pin hole was deformed toward high pitch. The D blade pitch change knob, recovered near the propeller, was missing its bearing. The D blade dowel pin hole was deformed toward high pitch.

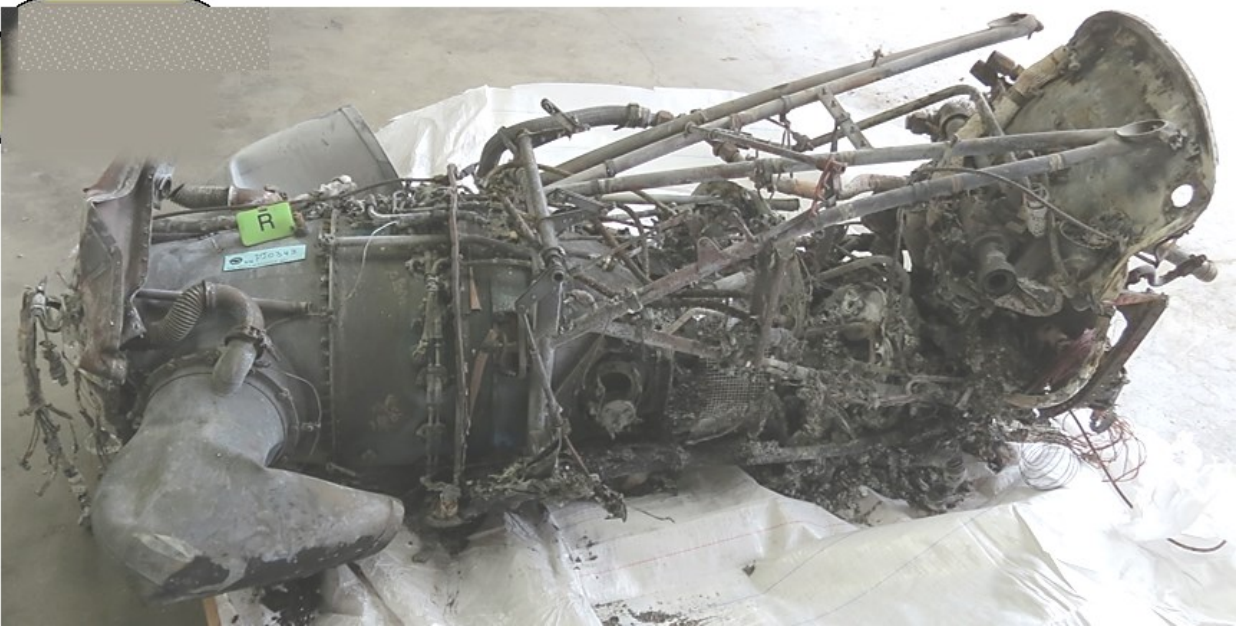
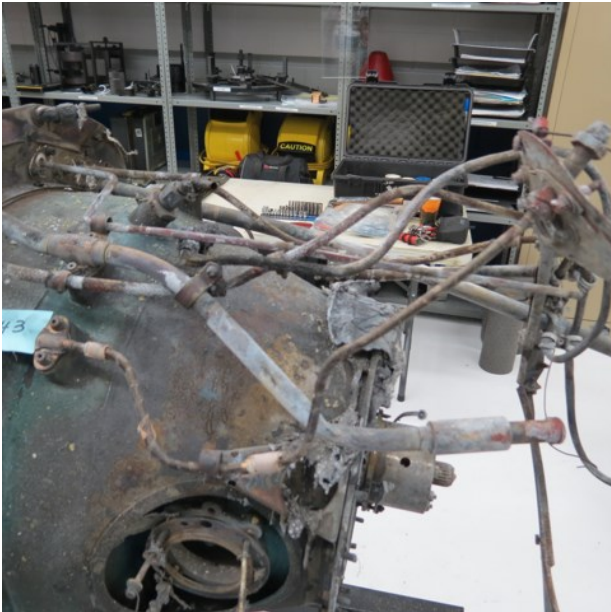
The right engine inlet case, AGB housing, and AGB diaphragm were thermally destroyed. See Figures 46 and 47. The gas generator case was slightly deformed at the rear; the forward section showed no distress. The engine tubes, accessories and electrical components were severely fire

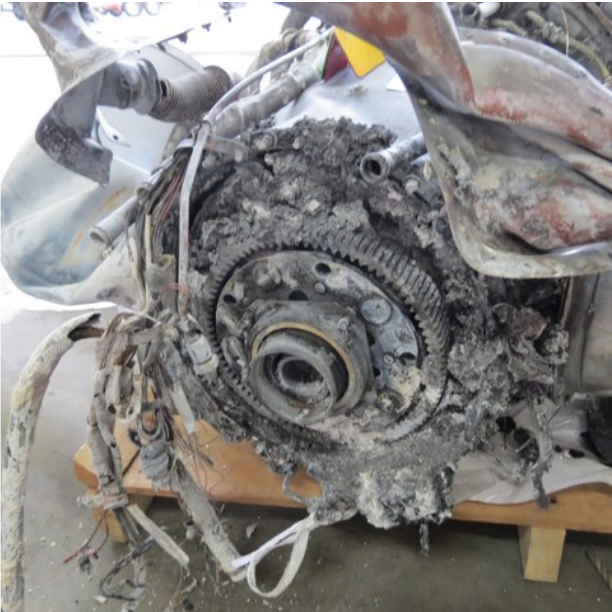
damaged. The high pressure bleed valve was thermally destroyed. The low pressure bleed valve was thermally destroyed. The aft fire seal mount ring was fragmented and the center fire seal mount ring assembly was mechanically deformed. The exhaust duct was slightly deformed at 12 and 6 o'clock. There was no dimpling damage to the inner flowpath surface. There were no case uncontainments. The RGB aft and forward cases and the propeller accessories were thermally destroyed. See Figure 48.

Figure 48. RGB cases destroyed by fire

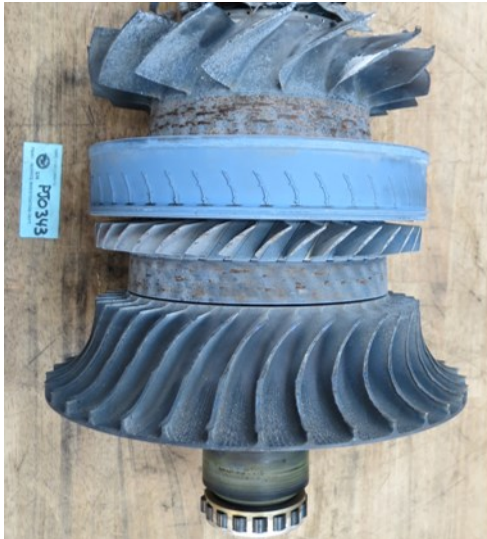
Figure 51 Compressor rotor

The S1 compressor rotor blade tips were rubbed and burred and several blades were bent. Some dents were observed on the S2 and S3 rotor LEs. The blades of all compressor stages were dented

near the blade platform and exhibited blade tip rub and burring. All of the compressor spacers were rubbed 360°. See Figure 51.

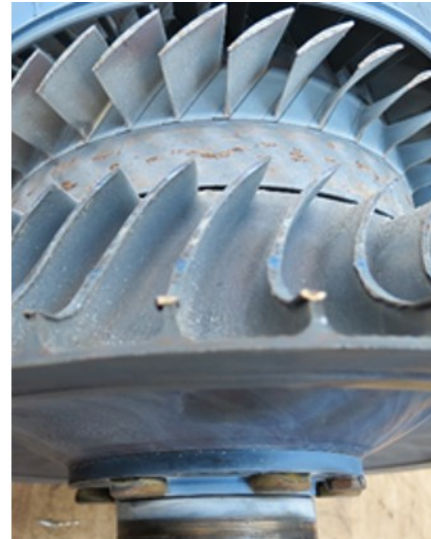
Figure 52. Impeller vanes

The impeller was lightly rubbed 360° and was burred at the exducers. See Figure 52. No distress was observed at the impeller inducer area, back face, or stub shaft.

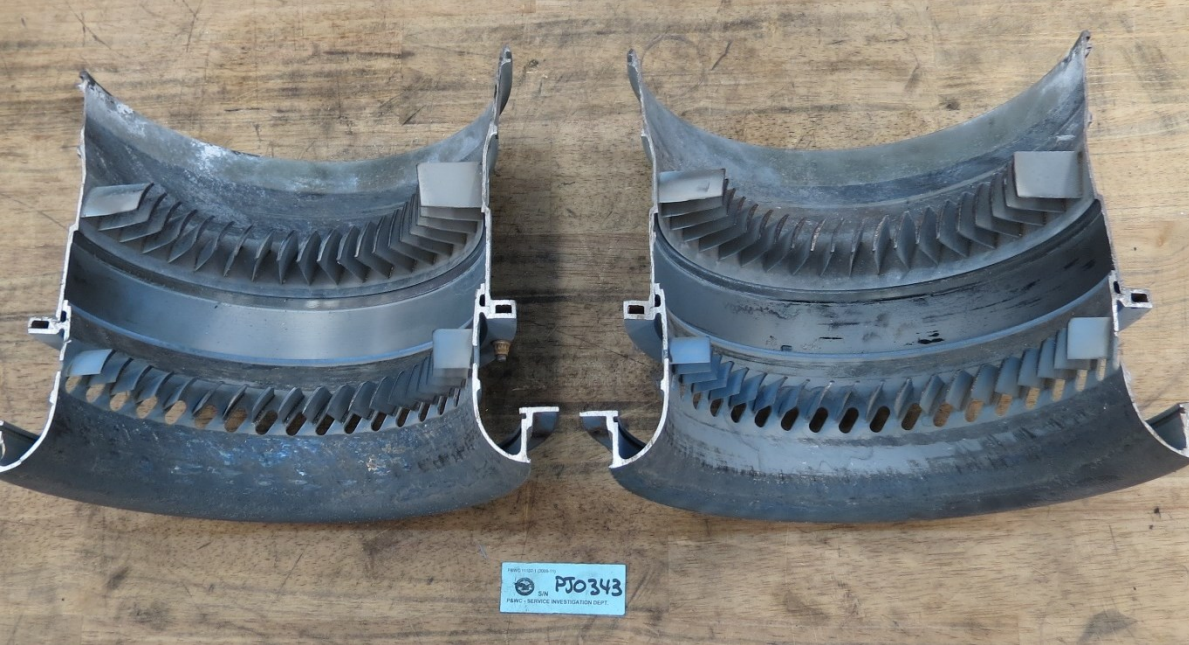
Figure 53. Compressor stator vane halves

All stator stages exhibited vane LE and TE tip curl, tip rub, and burring. Several S1 vanes exhibited light LE impact damage. The S3 vanes exhibited light rotational damage at the TE roots. All compressor spacers were lightly rubbed 360°. The impeller shroud showed signs of circumferential rubbing. See Figure 53.
