**NATIONAL TRANSPORTATION SAFETY BOARD
OFFICE OF AVIATION SAFETY
WASHINGTON, D.C. 20594**

**POWERPLANTS GROUP CHAIRMAN'S FACTUAL REPORT
NTSB ID: CEN15FA034**

Location: Wichita, Kansas
Date: October 30, 2014
Time: 0948 Central Daylight Time (CDT)
Aircraft: Raytheon Aircraft Company Super King Air B200, Reg. N52SZ

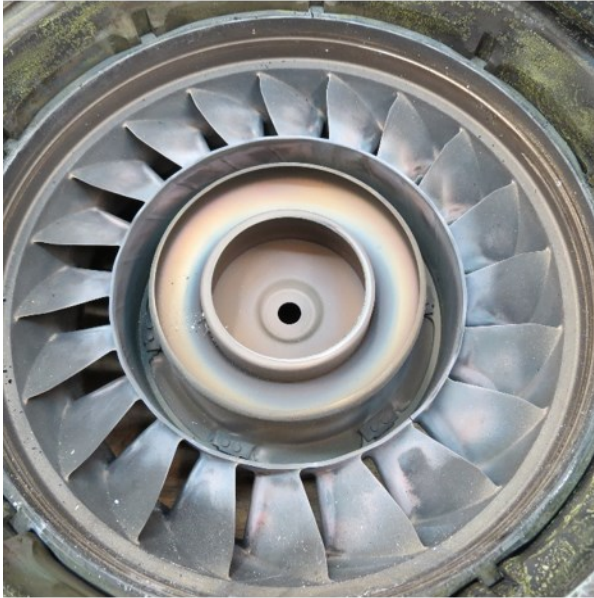
The downstream side of the CT vane ring inner drum showed a slight 120° arc of rub. See Figure 54.

Figure 54. CT vane ring downstream side

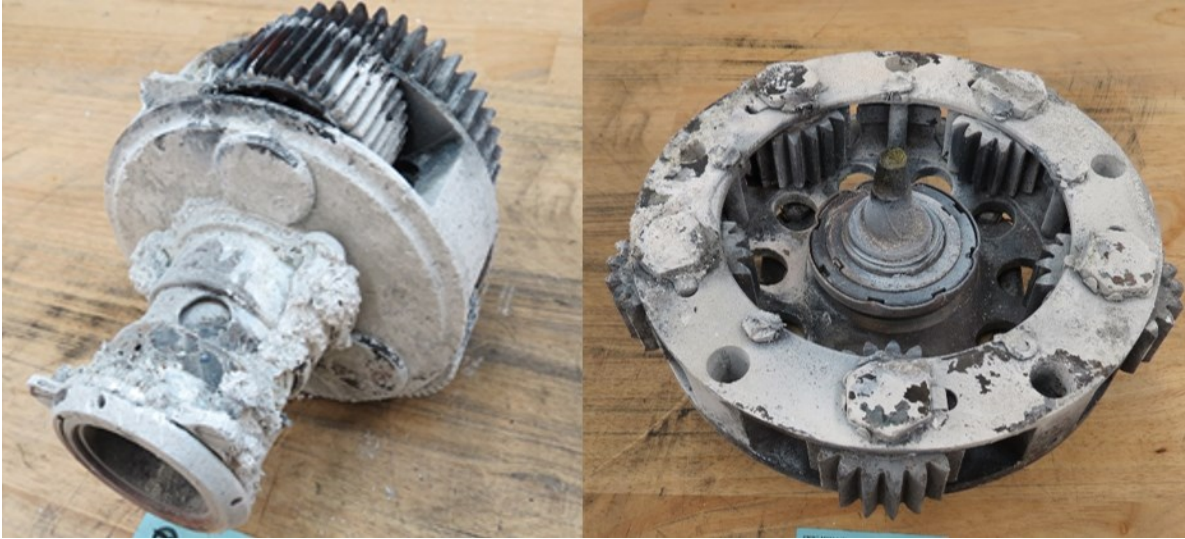
The RGB was thermally destroyed. Inspection of the S1 and S2 sun gears, carrier assemblies, ring gears, and the torquemeter piston found no evidence of pre-impact failure. See Figure 58. The propeller shaft was fractured adjacent to the propeller oil transfer sleeve and remained attached to the propeller system.

Figure 58. RGB planetary gearing recovered from wreckage debris

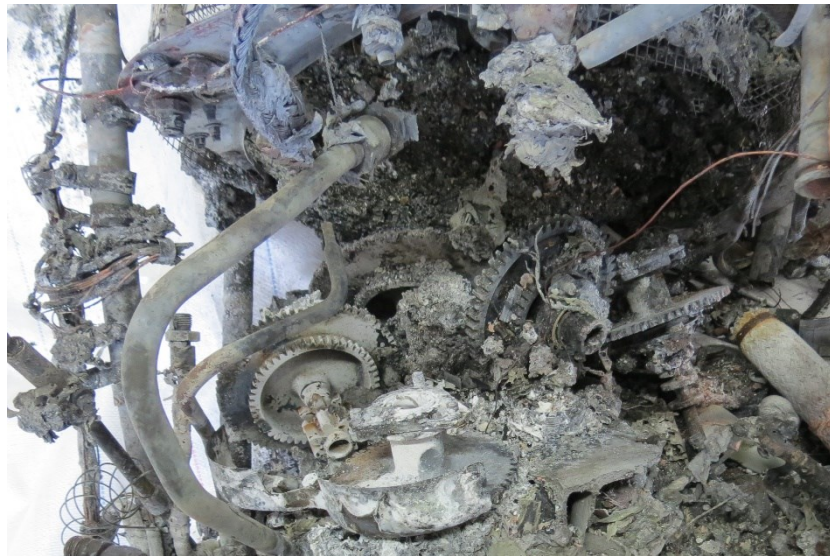
Accessory gears and other internal AGB components were recovered from debris where the AGB housing and diaphragm were consumed by fire. They were coated with soot/thermally destroyed material, and some were embedded in re-solidified molten material. All of these gears were intact and cursory visual inspection found no other obvious distress. See Figure 59.

Figure 59. AGB components with thermally destroyed diaphragm and housing
