NATIONAL TRANSPORTATION SAFETY BOARD
Office of Aviation Safety
Washington, D.C. 20594

POWERPLANT GROUP CHAIRMAN'S FACTUAL REPORT

NTSB No: CEN14LA239

Aircraft: Cessna 525C, Registration Number N718MV

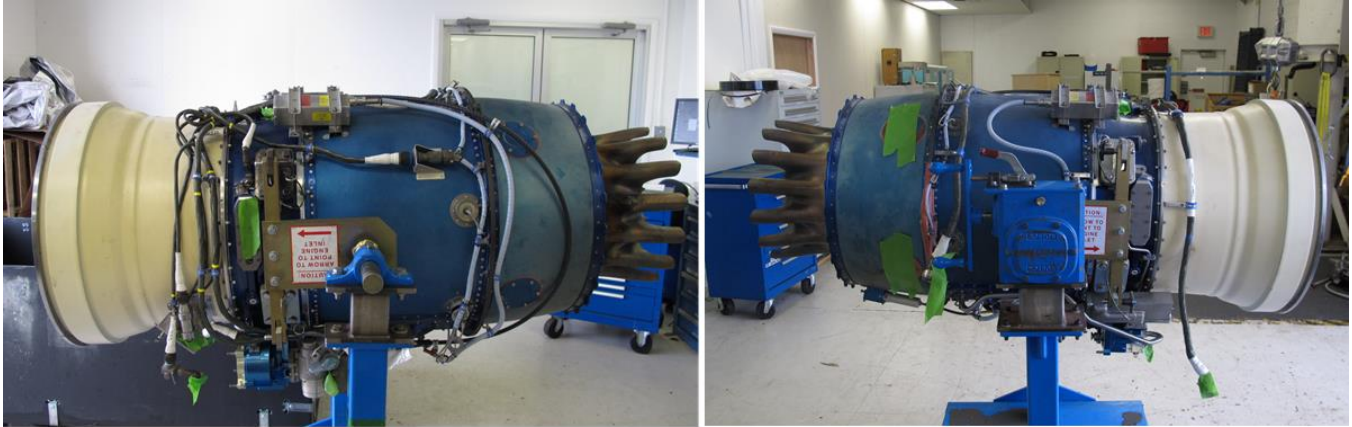
Members from Williams International and the National Transportation Safety Board (NTSB) convened at the Williams International facility in Commerce Township, Michigan to examine the engine. The engine was received in good condition without case breaches or thermal damage on external case surfaces. There was light sooting and dried fire retardant residue on the fan blades and the visible stator vanes. The stator vane assembly had melted polyurethane elastomer on vanes surfaces and along the outer diameter vane attachment points, most concentrated on the bottom half of the engine. The exhaust mixer lobes exhibited bluing and were sooted. The low pressure turbine (LPT) blades also had a layer of soot and dried fire retardant residue.

Photo 1- Engine (Left Side) and (Right Side), As Received

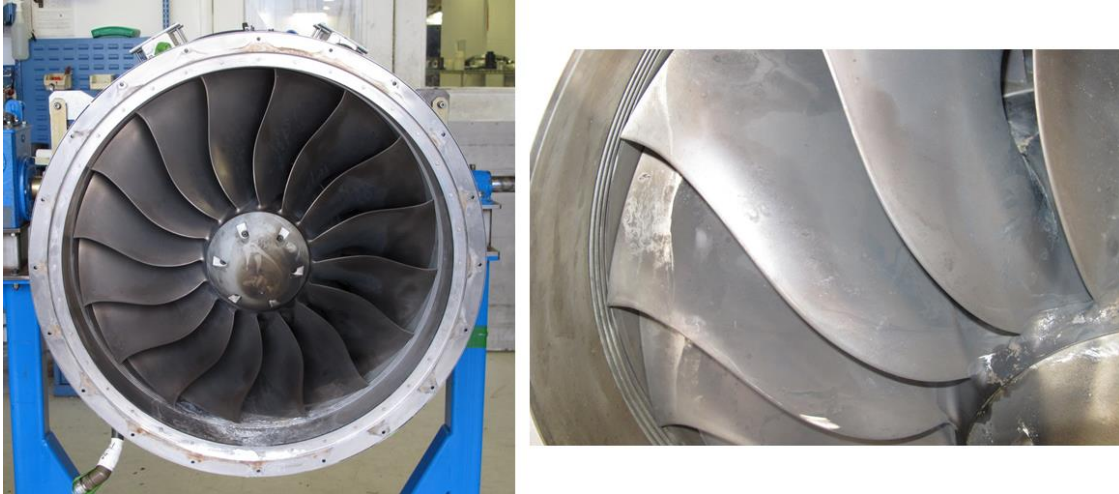
The fan was intact and in good condition with sooting and fire retardant residue on all fan blade surfaces (**Photo 3**). The soot was easily removed with a cloth and light pressure. The case and insert assembly surrounding the fan was also sooted and dried white fire retardant residue/powder had accumulated at the 6 o'clock position. The fan stator, visible behind the fan, was sooted and had a green colored substance the consistency of foam running down the vanes along the bottom half the engine (**Photo 4**). The green substance was also seeping from the outer diameter vane attachment points to the outer shroud 360 degrees around the engine.

Photo 3- Fan Blade Sooting and Surface Deposits

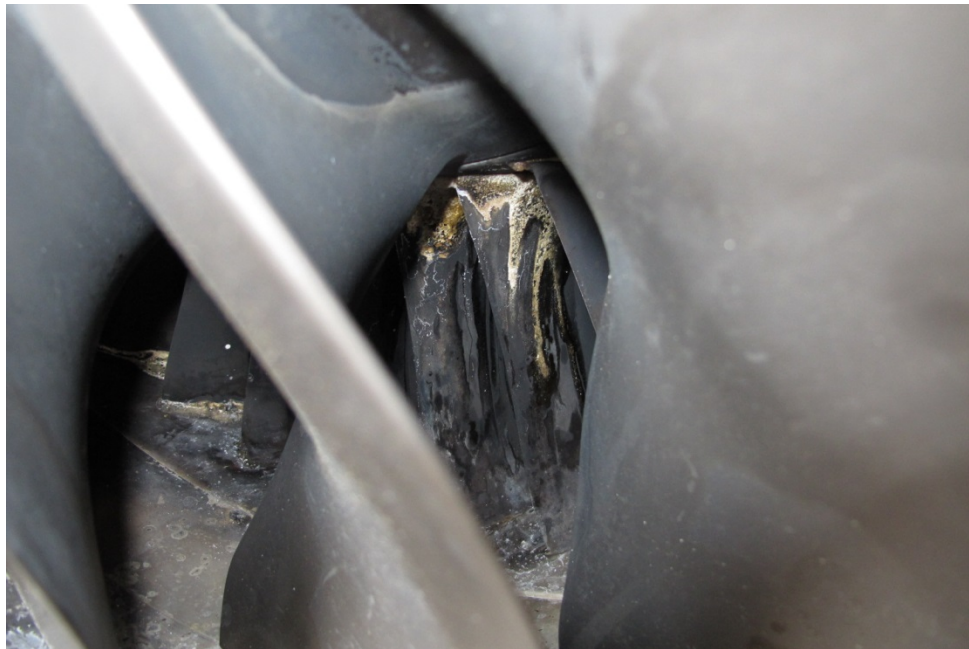
Photo 4- Fan Stator as Viewed Through the Fan (6 o'clock)

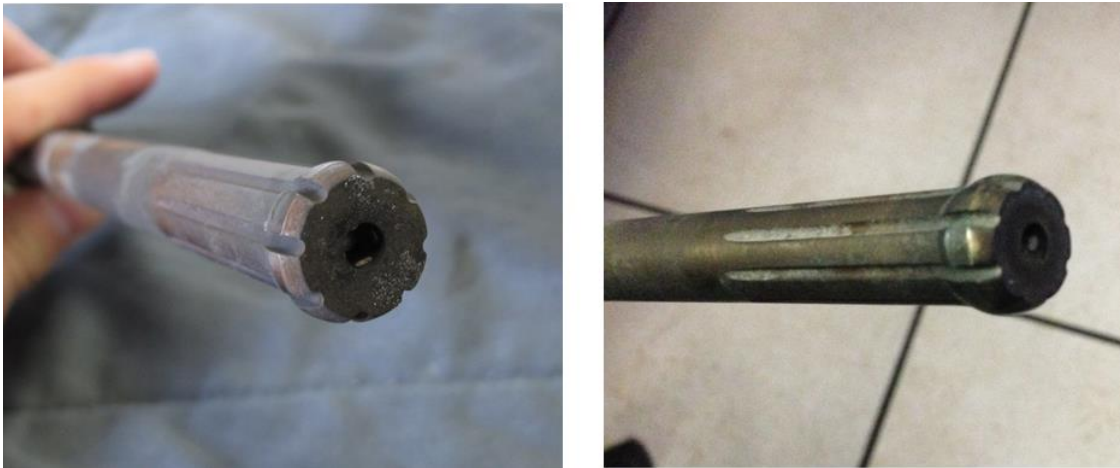
All external case surfaces were in good condition with no indications of thermal exposure or sooting. One of the two igniter plugs was not shipped with the engine but was located and express shipped from Cessna Aircraft in Wichita, Kansas on the first day of the engine examination. The igniter plugs were both inspected and in good condition (**Photo 5**). The oil sight glass was cracked and a review of pictures taken on scene at LCK confirmed the damage happened during engine removal/packaging.

Photo 5- Igniter Plugs

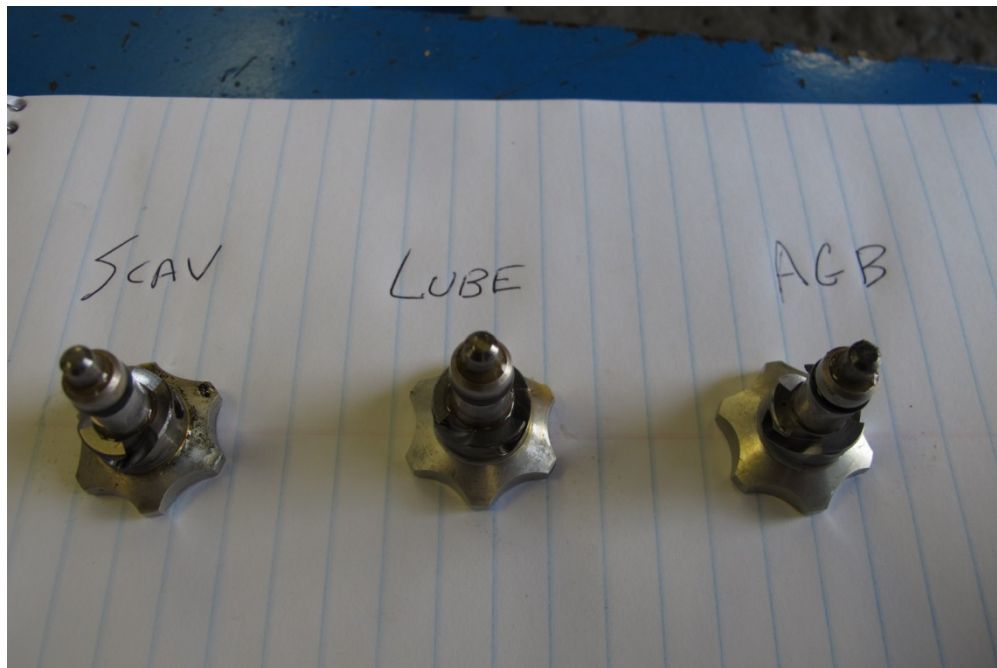
One of the ITT probes was found removed from the engine and hanging by the ITT harness. According to Williams, the igniter and ITT probes were both removed in order to borescope the engine at LCK prior to shipment. The three chip detectors were removed from the gearbox and were free of metal shavings and debris (**Photo 6**).

Photo 6- Chip Detectors, Free of Debris

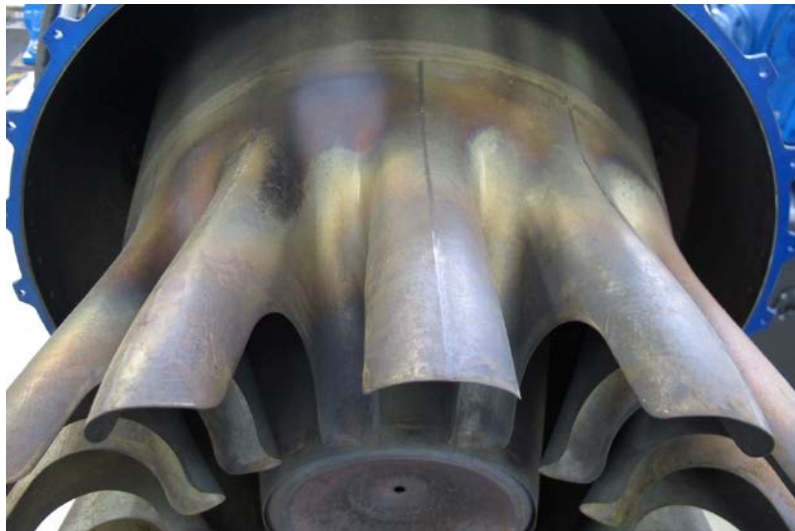
The exhaust mixer lobes exhibited bluing with discoloration and sooting consistent with exposure to fire (**Photo 7**). A significant amount of fire retardant residue had accumulated at the 6 o'clock position of the bypass duct. The visible LPT 2nd stage rotor blades were intact and in good condition but were sooted 360 degrees around (**Photo 8**).

Photo 7- Exhaust Mixer Lobes, Mild Discoloration and Sooting

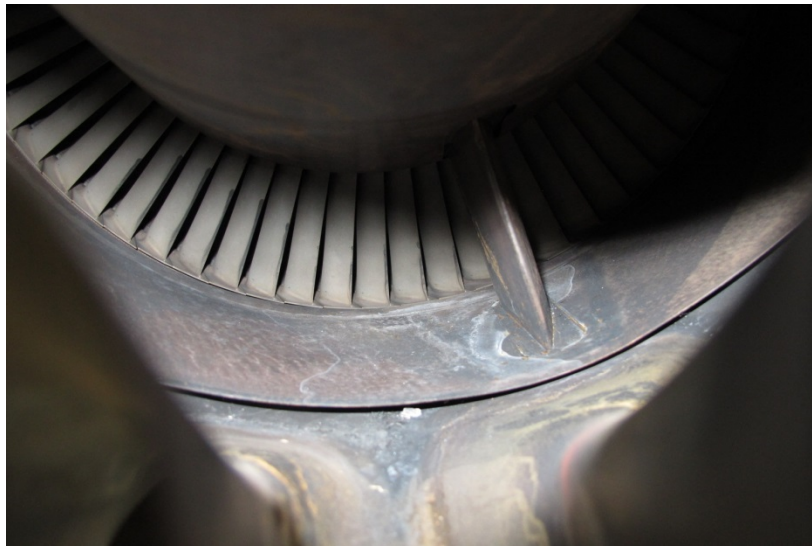
Photo 8- LPT 2nd Stage Rotor Blades, Viewed Through the Exhaust

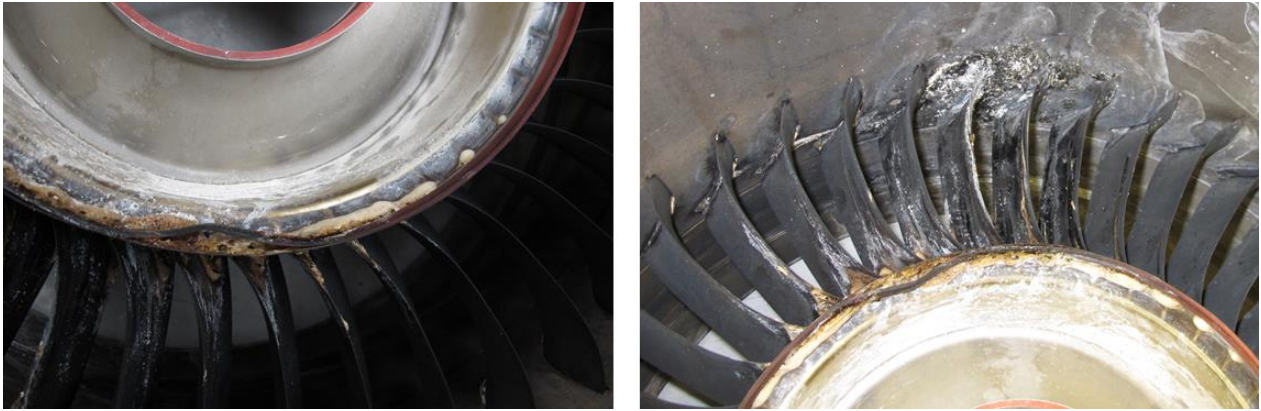
In order to better examine the thermal damage to the fan stator assembly, the fan and fan case and stator assembly were removed. As noted earlier, the fan stator had green residue seeping from vane connection points along the inner and outer shrouds (**Photo 9**). The stator vanes are secured in the case with a castable polyurethane elastomer. The elastomer is green and melts when exposed to temperatures above 140-150°F. A representative stator assembly with focus on the elastomer is shown in (**Photo 10**). The outer diameter of the fan stator is manufactured out of aluminum and exhibited bulging in multiple locations consistent with thermal exposure.

Photo 9- Fan Stator Assembly Elastomer Damage

After an evaluation by Williams International engineering it was determined that the engine was in an acceptable condition to run in the test cell to verify performance. Prior to placement in the test cell a new case and insert assembly was installed due to thermal damage to the stator vane elastomer material noted above². The engine was water washed to remove sooting and fire retardant from internal components. To ensure that software was not a causal factor, the FADEC from the accident airplane was shipped and installed in place of the test cell slave FADEC. A series of starts and performance checks were completed in accordance with Williams International specifications. Two starts were conducted operating on separate FADEC channels which verified that both igniter plugs were in working condition. Both starts were normal, without excessive ITT temperature spikes. Acceleration checks from ground idle to TO/GA power were normal. A timed acceleration check from flight idle to TO/GA power was completed in 5 seconds, meeting the specification for a new engine. A copy of the test cell run sheets are available as **attachment (1)** to this report.

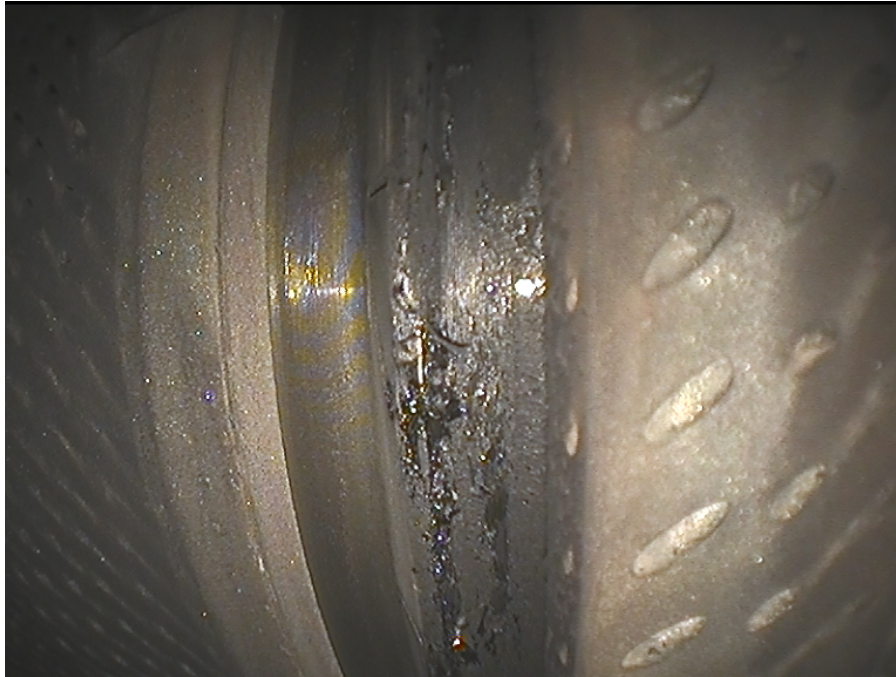
The IP compressor, HPC, combustor and HPT were borescoped to ensure there was no internal damage to the engine. All rotor and stator assemblies exhibited the same sooting and fire retardant residue coating as was seen on the fan. The combustion section was intact without indications of burn through or fuel streaking. A dark shiny carbon like residue was built up around the fuel slinger that is considered normal for engines with similar hours/cycles according to Williams International (**Photo 11**). All visible slinger fuel holes and slots appeared to be free of obstructions and coking. The fuel supply

and manifold lines were both intact and in good condition. The borescope findings at Williams International were consistent with what was observed on scene at LCK.

Photo 11- Borescope Photo of Fuel Slinger

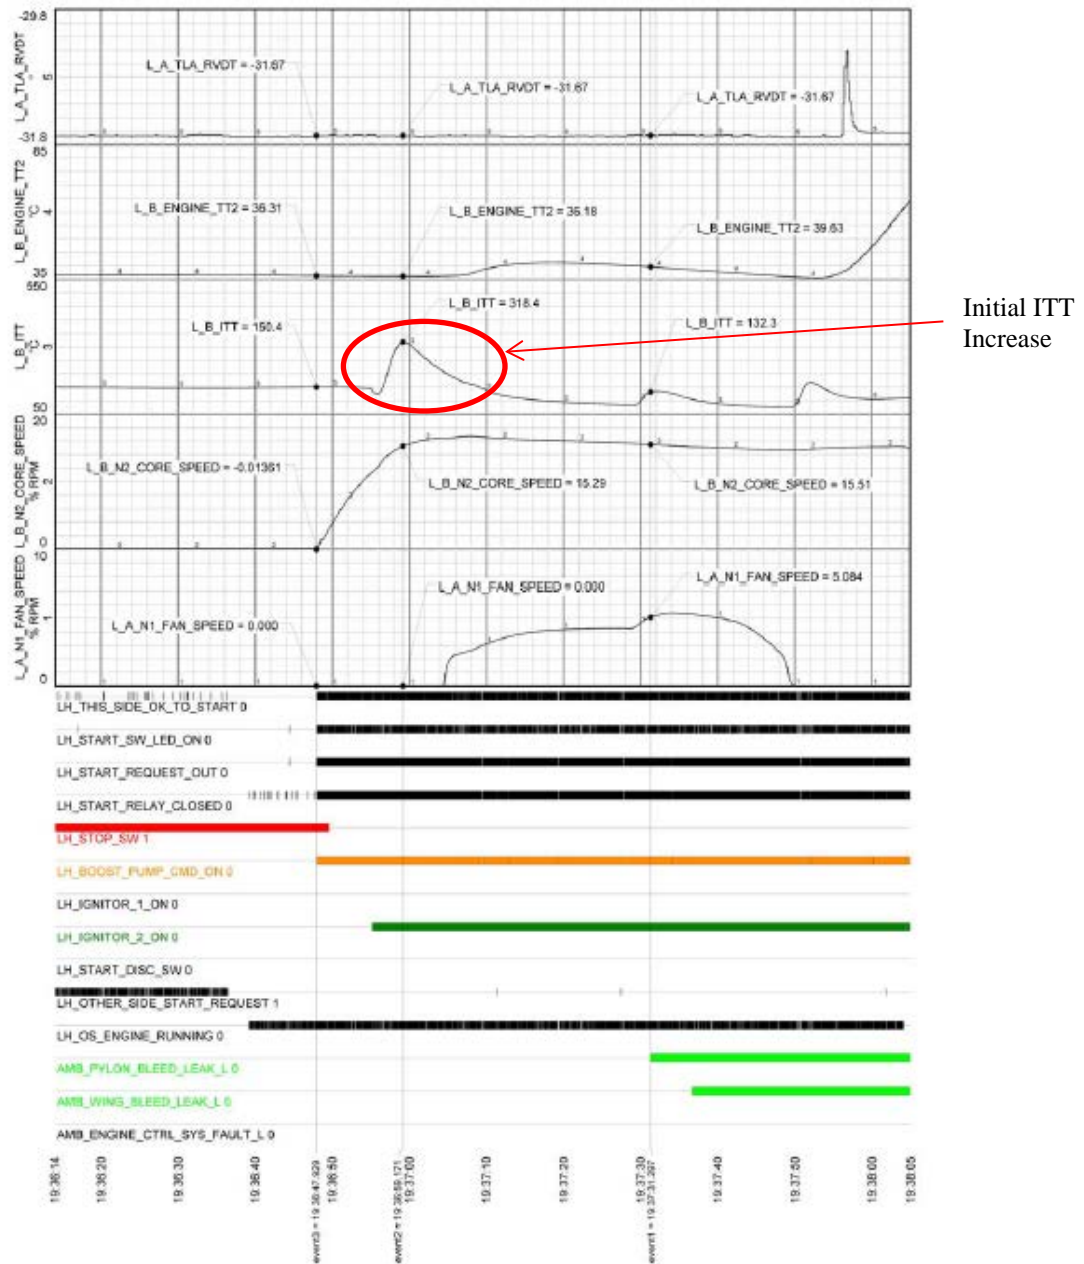
The airplane was equipped with a monitoring device that recorded engine parameters for the event start and subsequent fire. Shortly after start initiation, the engine flamed out, the interstage turbine temperature (ITT) briefly climbed before rapidly decreasing to pre-start levels, and engine N2¹ speed did not accelerate above starter driven level.

The engine parameters during the event were captured by the Cessna Aircraft Recording System (AReS) (**Figure 2**). Based on the data, the N2 speed never exceeded 16% which corresponds to the starter assisted rotation speed. This means the rotation of the high pressure spool of the engine was driven by the starter without any additional energy from combustion. The ITT briefly peaked at 318.4°C (605.1°F) when the start sequence was initiated before rapidly decreasing over the next 10 seconds to a

temperature below prestart levels. The N1³ speed never exceeded 6% which further confirms that a sustained engine start was never achieved.

Figure 2- AReS Data, No. 1 Engine Parameters
