**NATIONAL TRANSPORTATION SAFETY BOARD**  
**Office of Aviation Safety**  
**Washington, D.C. 20594**

**POWERPLANT GROUP CHAIRMAN'S FACTUAL REPORT**

**NTSB No: DCA15FA185**

Aircraft: British Airways, Boeing 777-236ER, registration number G-VIIO, flight number 2276

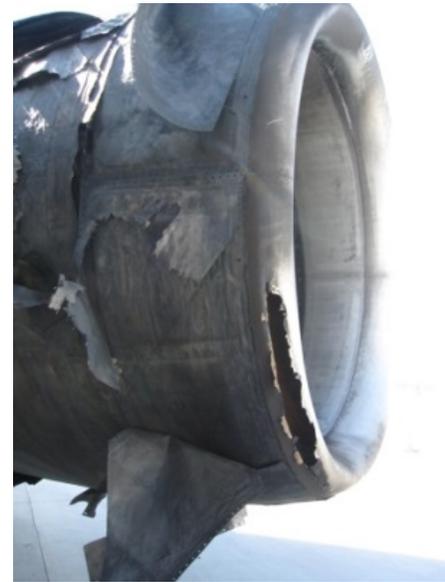
**PHOTO 8: INLET COWL W/  
OUTER BARREL BREACH**

The inlet cowl was still attached to the fan case; however, it exhibited thermal distress from the 12:00 to 8:00 o'clock position and was missing part of the outer skin of the lip from 4:00 to 5:30 (64 inches circumferentially x 5 inches axially) o'clock position but the inner barrel remained intact (**PHOTO 8**).

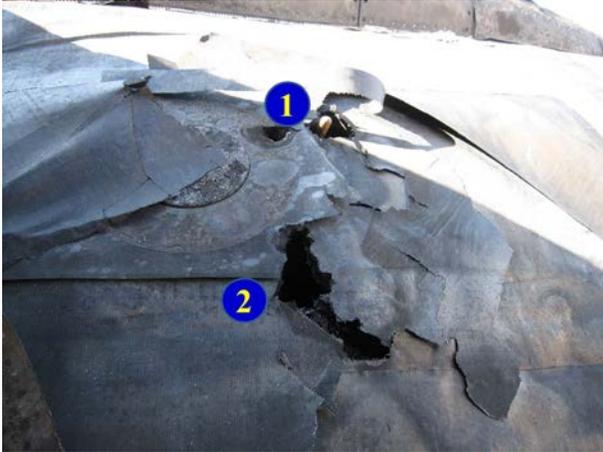
**PHOTO 9: RIGHT TR THRU-HOLES – SIDE VIEW – EXIT ANGLE FROM HOLE 1**

The TR exhibited the most thermal distress of any of the nacelle components. The right TR translating sleeve was heavily thermally damaged/burned (charred and loose composite sheets with almost all of the epoxy binder missing) and two confirmed penetration holes: 1) located at 1:30 o'clock position and 49 inches forward of the rear flange measuring 3 x 4 inches, 2) located at 2:00 o'clock position and 44 inches forward of the rear flange measuring 5.5 x 3 inches. The distance between the centers of the penetration holes was about 14 inches. Broomstick handles were placed in the penetration holes to provide a general fragment exit direction (**PHOTOS 9-12**). The trailing edge of the translating

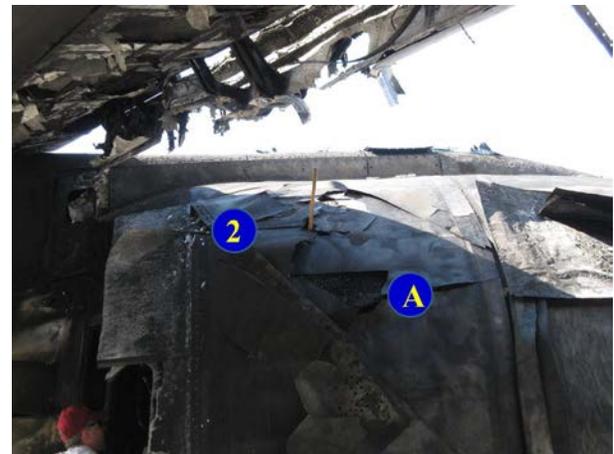
**PHOTO 12: RIGHT TR THRU-HOLE – SIDE VIEW - EXIT ANGLE FROM HOLE 2**

sleeve from about the 3:00 - 5:30 o'clock position (70 inches circumferentially) was missing 16 inches of axial material. In **PHOTO 12**, impact mark "A" was identified as a non-through hole where a piece of HPC stage 7 bleed air duct port and case (**PHOTO 13**) was found imbedded in the inner wall.

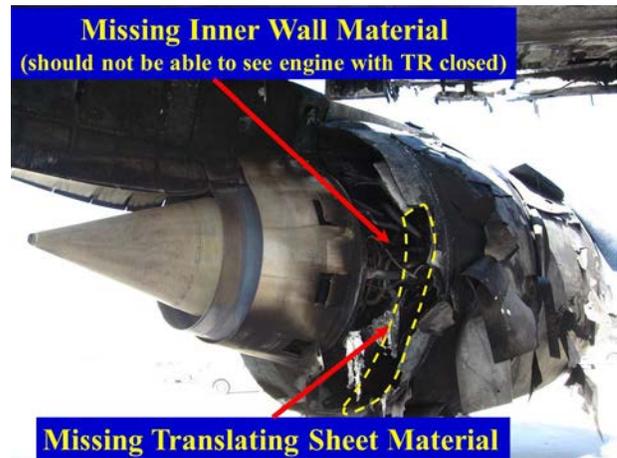
**PHOTO 14: MISSING TRANSLATING SLEEVE & INNER WALL MATERIAL ON RIGHT TR**

The TR inner wall from the 1:00 – 4:00 o'clock position was missing (about a 5 foot x 5 foot section) exposing the engine core – normally the engine core would not be able to be seen with the TRs closed (**PHOTO 14**).

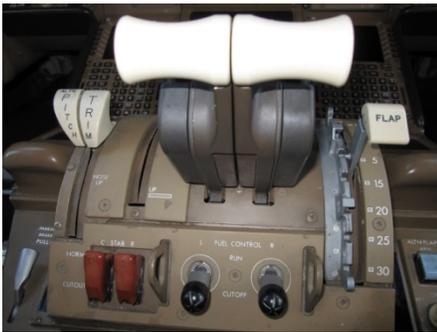
**PHOTO 16: THRUST LEVER AND FUEL CONTROL RUN/CUTOFF POSITION FOR BOTH ENGINES**

Examination of the cockpit revealed that both thrust levers (throttles) were against the aft stops, both fuel control<sup>10</sup> cutoffs knobs were in the down and CUTOFF position (**PHOTO 16**) and the No. 1 engine fire handle was pulled and twisted to the right in the direction of the No. 2 bottle discharge position (**PHOTOS 17** and **18**). The No. 2 engine fire handle was found not pulled and straight.

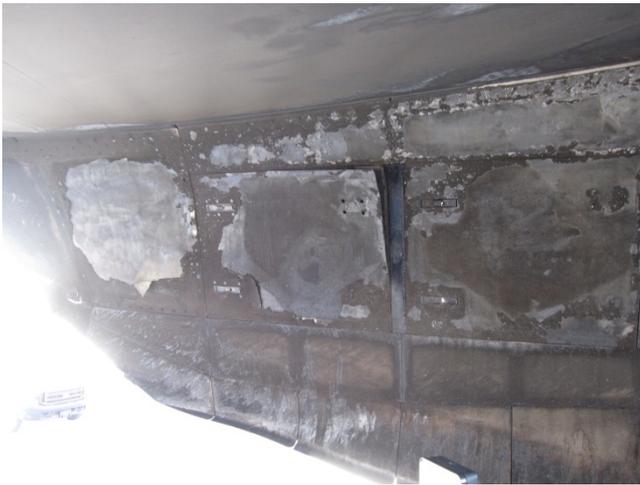
**PHOTO 23: ENGINE STRUT THERMAL/FIRE DAMAGE – LOOSE COMPOSITE PLYS**

Thermal distress/fire damage was only noted on the right side of the engine strut - the left side was in good condition and no soot patterns were noted (See **PHOTOS 6** and **7**). The right side of the engine strut was burned, charred and on some of the panels the epoxy binder was missing and the composite plies were loose (**PHOTOS 23** and **24**). No burn through holes were noted. All the access panels were CLOSED and latched except for the pressure/relief and fire detector access panel which was partially OPEN, melted, and the latch missing (**PHOTO 24**).

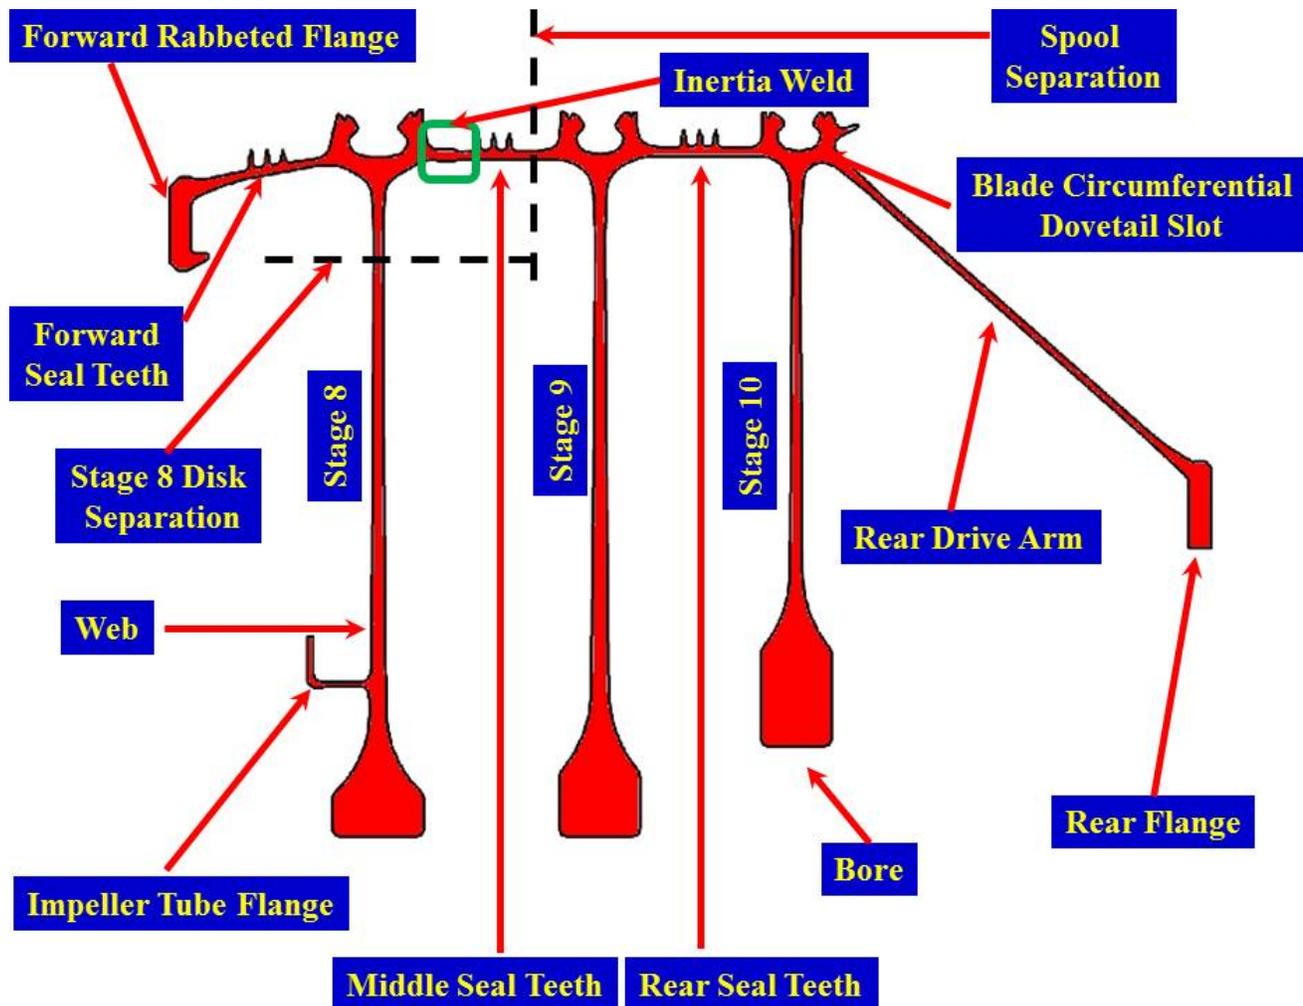
**FIGURE 6: BORESCOPE FINDING OF HPC STAGE 8-10 SPOOL SEPARATION**

A partial initial borescope inspection (BSI) was performed on the HPC and HPT sections. The HP rotor could not be rotated through the gearbox, so the BSI was limited to the length of the scope through the respective borescope ports or HPC aft extension case breach. BSI of the engine while it was still installed on the airplane through the borescope ports on the left side of the engine starting on HPC stage 2 revealed minor HPC stage 2 blade airfoil damage and significant airfoil and vane damage starting at HPC stage 4 progressing downstream. Severe distress of the entire HPC stage 8-9 was

observed and the spool (stage 8-10) was separated aft of the middle seal teeth between stages 8 and 9 and the stage 8 disk radially separated below the circumferential blade slot; this was consistent with hardware recovered from the runway (**FIGURE 6**). The stage 9 disk appeared intact with blade roots and platform present and still installed. The stage 10 disk was not visible.

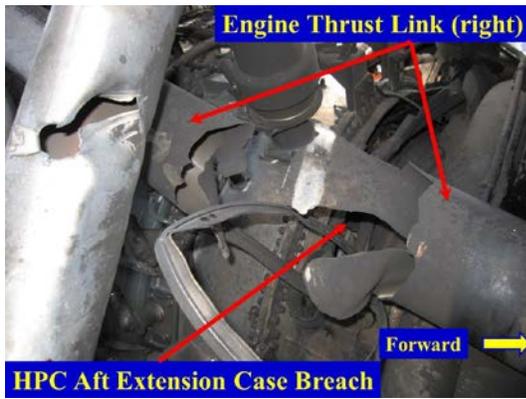
**PHOTO 26: SEVERED RIGHT THRUST LINK**

The right engine thrust link, located at about the 1:00 o'clock position was severed in-plane with the HPC aft extension case (**PHOTO 26**). Several bleed ducts from the 2:00 – 3:00 o'clock position were severed in-plane with the HPC aft extension case (**PHOTO 27**). The HPC stage 10 bleed duct was disconnected from the HPC aft extension case – the tube and case were intact, all the attachment bolts were fractured (**PHOTO 28**). The main fuel supply line was intact; however, the inlet elbow of the main fuel pump (MFP) housing was fractured; the fuel supply line was completely separated from the pump and pieces of the elbow remained attached to the main fuel supply line (**PHOTO 29**).

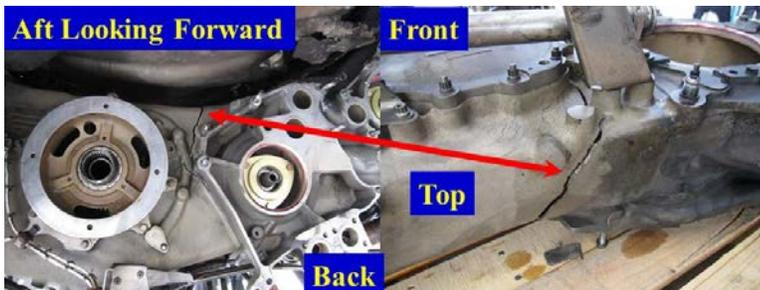
**PHOTO 30: FRACTURED REAR HOUSING OF GEARBOX**

The AGB housing exhibited a crack between the starter mount pad and the hydromechanical unit (HMU) mount pad that extended from the back of the gearbox (**PHOTO 30**), over the top, and stopped on the front. No visible oil was dripping from the crack. The lube and scavenge pump attachment flange was fractured around the entire circumferential and parts of the flange remained attached to the gearbox (**PHOTO 31**).

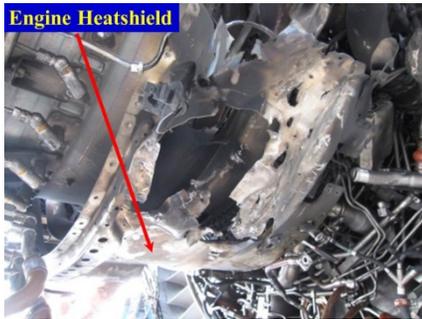
**PHOTO 32: PENETRATION HOLES IN THE ENGINE HEATSHIELD**

The engine heatshield exhibited numerous exit penetration holes centered about the 5:00 o'clock position in-line with the breach in the HPC aft extension case (**PHOTO 32**). The engine heatshield aft skirt was pierced by a section of what appears to be part of the HPC aft extension case flange (**PHOTOS 33 and 34**).

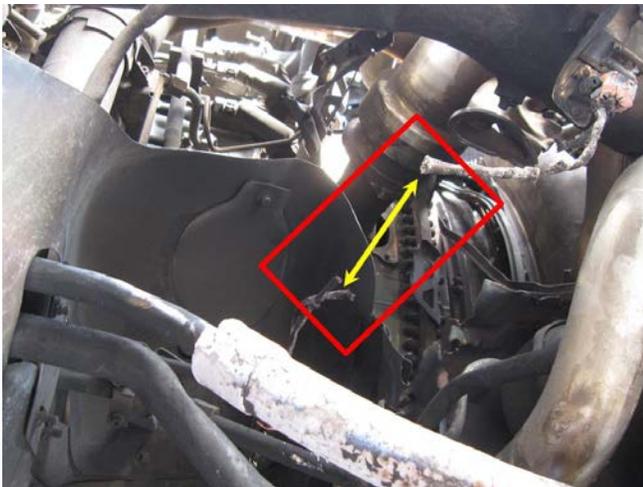
**PHOTO 35: SEVERED HMU ELECTRICAL LEADS**

The HMU electrical leads for the HPSOV were sooted, thermally damaged, and severed near the locations where the main fuel line was severed (**PHOTO 35**). A piece of what appears to be HPC aft extension case flange with an attachment bolt still installed pierced through the forward side of the HMU housing (**PHOTO 36**) with the HMU removed, the input shaft of the MFP was bound and could not be rotated by hand.

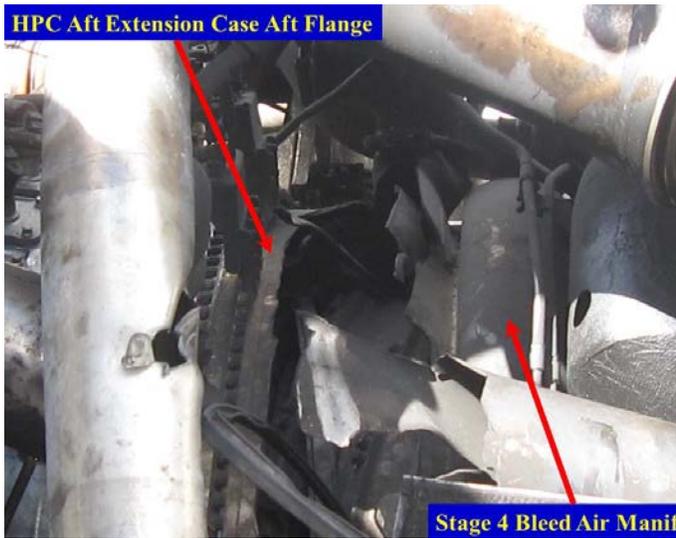
**PHOTO 37: HPC AFT EXTENSION CASE BREACH AT TOP OF ENGINE**

The HPC aft extension case was breached circumferentially from about the 11:30 – 5:00 o'clock position (58 inches circumferentially) (**PHOTOS 37 and 39**) and axially from the stage 4 bleed manifold to the rear flange. The case skin was missing but in those areas where it remained, the case skin was torn and pushed outwards. A breach of the HPC aft extension case was also located at about the 9:30 o'clock position, coincident with a HPC stage 7 bleed port (**PHOTO 40**), and the case skin was torn, pushed outwards, and pieces of compressor debris were wedged in the tear. The tear measured about 10 inches circumferentially x 2.5 inches axially.

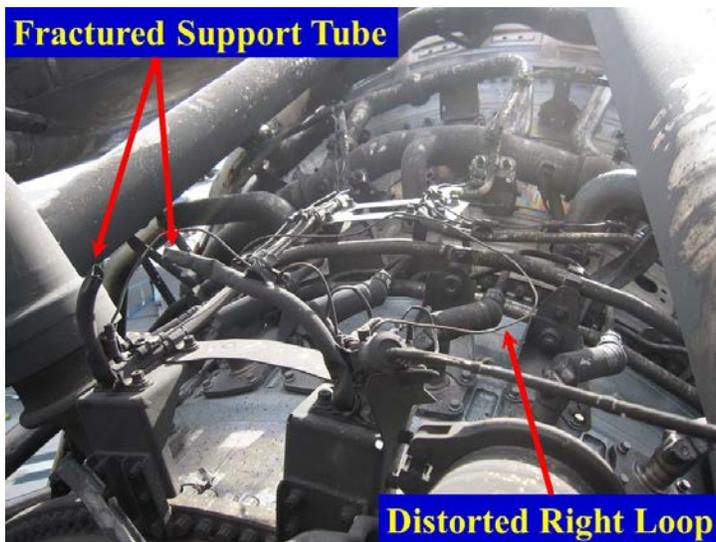
**PHOTO 41: FIRE LOOPS ON TOP OF ENGINE – RIGHT AFT DISTORTED**

The aft left, aft right, aft lower fire loops appeared to be intact; however, the aft right loop was distorted and its support tube fractured (**PHOTO 41**). All the fire loop isolators were present, most were sooted, and some exhibited minor thermal distress (**PHOTO 42**).

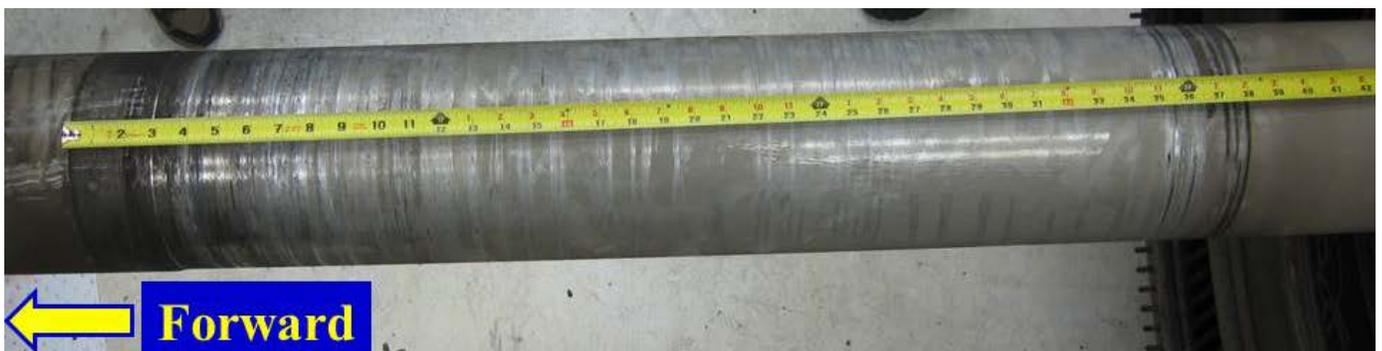
**PHOTO 45: LPT SHAFT CIRCUMFERENTIAL SCORE MARKS**

Removal of the LPT rotor revealed that the LPT shaft had circumferential score marks spanning 38 inches axially and starting 2.25 inches forward of the change in LPT shaft diameter (**PHOTO 45**). The LPT stage 1 nozzle vanes were all present, intact and in good condition as were the LPT stage 1 blades. The LPT module was not disassembled any further. The knife edges of the “B” sump aft inner air seals were damaged and worn down almost to the backing strip.

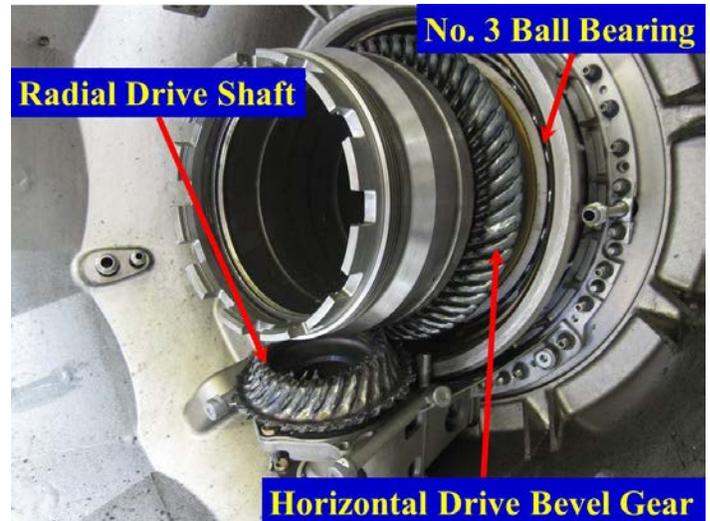
**PHOTO 46: INLET GEARBOX - DAMAGE TO BEVEL GEARS**

The fan hub module, comprised of the fan<sup>12</sup> and booster (LPC stages 1-3) sections, was removed exposing the No. 3 bearing area and the inlet gearbox. The bevel gear of the radial drive shaft and the horizontal drive bevel gear were both severely damaged (**PHOTO 46**). The radial drive shaft bevel gear teeth were smeared almost entirely flat (no appreciable tooth height left), melted, and exhibited a bluish heat tint. The horizontal drive bevel gear teeth were smeared; over the outboard 80% of the teeth length, about 50% of the tooth height was missing. The inboard 20% of the tooth length exhibited essentially the entire tooth height. The horizontal drive bevel gear did not exhibit the melting that the radial drive bevel gear did.

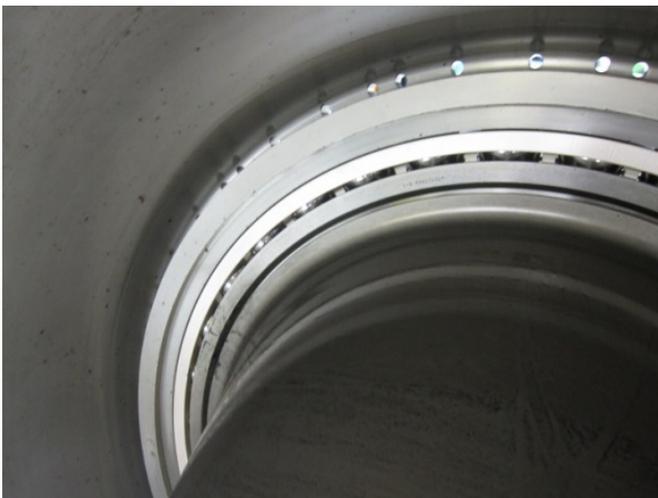
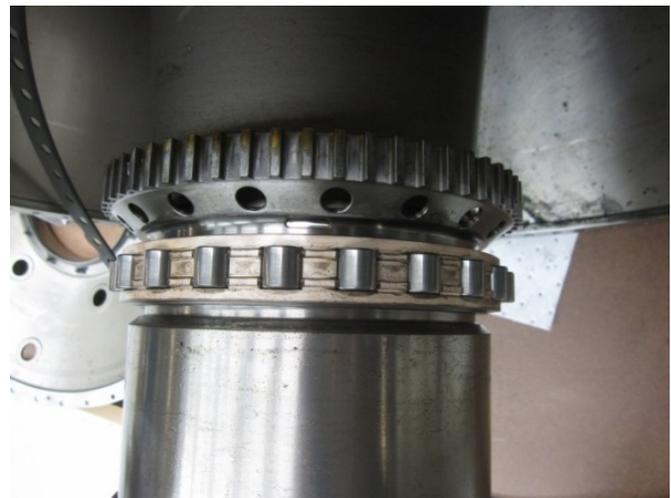
The No. 1 ball bearing (**PHOTO 47**), the No. 2 roller bearing (**PHOTO 48**), and the No. 3 ball (See **PHOTO 46**) and radial bearings all appeared intact, in good condition, and the roller elements were shiny.

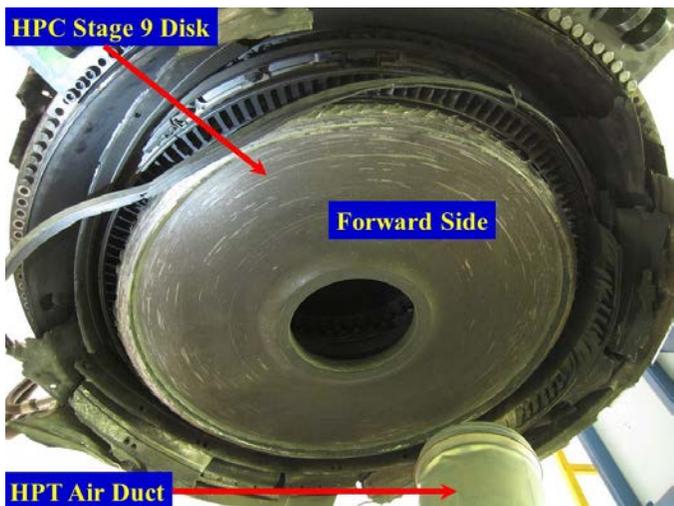
**PHOTO 50: HPC STAGE 9 DISK STILL ATTACHED TO BACK HALF OF THE COMPRESSOR**

After cutting through the HPC aft extension case, the back end of the engine was lifted off and the HPC stage 9 and 10 disks remained with the back portion (**PHOTO 50**). The HPC stage 8 disk remained with the forward end along with the HPT air duct. The HPC stage 8 disk was fully detached from the stage 7 disk, and the HPT air duct was loose within the bore (**PHOTO 51**). The stage 8 disk was fractured circumferentially about 200° around just at the transition radius of the web to the blade circumferential dovetail slot rim. About 37 inches of the dovetail slot rim remained attached to the disk (**PHOTO 52**).<sup>13</sup>

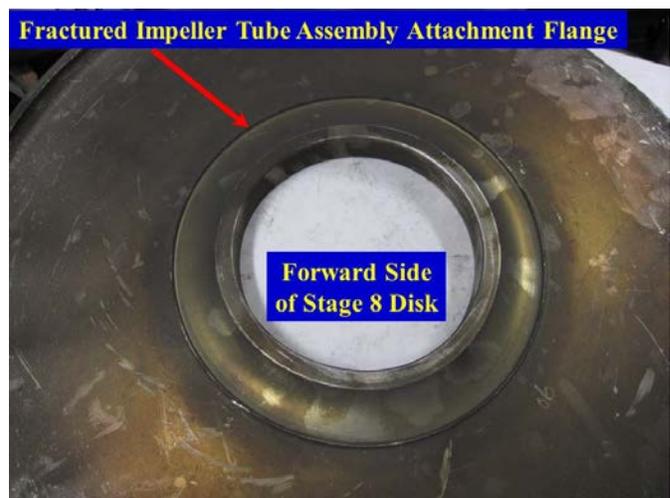
**PHOTO 54: MISSING IMPELLER TUBE ASSEMBLY ATTACHMENT FLANGE**

With the HPC stage 8 disk removed, the impeller tube assembly was exposed. The impeller tube assembly was fractured and detached from the front side of the stage 8 disk, and the carrier was ovalized; no longer round. The attachment flange on the impeller tube assembly carrier was partially present with all the bolt hole scallops pulled through and fractured. Some of the impeller tubes were fractured at the carrier, some were fairly intact, and some were splayed open (PHOTO 53). The mating attachment flange on the stage 8 disk forward side was completely fractured and missing (PHOTO 54).

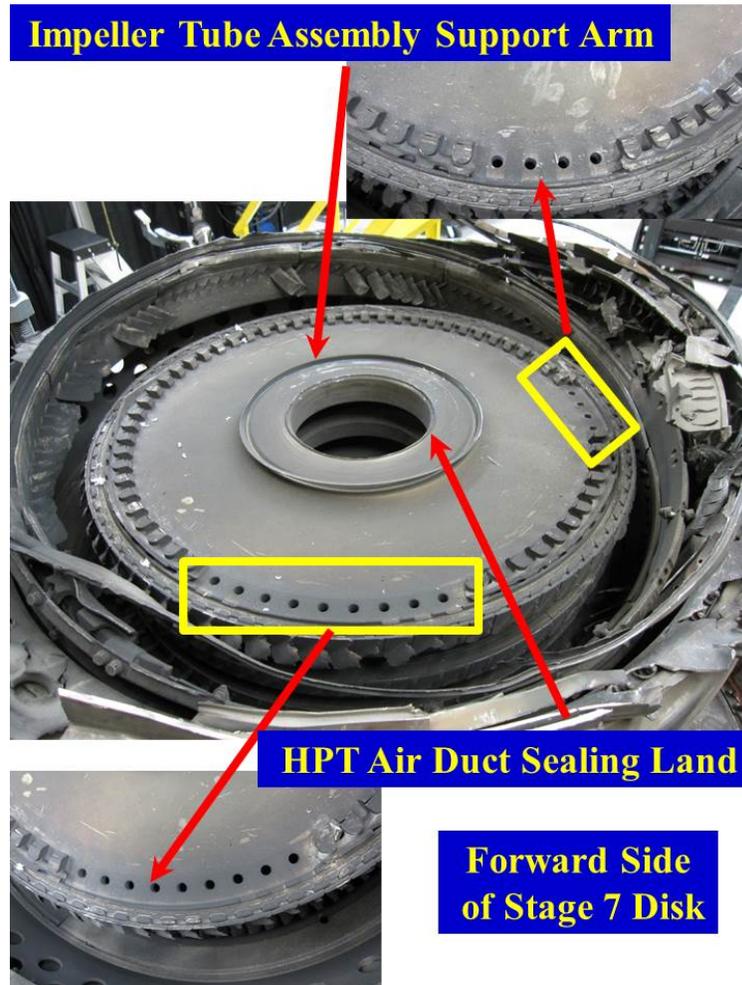
**PHOTO 55: HPC STAGE 7 DISK WITH IMPELLER TUBE ASSEMBLY SUPPORT ARM DAMAGE AND PIECES OF THE HPC STAGE 8-10 SPOOL FORWARD FLANGE STILL ATTACHED**

With the impeller tube assembly removed, the HPC stage 7 disk aft face was exposed. The impeller tube assembly support arm, which is integral to the back side of the stage 7 disk, was present and about a 240° continuous section was pushed outward and was torn near the transition radius of the support arm to the disk web. The HPT air duct forward seal land, integral to the back of the stage 7 disk at the bore, was completely fractured and missing. Two sections of the forward rabbeted flange remained attached to the aft face of the stage 7 disk; two sections of the flange, including the bolts, totaling 13 attachment bolt locations were also missing (PHOTO 55). These missing forward flange pieces were recovered at LAS and during the engine disassembly.

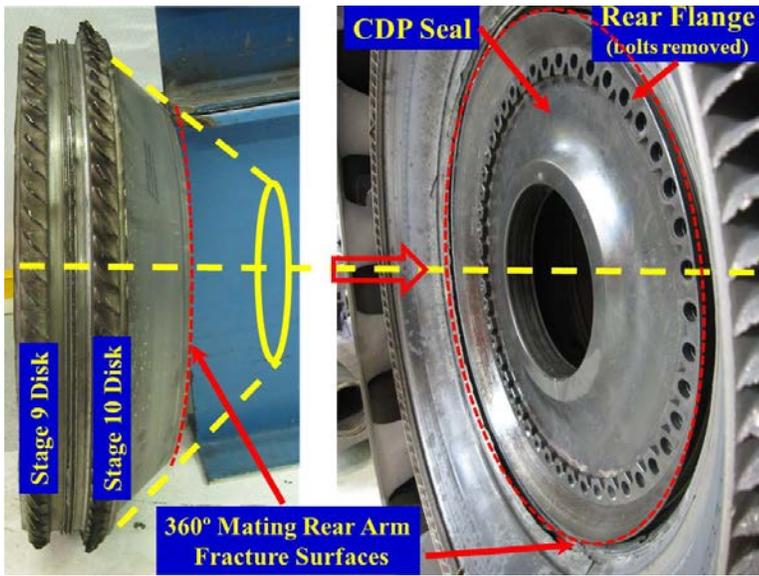
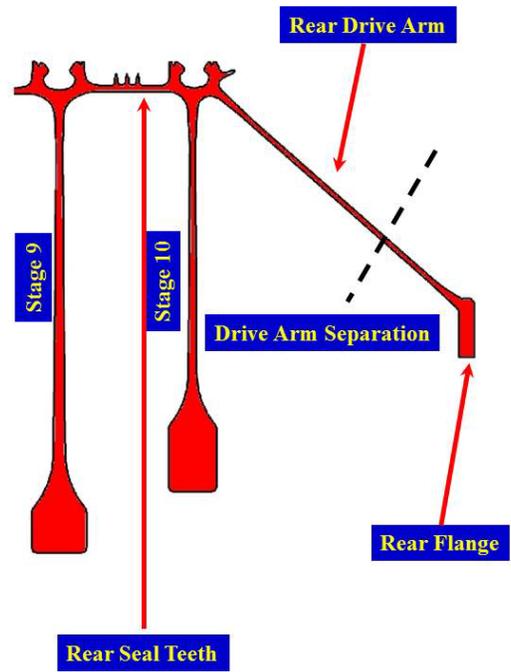
**PHOTO 56: FRACTURED REAR DRIVE ARM**

The rear drive arm of the HPC stage 8-10 spool was fractured and separated 360° about 1.375 inches forward of the rear flange (PHOTO 56 and FIGURE 9) in the general vicinity of the compressor discharge pressure (CDP) seal land. The portion of the rear drive arm that remained with stage 8 and 9 disks exhibited a 0.8 inch wide 360° circumferential scoring mark and bluish heat tinting. The aft portion of the drive arm remained attached to the CDP seal and all the bolts were present.

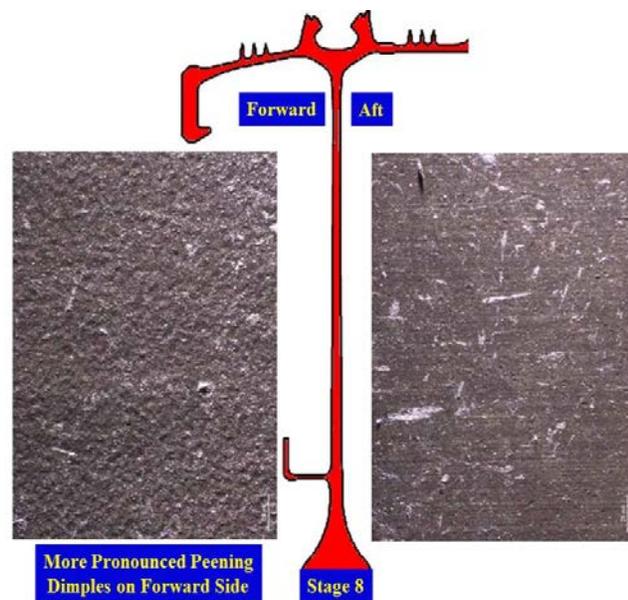
**PHOTO 68: VARIATIONS IN SHOT PEENING APPEARANCE**

Based on the shot peening irregularity found on the event part (and review of other similar vintage spools found a similar reduced coverage on the aft side of stage 8 disk), GE initiated two 2 corrective actions. First, GE issued SB 72-1149 to provide a one-time improved shot peen repair for all HPC stage 8-10 spools (all base model GE90 part numbers). Since this is a one-time shot peen repair, this repair will not be incorporated into the engine manual. Secondly, GE modified the print drawing for
