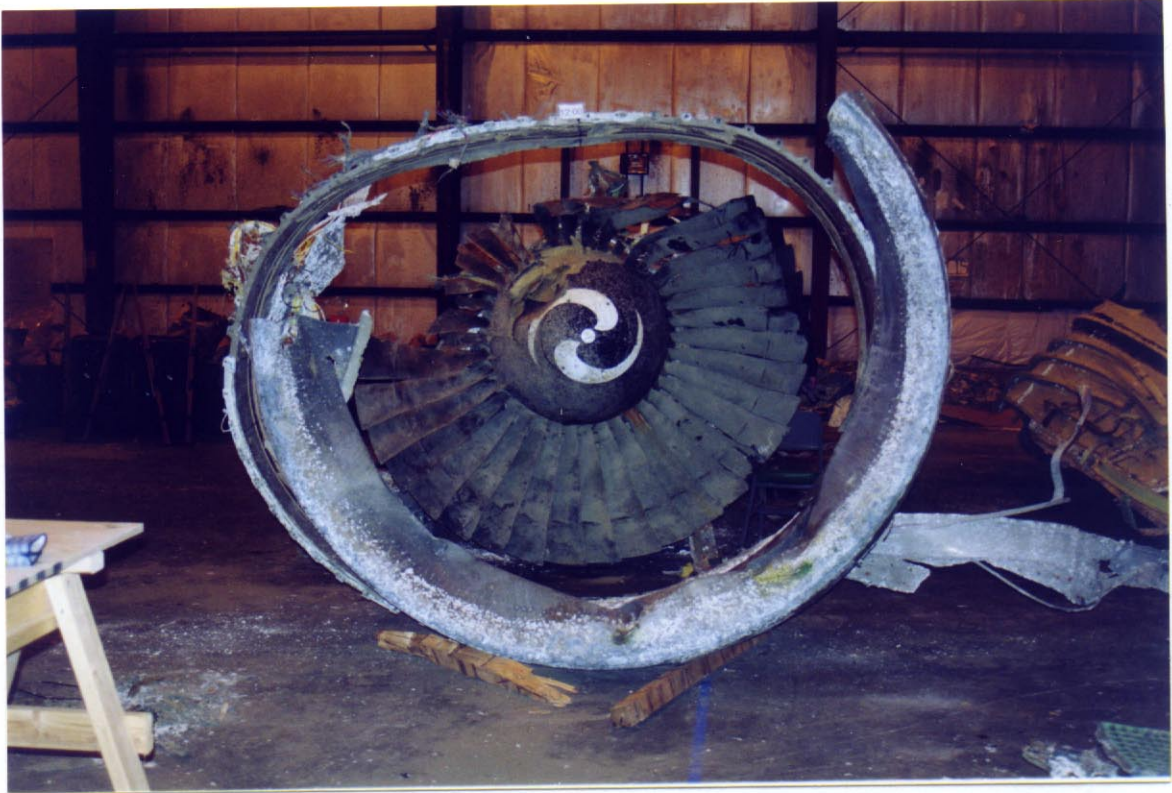
Photo 1. Front view of No. 1 engine inlet, fan containment case, and fan blades.

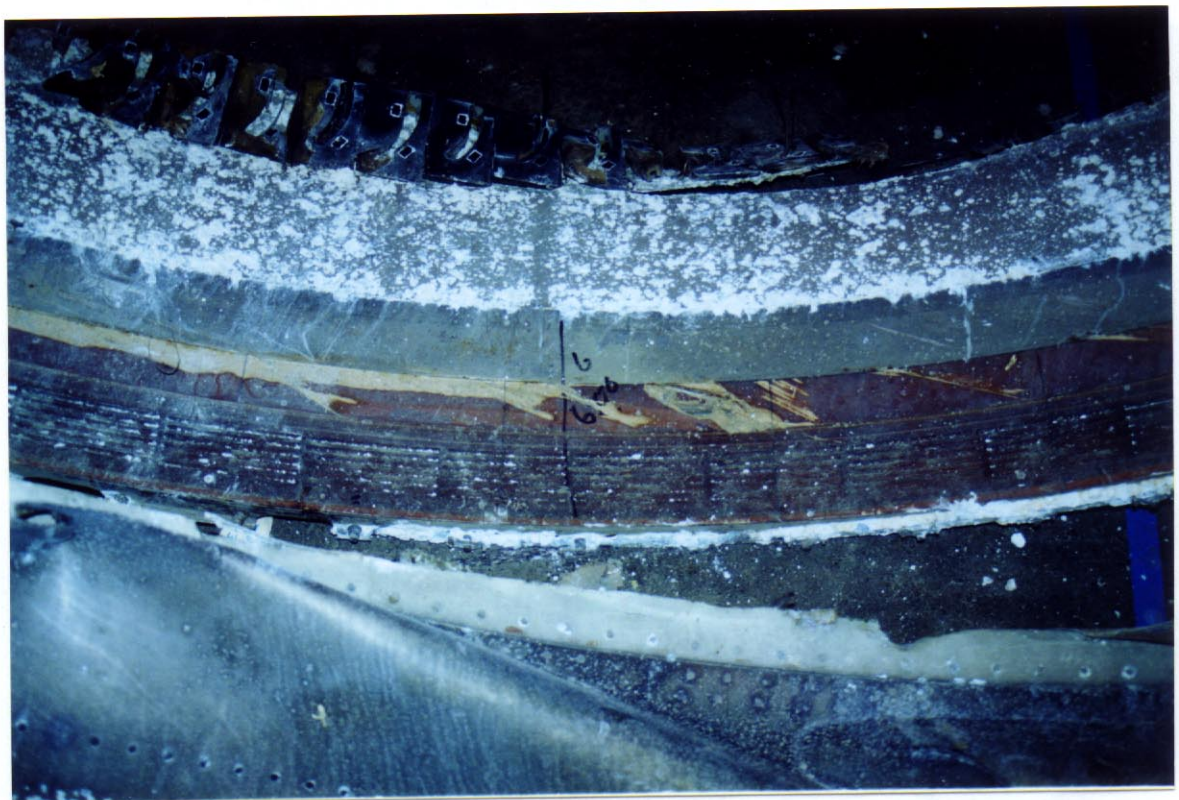
Photo 2. Closeup of No. 1 engine fan rubstrip showing imprints of fan blade tips.

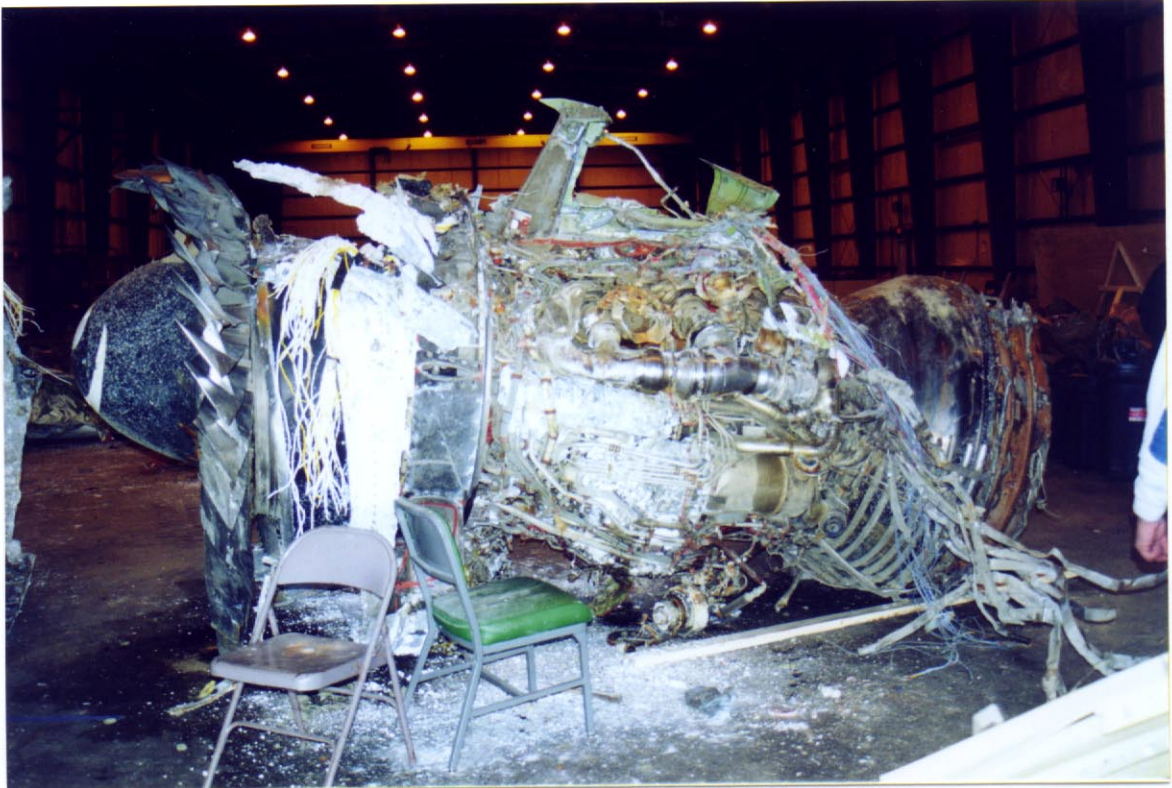
Photo 3. View of left side of No. 1 engine.

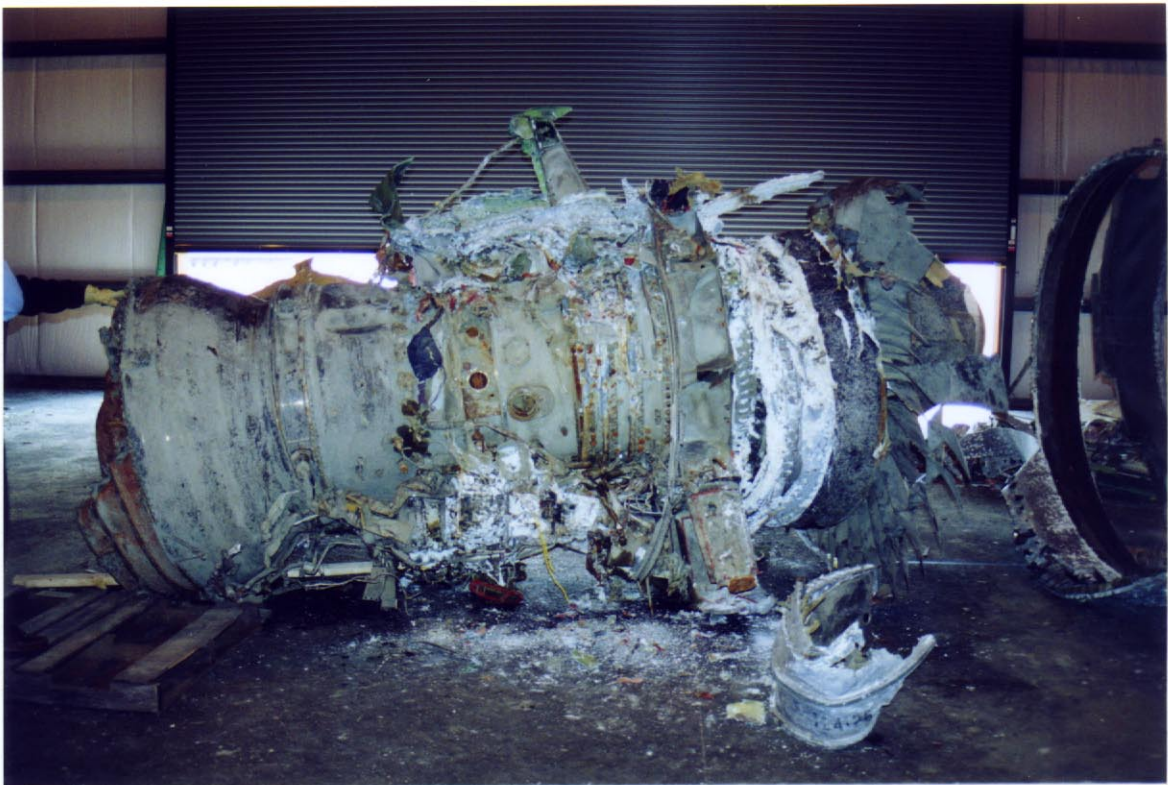
Photo 4. View of right side of No. 1 engine.

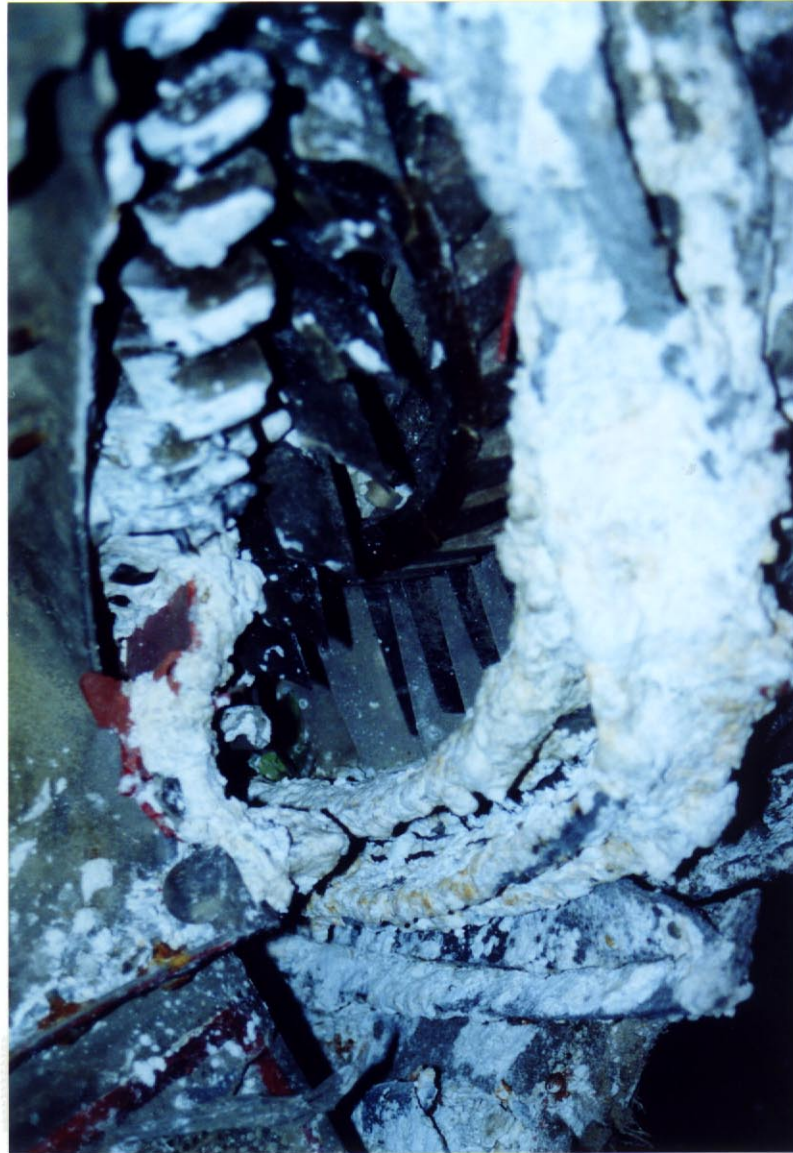
Photo 5. Close up view of LPC disk and blades visible through separated flange.

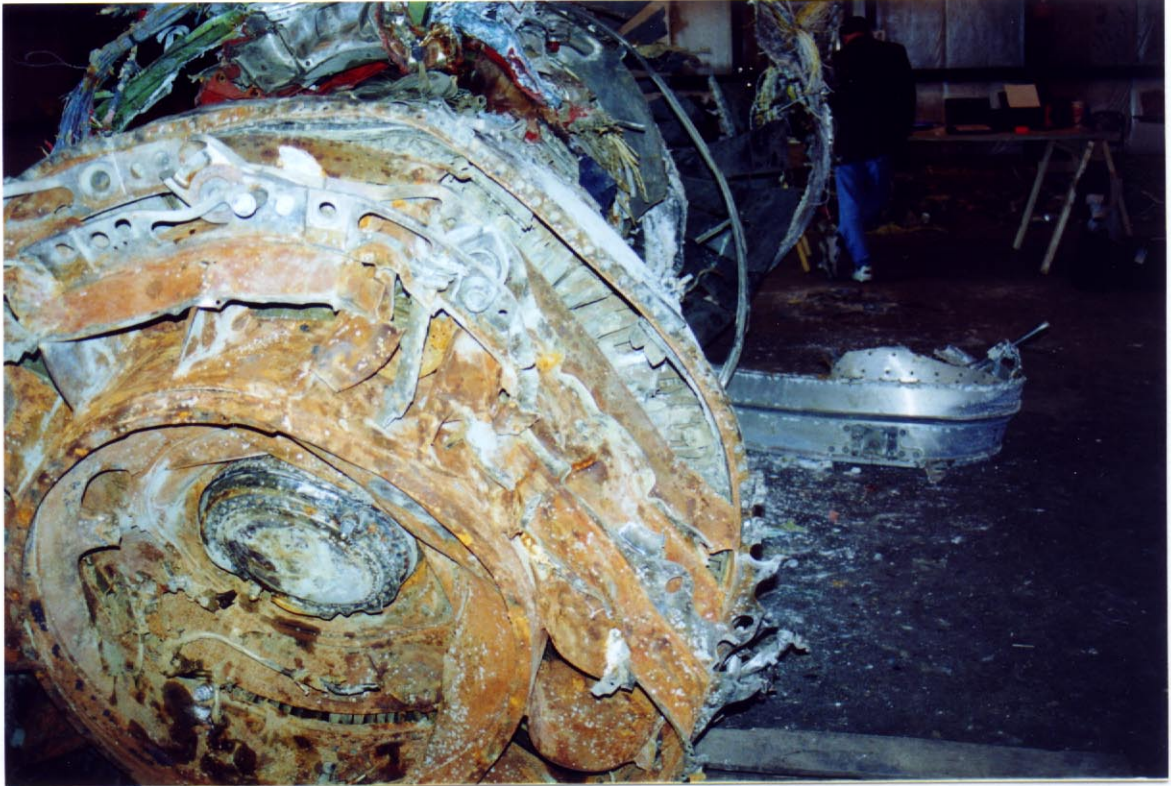
Photo 6. View of rear of No. 1 engine.

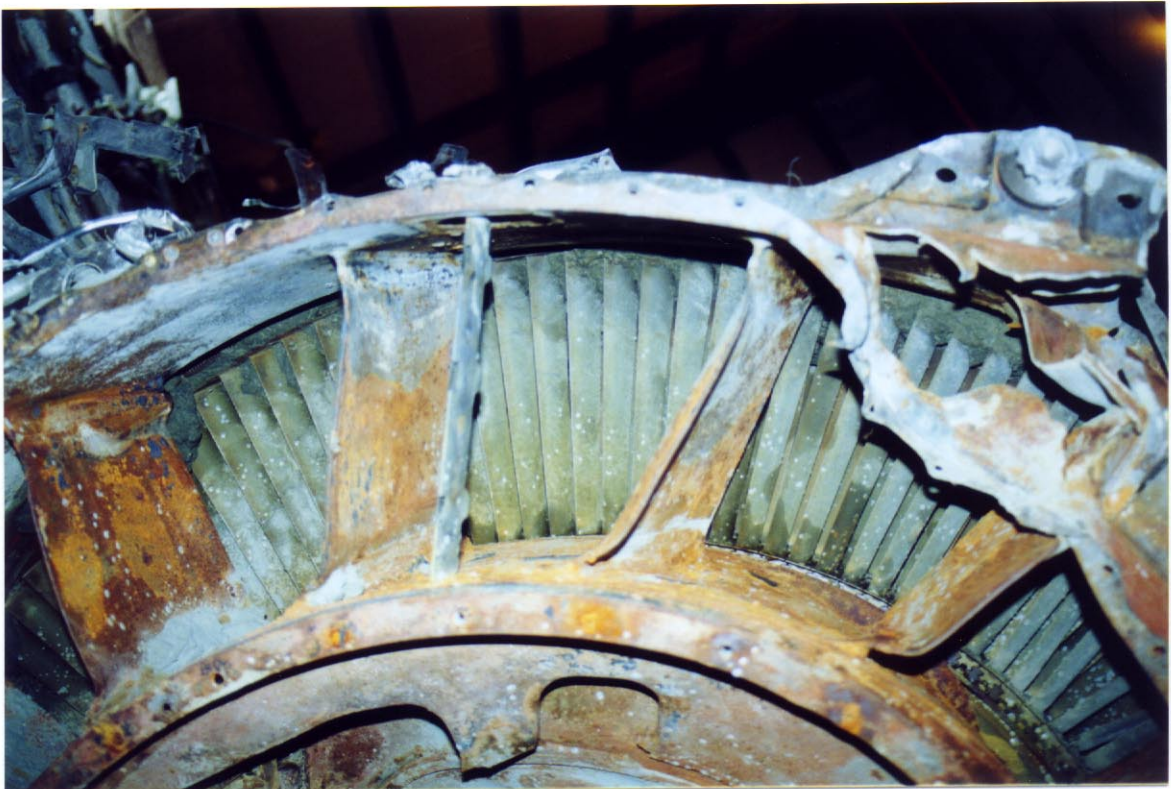
Photo 7. Closeup of rear of No. 1 engine showing full length 6th stage turbine blades.

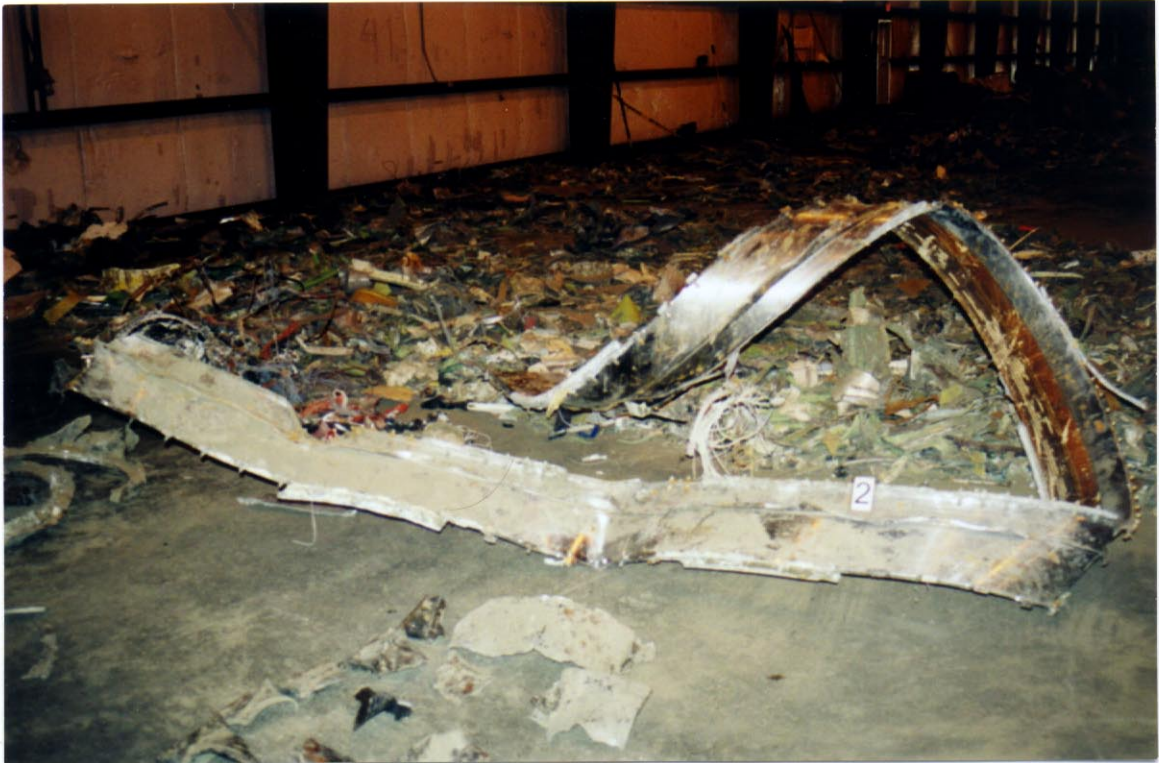
Photo 8. No. 2 engine fan containment case.

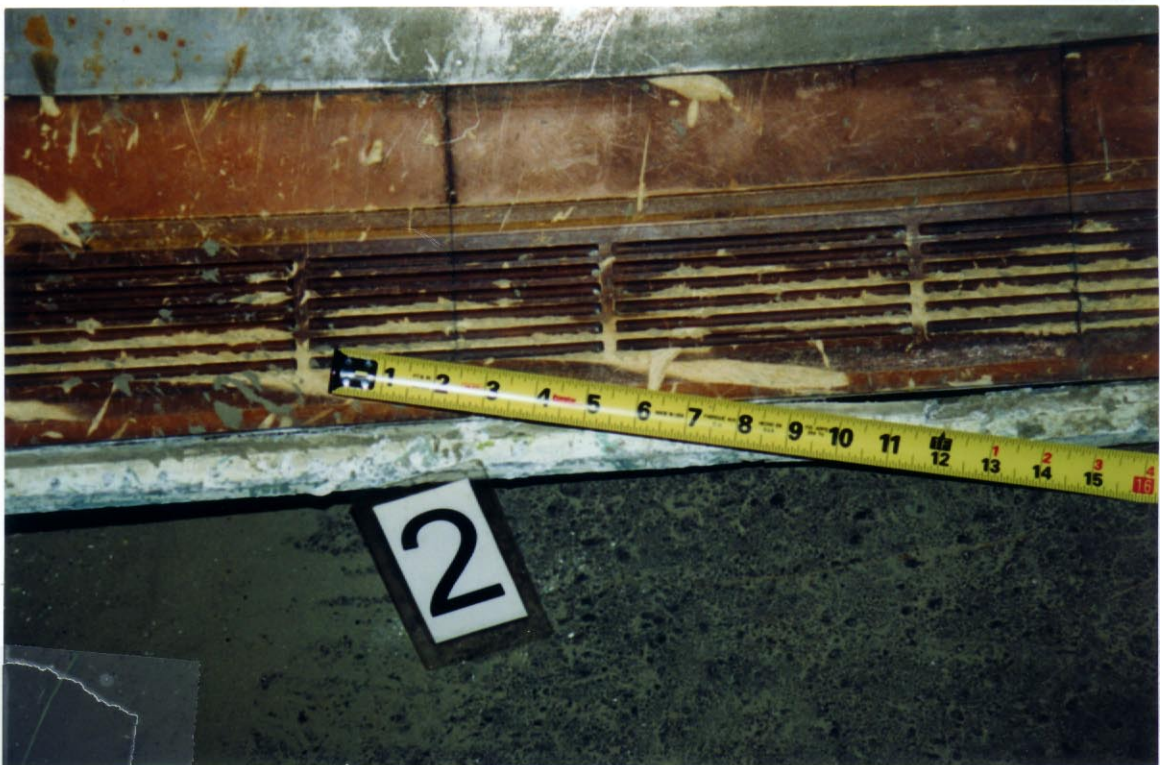
Photo 9. Closeup of No. 2 engine fan rubstrip showing imprints of fan blade tips.

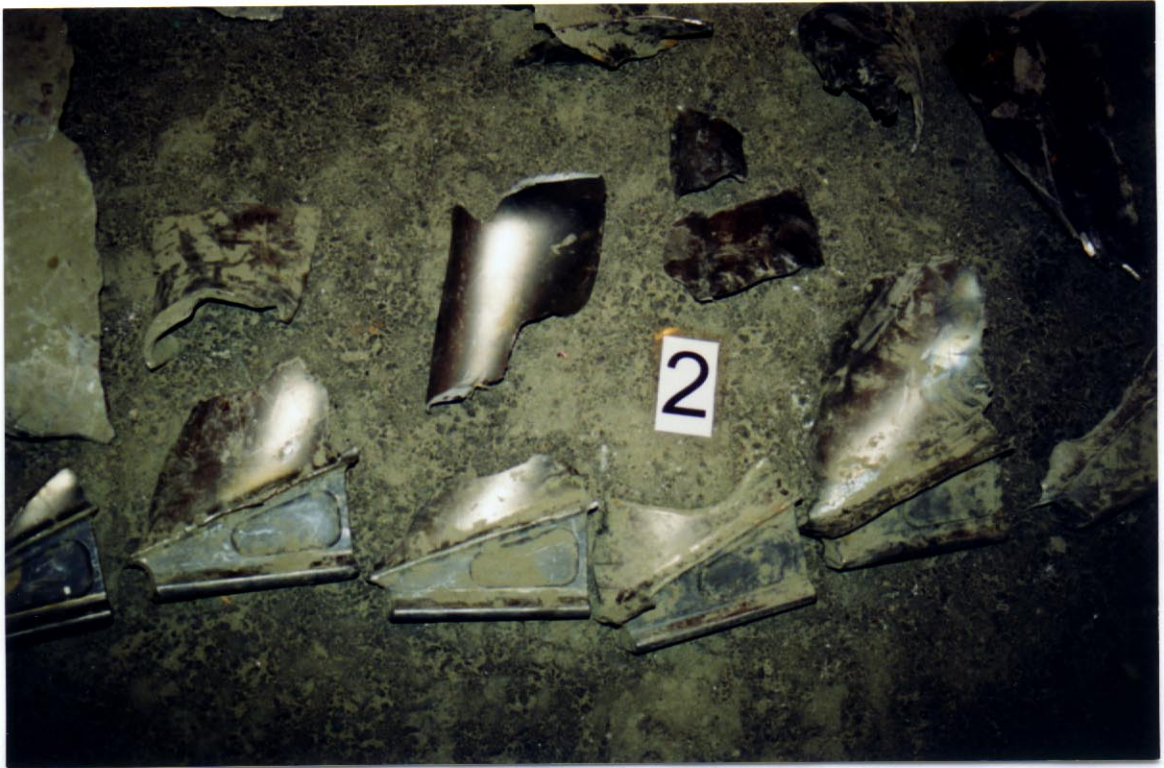
Photo 10. Pieces of No. 2 engine fan blades.

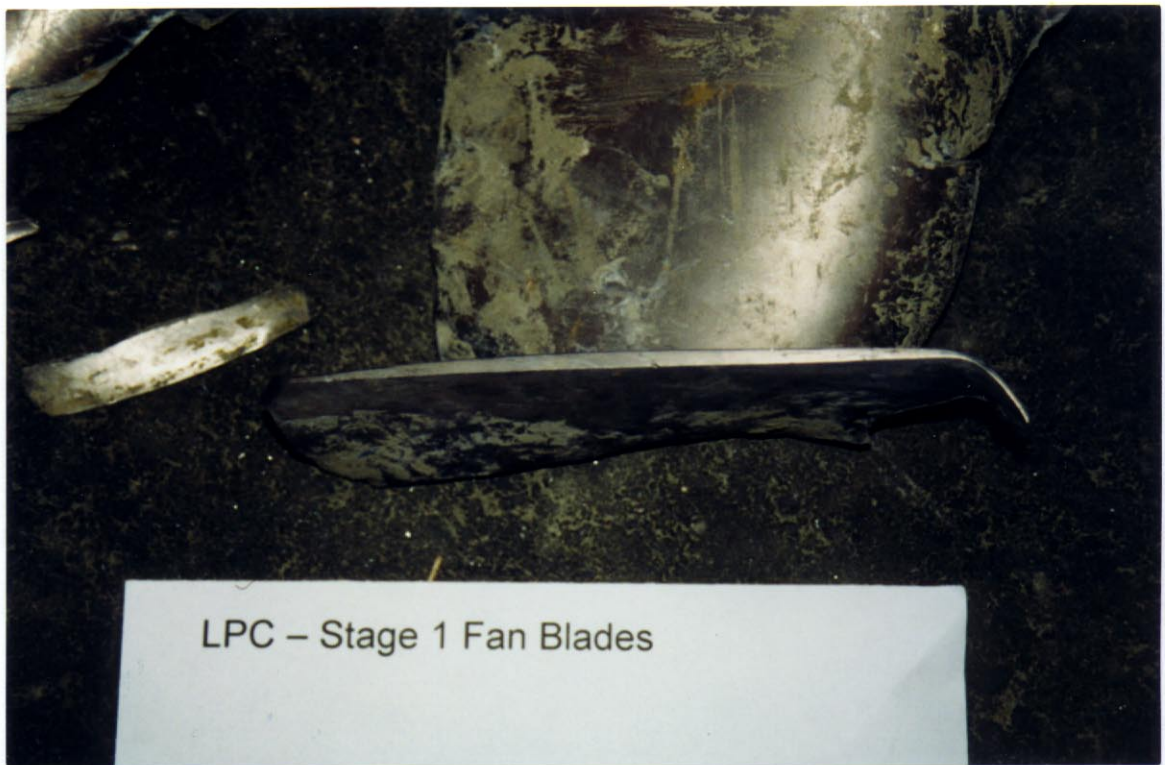
Photo 11. Closeup view No. 2 engine fan blade tips showing no rub marks.

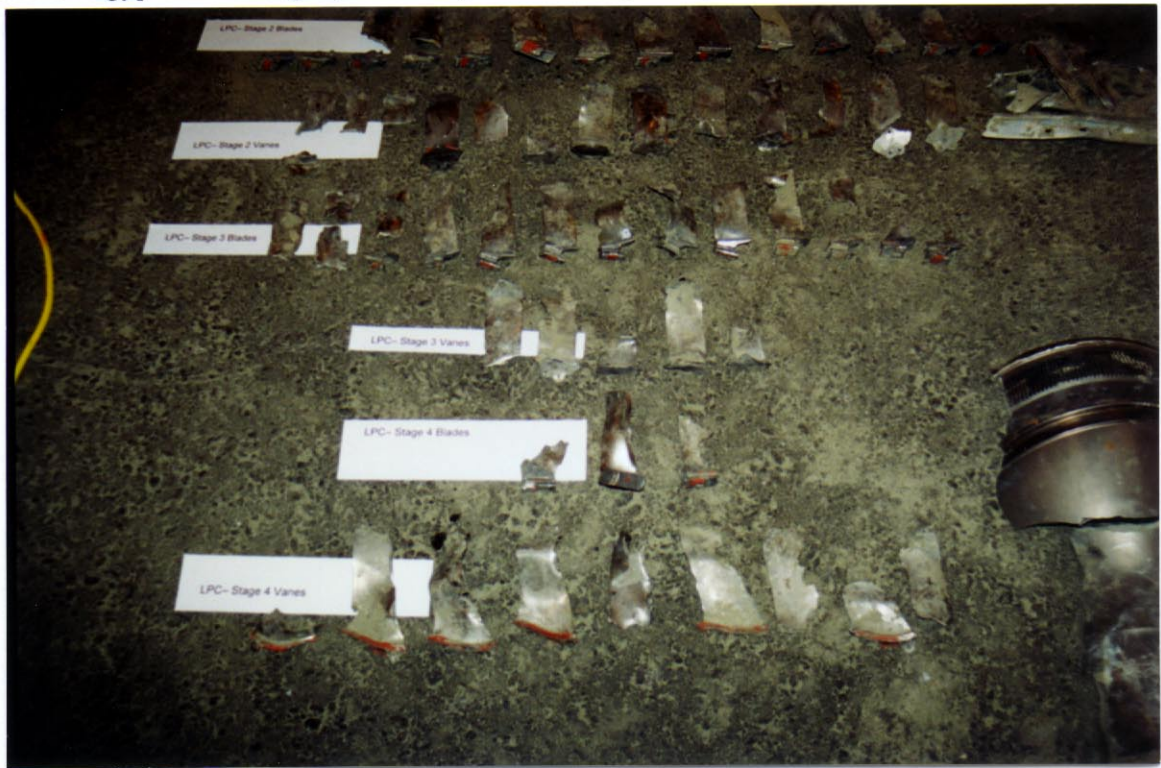
Photo 12. Pieces of No. 2 engine LPC blades and vanes.

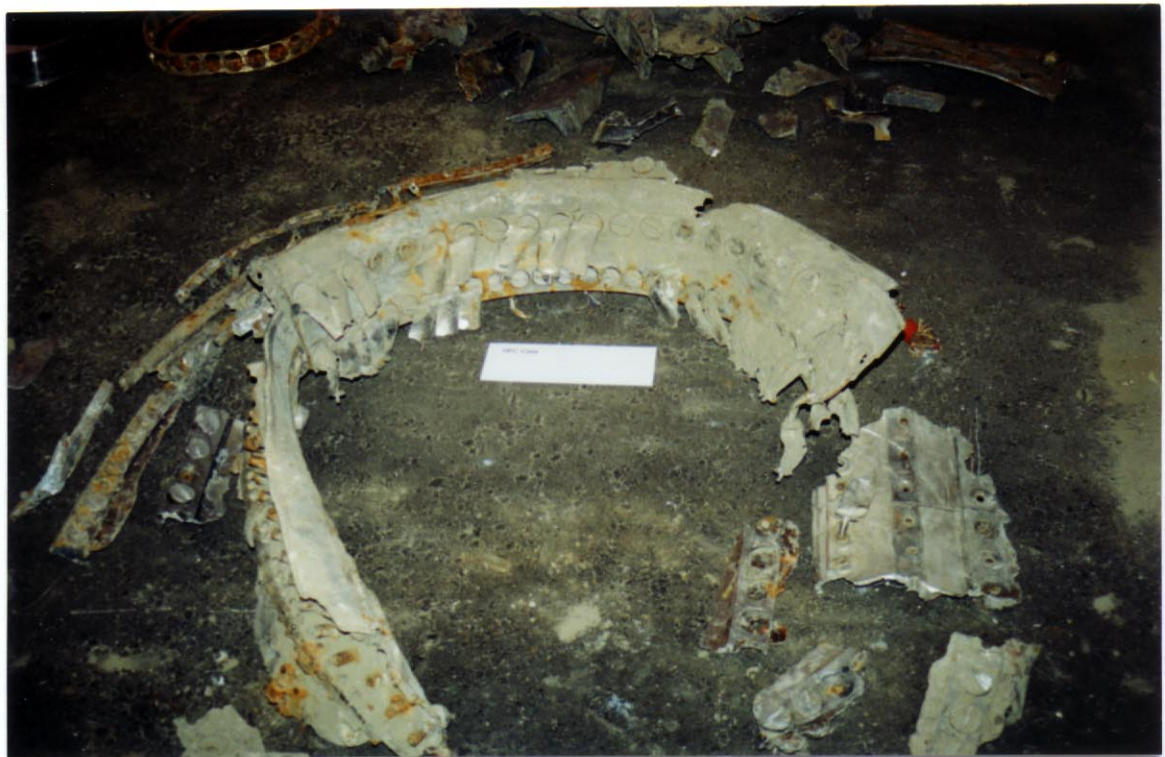
Photo 13. View of No. 2 engine HPC case showing variable stator vanes bent rearward.

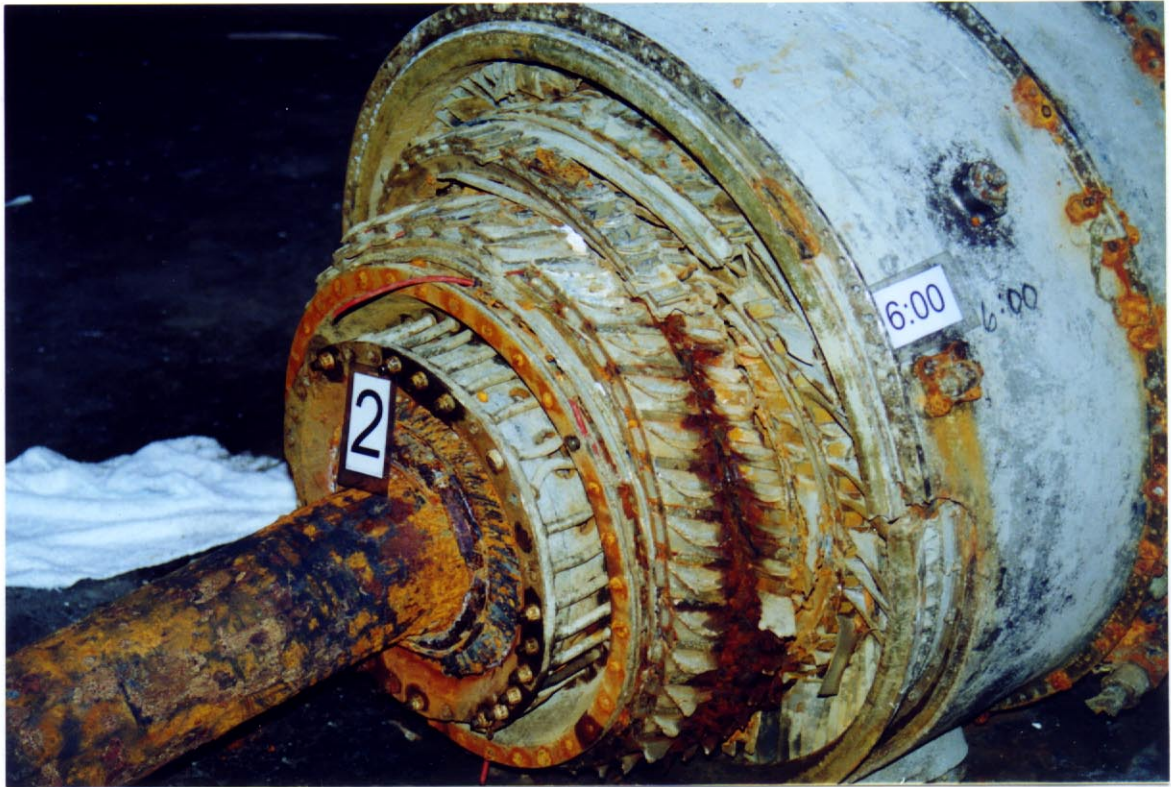
Photo 14. View of No. 2 engine HPC showing broken HPC disks and blades.

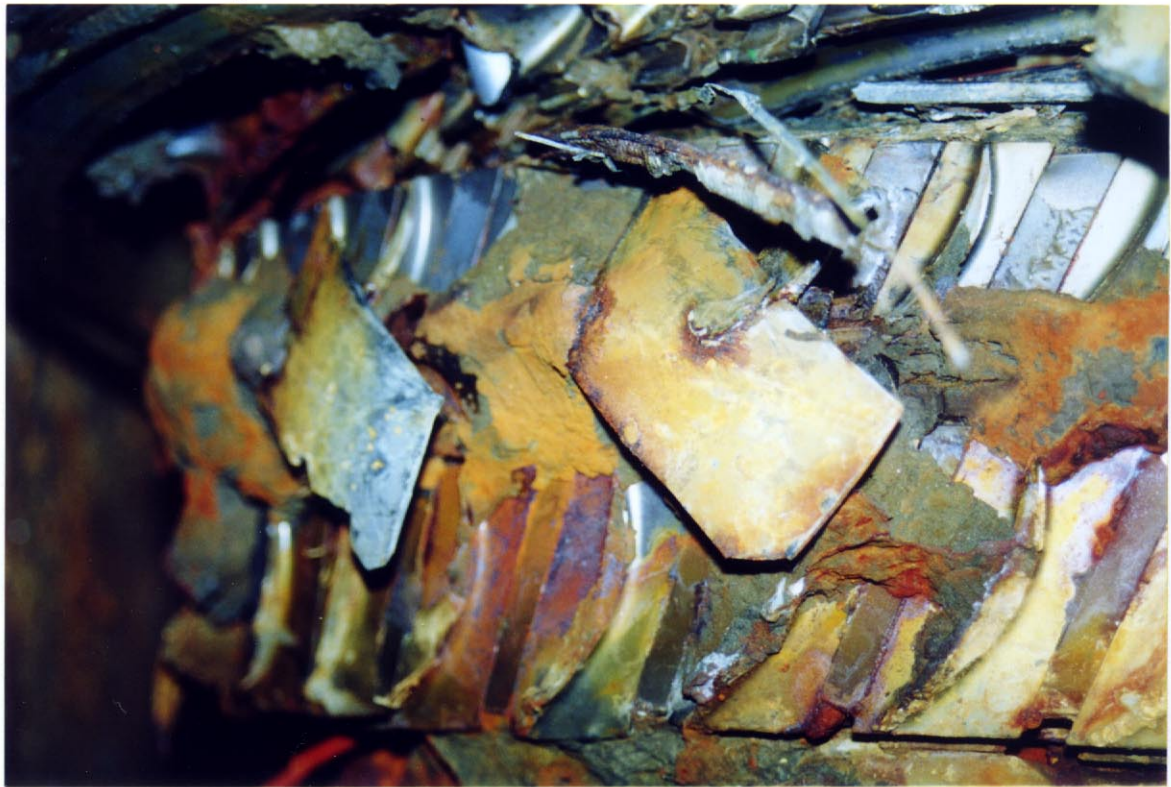
Photo 15. Closeup of No. 2 engine HPC blades showing no spanwise marks.

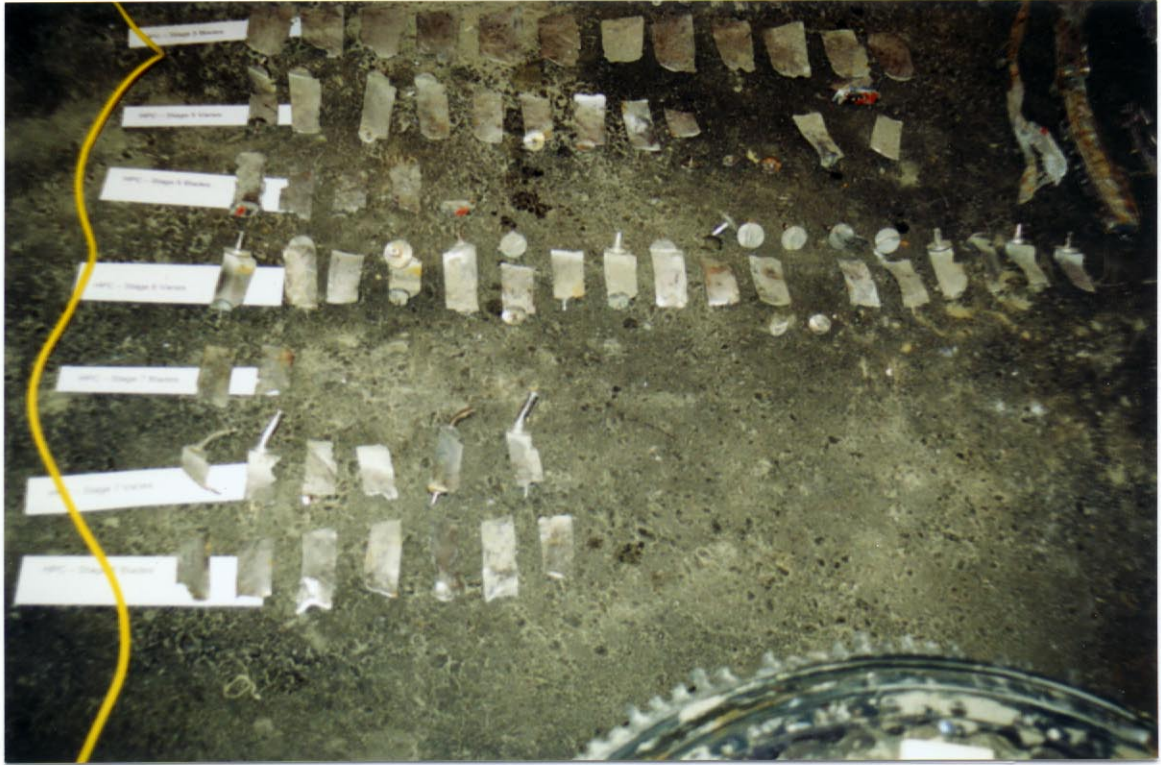
Photo 16. Pieces of No. 2 engine HPC blades and vanes.

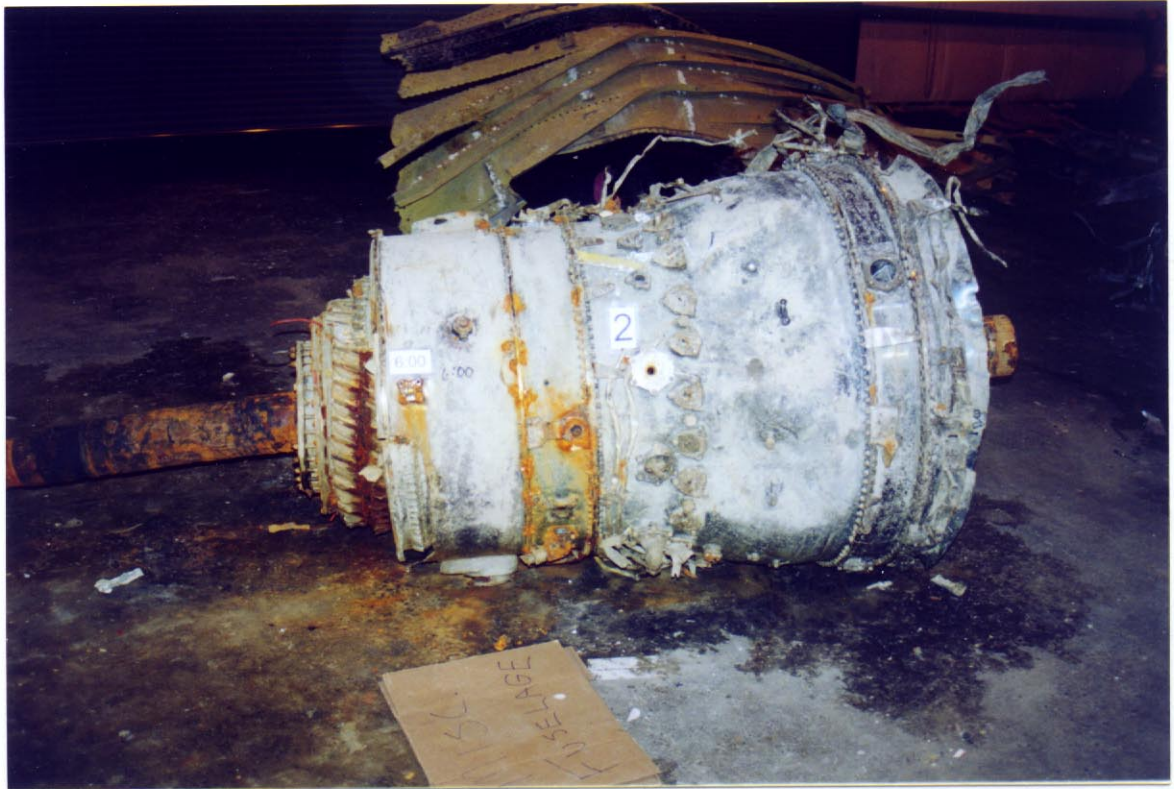
Photo 17. View of left side of No. 2 engine HPC, diffuser/combustor, and HPT cases.

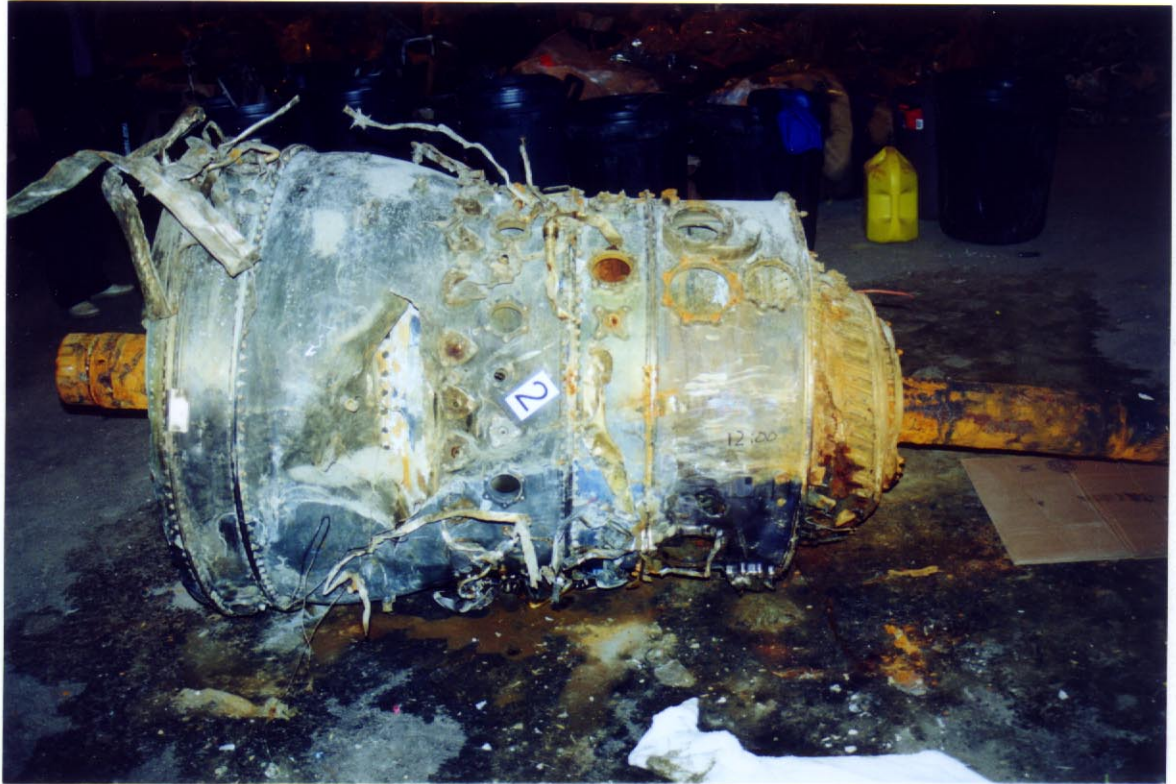
Photo 18. View of right side of No. 2 engine HPC, diffuser/combustor, and HPT cases.

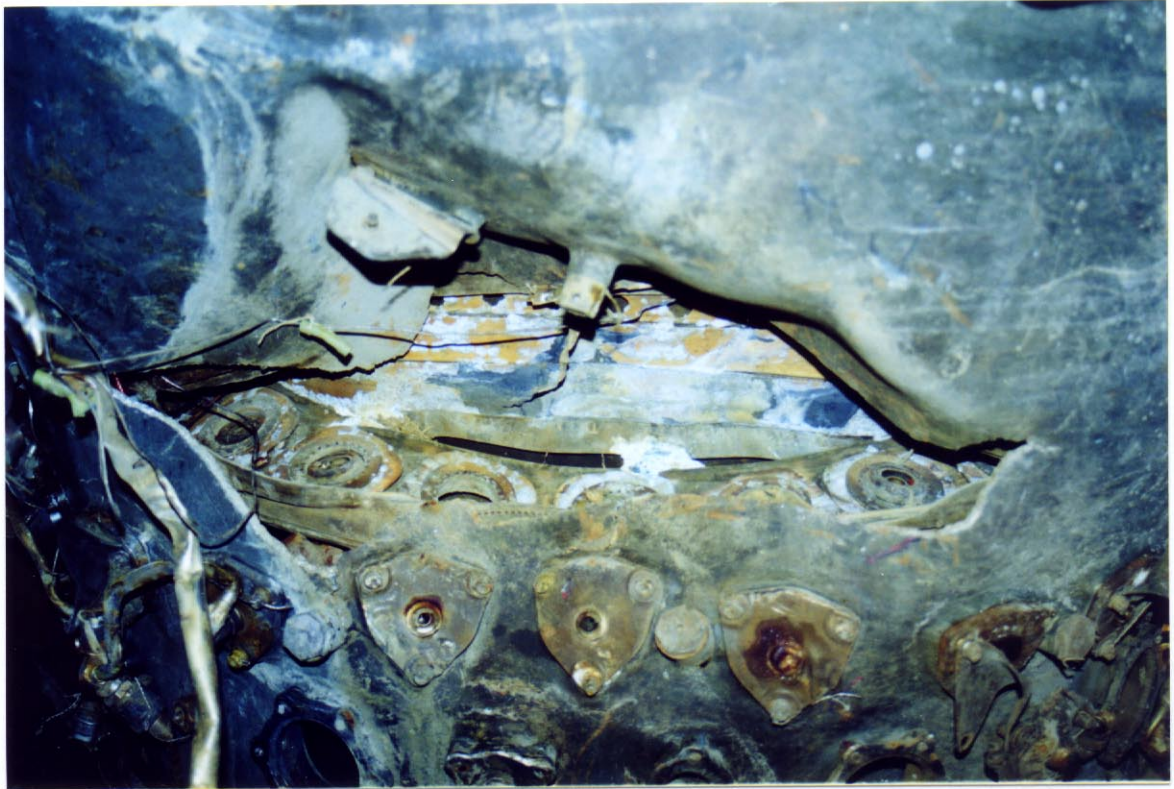
Photo 19. Closeup of hole in No. 2 engine combustor case showing no thermal distress to fuel nozzles and combustor liner.

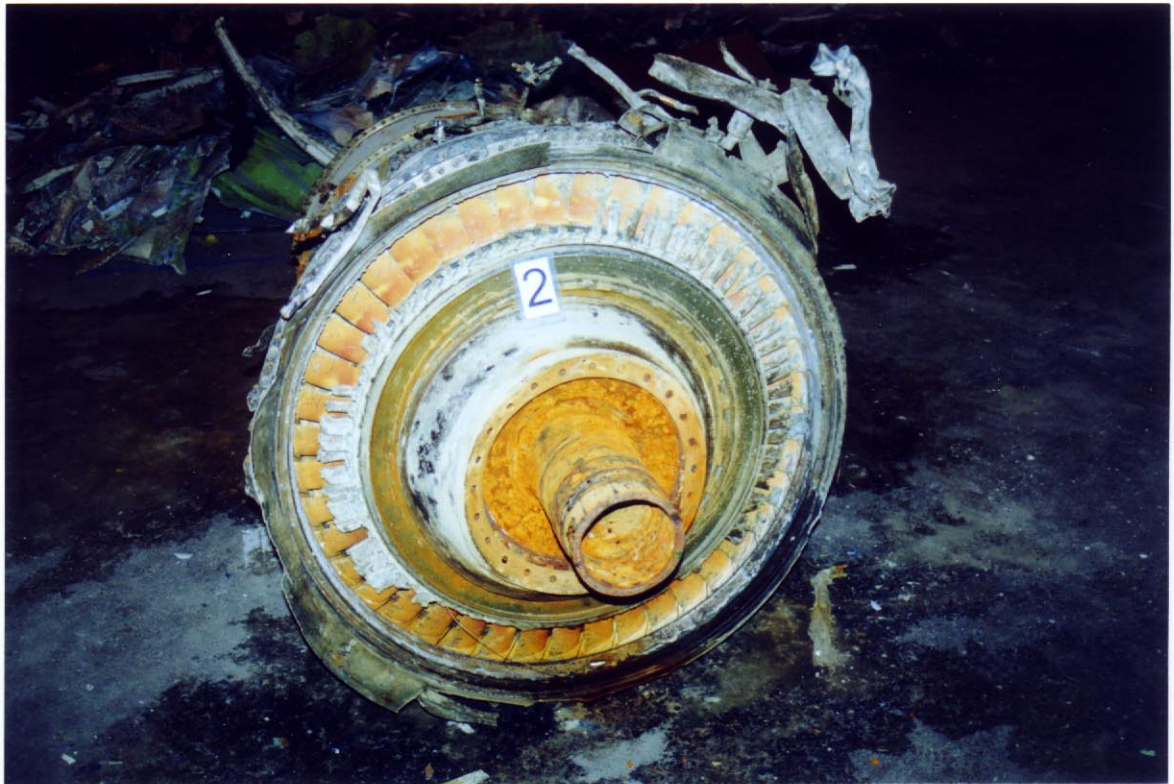
Photo 20. View of rear of No. 2 engine HPT.

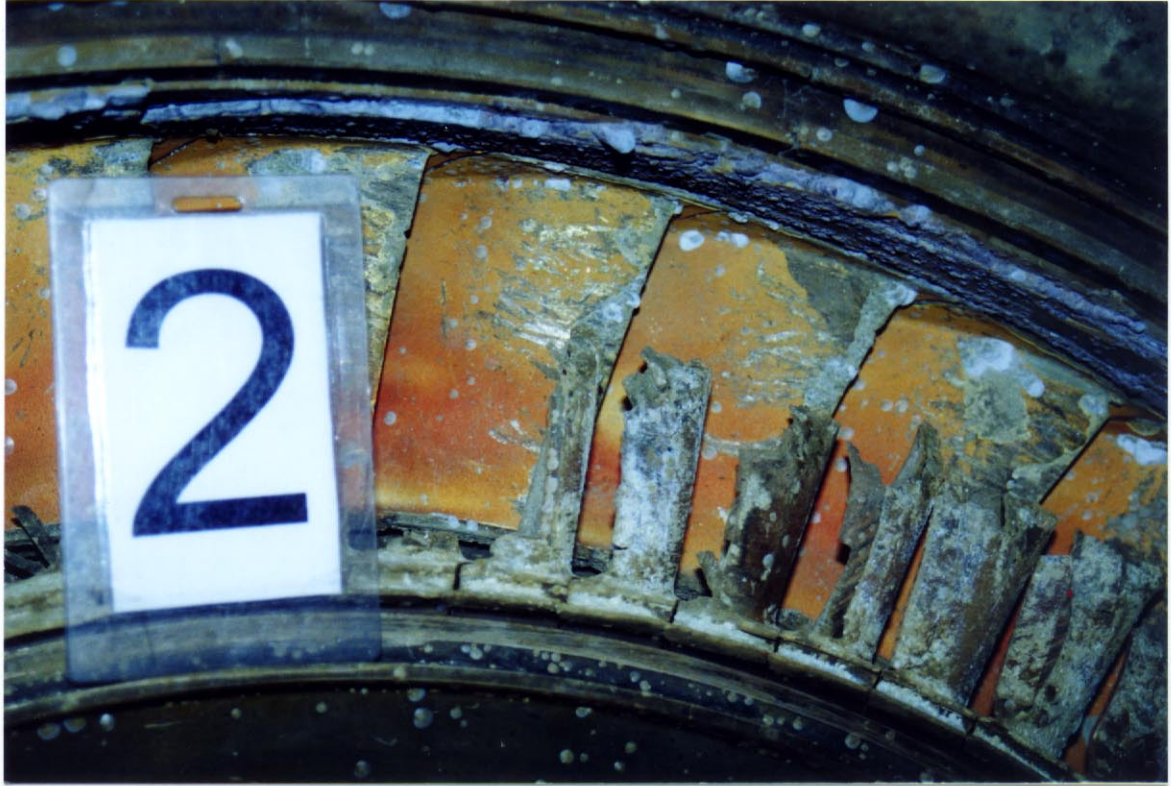
Photo 21. Closeup view of No. 2 engine broken HPT blades and intact vanes.

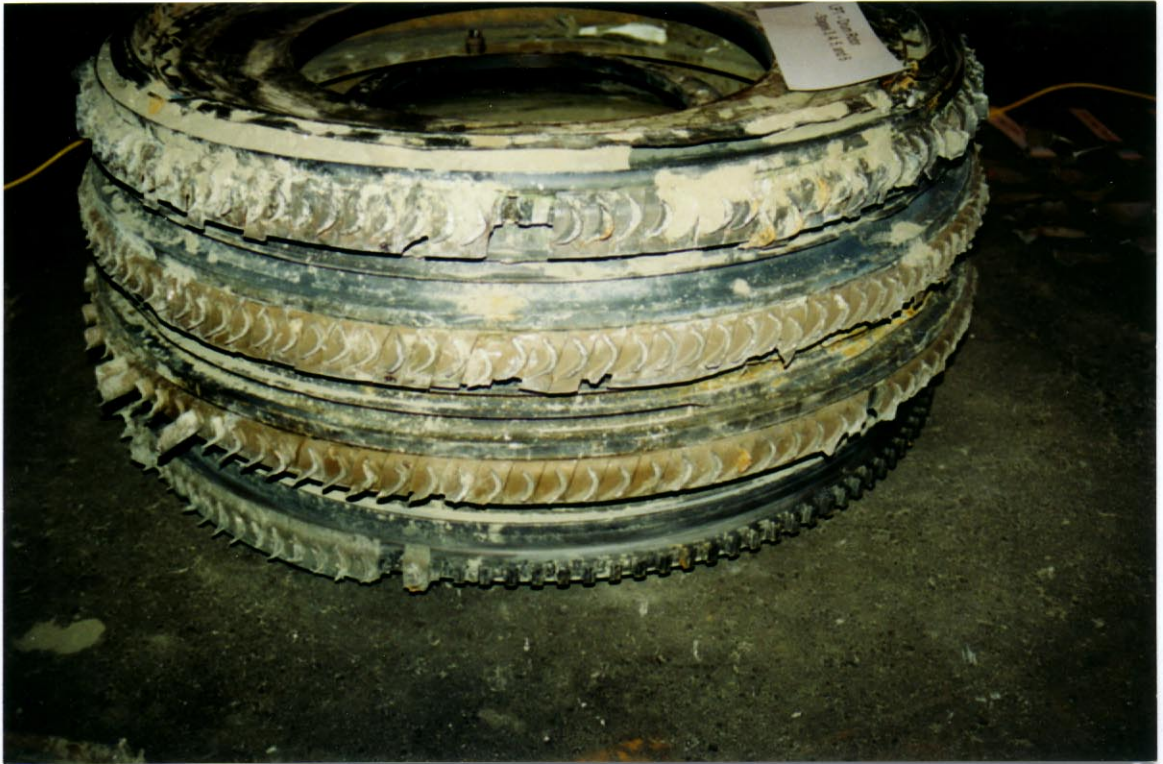
Photo 22. View of No. 2 engine LPT rotor with LPT blades broken off.

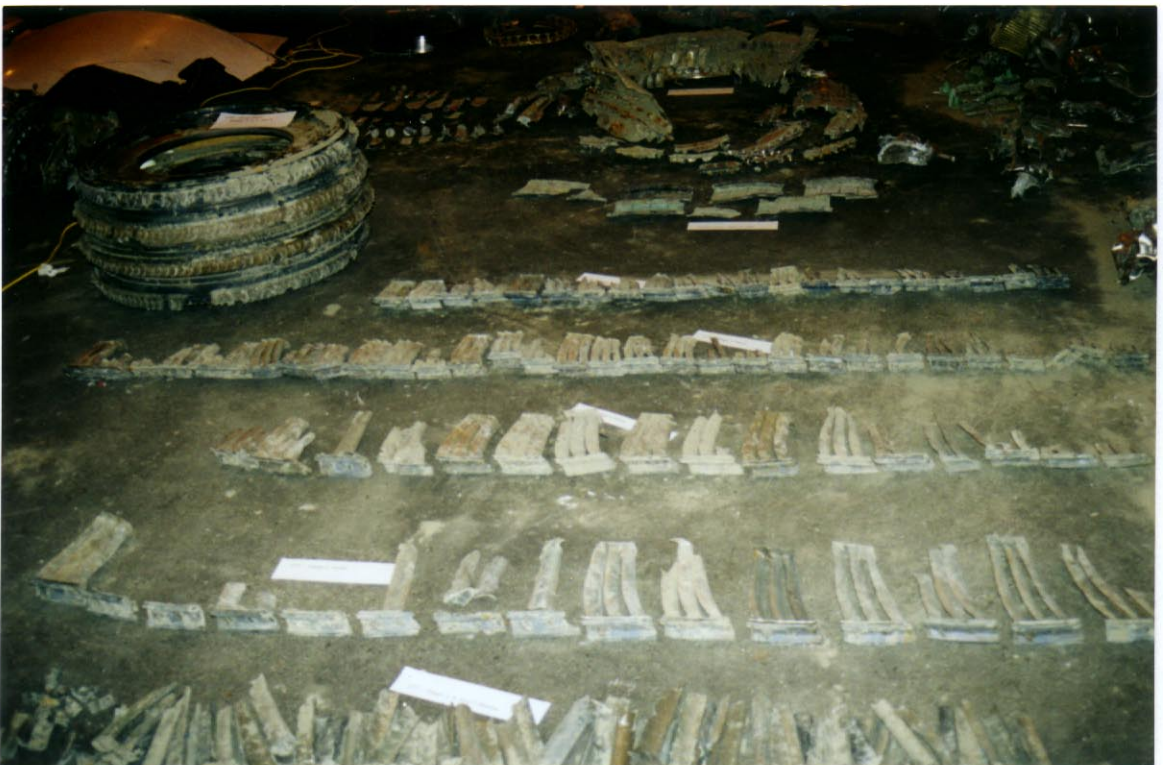
Photo 23. No. 2 engine LPT vanes showing straight airfoils and random lengths.

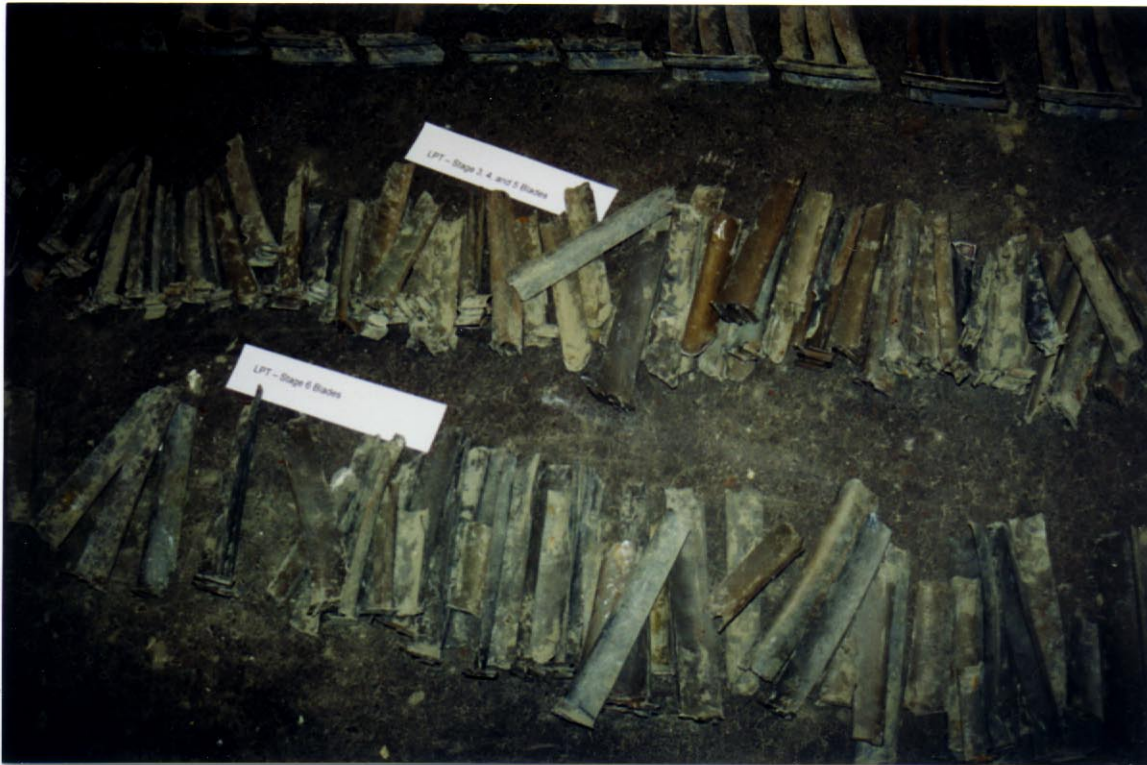
Photo 24. No. 2 engine LPT blades showing full length airfoils.

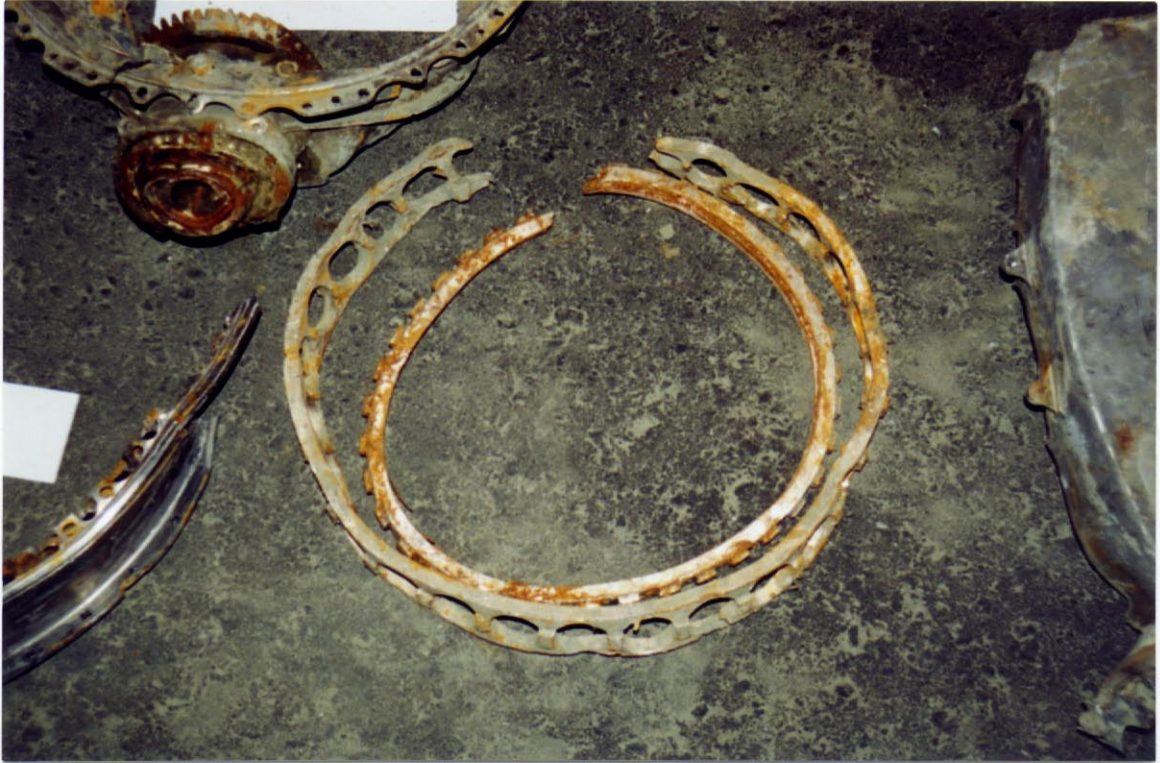
Photo 25. View of No. 2 engine No. 1 bearing cage.
