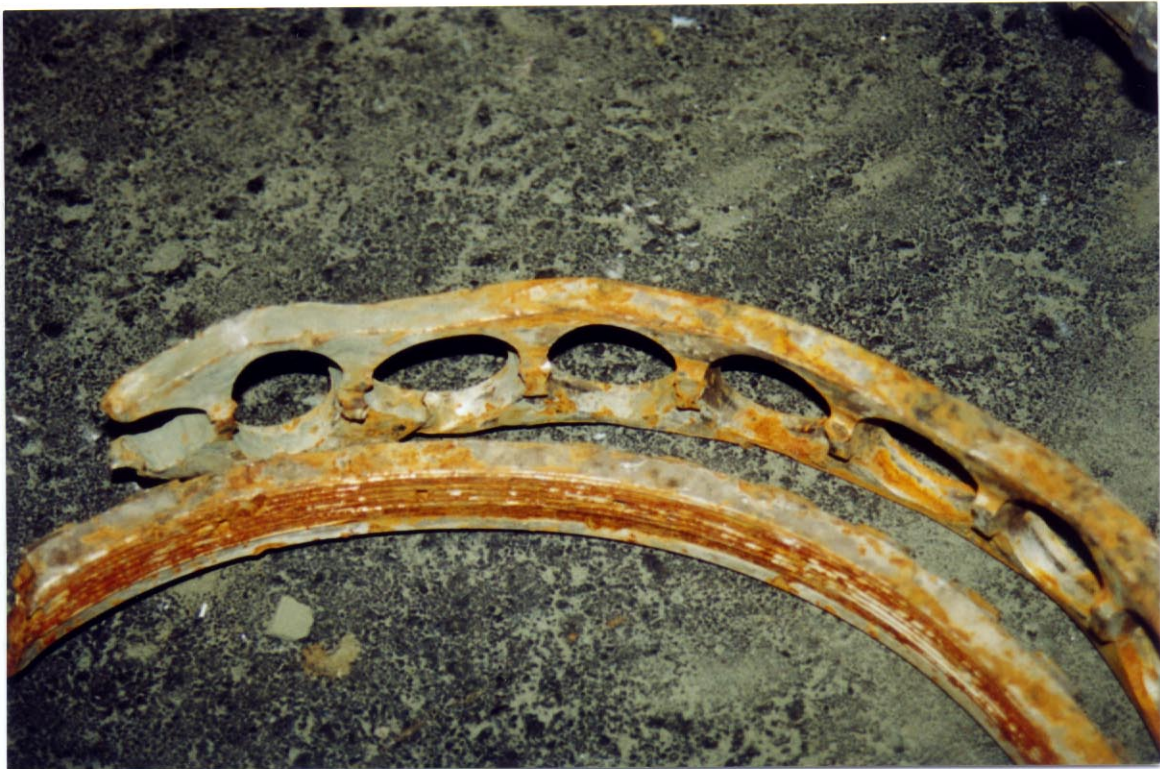
Photo 26. Closeup view of No. 2 engine No. 1 bearing cage pockets showing no rotational distress.

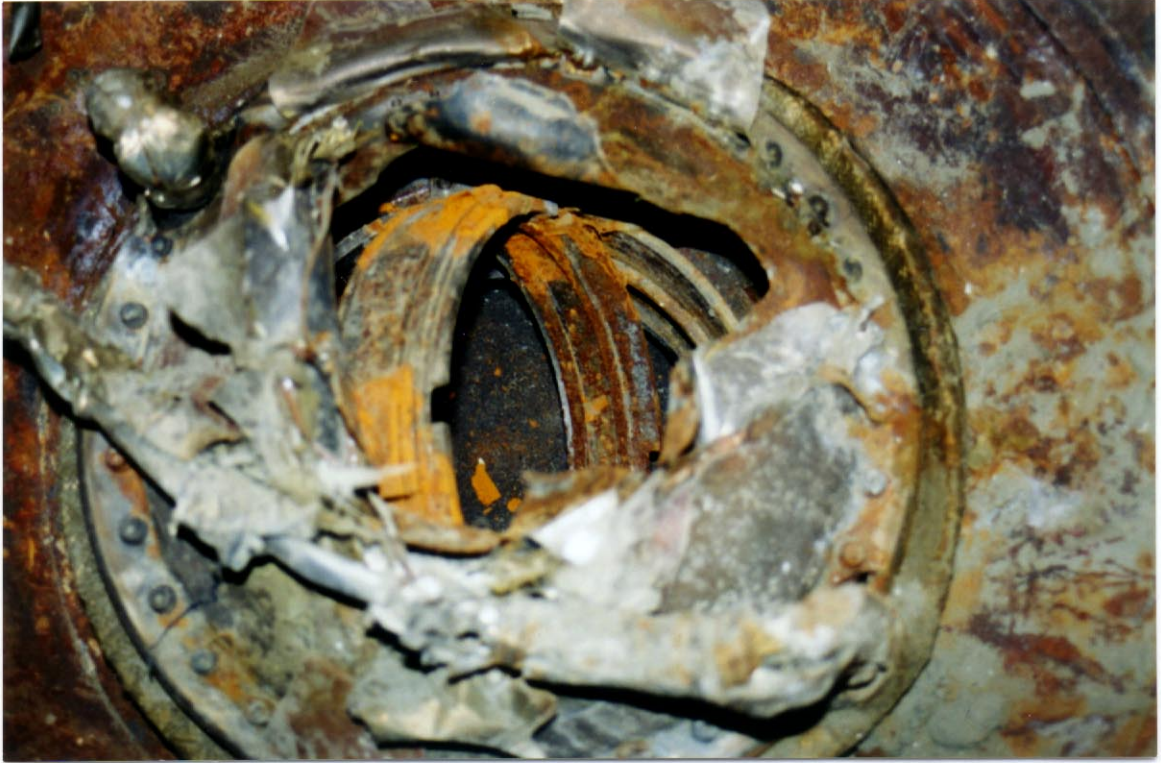
Photo 27. View of No. 2 engine No. 4 bearing outer race showing no rotational distress.

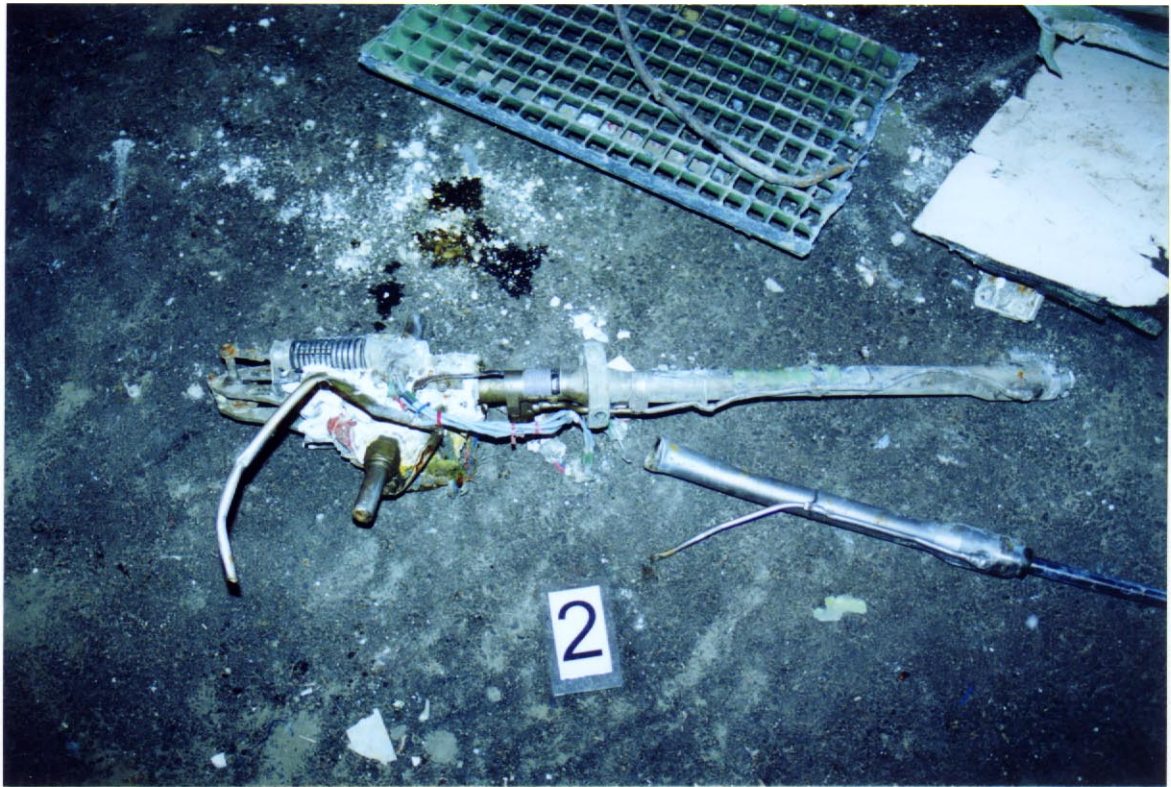
Photo 28. View of No. 2 engine thrust reverser actuator in the reverser-stowed position.

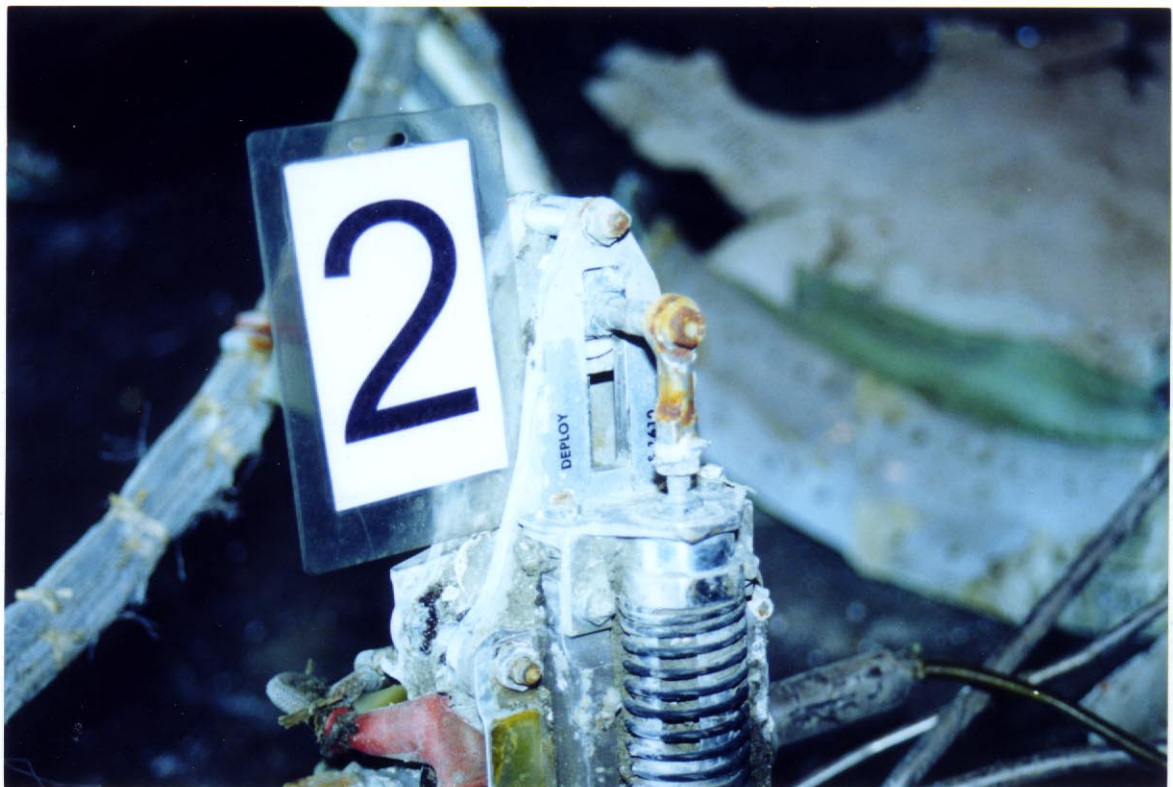
Photo 29. Closeup of No. 2 engine thrust reverser actuator showing indicator pin in reverser-stowed position.
