11 February 2000
B-H200-16888-ASI

Subject: Engine Fuel Flow FDR Data – Egyptair 767-300ER SU-GAP,
Accident Off Nantucket, Massachusetts – 31 October, 1999

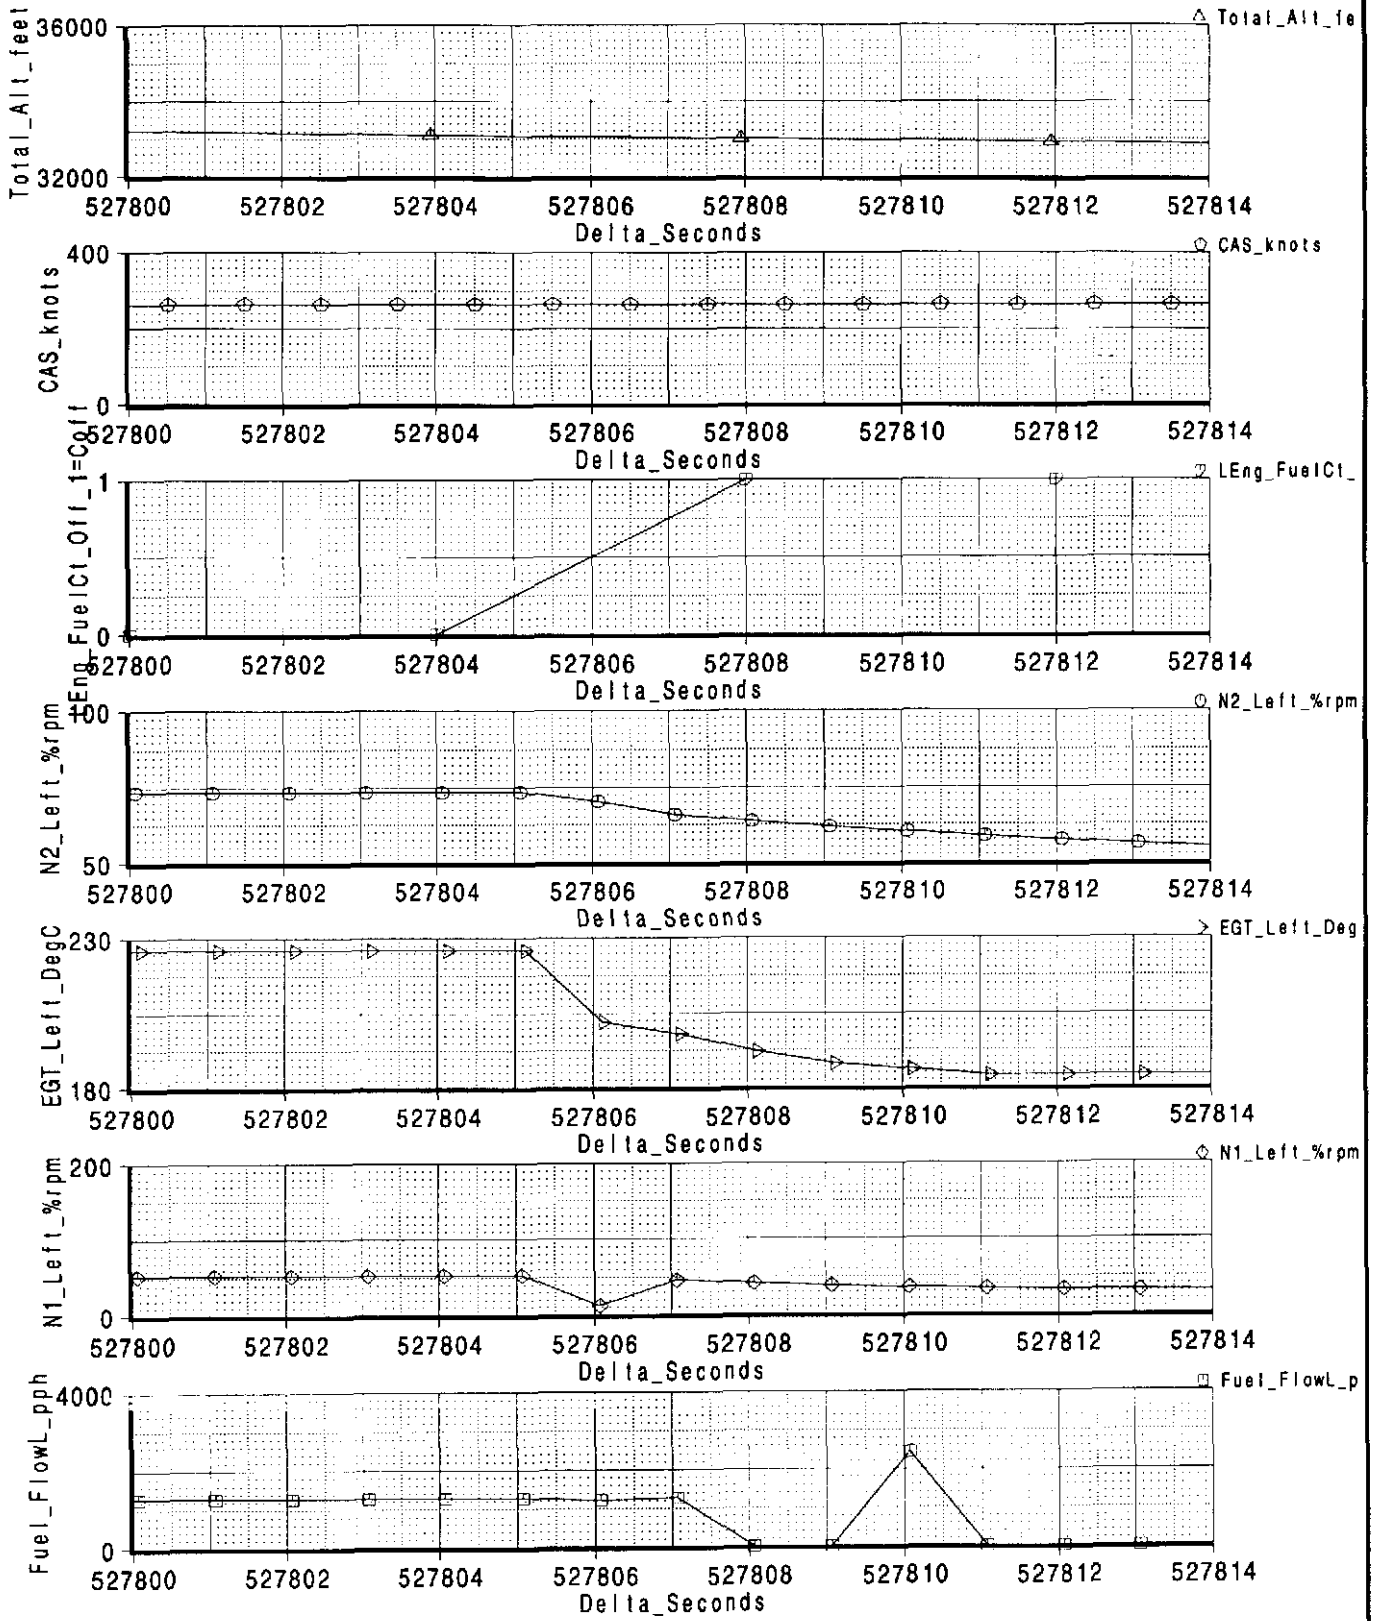
CALC	12Jan00	REVISED	DATE	767 / PW4000 / AMETEK FLOW METERS LEFT ENGINE SHUTDOWN B1 FLIGHT, 1-11-2000 BOEING	PAGE
CHECK					
APPD.					
APPD.

3. Following "fuel shutoff" (as defined by the initial decay in engine parameters), the left engine fuel flow remained at idle flow for 2 - 3 seconds, then showed a flow of zero. Five seconds after fuel shutoff, the left engine fuel flow showed a spike to 2400 lbs./hr (1100 kg/hr) for one data point, then back to a steady flow of zero.

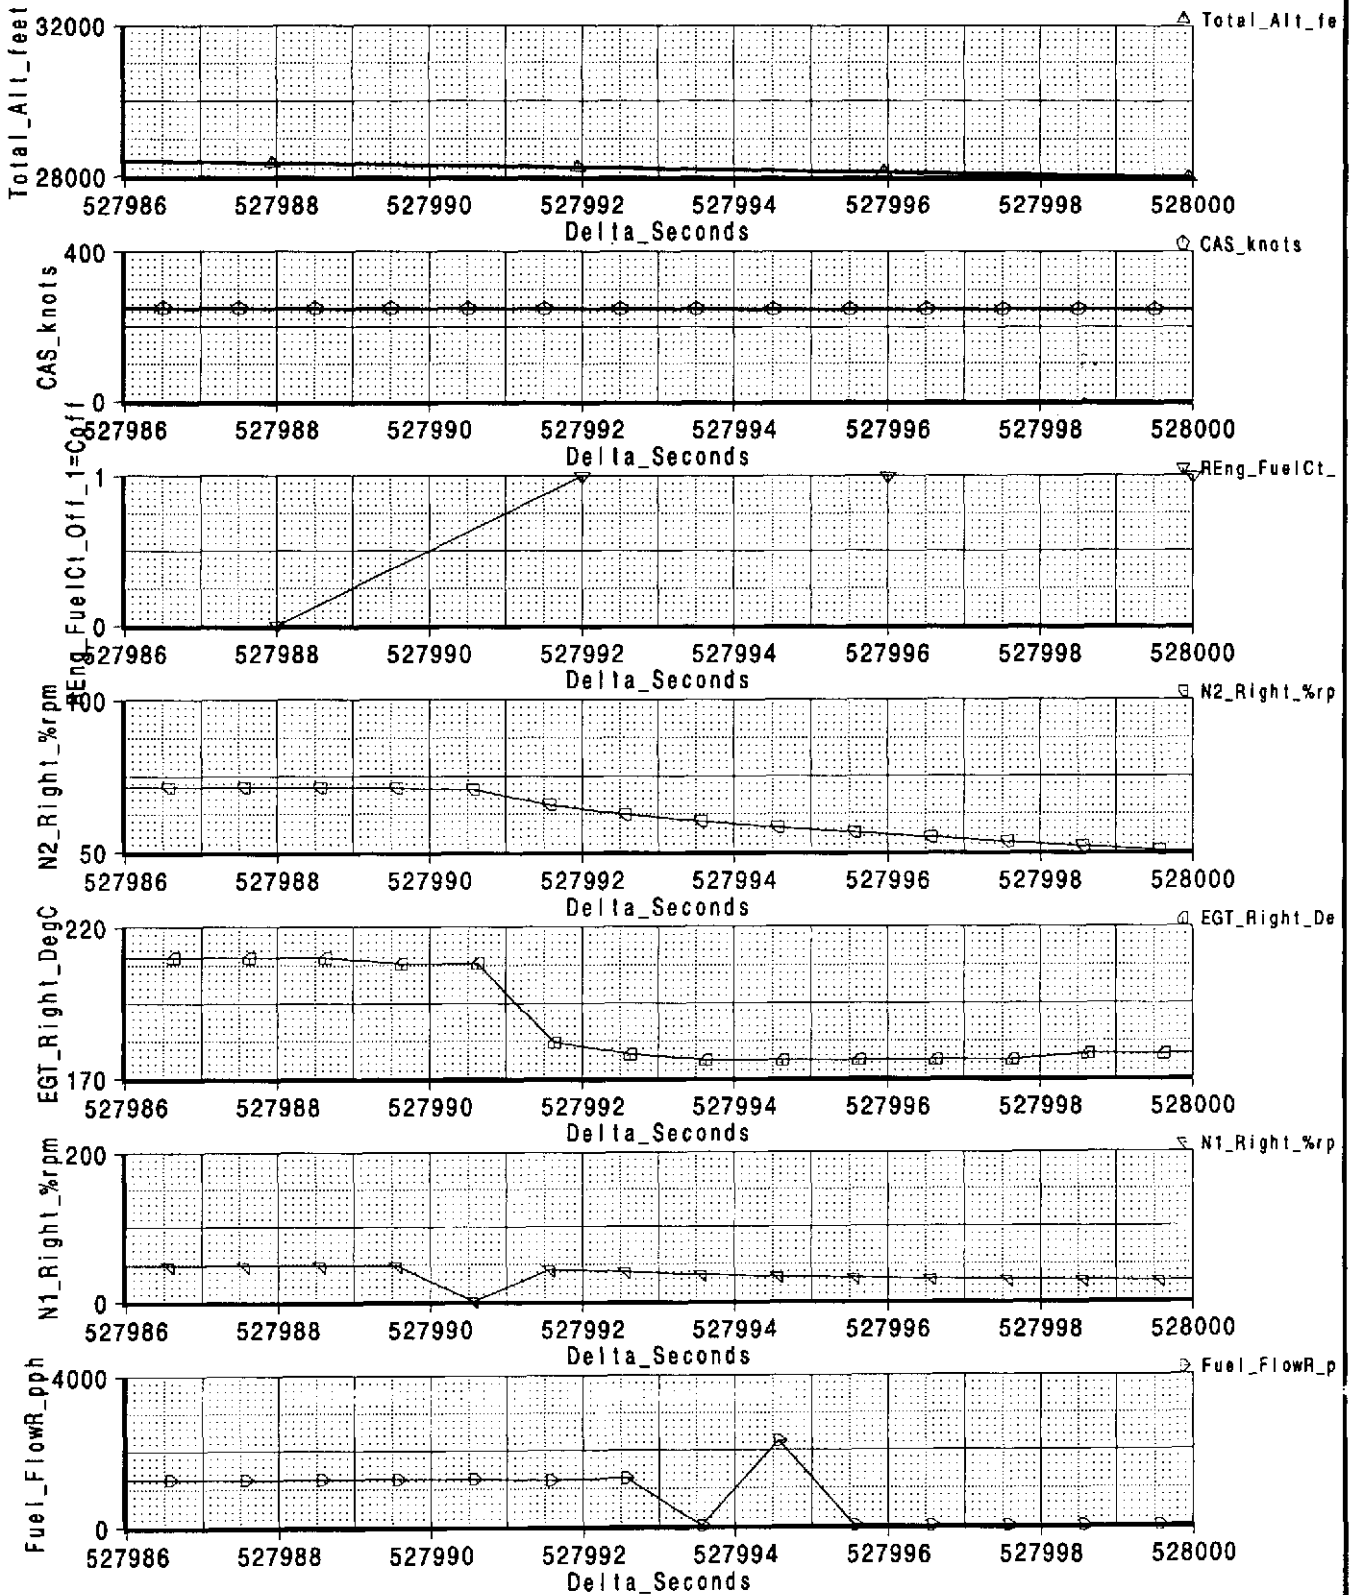
CALC	12Jan00	REVISED	DATE	767 / PW4000 / AMETEK FLOW METERS RIGHT ENGINE SHUTDOWN B1 FLIGHT, 1-11-2000	
CHECK					
APPD.					
APPD.					
				BOEING	PAGE

4. Following "fuel shutoff", the right engine fuel flow remained at idle flow for 2 - 3 seconds, then showed a flow of zero. Four seconds after fuel shutoff, the right engine fuel flow showed a spike to 2200 lbs./hr (1000 kg/hr) for one data point, then back to a steady flow of zero.
