P&WC: 37-2007R1

# Special Instruction

### PW305A, PW305B Individual Fan Blade Inspection and Replacement

P&WC No. 37-2007R1 ISSUED: August 24, 2007 REVISED: January 24, 2008

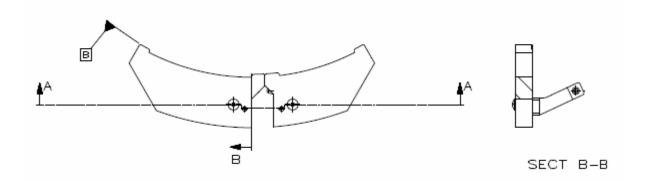
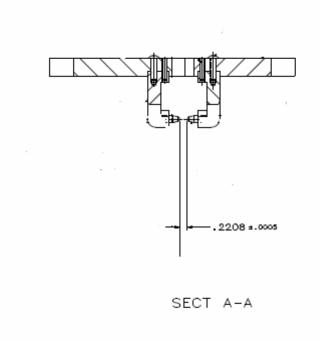
Inspection of Gauge Figure 1

- 8.5 Visually inspect gauge P/N PWC 40654, for signs of damage, distortion etc. If the gauge is damaged, distorted, or mishandled (for example, dropped from more than 4 feet on a hard surface, not properly stored in the carrying case, etc), inspect gauge dimension .2208 +/- .0005 in accordance with section AA of Figure 1.

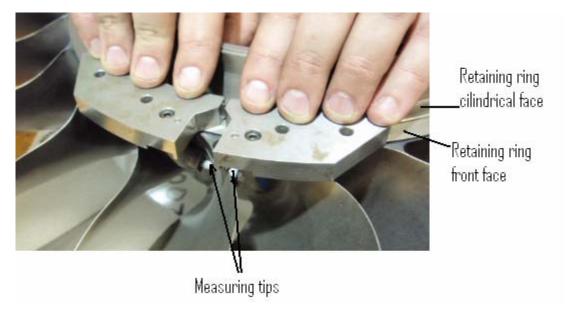
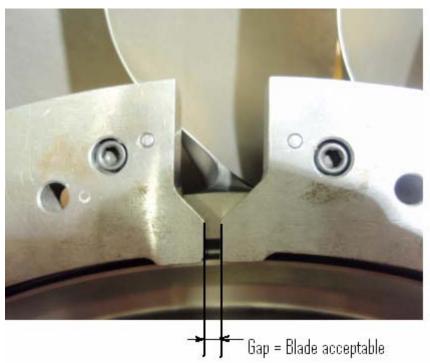
Fan Blade Airfoil Thickness Inspection Figure 2

8.6. Place the fan assembly on a clean suitable support with blades LE down. Inspect each individual fan blade airfoil thickness in accordance with the following procedure (Ref. Figure 2):

Ensure the fan blade being inspected is firmly seated against the rear retaining ring and is loaded radially out in the hub fixing.

- Install each half of the inspection gauge P/N PWC 40654 on the fan blade rear
  retaining ring and using minimal force gently touch the measuring tips to each side
  of blade airfoil surface. Ensure the gauge is fully in contact with the retaining ring
  frontal and cylindrical faces and check the circumferential gap between the two
  halves.

- If the gap between the two halves is less than 0.005 in, the blade airfoil thickness is below minimum dimension. Using an approved temporary marker, mark blades that are under the minimum dimension.

- 8.7 If there are no marked blades (i.e. with under-min airfoil thickness) do not disassemble the fan. Proceed to step 8.9.
- 8.8 Replace marked fan blade(s) (i.e. with under-min airfoil thickness) only, using the PW305 OHM, CH 72-30-01 procedure to disassemble the fan to get access to the fan blade(s) needing replacement.
