CF34 TURBOFAN (BUSINESS JET)

ALERT SERVICE BULLETIN

OIL - Lube and Scavenge Components (79-00-00) - Field Management Program to Prevent B-sump Oil Release Events

SERVICE BULLETIN (CF34-BJ) 79-A0015, REVISION 1

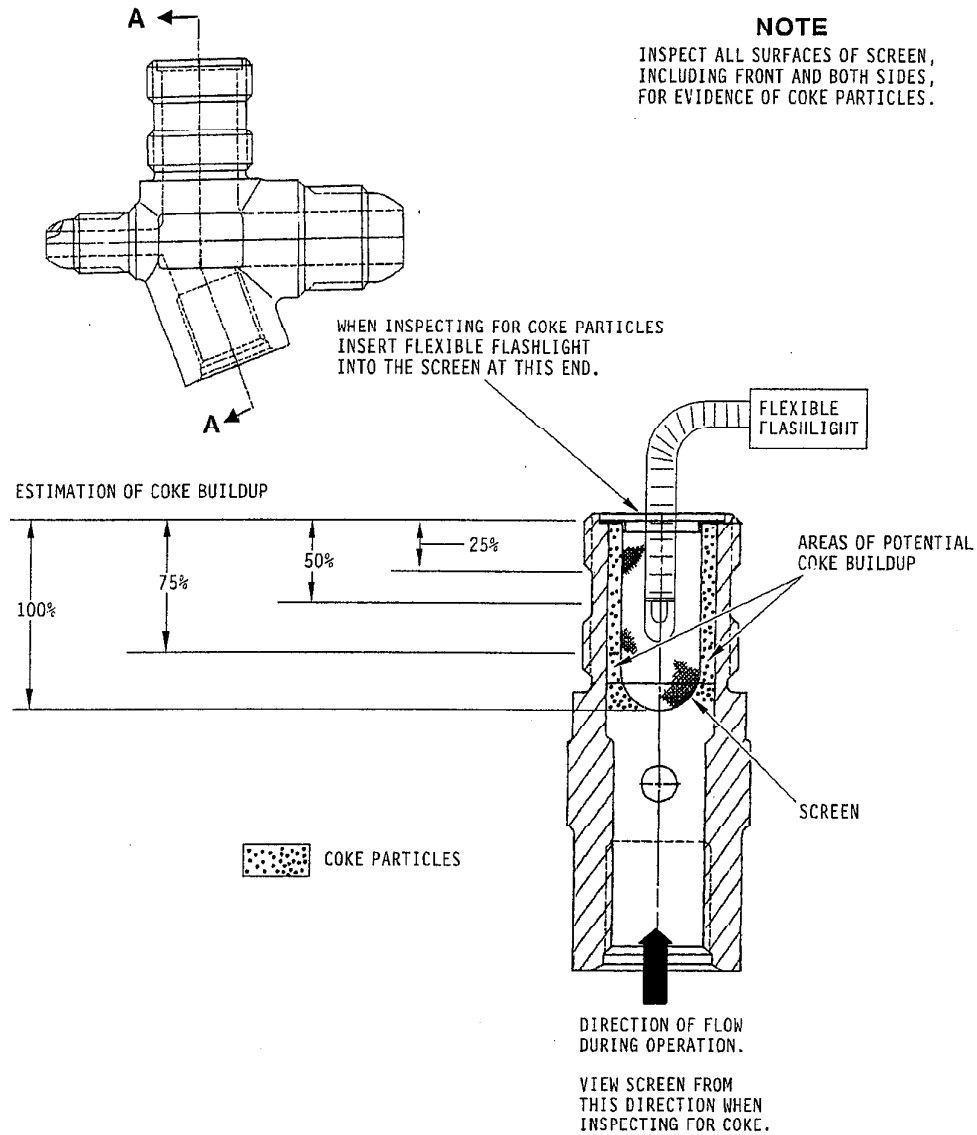
Inspection of Scavenge Filter Screen Bulkhead Tee PN 5054T86G02
Figure 1

CAUTION: COKE TENDS TO ACCUMULATE FIRST ALONG THE EDGES OF THE CONE-SHAPED SCREEN. BE SURE TO CHECK THE OUTSIDE EDGES OF THE CONE-SHAPED SCREEN FOR PRESENCE OF COKE PARTICLES, USING A BRIGHT LIGHT INSERTED INTO THE OPEN END OF THE SCREEN. CORRECT SCREEN COKE INSPECTION CAN NOT BE MADE WITHOUT A FLASHLIGHT BULB SMALL ENOUGH TO BE INSERTED UP INSIDE THE SCREEN.

screen toward the light source. Be sure to inspect the entire screen, including both sides of the cone-shaped screen, for coke particles. Refer to Figures 1 and 2.

- (c) Record whether there is any evidence of coke particles accumulated in the screen. If coke is present in the screen, record screen blockage percentage (refer to Figure 1 for interpretation). GE requests that the screen blockage data be provided to GE via your local GE rep, assigned Product Support Engineer, or Customer Support Manager. Include screen blockage percentage, ESN, TSN/CSN, and date of inspection.
- (d) Clean the tube screen insert nipple (79-00-00-10-265) and the scavenge filter screen bulkhead tee (79-00-00-10-315A) or obtain a new or previously cleaned tube screen insert nipple (79-00-00-10-265) and the scavenge filter screen bulkhead tee (79-00-00-10-315A). To clean the screens, do as follows:
 - 1 Loosen and dislodge the coke particles as much as possible with a dental pick or equivalent tool.

- 2 Remove any loose particles that remain by blowing the screens with compressed air or flushing with an approved fluid cleaner in the direction opposite from the flow of oil through the screen. Refer to GEK 9250.
 - 3 Use the ultrasonic cleaning method (GEK 9250, TASK 70-21-15-130-001) and remove any coke that remains on the screen.
 - 4 Screens that have large amounts of coke may need to have the coke removed by the baking method. If required, bake the screens. Refer to SEI-782 (72-09-01, SPECIAL PROCEDURE 25).
- (e) Use the instructions in SEI-780 (MAINTENANCE PRACTICE 28) and re-install the cleaned screens.
 - (f) Perform follow-on screen checks as specified in Table 1 until a screenless fitting can be installed. Once a screenless fitting has been installed (see Note above), the scavenge fitting inspections are no longer required.

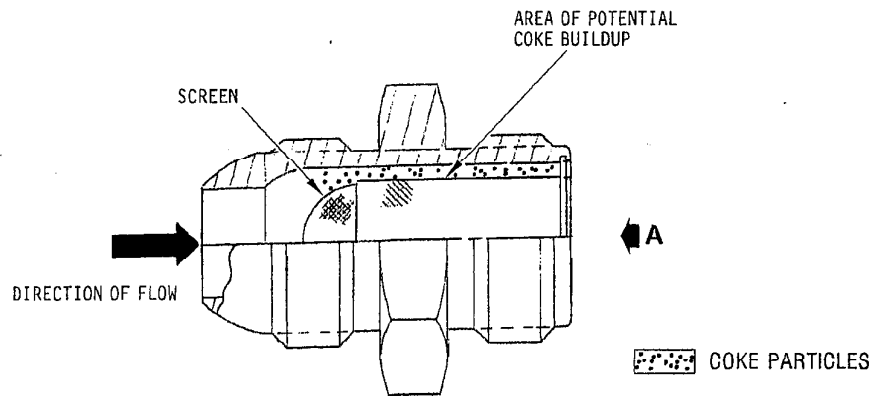
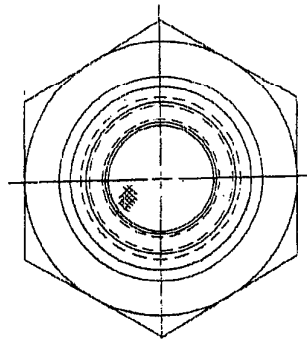
Inspection of Tube Screen Insert Nipple PN 4047T95P01
Figure 2

INSPECT ALL SURFACES OF THE SCREEN, INCLUDING FRONT AND BOTH SIDES, FOR EVIDENCE OF COKE PARTICLES.
