DOCKET NO. SA-515

NATIONAL TRANSPORTATION SAFETY BOARD
WASHINGTON, DC

POWERPLANTS GROUP CHAIRMAN'S FACTUAL
REPORT, REV. 1
MARCH 7, 1997
FIGURES AND PHOTOGRAPHS

DCA96MA068: Delta MD-88/JT8D-200, July 6, 1996

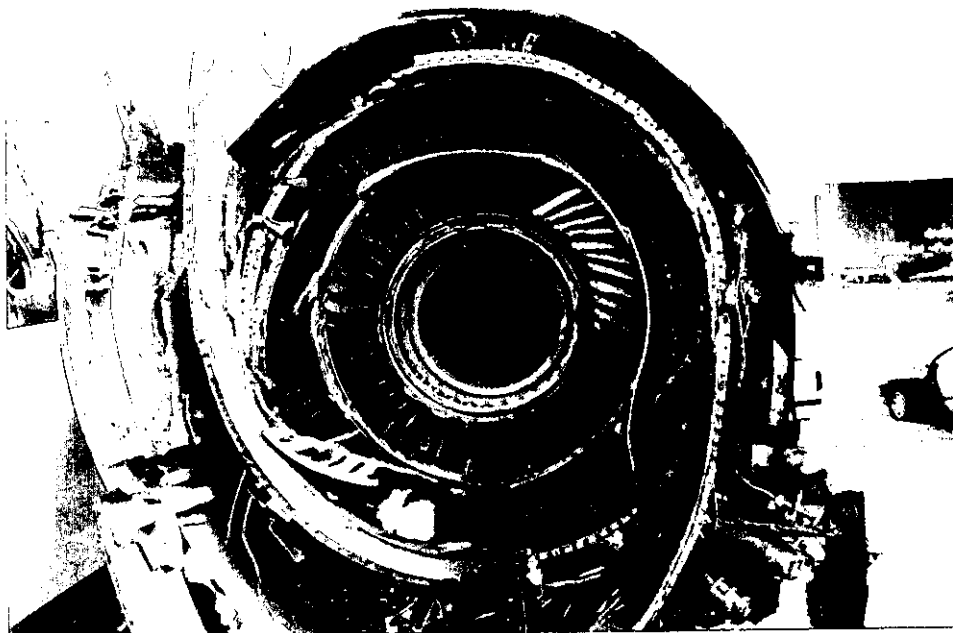
Photo 1

| <u>PHOTO</u> | <u>DESCRIPTION</u> |
|---|--|
| 1. | On Scene Front View of Accident Engine |

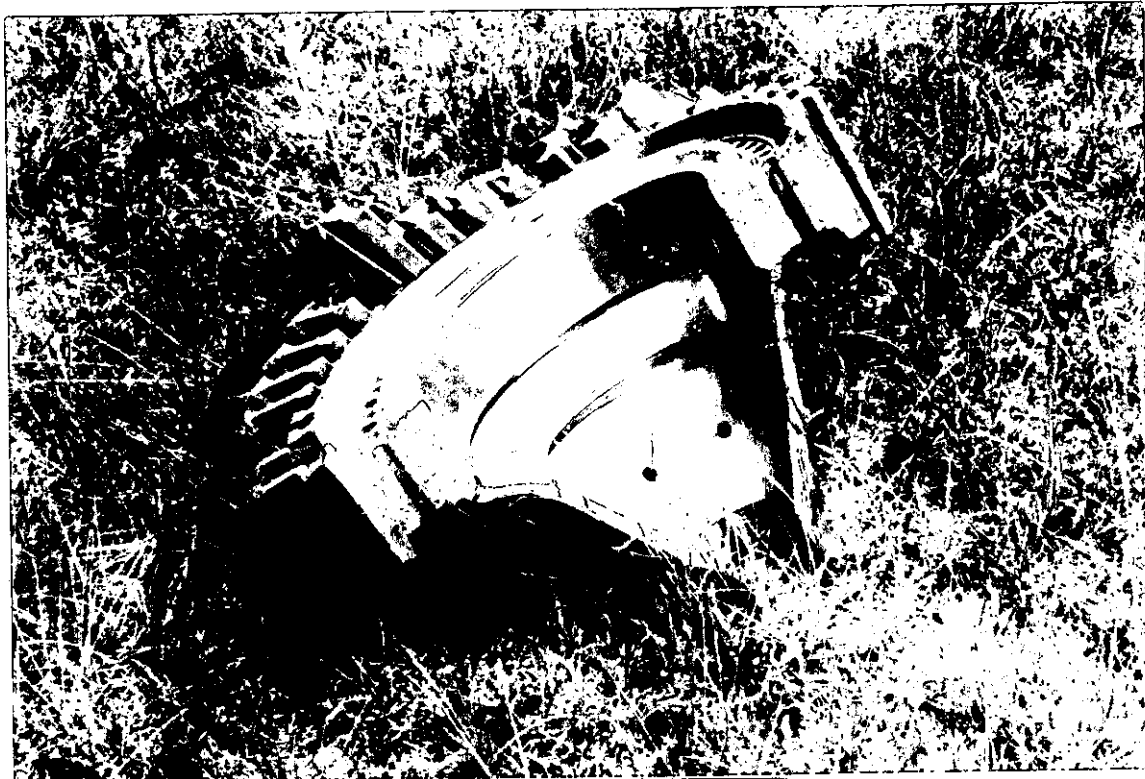
Photo 5

| <u>PHOTO</u> | <u>DESCRIPTION</u> |
|---|--|
| 5. | Large Hub Rim Segment as Found |

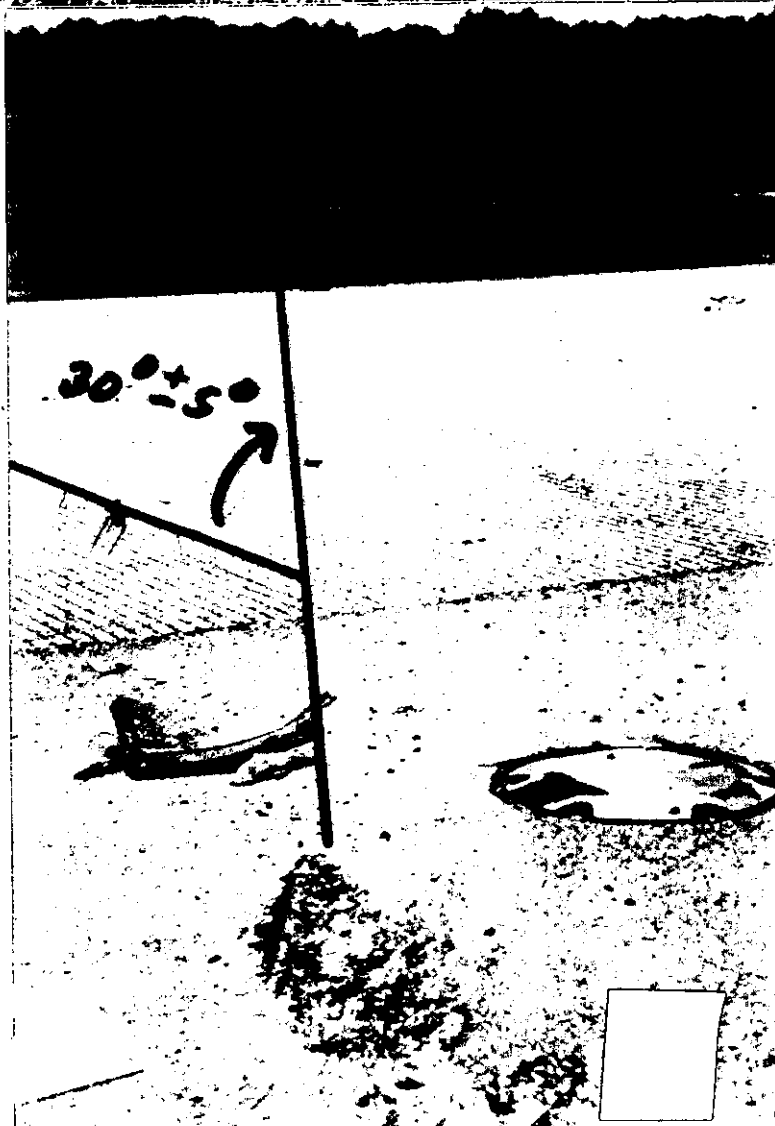
Photo 6

| <u>PHOTO</u> | <u>DESCRIPTION</u> |
|---|--|
| 6. | Gouge Mark on Runway Surface |

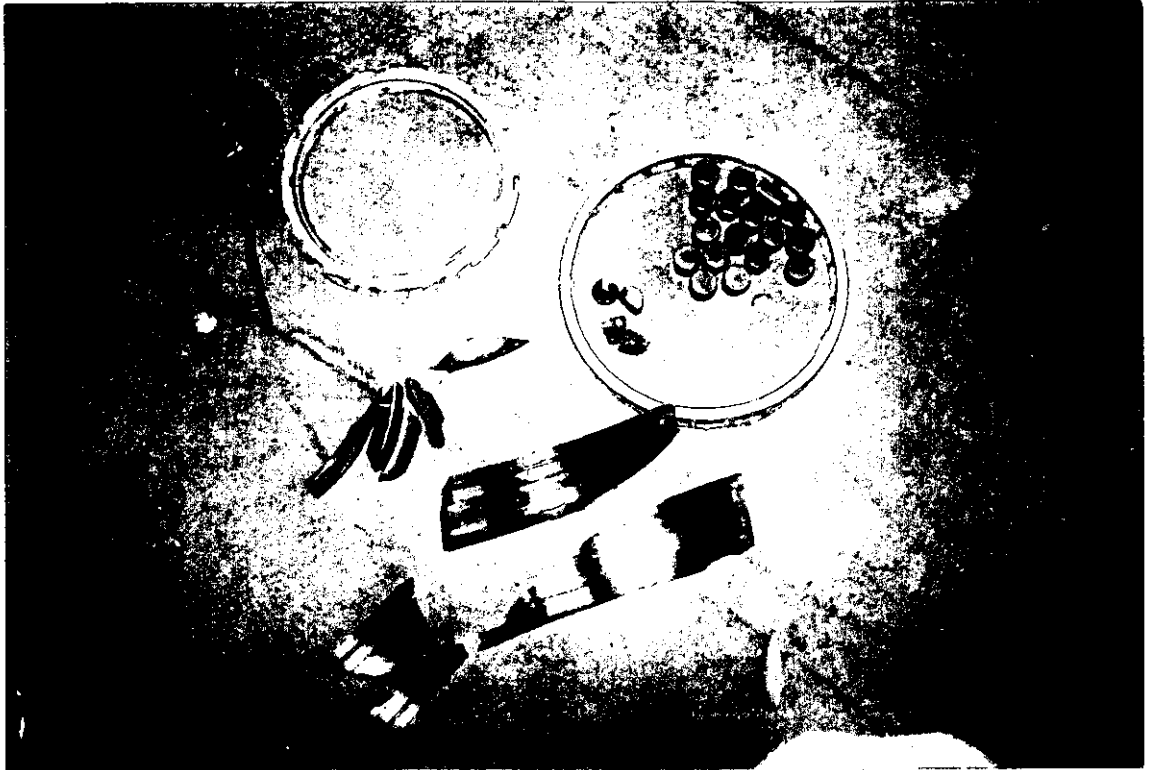
Photo 9

| <u>PHOTO</u> | <u>DESCRIPTION</u> |
|---|--|
| 9. | #1 Bearing Assembly Rollers and Outer Race Remnants |

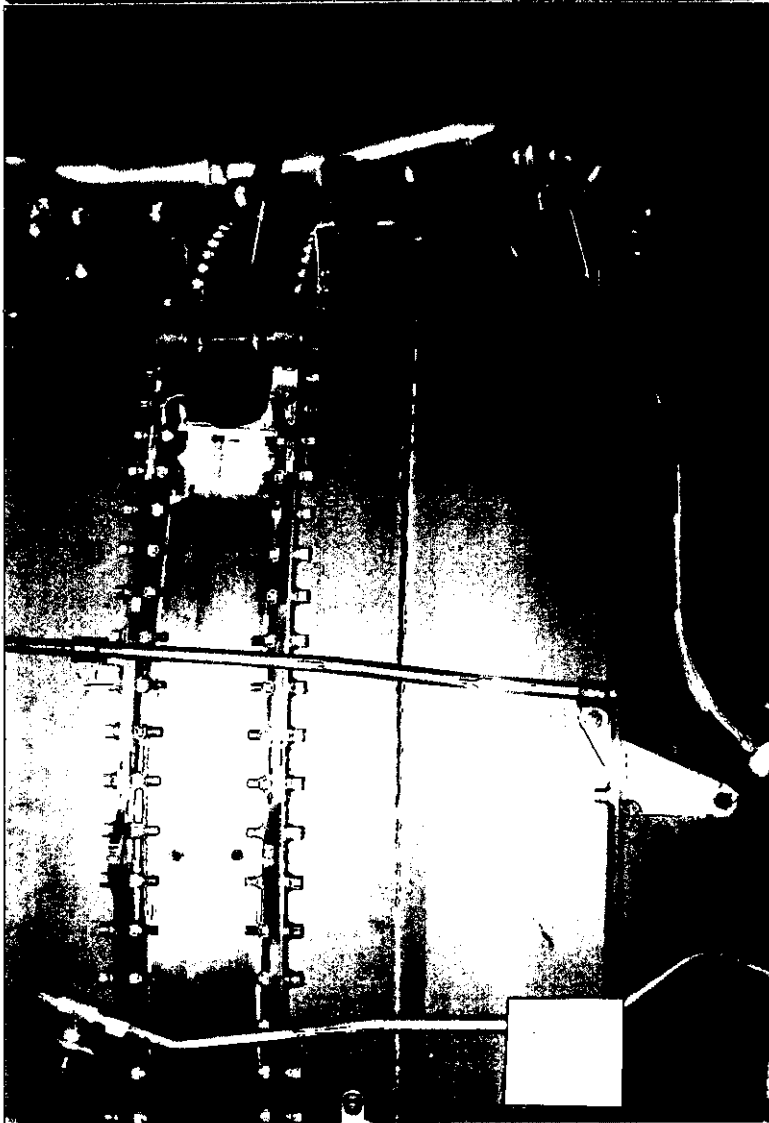
Photo 10

| <u>PHOTO</u> | <u>DESCRIPTION</u> |
|---|--|
| 10. | 360 Degree Fracture Just Forward of "F" Flange |
