DOCKET NO. SA-515

EXHIBIT NO. 8C

POWERPLANTS GROUP CHAIRMAN'S  
FACTUAL REPORT OF INVESTIGATION  
NTSB ACCIDENT MIA82IA051  
March 18, 1982

Location : Miami, Florida  
Airline : Pan American Airways  
Aircraft : Boeing, B-727-200 Tri-jet, N4734  
Date : February 17, 1982  
Time : 3:30 p.m. e.s.t.  
NTSB No. : MIA-82-1A-051

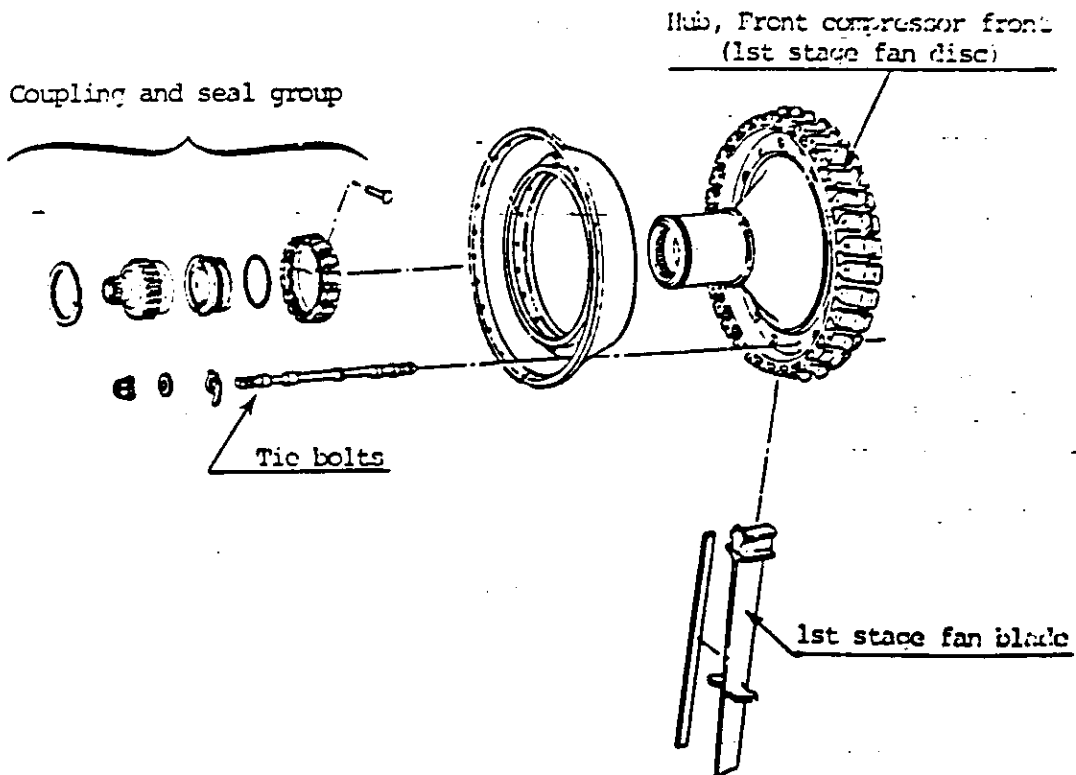
ATTACHMENT No. 2

Front compressor, front hub build-up  
and miscellaneous parts.
