NATIONAL TRANSPORTATION SAFETY BOARD  
WASHINGTON, DC

PRATT & WHITNEY RESEARCH REPORT  
704297-2440

PRATT & WHITNEY AIRCRAFT GROUP  
Commercial Products Division

REQUESTED BY	P.E. Rowe		DEPARTMENT	Engineering	
SEND REPORTS TO	P.S. Hopper, H.L. Lemasters, R.J. Milkay, J.B. Moore, A.W. Oberg, P.E. Rowe, H.C. Schatta R.J. Bergenholtz, J.J. Carino, W.E. Cockerille, R.F. Conway, T.G. Figlioli, R.H. Haines.				
PART NAME	Hub - Front Compressor Front		MATERIAL	PWA 1215 (6A1-4V) Titanium-base Alloy	
PART NUMBER	749701C		HEAT CODE	WENS-2028	SERIAL NO. 5A5786
ENGINE TYPE	JT8D-7B	NO.	P-654892	MFG. Forging: Wyman-Gordon Machining: PWA - North Haven	
PART TIME	12,634 Hours/9,360 Cycles		OPERATED BY Pan Am (PA)

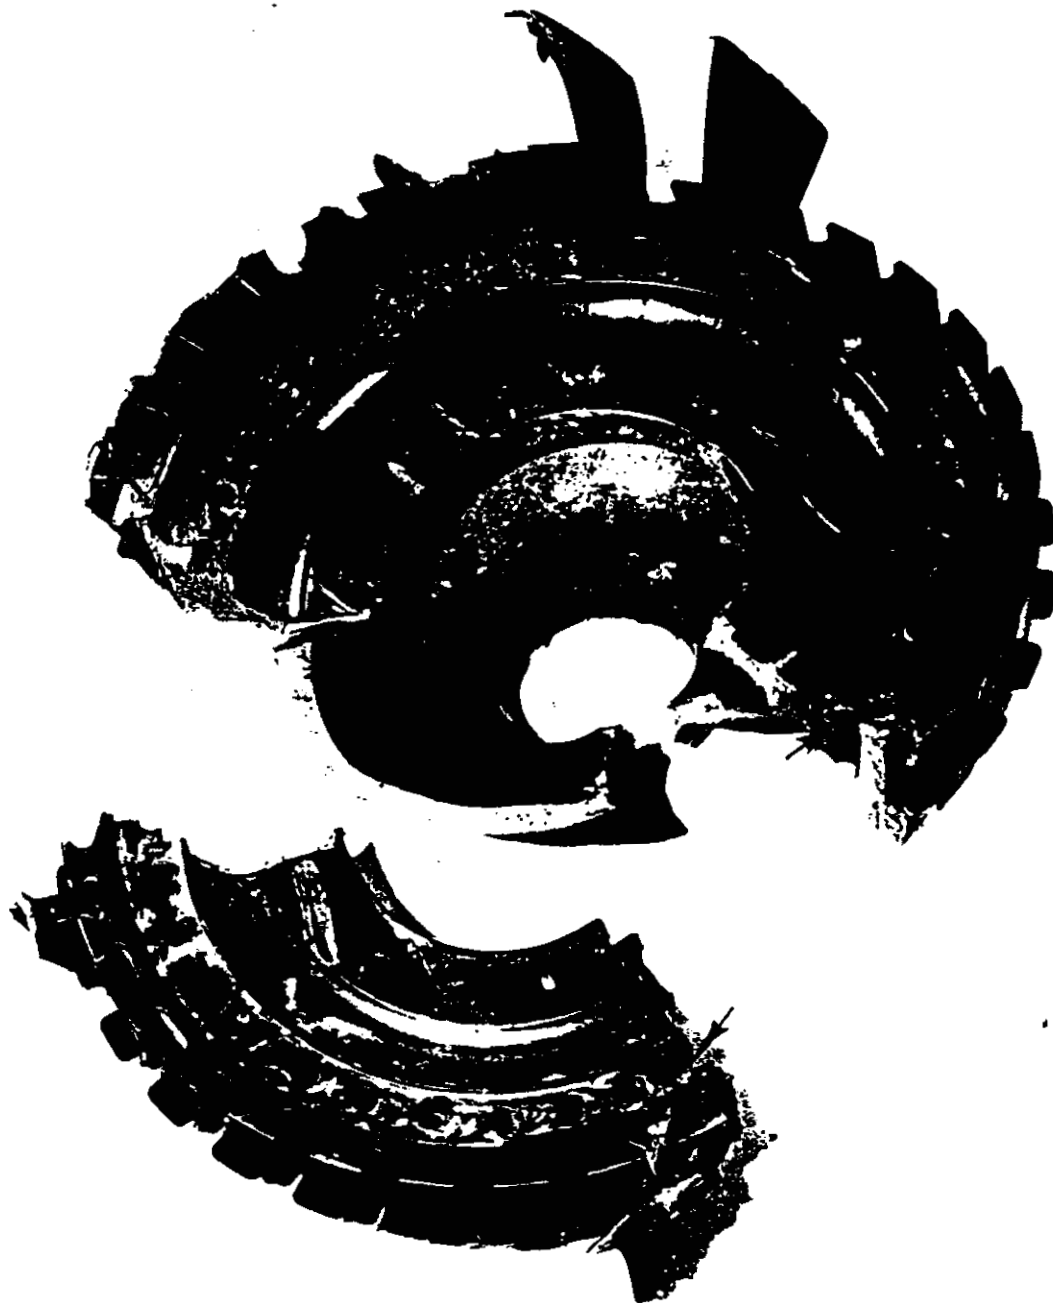
FIGURE 1

Front compressor front hub fractured radially through bore and rim in two locations releasing two sections comprising approximately  $120^{\circ}$  and  $240^{\circ}$  of circumference, respectively (Figure 1). Binocular examination of one radial fracture revealed fatigue which progressed from a circumferential groove at rear end of one tie rod hole (Figure 2). Fatigue extended approximately 1.25" inboard toward bore and 0.035" outboard toward rim (Figure 3). Remainder of fractures were typical of rapid tensile breaks. Material in groove at origin exhibited a very rough, smeared appearance with numerous axial cracks (Figures 4 and 5). Optical comparator dimensional inspection of replicas of groove measured a maximum groove width of 0.125" and depths of 0.010-0.025" below tie rod hole surface. Some narrow areas between groove and rear edge break of the tie rod hole were apparently machined flush with tie rod hole surface. Surface of the hole outside of the groove exhibited pattern typical of honing operation as required by the process sheet. Scanning electron microscope (SEM) examination of fracture surface revealed striations typical of low cycle fatigue (LCF). Striation count analysis revealed 7300 (+10%) striations of fatigue progression. X-ray emission spectroscopic (XES) examination of groove and surface of tie rod hole revealed small amounts of iron, possibly from contamination. There was no evidence of contamination from contact with tie rod (i.e. nickel or cadmium from plating).

JT8D-7B FRONT COMPRESSOR FRONT HUB, 749701C, S/N 5A5786, HEAT CODE WENS-2028, AFTER TOTAL PART TIME OF 12,634 HOURS/9,360 CYCLES (TIME SINCE OVERHAUL 4909 HOURS/2782 CYCLES) SHOWING LOCATION OF RADIAL FATIGUE FRACTURE WHICH PROGRESSED FROM ONE TIE ROD HOLE (ARROWS). HUB HAD BEEN OPERATED 7725 HOURS/6578 CYCLES IN NATIONAL ENGINE P-655019, THEN FOR 4909 HOURS 2782 CYCLES IN PAN AM ENGINE P-654882 PRIOR TO FRACTURE.

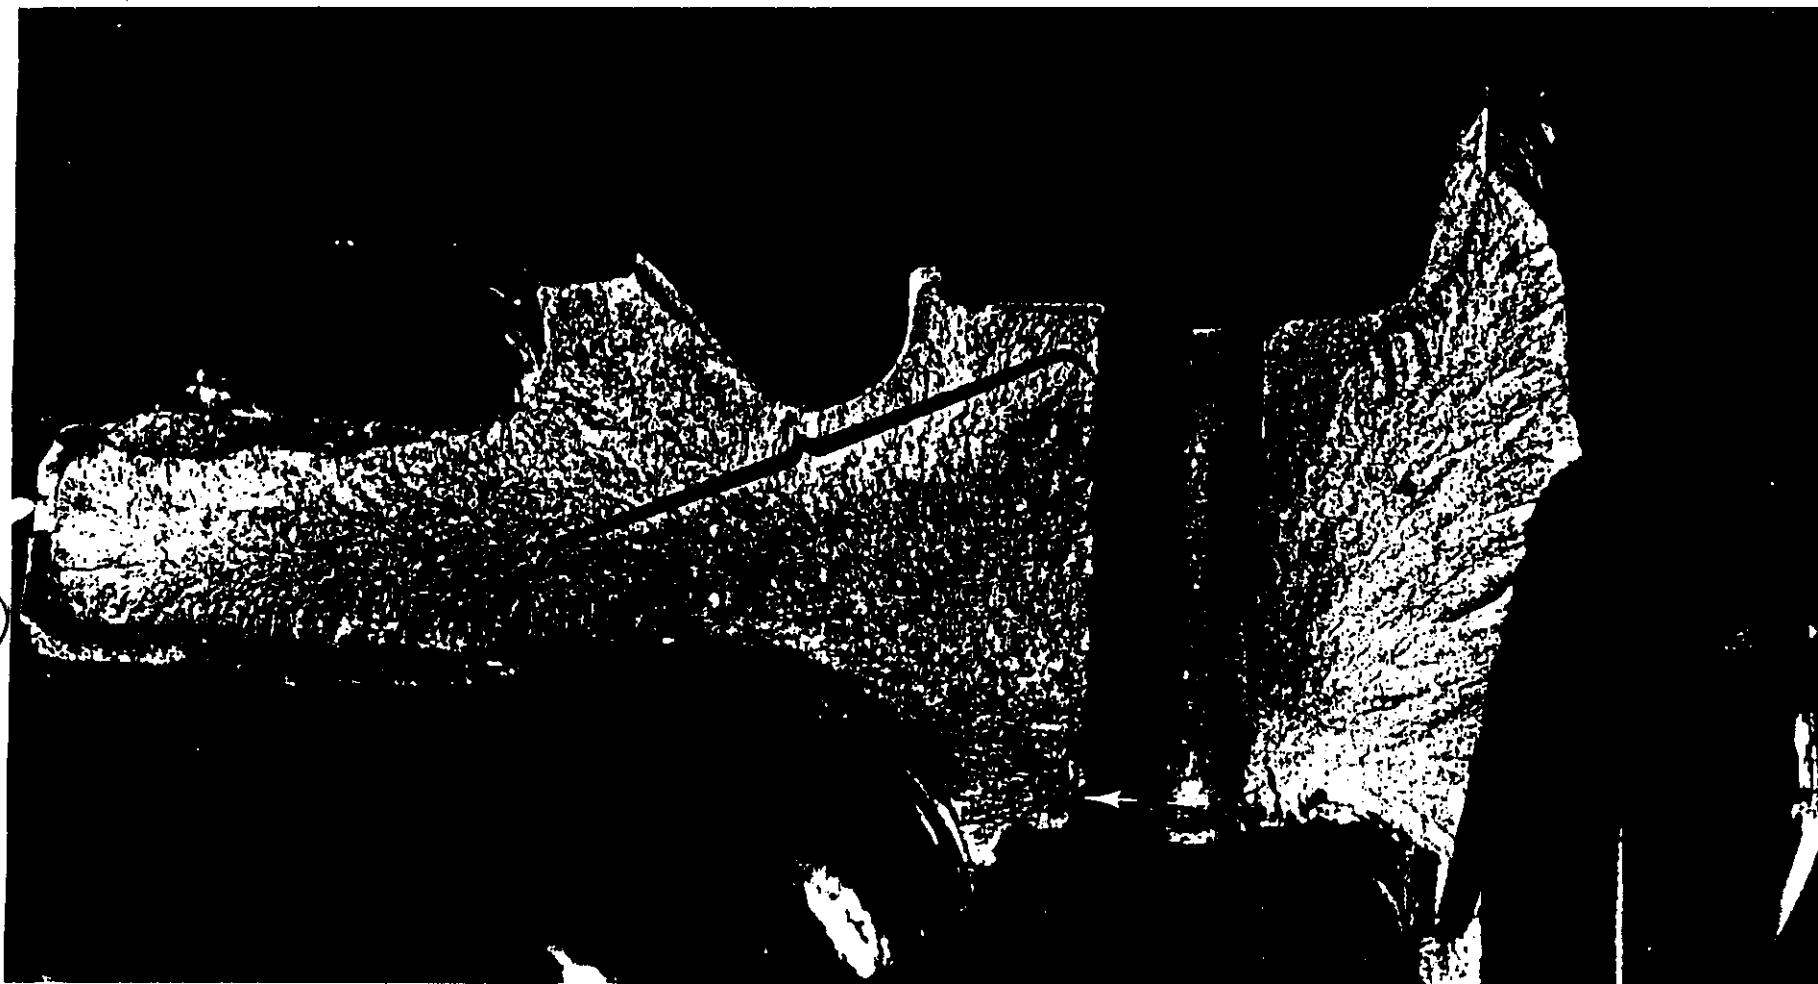
FIGURE 2

CLOSE-UP OF RADIAL FRACTURE SHOWING FATIGUE (BRACKETS) WHICH PROGRESSED FROM ORIGINS (ARROWS) AT GROOVE AT REAR END OF TIE ROD HOLE.

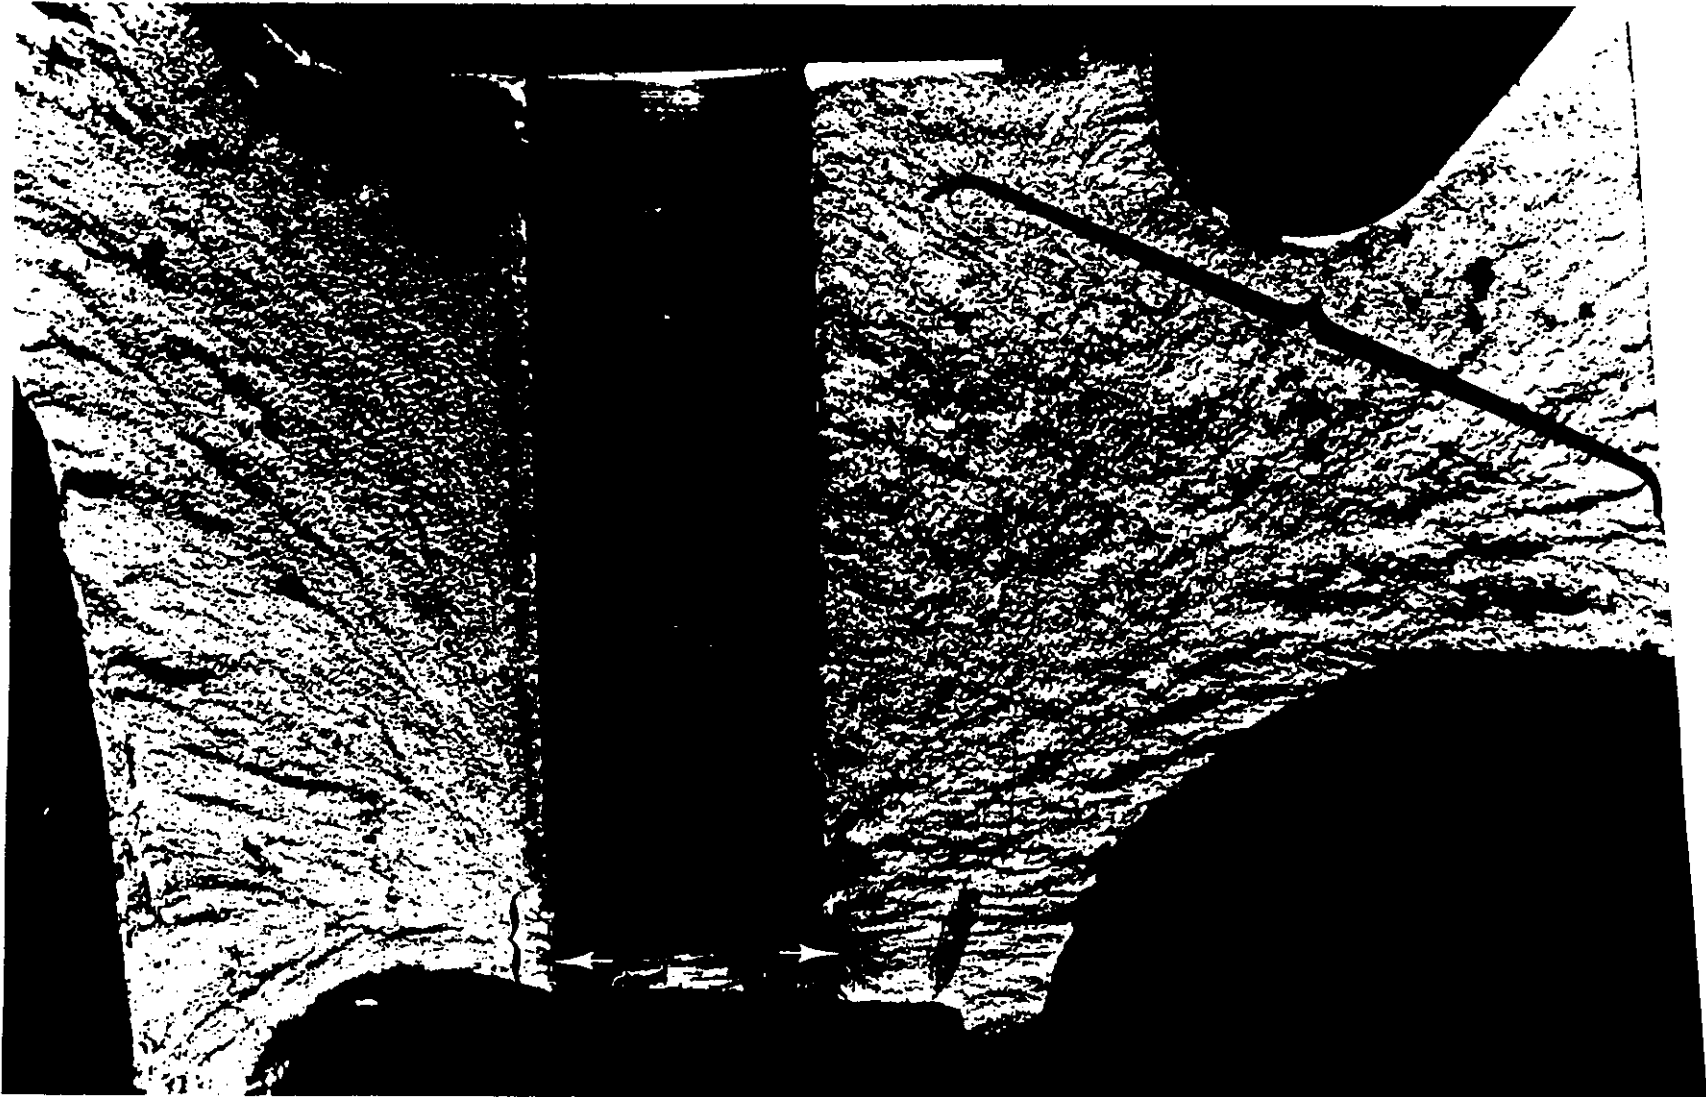
FIGURE 3

CLOSE-UP OF RADIAL FRACTURE SHOWING FATIGUE (BRACKETS) WHICH PROGRESSED FROM ORIGINS (ARROWS) AT GROOVE AT REAR END OF TIE ROD HOLE.

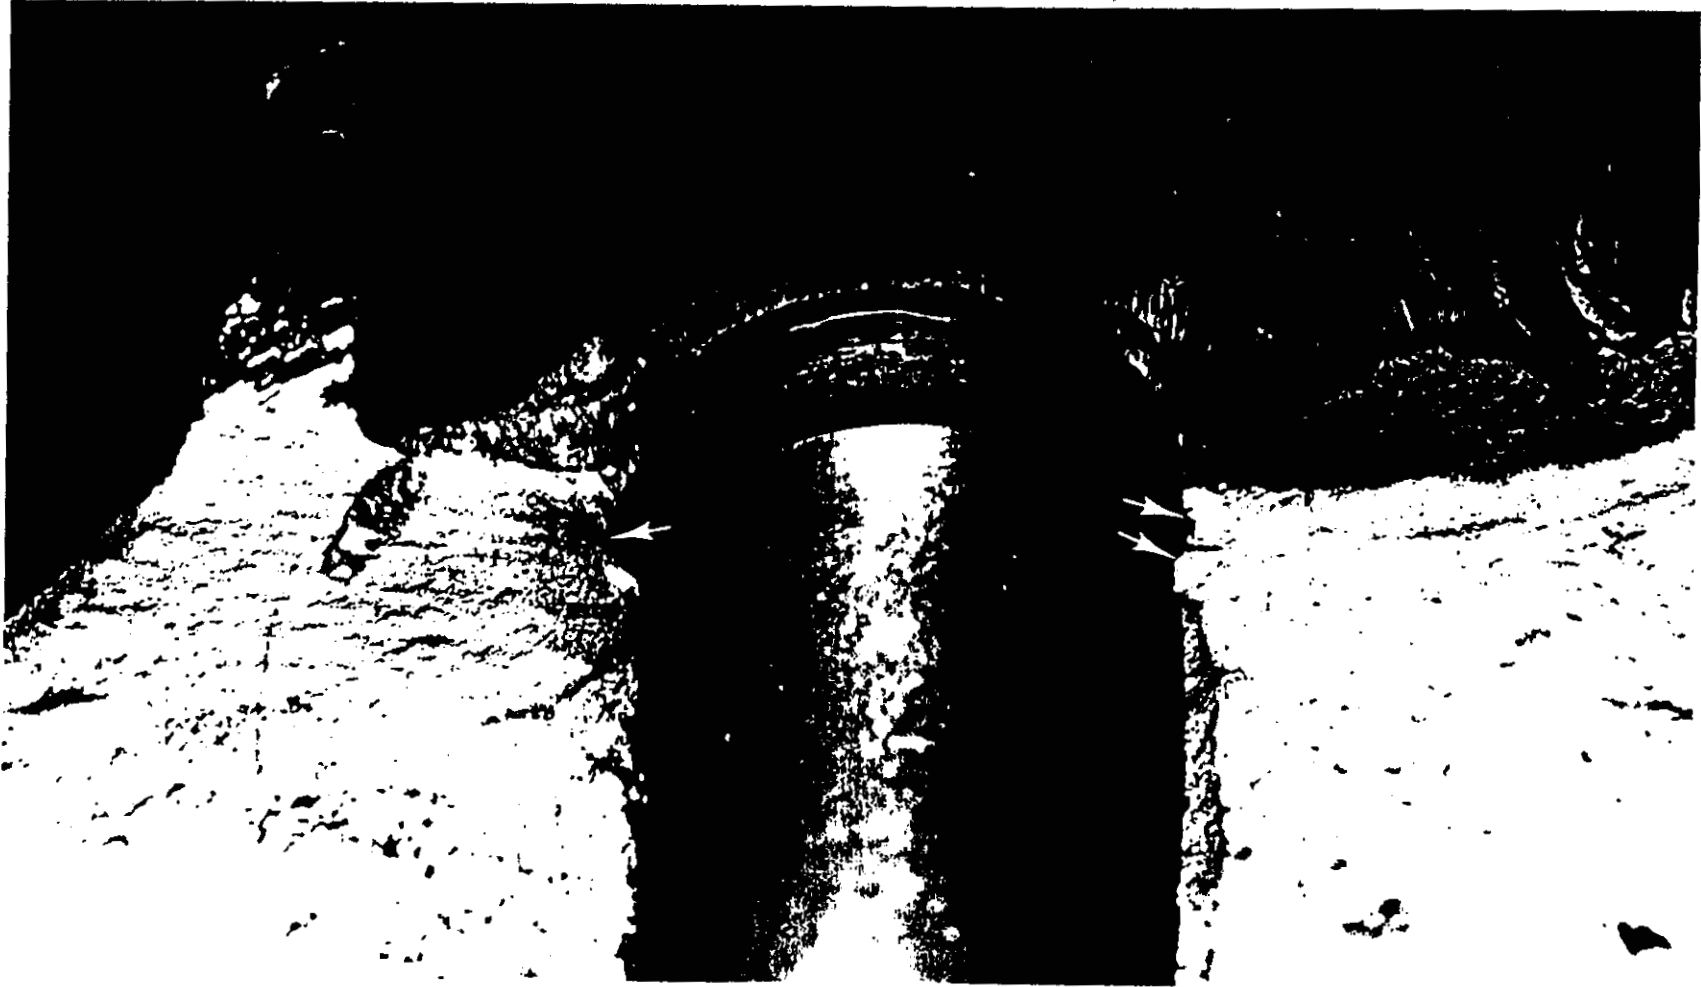
FIGURE 4

Radial fracture through front compressor front hub was due to low cycle fatigue (LCF) which progressed from origins at a circumferential groove at rear end of one tie rod hole. Groove was up to 0.125" wide and 0.025" deep and had a very rough, smeared appearance typical of abusive machining. Scanning electron microscope (SEM) examination revealed 7300 (+10%) fatigue striations. Work affected material, up to 0.025" deep and as hard as HRC 55, was present along surface of groove and adjacent machined surface of tie rod hole. Presence of worked material below finish machined and honed hole surface adjacent to groove indicates that damage occurred prior to final machining operations. Hub material away from groove conformed to hardness and composition requirements.

CLOSE-UP OF GROOVE AT REAR END OF TIE ROD HOLE SHOWING LOCATION OF FATIGUE ORIGINS (ARROWS) AND ROUGH, SMEARED APPEARANCE OF GROOVE SURFACE.

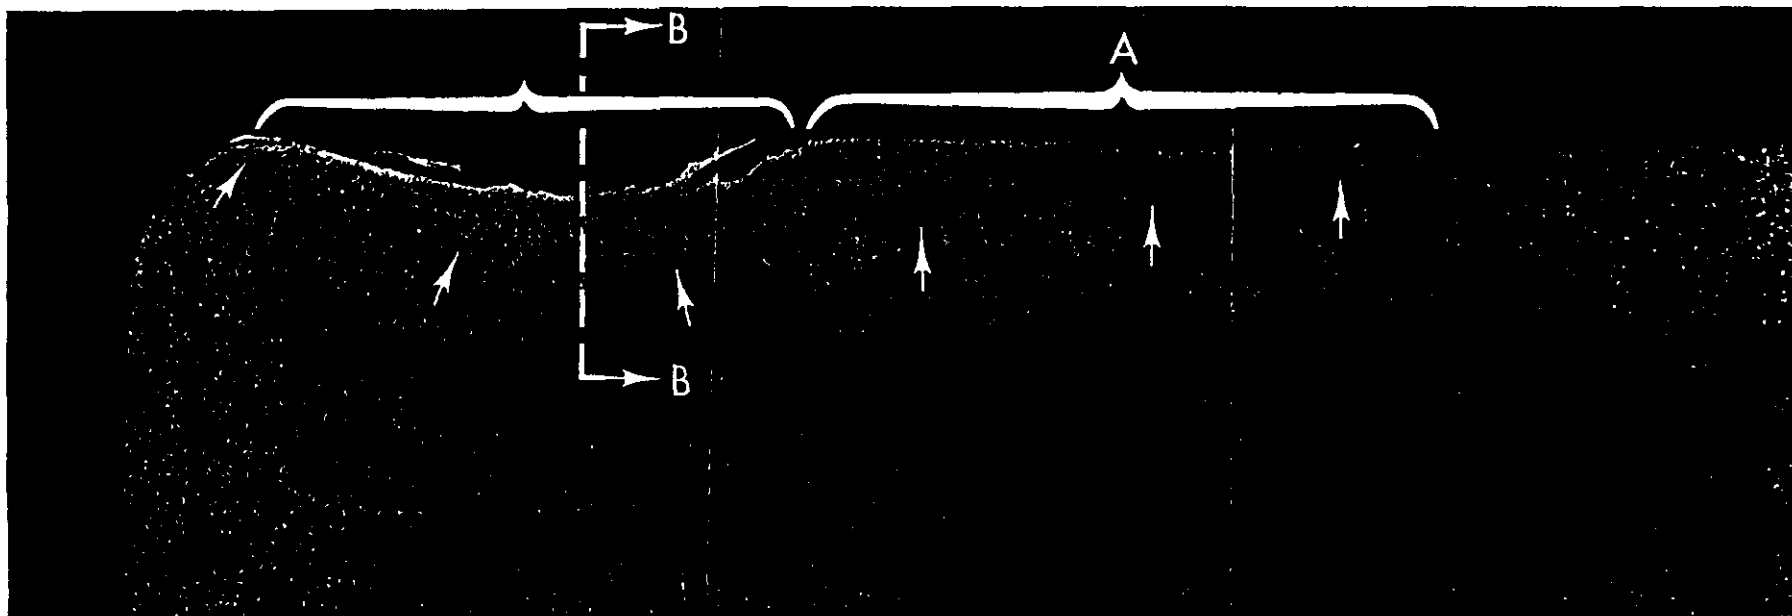
FIGURE 6

Metallographic examination of sections through fatigue origins revealed transgranular fracture path. Axial sections through tie rod hole surface and groove at fatigue origins exhibited work affected microstructure at surface of groove and along machined surface of hole up to 0.25" from rear face of hub (Figure 6). Work affected material extended up to 0.025" below surface of groove. Hardness of work affected material was as high as HRC 55 (HV conv.). Planar section through groove exhibited numerous axial cracks in heavily worked material (Figure 7). Microstructure away from tie rod hole surface was typical of PWA 1215 titanium-base alloy processed below the beta transus temperature and conformed to the requirements of Materials Control Laboratory (MCL) Manual Section E-72.

PHOTOMICROGRAPH OF AXIAL SECTION THROUGH TIE ROD HOLE NEAR FATIGUE ORIGINS SHOWING LAYER OF HARD, WORK AFFECTED MATERIAL (ARROWS) ALONG SURFACE OF GROOVE (BRACKET) AND ADJACENT FINISH MACHINED HOLE SURFACE (BRACKET A), SUGGESTIVE OF ABUSIVE MACHINING. PHOTOMICROGRAPHS OF SECTION B-B ARE SHOWN IN FIGURE 7.

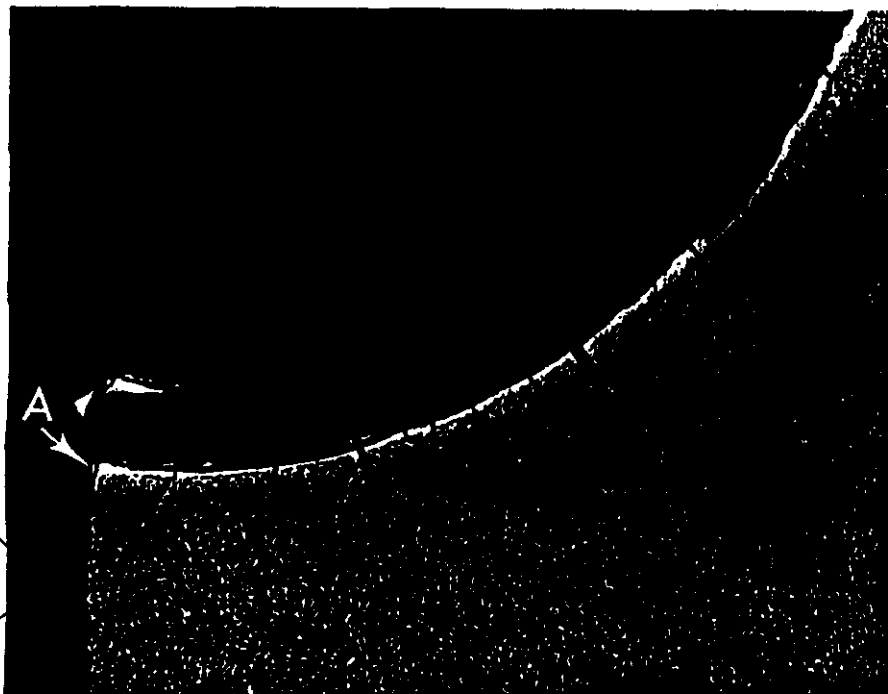
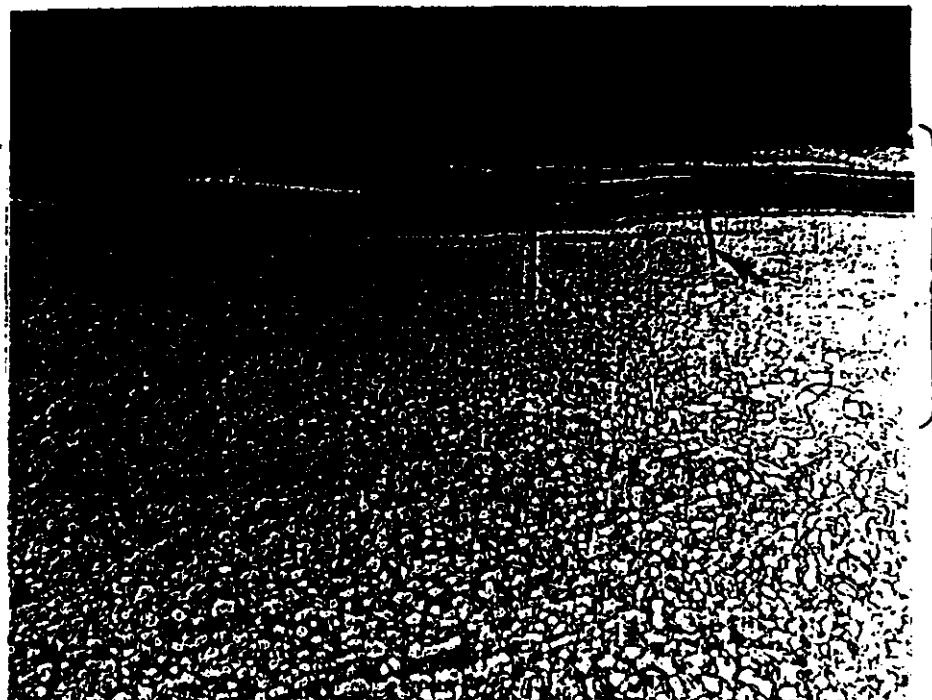
FIGURE 7

PHOTOMICROGRAPHS OF PLANAR SECTION (SECTION B-B SHOWN IN FIGURE 6)  
THROUGH GROOVE IN TIE ROD HOLE AT FATIGUE ORIGIN (ARROW A - LEFT)  
SHOWING DEFORMED AND WORK AFFECTED MICROSTRUCTURE (BRACKETS - RIGHT)  
AND MULTIPLE AXIAL CRACKS (ARROWS - LEFT AND RIGHT) SUGGESTIVE OF  
ABUSIVE MACHINING.
