**DOCKET NO.: SA-515  
EXHIBIT NO. 8J**

**NATIONAL TRANSPORTATION SAFETY BOARD  
WASHINGTON, D.C.**

**JTSD-200 SERIES FAN HUB INDUSTRY MEETING**

# JT8D-200 FAN HUB INDUSTRY MEETING AGENDA

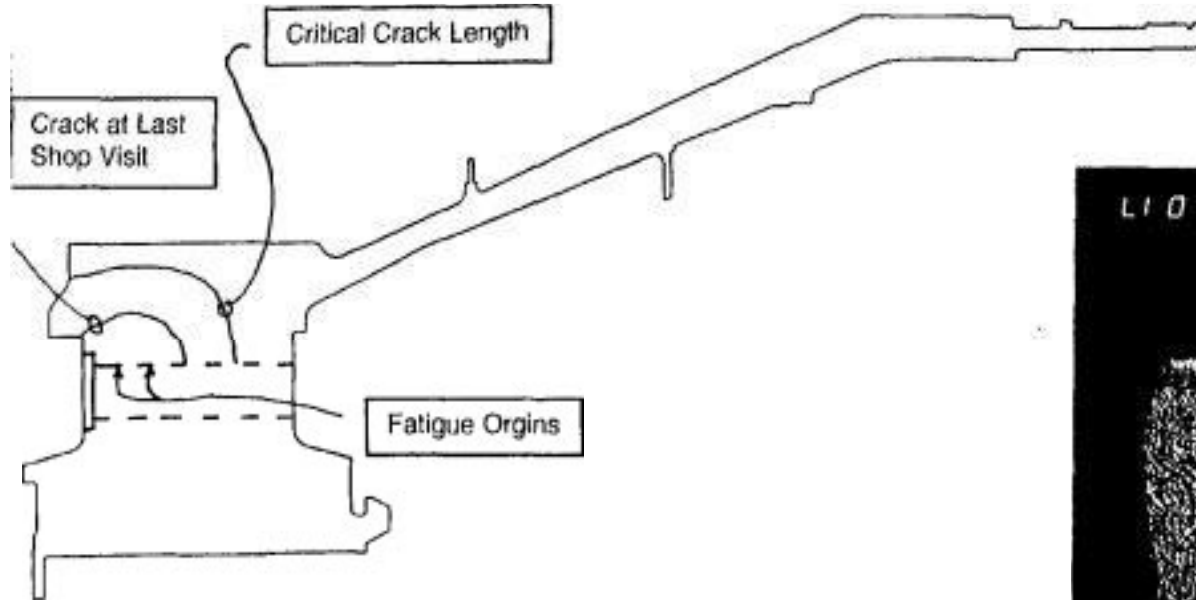
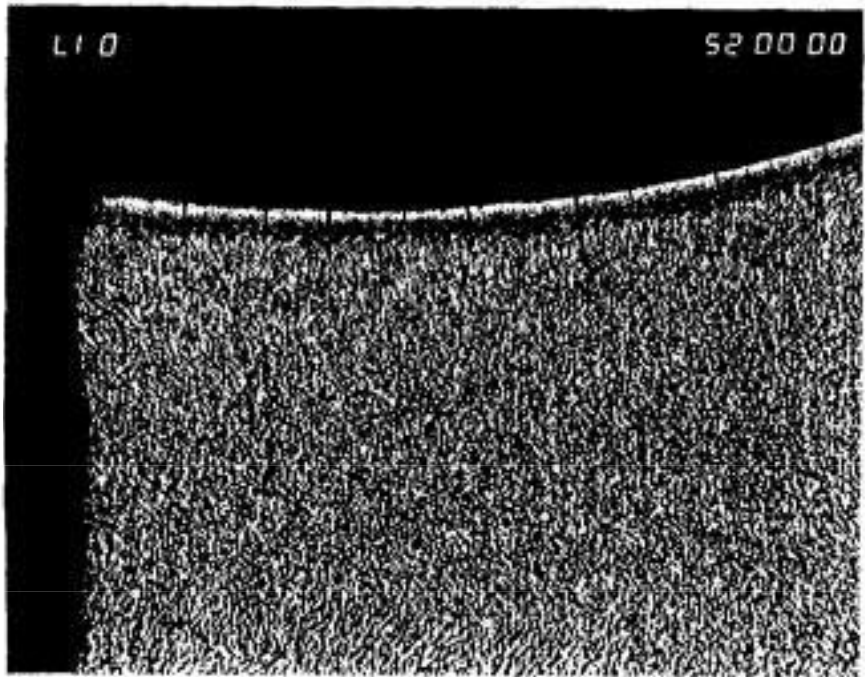
# FRACTURED FAN HUB METALLURGICAL ANALYSIS

- Low cycle fatigue
- Originated from a localized area of work hardened / deformed material
  - Located 1/2 inch inboard of the aft face in the tierrod hole
- Striation count shows crack had been present for 12,000 to 13,000 cycles

**WORK HARDENED LAYER**

- Hub was in the shop 9/95 and underwent a Fluorescent Penetrant Inspection
  - Total Time: 15,013
  - Total Cycles: 12,693
- Crack was approximately 0.9 inch along the length of the hole
- Crack had extended to aft side of the hub approximately 0.46 inch long
