**NATIONAL TRANSPORTATION SAFETY BOARD**

**POWERPLANTS GROUP CHAIRMAN'S FACTUAL REPORT**

NTSB ID No.: ENG08IA038

Location: McCarran International Airport, Las Vegas, Nevada  
Date: August 6, 2008  
Time: 15:40 Pacific daylight time  
Aircraft: Boeing 757-232, N666DN, Delta Air Lines, Flight 624

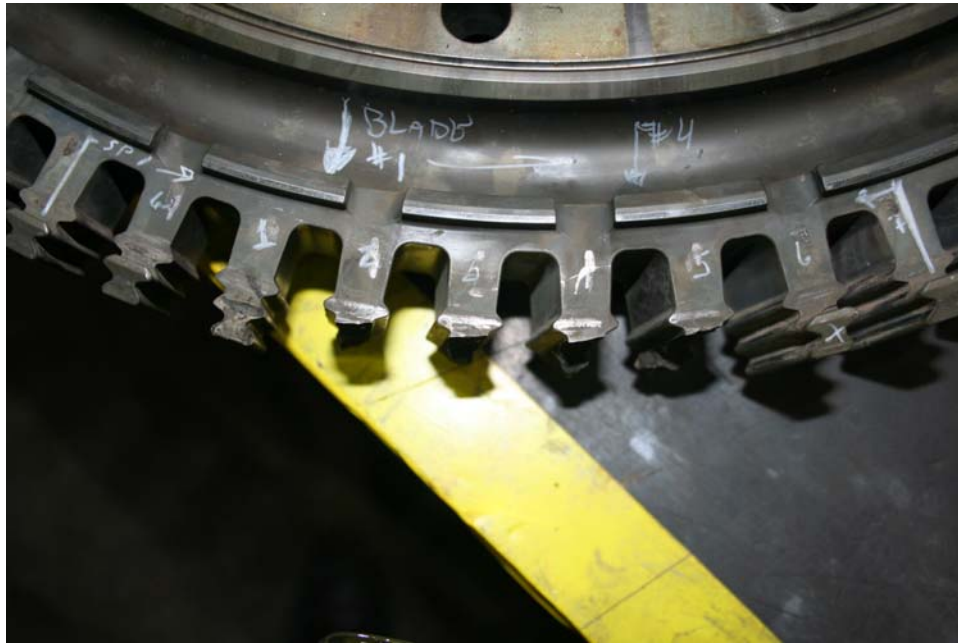
The 2nd stage turbine hub was intact except for five adjacent disk lugs, Nos. 2 through 5, that were fractured transversely through the fir trees.<sup>5</sup> (Photo 1) Disk lug No. 1 had the forward blade retaining plate retention hook fractured. The fracture surface on disk lug No. 1 had a dark-colored, elliptical-shaped flat surface radiating from the inner diameter of the retaining plate snap fillet outward. (Photo 2) The fracture surfaces on disk lugs Nos. 2 through 5 had dark-colored, elliptical-shaped flat features radiating from the front acute corner. (Photo 3) The visual inspection of the 2nd stage turbine hub revealed 11 other lugs, Nos. 6, 9, 13, 14, 18, 28, 29, 40, 47, 58, and 59 were cracked. (Photo 4) The front and rear faces of the hub as well as the hub bore did not have any rub marks. The following markings were noted on the 2nd stage turbine hub: PN 1B6602J, SN DKLBA86546, heat code PHNLS 2007, 33459 S/N, 408.

Photo 1: Close up of 2nd stage turbine hub showing fractured lugs Nos. 2 through 5 (P&W)

According to the Safety Board's Materials Laboratory report, the examination of lugs Nos. 2 through 5 revealed fracture surfaces that were smooth and flat, consistent with fatigue. The areas of fatigue on lugs Nos. 2 through 5 originated from multiple origins along the root radius between the middle and inner serration on the pressure side of the lug. The examination of the fracture surfaces on lugs Nos. 2 through 5 with the scanning electron microscope revealed the fractures were consistent with fatigue at elevated temperatures. Lug No. 5 had the largest area of fatigue. On both sides of the blade retaining lugs, but primarily on the pressure side, the

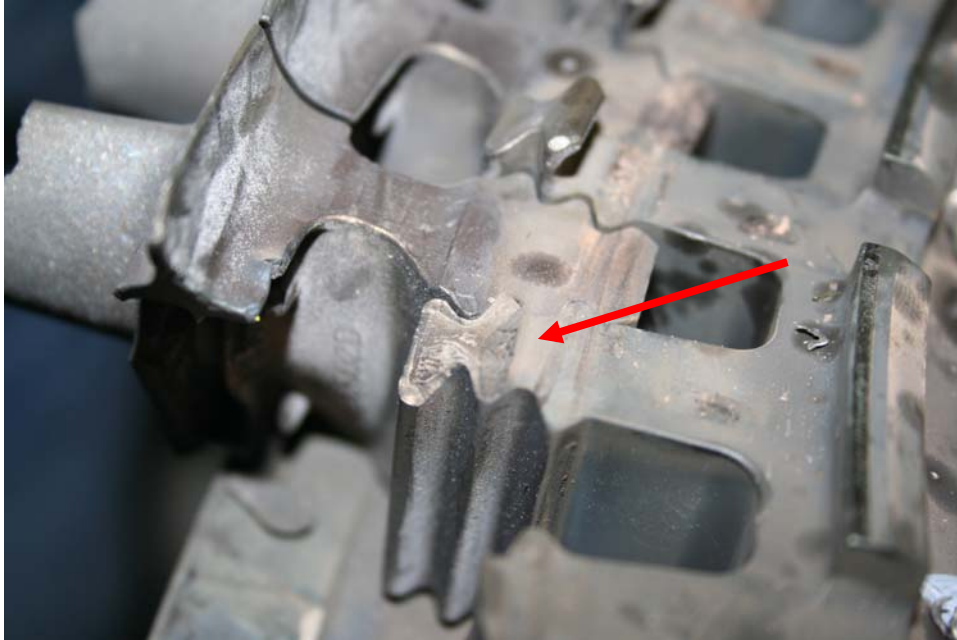
Photo 2: Close up of lug No. 1 with arrow pointing to the dark-colored, elliptical-shaped fracture surface feature (P&W)

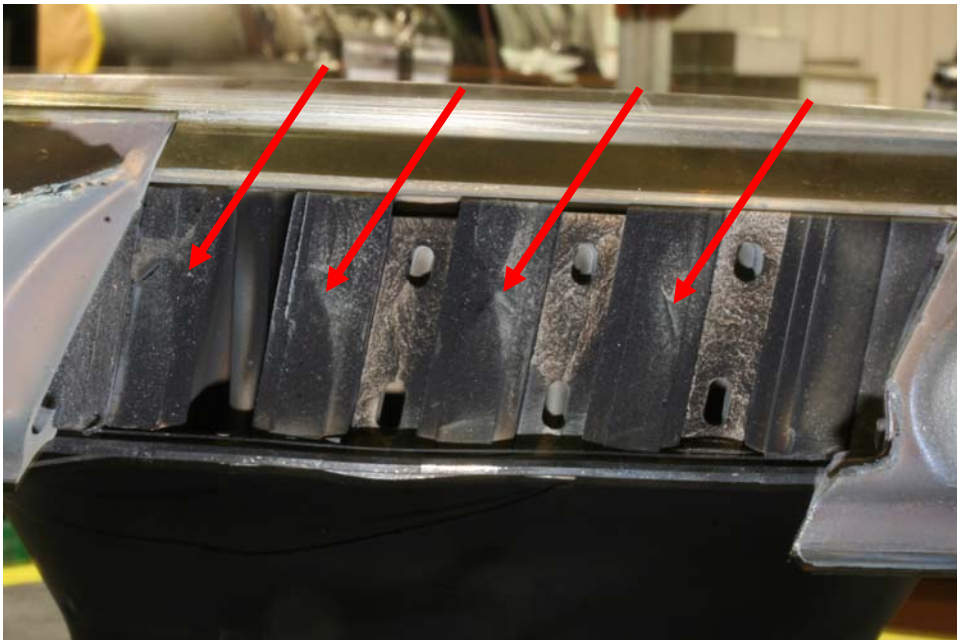
Photo 3: Close up of fracture lugs Nos. 2 through 5 with arrows pointing to the elliptical-shaped fracture surface features (P&W)

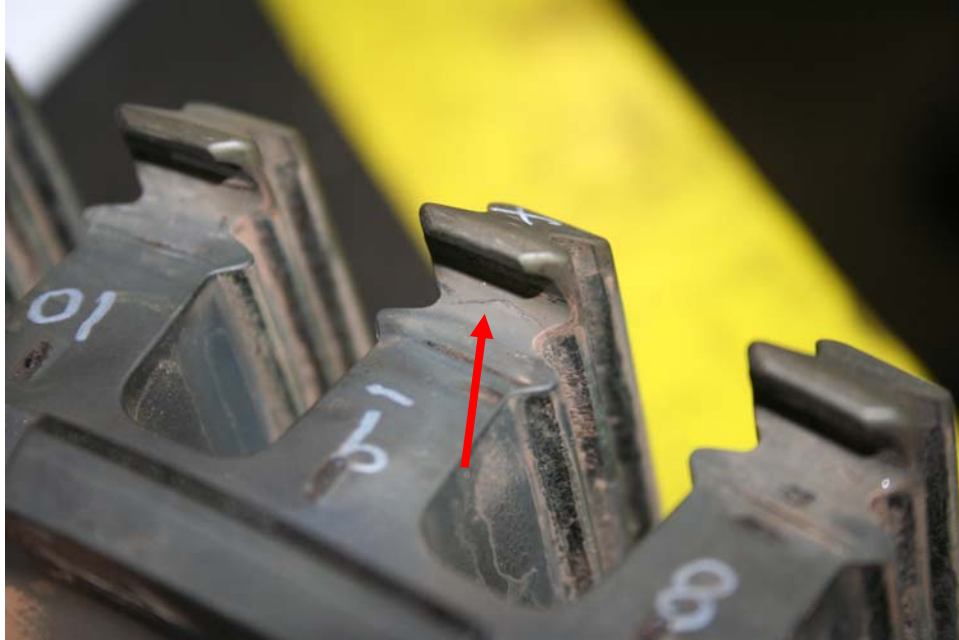
Photo 4: Close up of lug No. 9 with arrow showing crack (P&W)

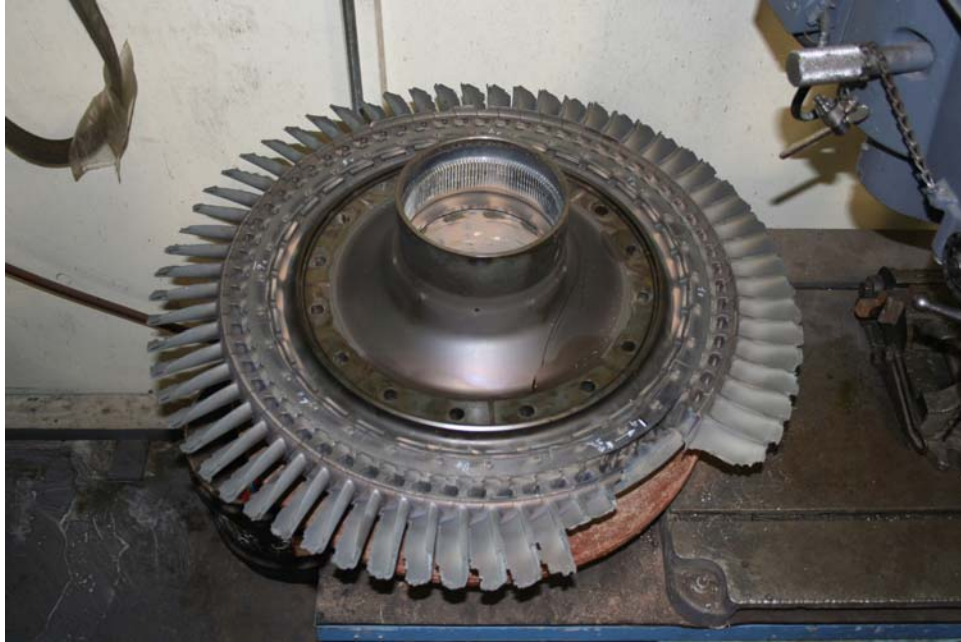
Of the 64 2nd stage turbine blades, 1 was missing completely, three were fractured transversely through the inner most blade root serrations, and the remaining blades were in the blade slots. The blades in slots Nos. 1, 2, and 3 were fractured transversely through the inner most blade root serrations. There was one 2nd stage turbine blade recovered that had an airfoil and partial root recovered with a fracture surface that corresponded to the fracture surface on the root section in blade slot No. 1. The blade in slot No. 4 was missing completely. Blade No. 5 had a crack in the inner most serration on the pressure side. The airfoils of blades Nos. 5 through 62 varied in length from 2 3/4 inches to 3 1/4 inches above the blade root platform. The airfoils of blades Nos. 63 and 64 were 3/4 and 1/2 inches long, respectively, above the blade root platform. (Photo 5) All of the near full length blades had rub marks with heat discoloration on the tips and nicks, dents, and break outs on the leading edges, trailing edges, and the airfoil surfaces. All of the blades roots had the cover plate over the aft cooling air hole. The fracture surface on blade root No. 2 had two-elliptical shaped, relatively flat dark colored areas radiating from just aft of the front corners of the blade root. The fracture surface on blade root No. 3 had a single elliptical-shaped, relatively flat dark colored area radiating from just aft of the front obtuse corner. (Photo 6) The fracture surfaces on blade root No. 1 and the remainder of the fracture surfaces on blade roots Nos. 2 and 3 were coarse and grainy.

Photo 5: 2nd stage hub with 2nd stage turbine blades showing missing blades, blades fractured near platform, and remaining blades damaged (P&W)

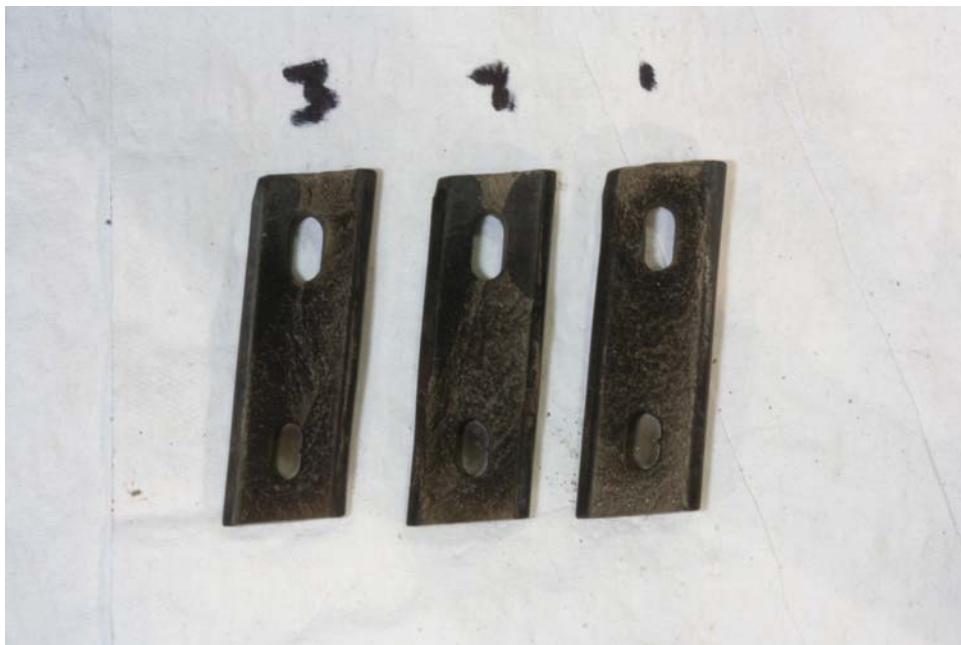
Photo 6: Close up of fractured 2nd stage turbine blade root ends (P&W)

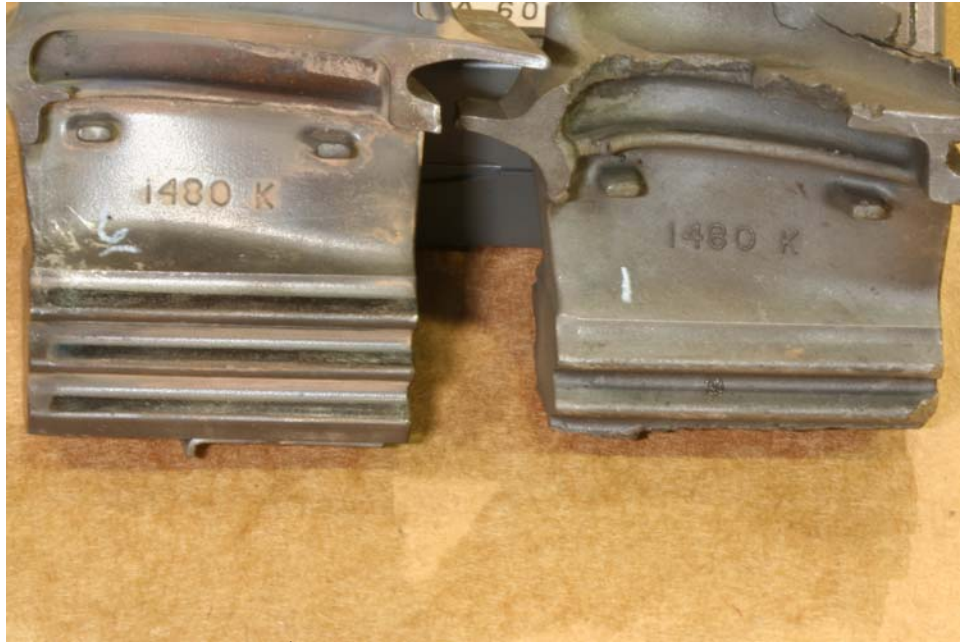
The contact patterns of the 2nd stage turbine blade root serrations were qualitatively evaluated. With the exception of blades Nos. 1 and 5, all exhibited six-tooth contact, but the degree/heaviness of the contact on the pressure side serrations varied from blade to blade. (Photo 7) Refer to Table 1.

Photo 7: 2<sup>nd</sup> stage turbine blades Nos. 1 and 6 showing different wear patterns on root fir trees (P&W)

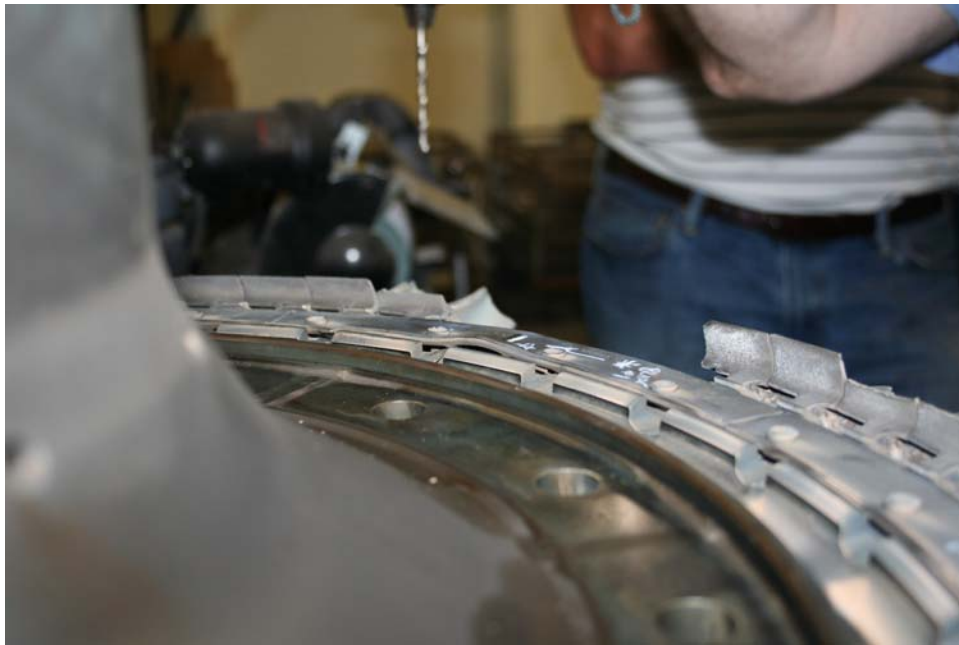
All of the 2nd stage turbine blade front retaining plates and the rear retaining plate were intact and in place on the 2nd stage turbine hub. The underlying wire seals were in place and intact. However, the front retaining plate segment adjacent to the broken turbine blades was bulged radially outward in the center and buckled out from the hub front face slightly. (Photo 8) The 2nd stage turbine blade front retaining plate segments were marked as being PN 1B0815E. All of the 2nd stage turbine blade front retaining plate segments had circumferential scuff marks on the front face. All of the 2nd stage turbine blade front retaining plates were returned to P&W, East Hartford, Connecticut for dimensional inspection on a CMM. The retaining plate that was adjacent to the broken blades could not be measured because of the aforementioned damage. However, the dimensional inspection of the remaining seven 2nd stage turbine blade front retaining plates showed that all of them conformed to the engineering drawing's dimensional requirements. All of the 2nd stage turbine blade front retaining plates, including the damaged one, were weighed and all were within one gram of the expected weight. (For further details, refer to Attachment 4.)

Photo 8: Front 2nd stage turbine blade retaining plate that was buckled (P&W)

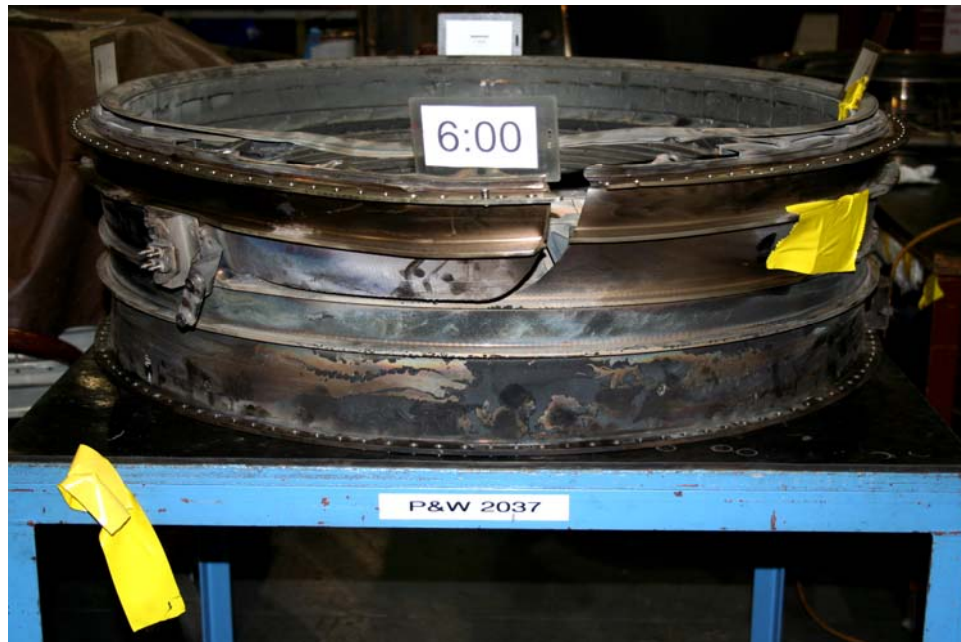
The HPT case had a 4 1/4-inch long axial crack at 6 o'clock between the rear flange and the rail that turned clockwise and progressed approximately 11 inches to the turbine cooling air (TCA) temperature probe boss at 8 o'clock. The flap of the fractured HPT case was displaced radially outward about 3 inches. (Photo 9) The fracture surface on the flap of the HPT case matched the fracture surface on the body of the HPT case. The HPT case, in the plane of the 2nd stage turbine vanes, had a purple discoloration 360 degrees around the case.

Photo 9: View of tab of displace material on ruptured HPT case (P&W)

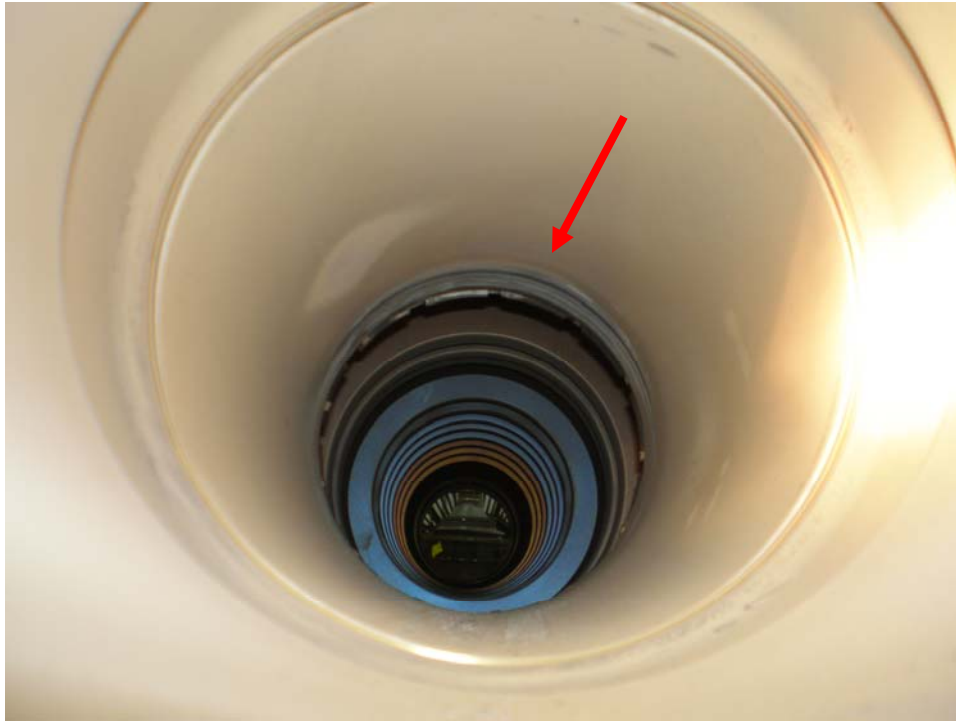
The HPT shaft was intact. The forward end of the HPT shaft heat shield on the inner diameter had an approximately 2-inch wide axial 180 degree rub mark that corresponded to the 2-inch wide rub mark on the outer diameter of the LPT shaft. (Photo 10) The center of the rub mark on the HPT shaft heat shield was located 180 degrees from the missing 2nd stage turbine blades.

Photo 10: Inside of HPT shaft with arrow showing rub mark

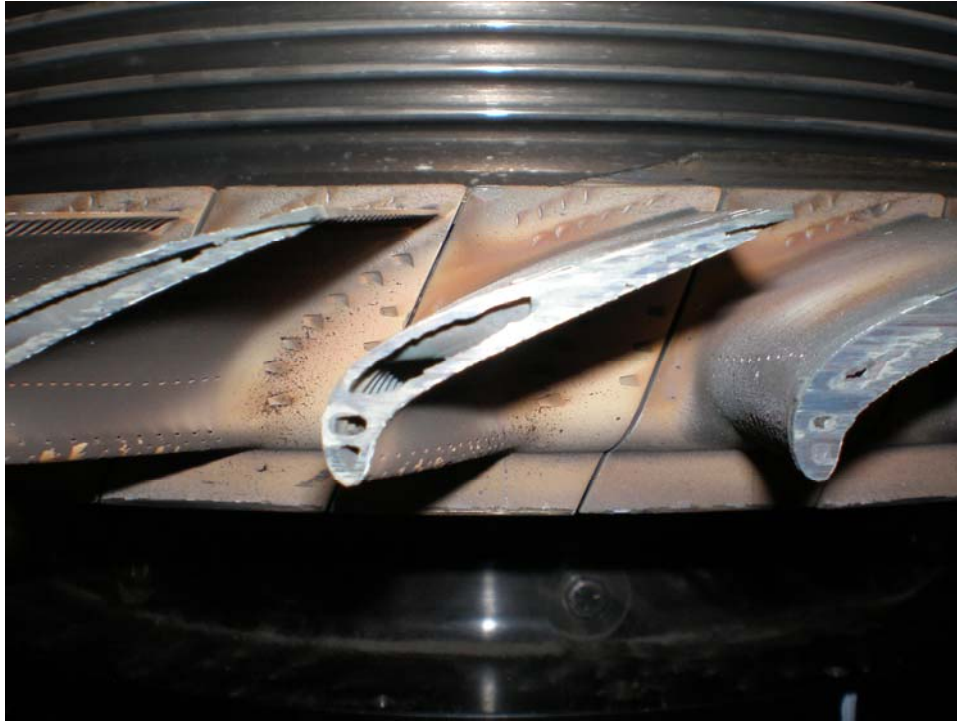
Photo 11: Close up of 1st stage turbine blade tips showing rub into internal cavity

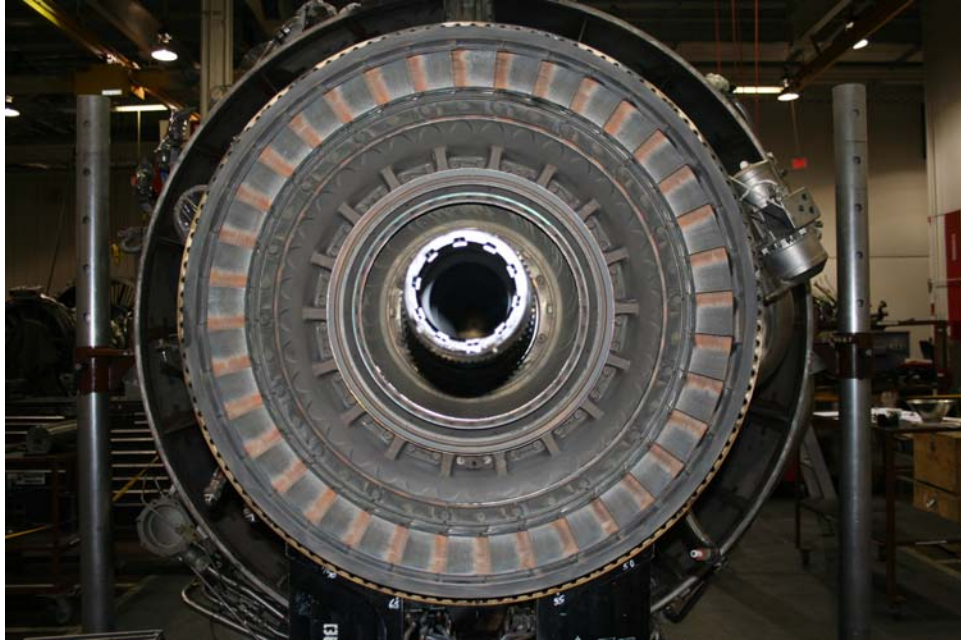
The 1st stage turbine vanes were all in place. (Photo 12) The 1st stage turbine vanes did not have any apparent damage, but the concave surfaces of the airfoils between the leading and trailing edges had a black-colored coating. The convex surfaces of the airfoils did not have any of the black-colored material. The thermal barrier coating on the convex surfaces of the airfoils appeared to be intact. The 1st stage turbine vanes did not have any indications of burning or hot gas erosion.

Photo 12: 1st stage turbine vanes all in place (P&W)

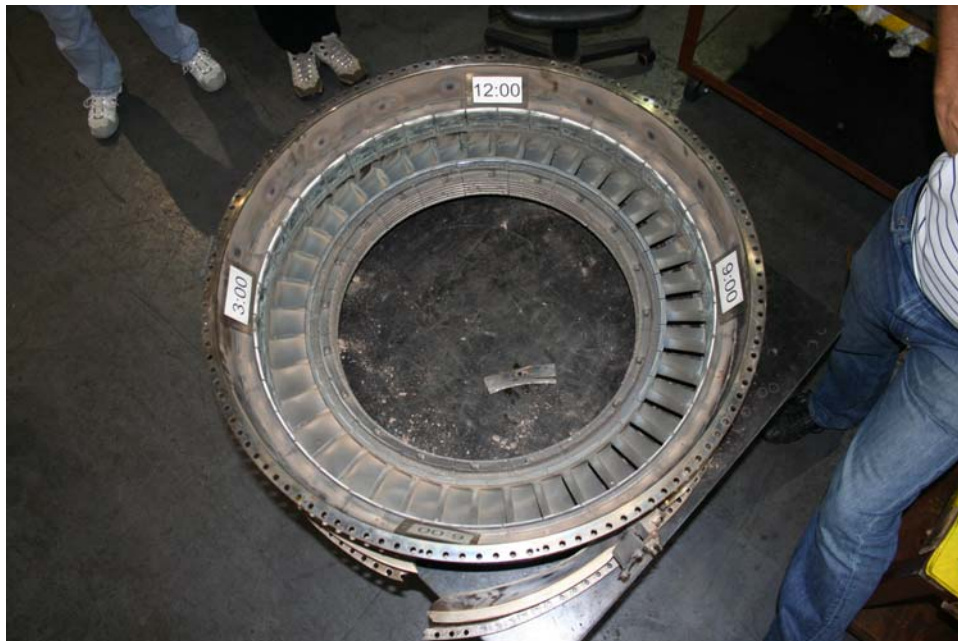
The 2nd stage turbine vanes were all in place in the HPT case. (Photo 13) There were several randomly located 2nd stage turbine vanes that had the rear flow guides missing. All of the other 2nd stage turbine vanes had circumferential scoring marks on the inner diameter of the rear flow guides. All of the 2nd stage turbine vanes had nicks and dents on the trailing edges and convex surfaces of the airfoil and the thermal barrier coating was chipped. The 2nd stage turbine vanes did not have any indications of burning or hot gas erosion.

Photo 13: 2nd stage turbine vanes all in place in the HPT case (P&W)

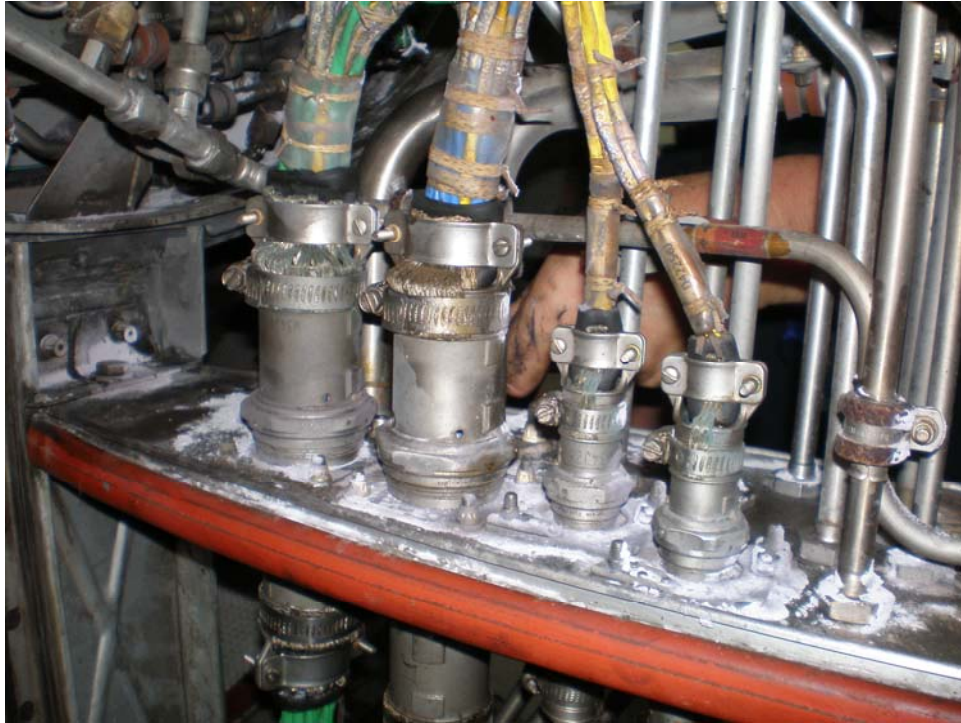
Photo 14: Close up of bifurcation panel showing dry chemical fire extinguishing agent

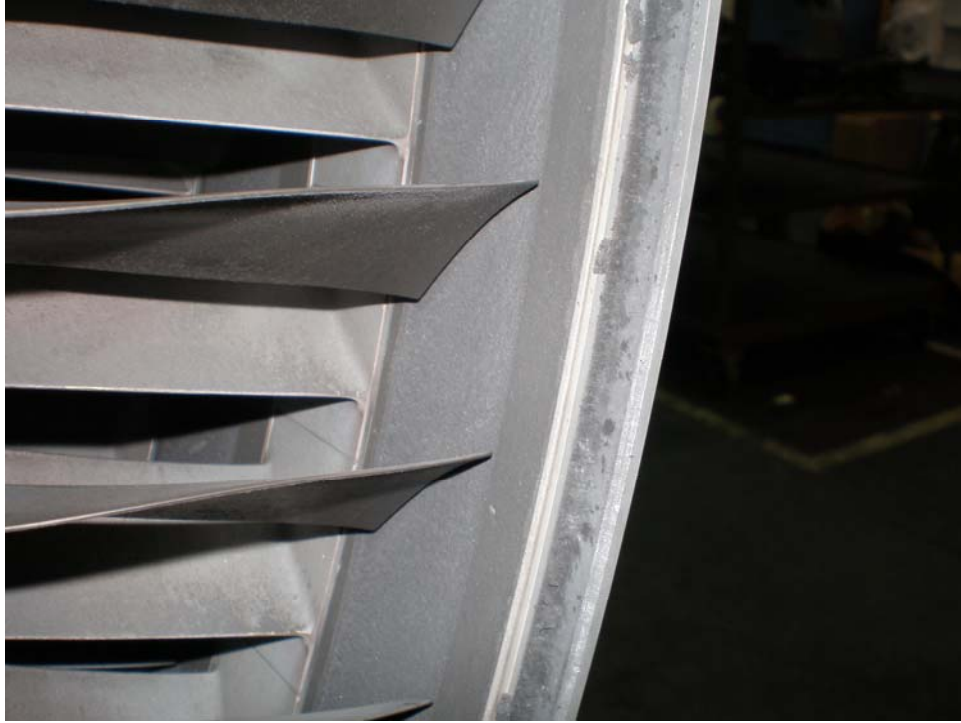
Photo 16: 5th stage compressor blades with groove worn in rub strip

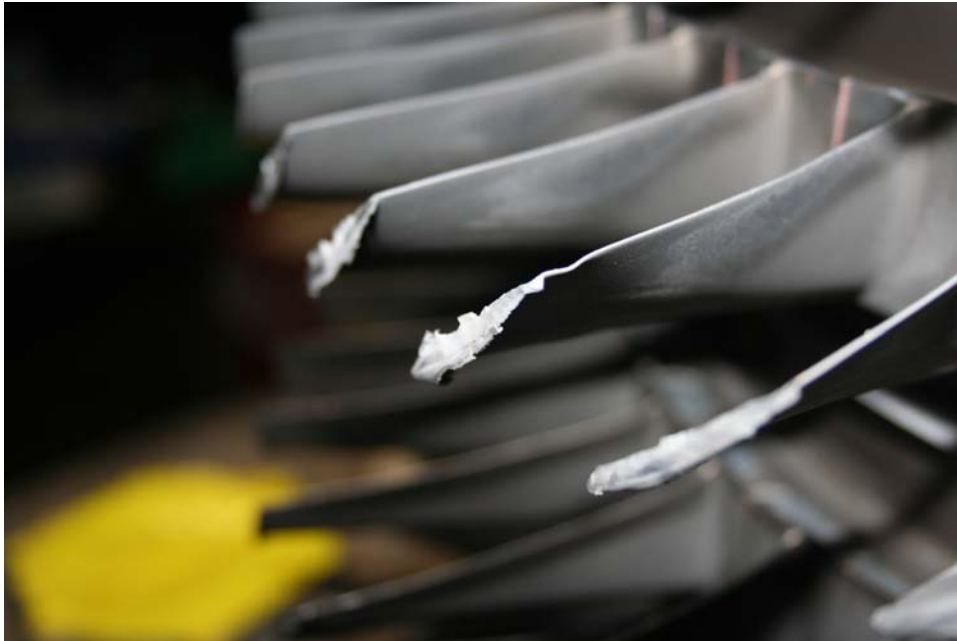
The tips of all of the 6th, 7th, 8th, and 9th stage compressor blades had circumferential rub marks. The 6th, 7th, 8th, and 9th stage compressor blades oriented towards the side of the rotor that had the missing 2nd stage turbine blades had the heaviest tip rubs with material displaced in both the direction of and away from rotation. (Photo 18) The 8th stage compressor blades were burned on the trailing edge tip corner between 7 and 1 o'clock. The 9th stage compressor blades were burned on the trailing edge tip corner between 8 and 2 o'clock. All of the 10th stage compressor blades were burned on the trailing edge tips corners. All of the 11th through 17th stage compressor blades were burned on the tips and leading and trailing edges that were progressively more severe towards the rear of the HPC. (Photo 19) There were several

Photo 18: 8<sup>th</sup> stage compressor blades showing displaced material on the tips (P&W)

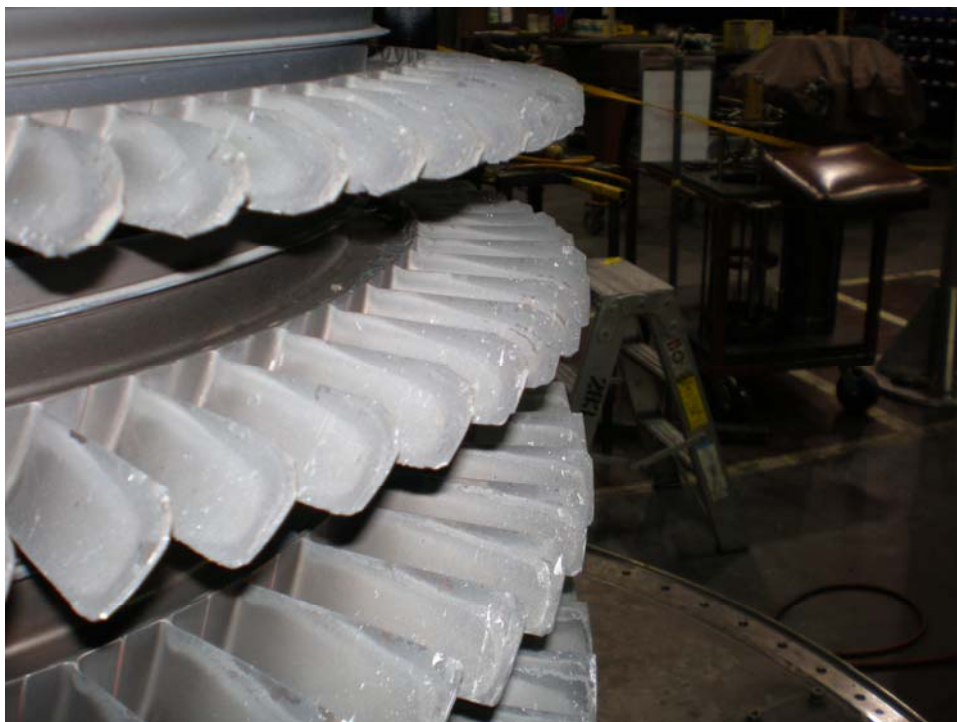
Photo 19: Burned compressor blade tips at rear of compressor

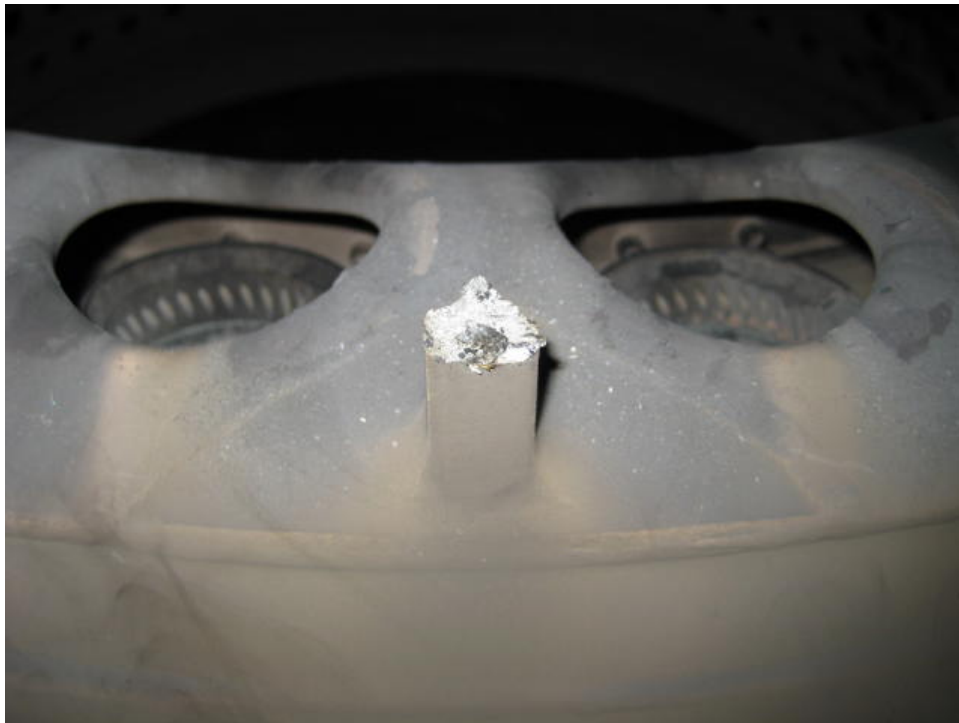
The combustor liner was in place in the diffuser case and the fuel nozzles were in place on the combustor liner. The combustor liner was intact except for the mount lugs at 3, 5, 7, and 11 o'clock that were broken off, although only three of the broken lugs were recovered from within the diffuser case. (Photo 20) The lugs at 1 and 9 o'clock were cracked. The combustor liner had an axial crack in the 4th louver at 2 and 5:30 o'clock and axial cracks in the 3rd, 4th, and 5th louvers at 8:30 o'clock.<sup>24</sup> The aft edge of the 5th louver was buckled slightly inward at 8:30 o'clock. There were four fuel nozzle guides adjacent to the igniter plug ports that had erosion around the edges. The interior and exterior of the combustor liner had numerous small pieces of black-colored, irregular-shaped material located randomly around the liner. There was a non-uniform deposit of black soot on the exterior of the combustor dome. The thermal barrier coating was intact and there were no indications of a burn through or hot gas erosion.

Photo 20: Broken lug on combustor dome (Delta)

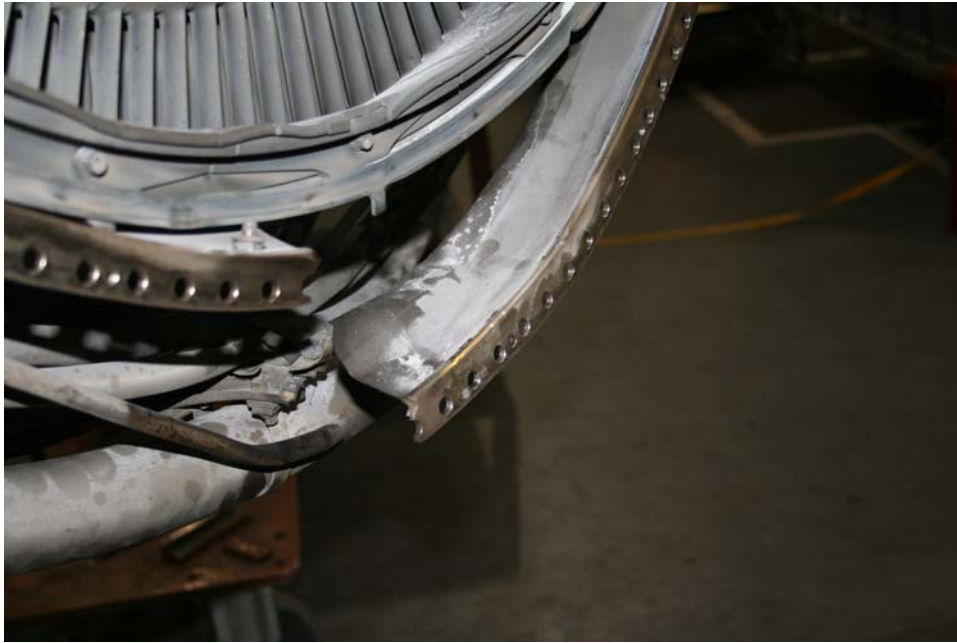
The LPT case was intact except for a 4-inch long axial crack from the front flange at 6 o'clock that progressed clockwise about 20 inches. (Photo 21) The flap of the fractured LPT case was displaced radially outward about 3 inches. The fractured surfaces of the LPT case matched. The three most forward LPT ACC tubes were bent aft at the bottom of the engine. The most forward LPT ACC tube was fractured.

Photo 21: View of LPT case showing displacement of fractured front flange (P&W)

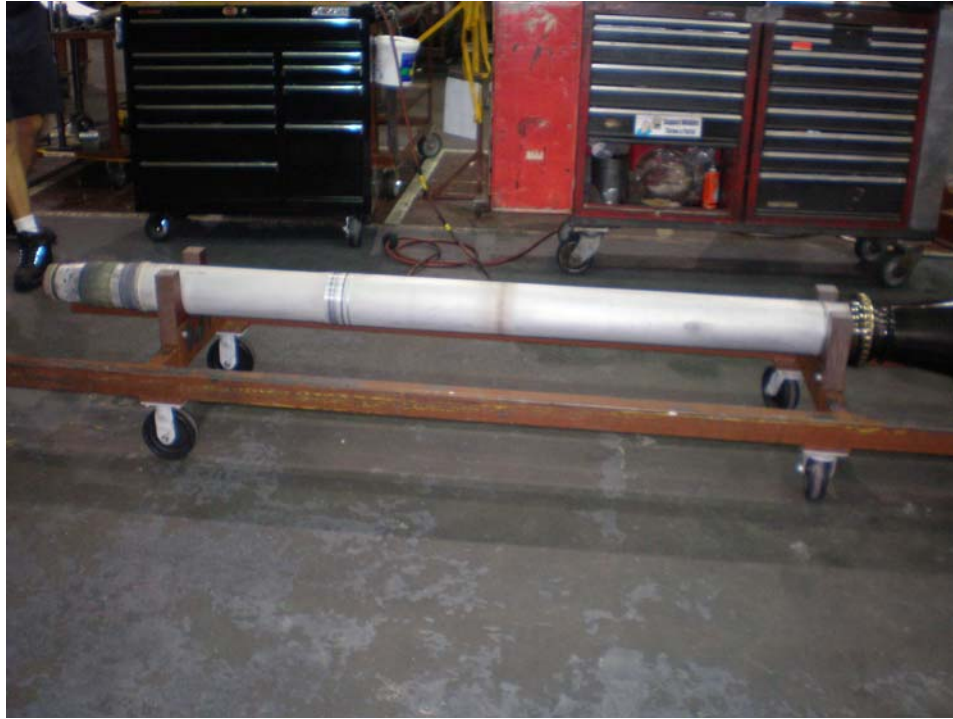
The LPT shaft was intact. The LPT shaft had four 360 degree circumferential rub marks. There was a 1/8-inch wide rub mark at 14 13/16 inches from the rear face, a 2-inch wide rub mark at 33 5/16 inches from the rear face, a 5/16-inch wide rub mark at 35 3/16 inches from the rear face, and a 1/8-inch wide rub mark at 84 1/2 inches from the rear face. (Photo 22) The 2-inch wide rub mark on the LPT shaft corresponded to the rub mark on the HPT shaft heat shield inner diameter.

Photo 22: LPT shaft showing various circumferential rub marks

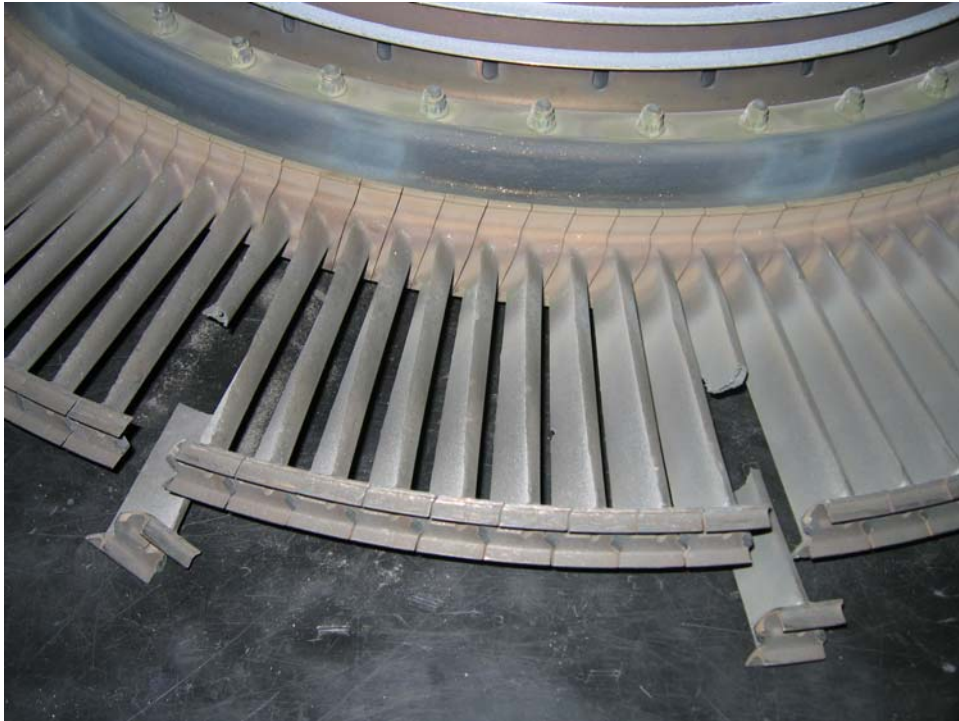
There were five randomly located 3rd stage turbine blades that were fractured between 1 7/8- and 3 1/4-inches above the blade root platform. (Refer to Photo 23.) The ends of four of the five fractured blades were found adjacent to the blade. There was one blade end that was not recovered. The fracture surfaces on all of the fractured blades were coarse and grainy. There were several 3rd stage turbine blades that had tears in the trailing edge with the material displaced opposite the direction of rotation. A piece of a 2nd stage turbine blade outer air seal segment was found in the 3rd stage turbine blade rotor.

Photo 23: 3rd stage turbine blades showing random broken blades (Boeing)

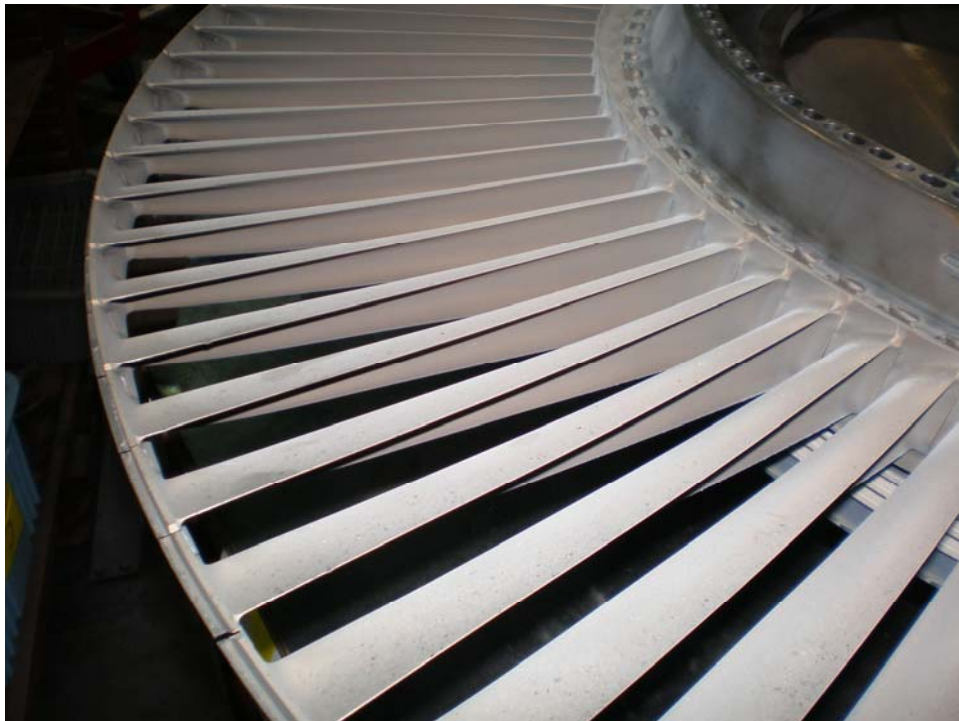
Photo 24: 4th stage turbine blades showing impact marks on airfoils

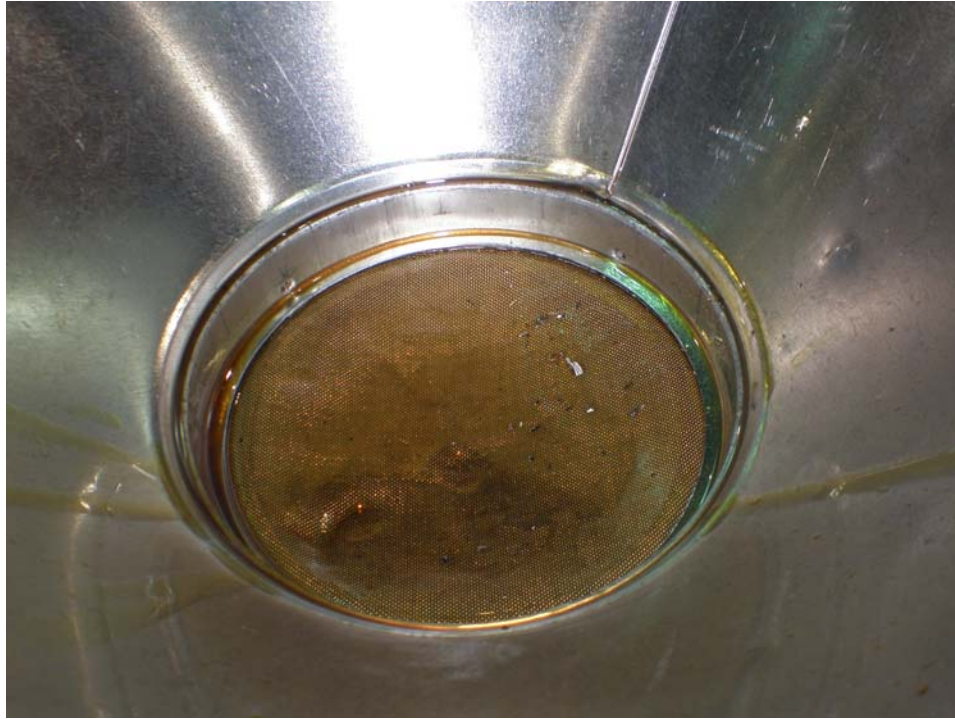
The oil in the oil tank was up to the bottom of the scupper. The oil was dark in color, but did not have an acrid odor. When the oil was drained from the tank through a screen, there were several small metallic shards collected in the screen. (Photo 26) When the oil was drained from the accessory gearbox, there was no debris collected in the screen. The oil filter had a few very small pieces of shiny metal and black-colored material in the filter element and there were several small pieces of shiny metal in the bottom of the filter bowl. (Photo 27)

Photo 26: Metal debris in screen from oil drained from engine oil tank

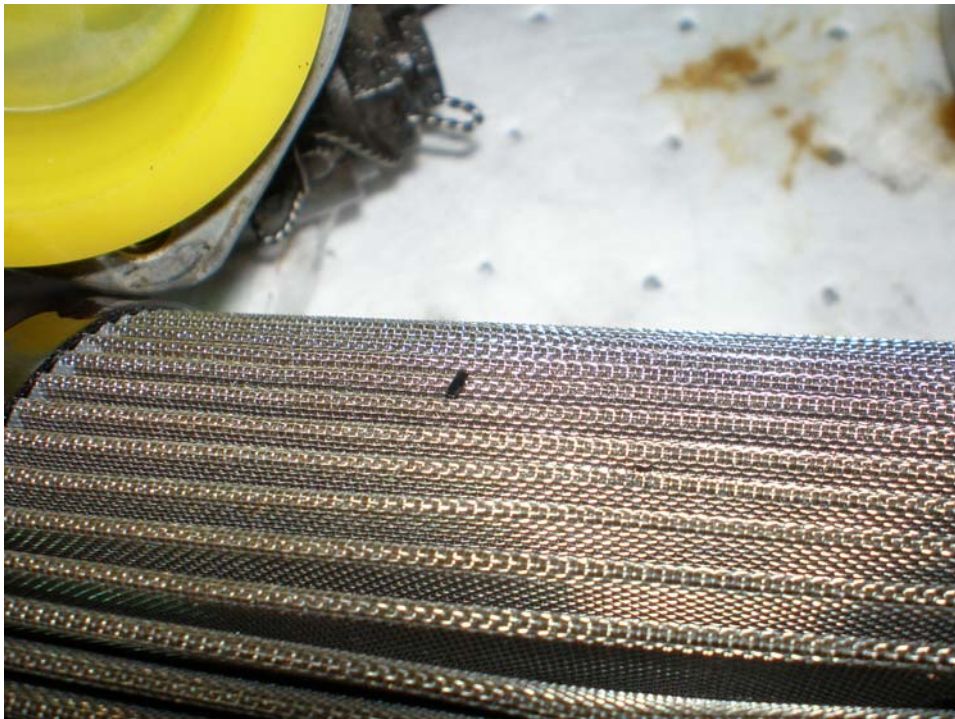
Photo 27: Debris in oil filter screen

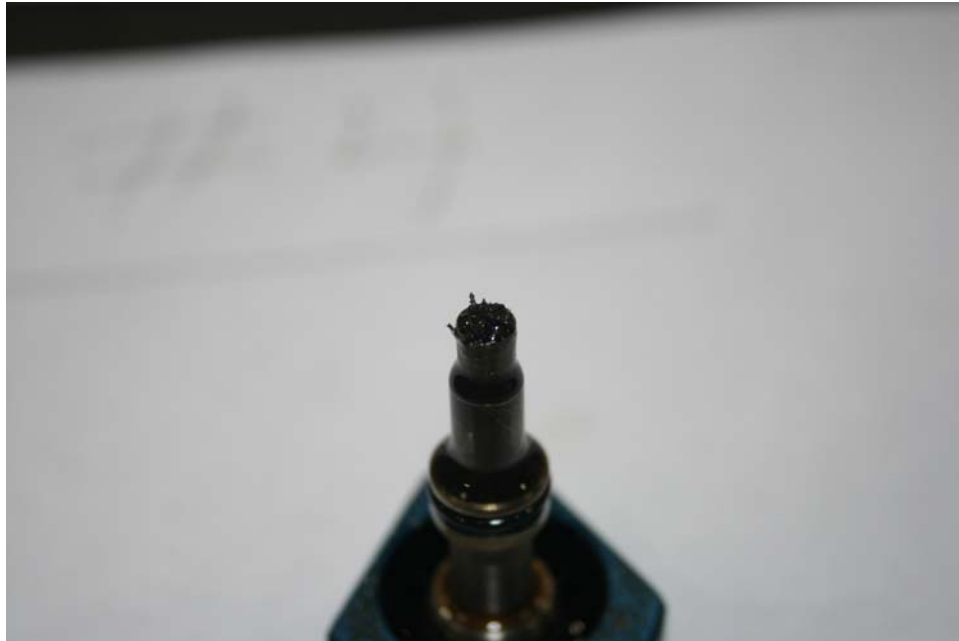
The magnetic chip detectors (MCD) were pulled. The MCD for the No. 4 bearing compartment had metallic fuzz around the perimeter of the plug. (Photo 28) The master MCD

Photo 28: Metallic material on No. 4 bearing MCD (P&W)

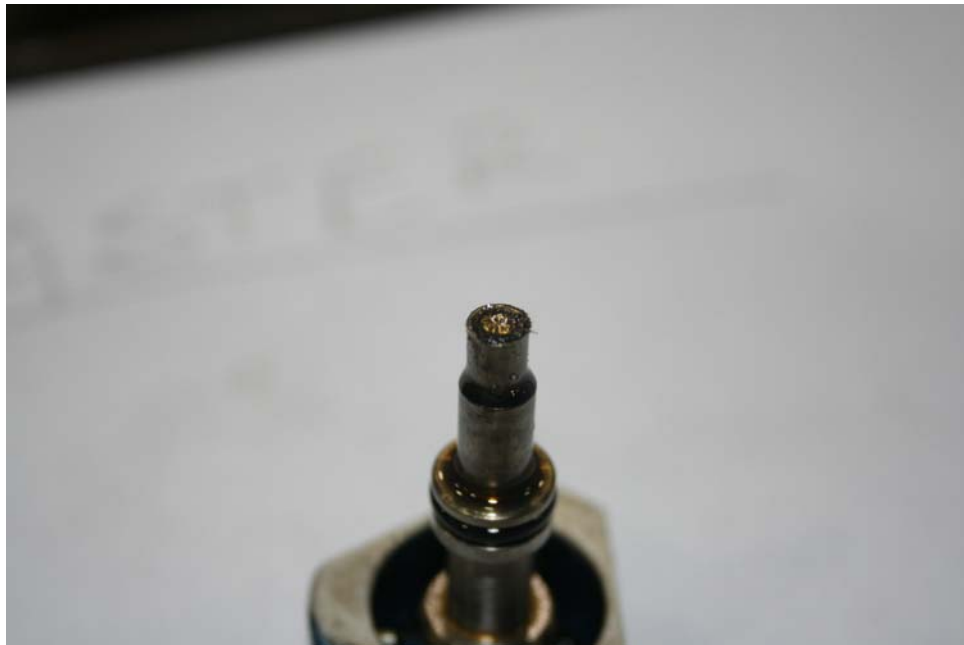
from the oil tank had a few small metallic shards on the tip. (Photo 29) The remaining MCDs did not have any debris on the plugs.

Photo 29: Metallic material on master MCD (P&W)

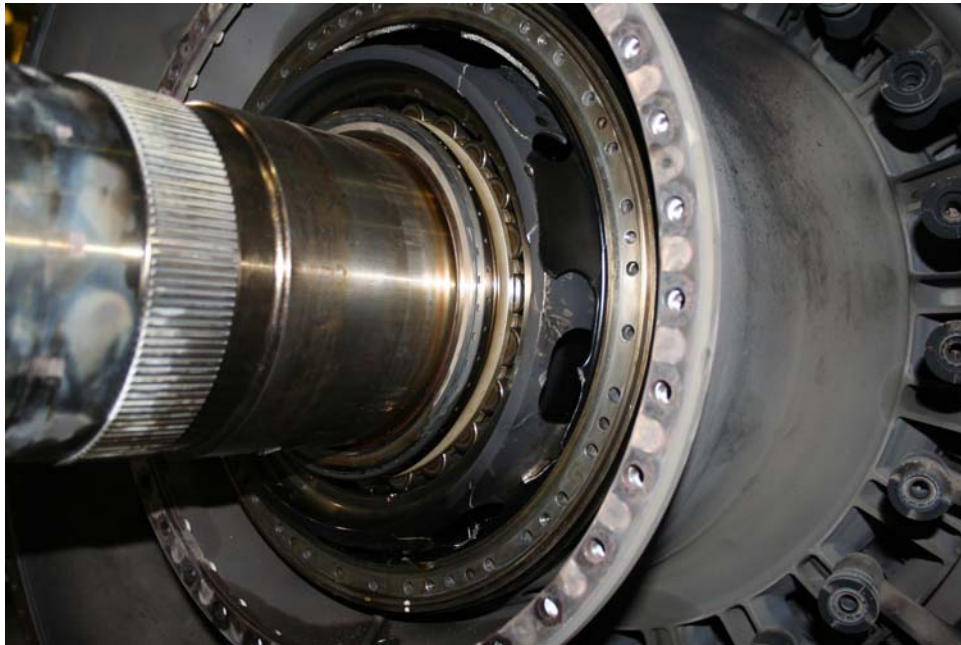
The No. 4 bearing housing cover was in place and intact. The interior surface of the No. 4 bearing housing cover had a black coating. The interior of the bearing housing also had an acrid smell. The No. 4 bearing support was broken through the race track slots 360 degrees around and the aft end was rotated and telescoped through the forward end. The No. 4 bearing was intact and wet with oil, but the ends of the rollers had rotational scoring. (Photo 30)

Photo 30: No. 4 bearing showing roller ends and broken housing (P&W)

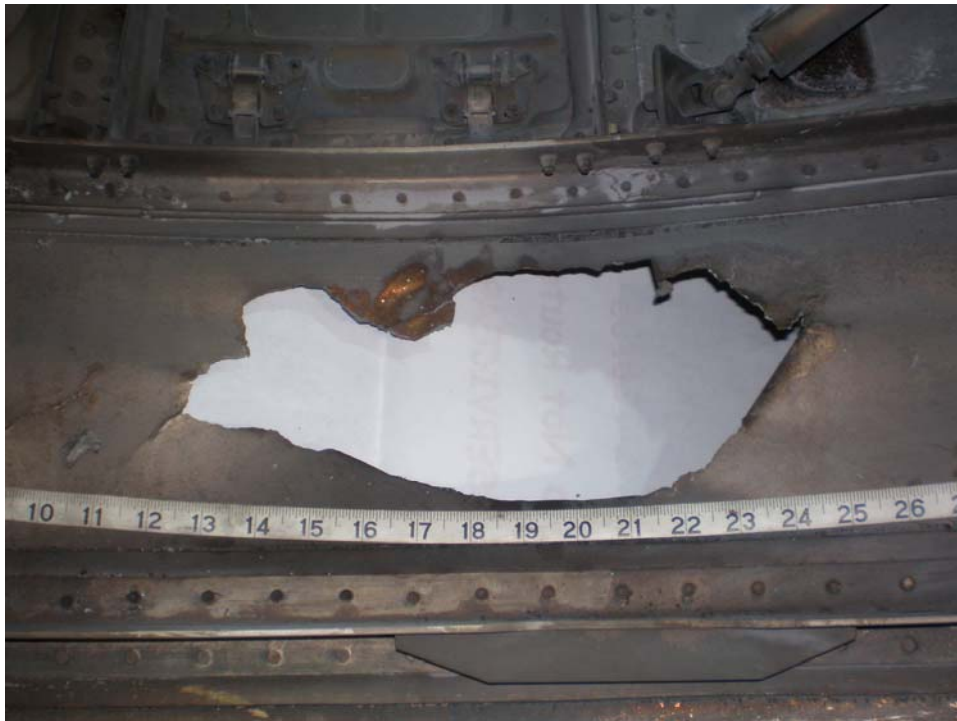
The left side core cowl had a 12 3/4-inch long circumferential by 5-inch wide axial hole at about 8 o'clock, 19-inches forward of the rear flange, centered between the ribs. (Photo 31) There was a 5-inch long circumferential crack at 8:30 o'clock in line with the hole. The core cowl was buckled on either side of the crack and hole. The total length of the damaged area was about 22-inches long. There were no indications of an under cowl fire. The latches and hinges were intact.

Photo 31: Hole in left core cowl
