**NATIONAL TRANSPORTATION SAFETY BOARD
OFFICE OF AVIATION SAFETY
WASHINGTON, D.C. 20594**

Powerplant Group Chairman's Engine Factual Report

NTSB ID No.: DCA-07-MA-310

Aircraft: American Airlines McDonnell Douglas DC-9-82 (MD-82), N454AA, Flight 1400

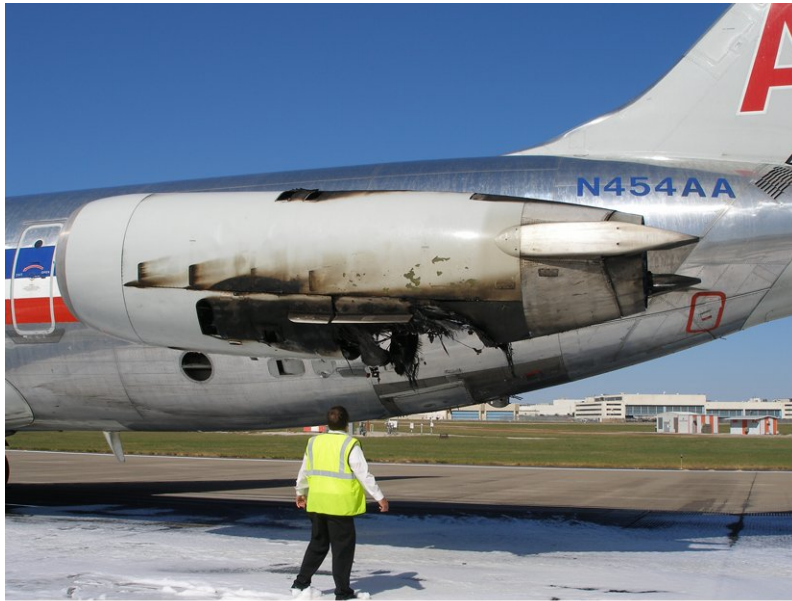
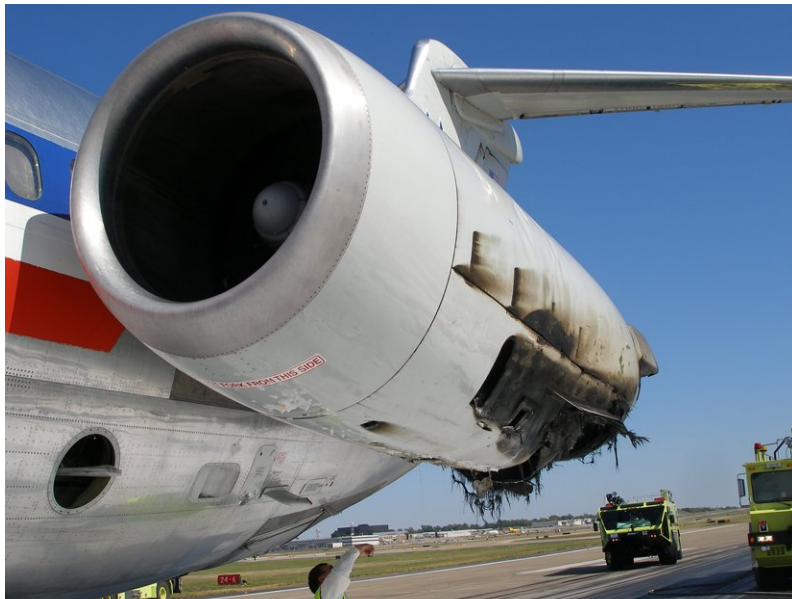
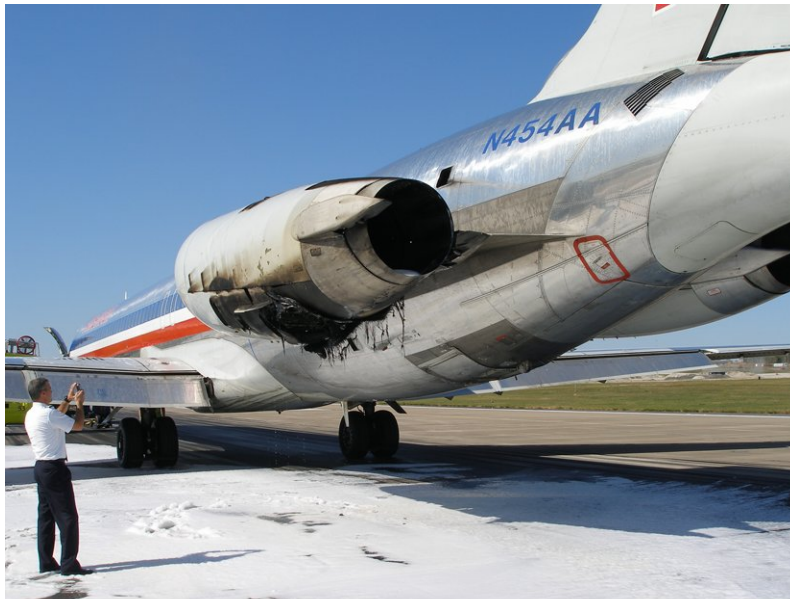
An overall view of the nacelle damage is seen on [Figure 1](#), [Figure 2](#) & [Figure 3](#). The upper cowl door, which is of a composite construction was burned and delaminated. Some of the skin panel was separated from the stiffening ribs. In several areas, no resin remained. The damage was most severe over the axial center third of the cowl with the outer thirds exhibiting mostly a sooty coating. The inside of the cowl from the aft nacelle seal rearward was clean of soot and undamaged. The outer surfaces of the cowl exhibited soot streaks consistent with the direction of airflow.

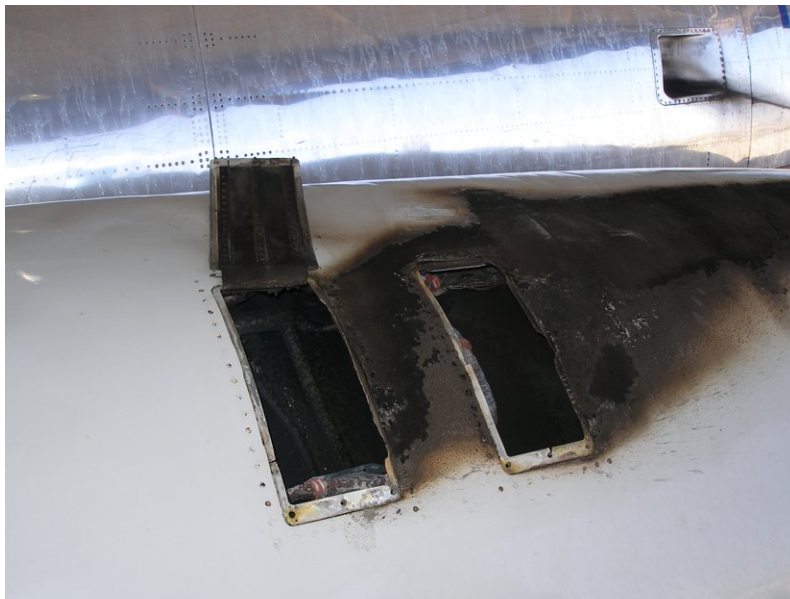
Figure 4 – Blow-out doors

The upper cowl door features two blow-out panels that limit internal nacelle pressure during sudden overpressure conditions by popping open ([Figure 4](#)). The forward blow-out door was open and still attached via the hinge to the cowl door and the hinge was bent aft. The aft blow-out door was not present; however, a section of its mating hinge was still attached to the cowl door and was melted. The outer surface of the cowl door displayed heat damage and sooting aft of each blow-out door.

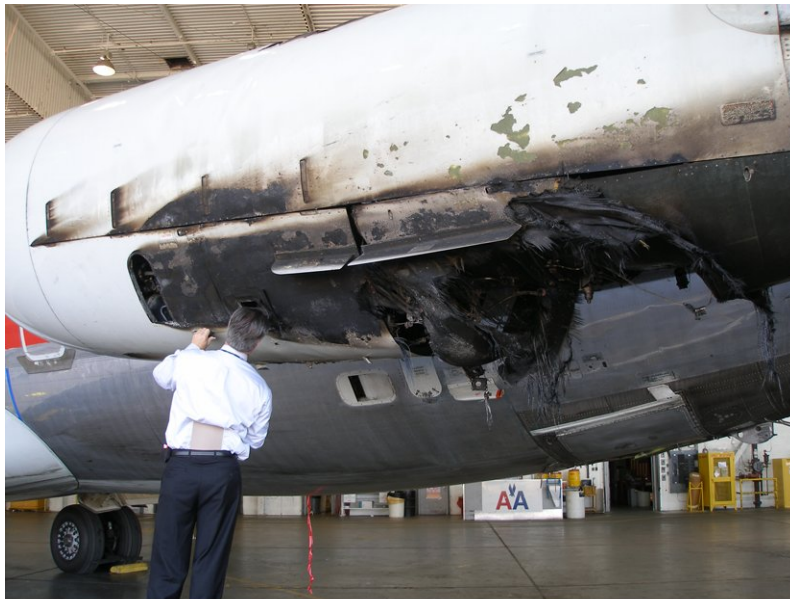
Figure 5 – Forward and aft lower cowl doors

The lower forward cowl door was burned ([Figure 5](#)). All of the stiffening ribs exhibited delamination, burning, and loss of resin material. The composite construction shell did not exhibit any punctures or holes. In several areas, no resin remained. The entire inside of the cowl exhibited a blackened sooty appearance. Re-solidified puddles of molten material interspersed with miscellaneous tube fittings, fasteners, and miscellaneous powerplant external ancillary hardware were found in the bottom of the cowl. The outer surfaces of the cowl exhibited soot streaks consistent with the direction of airflow. Nacelle access panels for the CSD, oil servicing, and ATSV were all liberated from the cowl door.

The lower aft cowl door ([Figure 5](#) & [Figure 6](#)) was burned forward of the aft nacelle seal. The cowl skins and stiffeners were not present over an estimated 80% of the door forward of the aft nacelle seal. The remaining material consisted mostly of frayed and delaminated composite fabric with some limited remnants of the stiffening ribs on the axial door split line located near the nacelle fasteners. The inside of the cowl from the aft nacelle seal rearward was clean of soot and undamaged.

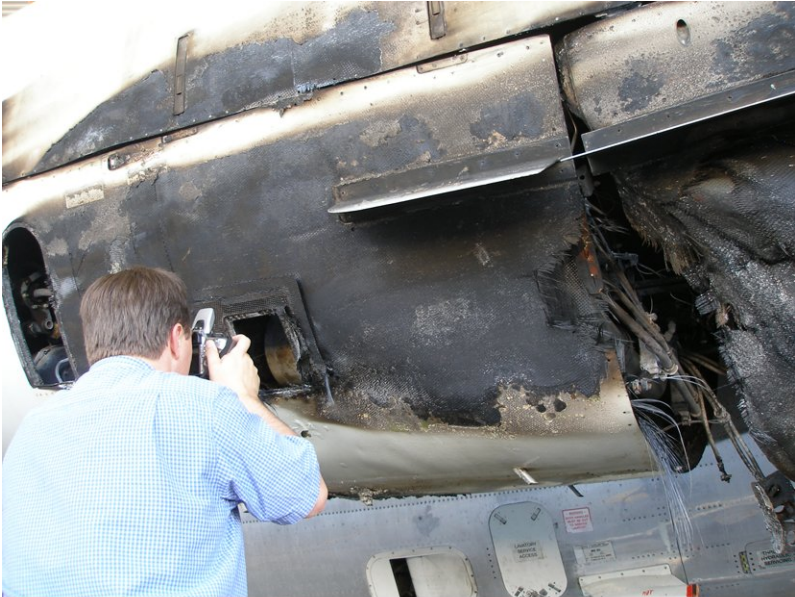
Figure 7 – Lower forward cowl door - detail

The lower forward cowl door ([Figure 7](#)) features three access panels: an oil service access panel, a CSD service access panel and an ATSV access panel. The oil service access panel was not present; however, a section of its mating hinge was still attached to the cowl door and was melted. The CSD service panel access and the ATSV

access panels were not present; however, a section of their melted hinges were still attached to the cowl door.

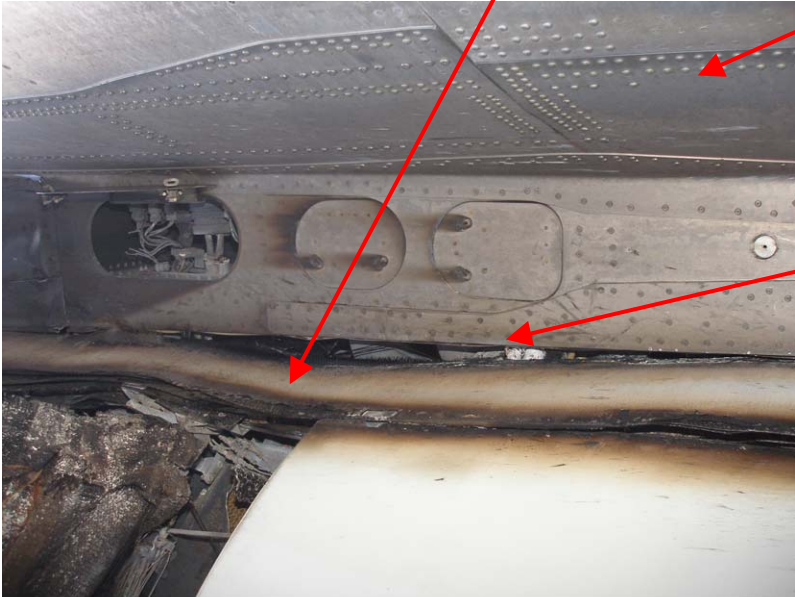
Figure 8 – Pylon close-out island – view looking up

The nacelle-to-pylon close-out island exhibited delamination, burning, and loss of resin material. The island panel was deformed, leaving a 1-inch wide gap between the pylon and the island panel (Figure 8).

1-inch gap

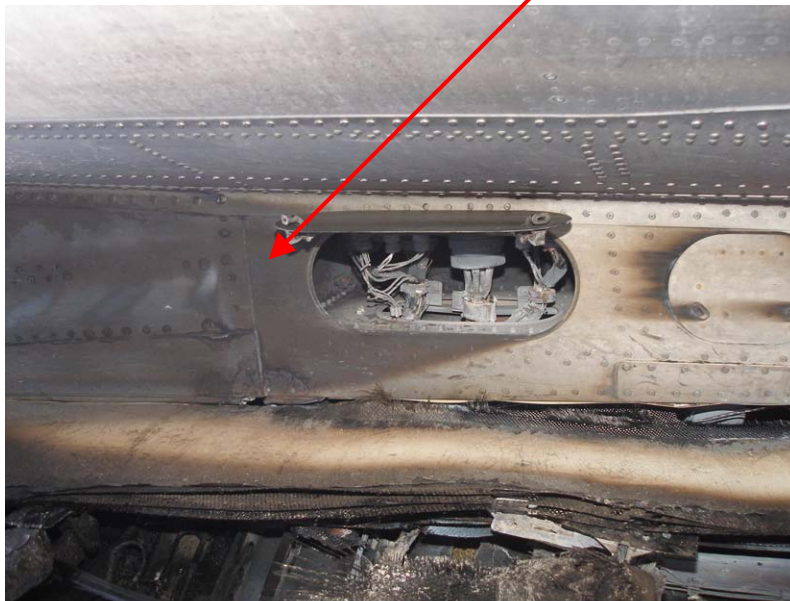
Soot was found on the inner surfaces of the left-hand pylon, which is beyond the nacelle firewall. Streaked soot patterns consistent with the direction of airflow were noted emanating from the panel joints along the lower surface of the pylon (Figure 9). The inside painted surface of the fuselage skin, normally a yellow colored zinc-chromate primer, was discolored to a light brown shade (Figure 10).

Figure 9 – Lower pylon surface – streaked soot pattern

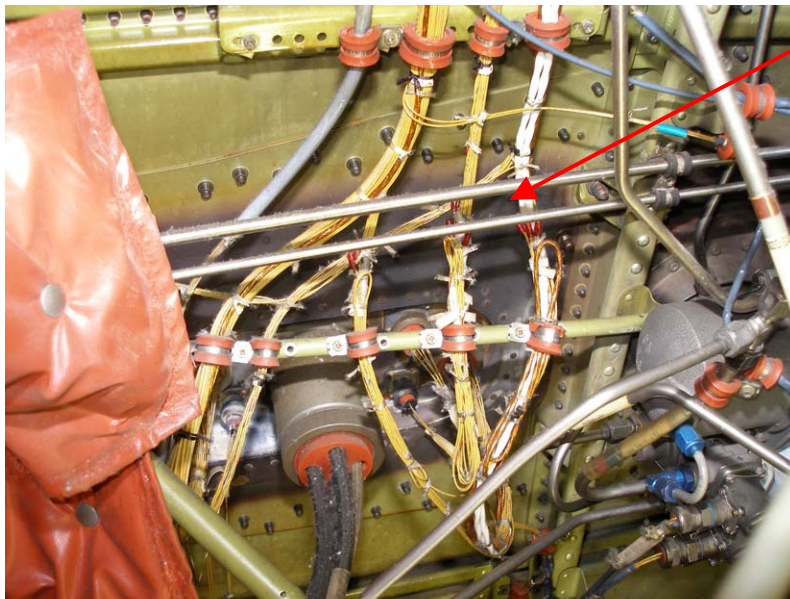
Figure 10 – Inner surface of fuselage skin at pylon interface

Brown discoloration

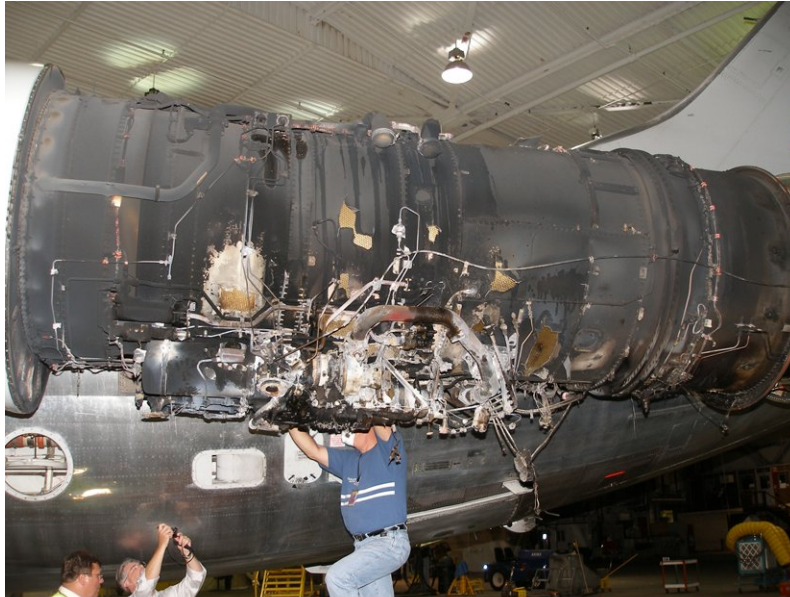
Figure 11 – Engine in-situ

The engine was in-place on its pylon (Figure 11). There were no indications of case rupture or uncontainment. The thrust reverser was in-place and intact on the engine. The reverser was in the stowed position.

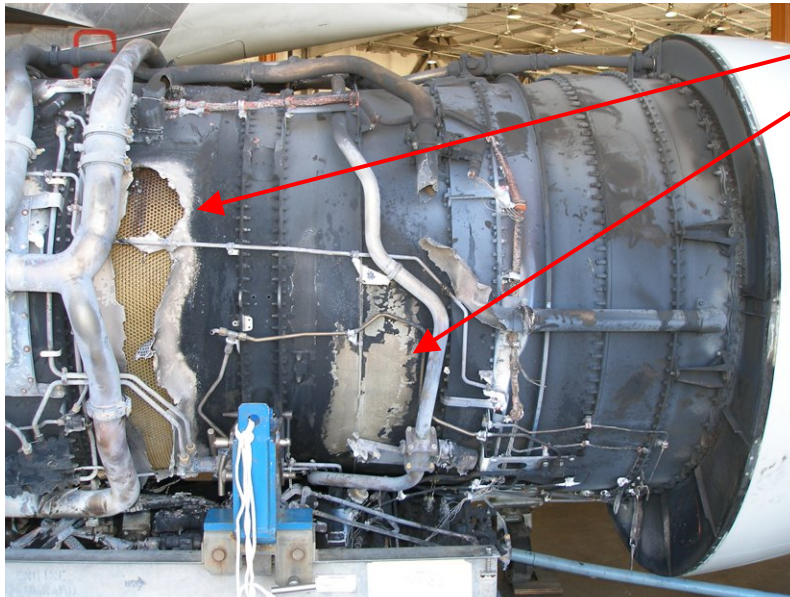
Figure 12 – Outer fan duct

The fan ducts exhibited distress to the outer face sheet of their honeycomb construction. The face sheet appeared to be melted and delaminated (Figure 12). No distress was noted in the underlying honeycomb cells. In areas where the outer face sheet was still in place there was a wavy appearance consistent with the face sheet being debonded from the honeycomb.

Melting and delamination of outer sheet of honeycomb

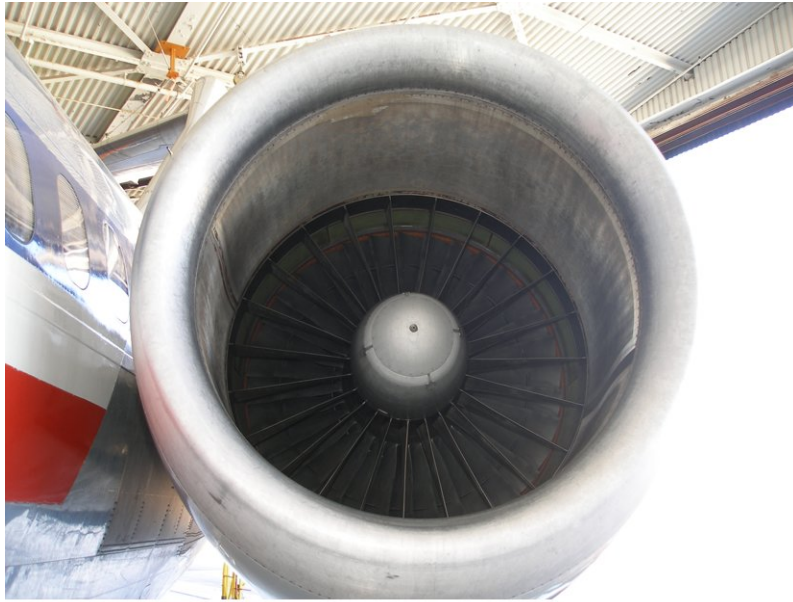
Figure 13 – Engine view from front

The nose bullet was in-place and intact on the engine with no noted distress. The inlet guide vanes were all in-place and intact with no noted distress (Figure 13). The fan blades were all in-place and intact. There were no indications of soft body² Foreign Object Damage (FOD) to the fan blades. The low pressure (LP) rotor rotated freely and smoothly by hand when turning the rotor by the fan blades.

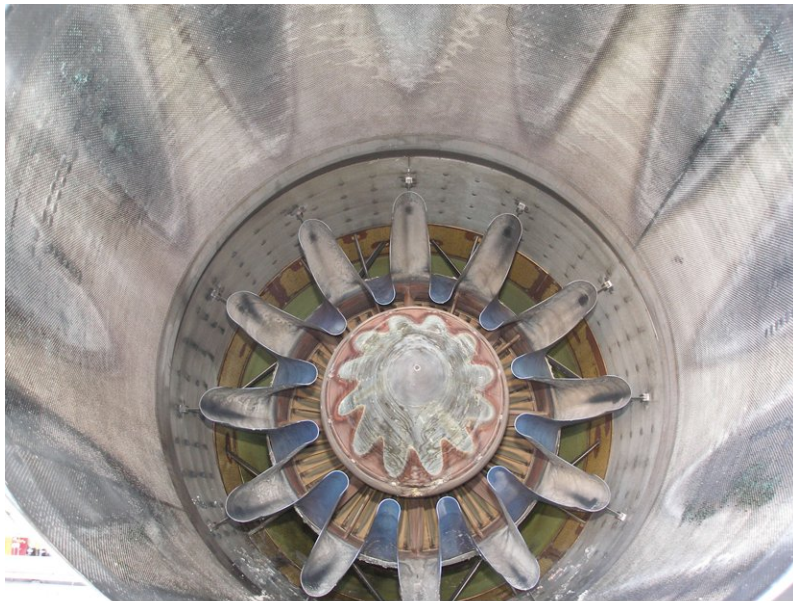
Figure 14 – Engine view from aft

The 4th stage turbine blades were all in-place and intact with no noted distress as viewed up the tailpipe of the engine (Figure 14). As viewed through the tailpipe there were no indications of heat distress or fire within the engine fan ducts. The tailplug was in-place and intact with no noted distress. The lobed mixer was in-place and intact with no noted distress or signs of sooting.

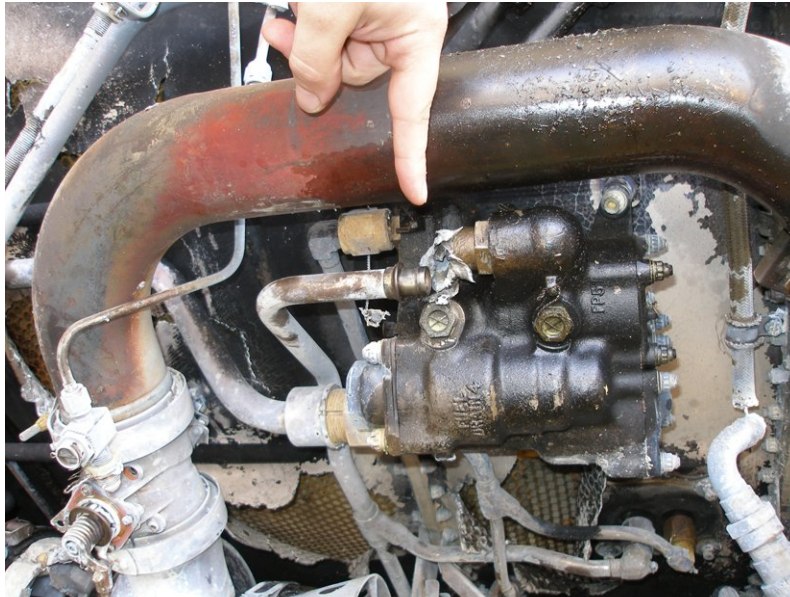
Figure 15 – Pressurization & Dump valve

The Pressurization and Dump (P&D) valve (Figure 15) was in-place and intact on the engine. The aluminum B-nut and adapter associated with the fuel line from the FP5 port were melted and the fuel line was separated from the P&D valve. The supply line and output line from the FP4 port were both in-place and secured to the P&D valve.

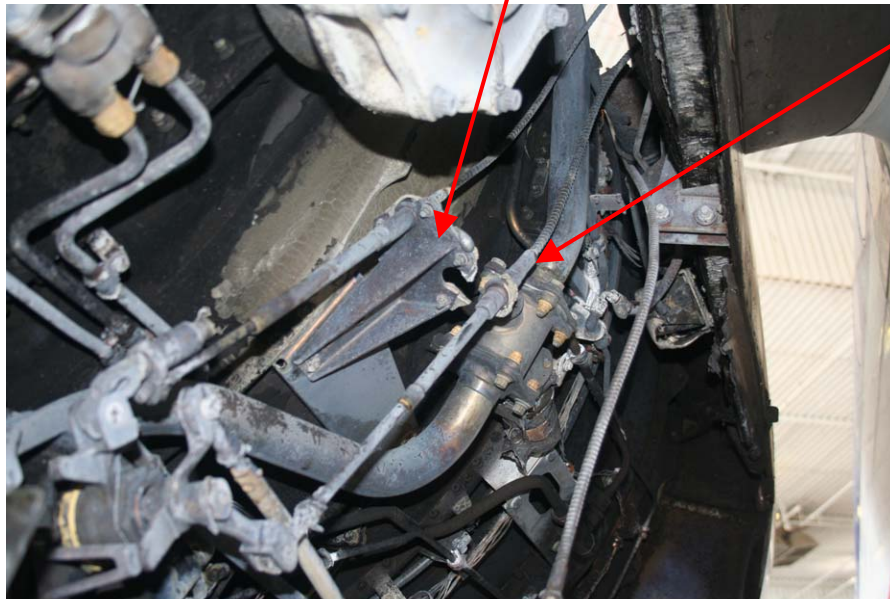
Figure 16 – Throttle cable bracket

Throttle cable disconnected

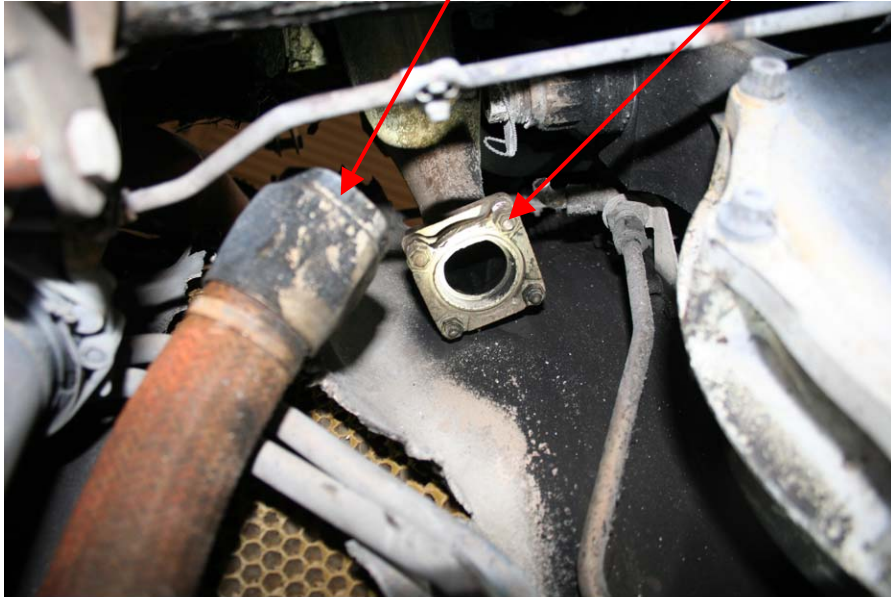
Figure 17 – Main engine fuel line – melted from flange

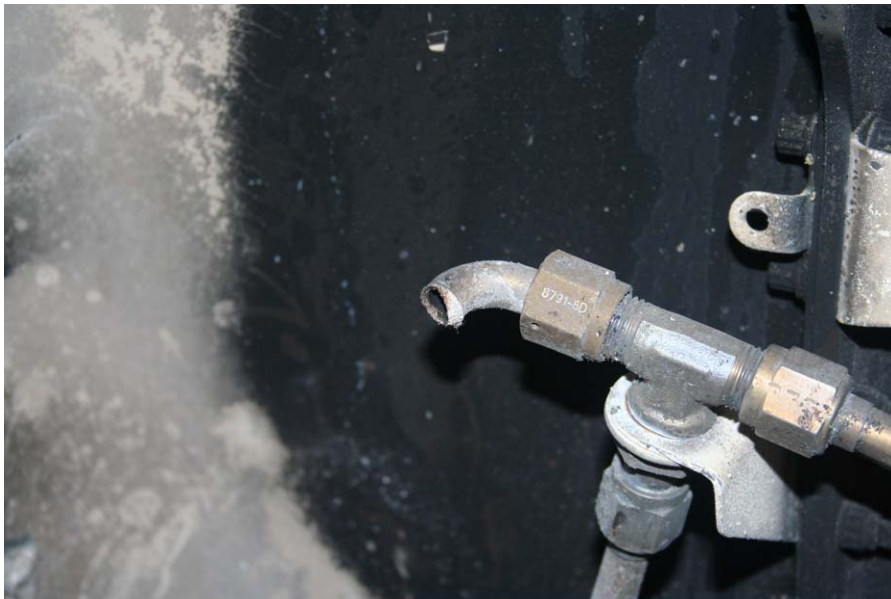
Figure 18 – Fuel line separated

A fuel vapor vent line was separated at the 3 o'clock location on the engine in the axial plane of G-flange (Figure 18). The exposed end of the tube exhibited damage consistent with thermal distress. The flexible hose end of this tube assembly had separated and was found resting on a tube below.

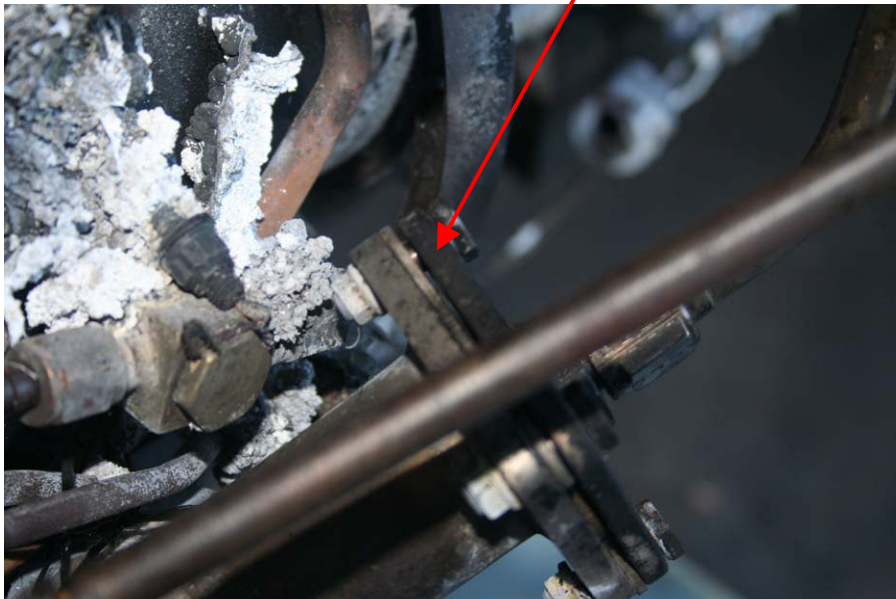
Figure 19 – Fuel bridle flange gap

A gap was observed on the four-bolt flange of the left-hand side fuel bridle between the bridle and the close-out plate (Figure 19). All 4 bolts and nuts were present but the washers under the nuts on the bottom side of the joint were not. Circular witness marks that were a larger diameter than the nuts were found on the underside of the flange. The washers are made of aluminum. The gap width between the fuel bridle and close-out plate was consistent with the thickness of a washer. Before the flange was split, the run-on torque of the four clamping nuts was taken. The run-on torque was less than 5 in-lb for each nut. After disassembly, the nuts were run back onto the bolts by hand and resistance to hand torque was felt consistent with the presence of the anti-rotation feature of the nut. A metal gasket with a rubber sealing o-ring on either side is sandwiched between the fuel bridle and the close-out plate. The metal portion of the gasket was present; however, the rubber o-ring on both sides was missing but black rubber-like material was noted in the recess grooves where the o-ring would normally have been.

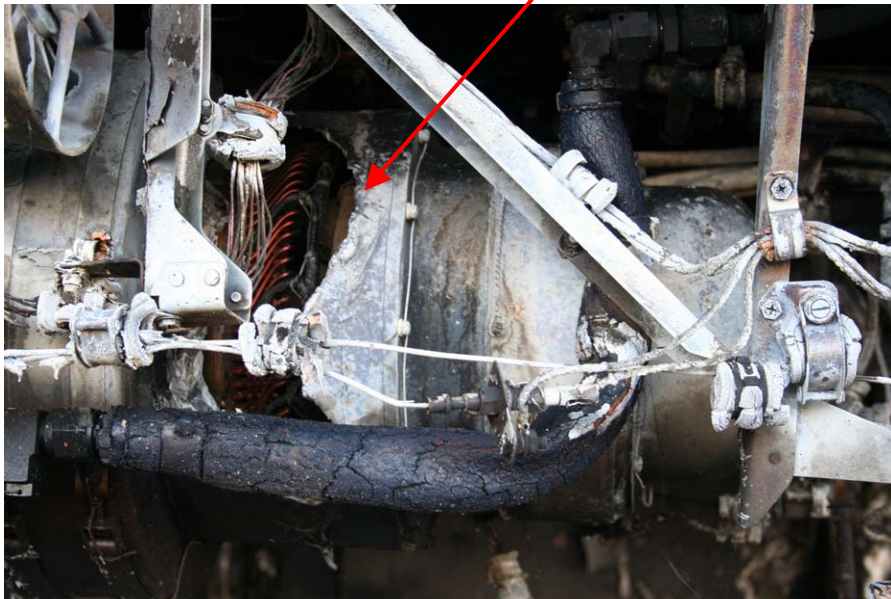
Figure 21 – AC generator housing breach

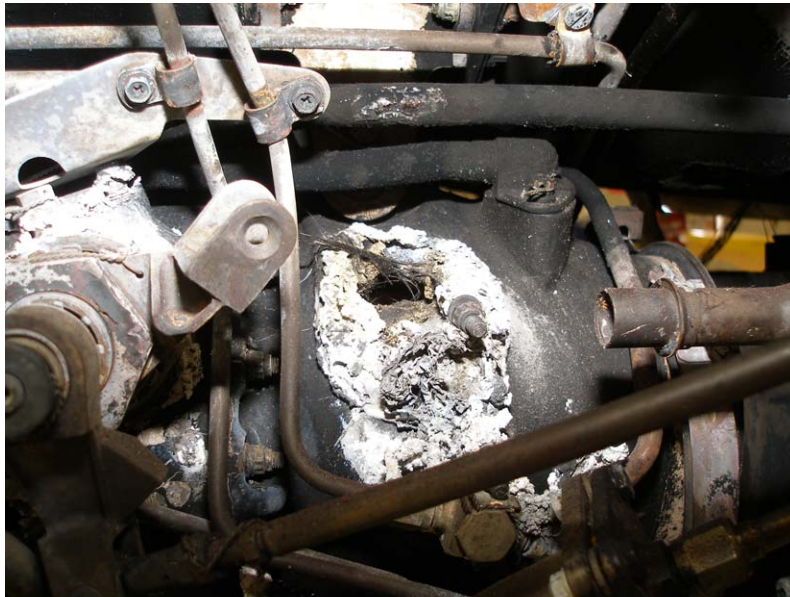
Figure 22 – AGB boss melted

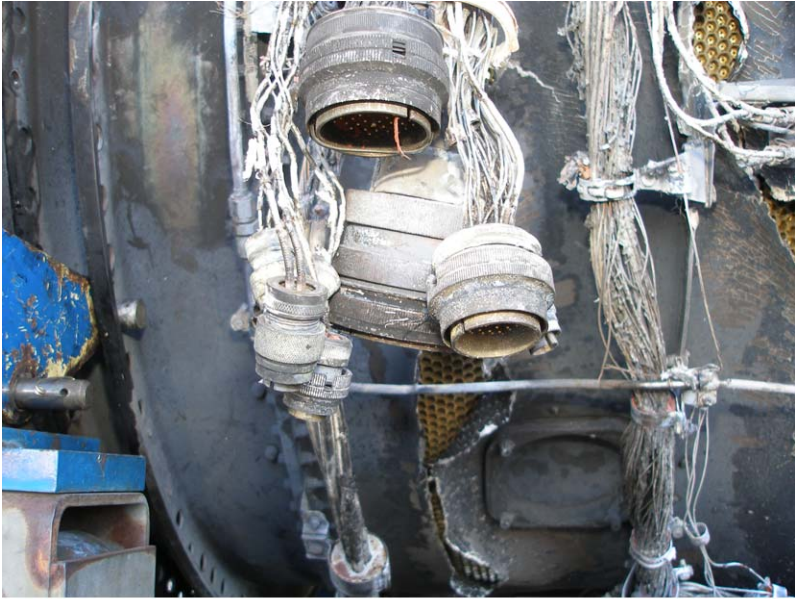
Figure 24 – Wiring harness & connector damage details

From the pylon connectors, the wiring harness routes vertically upwards until it reaches the top of the engine where it is fastened to a bracket. One wire bundle from the upper bracket attachment point then routes directly downward along the right side of the engine and at the 4 o'clock position it then turns forward and becomes distributed to the lower junction box and the Line Replaceable Units (LRUs) on the forward lower right engine area. All these lower wires were missing their insulation sleeves and were bare. A second wire bundle from the upper attachment point runs forward along the top of the engine. Near the front of the engine this bundle then becomes distributed into smaller bundles, which are then routed towards the bottom of the engine on the left side. There the smaller bundles are further distributed until single wires are visible and connect to their various plugs and connectors. Those bundles, which contained fewer than 20 wires near the bottom of the engine exhibited the most heat distress and were missing their insulation sheaths (Figure 24). Several connectors were missing, leaving loose bare wire ends.

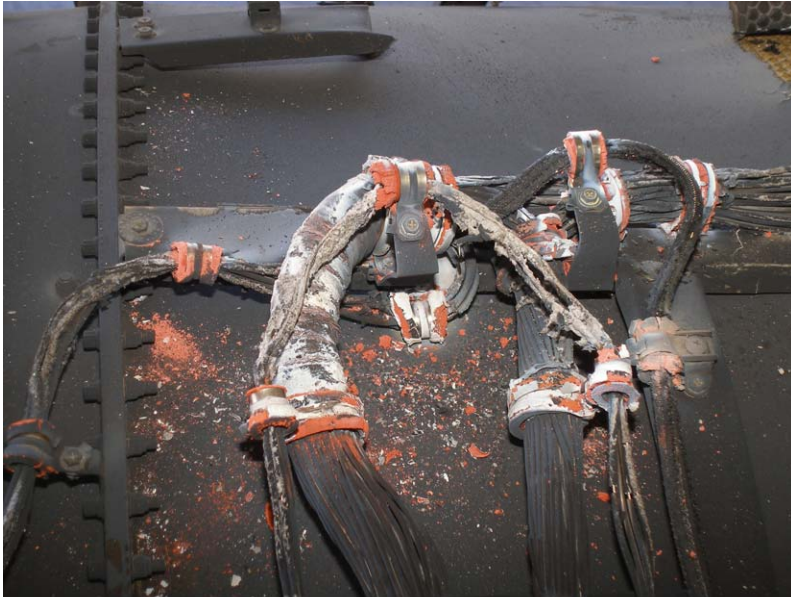
Figure 25 – Silicon rubber cushions in P-clamps

The silicon rubber cushions within the P-clamps on the externals and wire harness clamps exhibited charring, burning, and disintegration to the point where the wires routed through the clamps were observed to be loose within the remaining metal of the clamps (Figure 25).

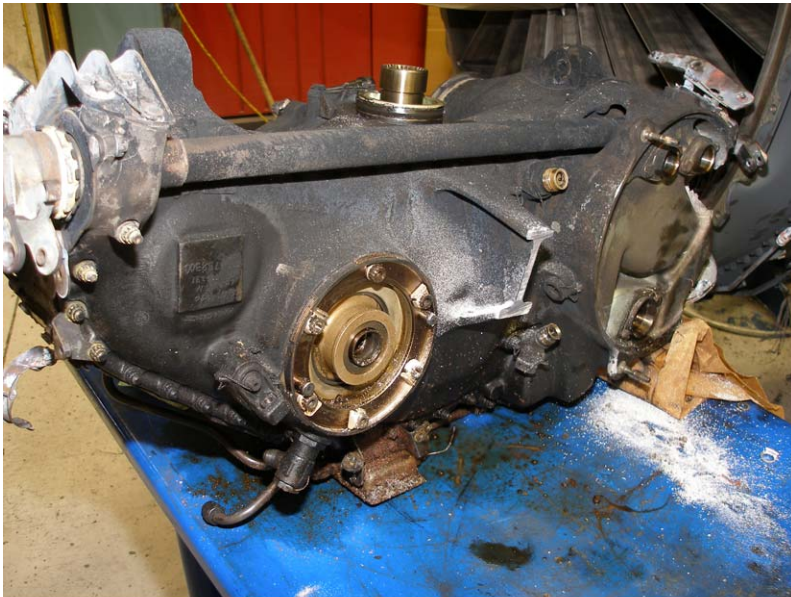
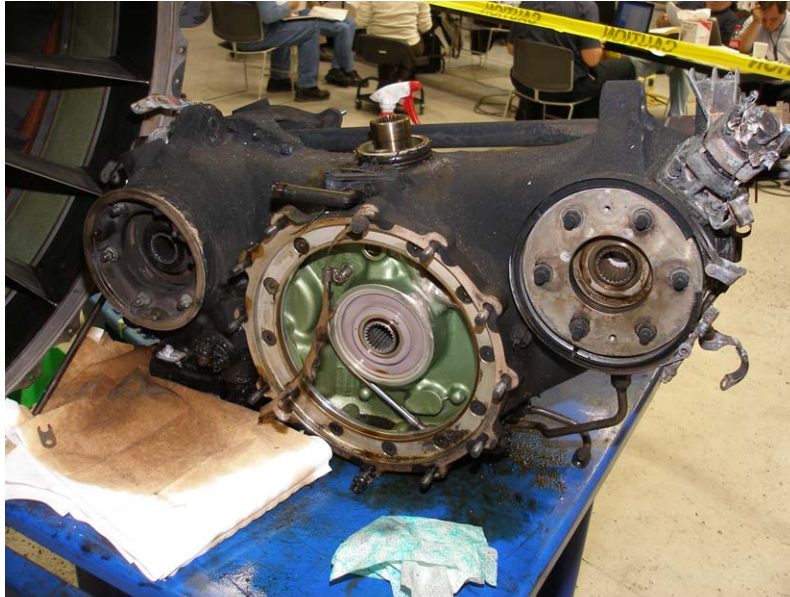
The accessory gearbox housing was coated with sooty deposits (Figure 26 & Figure 27). The accessory gearbox is supported in 3 locations by a forward and a left-hand and right-hand aft mount lug. The two aft mount lugs were visually intact. The forward mount lug was still in-place and attached to the gearbox but exhibited a crack that ran about $\frac{3}{4}$ of the perimeter of the lug at a location 1.6-inches aft of the forward face of the lug. The upper right-hand side of the gearbox housing exhibited multiple cracks and indications of insipient melting starting roughly in line with the bottom of the engine data plate and extending to the top of the gearbox right-hand side. The integral boss of the gearbox for the No. 4-5 bearing breather line and the aft area of the gearbox housing where the throttle linkage cross-over shaft exits the left-hand side was melted (Figure 22). The bolted-on aluminum elbow and the B-nut for the No. 4-5 bearing breather line were also melted away. The oil tank mount pad on the gearbox was melted from the 7:30-10:30 o'clock location including the mounting stud boss. The mounting areas for the oil tank and starter exhibited sooty deposits in the areas protected by those components. The soot deposit in the oil tank mounting area was a lighter shade compared to that of the starter location. The mounting areas for the CSD, FP, and hydraulic pump were clean in the areas protected by the in-position components.

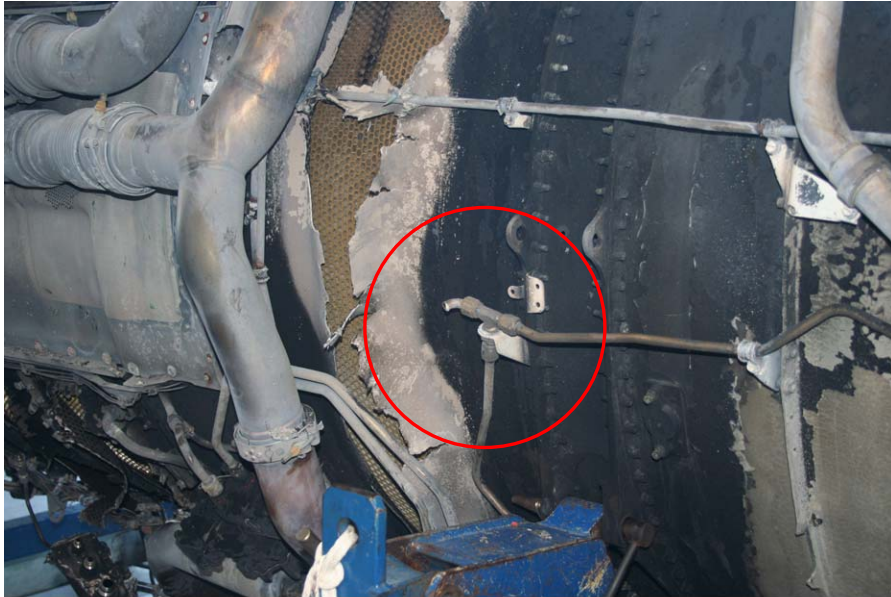
The pylon vapor vent line was found with the flex tube liberated (Figure 29). The 90-degree elbow remained attached to the engine side plumbing. The nut retaining the elbow was loose and could be removed by hand. Three fragments of the B-nut retaining the opposite end of the vapor vent flex line were identified among the debris in the lower forward cowl. A unique geometry and part number identified the nut. Each piece showed a distinctly varying degree of heat discoloration.

Figure 29 – Fractured fuel vent line

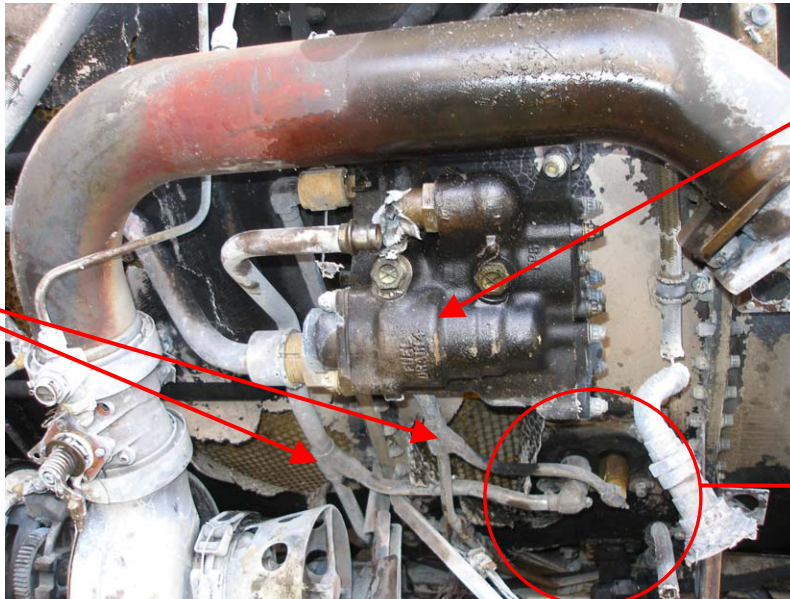
Figure 30 – Fuel manifolds

The fuel manifolds ([Figure 30](#)) could be moved by hand at the B-nut connections where the manifold passes through the outer fan duct. The amount of play was approximately 0.1-inch radial relative to the engine. This motion was found after removal of the P&D valve and present at all four fan duct penetration points (5 o'clock and 7 o'clock location for both the primary and secondary fuel manifolds). A pressure test of these manifolds detected a leaking condition at all four points. Dust consistent with degraded packing material was found after removal of all four of the B-nuts at the fuel manifold fan duct pass-through locations.

The P&D valve ([Figure 30](#)), P/N 766342, S/N 6155740, was in its correct location on the outer fan duct. The fan duct mount boss for the P&D Valve aft side lower mount lug was fractured. The fractured surface was flat.

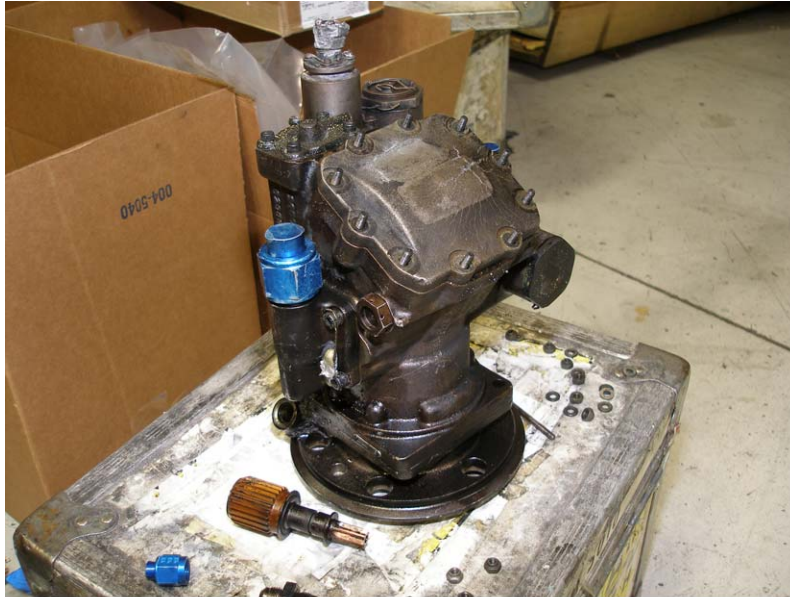
Figure 31 – Hydraulic pump

The engine-driven hydraulic pump ([Figure 31](#)) is a dual-range electrically depressurized variable displacement hydraulic pump. Outlet flow is 8.6 gallons per minute (GPM) at 3000 psi. The hydraulic pump was removed from the engine and examined in the American Airlines Hydraulic Shop. After cleaning, the following damage was noted:

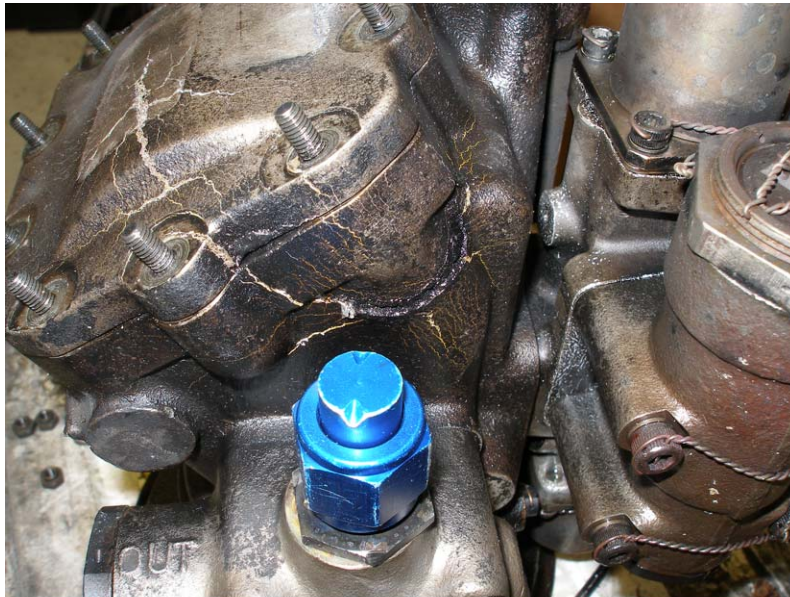
The rectangular shaped rear cover was distorted or bulged outward ([Figure 32](#)). The maximum deformation was at the lower half of the cover and near the centerline of the bottom edge. There were two major cracks and multiple thin “spider cracks” originating from this area of distortion. The two major cracks continued past the parting line and joined at one corner of the housing. A second fracture was also located in this area. A “coked” deposit consistent with overheated hydraulic fluid was on the interior of the rear cover as well as on the bottom interior of the housing. No internal mechanical damage was noted. No external fasteners were missing. The coupling shaft bolt was found loose. Two seals were found to be brittle, consistent with heat damage.

A source of hydraulic pressure was connected to the pump case drain connection. With approximately 20 psi applied, the housing emitted streams of fluid through the two fracture locations.

Figure 32 – Hydraulic pump fracture

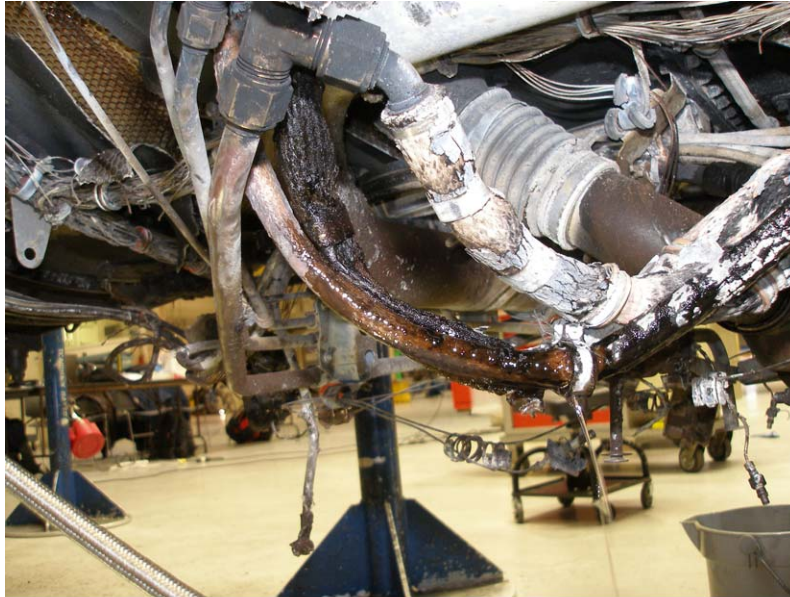
The hydraulic pump and hose assembly contained a small amount of burned hydraulic fluid. A hydraulic test unit was connected to the case-drain and pressure hoses and fluid was introduced to the system. Three leaks were identified at a very low-pressure setting ([Figure 33](#)). One leak was found on the pressure hose 3-inches below the bridge.

The second leak was found on the case drain hose at mid-length near a clamp that holds the fire sleeve onto the line. The third leak was found on the return hose and seepage was noted along the entire length.

Figure 33 – Hydraulic hose leaks
