**NATIONAL TRANSPORTATION SAFETY BOARD
OFFICE OF AVIATION SAFETY
WASHINGTON, D.C. 20594**

FACTUAL REPORT OF POWERPLANTS GROUP CHAIRMAN

NTSB ID: DCA12MA020

Location: 14 miles east of Las Vegas, Nevada
Date: December 7, 2011
Time: 1630 pacific standard time (PST)
Aircraft: Eurocopter AS-350-B2, S/N 2300, Reg. No. N37SH, Sundance Helicopters, Inc.

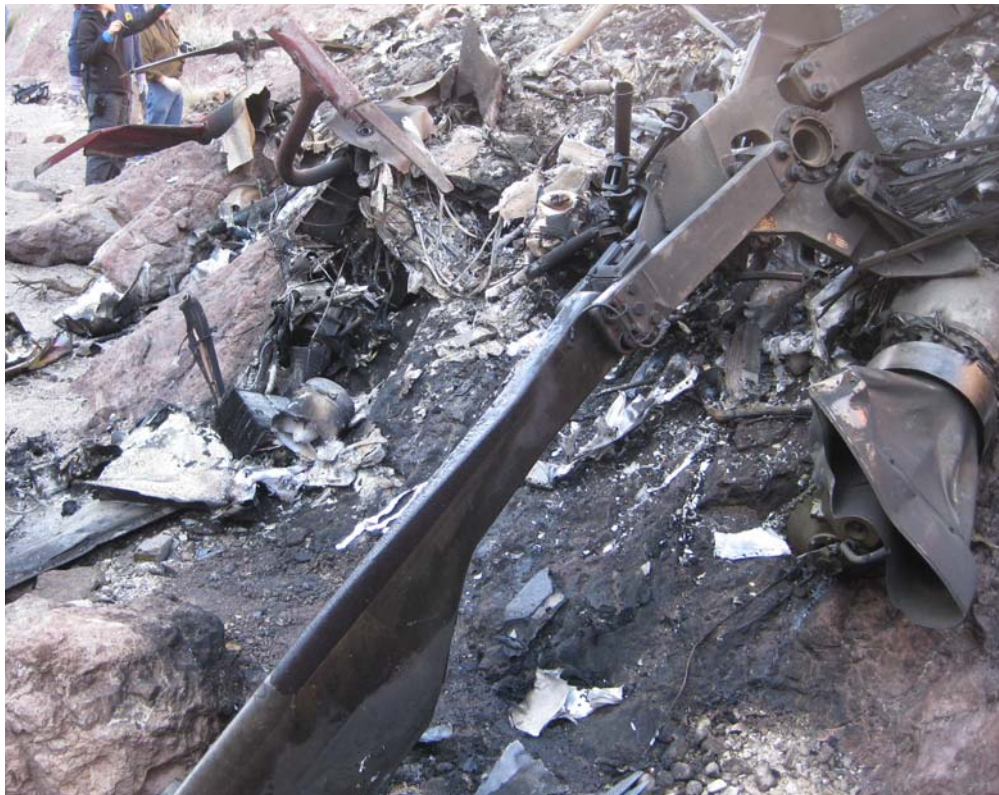
The aircraft fuel cell was fragmented, and much of the aircraft, including the tailboom and cabin, was consumed by fire. See Figure 1.

Figure 1. Aircraft wreckage

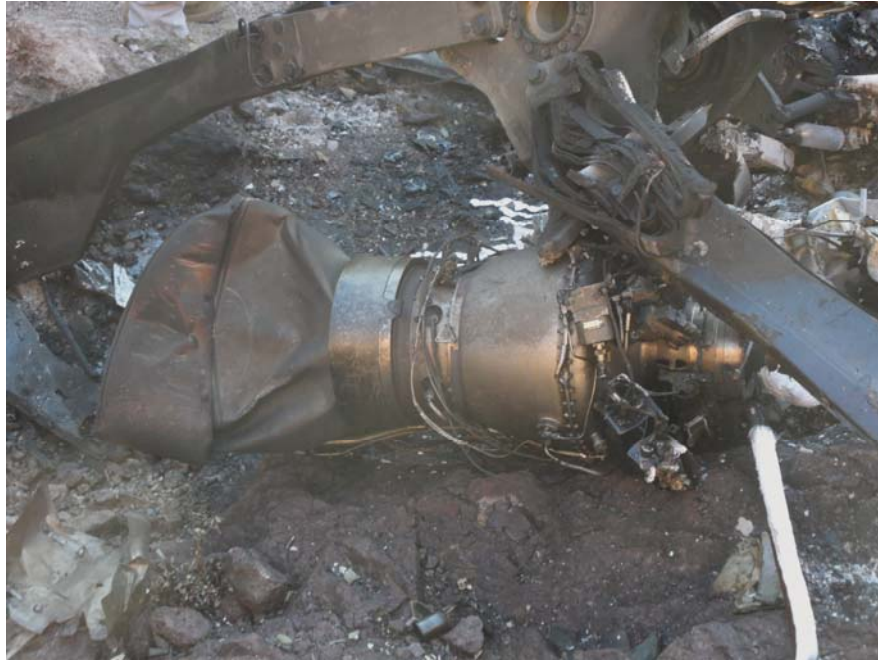
The engine was found in an upright position, near the main rotor head. See Figure 2.

Figure 2. Engine in debris field

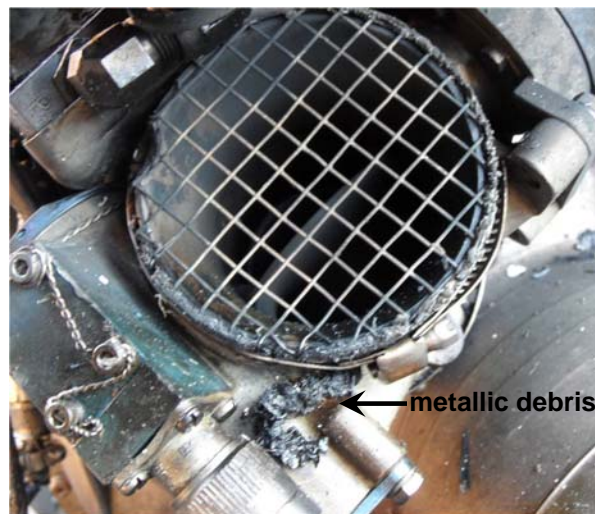
The engine data plate confirmed the engine model and serial number on record. The engine showed no evidence of in-flight fire. There was sooting on the axial compressor and thermal damage to external accessories, consistent with post-impact fire. The fuel control unit (FCU), the starter-generator, and the oil check valve were separated from the engine. There was severe thermal damage to the fuel inlet supply line, the engine wiring harness, the gas generator rear bearing chip detector, and the oil check valve. Metallic debris had collected at the bleed valve screen. See Figure 3. The location and appearance of the debris was consistent with material having been ingested by the engine during operation. The bleed valve screen was removed, and oil and debris similar to the debris noted at the bleed valve screen coated the inside of the valve housing.

Figure 3. Debris buildup at the bleed valve outlet

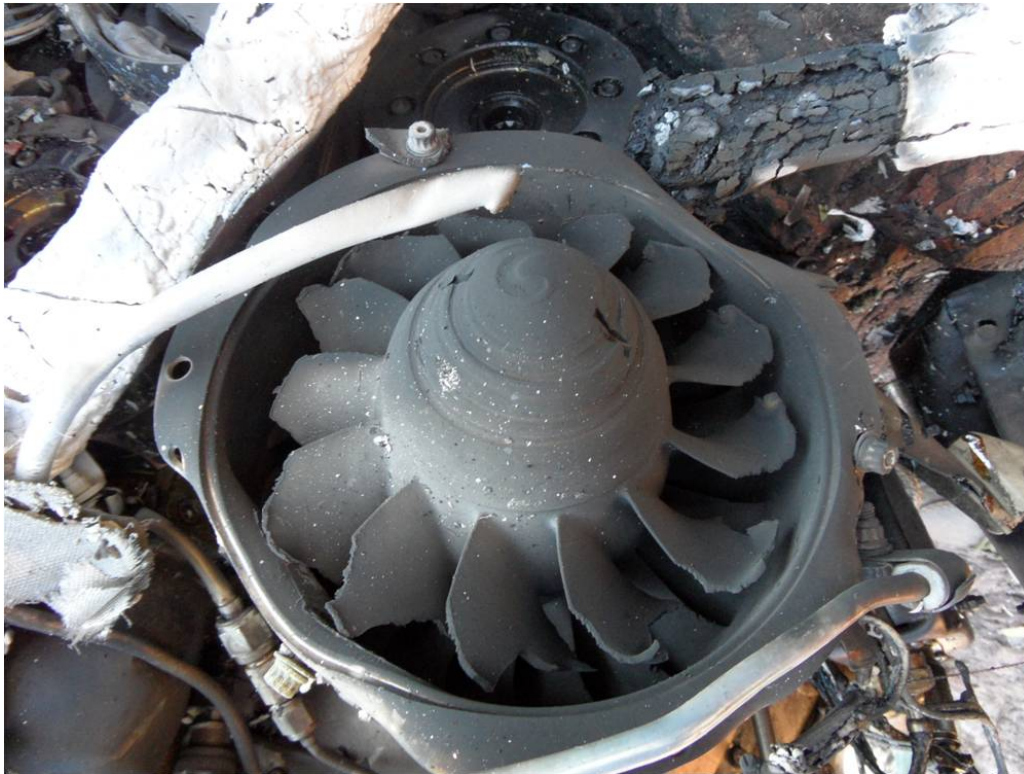
The axial compressor casing was deformed inwardly at 11 and 5 o'clock.³ See Figure 4. All of the axial compressor blades were battered and the blade tips were missing material; many of the blade tips were broken off.⁴ The remaining blade tip material was curled opposite to the direction of rotation. The casing deformation and blade tip breakage/curling were consistent with the compressor experiencing severe radial loading during engine operation. The battered condition of the axial compressor was consistent with the ingestion of objects into the engine inlet during operation. The compressor nose cone was heat damaged and exhibited scoring consistent with contact by a hard object while the engine was operating. The FCU was found separated from the engine and the FCU-to-overspeed and drain valve tube was fractured at the FCU end. The tube was deformed and a flattened area near the separated end of the tube was positioned close to the nose cone.

Figure 4. Engine inlet showing deformed compressor casing, severely damaged compressor axial stage, and circumferentially scored nose cone

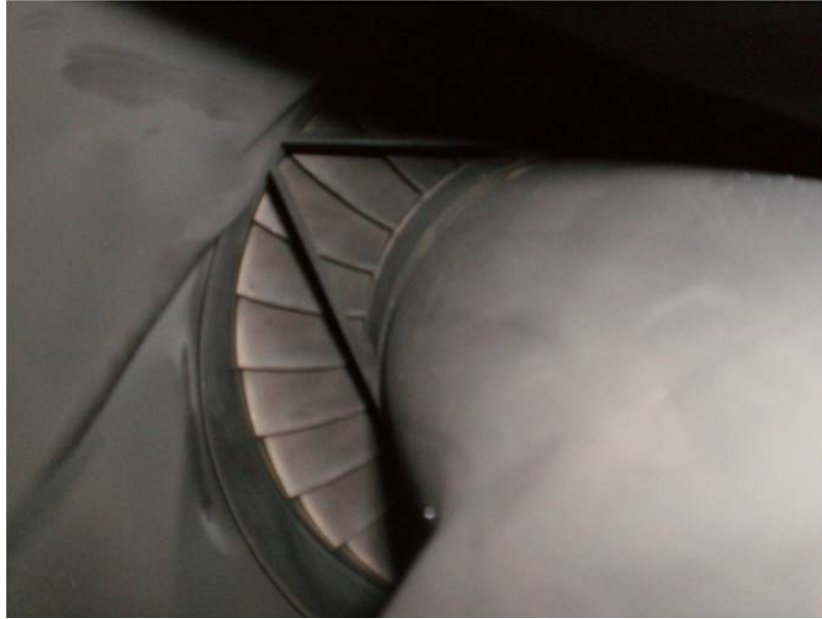
A segment of the power turbine (PT) was visible through the exhaust pipe, and was accessible by hand. See Figure 5. A tactile inspection of the rotor determined that all of the PT airfoils were intact, and that the rotor turned freely.

Figure 5. Power turbine viewed through exhaust

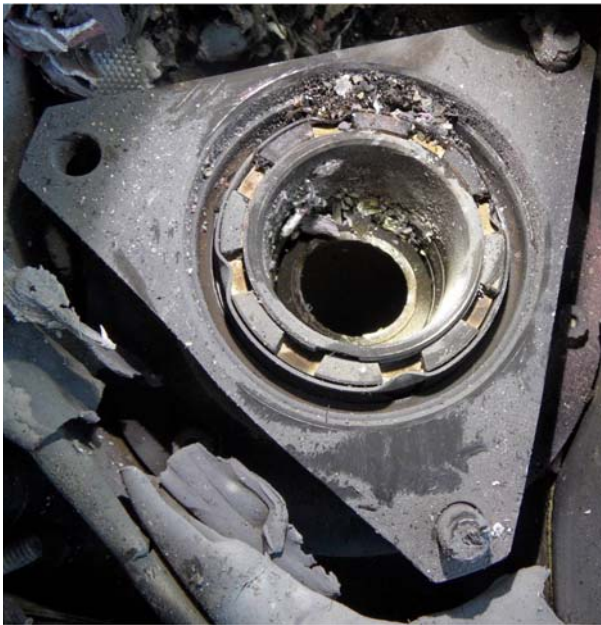
The freewheel unit had broken away at the power takeoff flange. The power takeoff flange was distorted, and two of the flange attachment bolts were sheared; the other bolt was not recovered. The freewheel shaft was separated. See Figure 6. The tail rotor drive coupling was cracked and distorted, and the flexible disks were splayed and broken. See Figure 7.

Figure 6. Power takeoff flange and aft fracture surface of freewheel shaft

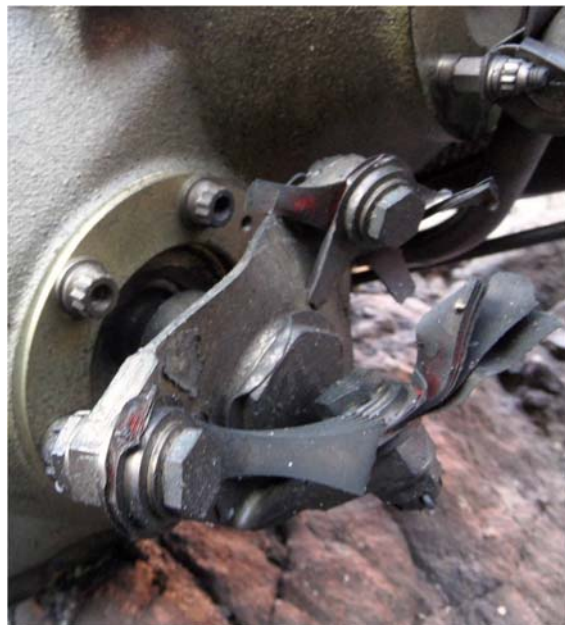
Figure 7. Tail rotor drive flange coupling damage

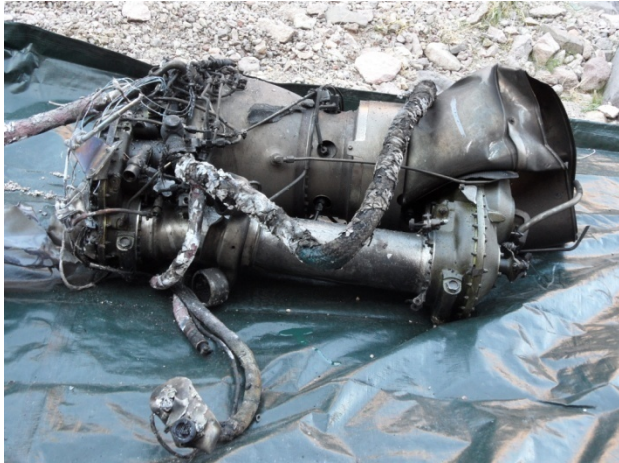
The engine and freewheel unit/helicopter main gearbox driveshaft and housing were removed from the debris field. The engine casings showed no evidence of uncontainment. See Figures 8 – 12.

Figure 8. Engine S/N 9043, left side view

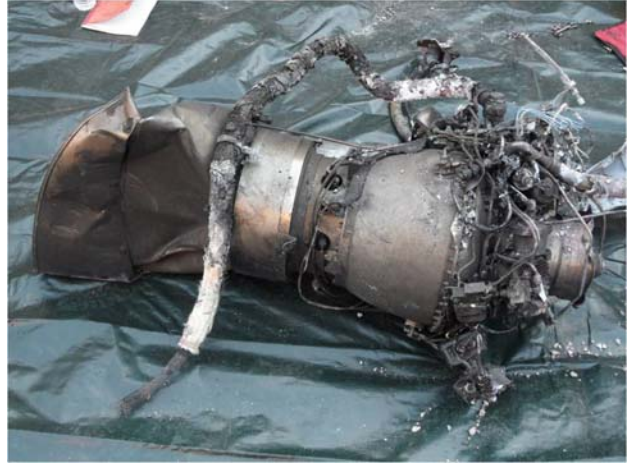
Figure 9. Engine S/N9043, right side view

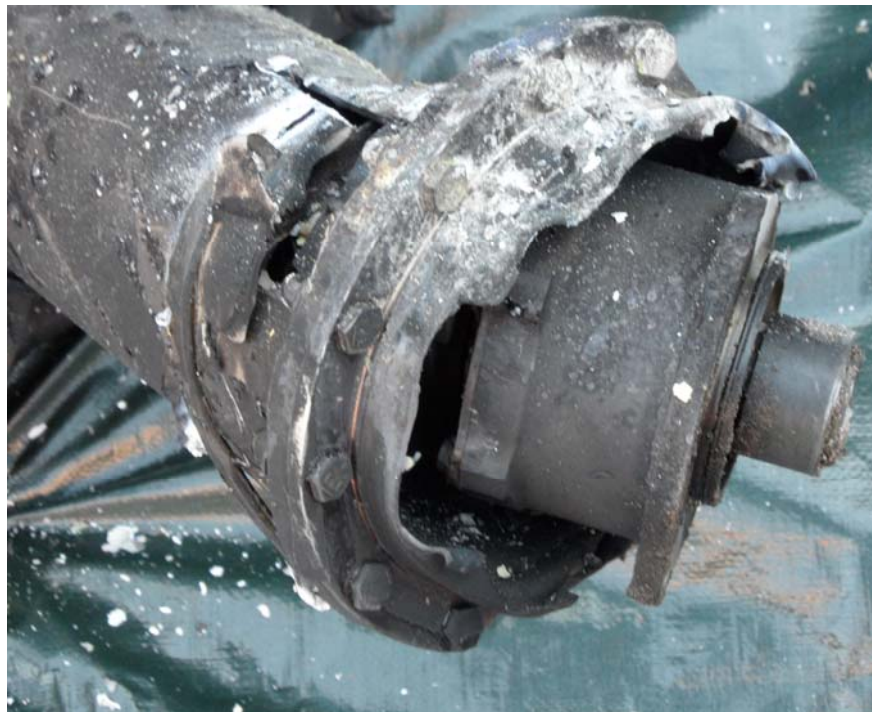
The freewheel clutch was rotated, and it turned freely in the drive direction, and did not turn in the opposite direction, verifying its operation.

Figure 10. Freewheel unit with forward section of freewheel shaft in helicopter main gearbox drive shaft housing

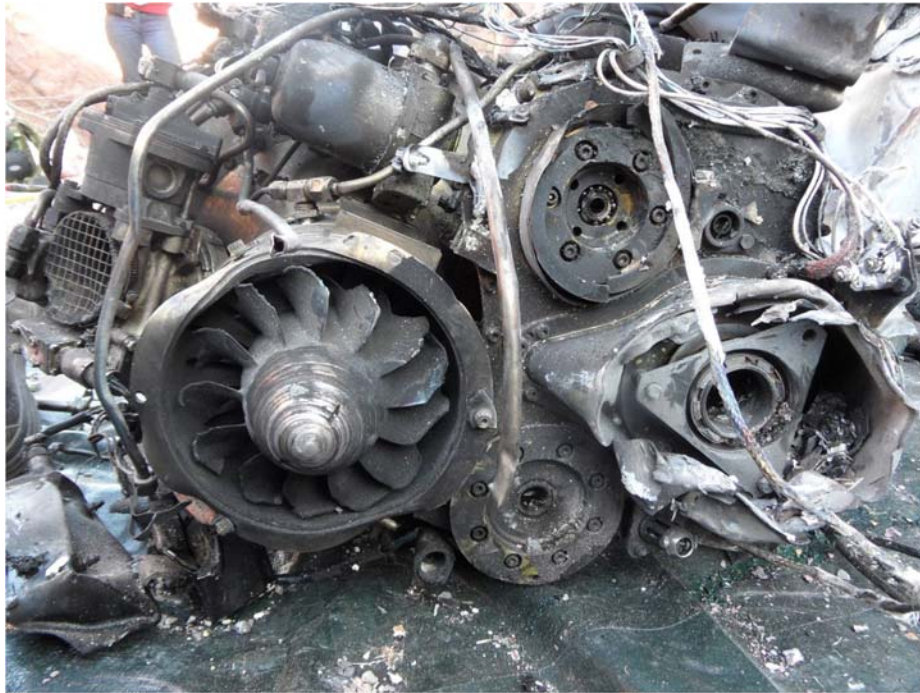
Accessory gearbox Ng gear train continuity was confirmed from both the FCU Ng drive pad and the Ng shaft to the starter drive pad. Accessory gearbox Ntl gear train continuity was confirmed from the power drive to the Ntl FCU drive pad. See Figure 11.

Figure 11. Engine S/N 9043 - front view

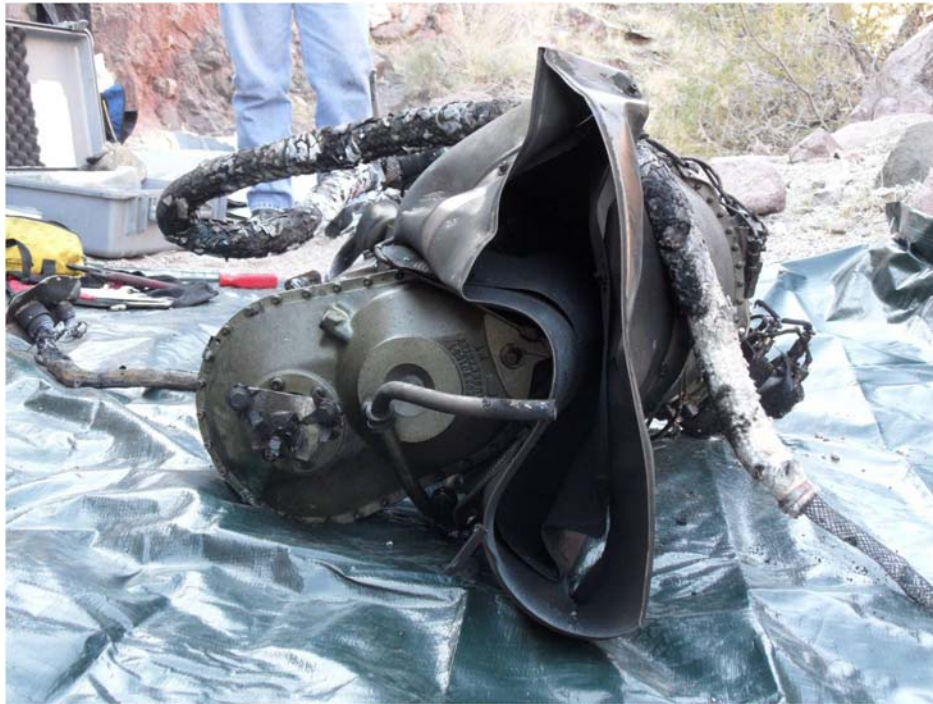
Figure 12. Engine S/N 9043 – back view

Two of the four bolts that attach the accessory gearbox to the axial compressor were sheared.

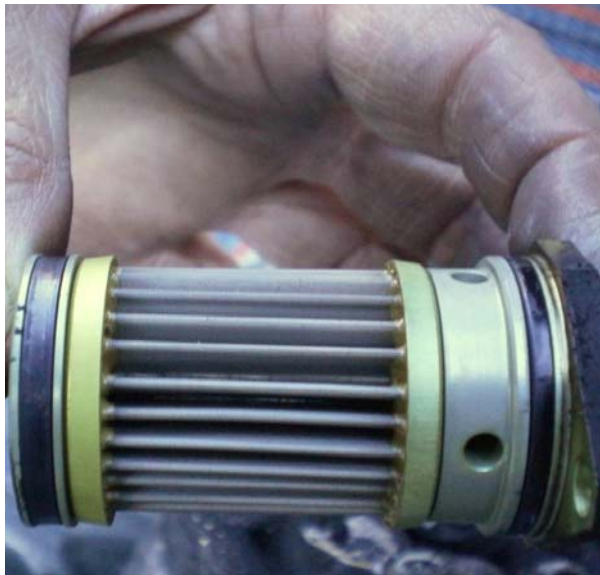
The engine was partially disassembled on site. The FCU fuel filter element was inspected and found clean. See Figure 14.

Figure 14. Fuel filter element

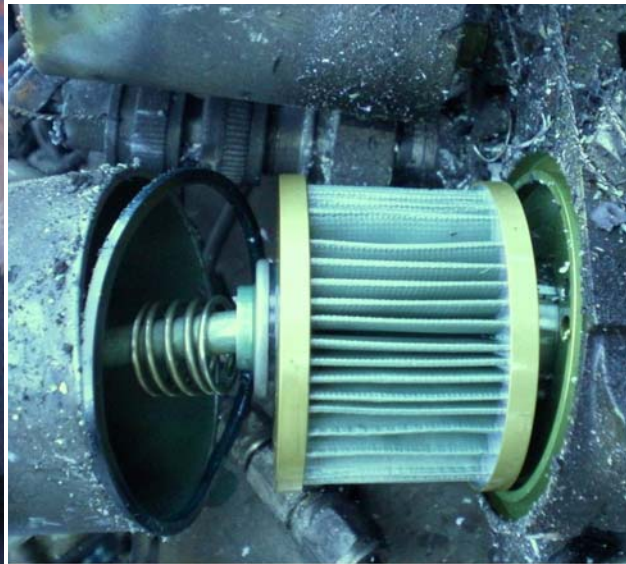
The oil filter was removed and was found clean. See Figure 15. The magnetic plugs were removed and inspected. Metal shavings and a single steel ball were found on the M01 module magnetic plug tip. The ball was consistent with the FCU drive bearing elements, several of which were missing. Metal shavings were found on the tip of the M05 magnetic plug. The two electric chip detectors were thermally damaged, with no relevant findings.

Figure 15. Oil filter element

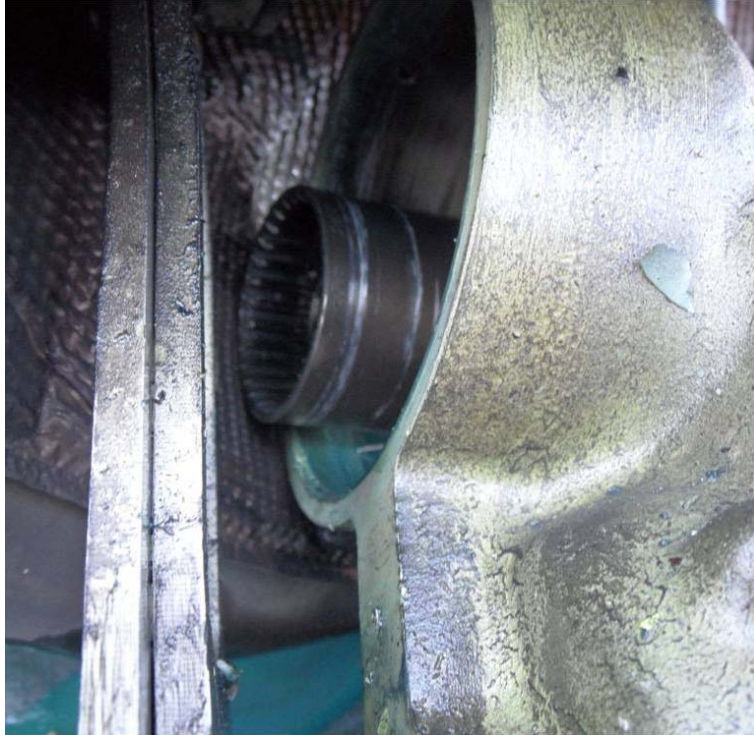
The reduction gearbox was removed, exposing the muff coupling, See Figure 16. The muff coupling is a 1 3/8-inch long internally-splined coupling that transfers the driving

Figure 16. Muff coupling exposed

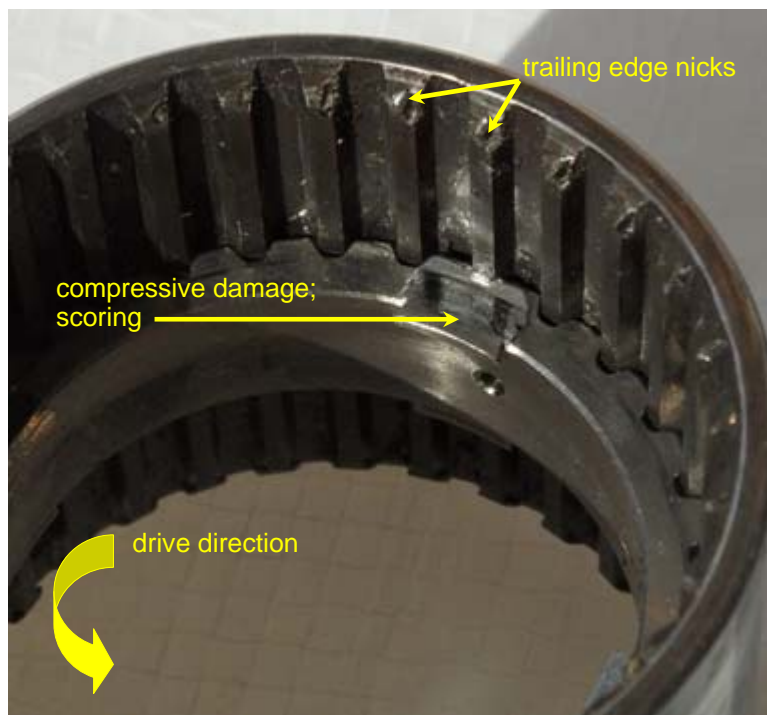
torque from the power turbine (module 04) to the reduction gear train input pinion (module 05). A 7/8-inch steel insert provides the stop for the respective shafts. The outside surface coating of the coupling showed shiny circumferential marks. There was a pattern of deep nicks on the trailing sides of the module 04 coupling splines, progressing from light to severe, and the forward faces of the four tabs on the module 04 side of the insert appeared

compressed and showed light scoring in the circumferential direction. See Figure 17. The beveled ends of the splines on the module 05 side of the coupling were roughened.

Figure 17. Muff coupling, showing damage on the drive sides of the driven splines and at tabs

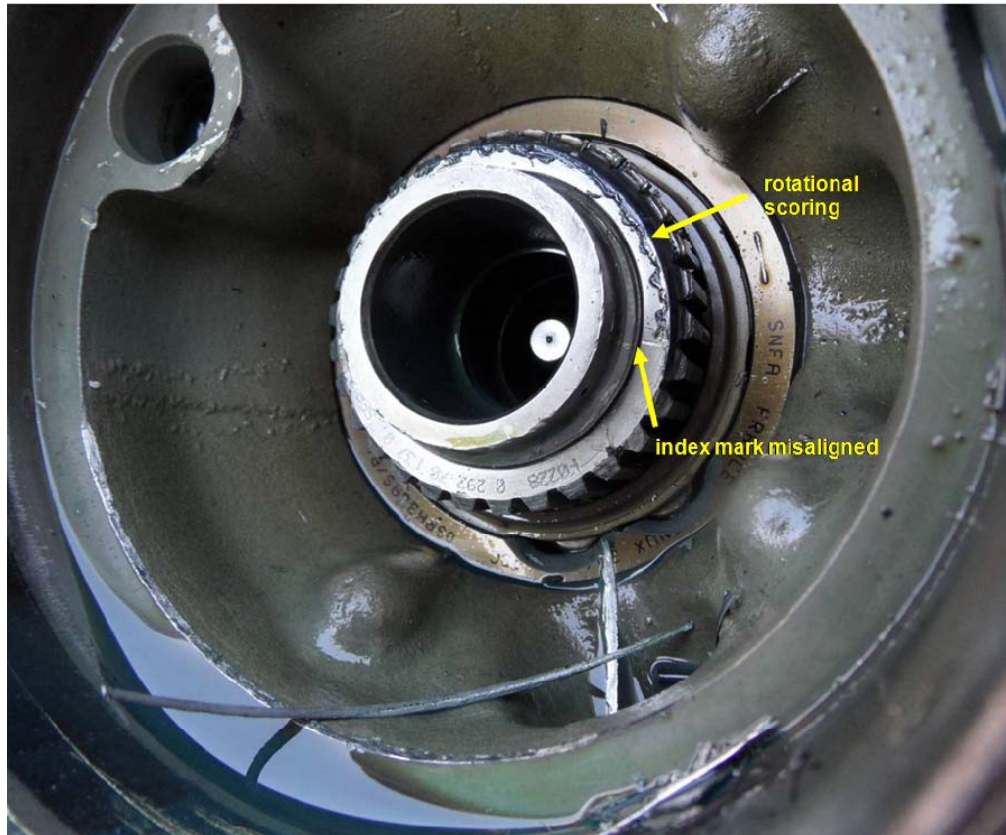
Arriel engine manual assembly instructions for the reduction gearbox require an alignment mark to be made across the left-threaded input pinion nut and the pinion shaft after assembly torque is applied.⁵ The alignment mark is used as a visual check following a rotor strike, over torque, or overspeed incident. The measured angular distance between marks represents nut over-tightening in the drive direction and serves as an estimate of the force load on the reduction gears.⁶

Figure 18. Input pinion nut showing assembly index mark misalignment in the driving direction

Examination of the pinion assembly found that the input pinion nut index mark was misaligned approximately 1 mm past the input shaft index mark, in the driving direction. See Figure 18. According to Turbomeca, 1 mm displacement indicates that just over 25 daNm, or 184.4 ft lbs, of force was applied to the drive pinion nut. The torque applied at the input pinion nut during operation at takeoff power is 11 daNm, or 81.13 ft. lbs.

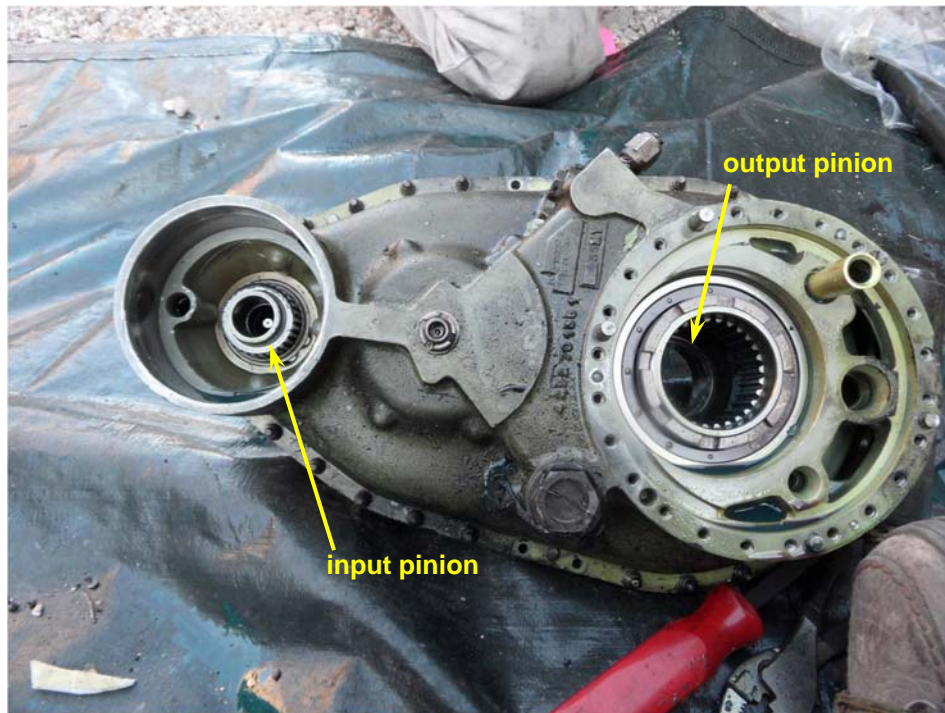
Reduction gear train continuity was confirmed from the input pinion to the output pinion. See Figure 19.

Figure 19. Reduction gearbox
