NATIONAL TRANSPORTATION SAFETY BOARD  
OFFICE OF AVIATION SAFETY  
WASHINGTON, D.C. 20594

**POWERPLANTS GROUP CHAIRMAN'S FACTUAL REPORT**

NTSB ID No.: ENG11IA016

Aircraft: Boeing 757-2Q8, N704X, Delta Air Lines flight 9931

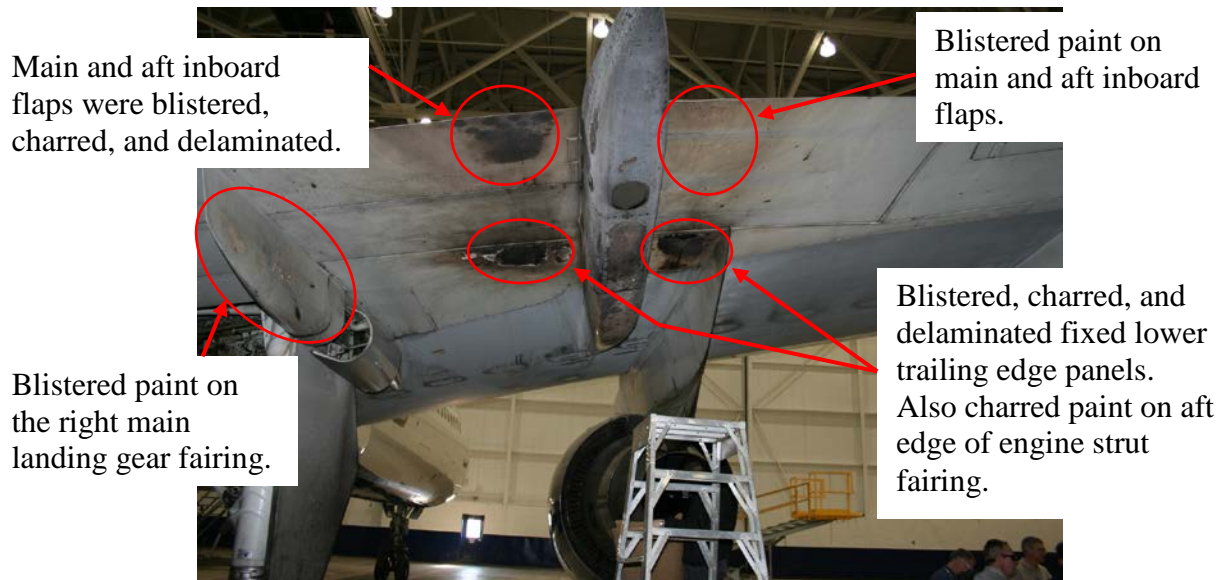
The lower surface of the main and aft inboard flaps inboard of the inboard flap track fairing were blistered, charred, and delaminated. The lower surface of the main and aft inboard flaps outboard of the inboard flap track fairing were blistered. The lower fixed trailing edge panels on either side of the inboard flap track fairing were blistered, charred, and delaminated. (Photo No. 1) There was no indication of internal damage to the inboard flaps or the fixed trailing edge panels. Grease on the inside of the panels was not melted.

Photo No. 1: View of the underside of the right wing from the rear showing areas that were blistered, charred, and delaminated. (P&W photo)

The right main landing gear fairing had a small area of blistered paint on the exterior surface. (Refer to Photo No. 1.)

The No. 2 engine strut aft fairing had small area of charred paint on the inboard side adjacent to the wing at the aft end. (Refer to Photo No. 1.)

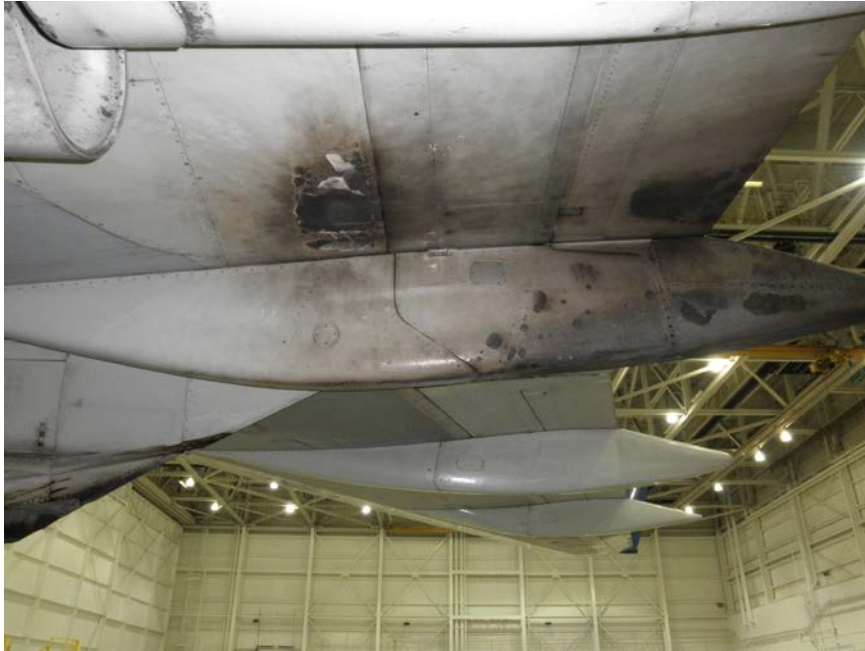
The exterior of the aft two-thirds of the inboard flap track fairing was charred, blistered, and delaminated. (Photos Nos. 2 and 3) There was no indication of internal damage to the fairing. Grease located on the inside of the fairing was not melted.

Photo No. 2: Left (inboard) side of the inboard flap track fairing showing damage on rear two-thirds of the rear fairing.

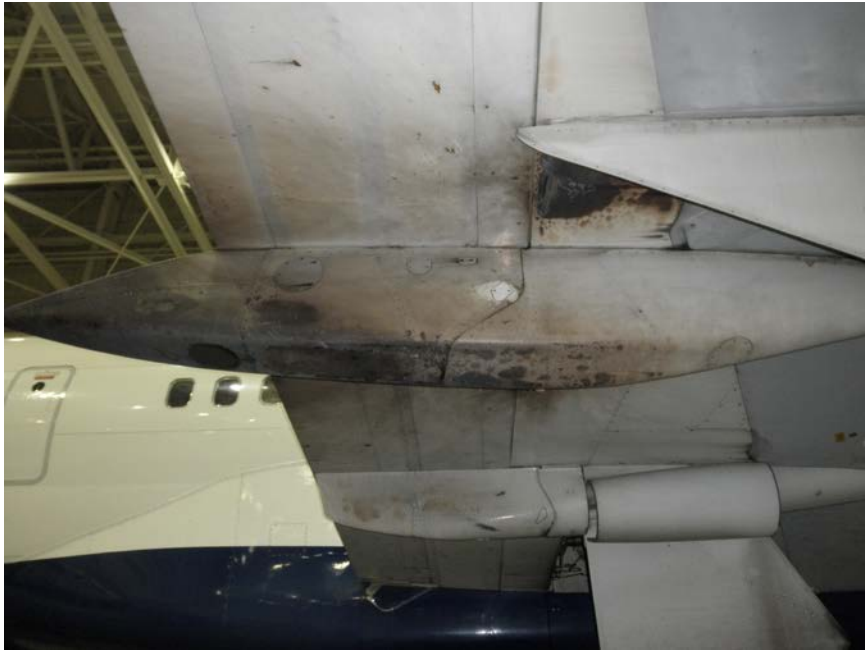
Photo No. 3: Right (outboard) side of the inboard flap track fairing showing damage on rear two-thirds of the rear fairing.

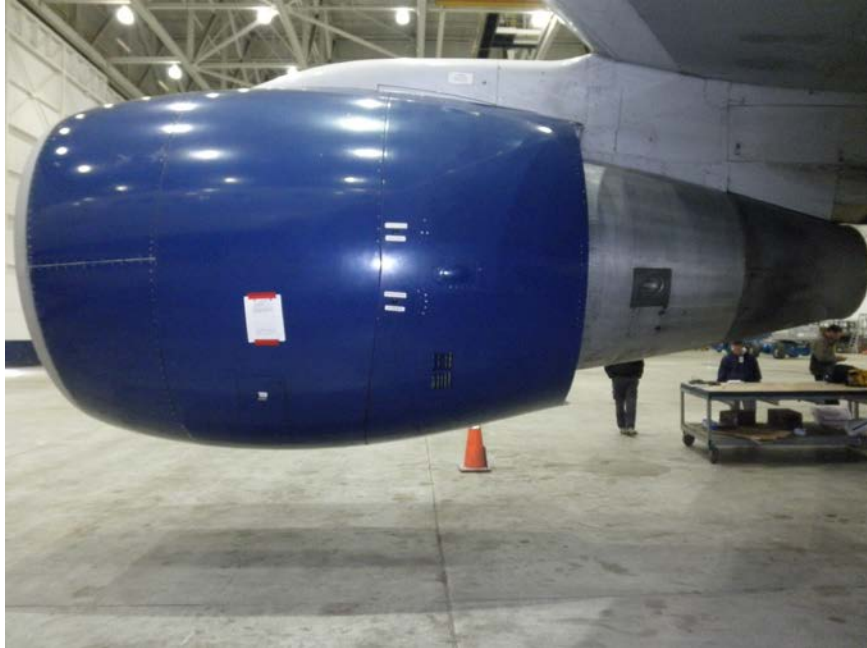
The No. 2 engine was in place on the strut. The exterior as well as the interior surfaces of the engine's nacelles did not have any indications of fire damage or sooting. (Photos Nos. 4 and 5)

Photo No. 4: View of the left side of the engine with the nacelles in place showing no damage or sooting.

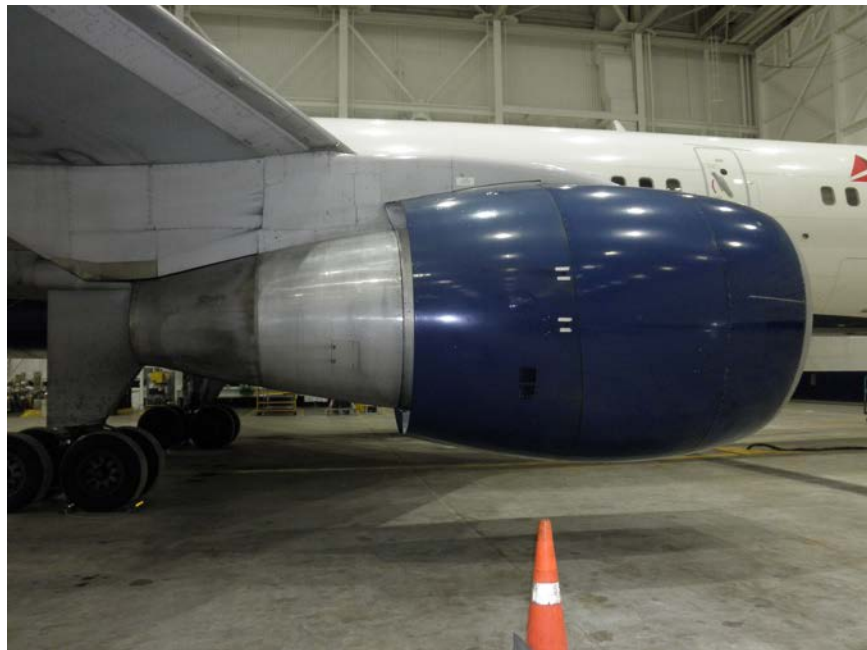
Photo No. 5: View of the right side of the engine with the nacelles in place showing no damage or sooting.

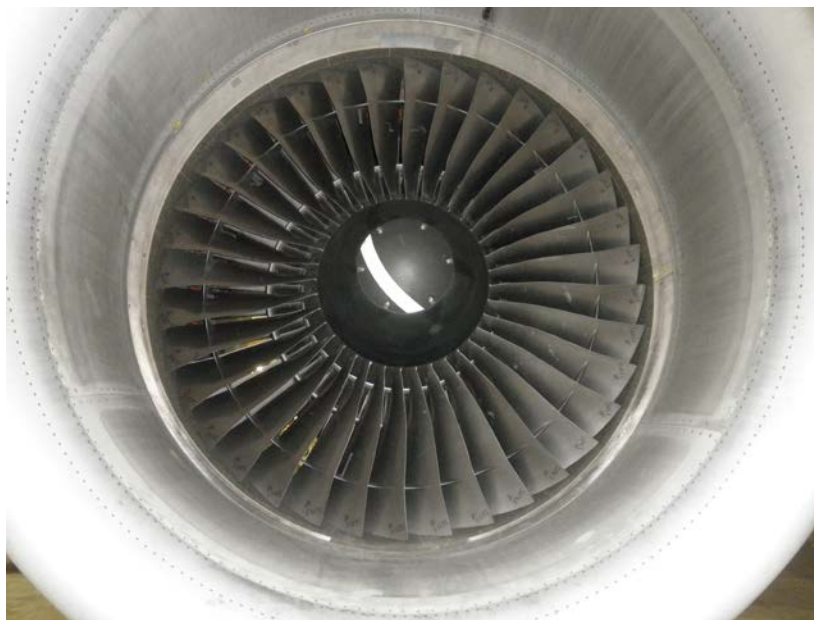
The fan blades were all in place and did not have any damage. (Photo No. 6) The fan could be rotated with light hand pressure and the 7th stage turbine blades rotated concurrently. All of the 7th stage turbine blades were in place and did not have any damage. (Photo No. 7) There were no abnormal noises heard when the fan was rotated.

Photo No. 6: View of the front of the engine showing all of the fan blades were in place and undamaged.

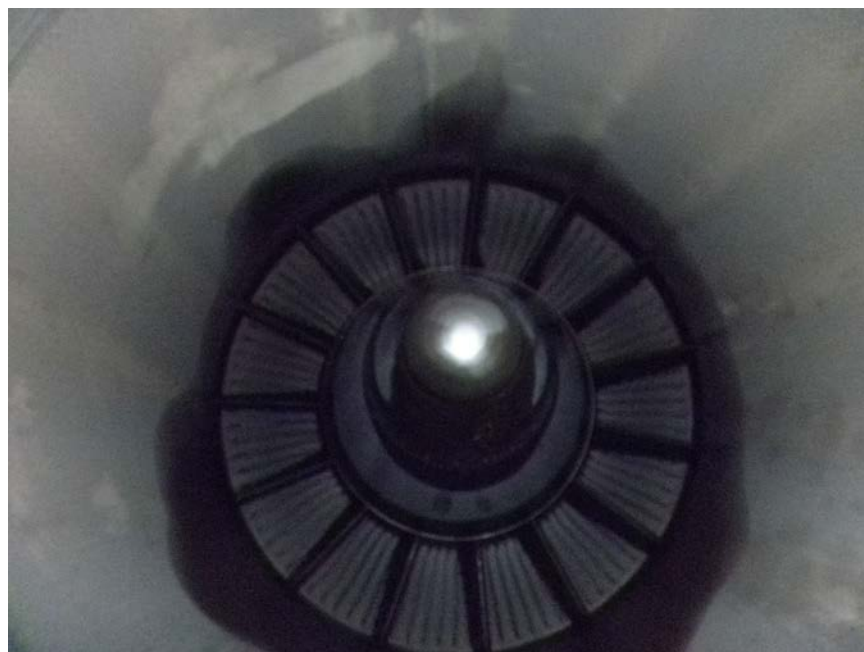
Photo No. 7: View of the rear of the engine showing all of the 7th stage turbine blades were in place and undamaged.

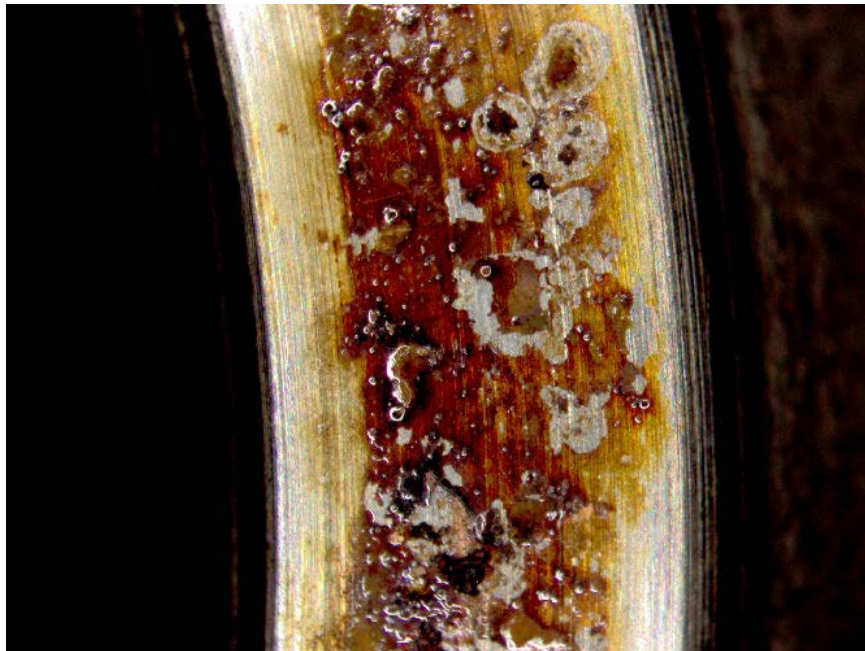
The FMV sleeve had brown substance around the base on the chamfered. (Photo No. 8) The inner diameter (ID) of the FMV sleeve also had the brown substance that had axial scratches. (Photo No. 9) The ID of the sleeve also had a witness mark, a circumferential dark mark, which corresponded to the O-ring on the FMV spool.

Photo No. 8: Close up view of FMV sleeve showing brown substance on chamfer.  
(Hamilton Sundstrand)

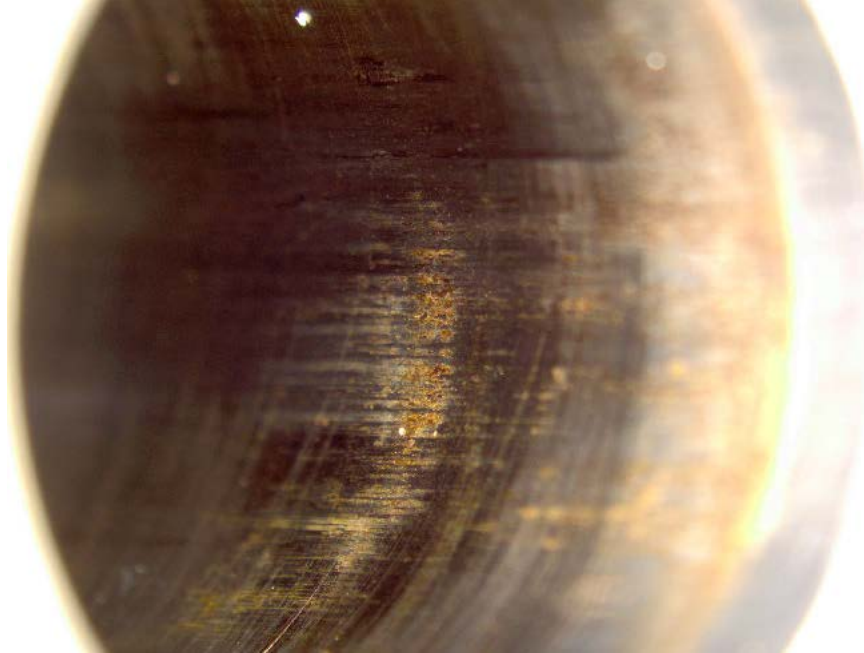
Photo No. 9: Close up view of FMV sleeve showing brown substance with axial scratches.  
(Hamilton Sundstrand)

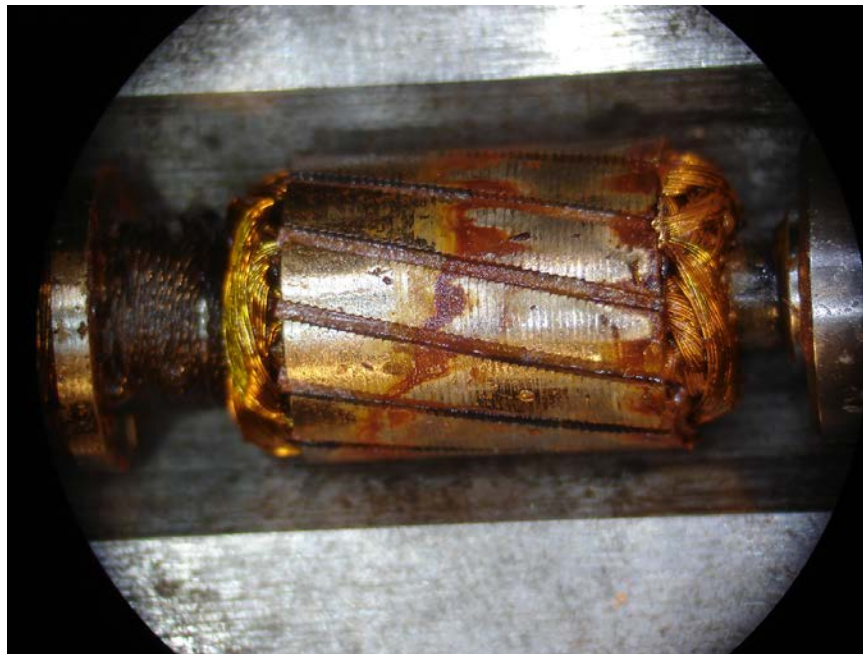
When the channel B resolver was disassembled, there was heavy corrosion and contamination on the rotor and internal cavity of the stator housing. (Photos Nos. 10 and 11) The rotor assembly was difficult to remove. There was moisture throughout the internal cavity of the resolver. The Kearfott personnel who disassembled the resolver stated that they had never seen that type of corrosion before.

Photo No. 10: Close up of FCU FMV channel B resolver showing corrosion on the rotor assembly.

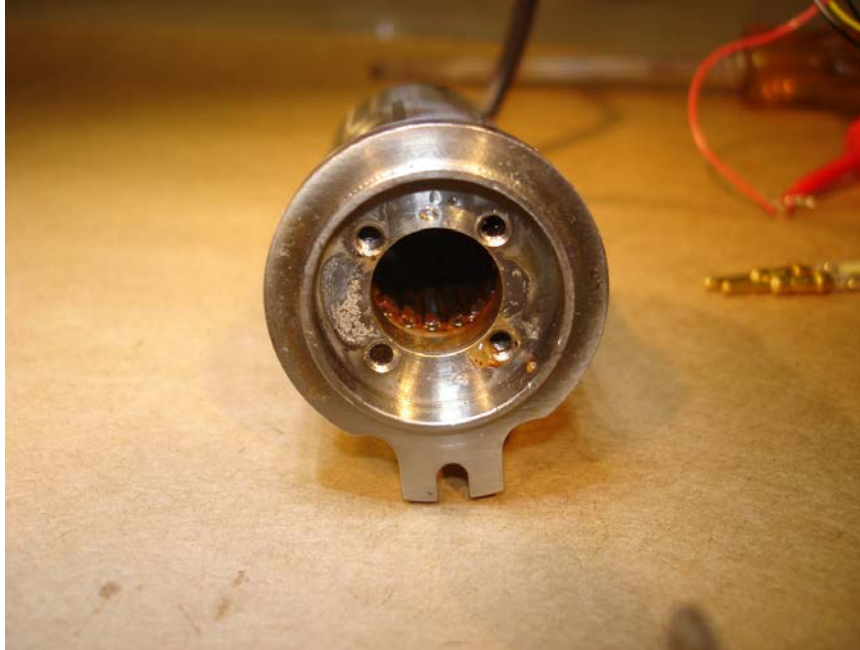
Photo No. 11: Close up of end of FCU FMV channel B resolver stator body showing corrosion on the inside of the housing.

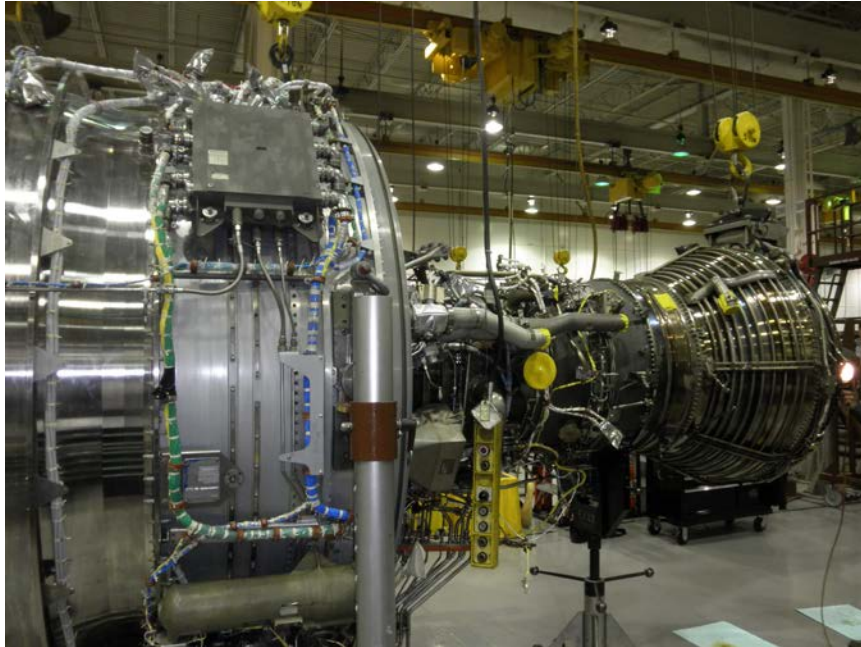
Photo No. 12: View of the left side of the engine showing no fire damage or sooting.

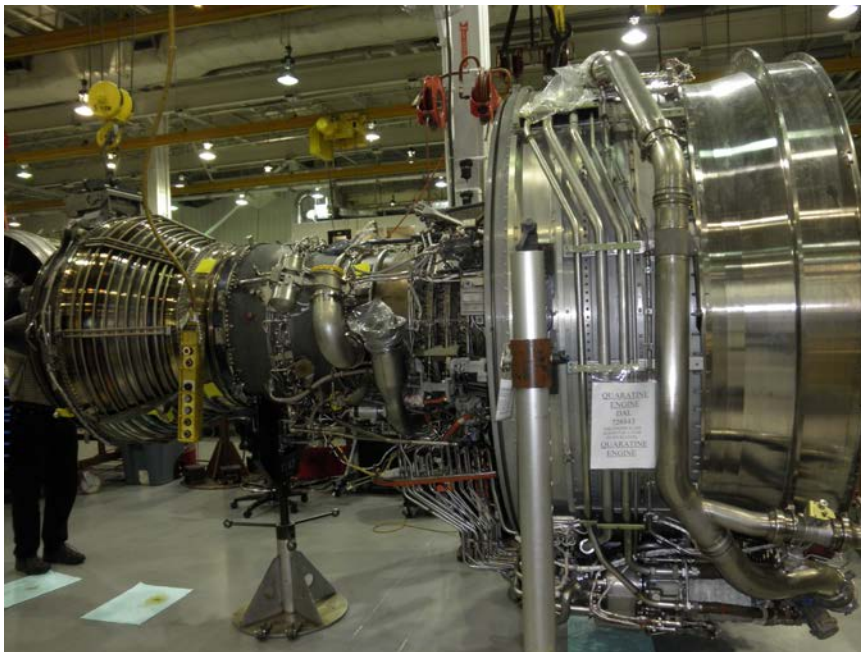
Photo No. 13: View of the right side of the engine showing no fire damage or sooting.

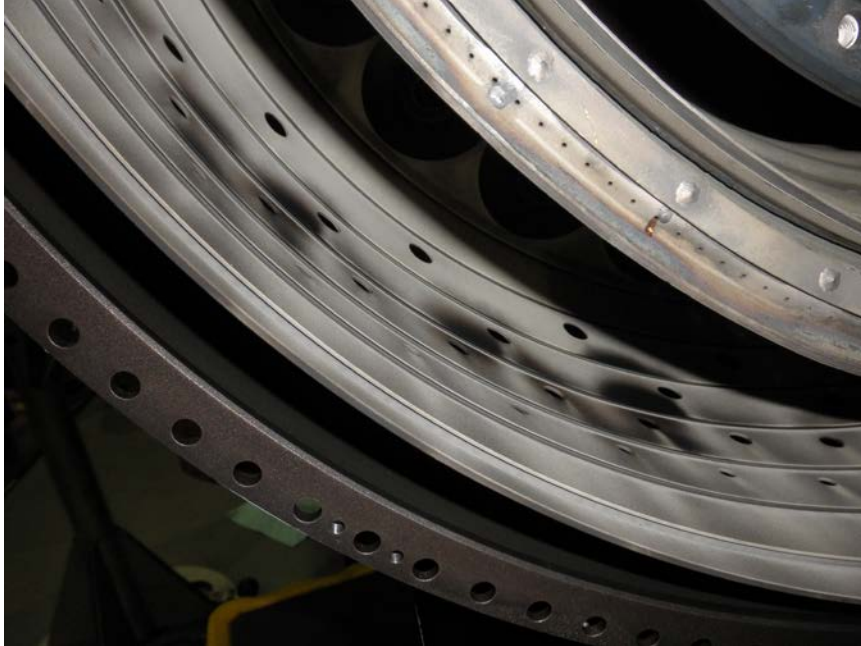
The combustor inner and outer liners and bulkhead were intact. The interior surfaces of the combustor inner and outer liners and bulkhead were a bright off-white color. (Photo No. 14) The interior surfaces of the combustor inner and outer liners had random areas of soot on the surface. The combustor inner liner had numerous trailing edge cracks on each of the louvers. The combustor was not disassembled to expose the exterior of the combustor liners.

Photo No. 14: View of the combustor outer liner showing random sooting.

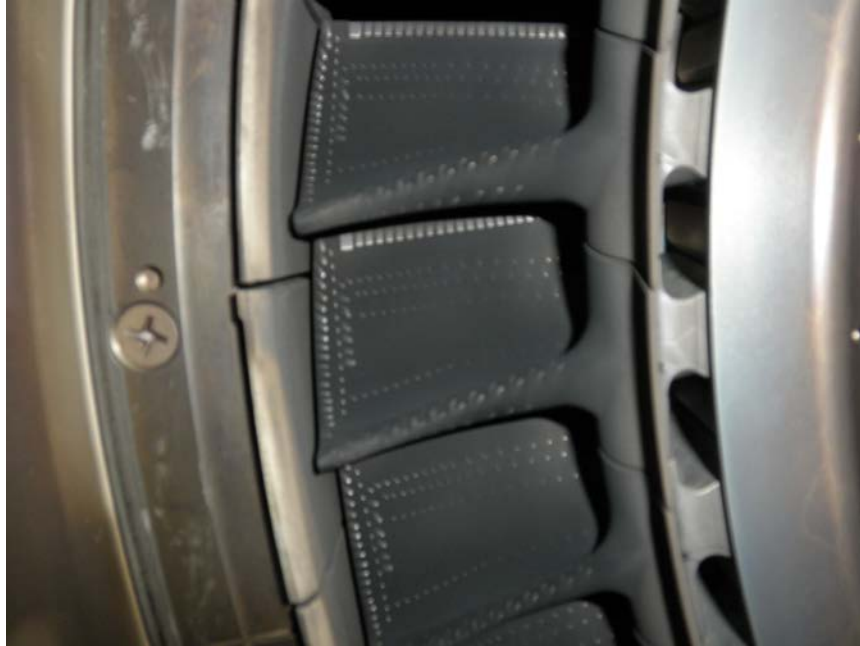
The 1st and 2nd stage turbine blades were all in place in their respective disks and did not have any apparent damage to the airfoils. The 1st and 2nd stage turbine blade airfoils and blade root platforms had a dark, almost black discoloration. (Photo No. 15)

Photo No. 15: Close-up view of the 1st stage turbine blades showing the dark discoloration on the airfoil surface.

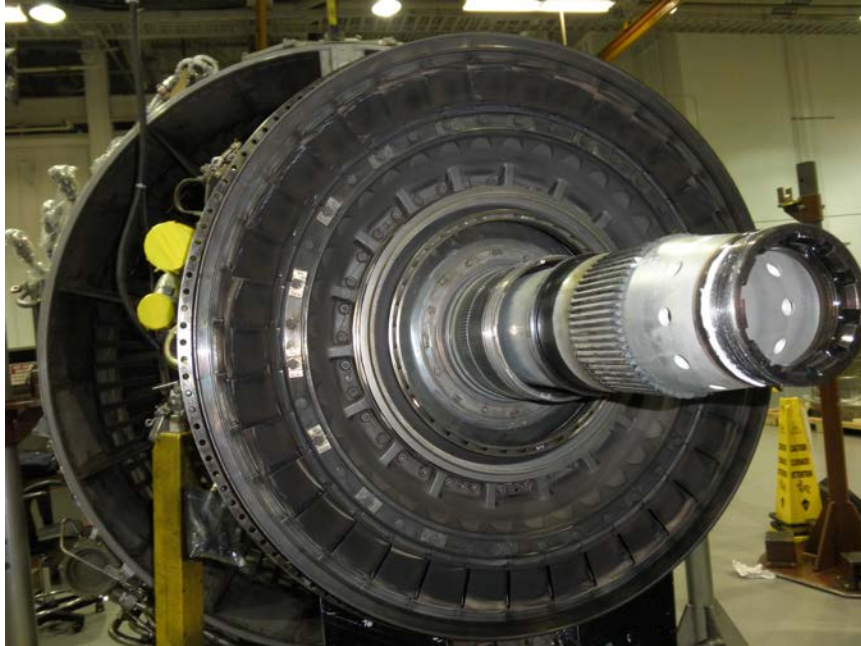
Photo No. 16: View of the 1st stage turbine vanes showing they were all in place and had a dark discoloration.

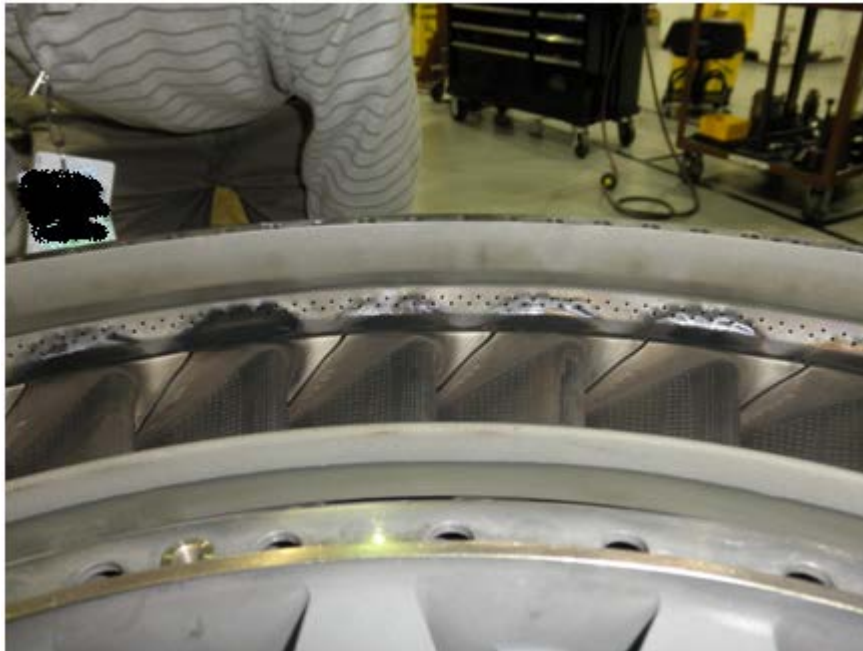
Photo No. 17: Close up view of the 1st stage turbine vanes showing dark discoloration on airfoils and light-colored areas on outer platforms.

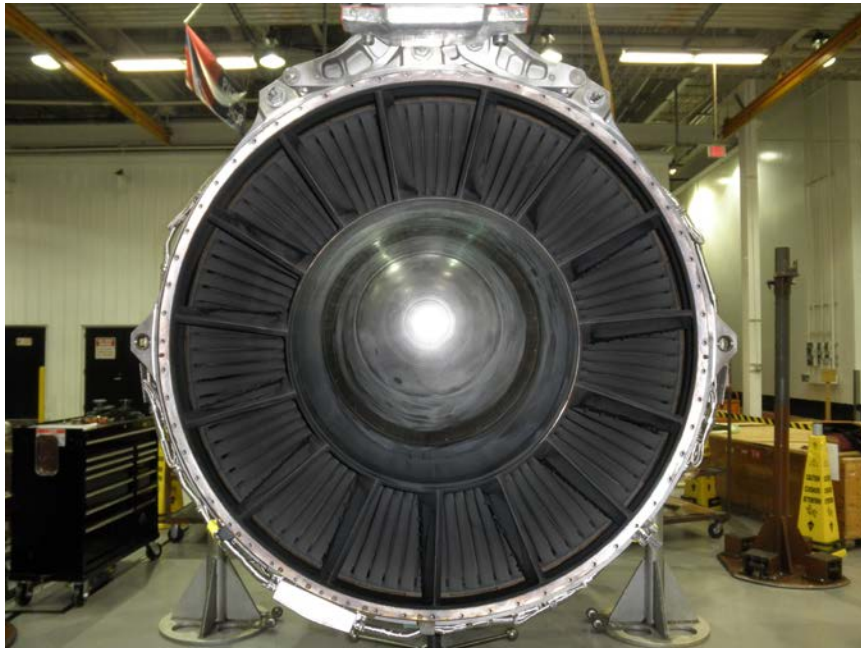
The 7th stage turbine blades were all in place in the disk and did not have any apparent damage. The 7th stage turbine blades had a dark, almost black discoloration. (Photo No. 18)

Photo No. 18: View of the 7th stage turbine blades showing dark discoloration.

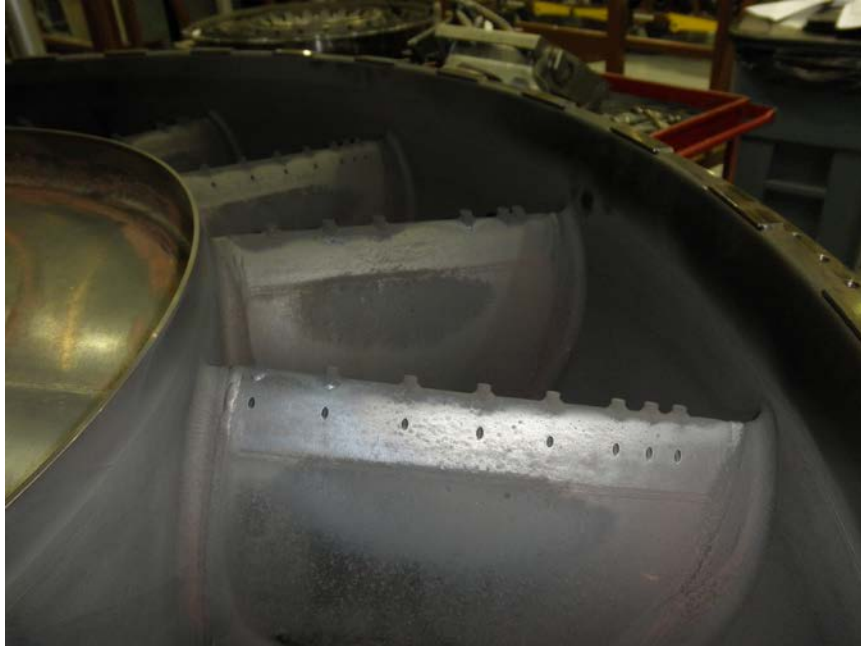
The turbine exhaust case and all of the struts were intact and in place. The ID of the turbine exhaust case and outer diameter of the turbine exhaust case inner duct and all of the struts had a dark, almost black discoloration. Many of the turbine exhaust case struts had elliptical-shaped areas on the convex side extending aft from the leading edge that although still a dark color, were more of a gray color rather than black. (Photo No. 19)

Photo No. 19: Close-up view of the turbine exhaust case inner and outer ducts and struts showing dark discoloration all around and the elliptical-shaped areas on the struts.
