NATIONAL TRANSPORTATION SAFETY BOARD
Office of Aviation Safety
Washington, D.C. 20594

POWERPLANT GROUP CHAIRMAN'S FACTUAL REPORT

NTSB No: DCA-09-MA-021

Location: Denver International Airport, Denver Colorado
Date: December 21, 2008
Time: 18:18 local Mountain Standard Time
Aircraft: Continental Airlines Boeing 737-524, flight number 1404, registration number N18611

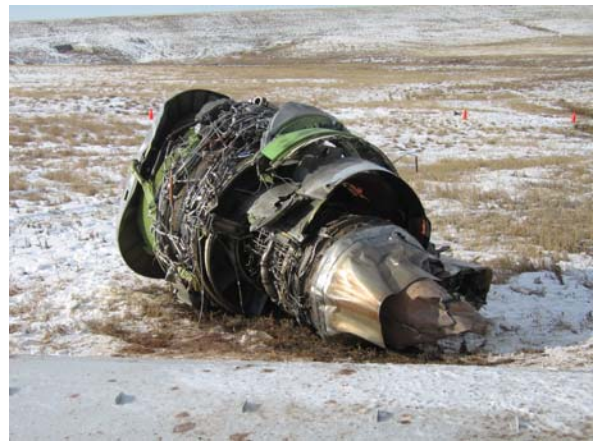
PHOTO 2: FORWARD & LEFT OF LEFT WING

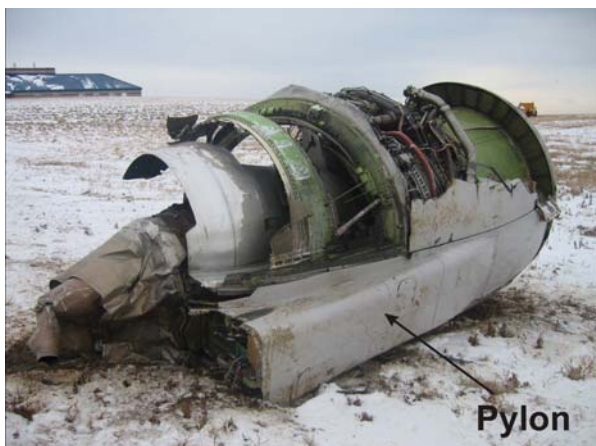
PHOTO 3: TOP OF ENGINE – PYLON ATTACHED

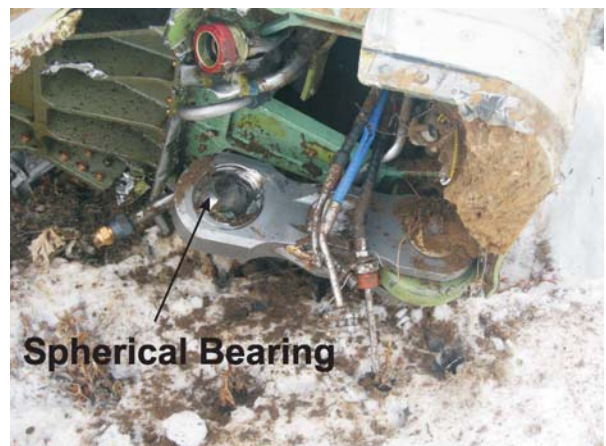
PHOTO 4: NO. 1 ENGINE 6:00 O’CLOCK POSITION

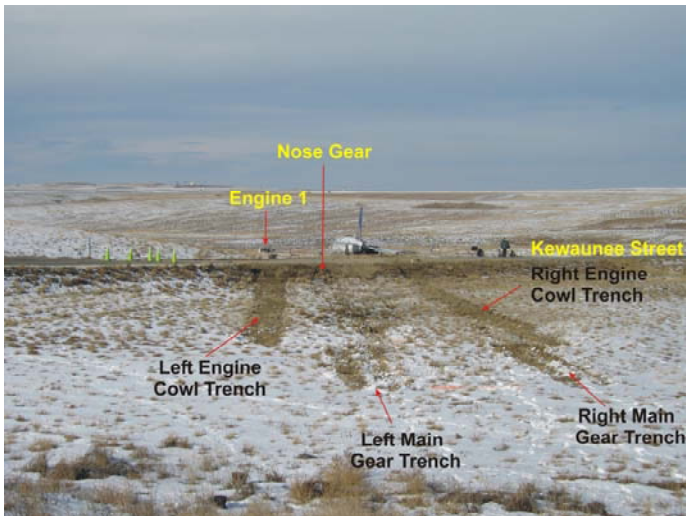
Ground scars were located north of taxiway WC between taxiway WC and Kewaunee Street that were consistent in size and shape with the engine cowlings and on the south side of the Kewaunee Street berm, were two large semi-circular impact marks consistent with the size and shape of the lower part of the inlet. Also noted were ground scars consistent with the airplane's nose and main landing gears (**Photo 5**).

PHOTO 5: AIRPLANE GROUND SCARS

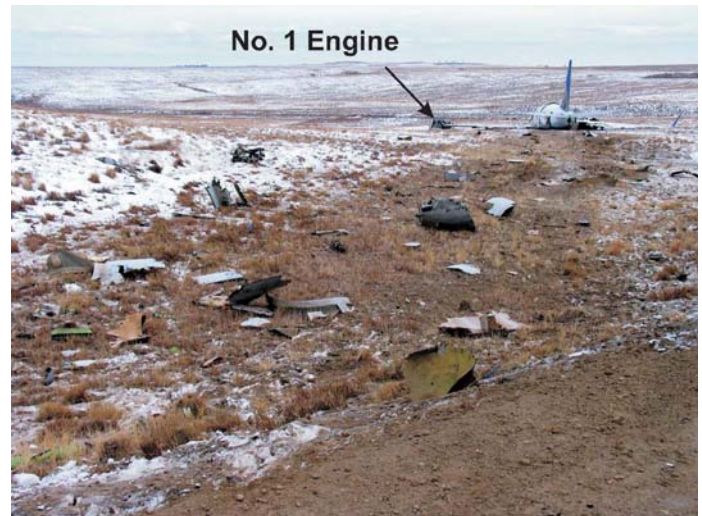
Scattered along the airplane's path of travel after it had departed the runway and went over the Kewaunee Street berm were various parts and components from the engine and thrust reverser. The following items were noted along the debris field: parts of the thrust reverser transcowl, thrust reverser blocker doors, thrust reverser cascades, part of the thrust reverser actuation ring (approximately a 180° section), part of the accessory gearbox, constant speed drive generator, engine lubrication and scavenge pump, fan cowl, and engine air turbine starter (**PHOTO 6**).

PHOTO 6: DEBRIS FIELD ALONG WRECKAGE PATH

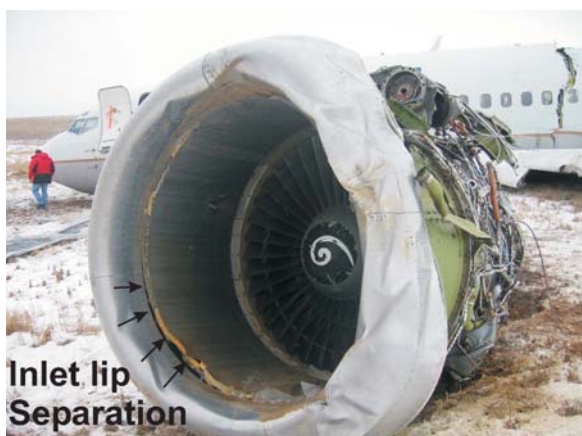
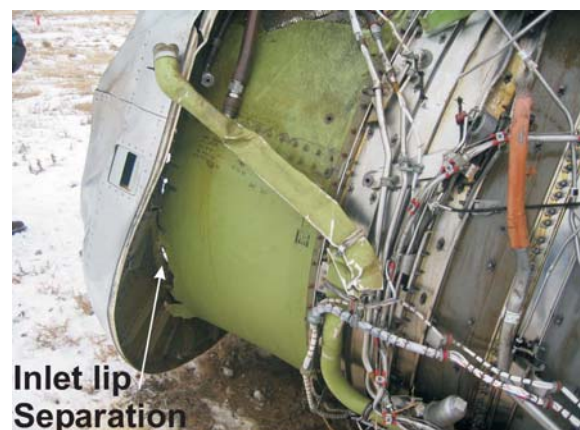
The inlet lip remained attached to the fan cowl inner barrel structure and the inner barrel structure remained attached to the engine's fan case "A"-flange. The inlet lip exhibited rearward impact damage from approximately the 3:00 to 9:00 o'clock position. The inlet lip was separated from inner barrel from approximately the 6:00 to 2:00 o'clock position (**PHOTOS 7 AND 8**). The inner barrel did not exhibit any exit holes or impact marks.

PHOTO 7: INLET LIP SEPARATION

PHOTO 8: INLET LIP SEPARATION

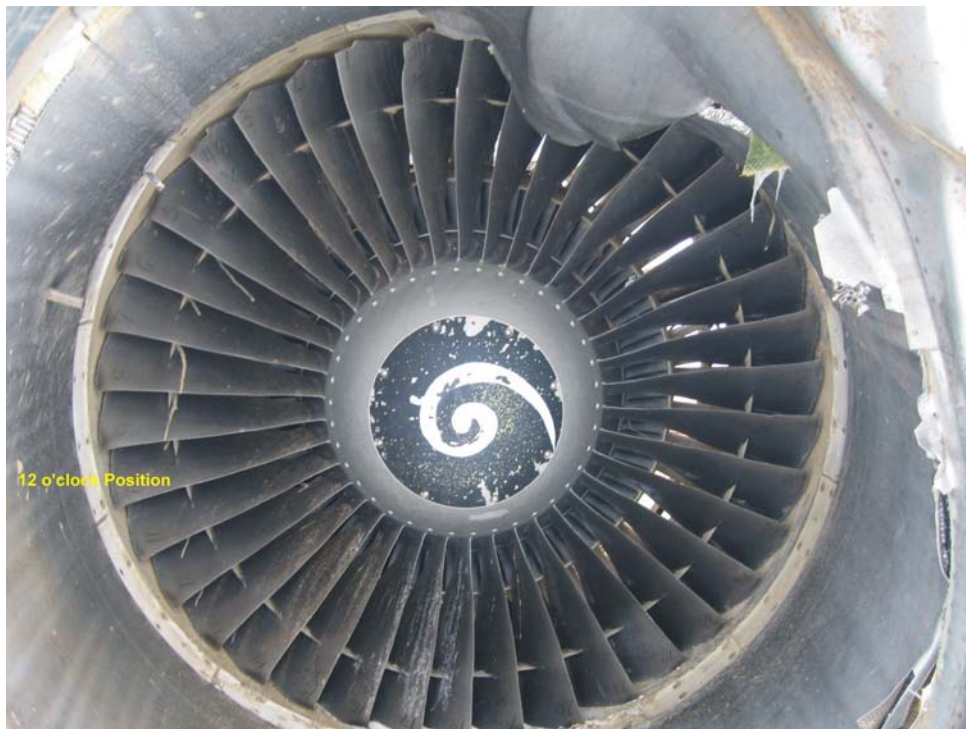
All the fan blades were present, installed in the fan disk, and relatively straight and intact with minimal if any airfoil leading damage. The majority of the fan blade tips were bent in the direction opposite rotation with five (5) consecutive blades (Nos. 38 – 4 in the direction of rotation)² missing leading edge corners. All the fan blade mid-span shrouds were intact and a few mid span shrouds were shingled.³ The front and rear spinner cones remained in place and did not exhibit any impact damage. Only black paint loss, consistent with normal operational erosion, was noted on the front spinner (**PHOTO 9**).

PHOTO 9: NO. 1 ENGINE FAN BLADE DAMAGE

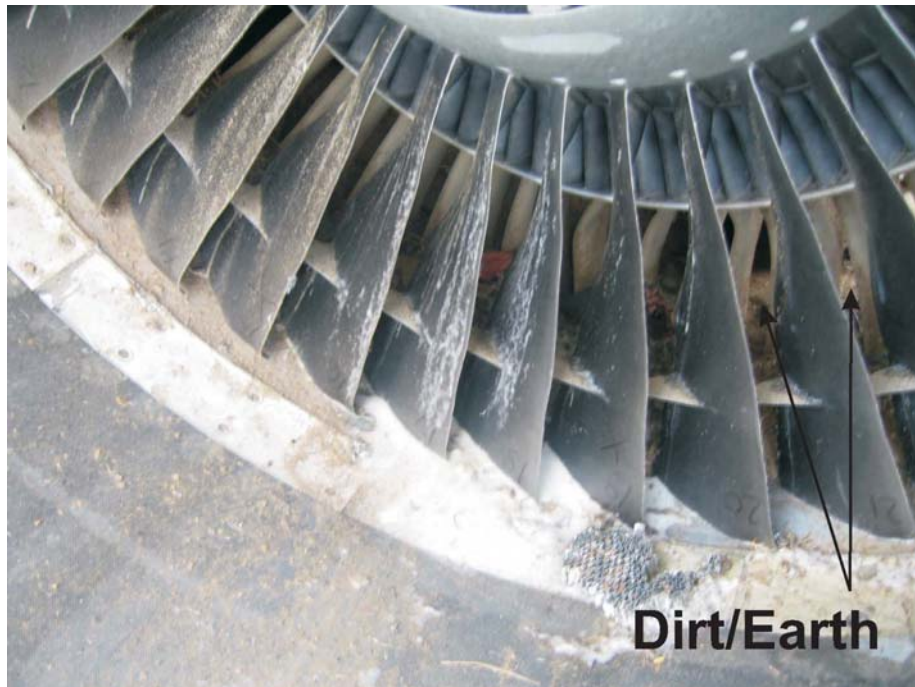
Looking both through the fan blades in the front and through the fan frame in the rear, dirt and earth debris were noted on and between the OGVs ([PHOTO 10](#)). The booster inlet guide vanes (IGV) were all present and exhibited no visible leading edge damage. Dirt and earth debris was also noted between most of the IGVs ([PHOTO 10](#)).

PHOTO 10: DIRT AND EARTH DEBRIS IN THE FAN AND BOOSTER SECTION

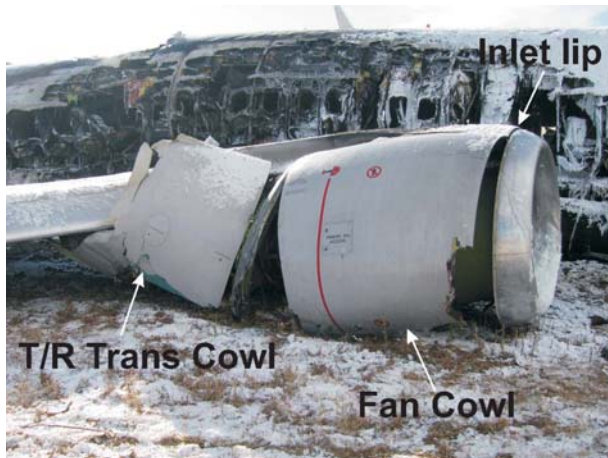
The No. 2 engine and its pylon remained attached to right-hand wing, and engine was resting on the ground (**PHOTO 11**). The outboard (right) fan cowl door was present, attached, and found in the OPEN position. The only damage to the outboard fan cowl was noted at the bottom where cowl material was torn and missing. No fire damage was noted under the fan outboard cowl and the oil tank, power management unit (PMU), and igniter boxes, along with the fan fire loops, were all intact, undamaged, and exhibited no signs of heat distress (**PHOTO 12**). The forward engine mount appeared visually intact and undamaged.

PHOTO 11: NO. 2 ATTACHED TO RIGHT WING

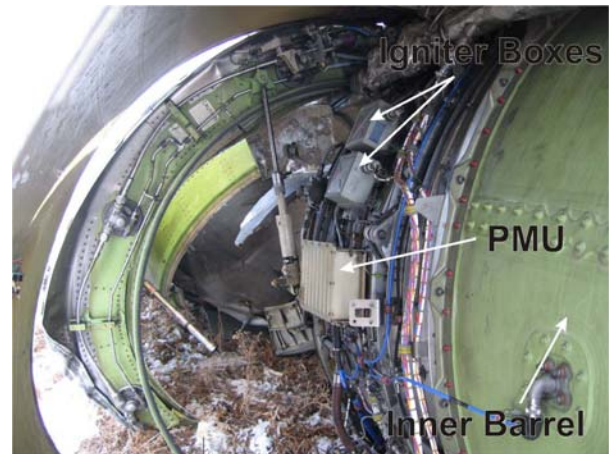
PHOTO 12: NO FIRE DAMAGE - OUTBOARD COWL

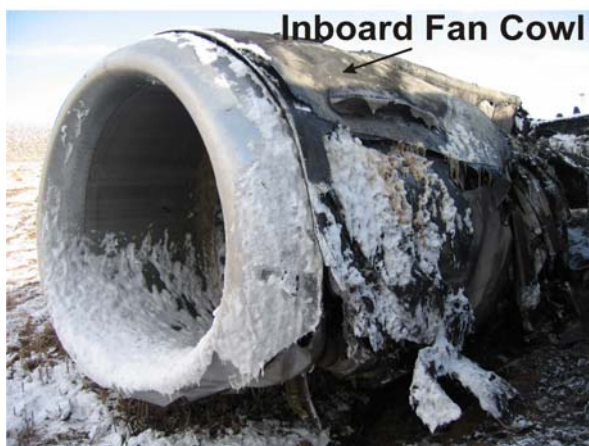
The inboard fan cowl was heavily burnt and fire damaged with much of the resin missing leaving only the carbon weave (**PHOTO 13**). The inboard fan cowl was held open by hand exposing the inner barrel and fan case area. Heat distress and fire damage was noted on the outer skin of the inner barrel from the 6:00 to 9:00 o'clock position but was not burned through. Aft of the accessory gearbox, the left-hand side of the engine exhibited widespread thermal distress and fire damage. The electric wires to the constant speed drive & generator exhibited thermal distress and were slightly melted. The accessory gearbox, all of the engine accessories, and the transfer gearbox, were intact and remained attached. The main fuel line remained intact with no signs of a fuel leak, its fire sleeve remained intact but was thermally damaged (**PHOTO 14**).

PHOTO 13: COWL FIRE DAMAGE INBOARD SIDE

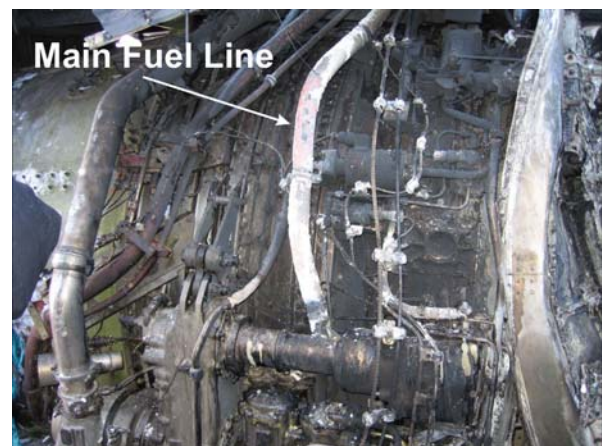
PHOTO 14: UNDERCOWL FIRE DAMAGE

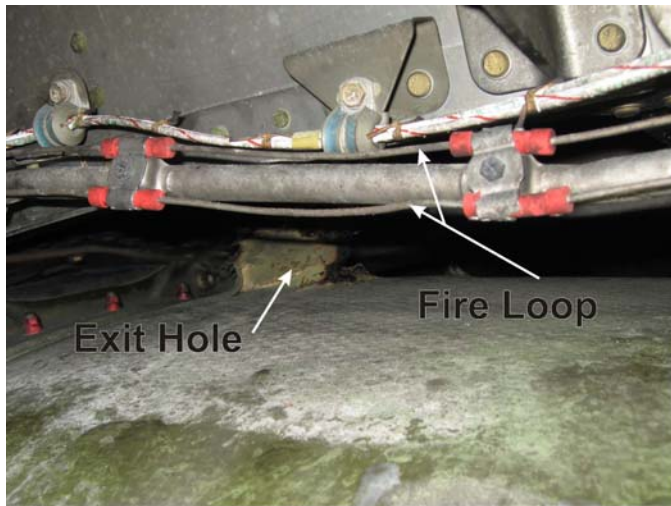
An exit hole was noted in the inner barrel⁴ at the 12:00 o'clock position but no impact damage was noted to the underside of the pylon in that area (**PHOTO 15**). An exit hole through the inner barrel was also noted at the 10:00 o'clock position and no visible impact damage was noted to the inboard fan cowl.

PHOTO 15: INNER BARREL EXIT HOLE

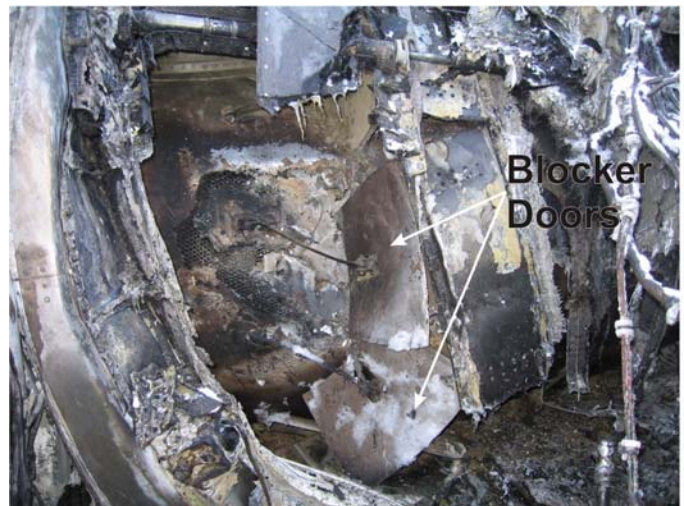
The thrust reverser outboard transcowl remained attached but was dislodged from the outboard half of the thrust reverser actuation ring. The outboard transcowl was damaged and had been pushed aft. The majority of the thrust reverser inboard transcowl was either missing or heavily fire damaged. Several of the inboard blocker doors were visible and they were found in the deployed position (**PHOTO 16**).

PHOTO 16: BLOCKER DOORS DEPLOYED

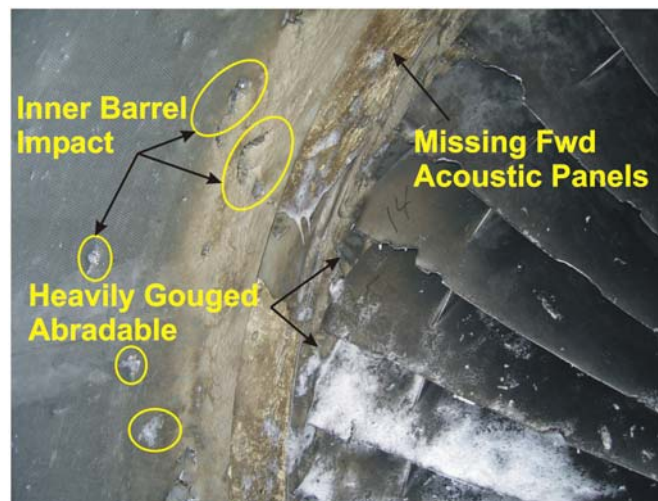
The inlet lip remained attached to the fan cowl inner barrel structure and the inner barrel structure remained attached to the engine's fan case "A"-flange. The inlet lip exhibited an inward impact from the 6:00 to 8:00 o'clock position pushing the inner barrel into the air flow path. The inner barrel exhibited impact marks 360° localized just forward of the fan blade position. The forward acoustic liners exhibited gouges and were rubbed down to the backing strip with some pieces of the liners missing (**PHOTO 17**).

PHOTO 17: INNER BARREL IMPACT DAMAGE AND FORWARD ACOUSTIC PANELING LOSS

The fan case stage 1 blade abradable liner was heavily gouged 360° through the circumference down to the case base metal (**SEE PHOTO 17**). Looking through the fan blades, all the OGVs were present and appeared undamaged. Looking through the back of the fan frame, some of the VBV's were visible and they were found in the OPEN position with the actuation ring and attaching hardware appeared intact and installed. All the booster IGVs were present and appeared undamaged. As a general observation, no dirt or earth debris was noted either on or between the fan blades, the OGVs, or the IGVs (**PHOTO 20**). The white substance is the remnants of the fire retarget agent used by ARFF personnel. The VSVs were found in the CLOSED position.

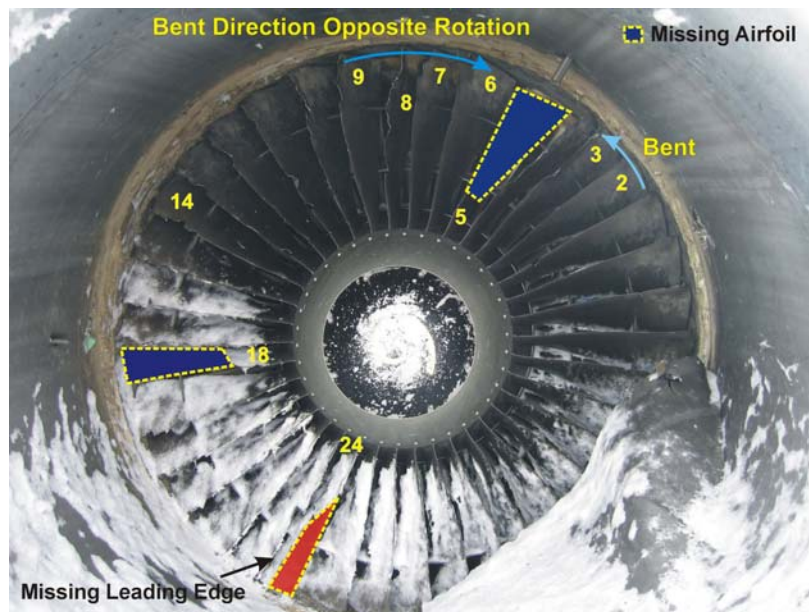
All the fan blade platforms and lower airfoil sections were present with blades numbered 5 and 18⁵ fractured below the mid span shroud (**PHOTO 18**). All the fan blade leading edges exhibited various amounts of hard body impact damage with the No. 24 blade missing about 50% of its leading edge (**Photos 18 and 19**). The majority of the fan blade leading edge tips were bent aft with four (4) consecutive blades (Nos. 6 – 9 in the direction of rotation) bent in the direction opposite rotation and blades numbered 3 and 4 bent forward. A large piece of fan blade was observed at the 12:00 o'clock position resting between the fan blades and the OGVs (**Photo 19**). The mid span shrouds were intact for all the blades at full length. The front and rear spinner cones remained in place and did not exhibit any impact damage. Only paint loss was noted, consistent with what was observed on the No. 1 engine.

PHOTO 18: ALL FAN BLADES REMAINED INSTALLED

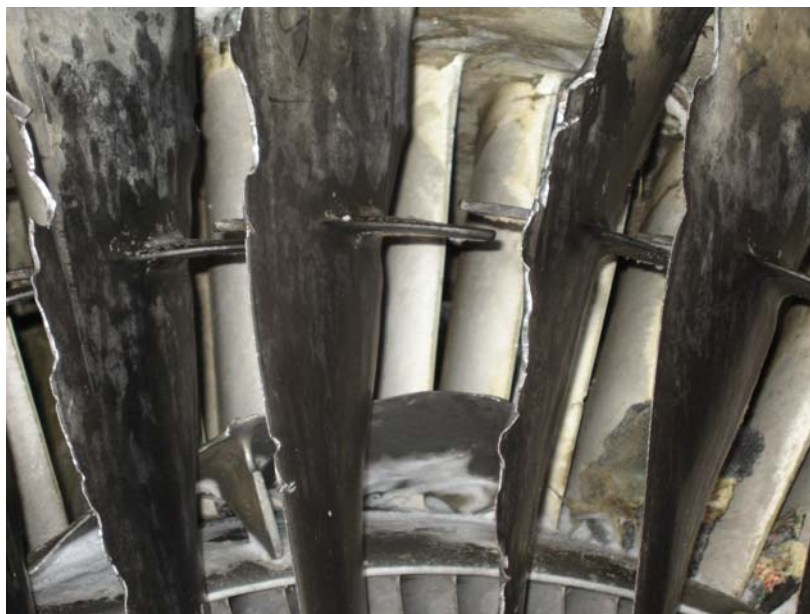
PHOTO 19: HARD BODY DAMAGE AND FAN BLADE FRAGMENT RESTING IN FRONT OF THE OGVs

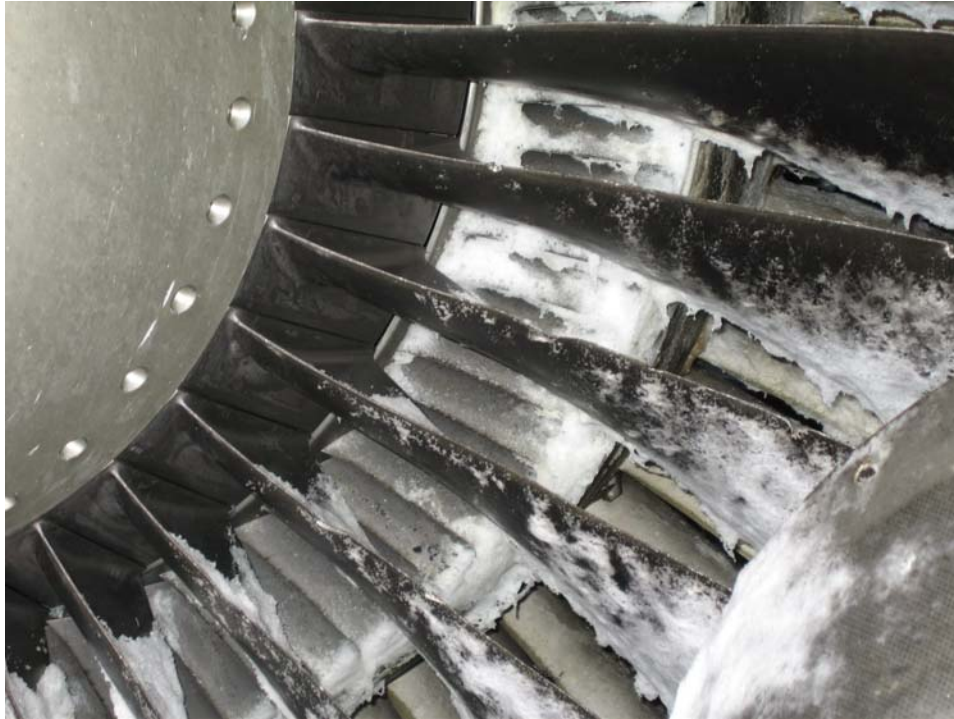
PHOTO 20: NO DIRT OR EARTH DEBRIS INGESTED

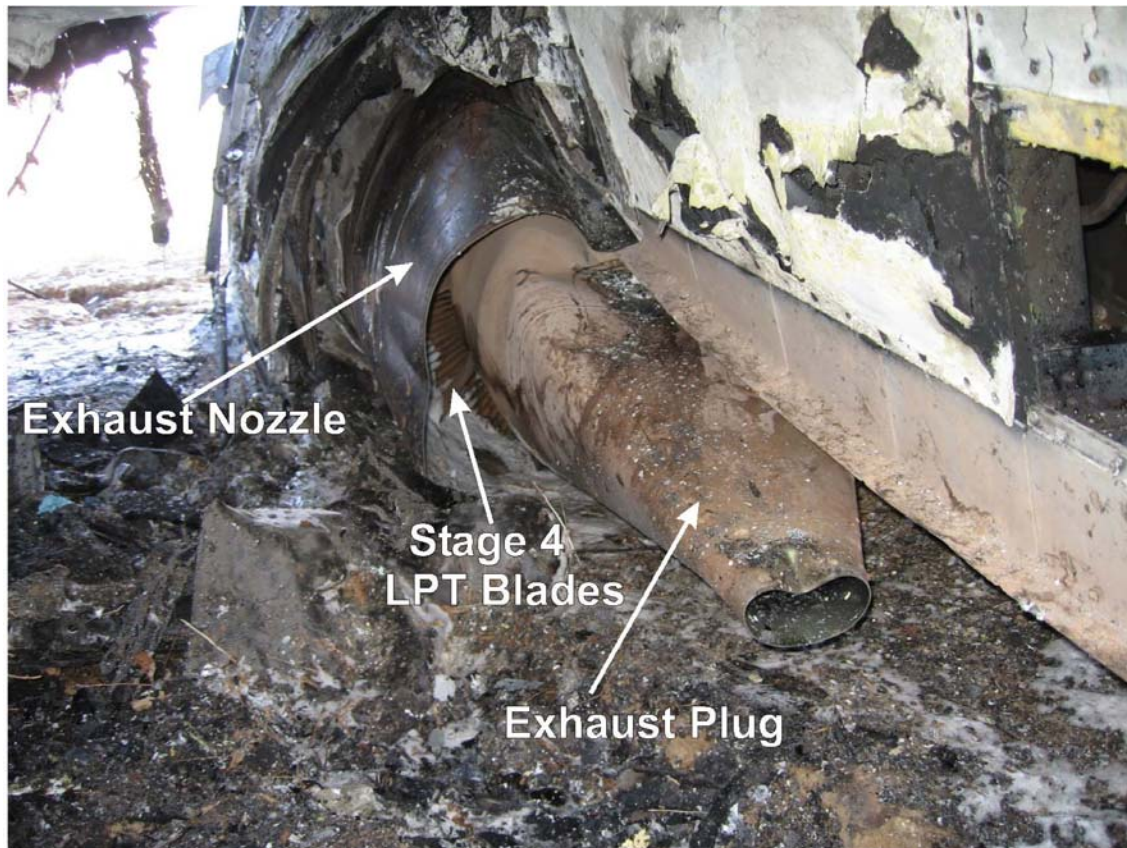
The exhaust nozzle remained installed to the rear flange of turbine rear frame and was crushed inwards. The exhaust plug remained attached to the turbine rear frame center hub and was buckled and pushed forwards. The stage 4 LPT blades from the 6:00 to 8:00 o'clock position were visible through the aft end of the turbine rear frame and the blades appeared straight and intact (**Photo 21**).

PHOTO 21: STAGE 4 LOW PRESSURE TURBINE BLADES APPEAR INTACT

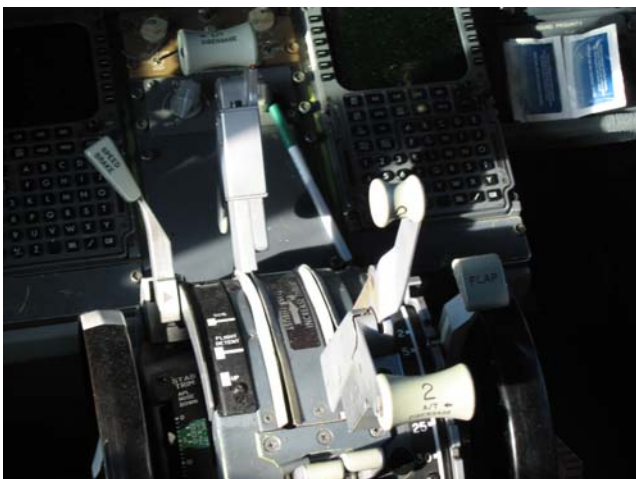
The No. 1 engine throttle was in the full forward position at the mechanical stop while the No. 2 engine throttle was at the idle stop and the thrust reverser lever pulled fully aft (**PHOTO 22**). Both fuel start valve levers were in the idle position (**PHOTO 23**). All the fire handles were found in the stowed position.

PHOTO 22: THROTTLE POSITIONS

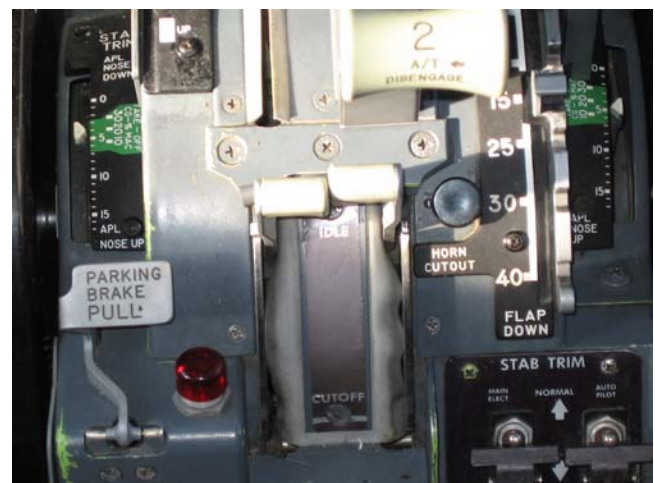
PHOTO 23: FUEL START LEVER POSITION

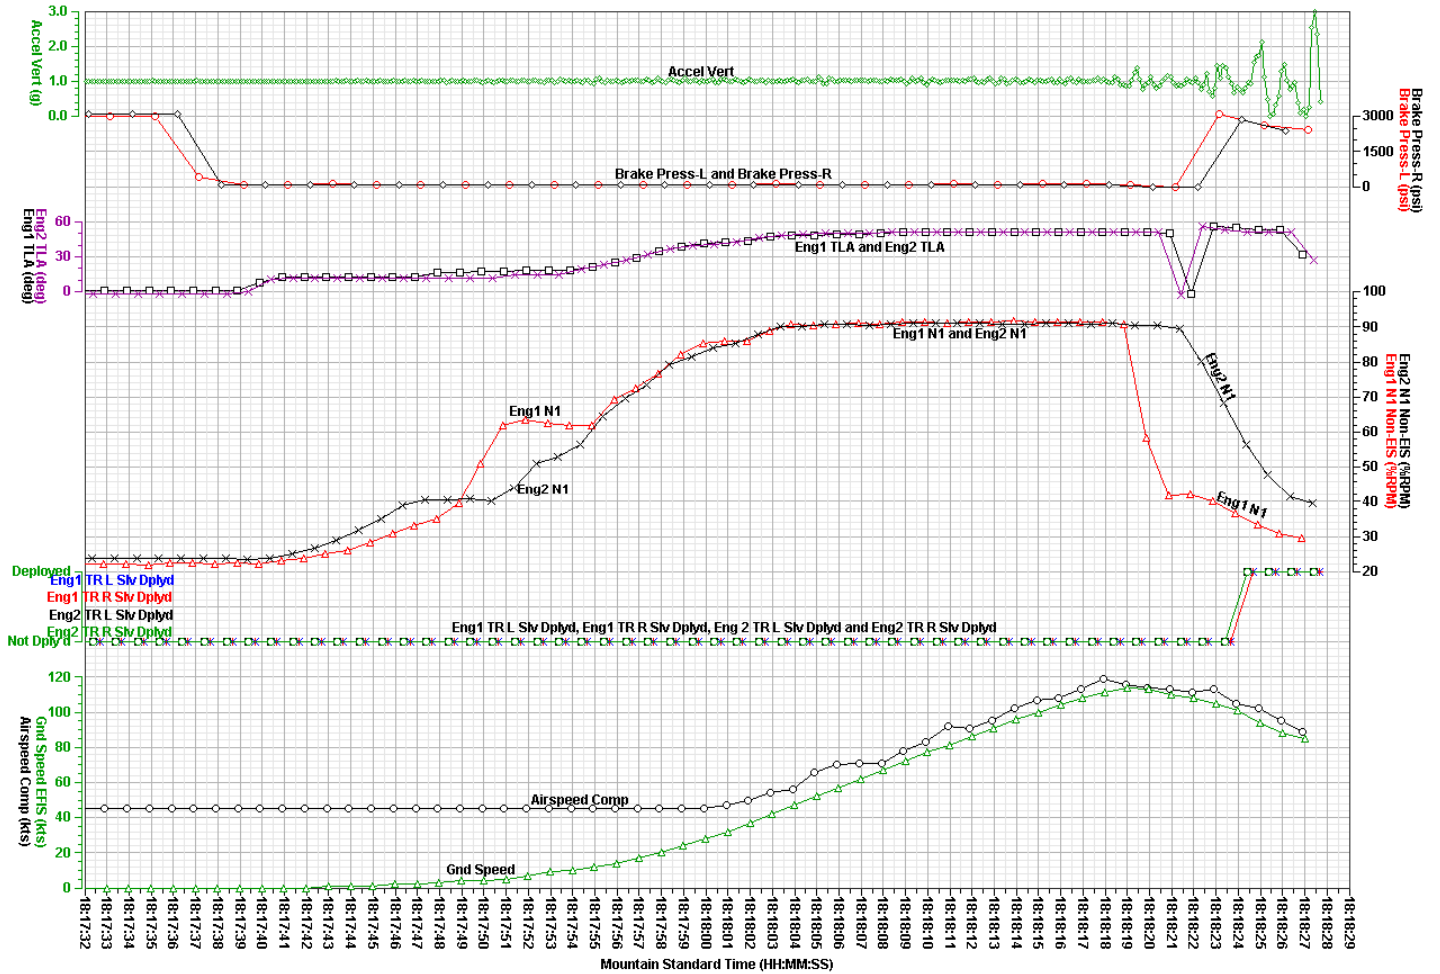
FIGURE 2: DIGITAL FLIGHT DATA RECORDER DATA

About three (3) seconds (MST 18:17:43) after both throttles were advanced (T=+4s) the airplane starts on its T/O roll. The acceleration of the engines was mismatched as they passed through 40% N1, even though the TLA for both were within about a percent of each other. According to the interview statement of the Captain (Flying Pilot), he commented that it [engines] was a little squirrely getting to 40% N1 and as they were going to 70% N1 there was still a split in the motors but when pushed through to around 90% N1 he made sure the engines were pretty well matched [N1 speed]. The First Officer (Non-Flying Pilot) stated in his interview that the captain pushed the throttles to 40% N1 to make sure there were two good spools and that when the throttles were pushed to 70% N1, the captain engaged the auto-throttles but commented that the throttles were mismatched but that they spooled up to the takeoff power without any problems (See Operations/Human Performance Group Chairman's Factual report for complete details of the interview of the Captain and First Officer). At about T=+17s (MST 18:17:56), both fan speeds of both engines came together at about 70% N1 and from that point, continued to accelerate and were closely matched while they accelerated to T/O power.

Both engines reached T/O power, about 90% N1 speed, at about T=+25s (MST 18:18:04) and remained at that level until about T=+40s (MST 18:18:19). According to the First Officer statement, the T/O power setting was to be 90.9% N1 based on their accuload program. At about T=+39s (MST 18:18:18), the airplane departed off the left side of the runway while both engines remained at about 90% N1. About two (2) seconds later (T=+41s/MST 18:18:20), the No. 1 engine experienced an uncommanded deceleration (no corresponding recorded TLA movement) to 58% N1 speed while the No. 2 engine fan speed remained at about 90%. At about T=+42s (MST 18:18:21) both throttles were brought back to idle and about one (1) second later (T=+43s/MST 18:18:22) the thrust reversers were deployed. The commanded reduction in power occurred about three (3) seconds after the airplane had departed the runway. According to the FDR data, the thrust reverser remained deployed to the end of the recording. The fan speed for the No. 1 engine continued to decrease after it reached 42% N1 at T=+42s but at a much slower rate than before until it reached its lowest recorded value of about 30% N1 at the end of the recording. The fan speed for the No. 2 engine continued to steadily decrease after the throttle lever was brought back to idle at T=+42s. Neither the No. 1 or 2 engine fan speed increased in value when the thrust reversers were deployed.
