**NATIONAL TRANSPORTATION SAFETY BOARD
OFFICE OF AVIATION SAFETY
WASHINGTON, D.C. 20594**

POWERPLANTS GROUP CHAIRMAN'S FACTUAL REPORT

NTSB ID: DCA11MA075

Aircraft: Boeing 707-321B, N707AR, operated by Omega Refueling Services, Inc.

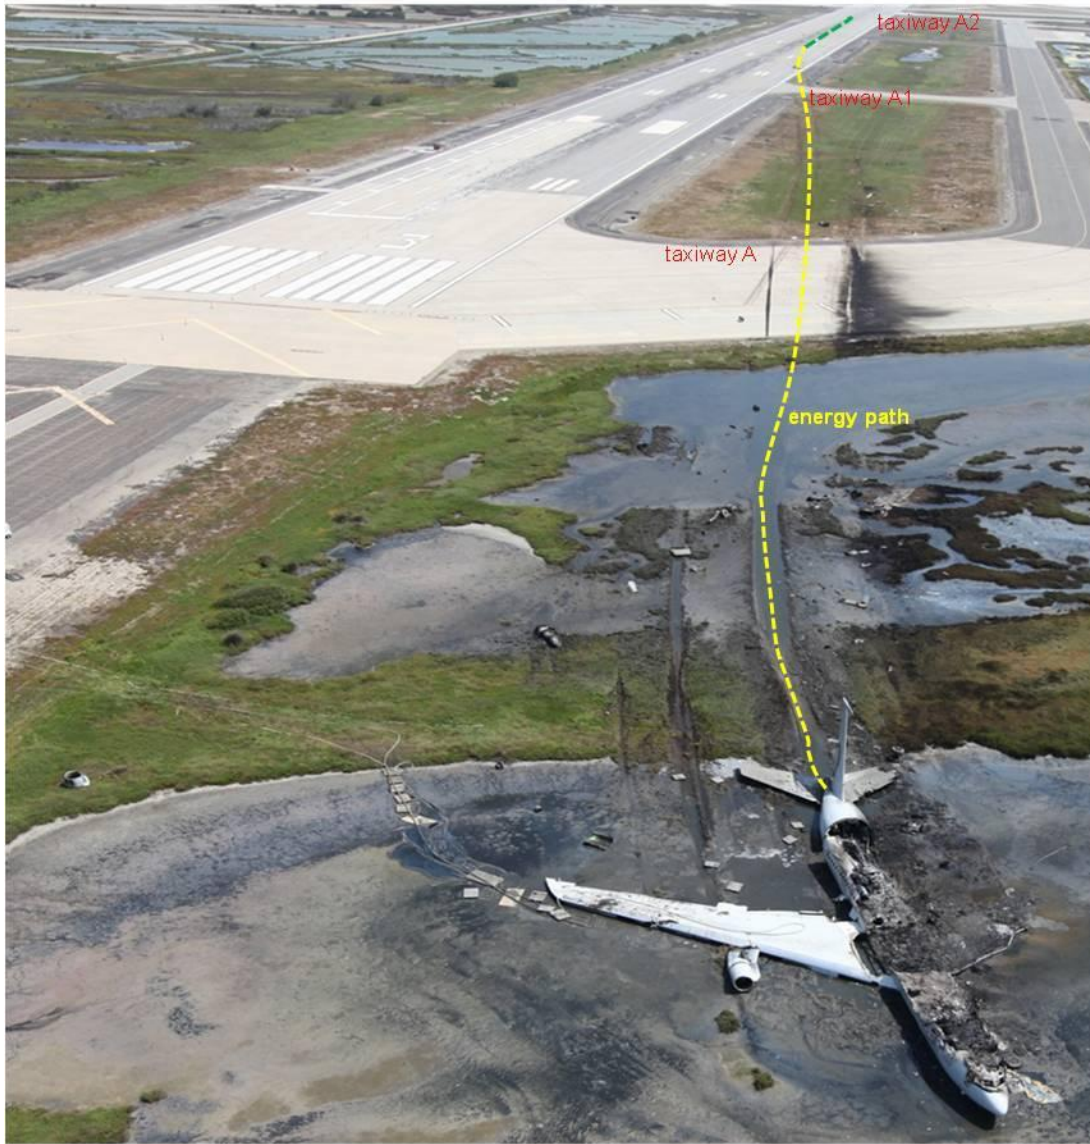
A 4,120-foot debris field began about 7,500 feet from the approach end of runway 21, near taxiway A2. Main landing gear (MLG) tire marks indicated that the airplane contacted the runway about 900 feet into the debris field and that the airplane departed the runway on a 218 degree heading near taxiway A1, continued across the grass infield and taxiway A, and came to rest in a saltwater marsh to the left of the runway overrun. See Figure 1.

Figure 1. Energy path of N707AR. The debris field before the main landing gear tire marks (Area A) is shown in green. Photograph courtesy of NBVC.

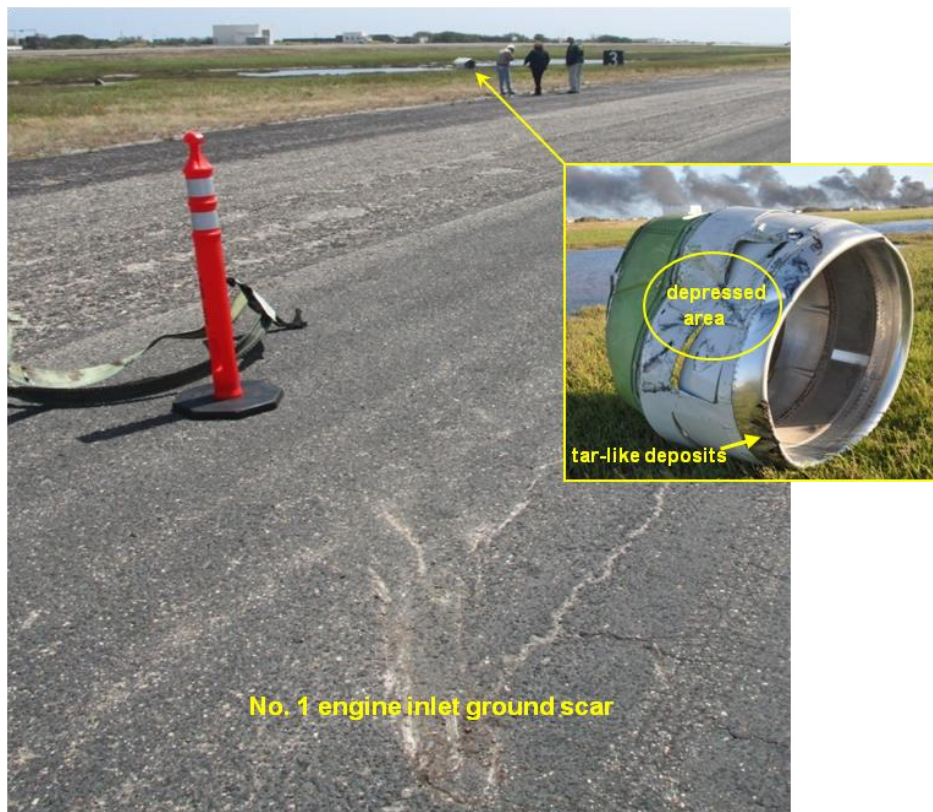
The first ground scar was found next to several fan cowl fragments near the left shoulder of the runway, about 170 feet into the debris field. The scar was diagonally orientated toward the left infield, and the No. 1 engine inlet cowl was located directly in line with the ground scar, about 450 feet away. See Figure 2. The inlet cowl was identified as the No. 1 cowl because it was the only inlet cowl in the wreckage that did not have a pylon turbocompressor housing attached, and the B707 No. 1 pylon lacks this structure.

There were two rubbed areas with tar-like deposits on the leading edge of the inlet cowl, consistent with the transfer of asphalt from the runway surface. The side of the inlet cowl showed a large depression between 1 and 6 o'clock.¹ Soot deposits were present in this depression, but not on the rest of the inlet cowl. There were no terrain features or objects on the ground that could have produced the depression. A main shaft dome extension was found floating in a pool of standing water about 50 feet beyond the inlet cowl.

Figure 2. Runway impact scar and No. 1 engine inlet cowl

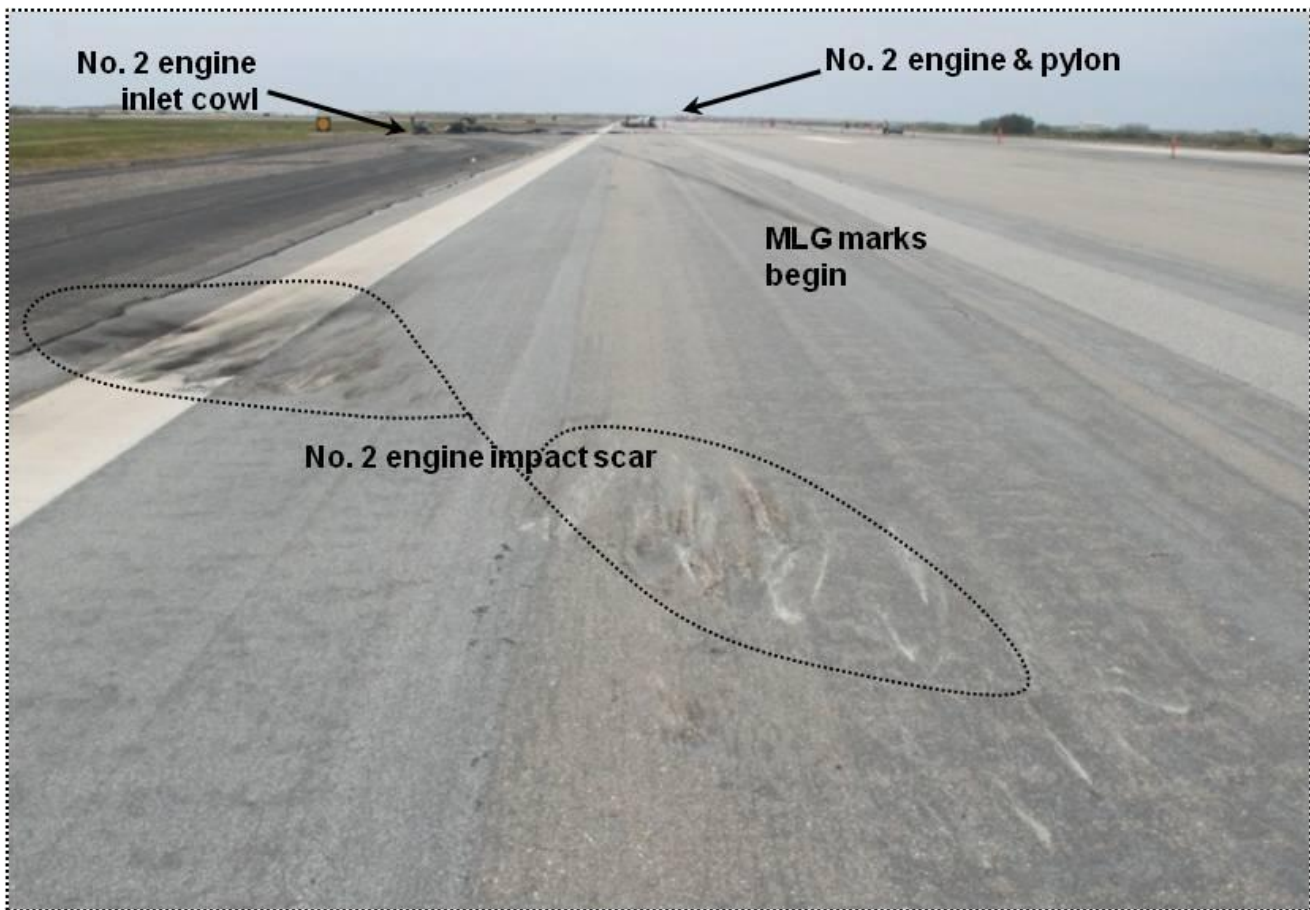
The next ground scar was a set of gouges located about 330 feet further into the debris field, on the left side of the runway. See Figure 3. There were rivet heads, white paint, aluminum, and soot embedded in the gouges. The corresponding damage found on the No. 2

Figure 3. No. 2 engine & pylon runway impact scar

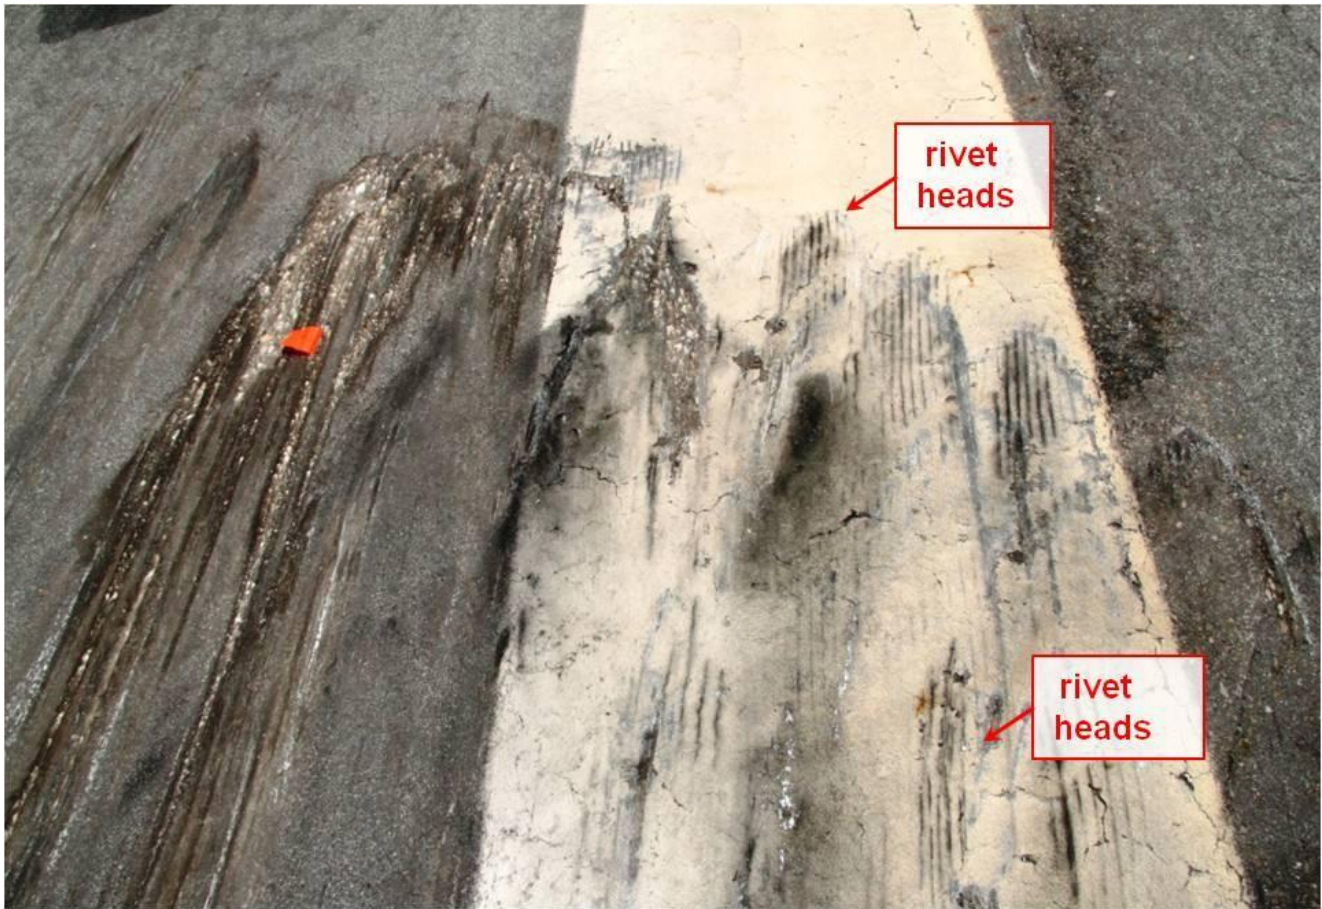
engine (see paragraph 2.2.1), and the fact that the final resting position of the No. 2 engine and pylon was in line with the direction of the scar, identified it as the place where the No. 2 engine and pylon first struck the ground. The orientation of the scars indicated that the No. 2 engine and pylon were transverse to the runway when they struck the ground, consistent with having separated from the airplane in flight. See Figure 4.

Figure 4. Detail of No. 2 engine & pylon runway impact scar

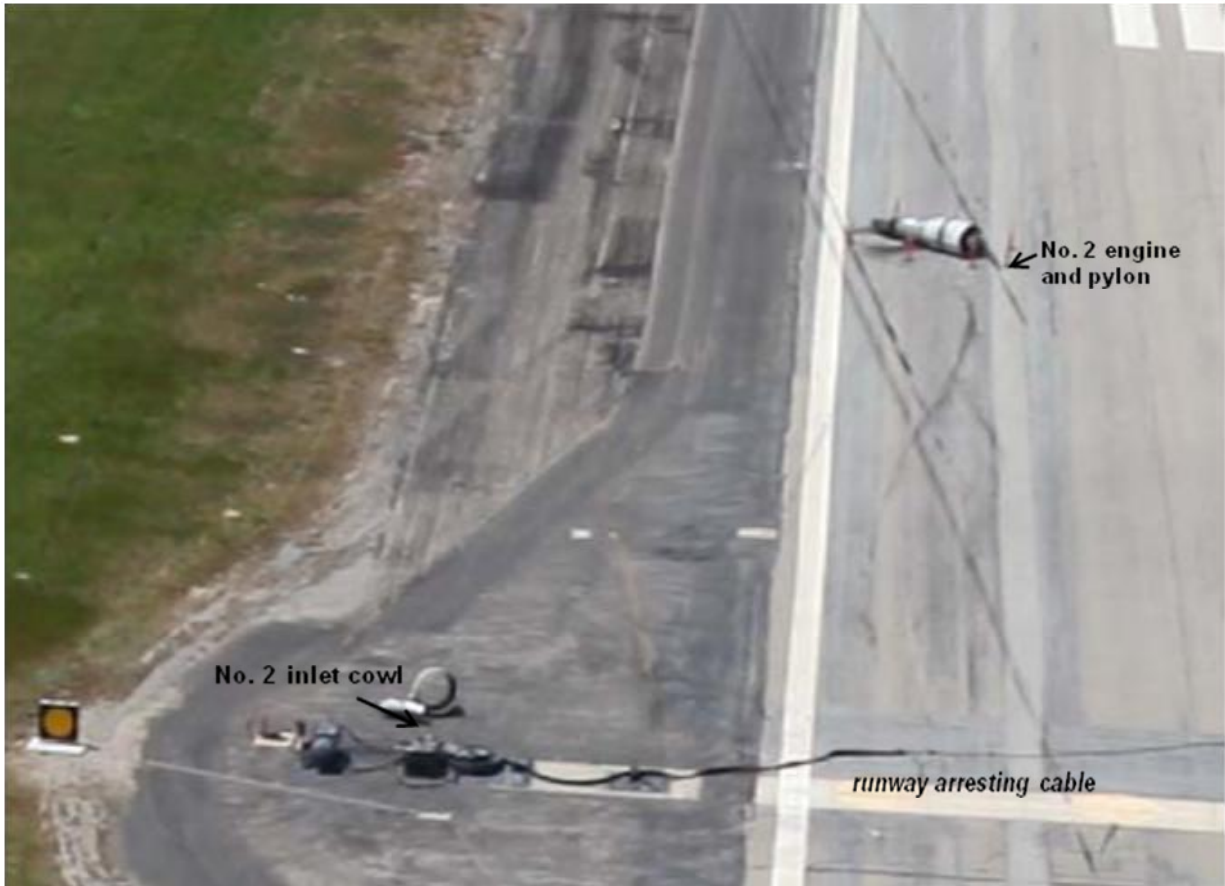
The No. 2 engine inlet cowl was found on the left shoulder of the runway at the arresting gear mechanism. The No. 2 engine and pylon were located about 700 feet beyond the double set of ground scars. See Figure 5. Some small fragments of turbine gas path components and cascade material were found on the runway between the engine ground contact scars and the No. 2 engine and pylon. The inlet cowl was not severely deformed. The turbocompressor cowling structure was still attached. See Figure 5.

Figure 5. No. 2 engine & pylon, and No. 2 engine inlet cowl *Photograph courtesy of NBVC*

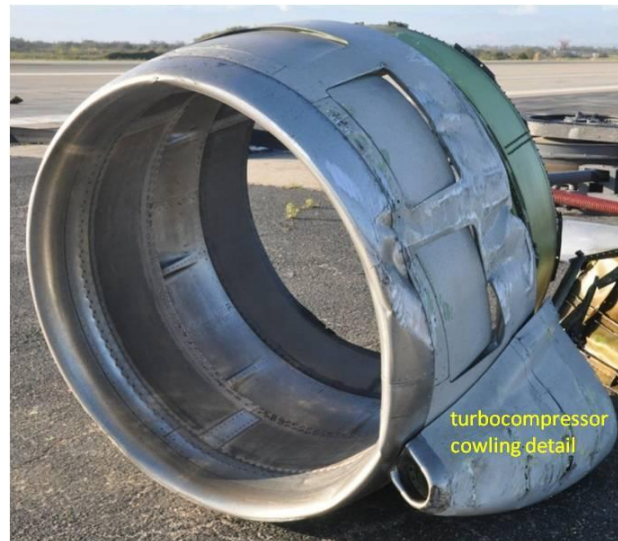
Figure 6. No. 2 engine inlet cowl

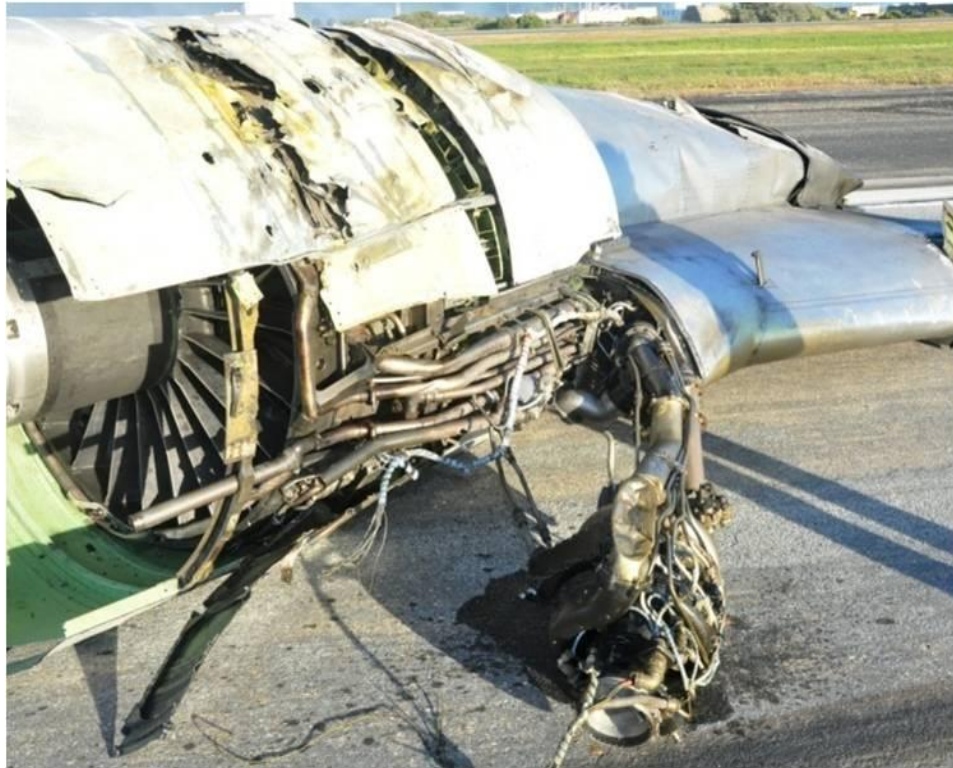
Both thrust reverser sleeves were partially deployed. The thrust reverser sleeves and core cowls were severely damaged, consistent with the engine scraping the ground while perpendicular to the runway. The material, paint, and rivets lost to scraping was consistent with the material found embedded in the runway gouges. See Figure 7.

Figure 7. No. 2 engine and pylon *Photograph courtesy of NBVC*

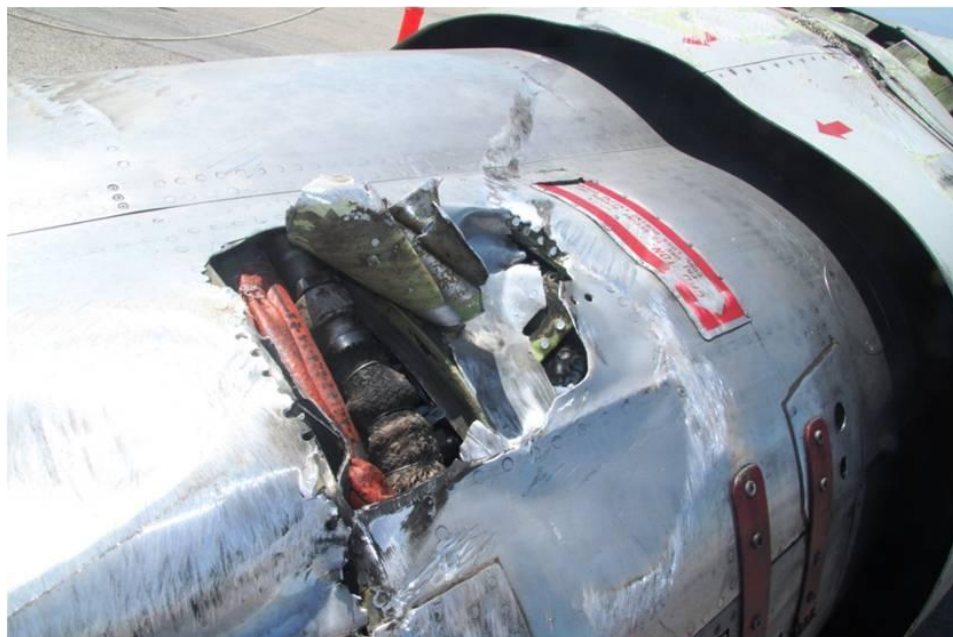
Inspections of the holed areas in the cowling determined that the holes were located over projections of engine externals that had penetrated the cowling when the engine struck the runway

and scraped along its surface. The annular casing was intact and the engine showed no signs of fire damage or uncontainment. See Figure 8.

Figure 8. No. 2 engine cowl damage from contact with runway

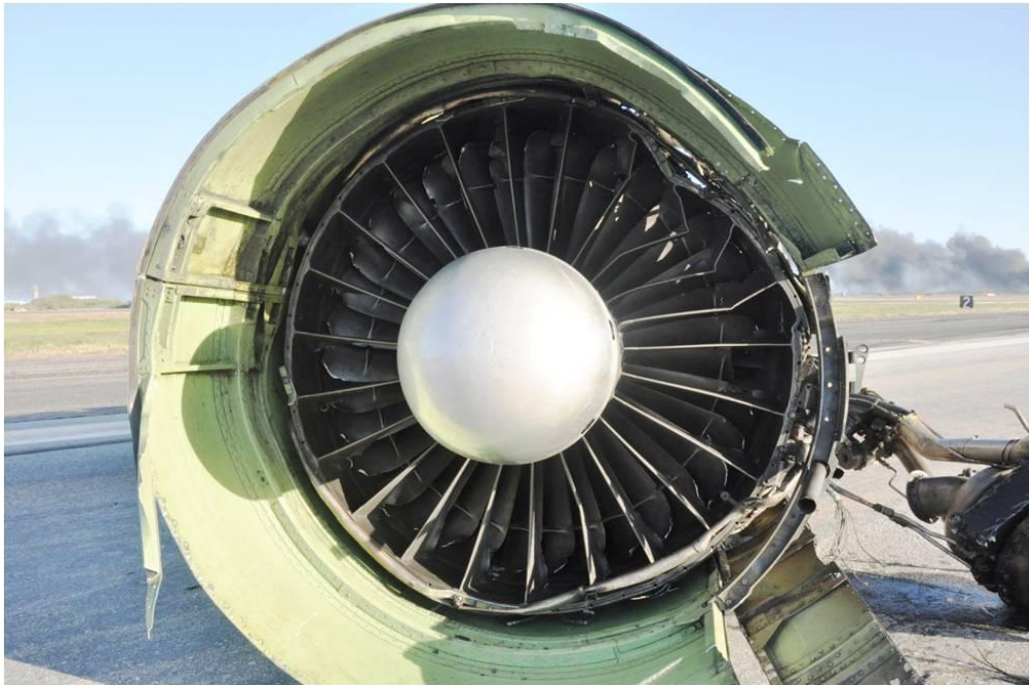
The No. 2 engine inlet case was deformed inward on the inboard side. See Figure 9.

Figure 9. View into No. 2 engine inlet *Photograph courtesy of NBVC*

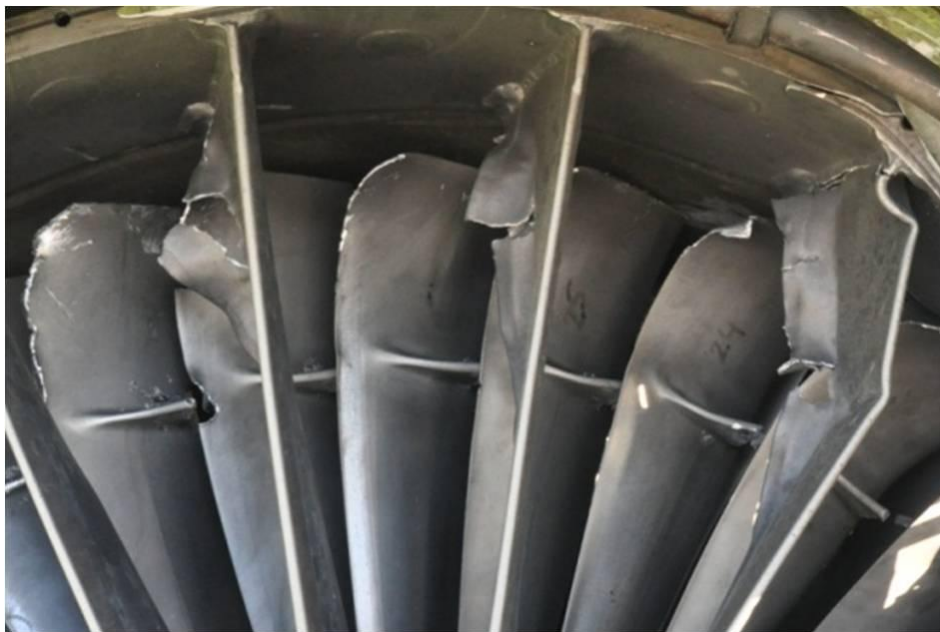
The trailing edges of the inlet guide vanes (IGVs) were torn and deformed in the direction of compressor rotation. All of the compressor first stage (C1) blade tip leading edges were missing material and/or curled opposite the direction of rotation, consistent with abnormal contact with the IGV trailing edges by the compressor rotor and with the blade path during rotation. See Figure 10.

Figure 10. No. 2 engine inlet guide vane trailing edge and C1 airfoil leading edge damage

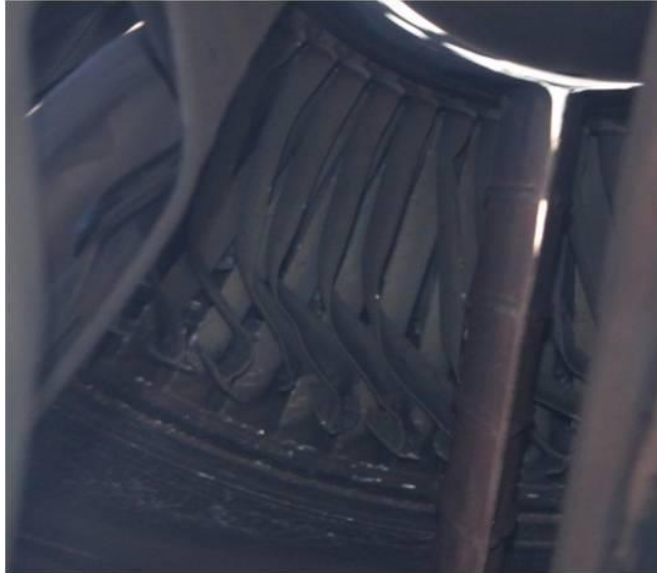
The exhaust nozzle was deformed inward, partially obstructing the view of the low pressure turbine (LPT). Several airfoil fragments were observed lying inside the exhaust case. The tips of observable 4th stage LPT airfoils were deformed opposite the direction of rotation. See Figure 11.

Figure 11. No. 2 engine, view through exhaust

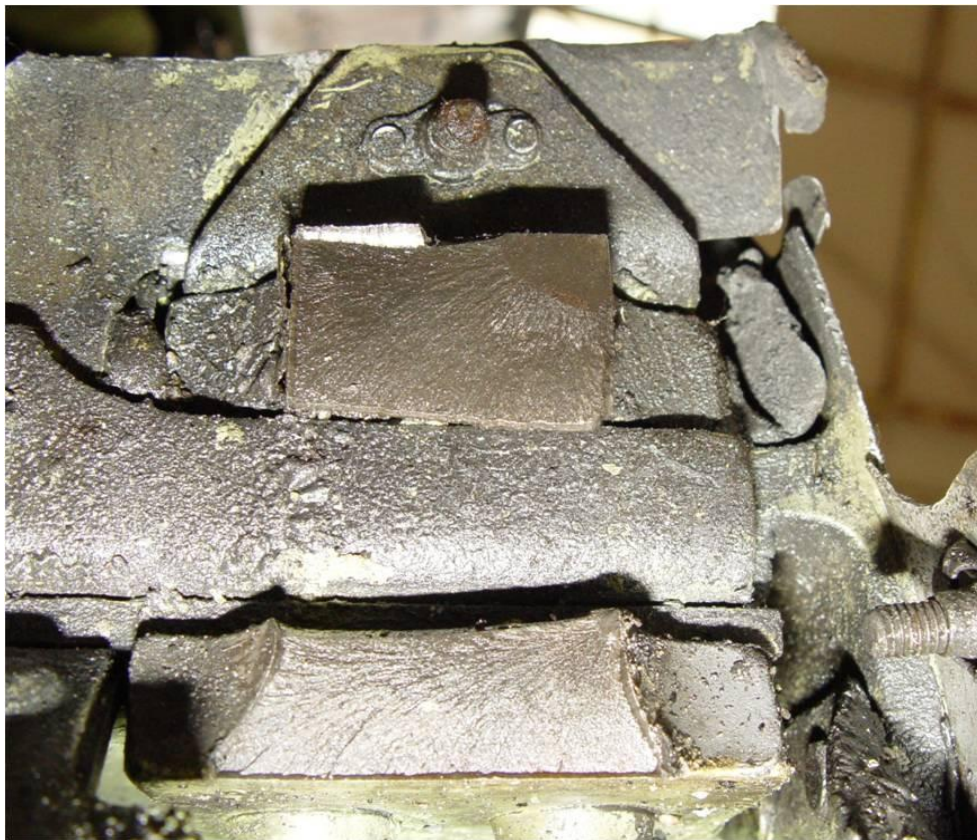
The No. 2 pylon had separated from the airplane at the wing attachment fittings. The inboard mid-spar fitting showed flat fracture surfaces with arcing termini. See Figure 12.

Figure 12. Fracture faces of the No. 2 pylon mid-spar fitting

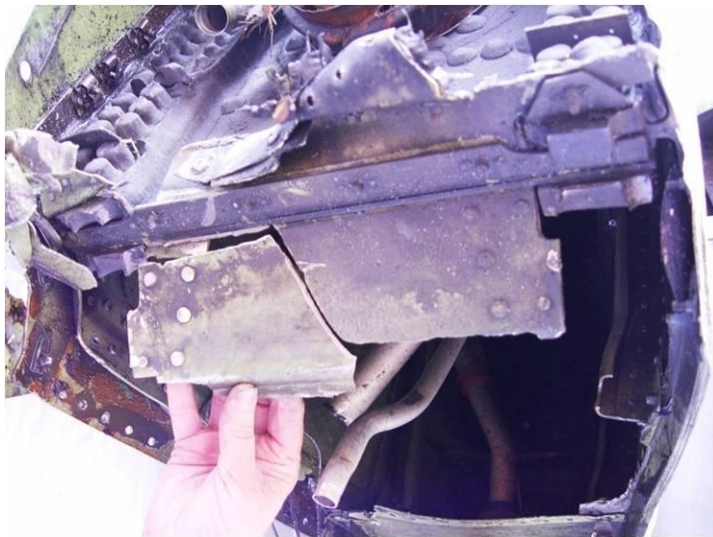
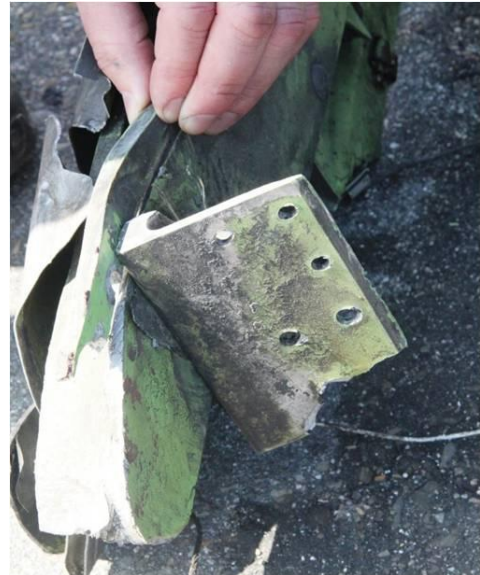
The pylon pieces found at the start of the debris field were matched to No. 2 pylon fractures. See Figure 13.

Figure 13. No. 2 pylon showing the first 2 pieces of wreckage found along the airplane's energy path: (a) torque bulkhead fragment and (b) overwing fitting fragment

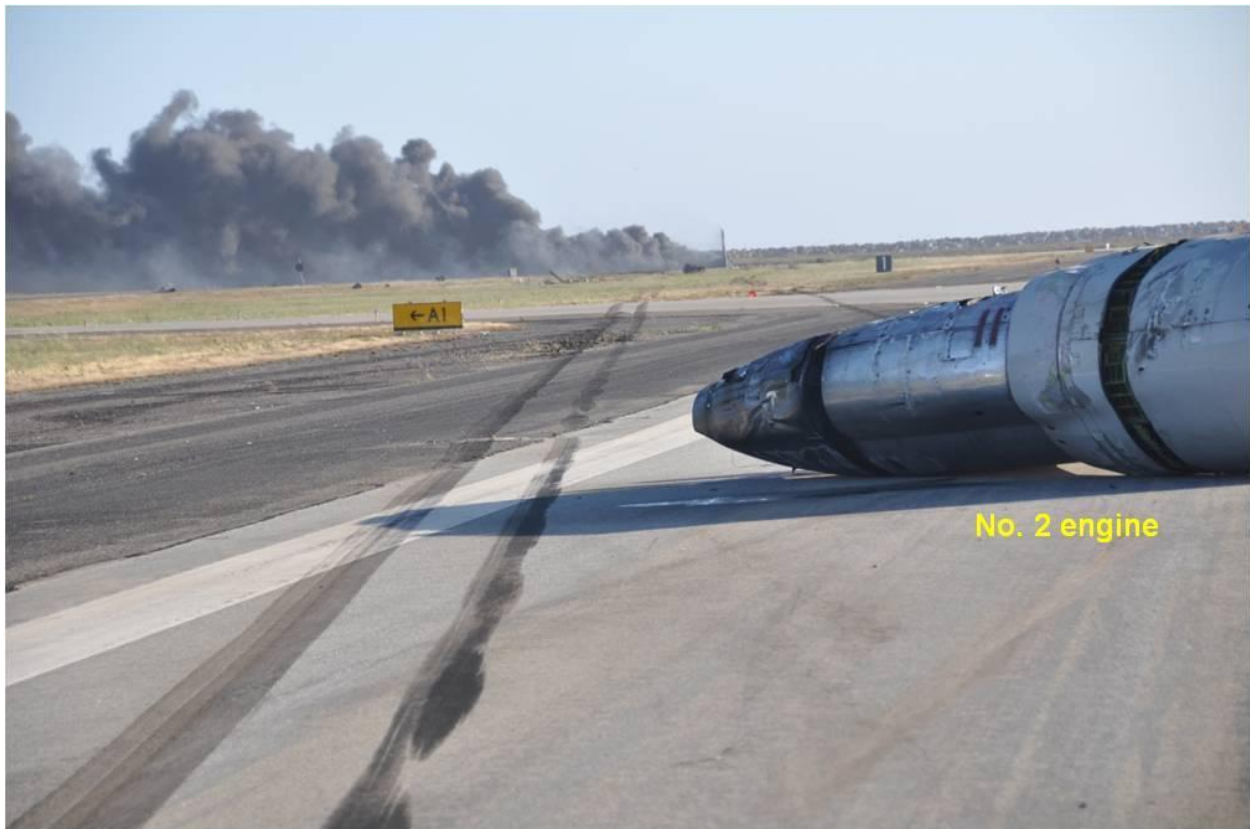
The airplane departed the asphalt surface near taxiway A1, which was 9,500 feet from the departure end of the runway. See Figure 14.

Figure 14. Runway departure *Photograph courtesy of NBVC.*

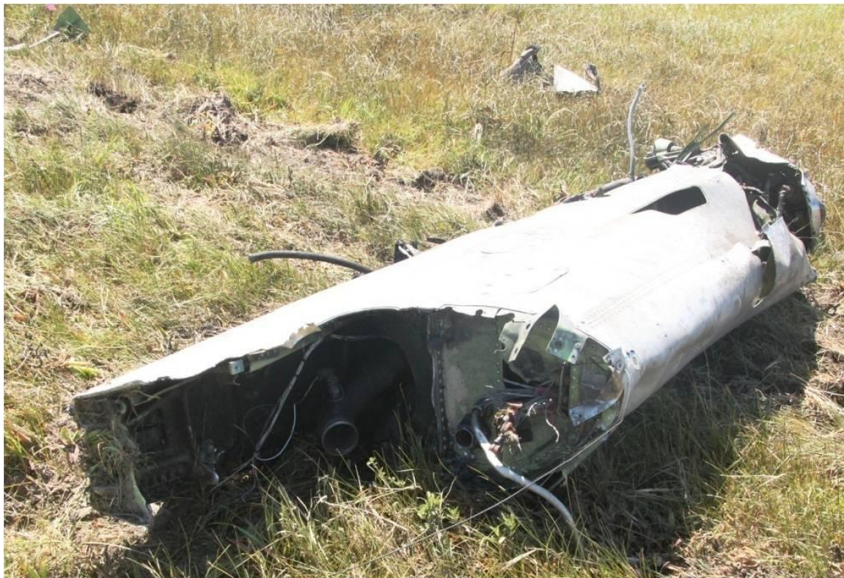
About 2,046 feet into the debris field, a furrow appeared amid the MLG scars, and engine components began to appear again, including engine fan blades, thrust reverser components, core cowl and exhaust fragments, and a pylon drag link. These components showed no evidence of pre-impact damage. The No. 1 pylon was found along the furrow, about 2,876 feet into the debris field. See Figure 15. The No. 1 engine was found about 145 feet beyond the pylon, near taxiway A.

Figure 15. No. 1 pylon, showing separation at wing, and lack of turbocompressor feature. *Photograph courtesy of NBVC.*

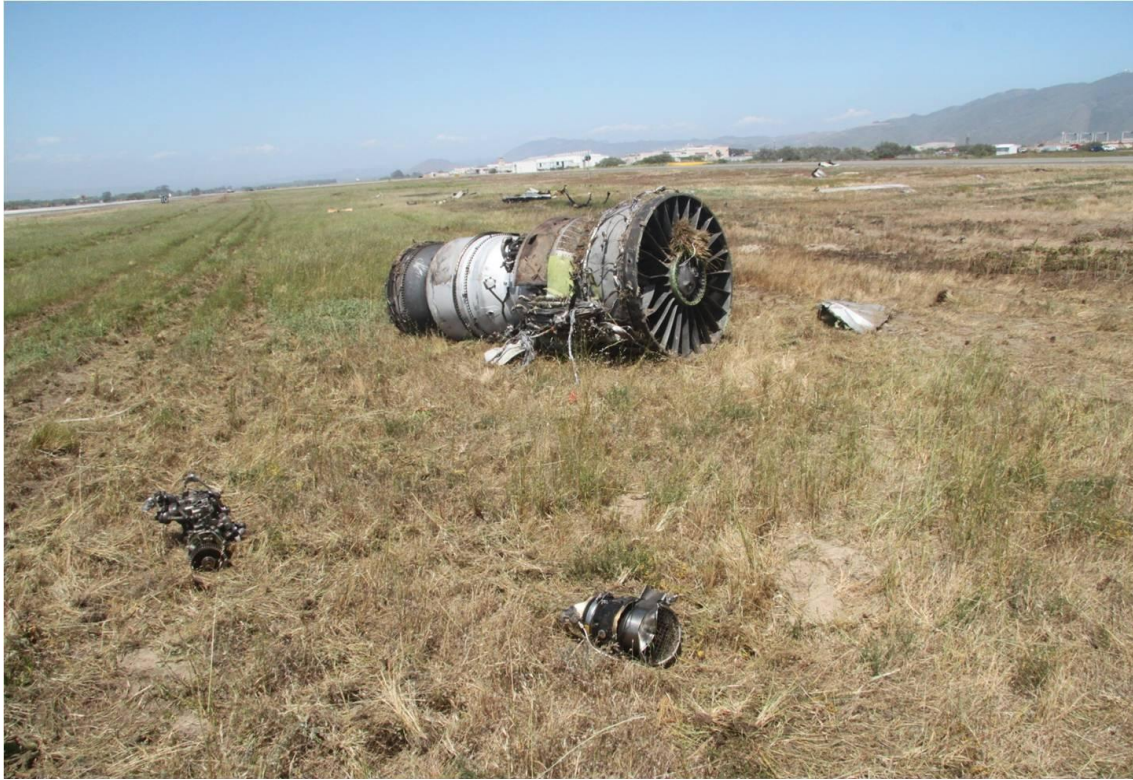
All of the cowlings were missing. There was no evidence of uncontainment or undercowl fire. The main gearbox was fractured, and gearbox fragments, the air starter, the constant speed drive and generator, and the fuel control unit were found strewn around the engine. See Figure 16. Soil and grass were embedded in openings, and the engine externals were crushed and fractured, consistent with the displacement of soil and grass along the furrow. See Figure 17.

Figure 16. No. 1 engine, right side

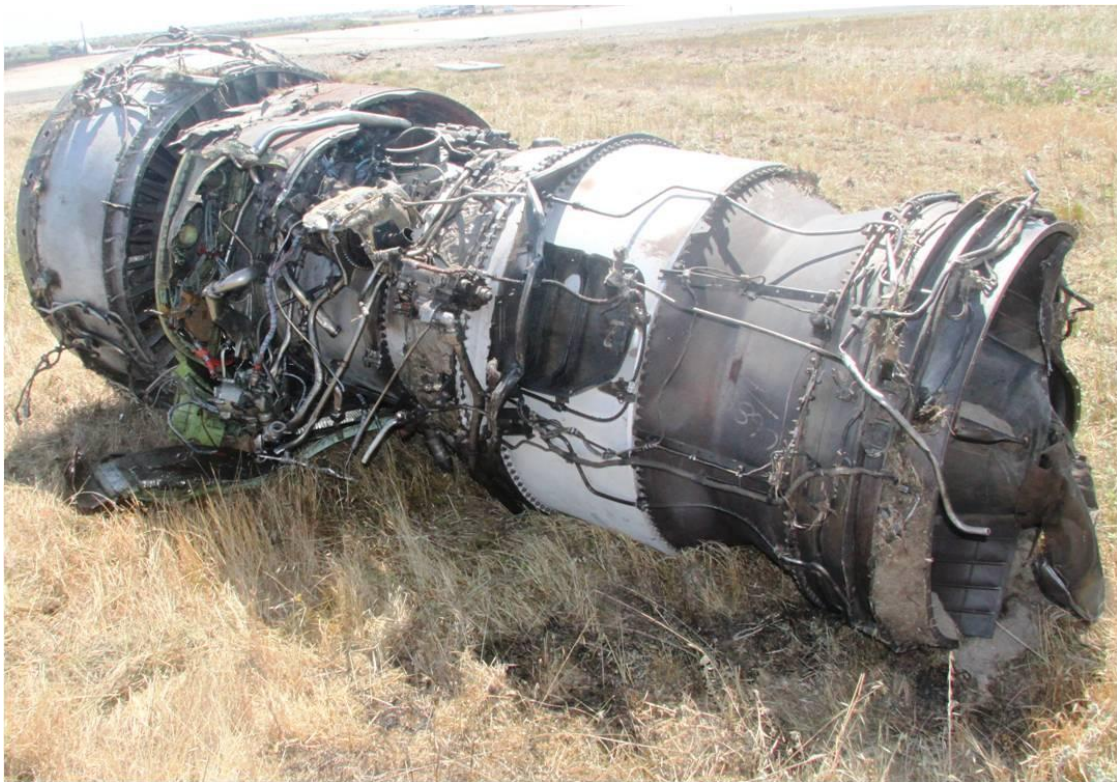
Figure 17. No. 1 engine, left side

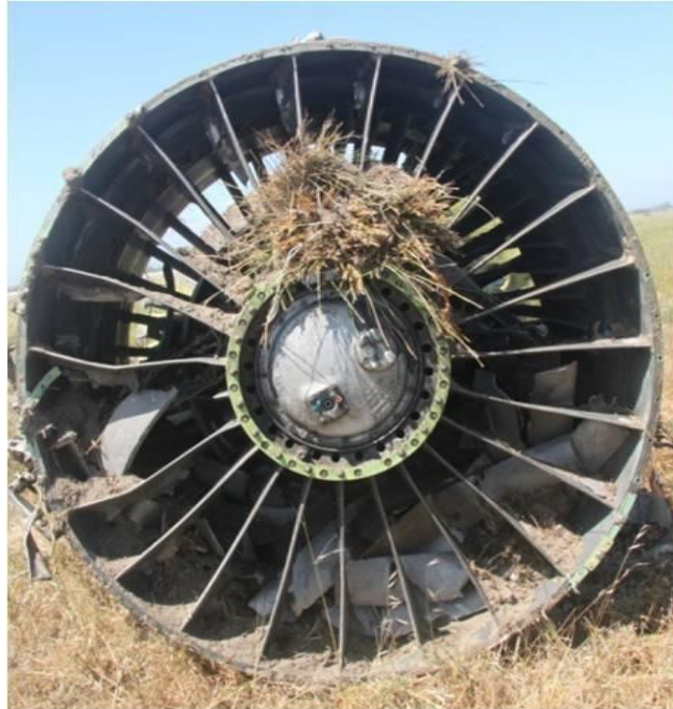
One IGV was broken at 12 o'clock. The IGV trailing edges were missing material and were curled and deformed in the direction of compressor rotation, consistent with abnormal contact of the IGVs by the low pressure compressor rotor during operation. Most of the C1 and C2 fan blade airfoils were fractured adjacent to their platforms, consistent with powered rotation during impact. See Figure 18.

Figure 18. No. 1 engine inlet, showing fractured fan blades

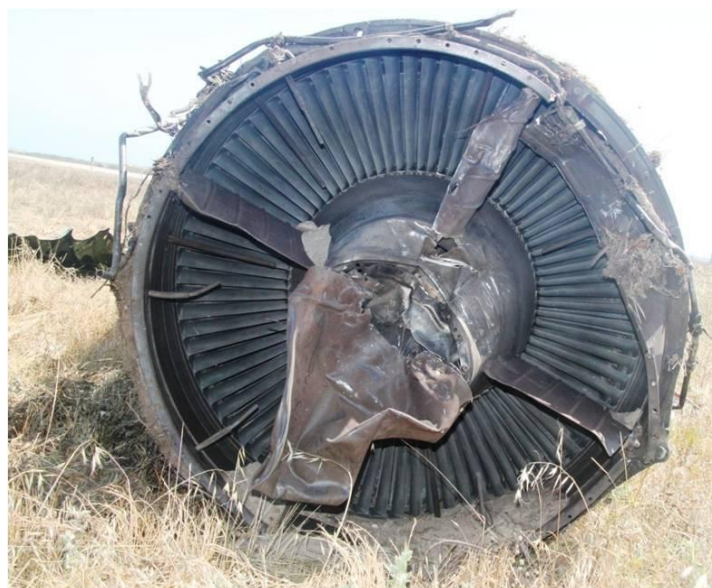
The engine tail cone was severely crushed and several exhaust gas temperature probes were bent. The LPT was intact. See Figure 19.

Figure 19. No. 1 engine exhaust with LPT intact

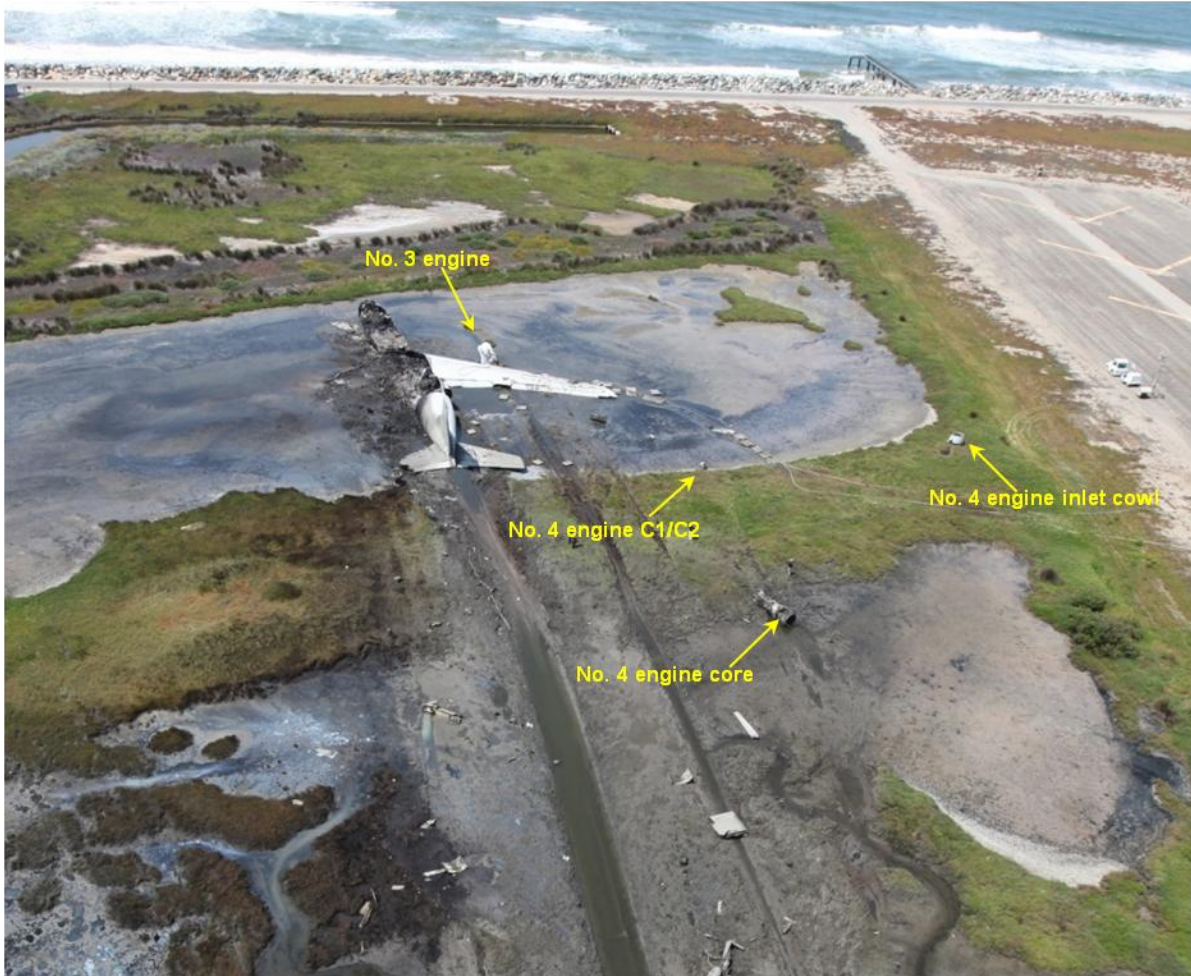
The ground scars and debris showed that the airplane then crossed taxiway A and entered marshy terrain. The main wreckage was partially submerged and partially consumed by fire. It consisted of the fuselage, the right wing with the No. 3 (right inboard) engine attached, and an inboard section of the left wing. Scattered debris aft of the main wreckage included remnants of the burned outboard left wing, the right main landing gear truck, the No. 4 (right outboard) engine, and the No. 4 engine inlet. See Figure 20.

Figure 20. Overview of Area D. *Photograph courtesy of NBVC*

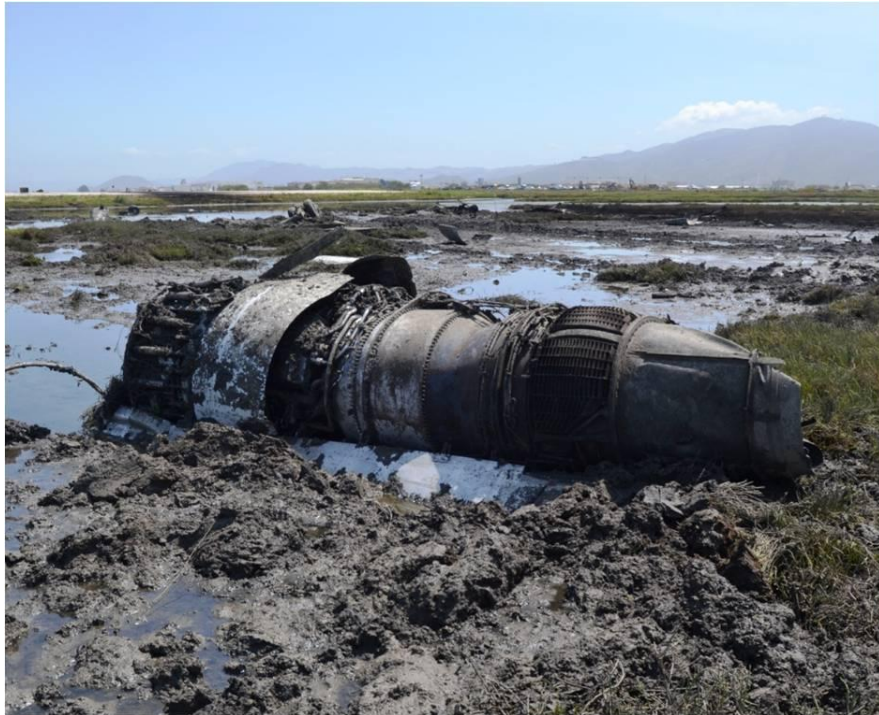
The No. 4 engine was found 3,845 feet into the debris field, 275 feet from the main wreckage. The engine was attached to the pylon. The cowlings, except for the inlet cowl, appeared intact. No evidence of uncontainment or engine fire was noted. The low pressure compressor rotor (C1 and C2) had liberated. The engine was partially submerged. See Figure 21.

Figure 21. No. 4 engine

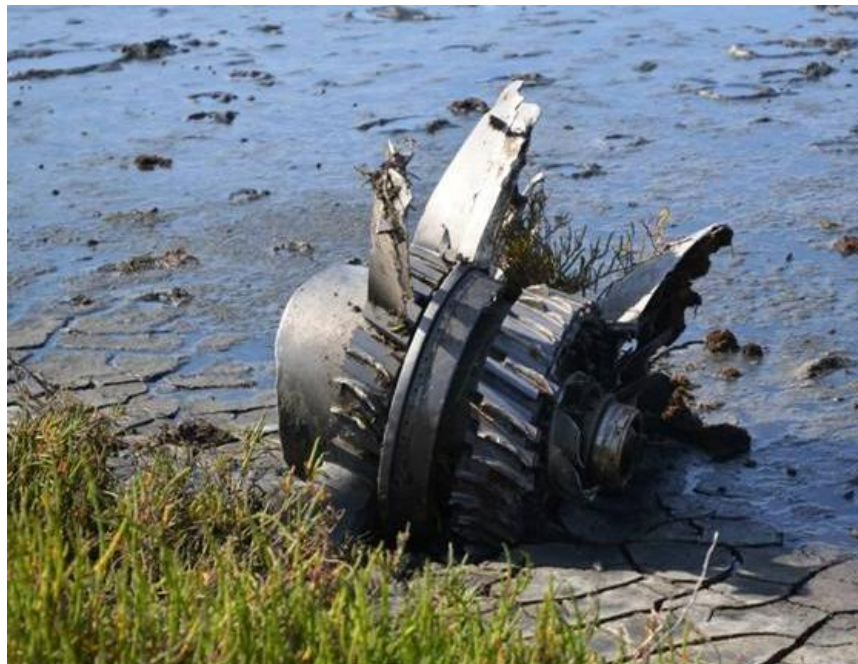
The No. 4 engine's separated first and second compressor rotor stages (C1 and C2) were found about 50 feet away. See Figure 22. An approximate 70° arc of both the C1 and C2 blade airfoils was fractured adjacent to the platform. The visible intact C2 blades were bent opposite to the direction of rotation.

Figure 22. No. 4 engine C1 and C2 rotor stages

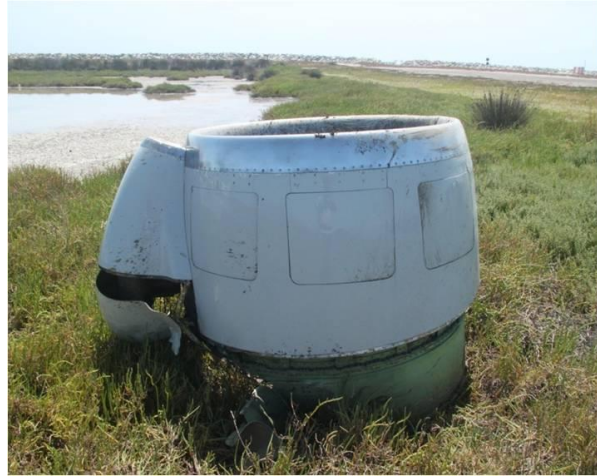
The turbine nozzle was severely crushed and did not permit inspection through the exhaust. The No. 4 engine inlet cowl was found about 152 feet to the right of the engine. It had landed in marshy grass and showed little distortion/impact damage. The turbocompressor inlet housing was attached. See Figure 23.

Figure 23. No. 4 engine inlet cowl with turbocompressor inlet

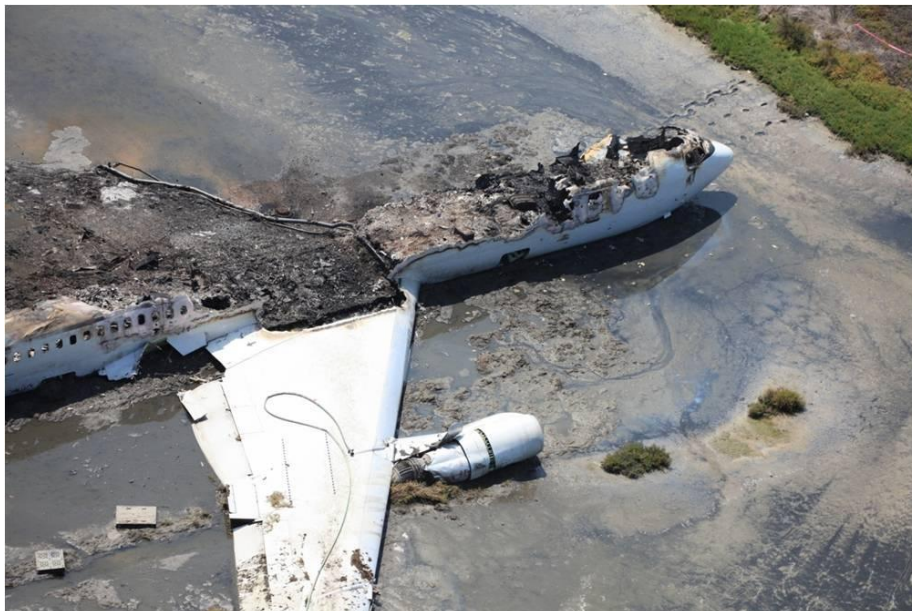
The No. 3 engine was found with the airplane fuselage at the main wreckage site, 4120 feet from the beginning of the debris field. It was partially attached to the airplane's right wing. See Figure 24.

Figure 24. No. 3 engine partially attached *Photograph courtesy of NBVC*

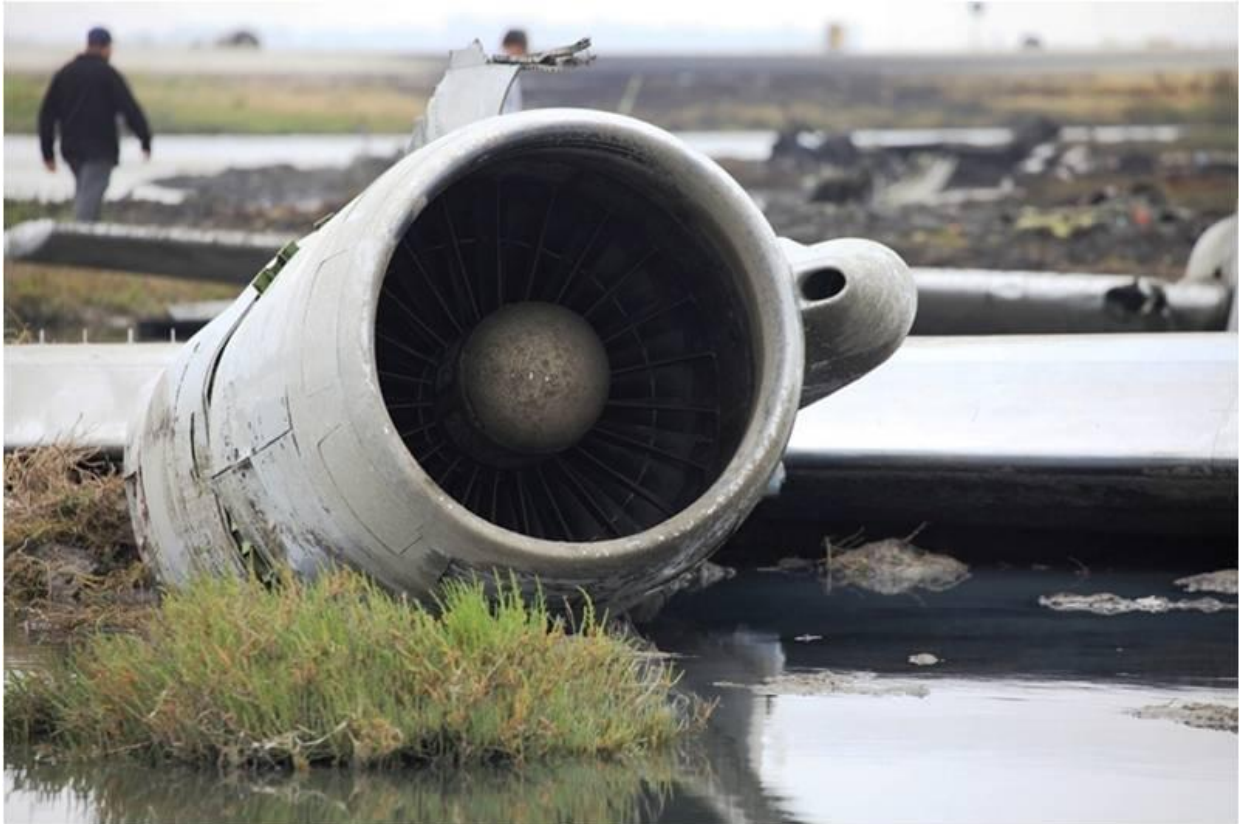
Access to the No. 3 engine was limited on site. The visible engine cowlings, including a view into the engine inlet, showed no signs of uncontainment or undercowl fire. See Figure 25.

Figure 25. No. 3 engine. *Photograph courtesy of NBVC*
