NATIONAL TRANSPORTATION SAFETY BOARD
Office of Aviation Safety
Washington, D.C. 20594

POWERPLANT GROUP CHAIRMAN'S FACTUAL REPORT

NTSB No: ENG-11-IA-051

Aircraft: United Airlines, Boeing 757-222, registration number N526UA, Flight 909

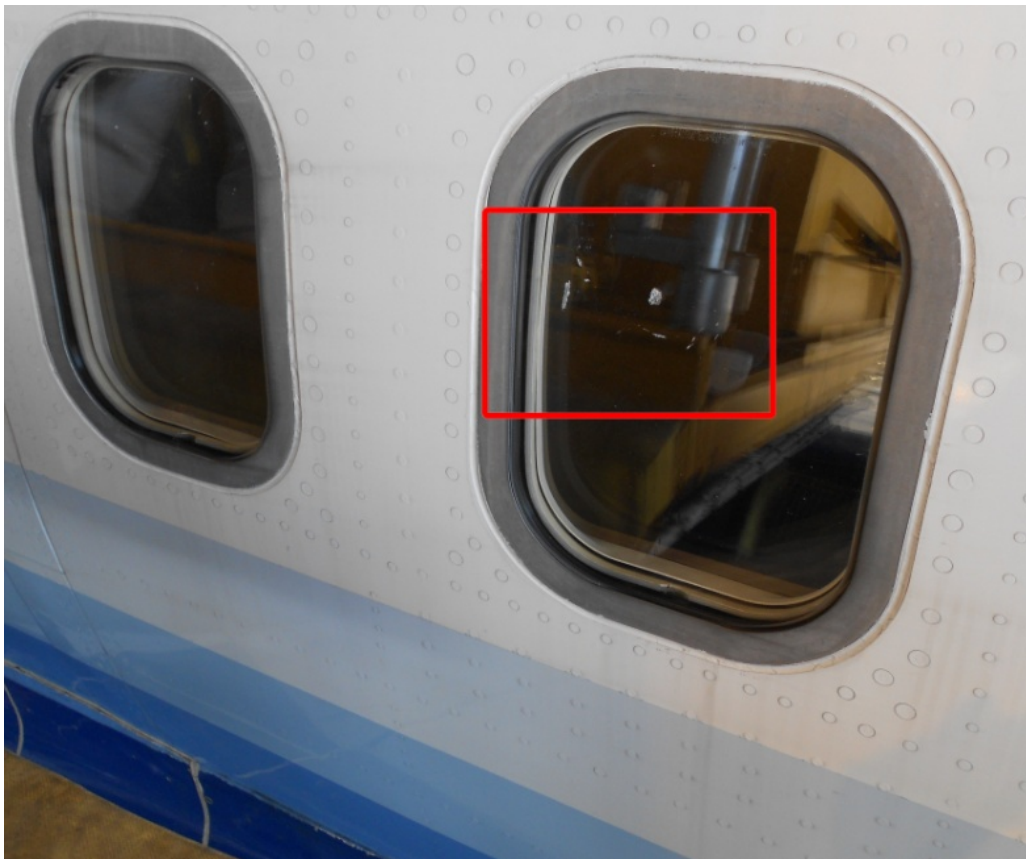
The left-hand main landing gear forward right tire exhibited a cut in the tread but the tire did not deflate. The left-hand lower wing skin inboard of the engine at wing station (WS) 130, stringer U23 exhibited what appeared to be three superficial gouges. The forward fuselage body exhibited the following: 1) a gouge at fuselage station (FS) 600, between stringers S-11L and S-13L, 2) three small nicks at FS 879, stringer S-11L, and 3) a passenger window (8th window aft of passenger door 2L) between FS 920 and 940 exhibited a 1.0-inch gouge and 0.5-inch impact on the outer pane (**PHOTO 1**). The left-hand aft fuselage body exhibited superficial gouges at the following locations: 1) FS 1360, stringer S-29L, 2) FS 1400, stringer S-29R; and 3) FS 1420, stringer S-28R.

PHOTO 1: IMPACT DAMAGE TO PASSENGER WINDOW

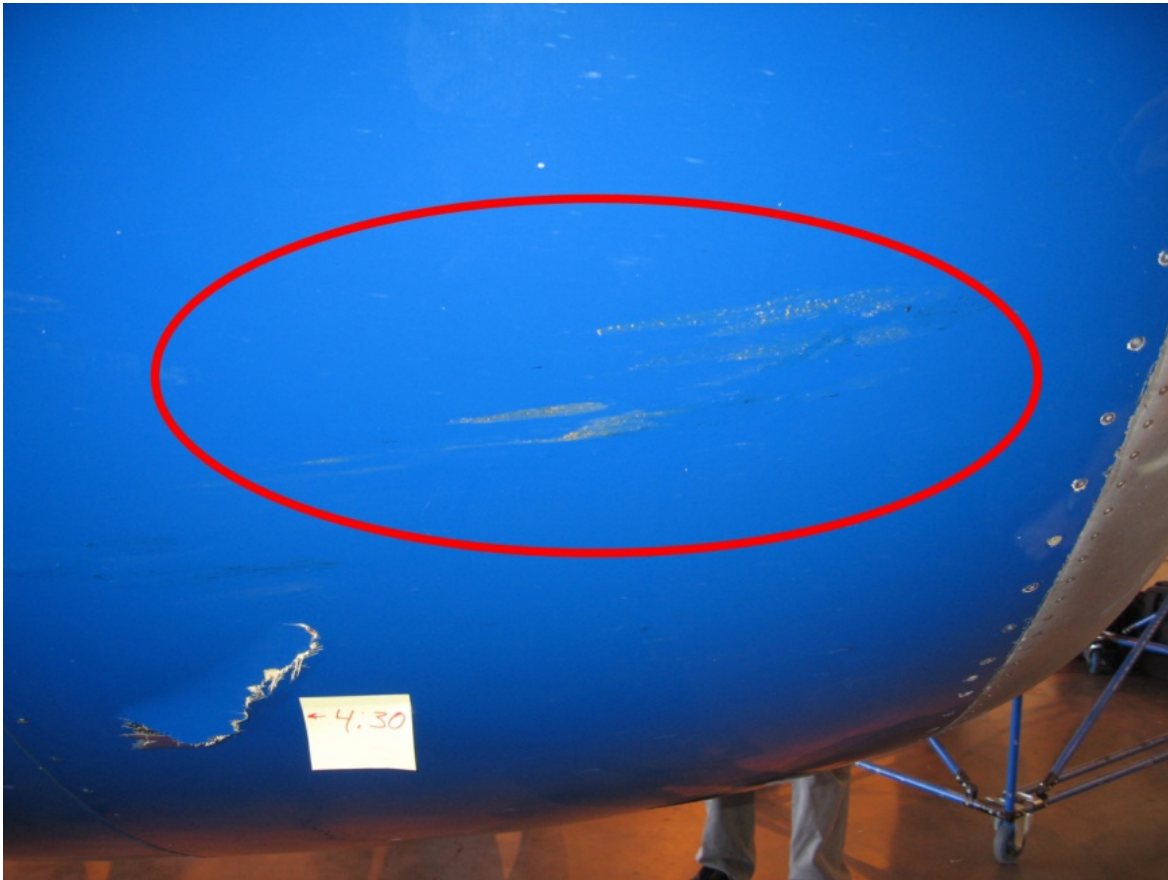
A smear consistent with possible bird remains was observed at about the 4:00 o'clock position on the inlet cowl outer skin with no associated impact damage observed in the area of the bird smear (**PHOTO 2**).

Photo 2: BIRD REMAINS ON THE NO. 1 ENGINE INBOARD INLET COWL

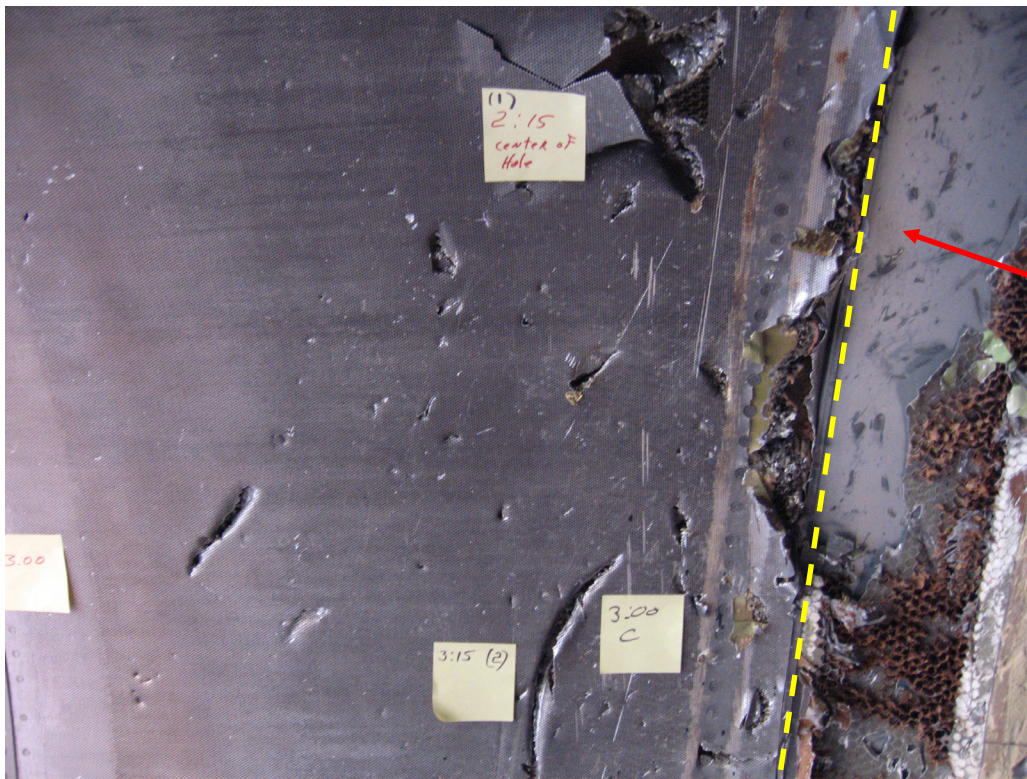
PHOTO 6: INLET COWL INNER BARREL DAMAGE - LOCATIONS 1 AND 2

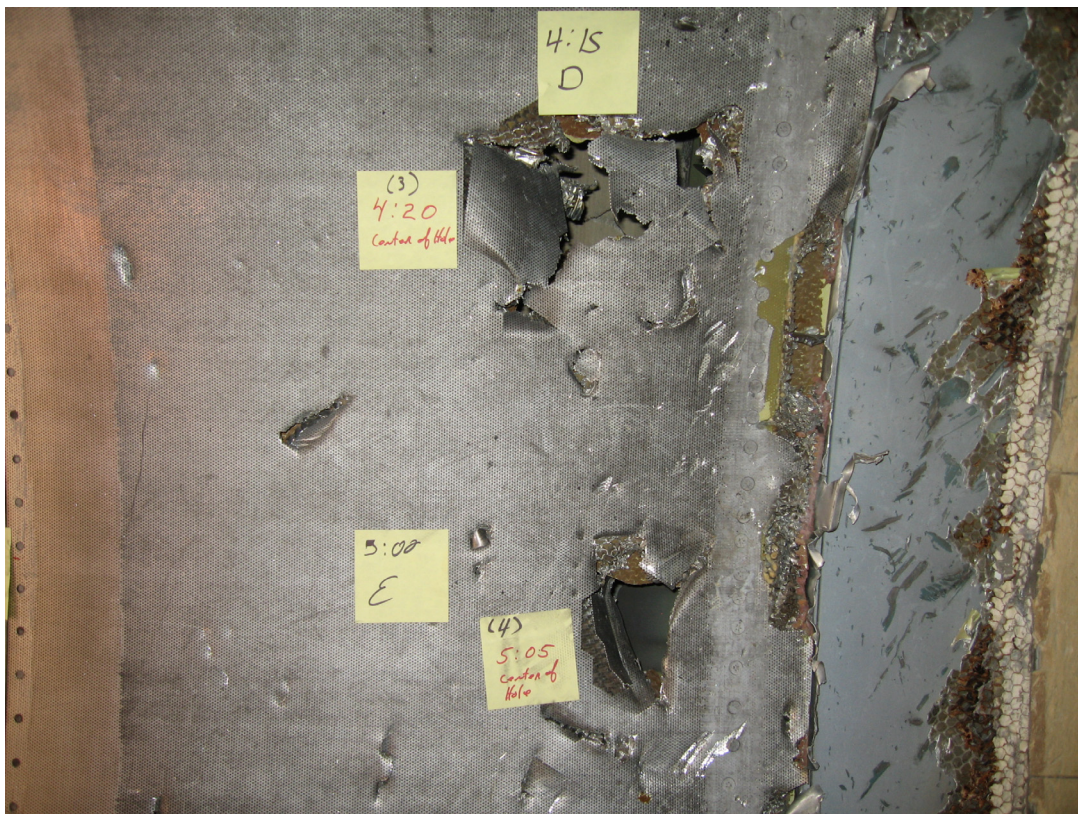
PHOTO 7: INLET COWL INNER BARREL DAMAGE - LOCATIONS 3 AND 4

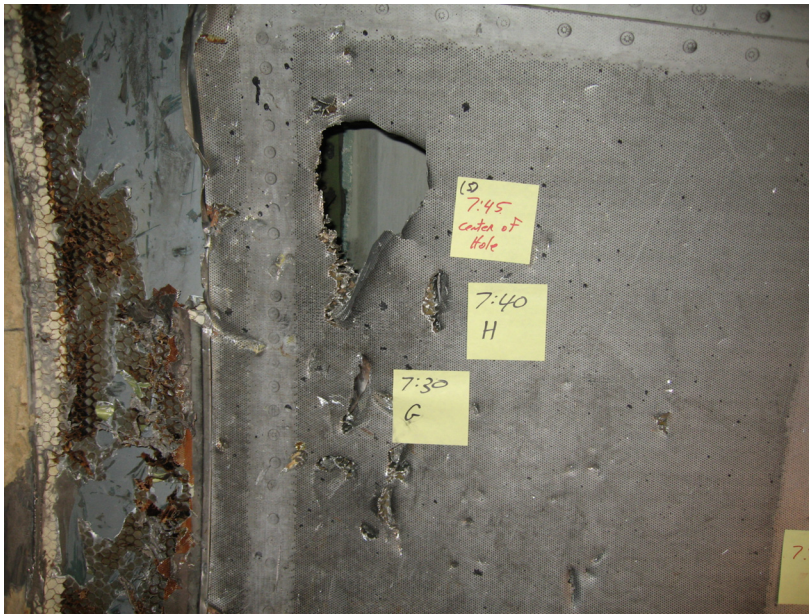
PHOTO 8: INLET COWL INNER BARREL DAMAGE - LOCATIONS 3 AND 4

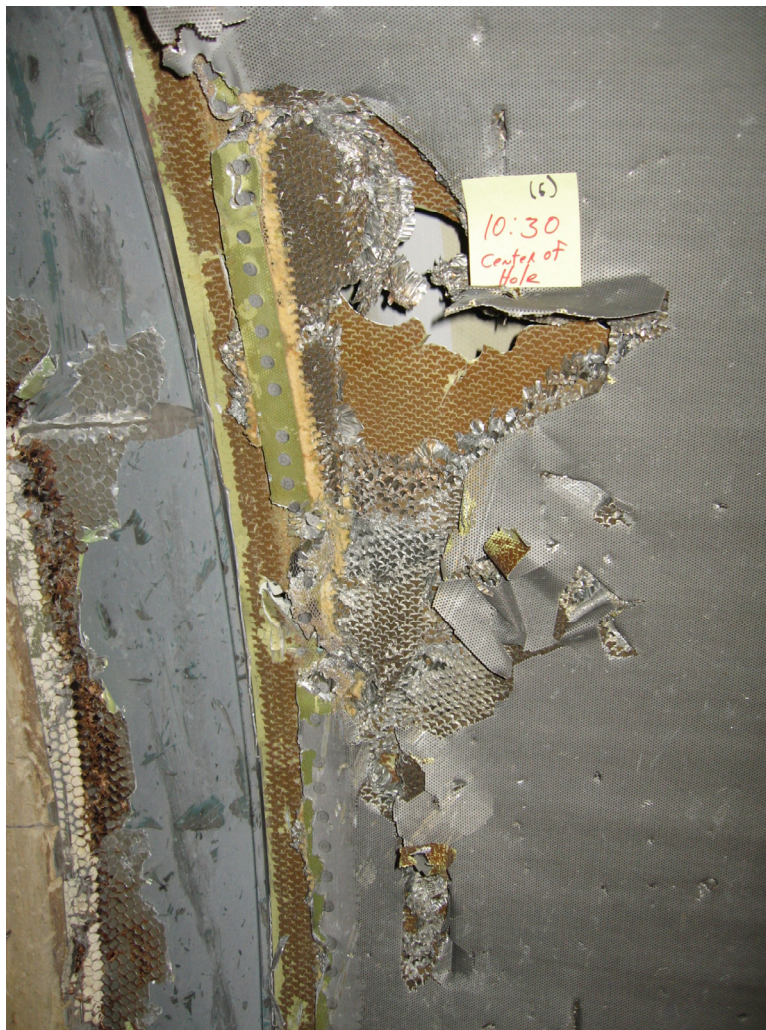
PHOTO 9: INLET COWL INNER BARREL DAMAGE - LOCATIONS 3 AND 4

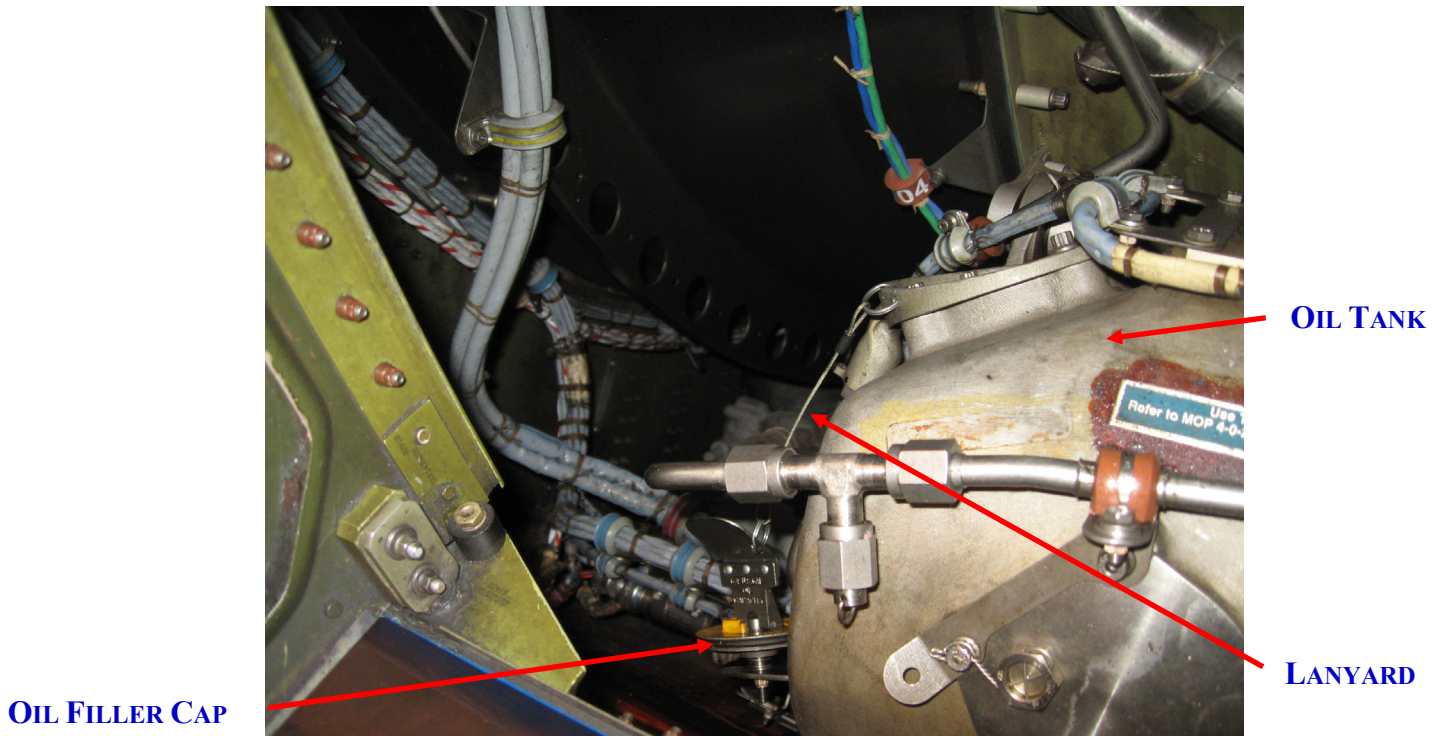
The No. 1 engine fan cowls, the thrust reverser (TR) halves, and the core cowls were each latched and secure. The outboard fan cowl has an engine oil fill and master chip access panel (also referred to as a pressure relief/oil tank access panel) located at about the 8:00 o'clock position. This panel was found in the OPEN position. Looking through the opening at the oil tank, the oil fill cap was found dislodged from the oil fill port but still tethered to the tank by its lanyard (**PHOTO 10**). No signs of an oil leak were observed. According to United mechanics, the oil level in the oil tank was measured to be about 1 quart low.⁴ The pressure relief doors on both the left- and right-hand sides of the core cowl were found in the OPEN position.

PHOTO 10: NO. 1 ENGINE OIL FILLER CAP DISLODGED FROM OIL TANK

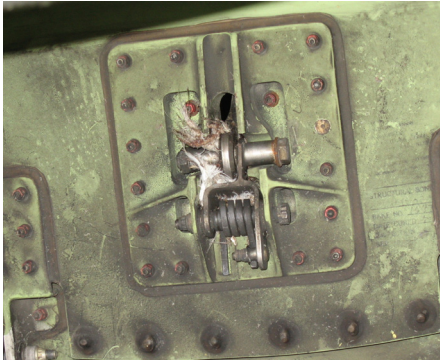
PHOTO 11: REMAINS IN SPRING MECHANISM

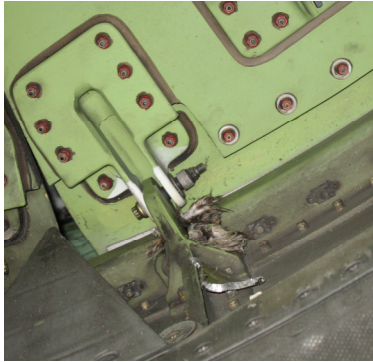
PHOTO 12: REMAINS IN HINGE

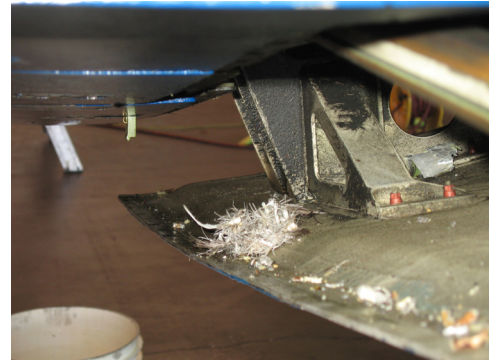
sleeves, along the lower bifurcation panel (**PHOTO 13**), and at the aft end of the translating sleeve. Acoustic panel material and fan blade fragments were found at the rear end of the translating sleeve.

PHOTO 13: REMAINS ON BIFURCATION PANEL

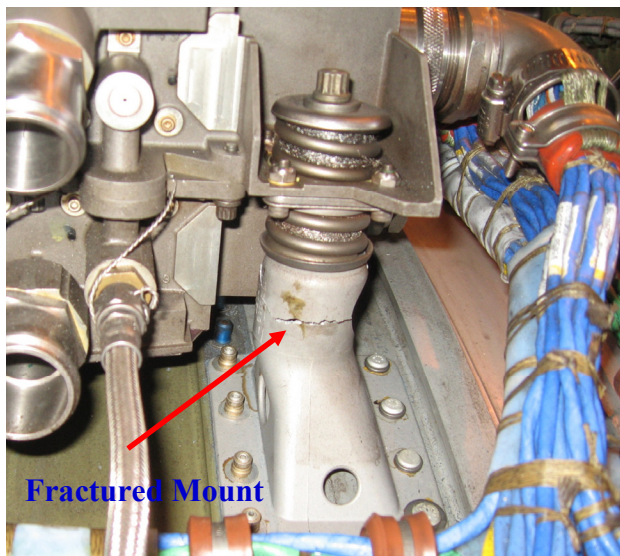
The fan cowls and the TR were opened to expose the engine. Examination of the external components on the engine and the TR actuation system revealed that several parts exhibited damage due to the bird strike and the subsequent imbalance loads. At the 4:00 o'clock position, a 'B'-flange bolt that is also used to secure a support bracket for the anti-ice and starter duct was fractured and the bolt was found resting on the inboard fan cowl ledge. The corresponding rod end bearing, used to attach the anti-ice and starter duct to the support bracket on the 'B'-flange, and the bracket itself were bent. The electronic engine control (EEC) is attached to the left-hand side of the fan exit case by four mounts. The upper and lower forward mounts were found cracked and the upper and lower aft mounts were fractured (**PHOTO 14**). The support bracket for the starter control valve electrical connector was fractured and the connector plug was loose within the support bracket but remained engaged with the electrical receptacle on the valve. When the TR was deployed a large quantity of hydraulic fluid poured from the bottom of the TR around. The source of the hydraulic leak was identified as coming from the upper right-hand TR actuator (**PHOTO 15**). The left-hand power door open system actuator rod (PDOS) was found fractured in the threads of the rod end.

PHOTO 14: FRACTURED EEC AFT MOUNTS

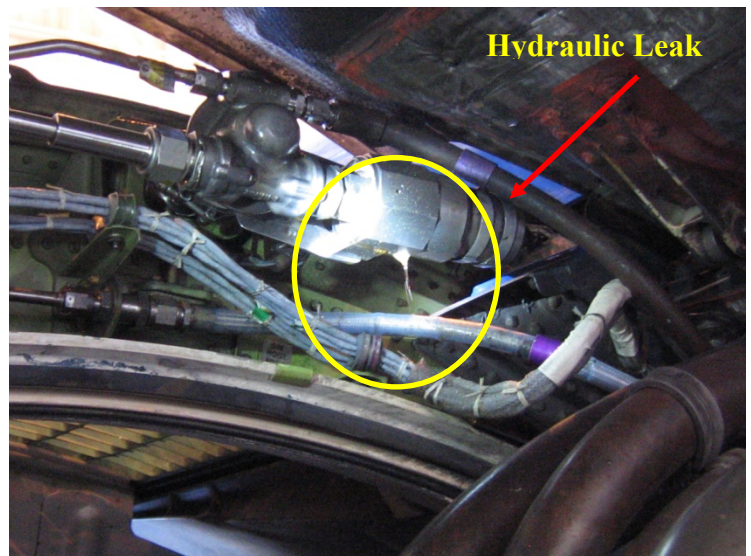
PHOTO 15: LEAKING UPPER RIGHT-HAND TR ACTUATOR

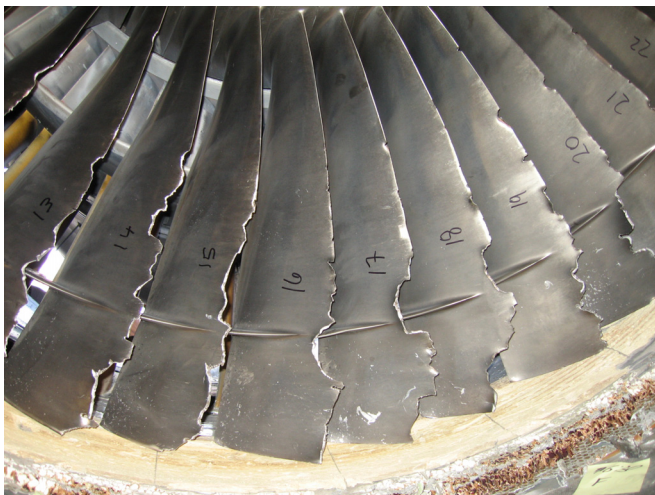
The fan rotated easily by hand. All the fan blades were present and installed in the fan disk and were numbered sequential in the direction of rotation (clockwise) for documentation purposes. The No. 1 blade was chosen because it was missing the most airfoil material. All the fan blades exhibited hard-body impact damage, with significant material loss along the length of the leading edge with the greatest amount of impact damage located outboard towards the blade tip portion of the airfoils (**PHOTO 16**). Fan blades Nos. 33, 34 and 35 also exhibited leading edge impact damage consistent with soft-body damage (**PHOTO 17**). Several fan blades exhibited leading edges that were bent in the direction opposite rotation.

PHOTO 16: HARD-BODY FAN BLADE DAMAGE

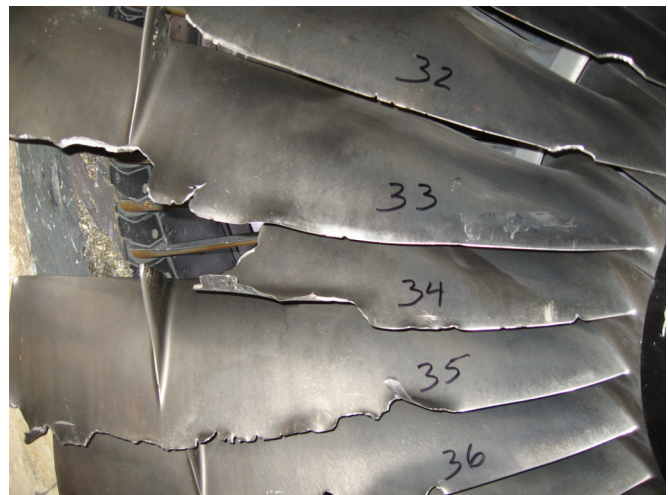
PHOTO 17: SOFT-BODY FAN BLADE DAMAGE

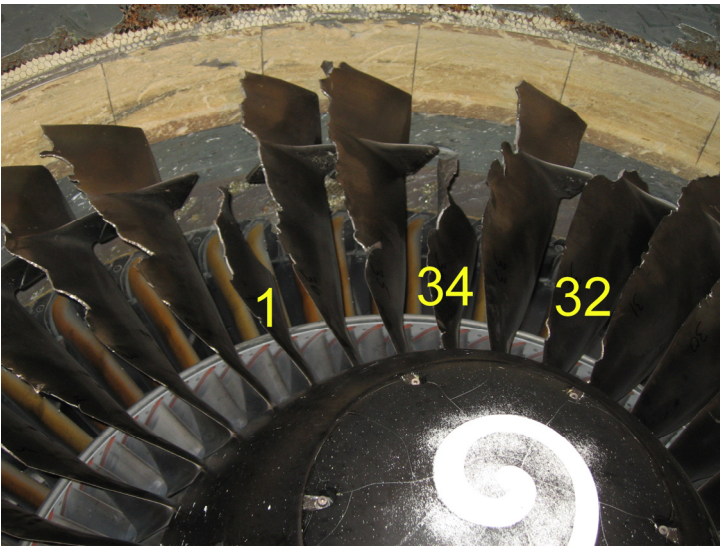
Three fan blades, Nos. 1, 32, and 34 were fractured transversely across the airfoil (**PHOTO 18**). The No. 1 fan blade was fractured below the mid-span shroud and was missing approximately 13.5-inches of the outer airfoil (**PHOTO 19**). The No. 32 fan blade was fractured above the mid-span shroud and was missing approximately 6.5-inches of the outer airfoil (**PHOTO 20**). The No. 34 fan blade was fractured below the mid-span shroud and was missing approximately 12.0-inches of the outer airfoil (**PHOTO 21**). The mid-span shrouds of fan blades sets 10 and 11; 11 and 12; 16 and 17; and 22 and 23 were found shingled⁶; however, other fan blade sets exhibited evidence of the mid-span shingling as well but were no longer shingled when examined by the Powerplant Group (**PHOTO 22**).

PHOTO 18: TRANSVERSELY FRACTURED FAN BLADES

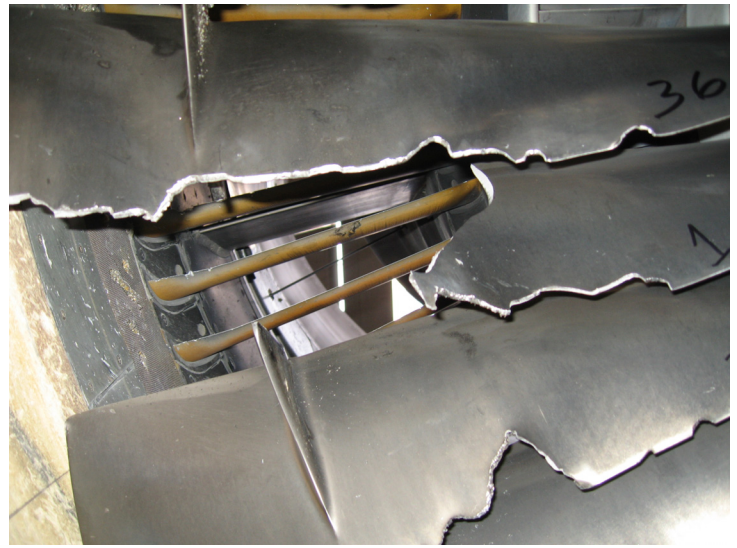
PHOTO 19: NO. 1 FAN BLADE FRACTURE

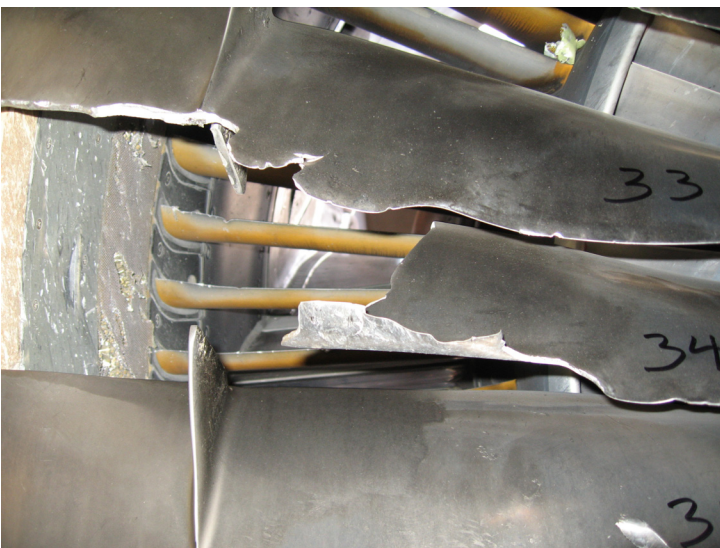
PHOTO 20: NO. 34 FAN BLADE FRACTURE

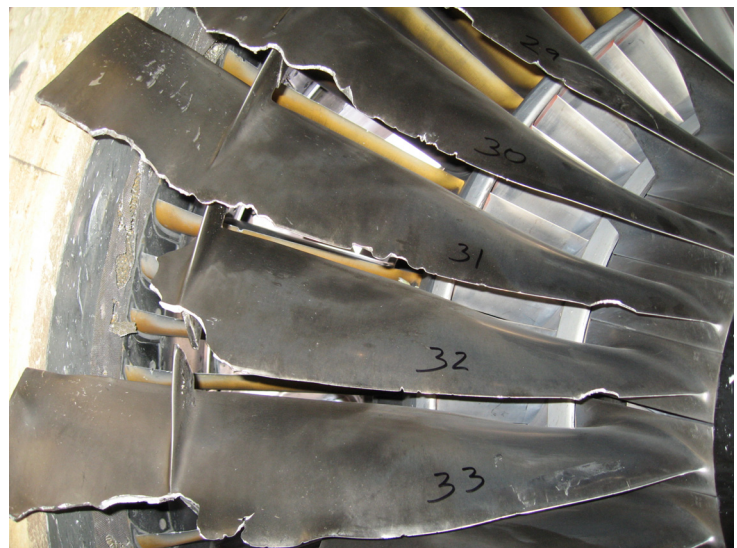
PHOTO 21: NO. 32 FAN BLADE FRACTURE

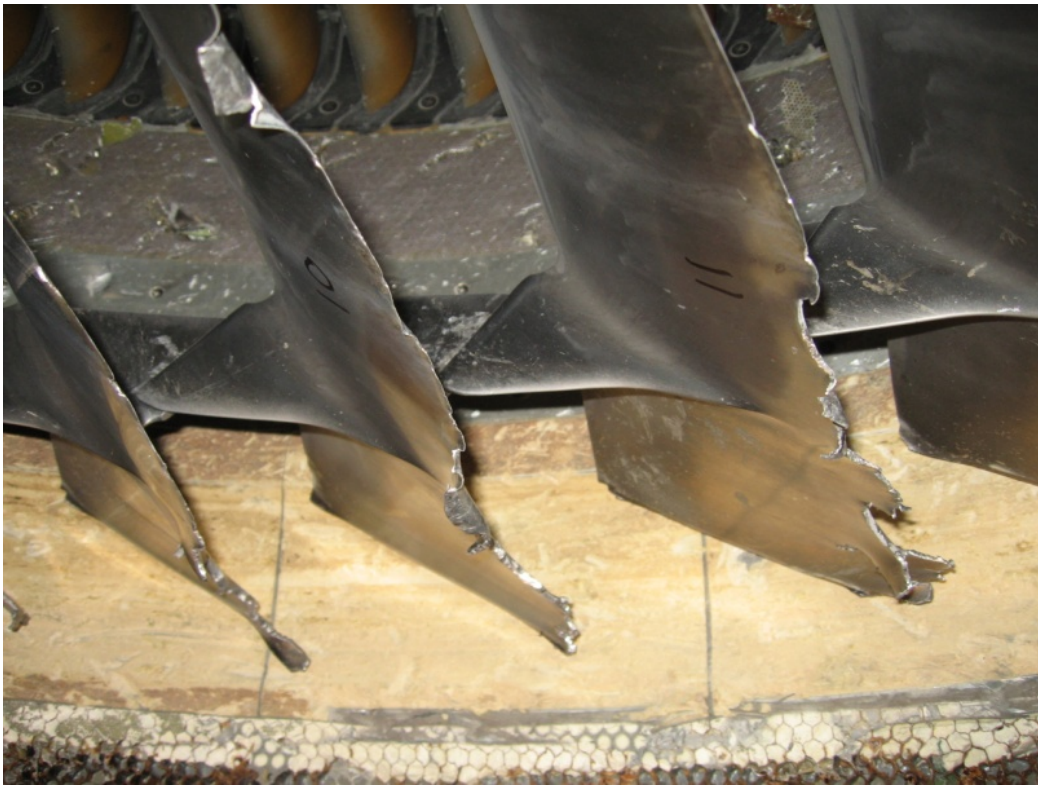
PHOTO 22: SHINGLED MID-SPAN SHROUDS

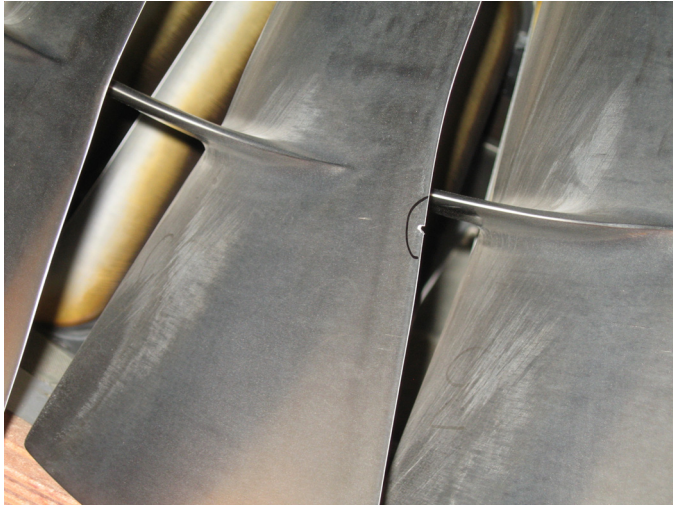
Both the front and rear inlet cone segments were intact and present. All the fan blades were present, intact and whole. Fourteen fan blades exhibited minor leading edge hard-body impact damage and cuts (**PHOTO 23**). All the impact damage, except for one fan blade – No. 2 – was located

PHOTO 23: NO. 2 ENGINE TYPICAL FAN BLADE DAMAGE

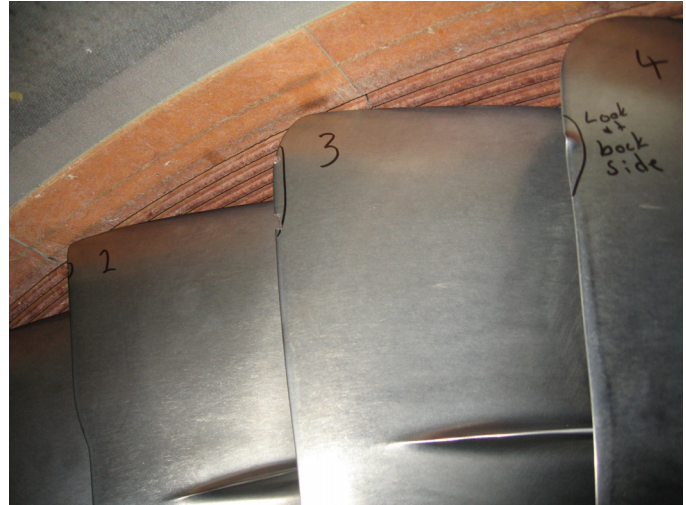
outboard of the mid-span shroud.⁷ Fan blades Nos. 3 and 4 exhibited the most severe impact damage of all the blades (**PHOTO 24**). The fan blade rub strip was intact and undamaged. The forward acoustic liner exhibited two minor gouges at the 11:30 o'clock position, with the largest measuring about 1.0-inch, and a 0.25-inch gouge at the 4:00 o'clock position. The inlet cowl inner barrel exhibited 5 minor/superficial impacts scuff marks, none of which passed through the inner acoustic liner.

PHOTO 24: NO. 2 ENGINE FAN BLADE NO. 3 & 4 DAMAGE

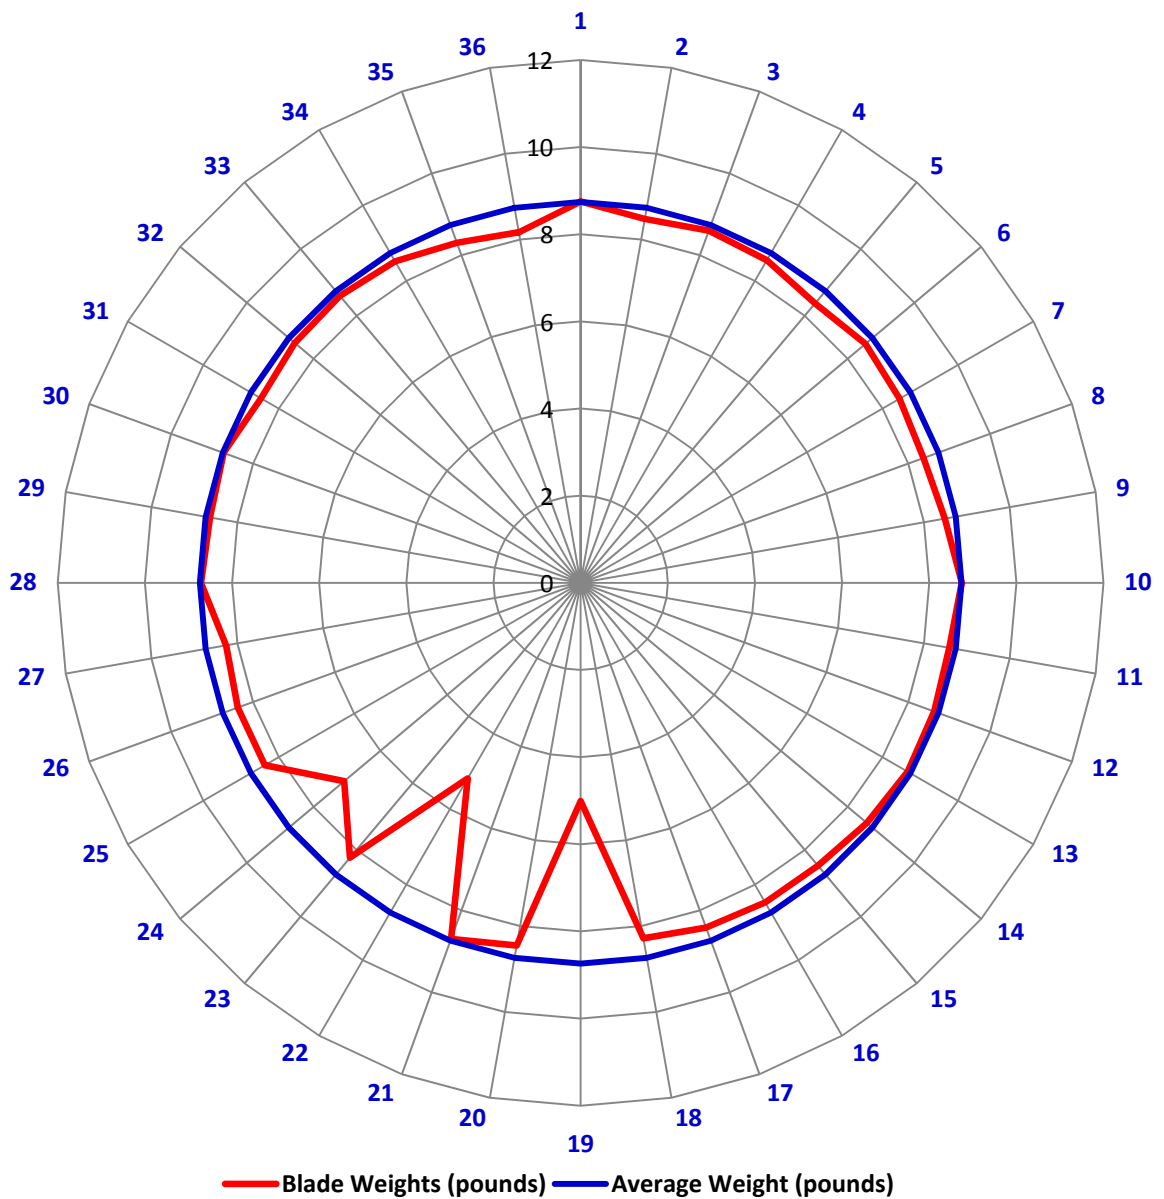
The fan blades were removed and weighed in order to calculate the amount of low pressure (LP) rotor imbalance induced by the missing fan blade airfoil material. **TABLE 3** provides the weights⁸ of all the fan blades and **FIGURE 2** is a radar map of those weights. P&W was asked to calculate the amount of rotor imbalance due to the missing fan blade material. Using the fan blade weights and photographic documentation of the fan blade damage, P&W estimated that the amount of rotor imbalance could be a maximum of 4,022 ounce-inches (equivalent to the loss of 1.24 fan blades). The PW2037 engine was certified for the engine mounts and cases to withstand loads generated by the loss of 2.9 fan blades per Part 33.23 (see *Section 6.2 FAA Bird Ingestion Standards When PW2037M was Certificated* for details).

FIGURE 2: RADAR MAP COMPARING FRACTURED FAN BLADE WEIGHTS TO AVERAGE FAN BLADE WEIGHTS

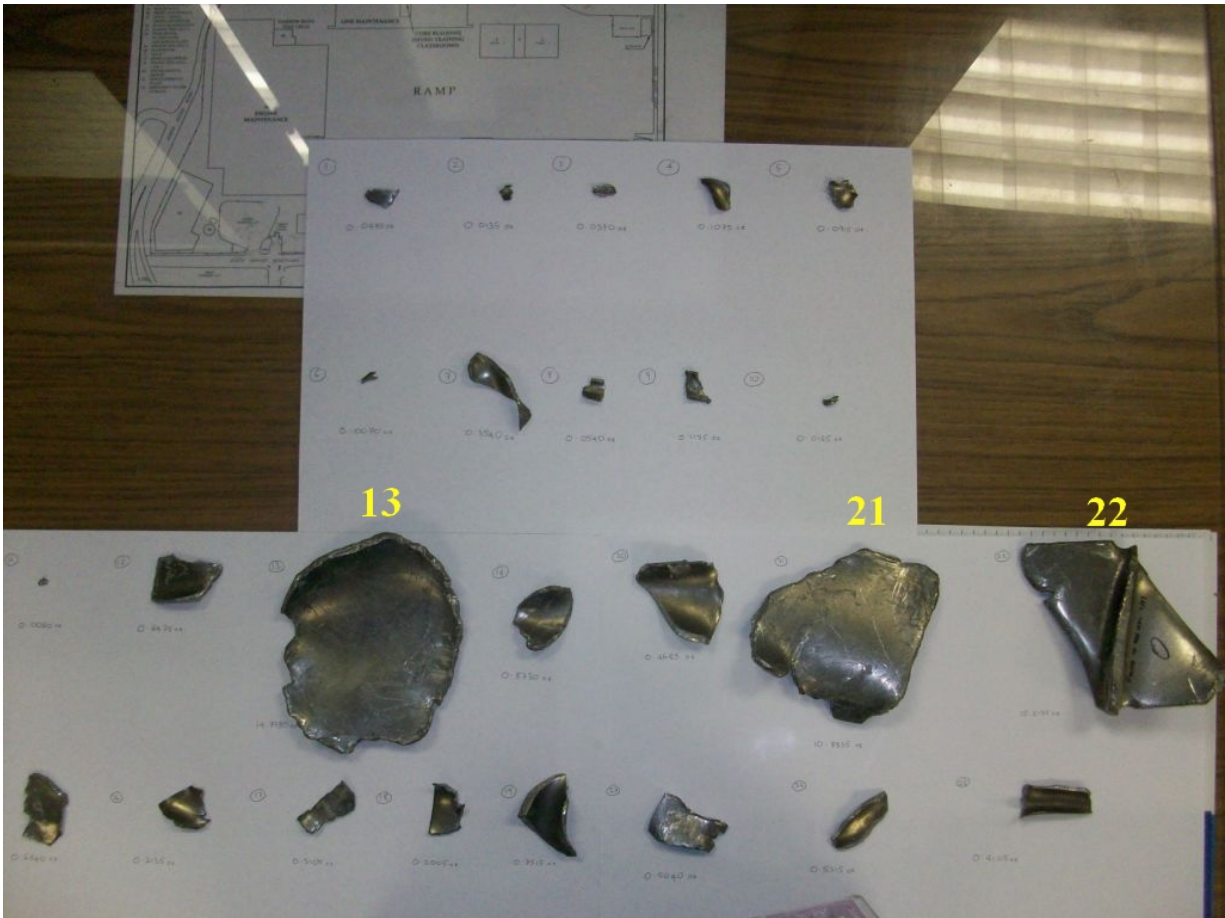
United was requested to collect and weigh any blade material found in the inlet cowl and thrust reverser during the course of the engine disassembly. **PHOTO 25** and **TABLE 4** provide the details of the debris collected from the inlet cowl and thrust reverser.

PHOTO 25: COLLECTED FAN BLADE FRAGMENTS FROM INLET COWL AND THRUST REVERSER (COURTESY OF UNITED AIRLINES)

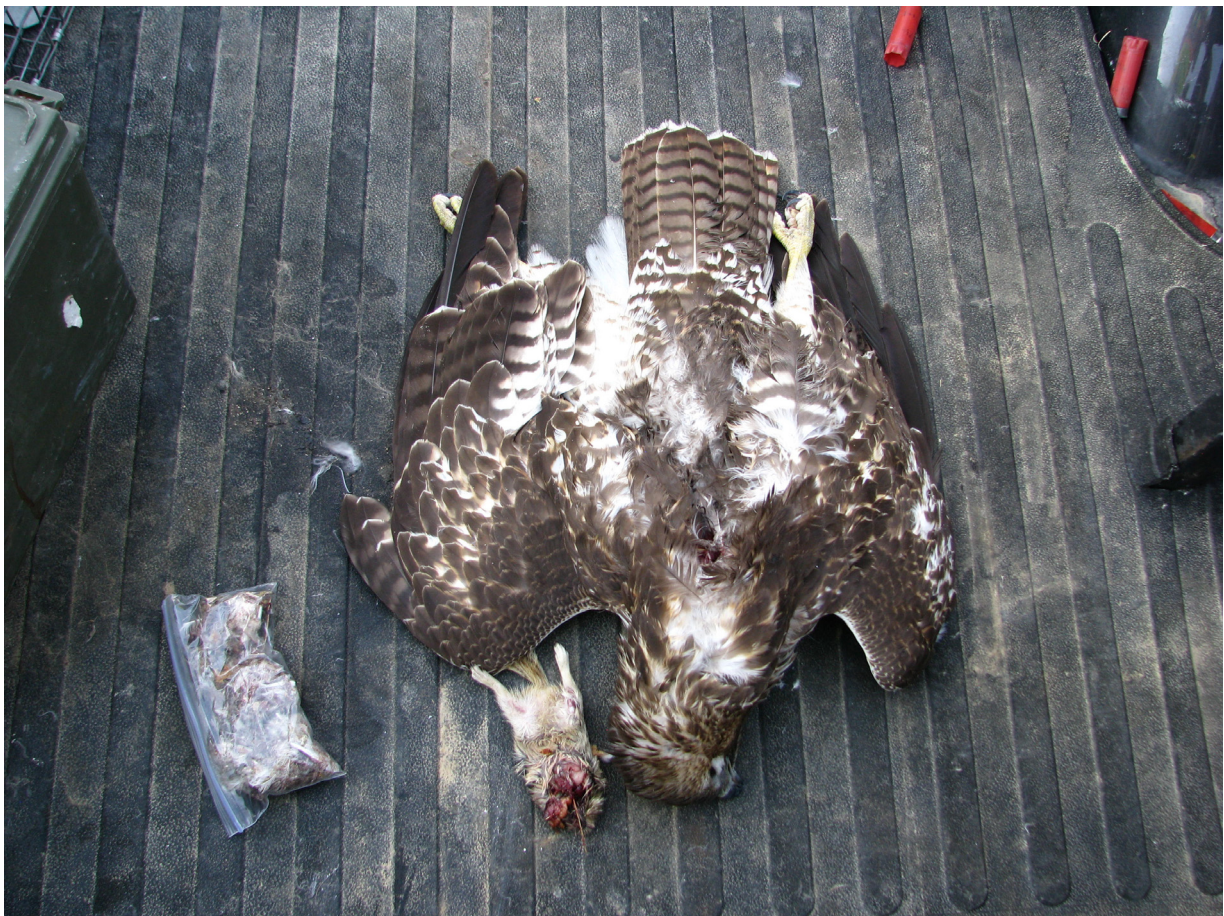
According to the wildlife strike report, No. 2011-9-26-211506, two separate birds struck the airplane. A whole bird, along with a partially consumed rodent was recovered from the right-hand edge of runway 35R (**PHOTO 26**). The wildlife biologist identified the bird as a juvenile Red-Tailed Hawk (*Buteo jamaicensis*) and the rodent as a thirteen-lined ground squirrel (*Spermophilus tridecemlineatus*). Remains of a second bird were scattered along the runway along with pieces of the engine. Inspection of the No. 1 engine revealed bird remains in the fan area. The bird remains collected by the wildlife biologist, along with samples collected by the Powerplant Group during their examination of the engine, were sent to the Smithsonian Institution National Museum of Natural History Division of Birds - Feather Identification Laboratory in Washington DC for analysis.

PHOTO 26: ANIMAL REMAINS RECOVERED BY THE WILDLIFE BIOLOGIST

The Smithsonian Feather Identification Laboratory, using feather identification and Deoxyribonucleic acid (DNA) analysis, identified the bird remains as coming from a Red-Tailed Hawk. The Red-Tailed Hawk ranges in weight from about 24.3 to 51.50 ounces (1.52 to 3.22 pounds) with the female larger in size.⁹ From the samples provided, the age of the bird – adult-vs-juvenile – was not possible. Additional DNA examination was able to identify the remains as coming from a female Red-Tailed Hawk. The average weight of the female Red-Tailed Hawk is about 1224 grams (43.2 ounces or 2.69 pounds).

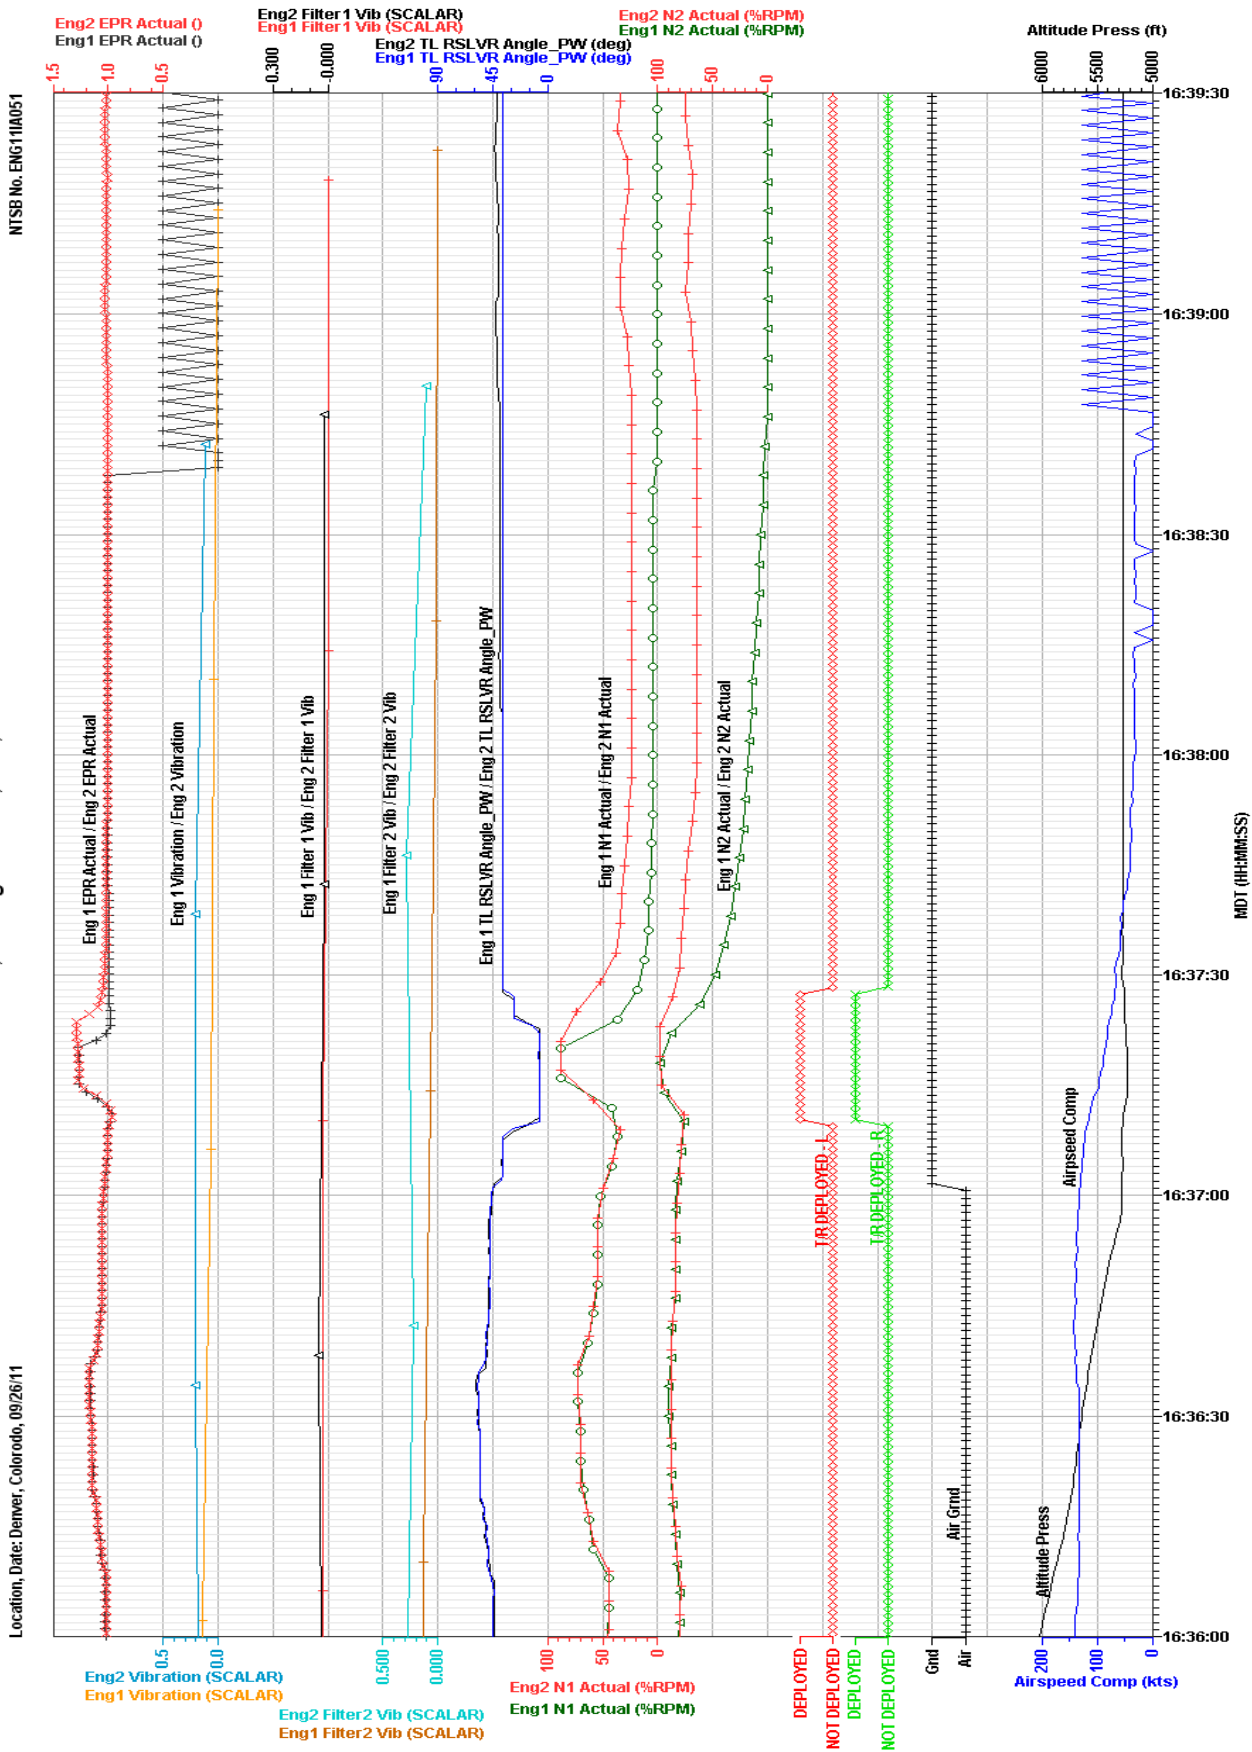
The digital flight data recorder (DFDR) was sent to the Safety Board's Headquarters in Washington DC and was readout by the Vehicle Recorder Group. A sequence of events timeline was created based on data from the DFDR for the incident flight. See **TABLE 5** for the timeline and also see the DFDR Group Chairman's Report for additional data (**FIGURE 3**). For the timeline, Time (T) equals zero was chosen as the time the airplane touched down and all subsequent events are based on that time.

FIGURE 3: FLIGHT DATA PLOT FOR EVENT LANDING
